**A PROGRAM OF INVESTIGATION AND LABORATORY RESEARCH OF
ACRYLIC-MODIFIED EARTHEN MORTAR USED AT THREE PREHISTORIC
PUEBLOAN SITES**

Robert Lyle Hartzler

**Presented to the Faculties of the University of Pennsylvania in Partial Fulfillment of the
Requirements for the Degree of Master of Science**

1996

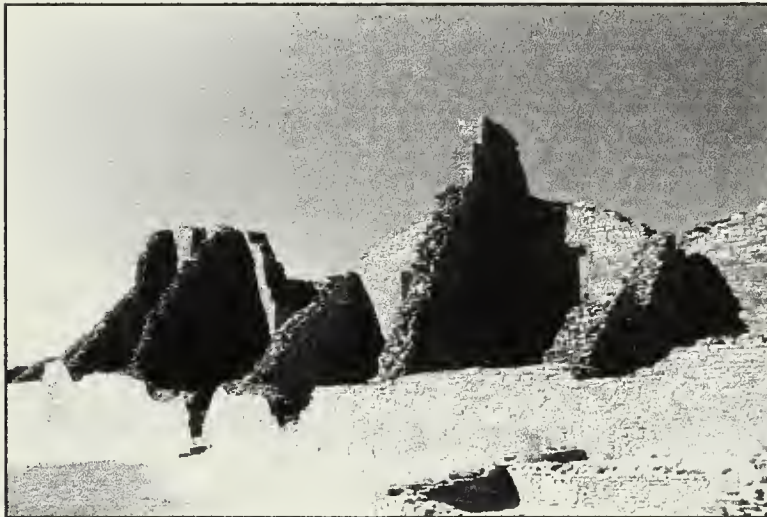
Figure 1. Abandonment and the inexorable forces of nature, particularly water and wind, have reduced the Anasazi pueblos to ruins. Pueblo Bonito at Chaco Culture National Historical Park is an example of such a ruin, fully exposed to the weather. The National Park Service is the modern day custodian of these sites, responsible for preserving and maintaining 29 national parks, monuments and sites in the area of the Colorado Plateau. Amended earthen mortar is one of the tools used by maintenance crews to repair the sandstone walls.

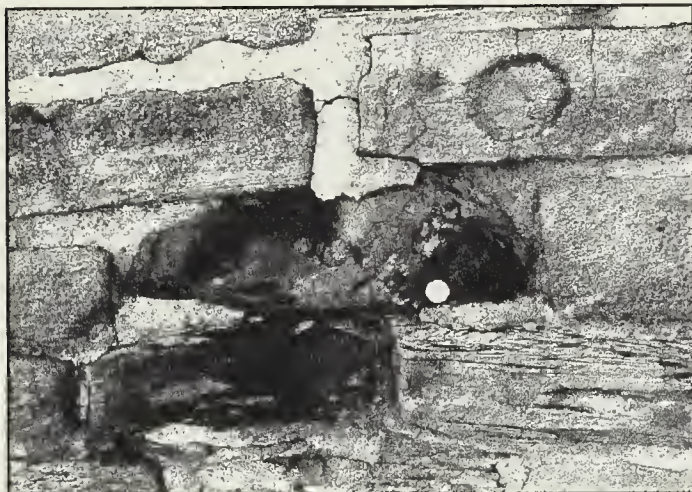
Figure 2. These sandstone masonry blocks at Aztec Ruins National Monument are eroding at a faster than normal rate because of the adjacent Portland cement-based mortar. The deleterious effects of cementitious mortars are one reason the National Park Service has shifted to more compatible acrylic emulsion-based earthen mortars at some ruins sites in the Southwest. (A quarter is shown for scale.)

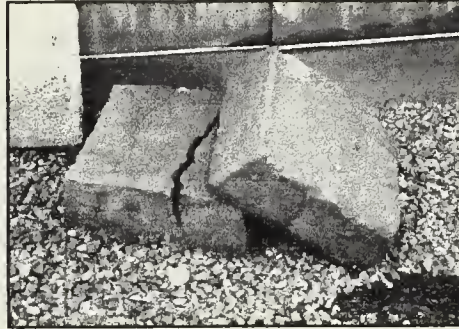
Figure 5. Placed on the University Museum roof in Philadelphia in 1975, these E-330 amended adobe bricks made by Darrell Butterbaugh were still in sound condition in 1995. Although a particle size analysis of the soil was unavailable, the soil appeared to have a high sand content. A quarter is shown for scale.

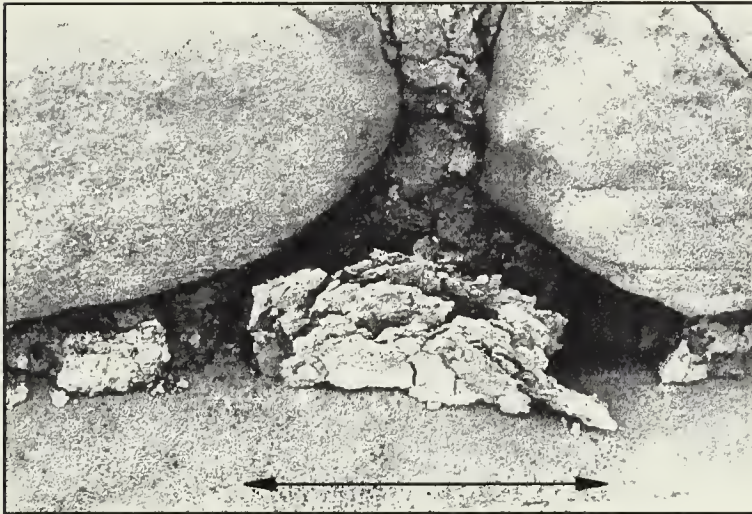
Figure 6. Flaking deterioration of the acrylic emulsion-modified earthen mortar was seen at some Mesa Verde National Park locations. A similar phenomenon was observed in the laboratory with Mesa Verde Blend earthen mortar. (Arrow is approximately two inches.)

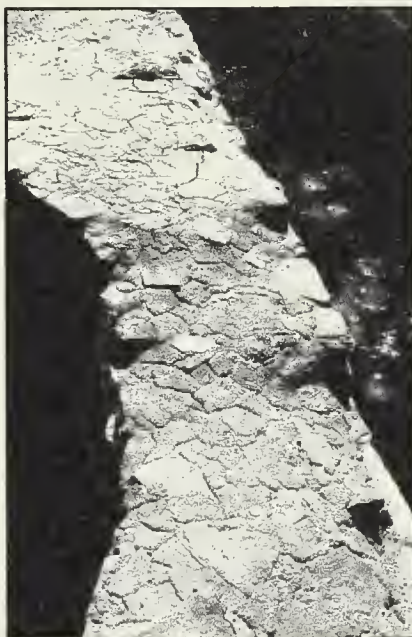
Figure 7. Cracking of acrylic emulsion-modified soil capping is a problem experienced at Aztec Ruins National Monument. But the cracks are a function of the mineral components of the soil mix, particularly the clay minerals, and not the acrylic amendment. The cracks are a cause for concern because they allow more water to enter the interior spaces of the walls.

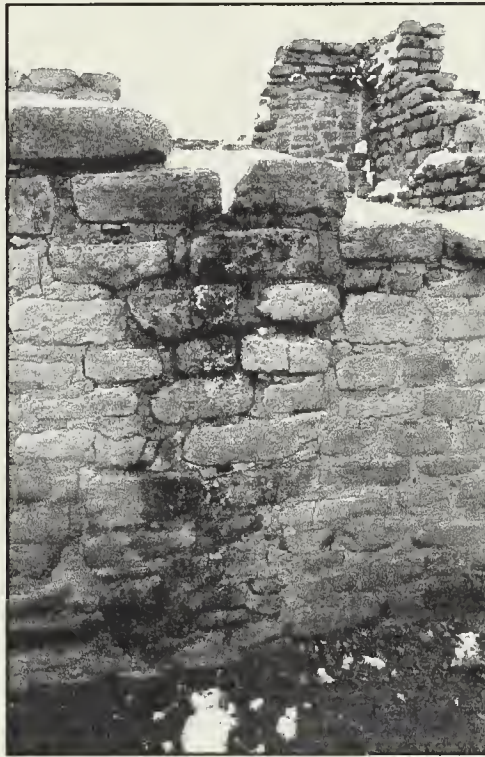
Figure 8. Water in the form of melting snow is one of the deterioration mechanisms at work on soil mortars in the Southwest. This photograph of Far View Ruin at Mesa Verde National Park reveals the wet stain of water flowing over the wall face after a fall snow. The wall is not wetted equally, and some areas are wet more often, and remain wet longer, leading to soil mortar erosion. (See *Appendix A* for SEM views of sound and deteriorated mortar from this ruins site.)

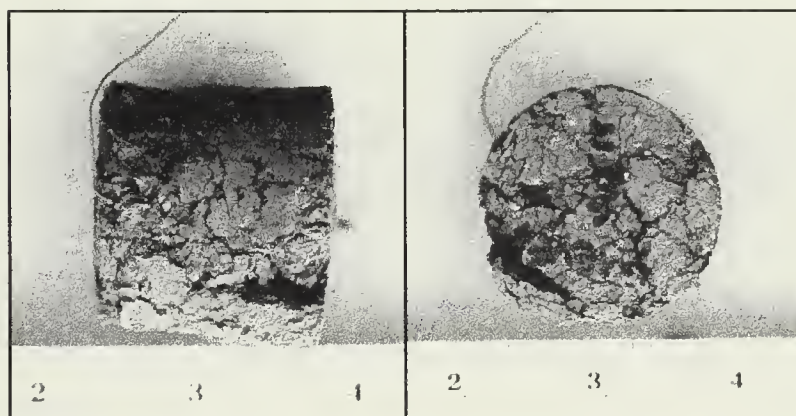
Figure 15. Flaking deterioration of this acrylic emulsion-modified Mesa Verde Blend earthen mortar cylinder can be seen in these photographs. The sample, modified with 6% E-330, had undergone 17 cycles of wetting and drying. A similar phenomenon was observed in the field.

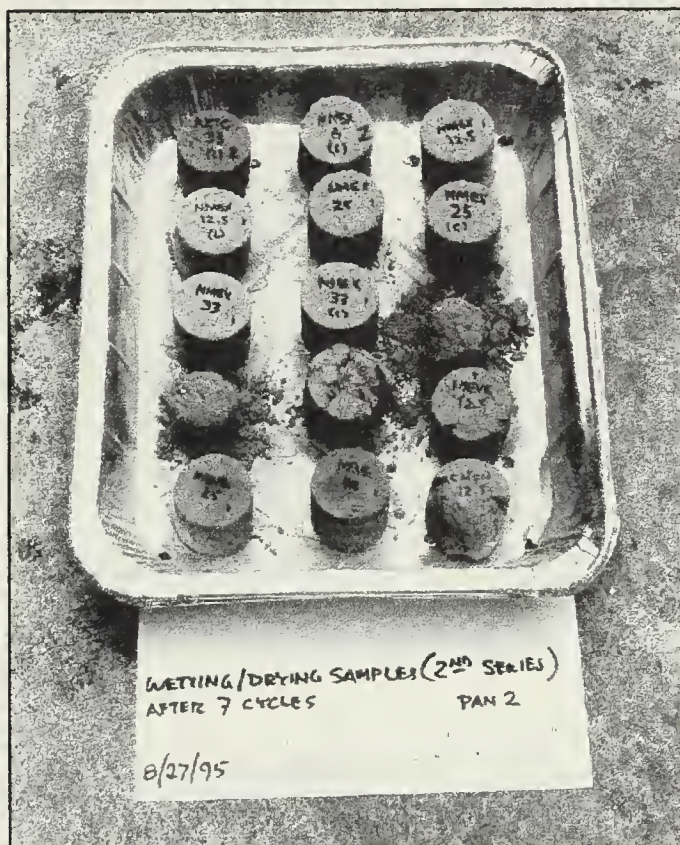
Figure 16. The wetting/drying test was the most challenging of the mortar tests. The samples were alternately soaked for five hours in room temperature water, and then dried in a warm oven, one cycle per day. The badly deteriorated samples in this tray are 6% Mesa Verde Blend earthen mortars, after 7 cycles.

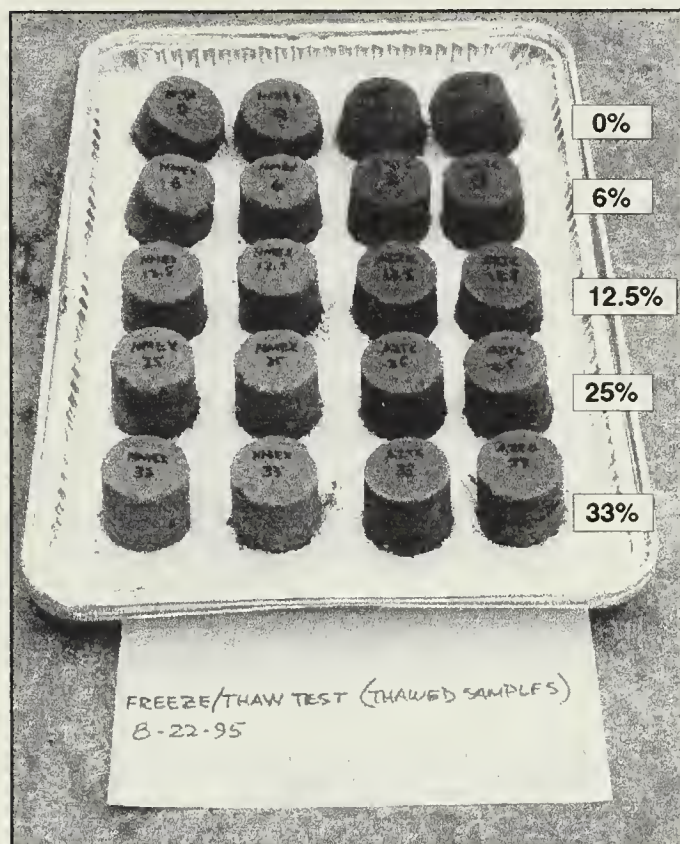
Figure 17. After 17 cycles of freezing and thawing, these mortar samples have been air-dried in the laboratory. The two columns of cylinders on the left are New Mexico Alcalde Adobe earthen mortar, and the two on the right, Aztec Ruins Blend. The row labels show the amount of E-330 in the mortar sample. The less Rhoplex in the mortar, the more the cylinders slumped. The 33% samples hardly changed in shape during the test. Compare these samples with the higher clay content soils, Mesa Verde Blend and Chaco Canyon BLM Quarry (Figure 18).

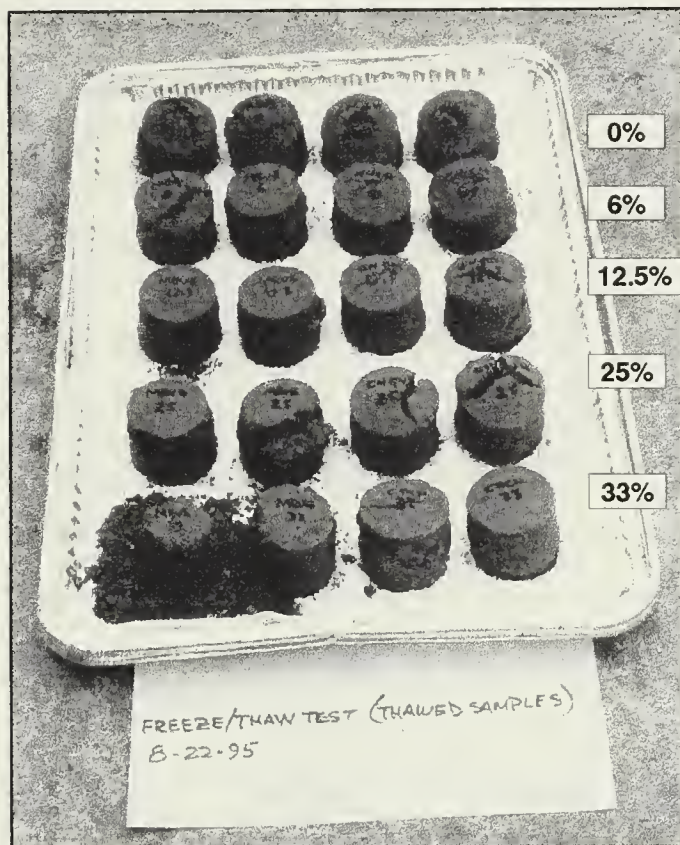
Figure 18. These air-dried mortar samples were subjected to 17 cycles of freezing and thawing. The two columns of cylinders on the left are Mesa Verde Blend earthen mortar, and the two on the right, Chaco Canyon BLM Quarry. The row labels indicate the amount of E-330 in the mortar samples. Notice how badly these earthen mortar samples have slumped and swollen. All the samples displayed dimensional instability, and some cracked badly on the top. The severe flaking of the 33% Mesa Verde sample (lower left) is probably due to "freeze-drying", dehydration of the swollen, saturated soil in the freezer over a three-month period. When it thawed, the top, or crown, of the sample sloughed off. Other samples also were deteriorated in this area.

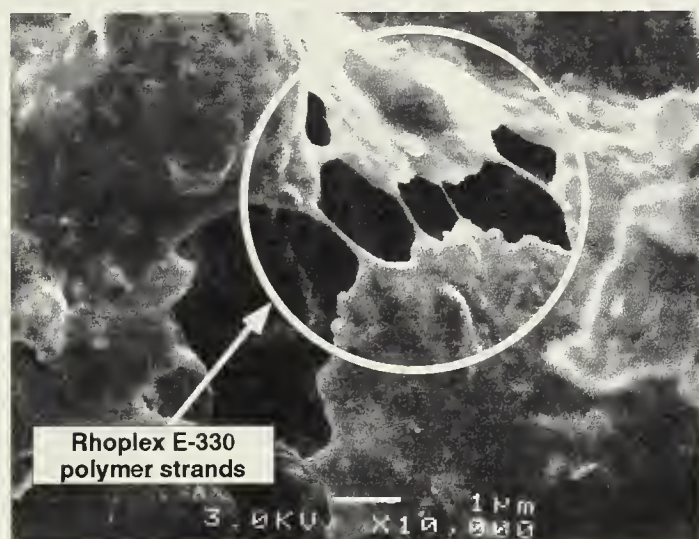
Figure 19. A mortar sample taken from Far View Ruin, a mesa-top site at Mesa Verde National Park, reveals the characteristic polymer strands bridging a microcrack in the soil. The polymer is an adhesive, and joins the particles of soil at the microscopic level. This SEM scan is 10,000 power. The white bar represents 1 μm .

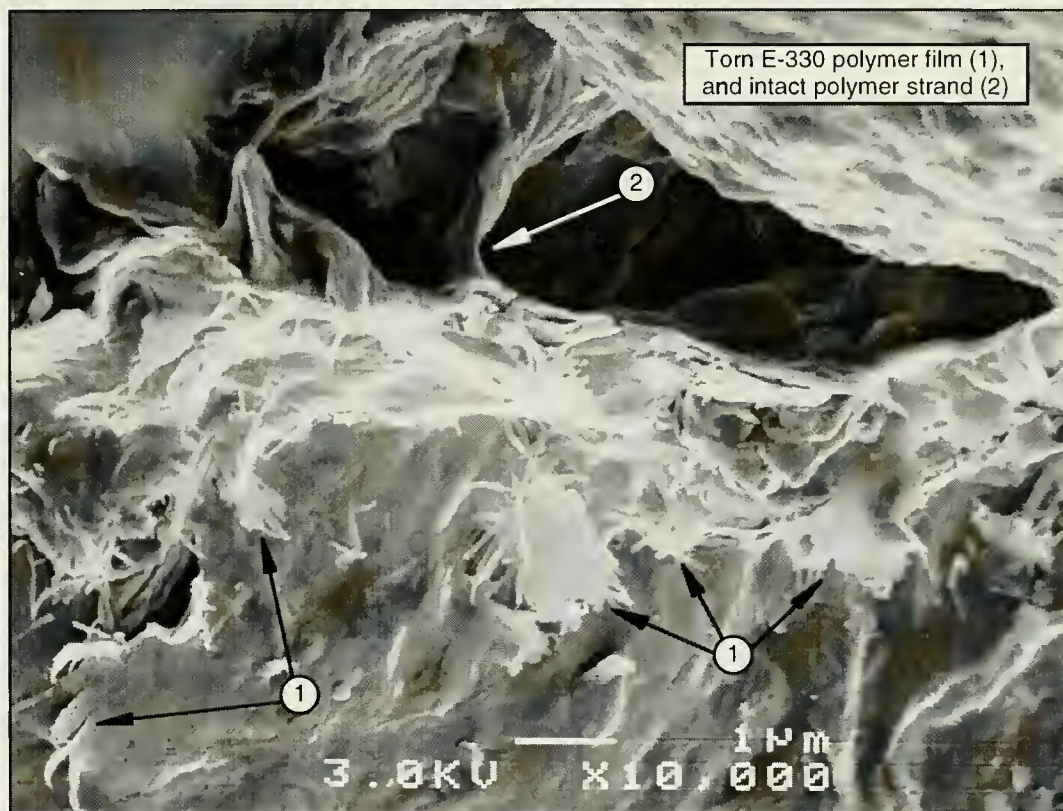
Figure 27. Far View Ruin amended earthen mortar, Mesa Verde, 10,000x magnification. This sample was taken from a highly deteriorated location. The mortar sample was in the path of water, from rain and melting snow, running down the ruin face, subjecting the mortar to frequent wetting and drying. Broken, feathery, fragments of the E-330 polymer film are visible. The polymer was unable to resist the dimensional changes caused either by wetting and drying of the soil minerals, or the expansion caused by freezing of the moisture in the soil. (Mortar contains between 25% and 33% E-330.) White bar is 1 μm .

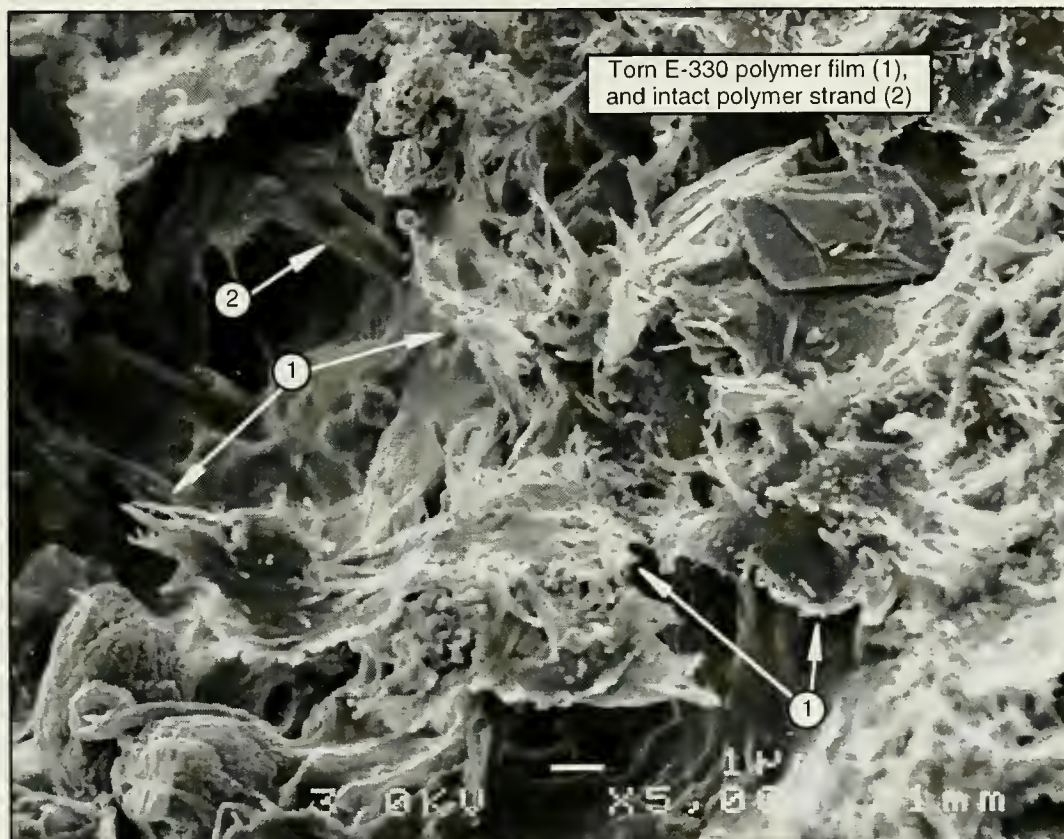
Figure 28. Mesa Verde Blend earthen mortar, 6% E-330, 5,000x magnification. Compare this photomicrograph of Mesa Verde Blend earthen mortar, subjected to wetting and drying in a laboratory test, to the Far View Ruin mortar, *Figure 27*. The same feathery, broken, polymer film is visible. This sample was a flake detached from an earthen mortar sample after 17 cycles of wetting and drying. White bar is 1 μ m.

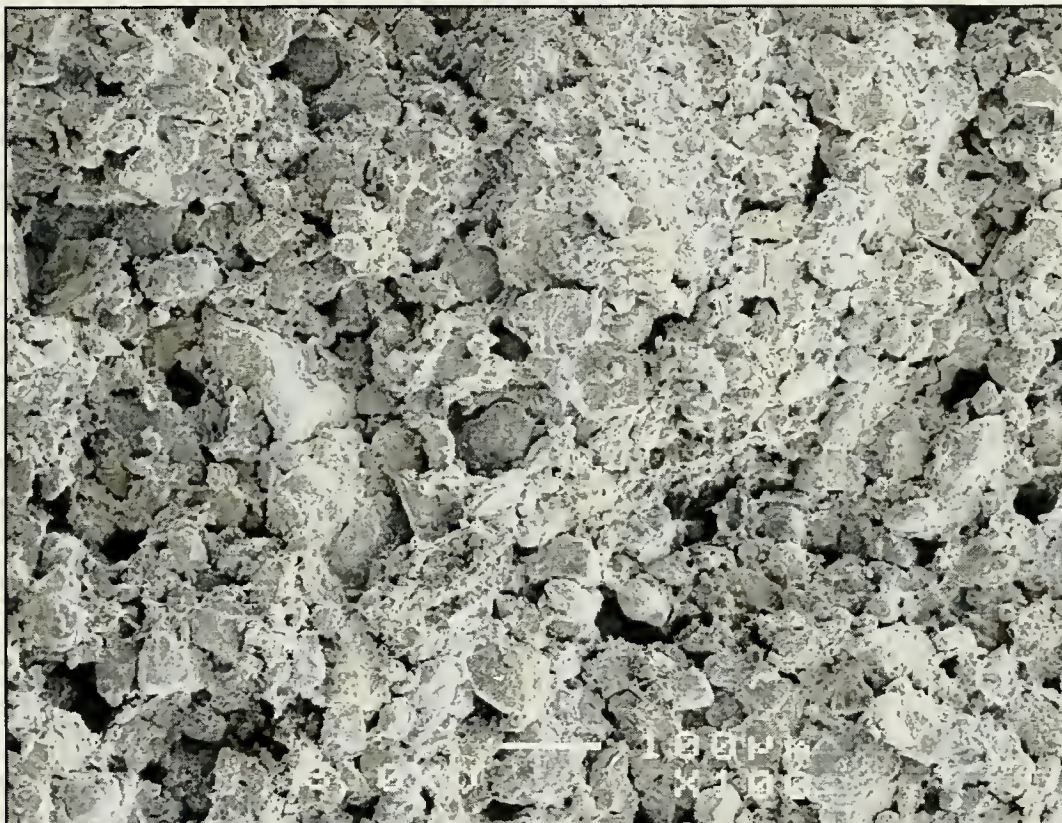
Figure 32. Coyote Village amended mortar, Mesa Verde, 100x magnification. This amended earthen mortar sample (between 25% and 33% E-330) was taken from a deteriorated mortar location at Coyote Village, near Far View Ruin, on Chapin Mesa. Compare the texture of this soil with the sandy modified adobe sample in *Figure 31*. White bar is 100 μm .

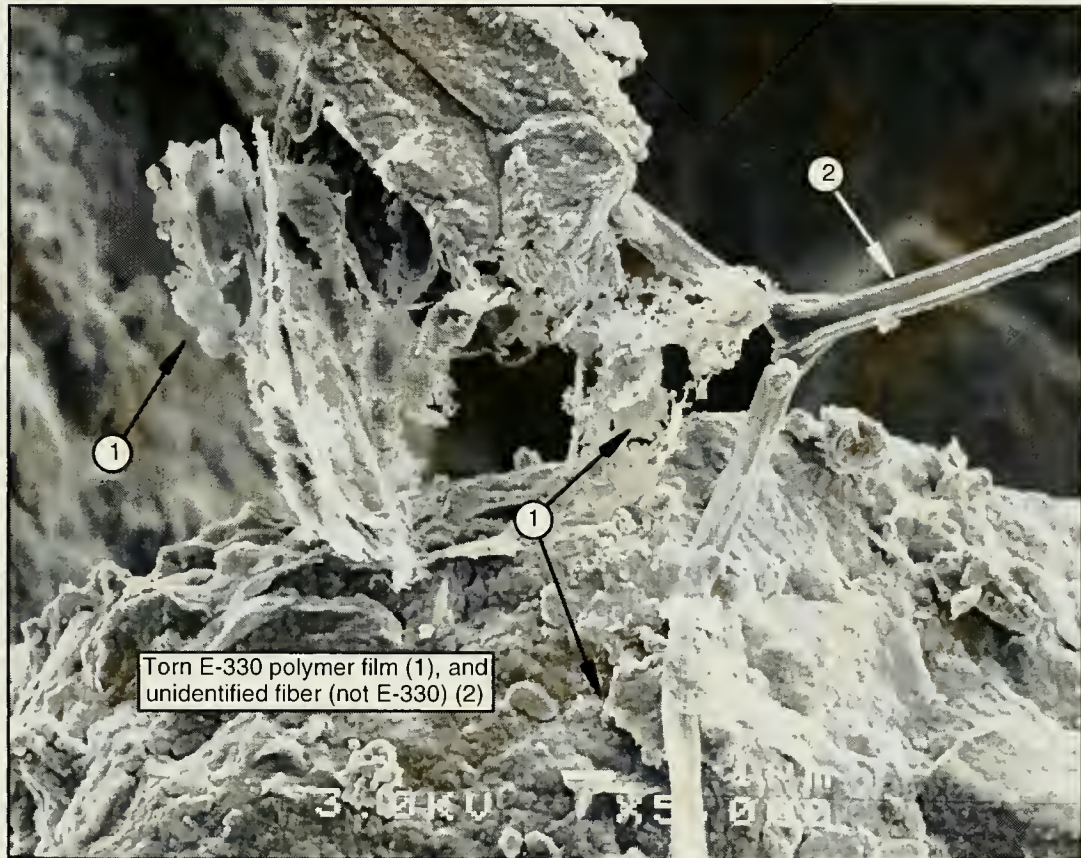
Figure 34. Long House Ruin amended earthen mortar, Mesa Verde, 5,000x magnification This deteriorated amended mortar was sampled from Long House, a cliff dwelling on Wetherill Mesa. The mortar there has a larger proportion of crusher fines, a sandier mix than that used on the mesa tops. Still, the mortar exhibited the flaking characteristic of Mesa Verde amended mortars. The damaged E-330 film is visible in the microphotograph. (The mortar contains between 25% and 33% E-330.) White bar is 1 μ m.

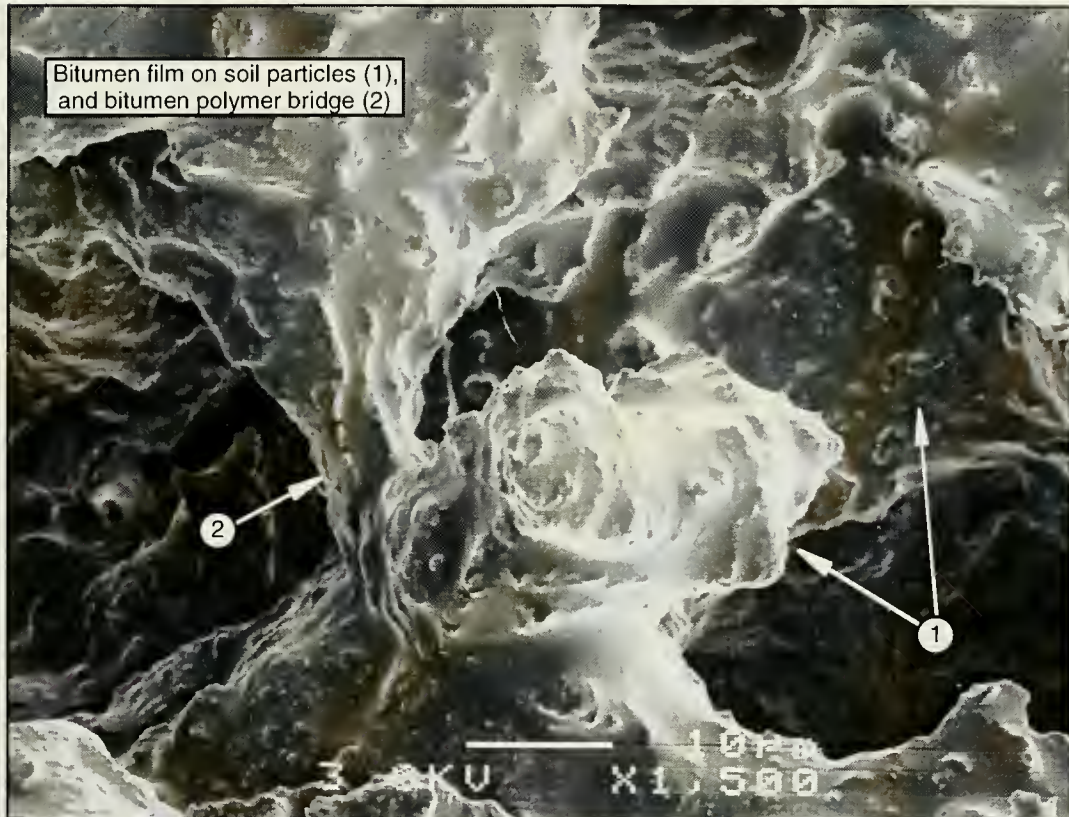
Figure 35. Bitumen-amended earthen mortar, Aztec Ruins, 1,500x magnification. This bitumen-modified earthen mortar sample was taken from early stabilization work at Aztec Ruins. The bitumen forms a much thicker coating around the soil particles than does E-330. It works by binding the particles together with a hydrophobic medium. Bitumen is the primary stabilizing ingredient used in commercial amended adobes. Compare this relatively low magnification image with any of the E-330-amended earthen mortar photomicrographs. (The percentage of bitumen in the mortar is unknown.) White bar is 10 μm .
