HIGH ARCH BRIDGE:  
A COST BENEFIT ANALYSIS OF PRESERVATION TECHNIQUES AS APPLIED  
TO A VERNACULAR CONCRETE STRUCTURE

Ann Marie DiLucia

A THESIS

1998

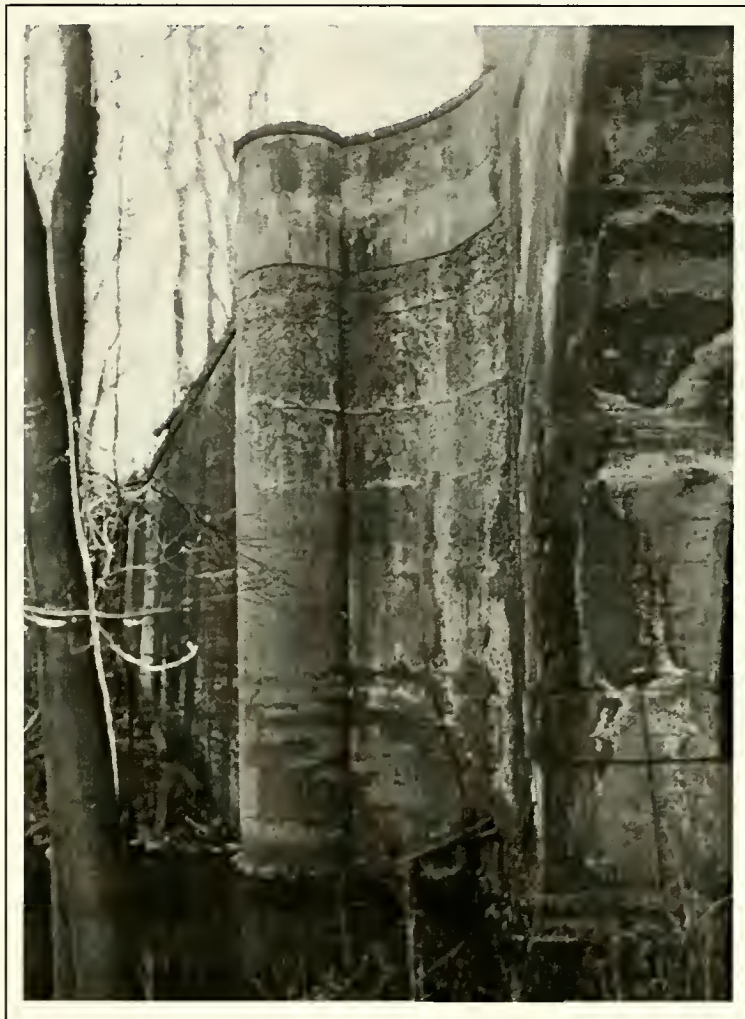
Figure 3 Southeast pylon.

The northeast pylon is no longer in place, exposing a vertical strip of two inch to ten inch mixed aggregate. The top 14' of the northwest pylon is gone, leaving behind an area of impressive overgrowth and bird's nests. A parapet on the deck of the bridge contains eight large and eighteen small posts, evenly spaced amidst 180 balusters (Figure 4).

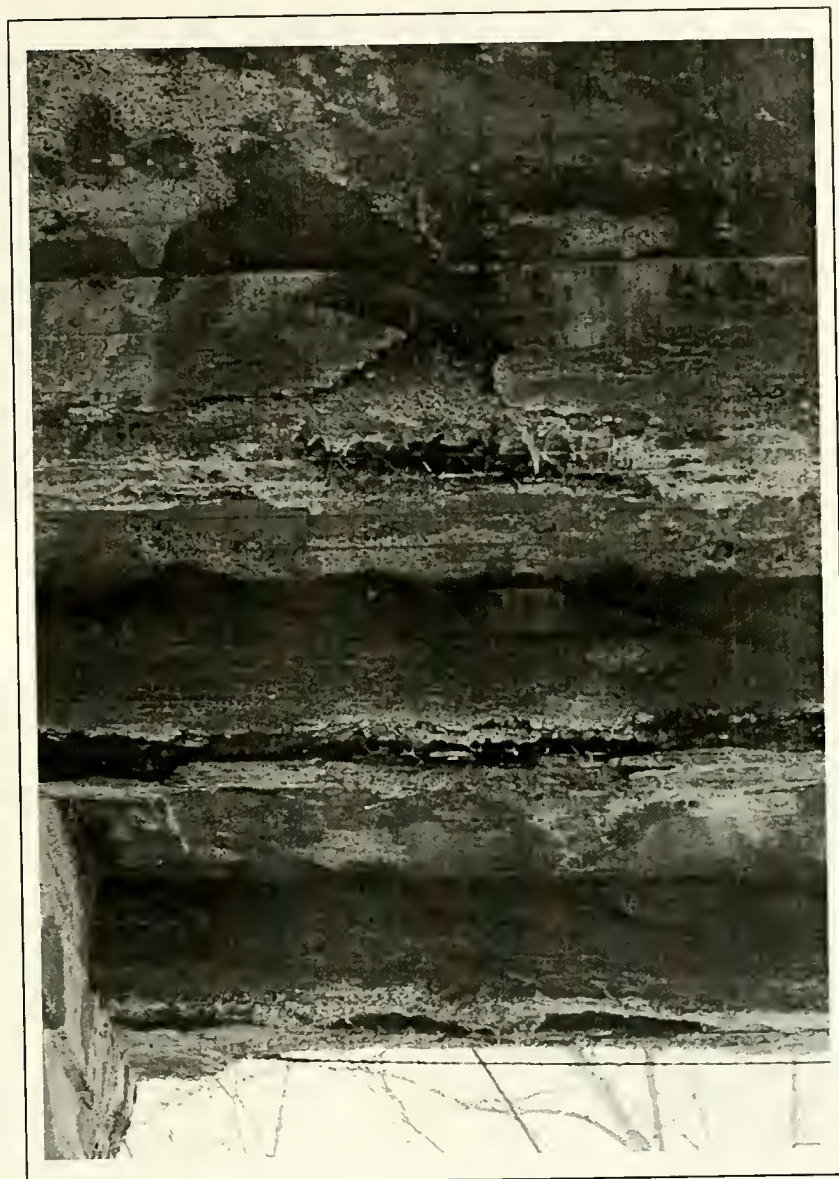
The corrosion of steel reinforcement is most visible in the superstructure of the bridge, specifically in the four I-beams that support the bridge deck through both straight spans (Figure 5). One-inch deformed steel rods in the piers of the structure have freed themselves from the concrete in which they were embedded, causing instability to architectural elements they had been designed to support (Figure 6). Exposed metal also protrudes from or is visible corroding within the upper rails of the balustrade (Figure 7). Dark stains on the balusters and posts in the parapet are a secondary failure caused by this corrosion.

Figure 5 Corrosion of I beam reinforcement.

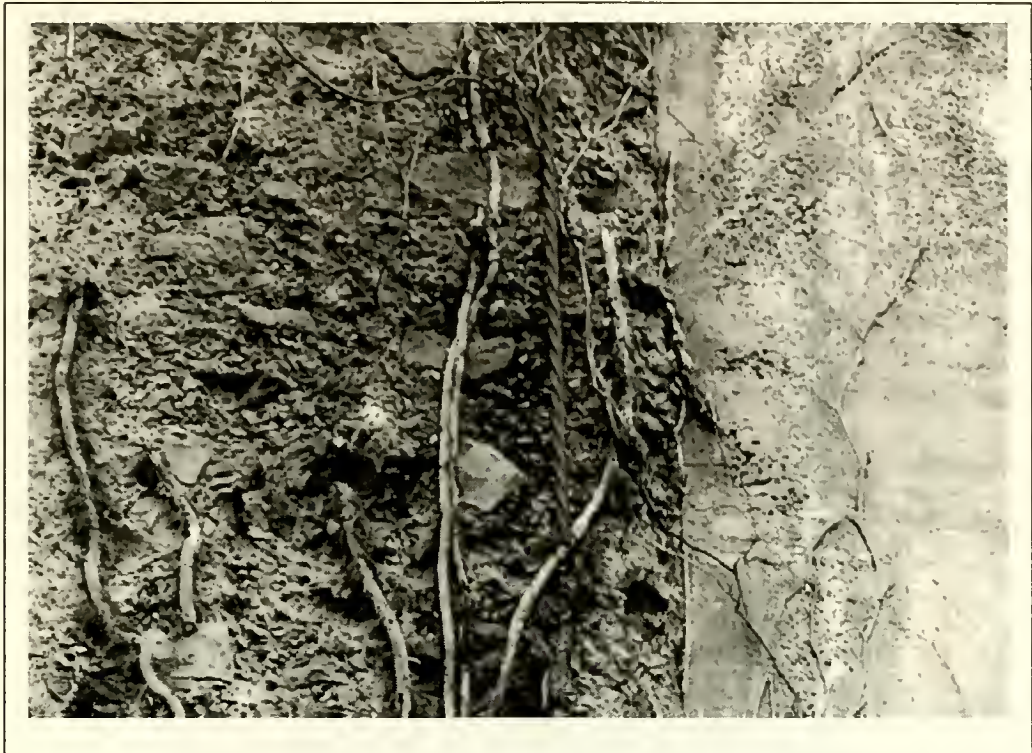
Figure 6 Deformed steel reinforcement projects from east pier face.

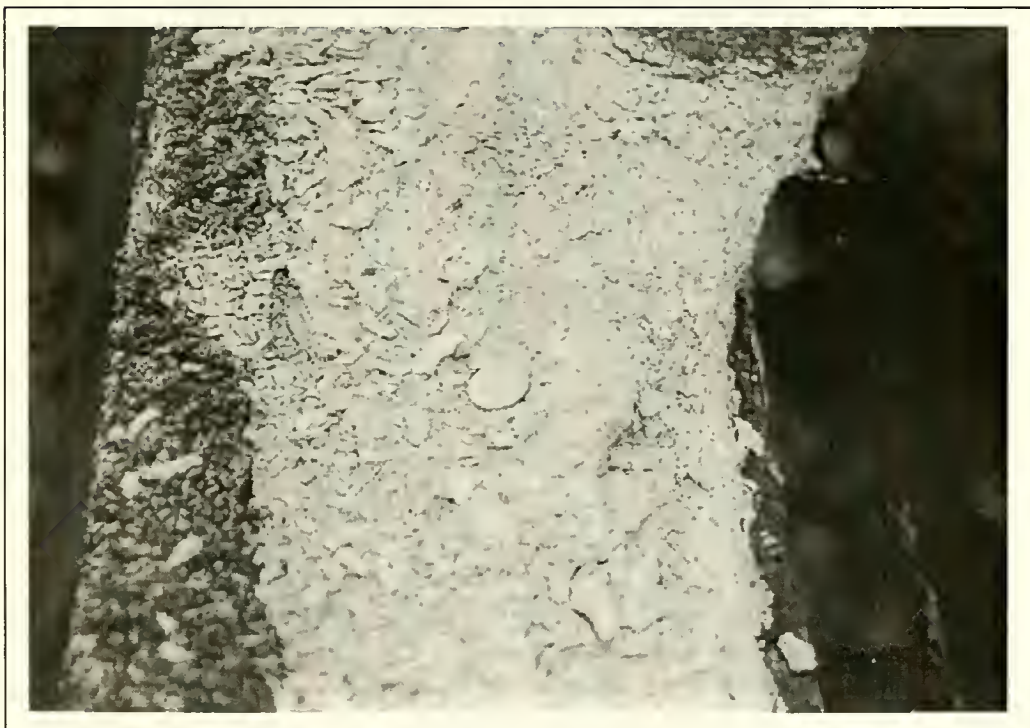
Figure 7 Loss of material due to rebar corrosion.

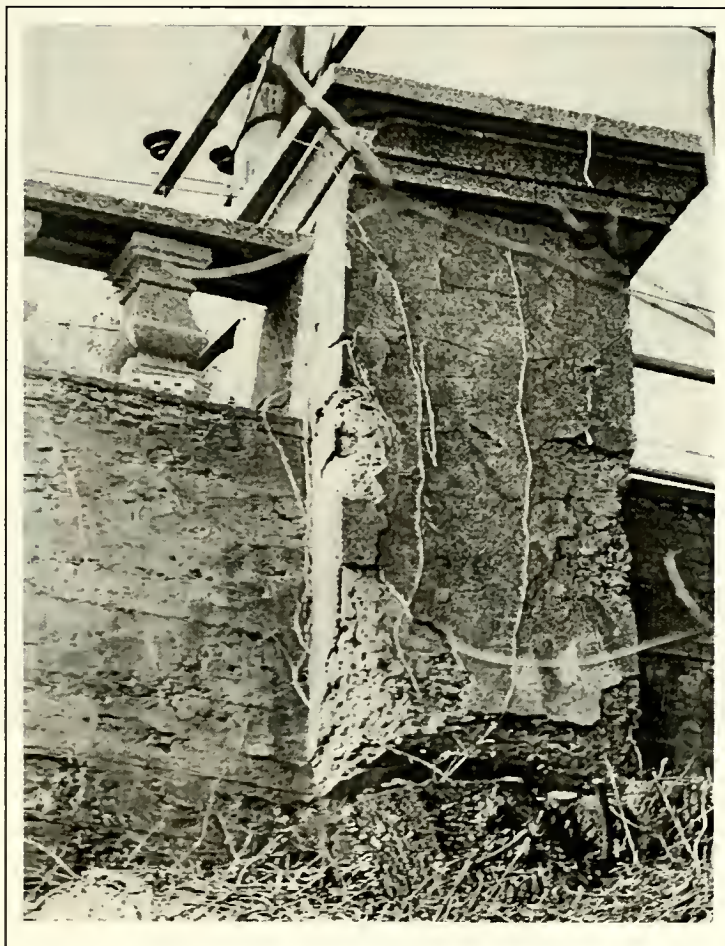
Figure 8 Loss of skim coat on balustrade post.

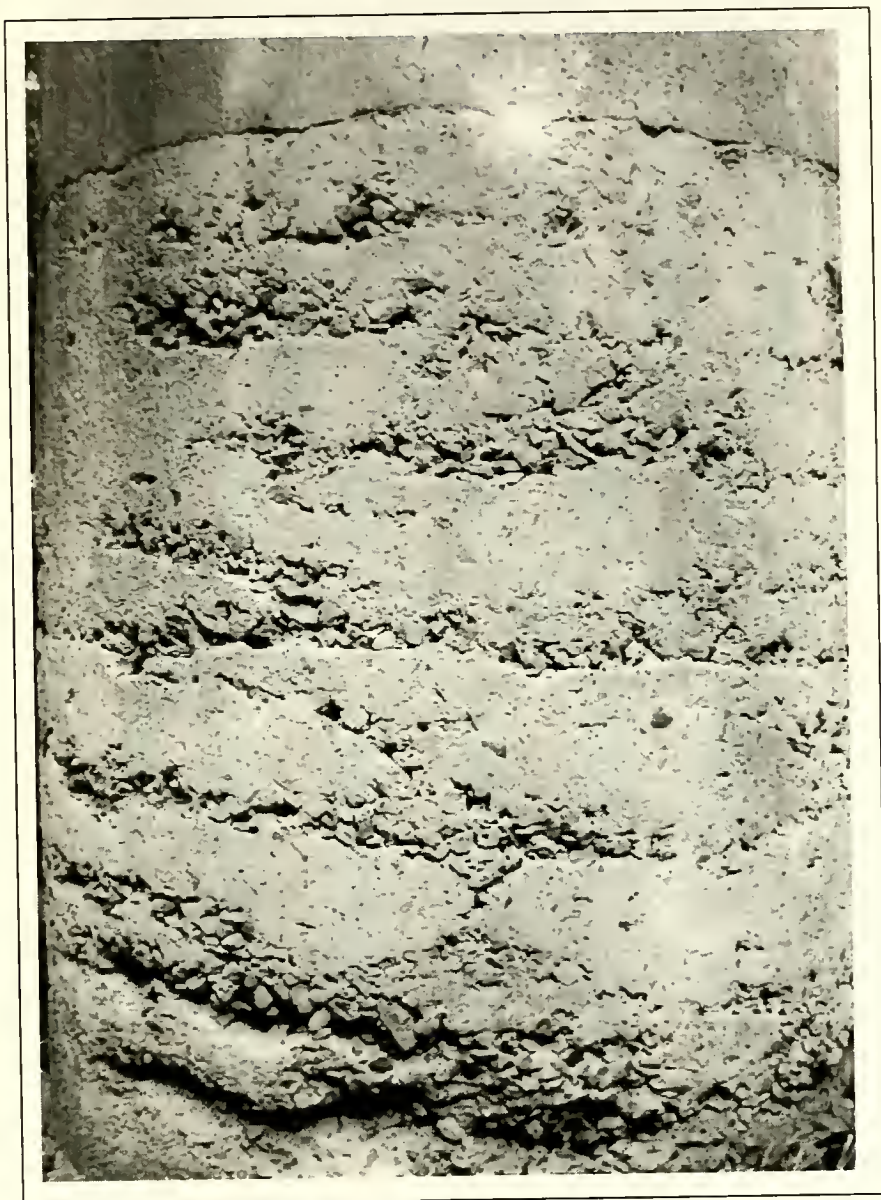
Figure 9 Honeycombing evident on northwest pylon.

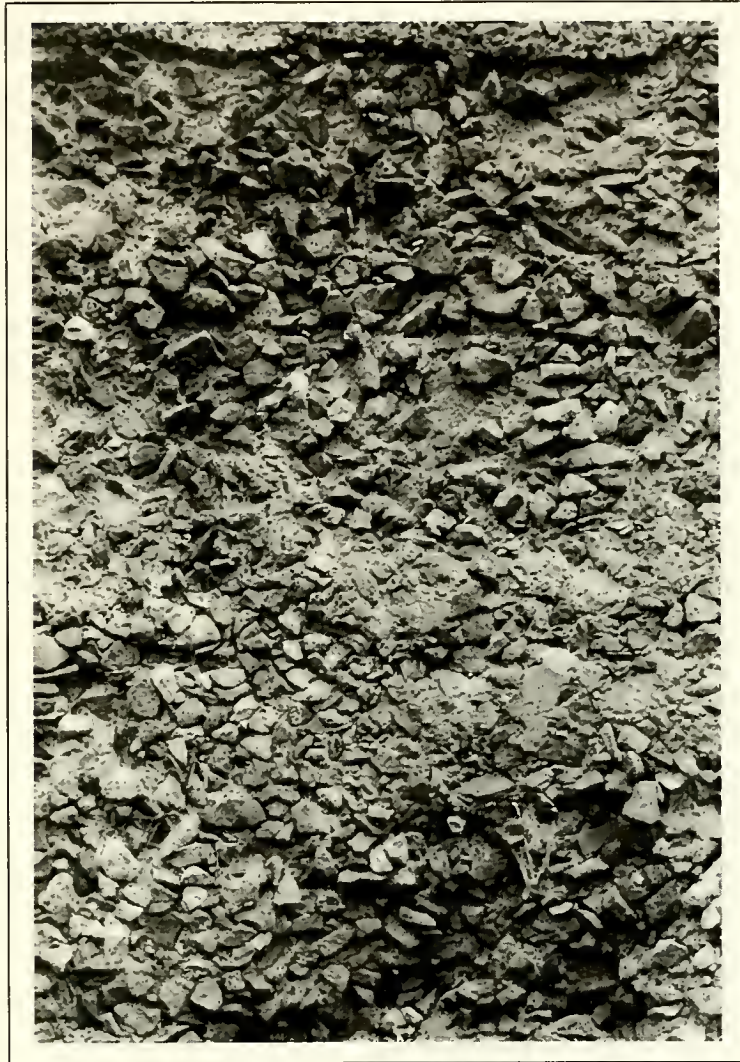
Material loss, the prevalent and most dramatic manifestation of concrete failure on the bridge, is attributed to man made and chemical influences. Seventy percent of the total surface area of the bridge exhibits losses ranging from one half inch to as deep as seven inches. Shallow losses surround the east and west faces of the vaulted arches, and the upper portion of both interior arches. Loss of the skim coat is visible on several balustrade posts (Figure 8), and on the north and south abutments. Honeycombing of material in the pour process is most evident in the pylons (Figure 9). Exposed aggregate caused by binder loss is visible on twenty percent of the total surface area (Figure 10).

Figure 10 Exposed aggregate on west wall.

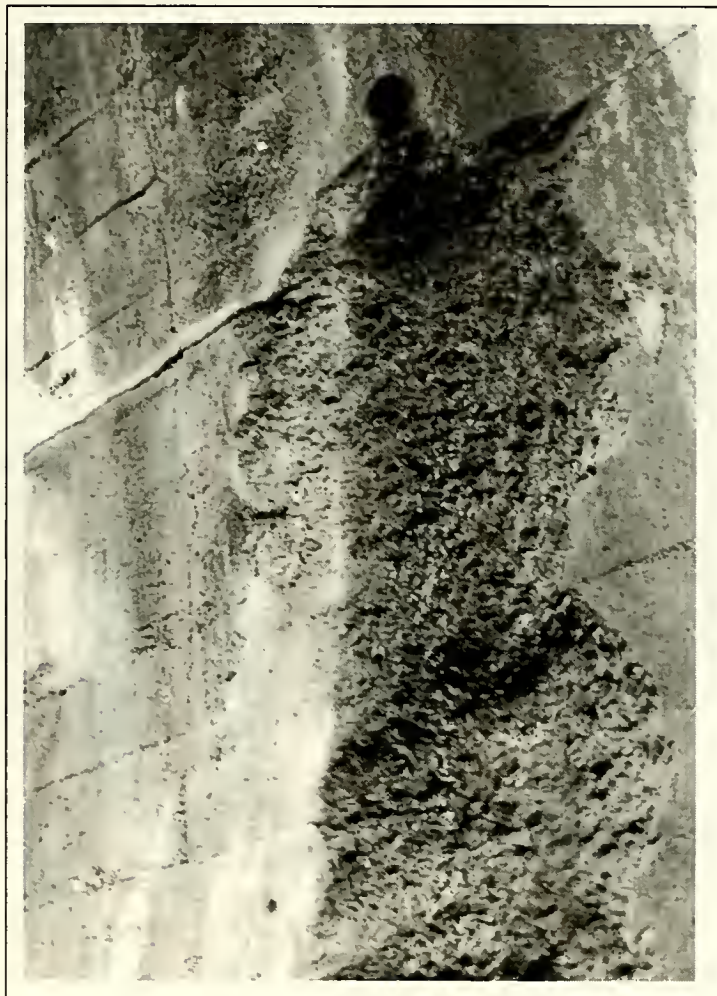
Deep losses are present on thirty percent of the structure, the result of several mechanisms. Two to four inch losses are found on the interior walls of both arches and are the result of weephole drainage (Figure 11). These surfaces are never dry, and

Figure 11 Loss to surface caused by weephole design.

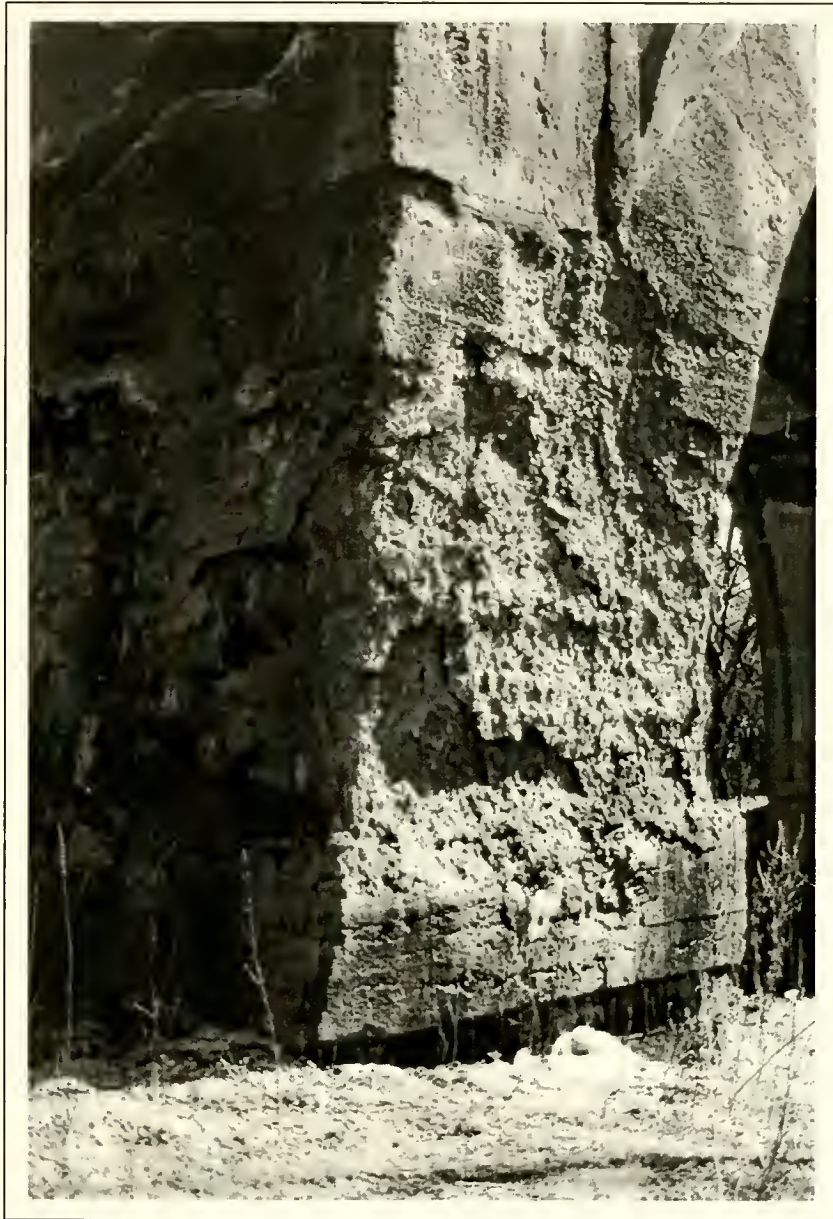
several of the weepholes drip constantly. The effects of freeze thaw cycling and erosion have resulted in extreme losses to Pier 1 (Figure 12). All faces of the pier display scaling to seven inches below the surface, with the area of loss extending to a height of ten feet above ground level. Weathering has caused all hard edges and angles on this pier to wear away.

Figure 12 Extreme loss to Pier 1, west side.

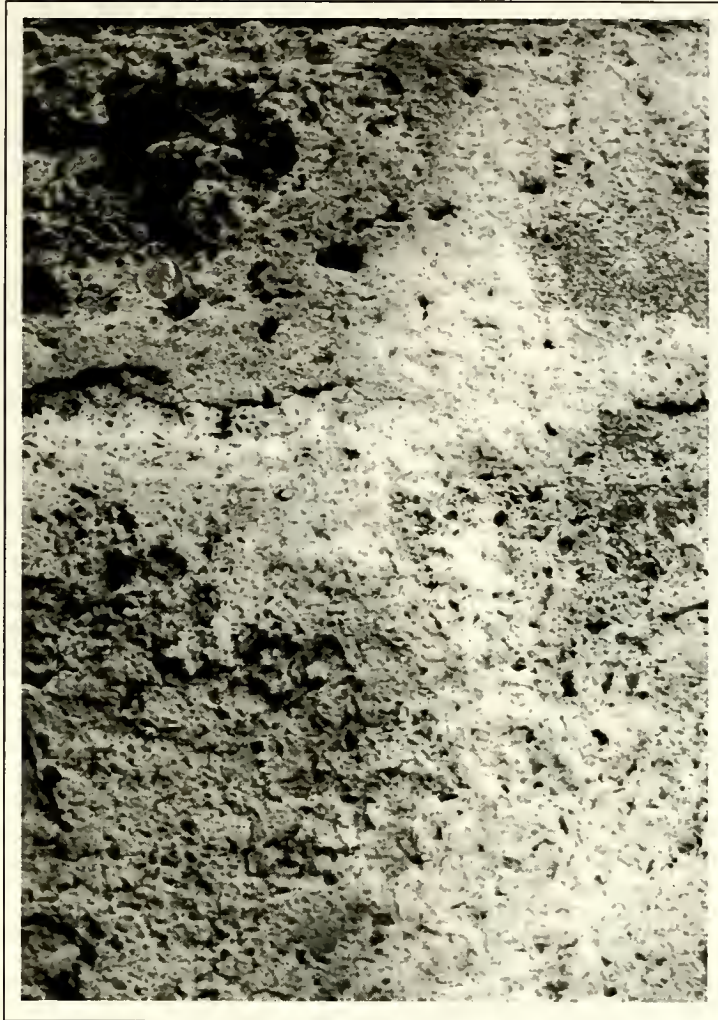
efflorescence and subflorescence. Heavy buildup of salts on the surface indicates large quantities present in the substrate (Figure 13).

Figure 13 Salts on surface of interior arch wall.

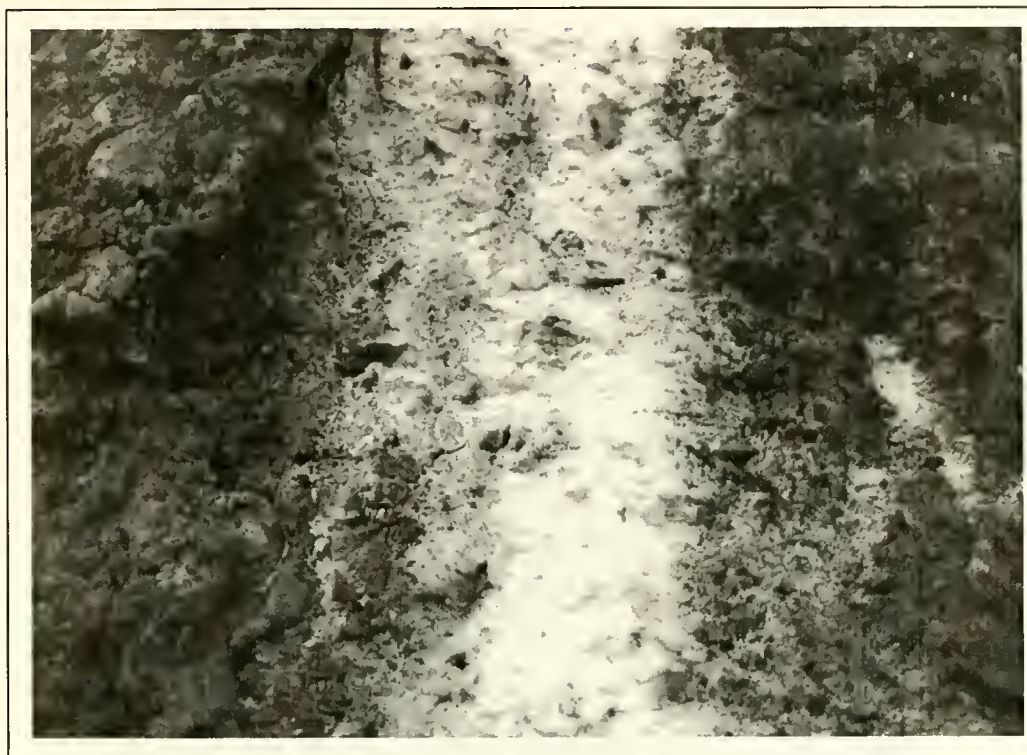
Further evidence of salts are found in the form of gypsum crusts clinging to the areas of loss on the arch interior walls mentioned above (Figure 14). Stalactites cling to the I-beams in the straight spans, emphasizing the action of salts within the deteriorating material.

Figure 14 Gypsum crusts evident around drainage area.

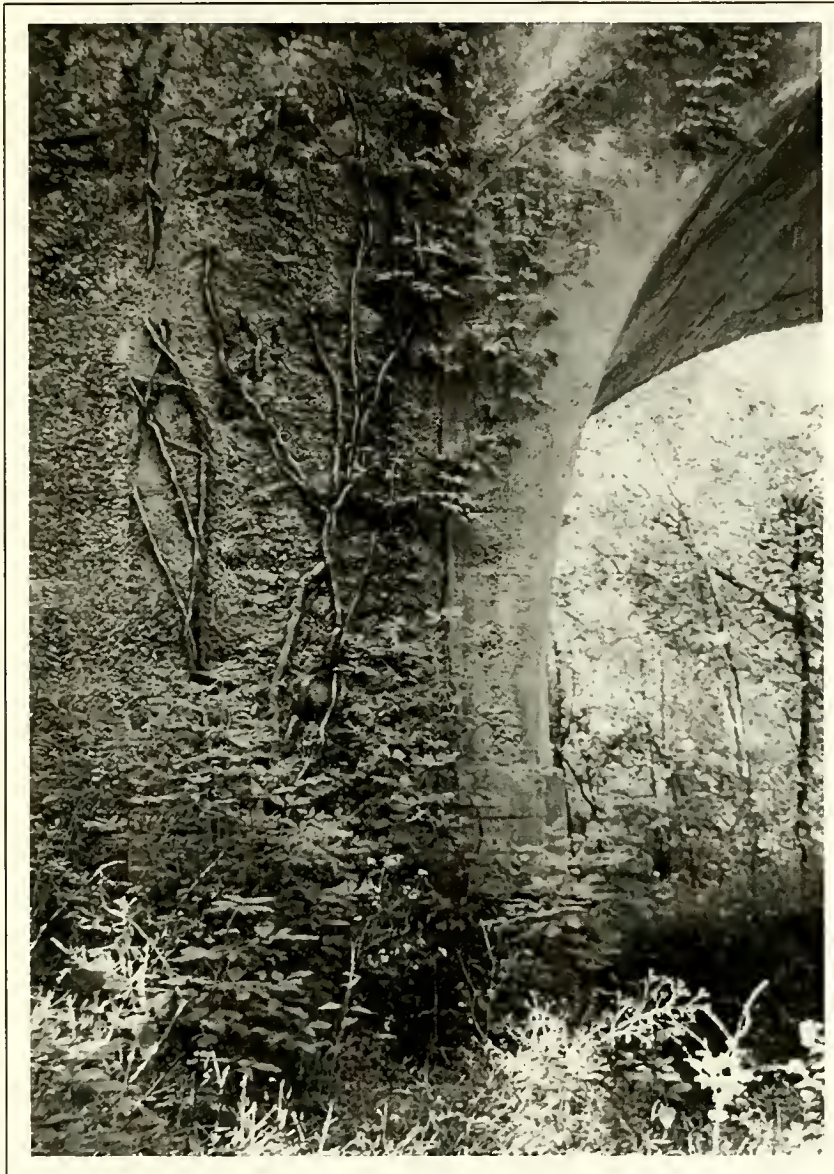
Biological growth and vegetative infestation are present on approximately forty percent of the bridge. It is manifest in the form of green material on the east face of the bridge and throughout the parapet. Lichens ranging in color from dark green to brown are prevalent on the lost areas of Pier 1. The most notable instance of vegetative overgrowth is found on the east face of the second pier in the space formerly occupied by a decorative pylon. Vines and small tree roots are here embedded in the substrate (Figure 15). The pylon on the west side of the bridge, its top 14 feet gone, is also overgrown with tall grass and small trees (Figure 16).

Figure 15 Extreme vegetative overgrowth, Pier 2.

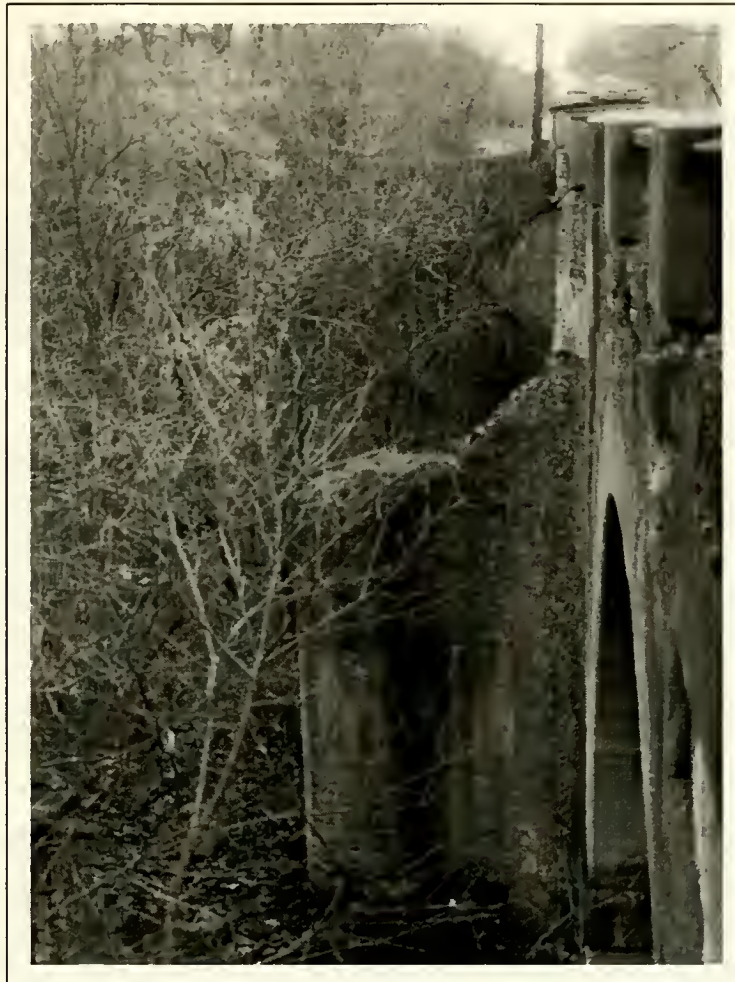
Figure 16 Plant growth on northwest pylon.

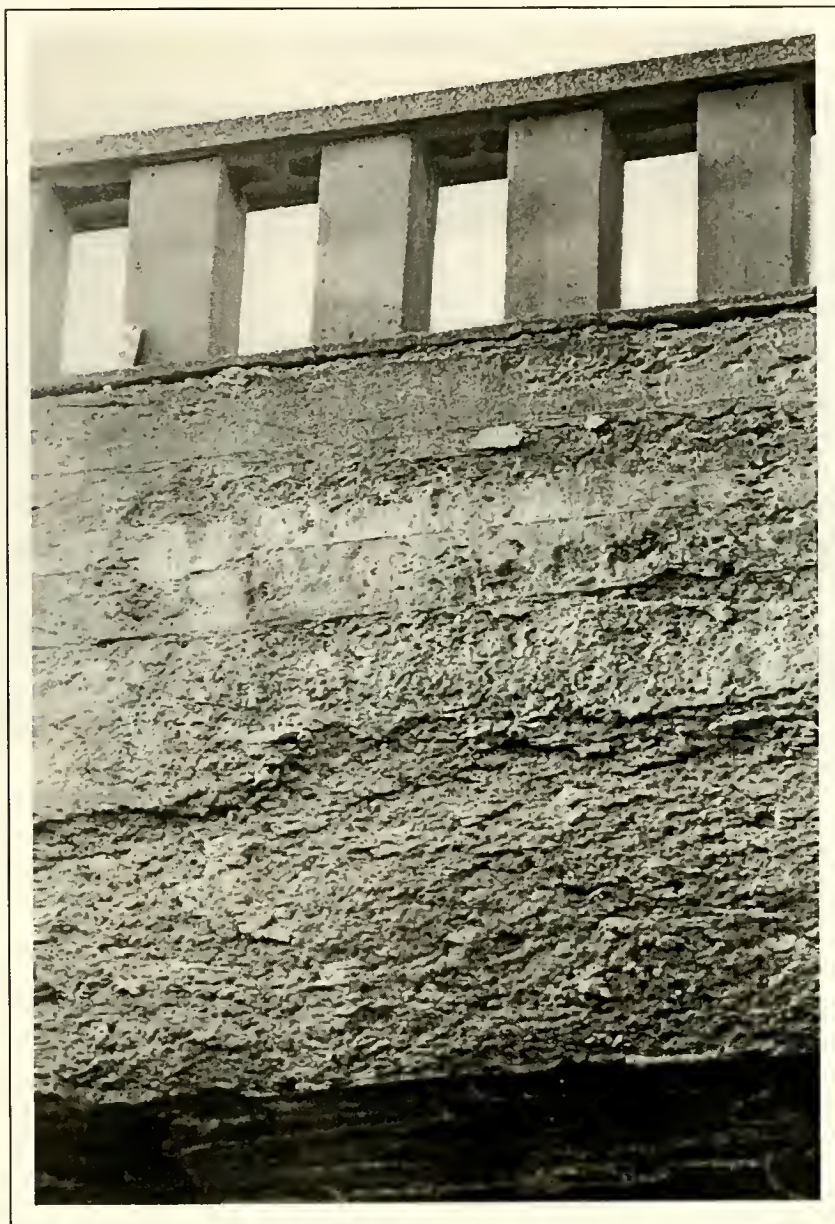
Finally, previous repair campaigns have created inconsistencies in the balustrade. Decorative balusters have been replaced in several areas with nine inch rectangular supports, an unfortunate circumstance causing aesthetic disharmony to the overall appearance of the bridge (Figure 16). In other sections of the balustrade, voids exist where no attempt was made to replace lost balusters (Figure 17). Integrity of the fabric and safety of the structure are jeopardized by these losses.

Figure 17 Rectangular replacement balusters

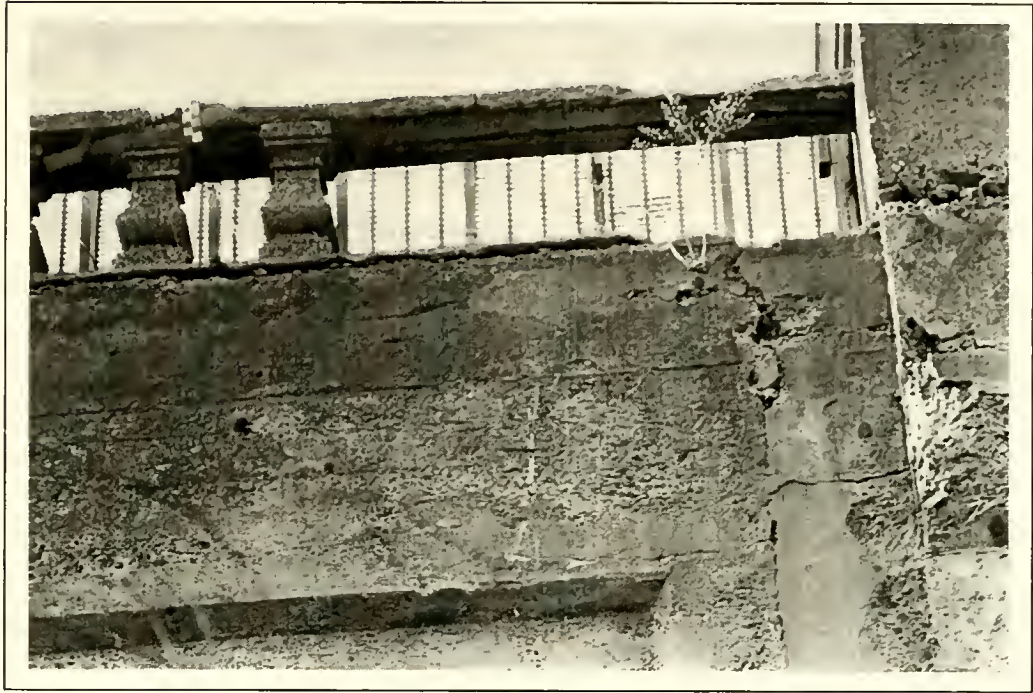
Figure 18 Voids in balustrade.
