THE NEW HOPE EXPERIMENT: AN INVESTIGATION AND CONSERVATION PLAN FOR THE
ANTONIN AND NOÉMI RAYMOND FARM

A THESIS

Historic Preservation

MASTER OF SCIENCE IN HISTORIC PRESERVATION

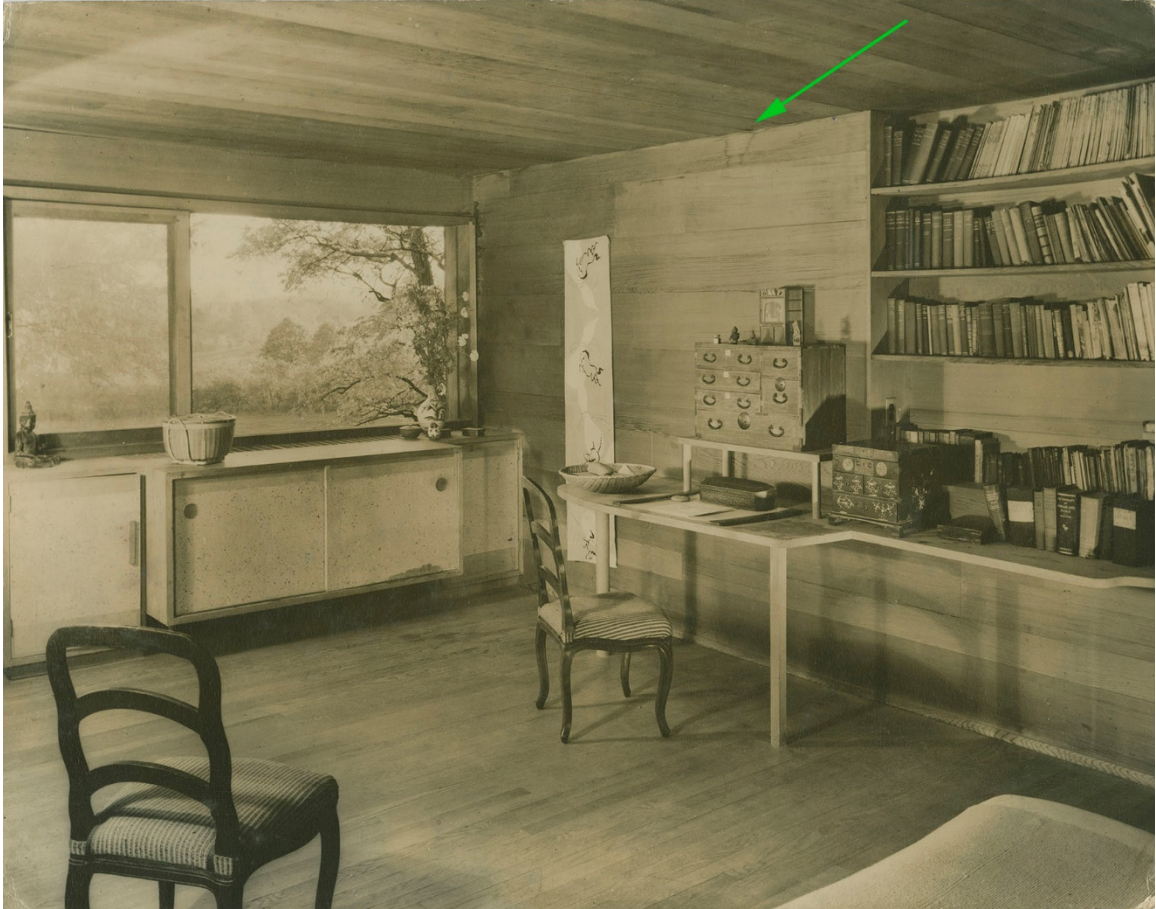
Archival research shows that water staining appeared on the cedar boards as early as 1940 (Figure 31). The stain in this photo is placed on the second-floor ceiling, generally underneath the bathroom on the third floor, indicating it is a plumbing issue rather than an exterior factor. While this is helpful in understanding the history of the site, it makes it difficult to determine which water stains in the house are historic and inactive, and therefore no longer an issue, or if they are active and need to be addressed in the overall conservation plan. There are a few options to investigate this research question: visual assessment during large-scale rain events, monitoring with a moisture meter, or use of infrared thermography. Because the stone envelope of the farm house is largely unoccupied with the exception of sporadic tours and programming, there is often no one present to witness active leaking during rain events. Scheduling prevented the author from visiting the farm house during a rain event, and the nearest one had been two days prior to a visit in early February.

Figure 31. Photograph of a water stain on the cedar interior, indicated by a green arrow. Source: Raymond Collection, University of Pennsylvania Architectural Archives, indicator arrow added by author.

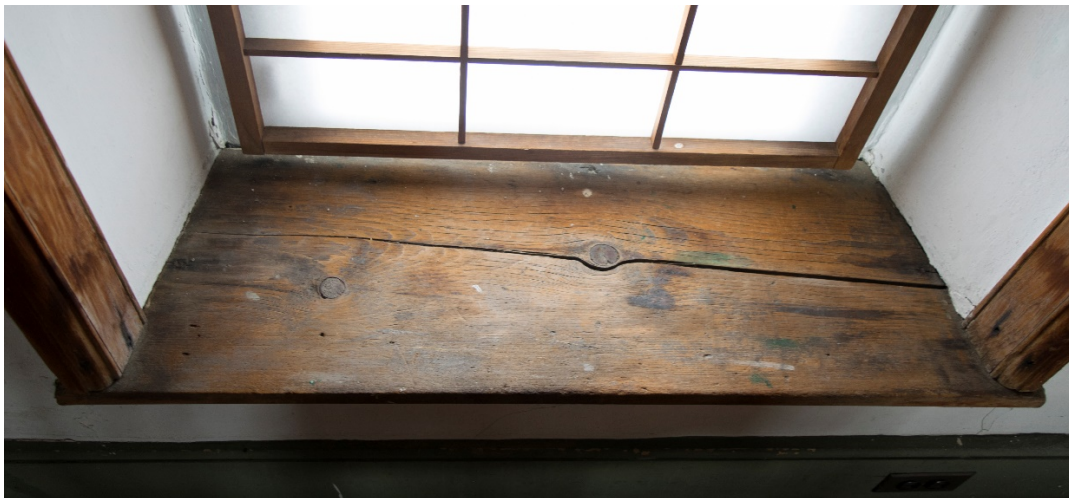
When Antonin and Noémi Raymond decided to remove a portion of the south façade and open their house to increased amounts of light, air and space, it is highly unlikely that they were thinking of the long-term lifespan of the materials on the interior. Suddenly, historic materials including the floor boards, mantels, and plaster were subjected to an exponentially higher amount of sunlight for prolonged periods of time. Also, the new cedar plank finishing on the exterior and interior and items brought by the Raymonds such as furniture, textiles and books began their now nearly eighty-year exposure to the same conditions. The first floor in particular, where the row of sliding glass doors on the south elevation extends for about 26' 3" allows light to hit the floor boards from shortly after sunrise until dusk, and maximum recorded infiltration was about fourteen feet into the interior from the southern elevation. This prolonged exposure has already shown to have deleterious effects, particularly in the older woodworking elements such as window surrounds on the south elevation, where photodegradation and color change have become readily apparent (Figure 32).

Figure 32. Showing checking of the wood sill and loss of color due to UV light. Source: Author, April 10, 2018.

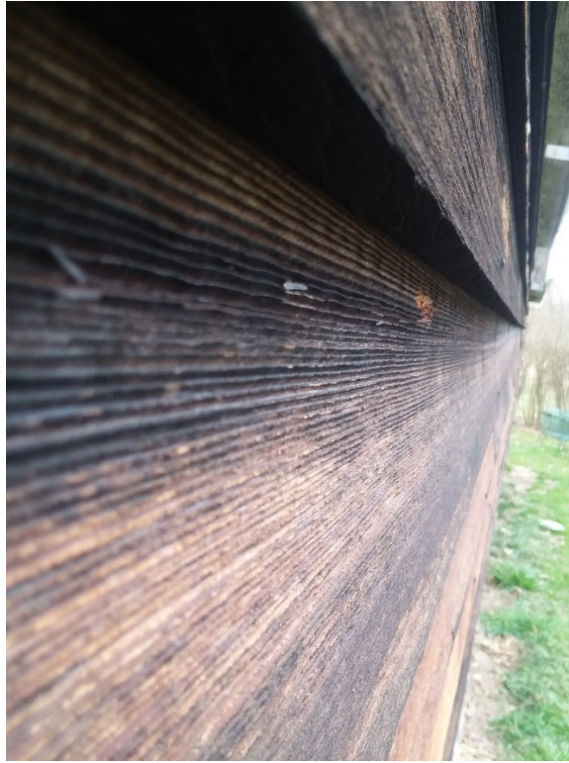
Ultraviolet degradation is prevalent throughout the exterior wood of the envelope. Described in-depth previously in this report, UV degradation occurs when UV light carries enough energy to break the chemical bonds between the lignin, cellulose and hemicellulose, which are the structural components of wood. This causes deterioration of the lignin in particular, which is eroded away through the action of wind and rain, leaving behind the white cellulose, giving the wood members and overall bone-gray driftwood type of appearance. Though found in all exterior wood locations, UV degradation is particularly severe on the unfinished cedar shiplap of the eastern addition's south elevation. Evidence of this is found in both the color of the shiplap boards as well as the surface loss of the earlywood, leaving raised bands of latewood (Figure 33). In some cases, the surface loss has been so severe that as the deterioration products are washed away, new surfaces are exposed to begin weathering. Both dirt and mold, a lower form of fungi, gather on the weathered surfaces, and though it looks aesthetically unclean, these products do contain melanin and act as a sort of protective barrier for the wood.

Figure 33. Raking view of decayed earlywood and therefore raised latewood in exterior cedar shiplap due to UV damage. Source: Author, March 27, 2018.

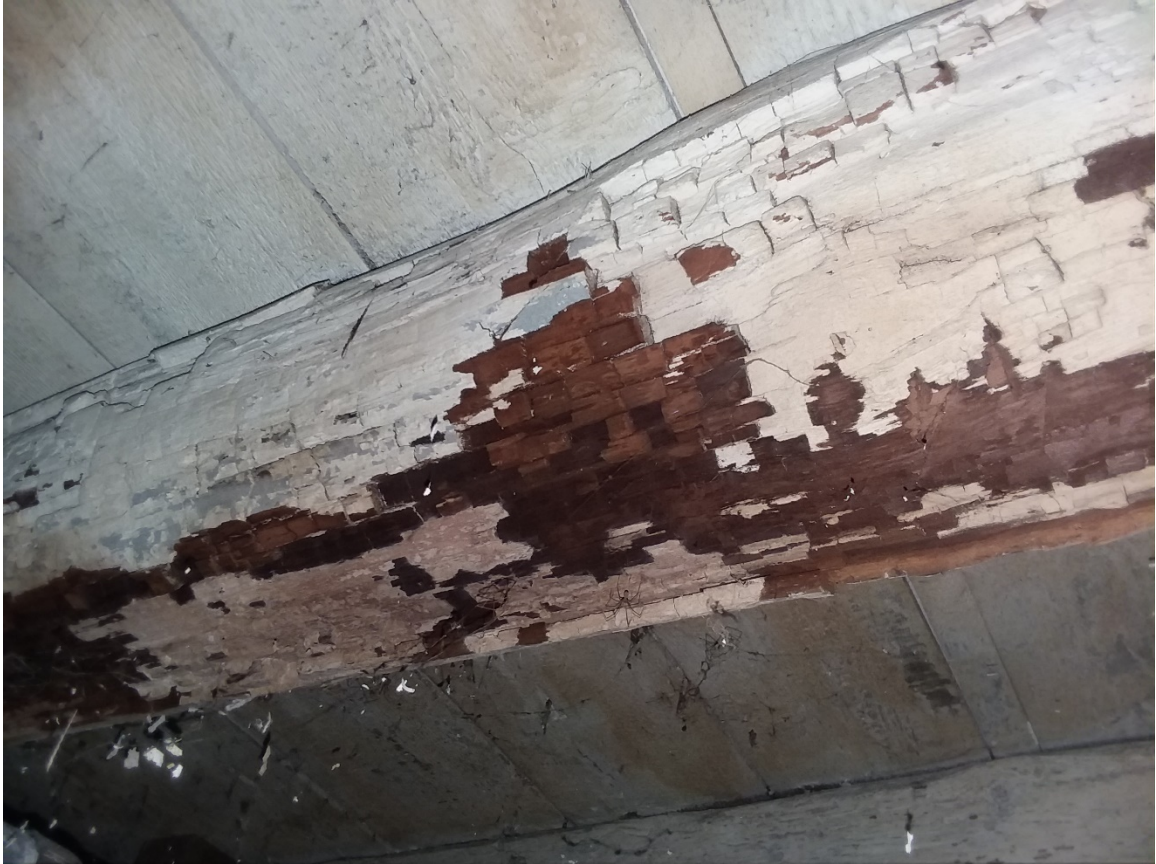
Moisture infiltration through ground water appears to have caused issues in the sub-grade basement. One joist on the southwest side of the house shows extreme checkering, indication of a severe case of brown rot (Figure 34). While other joists do not display the same level of degradation as this one, other joists are also displaying early signs of rot, dimensional loss exposing softer, sponge-like wood tissue. As described previously, rot needs a high moisture content to survive and thrive. A high moisture content also is necessary for some types of insect infestation, and many joists in the basement show signs of powder post beetle holes. These insects need about 15% relative humidity to survive. Adult females deposit their eggs into the pores of a wood member and the larvae consume the starch, creating long meandering tunnels, then bore their way out leaving small circular exit holes. One indicator of an active infestation is the presence of frass, a powdery waste product, near their exit holes. No accumulations of frass were seen near the exit holes, however the general dust and debris in the area might obscure this waste product. Other indicators support the hypothesis that this is not an active infestation, for instance the exposed holes and surrounding wood do not appear to be fresh, and these areas have weathered in conjunction with other non-infested areas, leading the author to determine that it has been some time since the insects were present.

Figure 34. Basement joist showing classic checkerboard pattern indicative of a type of brown rot. Source: Author, March 27, 2018.

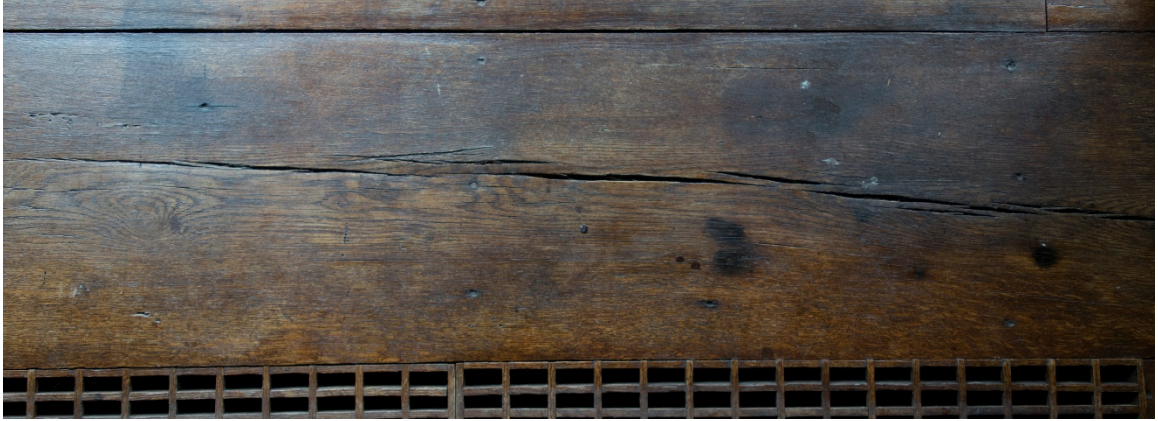
Interior areas of high exposure to light, particularly the wood members that comprise the oldest window surrounds in the eastern portion of the stone envelope show symptoms of UV degradation, including color and surface loss. Apart from these standard UV degradation symptoms, the older surrounds also display iron staining around fasteners, and subsequent mild dimensional loss. This staining is common in historic woodwork, as wood is naturally slightly acidic. When combined with water in liquid or vapor form, naturally occurring acetic free radicals hydrolyze to create acetic acid, which reacts with ungalvanized fasteners to create this dark corrosion product (Figure 35). Floor boards closest to the swath of sliding glass doors on the first floor's south elevation show a higher degree of checking than interior boards protected from prolonged direct sunlight (Figure 36).

Figure 35. Floor board near the center of the panel of glass doors on the first floor shows increased rate of checking compared to other boards due to cyclic exposure to sunlight.

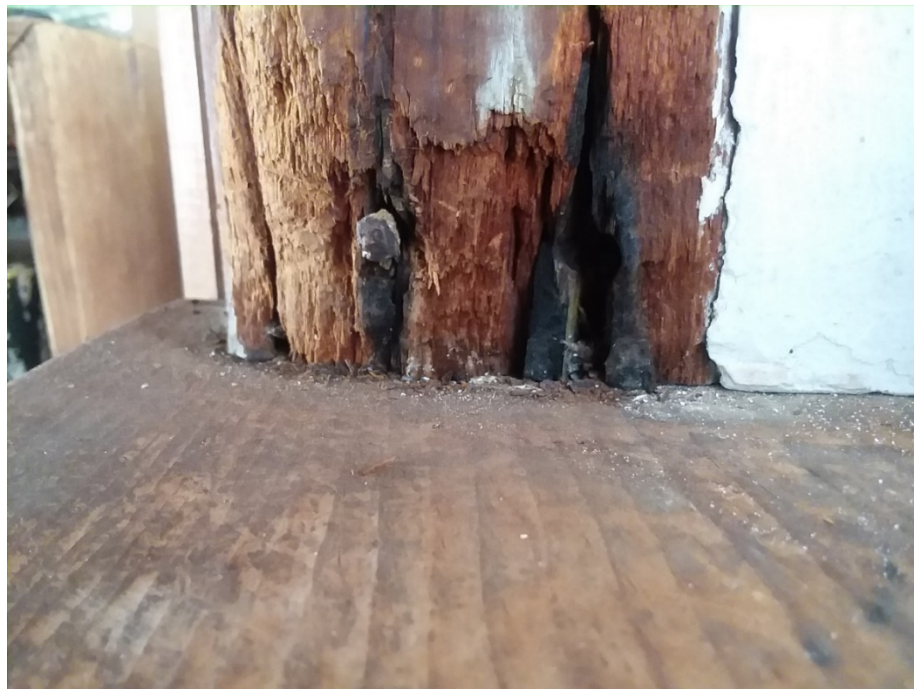
Figure 36. Black staining on a wood window surround due to untreated iron in wrought nails. Source: Author, March 27, 2018.

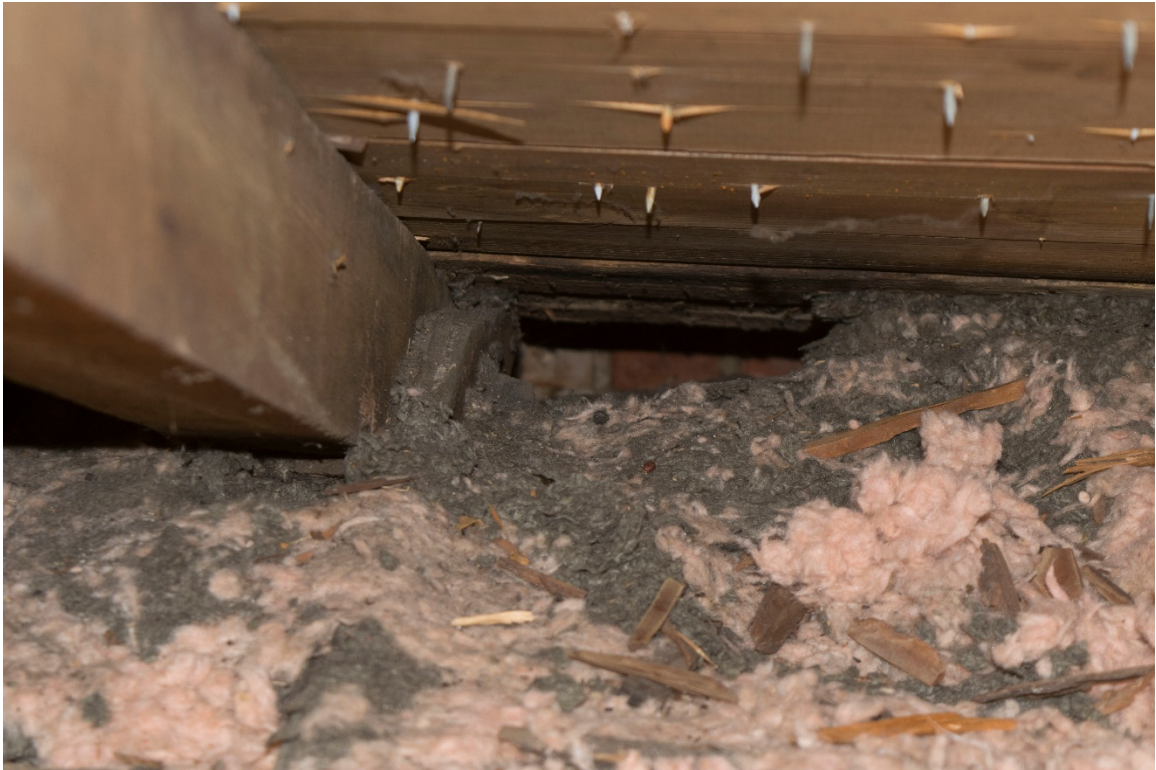
Figure 37. Image taken in the attic space showing holes between the roof decking and the cedar ceiling. Hole has presence of dirt and black staining on the wood, indicating the presence of water. Source: Author, April 10, 2018.

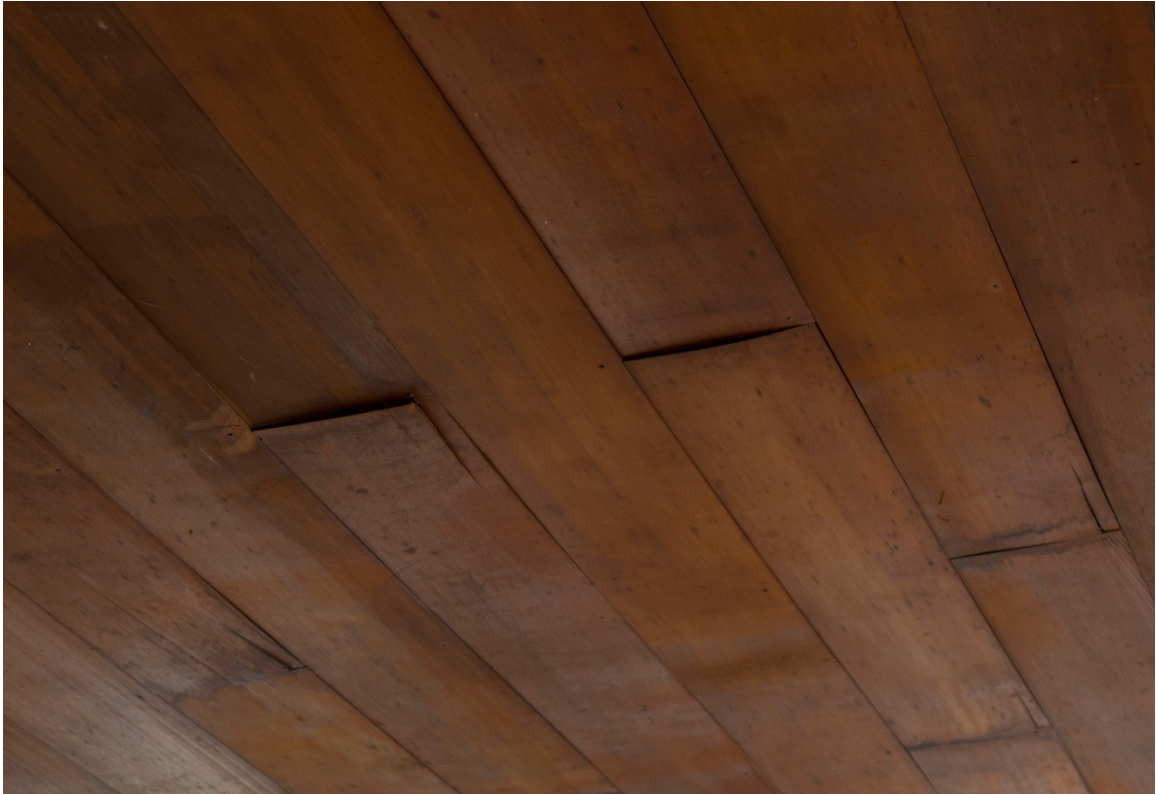
iron and water to create a dark corrosion product. Cupping and other deformation of the cedar boards sometimes occurs in conjunction with this increased moisture content, often exacerbating the issue by creating a larger portal of access (Figure 38). The cedar boards to the east of the light well on the first floor have acquired an overall wave-like appearance, as previous plumbing issues caused slight warping and deformation of the boards.

Figure 38. Example of cupping cedar boards after water infiltration, creating a larger opening. Source: Author, January 26, 2018.

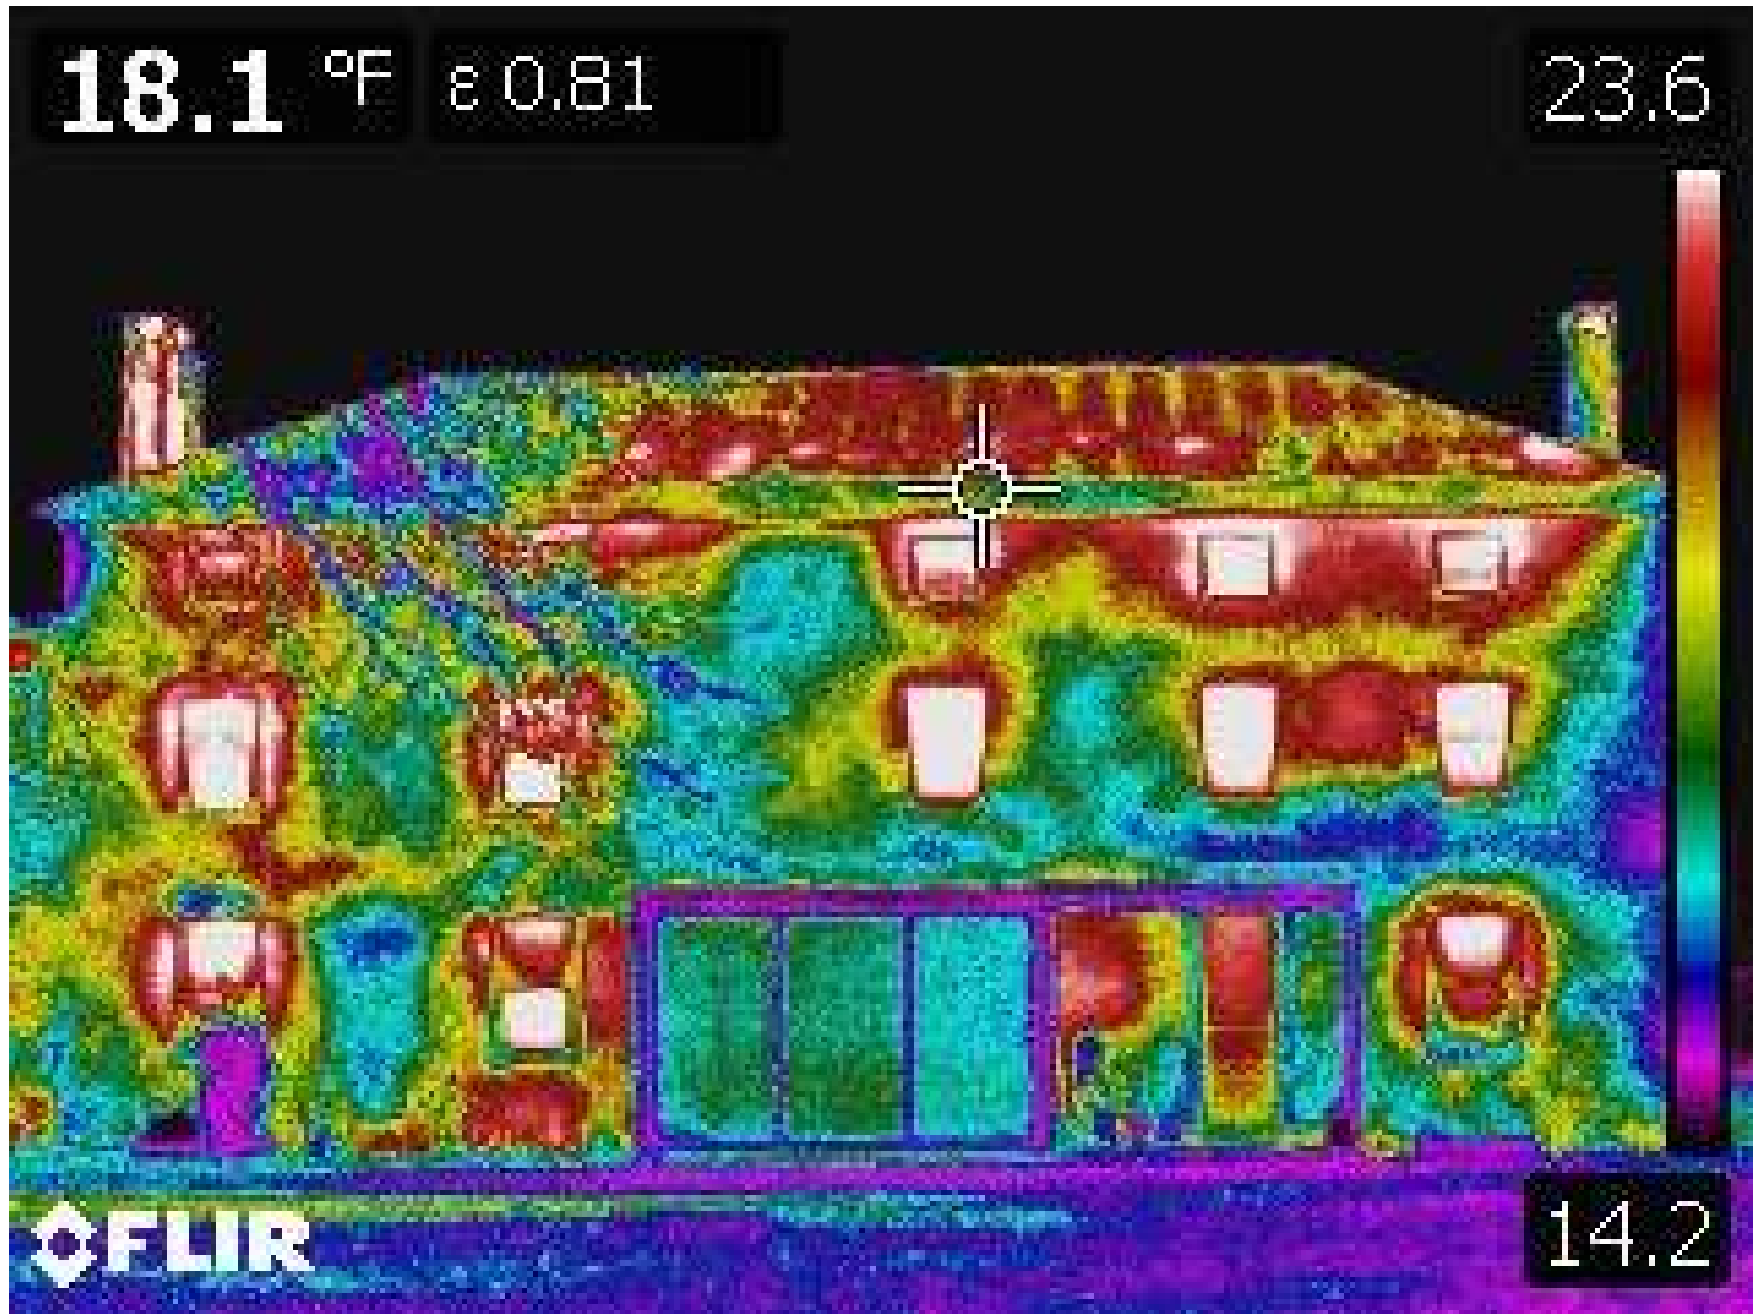
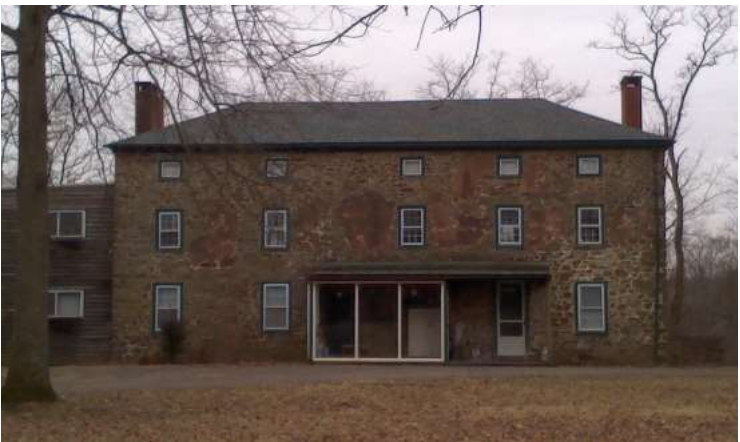
Notes: Heat escaping from interior through glass of windows as well as the eastern chimney. Areas of stucco show a lower temperature as the stucco acts as an insulator. Tree branch obfuscating portions of the roof, 2nd and 3rd floor. Roof showing high temperature, meaning heat is entering the attic space between insulation and roofing materials, and is therefore dissipating into the outer atmosphere.
Conditions: Overcast afternoon, high of 38 °F low of 23°F Rain event two days prior.

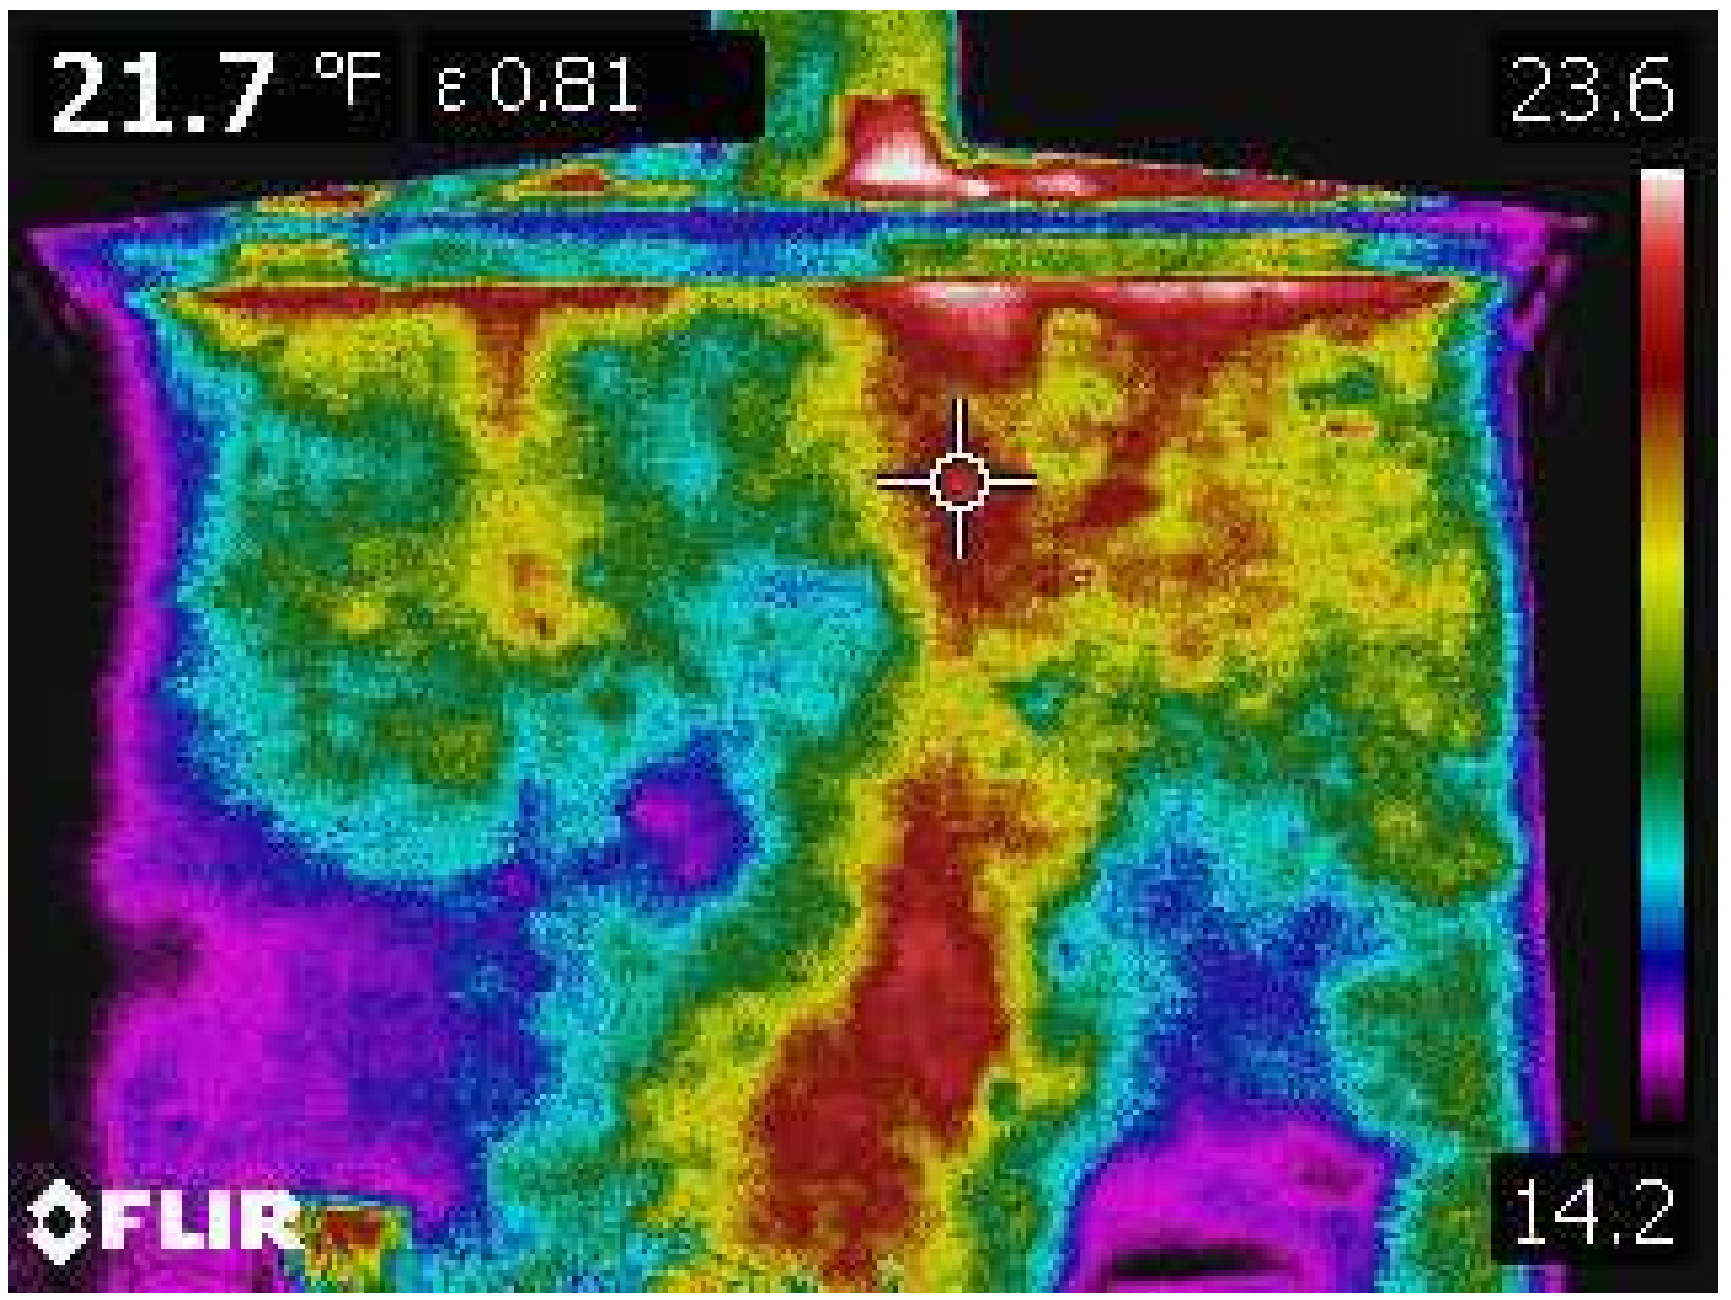
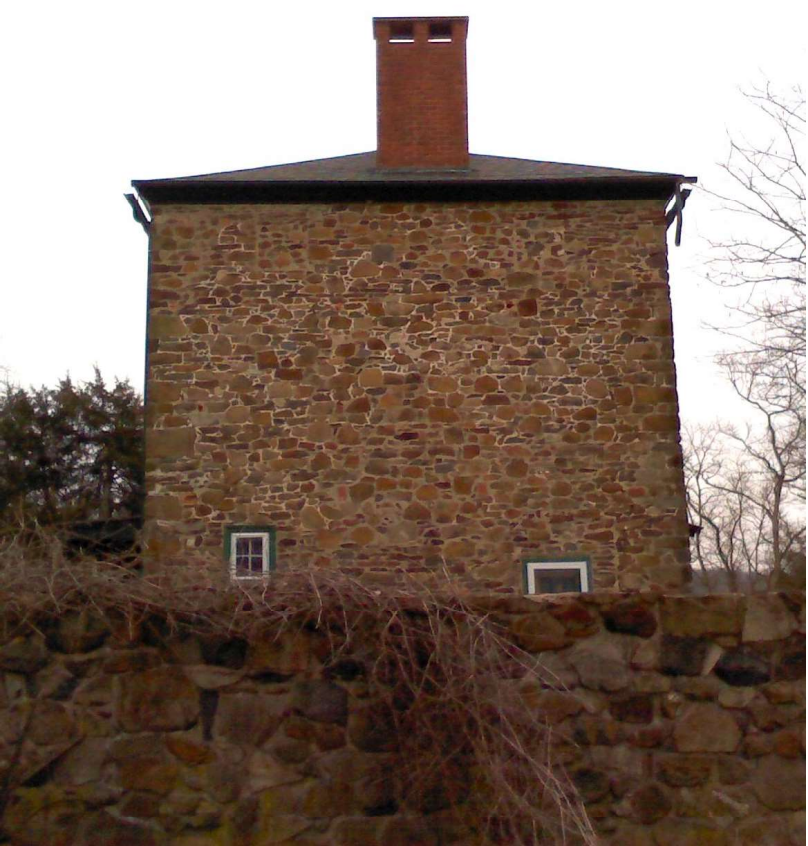
Notes: Higher thermal activity on west elevation follows chimney passages where distance between the interior and the exterior is shorter. Higher thermal activity along the roofline indicate areas where heat from the attic interior is escaping and heating the exterior roofing materials.

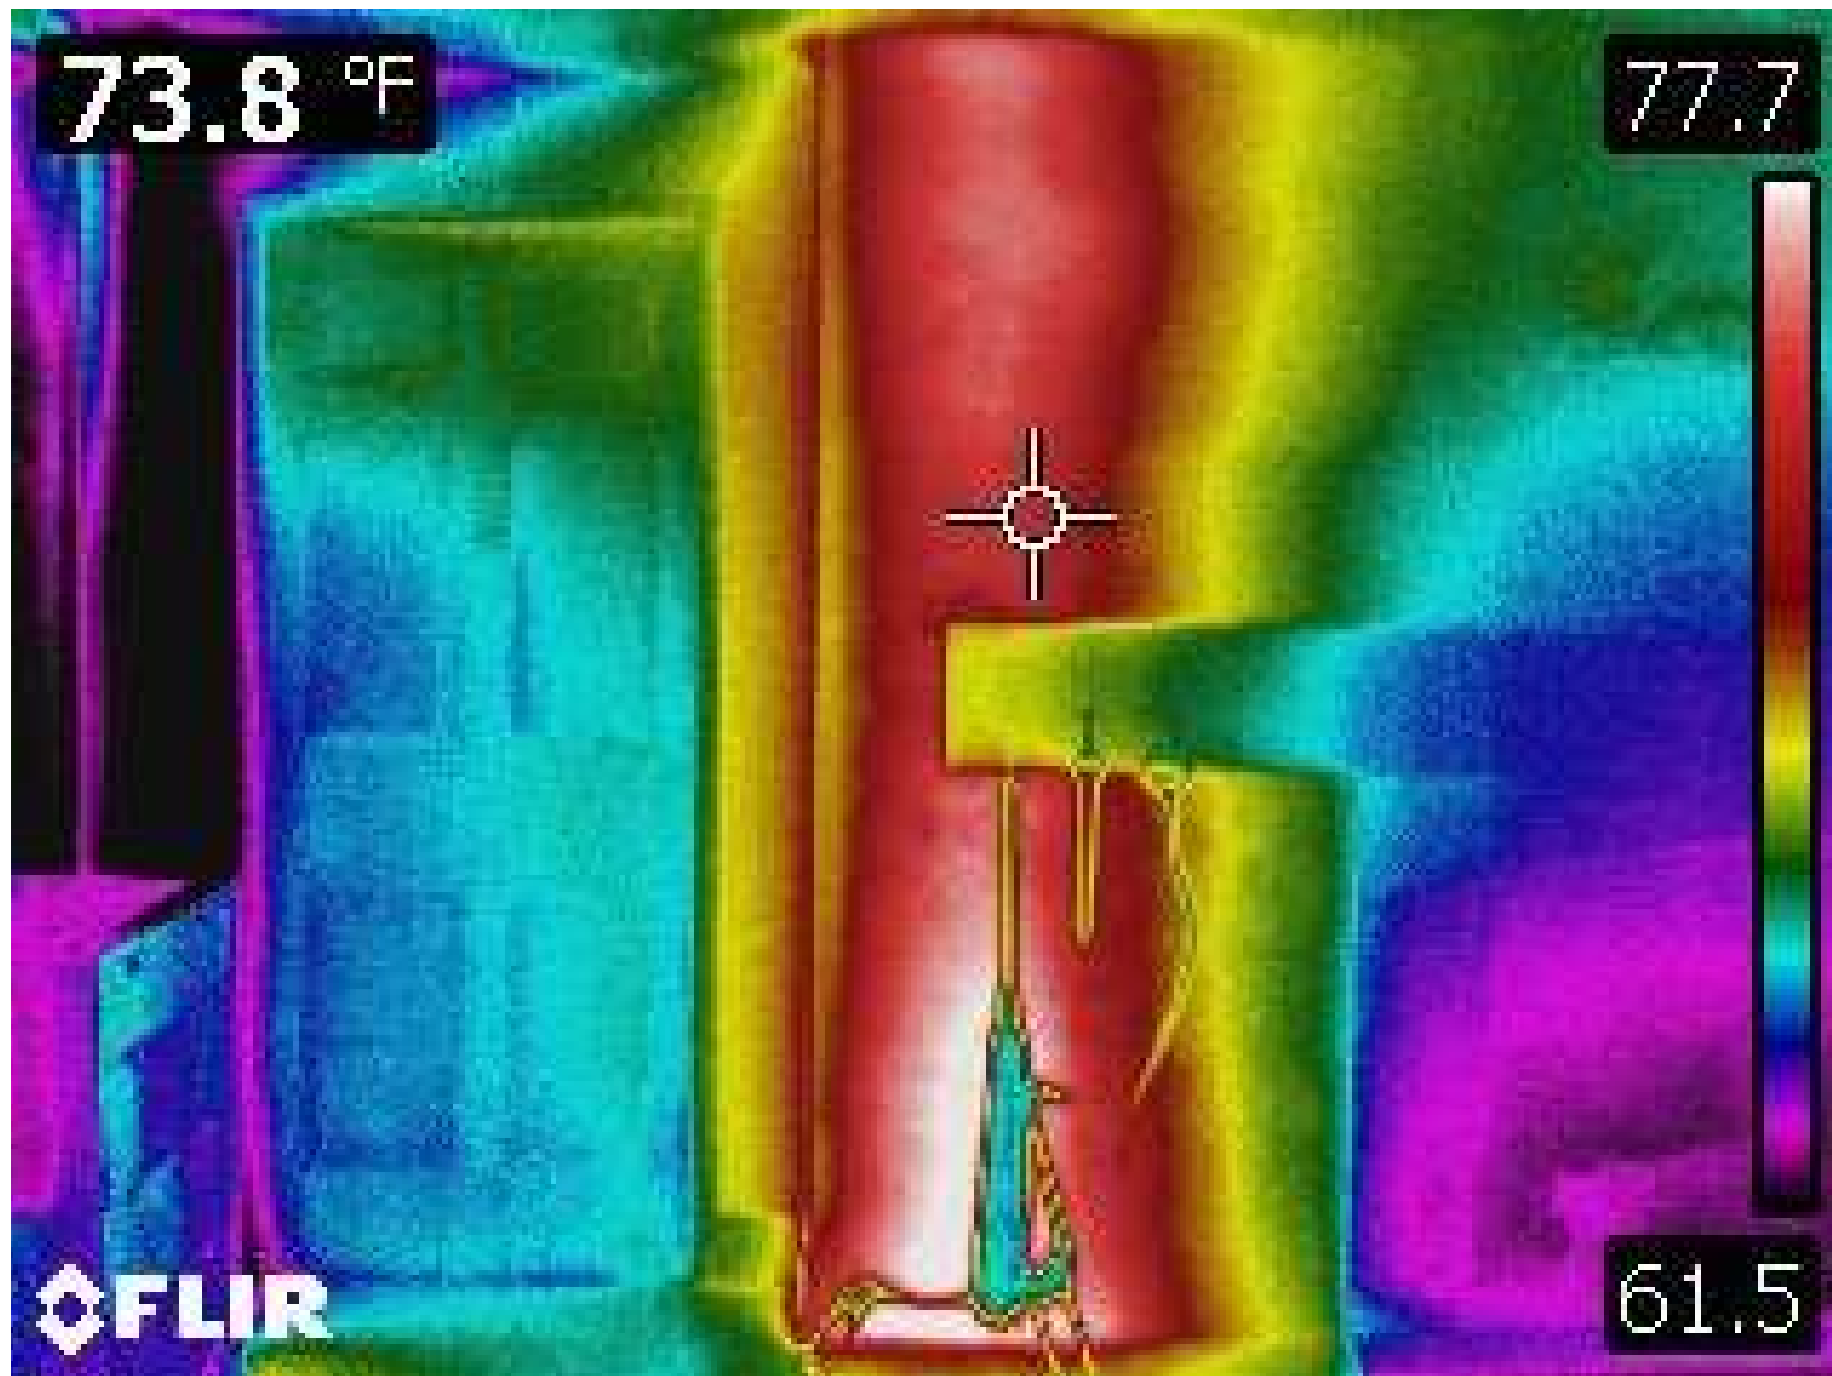
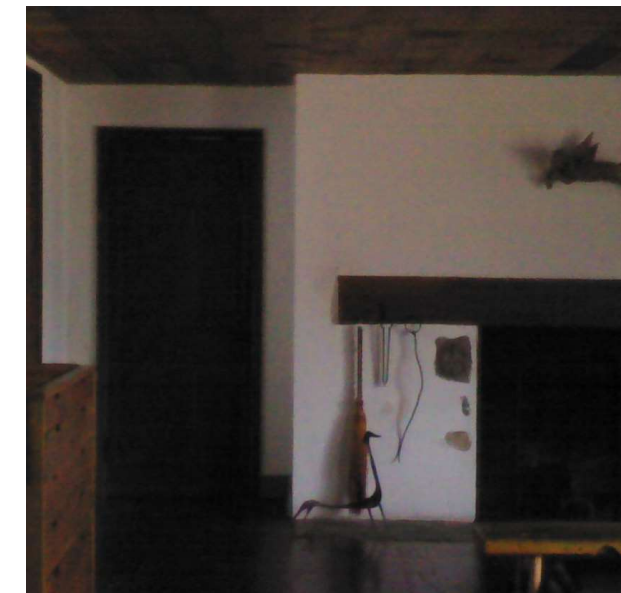
Notes: First floor main room. Hot water pipe embedded in the masonry travelling from the water heater in the basement to the upper floor radiators. This constant heat in the winter causes finish failure on the surrounding wall surfaces. This heating system is eventually leaking into the attic space above the layer of blown insulation.

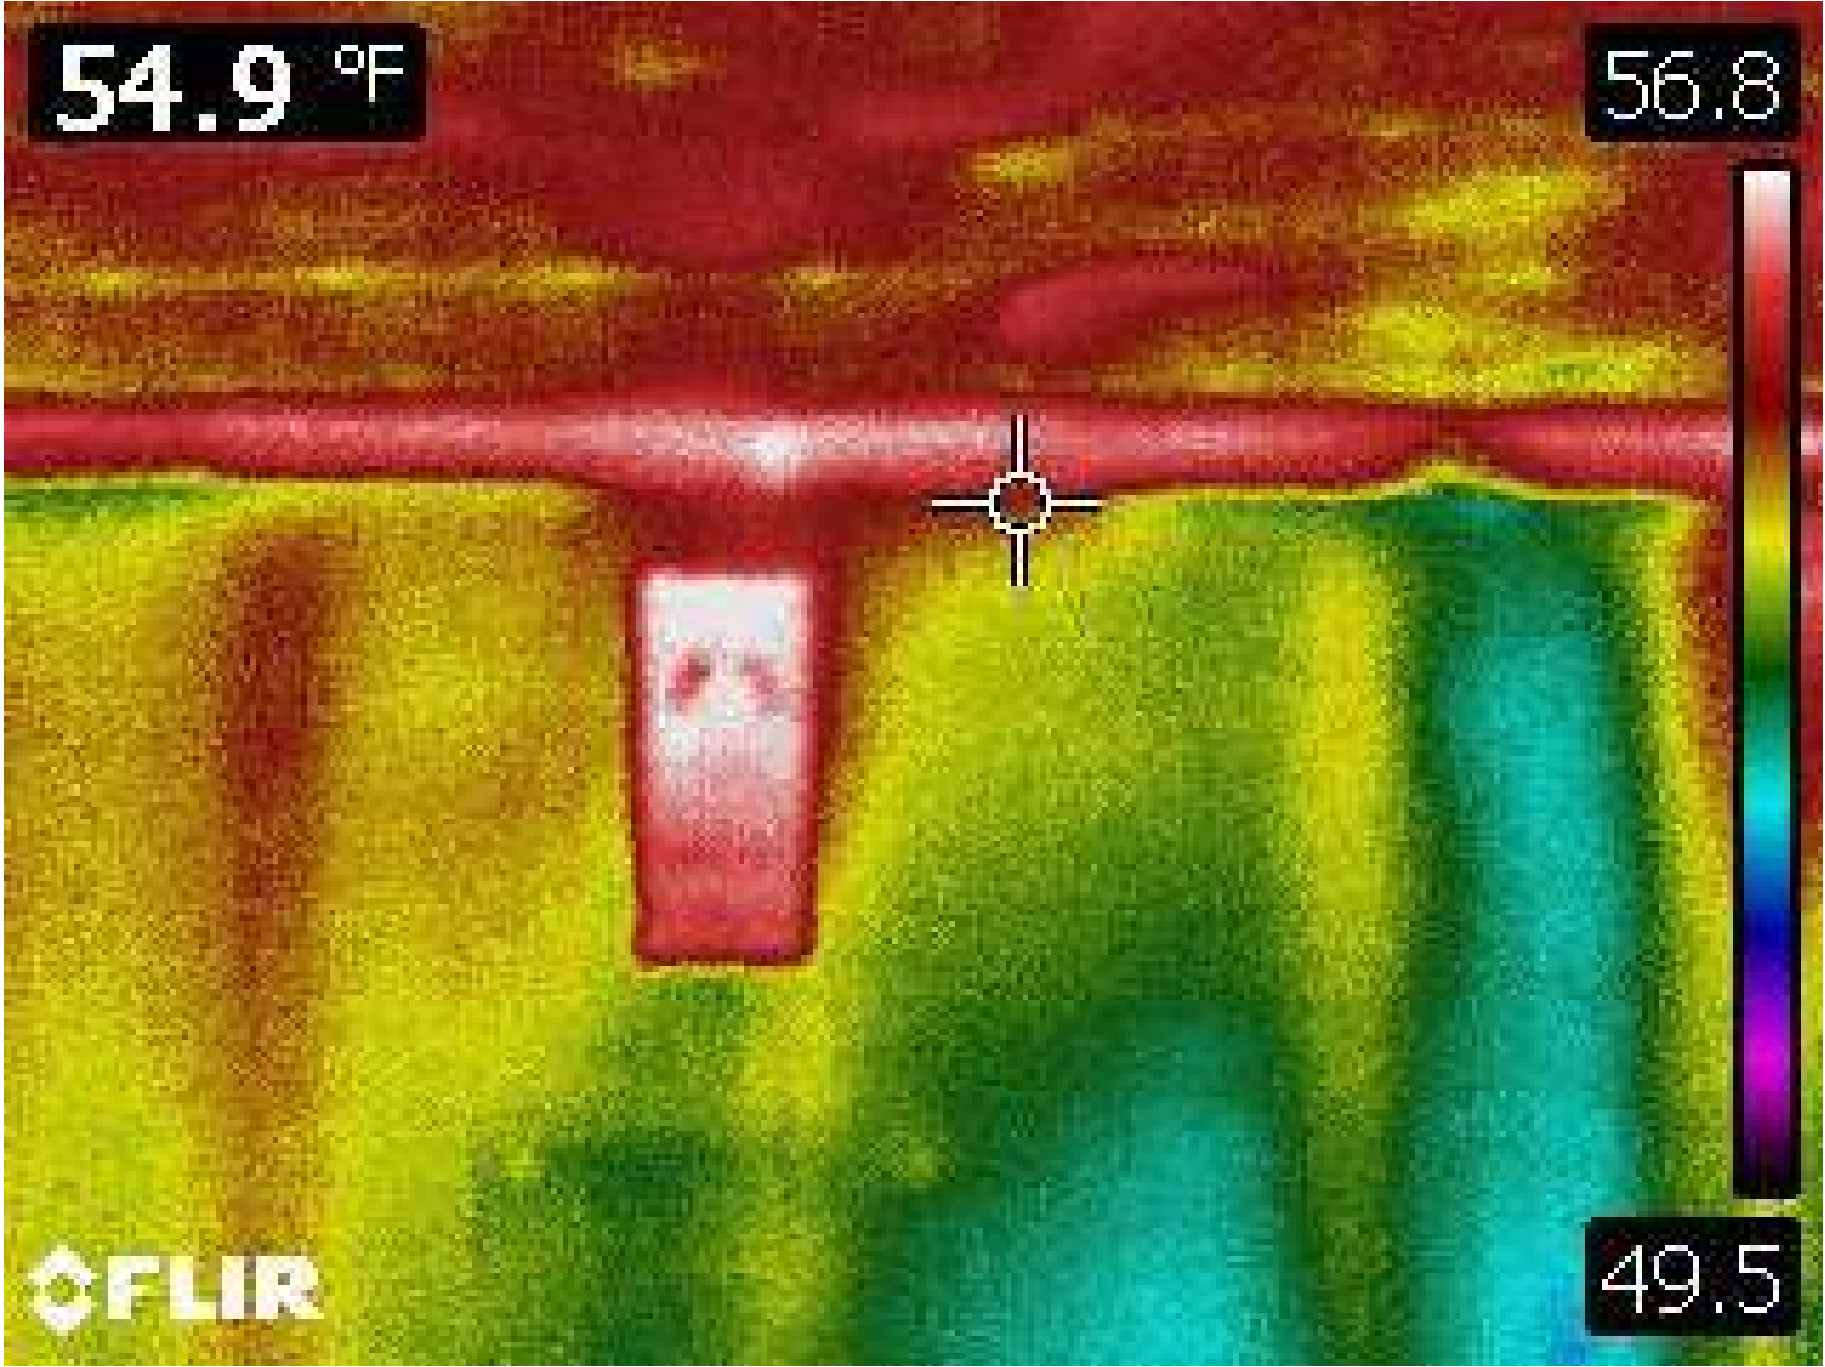
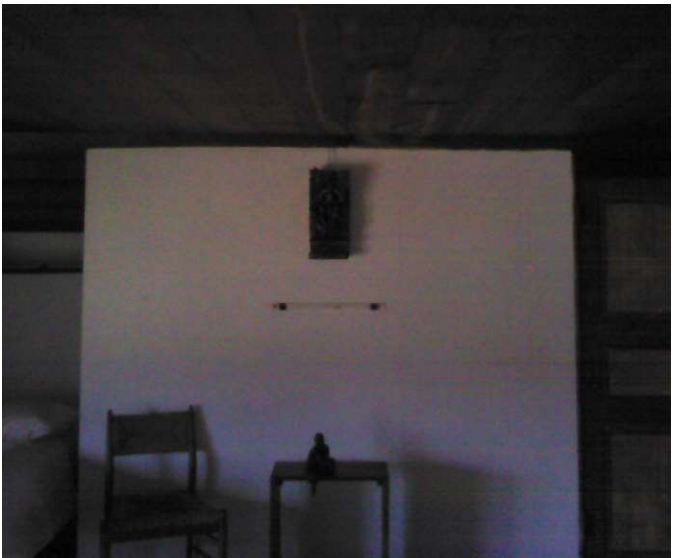
Notes: Third floor western bedroom. Heat trapped in the attic is entering the bedroom through joints in the woodwork at between the wood and masonry. Small amounts of liquid water is also likely leaking through the roof to enter the interior here.

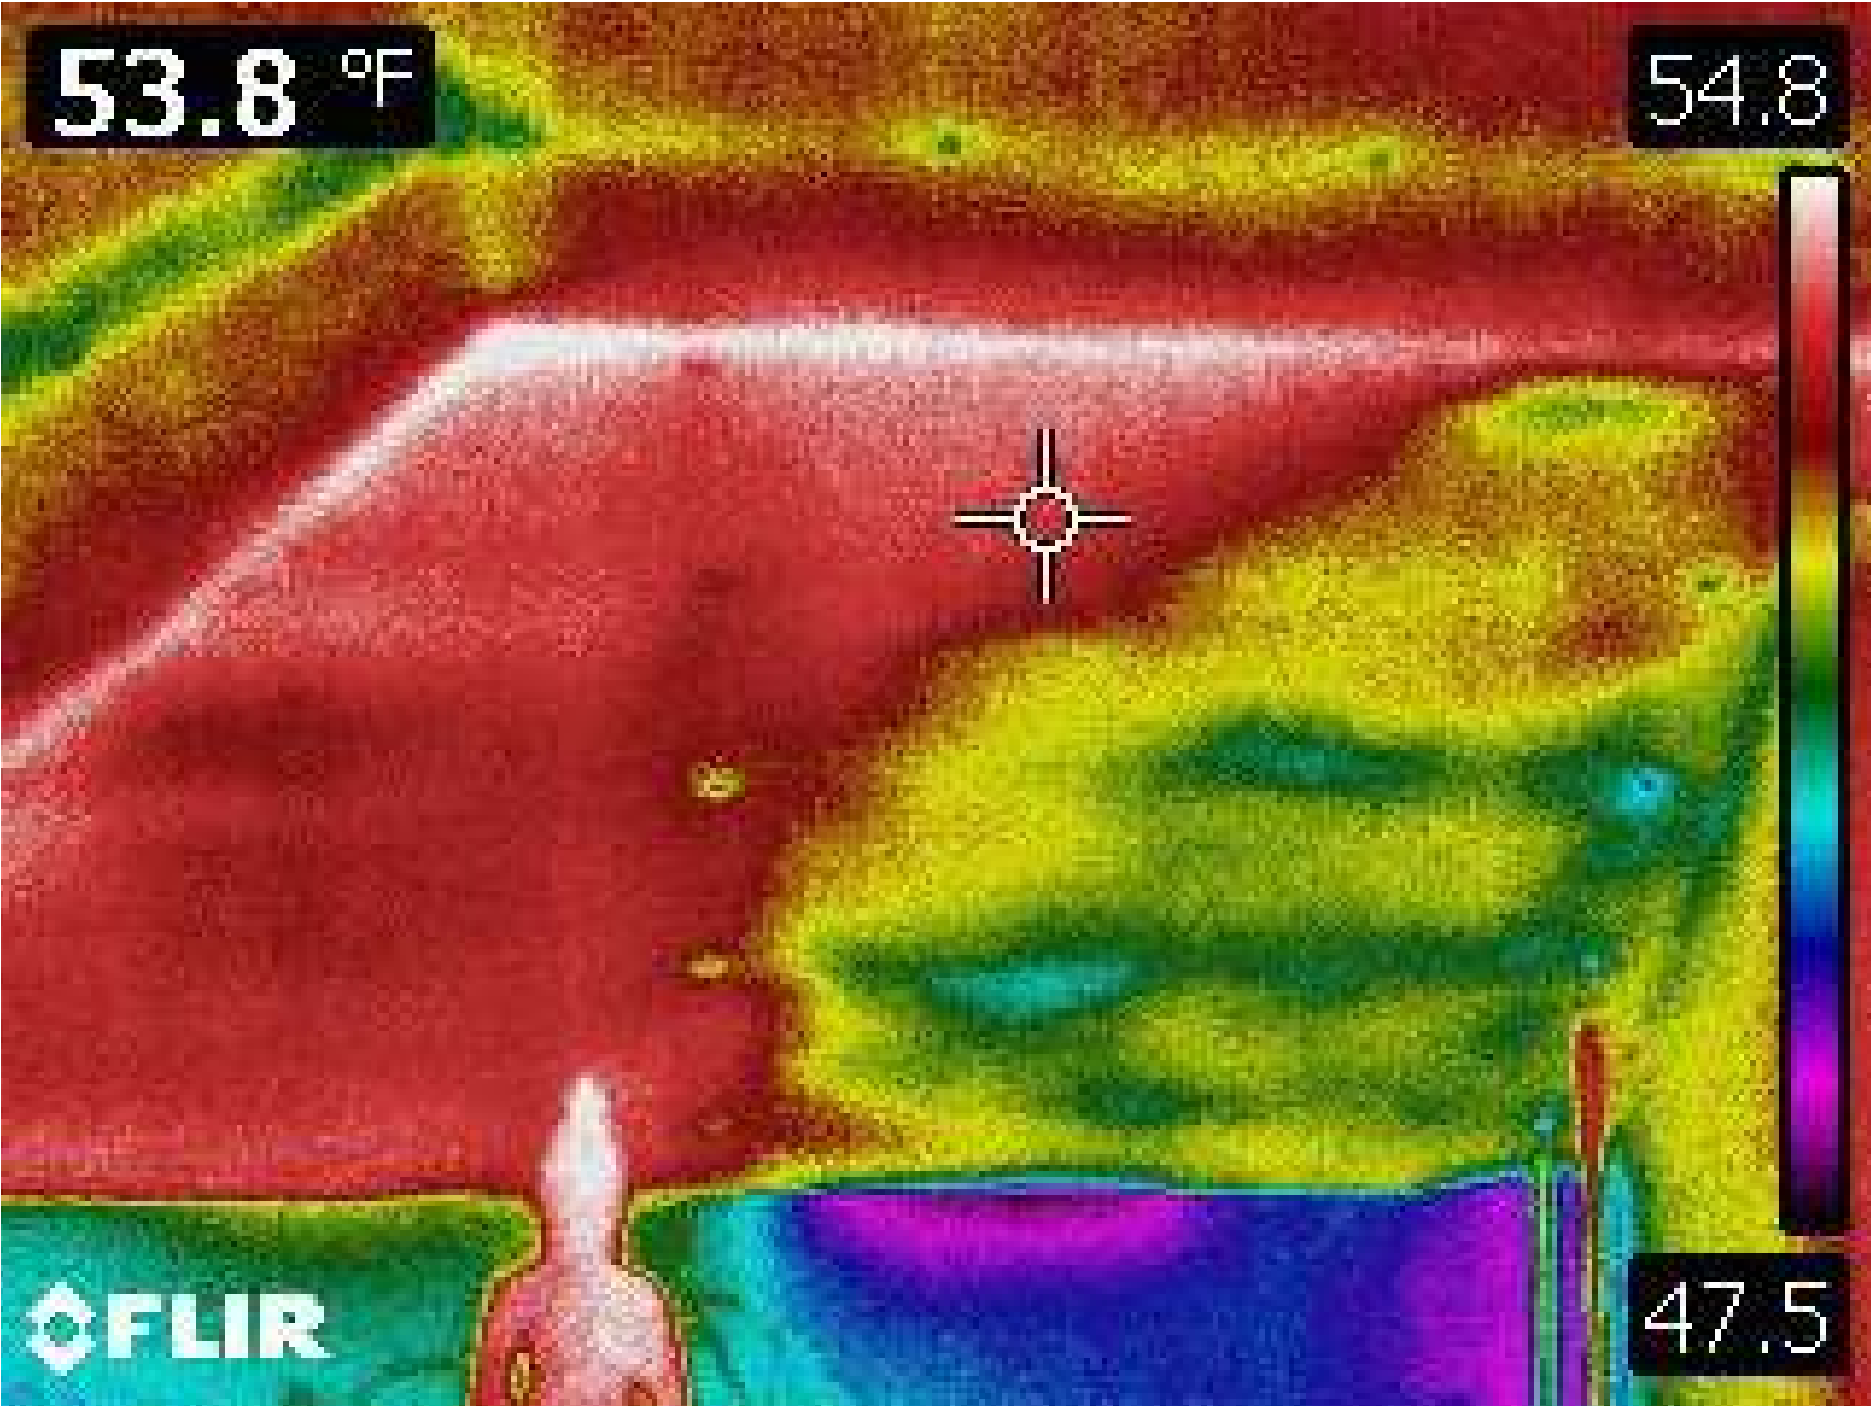
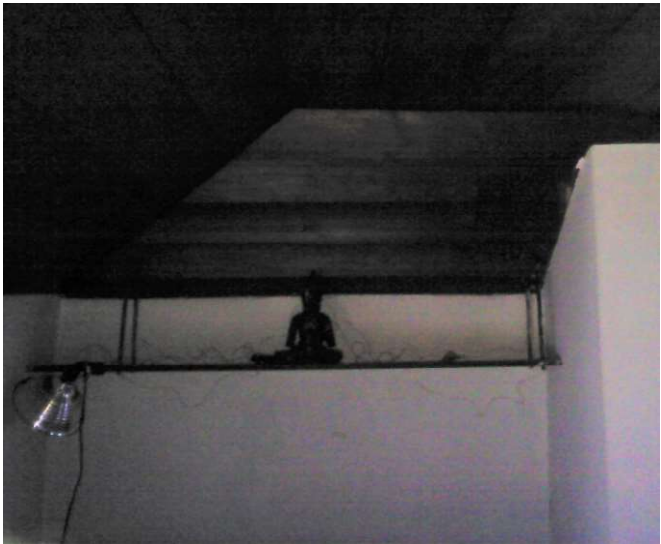
Notes: Third floor western bedroom. Heat trapped in the attic is entering the bedroom through joints in the woodwork at between the wood and masonry. Small amounts of liquid water is also likely leaking through the roof to enter the interior here.
