THE NEW HOPE EXPERIMENT: AN INVESTIGATION AND CONSERVATION PLAN FOR THE
ANTONIN AND NOÉMI RAYMOND FARM

A THESIS

Historic Preservation

MASTER OF SCIENCE IN HISTORIC PRESERVATION

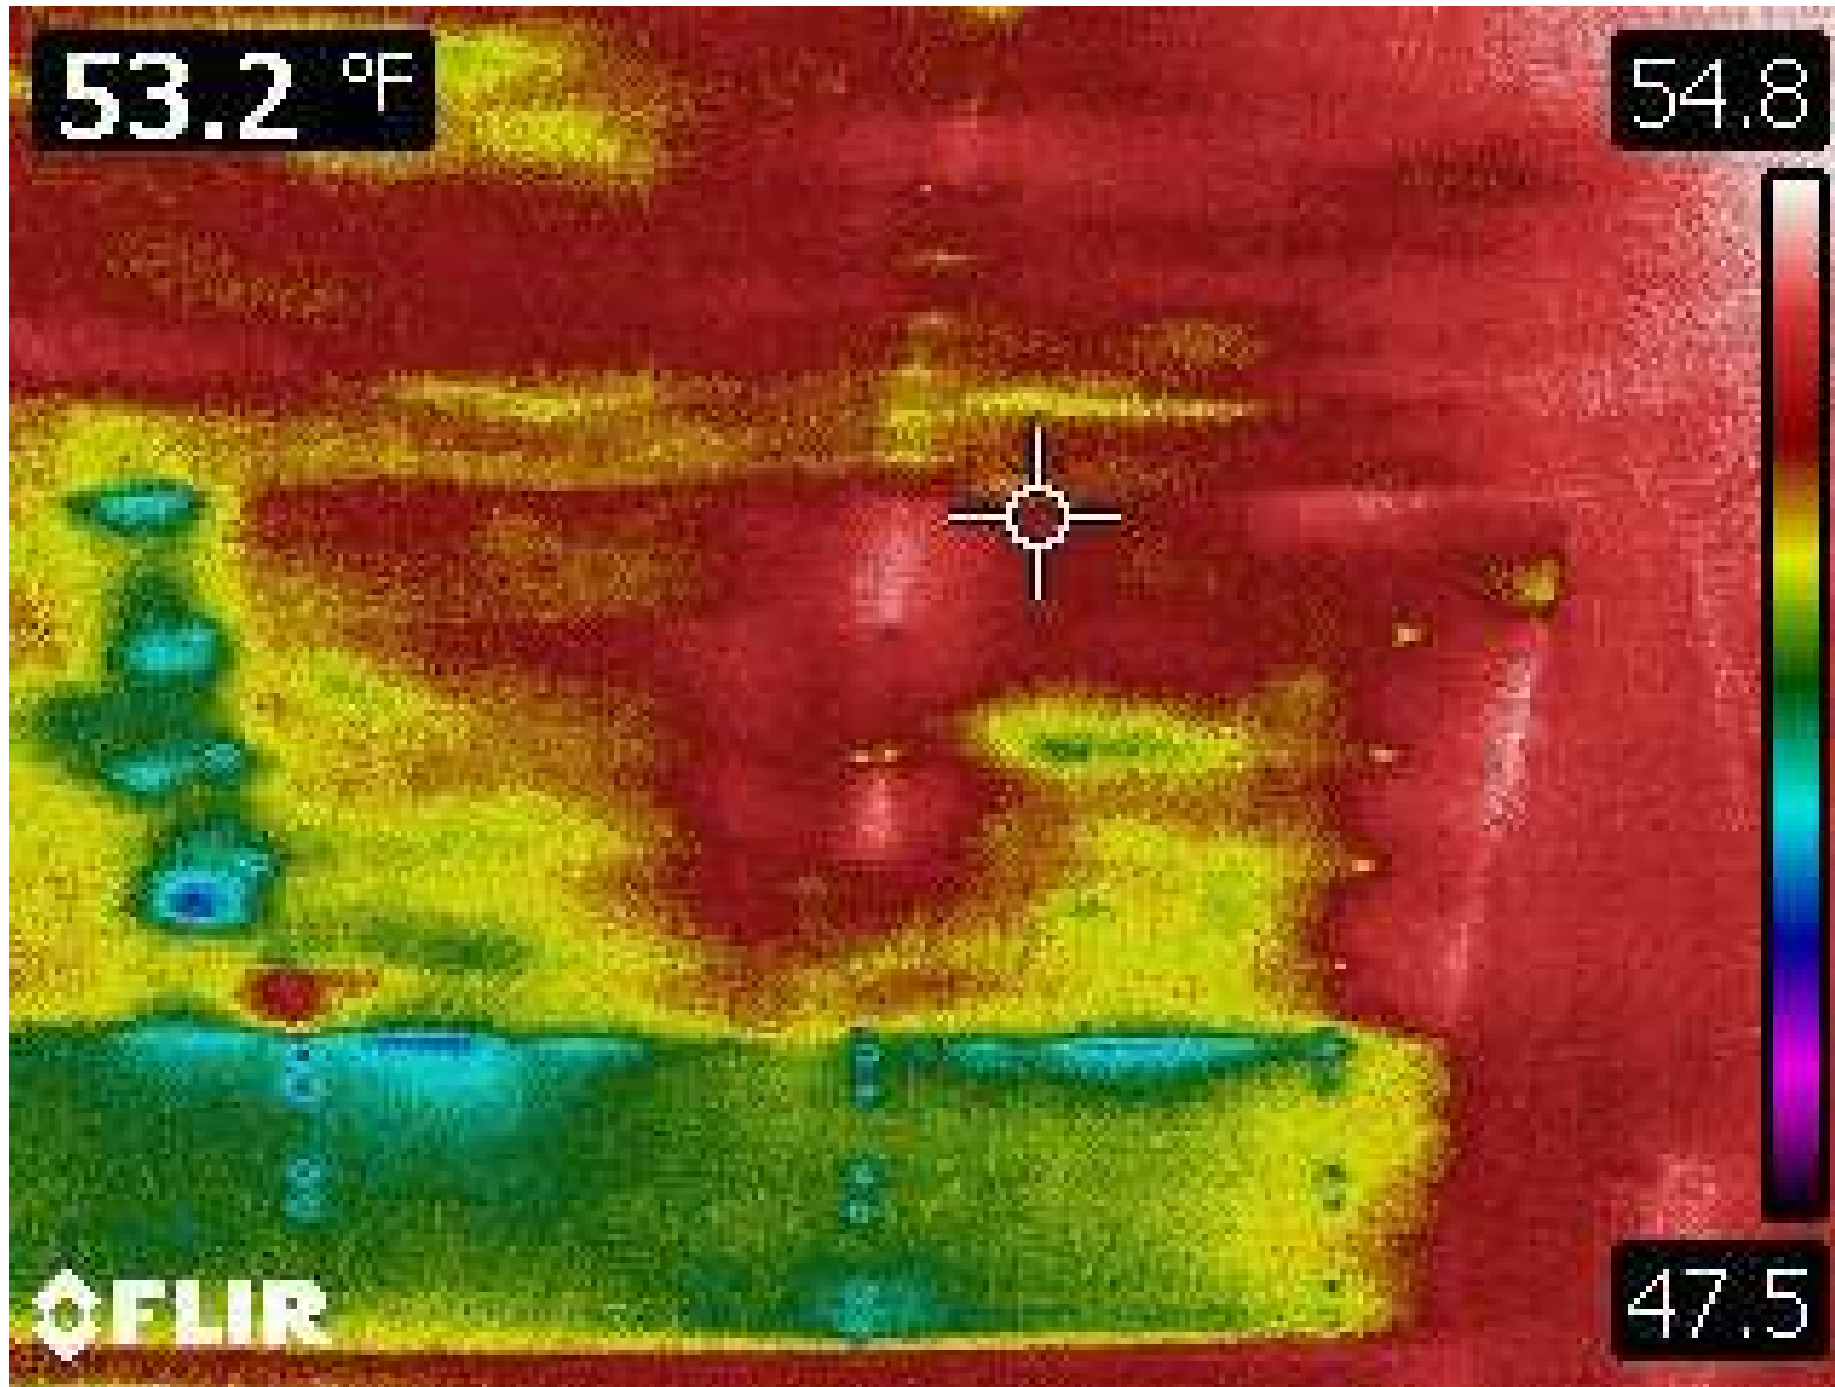
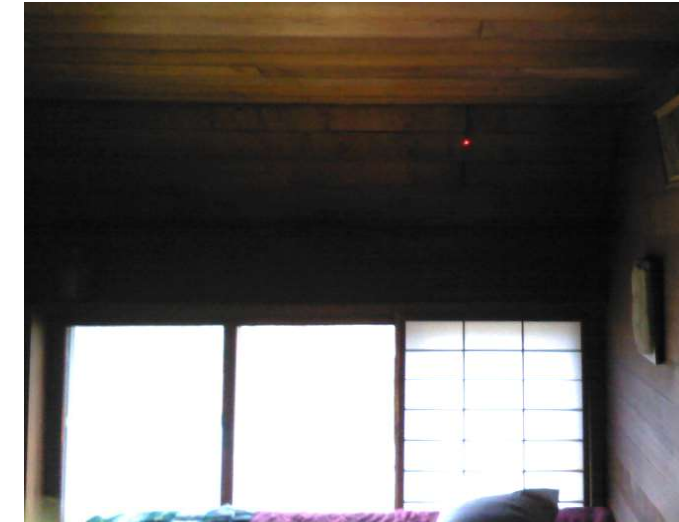
Notes: Third floor eastern bedroom south wall. Areas of higher thermal activity are areas that show black iron water staining. Mild cupping allowing heat trapped in the attic space to enter the room through crevices in the wood. Surrounding wood likely retaining heat due to higher moisture content, indicative of an active leak.

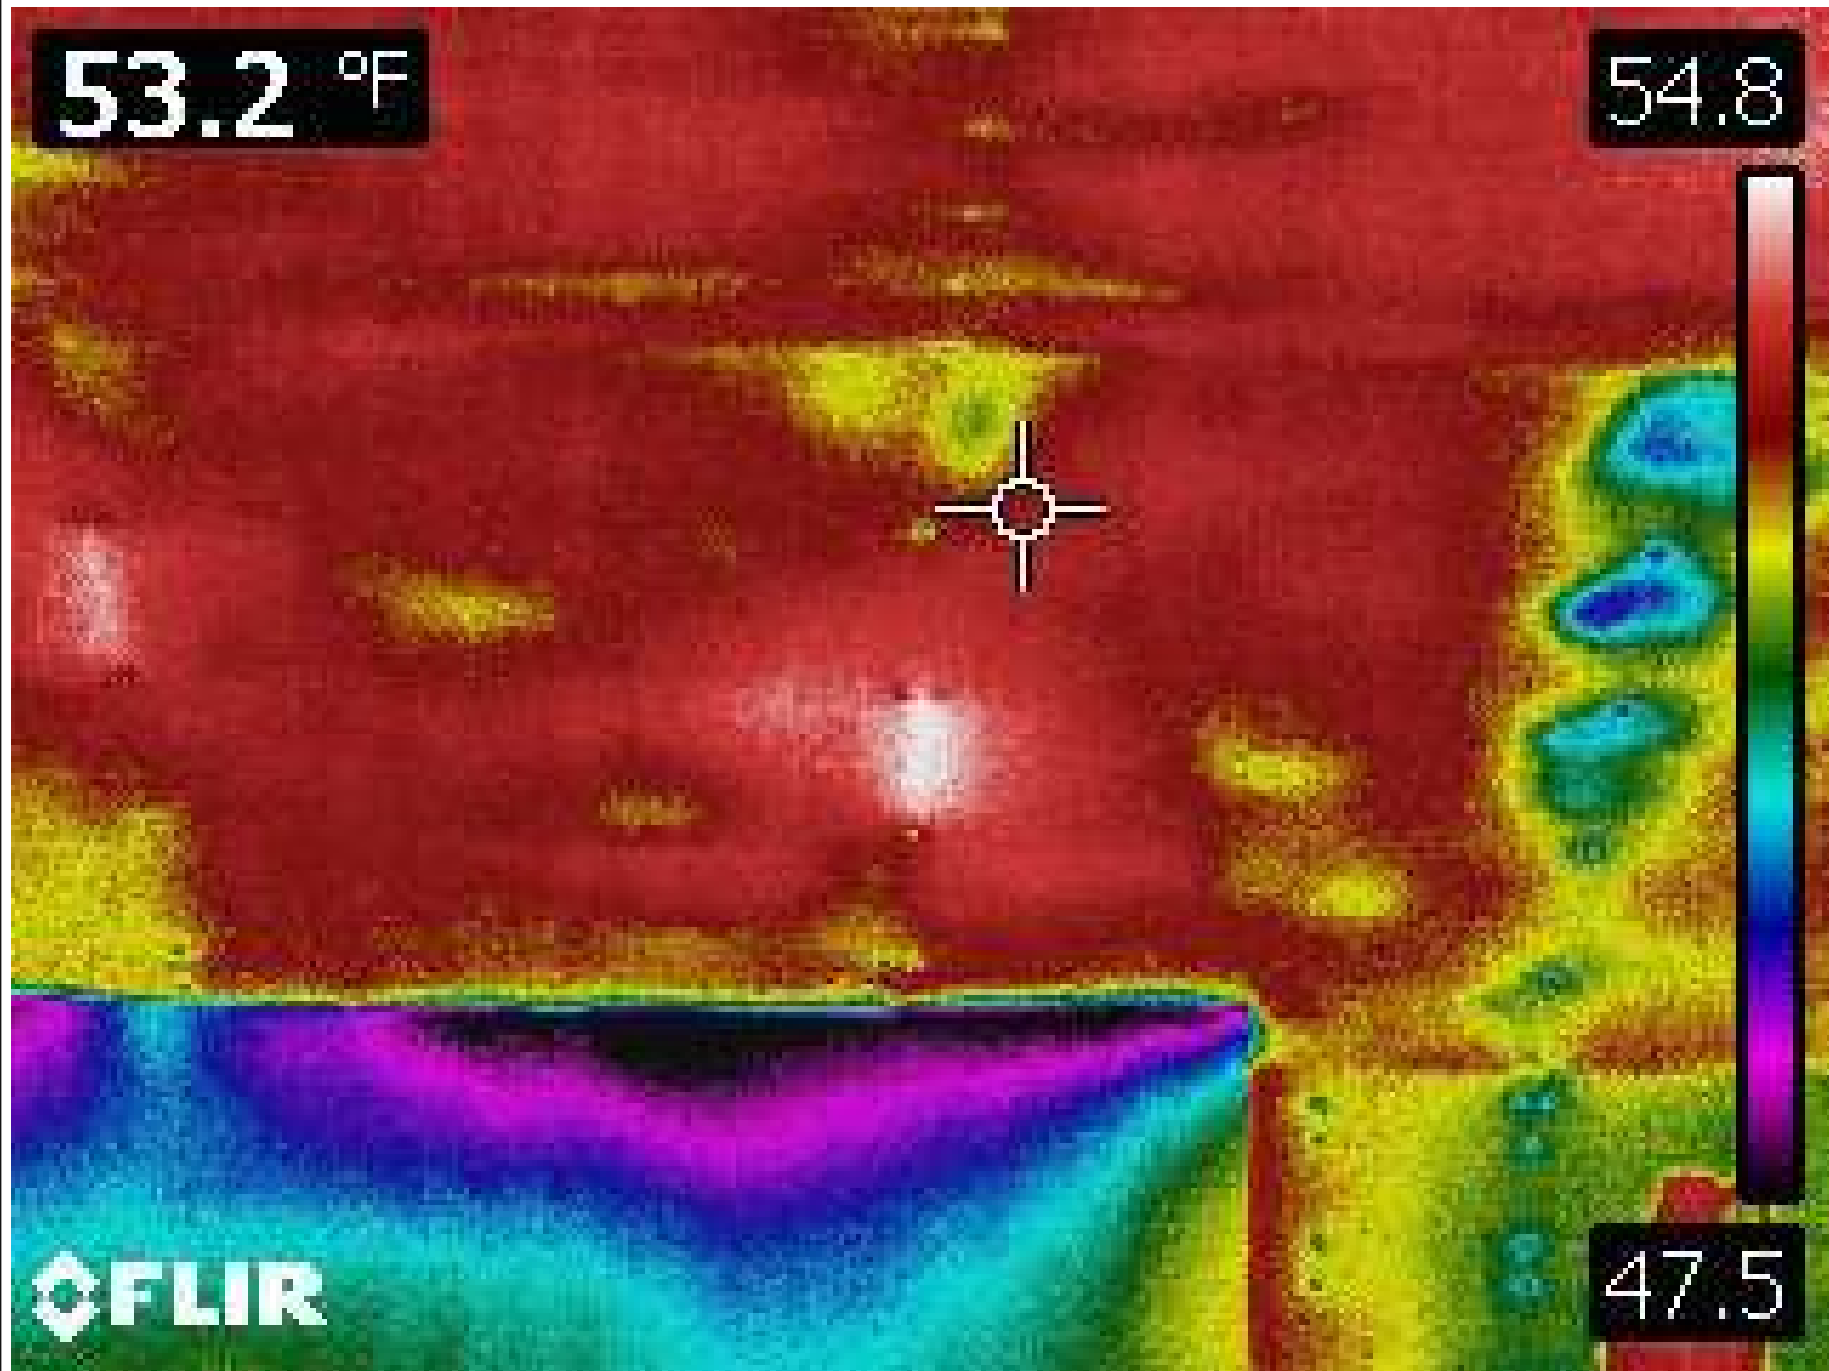
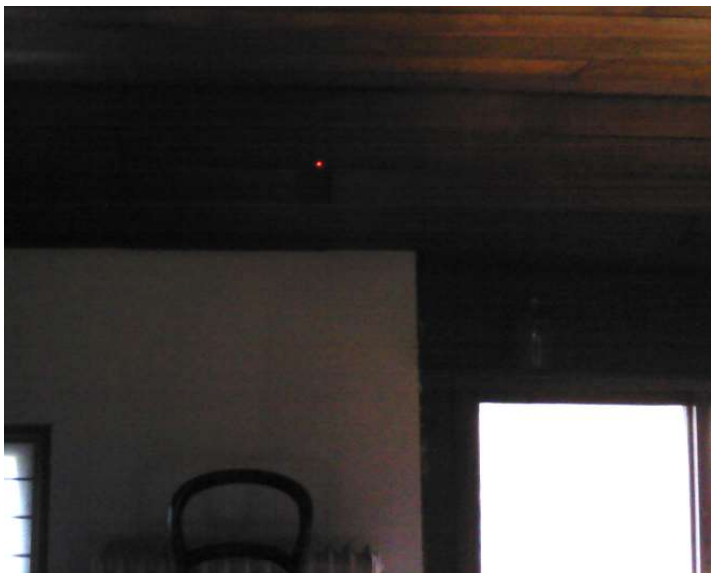
Farm House - 3-B South Interior Elevation

Notes: Third floor eastern bedroom south wall. Areas of higher thermal activity are areas that show black iron water staining. Mild cupping allowing heat trapped in the attic space to enter the room through crevices in the wood. Surrounding wood likely retaining heat due to higher moisture content, indicative of an active leak.
