CHARACTERIZATION AND CONDITIONS ASSESSMENT
OF THE
SACRISTY WINDOW
MISSION SAN JOSÉ Y SAN MIGUEL DE AGUAYO
SAN ANTONIO, TEXAS

Katherine Ann McDowell

A THESIS

1997

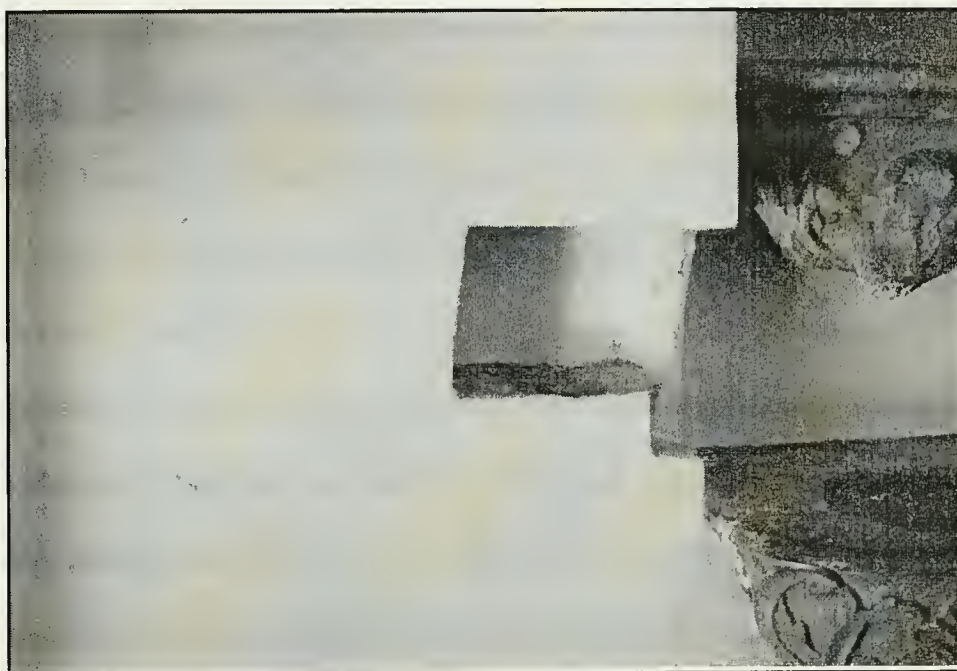
replastering job proceeded.¹²⁸ The replastering of the Sacristy was viewed by David Battle, of the National Park Service, as a remedy to the effect rather than the cause and he predicted it would fail within a few years.¹²⁹ His prediction has proved to be true. As of the summer of 1997, blistering plaster and white efflorescence can be observed in the interior of the south wall of the Sacristy and baptismal font.

Figure 9. Blistering plaster and efflorescence on the interior of the south wall of the Sacristy. (Same wall as Sacristy window.) Photographed by Katherine McDowell, June 1997.

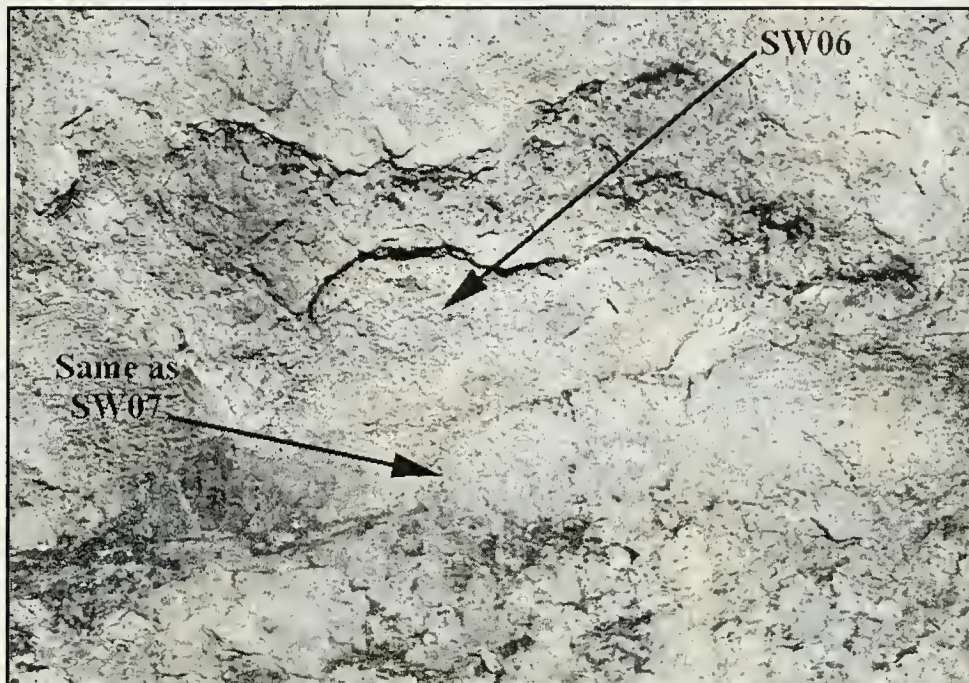
*Figure 27. Salts in the form of efflorescence adjacent to previous repair, similar to that of sample SW07.
(Photograph by Katherine McDowell, October 1996)*

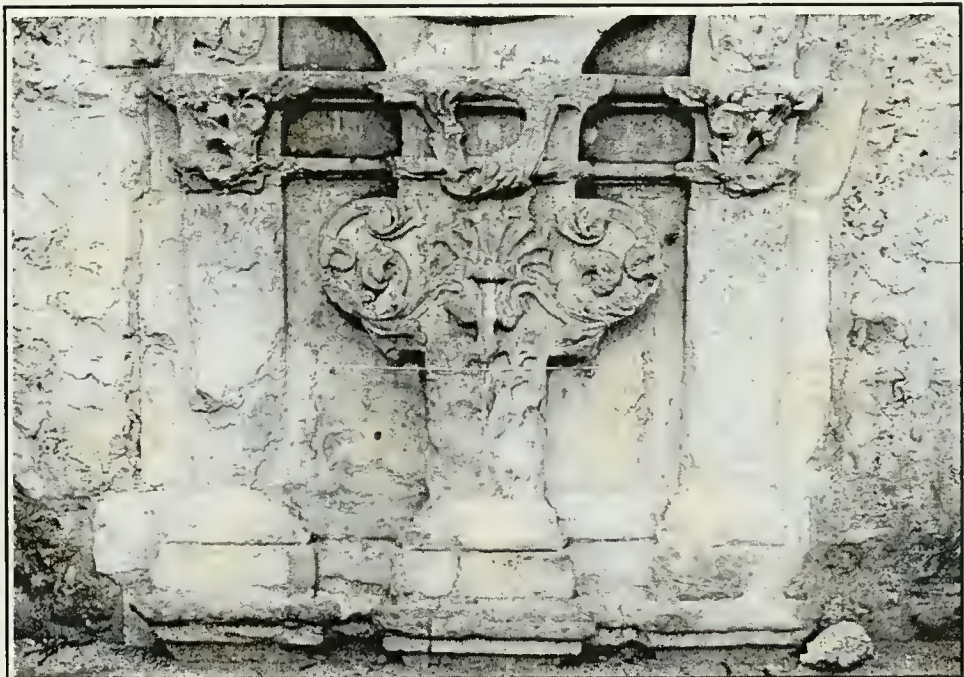
From the above data it can be concluded that moisture (from all sources but primarily ground water), salts, previous repairs, and specific faced-bedded limestone blocks are all assisting in the selective decay of a soft and permeable stone of variable composition. The stone is subject to differential erosion due its heterogeneous characteristics. The natural action of weathering is able to dissolve the weaker zones of the chalk. The combined action of water in the form of rising damp, soluble salts, and the stress of mortars which are harder than the stone, are accelerating this natural decay as evidenced at the base of the Sacristy window.

Figure 29. Base of Sacristy window in December 1996.

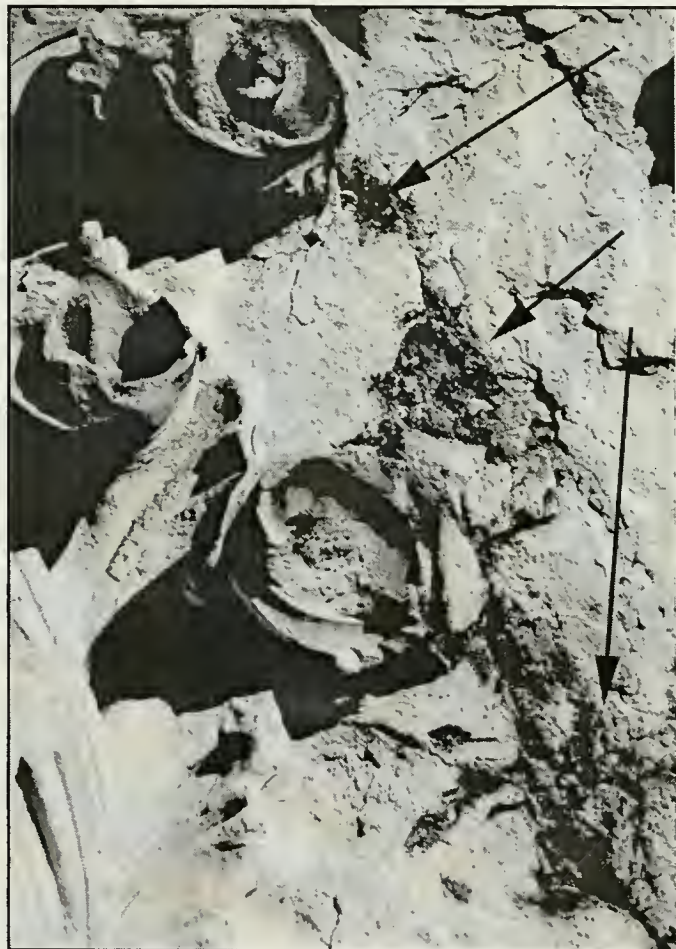
Figure 30. Biological growth.

Presence of microflora often found in association with cracks and delamination in areas of high moisture. Black fungal growth occurs in the area of the cornice and at the upper right side in an area of moisture. This condition is linked to a faulty *canales* and parapet design, which has allowed water to run down the face of the Sacristy in this area. The biological growth may also be aiding in the delamination of the stone, as organisms grow in small fractures and pores taking advantage of trapped moisture found in them. Projecting elements, which have contact with water, display this black microflora. Austin chalk also blackens in the quarry wherever it is not protected by a projecting element.

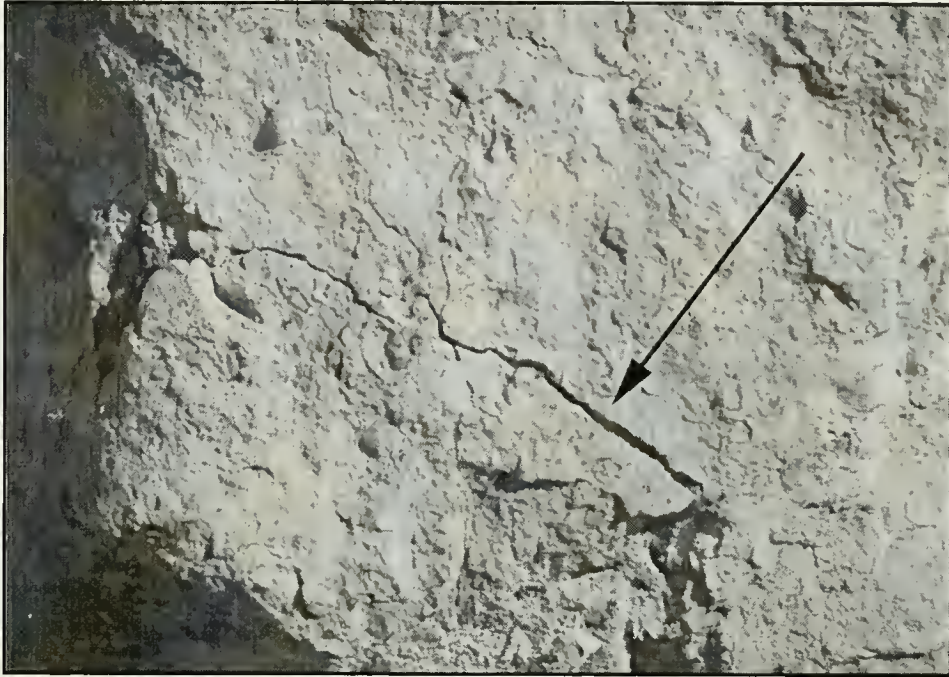
Figure 31. Cracking

(1) Narrow fractures (2 to 10mm in width) of variable length, width, depth, and orientation. Cracks occur predominantly in areas of active detachment.

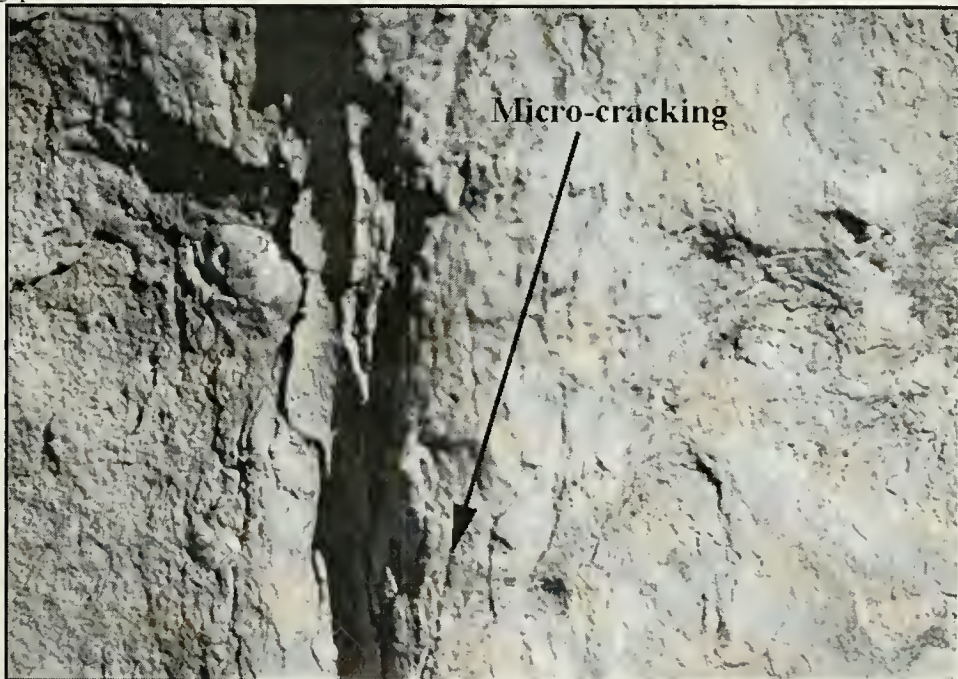
Figure 32. Micro-cracking

(2) Micro-cracking (less than 2mm wide): Localized cracks confined to a single block and linked to an inherent weakness within the stone, like the small fissures between bedding planes. Surface Area: 18 cm²

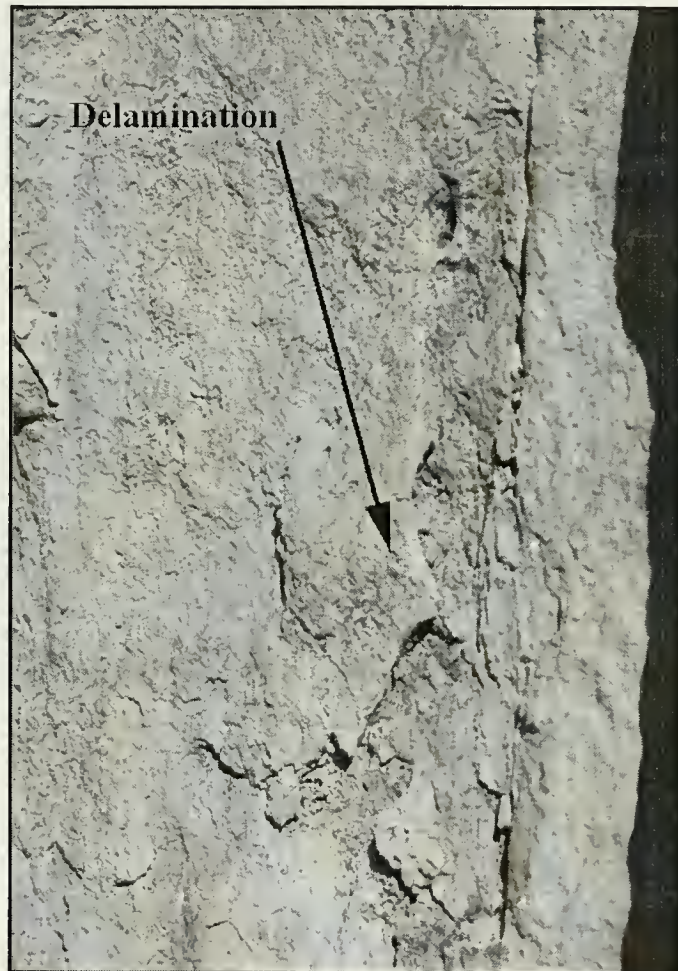
Figure 33. Delamination

The detachment and often partial loss of one or more surface layers of stone parallel to each other and in association with bedding and stone orientation. This condition occurs widely in the area in between the pilasters at the base of the window, where the stone appears to be “face bedded”, oriented at bedding planes parallel to the surface.

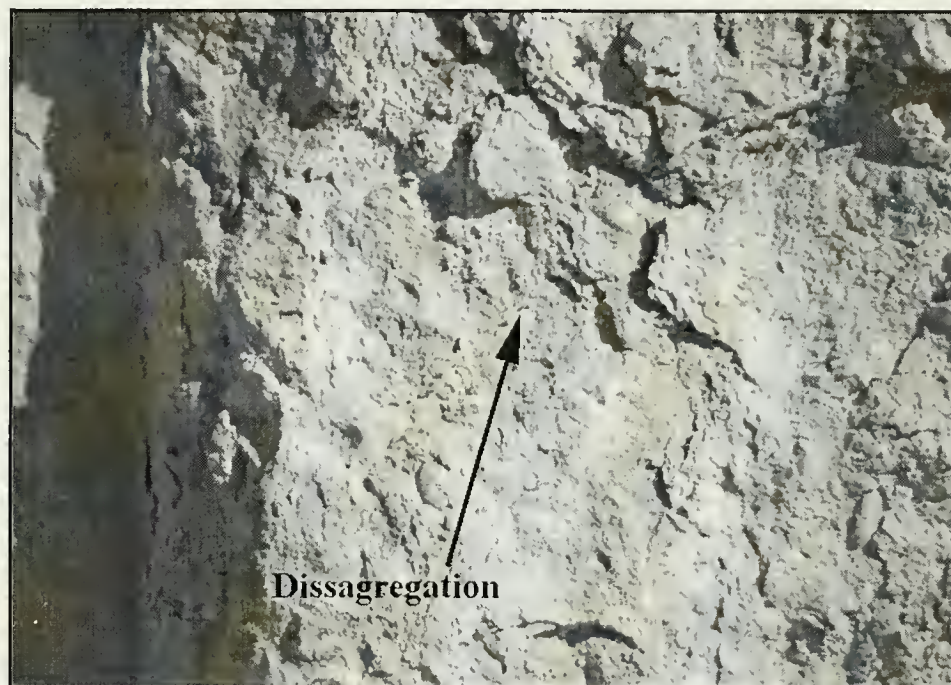
Active detachment of grains resulting in a rough texture or granular appearance, and an overall friability of the stone surface. The condition predominates at the base and localized areas in the window surround. This condition is caused by moisture, salt crystallization, and wet-dry cycling.

Figure 34. Disaggregation occurring adjacent to ridges of bedding orientation.

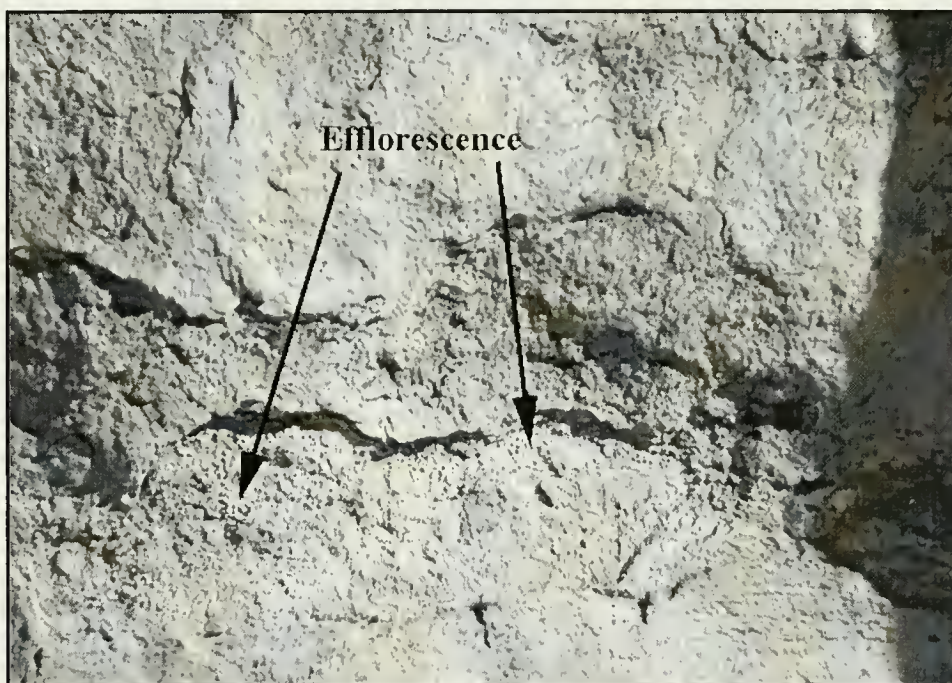
Figure 35. Efflorescence

White crystalline surface deposits composed of water-soluble salts, often found in areas of water penetration. The cause is normally the penetration and capillary rise of ground water and associated soluble salts through the stone. As the stone dries, these salts crystallize on or below the surface of the stone. Salts are also transitory, moving to increasingly higher areas of the window's base. The wet-dry cycling causes delamination and flaking due to the internal disruptive pressures of the crystallized salts in the stone pores. This condition occurs only at the base of the window in areas adjacent to cementitious repairs.

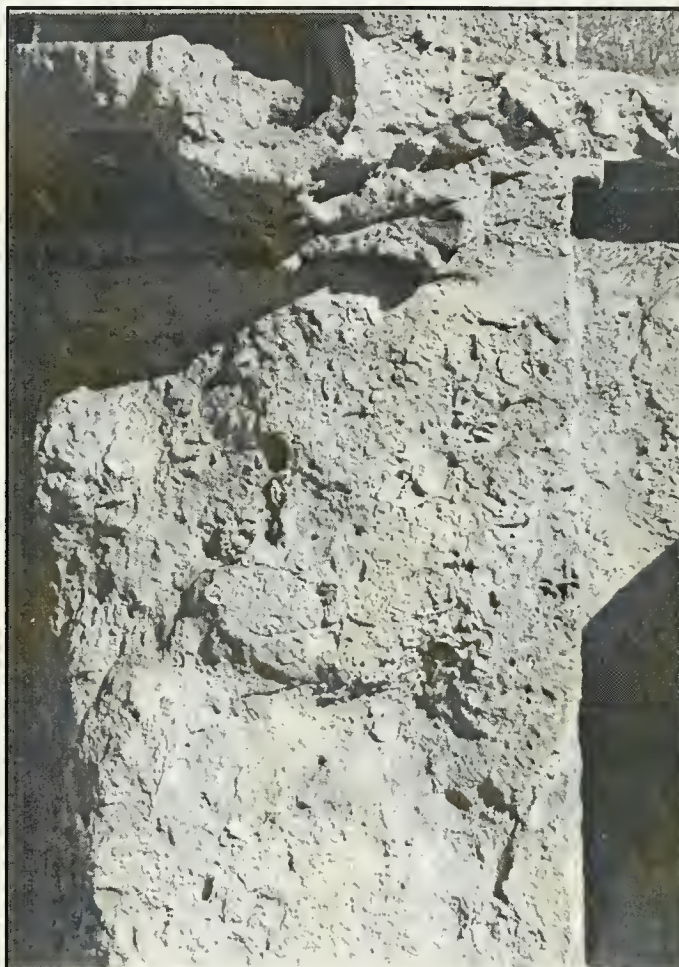
Figure 36. Erosion

Loss of surfaces, edges, corners, or carved details of the stone resulting in rounded and blurred details. This condition occurs predominantly in the area of the pilasters.

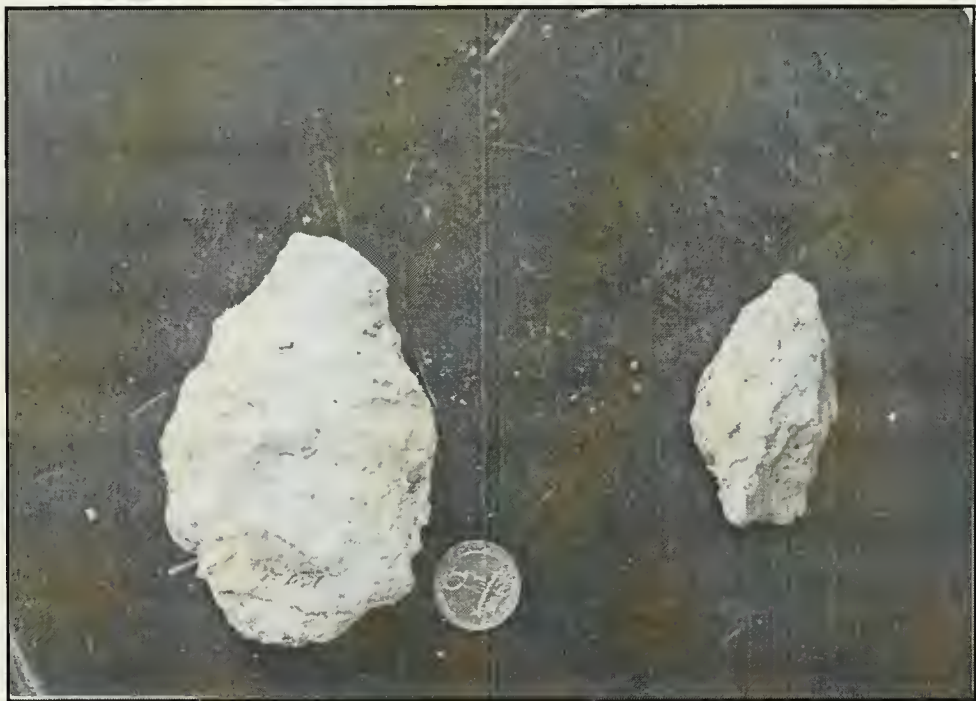
Figure 48. Active decay found at base of Sacristy window in June 1997.

The newly exposed surface is covered with efflorescence, further illustrating the damage active salt crystallization is causing to the stone.

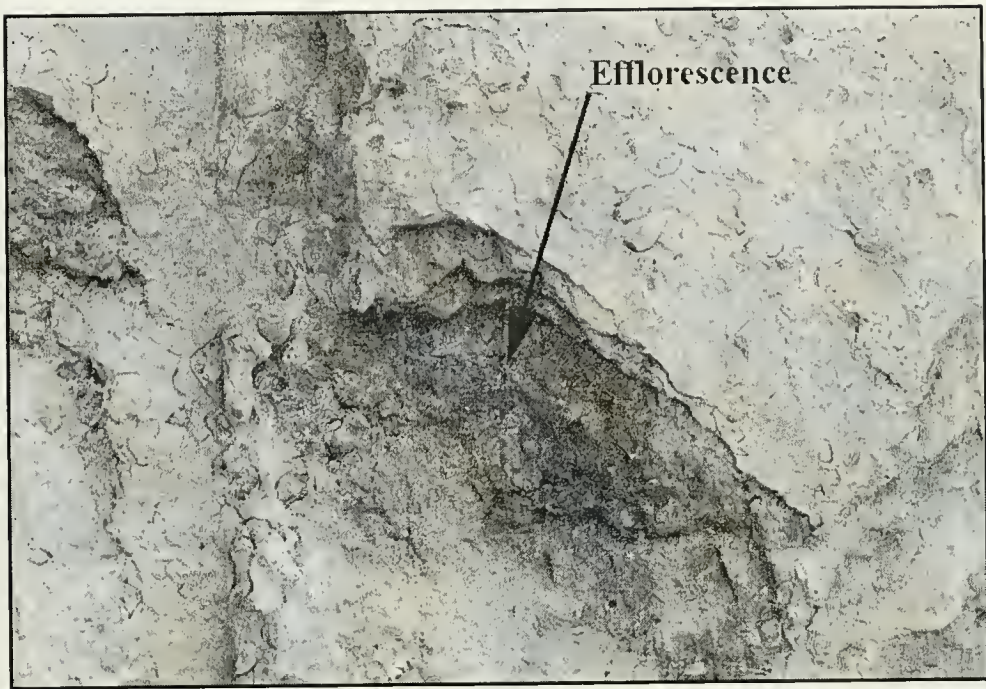
Figure 49. Detail of left pilaster in June 1997. This area can be compared with the photograph illustrating “Cracking” in the Condition Survey Glossary, which was a photograph taken in January 1997.
