# MANAGING CHANGE: THE ROLE OF DOCUMENTATION AND CONDITION SURVEY AT MESA VERDE NATIONAL PARK

FRANK G. MATERO

**ABSTRACT**—The approximately 600 cliff dwellings in Mesa Verde National Park in Colorado represent the apex of architectural sophistication of the Northern San Juan Ancestral Puebloan culture. The cliff dwellings, the final product of 600 years of cultural development on the Mesa Verde, were built between A.D. 1200 and 1300, and were abandoned shortly thereafter. The spectacular setting and the well-preserved state of these masonry structures and their surface finishes resulted in Mesa Verde's being the first nomination by the U.S. government to the World Cultural Heritage Sites List. Moreover, descendants of these ancient peoples, the Pueblo Indians of Arizona and New Mexico, continue to venerate these sites, representing a cultural continuity unique for North America. Excavation and preservation have been continuous since Mesa Verde became one of the first national parks in 1906. The structures interpreted to the public have been preserved over the years with a minimum of repair and replacement, resulting in a cultural resource of great integrity and authenticity.

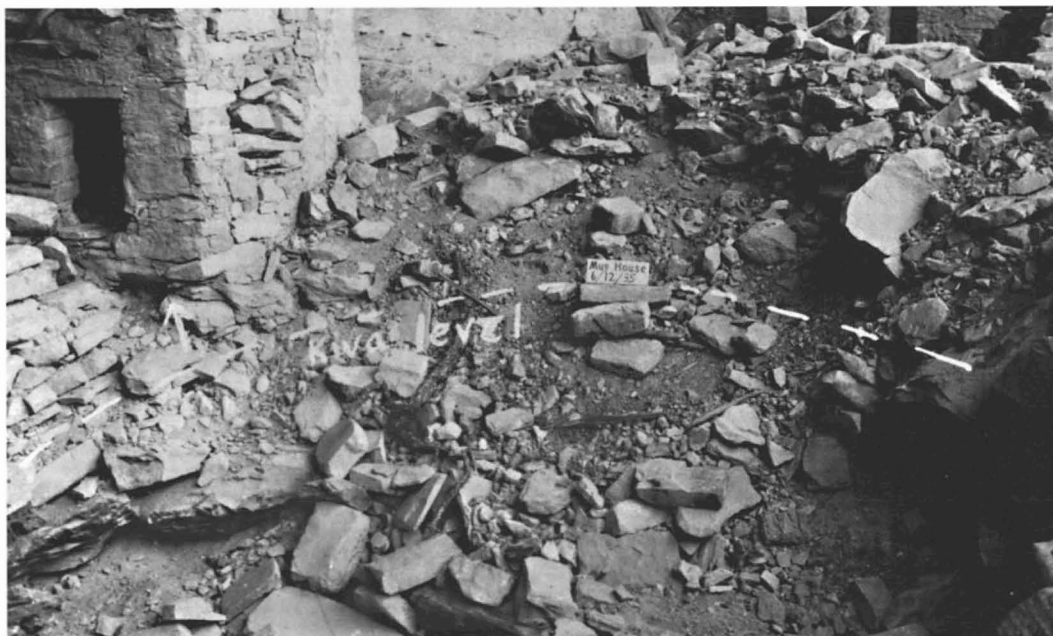
Fig. 9. Kiva C. Mug House, 1935, before repair. Courtesy of NPS-MEVE

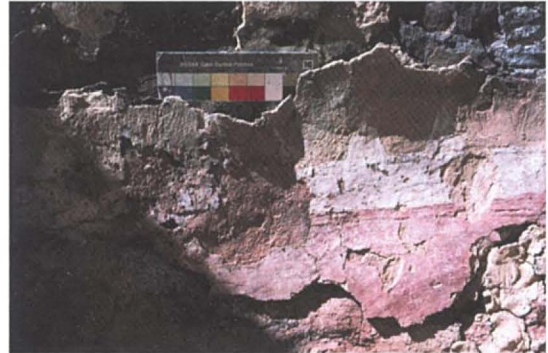
Loss of bond between the plasters and their masonry substrate occurs as either open or blind separation. This loss is found as a narrow linear zone across much of the upper top edge of the lower banquette wall. It is a discrete condition often occurring in conjunction with total or partial loss since excavation (recorded as "loss since Rohn"; see fig. 6, page 60) due to exposure and failure resulting from wet/dry deformation and stress cracking, debris accumulation pressure, and falling damp.

Fig. 4. Mug House, Kiva C, 1995, showing detail of detachment, delamination, and flaking before treatment. Courtesy Architectural Conservation Laboratory, University of Pennsylvania

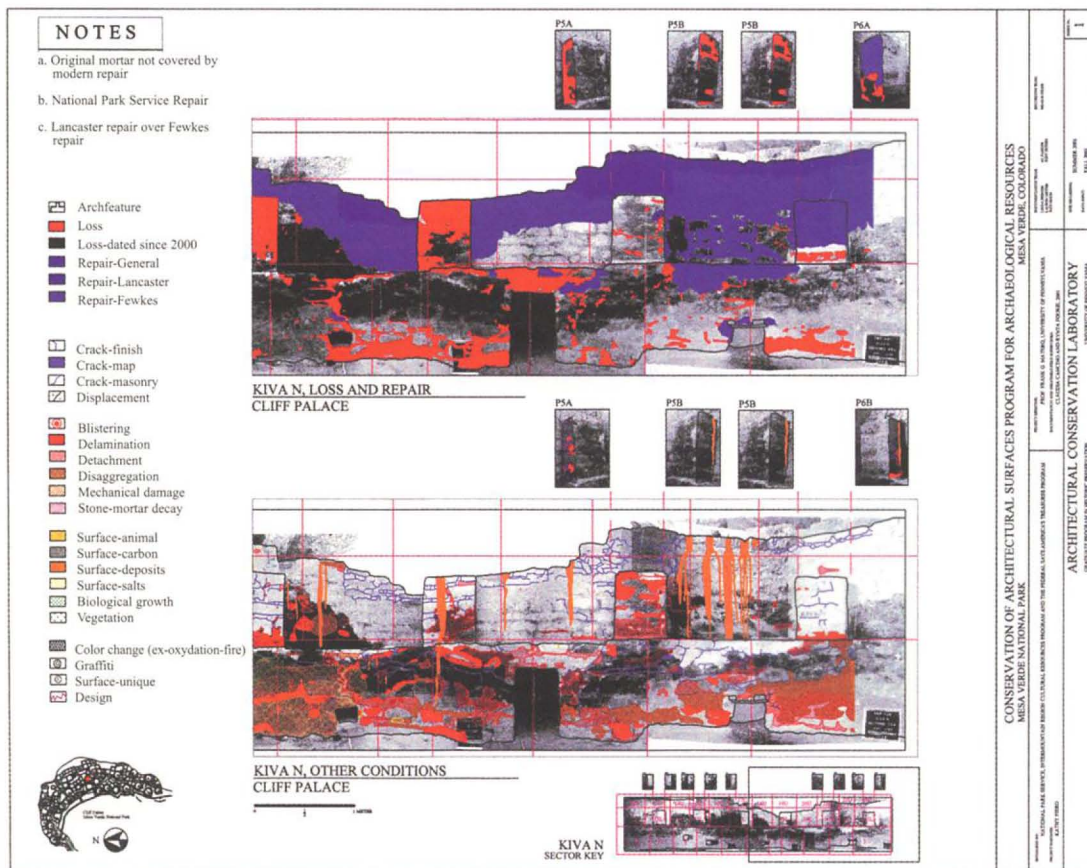
Fig. 5. Elevation montage of Kiva N, Cliff Palace, conditions. Courtesy Architectural Conservation Laboratory, University of Pennsylvania

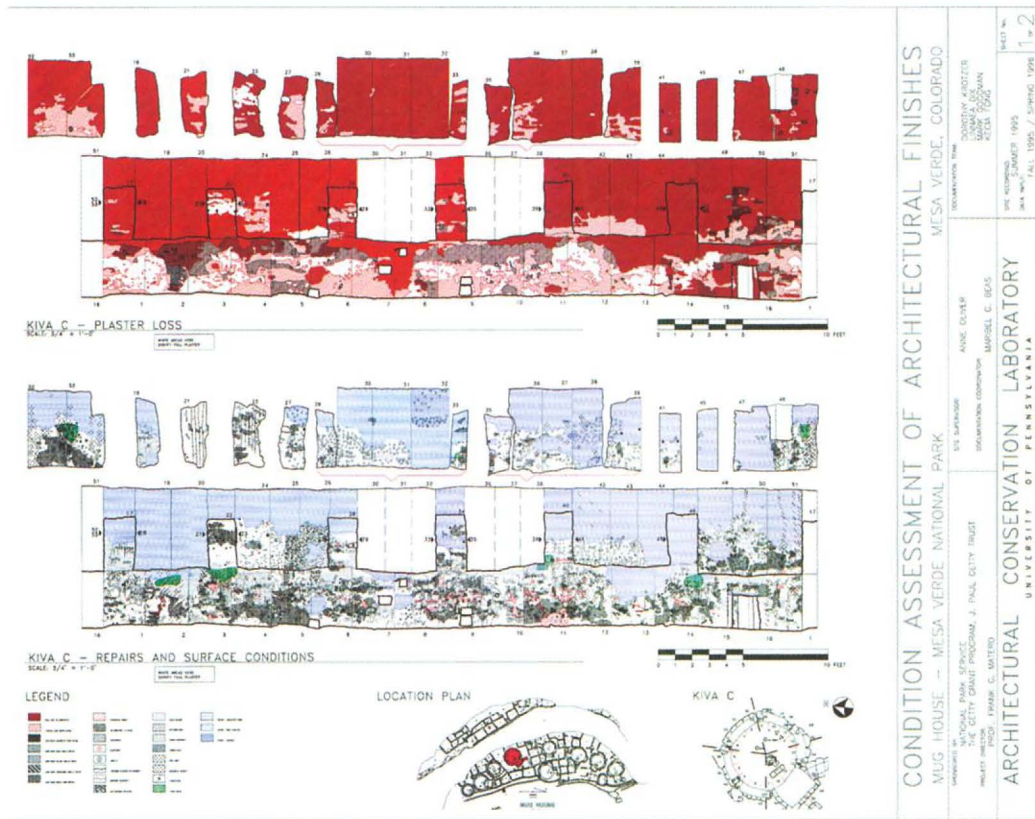
Fig. 6. AutoCAD elevation of Kiva C, Mug House, showing all recorded conditions, past and present. Courtesy Architectural Conservation Laboratory, University of Pennsylvania

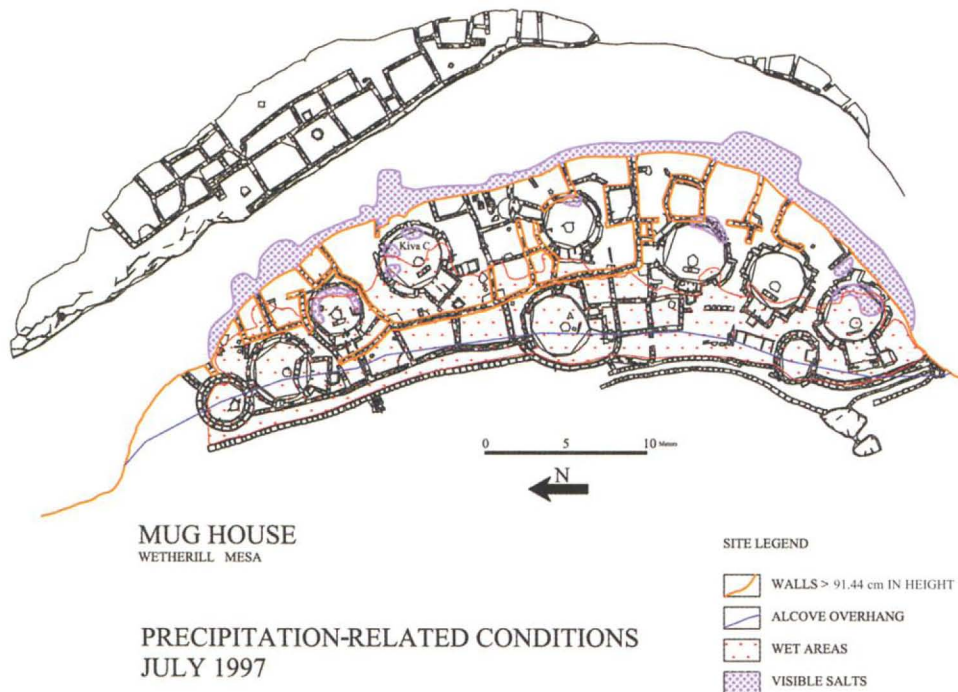
- Room/space location and orientation, in terms of exposure and grade, are significant factors in determining the overall condition of the stone, mortar, and architectural finishes of alcove sites, all other factors being equal. This relationship is due predominantly to the deleterious effects of water on the earthen materials either as direct precipitation (melting snow and rain) or as groundwater from percolation and rising damp through the sandstone (fig. 7, see page 60).

Overall patterns of groundwater emergence for the entire alcove are further complicated by the orientation of the north-south dip of the alcove's shaley layers, which affects the location and quantity of water emerging from the rock. For example, those kivas and rooms located along the rear of the northern half of Mug House, upslope of the shaley seam, exhibit far more salts, presumably due to the initial discharge of water at this end. Conversely, rooms along the rear of the southern half, downslope of the shaley seam, display less efflorescence and water damage where protected from wind-driven rain and snow.

Fig. 7. Plan of Mug House showing field-observed patterns of precipitation and active efflorescence. Courtesy Architectural Conservation Laboratory, University of Pennsylvania

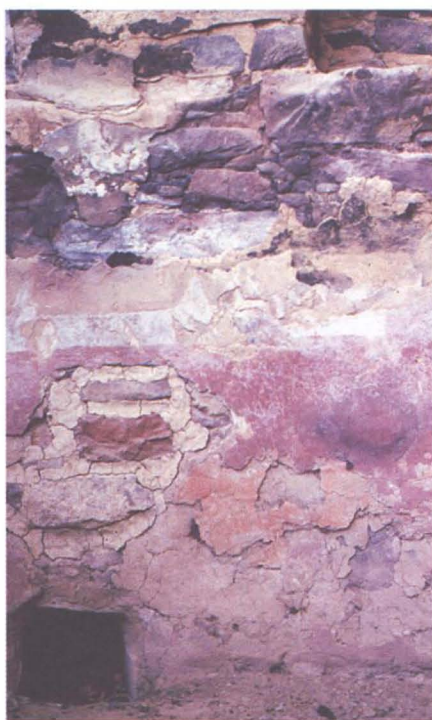
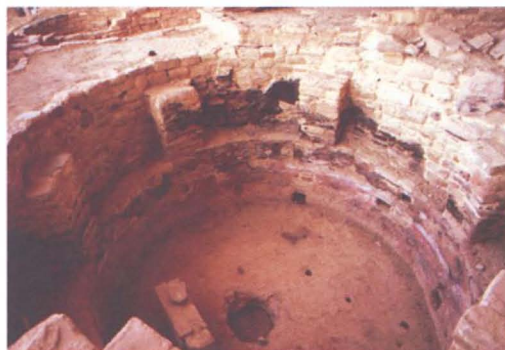
In Kiva C (and most other kivas), nearly all loss has occurred across the upper walls and along the upper quarter of the lower banquette walls (fig. 8, see page 61). This loss pattern is due to the overall vulnerability of these areas to weather exposure during occupation from roof leaks (prehistoric repairs are often found in the upper walls), after abandonment from associated roof collapse, and after excavation and rebuilding during stabilization. Early prestabilization photographs of Kiva C (1935) show masonry and roof collapse, exposed upper walls, and total plaster loss (fig. 9). The lower banquette walls—being concealed and possibly protected by fallen roof and debris—were observed in 1935 to be generally intact, a situation common for many kivas in cliff sites. A comparison of the extent of surviving plaster evident immediately after excavation and stabilization in 1959–60 to today overwhelmingly illustrates the loss of plaster that often results after excavation. At Kiva C more than 25% (surface area) of the existing plaster finishes recorded in 1960 was subsequently lost over the next 40 years of exposure, most of the loss occurring along the upper banquette.

Fig. 8. Kiva C, Mug House, north end, 1994, before treatment. Courtesy Architectural Conservation Laboratory, University of Pennsylvania

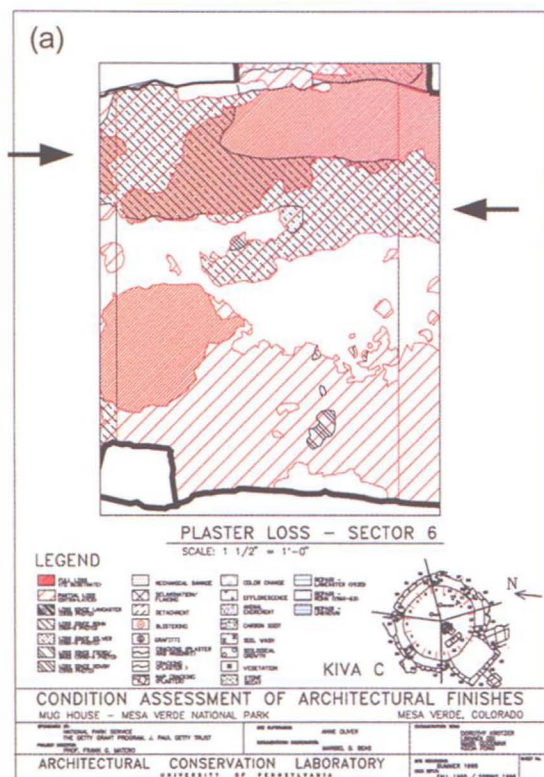
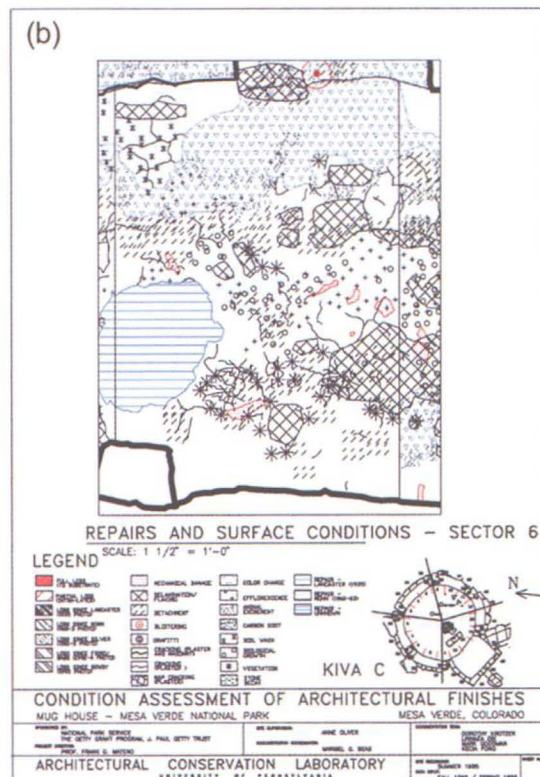
Note areas of loss since excavation (1959–60).

Fig. 10. Kiva C, Mug House, Sector 6-conditions. Arrows indicate areas of loss since excavation (1959–60) in a. Sector 6 photo elevation and condition drawing. Courtesy Architectural Conservation Laboratory, University of Pennsylvania

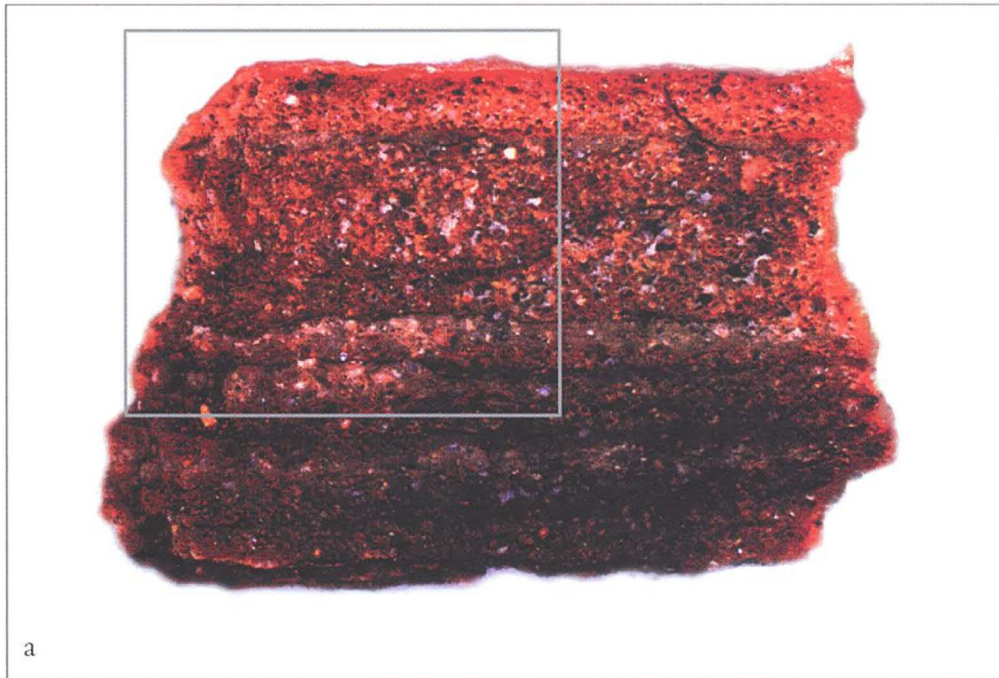
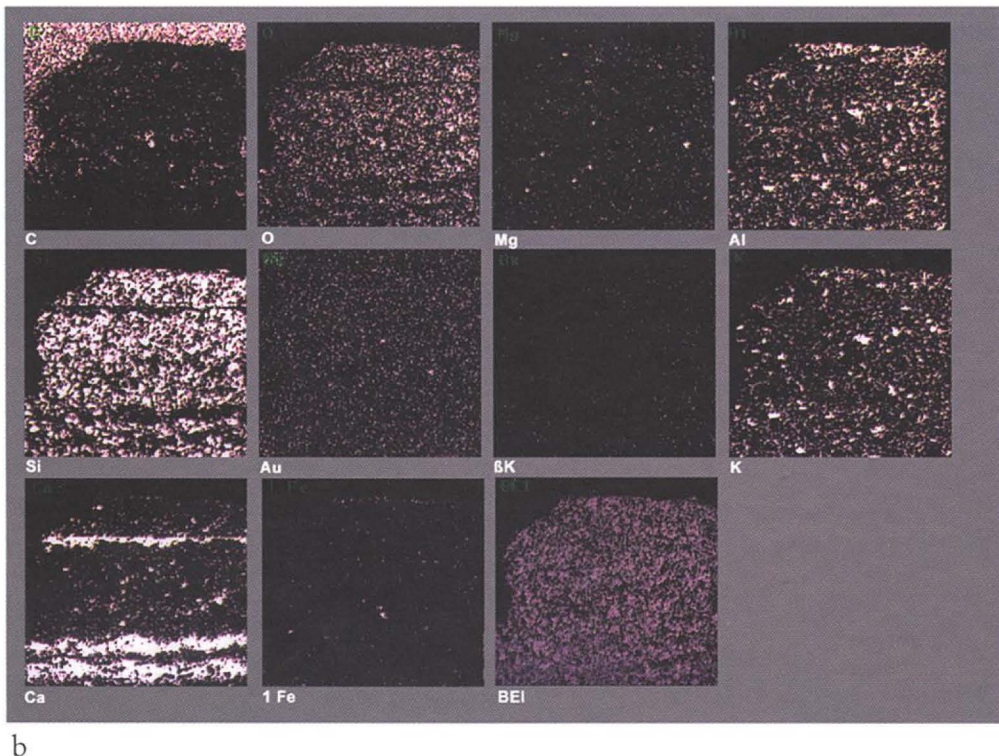
tion, is without doubt a significant factor in finish condition. With very few exceptions, each plaster layer applied probably represents a single campaign, evidenced by heavy carbon soot buildup and separation fractures that often occur between layers over time. Of all the building and room types, kivas, without exception, contain the greatest number and most complex application of surface finish layers and intralayer soot deposits (fig. 12, see page 63). This condition may well be due to the largely ceremonial

Fig. 12. Kiva C, Mug House, cross section, 25x in reflected light (a) and SEM electron dot map of sample 06 from lower dado wall identifying elemental composition of layers (b) (Dix 1996). Courtesy Architectural Conservation Laboratory, University of Pennsylvania
