EVALUATION OF COMPARATIVE REPAIR METHODS FOR STONE

A THESIS

Historic Preservation

2019

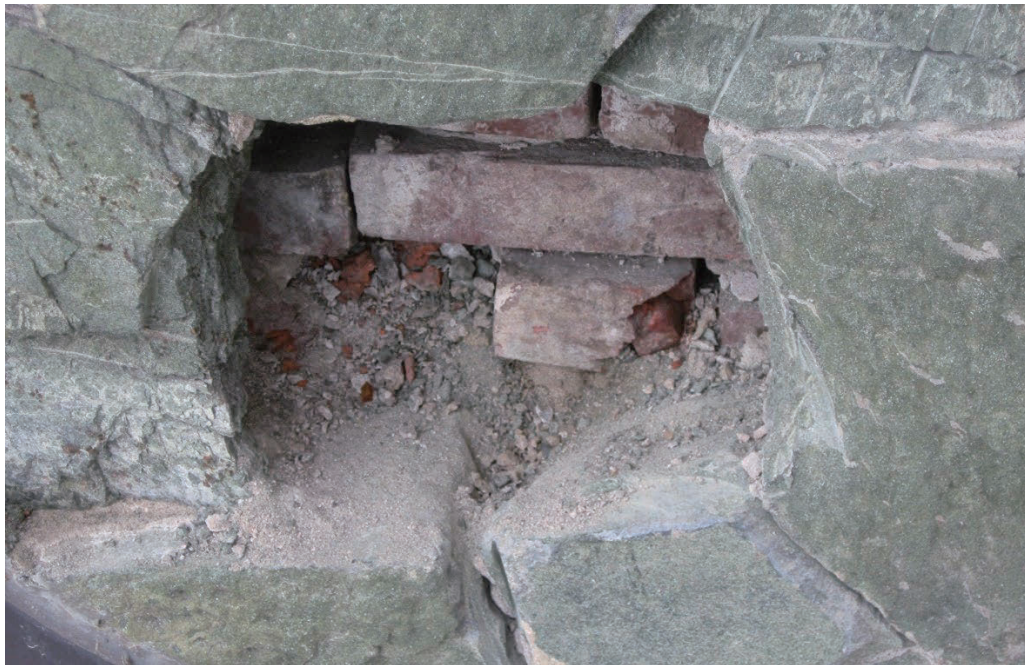
Figure 41. Parts of the back-up masonry were infilled with brick; it is not known if they are original or from subsequent repairs. (Courtesy of Caretti Restoration & Preservation Services, L.L.C., 2011)

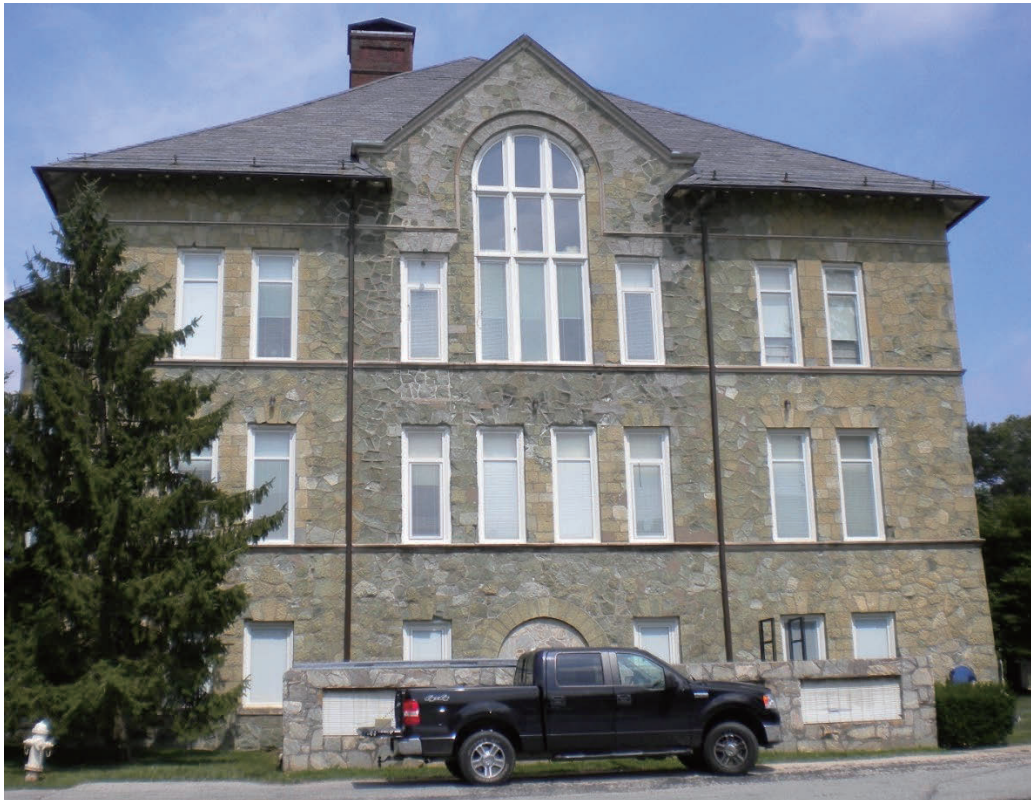
Figure 43. Pre-construction photograph of east elevation, Recitation Hall. Note the deteriorated stones below the third story window sills and on the gable. (Courtesy of Caretti Restoration & Preservation Services, L.L.C., 2010)

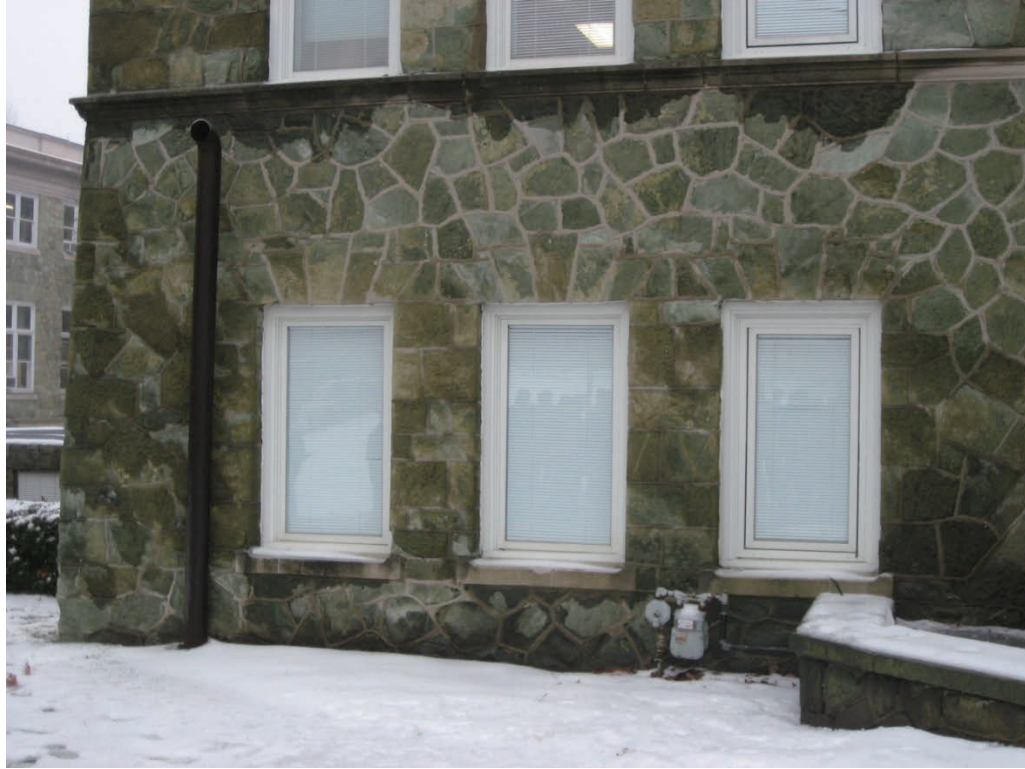
Figure 44. Stone underneath window sills are generally in worse condition. Note the dark stains formed from moisture accumulation. (Courtesy of Caretti Restoration & Preservation Services, L.L.C., 2009)

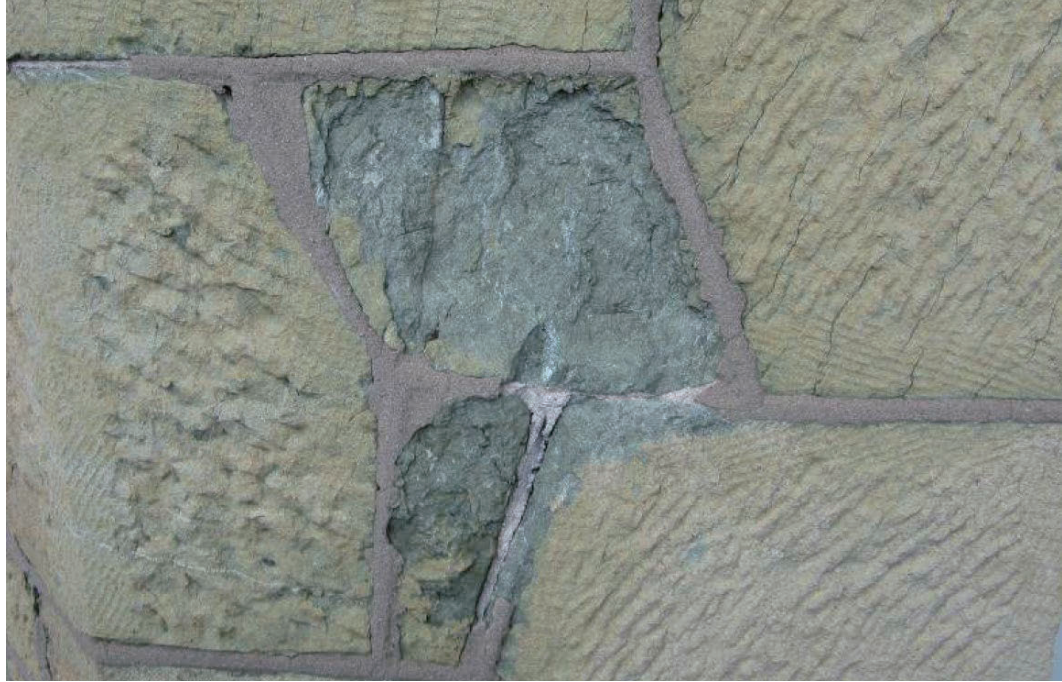
Figure 45. Detail photography showing the yellow crust on top of the serpentine, retaining its original tooling. The green stone has largely lost the crust with some remaining on the edges, it shows visible signs of erosion. (Courtesy of Schnabel Conservation L.L.C, 2008)

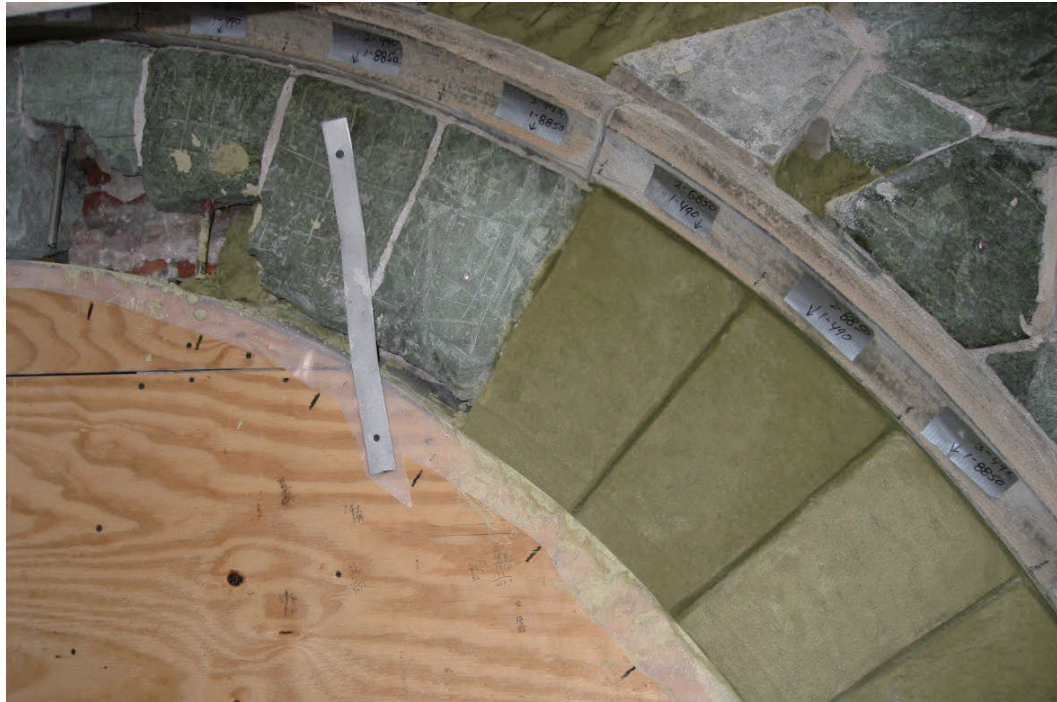
Figure 48. Serpentine patching in progress, stainless steel pins were inserted for additional structural support at areas of major loss. (Courtesy of Caretti Restoration & Preservation Services, L.L.C., 2011)

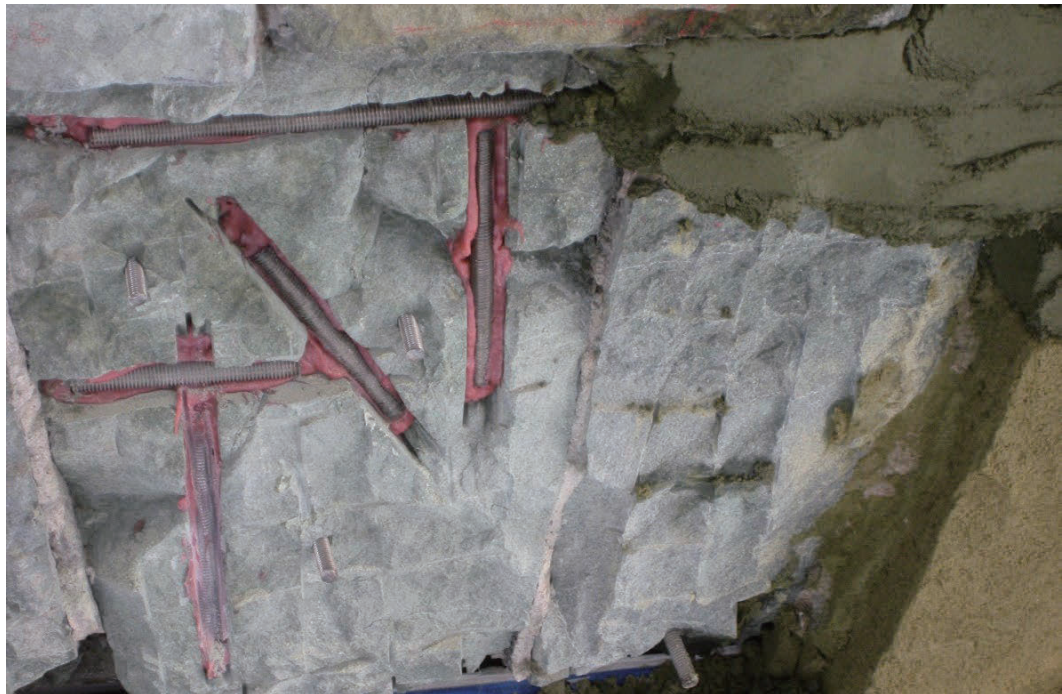
Figure 50. Stainless steel pins embedded in epoxy were used to provide additional support to keep the composite repair mortar in place. (Courtesy of Caretti Restoration & Preservation Services, L.L.C., 2011)

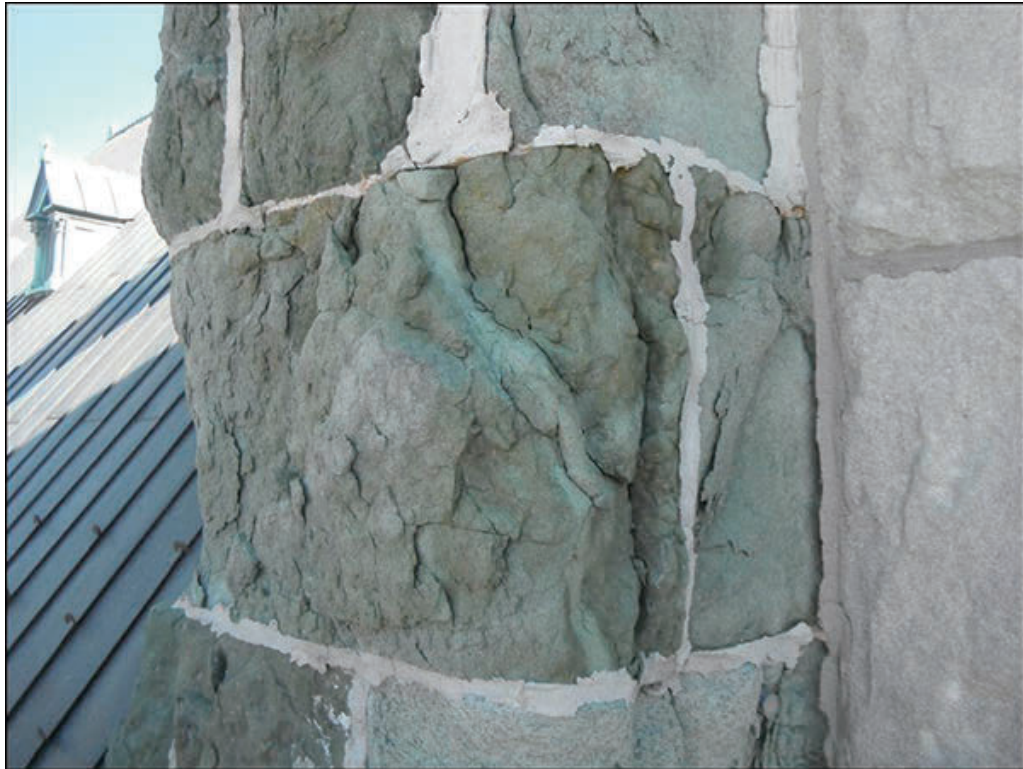
Figure 54. Close-up of the original serpentine displays extensive delamination and spalling. (stfrancisparish.org)

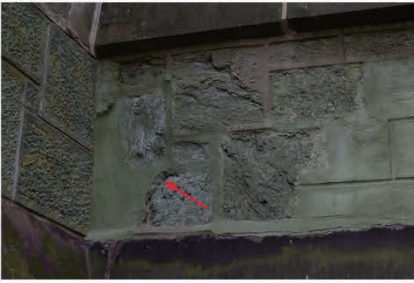
<p>Repair Type: Partially Stuccoed Serpentine Year Installed: Likely Post-2000</p> <p>Observation:</p> <p>This detail photograph shows the extent of serpentine degradation that is representative of most remaining exposed serpentine surface. Note the depth of some of these fissures (arrow), these spots allow water to penetrate deeply into the stone and cause accelerated damage. Much of these serpentine were patched with stucco as a temporary mitigation while the project awaits Phase VI.</p>
05

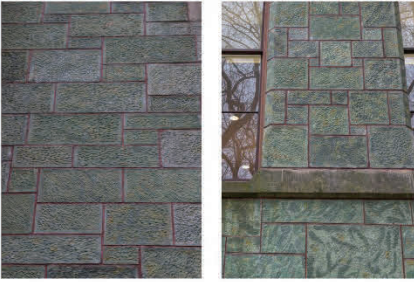
<p>Repair Type: Cast-stone Year Installed: 1994 - 1996</p> <p>Observation:</p> <p>Some aesthetic inconsistency in cast-stone replacements can be observed. The blending of colors of the units on the left look well integrated and natural, while the units on the left appear deliberate and unnatural.</p>

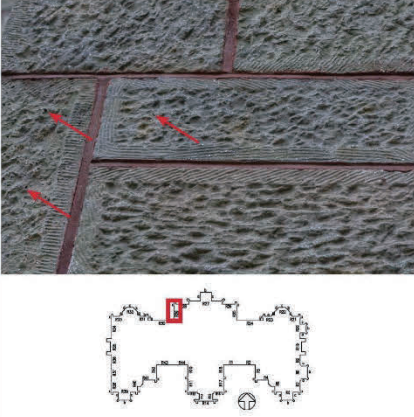
<p>Repair Type: Cast-stone Year Installed: 1994 - 1995</p> <p>Observation:</p> <p>Some voids on the surface in the size of large sand grains are observed. These could be made by air bubbles during casting or large aggregates popping out of the surface.</p>
09

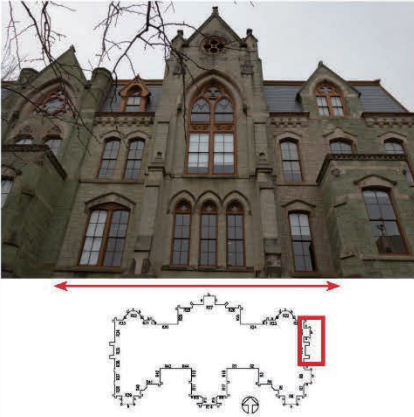
<p>Repair Type: Early Cement Stucco Year Installed: Mid 20th Century</p> <p>Observation:</p> <p>The section of the elevation indicated by red arrow is in a paler yellow-green color than the masonry on either side. This was from an earlier cement stucco repair campaign around mid 20th century.</p>

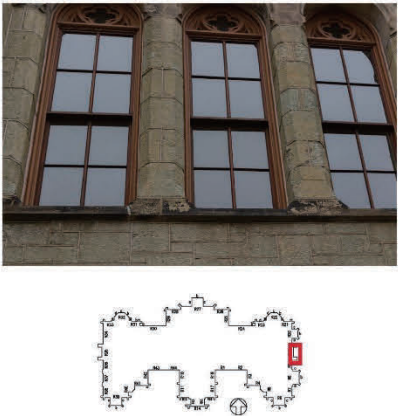
<p>Repair Type: Early Cement Stucco Year Installed: Mid 20th Century</p> <p>Observation:</p> <p>A close-up of the early pebbled cement stucco shows signs of deterioration: yellowing, spalls, partial loss, and erosion.</p>
11

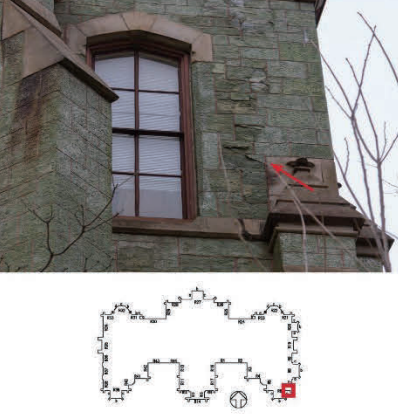
<p>Repair Type: Composite Repair Mortar Patching Year Installed: c. 1989</p> <p>Observation:</p> <p>Early attempts were made to patch the serpentine with composite repair mortar. The stone substrate continued to deteriorate, causing the patching mortar to detach and fall off. Some remains are attached to the surrounding mortar while the serpentine substrate has eroded (arrow).</p>
12

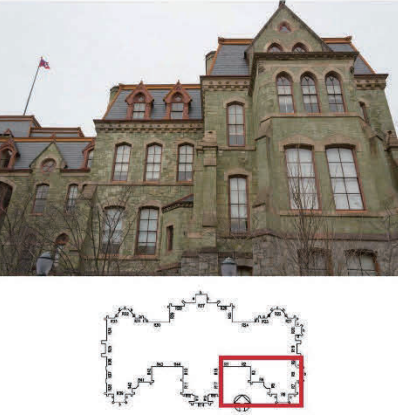
<p>Repair Type: Various Year Installed: Various</p> <p>Observation:</p> <p>The south elevation was not completely replaced with cast-stone. This view shows different past repairs varying in colors and textures, most are in good condition, some display signs of erosion and spalling.</p>

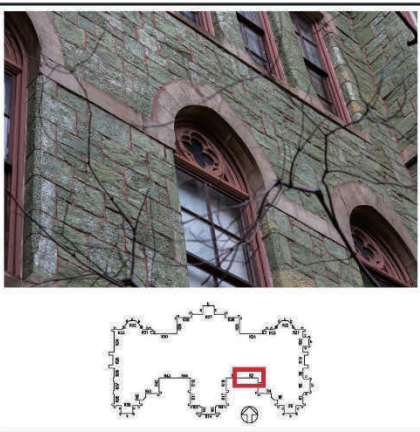
<p>Repair Type: Various Year Installed: c. 1987</p> <p>Observation:</p> <p>This section of the wall was tested as prototype in the early phase of the project. The team tried to preserve as much serpentine as possible. Various mixtures of stucco patching material was tested here.</p>
14

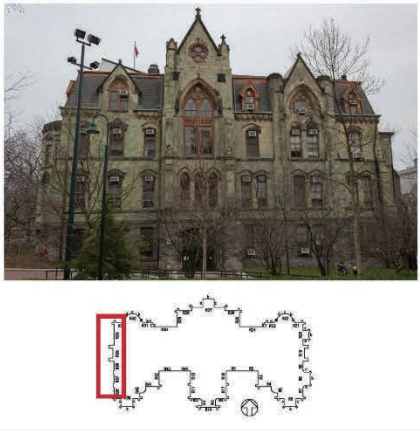
<p>Repair Type: Early Stucco, Early Cast-stone, Modern Stucco Year Installed: Various</p> <p>Observation:</p> <p>This photograph was taken from approximately 100 feet away. The discoloration of different type of repairs on this elevation are clearly visible. More recent deteriorations were patched with bright green stucco. Most if not all will be replaced with cast-stone during Phase VI.</p>
15

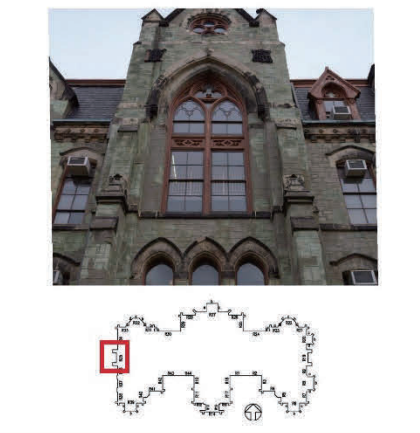
<p>Repair Type: Early Stucco, Early Cast-stone, Modern Stucco Year Installed: Various</p> <p>Observation:</p> <p>This close-up of the central bay shows deteriorated early repairs patched with bright green stucco, scored to create the illusion of mortar joints.</p>

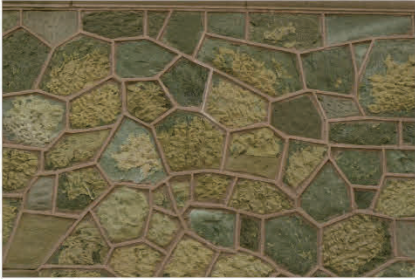
<p>Subject: Exterior Detail</p> <p>Observation:</p> <p>The serpentine stones vary in color and texture. The yellow surface is a crust formed by oxidized mineral. The crust preserved the original tooling in most cases. The green colored stones have lost this protective crust.</p>
02

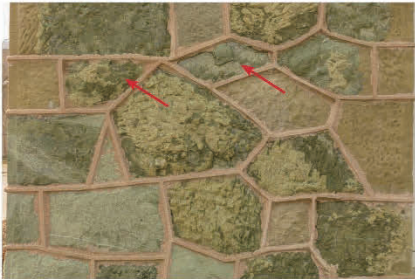
<p>Subject: Serpentine deterioration</p> <p>Observation:</p> <p>Original serpentine continues to deterioration, showing signs of flaking and spalling.</p>

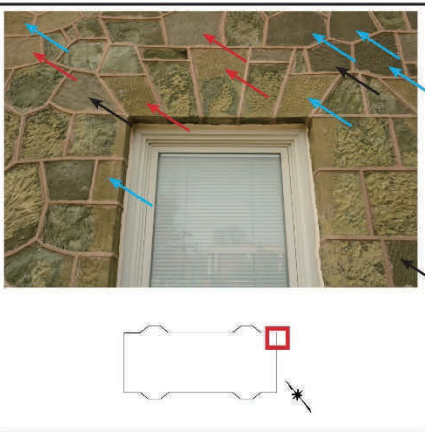
<p>Subject: Tooling</p> <p>Observation:</p> <p>A variety of tooling techniques can be observed here. Red arrows point to patches with a slashing pattern, blue arrows point to a pitted finish, and black arrows point to a surface made by removing pockets of the mortar.</p>
05

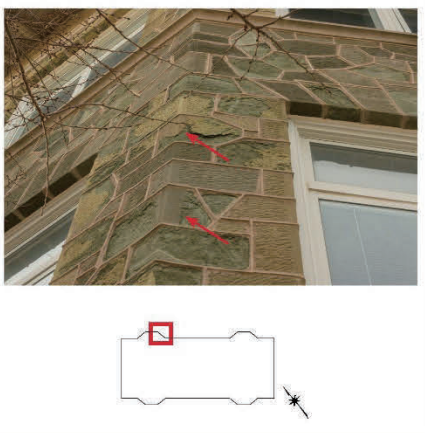
<p>Subject: Partially patched stones</p> <p>Observation:</p> <p>Some stones were partially patched. The boundary between the composite repair mortar and serpentine become more pronounced as the stone continues to deteriorate.</p>

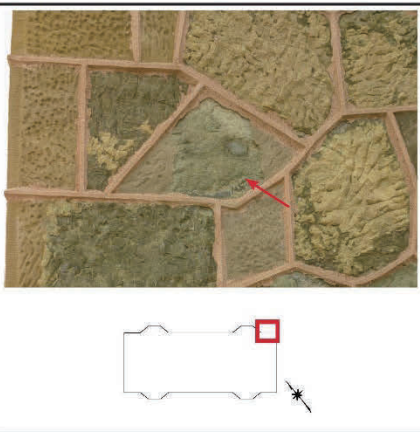
<p>Subject: Composite repair mortar</p> <p>Observation:</p> <p>The center of this patching has detached from the substrate.</p>
02

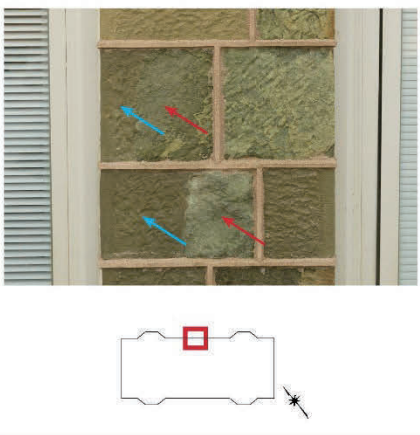
<p>Subject: Color matching</p> <p>Observation:</p> <p>Some color matches are close to the original serpentine. Others show a degree of variation. Composite repair mortar is indicated by blue arrows, original serpentine by red arrows.</p>
