Soft Capping of Archaeological Masonry Walls

Far View House

Mesa Verde National Park

A Thesis in Historic Preservation
Graduate School of Design
University of Pennsylvania
2009

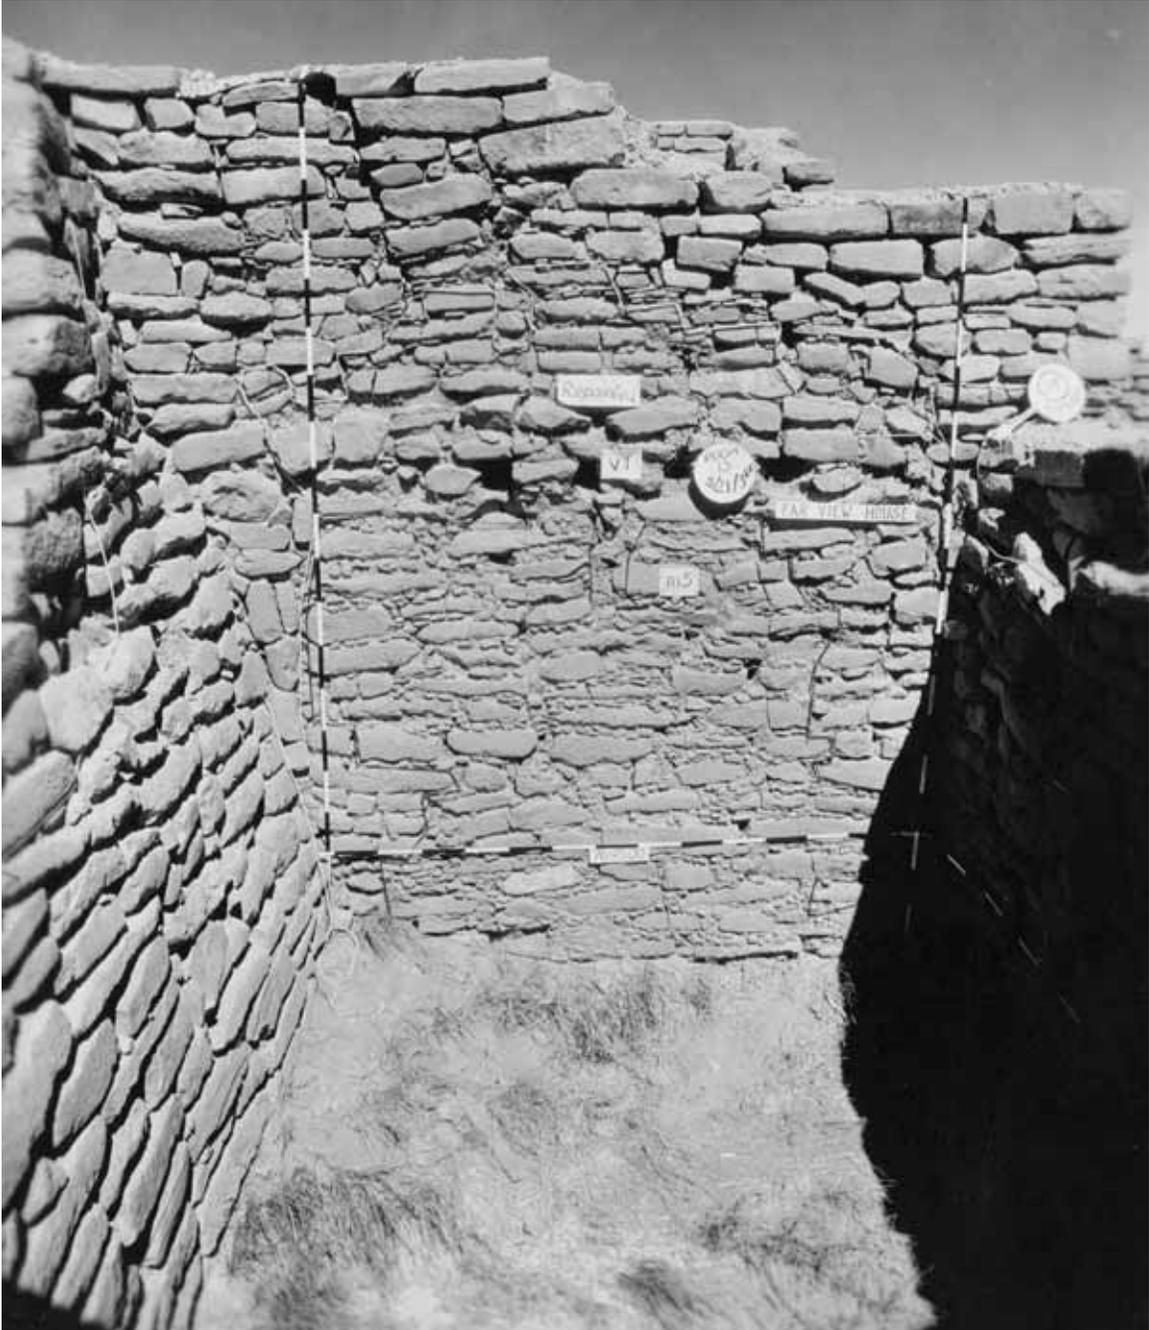
Figure 12. Room 13 East Wall in 1934 before Stabilization (Markely 1934) MVRC

(Room 13 East Wall) shows three different areas, offering clues to the extent of Fewkes' repair (Figure 12).

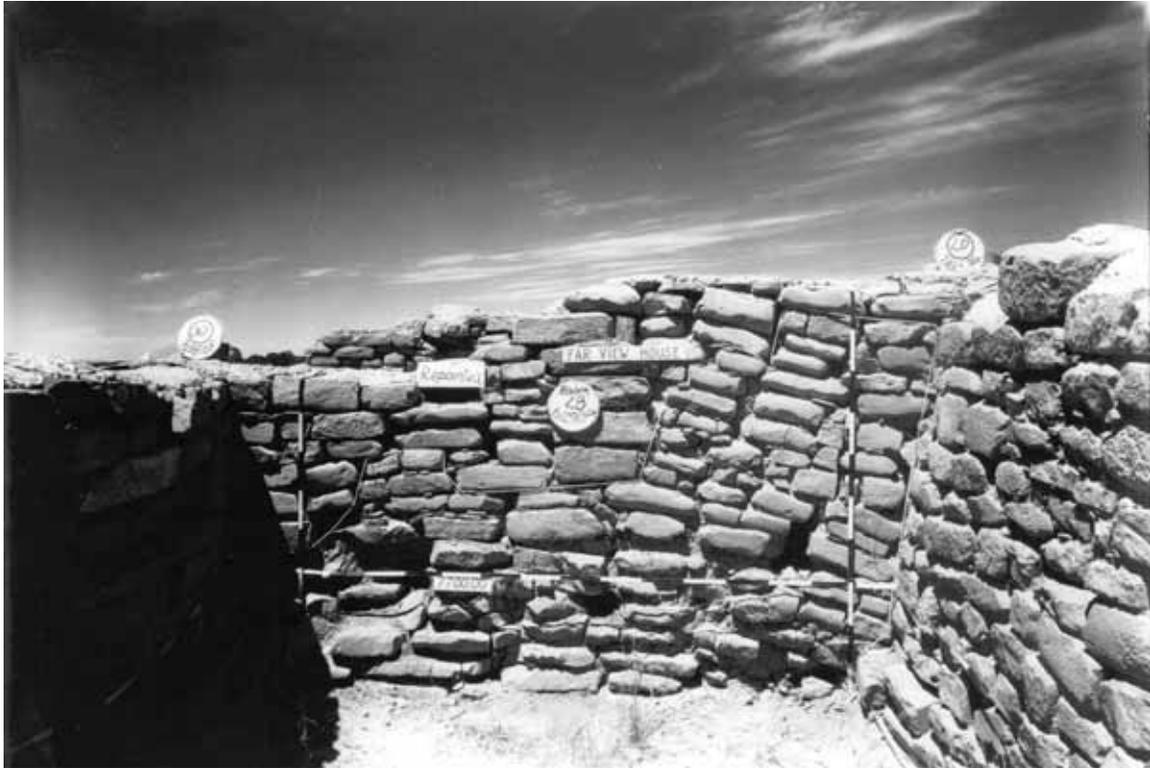
Figure 13. Room 28 West Wall in 1934 before Stabilization (Markely 1934) MVRC

The east face of the test wall (Room 28 West Wall) shows severe structural instability as evidenced by the sloped courses and significant lack of pointing (Figure 13). According to the report, the east face showed no signs of burning. The test wall, along with other walls at the site, was reported to have been either eroded by water or tunneled extensively by rodents, leaving the walls very unstable. The report found no evidence of original wall.

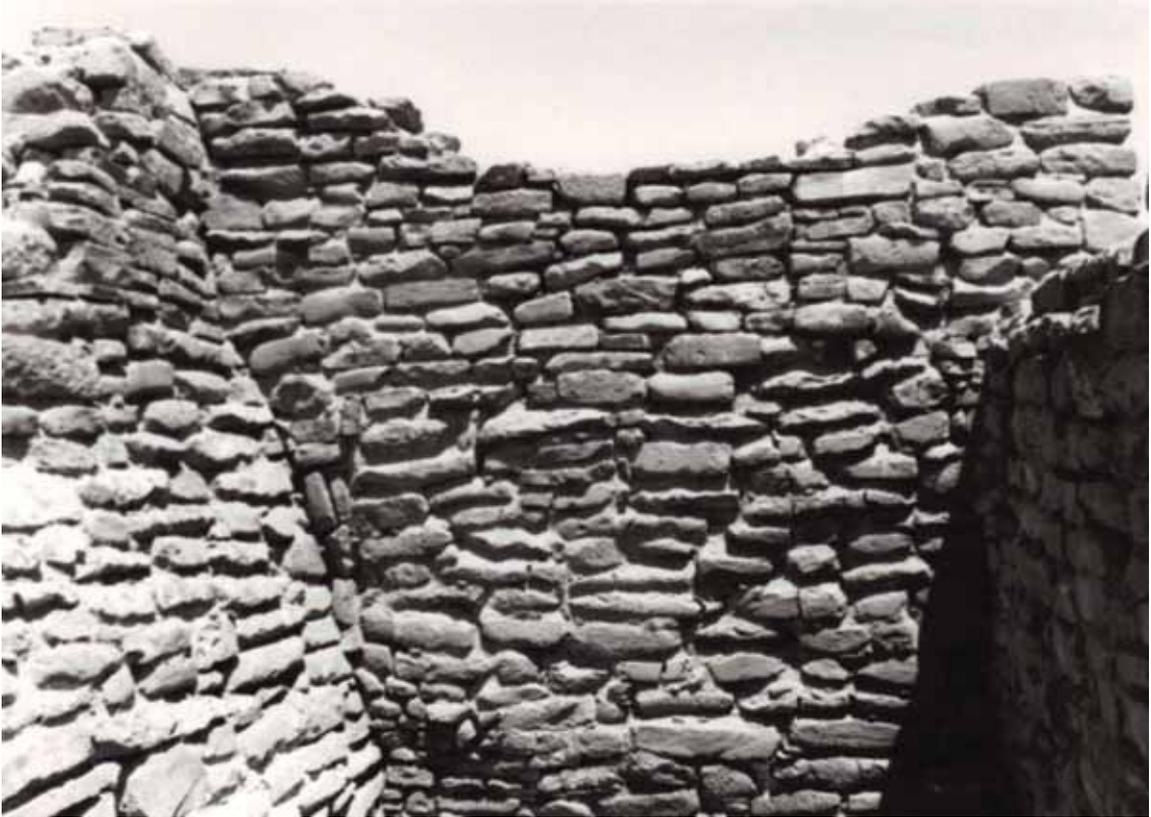
Figure 16. Room 13 East Wall in 1983 before Re-Stabilization (Fiero 1983) MVRC

By 1983, most of the chinking stones have disappeared and replaced by a patch work of repair mortar (Figures 16-17). The pointing mortar has eroded, resulting in recesses between sandstones. Overall, the wall retained most of the stones visible on 1967 photo.

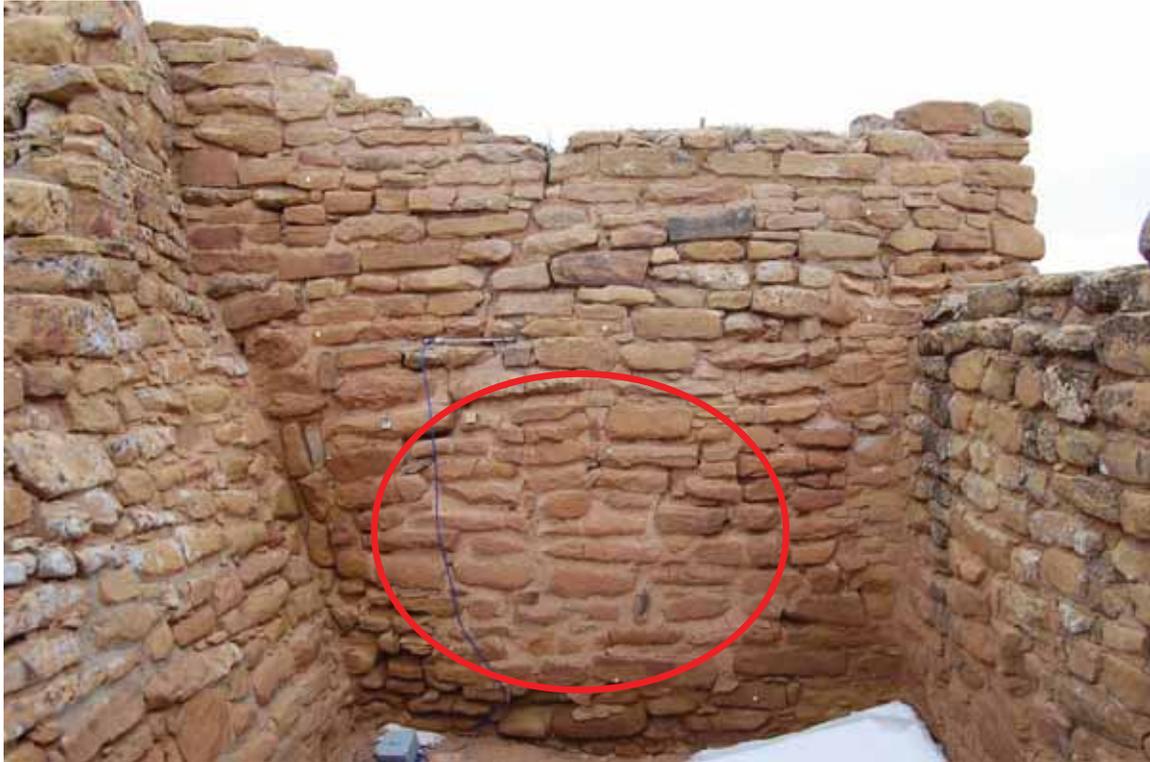
sandstone, and the deformation of the wall into a convex shape all indicate that the bulging has been active since at least 1934 and is still active posing a serious problem to the stability of the wall.

Figure 20. Room 13 East Wall in 2009 (Hovezak 2009) (Note: Red circle indicates bulging)

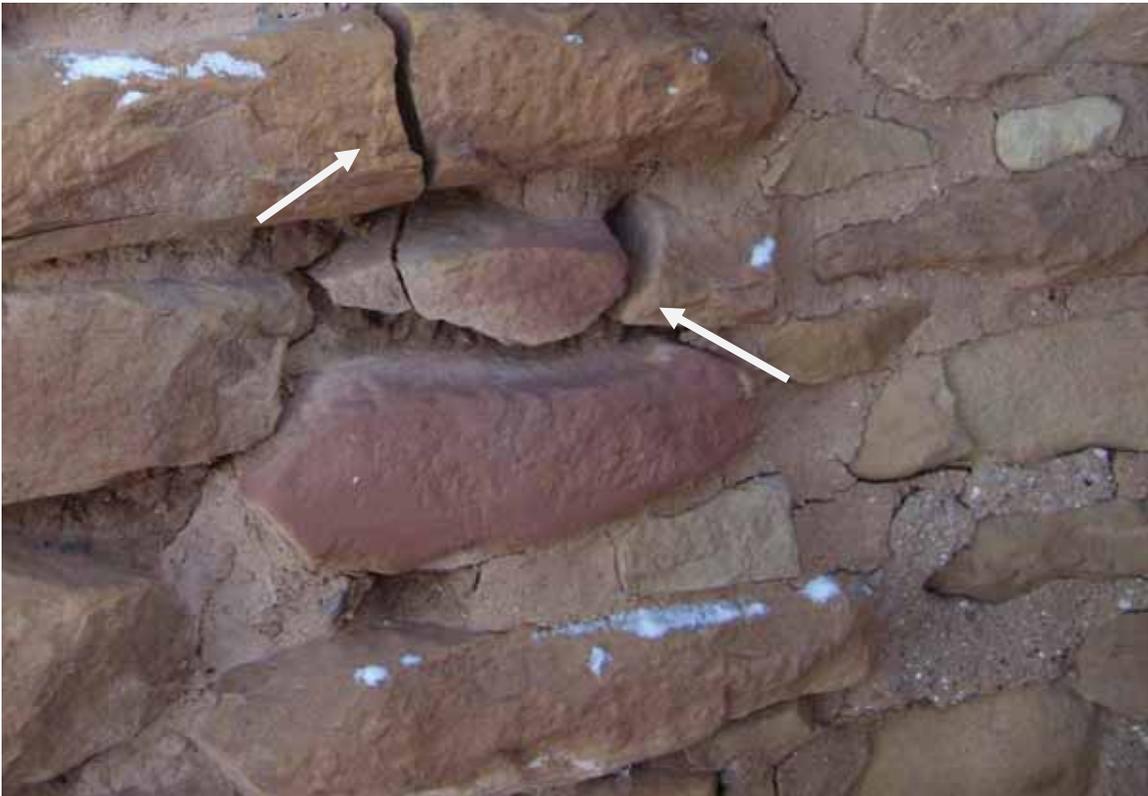
Figure 21. Enlarged Cracks (Lim 2008)

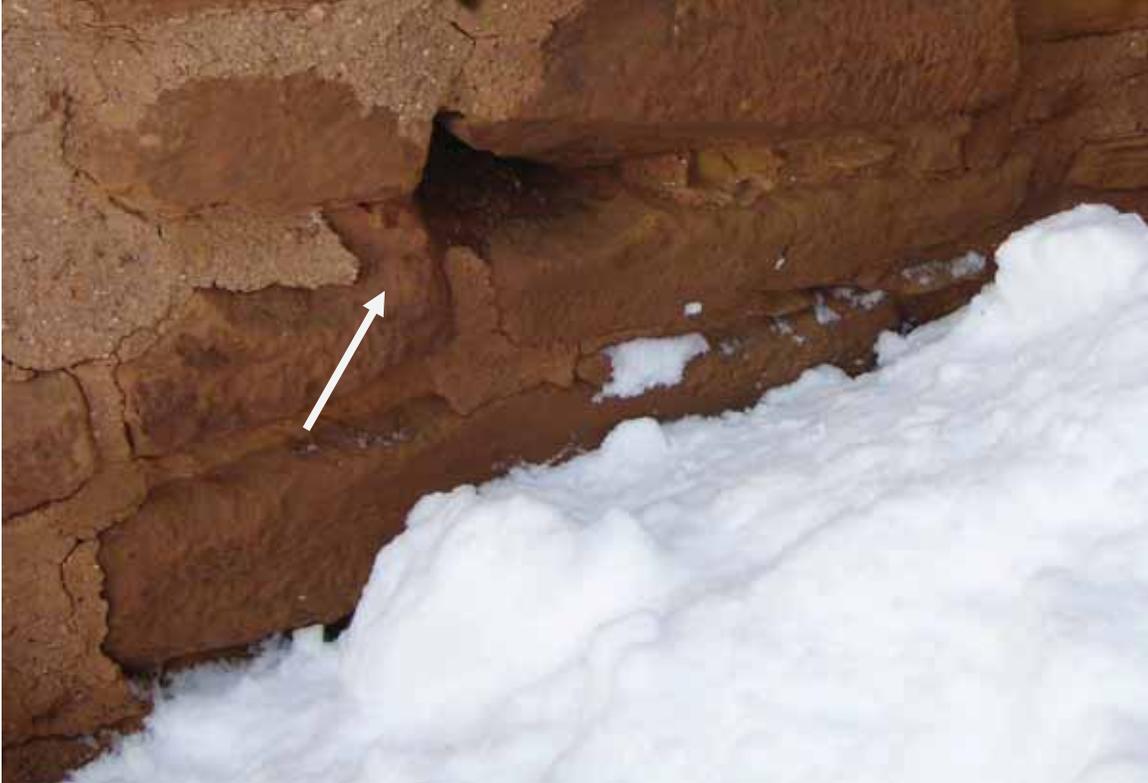
to eventual bond failure. The soil-based mortars would deform until they reach the critical moment before bond failure.

Figure 22. Loss (Lim 2008)

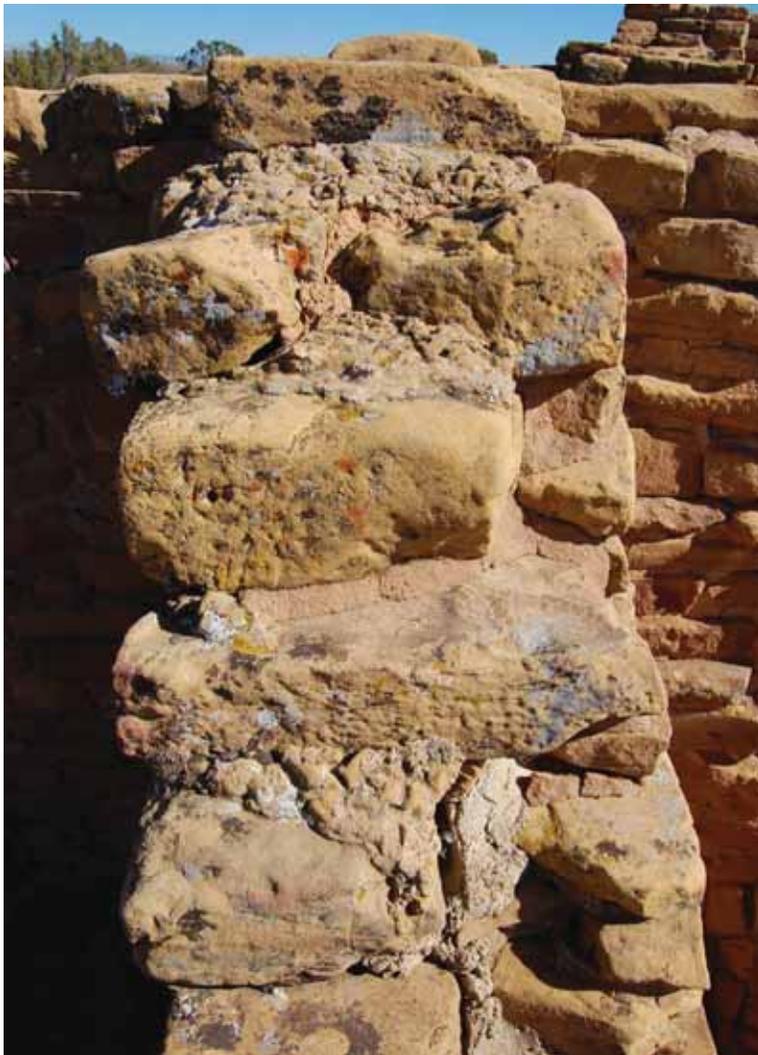
Figure 23. Discoloration (Hovezak 2008)

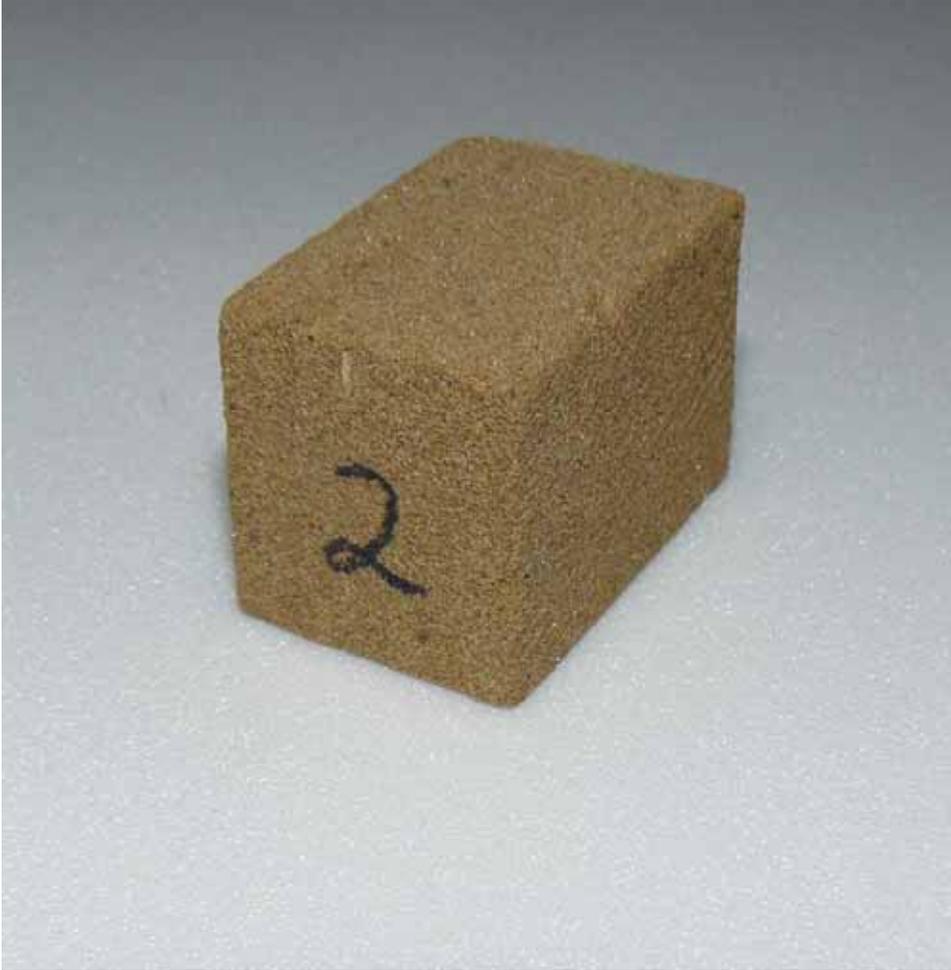
Figure 36. Sample after 32 cycles of Freeze/thaw (Lim 2009)
