ASSESSMENT AND ANALYSIS OF THE PLASTER EXHIBIT HALL CEILING  
AT THE WAGNER FREE INSTITUTE OF SCIENCE, PHILADELPHIA, PA

A THESIS

Historic Preservation

2008

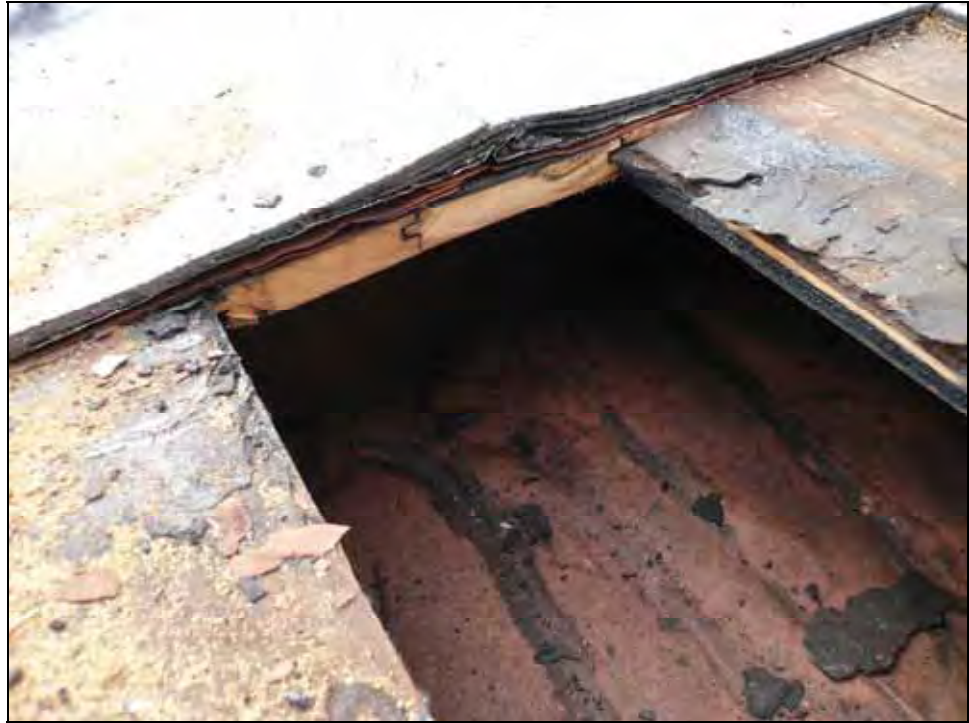
**Figure 10: Probe 2, above area of water staining and displacement. Note the layers of roofing material and the water damage to the roof paper. Photo by M. Goeke, 2007.**

The probes were valuable for several reasons. One, they offered a clearer understanding of the interior structure of the ceiling and roof. Two, they revealed conditions that cannot be seen from below but may be significant, such as insufficient- or broken keys. Insufficient keys are ones that were not properly formed, so they lack the mechanical attachment to the lath. The probes revealed that some of these have actually dropped, resulting in detachment. Three, the

probes directly linked the visible water staining below with poor conditions of the lath, keys, and framing elements. Water staining was visible in two of the

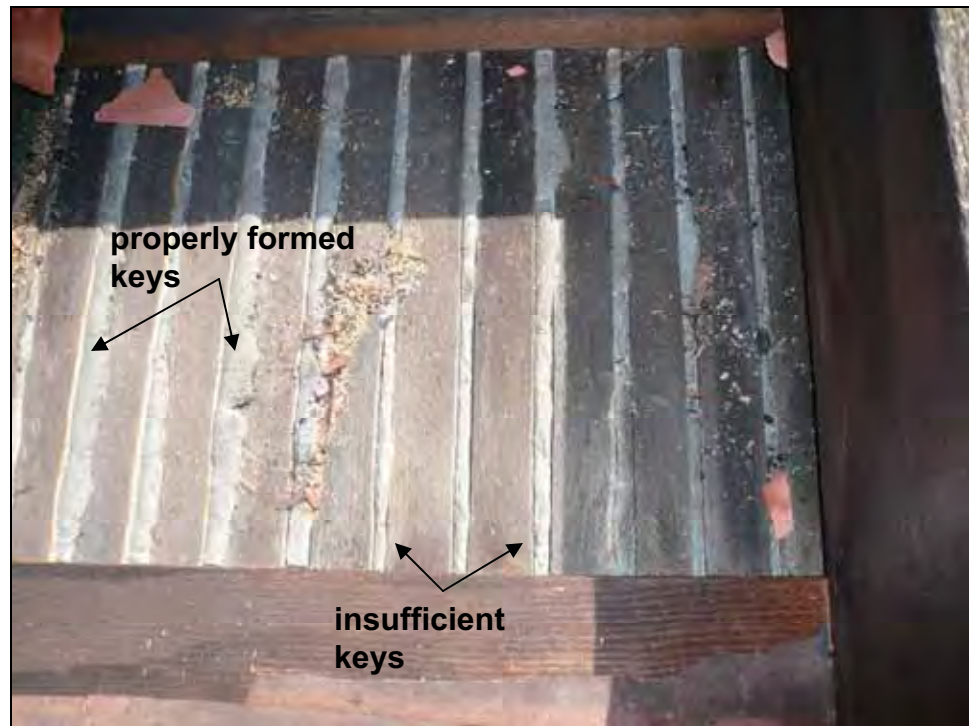
**Figure 11: Probe 6. Insufficient keys, where the plaster does not slump over the lath, do not have the proper mechanical attachment to the lath. Photo by M. Goeke, 2007.**

The lath that was inspected also appeared to be in good condition. In Probe 6, however, damage was visible due to warping and twisting of the lath. Probe 6 was over an area of water staining, so damage to the wood from water is likely. In some places, gaps exist between the lath and the key, perhaps from drying of the wood (or in combination with shrinking of the plaster). These small gaps between the plaster keys and the lath have implications on the stability of the plaster.

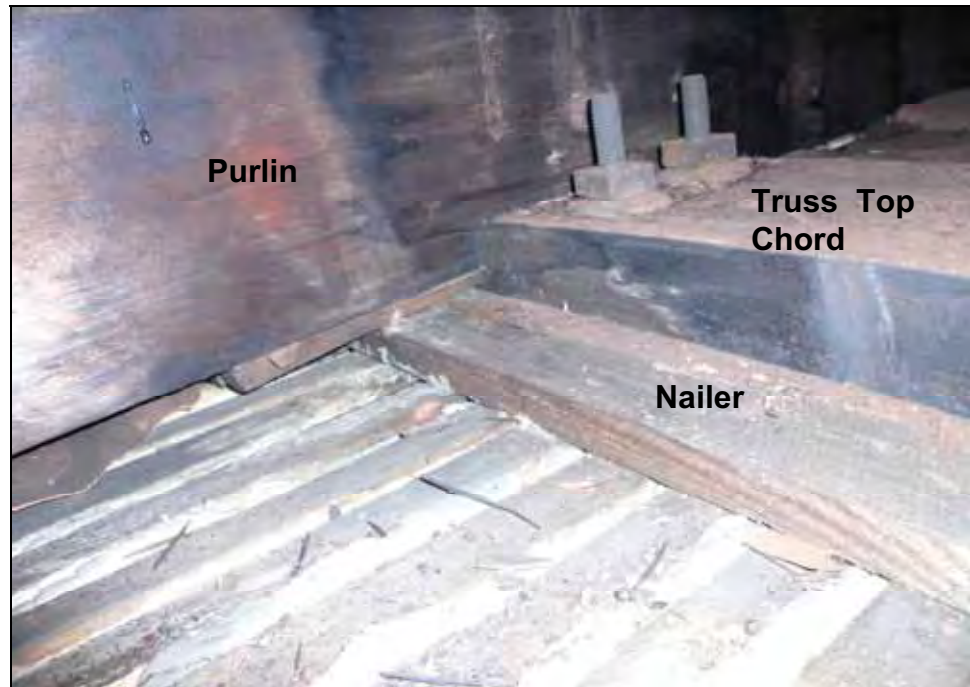
**Figure 13: Roof probe 2, showing intersection of the purlins, nailers and truss. Photo by M. Goeke, 2007.**

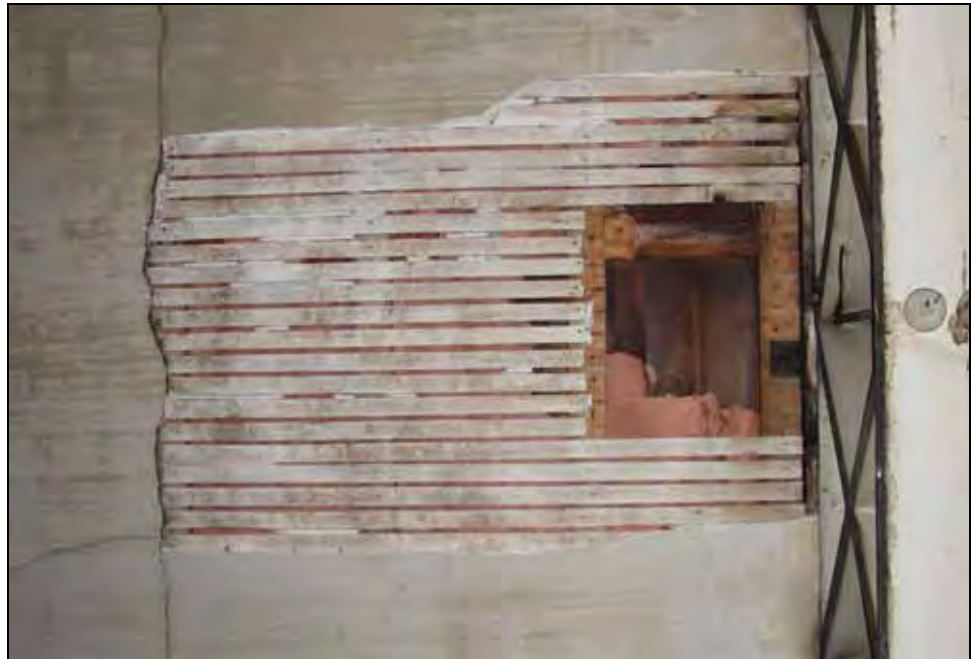
**Figure 14: Area of loss in Bay 2. A nailer abuts the top chord of the truss. They then are set 16 inches apart. Lath spacing, some too close together, is also visible.**  
Photo by A. Finke, 2007.

He suggests that in areas where keys will not form for two or more inches, the area be counter lathed.<sup>51</sup> Counter lathing, which consists of running lath strips perpendicular to the nailing member, provides for additional key formation in areas where no keys would form. However, no counter lathing is evident at the Wagner. If Verrall is correct, the presence of nailers of this width could compromise the integrity of the ceiling.

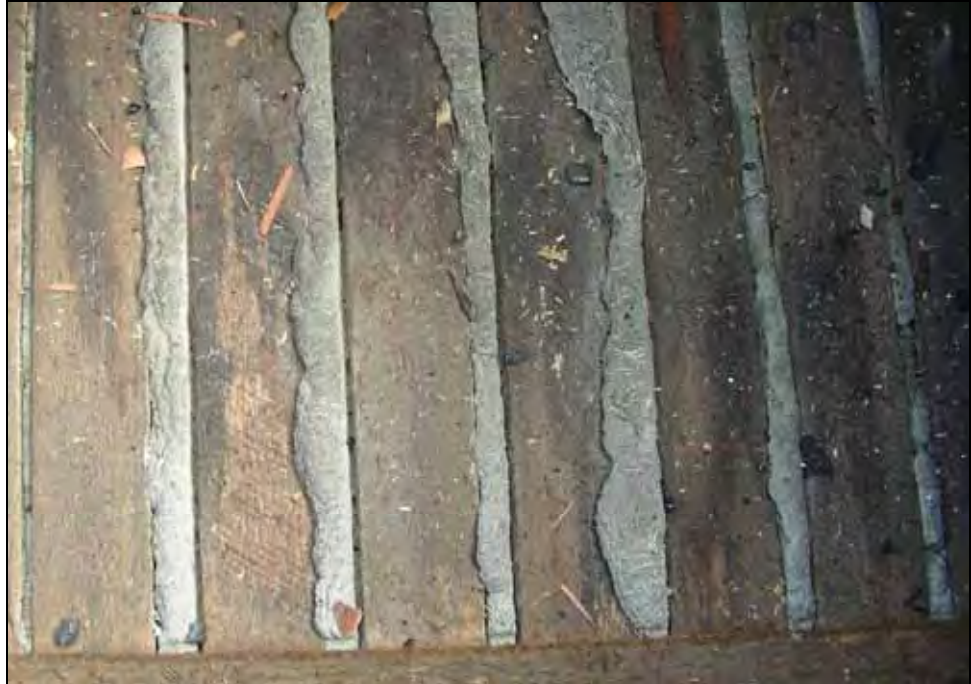
**Figure 15: Probe 2. Gaps between lath and plaster may indicate drying and shrinking of the wood. Photo by A. Finke, 2007.**

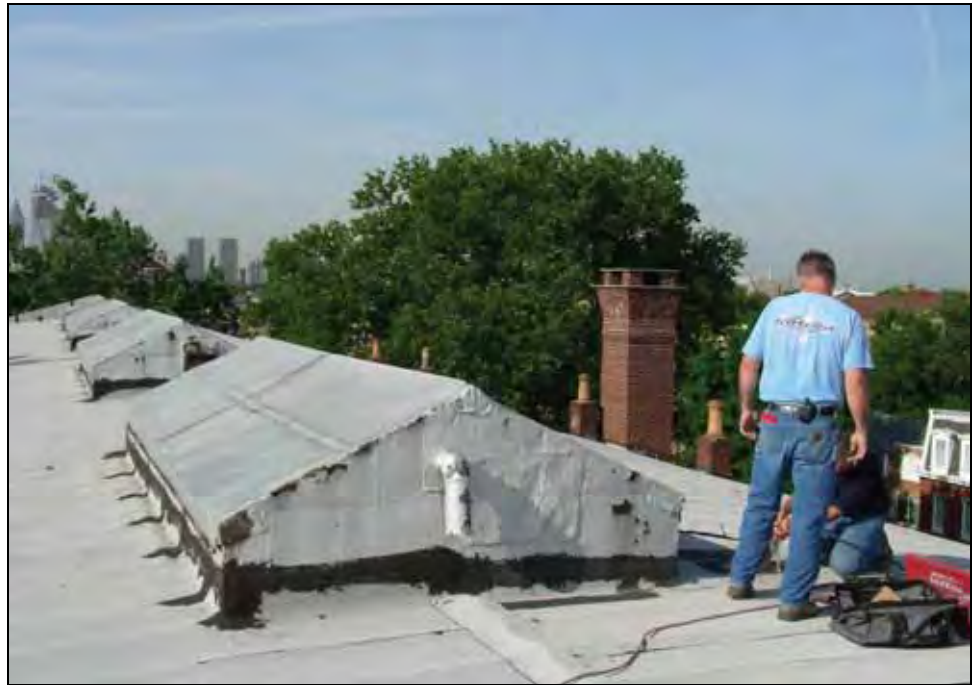
unknown.<sup>62</sup> The probes from 2007 revealed layers of roofing material in some sections, indicating years of patching and repairs. Patching is visible around the top of the skylights.

**Figure 16: Skylights from the roof. Note the patching around the edge of the skylights. Photo by A. Finke, 2007.**
