AN EVALUATION OF HISTORIC CEMENT STUCCO USING CONDITIONS ASSESSMENT METHODOLOGY AND DIGITAL VISUALIZATION TOOLS, GRAND TETON NATIONAL PARK, USA

A THESIS

MASTER OF SCIENCE IN HISTORIC PRESERVATION

2018

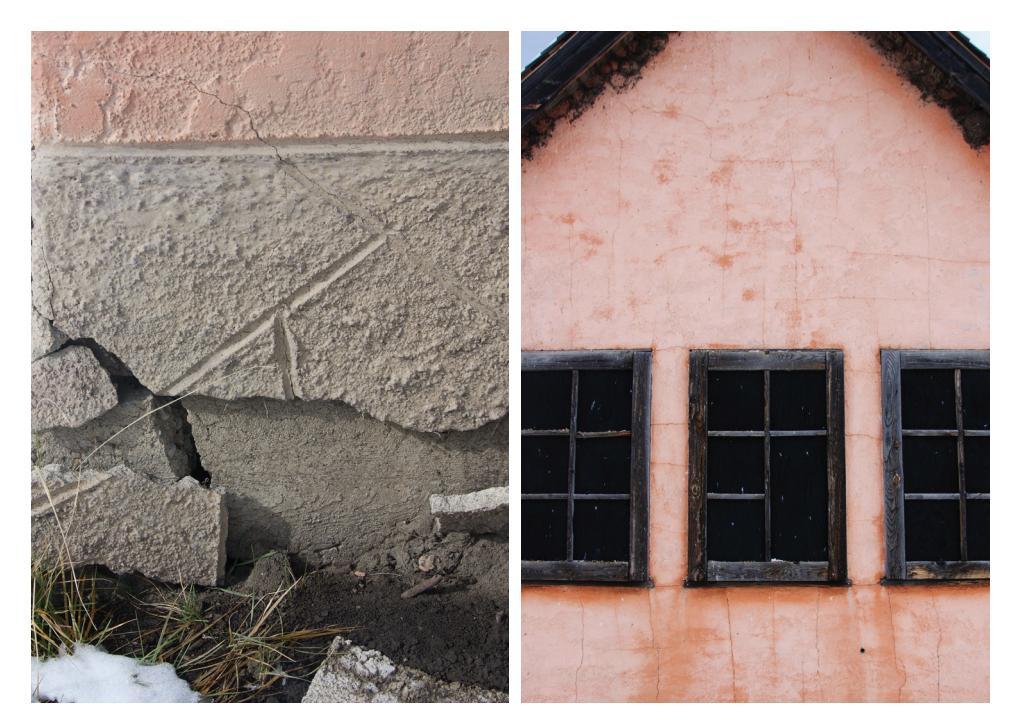
Figure 1.2 Primary deterioration concerns at the John Moulton homestead center on the evident cracking and loss of the exterior stucco. (Photos by author, 2017)

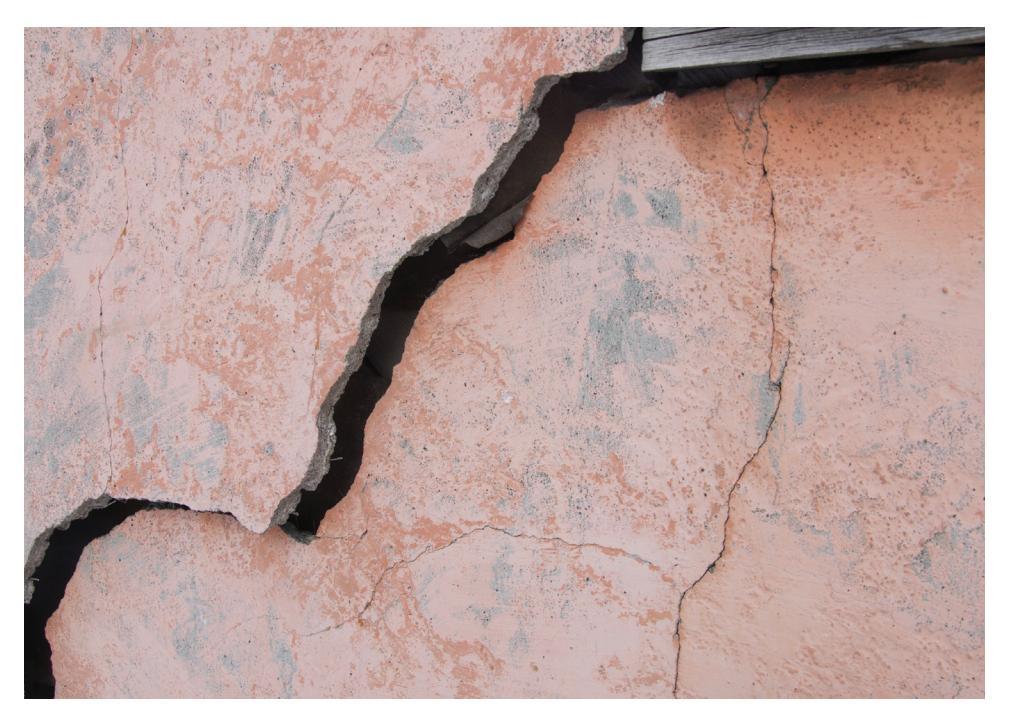
Figure 3.4 Evidence of the underlying vapor barrier, visible through a crack on the south elevation. (Photo by author, 2017)

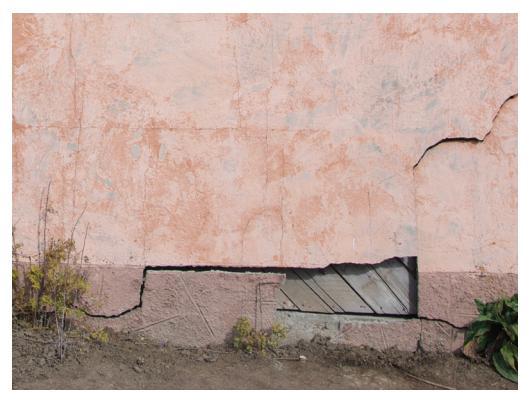
Figure 3.6 Only one layer of reinforcement is visible in cross section along the vertical edge of a crack. (Photo by author, 2018)

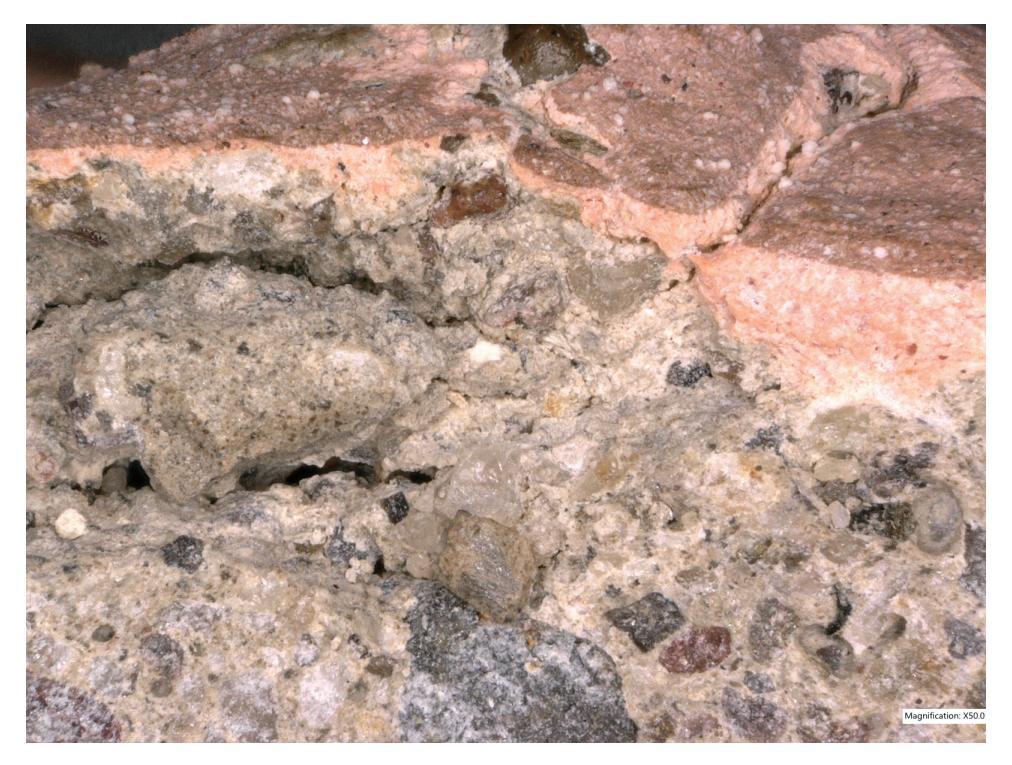
Figure 3.8 Cross section of a subsurface void directly connected to a surface crack, which shows that moisture can percolate through hairline cracks and exert force on the material with cycling temperatures. Magnification 50x. (Photo by M. C. Boileau, 2018)

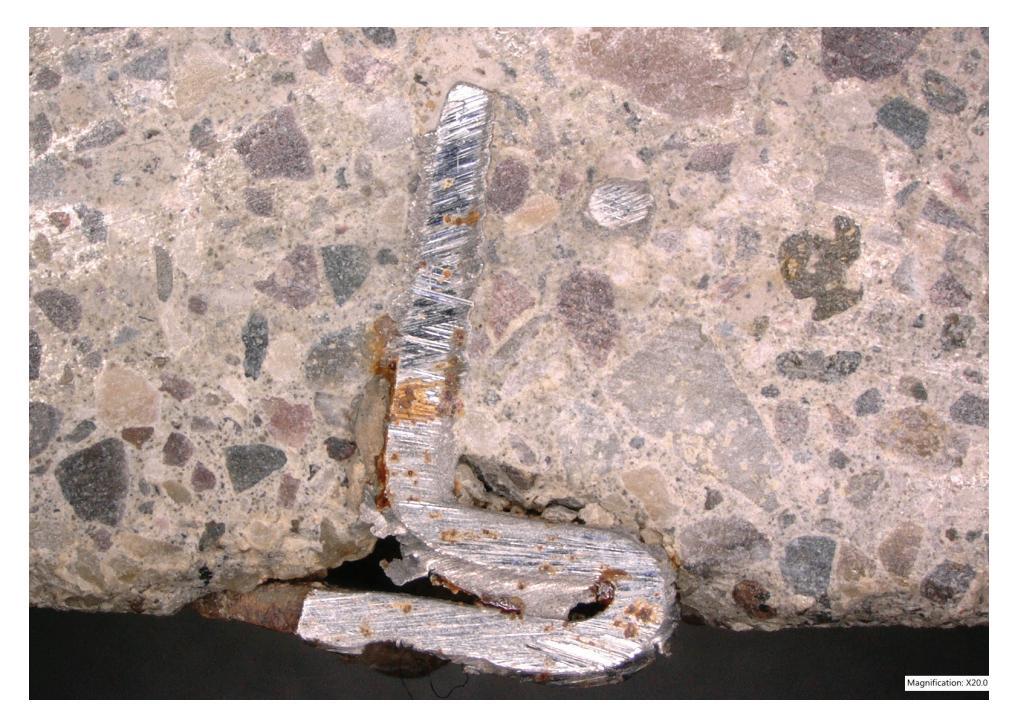
Figure 3.9 Cross section of furring device which shows some evidence of ferrous corrosion. Despite eighty years of exposure, the metal still has a significant amount of heathy cross section. Magnification 20x. (Photo by M. C. Boileau, 2018)

be inducing physical damage to the surrounding cement matrix. Where observable, the furring devices and wire lath look to have viable cross section (*Figure 3.9*). The relatively low levels of corrosion and cement carbonation could be due to the low levels of porosity in the cement.^{38, 39}

In the future, however, the cement material should be monitored for signs of deterioration relating to thermal cycling and its related pathologies.⁴⁰ One such pathology is corrosion jacking, in which the ferrous corrosion products can swell in volume and exert force on the surrounding concrete, stone, masonry, etc., which are reinforced with metal components which ultimately leads to damage.⁴¹ Carbonation, for example, is an inevitable phenomenon for cement and will eventually leave the metal reinforcements exposed to deterioration. While salt attack was not posited as a potential contributor to the deterioration of the stucco, salt testing strips indicate that the stucco contains moderate amounts of nitrites (25 to 50 mg/L) and sulfates (>1500 mg/L).⁴² Evidences of crystalline salt, however, were not observed in petrographic examination nor do the samples demonstrate damage patterns consistent with salt attack, although in a few instances sub fluorescence was observed within the cement matrix and on the building paper. Soluble salts can readily undergo crystallization cycles in environmental conditions with varying humidities and temperatures as is the case in Jackson Hole.⁴³

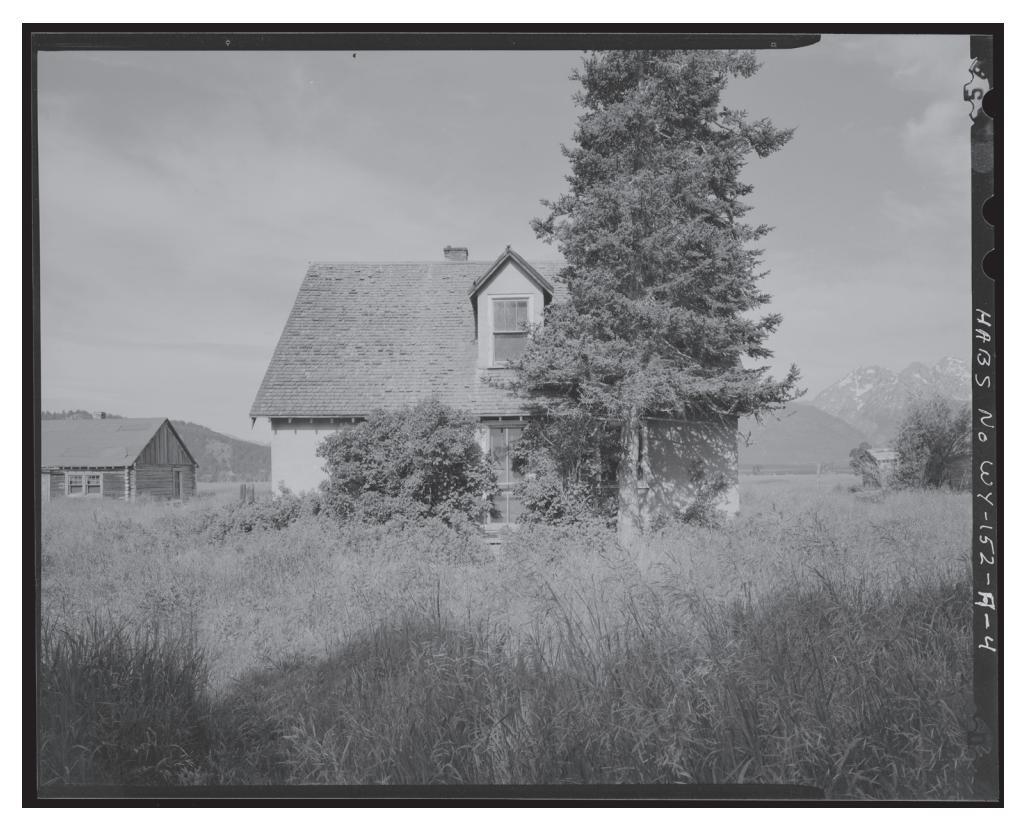
Figure 3.11 HABS photos from 1997 reveal trees and bushes encroaching on the east and south sides of structure, potentially impacting the stability of the foundation. (Historic American Buildings Survey, WY-152-A)

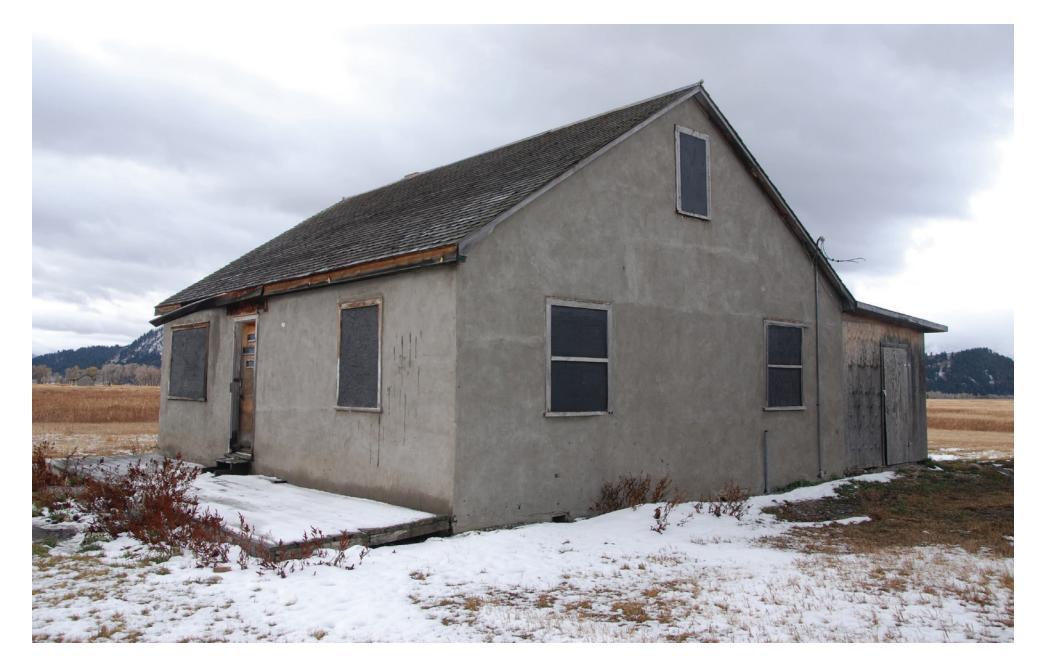
Figure 3.12 The stuccoed exterior of the Reed Moulton home does not exhibit diagonal cracking, as would be expected from earthquake damage or foundation subsidance. There is evidence of similar orthagonal cracking on the south and north (pictured here) elevations of the R. Moulton home. (Photo by author, 2017)

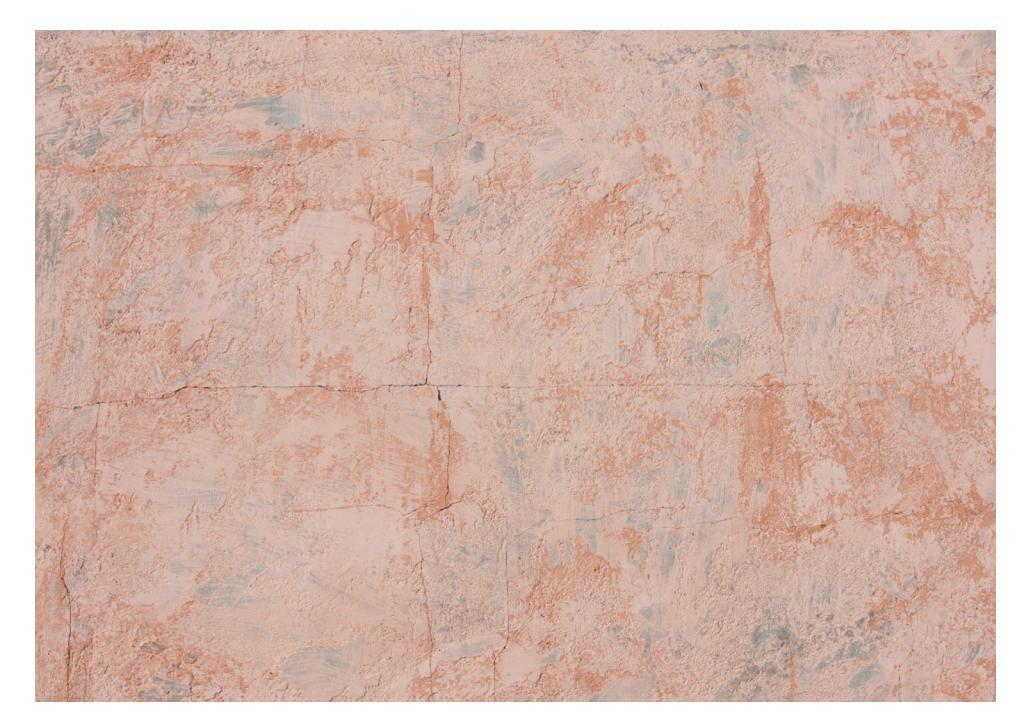
Figure 5.4 Fine orthogonal cracks evident on the south elevation are likely the result of differnetial thermal expansion of the metal reinforcements. What is unseen is the extent of detachment around the large crack extending from the corner of the east window. (Photo by author, 2017)

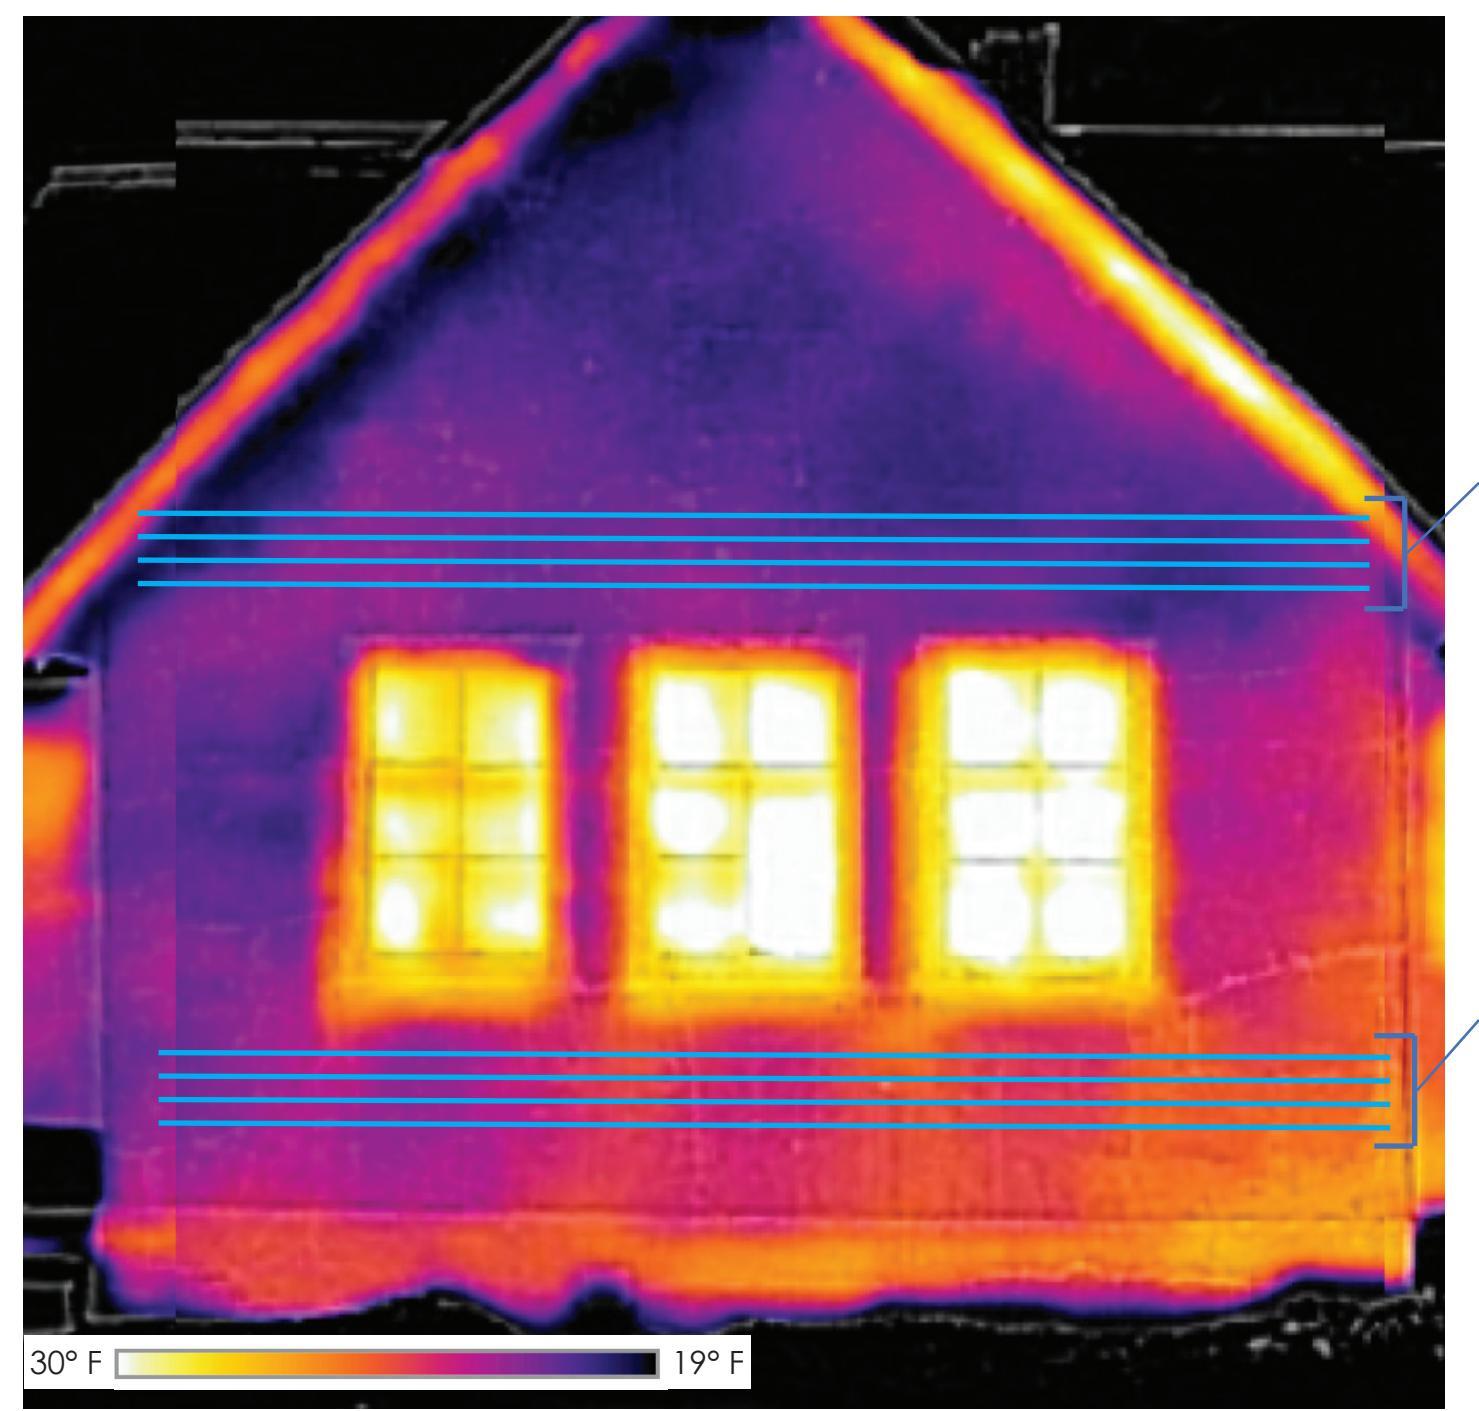
Cross sections from the west elevation appear to be plane. The stucco on the west elevation of the ell is likely to be in good condition and not detached because it may not be undergoing the same amount of movement as the main structure. Further testing with a higher resolution IR camera will be required to confirm this condition.

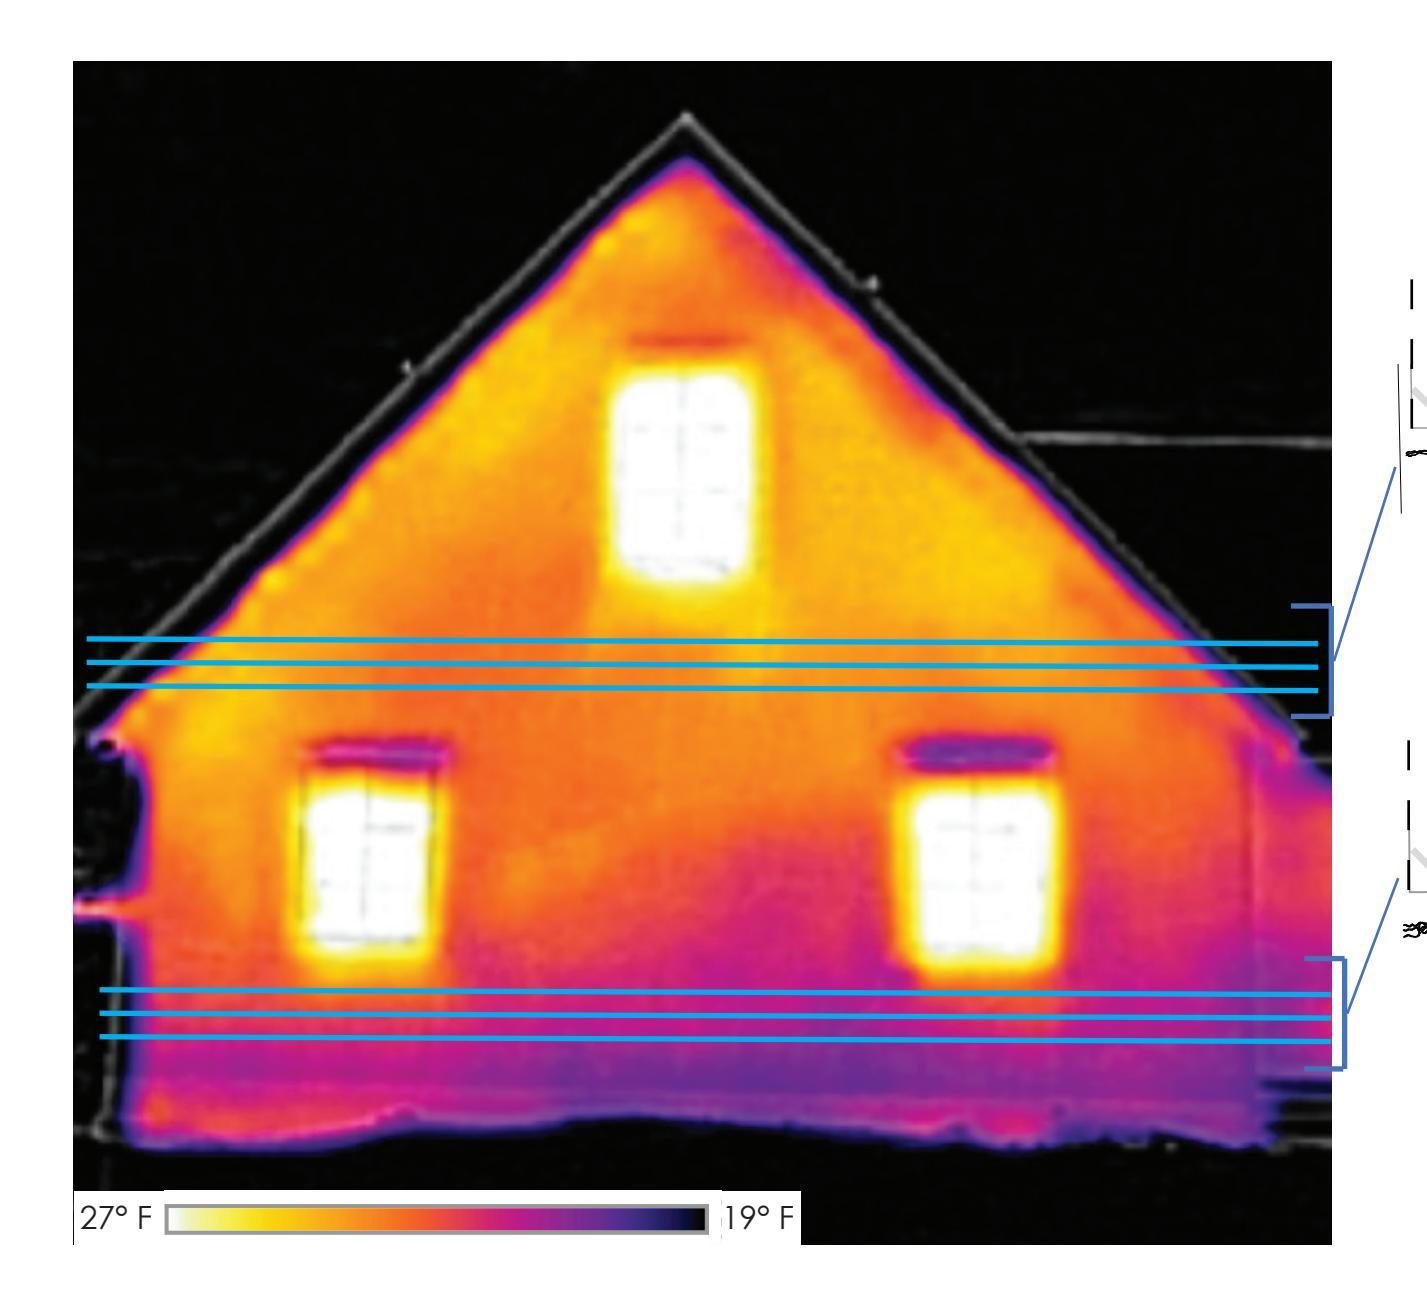
The photogrammetric model for the north elevation has the poorest resolution of the set and is less accurate. The resulting cross section appears to be concave, which is likely due to a lack of photos taken from oblique angles. Nonetheless, the section does not reveal significant irregularities that would suggest detachment of the stucco. The thermal signatures are more likely to be the result of external environmental factors than revealing characteristics about the stucco.

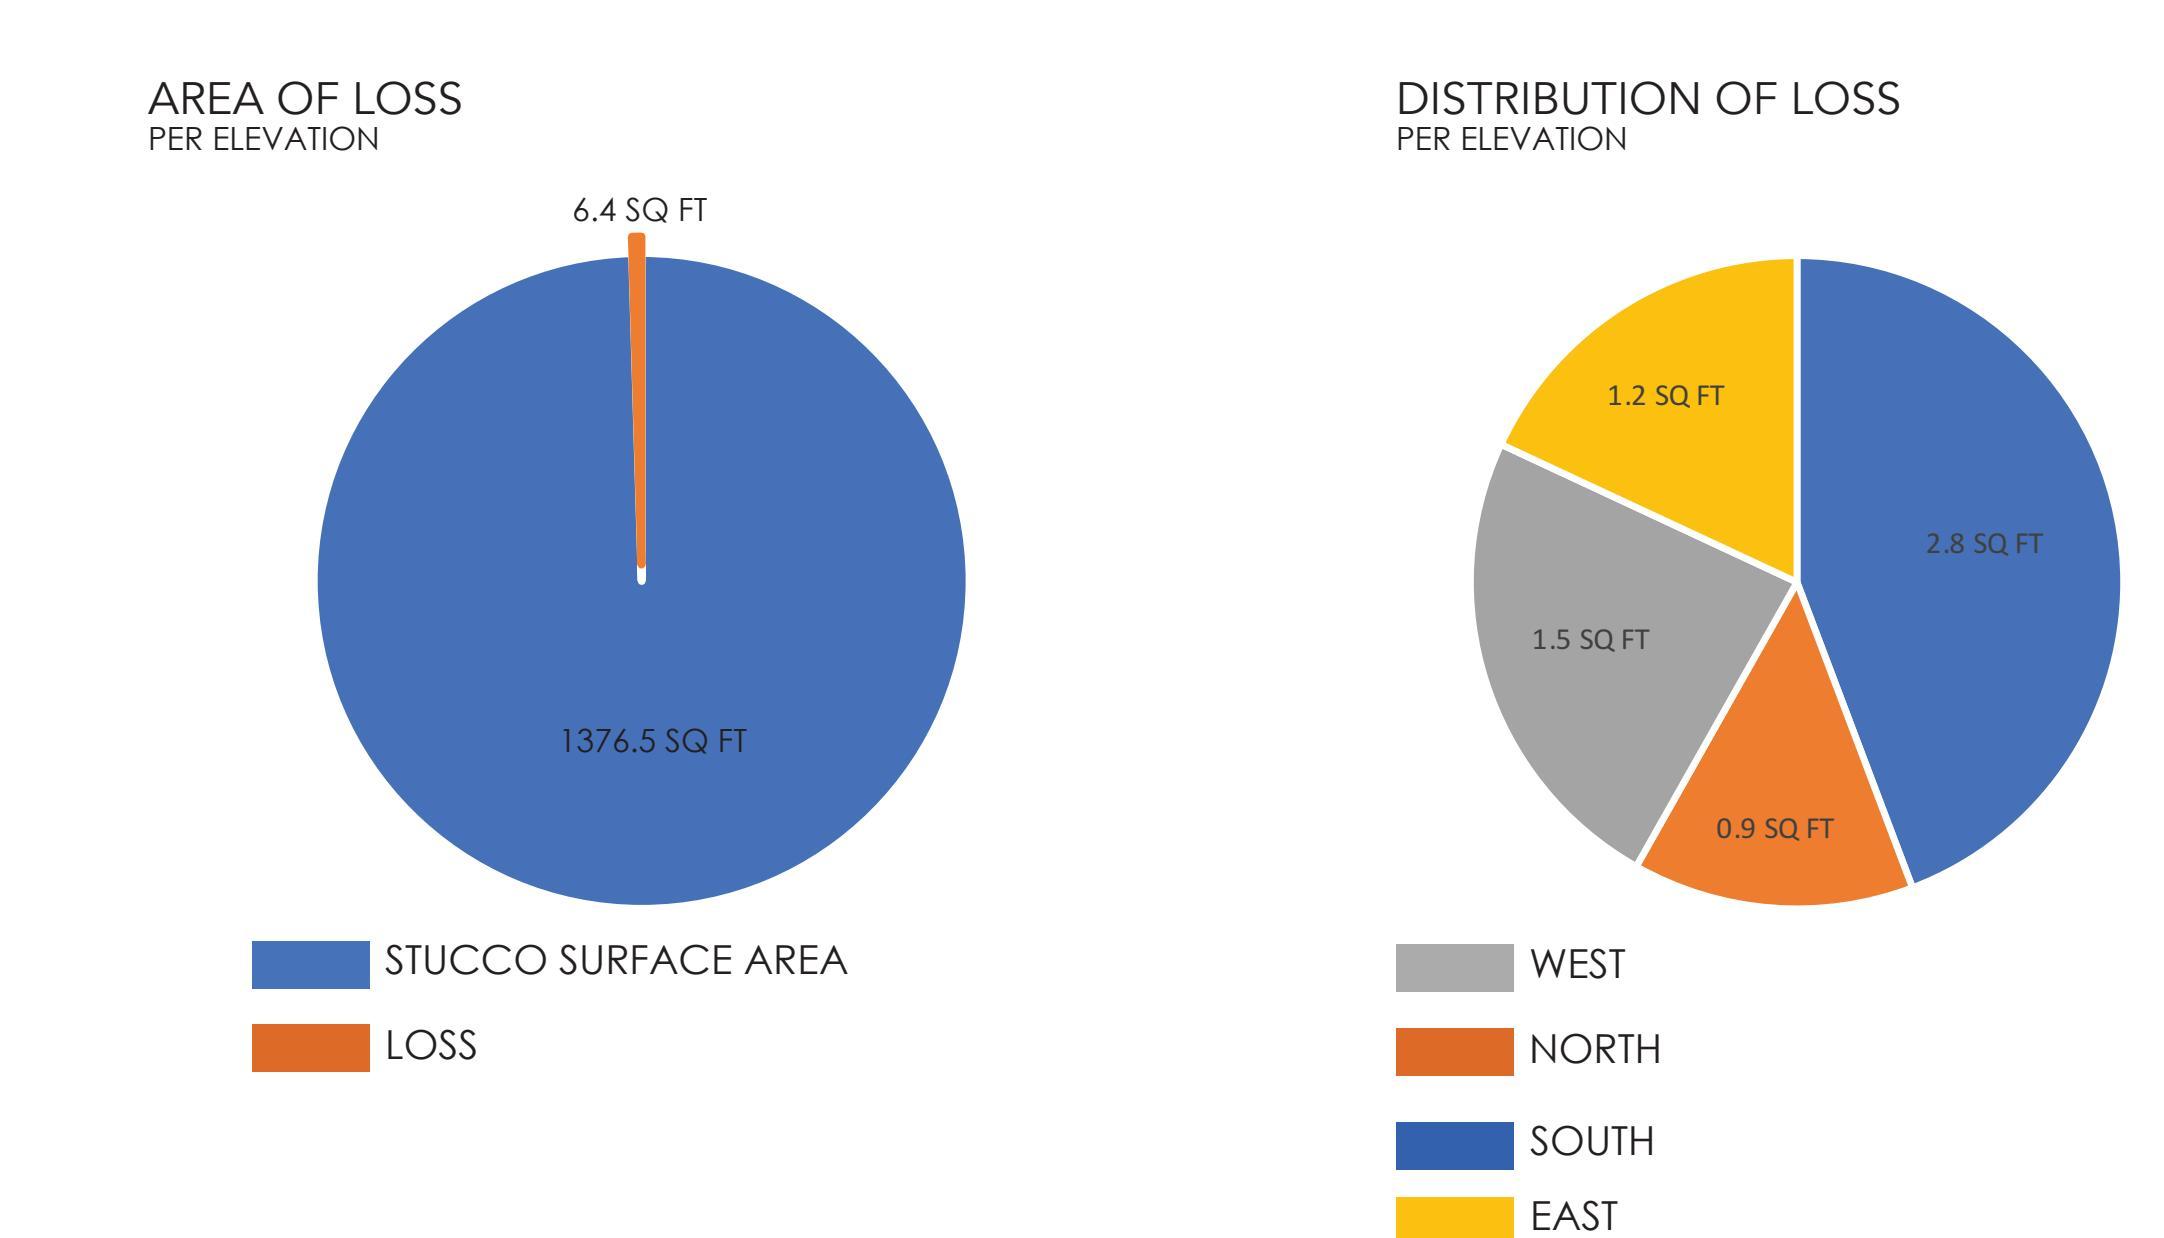
Loss is a highly worisome condition, but the area of loss is relatively low in comparison to the total surface area. The south elevation is the most affected by loss, which contributes to the theory that the south is the most affected by movement of the foundation. The west elevation is likewise affected, but to a lesser extent, because of the openings on that elevation and the ell. The degree to which the west elevation is affected by detachment is warrented.

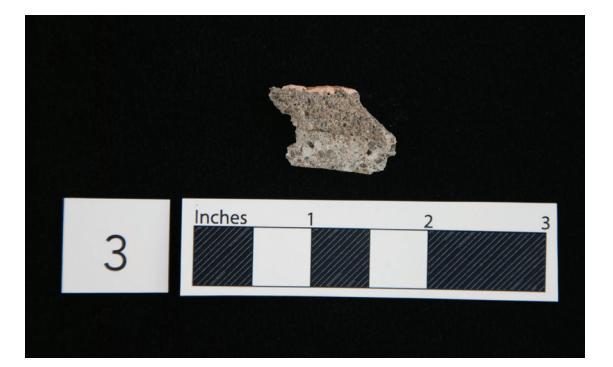
JMH 3 taken from displaced crack (+) below left corner of east window on south elevation.

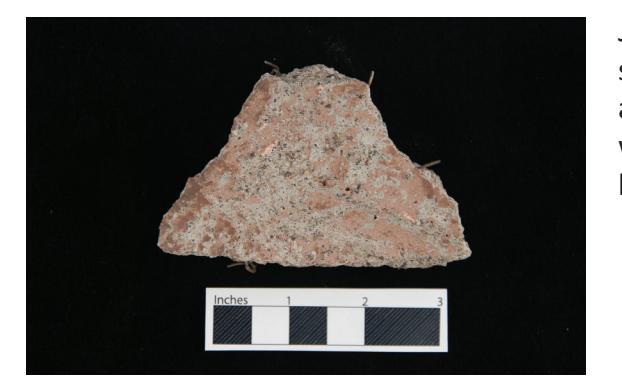
JMH 22 was found detached from the structure and collected from the ground adjacent to the southwest corner of the west L addition. Sample taken in July 2017 by J. Hinchman. Photo by author, 2017.

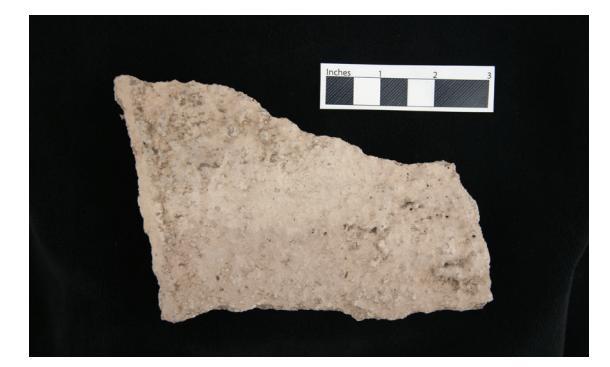
JMH 23 was found detached from the structure and collected from the ground adjacent to the south corner of the east elevation. Sample taken in July 2017 by J. Hinchman. Photo by author, 2017.

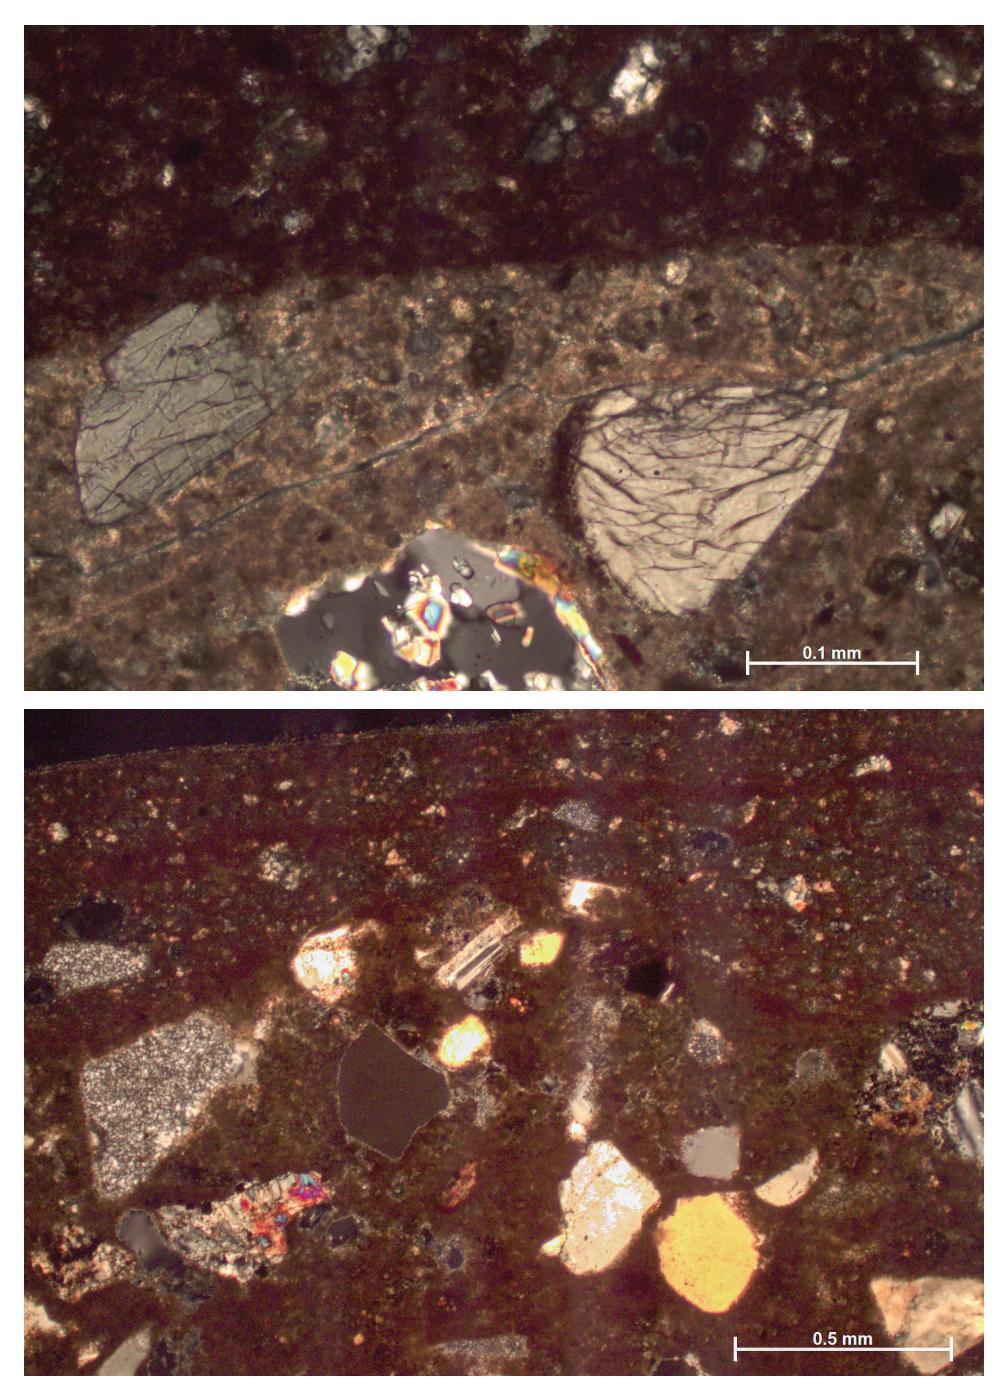
Figure Diii.2 Samples show differing depths of carbonation. JMH 16 (top) has carbonated cement matrix extending into the brown coat, while JMH 18 (bottom) demonstrates little carbonation. (XPL, 50x magnification)

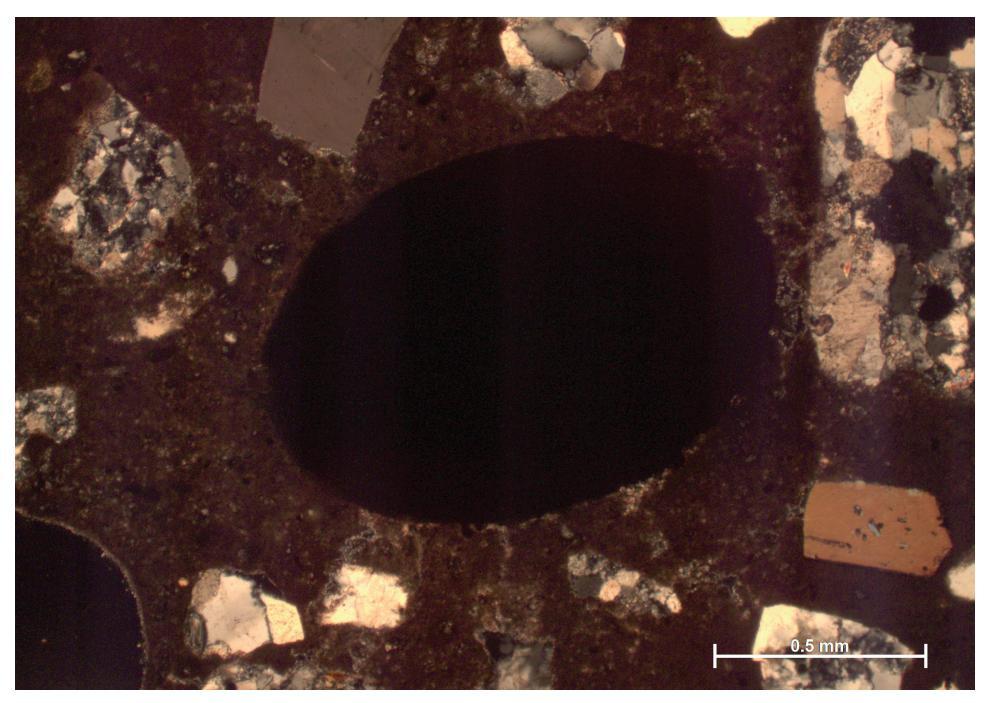
Figure Diii.4 The cement matrix surrounding the metal wire (opaque, center of image) appears to only have minor microcraking and carbonation of the cement matrix. No rust deposits were observed. (JMH 16, XPL, 100x magnification)
