Summer 2008 • Volume 47 • Number 2

Calcium Tartrate Tetrahydrate Preconsolidation of Salt-contaminated Limestone at Mission San José y San Miguel de Aguayo

JENNIFER CORREIA AND FRANK MATERO

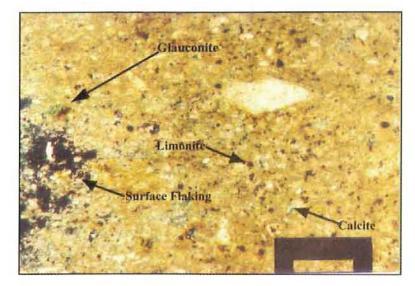
Fig. 2. Petrographic thin section of Sacristy window basal limestone. Note fine micritic texture and the presence of accessory minerals limonite and glauconite. Surface decay is evident on the left, mag. $100 \times$, cross polarized light (McDowell 1997).

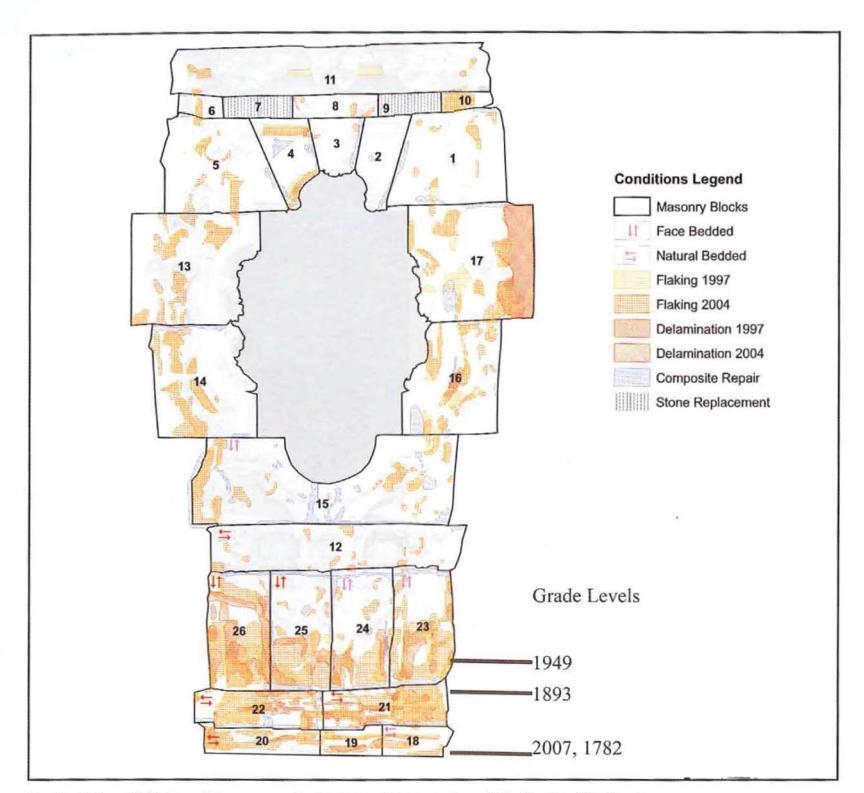
Fig. 3. 1997 and 2004 condition surveys for flaking and delamination of the Sacristy Window limestone.

the total percent area of flaking with 10% in 1997 and 20% in 2004 (Correia 2005). Delamination, a more serious form of detachment than flaking, was less extensive but also showed a significant increase. Total percent area of delamination in 1997 was 2% and increased to 6% in the 2004 assessment (Correia 2005). Historical photographs from the late 19th century reveal that a significant rise in the grade level had occurred, resulting in burial of the lower stonework for at least 50 years (see figs. 1, 3). This condition has led to salt contamination from groundwater and later wet-dry cycling after the base was exposed for display in 1950 (McDowell 1997). The resulting flaking and delamination caused by salt crystallization, dissolution, and recrystallization, in an open environment, have clearly accelerated over the past decade since condition recording began (1997–2007) and can be attributed to the excessive precipitation recorded for southern Texas from the late 1990s to 2004 (Correia 2005).

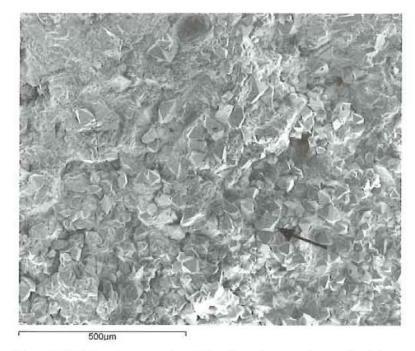
Fig. 4. SEM micrograph of the interior surface of a laboratory sample from group H (salt-contaminated and treated with HCT) after a poultice treatment. The arrow points to a single CTT grain. Note the clean faces of the CTT grains, and the good coverage on the calcite grains, mag. 100×, 2005.

The results were assessed by examining the untreated and salt-treated samples with SEM. Surface topography and crystal morphology were studied to ascertain the formation of CTT on the calcite grains and any potential interference from salt impregnation. Although CTT could not easily be identified with EDS on the limestone, as it is a calcium compound, it was possible to identify CTT formation through visual observation of its characteristic crystal morphology under high magnification. Original and quarry stone samples were prepared for SEM examination by breaking off an edge of the treated cube samples, mounting the interior edge on an SEM stub mount, and coating the sample with gold. The formation of CTT crystals was clearly observed in the HCT treated samples as orthorhombic grains on the calcite matrix (fig. 4). Where salts were present, these appeared to have formed around and on top of the CTT crystals, thus suggesting post CTT recrystallization (fig. 5).

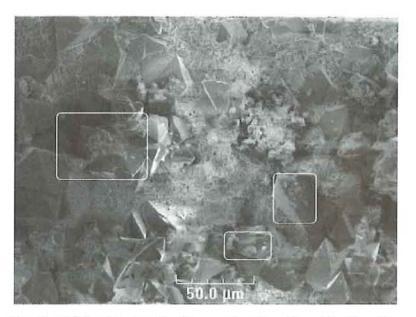
Fig. 5. SEM micrograph of a sample taken from the Sacristy Window after two applications of the preconsolidant HCT. Note salt recrystallization on the faces of the CTT grains in the outlined areas, mag. 500×, 2006.

The results confirmed that the white crystalline pustules on the flaking surfaces of the lower stonework are predominately gypsum. The identification of CTT on the pustules scraped from preconsolidated stone surfaces also confirmed the successful introduction of the HCT. SEM examination also revealed that the salts recrystallized onto and around the CTT grains in a sample taken from the window after preconsolidation. Similar results were also observed in the laboratory impregnated quarry linestone (figs. 4, 5).

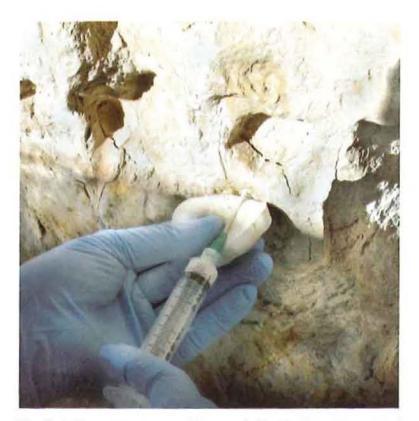
After emergency stabilization was complete, carved details that were found to be detached due to micro-cracking and bedding delamination were pinned. Micro-pinning with 1/16 in. diameter pins was reserved for small and ornate areas of the carved surfaces while larger areas of detachment required 1/8 in. diameter pins.

Pinning methods were selected based on previous research by the ACL at the Second Bank in Philadelphia, and Victoria Mansion in Portland, Maine, using ceramic pins seated in a filled Paraloid B-72 adhesive (Glavan 2004; Glavan and Matero 2005). Ceramic pins of 1/8 in. and 1/16 in. diameter of Does 1/16 in. larger than the diameter of the pin, and fixed in place with an adhesive (fig. 7).

Fig. 7. Micro-pinning by filling a drilled hole with a filled B-72 injection before insertion of an alumina ceramic pin.

A 1:1 (by weight) solution of Paraloid B-72 in acetone was prepared. Both 0.01% fumed silica (Cab-O-Sil, extra fine) and 20% precipitated calcium carbonate (Ultra-Pflex) were added to the B-72 solution (by weight) to increase viscosity, increase bond strength, and control shrinkage. Holes were drilled beyond the detachment into the sound stone; a recess of 1/4 in. was allowed at the surface of the hole for a mortar fill. The adhesive was injected into the hole through a 14-gauge Teflon cannula secured to a 10cc syringe. The pin was degreased in acetone before seating the pin in the adhesive. The area was then capped off with the same adhesive. Pins were inserted perpendicular to the direction of the detachment and at an upward angle.

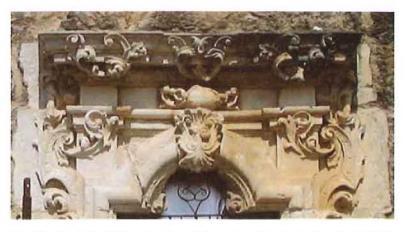
Field and laboratory analysis had revealed the partial application of a pigmented cementitous wash and possible silicone-based water repellent that had darkened the stone surface, especially in repair areas. For the test trial cleaning, a portable low-pressure microabrasive cleaning system (Sensi-Clean) was selected because of its extreme sensitivity and control. The system utilizes a very fine calcium carbonate precipitate as the aggregate, delivered at low variable pressure and volume. The lowest settings were chosen during the pilot test cleaning, delivering approximately 10cc of medium/second at 7.5 psi (Correia 2006).

The lowest setting of 1:1 (media:pressure) was used on most areas of the stonework. Only heavily soiled, recessed, and discolored areas were cleaned with a 2:1 setting, utilizing more medium rather than higher pressure, to address heavier surface accretions. The nozzle was kept at a uniform distance of at least one inch from the surface and was not allowed to dwell in one area for more than a few seconds. Approximately $2-1/2 \times 50$ lb. bags of medium were

Fig. 8. Detail of the Sacristy Window during cleaning (left) with the Sensi-Clean microabrasive cleaning system.

used for the entire carved surround and metal grille (fig. 8).

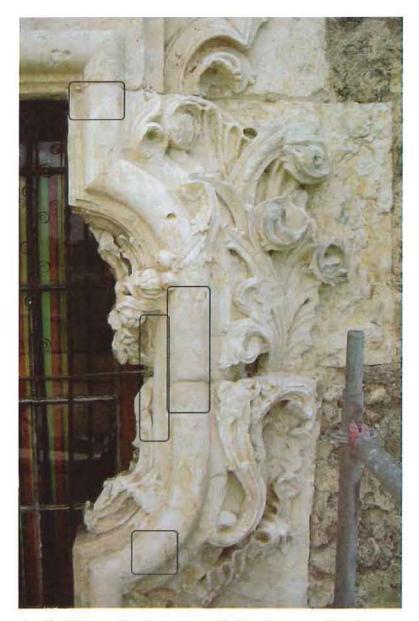
During the initial treatment, many of the previous 1940s mortar repairs and poorly repointed joints were found to be visually disfiguring and unsound. Joints were raked back at least 1/4 in. from the surface of the stone, and defective mortar repairs were removed. Newly exposed stone was then treated with HCT and OH100.

Fig. 9. The outlined areas are finished mortar fills that replaced incompatible previous repairs.

ratio (by volume) of 3.5 NHL (St. Astier) and yellow bar sand formulated to match the existing original lime mortar in color, texture, and overall properties. Where necessary, mortars were tinted with raw sienna and marble dust to match the darker cleaned stone surfaces. Larger areas of compensation, where previous repairs had been removed, needed to be applied in layers over a 2 to 3 day period. Final finishes were achieved on the molded elements with sheet metal profiles cut to match the original. Surfaces were then pressed with natural sponges to pull excess water from the mortar and leave a slightly granular finish to match the weathered stone surface (figs. 9, 10).
