# ASSESSING THE DETERIORATION OF PENNSYLVANIA MARBLE IN WILLIAM STRICKLAND'S MECHANICS' BANK

# A THESIS

# MASTER OF SCIENCE IN HISTORIC PRESERVATION

2018

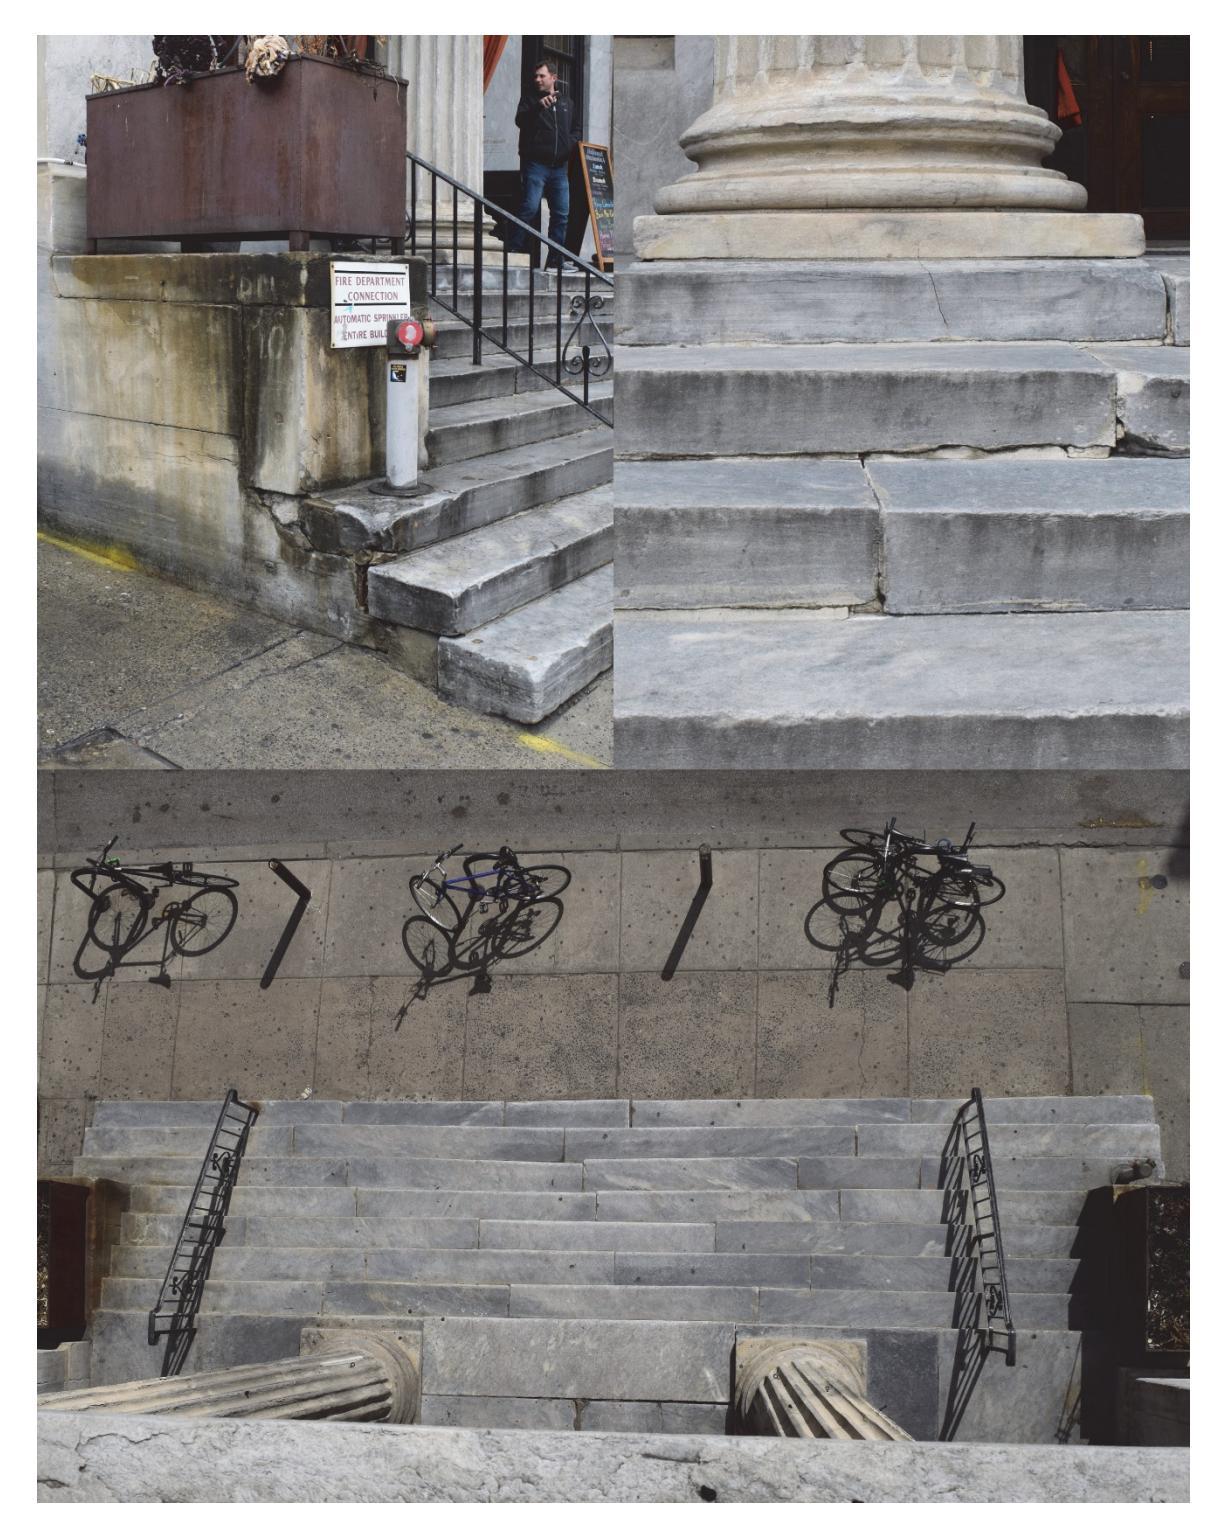
Figure 8: Conditions at steps, left-right and top-down: SE corner with effects of car crash and metallic staining; open joints, structural cracks and differential washing below south column; aerial view of displaced steps.

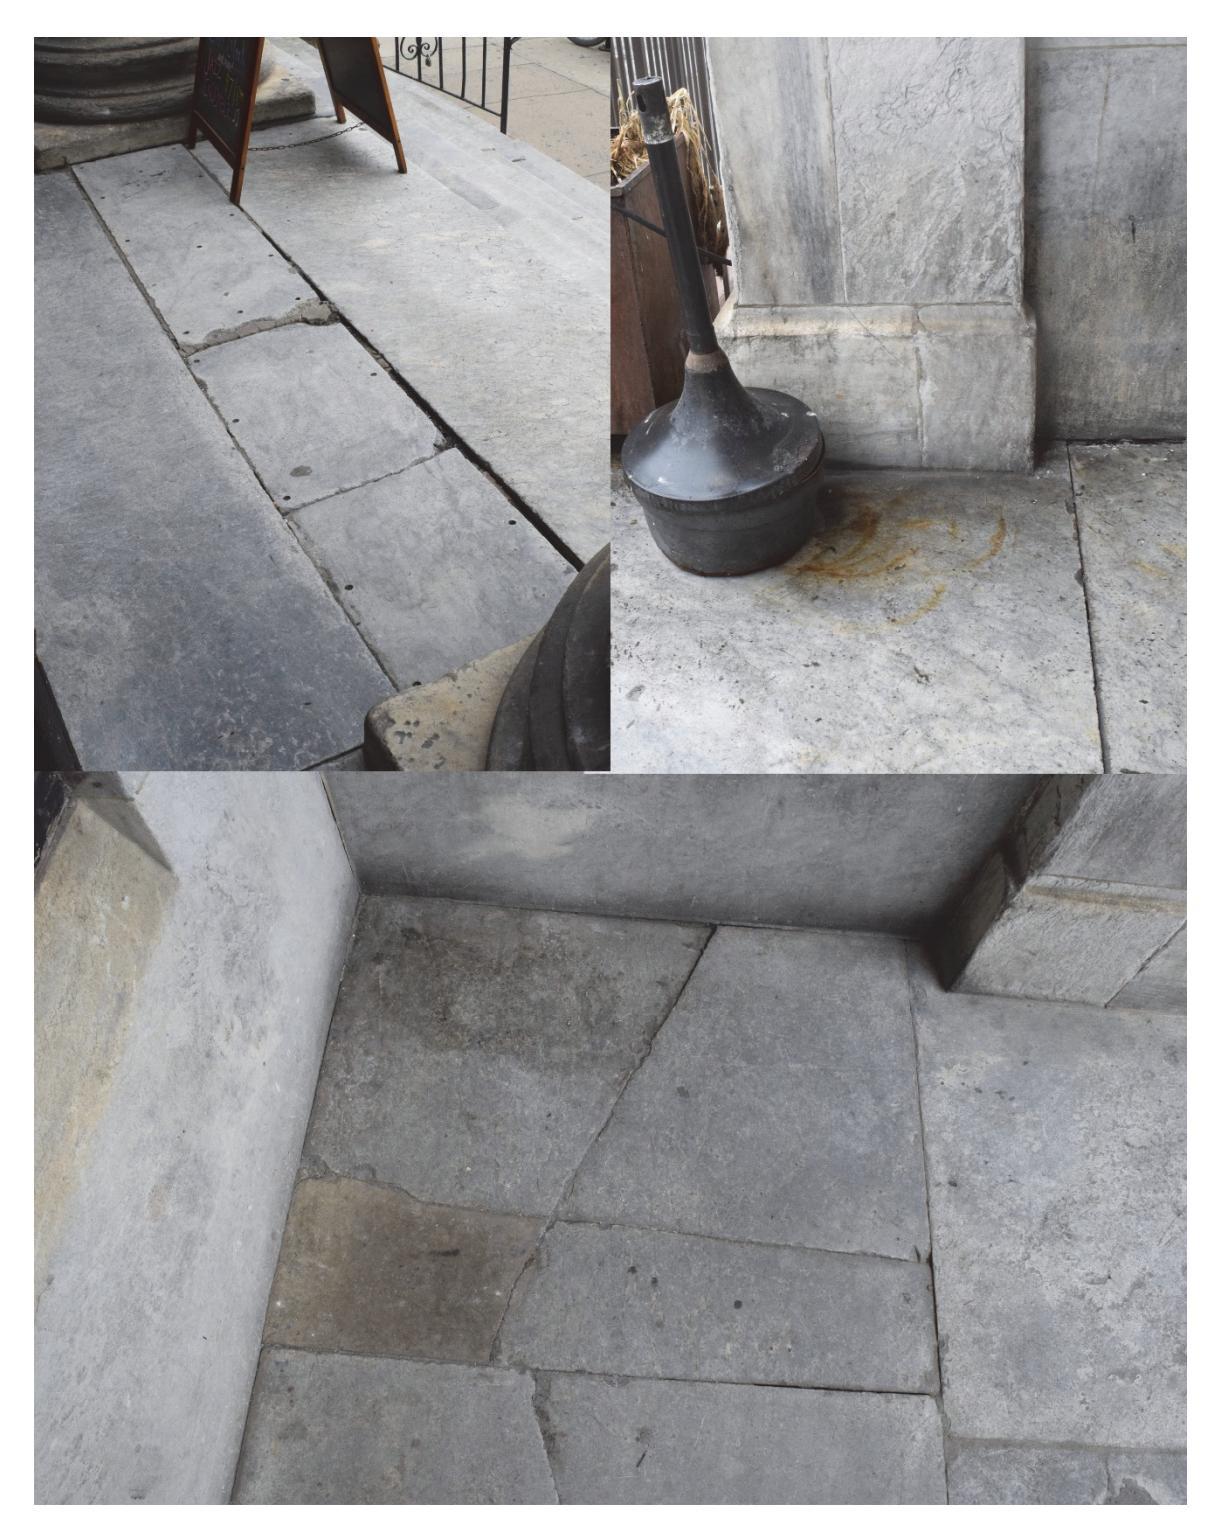
The 1957 metal handrails have their top anchoring point near the edge of the floor and present here the same conditions as at the steps.

Figure 10: Conditions at floor, left-right and top-down: cracking and displacement at center, with holes for metal attachments; soiling and metallic staining at south wall; cross-shaped crack (mortar repair at bottom left).

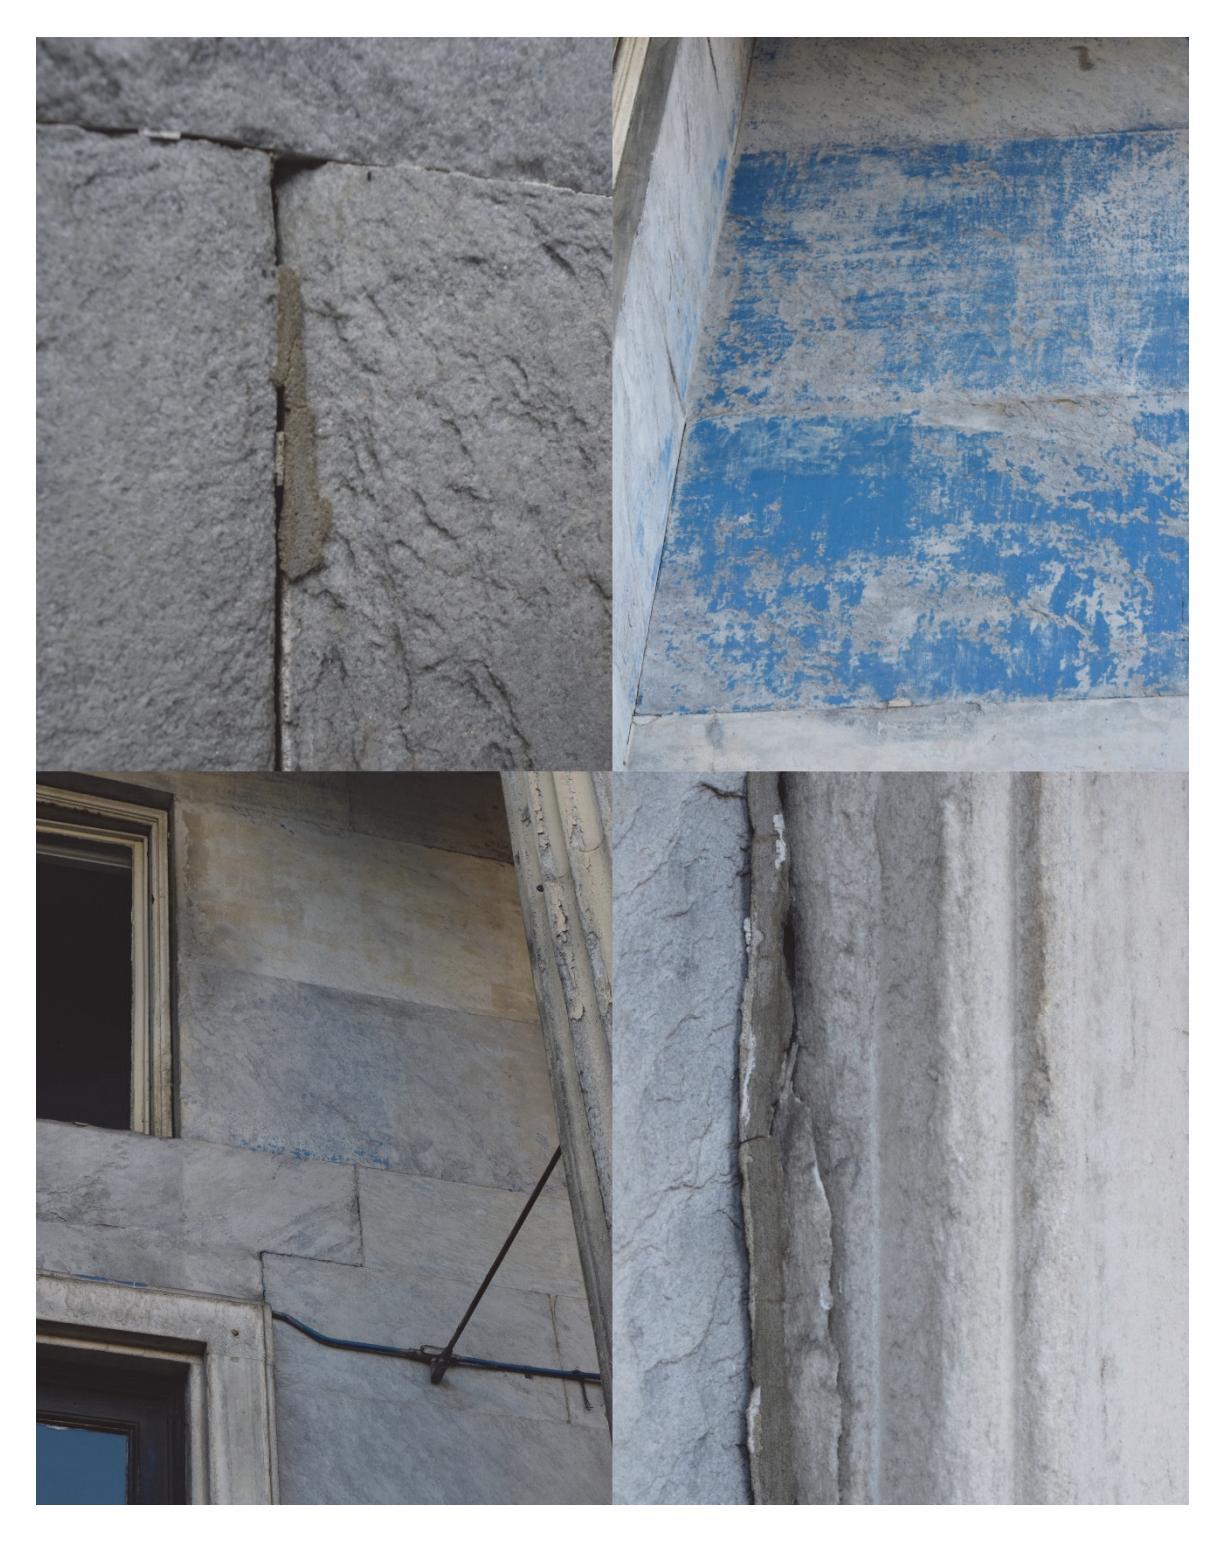
between them and the back wall have historically opened, and continued to do so after repointing with hard cement mortar; as a result, the mortar has pulled the friable marble away from the jamb in large flakes that can be detached by hand, especially at the south jamb. The lintel, being face-oriented, shows surface friability instead. Two anchor holes at the lintel suggests metallic ornament at the corners, since disappeared; metallic staining, however, follows the path of the electrical conduit mentioned above, which rests directly on the lintel. Some encrusted soiling is present at the south jamb.

Figure 12: Conditions at pronaos walls, left-right and top-down: contour scaling and repointing; top of north anta with paint coating; open joints, soiling and electrical conduit; mortar causing marble flaking at south jamb.

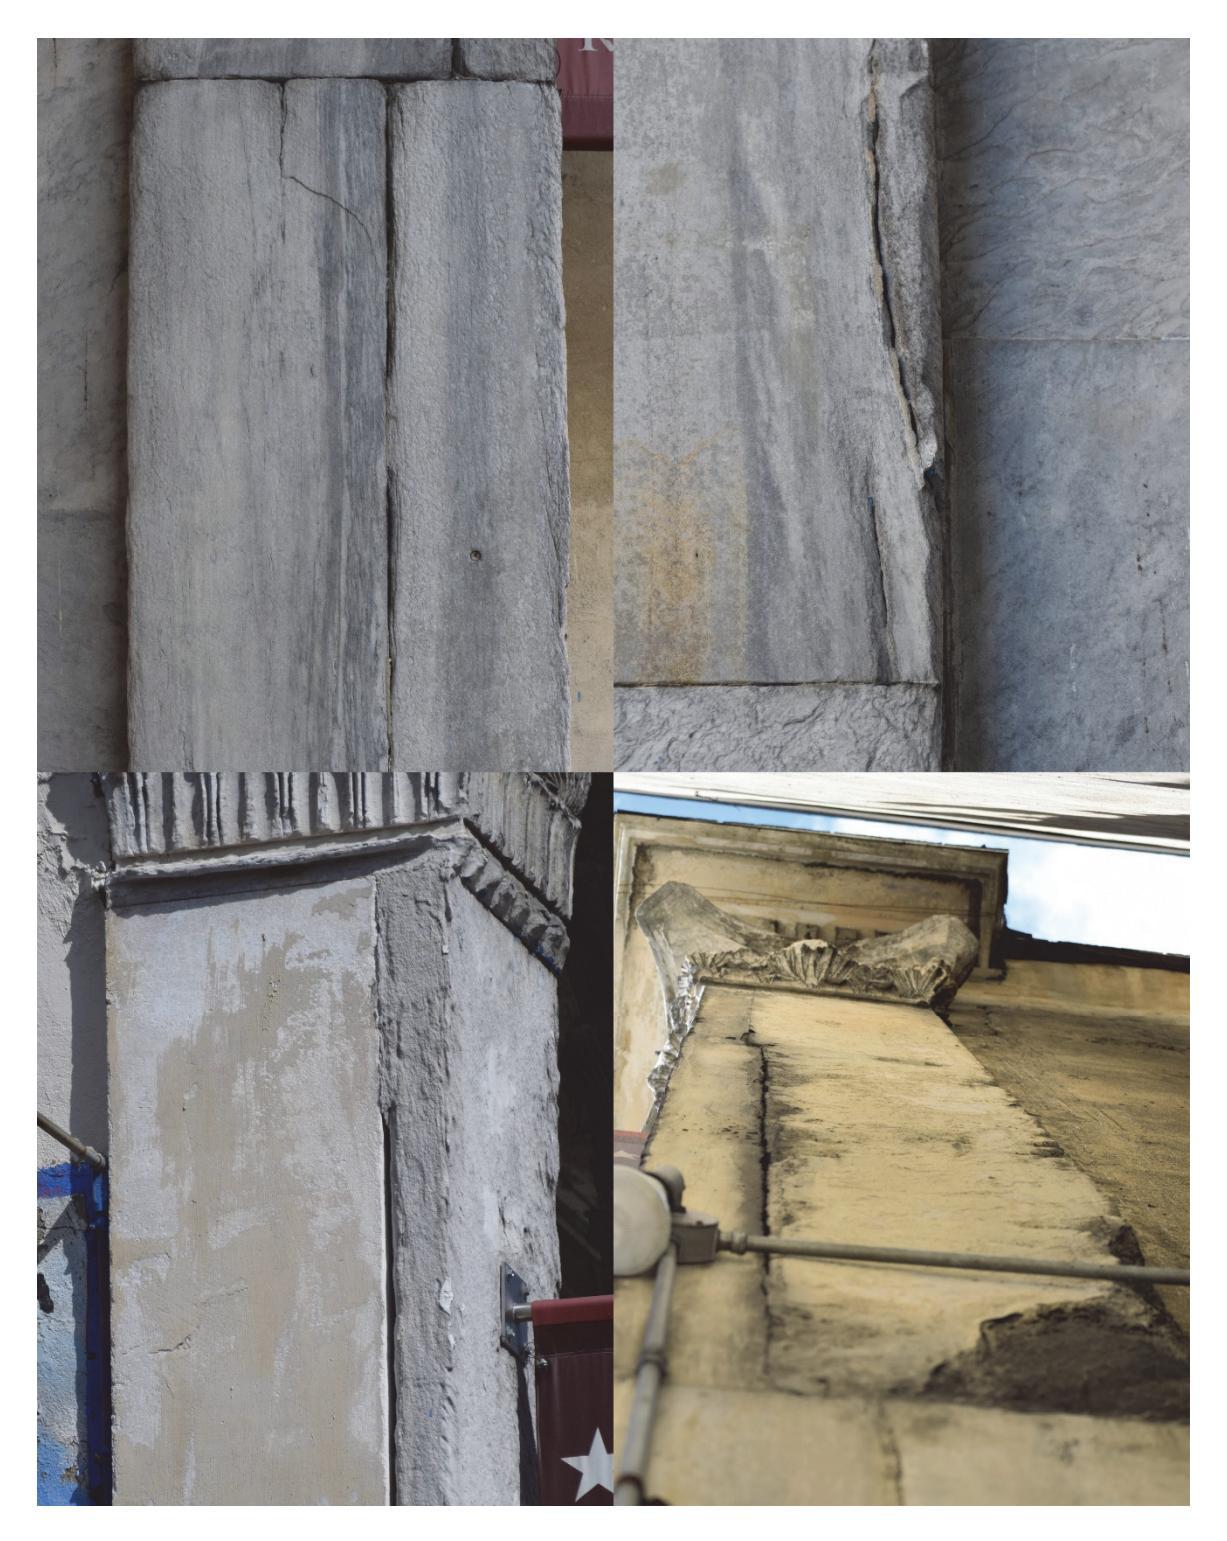
Figure 14: Conditions at pilasters, left-right and top-down: structural spalling (north inward); spalling and erosion (south inward); paint residue and severe friability (south); soiling and large spalling (north at alley).

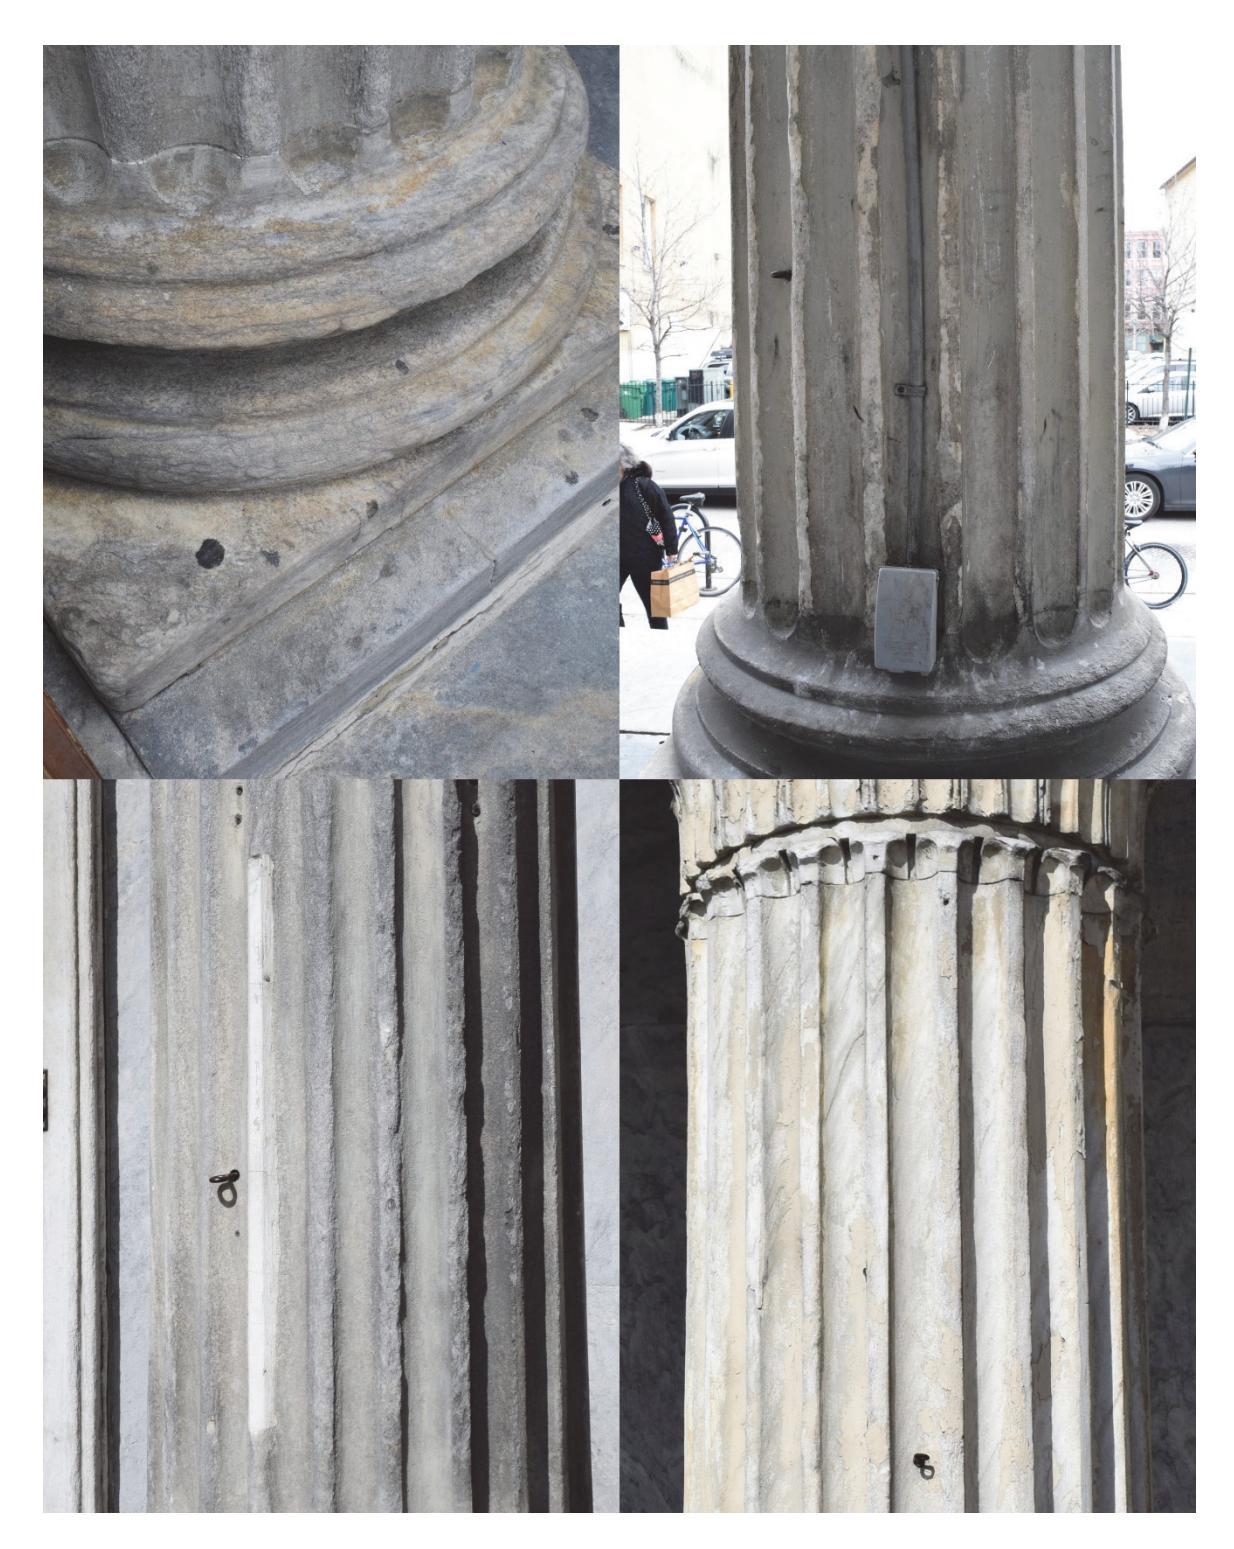
The columns were twice painted white and much of this paint coating is still present throughout. A middle band with loss of paint coating is related to the former presence of flagpoles attached to a ring. Along the interior elevation of each column rises a vertical electrical conduit connecting to the pronaos wall; encrusted soiling is prevalent around these but there is little evidence of metallic staining. The latter is more prevalent at the top of the columns on the exposed areas, where it can be associated with the now removed capital cages.

Figure 16: Conditions at columns, left-right and top-down: microcracking, erosion and staining (north base); electric conduit (south); spalling of fluting and repair (north); diagonal cracking and incipient spalling (south).

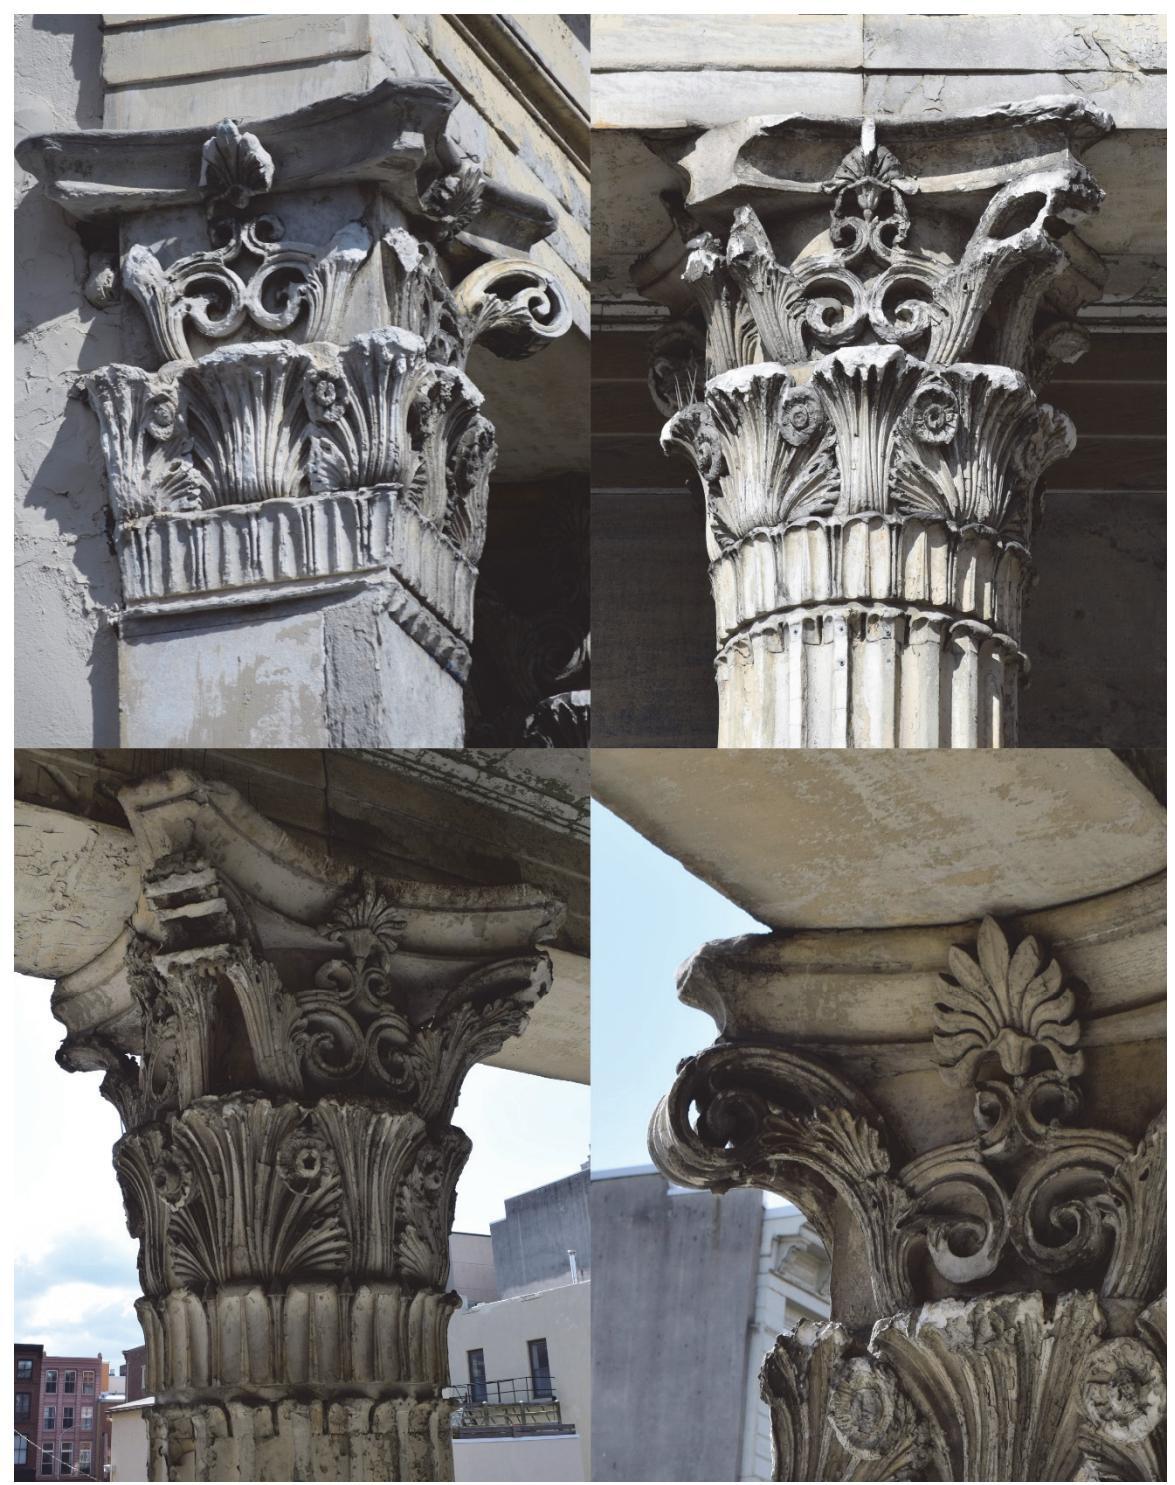
Figure 18: Conditions at capitals, left-right and top-down: friability and spalling (south pilaster); abacus spalling (north column); intact leaf tips and metal spikes (south column); only intact volute and fleuron (south pilaster).

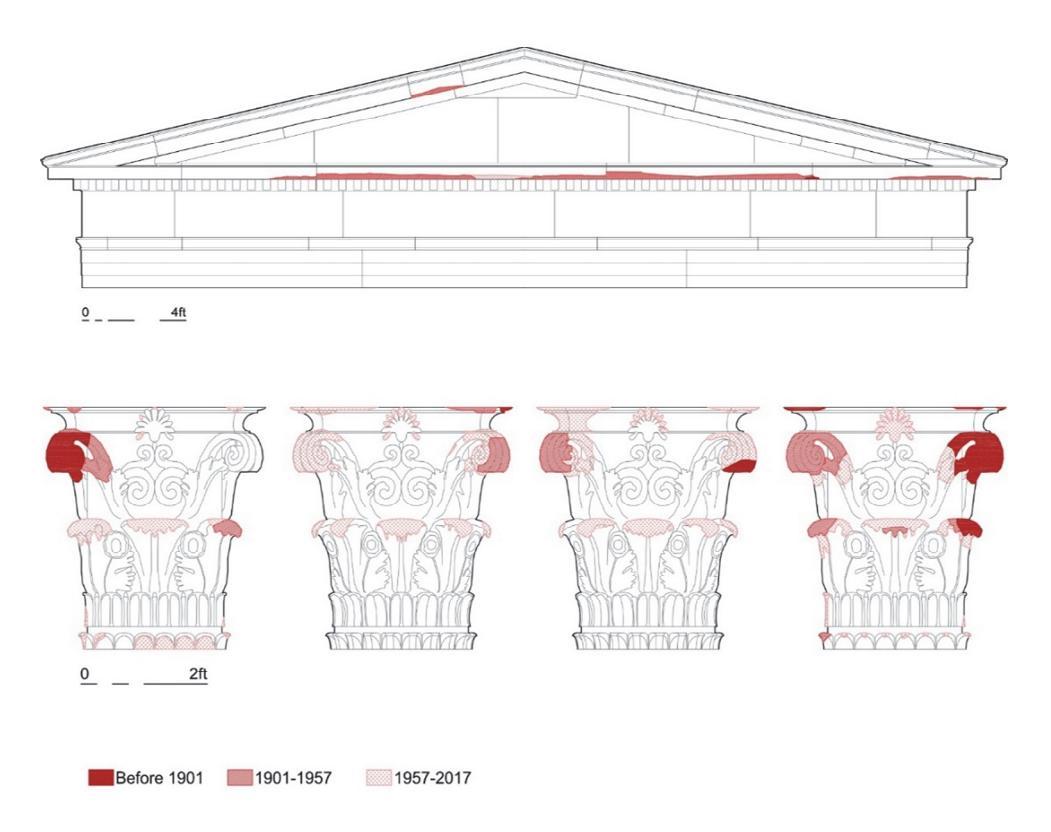
Figure 20: Evolution of dimensional loss at entablature and capitals (Sources: King, HABS). The former seems to have stabilized after 1957. Spalling of capitals began at building's corners and generalized in the last fifty years.

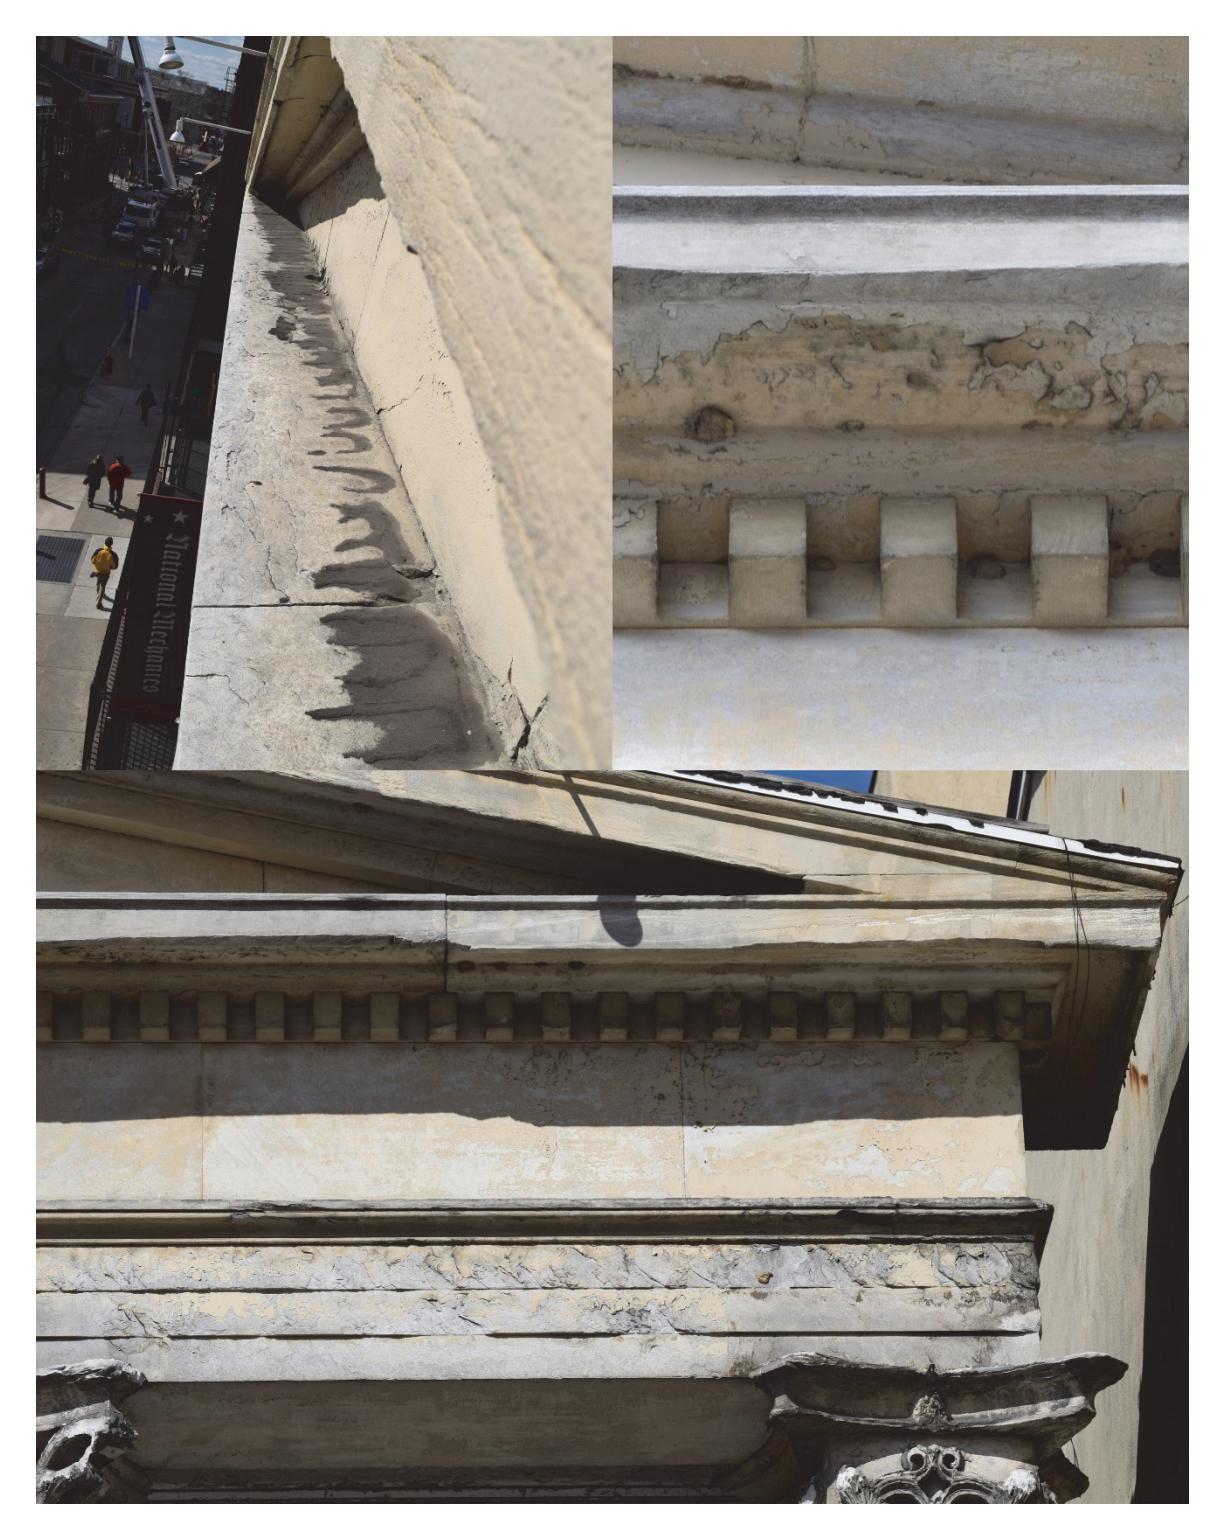
The face-oriented units at the pediment tympanum show few visible conditions. There is localized contour scaling and soiling at protected corners and in the vicinity of the sill. The central unit, however, shows diagonal cracking with some shearing movement of unclear origin.

Figure 21: Conditions at entablature, left-right and top-down: encrustation and contour scaling at pediment; paint coating and insect nests at dentils and cornice; contour scaling at architrave and spalling at cornice.

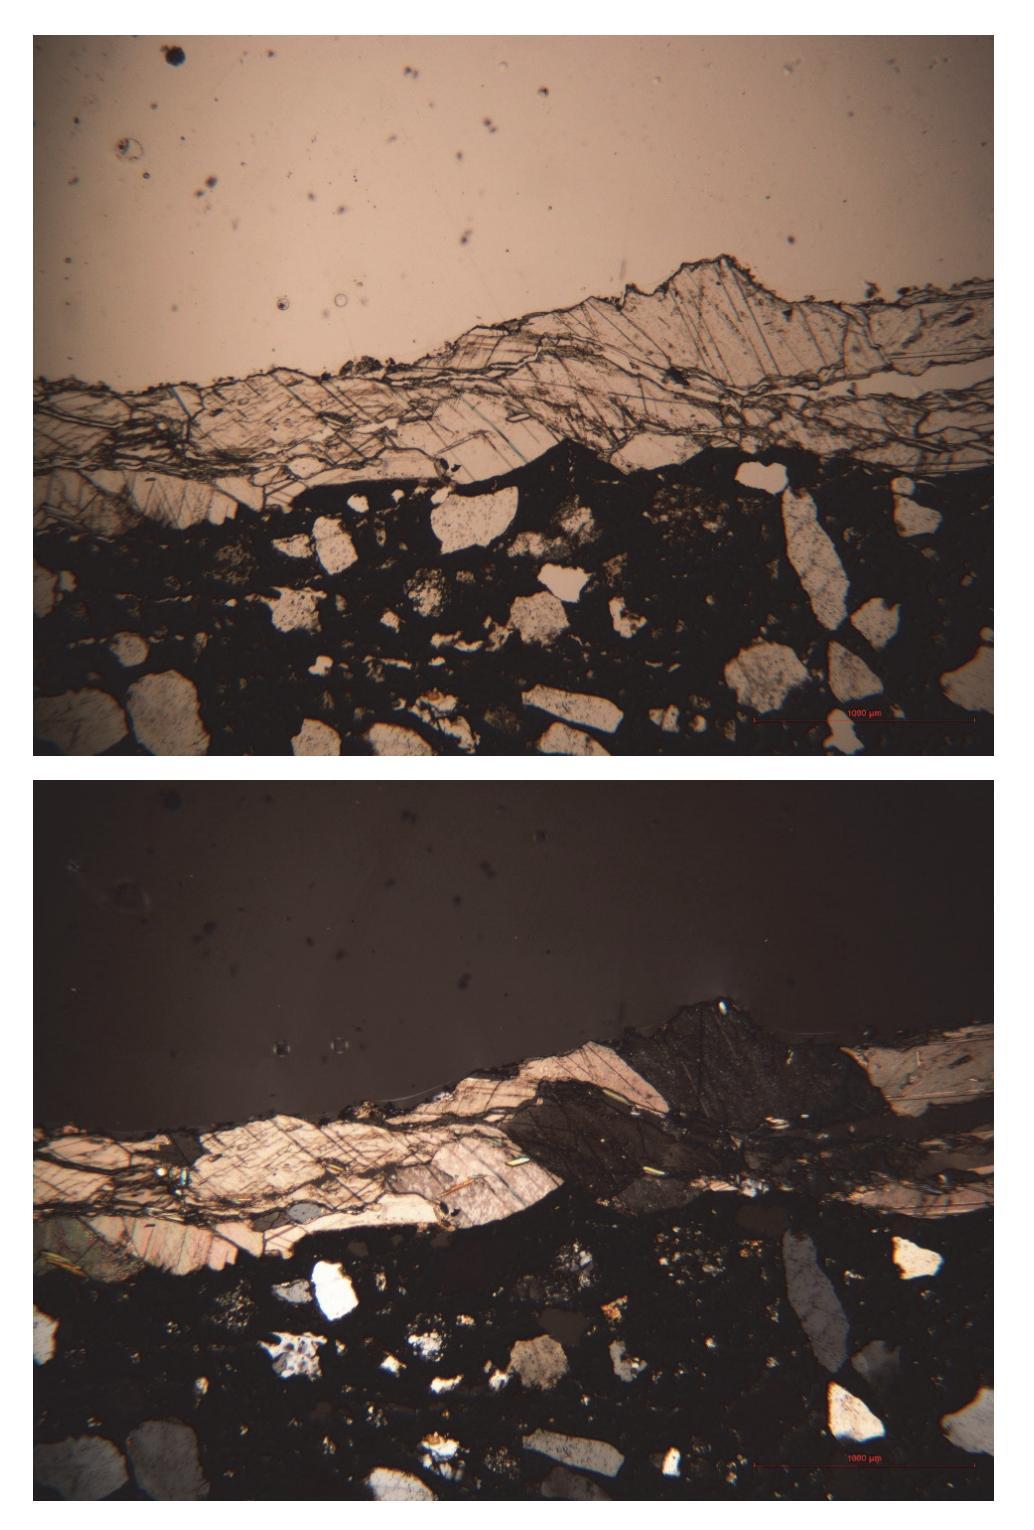
Figure 25: Sample SS04(b) under PPL and XPL (40x). Note cracking and small quartz and mica crystals.

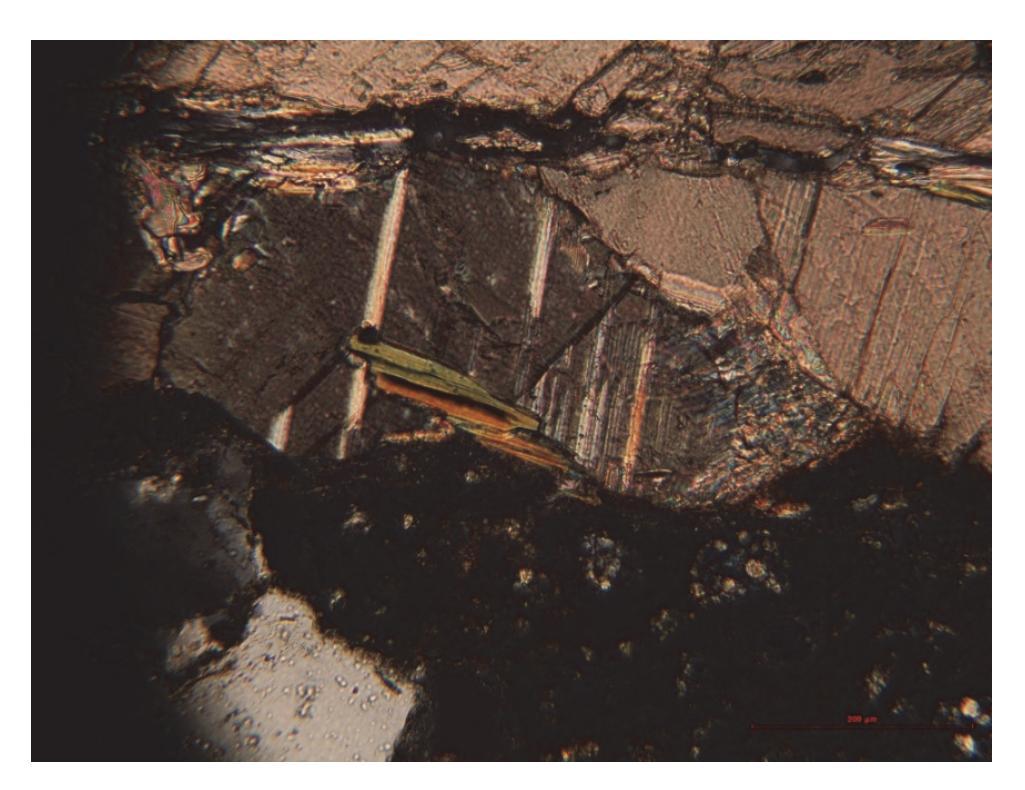
Figure 26: Detail of micaceous laths both intact and split at crack in SS04(b). XPL (200x).

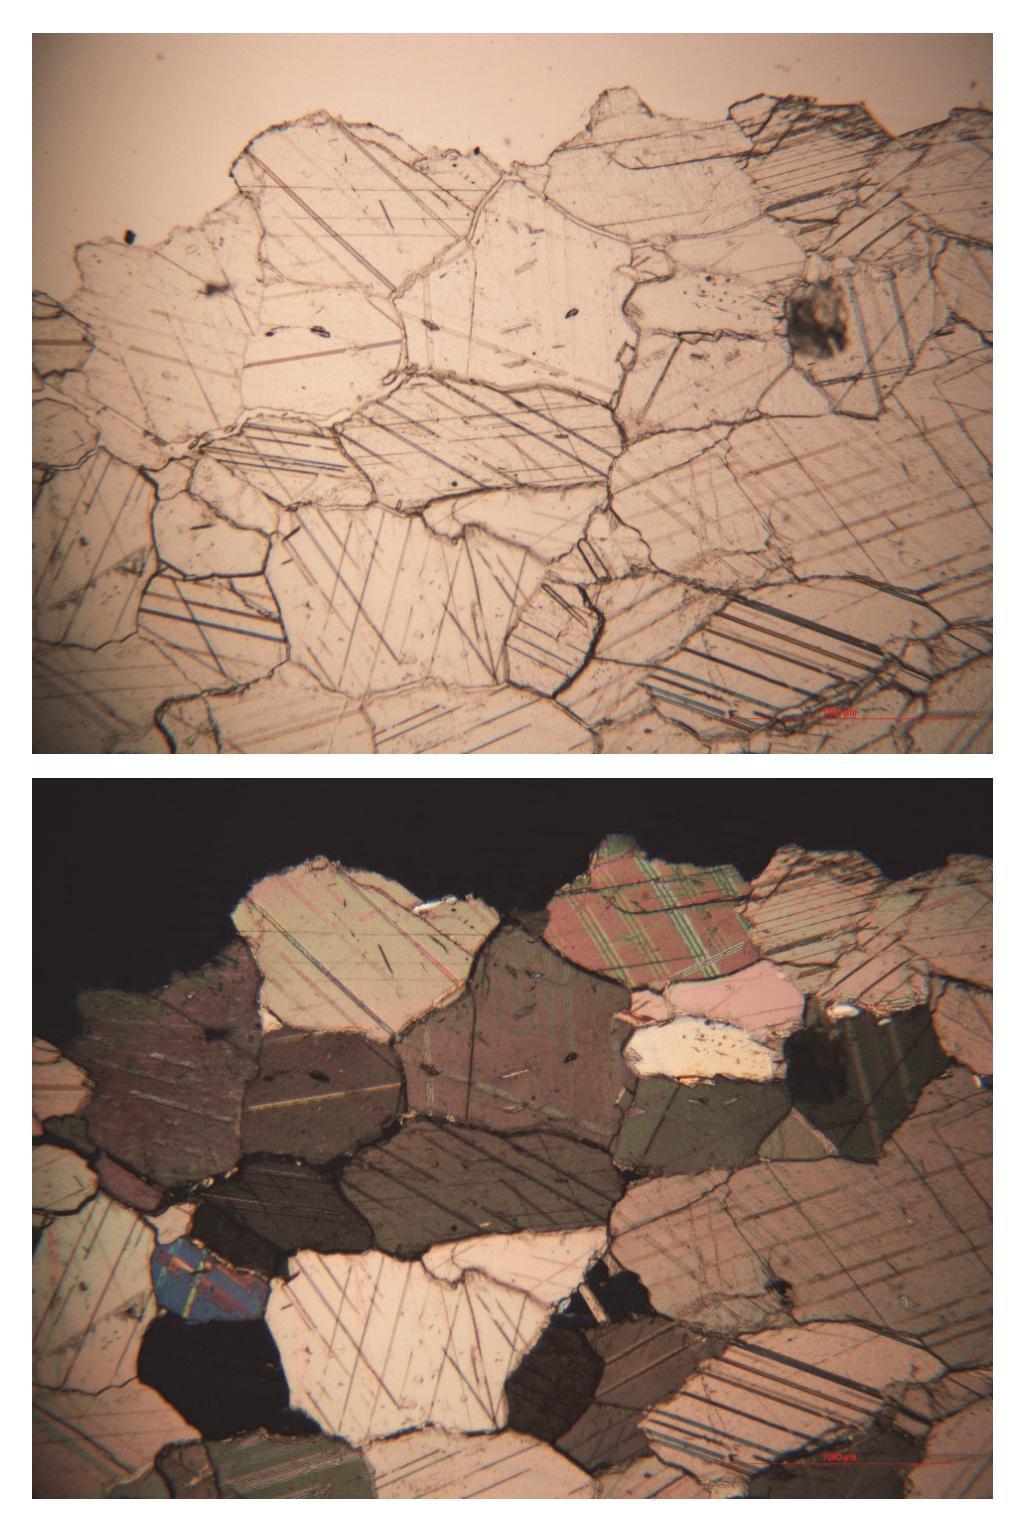
Figure 27: Sample SS05 under PPL and XPL (40x). Note cracking with lenticular growth and small mica laths.

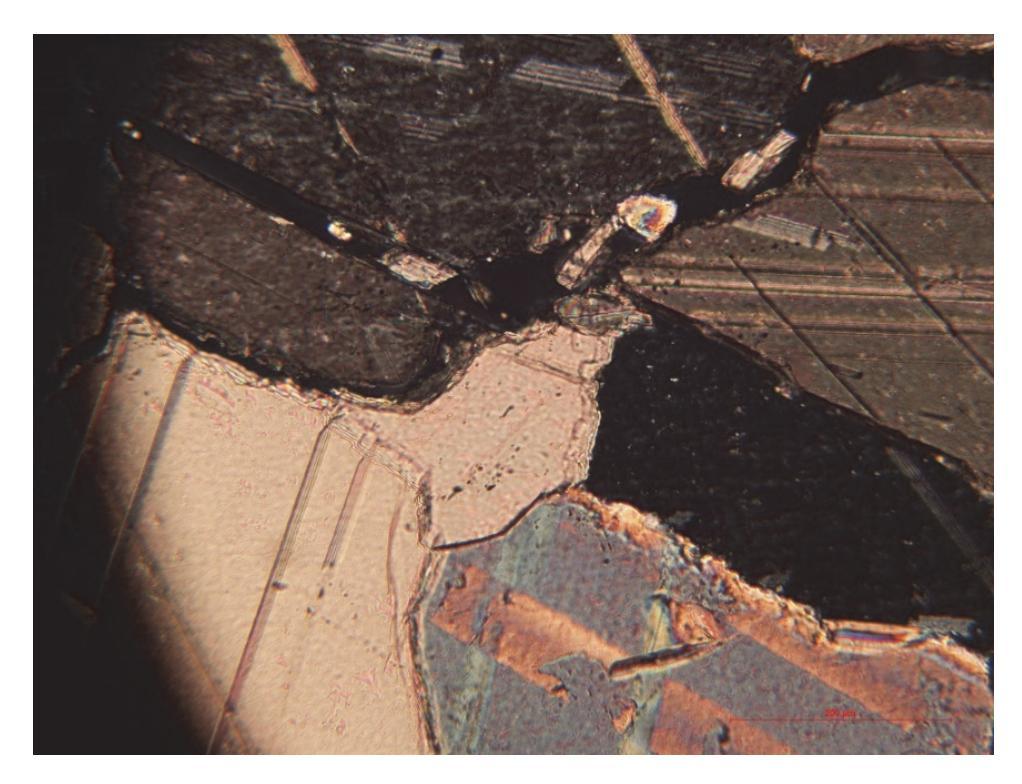
Figure 28: Crystal growth at intergranular crack and cleavage plane in SS05. XPL (200x).

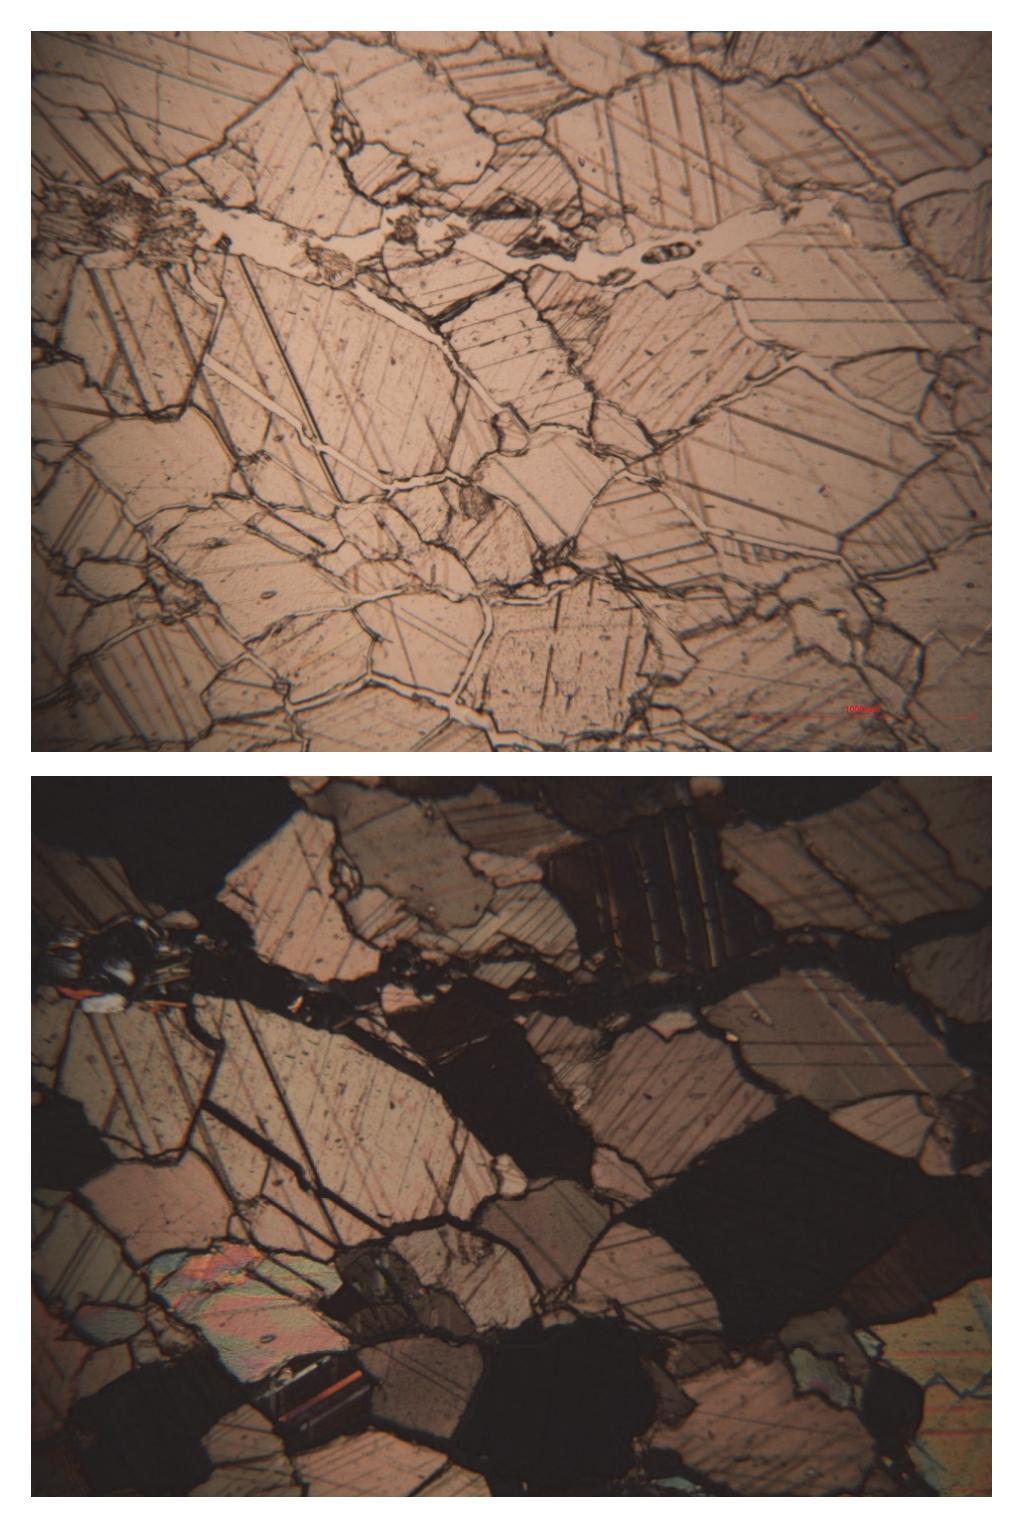
Figure 29: Sample SS04(w) under PPL and XPL (40x). Note large cracks, both inter- and intragranular; and split micaceous lath at top left.

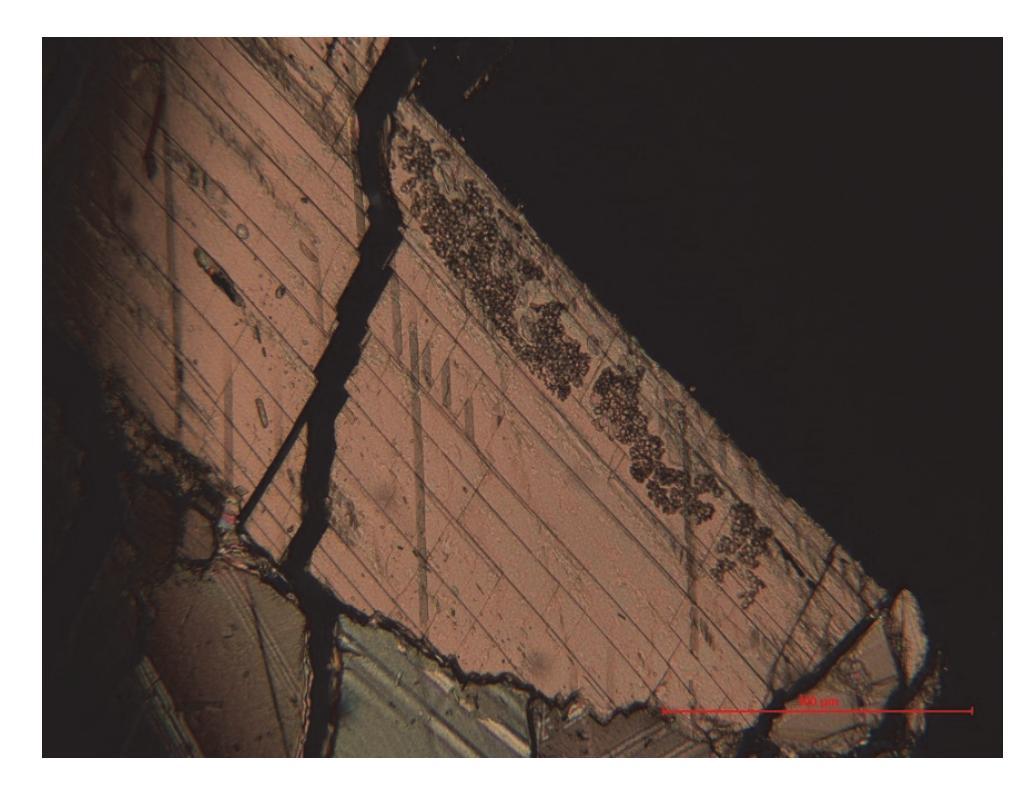
Figure 30: Cracking of calcite along cleavage planes in SS04(w). XPL (100x).

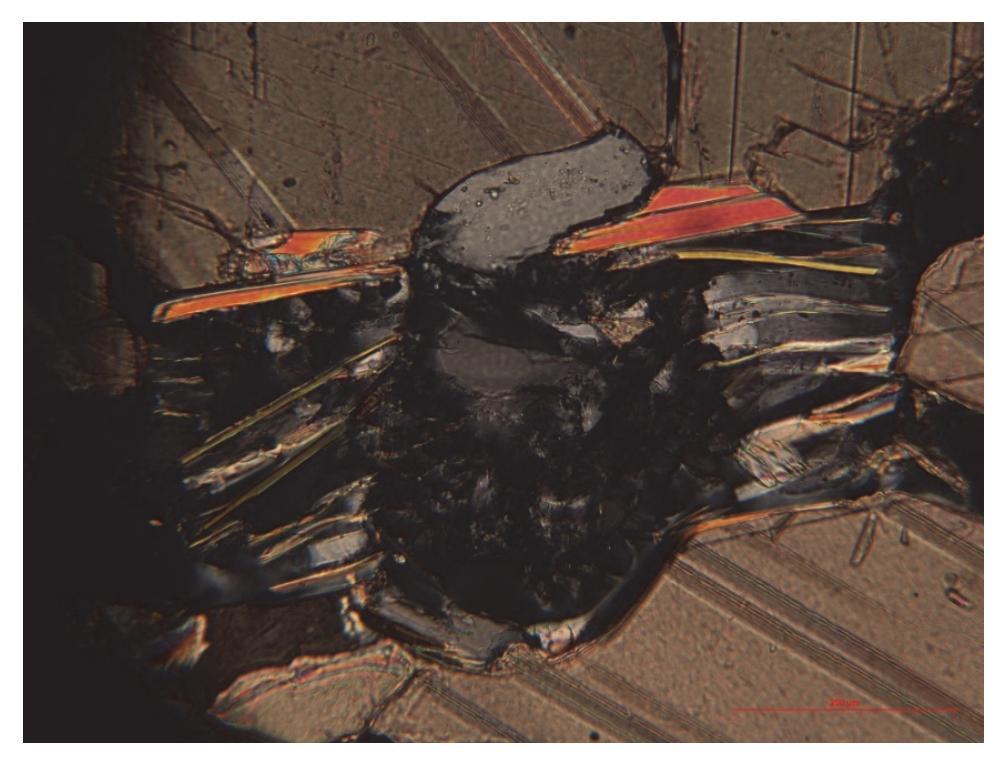
Figure 31: Quartz grain and splitting micaceous lath with growth of salt crystals in SS04(w). XPL (200x).
