# ASSESSING THE DETERIORATION OF PENNSYLVANIA MARBLE IN WILLIAM STRICKLAND'S MECHANICS' BANK

# A THESIS

# MASTER OF SCIENCE IN HISTORIC PRESERVATION

2018

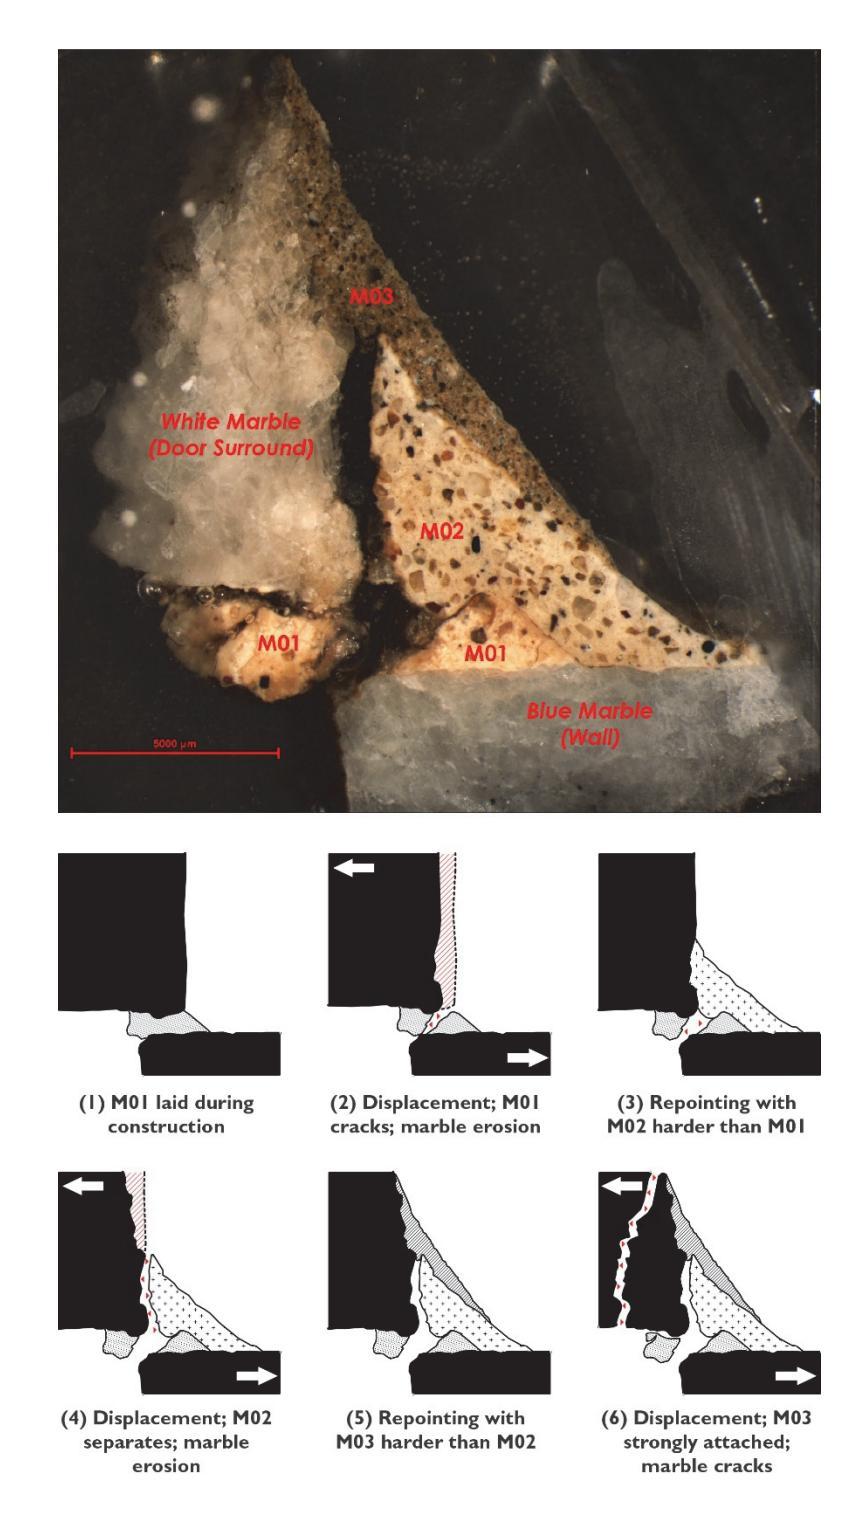
Figure 32: Section of Sample PS4 (1.25x) showing successive repointing campaigns. As movement caused the original mortar to crack, two increasingly more rigid and mechanically stronger ("harder") mortars were substituted resulting in cracking of the marble itself.

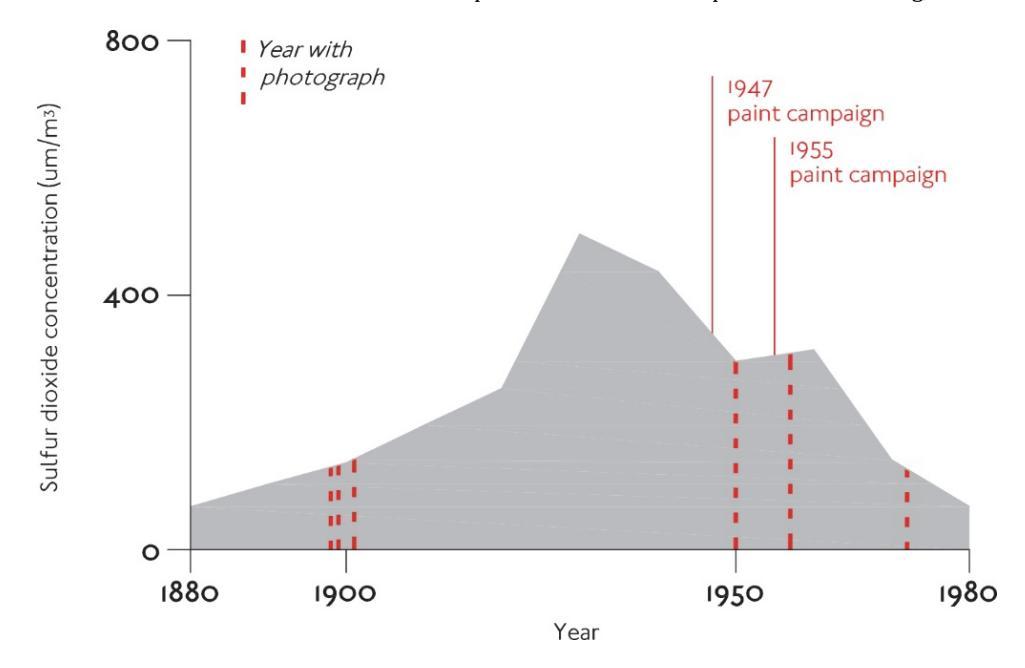
Figure 36: SO<sub>2</sub> concentration in Philadelphia, 1880-1980, and appearance of the building. Photographs from c. 1900 show little deterioration; paint campaigns in 1947 and 1955 probably responded to quick deterioration c.

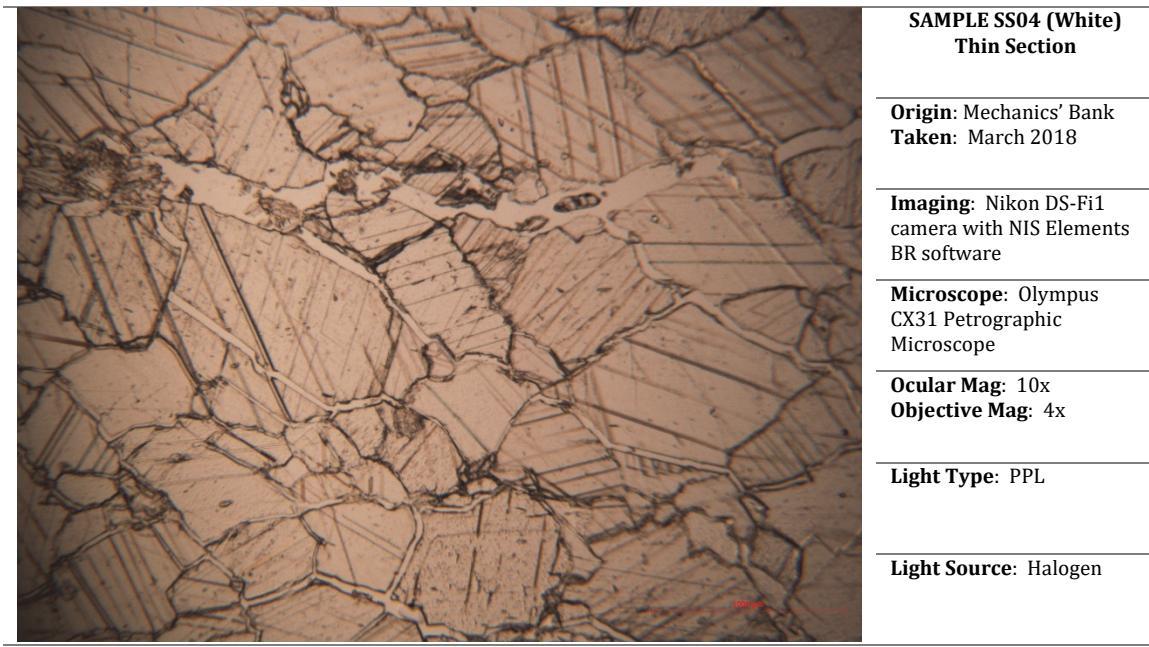
**NOTES:** Interior of sample. Texture is granoblastic to foliated. Medium to large-sized subhedral grains, equant to subelongate. Severe intergranular cracking following foliation planes of rock and intragranular cracking at cleavage planes. Boundaries between grains less irregular than SS03, with a few triple junctions.

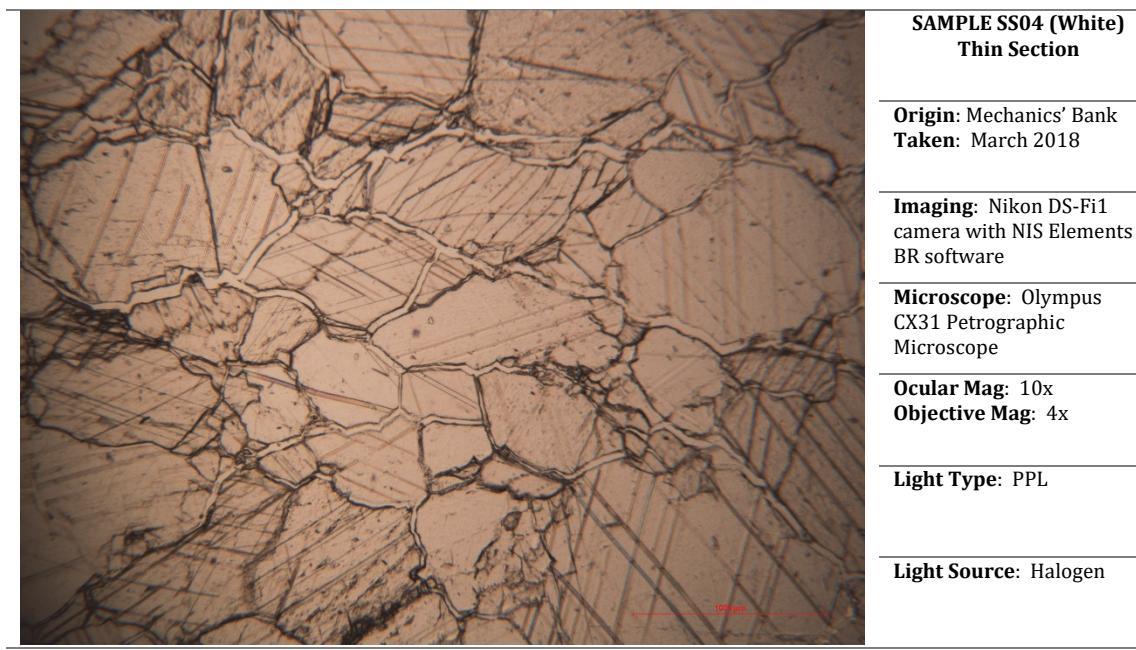
**NOTES:** Interior of sample (2). Texture is granoblastic to foliated. Medium to large-sized subhedral grains, equant to subequant. Intergranular cracking following foliation planes of rock and intragranular cracking at cleavage planes. Boundaries between grains less irregular than SS03, with a few triple junctions.

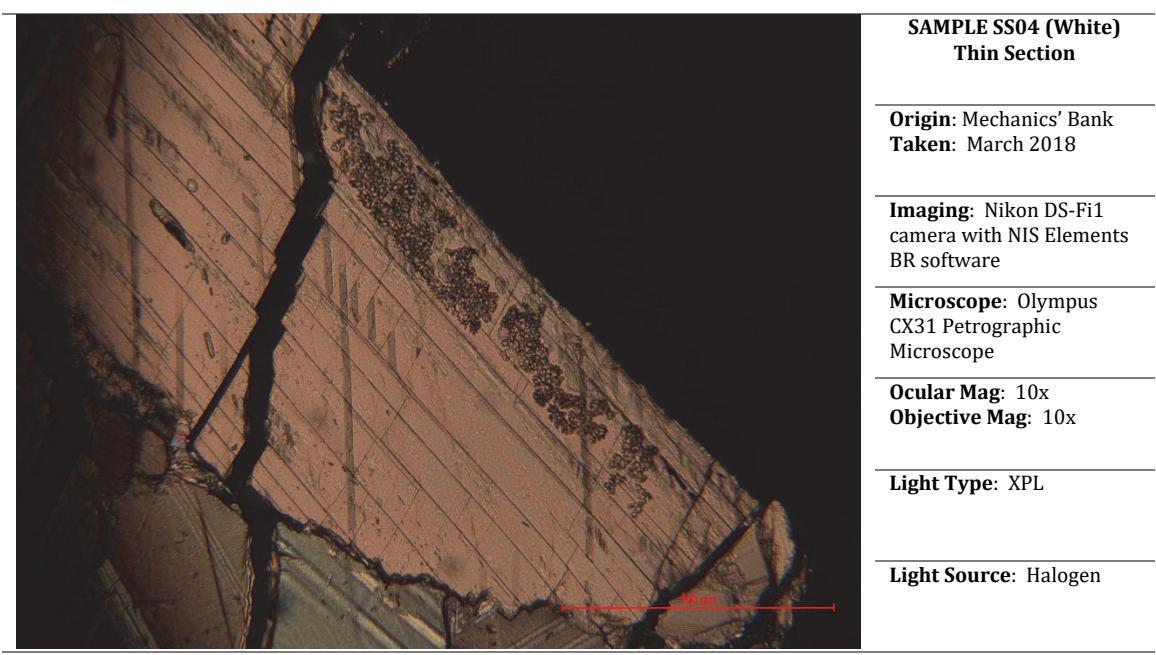
**NOTES:** Detail showing crack in calcite/dolomite grain along cleavage planes. Surface alteration along spall surface visible at right, indicating the spall was exposed for some time.

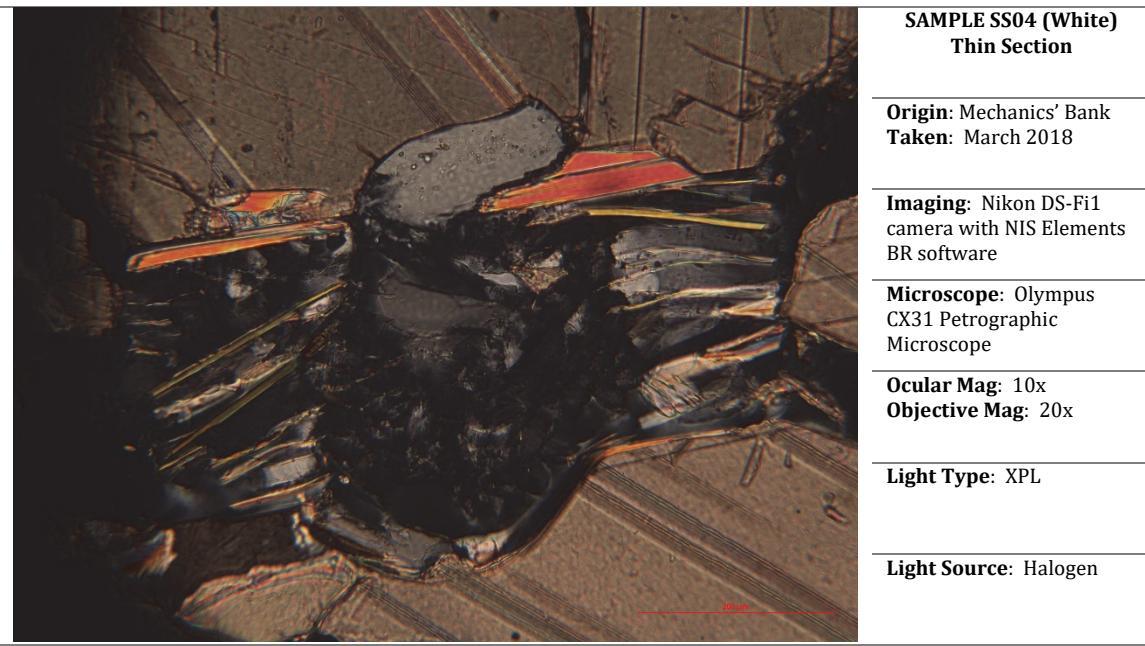
**NOTES:** Crystals at intergranular crack. Small quartz grain at center (evidenced by high relief and lower first order gray color) and large, platy micaceous lath (probably muscovite) showing splitting. Crystal growth inside splitting lath suggests crystallization of unidentified soluble salts, such as gypsum, causing the splitting.

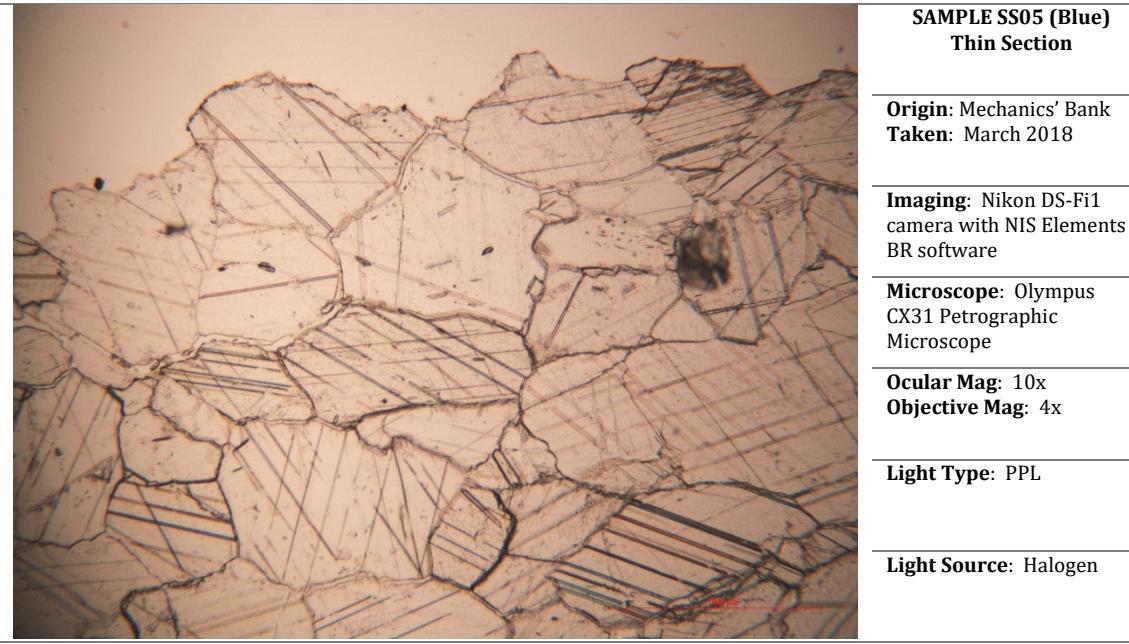
**NOTES:** Surface. Texture is granoblastic to foliated. Medium-sized, mostly subhedral grains, subequant to elongate. intergranular cracking but little intragranular cracking and no damage at cleavage planes. Boundaries between grains less irregular than SS03 and SS04 with some triple junctions.
