THE WOODLANDS: DOCUMENTATION OF AN AMERICAN INTERIOR

A THESIS

Historic Preservation

1997

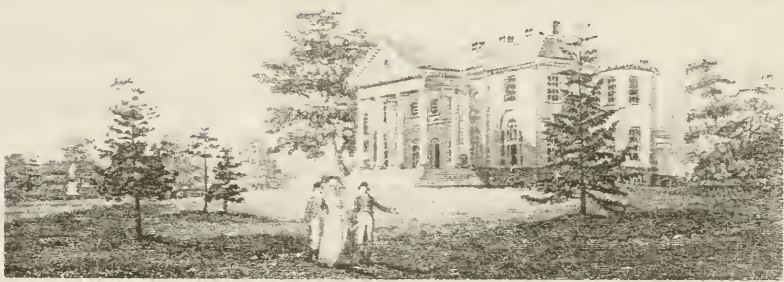
FIGURE 1.1.4

1809 William Strickland engraving for the periodical Port Folio. Note again the north pavilion protruding to the right. From a photograph courtesy of the Historical Society of Pennsylvania.

arrangement of the fanlight glazing. The panes are 10-1/2" wide by 14-1/2" tall. The Executive Committee's annual report of 1850 states that all the window sash in the house were replaced during the previous year as they were sorely deteriorated. The narrow profile of the muntins is consistent with the recorded replacement date of 1850. The muntins in the original Southeast Parlor sash should probably have aligned with the concentric muntins of the semicircular fanlight above.¹⁶⁶ (See Figure 3.3.13.) The proposed glass size is 15" wide, very large by eighteenth century standards but corroborated by the Mutual Assurance survey recorded in 1811. [Reference #6] The William Strickland engraving of 1808, if interpreted literally, shows lights of a similarly large size. (See Figure 1.1.4.)

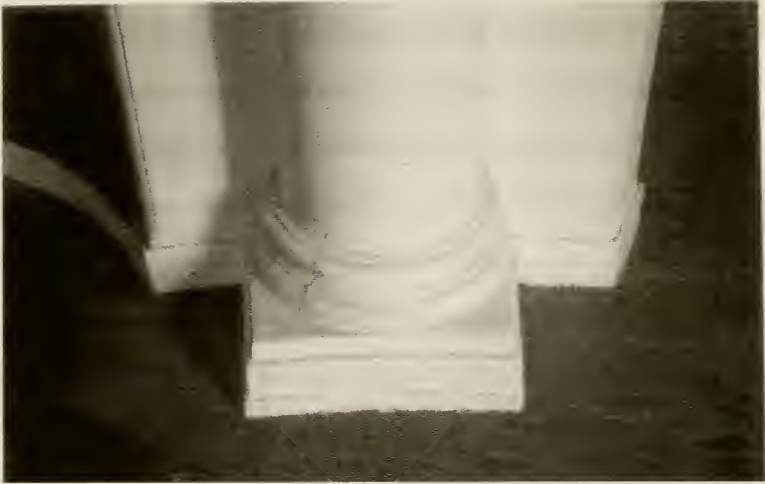
FIGURE 3.1.5

Column base in the Vestibule. Note separation of the vertical staves which form the column. Photograph by author.

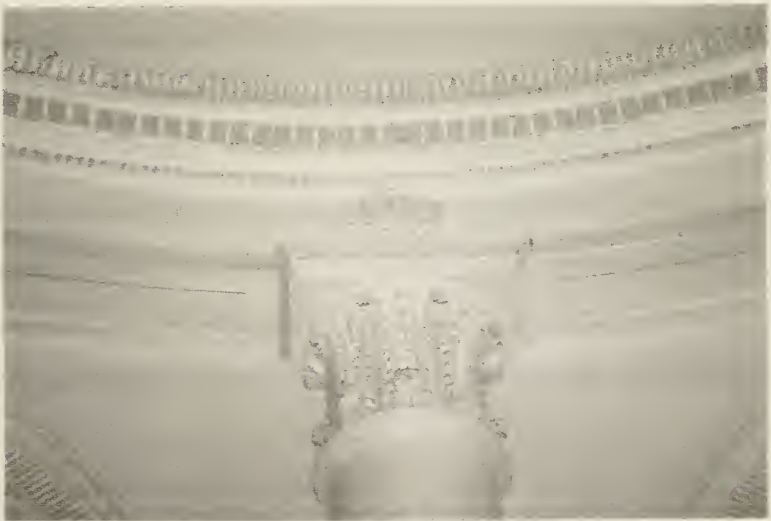
FIGURE 3.1.6

Column capital and cornice in the Vestibule. Note significant loss of composition ornament. Photograph by author.

reproduced in Figure 3.1.3 from the 1940 HABS drawings.¹³³ The underside of the entablature is a simple panelled soffit. Examination of the paint samples from the cornice and frieze suggests a color history similar to that of the column capitals described above.

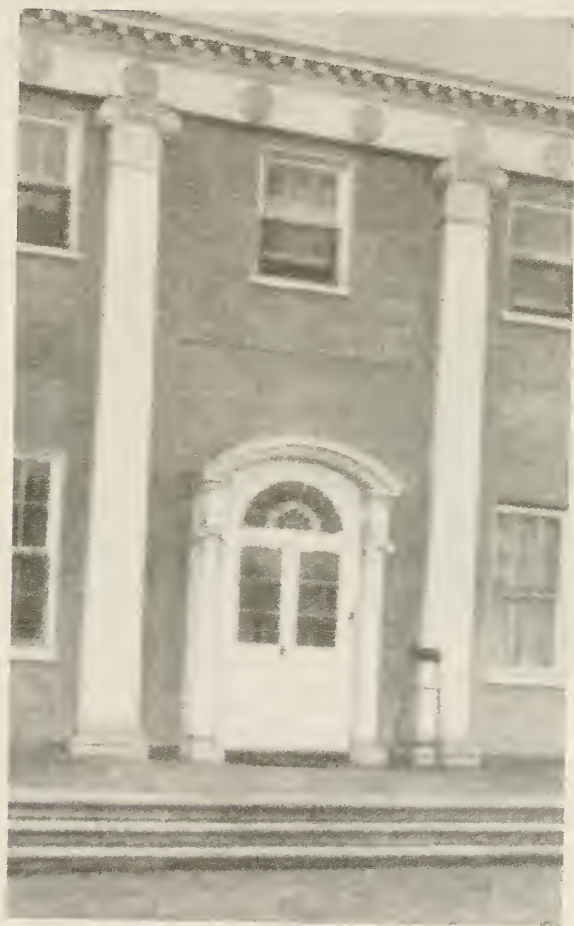
FIGURE 3.1.7

Detail of a c. 1920 view of the north facade of The Woodlands from Kimball, Domestic Architecture. The double doors shown were in place at least through the preparation of the HABS drawings in 1940.

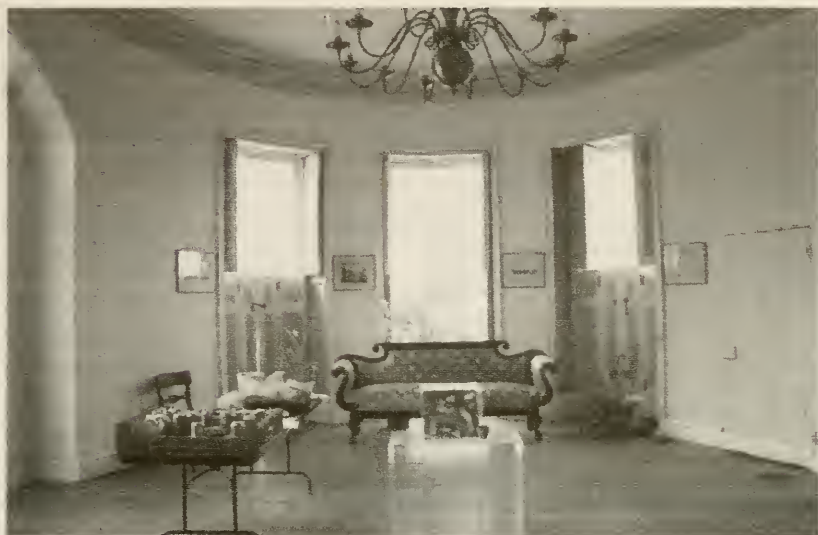
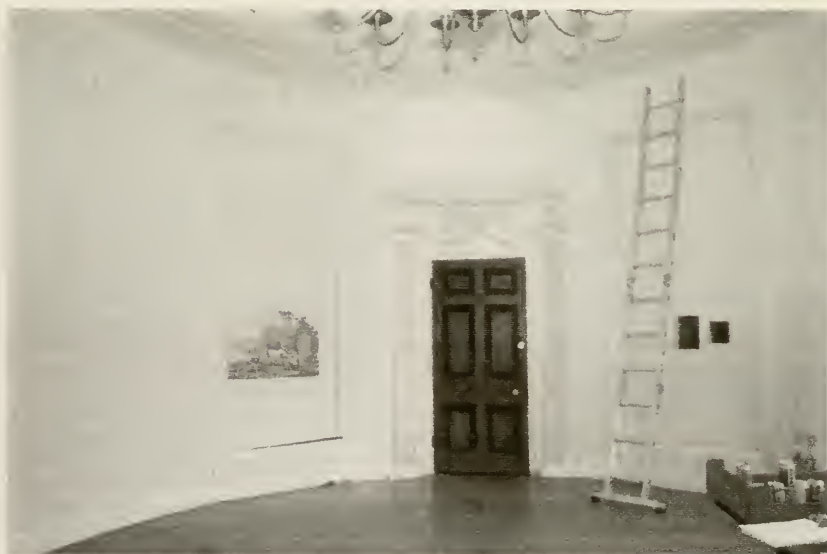
Figure 3.2.3 1997 Existing conditions in the Oval Drawing Room. Photographs by the author. This page includes the east (top) and the west (bottom) elevations.

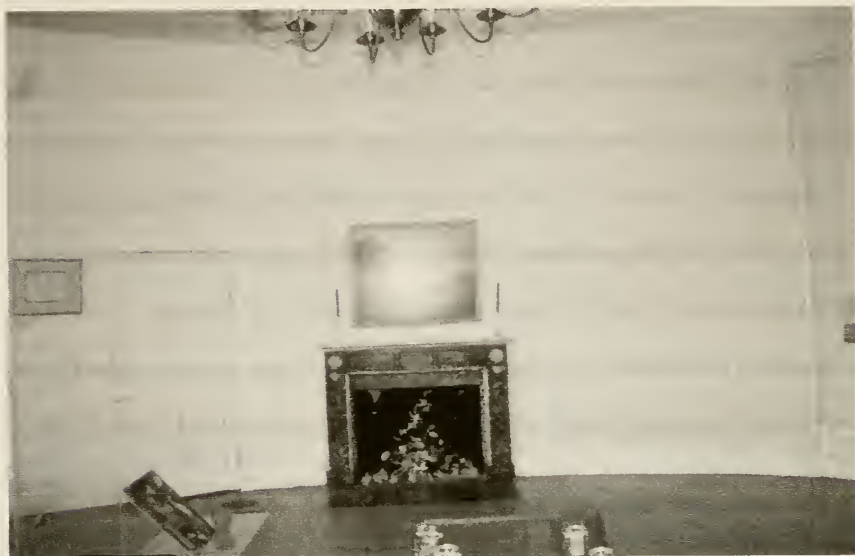
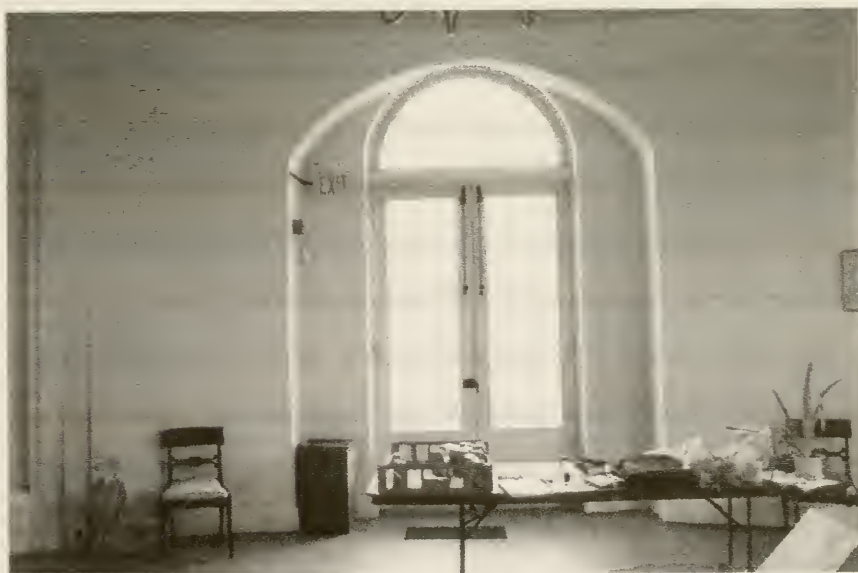
FIGURE 3.2.3 1997 Existing conditions in the Oval Drawing Room. Photographs by the author. This page includes the north (top) and south (bottom) elevations.

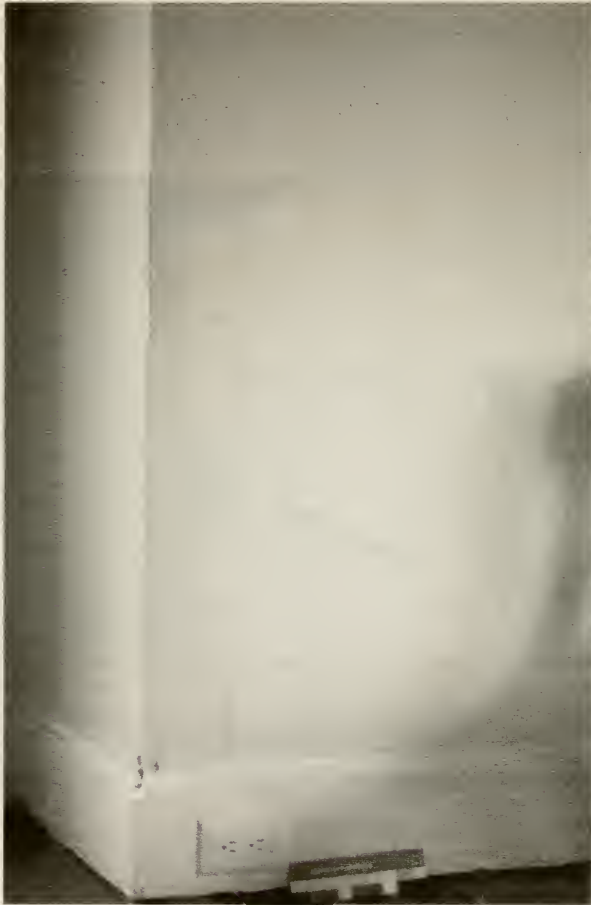
Figure 3.2.4 Typical configuration of plaster grounds / nailers in the Oval Drawing Room. The thin shadow lines denote where these members have expanded and contracted over many years, cracking the thin surface plaster. Photograph by author.

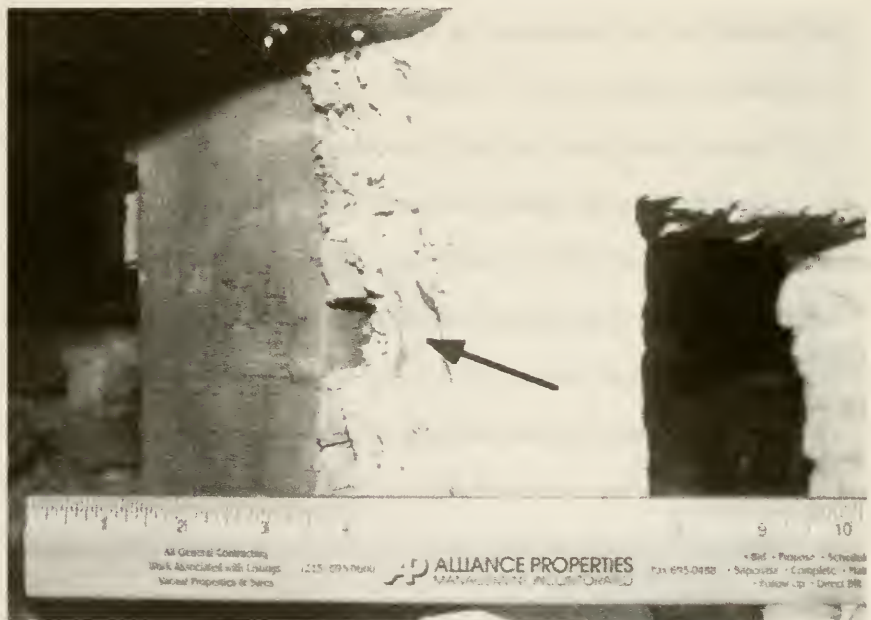
Figure 3.2.5 Plaster application and framing at the perimeter of the observation window cut in the northwest niche in the Oval Drawing Room. The brown fragments between the two campaigns of plaster appear to be extremely heavy paper, though probably not wallpaper. Photograph by the author.

Simultaneous to this study, other researchers investigating the evolution of the earlier portions of The Woodlands opened an observation hole in the northwest niche in the Oval Drawing Room.¹⁴⁸ Through this hole, the verso of the wall fabric can be studied. The studs supporting the finished surface of the recessed niche appear to be a combination of straight sawn and pit sawn material based on the regular and irregular marks left on the wood surfaces. Curiously, the back side of this partition is finished with lath and plaster like the back of the niche in the Vestibule, perhaps for sound, draft or rodent-proofing. The lath on both sides of the partition is hand-split and the nails are hand wrought iron, both suggesting an eighteenth century installation. To have completed the plastering behind the recessed niche, the plasterer would have had to exit through the top of the cavity through an unfinished floor or through an opening in the north masonry wall. What appears to be a window in the north wall closed with rubble fill is visible at this location on the exterior. The plaster finish itself is extremely thick, generally exceeding 2-1/2" and consists of what appear to be two campaigns of both scratch and brown coat. The earlier campaign is a coarser material containing large amounts of animal hair binder and has a floated surface. Shreds of paper are sandwiched between the two campaigns of plastering, though no pattern is visible to confirm that these fragments were wallpaper. (See Figure 3.2.5.) The bottoms of the niches were encapsulated by paneling installed in the mid-nineteenth century. Behind this paneling, shreds of wallpaper were discovered, still

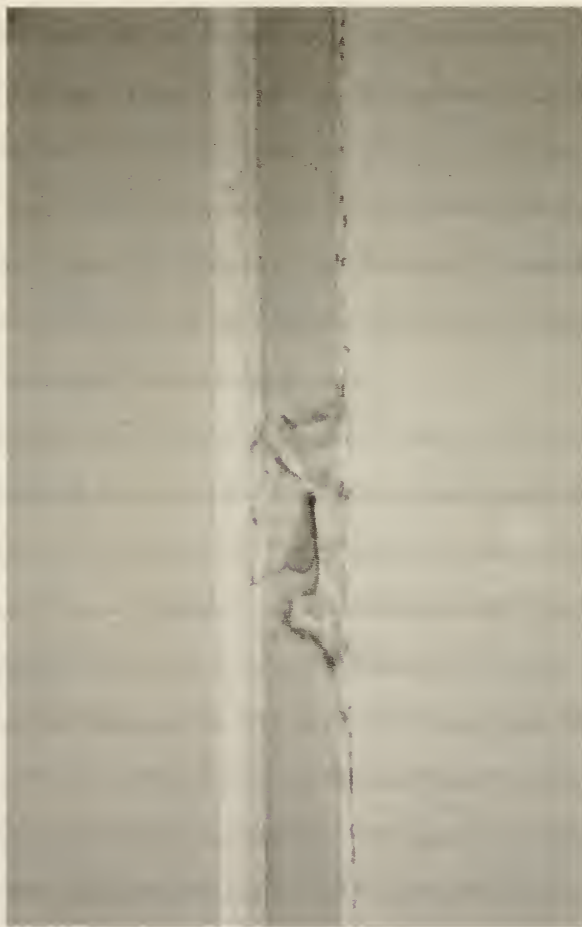
Patch at chair rail level in the north trim of the south niche in the Oval Drawing Room. The rough profile indicated corresponds closely with the profile of the surviving chair rail in the Southwest Parlor. Photograph by author.

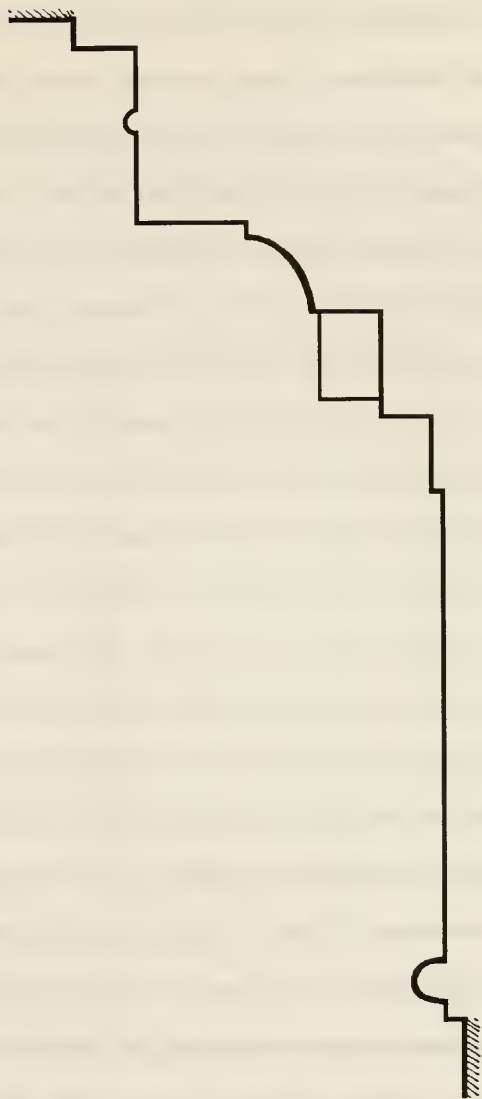
FIGURE 3.2.10

Cornice profile in the Oval Drawing Room. The frieze and bottom molding may not be original. Drawing, half size, by the author.

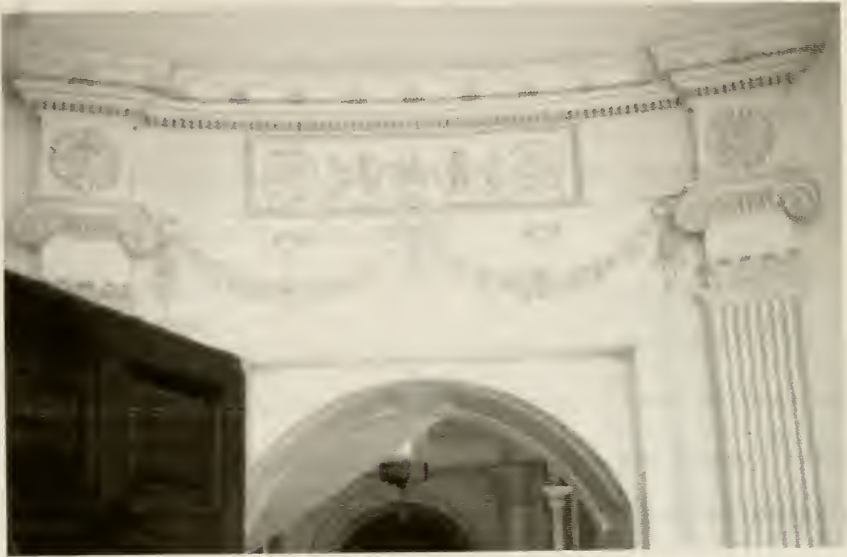
FIGURE 3.2.12 West door surround detail and door panel profile in the Oval Drawing Room. Photograph and drawing by author.

which is identical to that on the interior face. (See Figure 3.2.12.) However, the panels on this side are raised with a profile matching that of the paneled door jambs. Lines of paint buildup around the perimeter of the panels on both sides of the door suggest that it was completely stripped relatively recently. The door measures 7'-1" high by 3-1-1/2" inches wide by 2" thick. It is not curved to fit the shape of the room. The hardware consists of two large cast iron five knuckle butt hinges. A mortised lockset has been removed and the mortise repaired with a dutchman patch but the glass knob and keyhole remain. A modern deadbolt provides security.

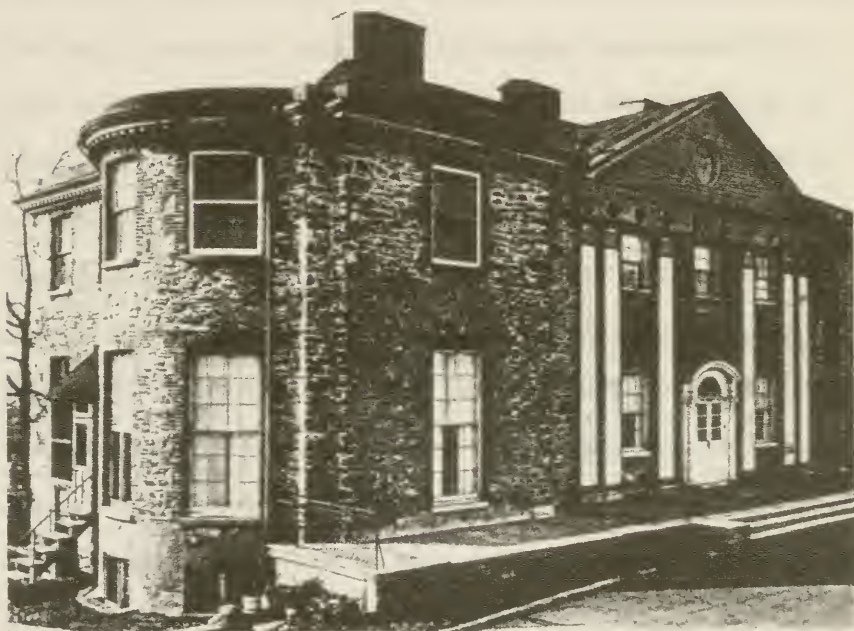
FIGURE 3.2.13

1936 exterior photograph by Cortlandt Van Dyke Hubbard showing the late nineteenth / early twentieth century appearance of the north window opening. Photograph courtesy of the Philadelphia Historical Commission.

shows the appearance of this earlier window. Preceding this window, as described in Section 1.1 - History of the Mansion, was presumably a door which provided access to the projecting pavilion. Little is known about these structures as the north elevation of the house was generally ignored by early painters and engravers in favor of the more imposing south facade. The 1808 William Birch engraving barely shows the northeast corner of the Oval Drawing Room pavilion, and is the only known graphic documentation of this construction. (See Figure 1.1.4.) Brumbaugh's investigations in 1964 uncovered evidence of the c. 1806 additions in the form of two recessed arches hidden beneath the later rubble fill. The outer arch covered in exterior stucco and the inner arch retaining interior finish plaster in excellent condition. These arches and the large stone sill at floor level are all that remain of the former door to the pavilion. According to Brumbaugh, the diameter of the arches was too large to have spanned a single door, therefore a pair of doors was indicated. The height of the new doors and fanlight installed, however, conflicts with a preexisting arched niche in the north wall. The awkwardness of the resulting configuration suggests that the evidence surrounding this door opening, and the matching opening in the Dining Room, should be reassessed. The appearance of the door to the pavilion, while a fascinating mystery, should not be overemphasized as the pavilions are not original to the eighteenth century plan of the house. William Hamilton's correspondence of September 27, 1789 would seem to indicate that in his original scheme for the Oval Drawing Room this opening contained a "venetian" or Palladian window, probably much like the ones which survive in the Southeast and Southwest Parlors.

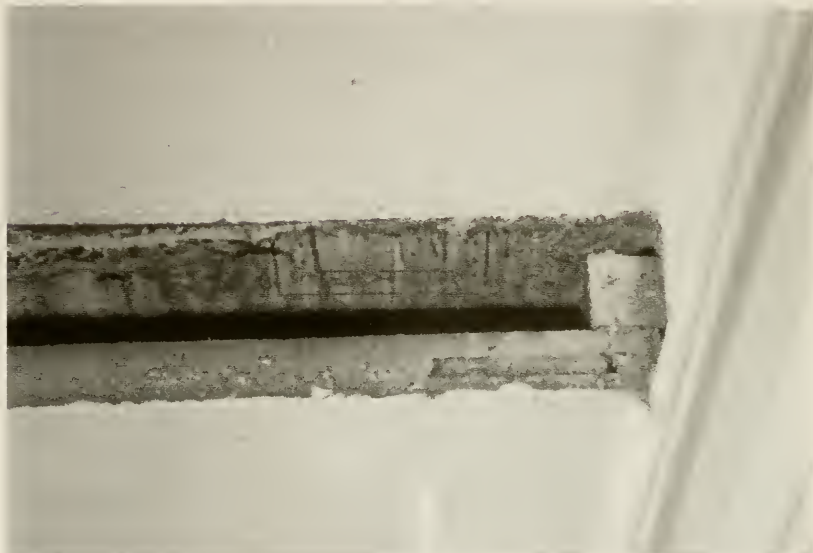
FIGURE 3.2.20 Location of remaining wallpaper behind the south niche paneling in the Oval Drawing Room. Photograph by the author.

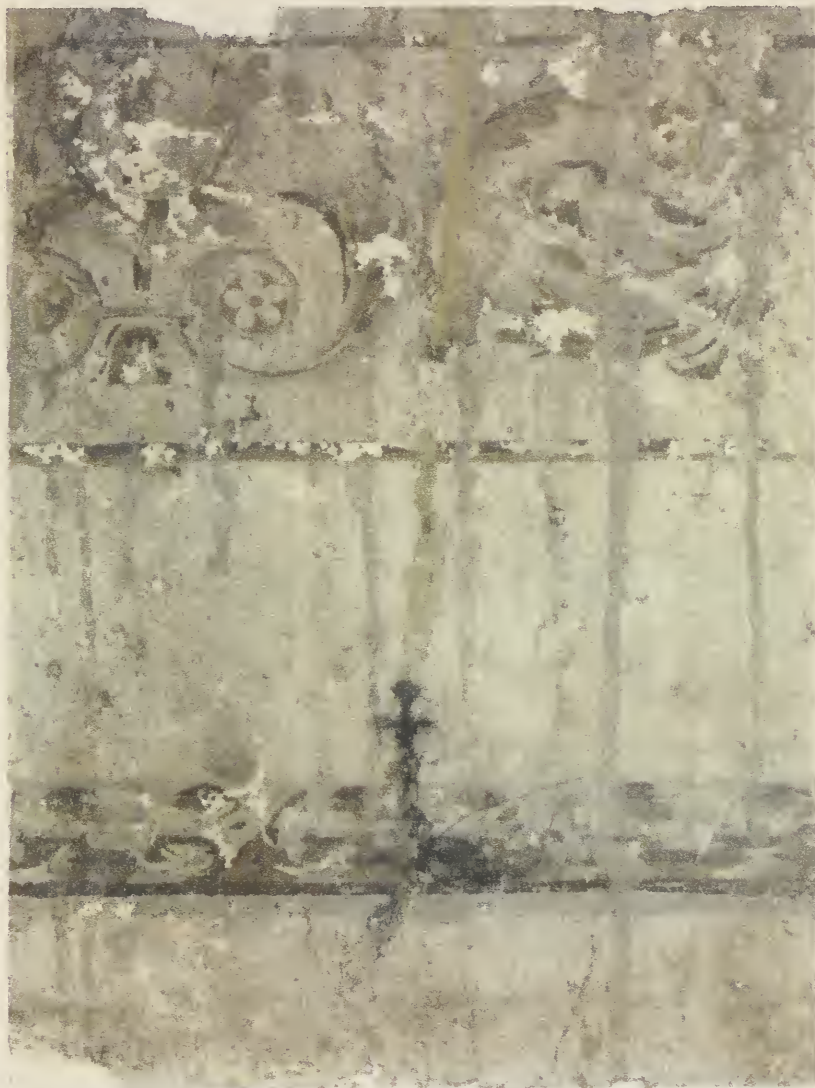
Sample of eighteenth century wall covering from behind the paneled niche in the Oval Drawing Room.

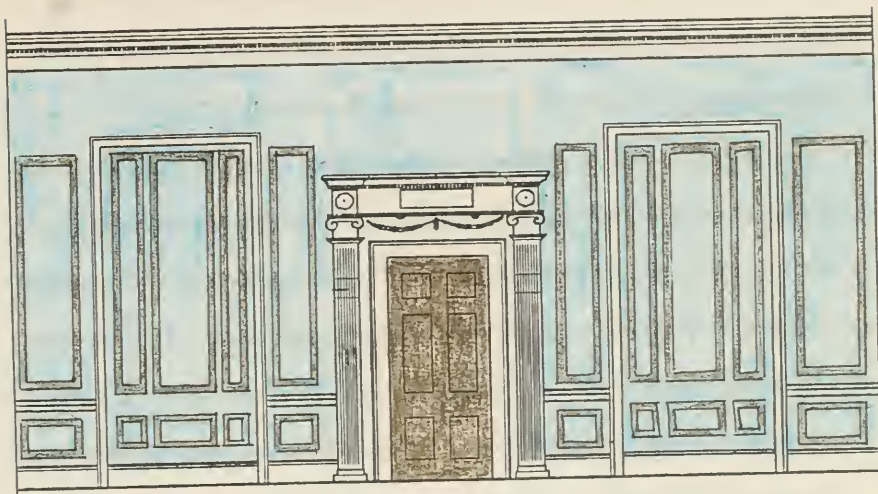
Proposed wallpaper “panel” treatment in the Oval Drawing Room.
Drawing by author based on evidence remaining in west end
niches.

strangely small if terminated below the chair rail, suggesting instead that they may have extended the full height of the niche. The treatment illustrated in Figure 3.2.24 shows all panels divided around the chair rail.

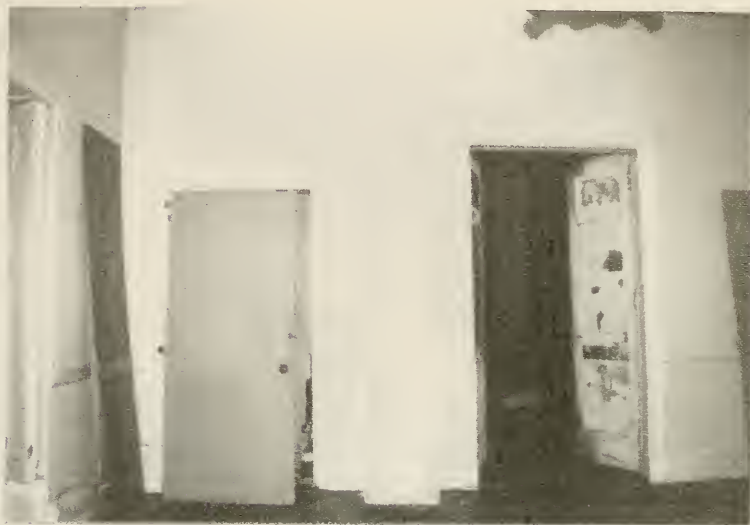
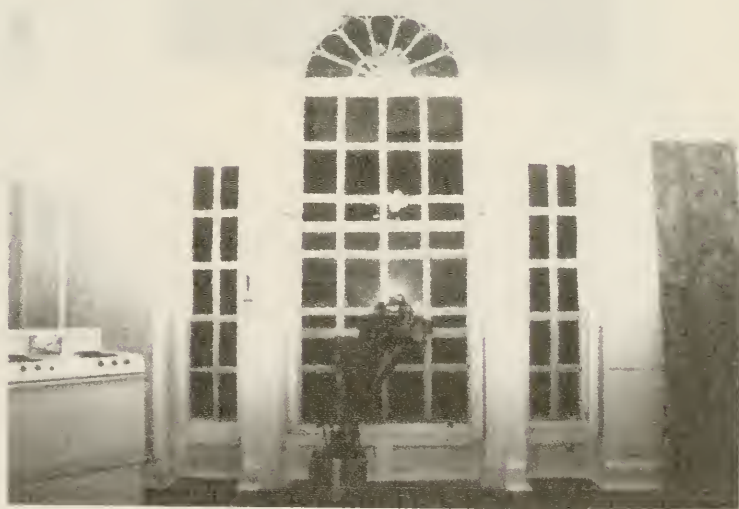
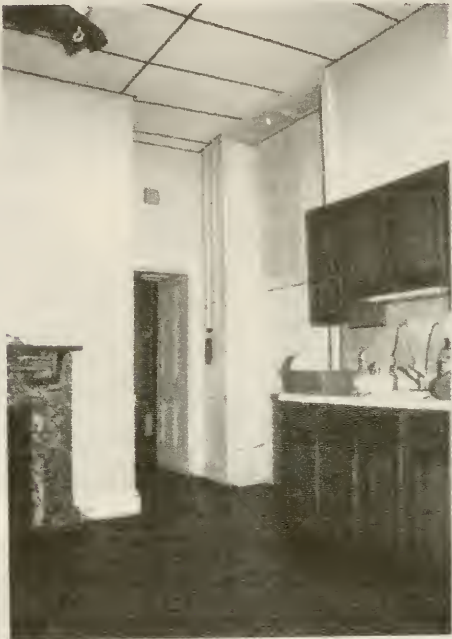
FIGURE 3.3.1

The Southeast Parlor prior to removal of gypsum wallboard in 1994. West elevation (top) and South elevation (bottom). Photographs by the author.

(continued from previous page) Southeast Parlor prior to the removal of gypsum drywall in 1994. North elevation. Photograph by author.

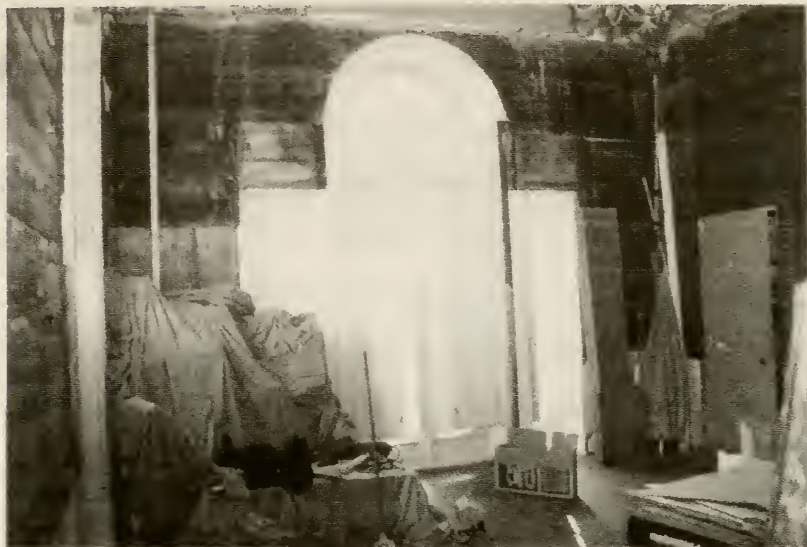
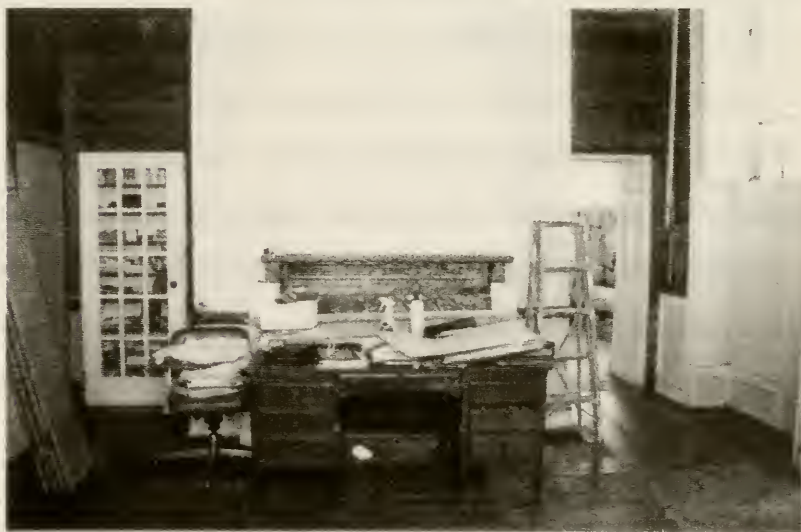
FIGURE 3.3.2 1997 Existing conditions in the Southeast Parlor after removal of gypsum drywall. South elevation (top) and North elevation (bottom). Photographs by author.

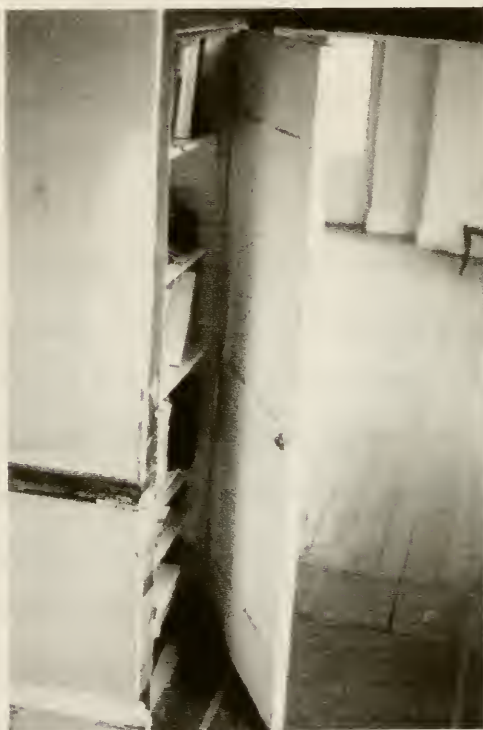
Shallow book closet with adjustable shelving in the east side of the fireplace mass of the Southeast Parlor. Photograph by author.

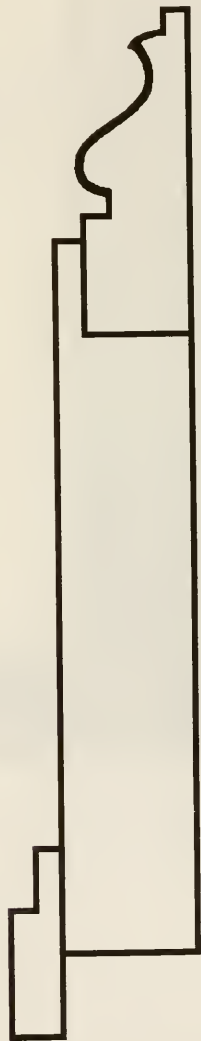
FIGURE 3.3.6

Baseboard configuration in the Southeast Parlor. The shoe molding appears to be a late nineteenth or early twentieth century addition. Drawing by author, half actual size.

The baseboard consists of a plain board 5-1/2" inches wide by 1" thick with a 3/4" deep rabbet in its top edge to receive a top molding. The fascia board is fastened to the framing behind with cut finish nails. The profile of the ogee molding appears to be much the same as that found in the Oval Drawing Room and the Saloon. The asymmetrical curve of the ogee is consistent with profiles published in popular architectural pattern books of the late eighteenth and early nineteenth centuries. The fascia board appears to

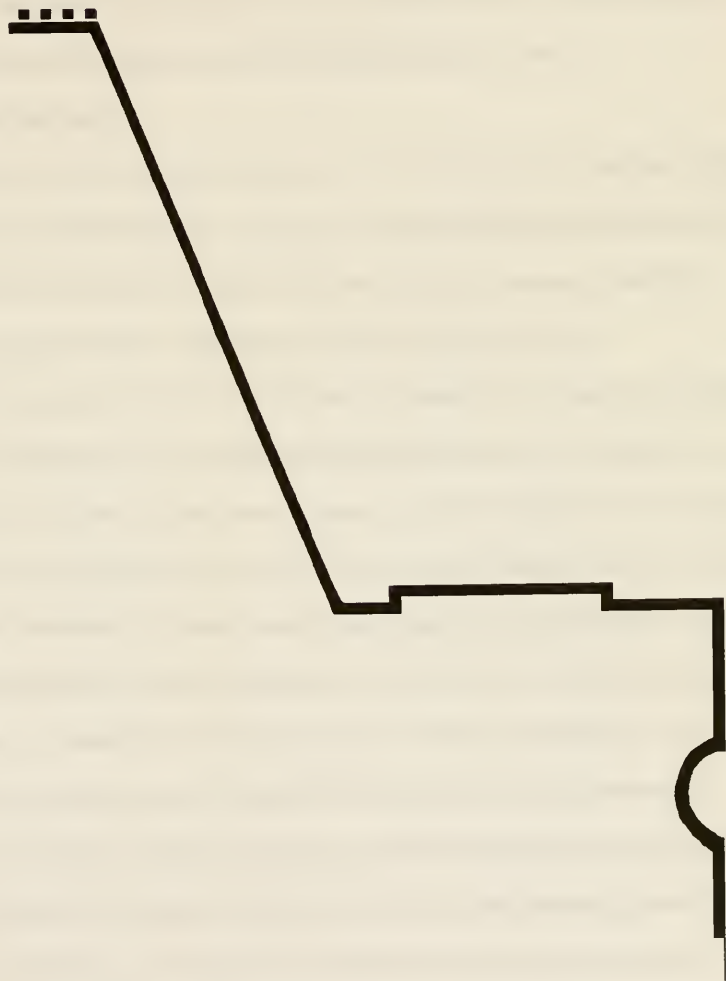
FIGURE 3.3.12

Plaster cornice profile in the Southeast Parlor, probably dating from ceiling replacement in 1885. Drawing by author, actual size.

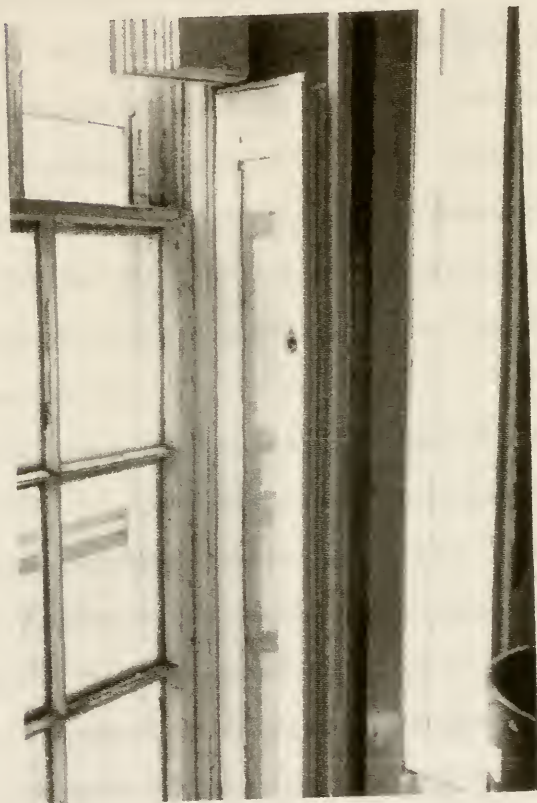
Original mirrors remaining in the outermost leaves of the venetian window shutters in the Southeast Parlor. Photograph by author.

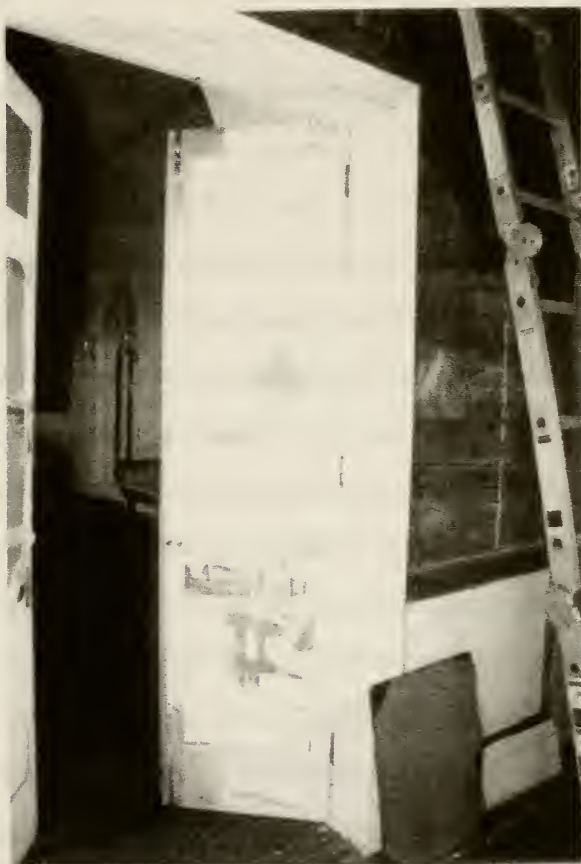
FIGURE 3.3.16

Existing gate doors to the Saloon. The original doors, with mirrored inserts on the Southeast Parlor side, have been fastened to a new pair of doors with mirrors on the Saloon side. This alteration dates to the Saloon restoration in 1983. Photograph by author.

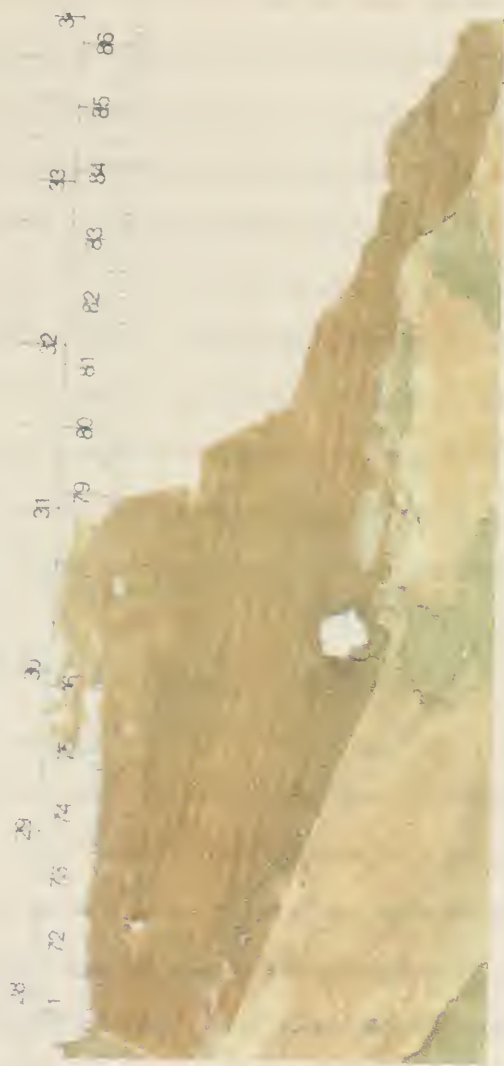
FIGURE 3.3.24

Layer No. 4 -- Varnished wood grain paper applied floor to ceiling, c. 1909.

Note that this description is based on a scattered small fragments. The pattern is a simulated wood grain, oriented vertically. The very thin ground is a golden brown with vertical grain lines in a slightly darker golden brown. Figuring in cream and brown is applied to more closely approximate the appearance of oak. The wood pulp paper is extremely thin and brittle, certainly machine made. The surface has been varnished for appearance and durability. This paper is hung on the same burlap backing as the previous three layers down to chair rail level. This wood grain paper then continues down to the baseboard as the first finish layer on a new backing of fine muslin. There is a reference in the Woodlands Cemetery Company records regarding the “hanging of burlap and papering” in the “Parlor” in 1909 which may provide the date for this treatment though such wood grain papers were probably more fashionable several decades earlier. (See Figure 3.3.24.)

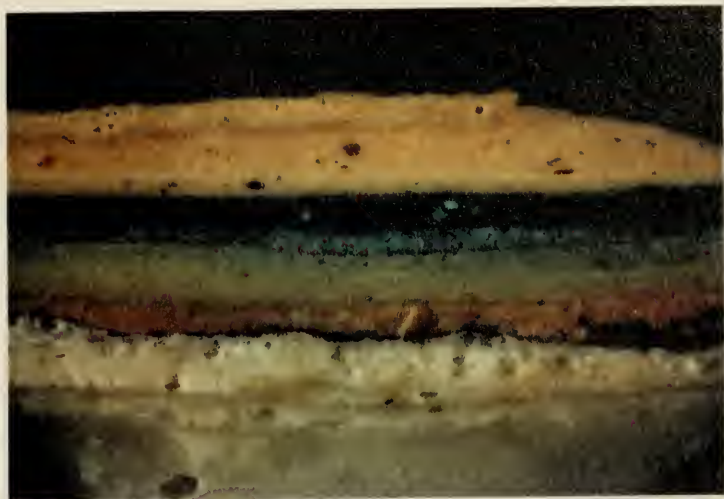
Sample No.: ODR - C - 001

Summary: Original finish appears to have been white pigment, probably whiting, in distemper. Samples taken near the edges of the ceiling show yellow gray and strong red-orange layers between 6. and 7. suggesting possible stencil or striping at the perimeter in the mid-nineteenth century. An exposure window is recommended.

The paint evidence remaining on the ceiling is somewhat problematic. After the campaigns of white distemper, which most likely relate to Period I, is seen a very thin layer of intense blue. [Sample No. ODR-C-001] The blue finish appears as a thin layer of distinct, fine particles rather than a layer of pigment in a binder a fact which seems to suggest a distemper rather than an oil based paint. Microchemical testing suggests the presence of artificial ultramarine as the blue pigment, dating to c. 1860. Staining, in an attempt to identify glue or oil binders, was inconclusive. Thus it would appear that the blue ceiling color was contemporary with the greenish blue wallpaper. Aesthetically, the only wallcovering of the three later fragments which could have been remotely compatible with such a ceiling finish is the c. 1865 greenish blue floral. However, the use of such a dark paint color with a relatively light wall finish would not necessarily have been in keeping with recommended decorating practice.¹⁶⁰

Following this granular blue layer is a thick coating of what appear to be a semi-translucent size, perhaps applied to prepare a chalky surface for the strong orange red paint that follows. What is puzzling is that this semitranslucent layer and the following orange red were only found in samples taken from around the perimeter of the room. No evidence of either finish was found on samples taken from the middle of the ceiling.

[Orange red not found in Sample No. ODR-C-001] Whether this is indicative of a border stencil or similar treatment should perhaps be investigated further by means of an exposure window. Without further investigation, the relation of the various campaigns of ceiling color to the proposed wall treatments cannot be confirmed.

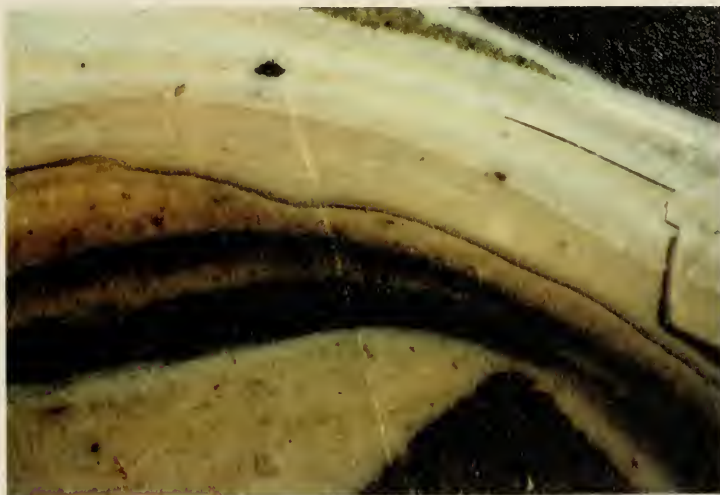
Sample No.: ODR - WW - 021A

Summary: At least some of the baseboard in the Oval Drawing Room is original based on the wrought headed nails used to fasten it. This particular sample, however, displays no visible evidence of the early

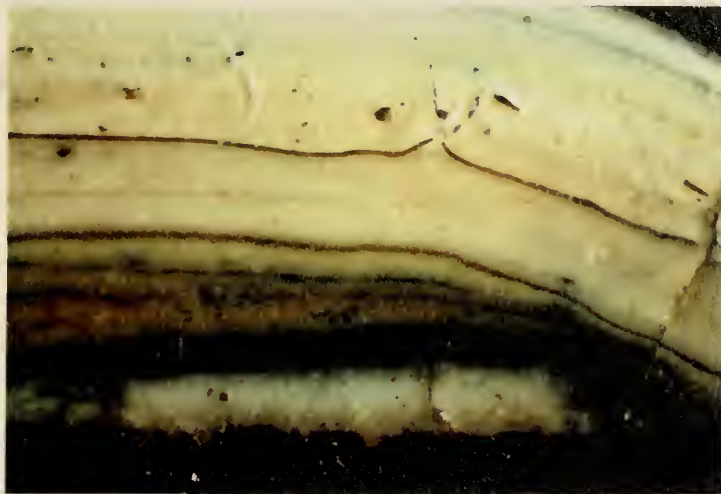
Sample No.: ODR - WW - 23A

Summary: The existing window sash throughout the house are known to have been replaced c. 1850 which indicates the earliest possible dates for the paint layers in this sample. The remainder of the layering sequence is identical to that found on the other woodwork in this room.

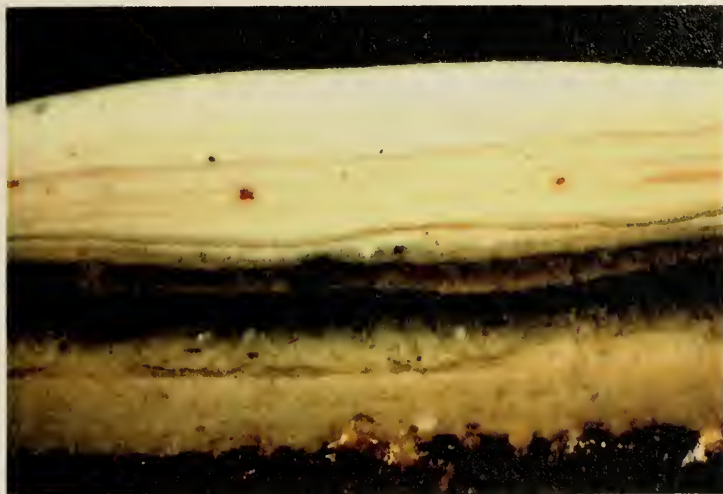
Sample No.: ODR - WW - 23C

Summary: The window trim is almost certainly not original to the room, however, there appear to be more than one generation, fabricated to neary identical profiles. The paint stratigraphy in this particular sample closely parallels that found on the paneling below the recessed niches, known to date from the arrival of the Woodlands Cemetery Company.

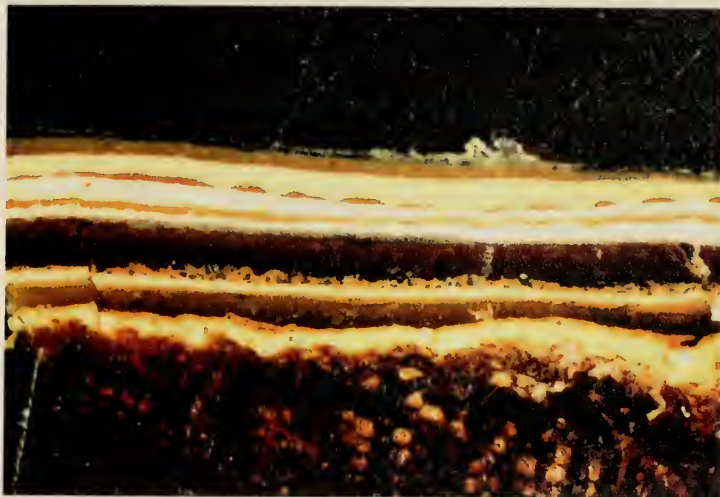
Sample No.: ODR - F - 001

Summary: This floor appears to have been covered for much of its life to to the small number of paint and graining campaigns. There is no wax or dirt buildup to suggest the floors were left bare.

Samples of the surviving original floorboards show no sign of a painted or grained finish during Period I. The first paint campaign on the original floorboards matches that found on the patched material around the enlarged fireplace hearth, probably installed after William Hamilton's death. Heavy paint buildup around the perimeter of the baseboards obscures any evidence of tack holes or other means of fastening carpet though carpet would seem to be the logical floor finish in such an elegant reception room.

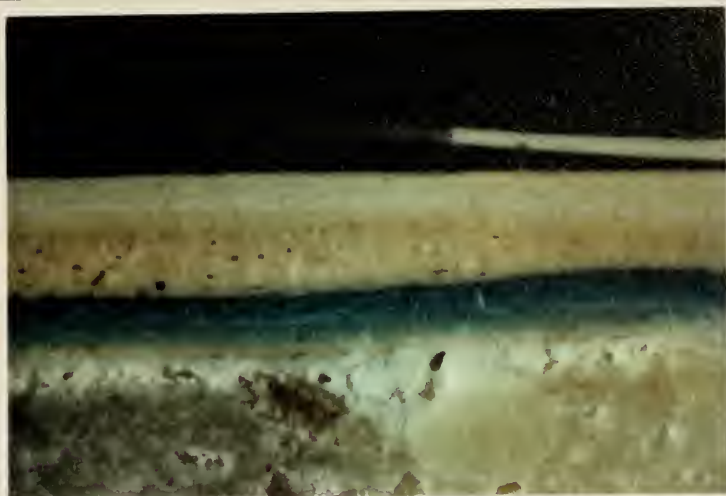
Sample No.: SER - C - 001A

Summary: The initial layer visible appears to be either a thick paint layer or a very thin skim coat applied prior to painting. This ceiling was replaced in 1885 due to water damage. The earliest layers are not relevant to the eighteenth century period of significance but they are useful for dating finishes found elsewhere in the room.

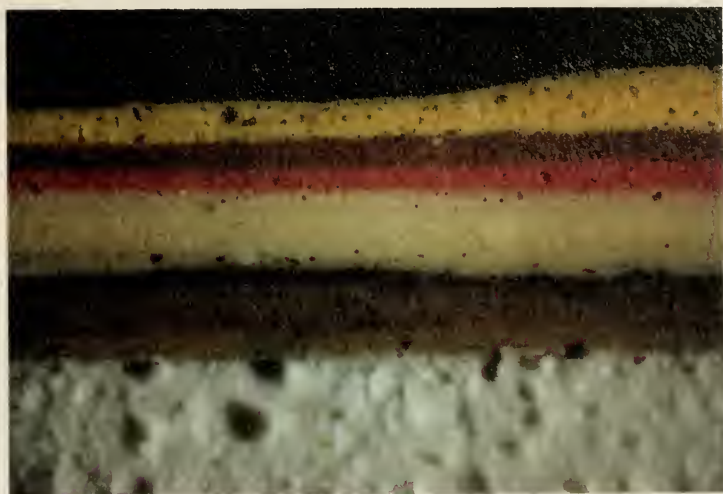
Sample No.: SER-W-005A

Summary: The plastered chimney mass is believed to have received a wallpaper or fabric finish until some time in the late nineteenth or early twentieth century. Therefore the earliest layers seen in this sample are of little interest other than for purposes of dating other elements in the room.

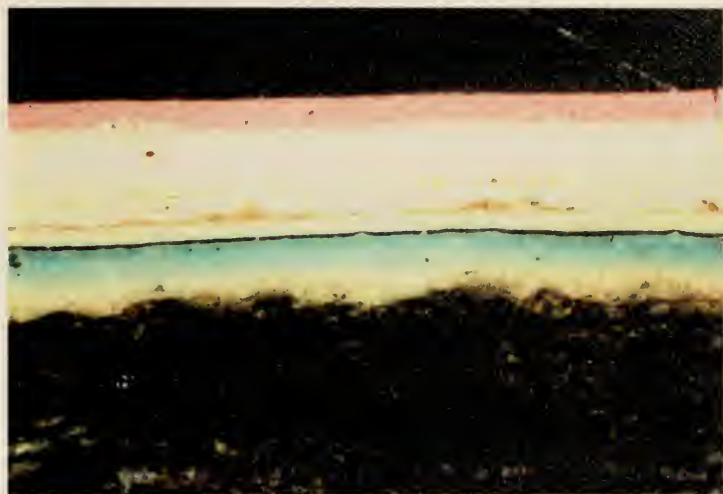
Sample No.: SER - W - 006

Summary: The gypsum wallboard removed from the walls of the Southeast Parlor may be dated to 1921 at the earliest based on its patent date. Therefore, the stratigraphy on this sheathing is useful for dating the adjacent ceiling and cornice sequences.

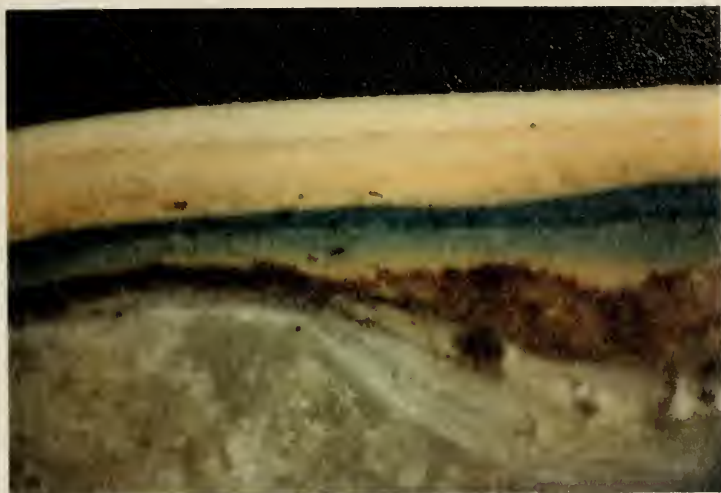
Sample No.: SER - W - 009A

Summary: The cornice was apparently replaced at the same time as the ceiling in 1885; however, the paint sequence shows a number of additional layers. Layers 6. through 17. match the sequence of the ceiling. One possible explanation is that the ceiling could have been papered, a common treatment in the late nineteenth century.

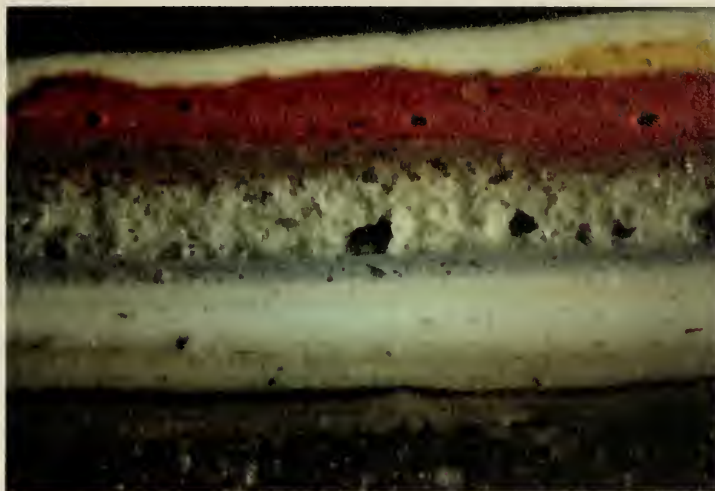
Sample No.: SER-WW-001

Summary: The existing chair rail dates from the installation of the gypsum wall sheathing some time after 1921. The earliest layers on this element appear to represent primer and a graining campaign, perhaps to match the adjoining woodwork which was apparently already grained.

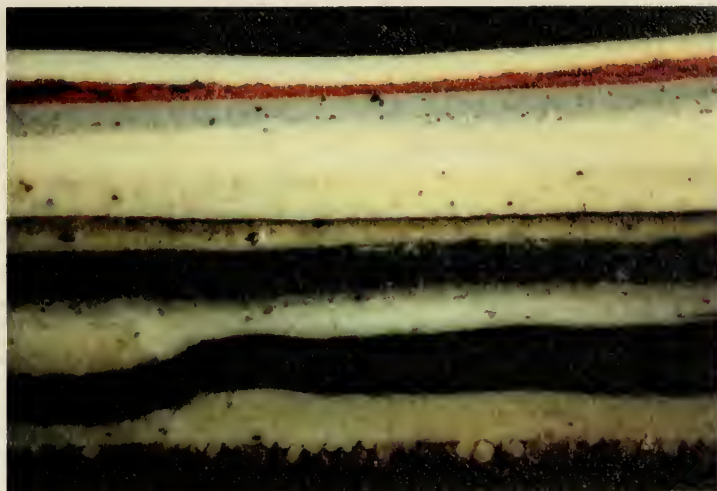
Sample No.: SER - WW - 002D

Summary: The baseboard fascia and ogce appear to be original to the room based on the means of fabrication and the nails used for their attachment. Thus the earliest layers on this sample are of interest to the restoration of the room. The Munsell notation that best matches this color is 2.5 YR 8.5/3 though it must be noted that this paint remains slightly yellowed in spite of bleaching by sunlight.
