BUILDING MATERIAL ANALYSIS OF THREE FAIRMOUNT PARK HOUSES

Melissa Vernon Johanningsmeier

The Graduate Program in Historic Preservation

1988

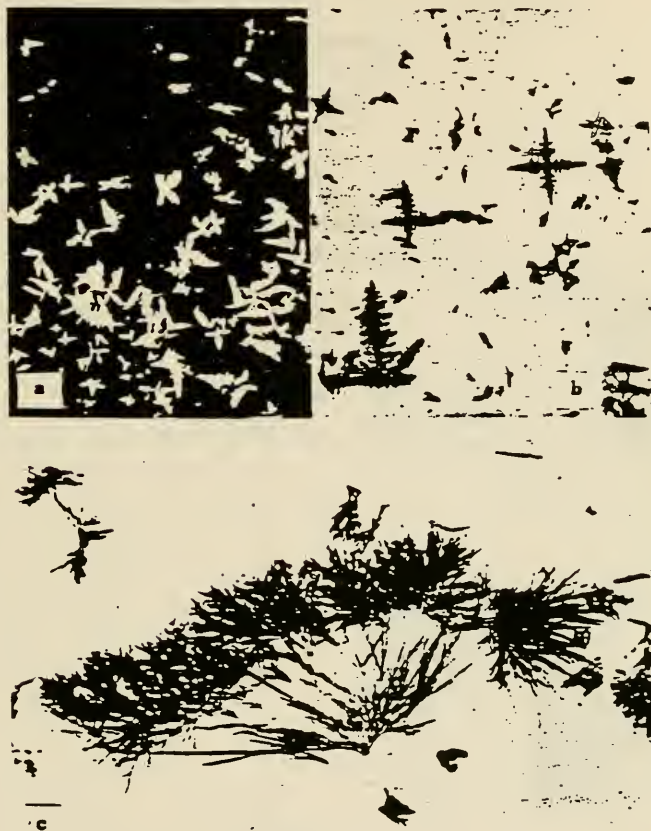
FIGURE 5. Crystals of zinc mercuric thiocyanate show highly characteristic forms. In *a*, white, feathery aggregates of these crystals are seen by reflected light at 50X. In *b*, by transmitted light at 100X, crosses with fern-like arms predominate. In *c* with the same illumination and magnification another preparation shows this precipitate in mossy aggregates. Differences in concentrations of the reagents cause these differences in form.

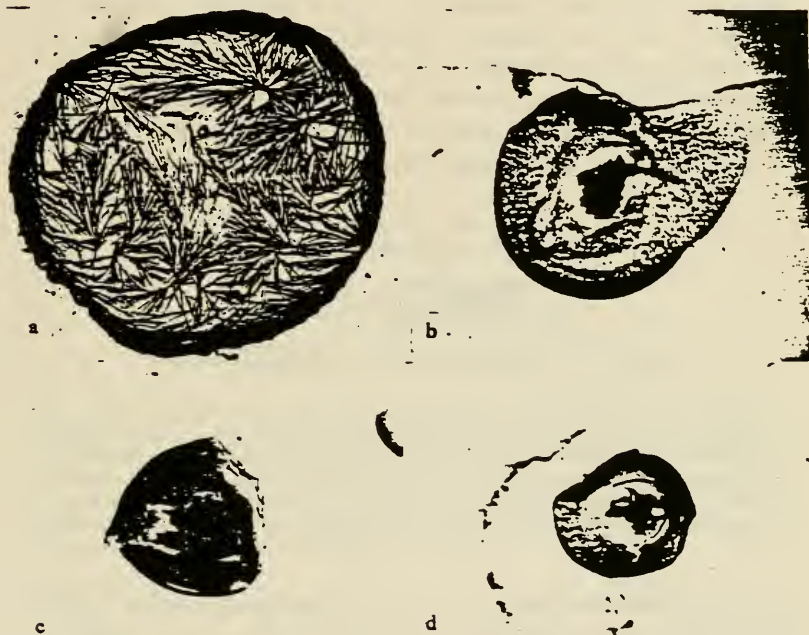
FIGURE 6. When dilute hydrochloric acid is added to most of the copper pigments, a residue of pale green, grass-like crystals of cupric chloride is obtained. When warmed, these crystals turn dark orange-brown, as may be seen in *a*, by transmitted light at $25\times$. In *b*, *c*, and *d* are shown, by the same illumination and magnification, variations of the pinkish-red envelope that surrounds a particle of a copper-bearing pigment when it is treated with acid-ferrocyanide solution. The dark particle in the middle is the treated specimen. In *b* and *d* the edge of the test drop is seen.

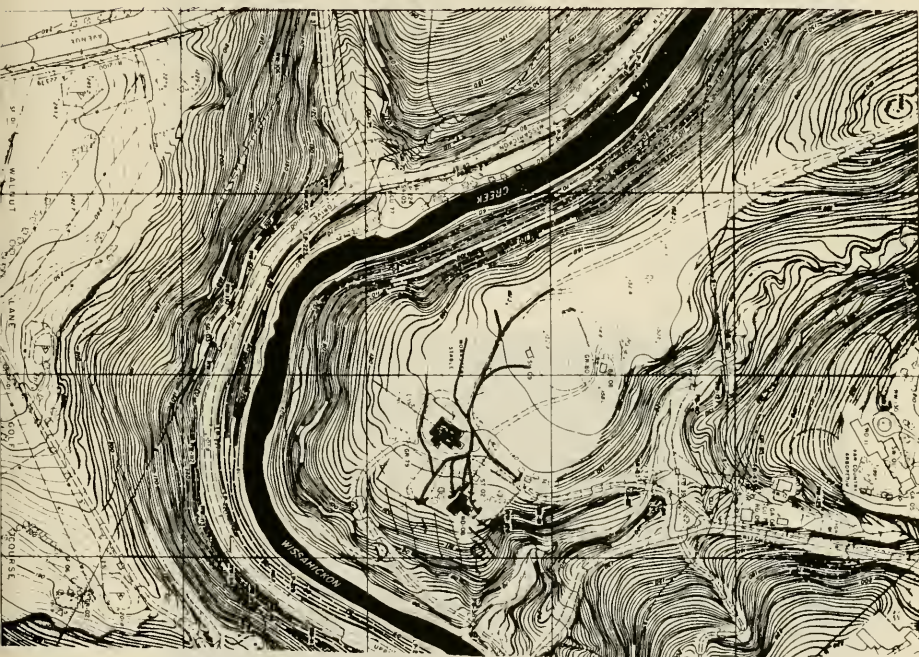
Appendix #2
Ground Drainage

The second source of leakage into the building is via ground drainage. The Monastery sits on a plateau above the Wissahickon Creek, but not at the highest point of the surrounding grounds. Higher fields behind the house drain into the back yard of the building. Here, water pools along the west wall and back porch of the building. As a result, water is absorbed into the masonry wall by capillary action. In turn, both the interior plaster and the exterior stucco are spalling off the stone surface (see typographical map of site Appendix #9).

One of the problems facing the Monastery is ground water entering the building. This topographical map with the red arrows shows how the water drains on this site. The drainage problem could be eliminated through regrading of the area so that water was directed into existing storm drains. Following photographs demonstrate drainage patterns into the back yard of the building.

Deterioration caused by water penetration into the basement and the foundations of the building could be eliminated or mitigated by placing gutters on the building and regrading the land in the upper fields behind the building. Gutters would keep water out of the basement and regrading would redirect water runoff to storm drains that lined the access road to the site.

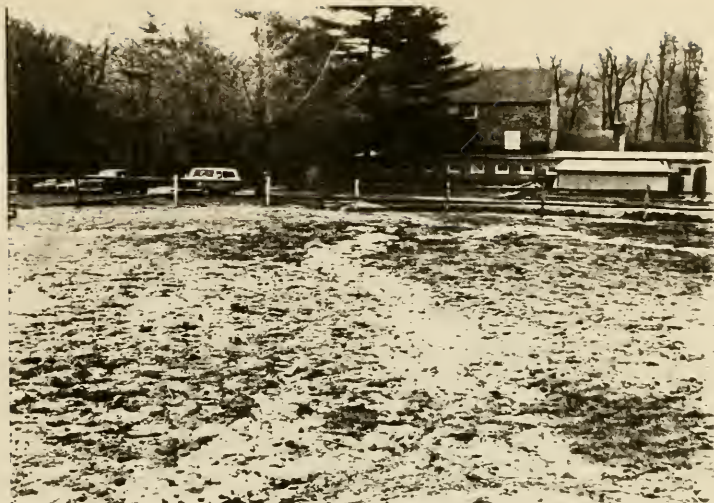
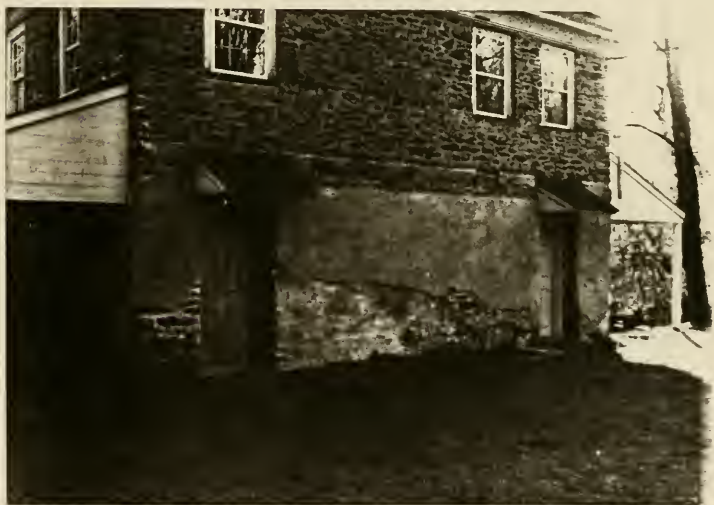
There is one structural crack in the main building, hidden by the roof of the kitchen. This crack is in the

northwest corner of the main building and runs from the second floor northwest window on the west wall of the building to a hole in the wall where plumbing has been punched through the exterior wall of the main building (see Appendix #10). The positioning of the crack seems to indicate that this corner of the wall has moved or is moving away from the rest of the building. Whether or not this crack is growing is unknown. At this point the progress on this crack cannot be monitored.

Crack found in the main building wall looking from the loft above the kitchen. Below the structural crack plumbing and heating pipes have been introduced through the main buildings exterior wall.

The introduction of hot air heat into the first floor should be done with caution. Punching a large hole through the main building wall below a stress crack may destabilize this corner of the building. Also, introduction of this type of heating system into the first floor will require partial removal of the 19th-century floors. Before this type of heating system is introduced into this building it is recommended that a complete study of the wall movement be made. Alternative heating systems with less impact on the structure should be considered. This would determine if a hot air system is appropriate for this building.

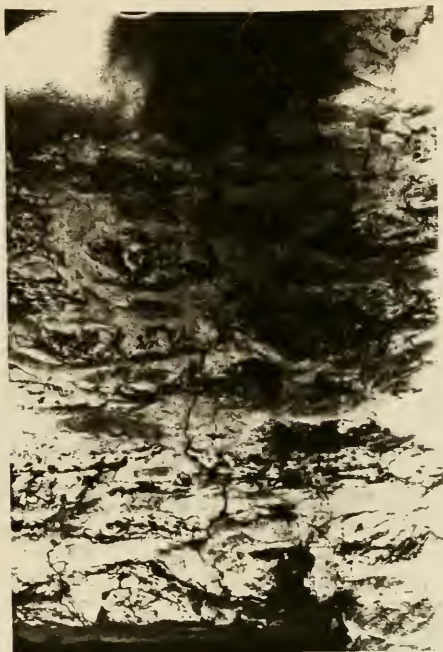
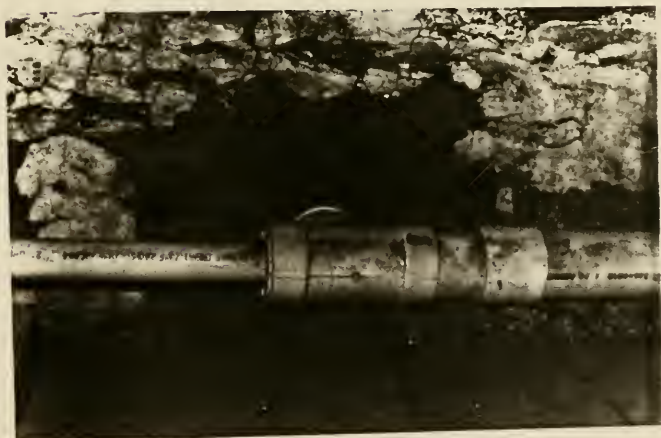
Northwest and Southwest Elevation

The building needs gutters, repointing and repainting. The effect of rising damp are seen on the southwest elevation.

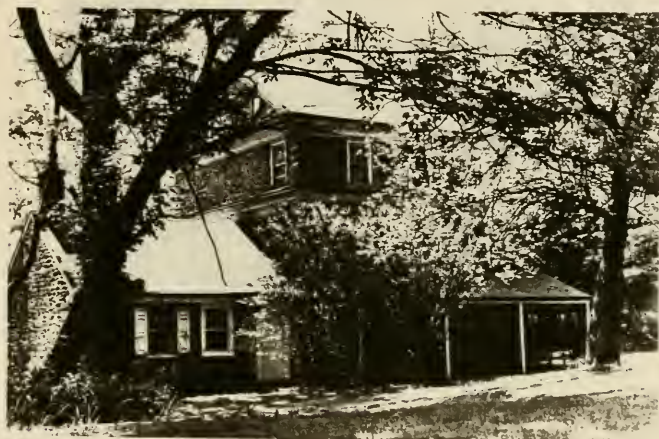
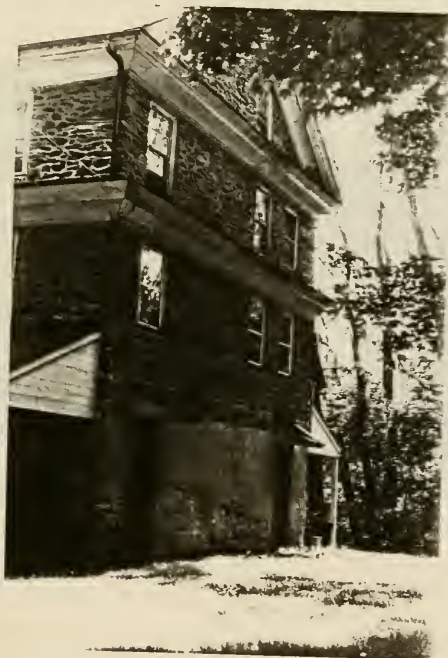
Southeast Elevation

The cornices and porch need repainting. The stucco of the first story needs to be removed and the wall underneath repaired.

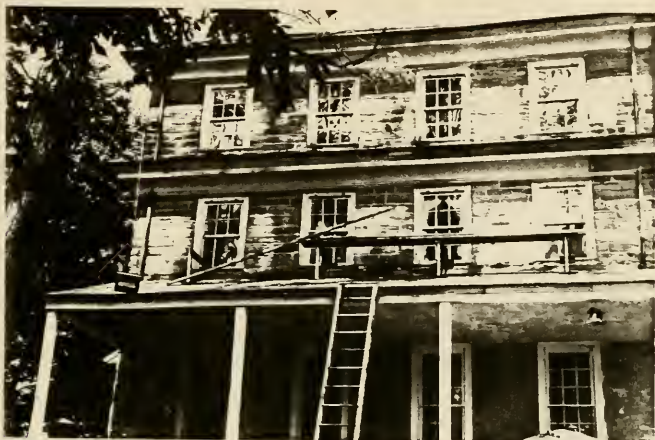
Northeast Elevation

The other outstanding problem with the Monastery is the condition of the masonry joints (see Appendix #11). The gaps between the stone at the peaks are very large. 100 % repointing may not be necessary. However, the roof peaks, foundations and kitchen wing require immediate repair.

The peaks on the main building and the kitchen wing need repointing.

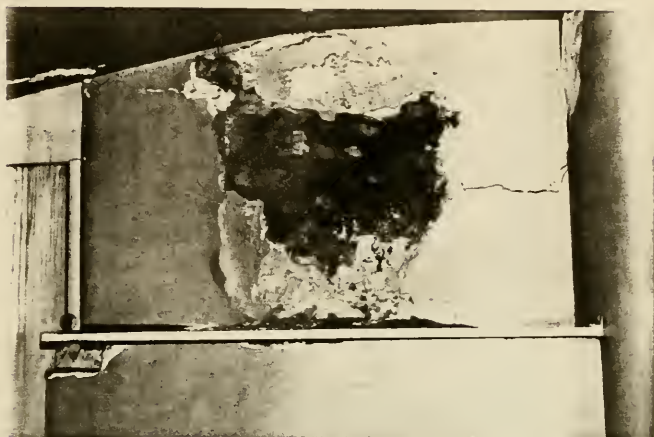
Third Floor Vest Room.
Water damage to the plaster surface on the
chimney stack.

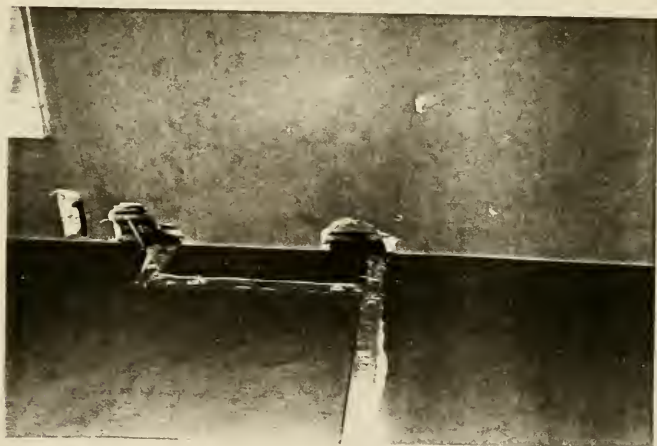
Third-floor vest room: evidence of the removal of an old
electrical system. The ceiling and walls were never repaired.

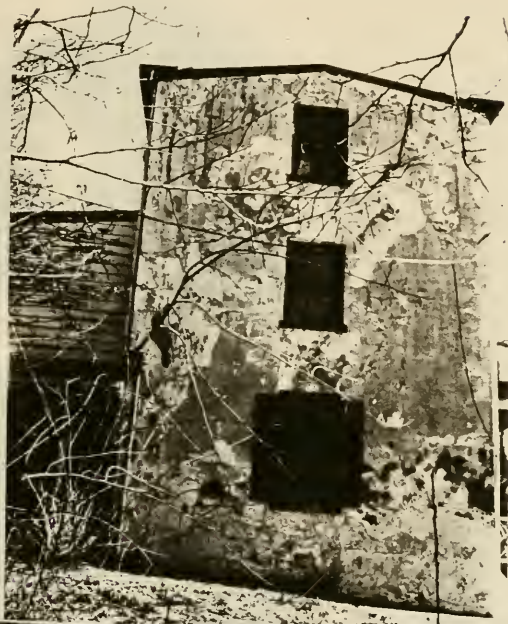
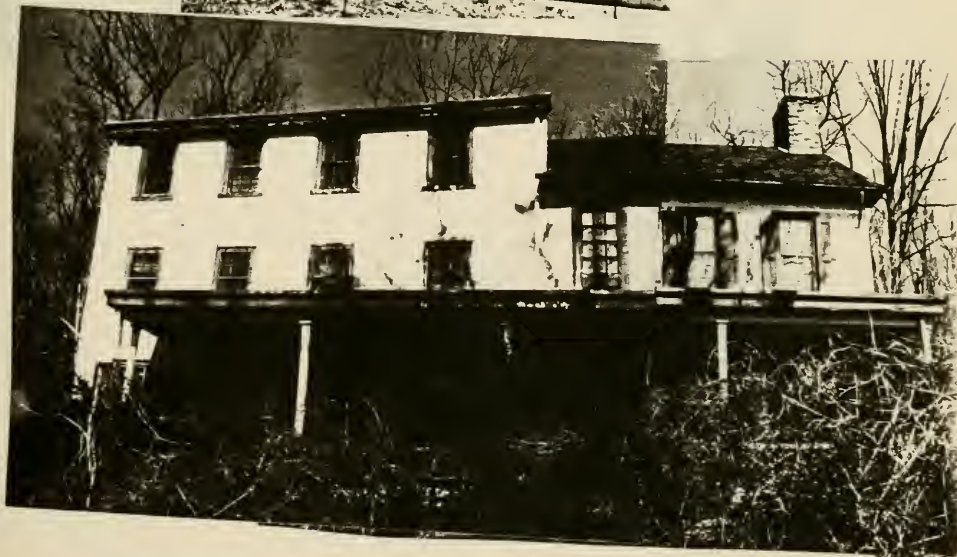
North and West Elevation

The paint is peeling on all surfaces and the porch ceiling is in poor condition.

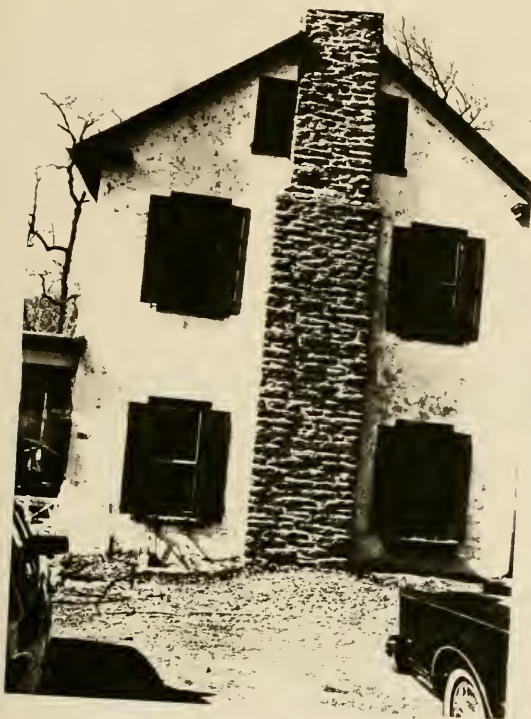
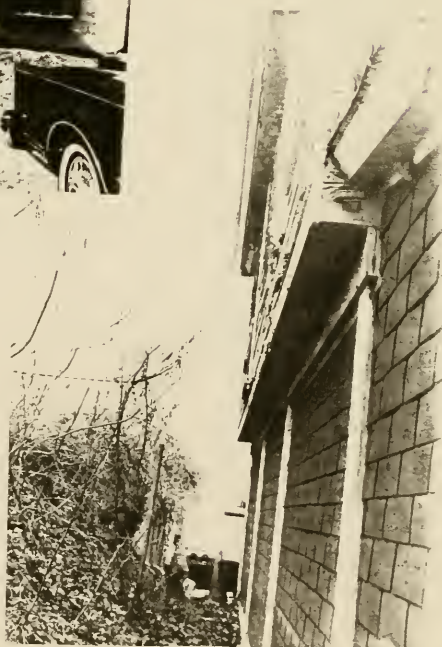
East Elevation

This is the newer Victorian addition but the same conditions still persist (peeling paint and stucco). The north elevation also shows the same problems.

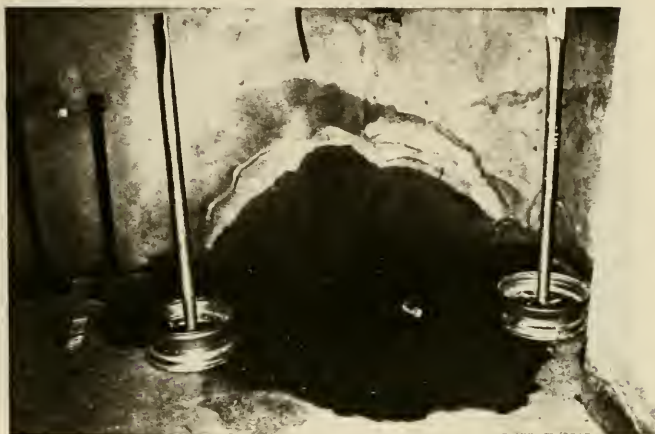
Leaking Water Valve in the Basement

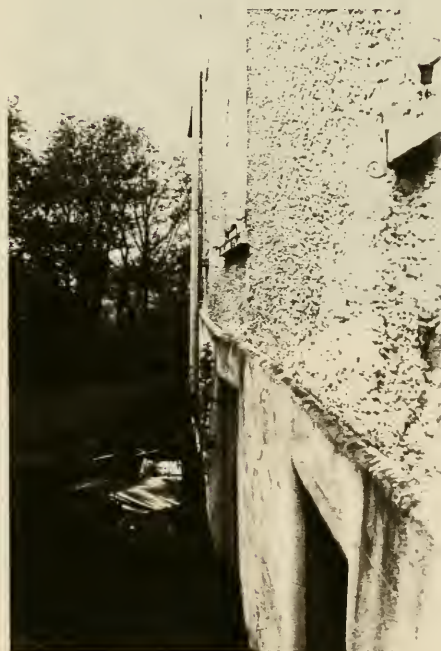
South Elevation, structural problem: this wall drops and bulges out.

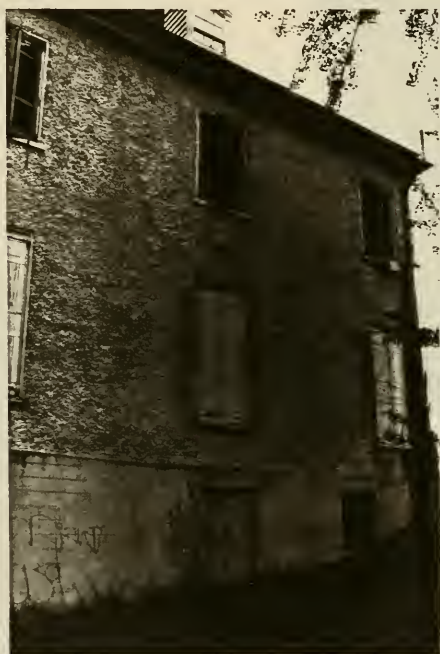
Crack in South Wall Extending from Roof to above the
Deformation.

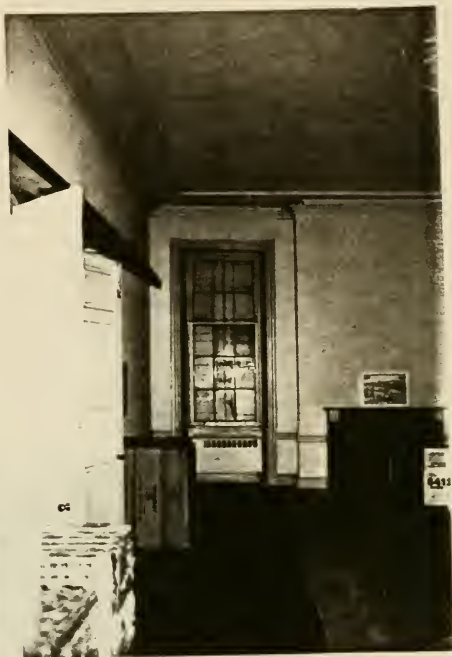
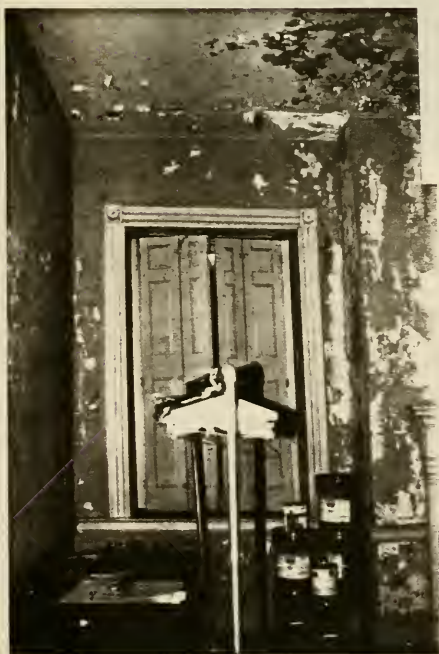
The interior first floor window in the dining room and the second floor window above show the effect of the drop in the wall.

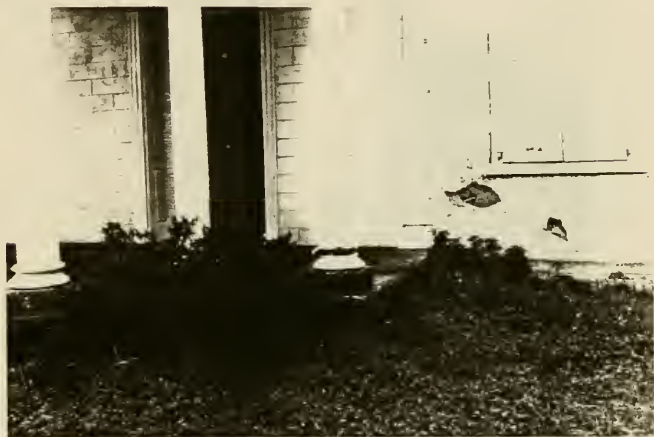
Water penetration into the wall has caused the delamination of the rubble dash stucco in certain areas. The wooden porch column also shows the effects of water.

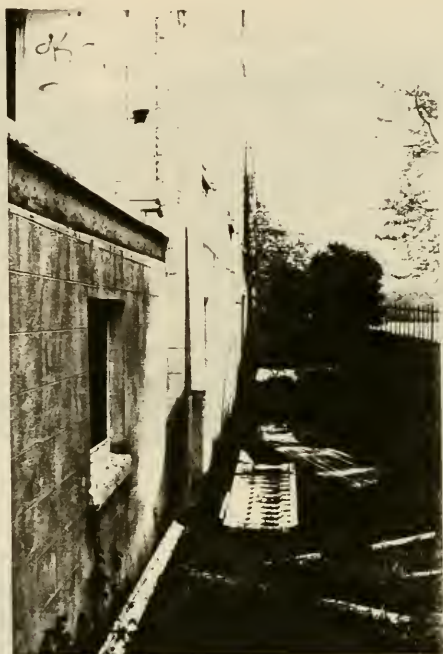
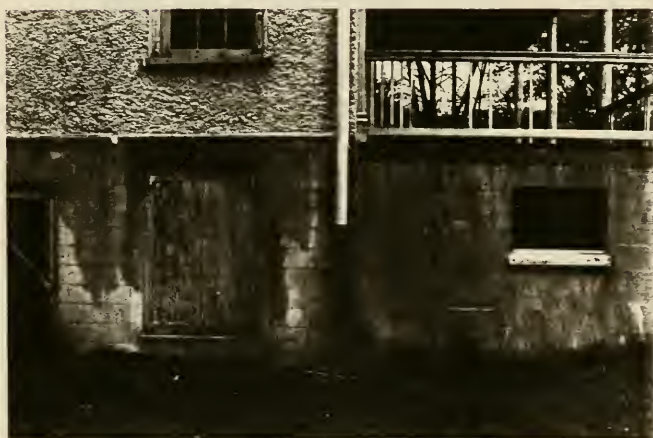
A broken leader pipe drains rain water onto the building wall and a section of porch balluster is seen on the ground. On the opposite side of the building the leader is also broken

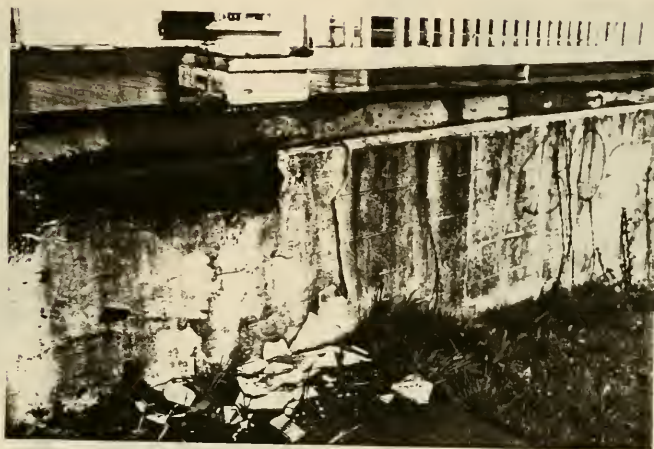
When the back porch stairs were removed some of the ruled stucco was damaged.

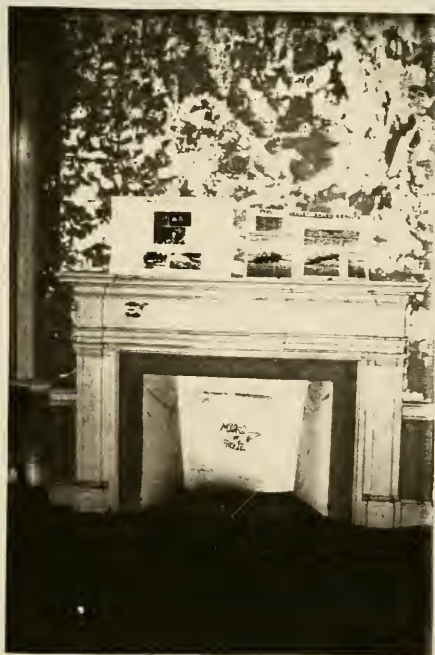
All of the interior surfaces are peeling.

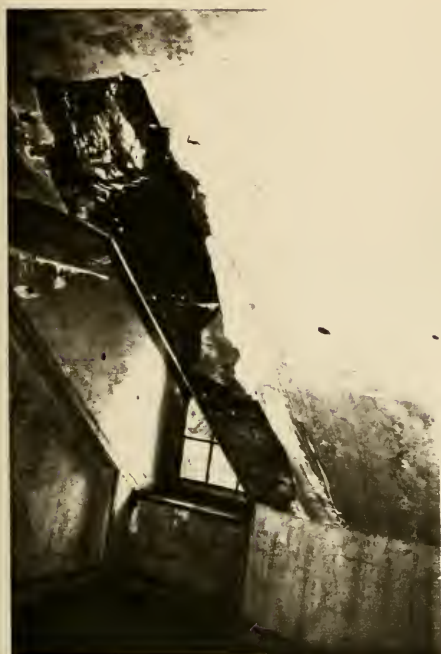
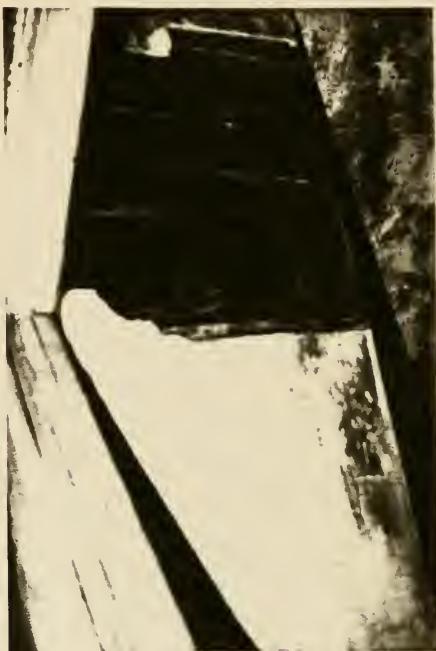
Damage to the third floor ceiling caused by a bad roof.
