MEMORIAL HALL  
AN HISTORIC PHILADELPHIA EXHIBITION SPACE  
A PAINT ANALYSIS OF THE GREAT HALL

A THESIS  
in  
Historic Preservation

MASTERS OF SCIENCE  
2003

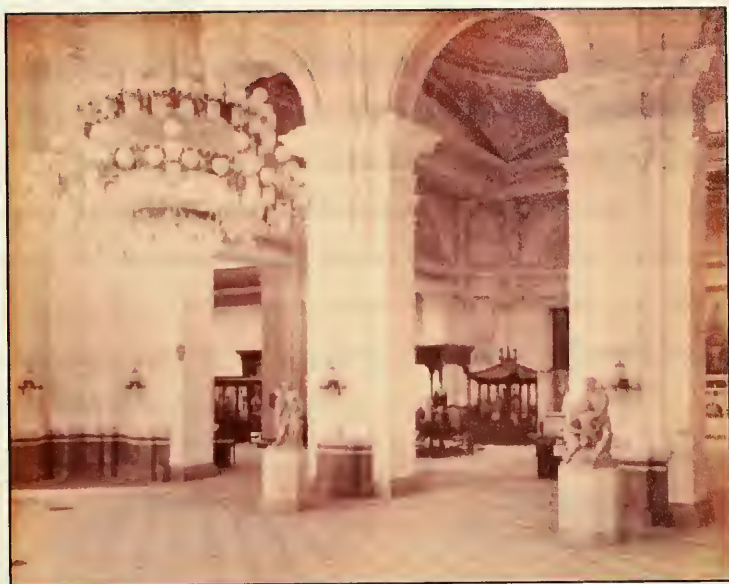
Fig. 11. Taken in the South Foyer, looking into the Great Hall. Areas around panels appear to be a darker tone. (Photograph from the Centennial Photographic Collection, Free Library of Philadelphia, 1876.)

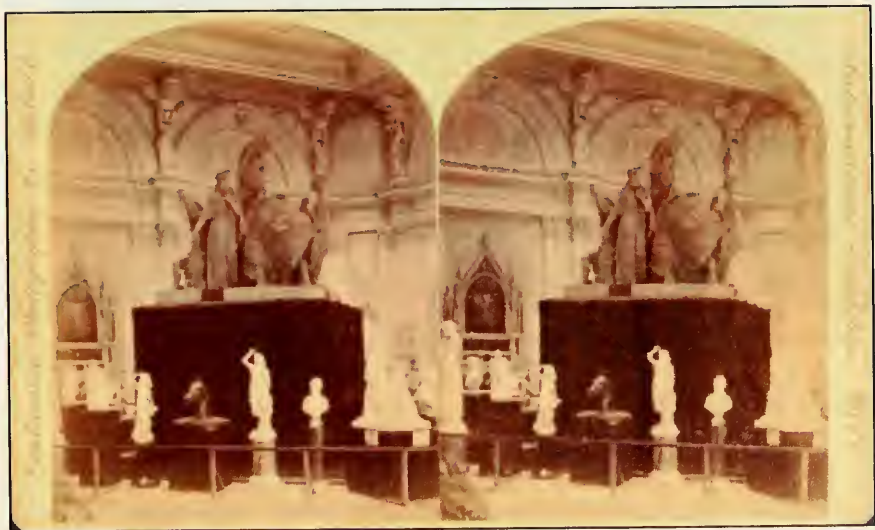
Fig. 12. Sculpture exhibition during the Centennial Exposition. Areas of freize and inset panels appear in a darker tone. (Photograph from the Centennial Photographic Collection, Free Library of Philadelphia, 1876.)

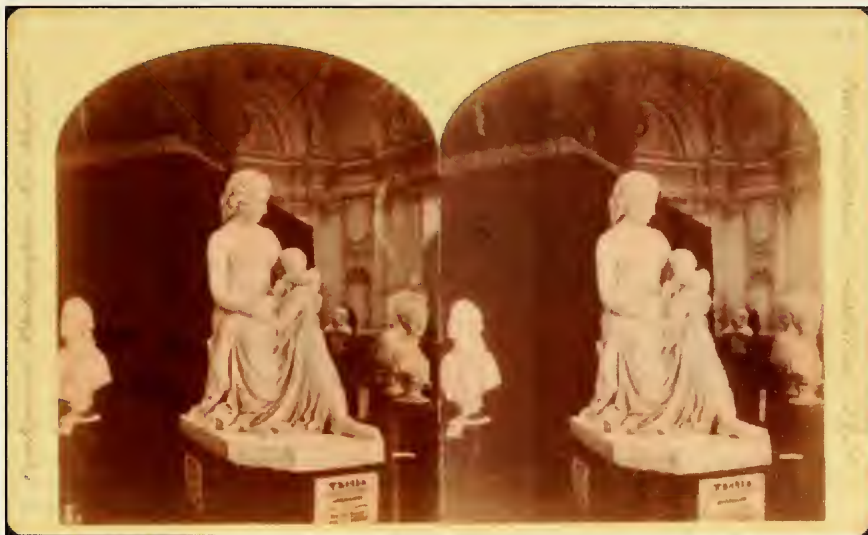
Fig.13. Areas of freize, niche, and inset panels appear in a darker tone. (Photograph from the Centennial Photographic Collection, Free Library of Philadelphia, 1876.)

were differences in hue as well, although it was not clear as to if this due to the lighting in the image. The frieze of the cornice also appeared to be of a darker tone than the surrounding areas.<sup>53</sup> Upon further review for this paint analysis of the Great Hall, these statements in the AVA report were reviewed and felt to be plausible, however a complete on-site investigation and the extraction of samples was necessary. Frank S. Welsh also expressed the necessity to take samples from the upper areas that were thought to have varying colors or hues to verify the ideas discussed in the AVA report. It is also important to note that no other descriptive documentation of the paint finish during the Centennial time period was located during this study.

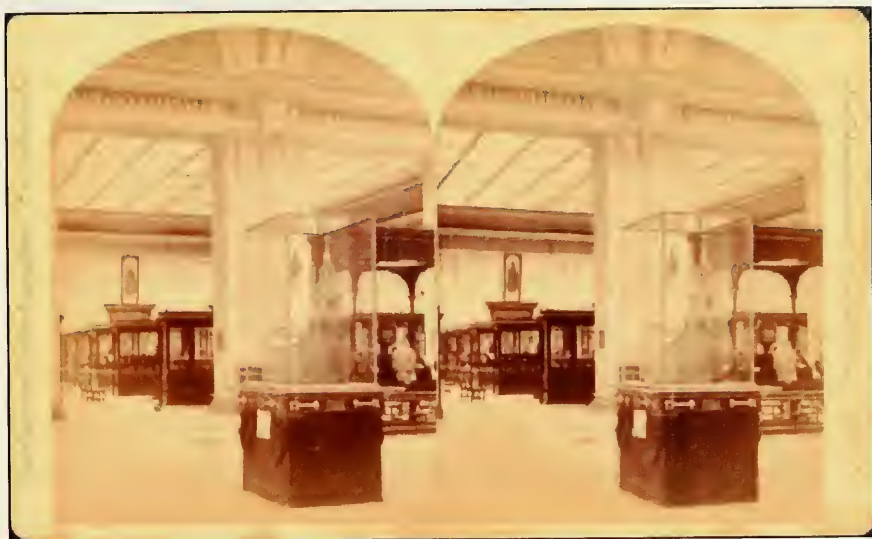
Fig.14. “The Pennsylvania Museum and School of Industrial Arts” seen on the frieze in the Great Hall, with inset panels appearing in a darker tone. (Photograph by the Centennial Photographic Collection, Free Library of Philadelphia, 1876.)

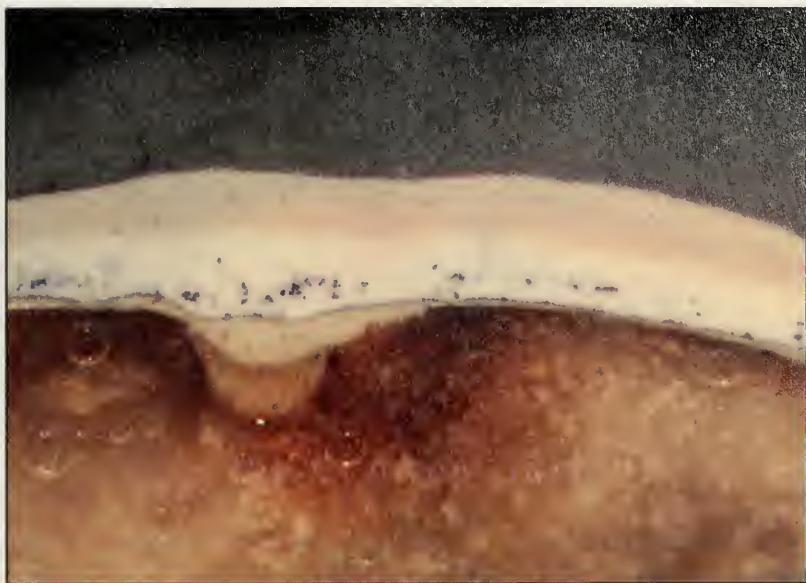
Fig. 18. Sample GH 82 at 5X, which shows the original resinous shellac layer, then the following ca.1876, 1901, and 1956-67 paint campaigns. (Photograph by Rynta Fourie and the author, 2003.)

The first finish applied to the gypsum surfaces was an oleo-resin or shellac, which was used to size the walls before an oil based paint was applied. This resinous coating can be seen in all of the samples collected with a gypsum substrate. Soon after the shellac or resin mixture was applied, a primer and finish coat of a light yellowish gray, with the Munsell notation of 5Y 9/2 was applied. This paint was also applied to all of the metal work as well during this period. This finish campaign was completed ca.1876 when the building was constructed. It is also possible that the painted finish was not applied until after the Centennial Exposition, since the construction of the building was completed so quickly for the big event. However, there was no visible dirt layer or any cleaving between the shellac coating and the paint, which suggests two finishes applied within a short time span.

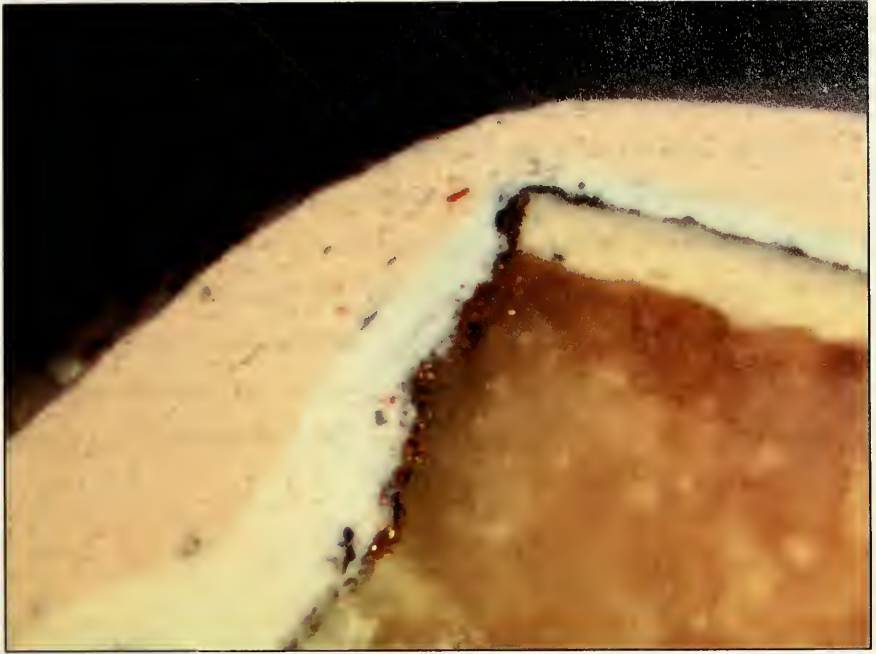
Fig.19. Although an incomplete stratigraphy, sample GH 19 at 10X, shows the gold leaf decorative paint scheme. (Photograph by Rynta Fourie and the author, 2003.)

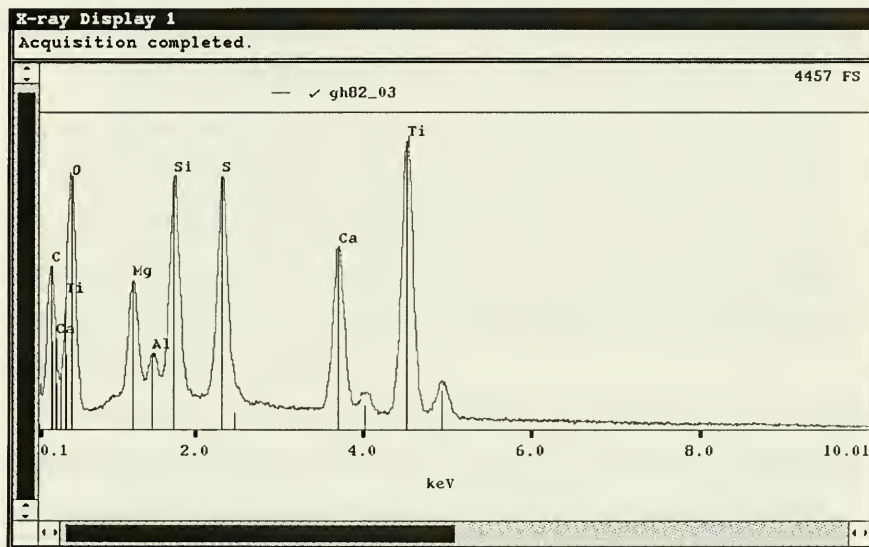
Fig. 22. Sample GH 82, layer 3, SEM-EDS data indicating large peaks of titanium, silicon, sulfur, calcium and oxygen. Smaller peaks of aluminum, and magnesium. (Graph courtesy of LRSM at the University of Pennsylvania, 2003.)

in the targeted collection points in the SEM-EDS data of both the primer and finish paint layers.<sup>70</sup> Also present in the final layer as well as the primer is magnesium (Mg) and silicon (Si). The combination of these elements suggests a form of hydrous magnesium silicate ( $\text{Mg}_3\text{Si}_4\text{O}_{10}(\text{OH})_2$ ), more commonly known as talc, which is used in paints as an extender or filler.<sup>71</sup>

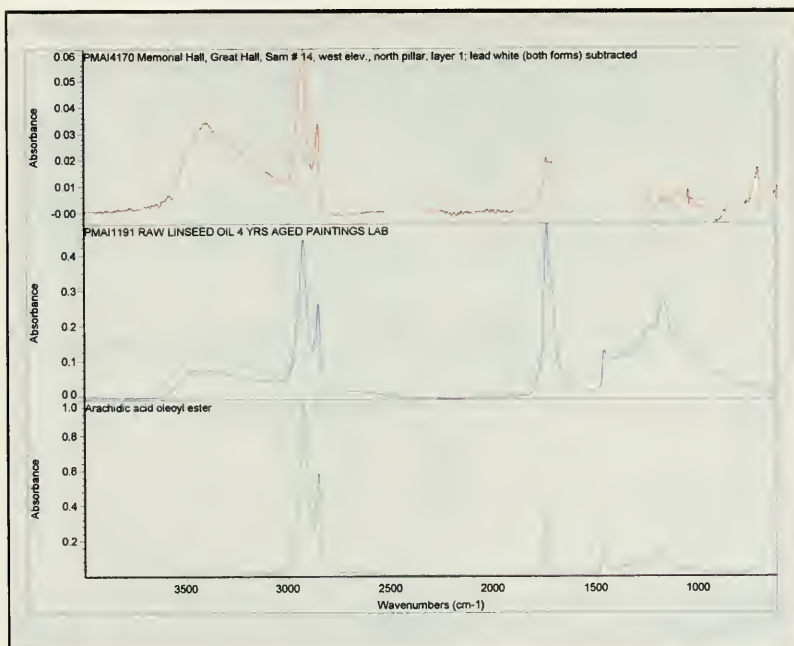
Fig. 25. Sample GH 82, MFTIR data of first paint layer, suggesting linseed oil and a fatty acid medium. (Graph courtesy of the Analytical Laboratory at the Philadelphia Museum of Art, 2003.)

characterize the binding media within the white lead layers. By subtracting the bands for both forms of lead white, the resulting spectrum matched well with reference spectra of linseed oil and arachidic acid oleoyl ester. The main components of linseed oil are “glycerides of linolenic, oleic, linoleic, and saturated fatty acids. The drying property is due to the linoleic and linolenic groups.”<sup>74</sup> Both oils and fats contain esters.<sup>75</sup> Found in both samples of layer one was oleoyl ester, which is fatty acid. While the MFTIR analysis suggested linseed oil as the medium for the first layer, it is important to note that the data is merely consistent with or comparable to linseed oil since MFTIR can not distinguish between linseed oil and other oils.

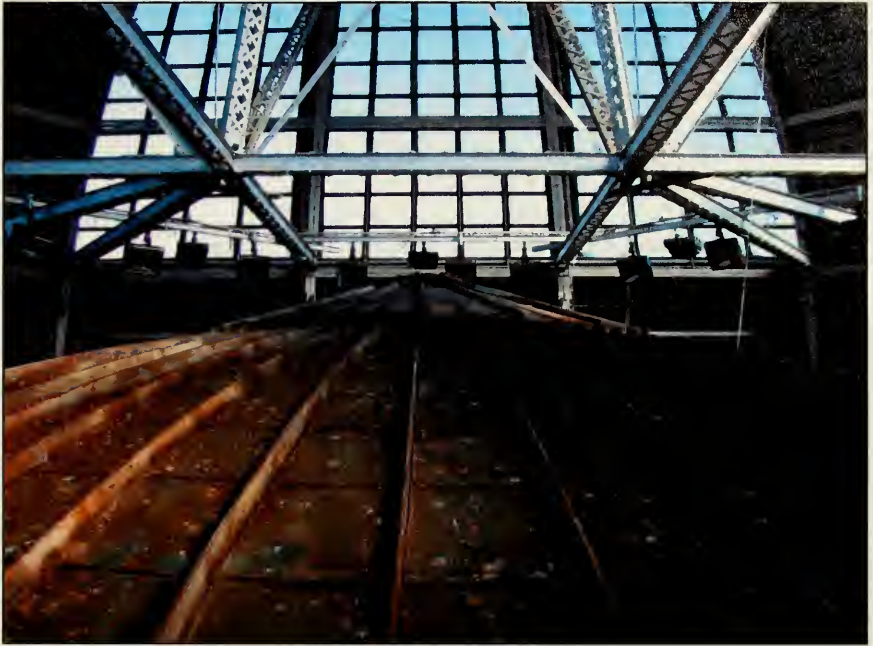
Exterior of interior dome sample taken from iron structural member.

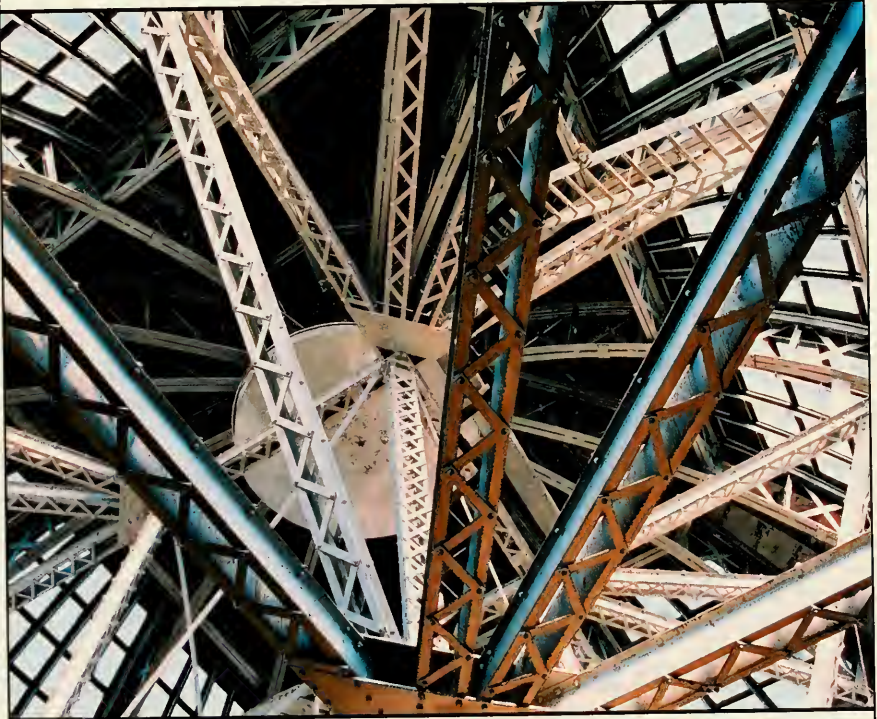
Structural iron-work between the interior and exterior domes of Memorial Hall.  
Photograph by the author, 2003.
