## Plants in the Service of Archaeological Preservation

by Naomi F. Miller

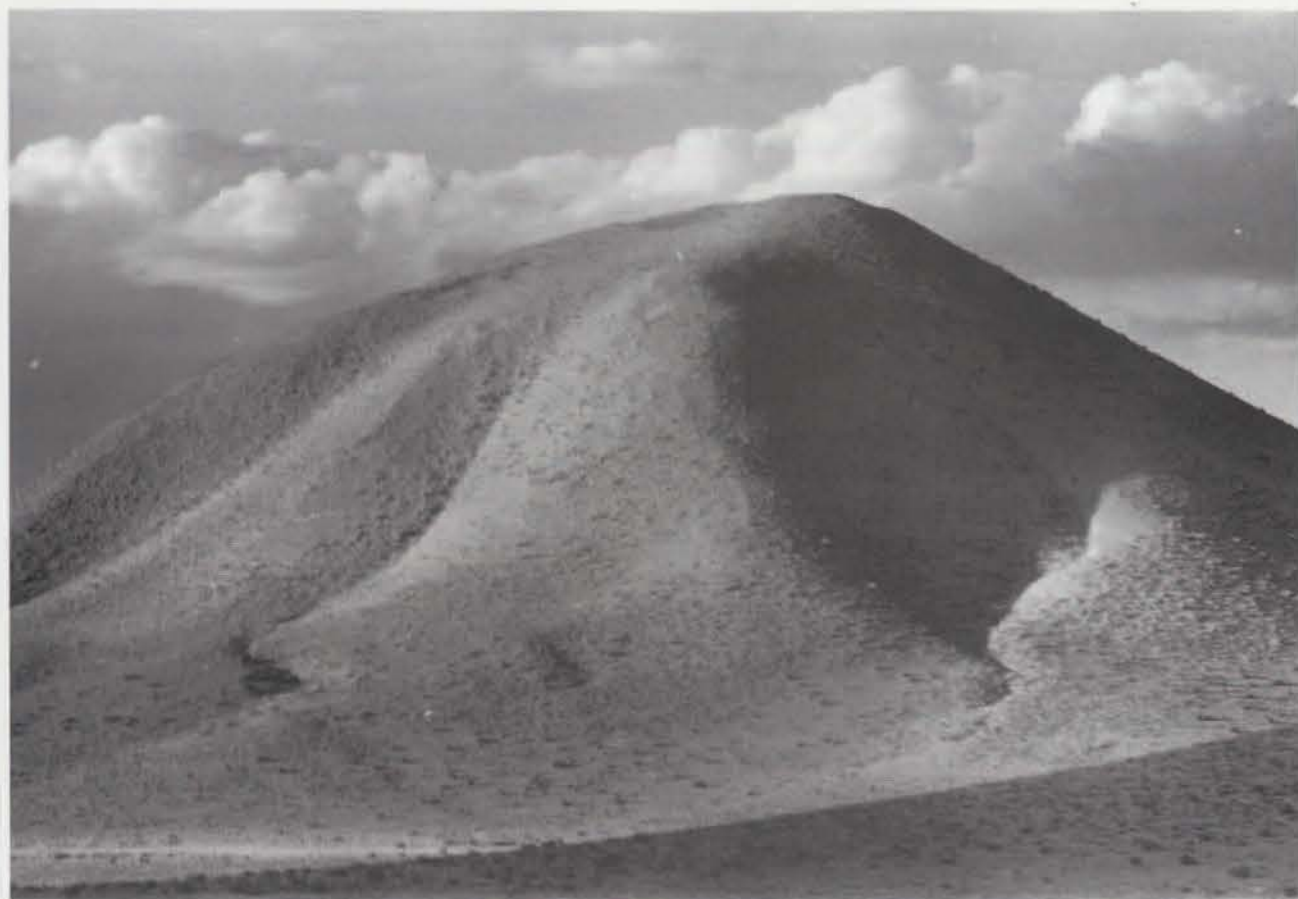
Fig. 1. It is dramatically clear from this photograph, taken in 1957, that the surface of the Midas Mound has been eroding for some time.

Several years ago Dr. İlhan Temizsoy, director of the Museum of Anatolian Civilizations, expressed concern about erosion on the Midas Mound at Gordion (Fig. 1). It occurred to me that the most effective way to reduce soil loss would be to have an uninterrupted cover of plants grow on the mound surface. At that time, the vegetation looked much like the surrounding overgrazed pasture, which is characterized by bare ground, many spiny plants, and plants that defend themselves against grazing goats and sheep

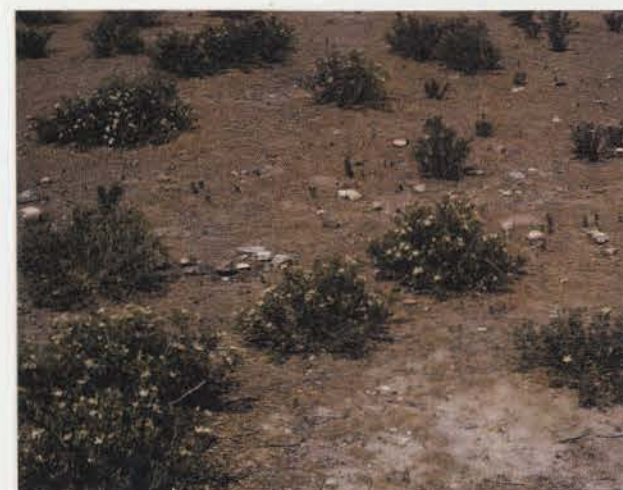
Fig. 2 (top). An overgrazed area at Gordion shows patches of *Peganum harmala* (wild rue). The flocks avoid *Peganum*, because the leaves contain a bitter alkaloid (harmaline), but have eaten almost everything growing between the plants.

by producing bitter compounds in their leaves (Fig. 2). I also began to envision an even grander project—recovery or partial restoration of the vegetation native to this part of Turkey. The central Anatolian steppe grassland is highly diverse, and includes many perennial grasses, wildflowers, and small shrubs that stay green all or most of the year and that are palatable to grazers (Fig. 3). Restored vegetation would not only be beautiful, but would also improve the rangeland.

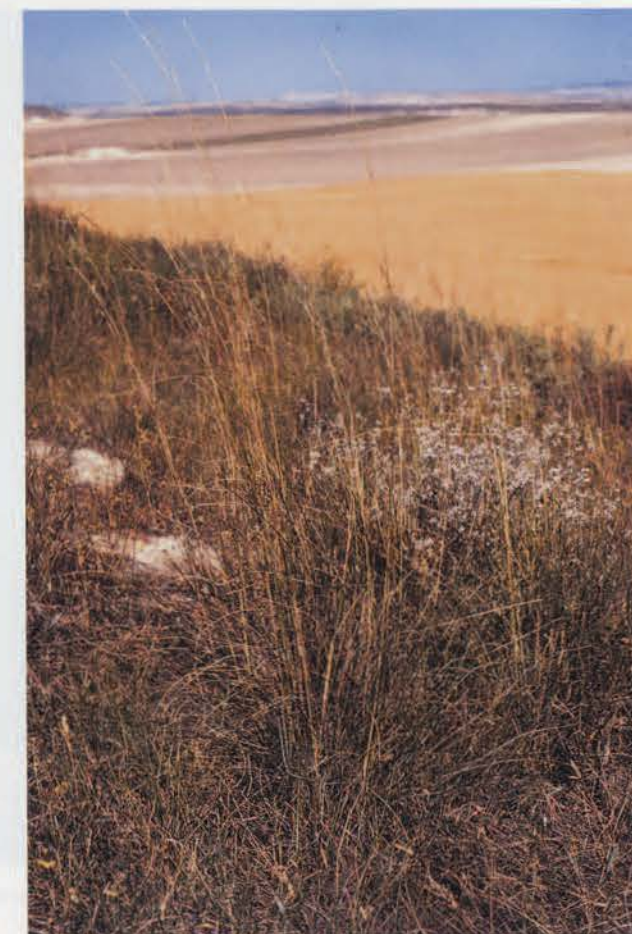
Fig. 3 (right). The inspiration for the Midas Mound conservation and revegetation project came after a visit to this small patch of (then) relatively undisturbed grassy steppe. Surrounded by dry-farmed fields and lying about 5 kilometers from the nearest village, the naturally high diversity of plants was able to grow here.

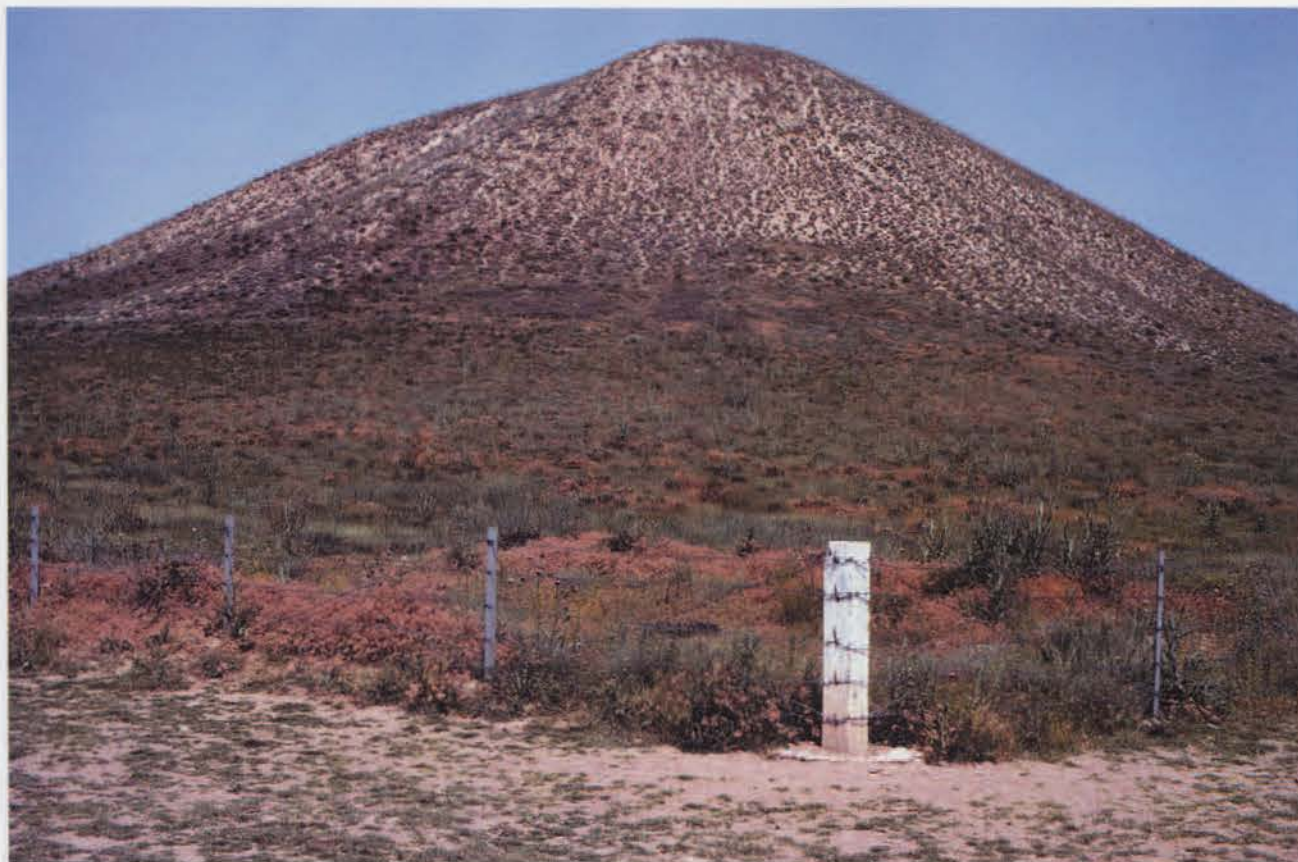
Fig. 4. Protected by the fence, it has not taken long for plants to spread onto the base of the mound. Outside the fence, the flocks still pass by and plant cover is sparse.

Following the concept, "first do no harm," it seemed best initially just to encourage the existing plant cover to spread; thus, in April 1996 the General Directorate of Monuments and Museums erected a fence to keep animals and people off the mound (Fig. 4). By the summer of 1997, a luxuriant cover of grasses and other plants on the lower slopes demonstrated that the fence had begun to work at the base of the mound. Further

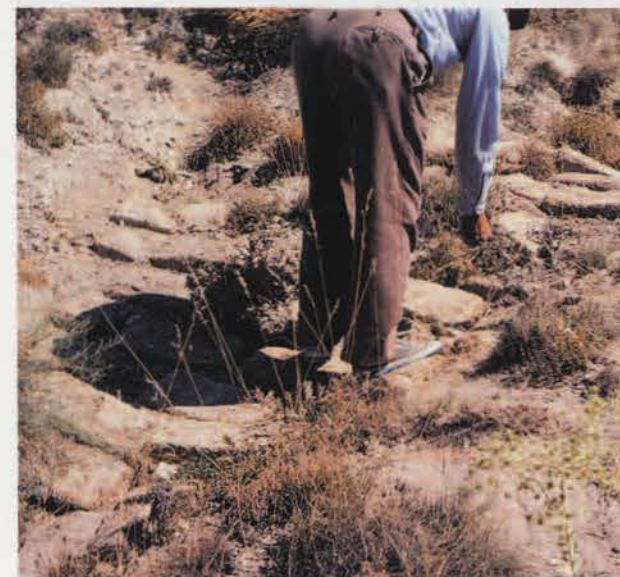
Fig. 5 (top left). Remzi Yilmaz sprinkling seeds between the bricks in one of the erosion channels. The bricks are laid across the channel in rows about 5 cm apart. Although several types of seeds were planted, only annual grasses survived.

The Gordion Project arranged to have 1000 mudbricks from a dismantled village structure placed in two of the erosion channels. The Gordion site caretaker, Remzi Yilmaz, was drafted to supervise the laying of bricks in the fall of 1997 (Figs. 5, 6). The work had to be done by hand because heavy equipment would destroy the soft surface of the mound. As I described the plan to Remzi, the watchman for the dig house listened in. I explained that it was just an "experiment"; if it did not work out, I didn't want Remzi to blame himself. But then I caught the eye of the watchman. "You think I'm crazy, don't you?" I asked him; he smiled and said, "Well, if it works, you're not crazy."

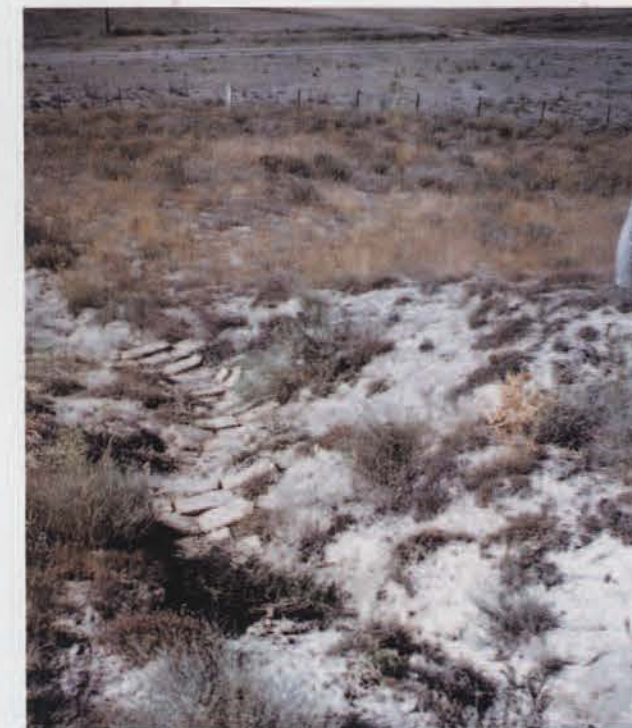
Fig. 6 (top right). Looking downhill after some of the mudbrick was laid in 1997.

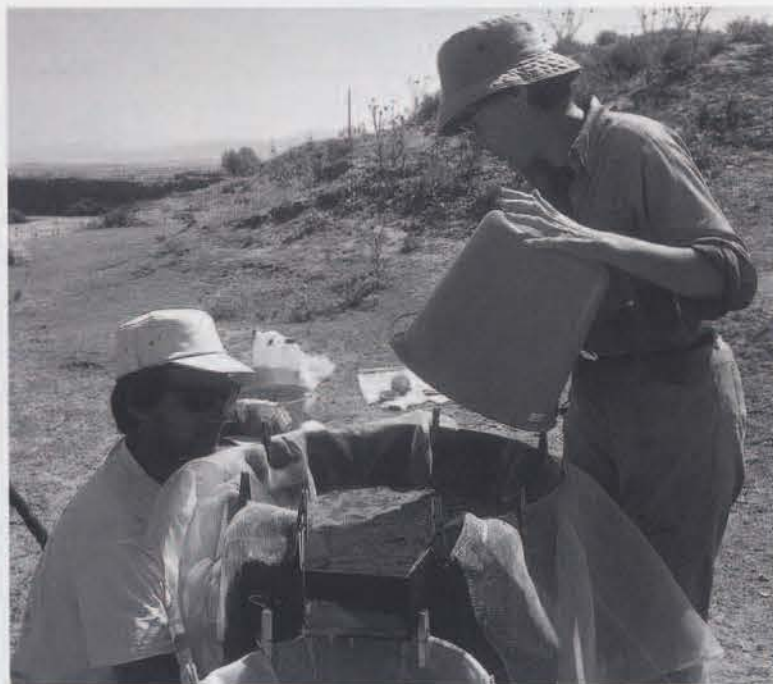
At Gordion, we used a pump-driven flotation device to extract and concentrate the tiny bits of charred seeds and wood from samples of the archaeological deposits. Here I am pouring a bucket of dirt into the tank while my assistant adjusts the water level. As the water flows up and out of the tank, charred seeds and wood bits are caught in a cloth. After they dry, they are examined at low-magnification under a light microscope. Changes through time in the proportions of different types help us interpret corresponding changes in ancient vegetation and land use.

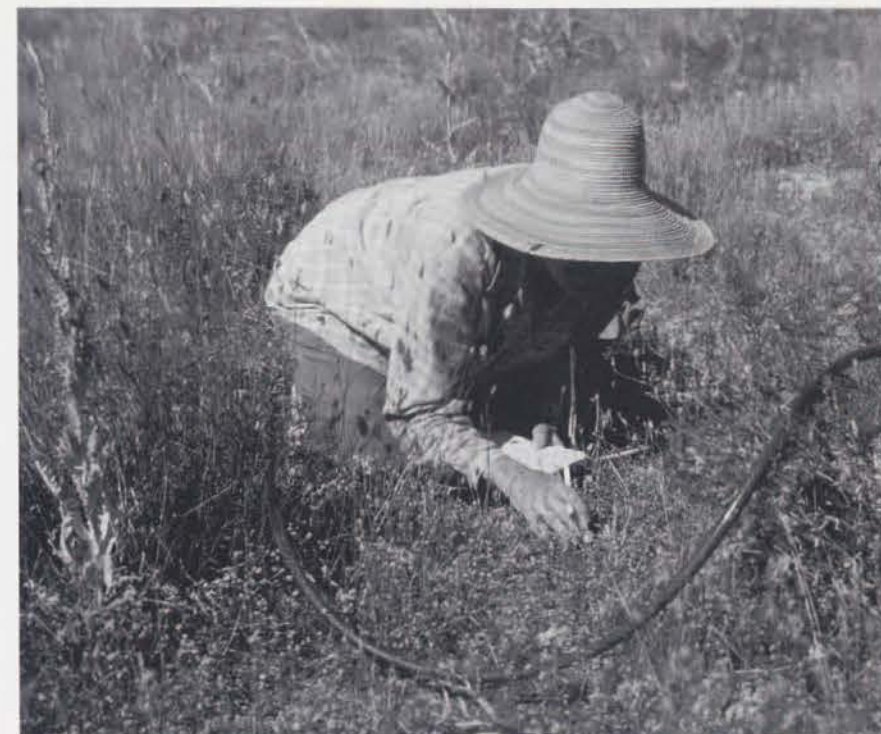
Fig. 8. Part of our conservation efforts involves gathering information as the project evolves. Here, I am in the midst of censusing plants on the Midas Tumulus: every 10 meters along a transect, I identify all the plant types growing in one square meter (the area encircled by the 3.54 m length of garden hose).

By the spring of 1998, plants were thriving in both channels where the bricks had been laid (Fig. 7), and I have counted and mapped over 125 different types of plants, distributed according to their own growth requirements (Fig. 8).

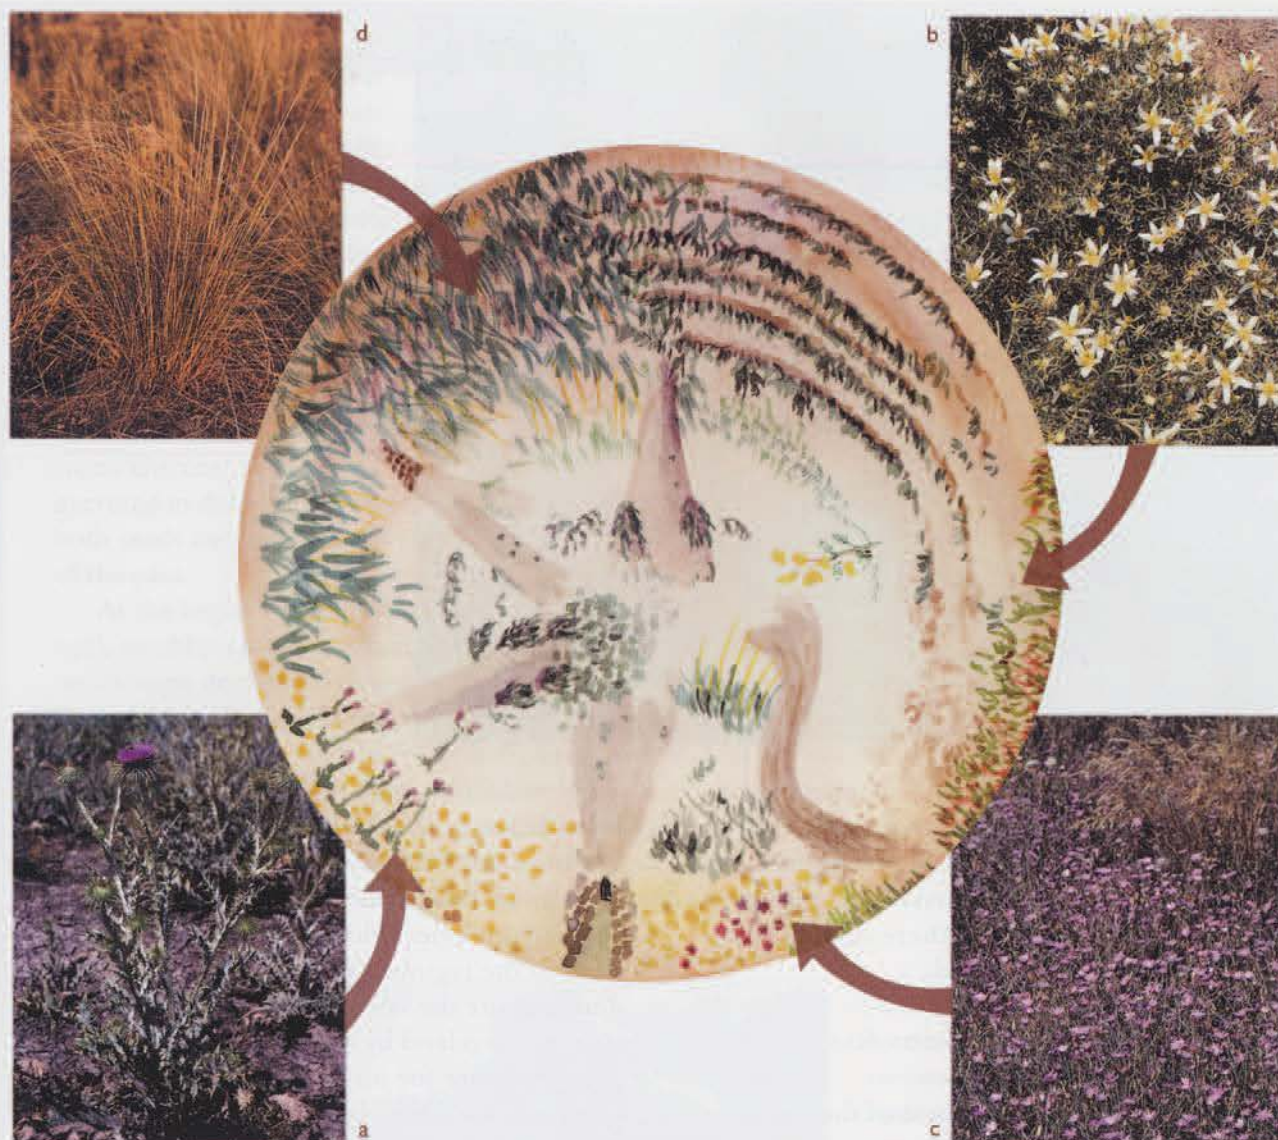
Fig. 9. Schematic watercolor of prominent vegetation on the mound as if seen from the air as we began the experiment with the bricks. Note that plant distribution varies according to slope and aspect. Thistles (probably *Onopordum* sp.; see 'a') thrive on the lower southwest slope and wild rue (*Peganum harmala*; 'b') continues to grow profusely on the southeast side of the mound along one of the main paths to the village from the surrounding pastureland. A small member of the daisy family (*Xeranthemum inapertum*; 'c') grows toward the base on the south side. Wormwood (*Artemisia* sp.), so common but nondescript that I did not think to paint it, is relatively sparse only in the northeast sector. The painting also illustrates trails beaten through the wild thyme by sheep in years past on the northeast side, and perennial grasses thriving on the north side. One of these grasses, *Stipa holosericea* ('d'), is an important part of the native steppe vegetation of central Anatolia and makes a fine fodder.

The mapping demonstrates that there is no one plant or even group of plants that is best for the mound (Fig. 9). For example, one perennial grass, *Stipa arabica*, does very well in the southeast sector, while another one, *Bromus cappadocius*, is most abundant in the north sector.
