A COMPARISON OF FRESH AND WEATHERED MARBLE  
FROM THE TWEED COURTHOUSE

A THESIS

Historic Preservation

2001

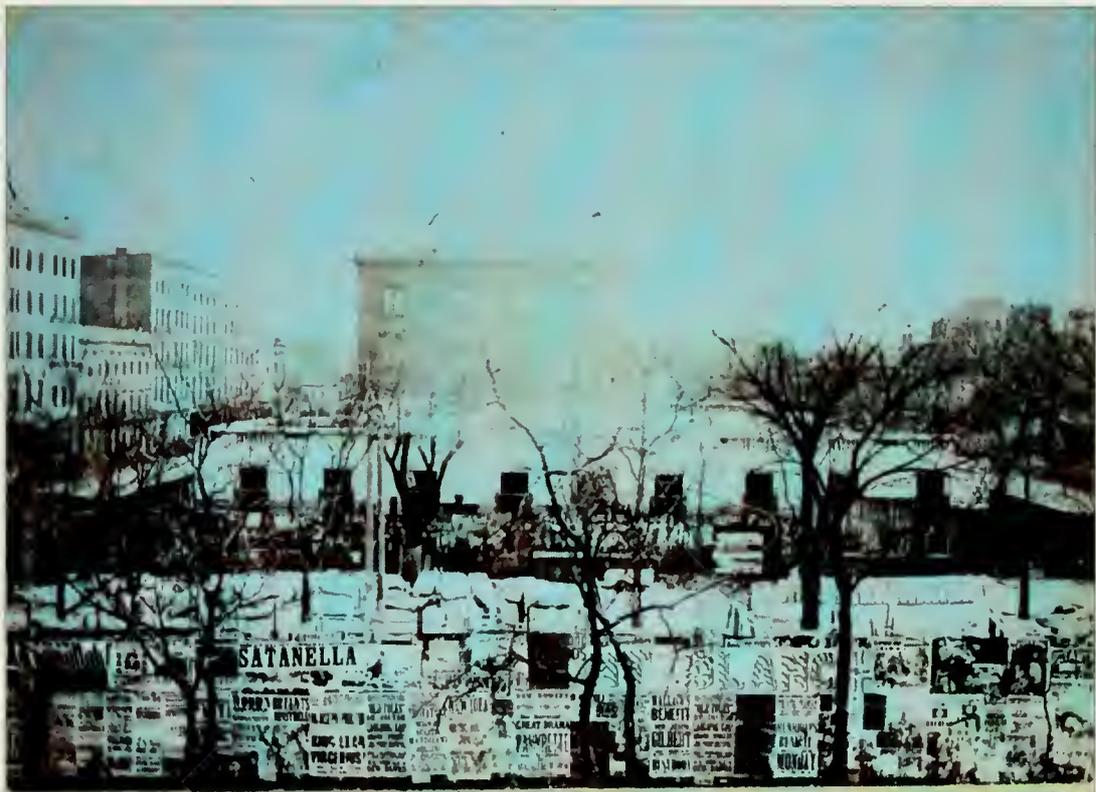
**Figure 2.2:** An 1863 daguerrotype of the construction site as seen from Broadway. Numerous blocks of marble lie in the yard directly behind the fence. A stonecarver's shanty appears to the right behind a line of carved elements, and a hoist is seen to the left of the image. Stonework has been completed on the first floor/ rusticated basement. Courtesy of the Scrapbook Collection, New York Public Library.

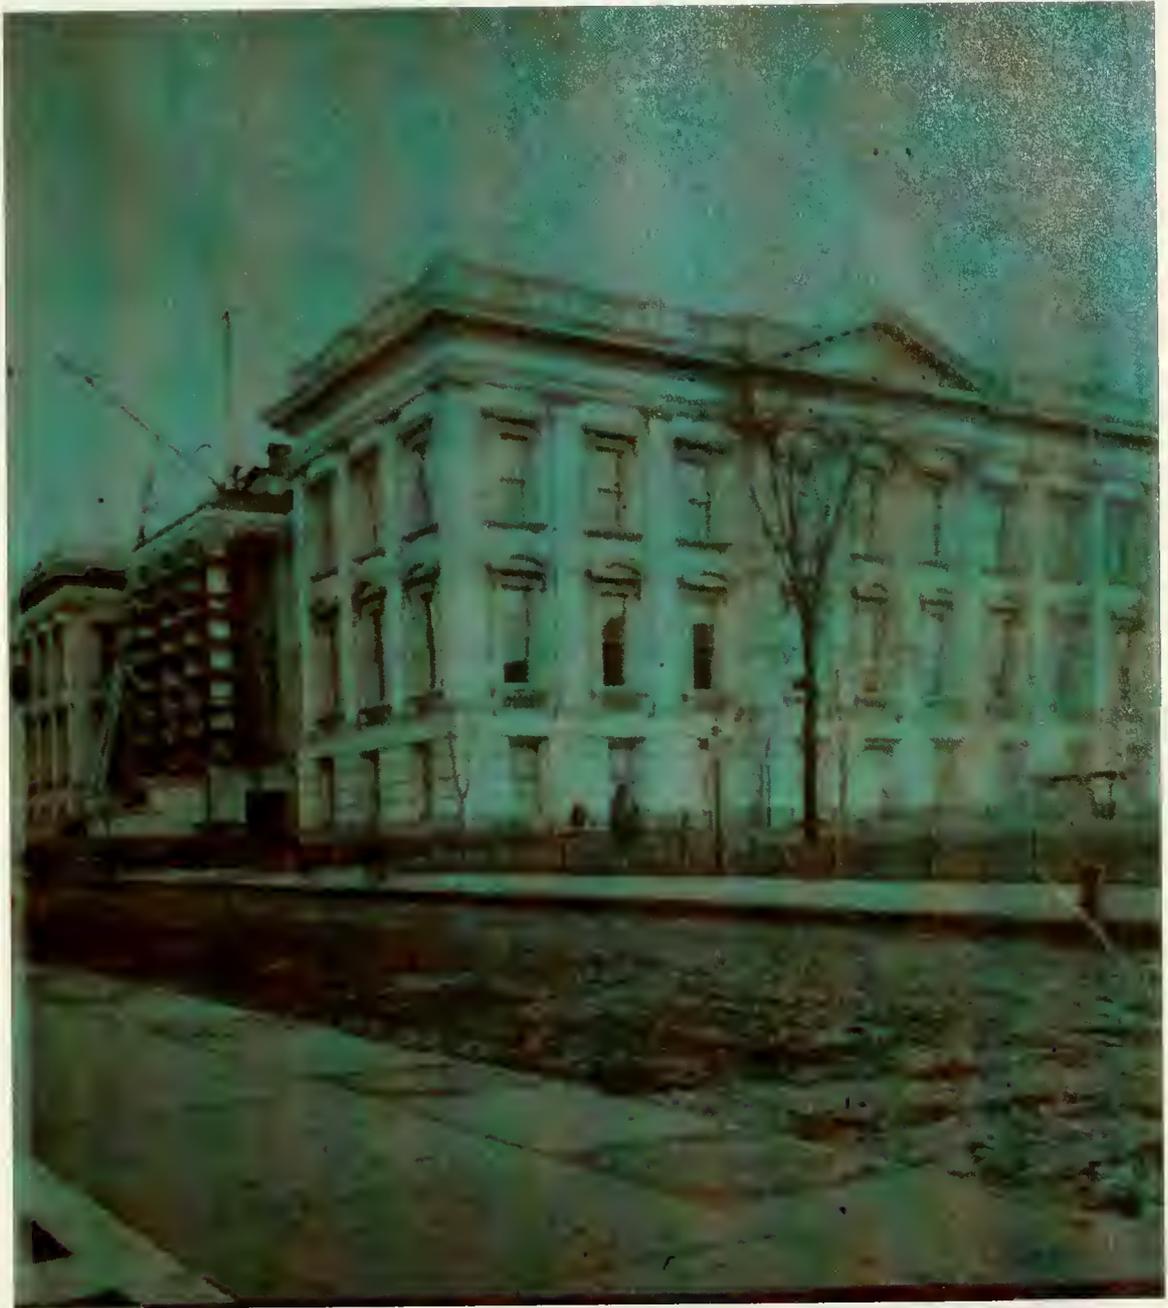
**Figure 2.3:** Image of the unfinished building taken from an 1873 stereoscopic photograph. The columns on the North Portico are not completed, and the pediment has yet to be installed. This view became emblematic of the plagued construction process. Courtesy of the Scrapbook Collection, New York Public Library.

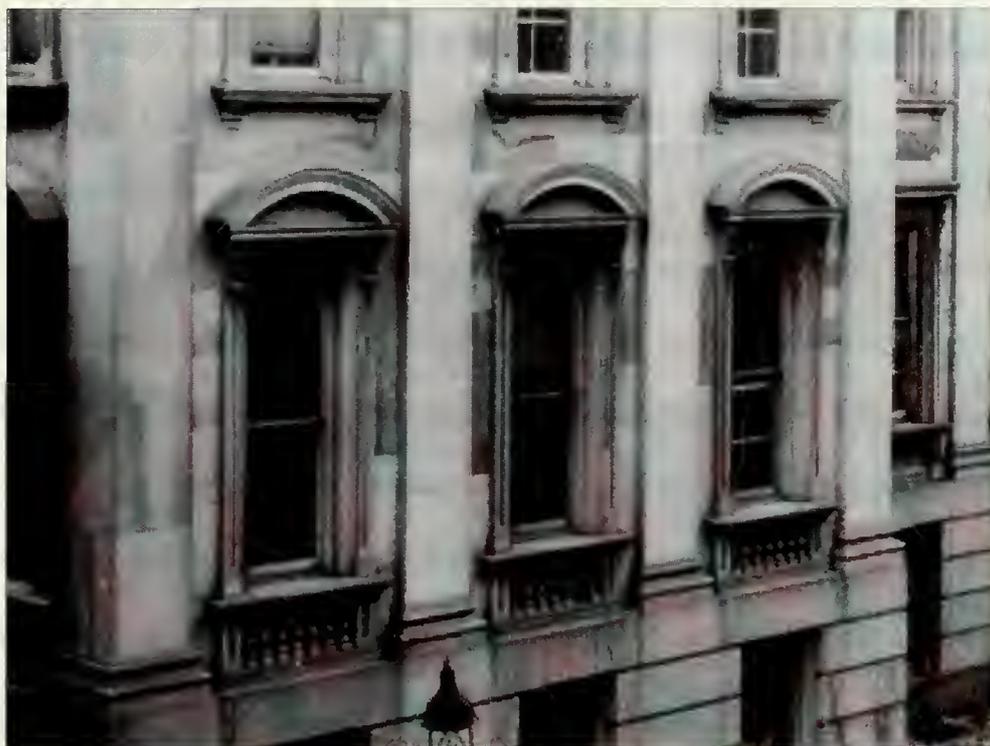
**Figure 2.5:** Close-up view of the same photograph showing differential staining of exterior marble around the second floor windows. The darker blocks are probably Sheffield marble.

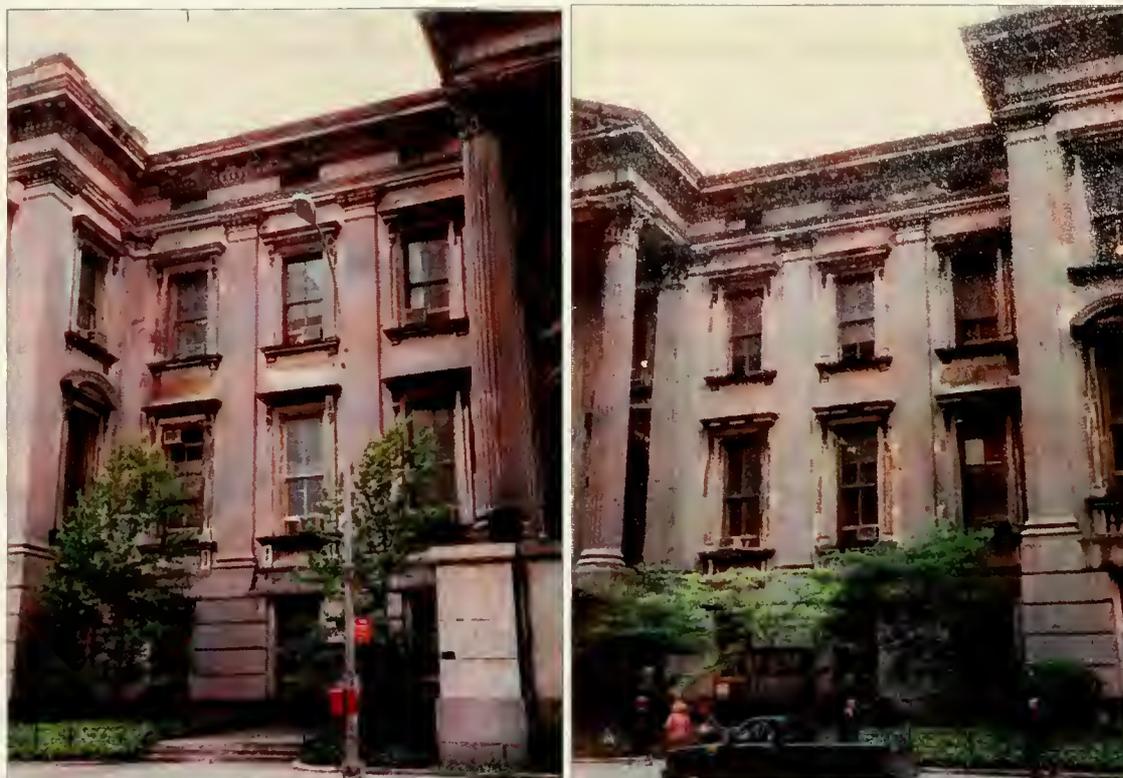
Figures 3.1 & 3.2: Discoloration on the north façade, east and west sides of the portico. May, 1989.

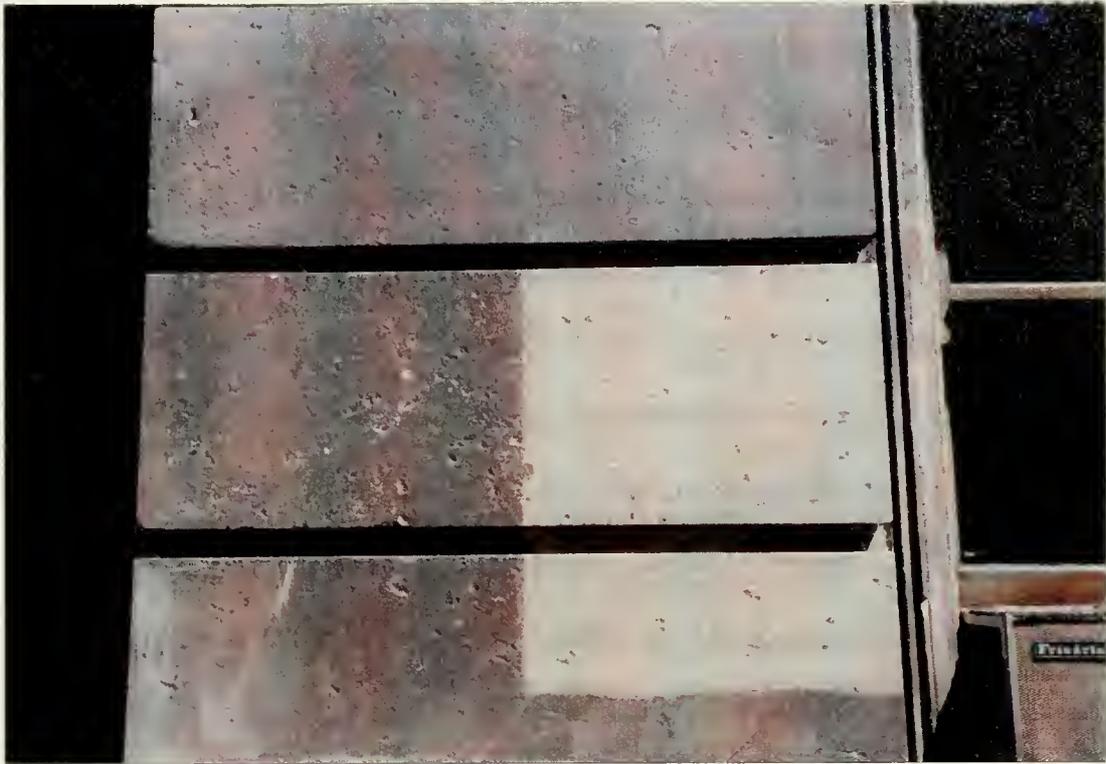
Figure 3.3: Cleaning test number 10 performed on two blocks of Tuckahoe marble at the first floor level, July 1989.

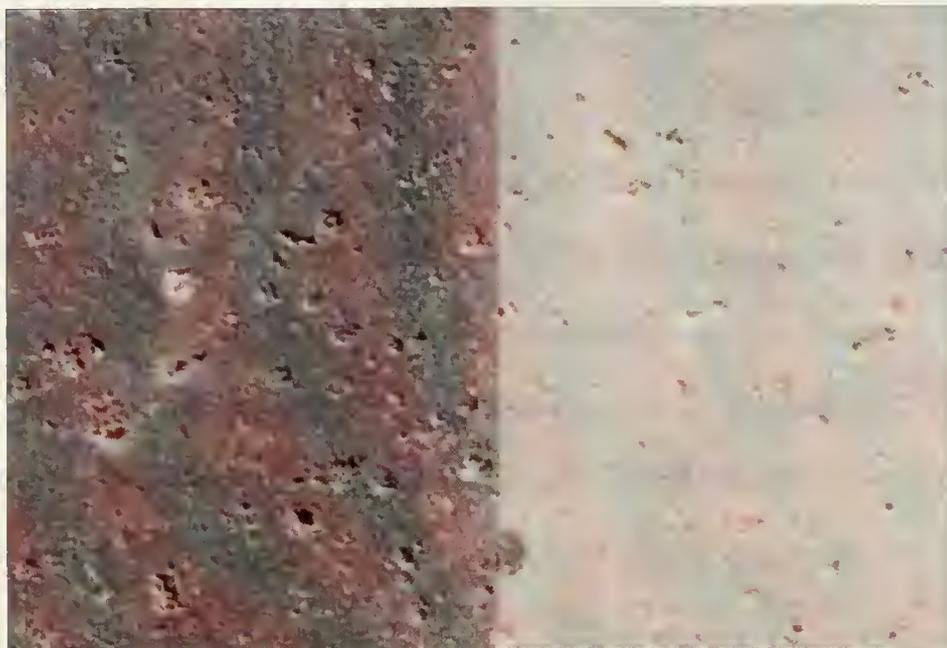
Figure 3.4: Close-up of cleaning test number 10. Gray discoloration and pock-marking are evident.

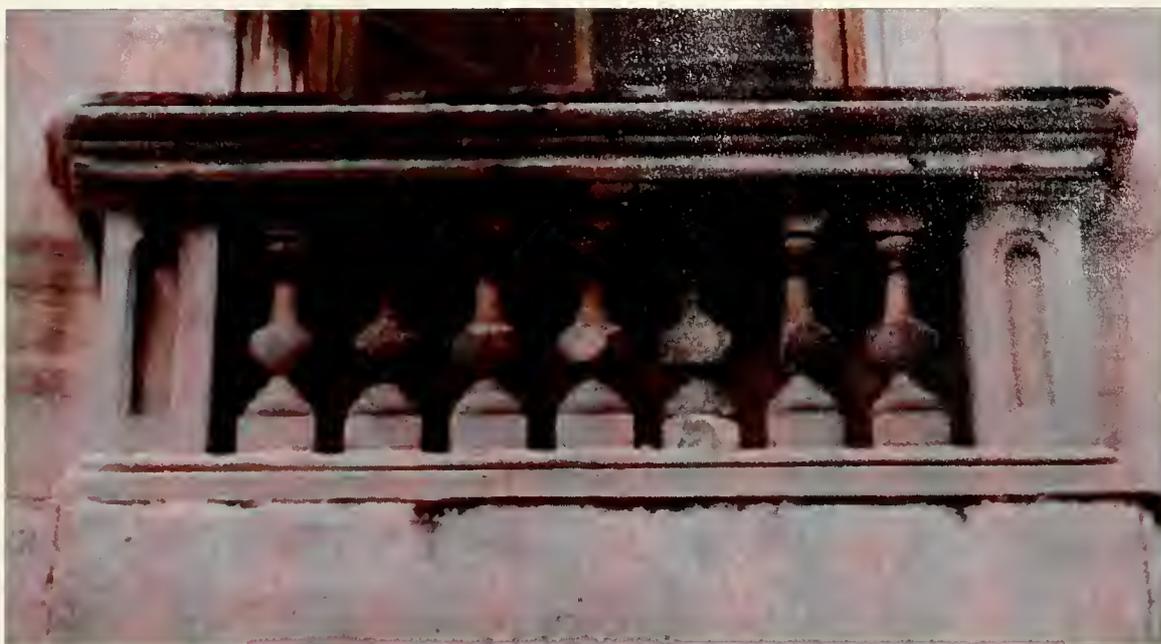
**Figure 3.5: Tuckahoe marble balusters showing extreme degradation due to weathering. Characteristic gray discoloration and blackening from the accretion of pollutants are evident. Projecting elements of both types of marble tend to look alike because of pollution staining. Photo taken May, 1989.**

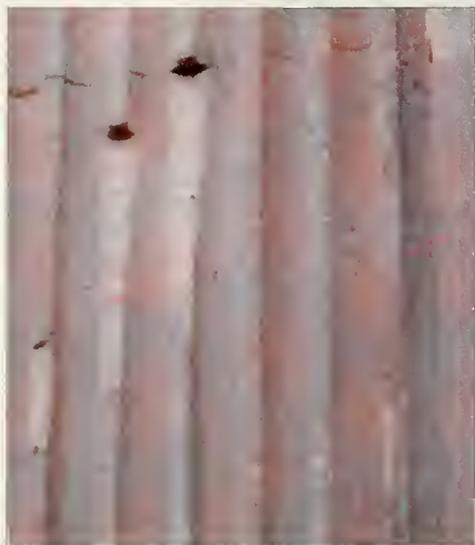
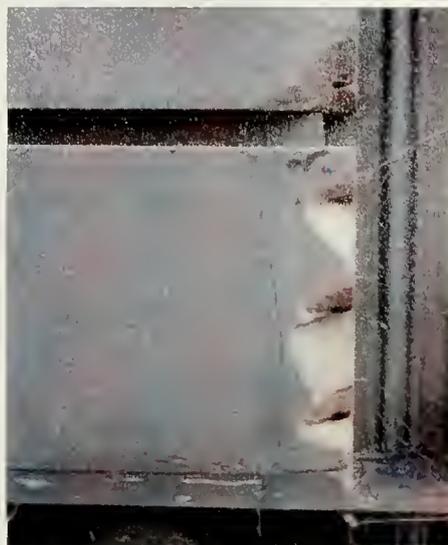
**Figures 3.6 & 3.7: Chipped pilaster flutes to the left and a chipped rusticated basement block to the right. Many of the finer details of the Tuckahoe marble have detached due to weathering. The whiter substrate has been exposed, revealing the level of discoloration. Photos taken May, 1989.**

1) The gray stained marble shows the characteristic properties of Tuckahoe marble: medium to large grain size, gray surface deposition of sooty pollutants and gypsum crust formation on projecting elements (See Figure 3.5.) Surface friability is often extreme. Figure 3.6 and 3.7 show that in areas where the stone is thin, it has detached from the substrate. Small iron spots are also visible on many of the elements, as shown in Figure 3.8. The graying of Tuckahoe marble is likely to be an urban phenomenon, since Tuckahoe samples on the Stone Exposure Test Wall at the National Institute of Testing and Standards in rural Maryland have not become gray in 50 years of exposure (see Figure 3.9.).

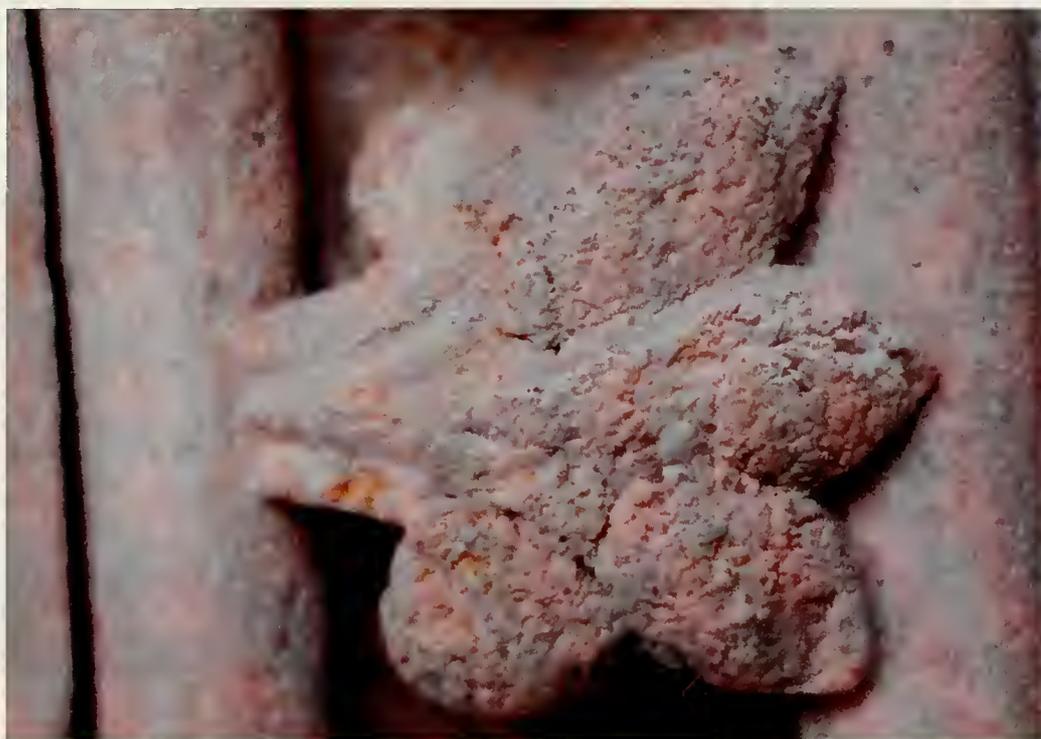
**Figure 3.8: Leaf detail with degraded surface showing exposed individual grains and iron stains. Weathering has made the surface extremely friable. Photo taken August 2000.**

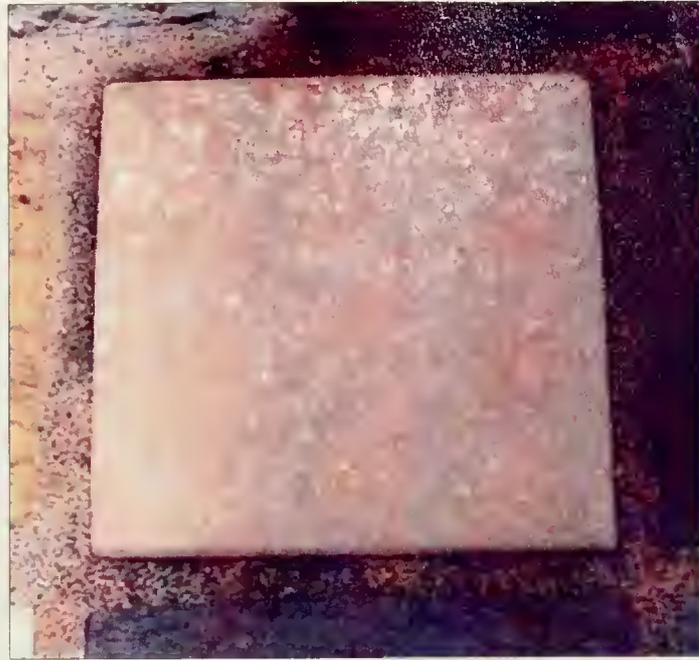
**Figure 3.9:** A smooth but slightly iron-stained sample of Tuckahoe marble in the Stone Exposure Test Wall at the NIST. After 50 years of exposure, no gray discoloration was visible. The large grains are highlighted by the reflection of the sun on the surface.

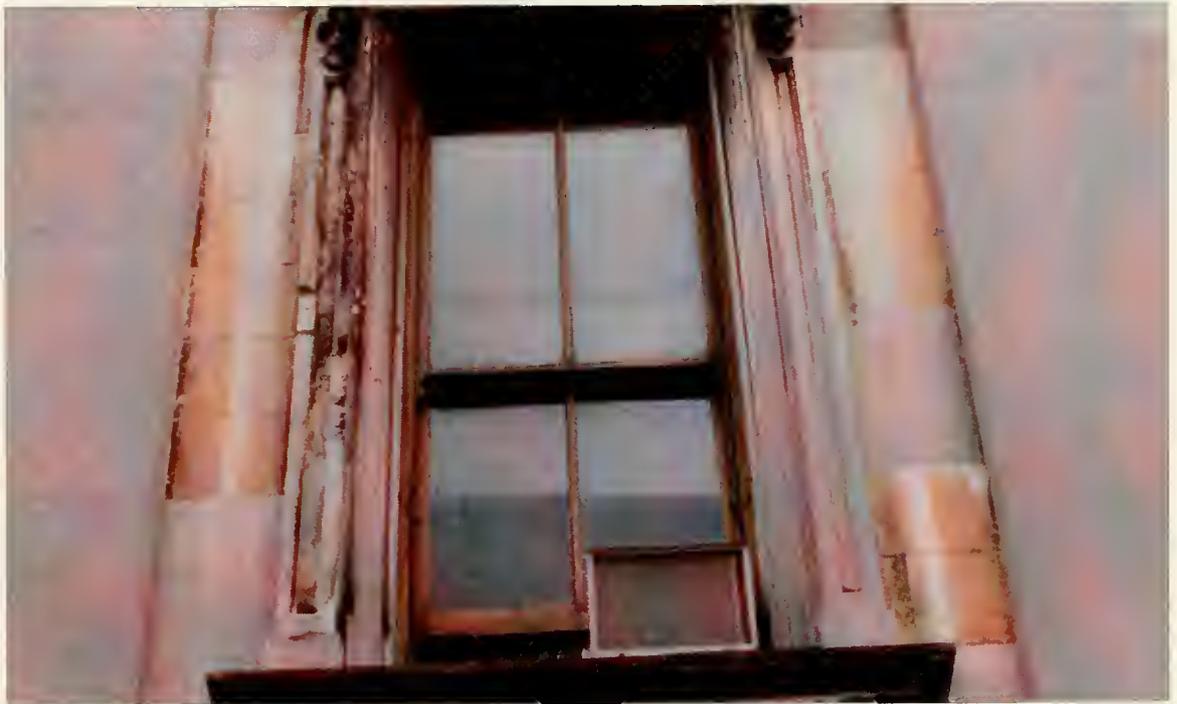
**Figure 3.10:** Iron-stained marble, probably Sheffield, interspersed with blocks of Tuckahoe. Iron staining may be due to the leaching out of ferruginous minerals such as pyrite. Note how the stone has been washed white in areas of rain runoff near the Tuckahoe marble while the Tuckahoe has remained a solid gray color. Photo taken May, 1989.

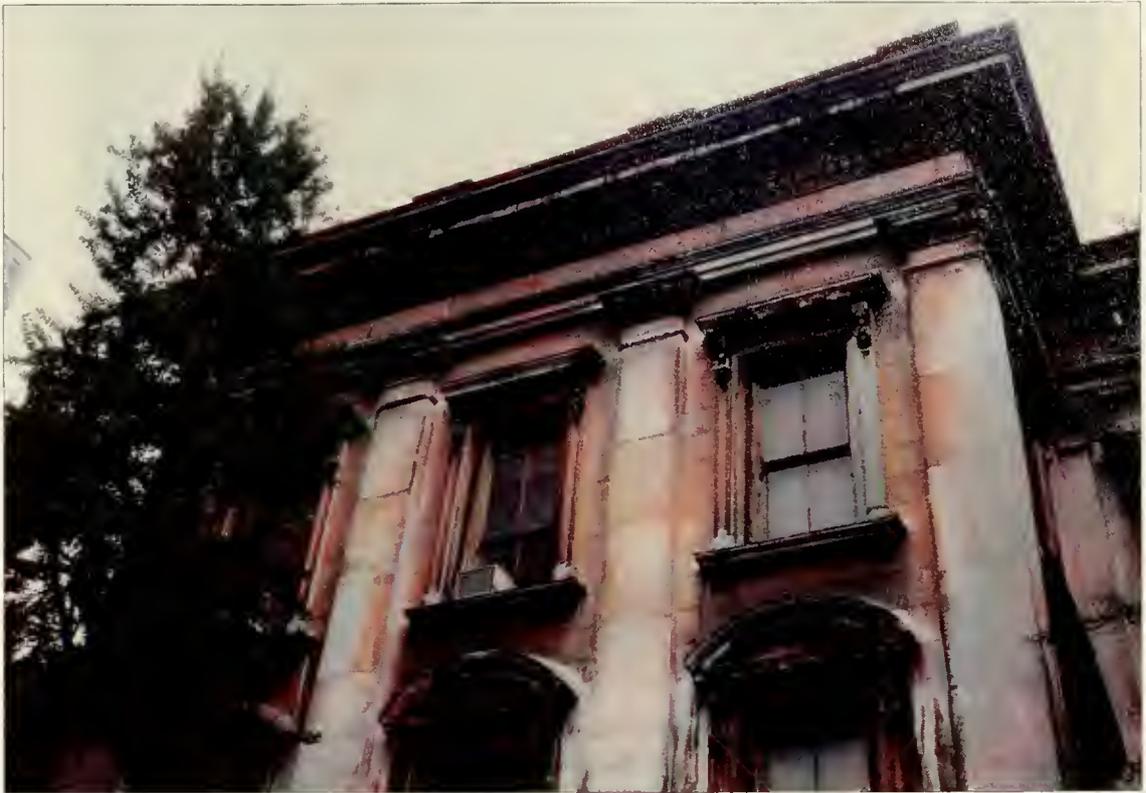
**Figure 3.11: South facade, west end, May, 1989. Extreme staining is visible across the entire surface. This type of discoloration is typical of Lee marble, a stone quarried within 20 miles of Sheffield, MA. The south façade exhibits the worst weathering on the building.**

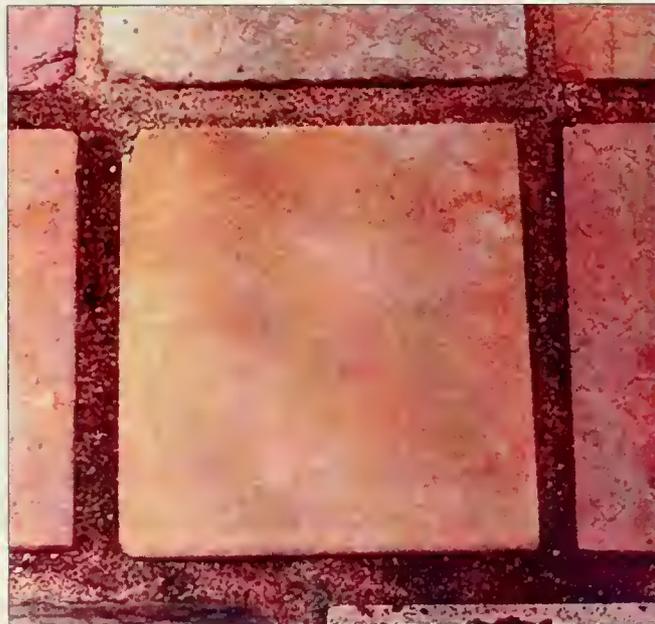
**Figure 3.12: An iron-stained sample of Lee marble in the Stone Exposure Test Wall at the NIST. Like the Tuckahoe sample, discoloration due to pollution was not noticed.**

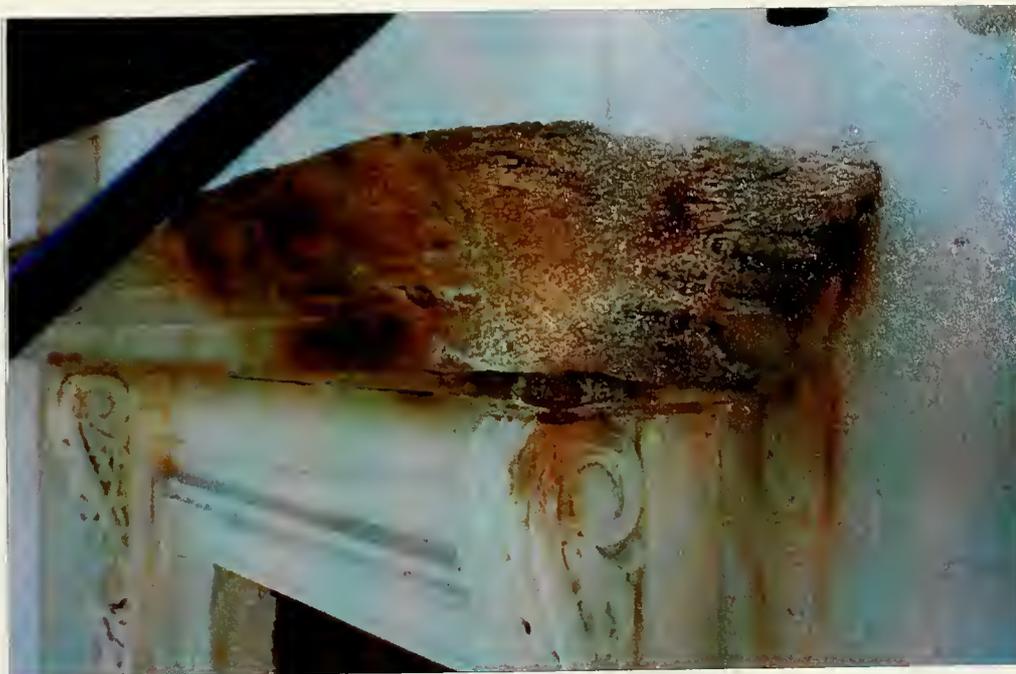
**Figure 3.13:** A Sheffield window header that had been covered with bituminous bird-proofing. The corner shows the effects of trapped moisture. This part of the stone could be removed merely by scraping the surface.

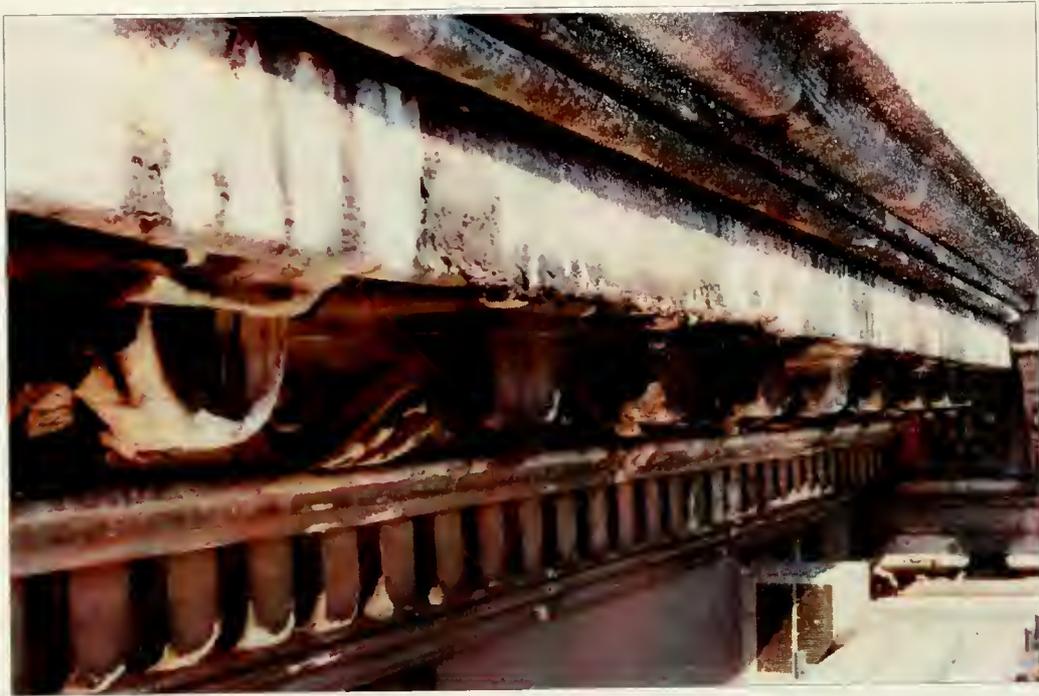
**Figure 3.15:** Exposed areas where moisture is likely to collect, such as the cornice, show the most intense staining and decay.

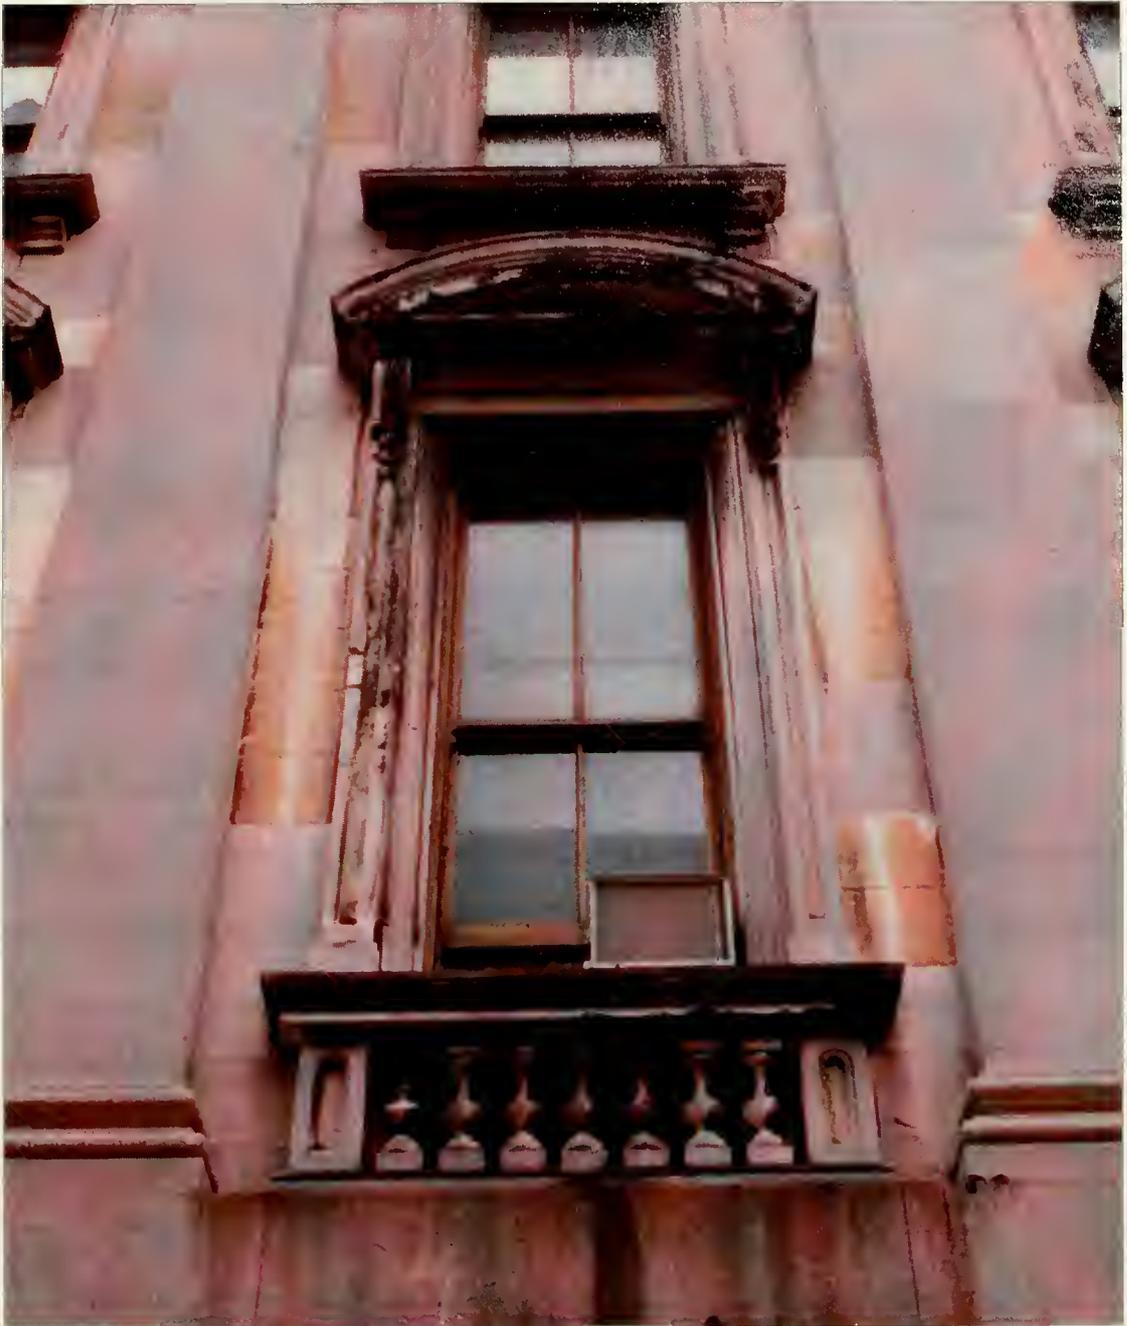
**Figure 3.16:** This photograph illustrates the juxtaposition of different stone types that is clear today but which was not obvious at the time of construction. Iron-stained blocks in the wall, probably Sheffield marble, are visually distinguishable from the gray, discolored stone, which is probably Tuckahoe. The window jambs both appear to be Tuckahoe, although the one on the left is significantly more chipped and discolored.

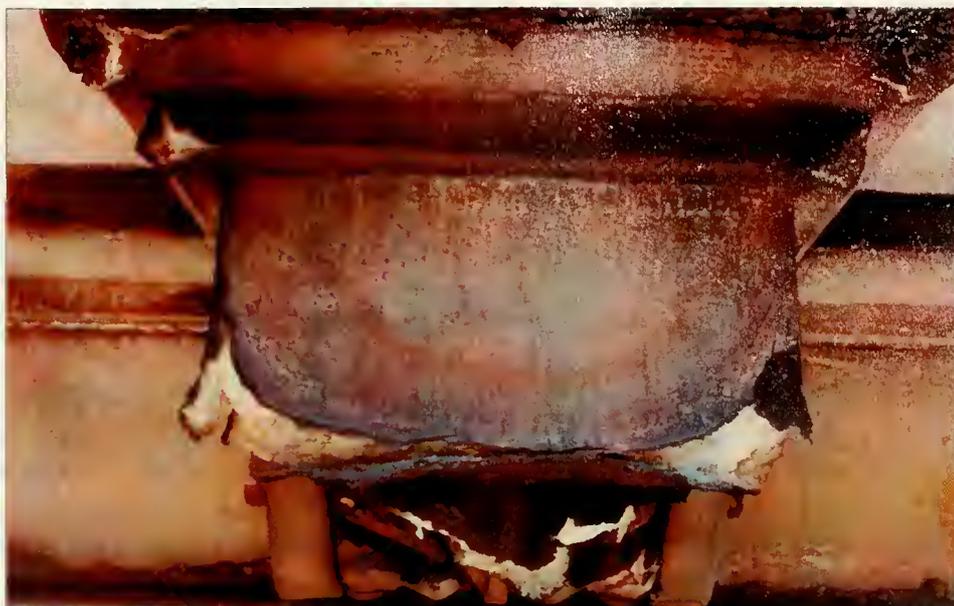
**Figure 3.17: A modillion appears to be splitting at the seams due to continued freeze/thaw cycling beneath a hard surface crust of gypsum. Note the semicircular patterns of brownish and blackish iron deposits due to the diffusion of iron leachates and other atmospheric pollutants.**

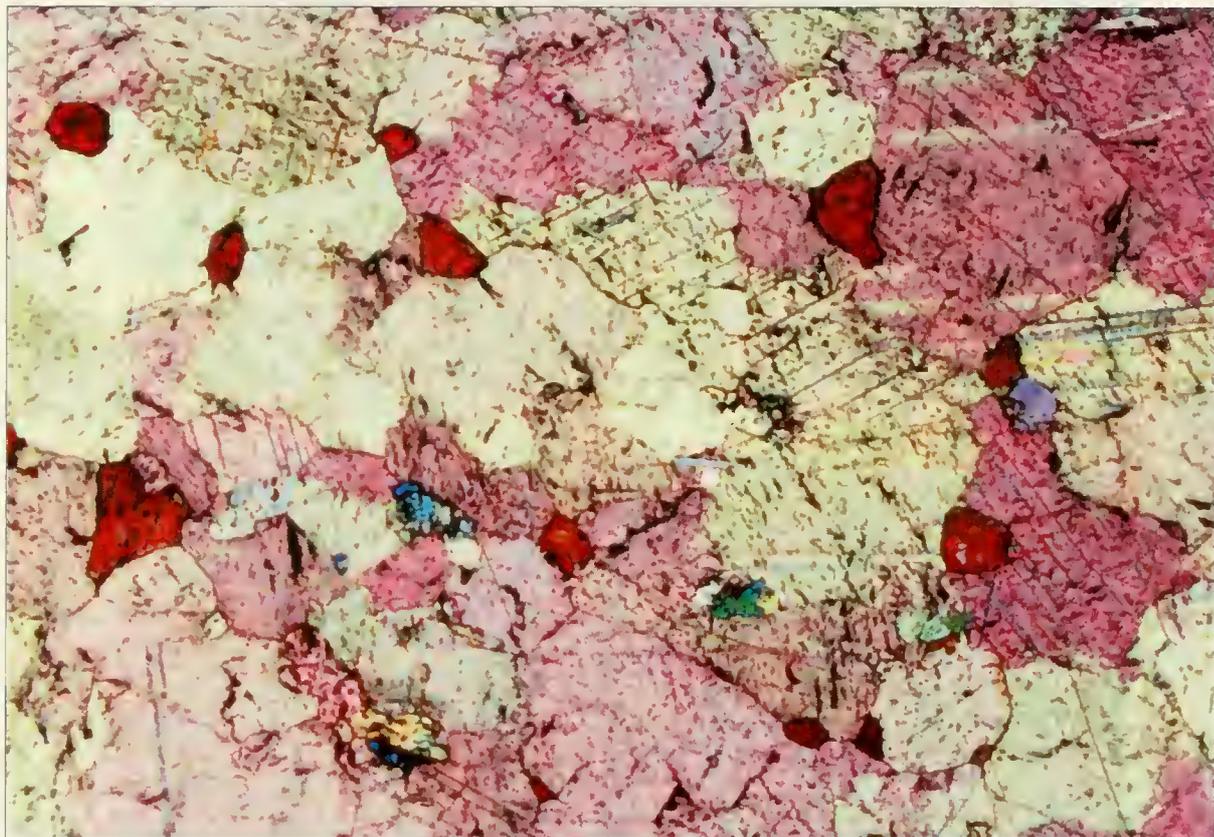
**Figure 4.2:** A typical view of fresh Tuckahoe marble from thin section slide T-8. Red stained calcite is interspersed with dolomite. The structure appears uniform and crystalline at the top of the photomicrograph. In the lower left, the structure appears more conglomerated. 5x magnification, cross-polarized light.

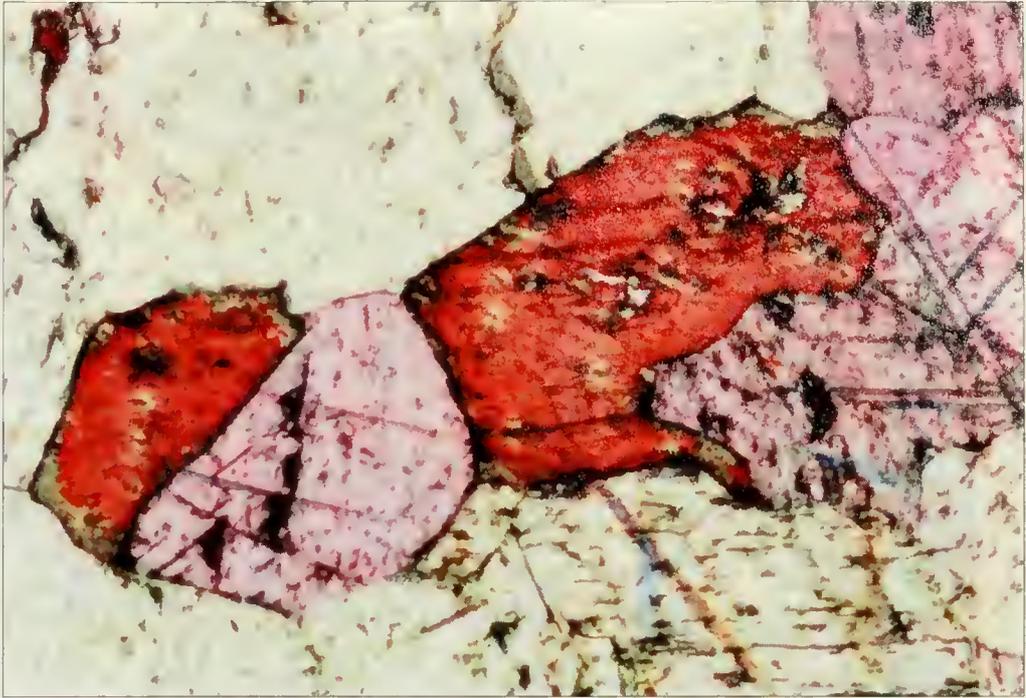
Figure 4.3: Calcite and dolomite distinguished by calcite staining. Lamellar twinning can be seen in crystals to the right of the photomicrograph. The structure is very compact and uniform in some areas but less so in others. The grain boundary shows no separation between crystals. 10x magnification, cross-polarized light.

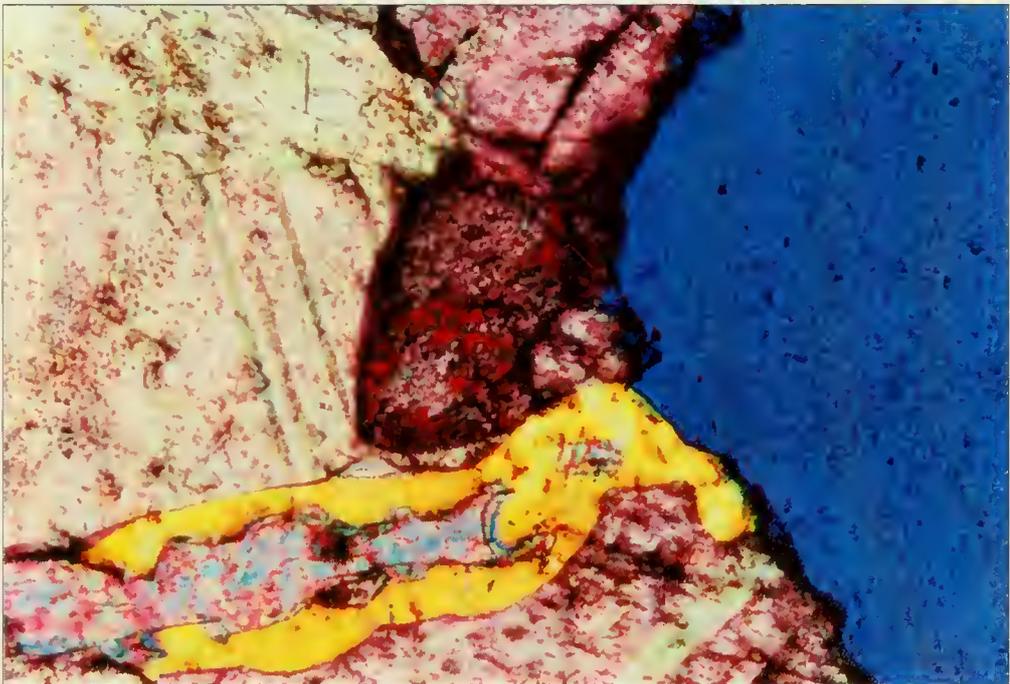
Figure 4.4: Dolomite, red-stained calcite, and phlogopite at the surface of the fresh Tuckahoe sample on slide T-8. Different expansion behavior during thermal cycling will probably cause surface pitting. This image is an interesting contrast to Figure 4.19, a similar but weathered surface. 20x magnification, cross-polarized light.

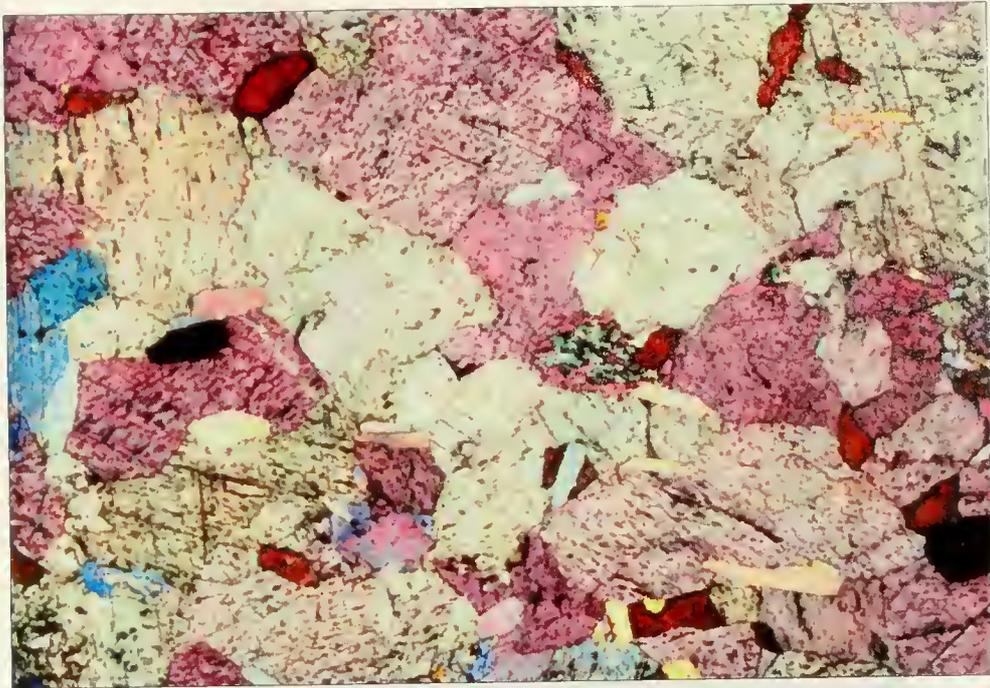
**Figure 4.5:** Numerous inclusions are seen in the lower half of the picture. The green inclusion appears to be tremolite, while the numerous oblong inclusions are phlogopite. The variety of minerals creates a heterogeneous structure. 5x magnification, cross-polarized light.

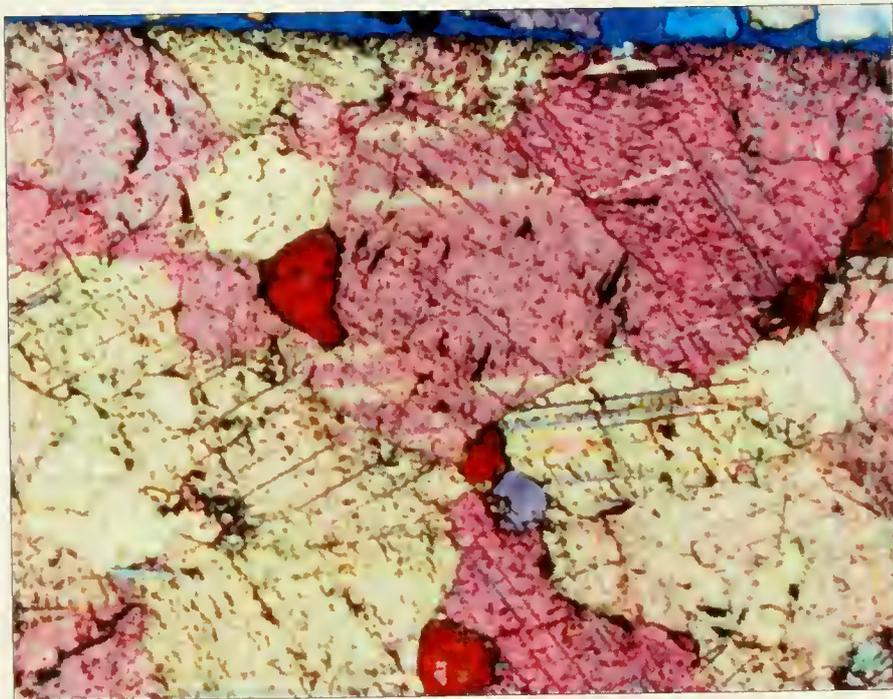
**Figure 4.6:** An absence of microcracking is evident in this photomicrograph of slide T-8. Vacuum impregnation with blue dye did not reveal any fractures. The clean surface is seen in the upper portion of the photomicrograph bordered by the blue dye. Close-up of 5x magnification, cross-polarized light.

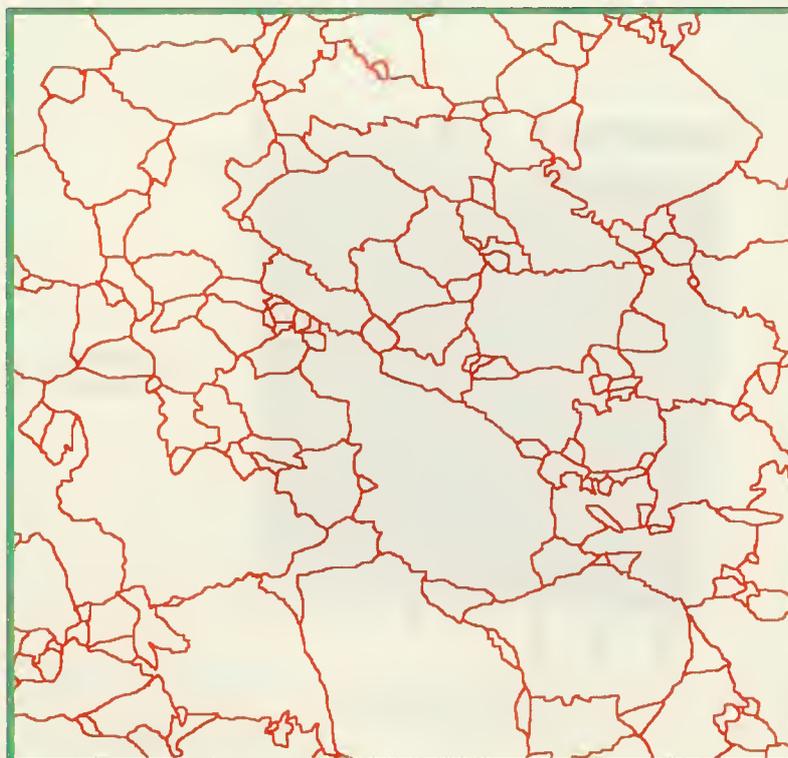
**Figure 4.8:** Digitized grain boundary image of 1 square cm of Tuckahoe slide T-8.

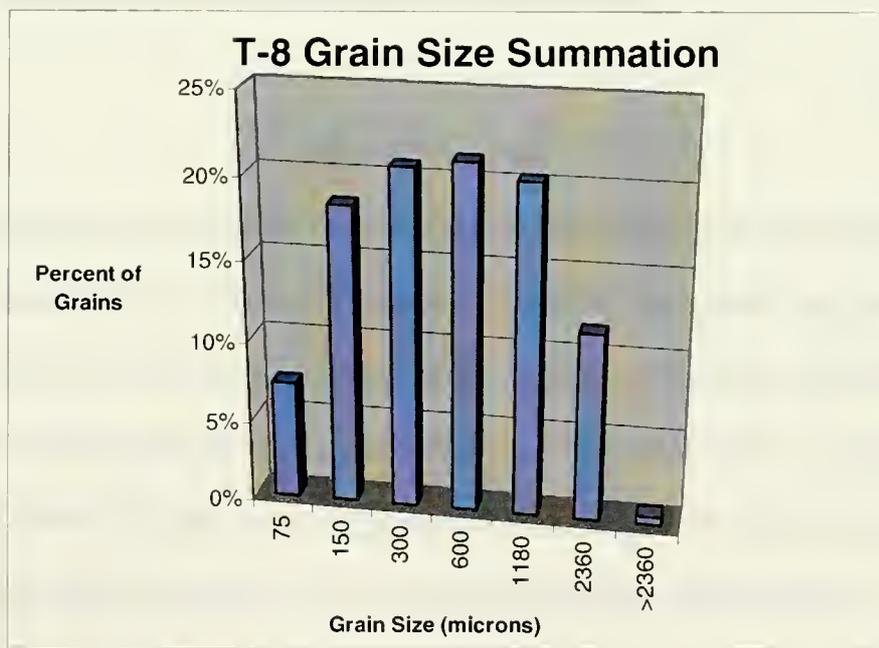
Table 4.1 Summary of Bioquant<sup>®</sup> data and related measurements for slide T-8.

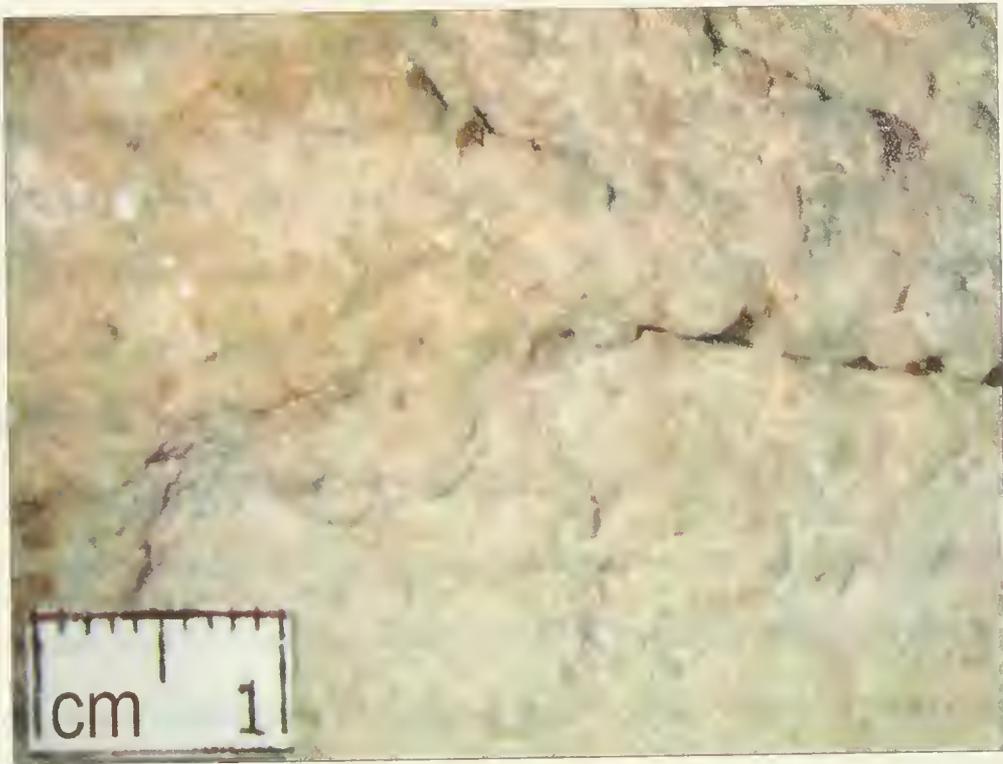
**Figure 4.9: Sample 1, a typical weathered Tuckahoe surface. Individual grains have been exposed and rounded. The original white color has turned to a yellowish brown.**

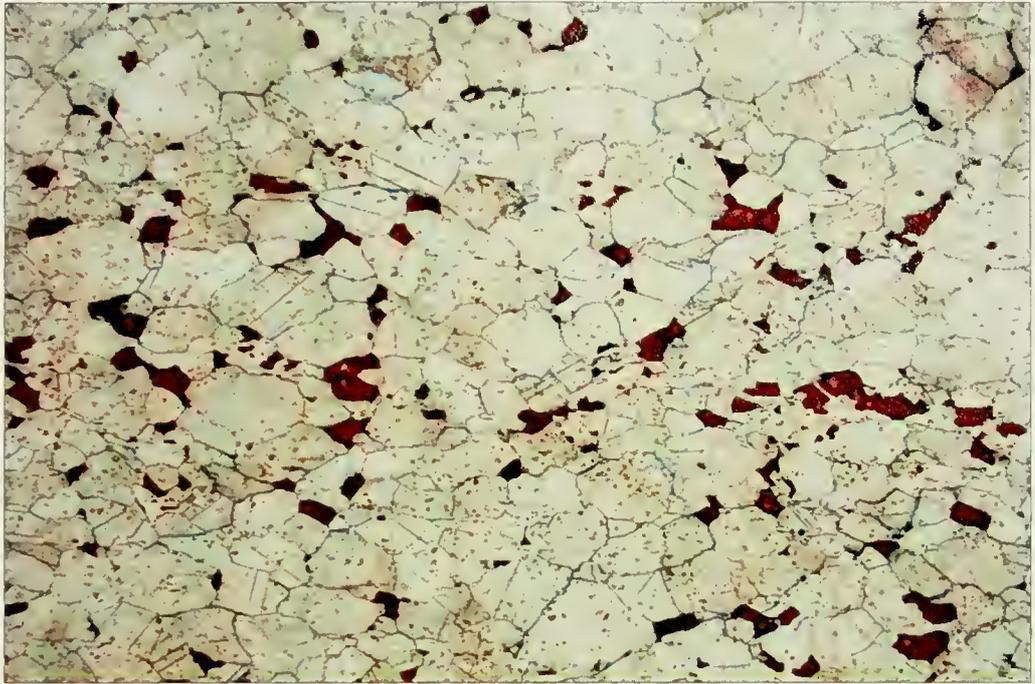
Figure 4.10: Thin section slide T-4 from the Eidlitz wing. Calcite is interspersed with dolomite. The grains are much finer and rounder, and fewer inclusions are seen in this sample than in the fresh sample. Grains are oriented more or less horizontally. Intergranular cracking is indicated by the vacuum impregnated blue dye. 1.25x magnification, plane polarized light.

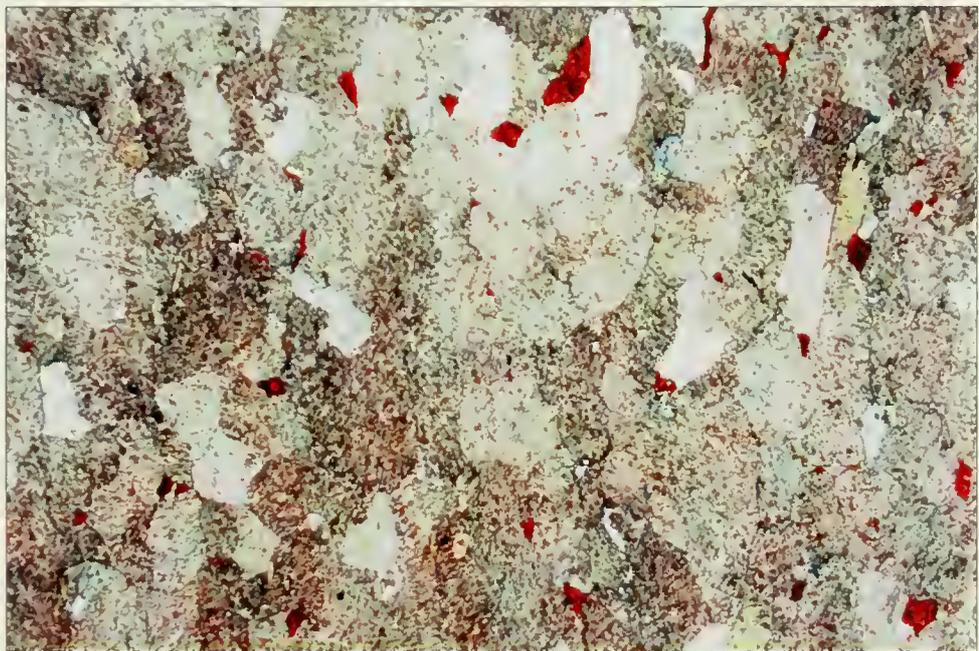
Figure 4.11: Thin section slide T-12B from the Eidlitz Wing. Again, calcite is interspersed with dolomite. Grains show a more or less vertical orientation relative to the photomicrograph. 1.25x magnification, cross-polarized light.
