A COMPARISON OF FRESH AND WEATHERED MARBLE  
FROM THE TWEED COURTHOUSE

A THESIS

Historic Preservation

2001

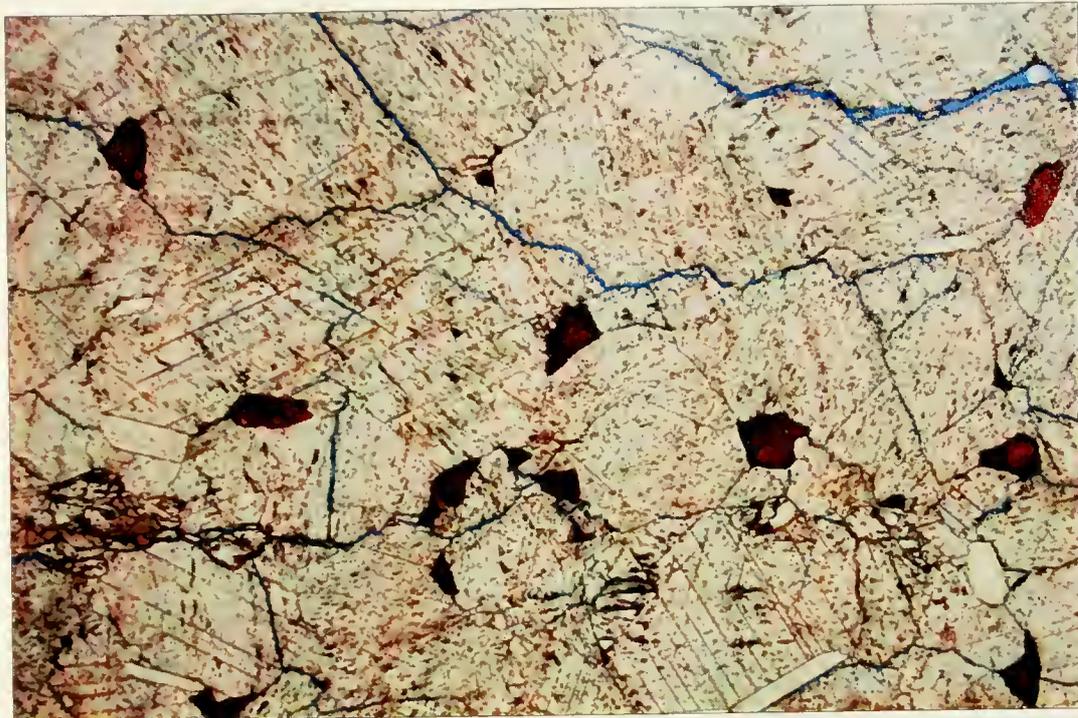
Figure 4.12: Thin section slide T-1B. Red-stained calcite is scattered throughout, and oblong phlogopite inclusions are visible in the lower right. Cracking, seen in blue, seems to emanate from and connect the calcite grains. 5x magnification, plane-polarized light.

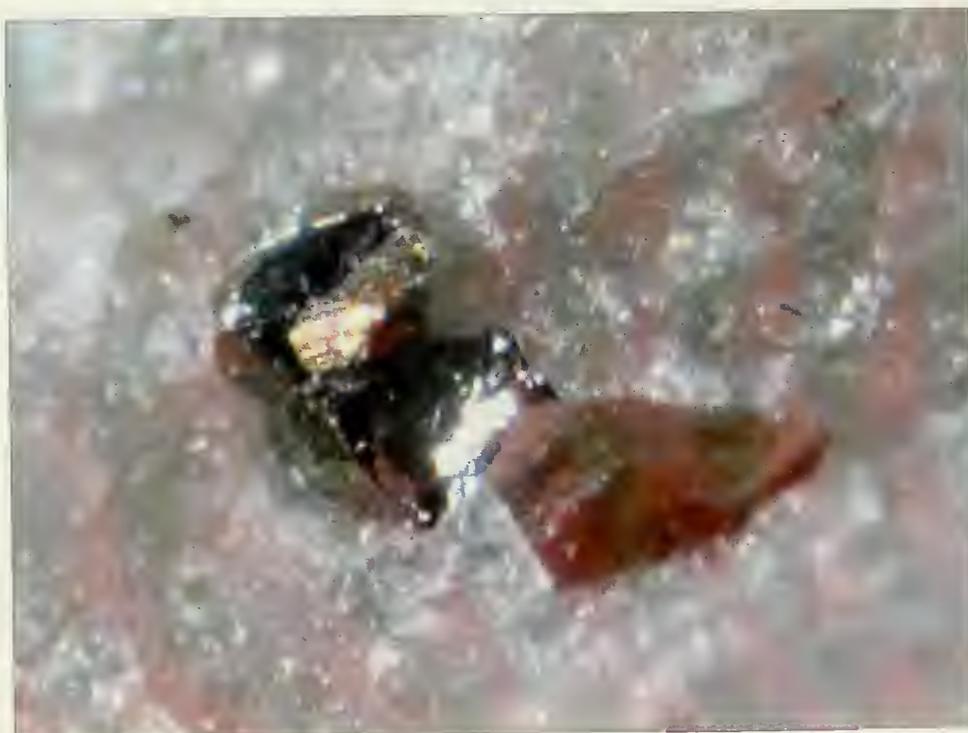
Figure 4.13: Pyrite (left) and phlogopite (right) in a fractured surface of sample 1 seen under a stereomicroscope. 38x magnification, fiber-optic illumination.

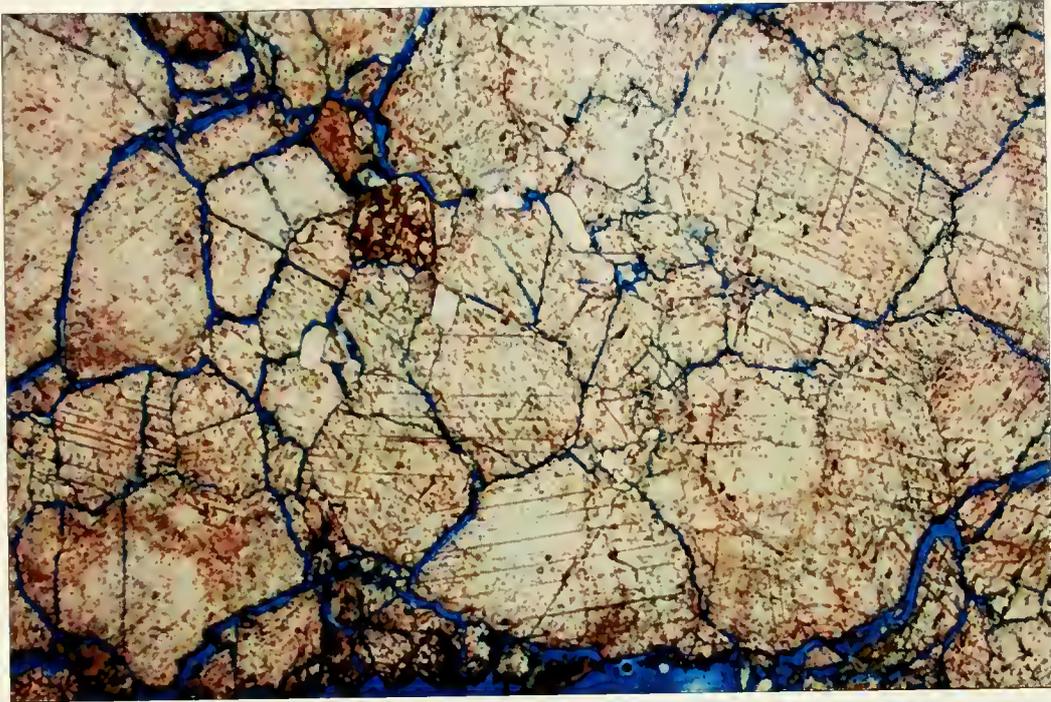
Figure 4.14: Slide T-1A, a typical weathered specimen with extensive microcracking. Crack networks are highlighted by vacuum-impregnated blue dye. Oblong phlogopite inclusions are visible at the center of the image. The exposed weathered surface is at the bottom of the picture. Photomicrograph is 1 cm wide, slide is unstained for calcite. 1.25x magnification, plane-polarized light.

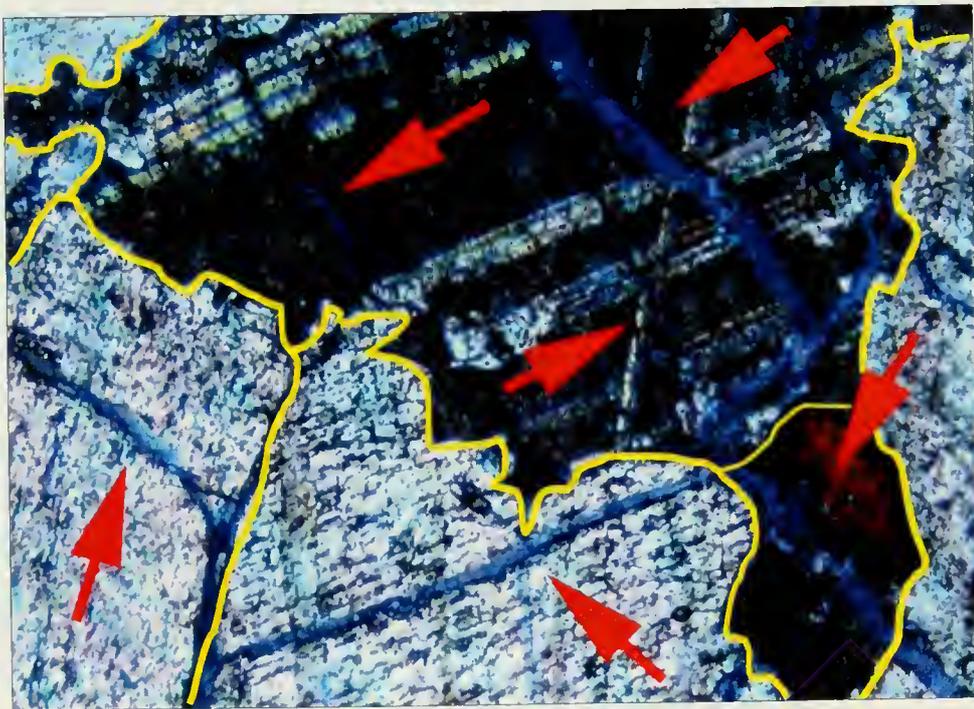
Figure 4.15: Intragranular cracking below a weathered surface in thin section slide T-1B, taken from an abacus on the North Portico. The original grain boundary is shown in yellow, cracks are indicated by the presence of blue dye, and intragranular cracks are indicated by red arrows. 50x magnification, cross-polarized light.

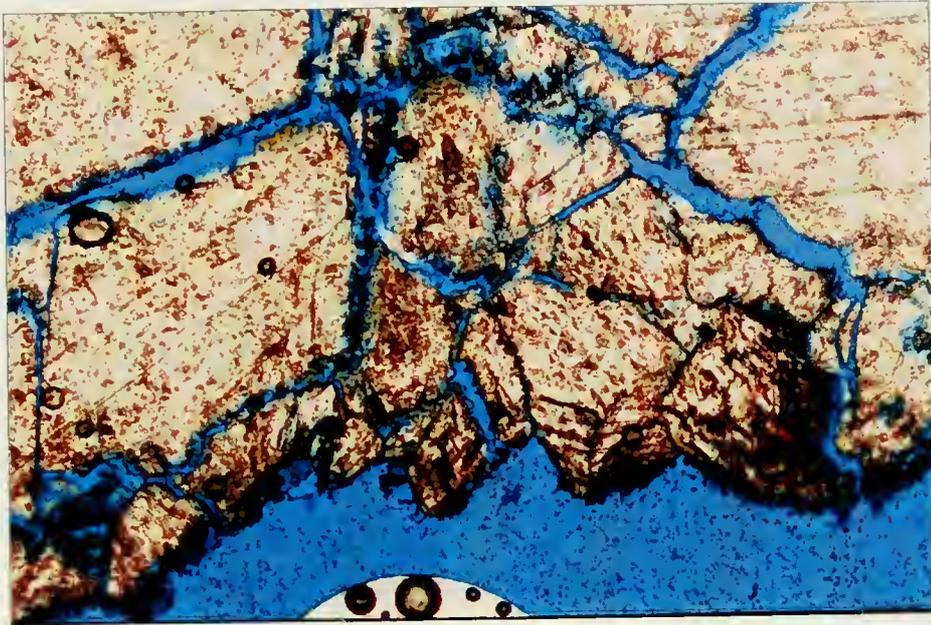
Figure 4.16: Heavy etching, cracking, and iron staining of surface grains, slide T-1B. The weathered surface is bordered by the blue dye matrix. 5x magnification, plane polarized light.

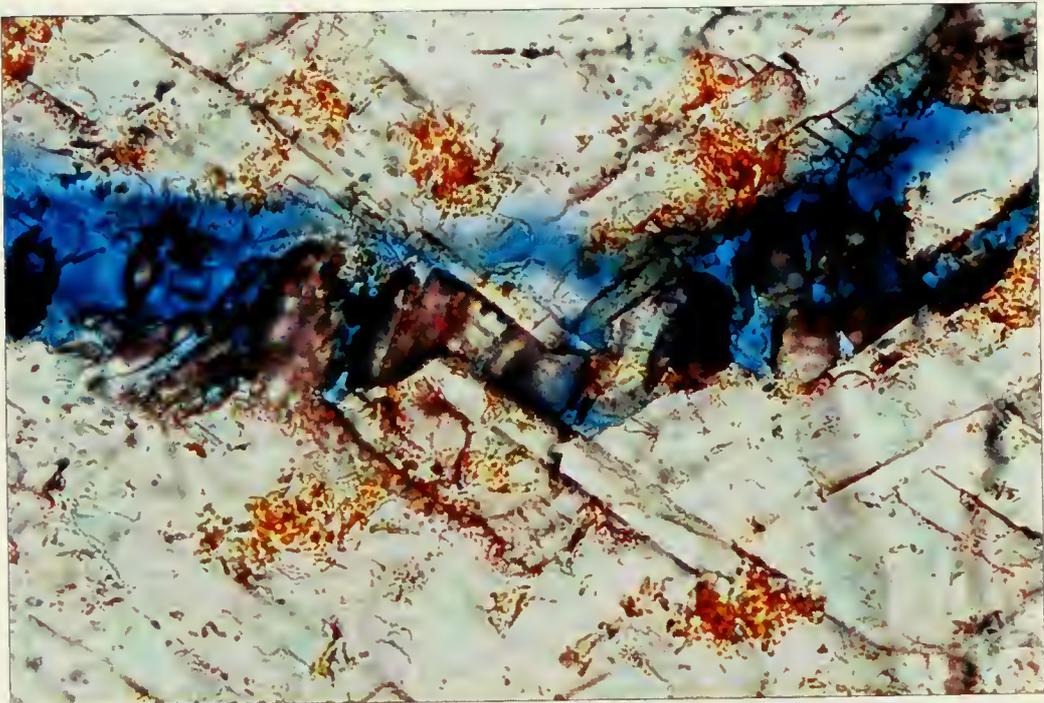
Figure 4.19: Gypsum recrystallization within microcracks, slide T-1B. Due to its relative higher solubility, it has penetrated the stone and recrystallized, creating additional pressure in the openings. Iron spots are also visible. The rhombohedral structure of the dolomite grains is seen in the translucent cross-hatching patterns. 40x magnification, plane-polarized light.

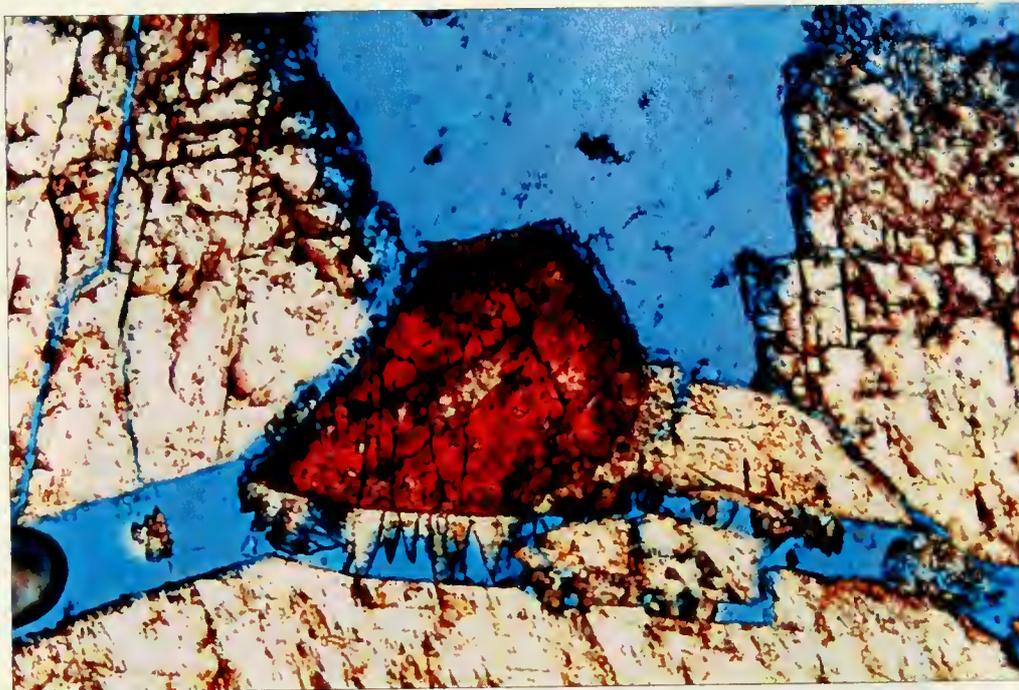
Figure 4.20: A surface grain of calcite wedged between two surface grains of dolomite, slide T-1B. The etching of dolomite beneath the calcite grain has created a saw-toothed pattern. Recrystallized salts are also seen. Thermal dilatation is the most probable cause of the microcracking surrounding the calcite grains. The space above the calcite grain may have held an ejected dolomite grain. 20x magnification, plane-polarized light.

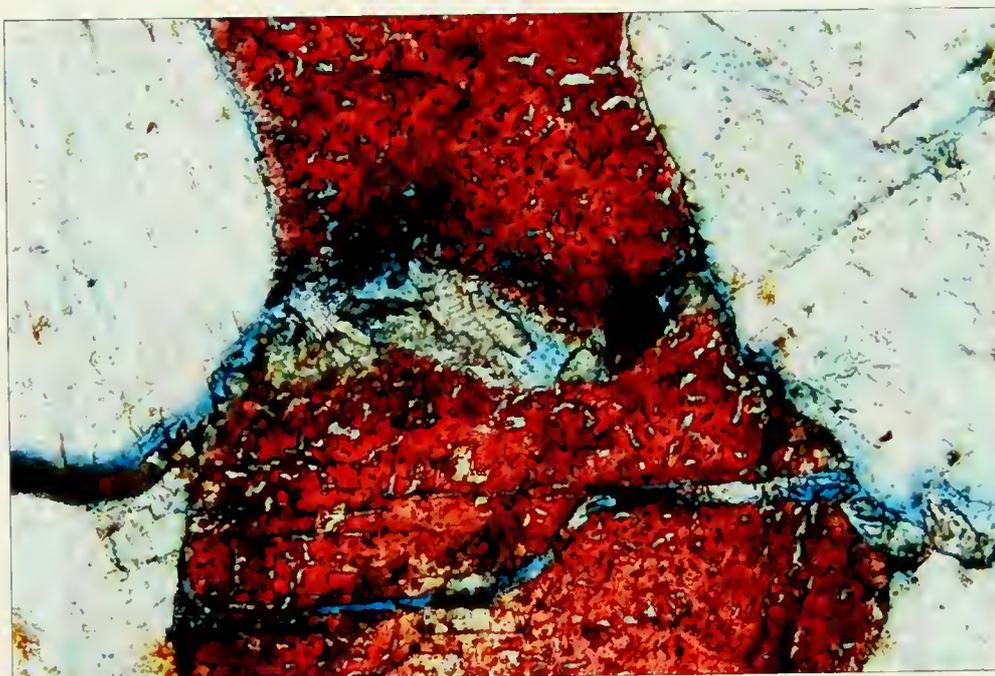
Figure 4.21: Recrystallization of calcite or salts in microcracks, slide T-1B. A red stained calcite grain is seen in the center of the photo surrounded on either side by white dolomite grains. Gypsum appears in a dolomite crack to the bottom right. 40x magnification, plane-polarized light.

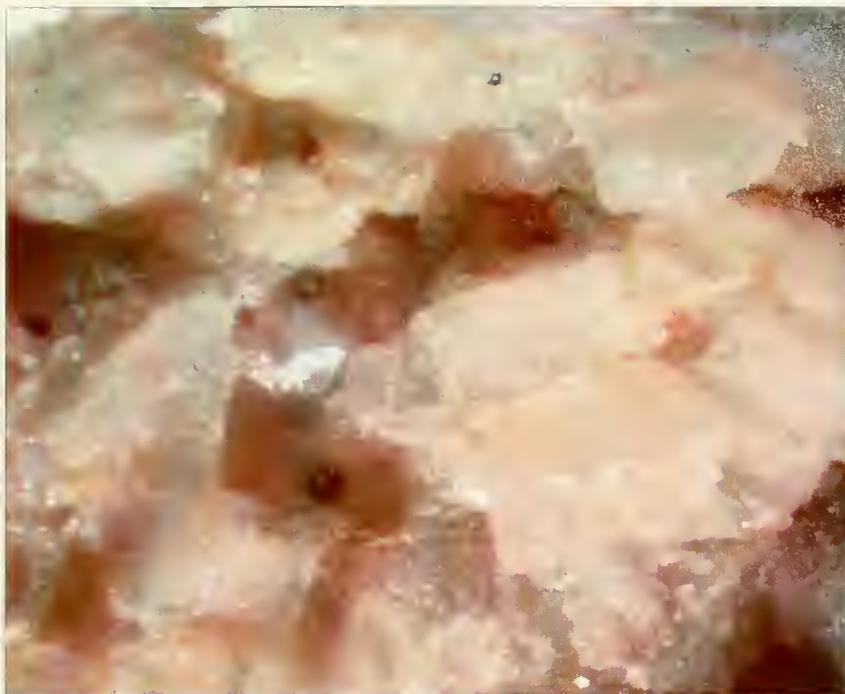
**Figure 4.22:** A fractured surface of sample 1. Intergranular cracking is more common in the weathered sample than in the fresh sample. Brown flecks of phlogopite are visible in the cracks. 7.5x magnification, fiber-optic illumination.

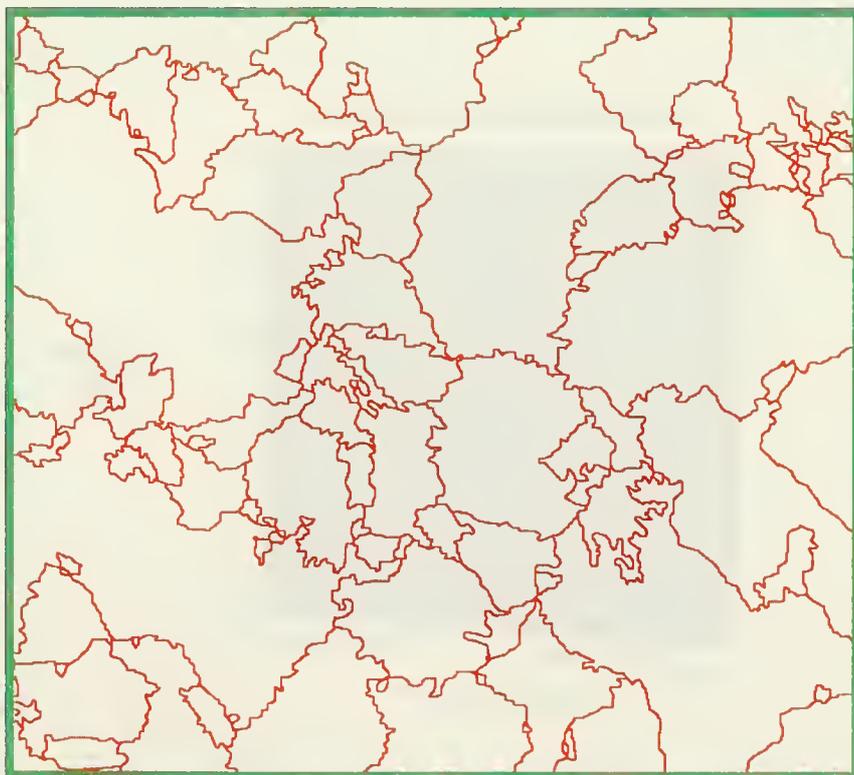
**Figure 4.23:** Digitized grain boundary image of 1 square cm of Tuckahoe slide T-1B.

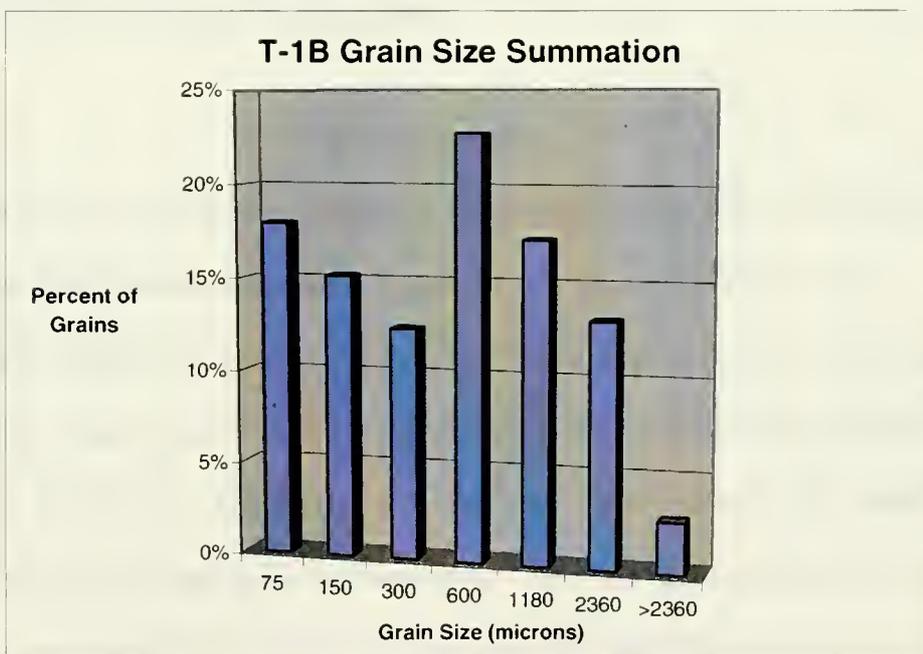
Table 4.2: Summary of Bioquant® data and related measurements for slide T-1B.

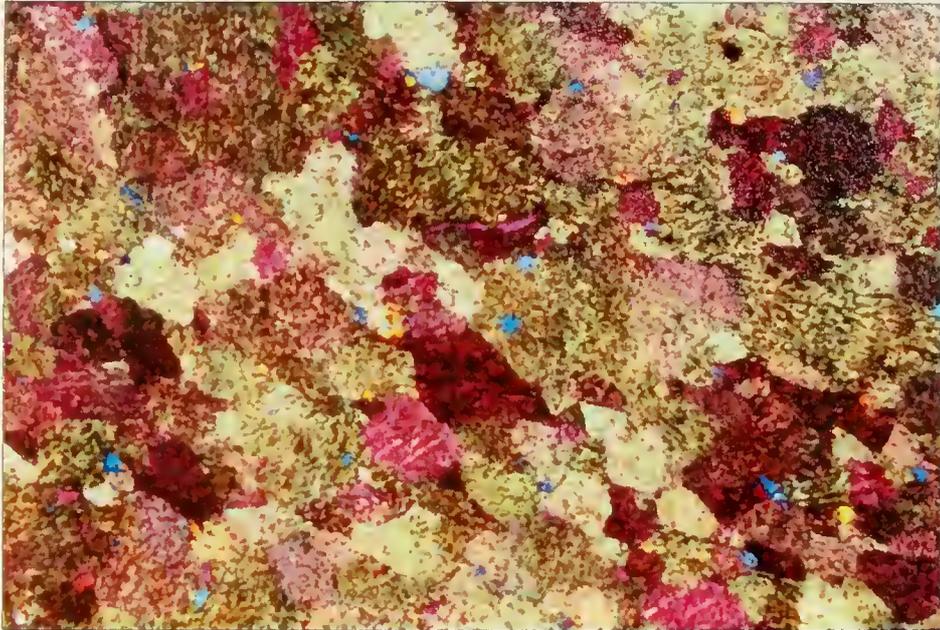
**Figure 4.25:** Typical view of fresh Sheffield grains from slide S-38 in cross-polarized light. Calcite is seen throughout, and silica is seen distributed regularly in blue and orange. 1.25x magnification, unstained for calcite.

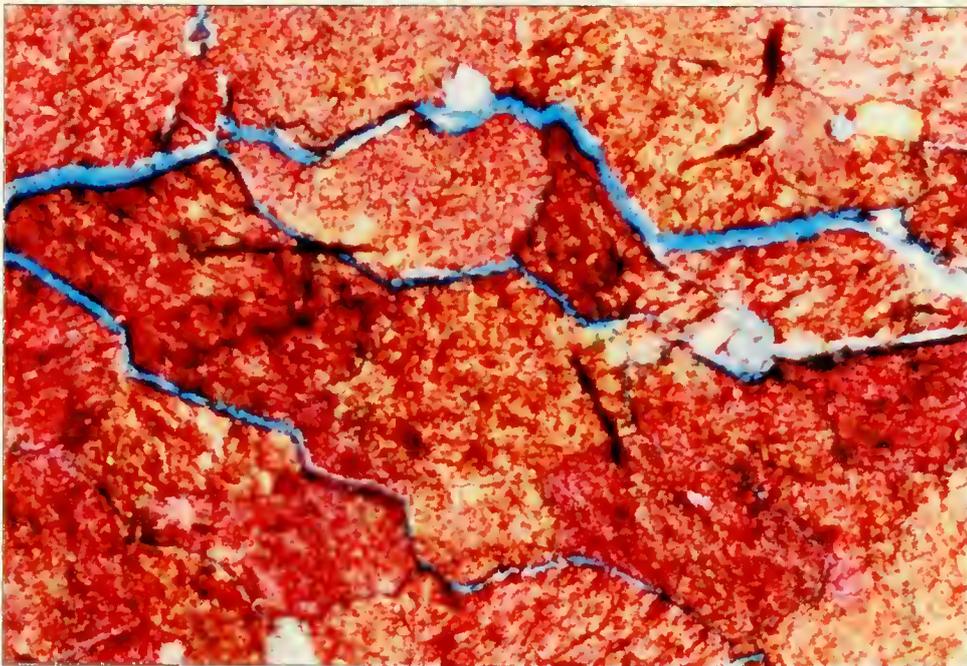
**Figure 4.26:** Intragranular cracking seen on fresh slide S-38. Cracking appears to propagate parallel to the bedding plane in this case. 5x magnification, plane-polarized light, stained for calcite.

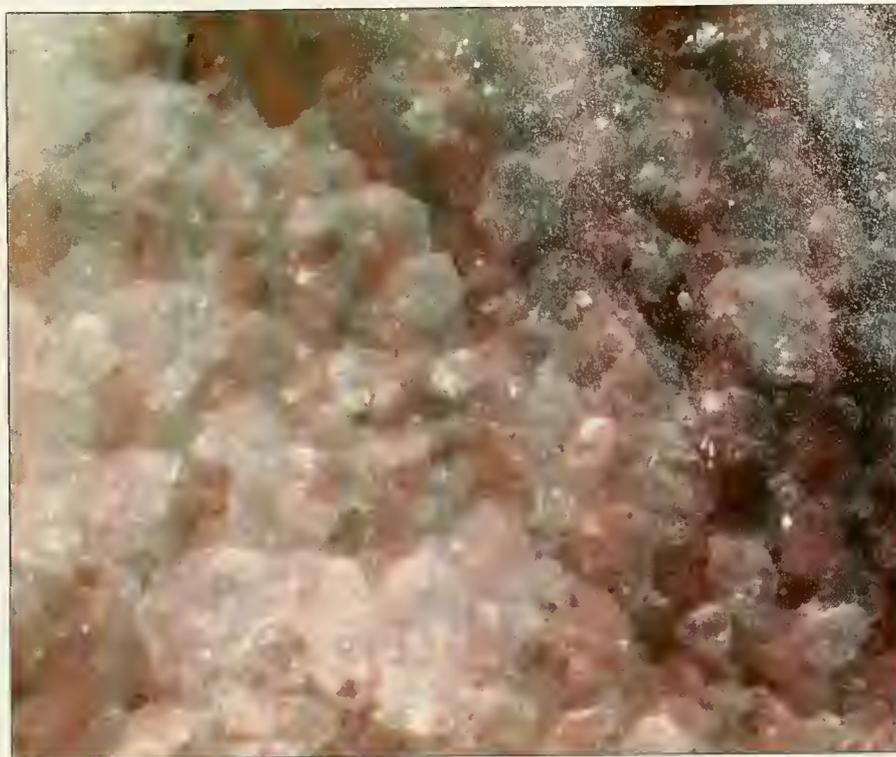
Figure 4.27: A typical fresh fractured Sheffield surface from sample 38. 7.5x magnification, fiber optic illumination.

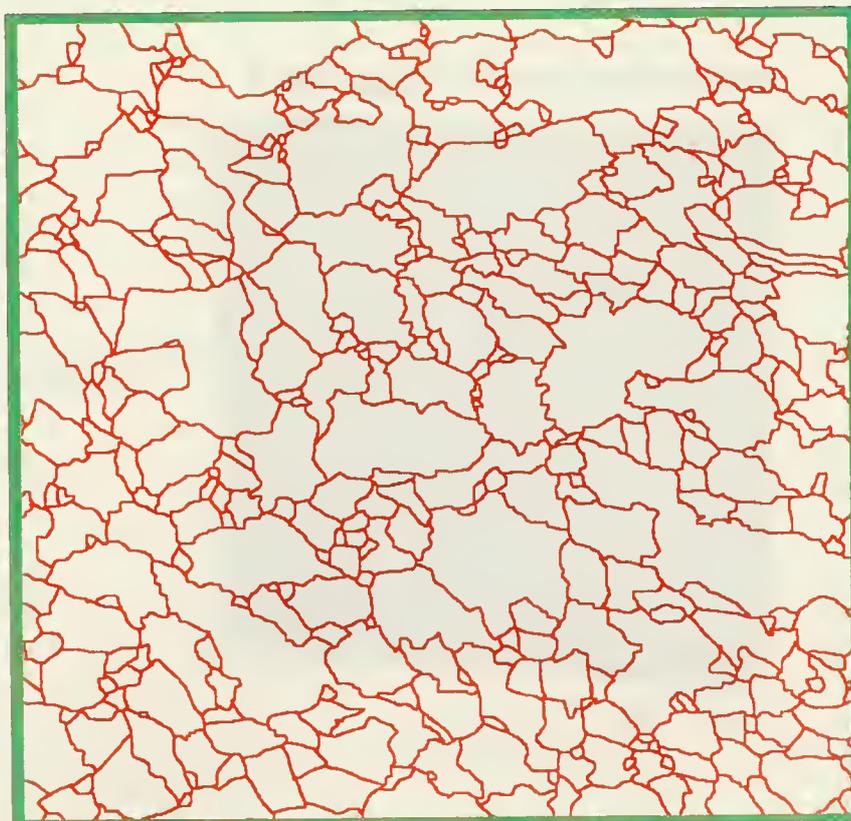
Figure 4.28: Digitized grain boundary image of 1 square cm of slide S-38.

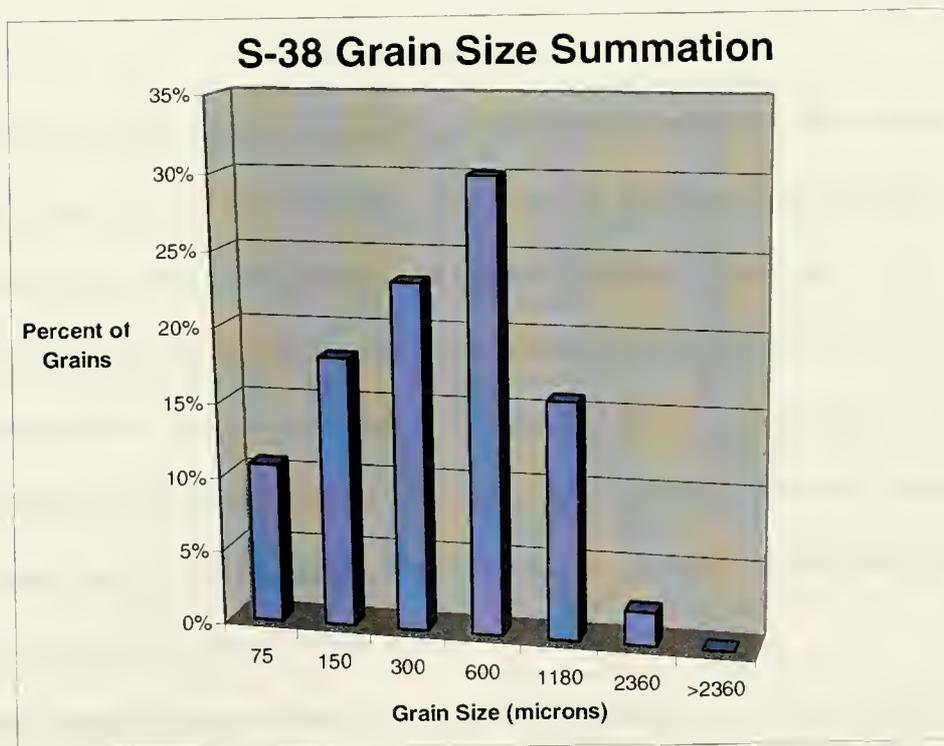
Table 4.3: Summary of Bioquant<sup>®</sup> data and related measurements for slide S-38.

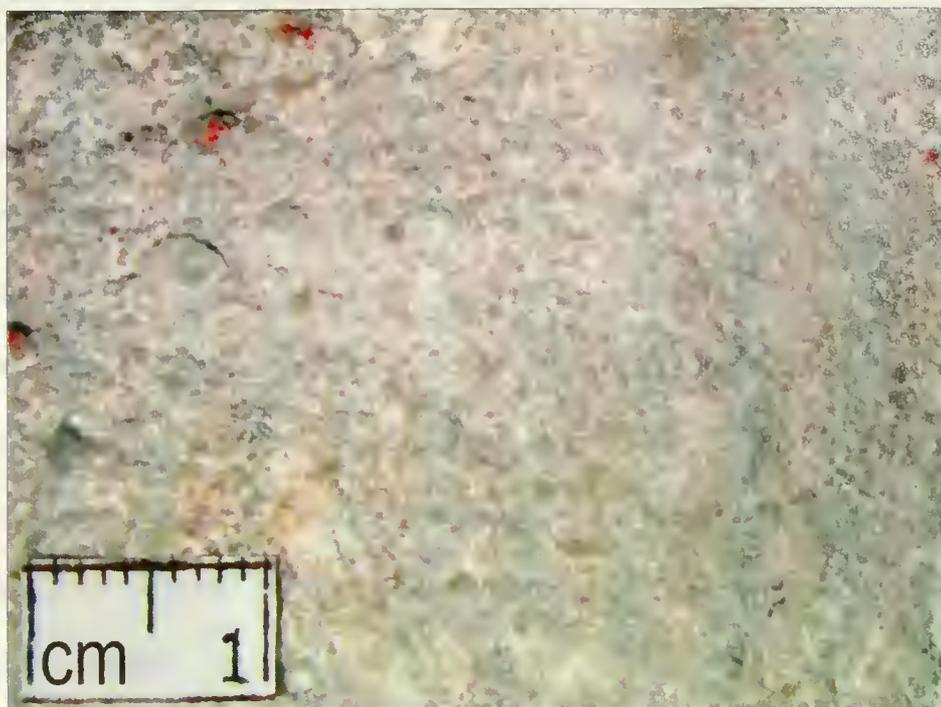
**Figure 4.29:** A typical weathered Sheffield surface from sample 37. Exposed surface grains have been rounded. The original white color has changed to a darker color than the weathered Tuckahoe.

Thin section slides for the weathered Sheffield marble were made from samples found on the Kellum section of the building. They were all medium to fine-grained, yellow to brownish in color, and demonstrated extreme friability. To a depth of up to several centimeters, individual grains could be scraped from the surface like sand. S-36 and S-37 are taken from window surrounds at the west end of the south elevation. They closely resembled the quarried sample, S-15. S-15 is also considered because it presents different weathering phenomena, namely biological decay. A typical weathered surface rounded exposed grains is seen in Figure 4.29.

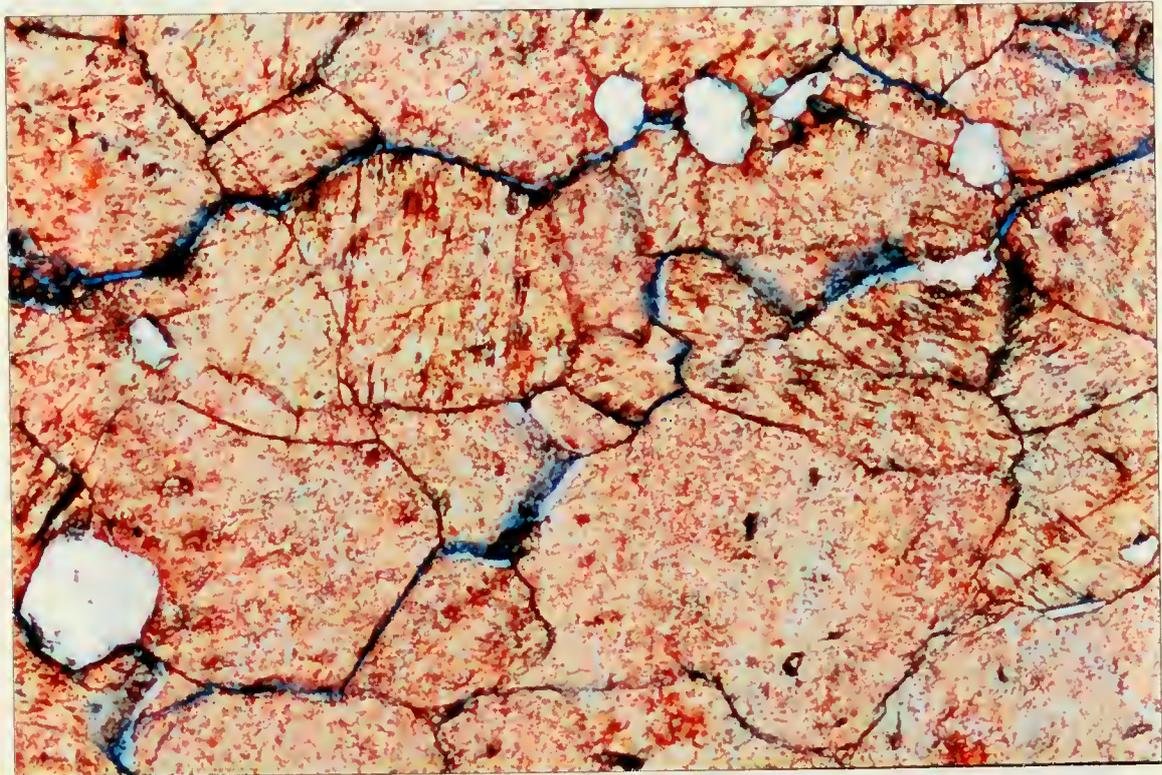
**Figure 4.30:** Calcite with occasional silica (white) along the grain boundaries on slide S-15. Note red staining for calcite. 5x magnification, plane-polarized light, stained for calcite.

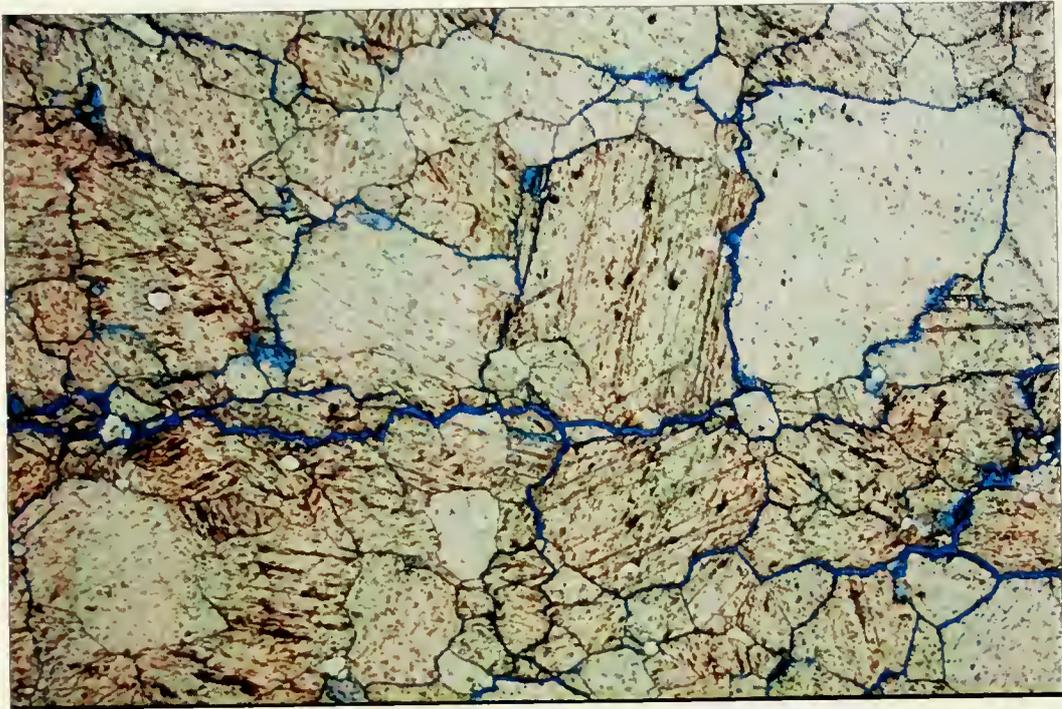
Figure 4.31: Even in the quarry sample S-15, intense microcracking was seen. Notice the jumbled of grain sizes and the lack of preferred orientation. Cracks are indicated by the vacuum-impregnated blue dye. 5x magnification, plane-polarized light.

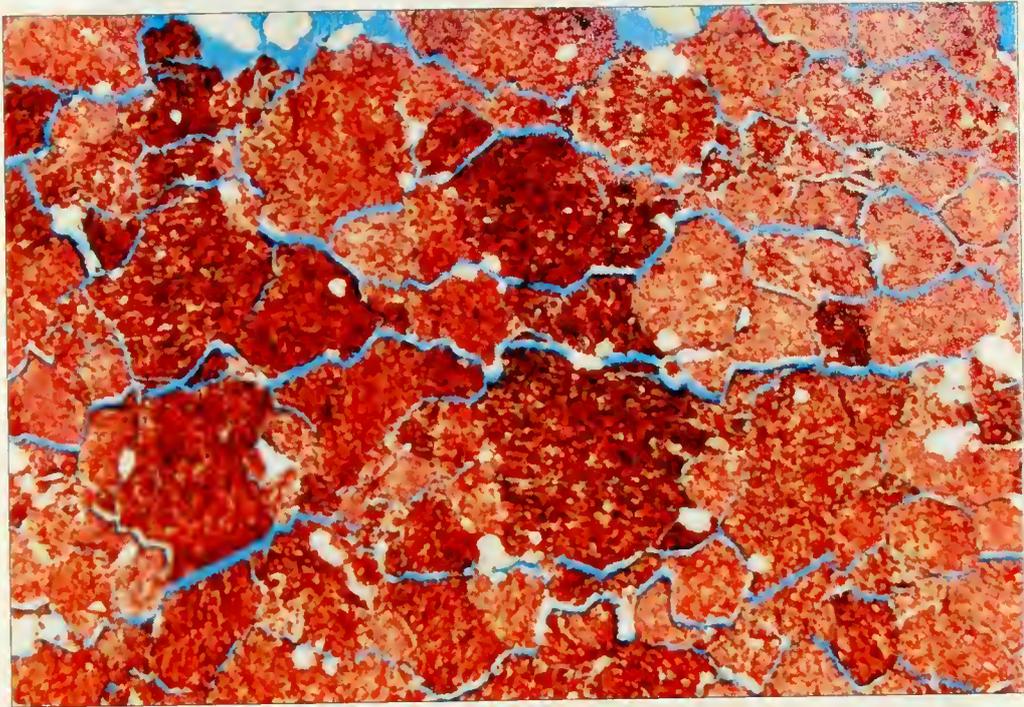
Figure 4.33: Extreme surface friability on slide S-37. The surface is bordered by blue above. Note the predominance of intergranular cracking and siliceous inclusions. 5x magnification, plane-polarized light, stained for calcite.

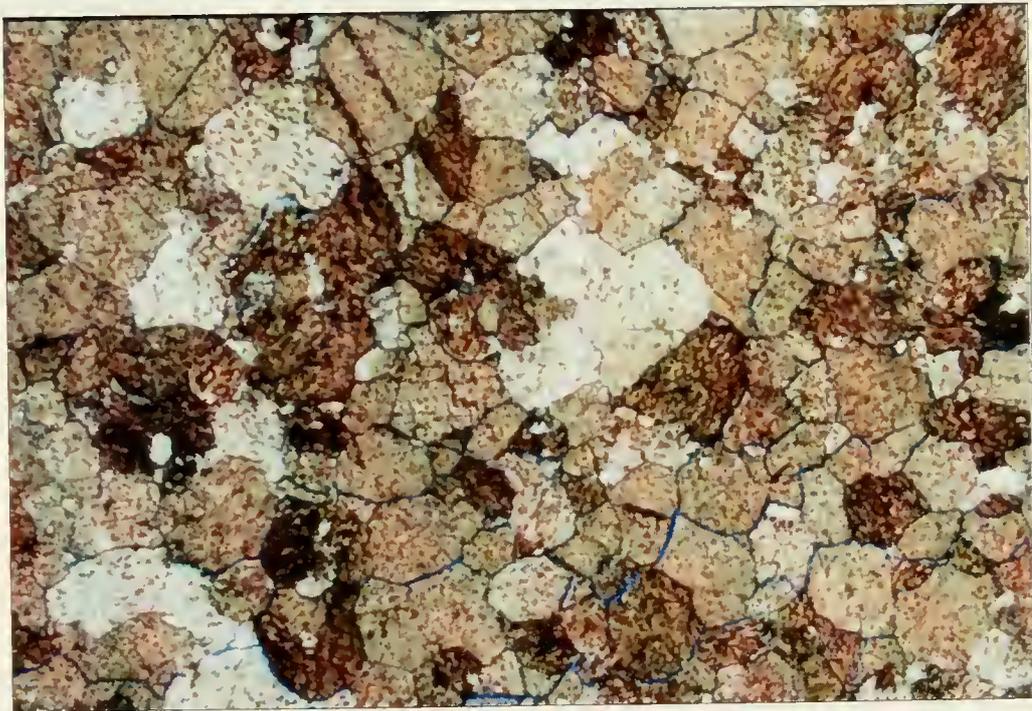
Figure 4.34: More extensive intergranular cracking in slide S-37. 1.25x magnification, cross-polarized light, unstained for calcite.

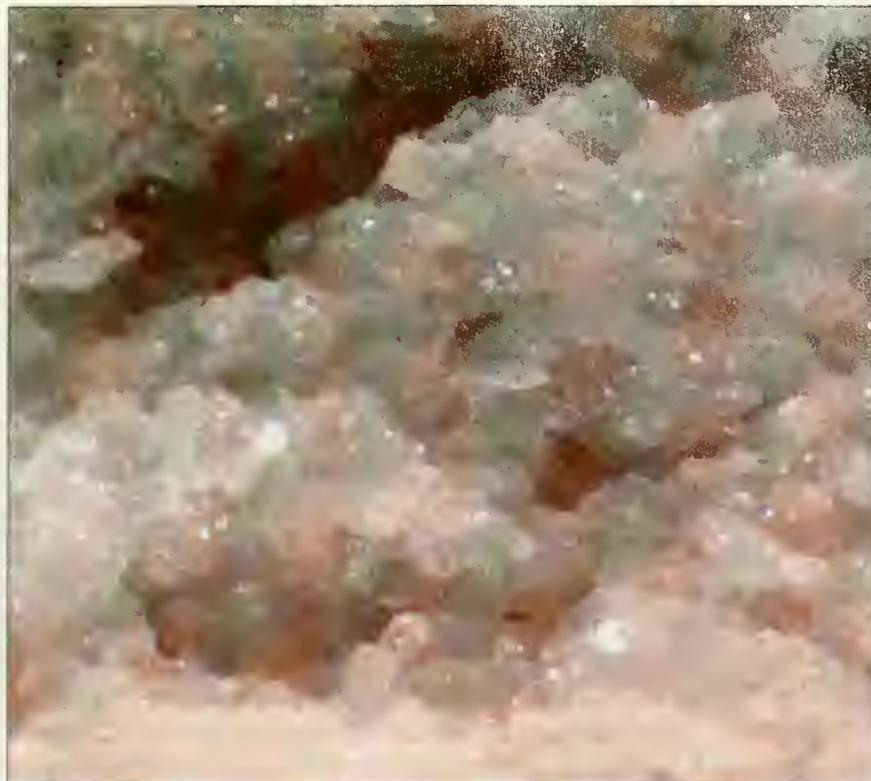
Figure 4.35: A typical fractured, weathered Sheffield surface from sample 37. 7.5x magnification, fiber optic illumination.

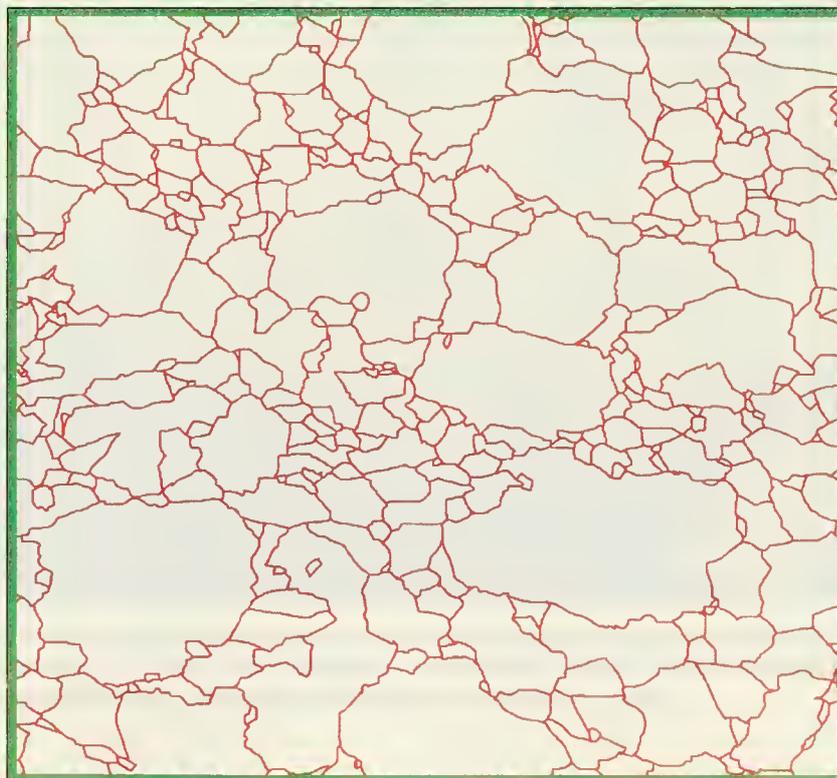
Figure 4.36: Digitized grain boundary image of 1 square cm of slide S-15.

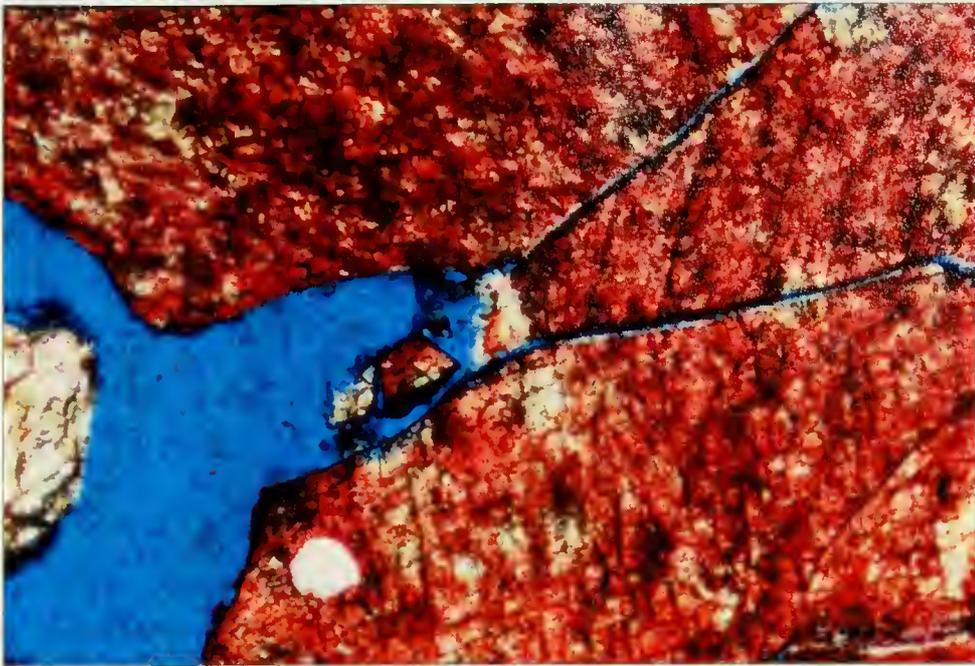
Figure 4.37: A surface grain detaching from the substrate on slide S-36. Thermally-induced deformation causes surface grains to fall off, opening microcracks that facilitate moisture penetration. 10x magnification, plane polarized light, stained for calcite.

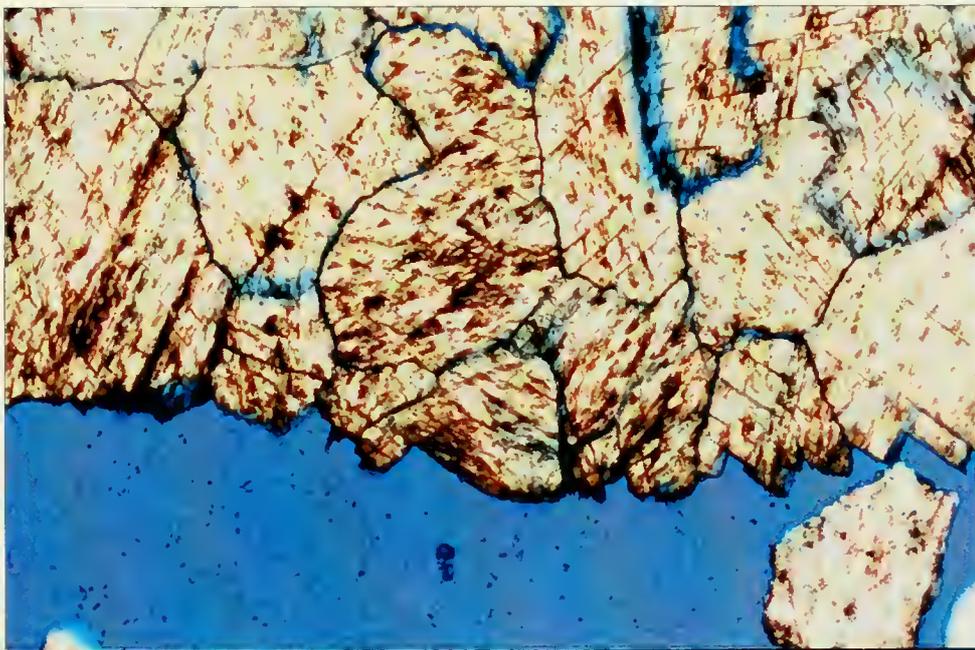
Figure 4.38: Etched surface grains oriented at various angles to one another on slide S-15. The random orientation of grains may contribute to thermally-induced surface damage in Sheffield marble. 5x magnification, plane-polarized light, unstained for calcite.

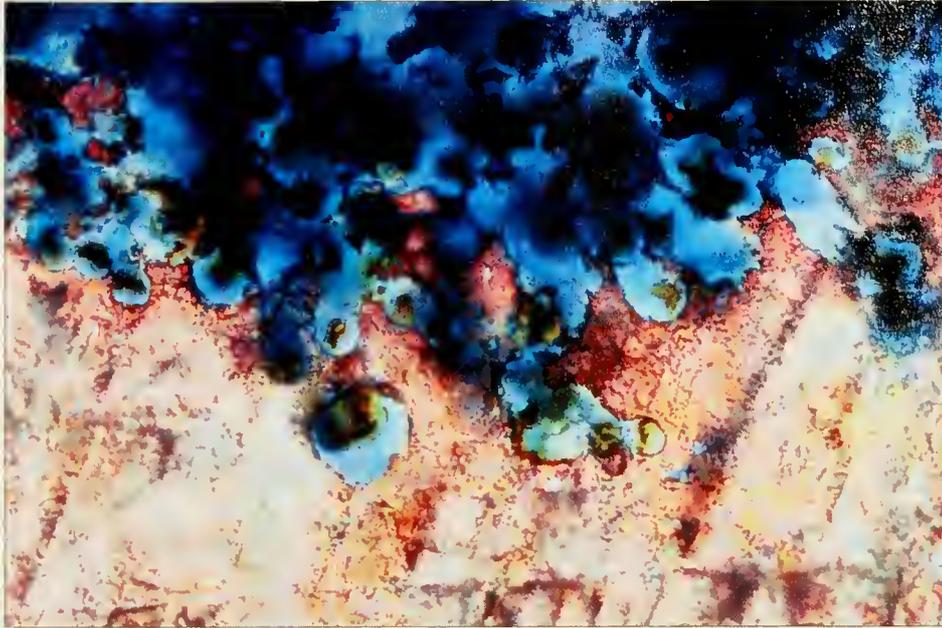
**Figure 4.39:** Biological growth on the surface of the quarry sample, slide S-15. Fungi have digested the first 2 mm of the surface, creating a porous substrate. 20x magnification, plane-polarized light, stained for calcite.

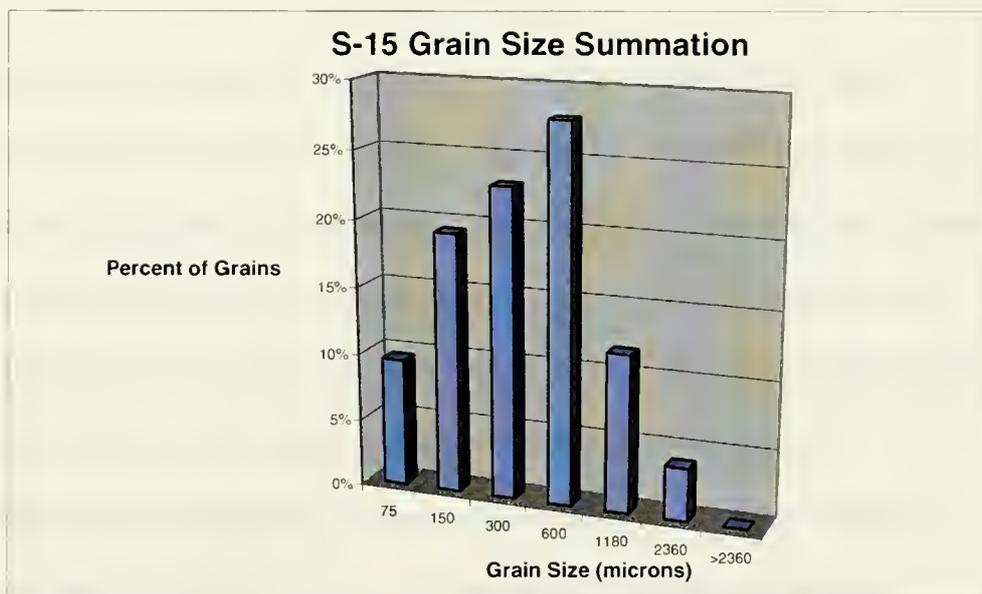
Table 4.4: Summary of Bioquant<sup>®</sup> data and related measurements for slide S-15.

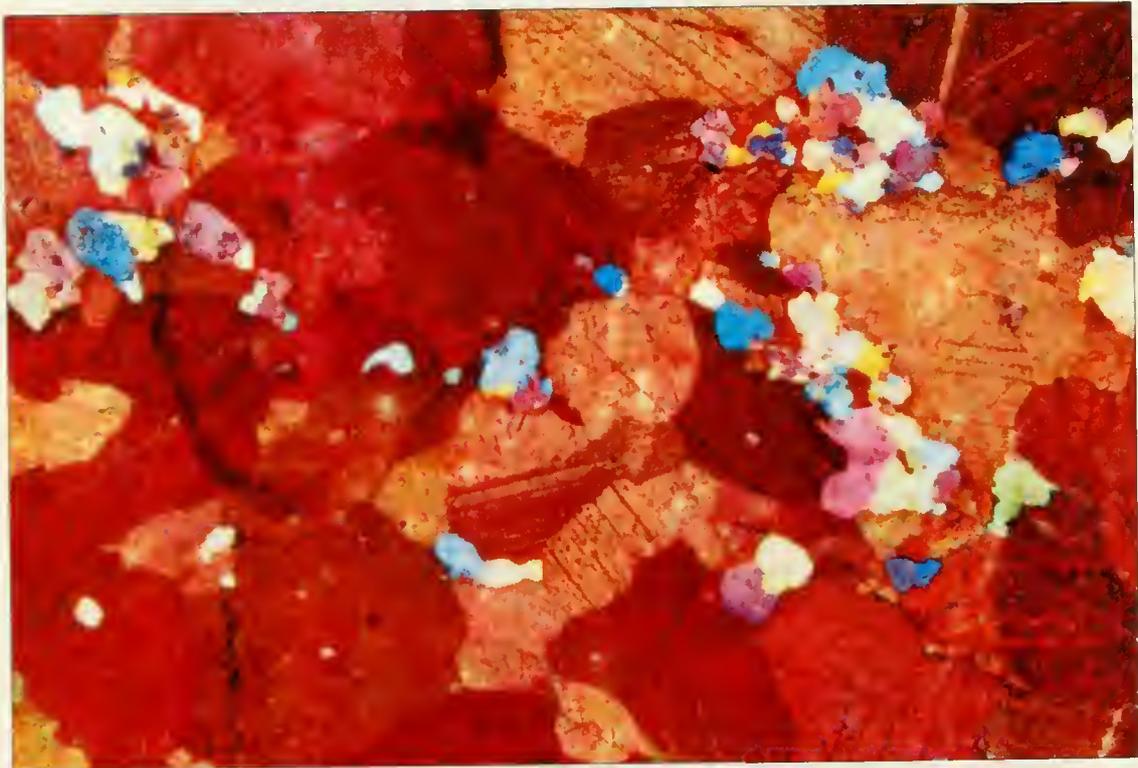
**Figure 4.41:** Crystalline calcite grains (red and orange) and silica inclusions (blue, purple, white, yellow). The silica occurs occasionally in the Cherokee marble. An unusually dense concentration is seen here. The silica forms both along the grain boundaries and within the calcite grains. 1.25x magnification, cross-polarized light, stained for calcite.

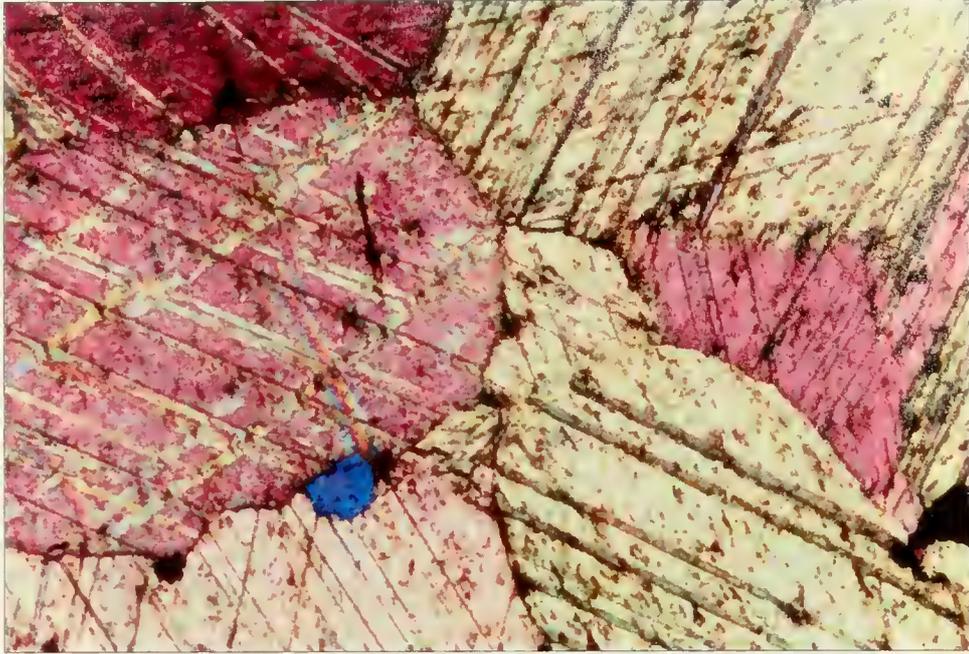
**Figure 4.42:** Highly crystalline calcite grains in slide G-26. Note highly angular, fused grain boundaries. A siliceous inclusion, seen in blue occurs along the grain boundary towards the bottom of the photomicrograph. Twinning of calcite is also seen. 50x magnification, cross-polarized light, unstained for calcite.

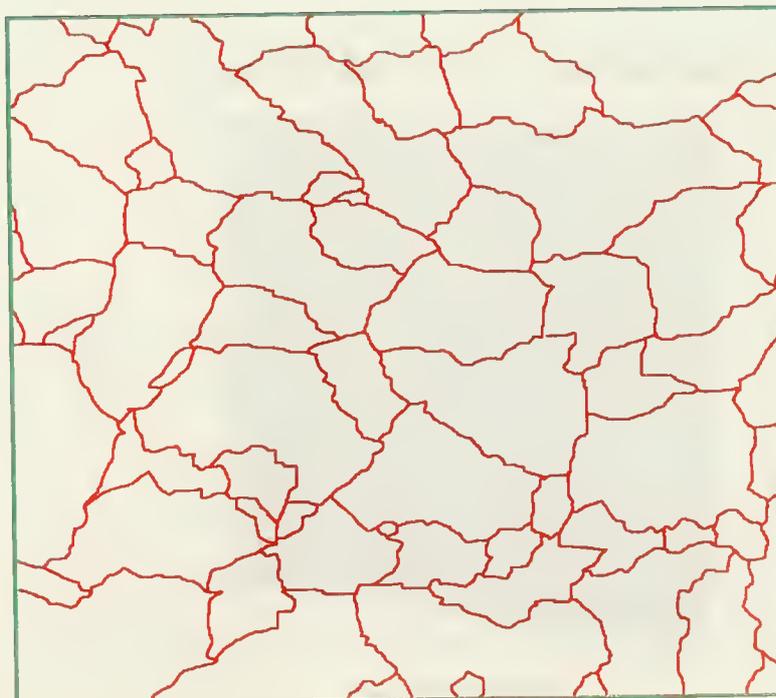
Figure 4.45: Digitized grain boundary image of 1 square cm of slide G-29.

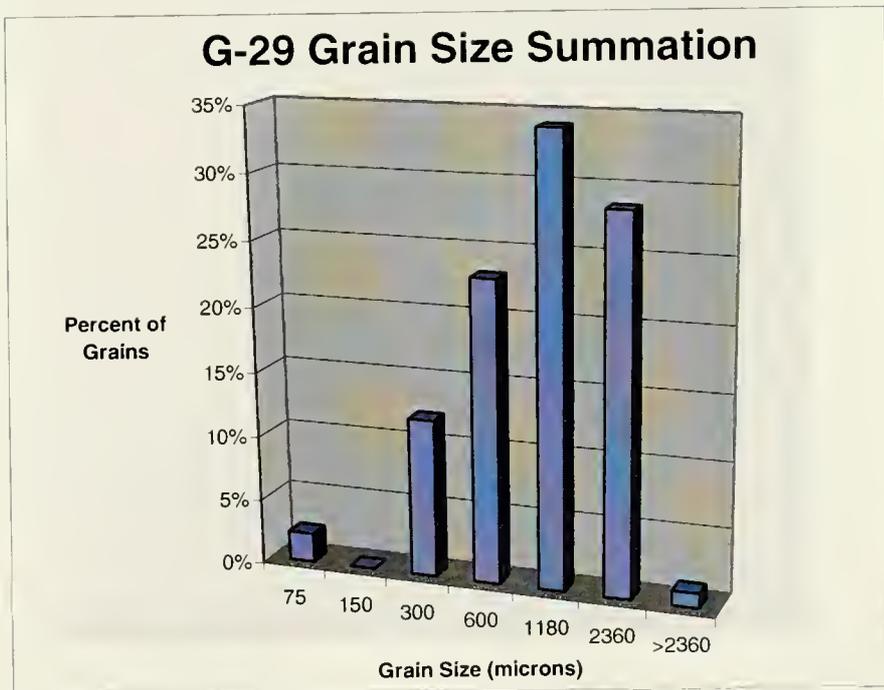
Table 4.5: Summary of Bioquant<sup>®</sup> data and related measurements for slide G-29.
