A COMPARISON OF FRESH AND WEATHERED MARBLE  
FROM THE TWEED COURTHOUSE

A THESIS

Historic Preservation

2001

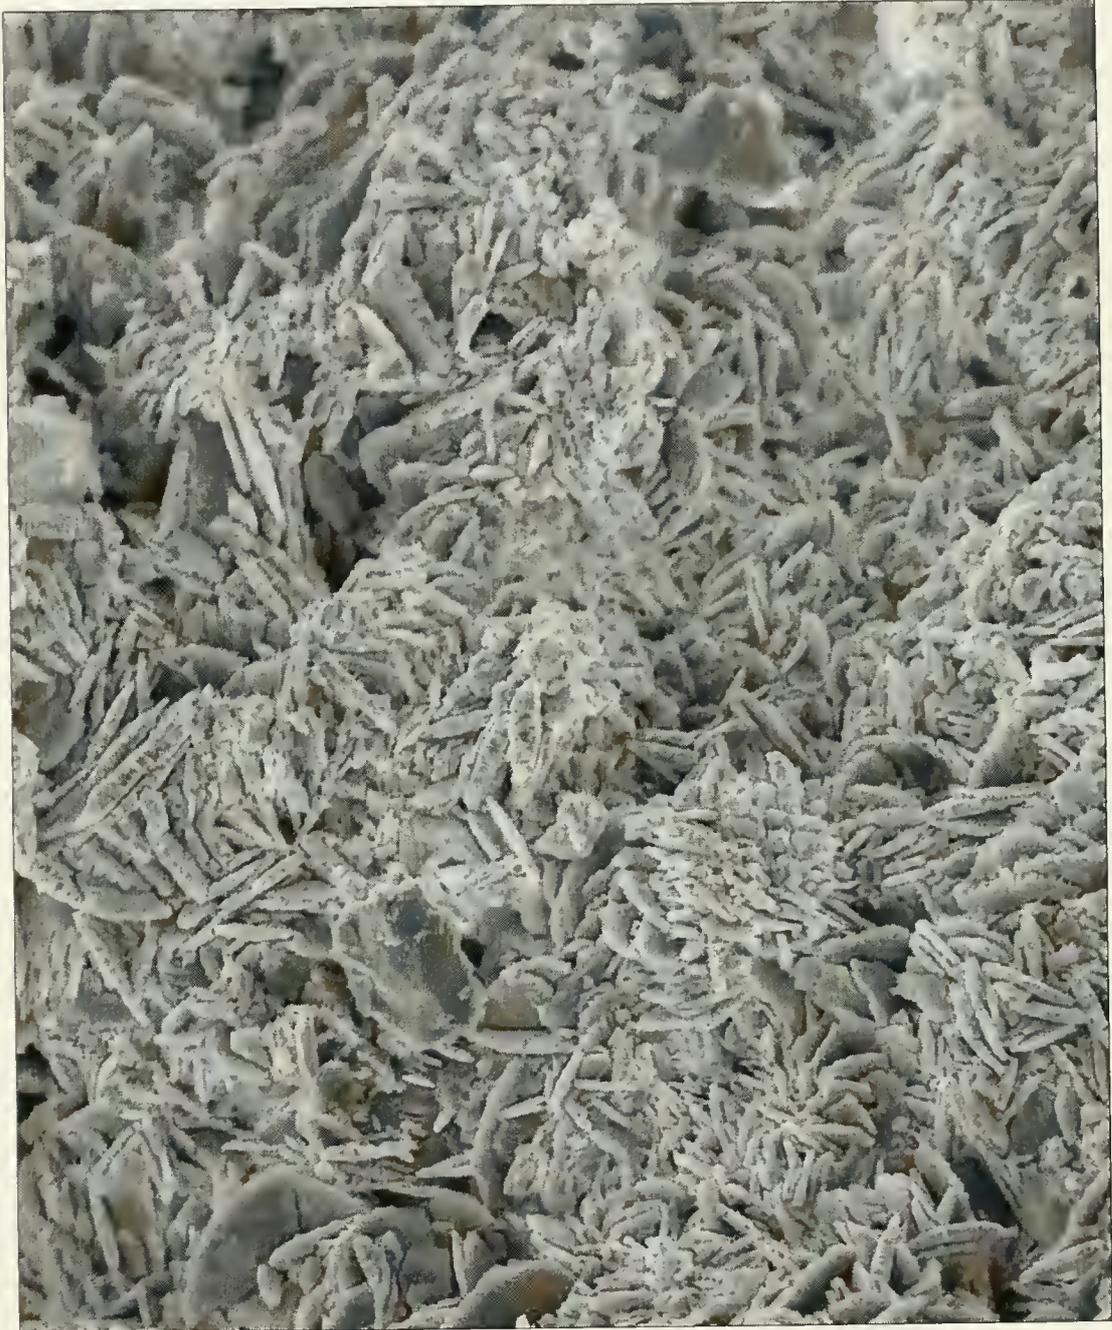
Figure 4.48: Gypsum encrusted surface of sample 1. 100x magnification, JEOL 6400 Analytical SEM.

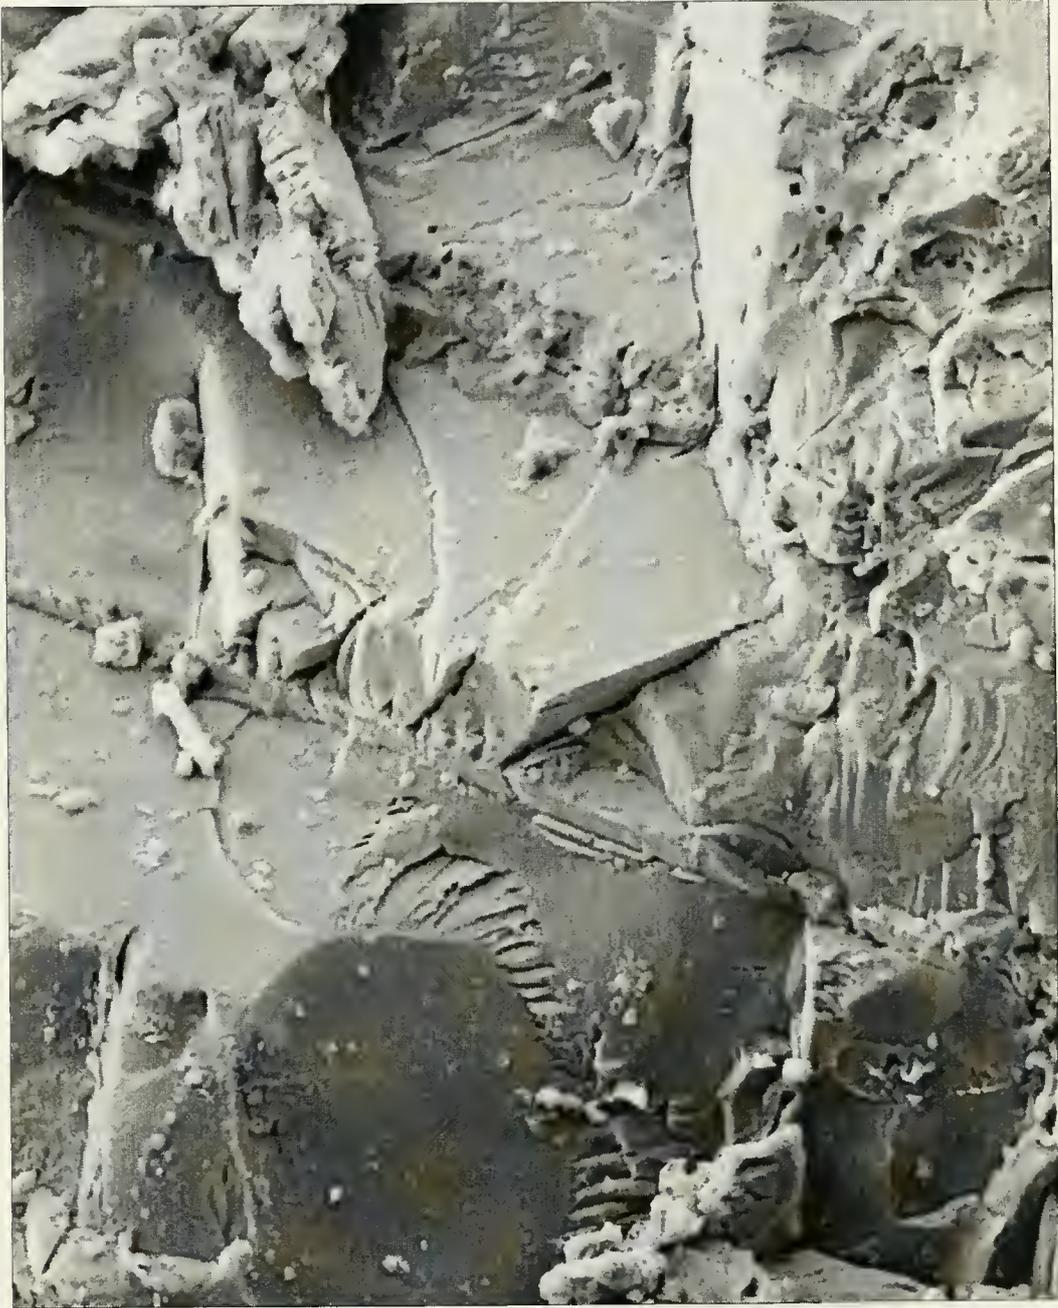
**Figure 4.49:** A fresh fractured Tuckahoe surface from sample 1. Jagged intragranular cleavage is seen to the right and top of the image and straight intergranular cleavage is seen in the center. 100x magnification, JEOL 6400 Analytical SEM.

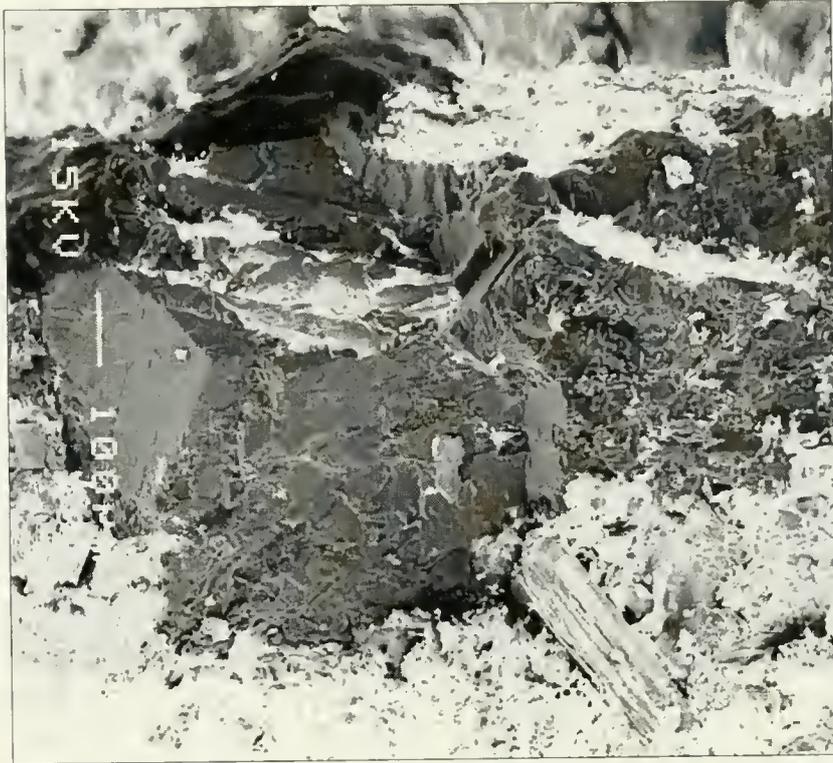
Figure 4.50: Sample 1 surface with a distinct dolomite grain, center, adjoining a micaceous phlogopite inclusion, right. 50x magnification, JEOL 6400 Analytical SEM.

A typical Tuckahoe inclusion is seen in Figure 4.50. A large dolomite crystal is surrounded by partial intragranular cleavage. The crystal is bordered on the bottom right by a micaceous phlogopite inclusion.

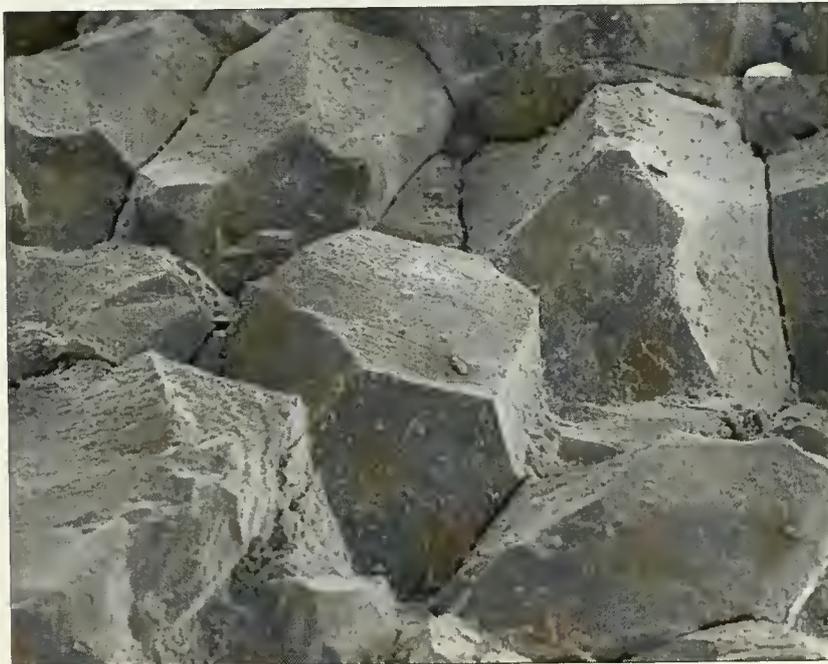
Figure 4.51: Distinct calcite crystals on a fractured Sheffield surface from sample 37. Fine cleavage planes can be seen between grains. 100x magnification, JEOL 6300FV Field Emission HRSEM.

The previous observations about the Sheffield marble were also supported by SEM analysis. A clear predominance of intergranular cleavage is seen on a fractured surface in Figure 4.51. Fine cleavage is seen between very distinct calcite crystals, and very little intragranular cleavage is visible in the same image. The fine cleavage planes create a strong capillary absorption capacity in the stone. On the weathered surface, both etching of calcite grains (Figure 4.52) and an accretion of fine pollution or sediment (Figure 4.53) were visible. EDS confirmed that the primary constituents of the grains were calcium and oxygen. Appendix 3 contains the EDS readings.

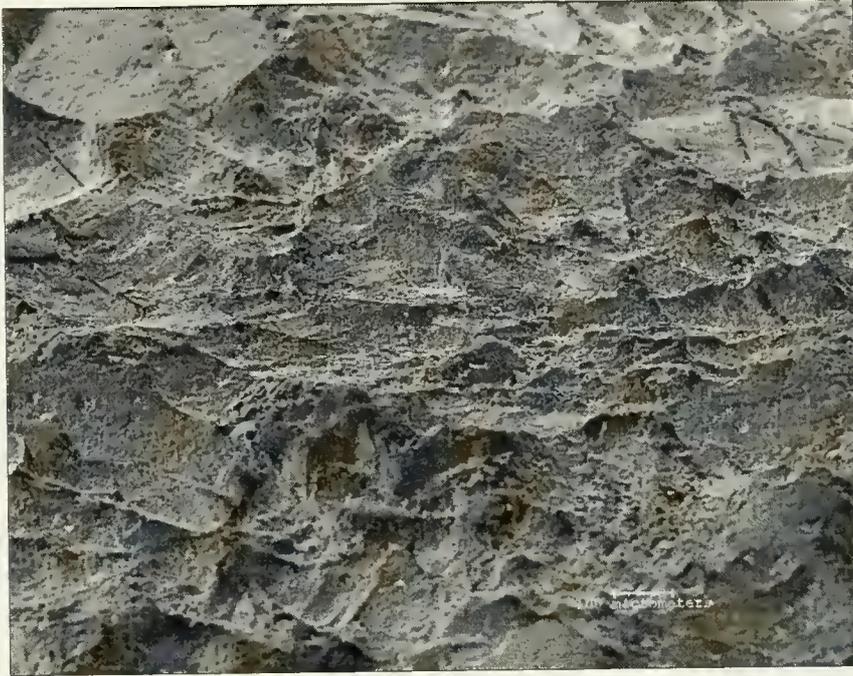
**Figure 4.52:** Etching of calcite grains on a weathered Sheffield surface from sample 36. Note the outline of an individual calcite crystal in the upper left hand of the image. 100x, JEOL 6300FV Field Emission HRSEM.

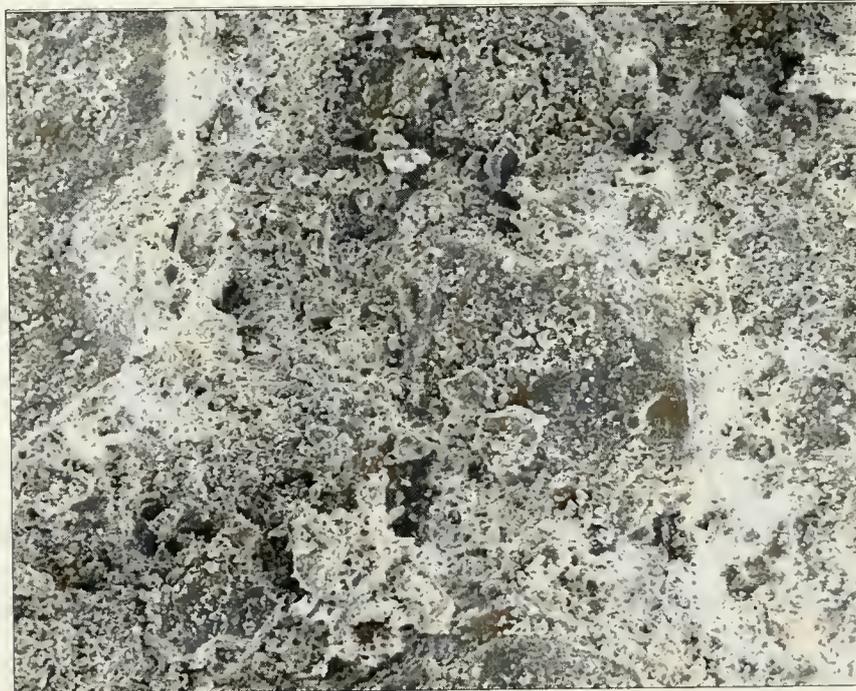
**Figure 4.53:** Accretion of pollutants or fine sediment on the weathered surface of sample 36. The vague outline of a coated individual crystal can be seen in the center of the image. 100x magnification, JEOL 6300FV Field Emission HRSEM.

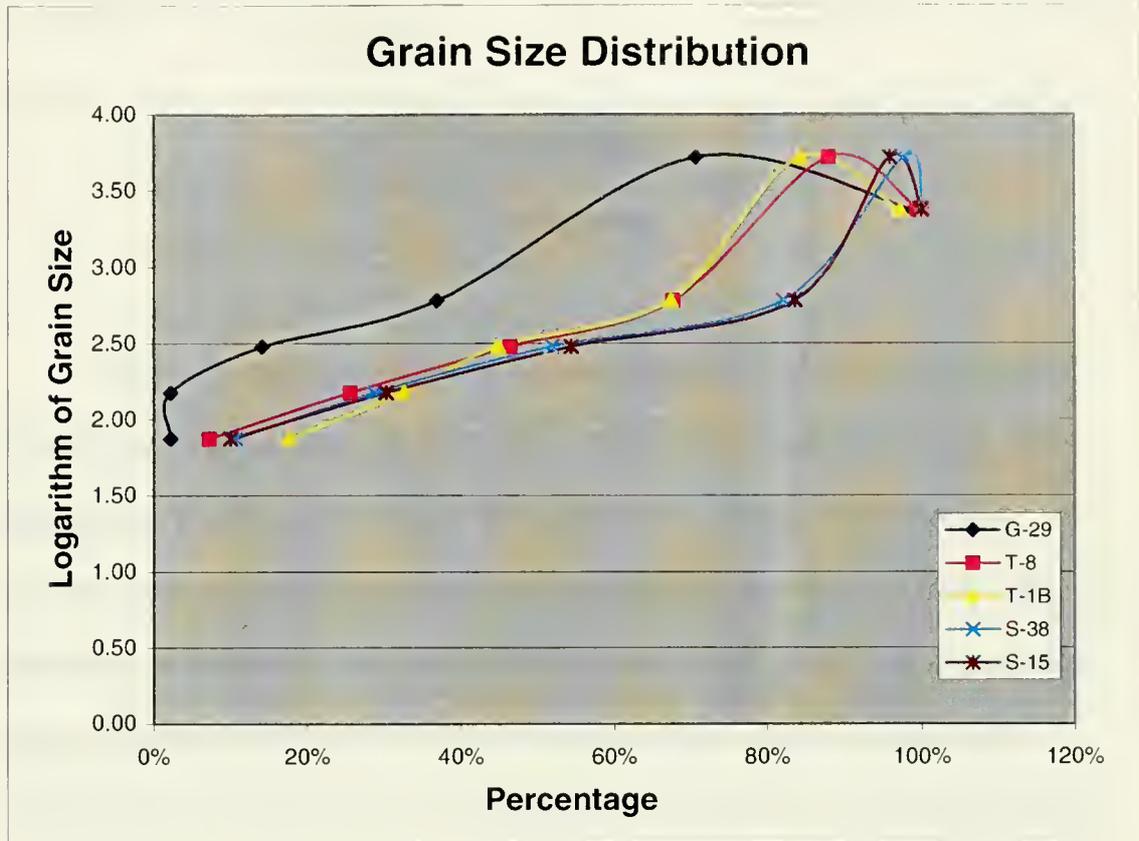
Table 4.6: Comparison of Grain Size Summation for the five marble types: G-29 Cherokee Fresh; T-8 Tuckahoe Fresh; T-1B Tuckahoe Weathered; S-38 Sheffield Fresh; and S-15 Sheffield Weathered. Grain sizes have been converted to logarithms of the actual grain sizes. Both Sheffield curves correspond to each other, as do both Tuckahoe curves. The Cherokee curve is noticeably distinct from the rest.

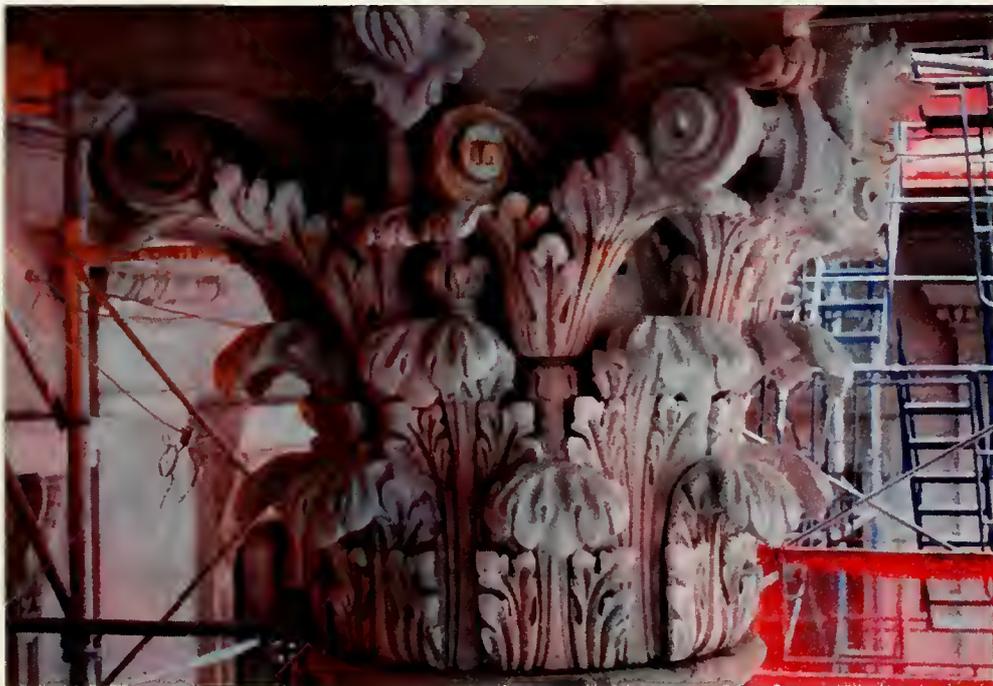
**Figure 5.2: Cherokee replacement abacuses on a Tuckahoe capital. Although the difference between the two types of marble is noticeable and will become more distinct as the stone weathers, the mixture of Cherokee with the Tuckahoe and Sheffield has been limited to areas of the building where it will not be as noticeable.**

The introduction of Georgia Cherokee marble as a replacement stone adds another dimension to the differential weathering patterns of the past. Superficially similar to the Tuckahoe in grain size and general color, at least when the Tuckahoe has been cleaned, the Cherokee would seem to be a logical replacement. However, its greater durability and tendency not to discolor over time point out potential problems for the future. In planning the replacement of stone at the Tweed Courthouse, care is being taken to minimize this type of contrast. The architect overseeing the project originally specified that Cherokee replacement stone should be used mostly above the first floor and in the area of the cornice, out of normal viewing range. Due to a limited quantity of salvage and Sheffield quarried stone, the Cherokee is being used more and more on the lower parts of the building.

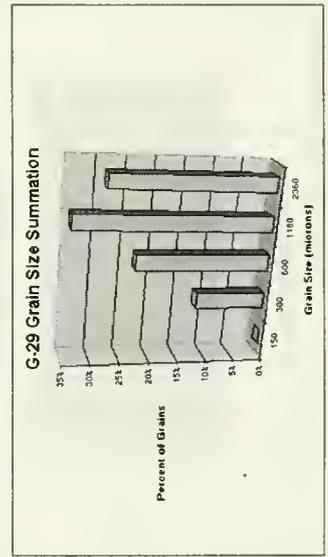
**Data Set Name: G-29**

Sieve Number	Size (microns)	Number of Grains	Percent
200	75	2	2.20%
100	150	0	0.00%
50	300	11	12.09%
30	600	21	23.08%
16	1180	31	34.07%
8	2360	26	28.57%
		1	1.10%

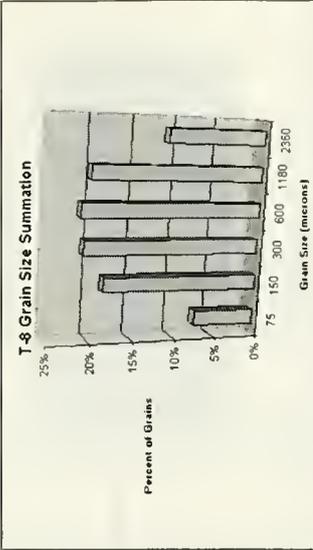
**Data Set Name: T-8**

Sieve Number	Size (microns)	Number of Grains	Percent
200	75	15	7.25%
100	150	36	18.36%
50	300	43	20.77%
30	600	44	21.26%
16	1180	42	20.29%
8	2360	24	11.59%
		1	0.48%

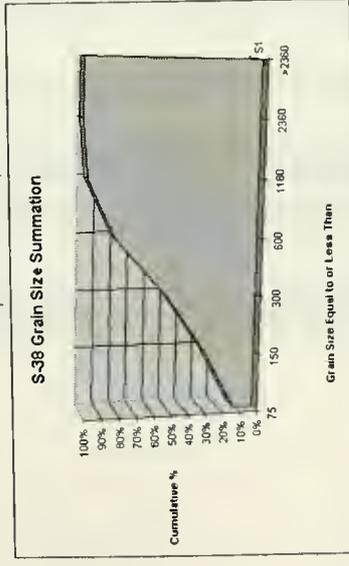
**Data Set Name: S-38**

Sieve Number	Grain Size (microns)	Number of Grains	Percent	Log
200	75	48	10.69%	1.875
100	150	81	28.72%	2.176
50	300	104	51.89%	2.477
30	600	136	81.96%	2.778
16	1180	71	97.77%	3.200
8	2360	10	100.00%	3.373
	>2360	0	100.00%	3.360
		449

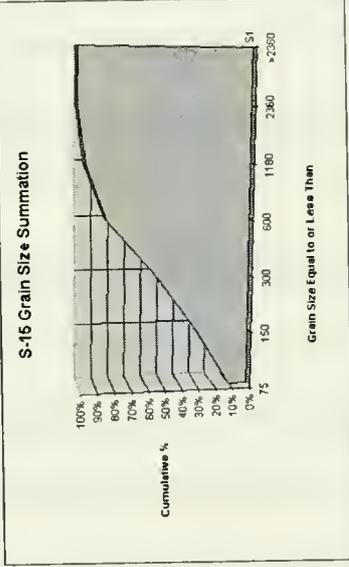
**Data Set Name: S-15**

Sieve Number	Grain Size (microns)	Number of Grains	Percent	Log
200	75	39	10.00%	1.875
100	150	79	30.36%	2.176
50	300	94	54.36%	2.477
30	600	114	89.59%	2.778
16	1180	48	95.90%	3.200
8	2360	16	100.00%	3.373
	>2360	0	100.00%	3.360
		390

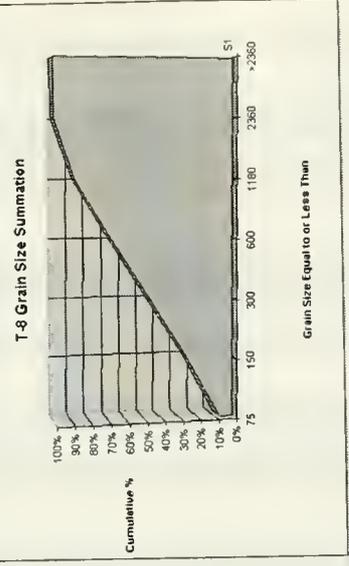
**Data Set Name: T-8**

Sieve Number	Grain Size (microns)	Number of Grains	Percent	Log
200	75	15	7.25%	1.875
100	150	38	25.60%	2.176
50	300	43	46.36%	2.477
30	600	44	67.63%	2.778
16	1180	42	87.92%	3.200
8	2360	24	99.52%	3.373
	>2360	1	100.00%	3.360
		207

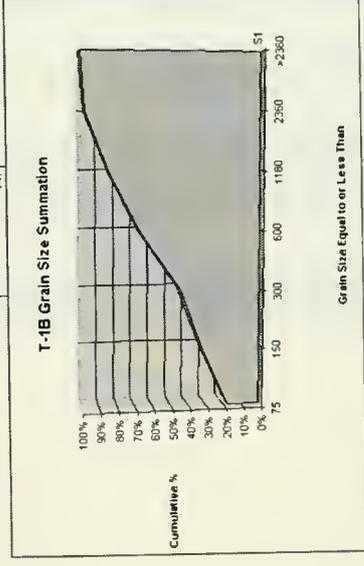
**Data Set Name: T-1B**

Sieve Number	Grain Size (microns)	Number of Grains	Percent	Log
200	75	26	17.69%	1.875
100	150	22	32.65%	2.176
50	300	18	44.90%	2.477
30	600	33	67.35%	2.778
16	1180	25	84.35%	3.200
8	2360	19	97.29%	3.373
	>2360	4	100.00%	3.360
		147

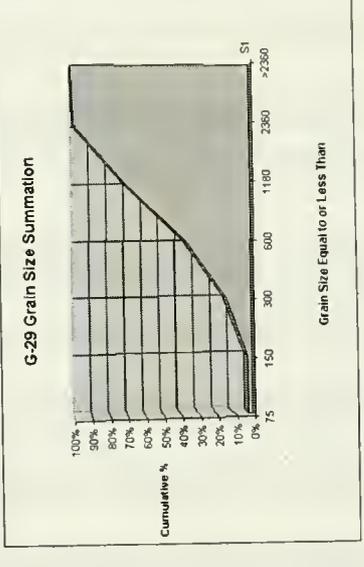
**Data Set Name: G-29**

Sieve Number	Grain Size (microns)	Number of Grains	Percent	Log
200	75	2	2.17%	1.875
100	150	0	0.00%	2.176
50	300	11	14.13%	2.477
30	600	21	36.96%	2.778
16	1180	31	70.66%	3.200
8	2360	26	96.91%	3.373
	>2360	1	100.00%	3.360
		92

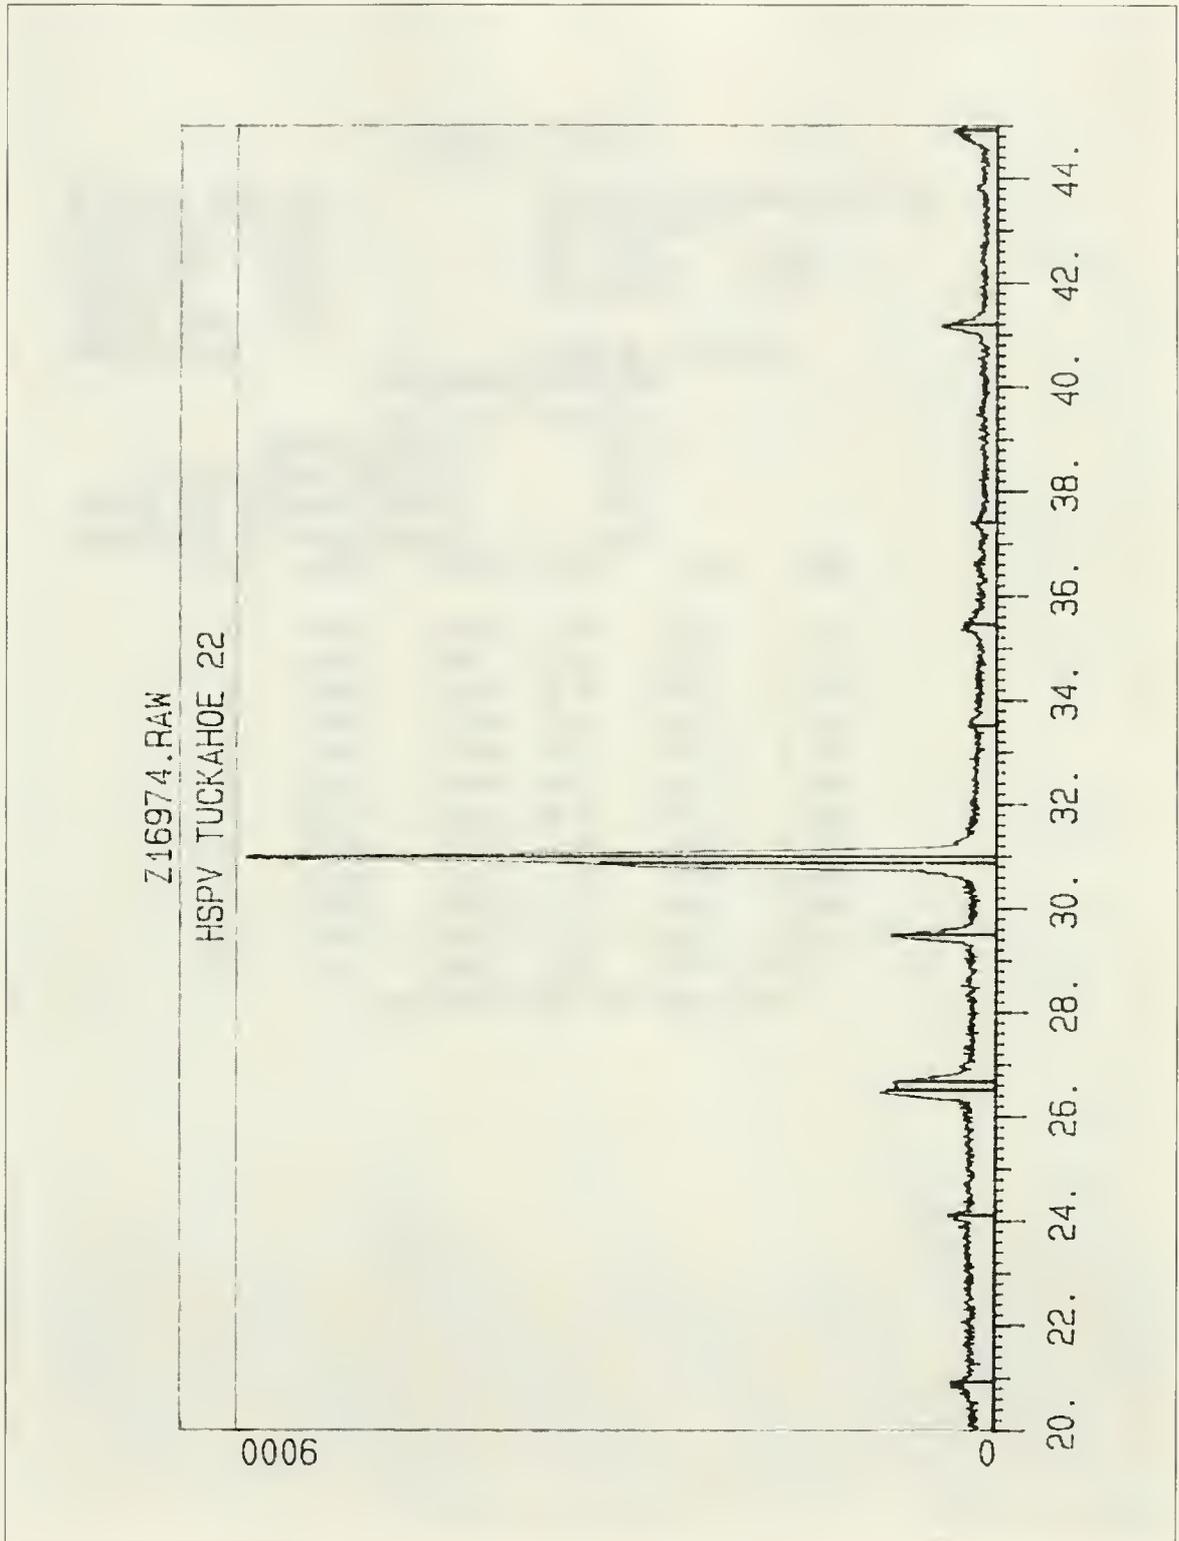
DATA FILE: 116972.PKS COLLECTED ON 13-MAR-01 AT 10:29:13  
 SAMPLE IDENTIFICATION: HSPV TUCKAHOE 1  
 START 2THETA: 20.000 STOP 2THETA: 45.000  
 STEP SIZE: 0.020 SCAN SPEED: 5.000  
 COUNTING TIME: 5.000  
 PEAKS FOUND ON: 13-MAR-01 AT 11:42:42

PEAK	2-THETA	D-SPACE	I(REL)	I(CPS)	FWHM
1	20.960	4.2384	6.50	187.0	0.040
2	24.191	3.6792	6.08	175.0	0.039
3	25.749	3.3328	34.73	1000.0	0.022
4	29.652	3.0128	6.95	200.0	0.200
5	31.000	2.8840	94.20	2712.0	0.040
6	31.140	2.8722	81.04	2333.0	0.200
7	31.950	2.6558	25.78	771.0	0.101
8	35.471	2.5308	6.95	200.0	25.000
9	36.716	2.4478	5.94	171.0	0.128
10	37.527	2.3967	12.02	346.0	0.002
11	39.708	2.2700	5.80	167.0	0.180
12	41.340	2.1840	100.00	2879.0	0.120
13	41.440	2.1790	60.19	1733.0	0.120
14	42.171	2.1429	5.35	154.0	0.040

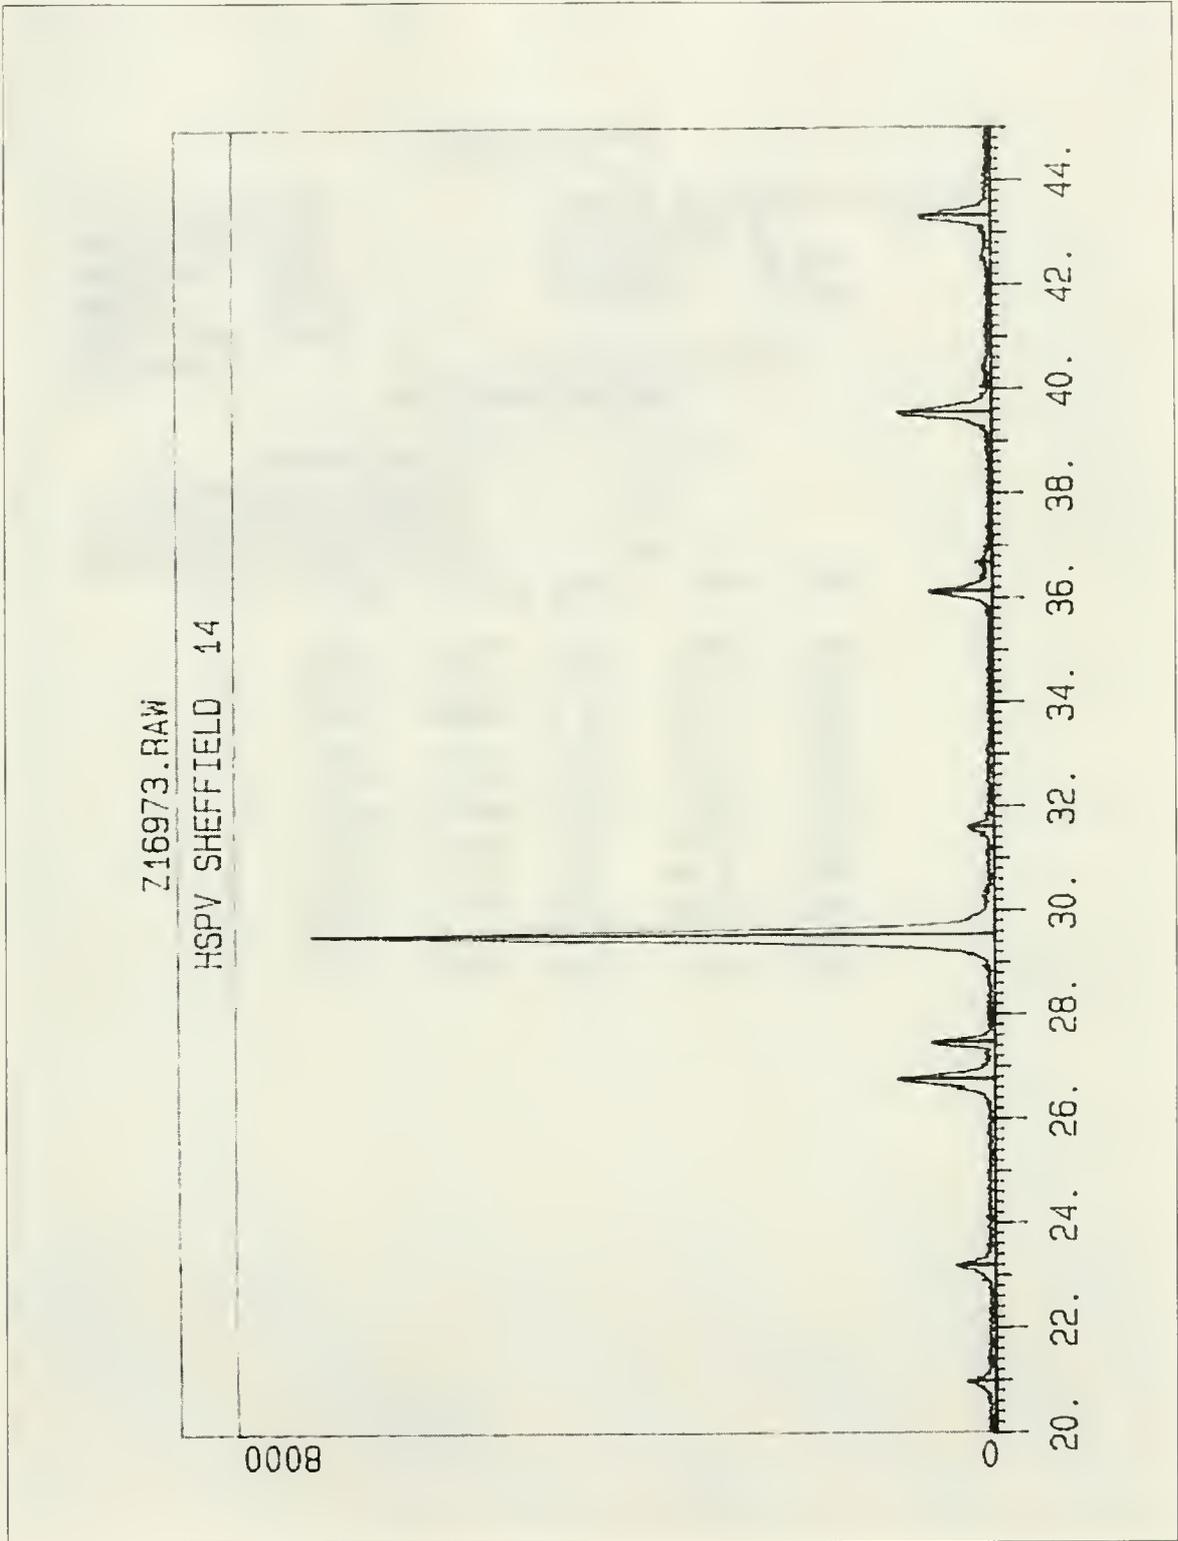
DATA FILE: E16974.PKS COLLECTED ON 13-MAR-01 AT 10:43:53  
 SAMPLE IDENTIFICATION: HSPV TUCKAHOE 22  
 START 2THETA: 20.000 STOP 2THETA: 45.000  
 STEP SIZE: 0.020 SCAN SPEED: 5.000  
 COUNTING TIME: 5.000  
 PEAKS FOUND ON: 13-MAR-01 AT 12:01:23

PEAK	2-THETA	D-SPACE	I(REL)	I(CPS)	FWHM
1	20.917	4.2471	5.56	521.0	0.324
2	24.099	3.6930	6.38	567.0	0.294
3	26.500	3.3636	14.58	1296.0	0.305
4	26.660	3.3438	13.13	1167.0	0.640
5	29.485	3.0295	14.11	1254.0	0.208
6	30.860	2.8976	53.12	4721.0	0.120
7	30.979	2.8867	100.00	8887.0	0.248
8	33.500	2.6750	3.52	313.0	0.140
9	35.440	2.5329	4.35	387.0	25.000
10	37.400	2.4046	3.47	308.0	0.260
11	41.178	2.1923	7.45	662.0	0.010
12	44.903	2.0187	5.82	517.0	0.260

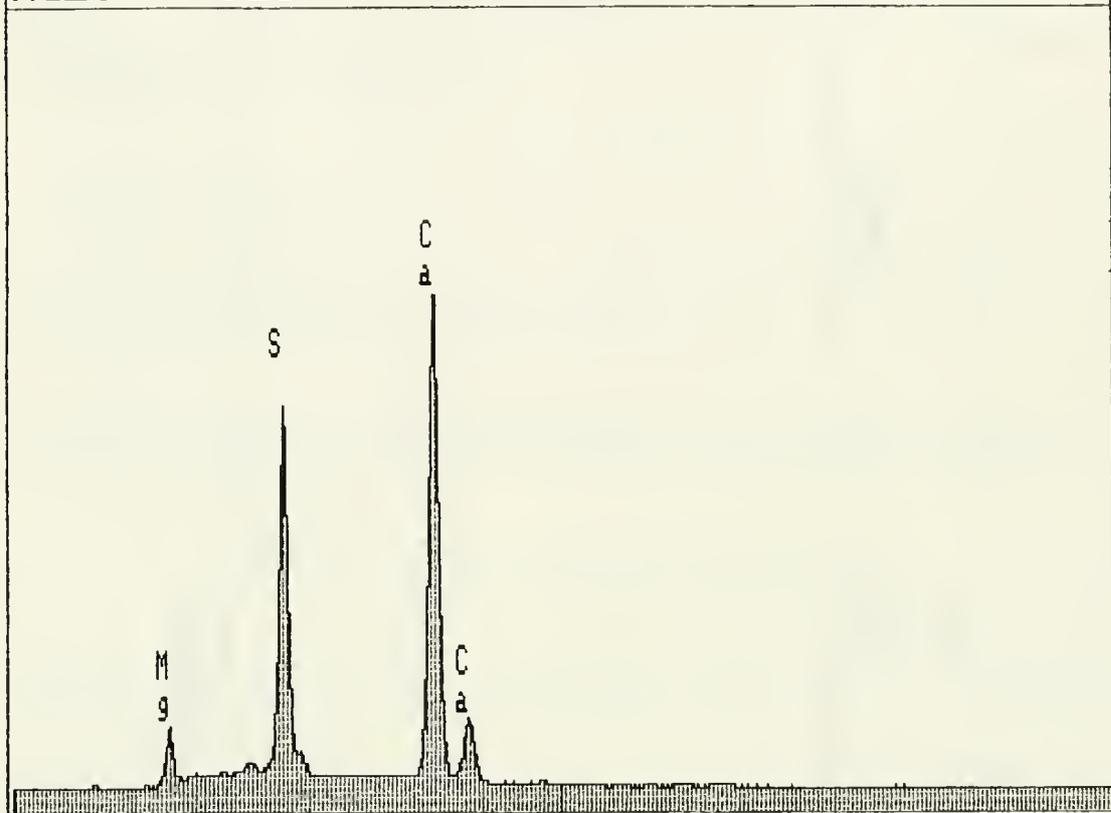
X-RAY: 0 - 20 keV Window : None  
Live: 60s Preset: 60s Remaining: 0s  
Real: 96s 38% Dead
