AN INVESTIGATION OF SANDSTONE CONSOLIDATION METHOD  
FOR THE NORTHERN GOPURA OF THE PHIMAI SANCTUARY,  
A KHMER MONUMENT IN THAILAND

Nuanlak Watsantachad

A THESIS

Historic Preservation

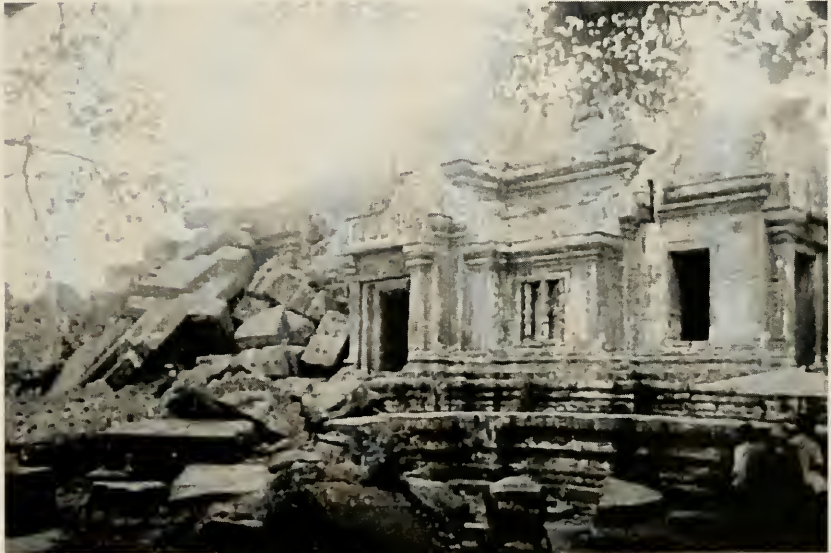
**Figure 1.2:** Collapse of the Viharn Sanctuary located in the border of Thailand and Cambodia. (July 2000)

Due to their age, many of these monuments were in a near state of collapse when the survey projects began in the early twentieth century. Only about 60% of the structures were standing while the other 40% had collapsed. Although the condition assessment of the stones—sandstone and laterite—used as building material was quite good, the construction was unstable. (See Figure 1.2)

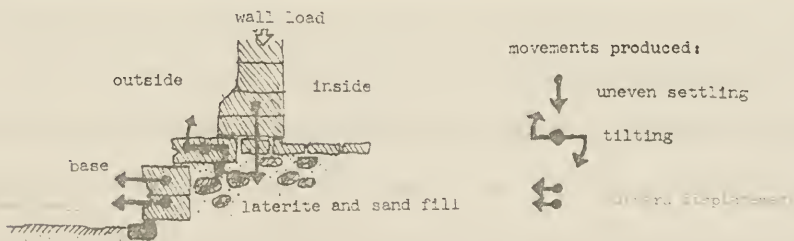
Figure 1.3: Sketch of structural failure due to unequal support of the foundation.

The foundations of Khmer monuments are often defective. They were built of one or more layers of laterite, either in blocks or as rubble, under the first course of sandstone. Due to the heavy loads and the infiltration of rainwater, the laterite foundation became crushed and disaggregated. In addition, the physical and chemical properties of the laterite itself varied for each block. This resulted in uneven load bearing as a function of its origin, orientation, and composition, and resulted in unstable support. The aesthetics of construction also contributed to failure due to unequal support under the walls. The builders placed sandstone blocks to support the heavy loads of the walls only in places where it was necessary; the outside elevation needed the aesthetic appearance, so that the builders placed sandstone blocks as the wall base, while they placed only unstable laterite and sand fill base to support the same wall on the interior elevation. (See Figure 1.3)

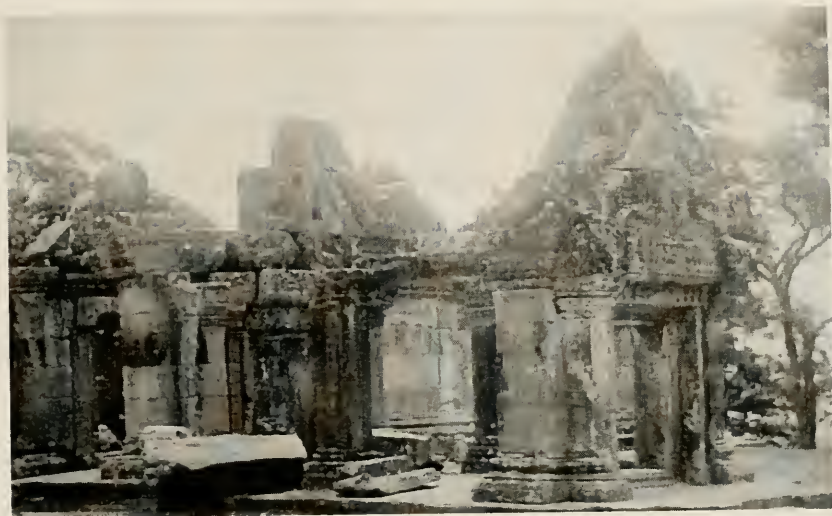
**Figure 1.4:** Interior walls and floors that are exposed due to the collapse of the roof.  
The Gallery of the Viharn Sanctuary, July 2000.

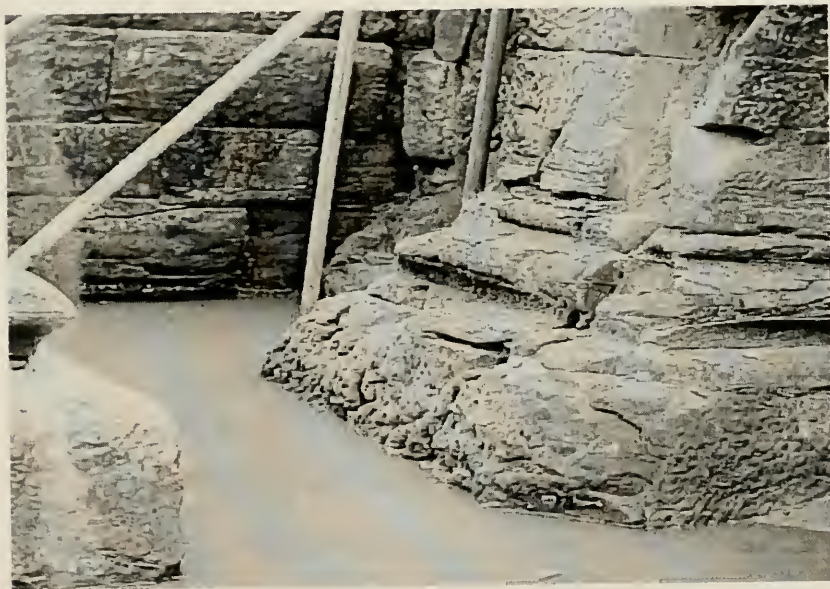
**Figure 1.5:** Unsheltered room retains water on the floor for several days before the water evaporates.  
The Northern Gopura of the Phimai Sanctuary, June 2000

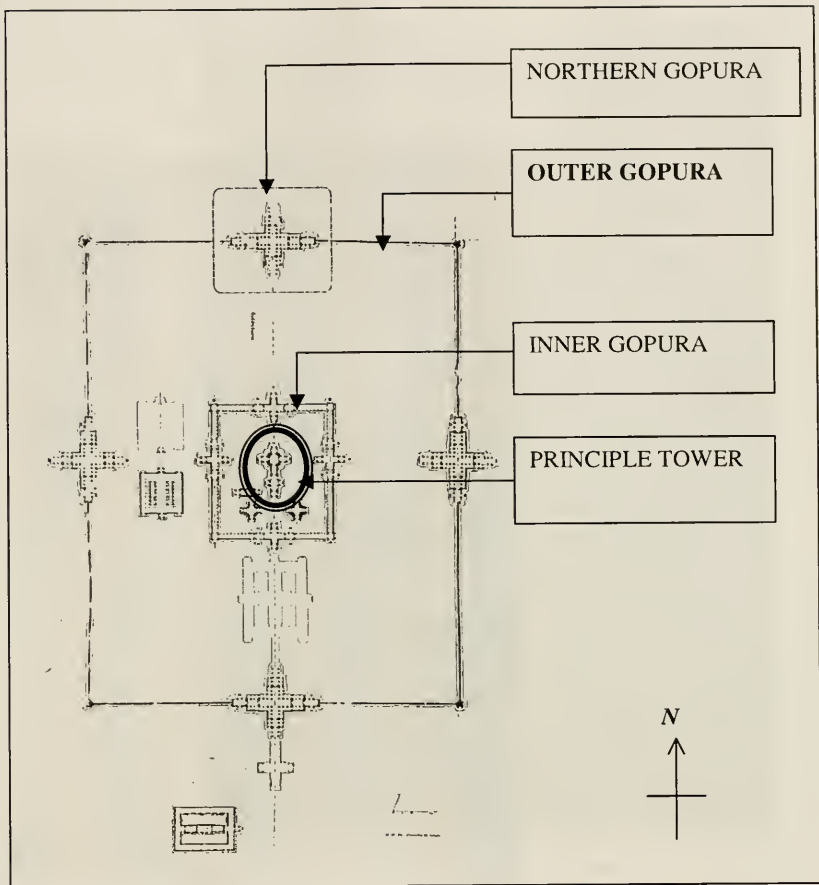
**Figure 1.7:** Restoration Master Plan of the Phimai Sanctuary, 1962.

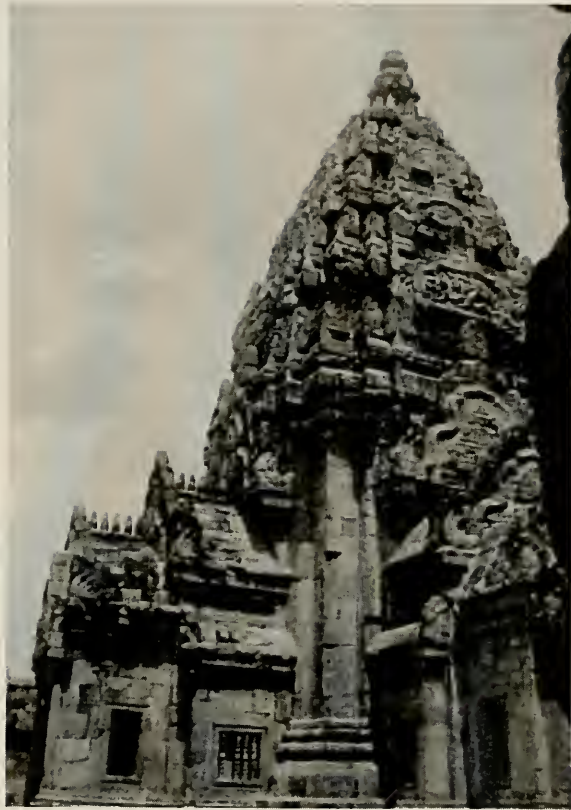
**Figure 1.8:** The Principle Tower after anastylosis restoration, 1964-1969.  
(June 2000)

The siliceous sandstone principal tower was successfully restored with anastylosis more than 30 years ago. This was carried out between 1964 and 1969 at the request of the French Ambassador in Thailand, by B.P. Groslier, who was then director of Archaeological Research at the Ecole Francais d'Extreme-Orient and Curator of the Angkor Monuments. The sanctuary was reconstructed on a new reinforced concrete foundation with an inserted bracing structure inside the walls and under the vaults, and the tower was restored to its original height. (See Figure 1.8)

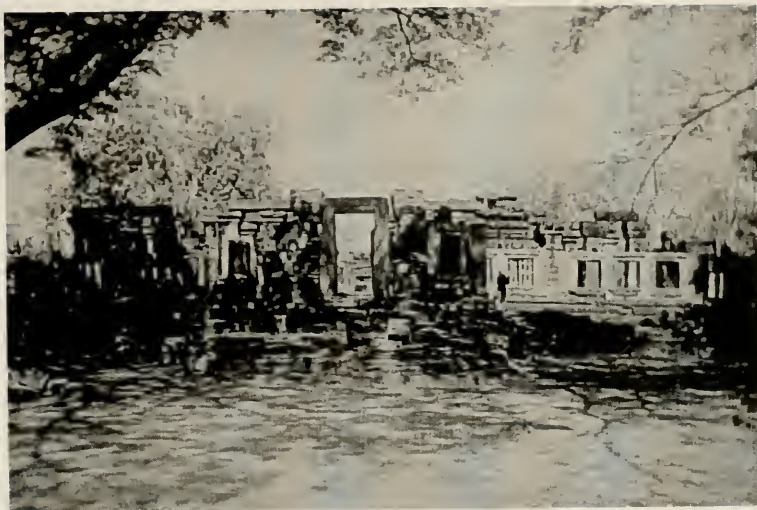
**Figure 1.9:** The condition of the Northern Gopura of the Phimai Sanctuary before restoration.  
(Fine Arts Division, the Department of Interior, 1998)

Unlike the tower, the outer Gopuras were built of a litharenite sandstone<sup>6</sup> which is weaker and more susceptible to weathering. (See Figure 1.9) The condition of the

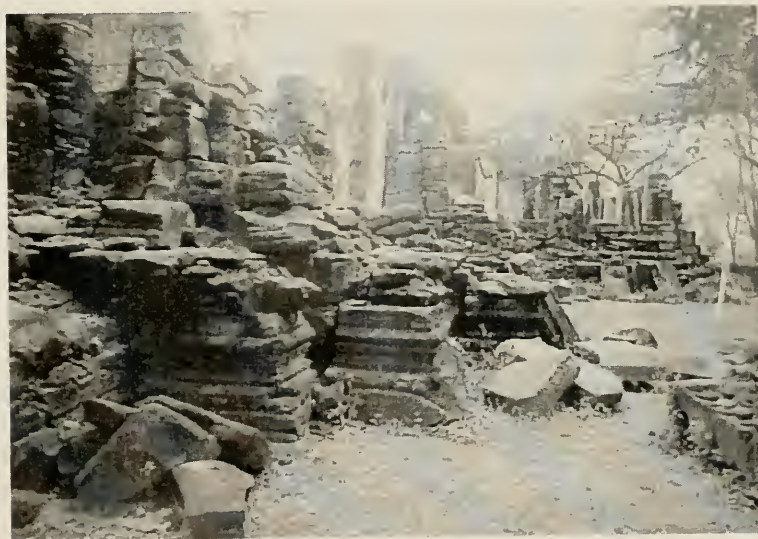
**Figure 1.10:** The condition of the Northern Gopura of the Phimai Sanctuary before restoration.  
(Fine Arts Division, the Department of Interior, 1998)

Gopuras was very critical when the survey was conducted. (See Figure 1.10) The building had collapsed, some pieces of stones had fallen down, and the stone itself was deteriorated in sections to a very high degree, as noted in 1972,

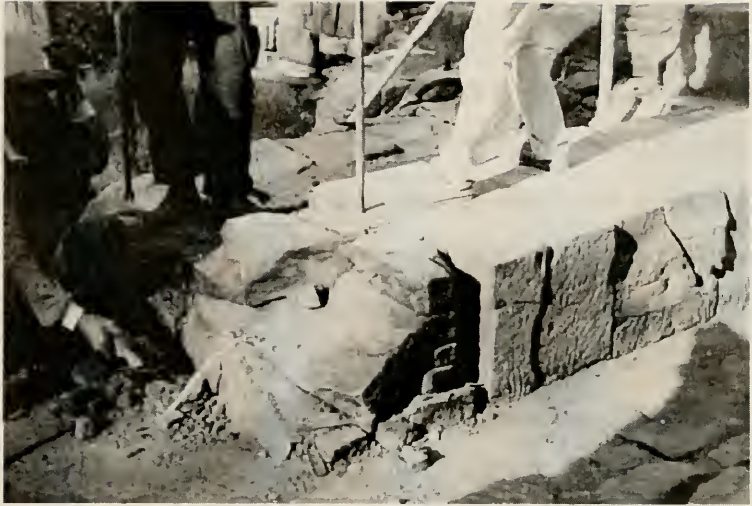
**Figure 1.11:** Ancient stone block broke during the restoration project.  
(Fine Arts Division, the Department of Interior, 1998)

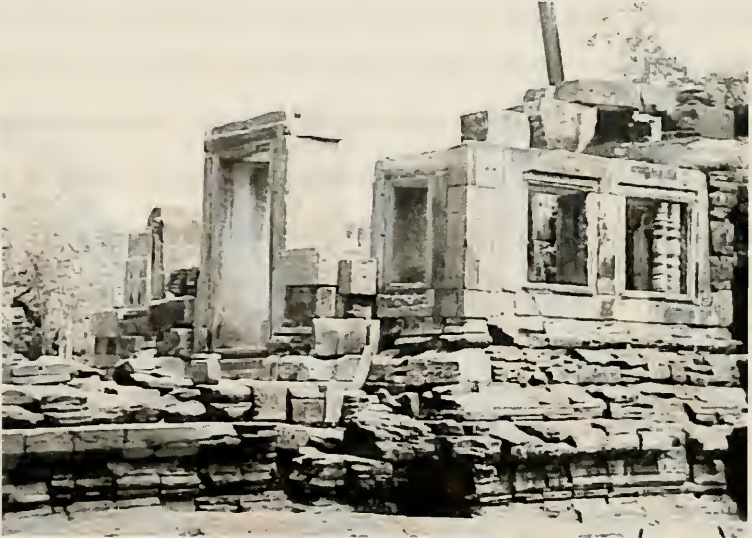
**Figure 1.12:** New stone replacement during anastolysis restoration project.  
(Fine Arts Division, the Department of Interior, 1998)

The Division of Fine Arts of the Department of the Interior in Thailand recently attempted to restore the Northern Gopura by anastylosis. They tried to follow the previous successful reconstruction project carried out on the main sanctuary in 1962. All of the remaining stones were dismantled first and new concrete was poured before replacing the historic stones into their original locations. Unfortunately, because of the extremely disaggregated and delaminated condition of the stone blocks, most of them were damaged during dismantling and were not reusable. (See Figure 1.11) Subsequently, new stone replacements were obtained in order to re-construct the Gopura; the new stone was brought from quarries in Sikhew district in the Nakhon Ratchasima Province, and, although the same type of sandstone, the fresh stone contains more mica than the ancient stone. Hence, the original concept and purpose of the preservation project—to preserve the ancient stones and original construction—had to be changed due to the loss of the original masonry. Consequently, the project might be considered a failure from the point of view of conservation although it was a successful reconstruction. (See Figure 1.12)

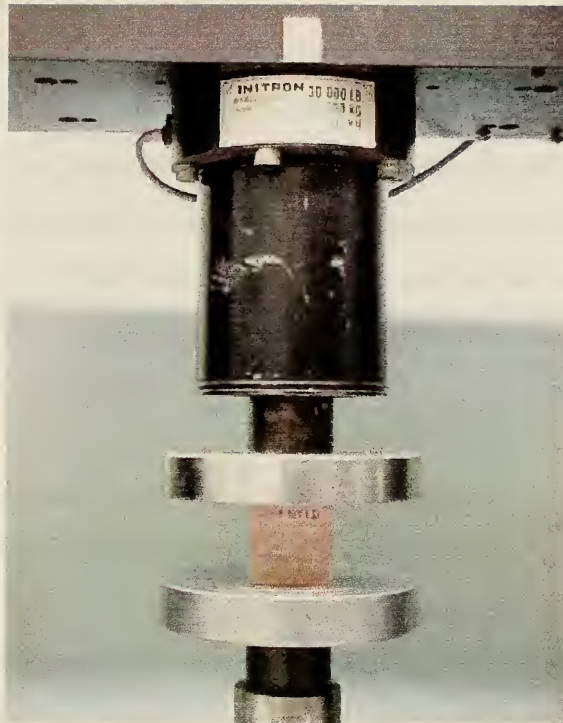
**Figure 2.1:** Compressive strength test with an Instron Testing Machine 1125. In the photo, a stone cube was tested with the load perpendicular to bedding planes

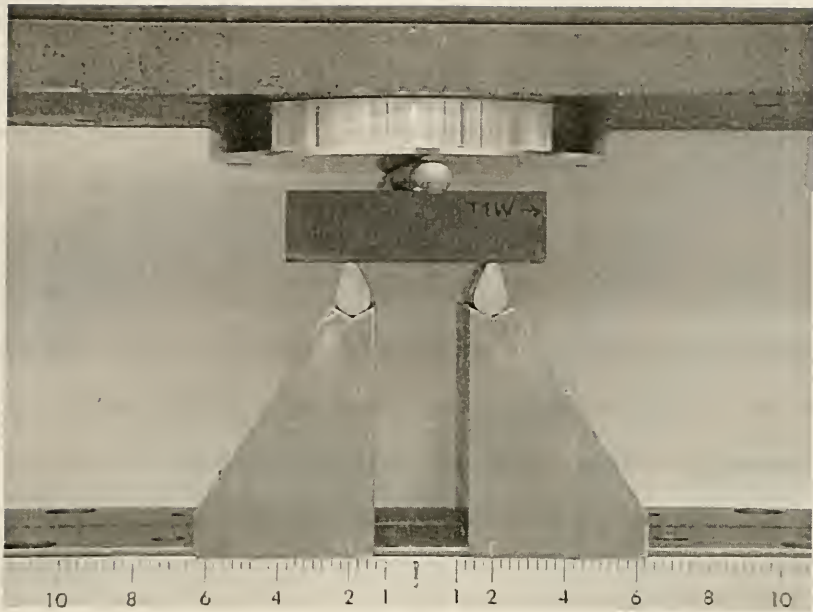
**Figure 2.2:** Flexural strength test (3-point bending test) with an Instron Testing Machine 1125 set at 2-inch gage length

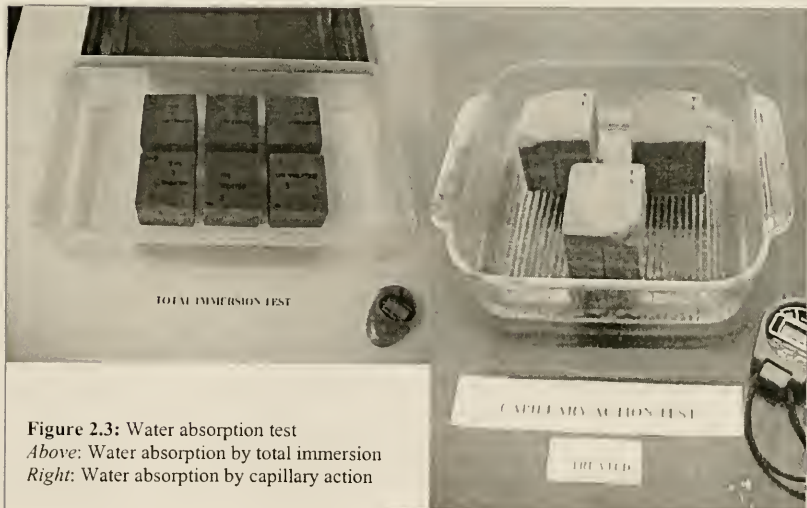
**Figure 2.3:** Water absorption test  
*Above:* Water absorption by total immersion  
*Right:* Water absorption by capillary action

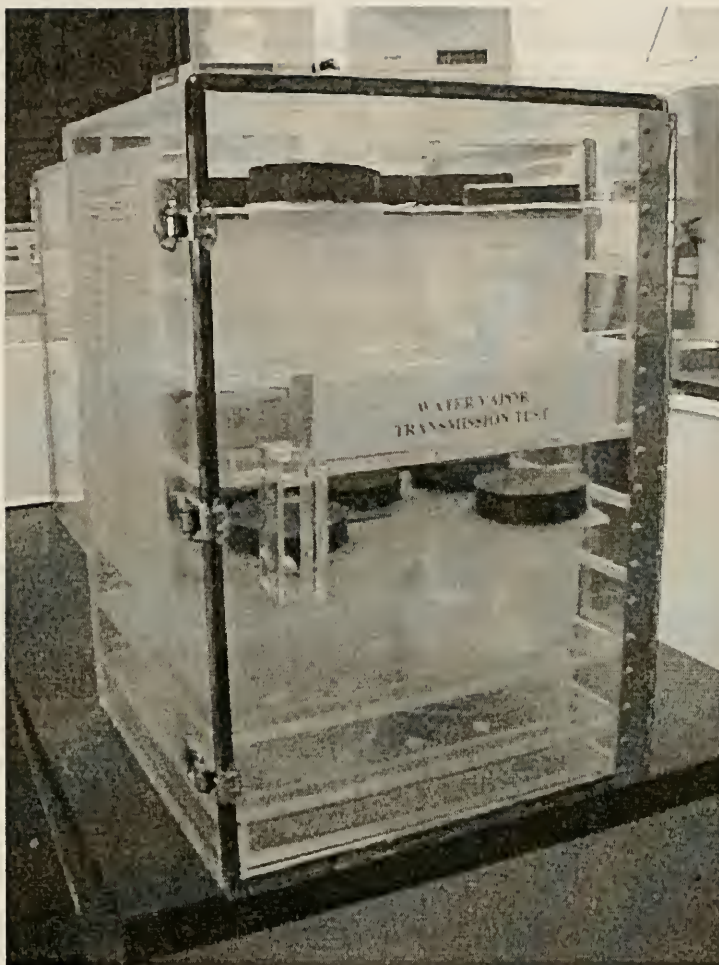
**Figure 2.4:** Water vapor transmission test

The assemblies were placed in a desiccator under the average temperature of 69°F and the average relative humidity of 18.5%

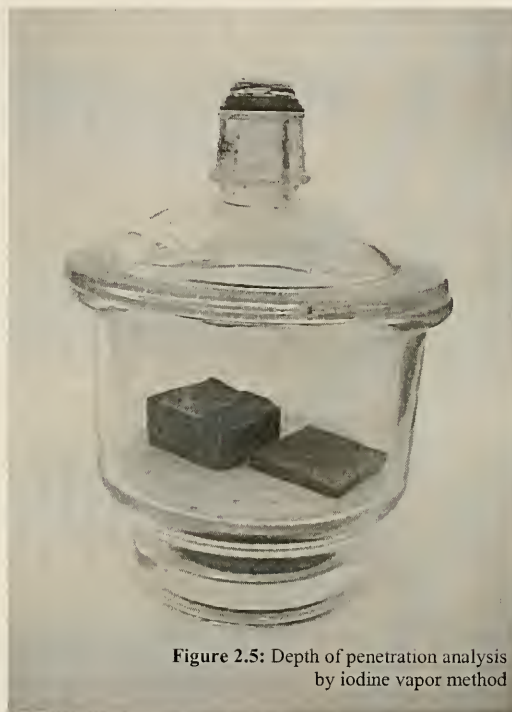
**Figure 2.5:** Depth of penetration analysis  
by iodine vapor method

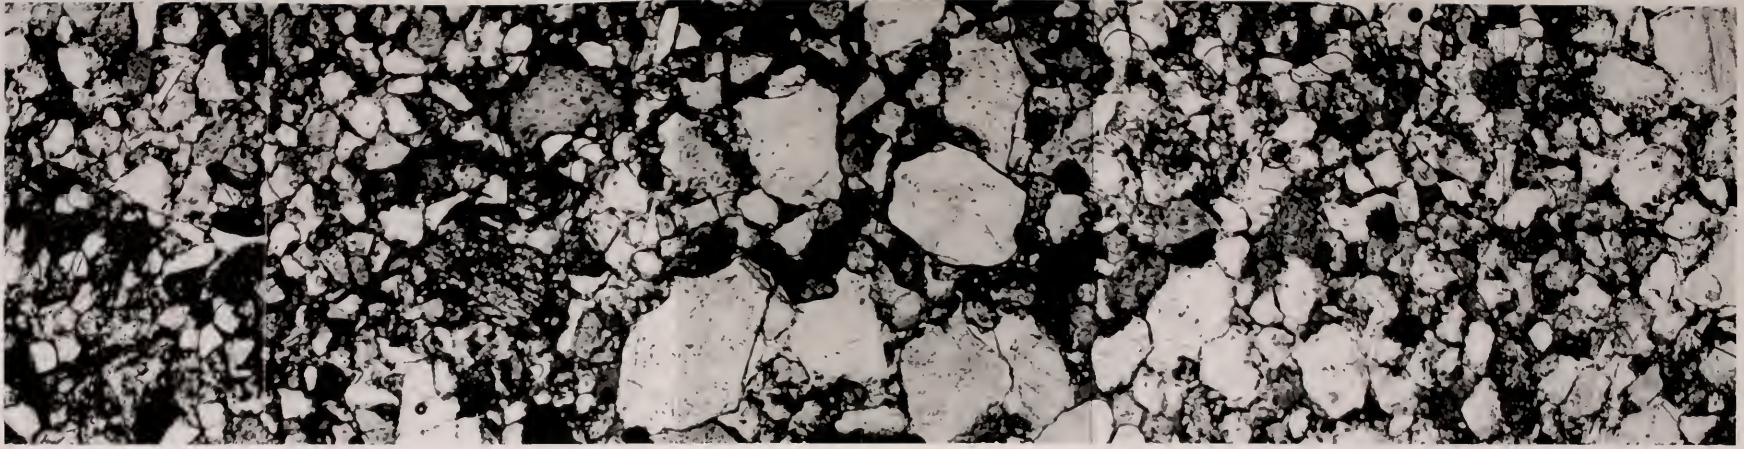
**Figure 3.1:** Plane-polarized light microscopic image of the stone. (100x magnification). The different grain sizes of each layer could be observed.

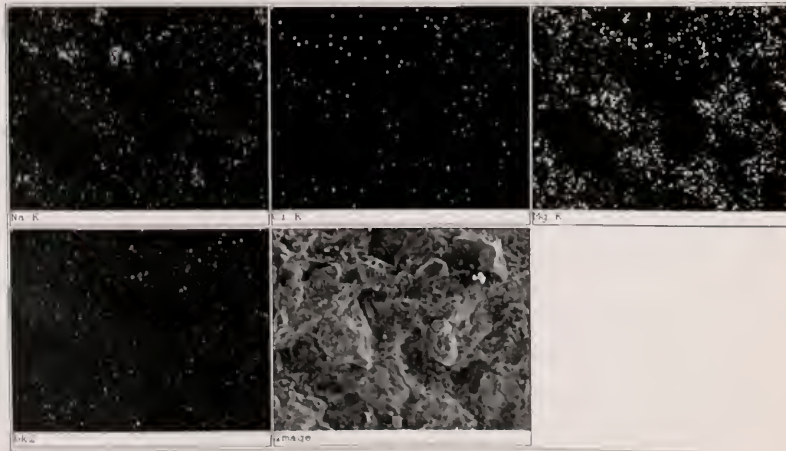
**Figure 3.2:** The electron dot maps of sodium, chloride, and magnesium.

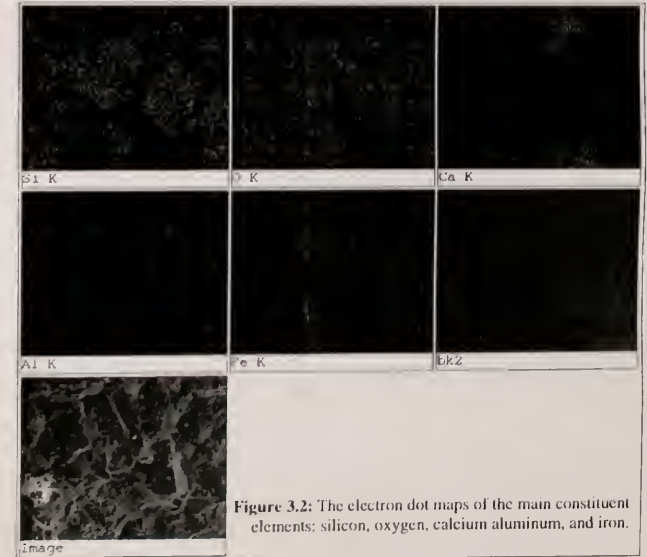
**Figure 3.2:** The electron dot maps of the main constituent elements: silicon, oxygen, calcium aluminum, and iron.

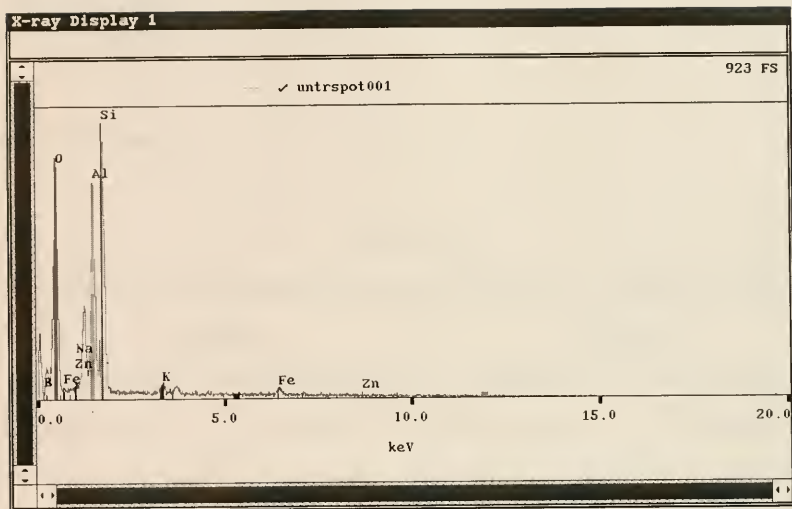
**Figure 3.4:** X-ray diffraction analysis of untreated weathered sandstone of the Northern Gopura. The main elements are silica, oxygen, and aluminum, with the presence of some sodium and iron.

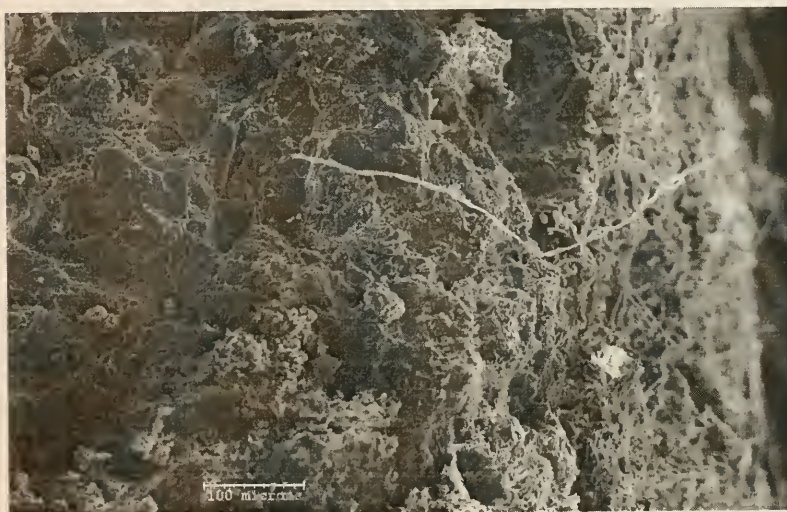
**Figure 3.5:** SEM image of biological growth depositing on the stone surface. (100x magnification, 15 KV)

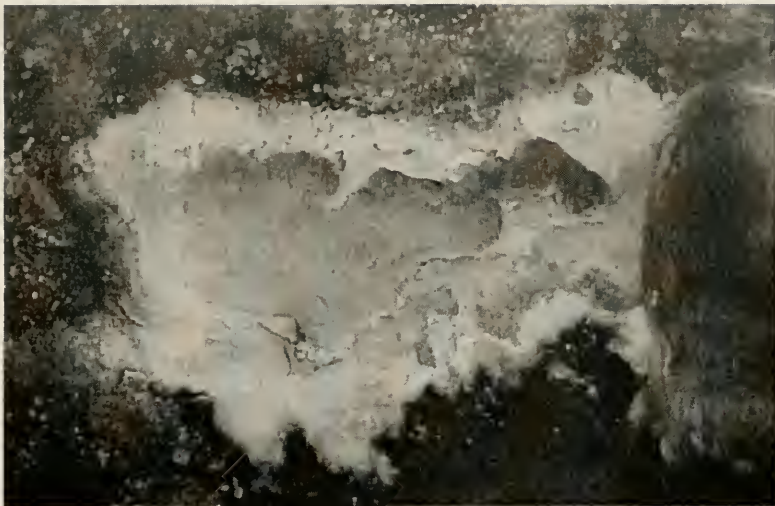
**Figure 4.1:** Flaking of sandstone surface  
The evidence of dampness in stone leading to the flaking of thin layers of the stone surface.  
Stone condition under the lintel of the Northern Gopura's Hall(June 2000)

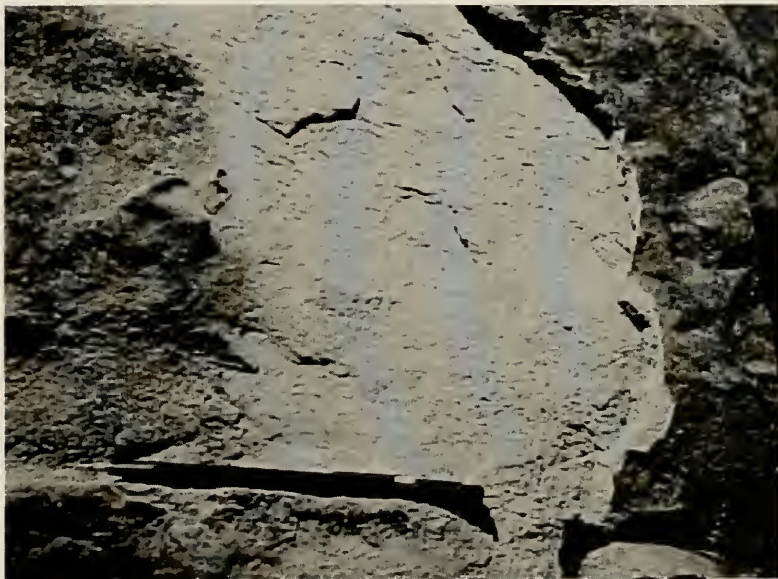
**Figure 4.2:** Scaling of sandstone surface  
The deeper dampness in the stone leads to the flaking and scaling of the stone surface.  
The condition of the stone wall of the Northern Gopura. (June 2000)

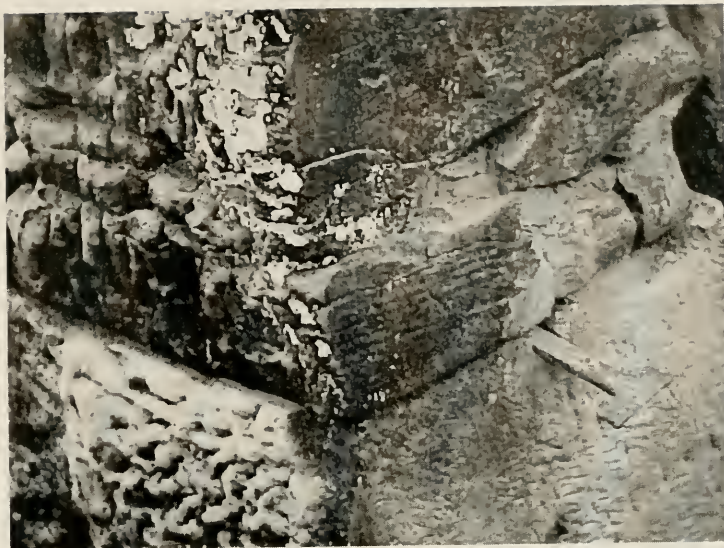
**Figure 4.3:** Crumbling and disaggregation of sandstone. The friability of the sandstone blocks of the Northern Gopura's wall is due to the loss of cementing material. (June 2000)

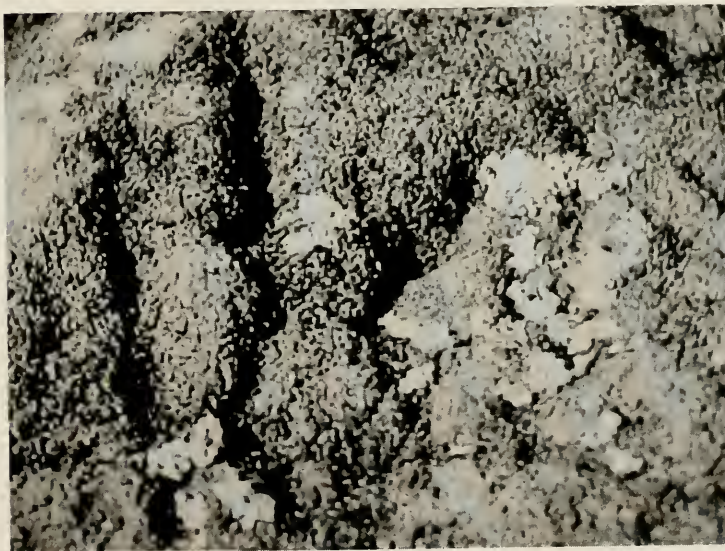
**Figure 4.4:** Lichen on sandstone surface. The biological growth indicates an evidence of dampness in the sandstone of the Northern Gopura's wall. (June 2000)

There are some evidences of biological growth depositing on the sandstone of the Northern Gopura of the Phimai Sanctuary. The types of biological growth and their effect, however, need further study in order to provide appropriate treatments to the stone, such as cleaning and protection, which will not be investigated and discussed in this thesis. (See Figure 4.4)

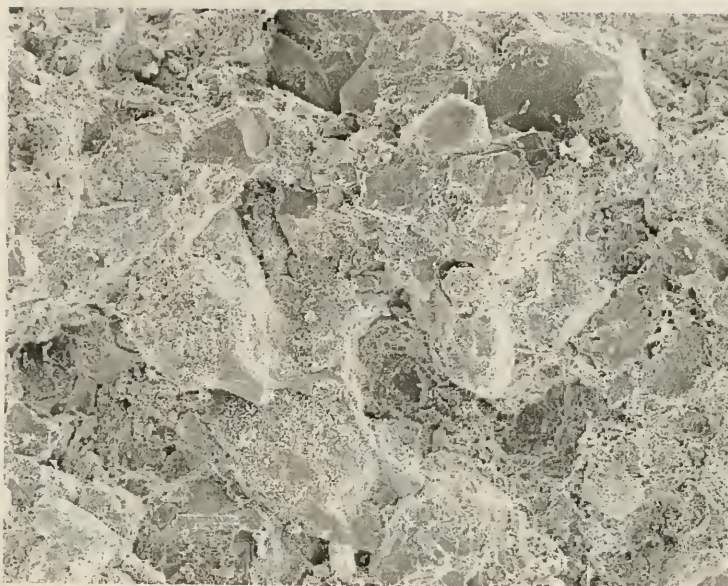
Figure 6.1: SEM image of untreated stone (100x magnification, 15 KV)

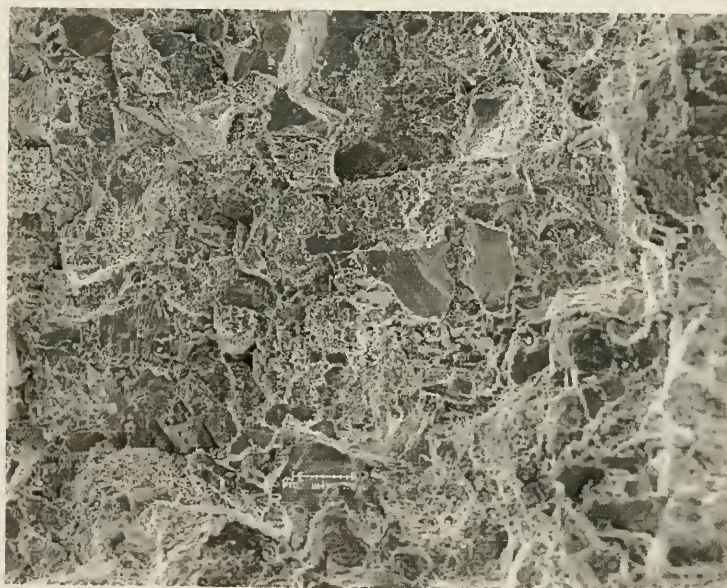
Figure 6.2: SEM image of treated stone (100x magnification, 15 KV)

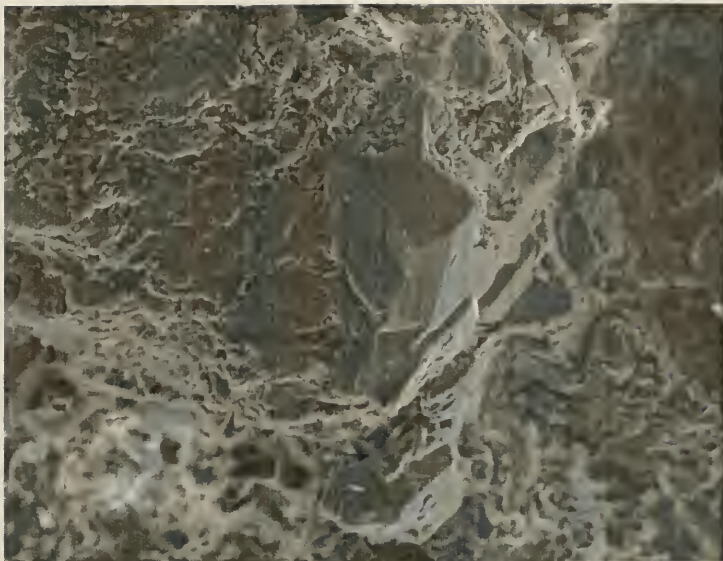
**Figure 6.3:** SEM image of untreated stone (600x magnification, 15 KV)

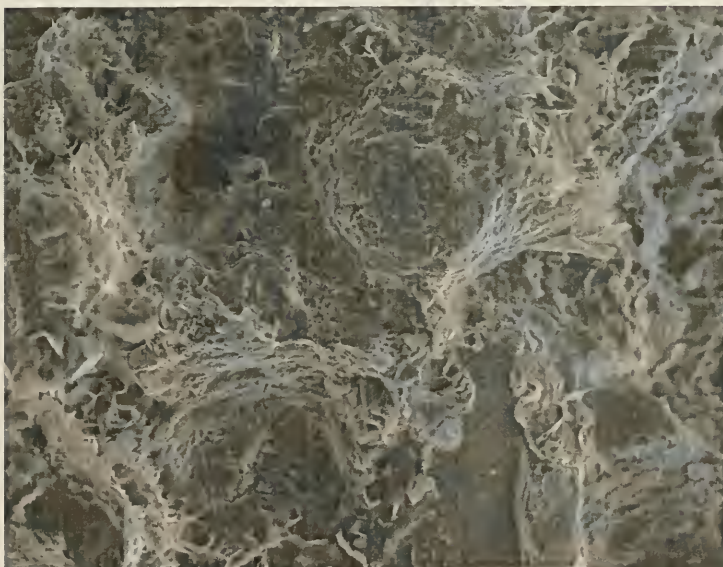
**Figure 6.4:** SEM image of treated stone (600x magnification, 15 KV)

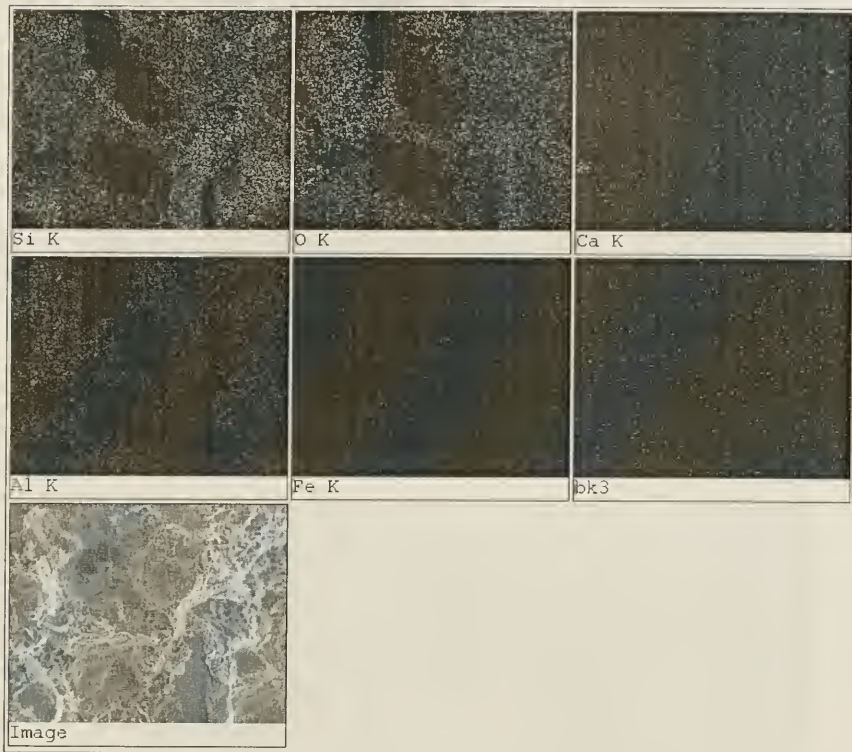
Figure 6.5: X-ray Diffraction Map of the main elements in a spot of treated stone.

The map displays the location of silica, oxygen, calcium, aluminum, and iron. The matched location between silica and oxygen indicates the location of silicon dioxide—either the original quartz grains or the amorphous silica polymerized from ethyl silicate. In the map, silicon dioxide spreads throughout the whole area, and is also seen as a network around the grains, which is visible in the SEM image at the left bottom of the map. This network indicates the replacement of cementing elements—aluminum, iron, and calcite—with silicon dioxide. The black spots in every map, however, can be either other elements if seen in color in the background map or the geometric error of X-ray diffraction analysis if also seen in black in the background map.

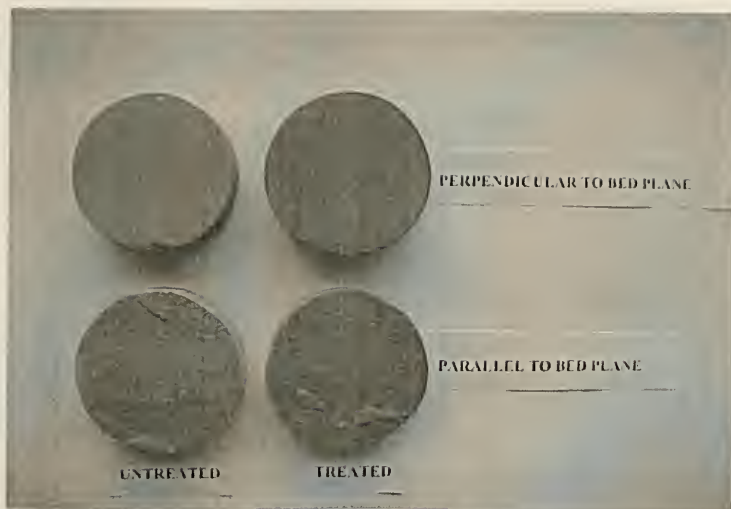
**Figure 6.6:** Color Comparison of untreated and treated stone after 3 weeks of curing time

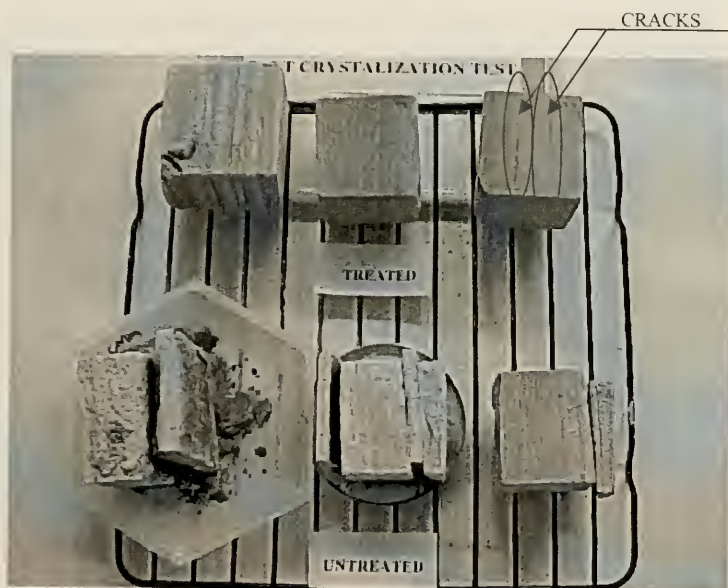
**Figure 6.7:** Untreated and treated stones after salt crystallization test (10 cycles)

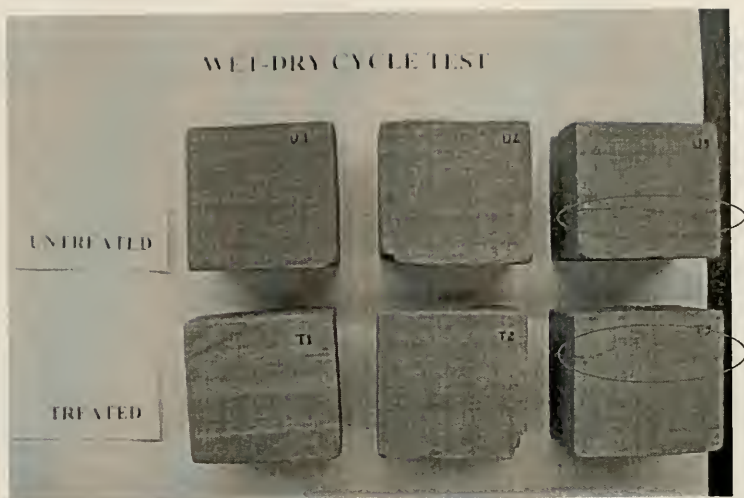
**Figure 6.8:** Untreated and treated stones before wet-dry cycling test  
The untreated stone 3 and treated stone 3 had pre-existing cracks before being tested.

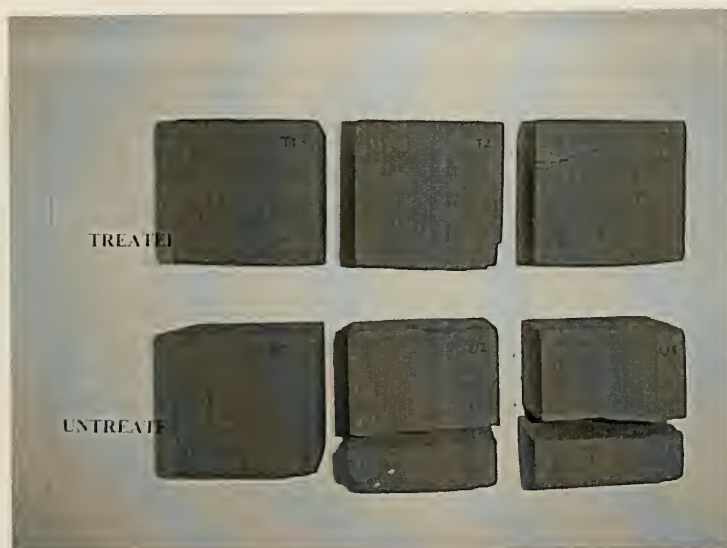
**Figure 6.8:** Untreated and treated stones after wet-dry cycling test  
The untreated stone (#3) that had pre-existing cracks before being tested broke while the treated stone (#3) could resist the damage caused by wet-dry cycling. The untreated stone (#2) broke after the test although the pre-existing damage did not perform.

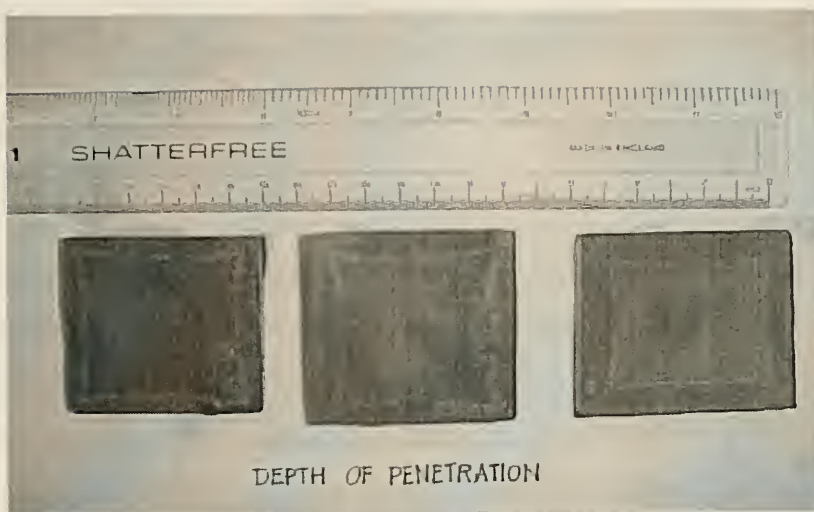
Figure 6.10: Depth of penetration measurement carried out in wet treated stone cubes

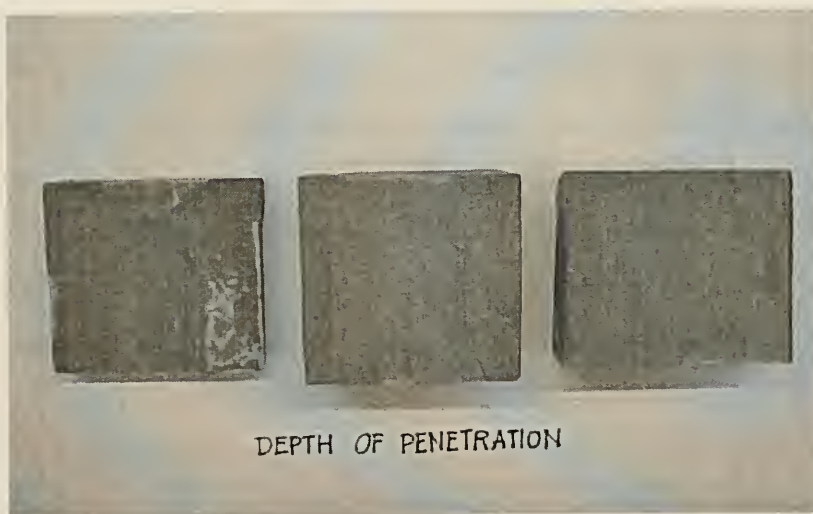
Figure 6.11: Slight discoloration of dry treated stone

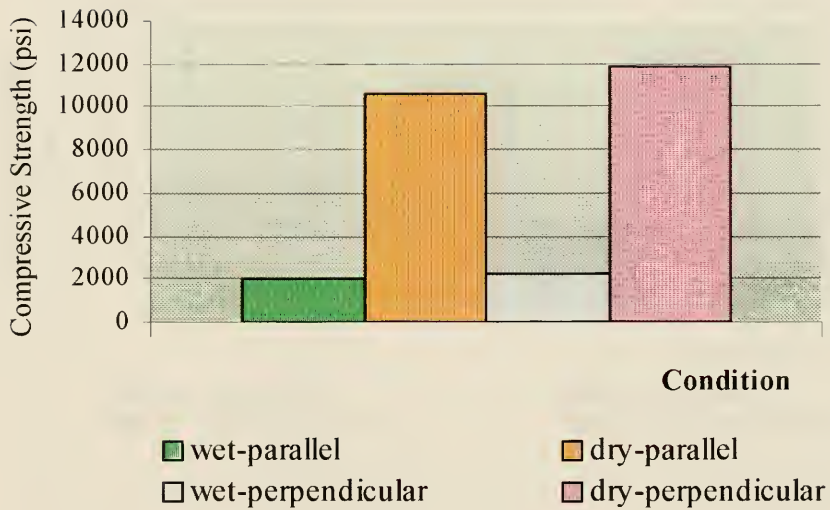
# COMPARISON OF COMPRESSIVE STRENGTH OF WET & DRY UNTREATED STONES

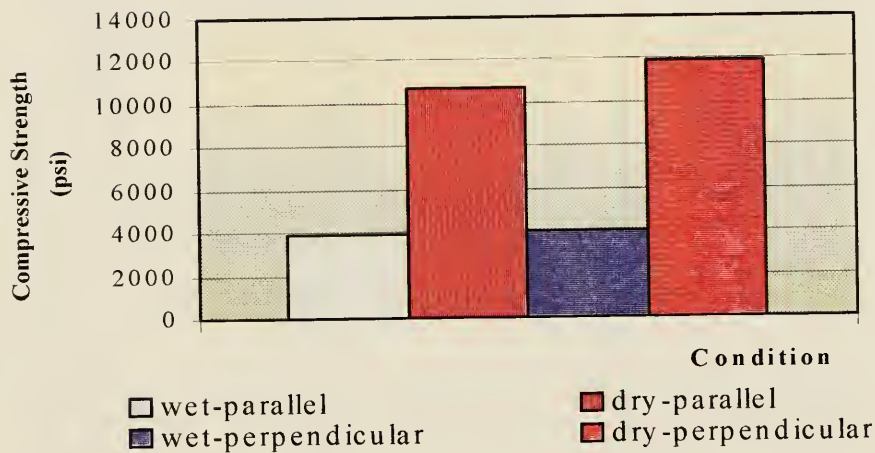
# COMPARISON OF COMPRESSIVE STRENGTH OF WET & DRY TREATED STONES

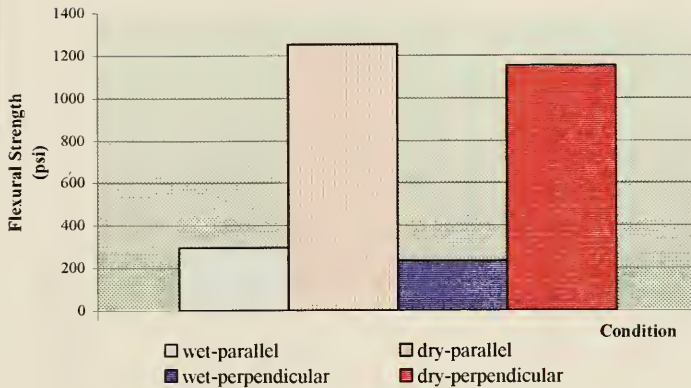
### COMPARISON OF FLEXURAL STRENGTH OF WET & DRY UNTREATED STONES

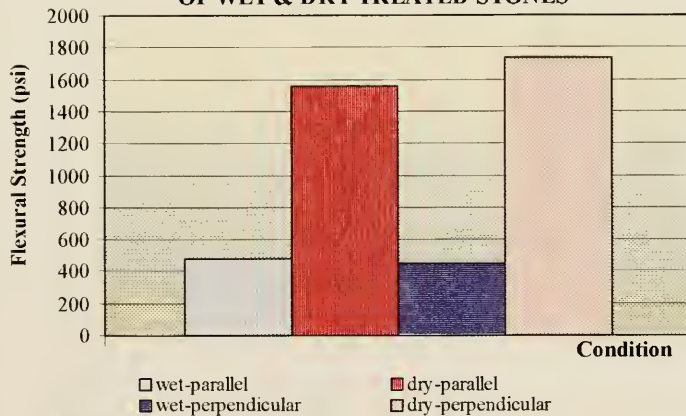
### COMPARISON OF FLEXURAL STRENGTH OF WET & DRY TREATED STONES

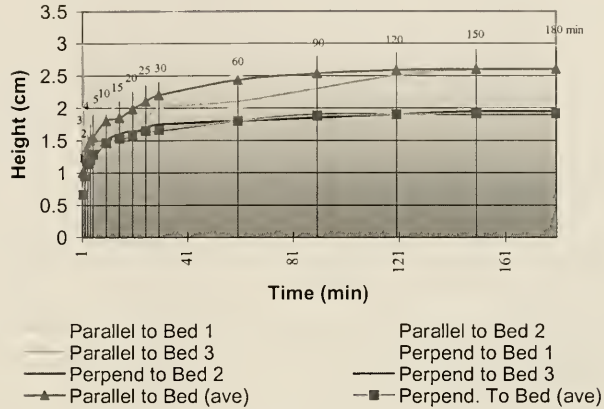
### Capillary Action (Untreated Stone)

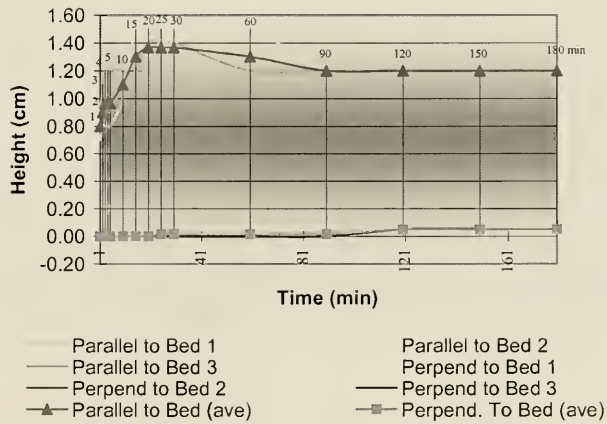
### Capillary Action (Treated Stone)

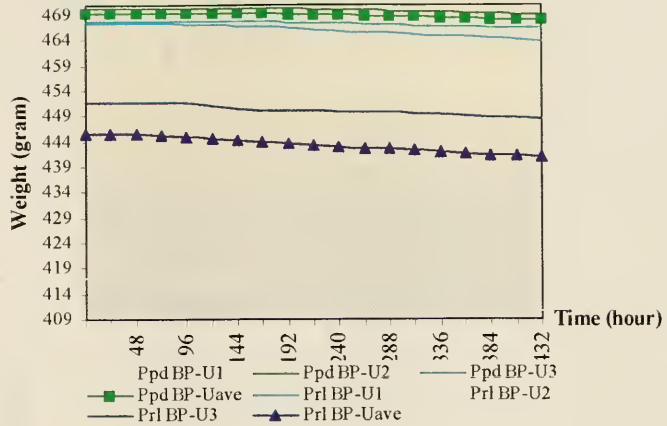
### Water Vapor Transmission (Untreated Stone)

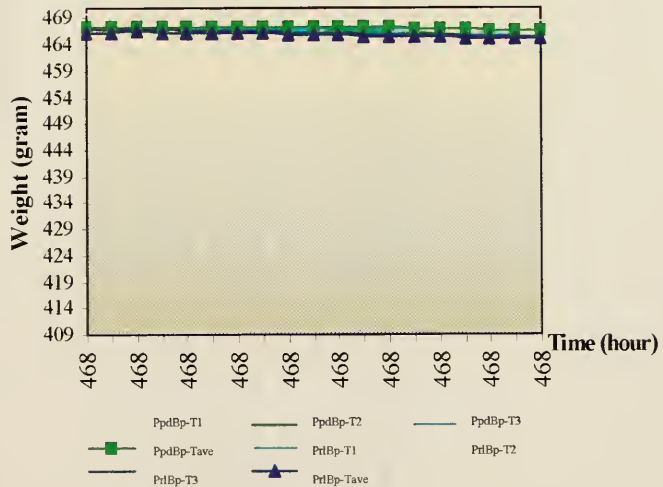
### Water Vapor Transmission (Treated Stone)
