BEHIND THE CURTAIN:  
MECHANICAL TREATMENTS FOR BOWED MARBLE PANELS

A THESIS

Historic Preservation

MASTER OF SCIENCE IN HISTORIC PRESERVATION

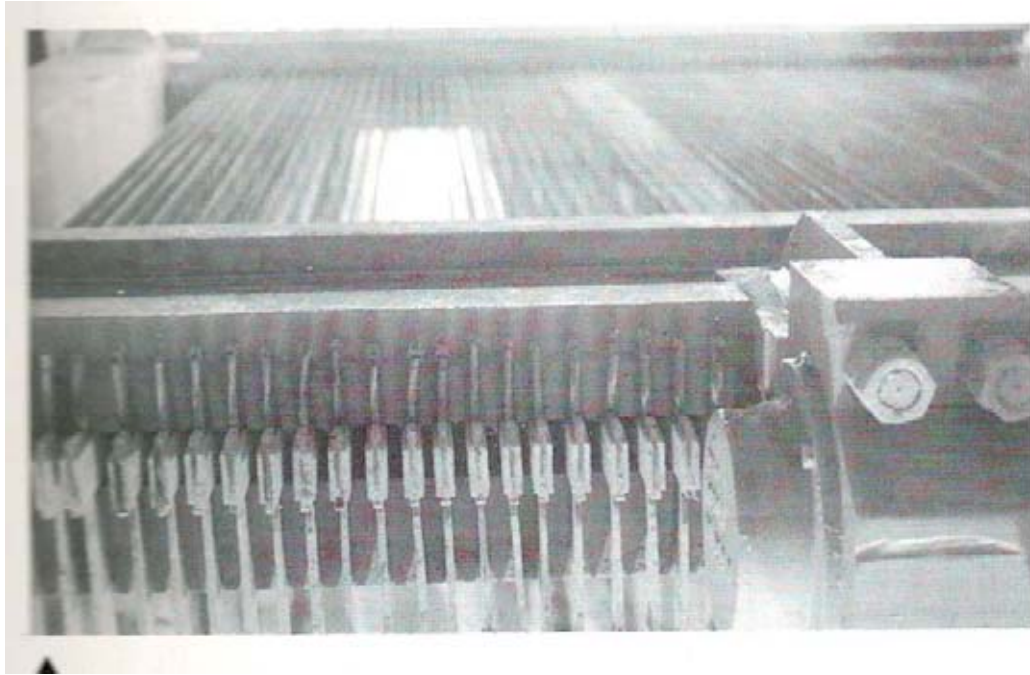
**Figure 1.1 Multi-bladed gang saw. (Photo from Lewis, 19.)**

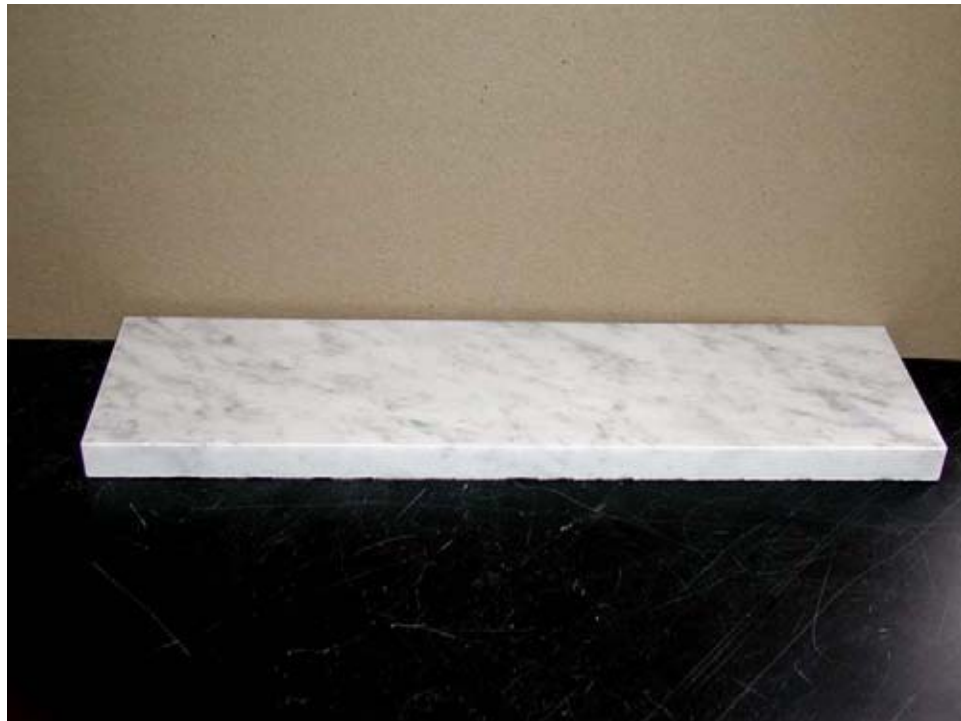
**Figure 3.1 Carrara marble sample.**

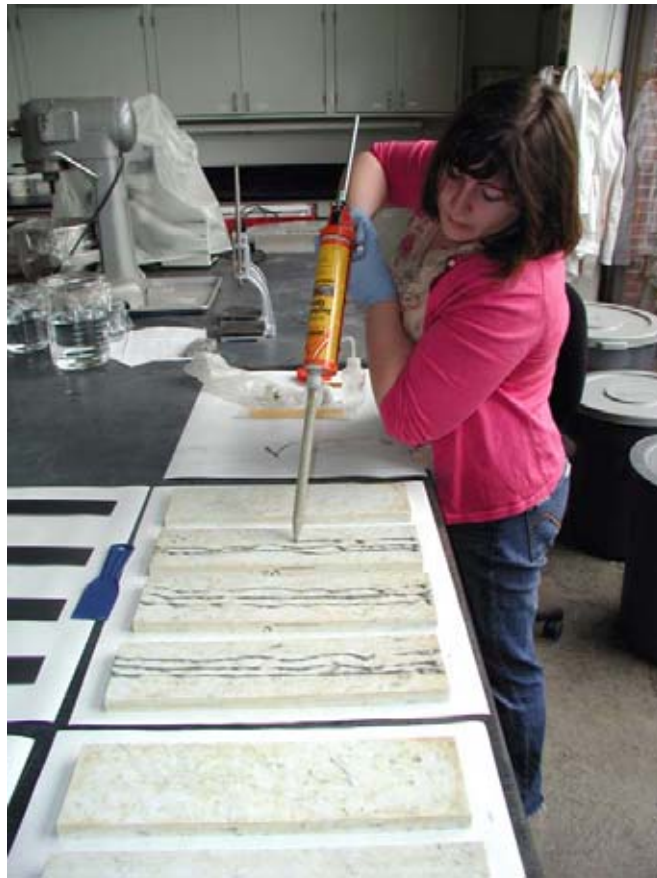
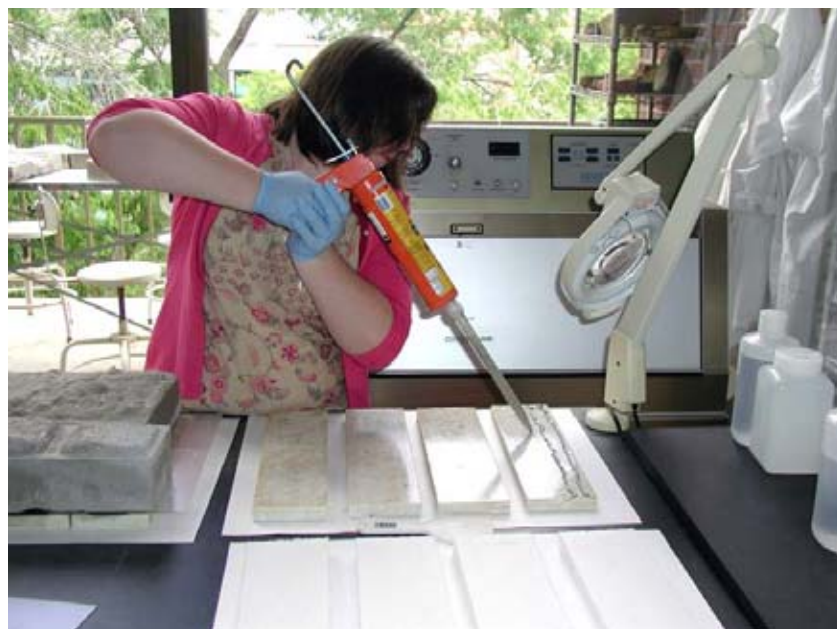
**Figure 3.4 Step one: Apply epoxy to the marble panel.**

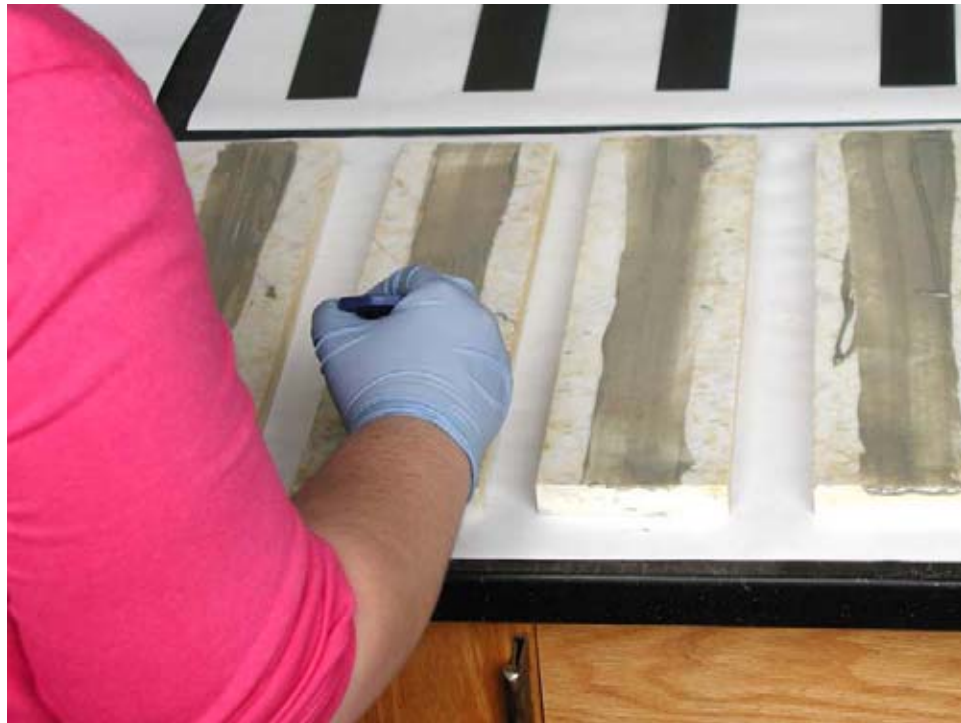
**Figure 3.5 Step two: Spread the epoxy over the marble panel.**

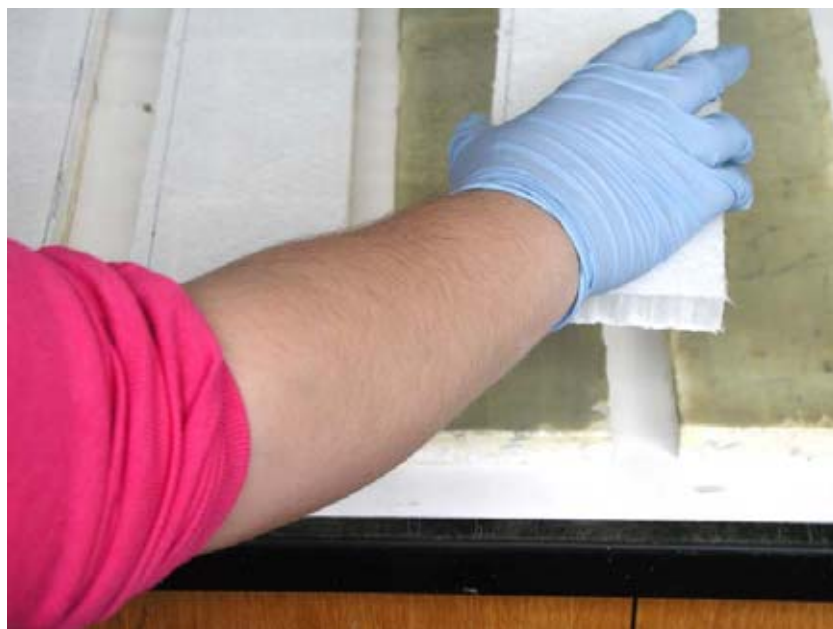
**Figure 3.6 Step three: Apply treatments to the marble on top of the epoxy.**

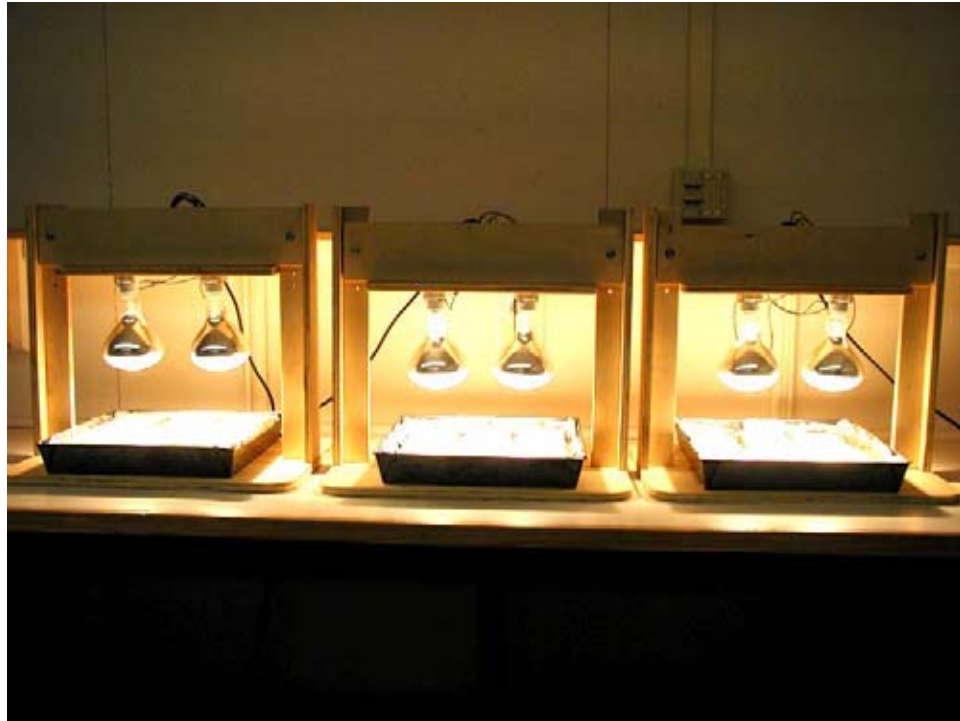
there are two wired light sockets for the infrared heating lamps. Three pieces of marble were placed on top of  $\frac{1}{2}$ " depth of glass marbles and sand in one steel pan (17" x 16" x 2  $\frac{1}{2}$ "). One of these set-ups was needed for the three samples that were cycled for twenty days, and three assemblies were needed for the nine samples that were cycled for forty days.

**Figure 3.8 Constructed bowing potential assemblies.**

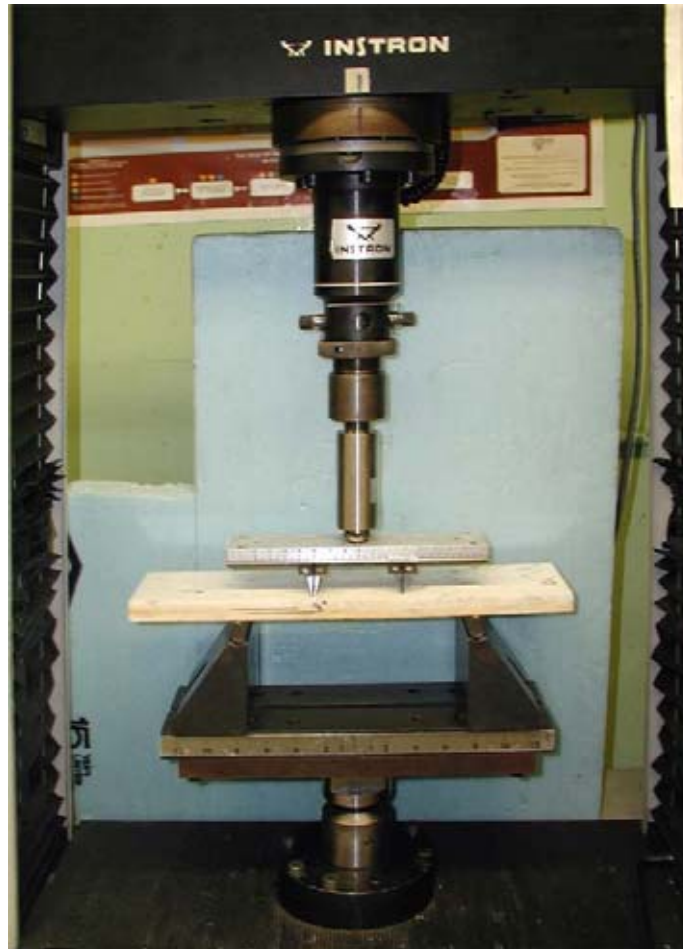
**Figure 3.12 Flexural strength, quarter-point loading Instron test assembly.**
