CONTROL OF BIODETERIORATION OF SANDSTONE  
ON THE FISHER FINE ARTS LIBRARY

A THESIS

MASTER OF SCIENCE IN HISTORIC PRESERVATION

The Fisher Fine Arts Library, on the campus of the University of Pennsylvania, was designed by the Philadelphia firm of Furness, Evans & Co. to serve as the university's main library. The library was constructed between 1888 and 1890 in the Gothic style with Romanesque elements. The apse of the building, located on the north side of the structure, is mostly faced with rough-cut sandstone blocks. The lower courses suffer heavy biocolonization, which is an aesthetical problem while also contributing to the deterioration to the stone. As there is a complete record of past treatments that have been carried out on the building, this will allow to determine when biocolonization first became obvious and to analyze whether and when previous campaigns to eradicate it were carried out.

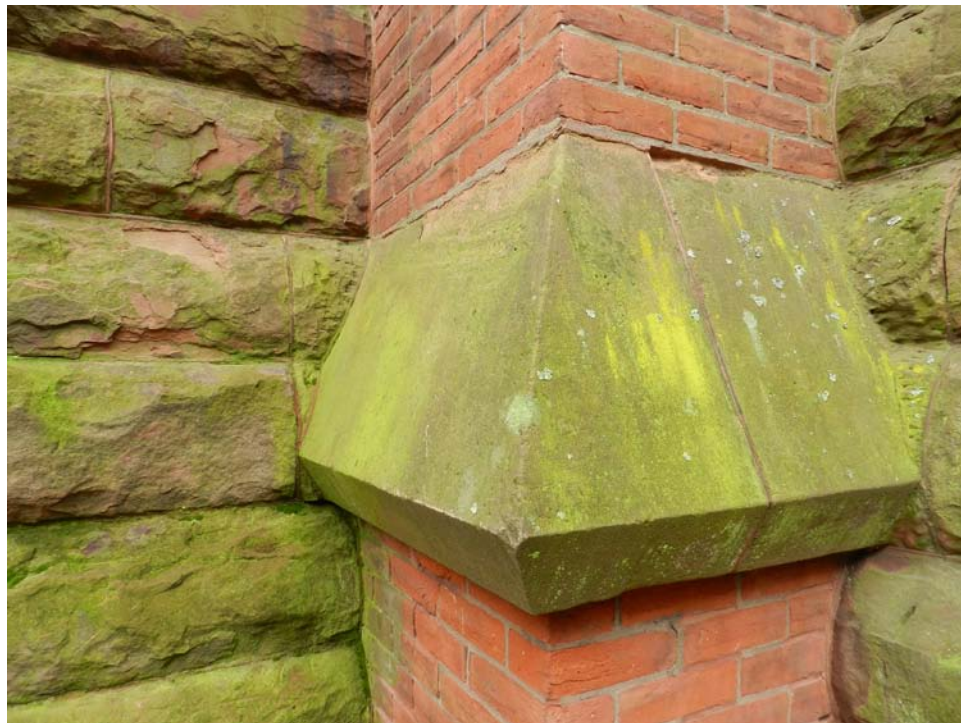
Figure 3.2: Green biocolonization, mostly algae and some lichens on the Fisher Fine Arts Library, 2012. (J. Focht)

Algae and cyanobacteria are photoautotrophic organisms that are devoid of tissues and organs (Figure 3.2). Algae consist of a diverse group of eukaryotic organisms that can be unicellular or multicellular which contain pigments such as chlorophyll, carotenoids, and xanthophylls.<sup>30</sup> Depending on the type of pigment present, algae can appear in a variety of colors, green, gray, black, orange, yellow, brown, red or violet. Cyanobacteria are prokaryotic organisms which are actually bacteria, but they are commonly referred to as blue-green algae, where each cell is surrounded by a gelatinous pigmented sheath that provides color to the cell and allows for rapid absorption and the slow release of moisture allowing the microorganism to survive in adverse environmental conditions, such as persistent desiccation.<sup>31</sup> The color of cyanobacteria can be golden yellow, brown, red, emerald green, dark blue, violet, and azure.

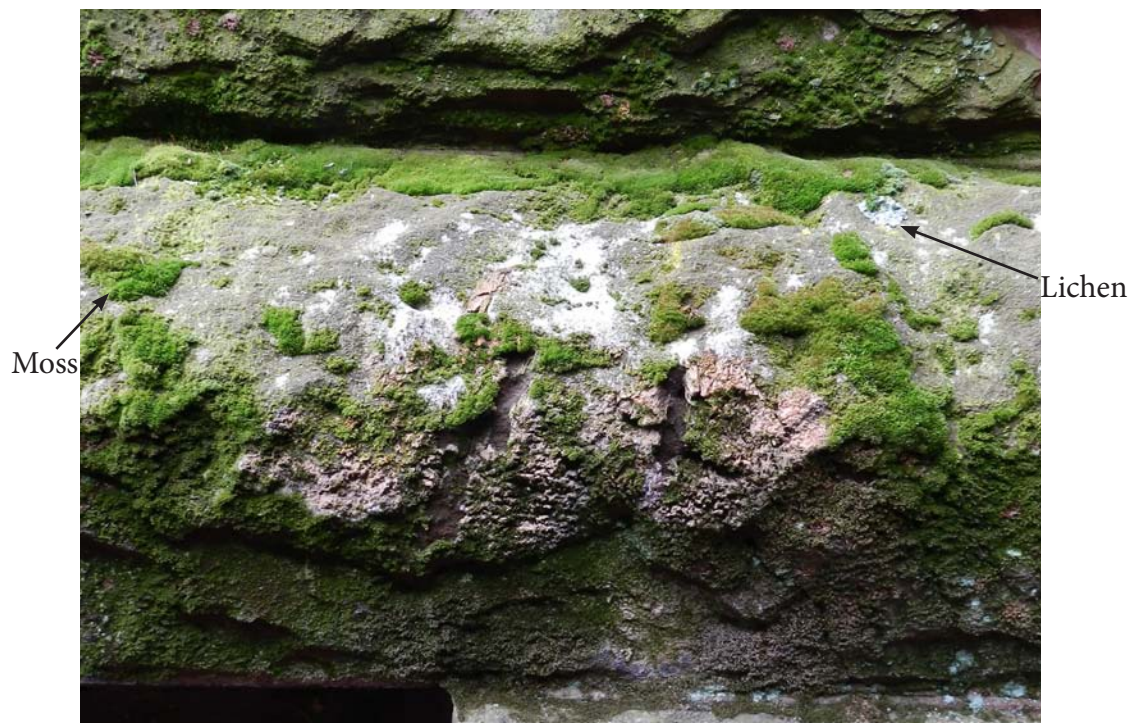
Figure 3.3: Fisher Fine Arts Library, 2012. 1. Lichens. 2. Moss. (J. Focht)

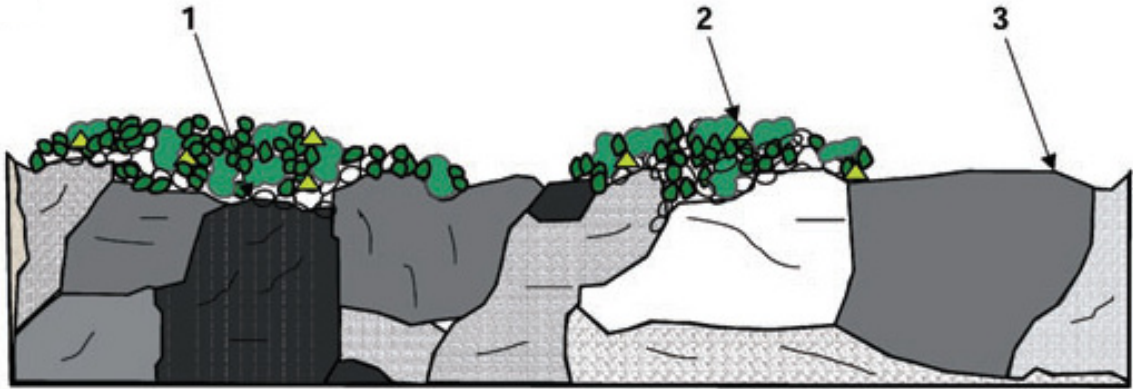
Figure 3.4: Interaction between substrate, microorganisms, and atmosphere in a SAB. 1. inter-organism interaction, 2. biofilm - atmosphere interaction, 3. atmosphere - substrate interaction. (Gorbushina, "Life on the Rocks")

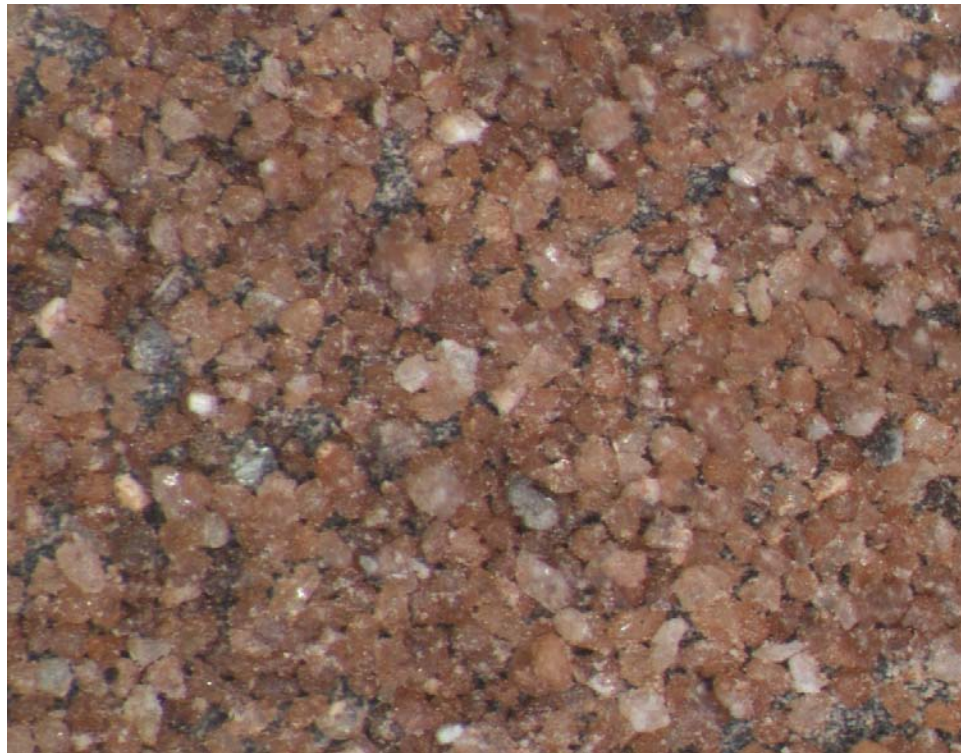
Figure 5.2: Particles retained on the 150 mm sieve magnified to 4.0x.

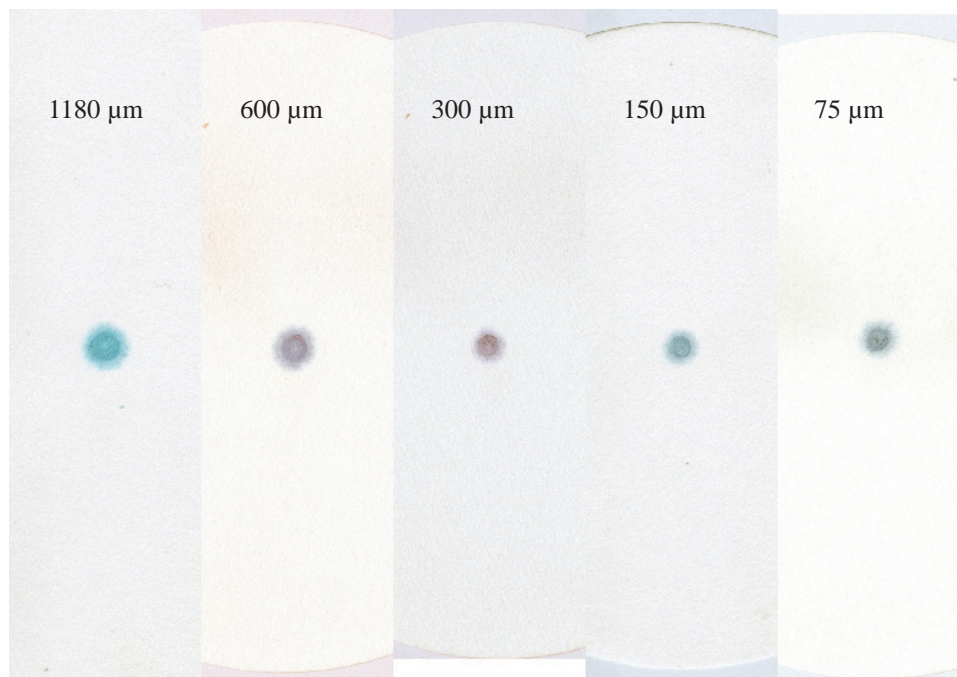
Figure 5.3: Methylene Blue test results.

The Methylene Blue test<sup>75</sup> was applied to all particle sizes retained on 1180, 600, 300, 150, and 75 micron screens. Since a halo was formed around all test spots, as shown in Figure 5.3, this indicates that none or very few expansive clays are found in this stone.

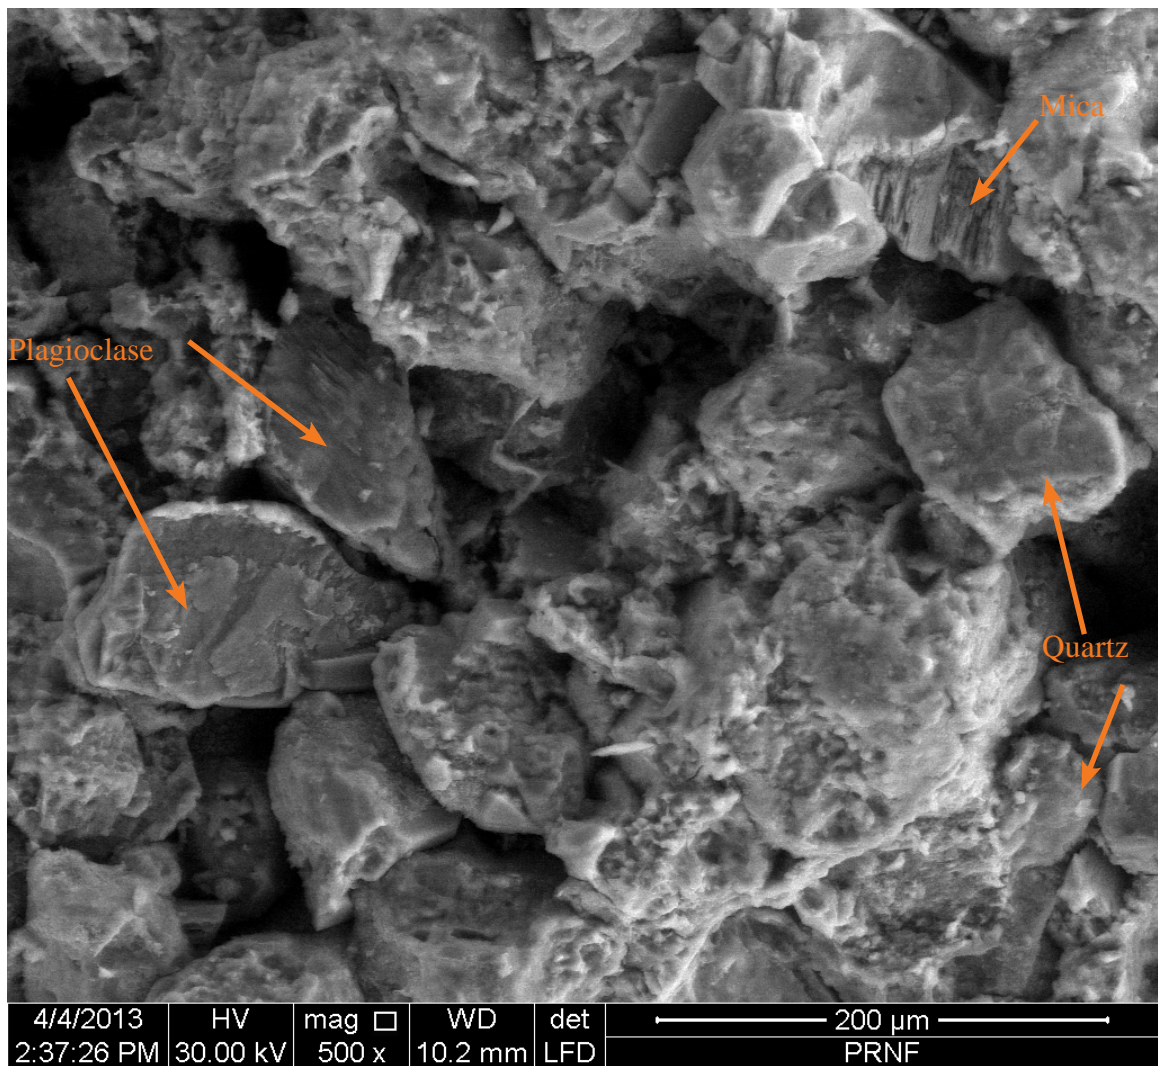
Figure 5.11: Quartz and plagioclase feldspar grains in the fracture surface of the control sample.

ESEM was carried out on three sandstone specimens from the library; a stone free of biocolonization that served as a control, one with green biocolonization, and the third one with black biocolonization. The images obtained with the ESEM provide three-dimensional images of the sandstone morphology as well as that of the surface biocolonization. These images also contribute information about the micromorphology and mineralogy of the stone. The control sample was a fracture surface and provided a clear look at a fracture surface, showing the individual quartz and plagioclase feldspar grains as well as the overall texture (Figure 5.11). Figure 5.12 exemplifies the plate structure of the plagioclase feldspar grains that can be found in this sandstone. When looking at this sample, a honeycomb like coating was noticed on some of the grains (Figure 5.13). Using Energy Dispersive Spectrometry (EDS) it was determined that this coating corresponds to iron oxide and/or ferruginous clays.

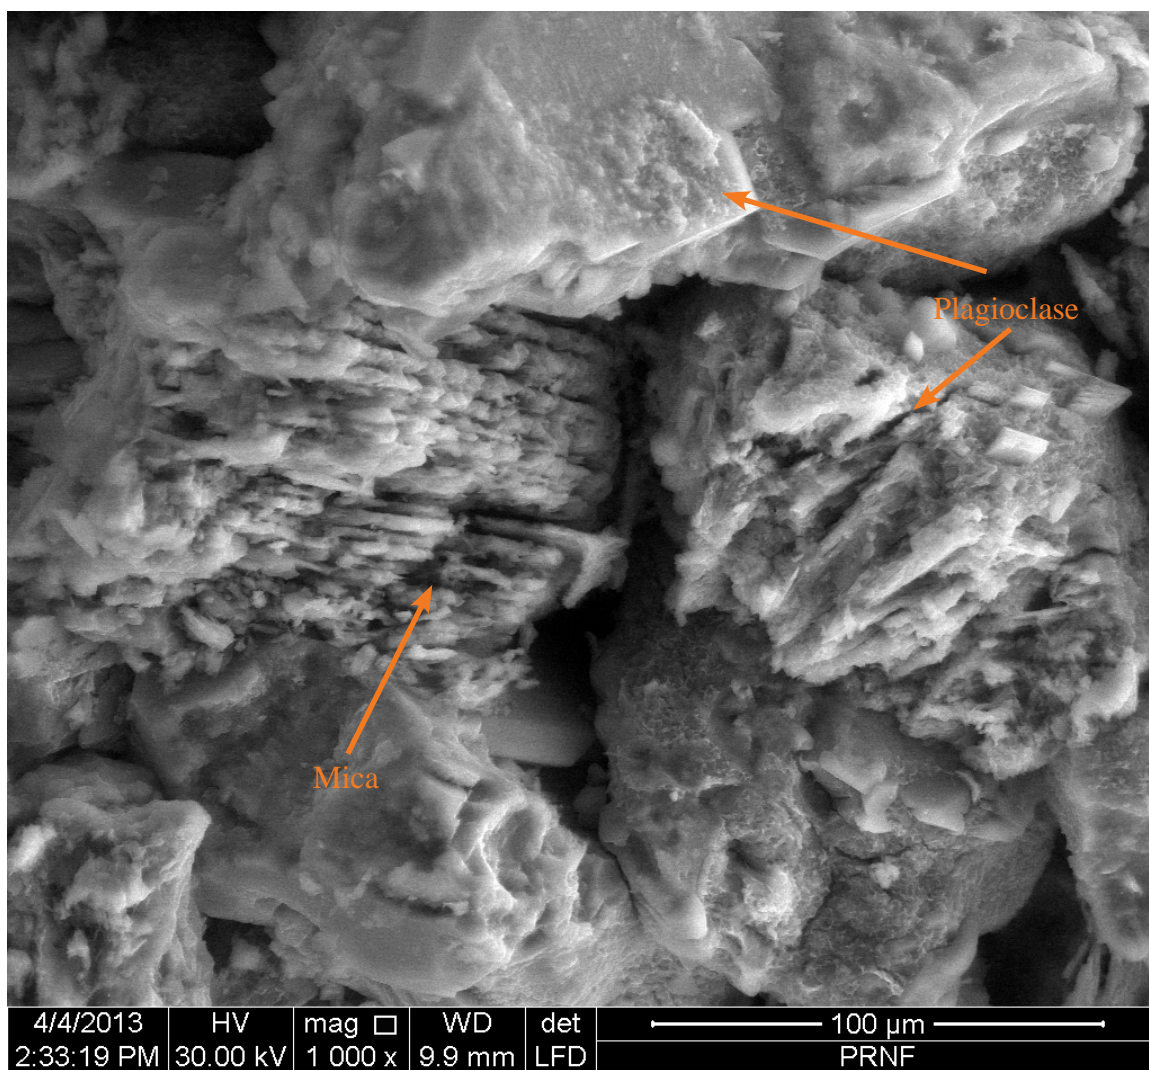
Figure 5.12: Grains of weathered plagioclase feldspar and detail of mica booklets from the above control sample.

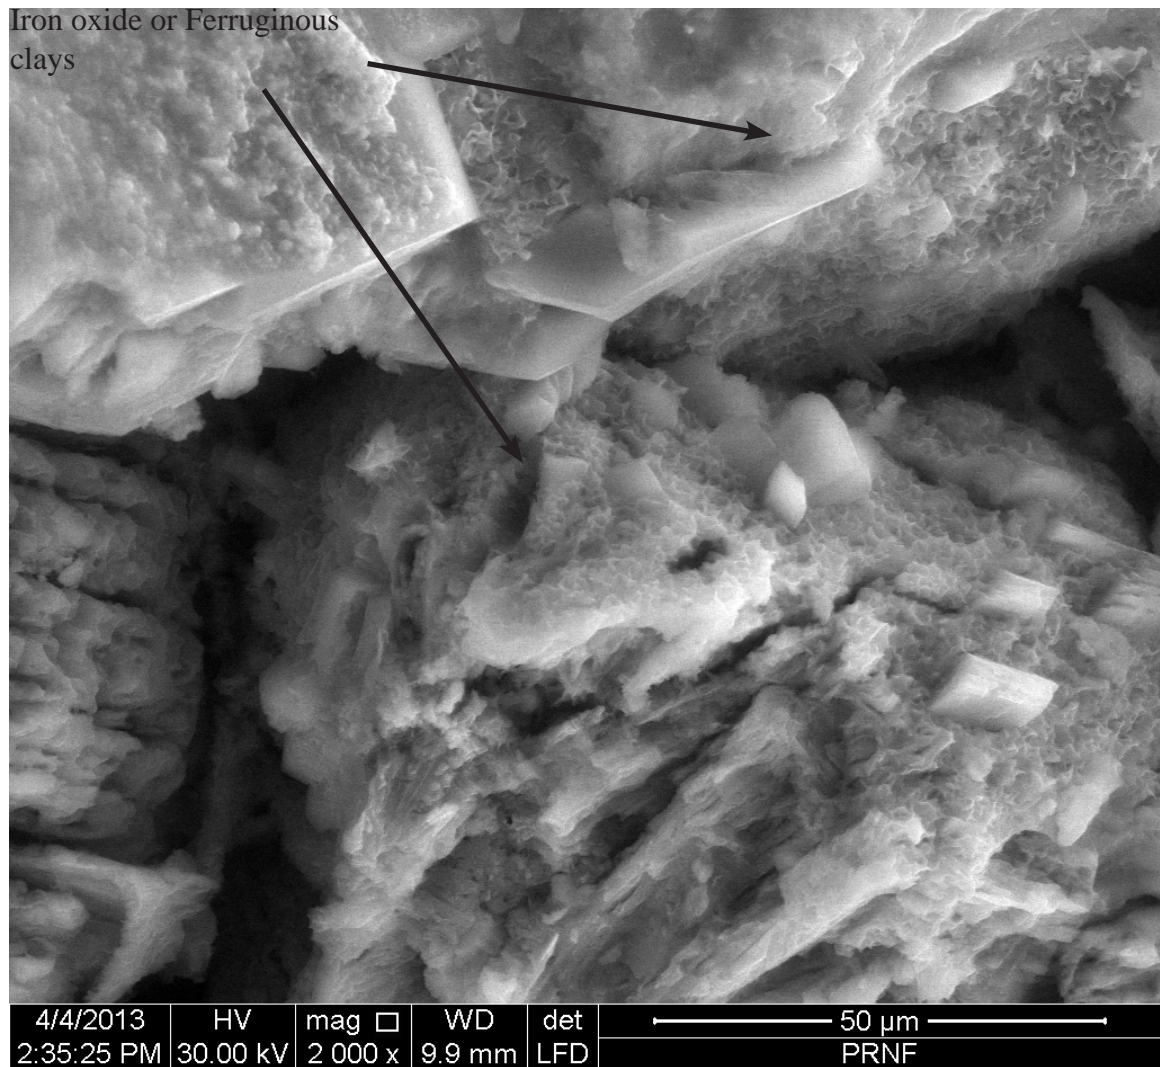
Figure 5.13: Iron oxide or ferruginous clay coating on the grains on the fracture surface of the control sample.

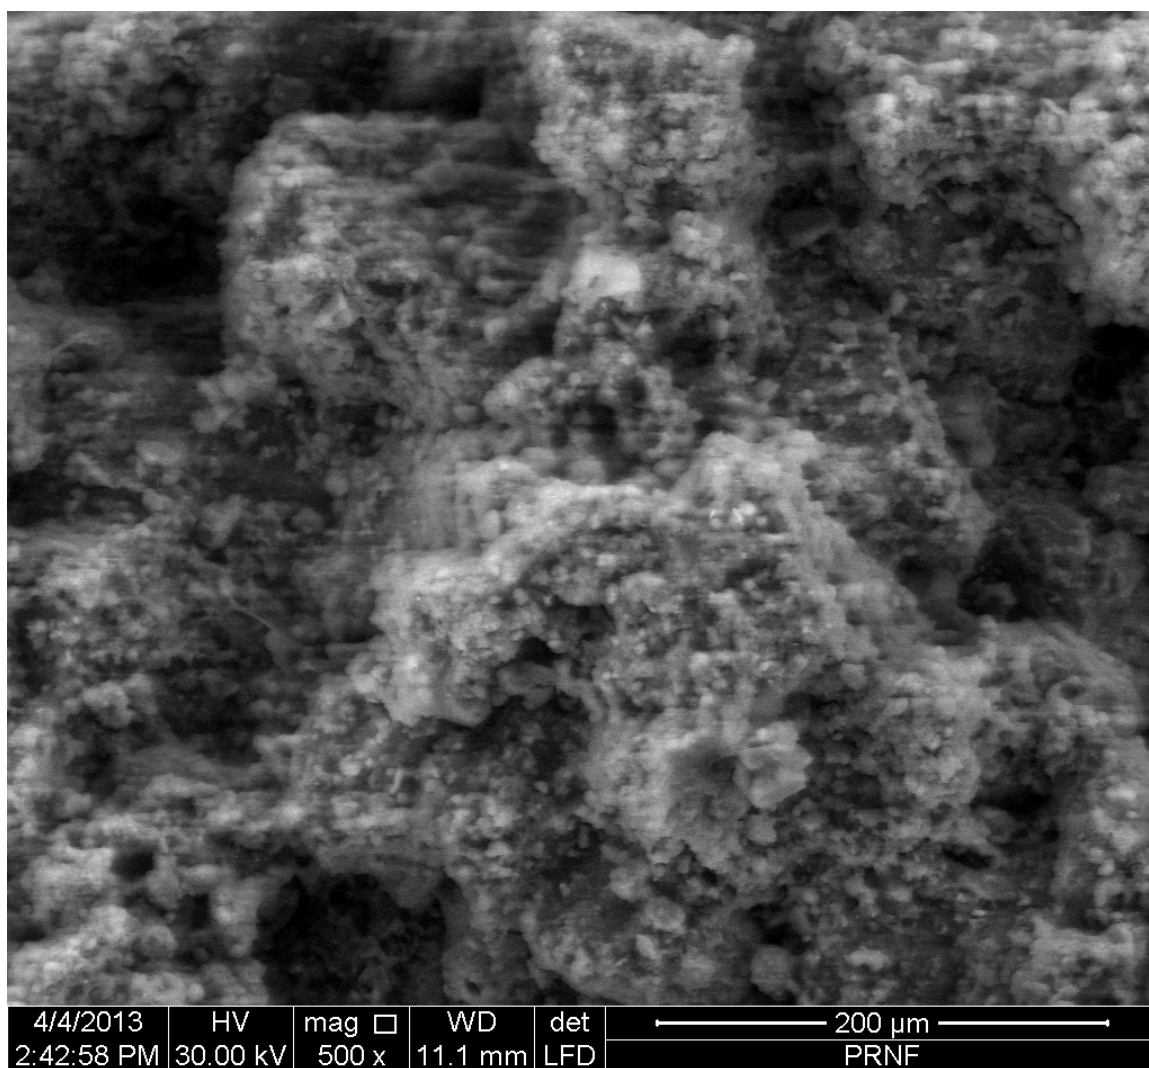
Figure 5.14: Appearance of the black biocolonization covering the surface of the stone.

Two areas of the black biocolonized stone surface were observed. In the first area the biocolonization completely coated the surface of the mineral grains (Figure 5.14) and in the second area the biocolonization was thinner and more sporadic, which allowed the grains to be seen through the biocolonization (Figure 5.15). Under higher magnification it became evident that biocolonization had established itself between the grains of the stone (Figure 5.16).

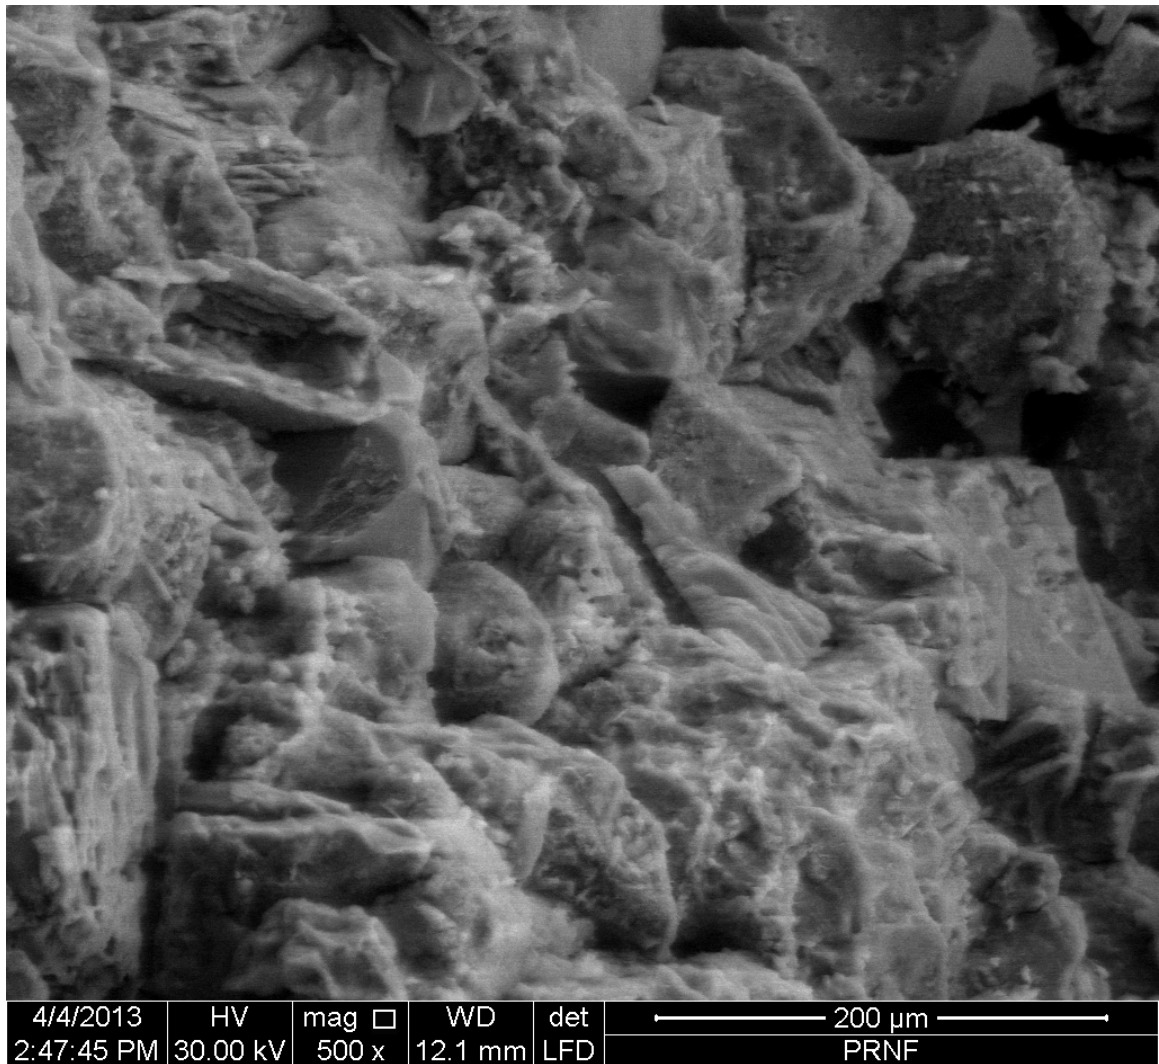
Figure 5.15: Black biocolonization in the subsurface of the stone.

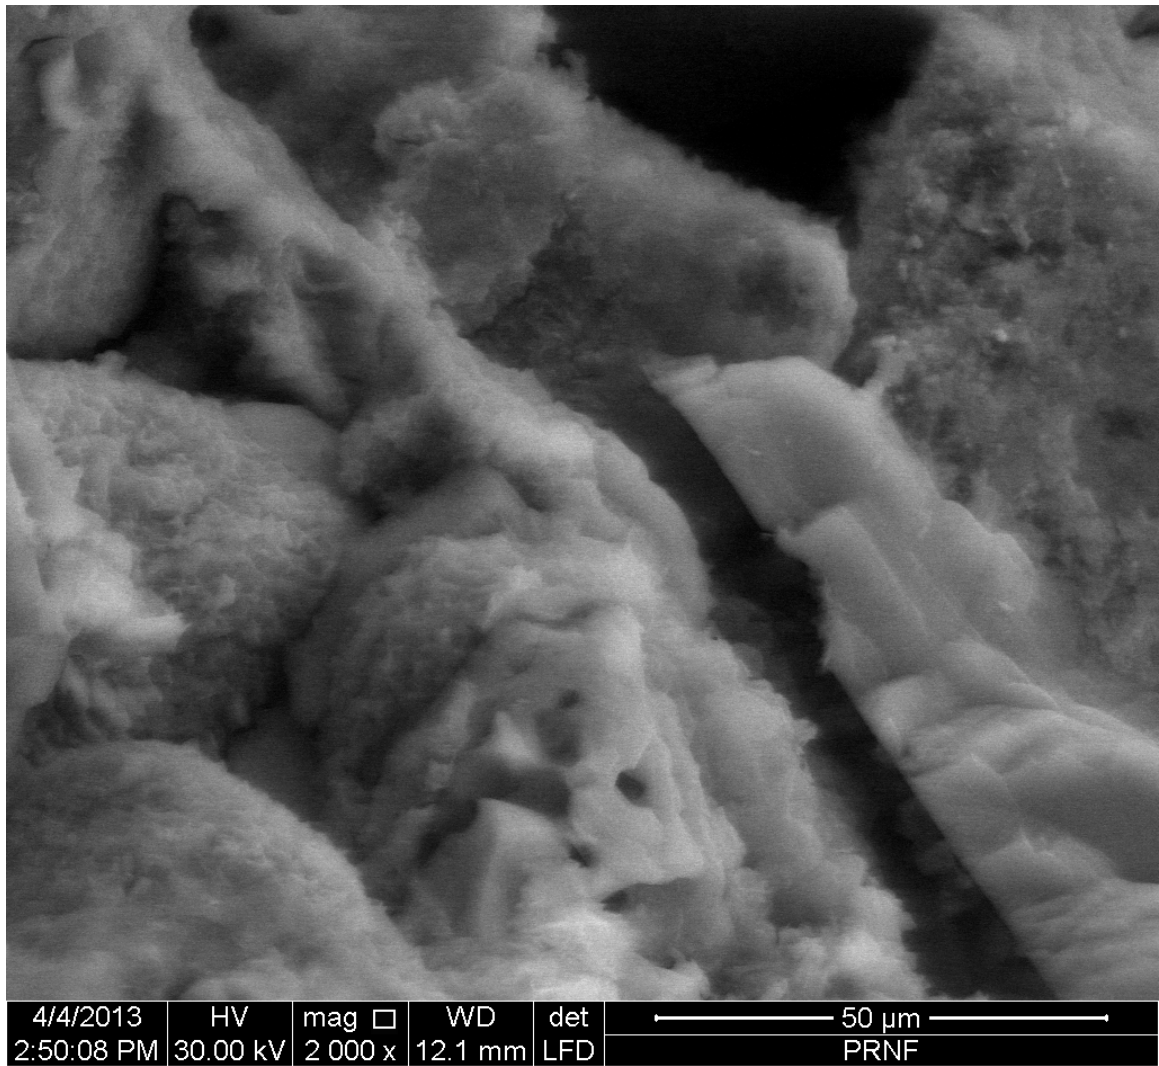
Figure 5.16: Detail of the black biocolonization from the previous figure.

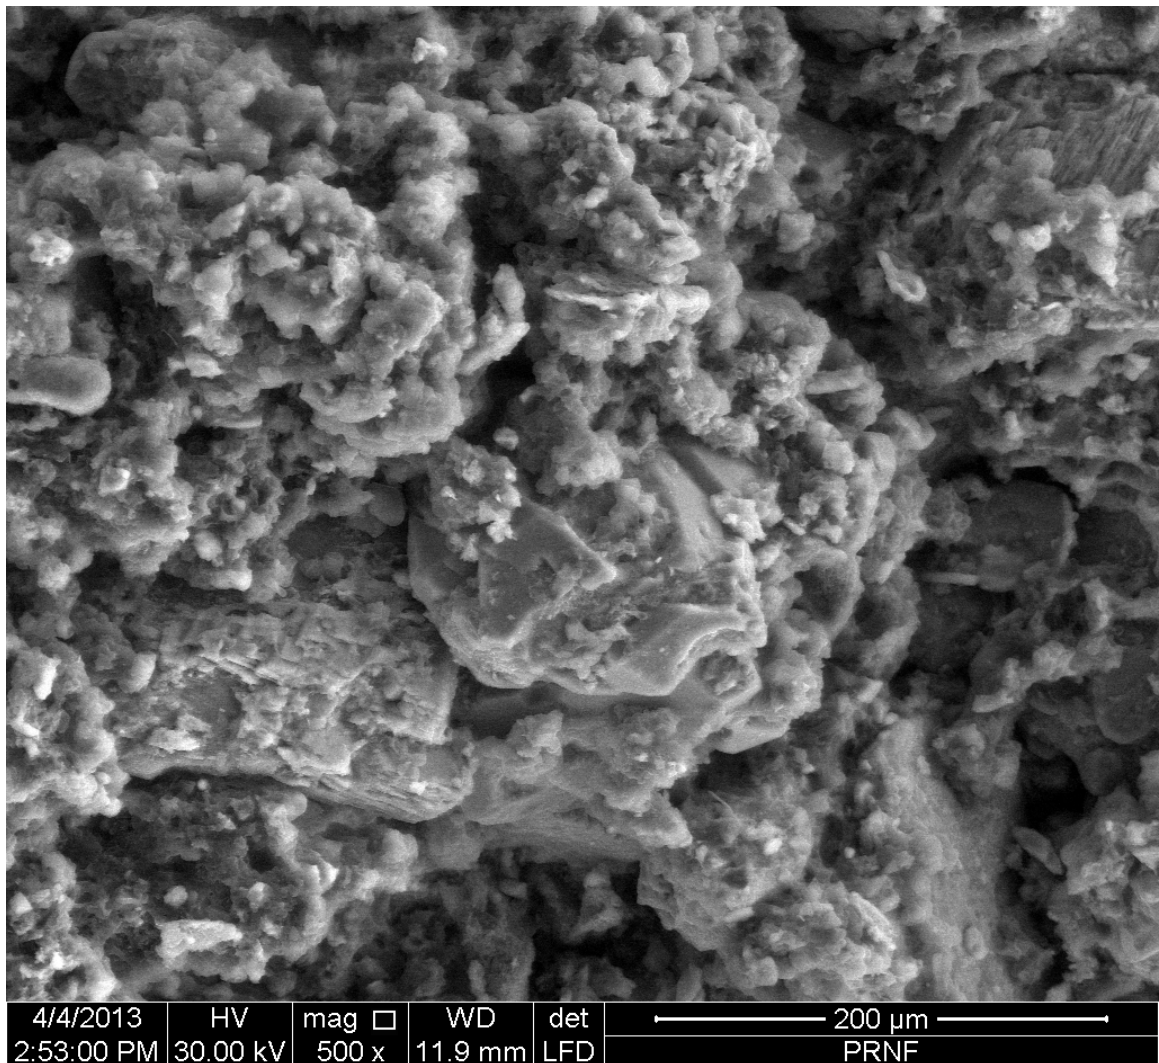
Figure 5.17: Green biocolonization covering the surface of the stone.

The green biocolonization appears to be more evenly distributed on the surface of the sample. Two areas were examined and on both the mineral grains could be observed under the green biofilm (Figure 5.17 and 5.18). At higher magnification the individual cells of the microorganisms present in the biofilm could be distinguished, as seen in Figure 5.19. While individual species of microorganisms could not be explicitly identified, it was suggested that the spherical cells seen in figure 5.19 might be algae.

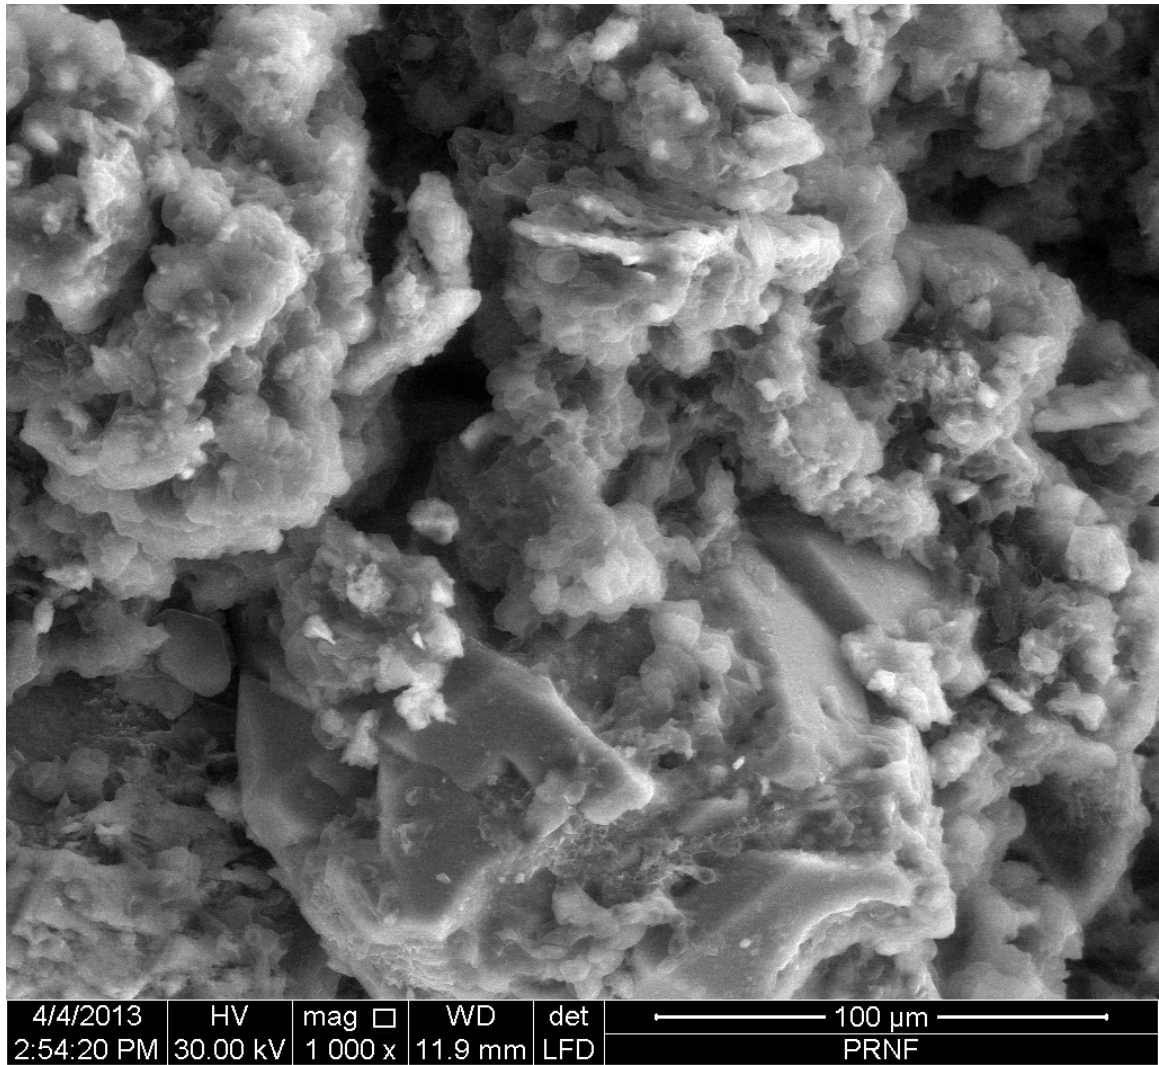
Figure 5.18: Green biocolonization partly covering a quartz grain.

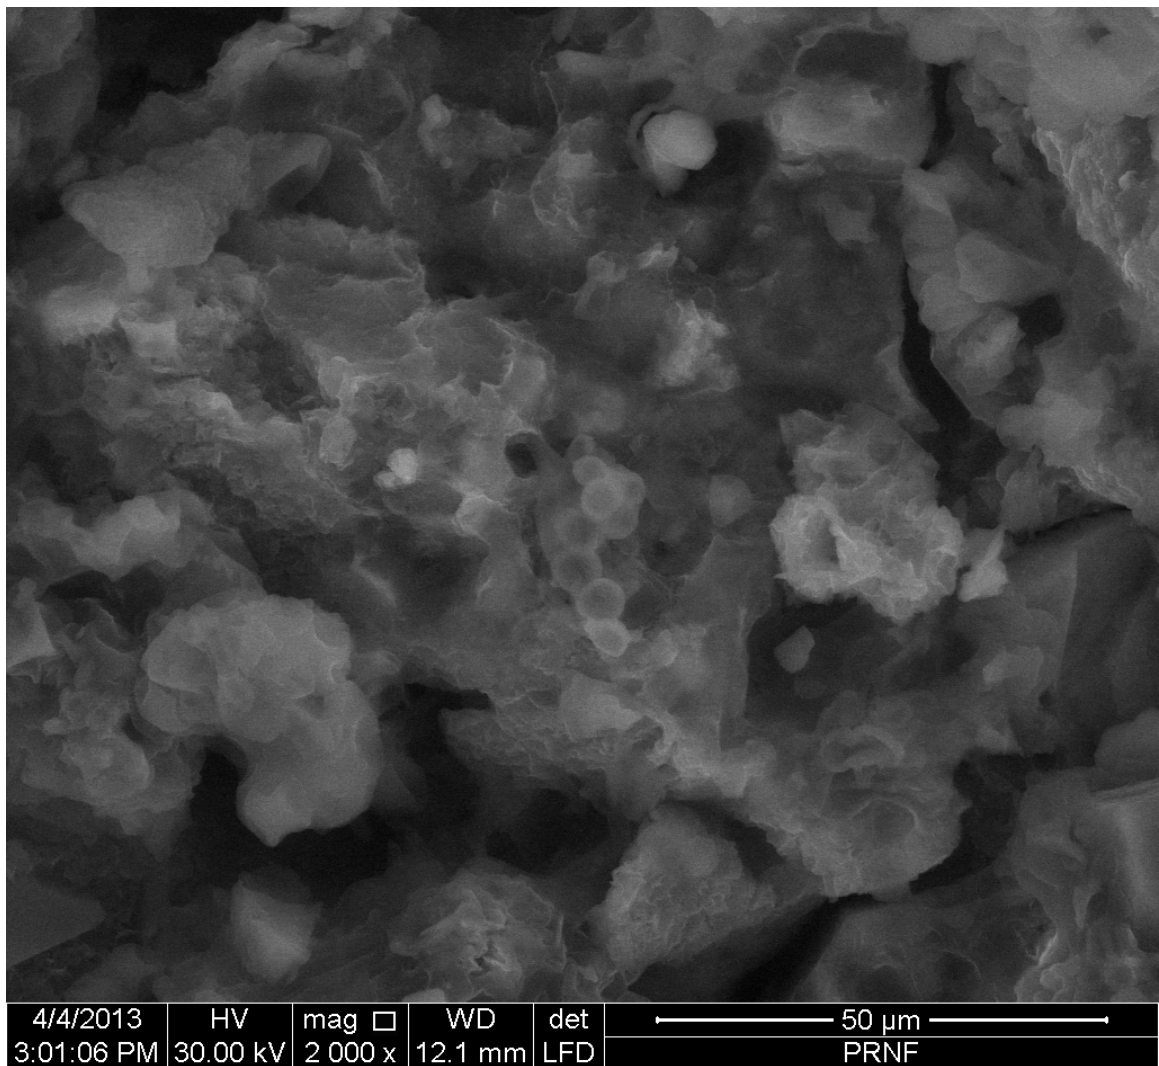
Figure 5.19: Some organisms of green biocolonization are visible in the center of the photo.

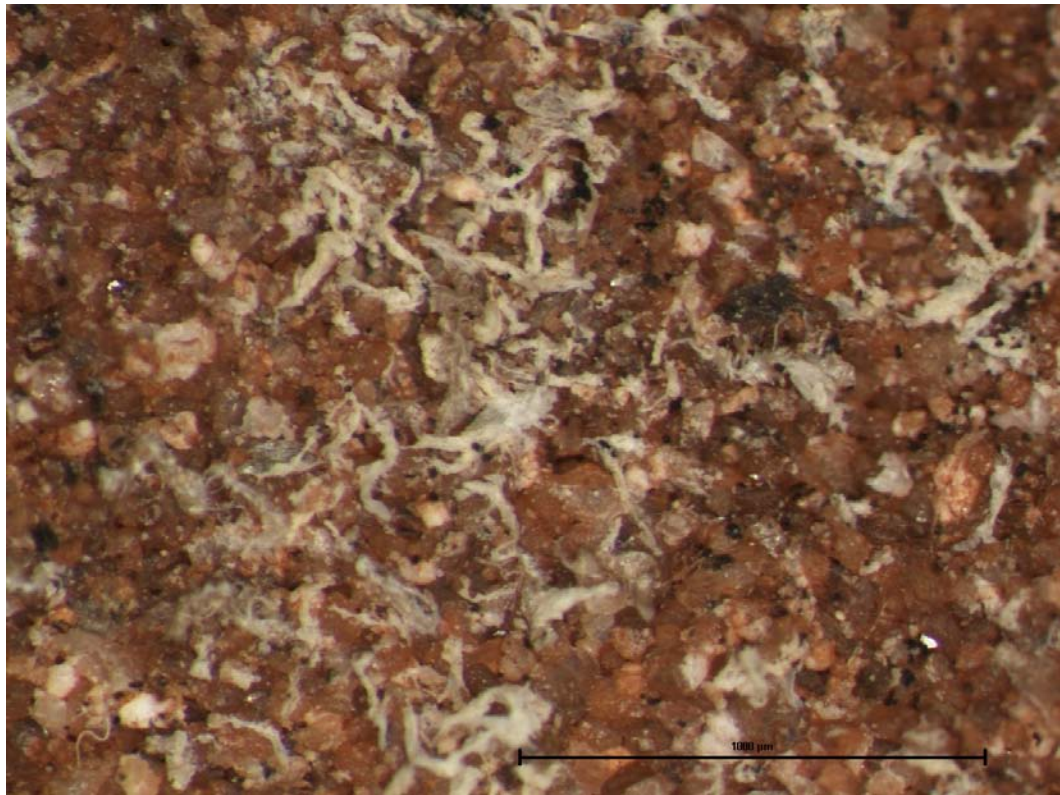
Figure 5.20: Underside of green biocolonized sample. The white threads appear to be fungal hyphae. Magnification 4x. Scale bar 1000μm.

A detached flake of the sandstone with green biocolonization was observed under a microscope to try to visualize the appearance of the microorganisms that are growing on the sandstone. Identification of these possible microorganisms is based on their appearance and would require a microbiologist to identify them. The different looking microorganisms are shown in Figures 5.20 through 5.23.

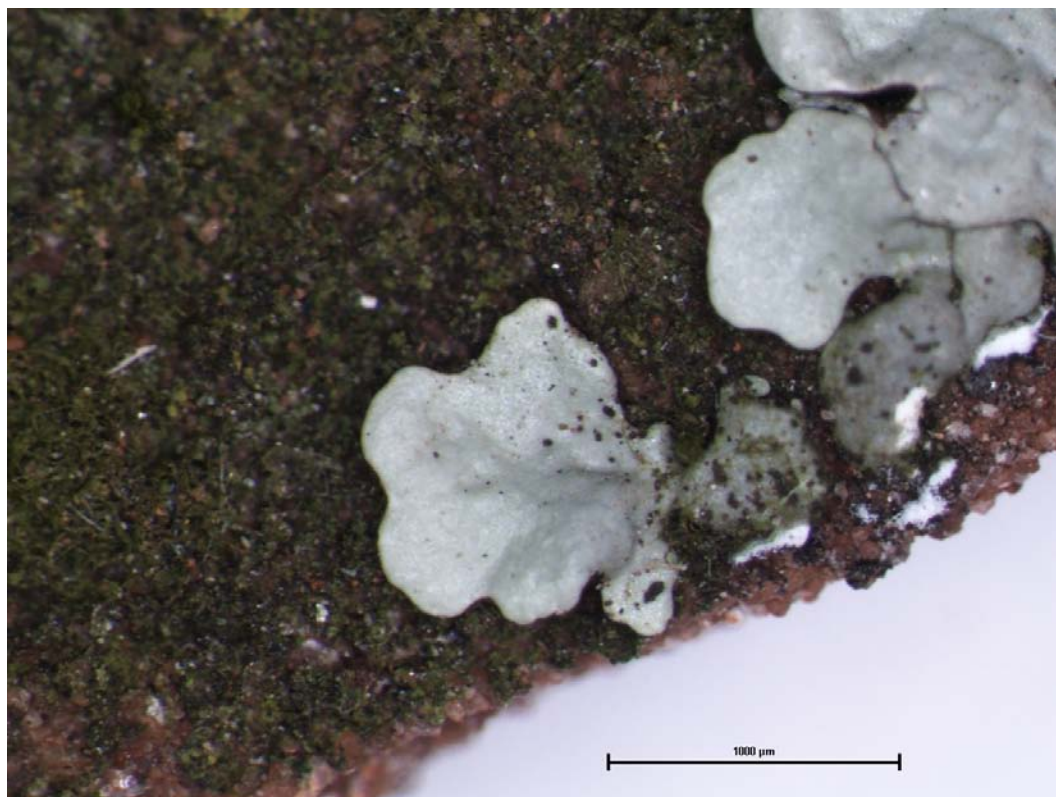
Figure 5.21: White lichen attached to the sandstone. Magnification 2.5x. Scale bar 1000μm.

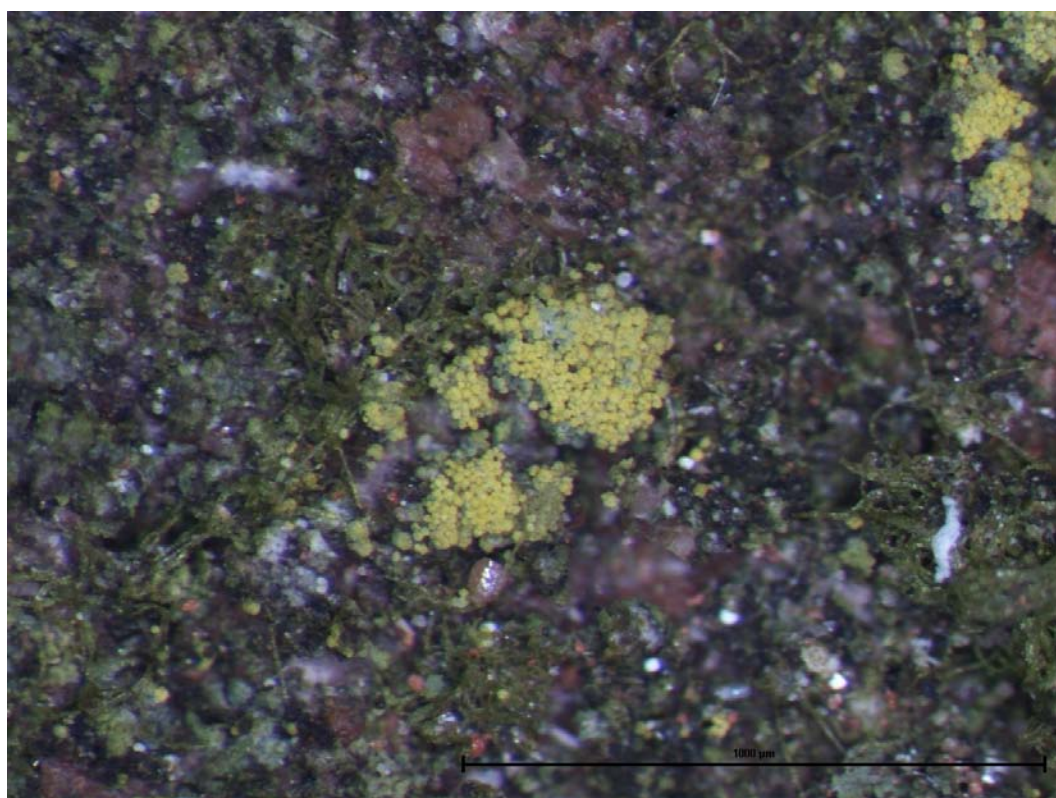
Figure 5.22: Lichen attached to the sandstone. Magnification 5x. Scale bar 1000μm.

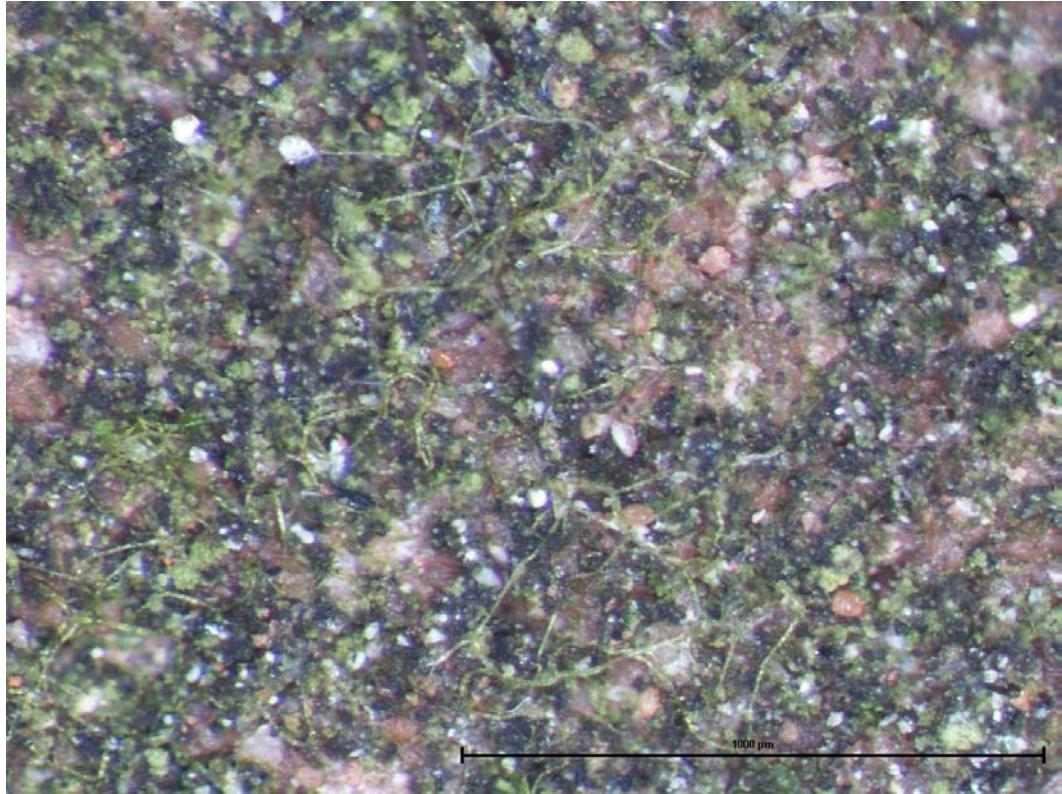
Figure 5.23: The green organisms on the surface of the flake are presumably algae, while the strands would correspond to fungal hyphae.. Magnification 5x. Scale bar 1000µm.

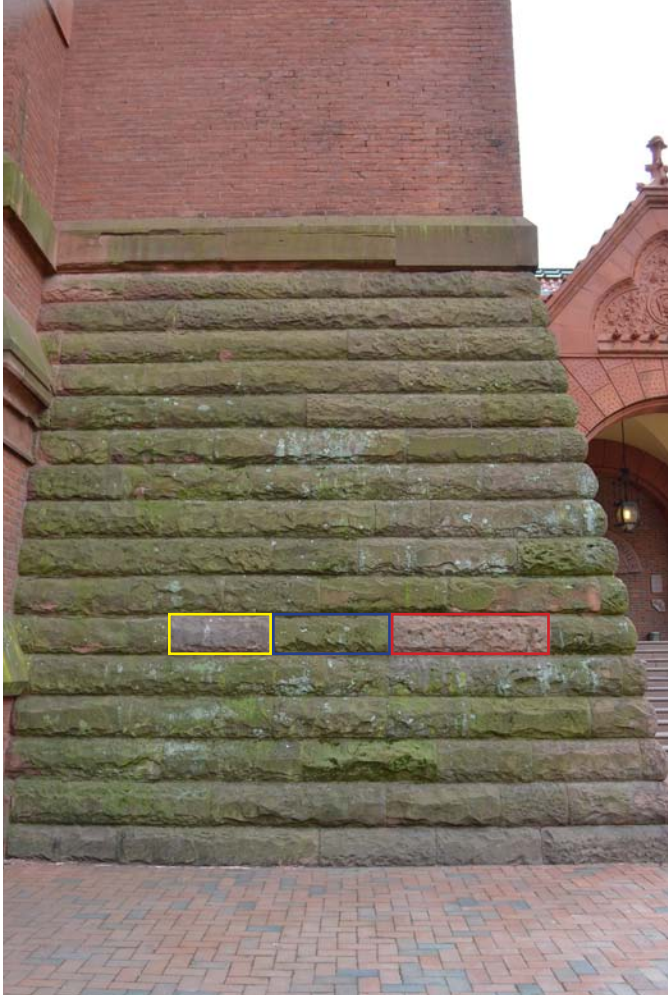
Figure 6.2: North wall of Fisher Fine Arts Library. Test area for green biocolonization. Yellow is D/2 test area. Blue is control. Red is BioWash test area. (Right)

Figure 6.3: West side of the Fisher Fine Arts Library apse. Test areas for black biocolonization. Yellow is D/2 test area. Blue is control. Red is BioWash test area. (Bottom)

The test areas located on the fifth course of stone from the ground and consist of three stones each, one for each of the two biocides and the third, located between the two, an untreated stone serving as a control. Having the untreated stone in the middle provides a buffer between the two biocides. Due to the fact that different types of biocolonization appear on the building in different locations, the green biocolonized test area is on a north facing wall (Figure 6.2) so as to have it at the same height as the black biocolonized test area on a west facing wall (Figure 6.3).

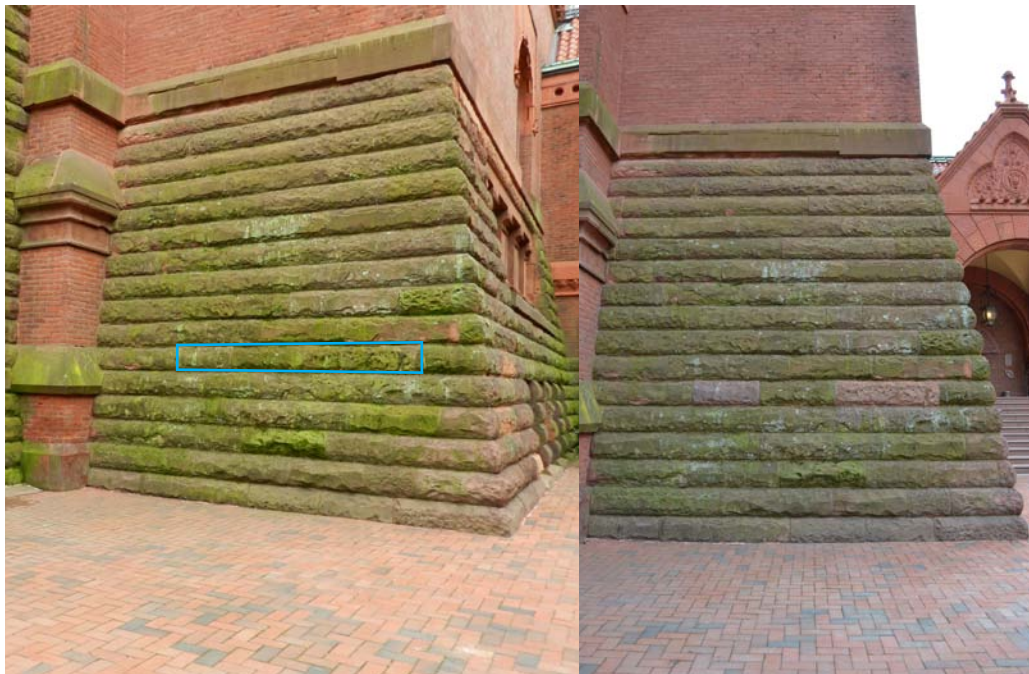
Figure 7.2: North wall of the Fisher Fine Arts Library where the treatment was applied to remove green biocolonization. Left, in May 2012 . Right, March 2013 four months after biocide application. Note that the stones to which the biocide(s) was applied can be easily identified.

Prior to the application of the two biocides photographs were taken of the chosen test blocks. The same images were then taken after treatment to visually compare the effectiveness of the biocides. Comparison of photographs before and after a treatment application is fundamental in documenting any action taken on a historic building. The photographs below (Figure 7.2) shows the area on the building where green biocolonization has developed, located on the north wall adjacent to the apse, before and after treatment. Note that this wall does not receive much sunlight which explains why green biocolonization has reached higher courses than on the apse.

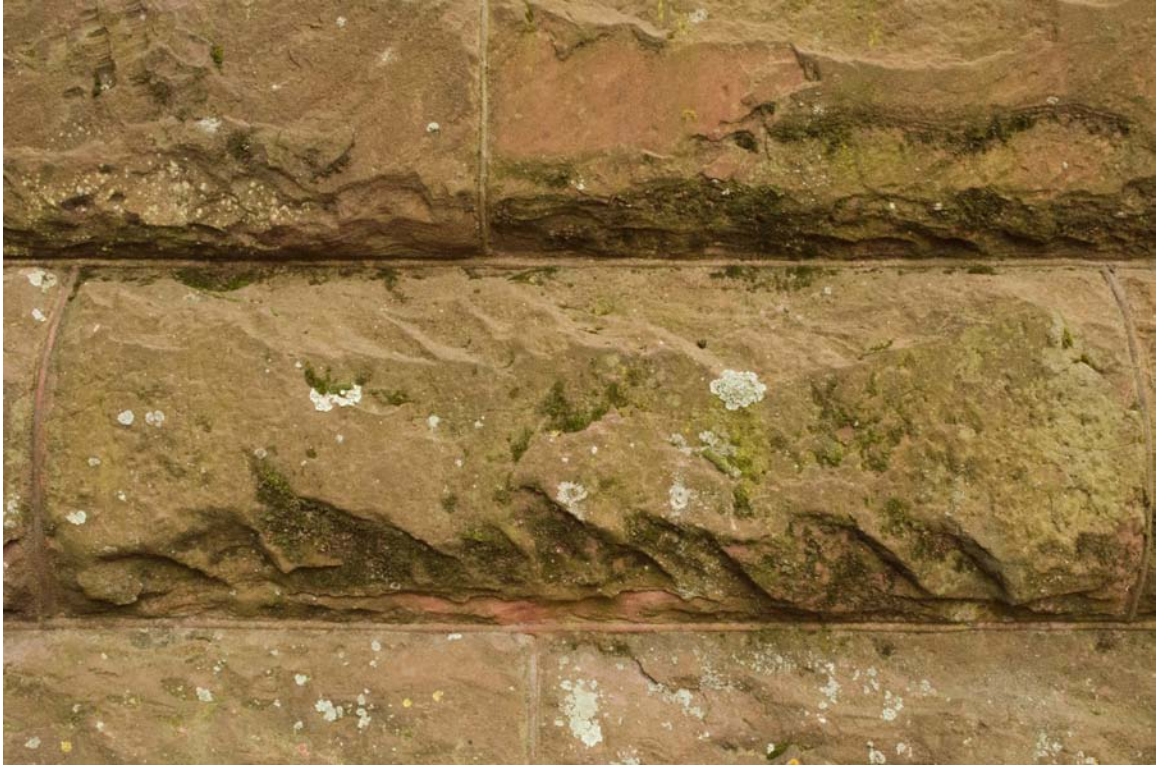
Figure 7.3: Top. Control block for green biocolonization, November 2012. Bottom. The same block ,four months later, March 2013.

Close up photographs of the blocks show the results better, but it has to be considered that the initial photographs were taken in the fall, when biocolonization was in decline. Figure 7.3 depicts the control block for green biocolonization, before and four months after treatment. Note the increased biocolonization as spring begins.
