CONTROL OF BIODETERIORATION OF SANDSTONE  
ON THE FISHER FINE ARTS LIBRARY

A THESIS

MASTER OF SCIENCE IN HISTORIC PRESERVATION

The Fisher Fine Arts Library, on the campus of the University of Pennsylvania, was designed by the Philadelphia firm of Furness, Evans & Co. to serve as the university's main library. The library was constructed between 1888 and 1890 in the Gothic style with Romanesque elements. The apse of the building, located on the north side of the structure, is mostly faced with rough-cut sandstone blocks. The lower courses suffer heavy biocolonization, which is an aesthetical problem while also contributing to the deterioration to the stone. As there is a complete record of past treatments that have been carried out on the building, this will allow to determine when biocolonization first became obvious and to analyze whether and when previous campaigns to eradicate it were carried out.

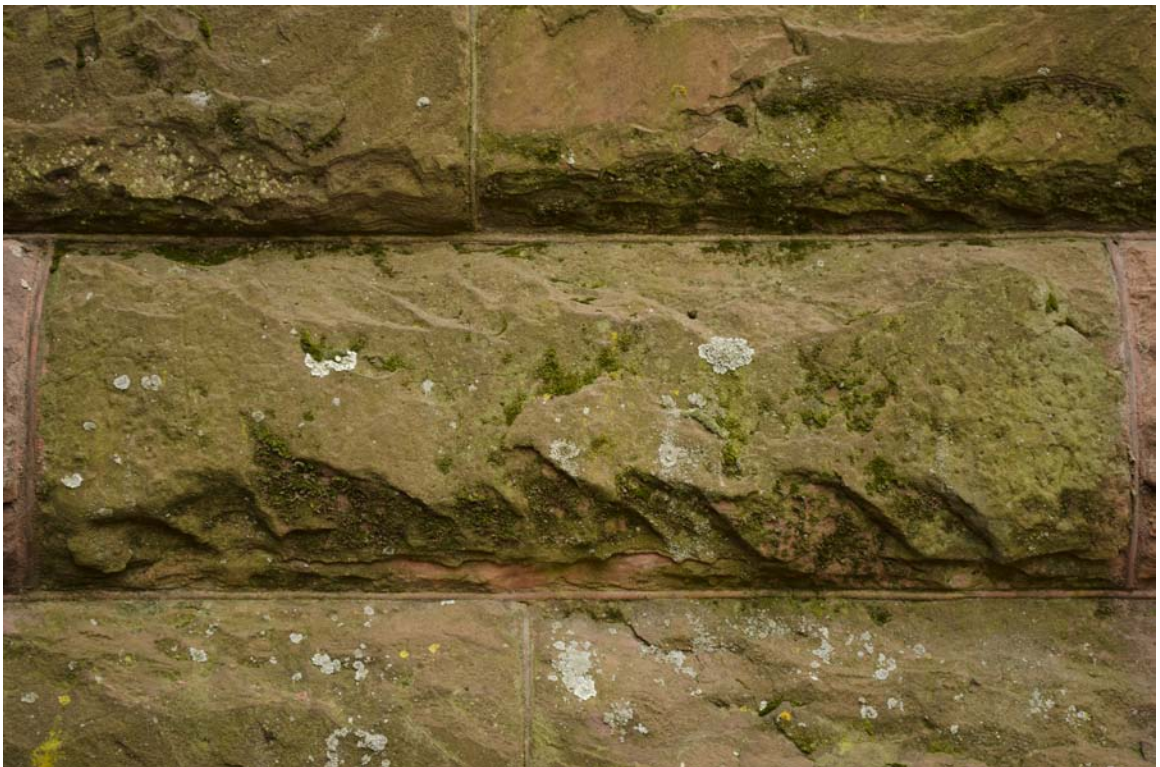
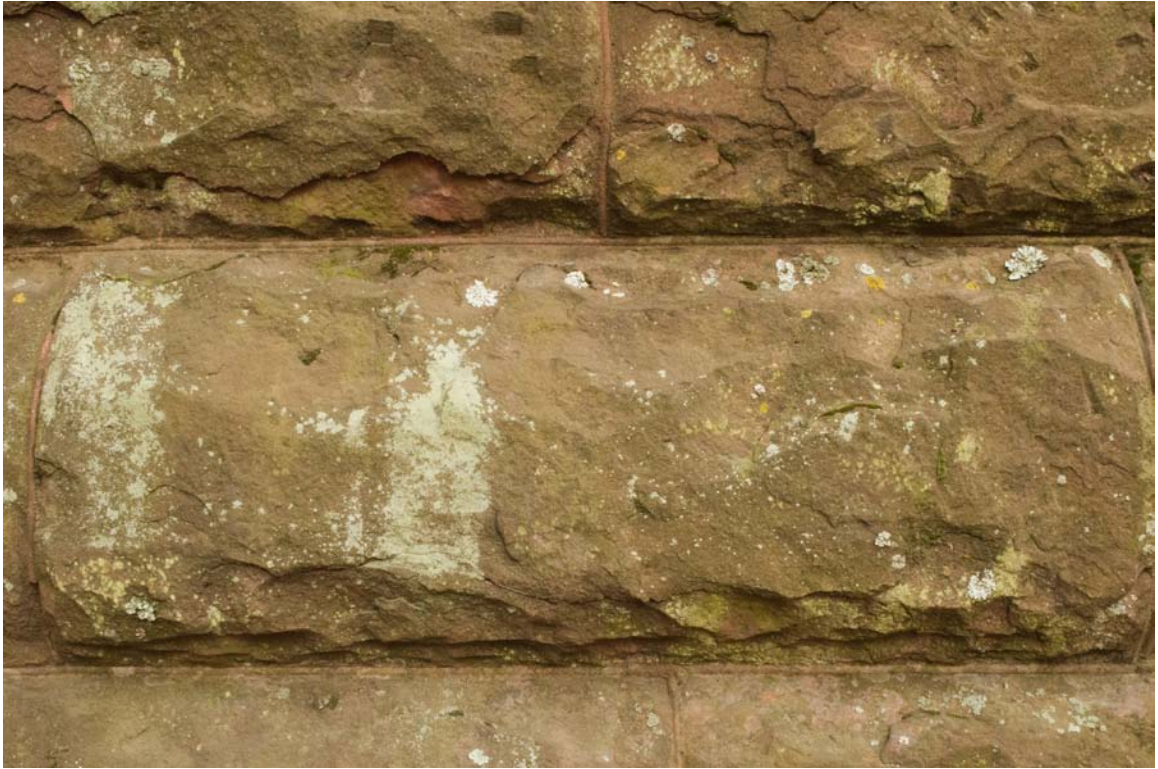
Figure 7.4: Top. Block with green biocolonization in November 2012 before application of the D/2 biocide. Bottom. The same block after 4 months (March 2013). Note that the biocide prevented growth of biocolonization (compare with the blocks above and below) and that it even managed to eliminate some of the white lichens that were present on it.

The green biocolonized block treated with D/2 is shown in Figure 7.4 and it can be seen that the biocide prevented biocolonization (compared with blocks above and below) and that it even managed to eliminate some of the white lichens that were present on it. As a result of the biocide application the microorganisms died, and the color of some of them changed. This can be seen with the lichen in the upper right hand corner of this block, which turned a reddish-brown color, almost the same color as the sandstone.

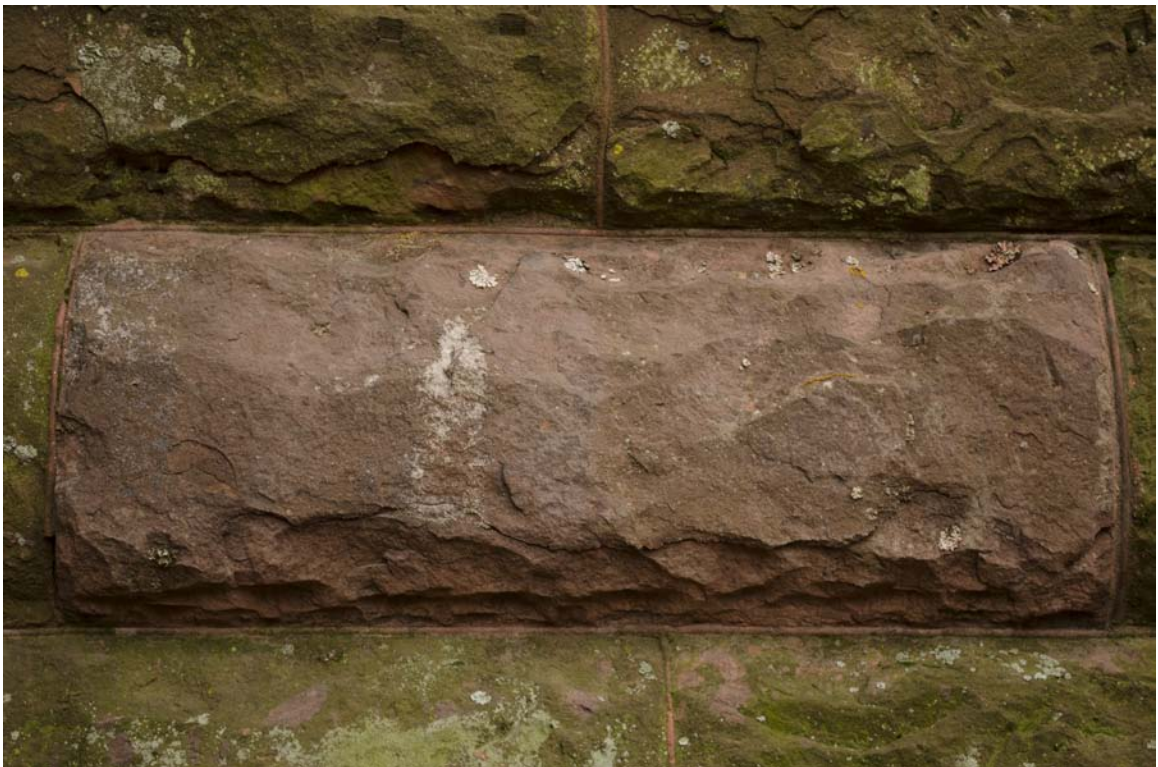
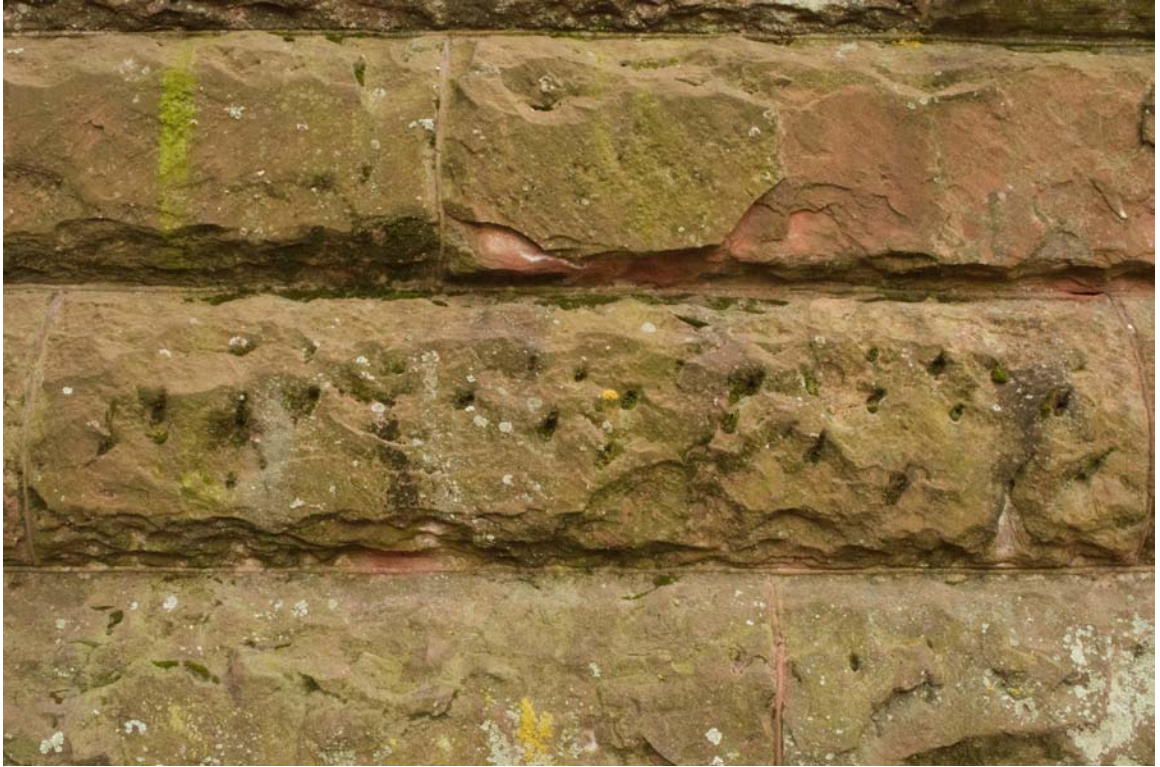
Figure 7.5: Top. Block with green biocolonization in November 2012, before application of the BioWash biocide. Bottom. The same block after 4 months, March 2013.

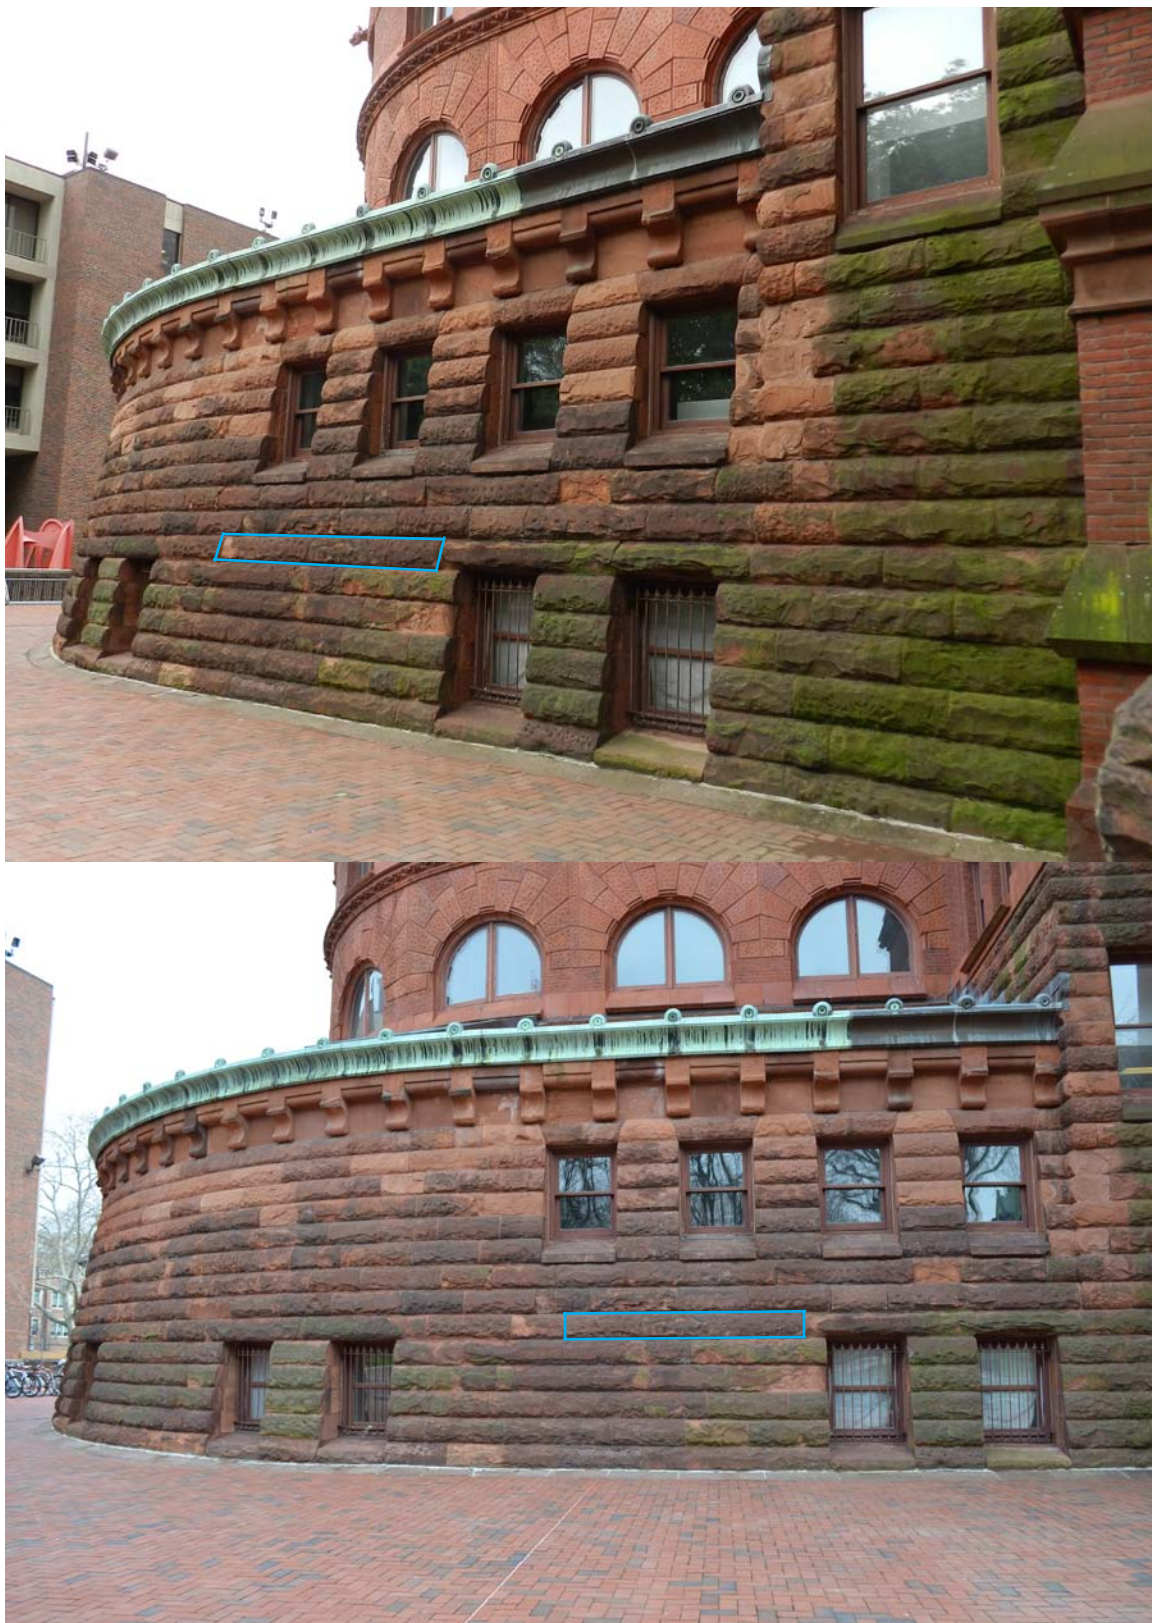
Figure 7.6: West wall of the Fisher Fine Arts Library apse where the treatment was applied to remove black biocolonization. Top, in May 2012 . Bottom, March 2013 four months after biocide application.

Testing on the black biocolonization was carried out on the apse, where it is predominantly present on the center courses. The test area is located on the west facing side of the apse. The photographs below (Figure 7.6) depict the area prior to treatment and four months after the biocides were applied. Figure 7.7 shows a close up of the control block with black biocolonization. Colonization has not changed significantly as in the case of the green biocolonization. The same trend occurs with the black biocolonized blocks that were treated with D/2 (Figure 7.8) and BioWash (Figure 7.9) where no significant change can be seen between the before and after treatment photographs. However, because of the rather wet spring, some traces of green biocolonization can be found on the control block and surrounding blocks of the biocide treated one, but none on the treated surfaces.

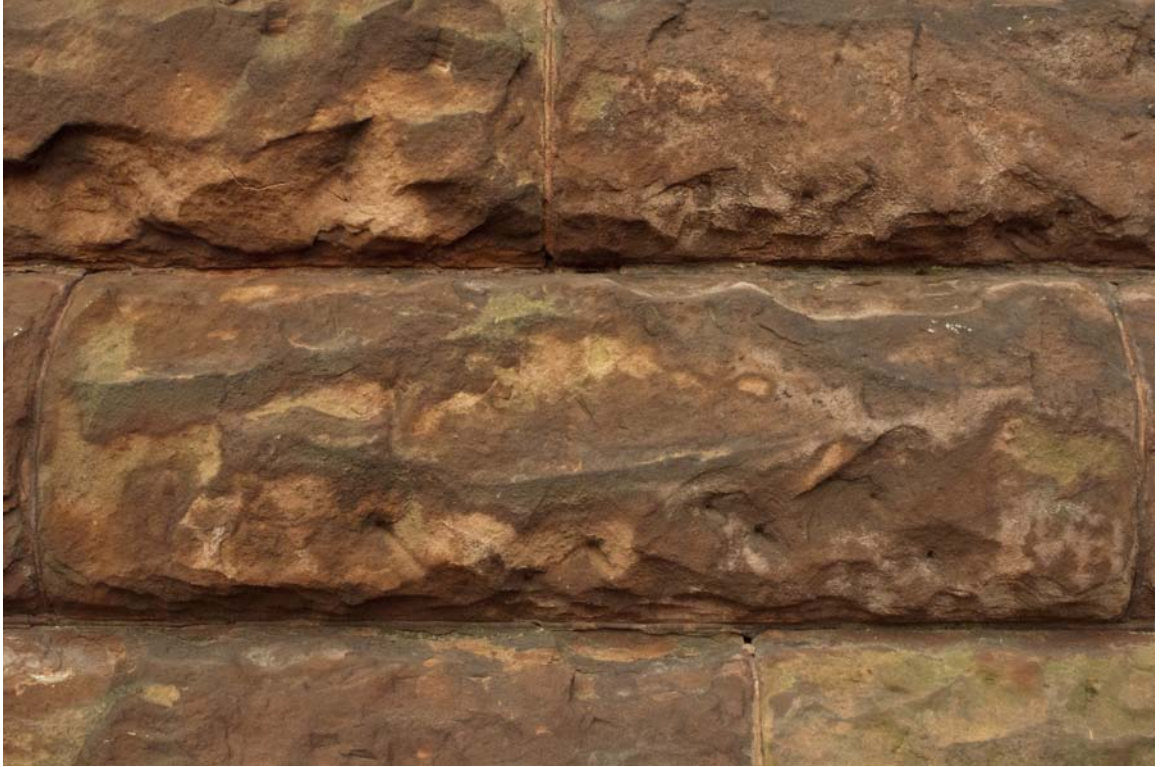
Figure7.7: Top: Control block with black biocolonization in November 2012. Bottom: The same block in March 2013. Note that some green biocolonization can also be found.

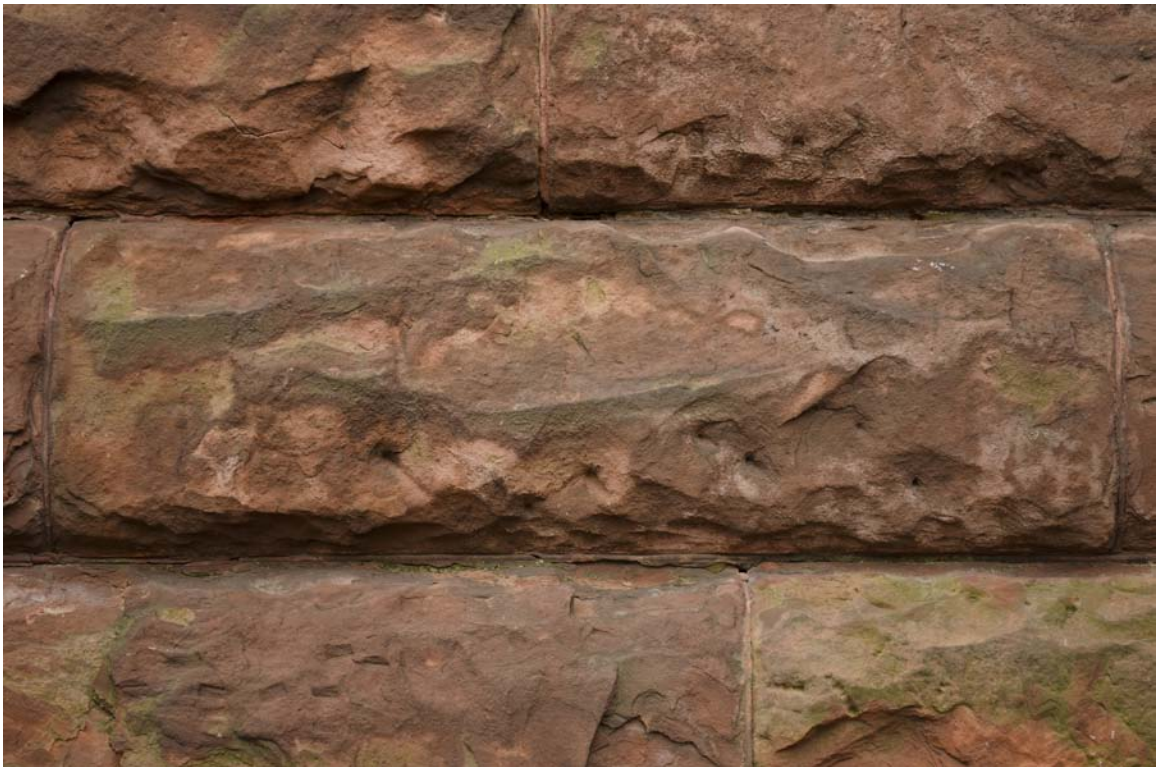
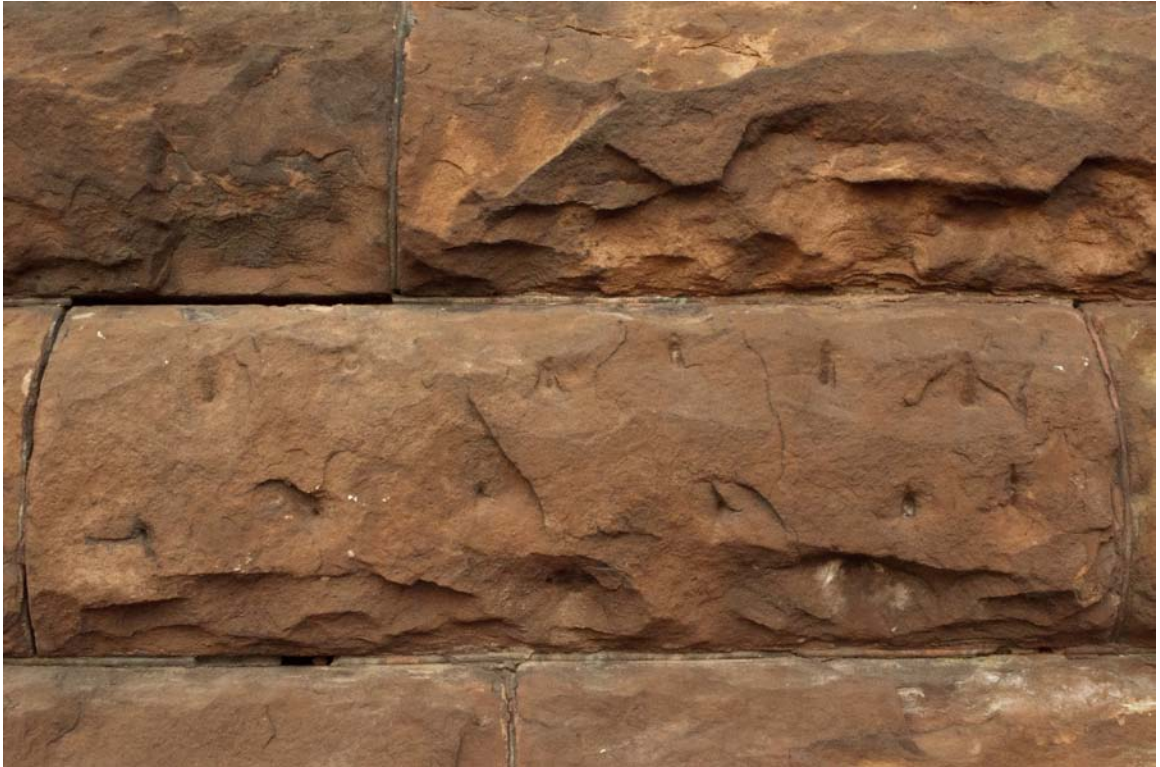
Figure 7.8: Top. Block with light black biocolonization before application of the D/2 biocide in November 2012. Bottom. The same block 4 months after the biocide was applied, March 2013

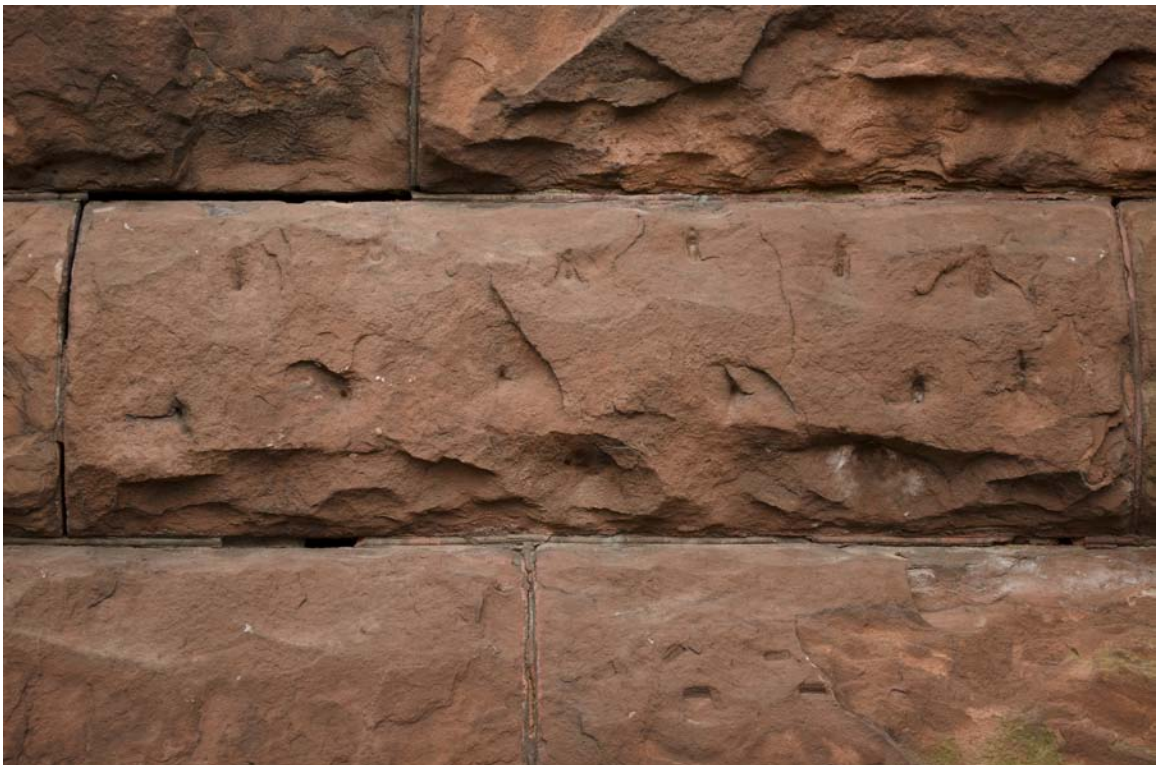
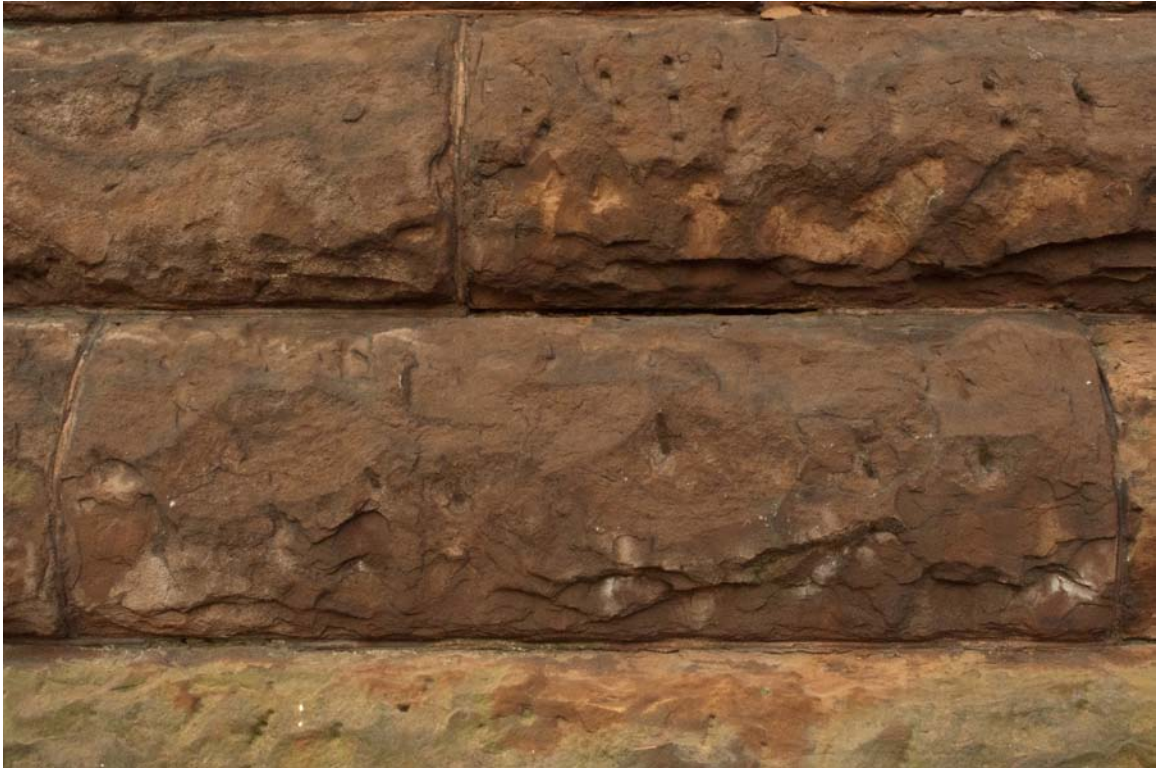
Figure 7.9: Top. Block with black biocolonization prior to treatment with BioWash, November 2012. Bottom. The same block, 4 months after application, in March 2013. Note that some green colonization developed on the block below, but not on the treated block.

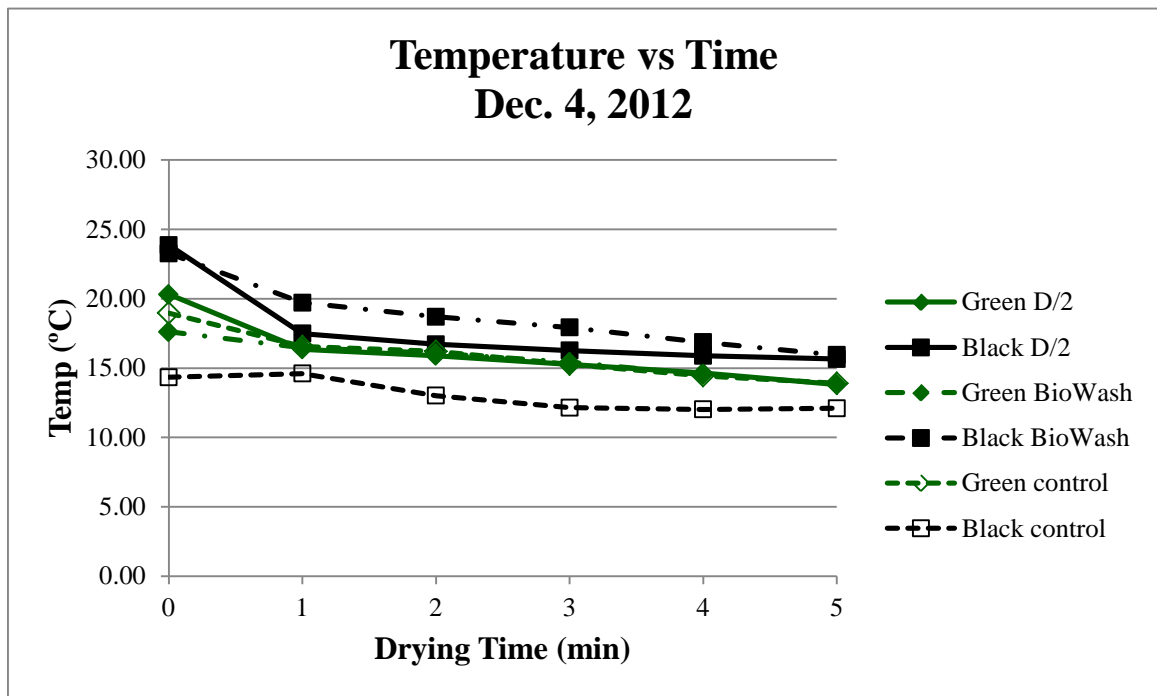
Figure 7.12: Temperature change of blocks, January 2013.

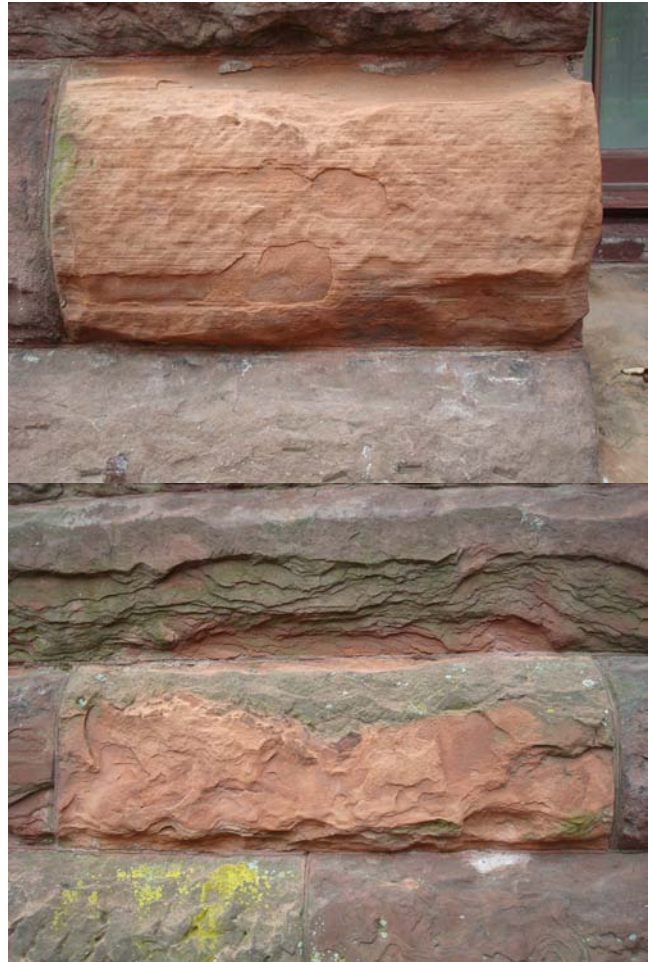
Figure 7.22: Top. Clean stone naturally bedded. Bottom. Clean stone face bedded.

RILEM tube testing was carried out *in situ* on the three green and three black biocolonized stones and the clean stone to measure surface water permeability. Testing was also done on a second clean stone that is face bedded (the original one being naturally bedded), similar to the biocolonized stones (Figure 7.22). The tubes were applied with putty and left on the stones for a duration of two hours and the amount of water absorbed was recorded at 5, 10, 15, 20, 30, 60, and 120 minutes. The data collected for each stone was used to plot water absorption vs. time to determine rate of water absorption or water permeability. The data is presented in Table 7.1.

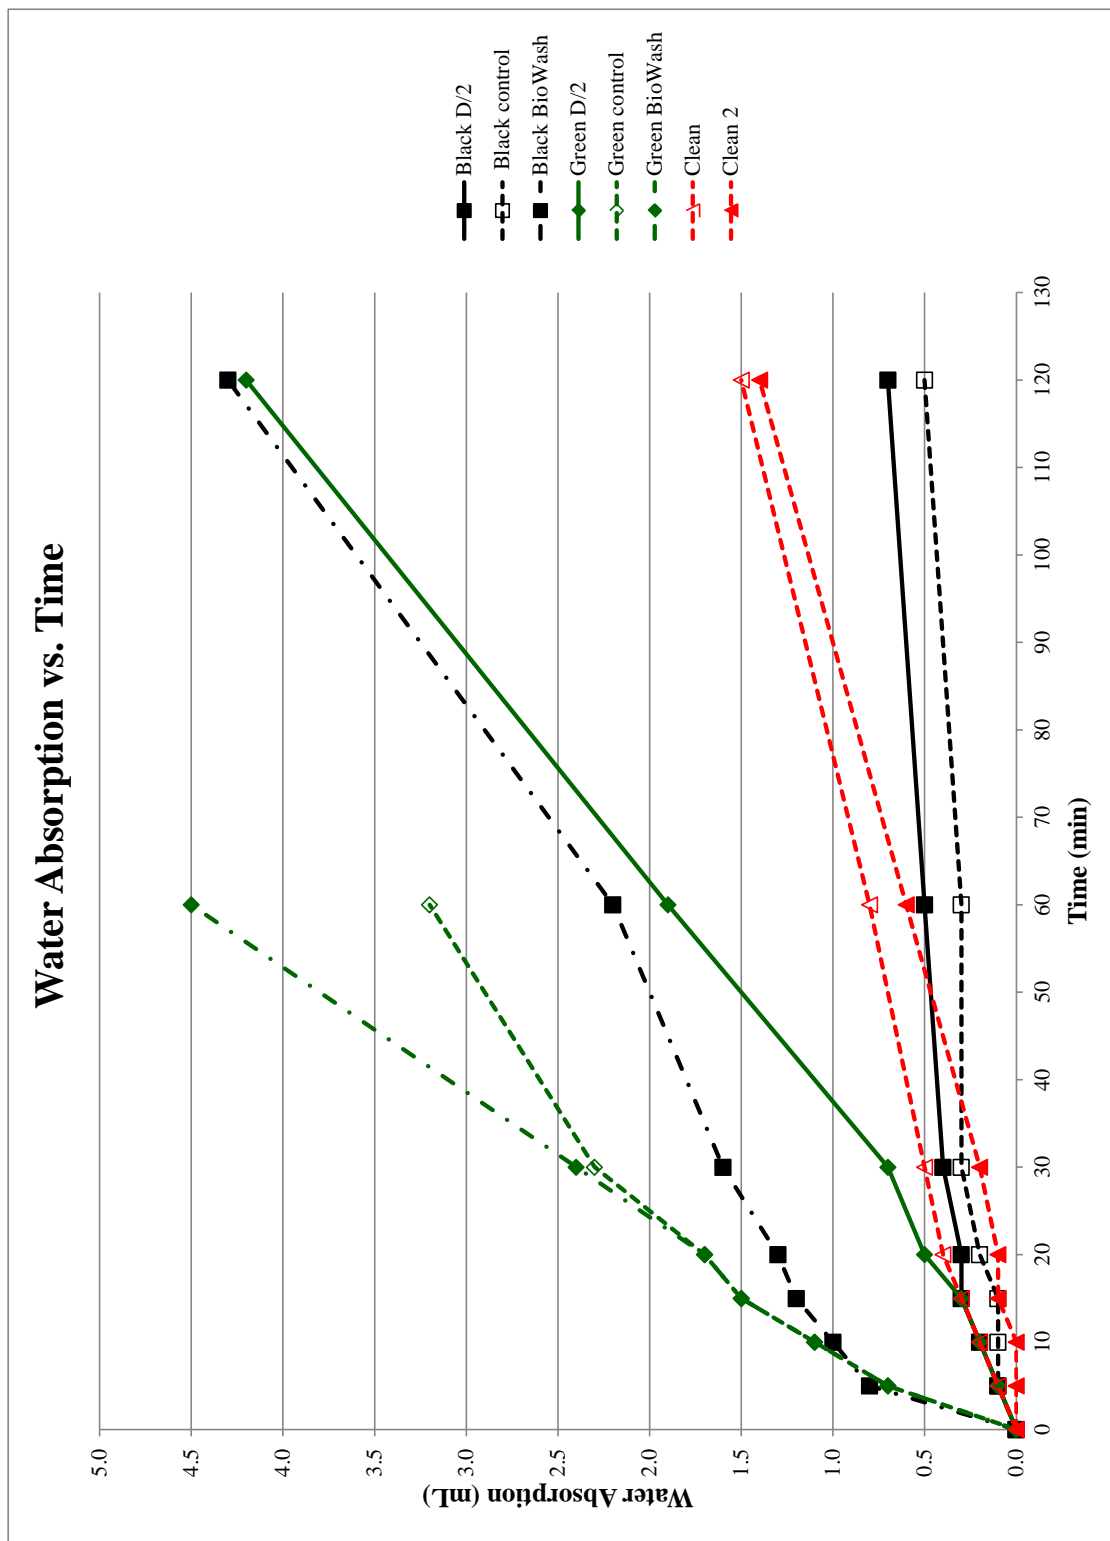
Figure 7.23: Water apsorbtion graph for all biocolonization

This was not observed for the control stone, possibly because the biofilm was absorbing the water as mentioned above. The fact that all stones with green biocolonization, whether removed or not, had a higher water absorption suggests that the biogrowth can contribute significantly to the deterioration of the stone.
