**EVALUATION OF REPAIR METHODS FOR STRUCTURAL CRACKS: EARLY  
PERIOD MONASTIC ARCHITECTURE, LADAKH  
CASE: MANGYU MONASTERY**

A THESIS

Historic Preservation

MASTER OF SCIENCE IN HISTORIC PRESERVATION  
[2006]

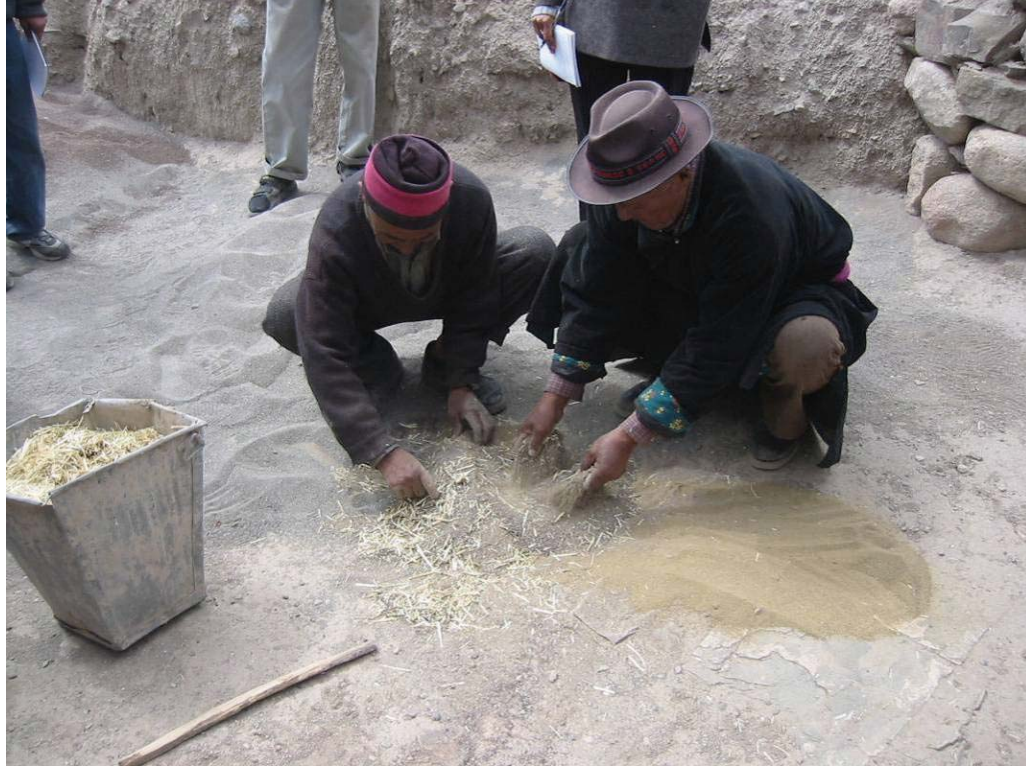
**Figure 4 Preparation of raw material at site**  
**Source: Kuang Han Li**

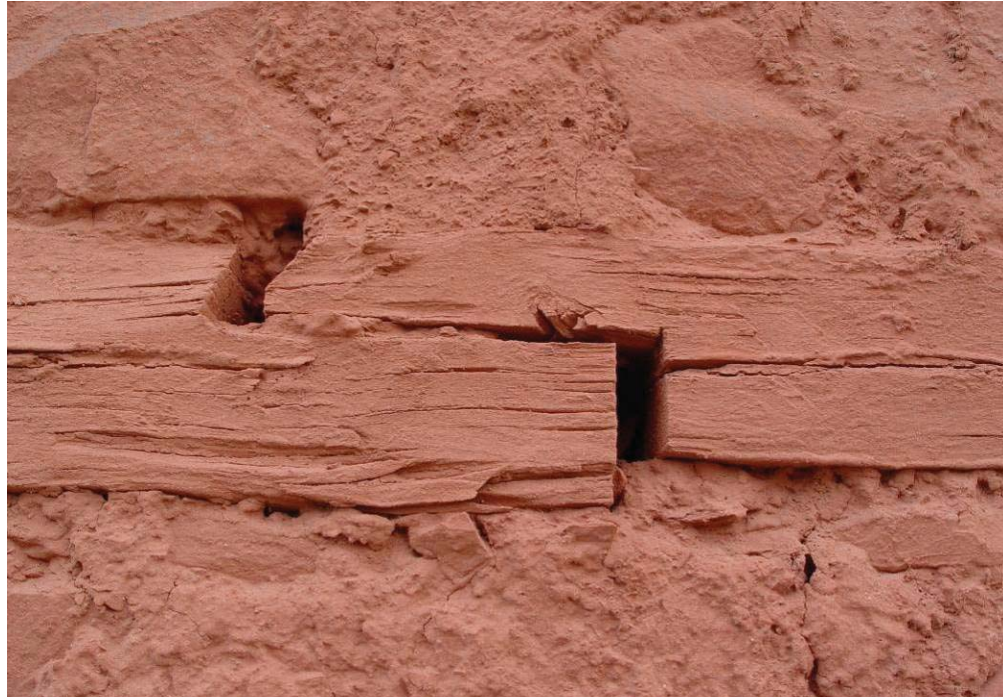
**Figure 7 Joint detail - Wooden ring beam, Themisgam, Ladakh**

bearing walls below, heightened in case of an earthquake. Long lintels are the one of the provisions in these buildings that helps to keep the walls together and tied. The timber beams and floors well connected act as diaphragms and keep the individual wall sections from separating. The floor, especially at the lower levels acts as a diaphragm where the walls are weak and depend on other structural members for strength.

Horizontal wooden members in form of ring beams are a well known technique found in many parts of the world and in the Himalayas from Hunza to central Nepal.<sup>15</sup> The earthen structures in the western Himalayan region also utilize the horizontal reinforcement to resist any movements due to earthquakes. In a number of cases, the load bearing walls of the monasteries are reinforced with a wooden framework of horizontal wall ties as ring beams. A ring beam also known as a crown, bond or tie beam or seismic

band depending on the location in the building, helps tie the walls. It is one of the most essential components of earthquake resistance for load-bearing construction. These elements run on the periphery of the building, and are flushed with the exterior walls. The ring beams tie the entire structure together but their position does not necessarily bear any relationship to the height of the floor beams. Adjacent timber members are simply connected using tension resisting scarf and pegged joints.

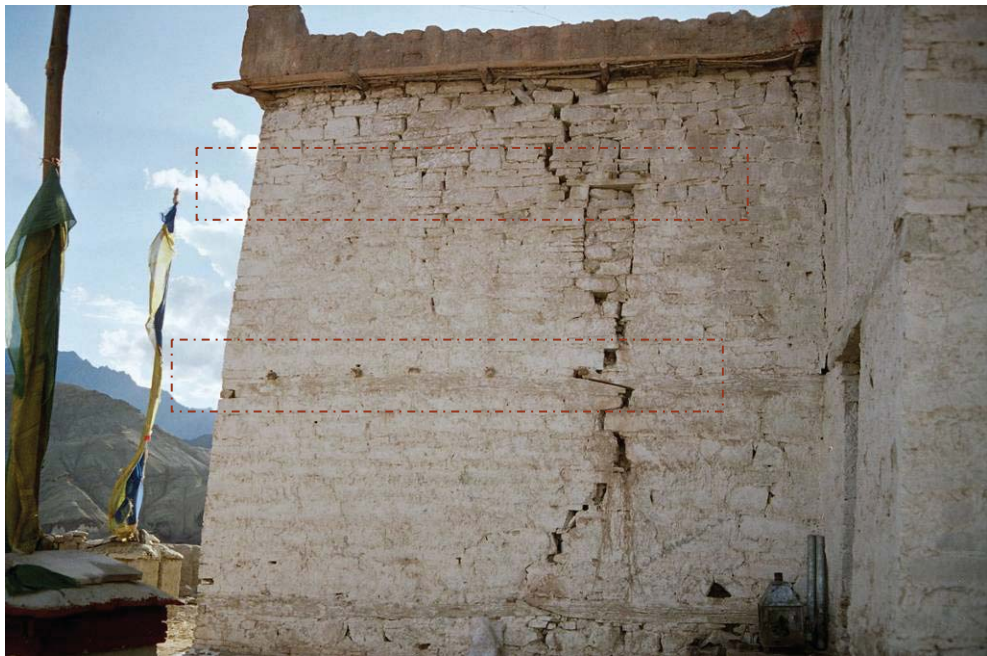
**Figure 8 Wooden beams located at intervals, temple at Basgo**  
**Source: Kuang Han Li**

The corners in the buildings are cross jointed so that the whole building behaves as one. The importance of these tying elements is that they serve to tie the un-reinforced walls making them work as single unit. It prevents the distortion or displacement of walls in the event of an earthquake. Timber lacing (also called stringers) provides added tensile strength to the walls to prevent the development of vertical cracks.

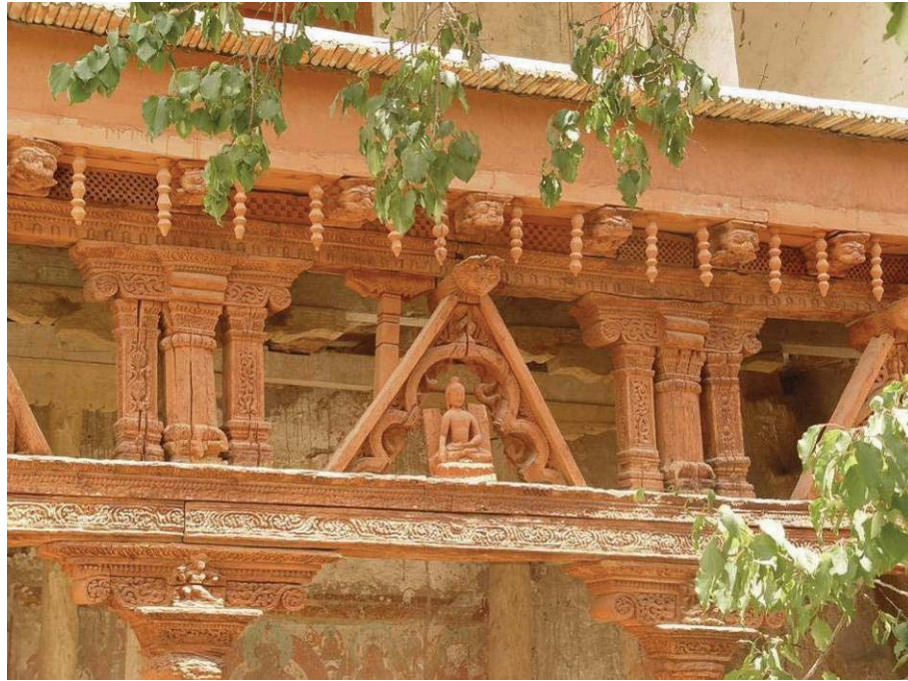
Tibetan artistic styles which is reflected in the plastic art forms, wooden architectural elements and large standing images.

**Figure 15 Wooden ornate porch, Alchi, Ladakh**
