A PROPOSED APPROACH FOR STABILIZING VERDANT CONCRETE OF  
*STAIRWAY TO THE SKY, LAS POZAS, MEXICO*

A THESIS

Historic Preservation

2011

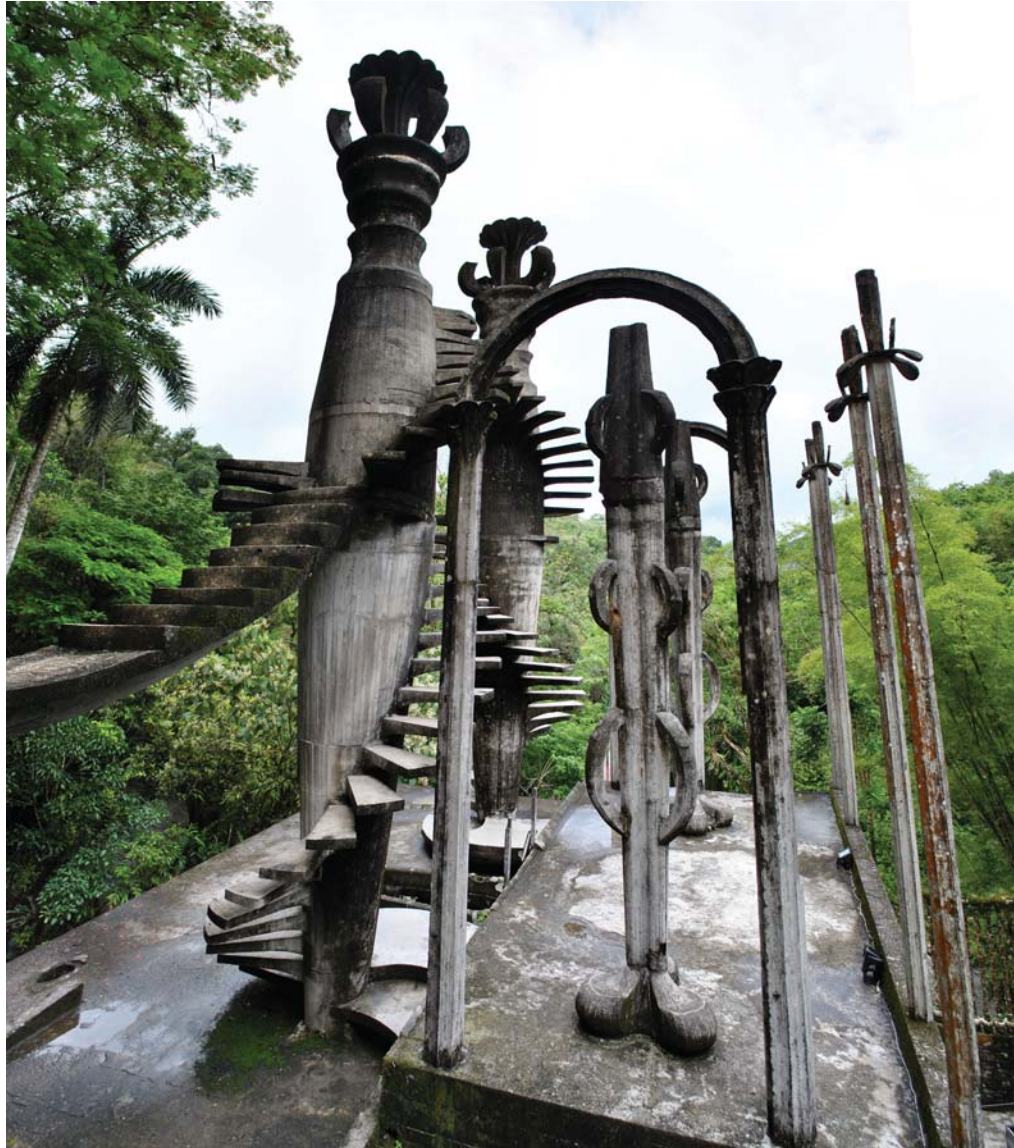
**FIGURE 1:** VIEW OF *STAIRWAY TO THE SKY* LOOKING EAST. THE FORMERLY WHITE CONCRETE STRUCTURE NOW DISPLAYS A MYRIAD OF BIOLOGICAL ORGANISMS ON ITS SURFACE, CHALLENGING TRADITIONAL APPROACHES TO THE CONSERVATION OF CONCRETE. *SOURCE:* AUTHOR, 2010.

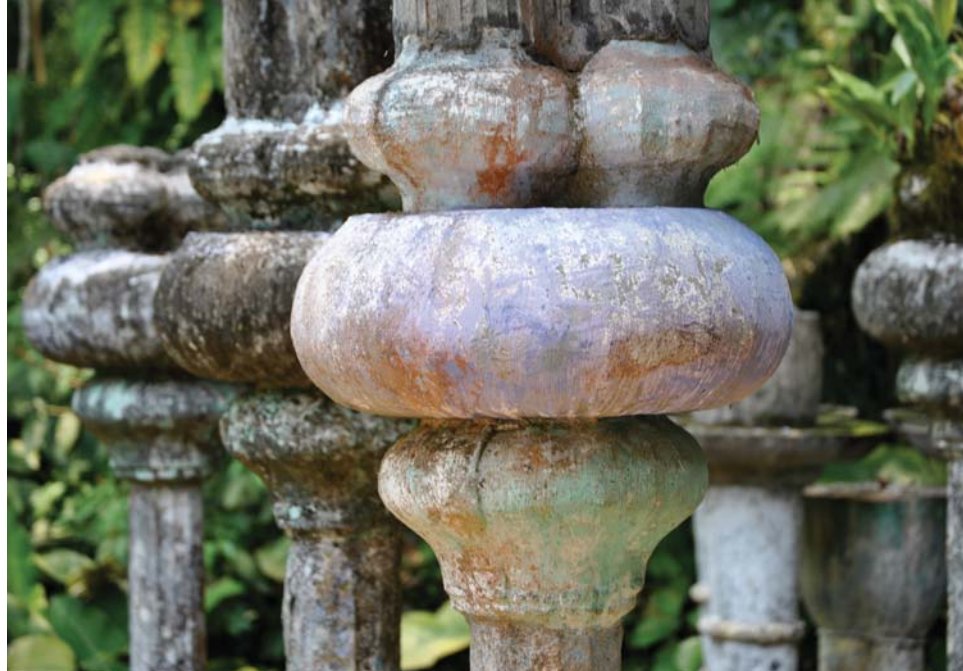
**FIGURE 7:** A POLYCHROMATIC CEMENT SURFACE EXPOSED AFTER CLEANING.  
*SOURCE: AUTHOR, 2010.*

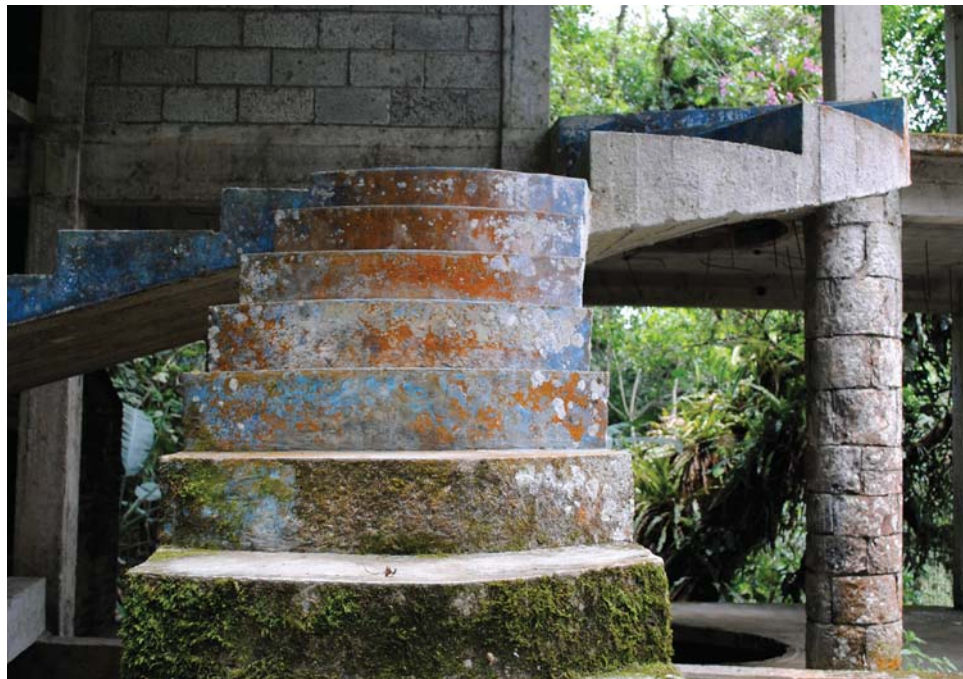
**FIGURE 8:** VARIOUS SPECIES OF BIOLOGICAL ORGANISMS COLONIZING BLUE PIGMENTED STAIRS OF THE *THREE STORY HOUSE THAT MIGHT BE FIVE*. ALTHOUGH SOME SPECIES MAY THREATEN MATERIAL INTEGRITY, THEY PROVIDE AN AESTHETIC THAT IS CHARACTERISTIC OF JAMES'S WORKS AT LAS

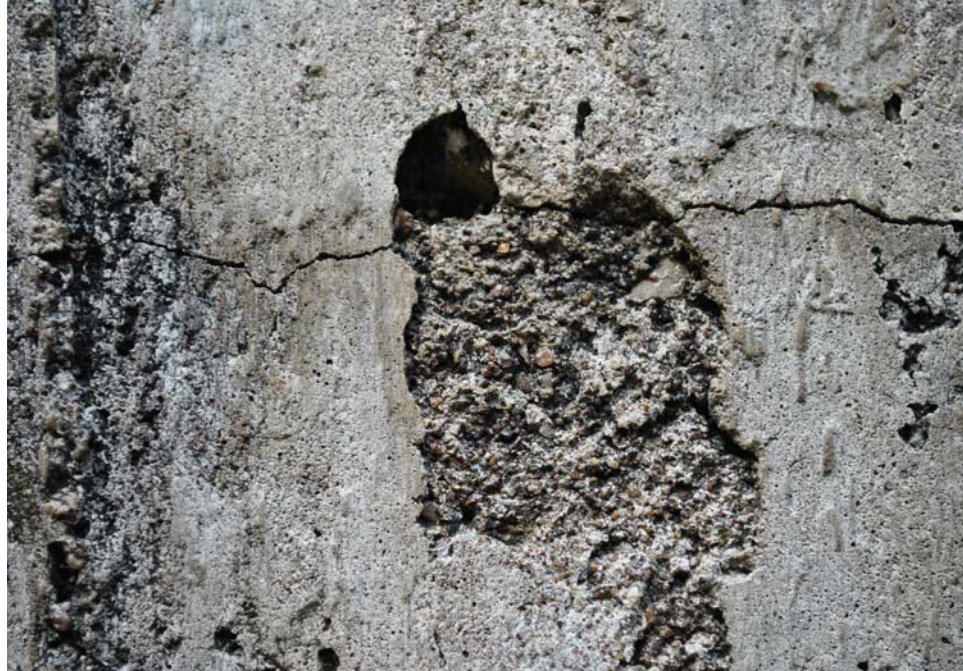
**FIGURE 9:** VOIDS, CRACKING, AND EXPOSED AGGREGATE ARE REVEALED ON THE WEST COLUMN, *STAIRWAY TO THE SKY*. SOURCE: AUTHOR, 2010.

Microcracks and cracks are ubiquitous on both exposed concrete and parged surfaces. Numerous craze cracks are present on the stairs, and of notable interest is a widespread cracking pattern on the east column. Causes of cracking are unknown, and may be resultant of drying shrinkage, loading, or internal pressure caused by reinforcement corrosion.

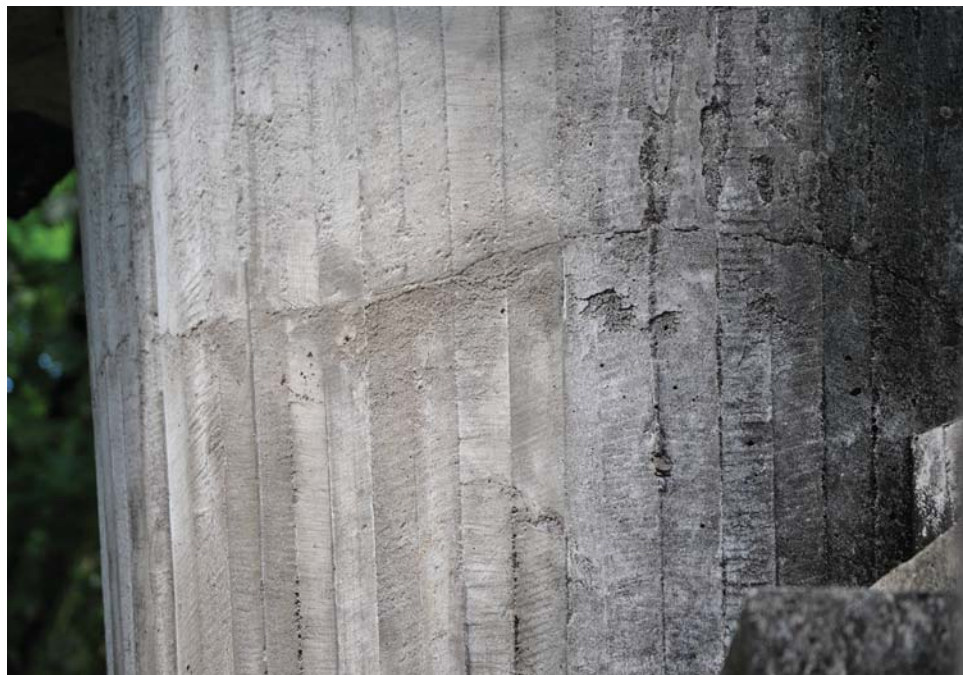
**FIGURE 10:** IMPRESSIONS OF FORMWORK ON THE MONUMENTAL COLUMNS OF *STAIRWAY TO THE SKY*. SOURCE: AUTHOR, 2010.

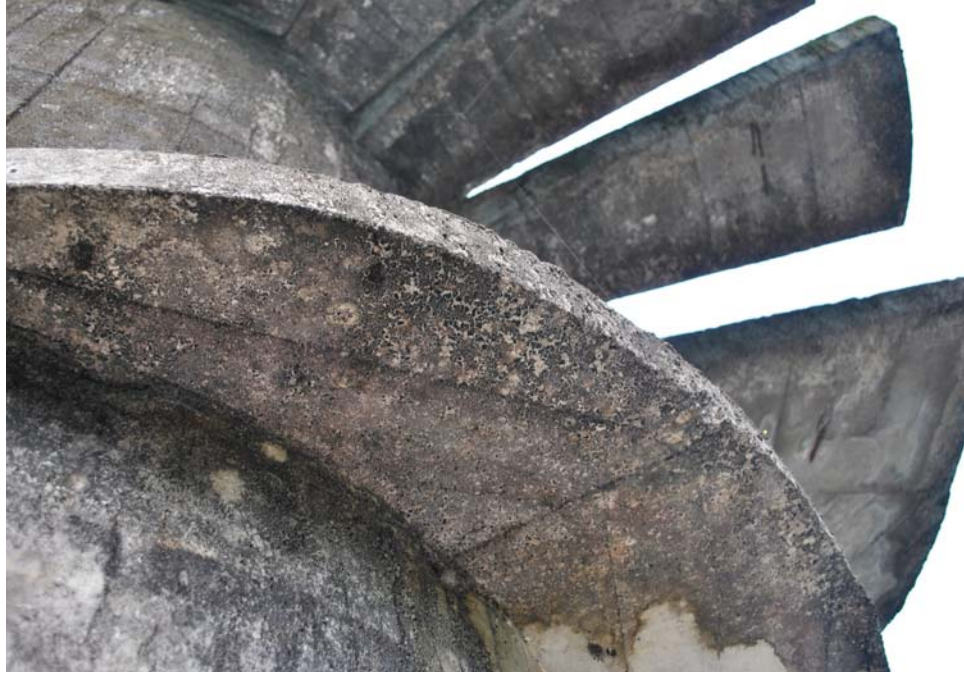
**FIGURE 11:** BLACK FUNGAL BIOGROWTH COLONIZE SHADED SURFACES OF *STAIRWAY TO THE SKY*. *SOURCE: AUTHOR, 2010.*

23 This was observed in many areas at *Stairway to the Sky* and occurs most prominently with black fungal growth. The presence of black fungal biogrowth is evident inside of the material's pores.

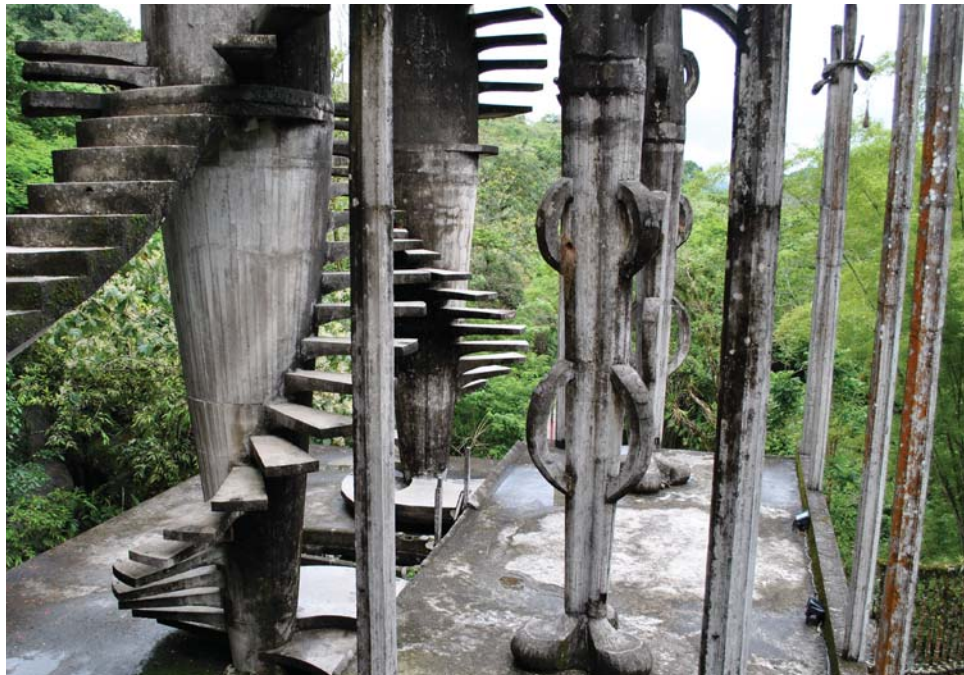
**FIGURE 12:** THE STRUCTURE'S CURRENT APPEARANCE AFTER DECADES OF EXPOSURE TO THE DAMP *HUASTECA* ENVIRONMENT. *SOURCE: AUTHOR, 2010.*

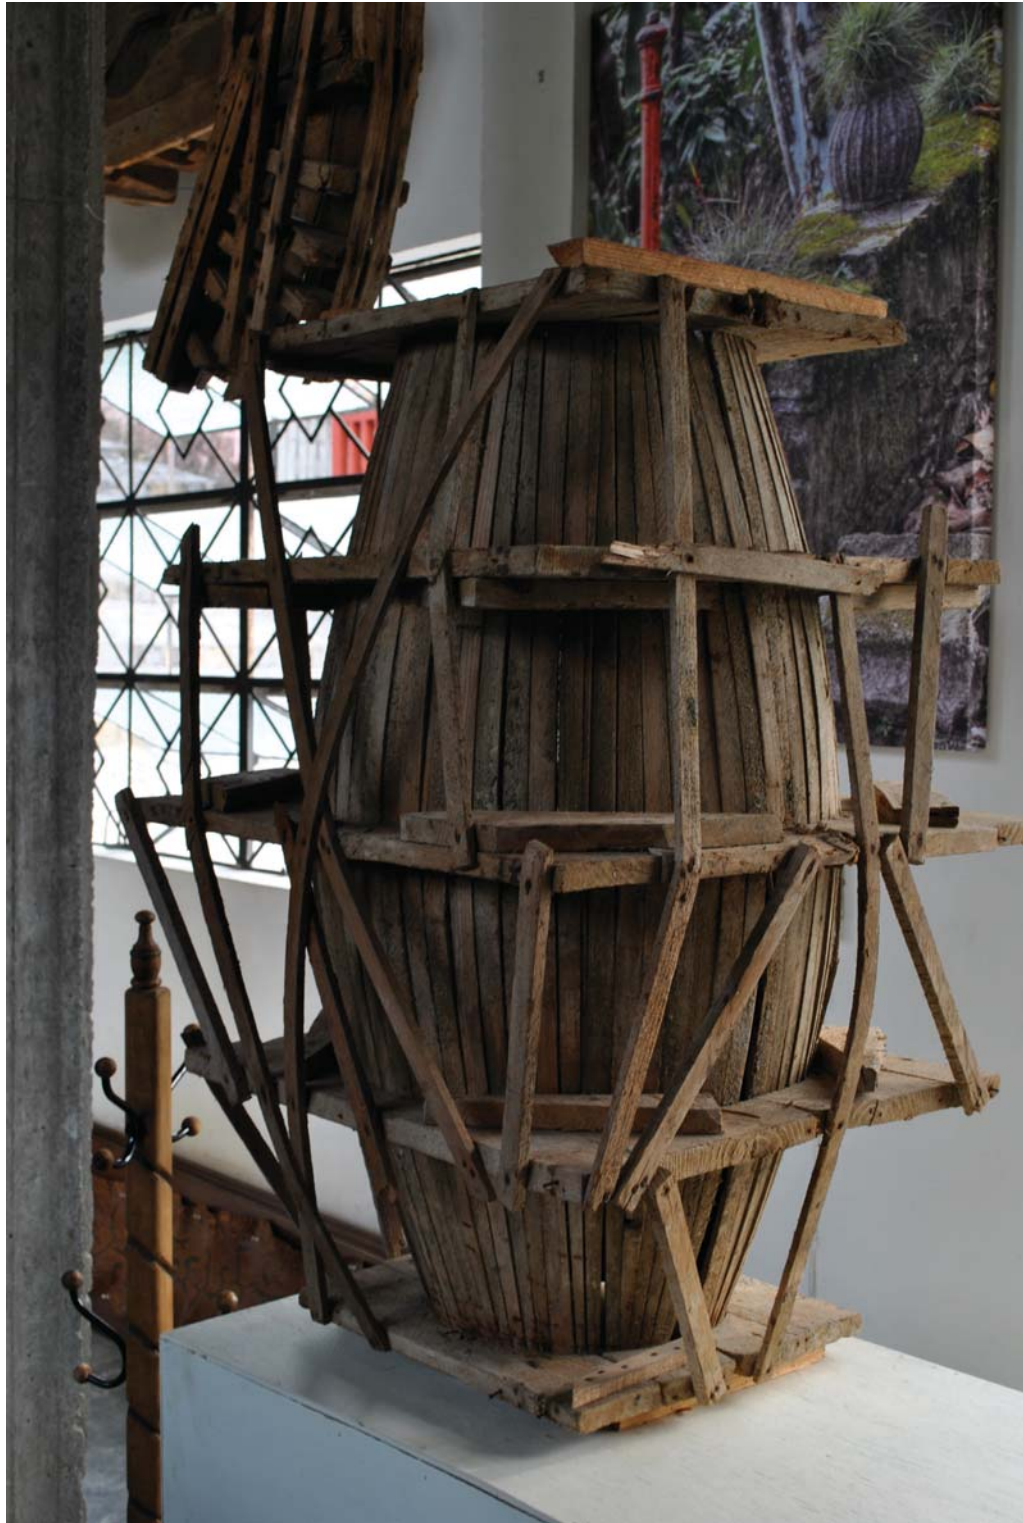
JOSE LUIS AGUILAR'S ELABORATE WOODEN FORMWORK ON DISPLAY AT *EL CASTILLO* IN CENTRAL XILITLA. *SOURCE: AUTHOR, 2010.*

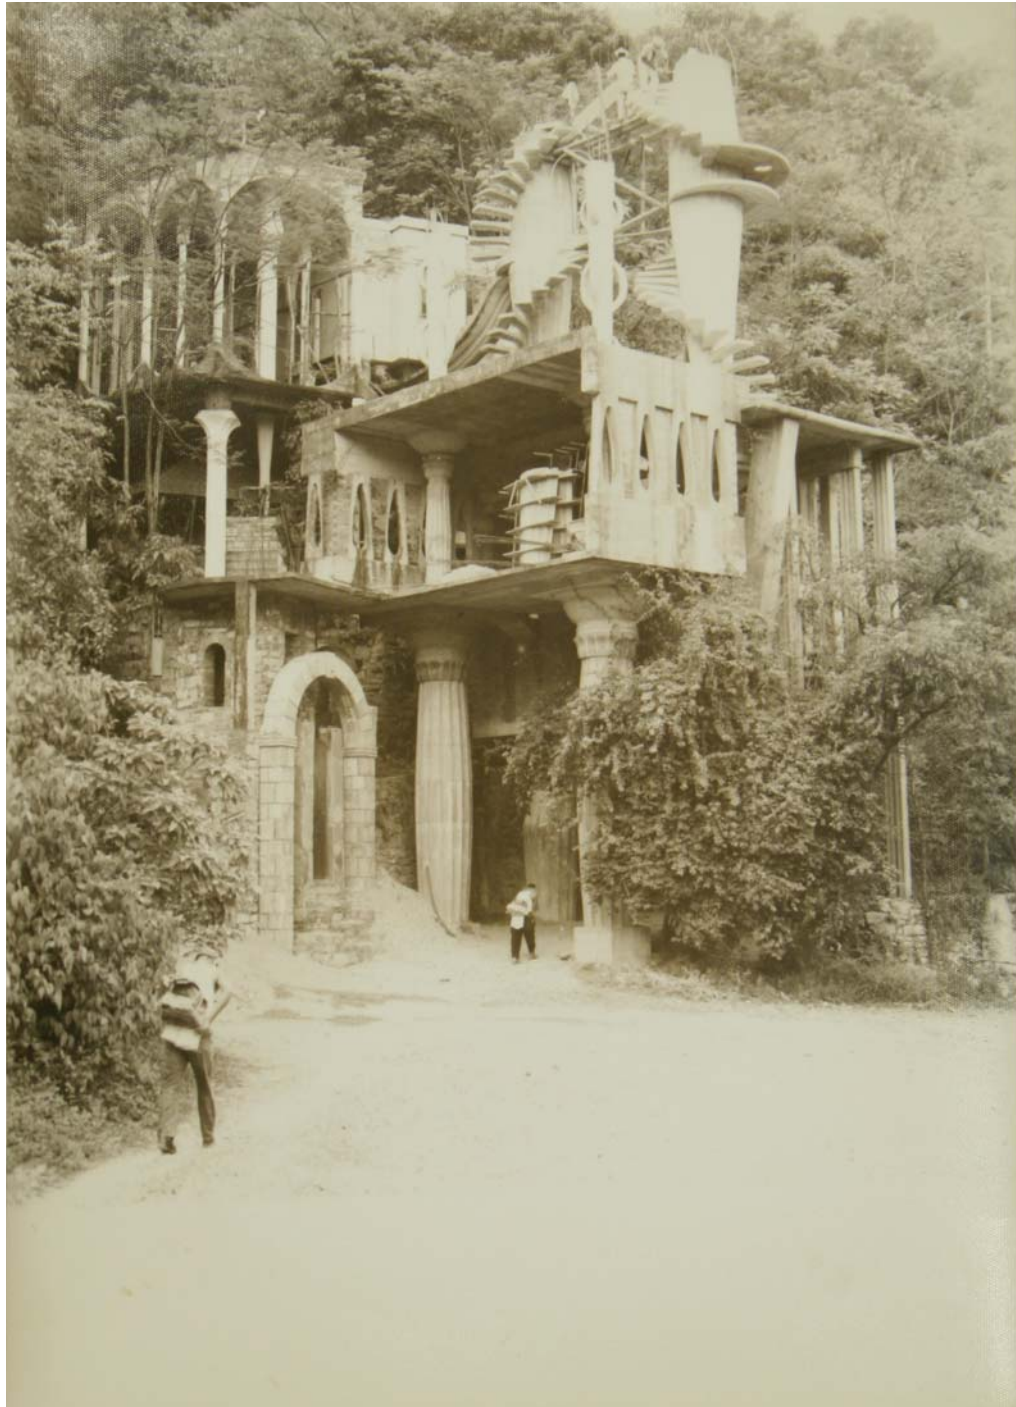
CONSTRUCTION OF *STAIRWAY TO THE SKY*. TODAY, THIS LOCATION SERVES AS THE ENTRANCE TO *LAS POZAS*. SOURCE: EJA, WEST DEAN COLLEGE.

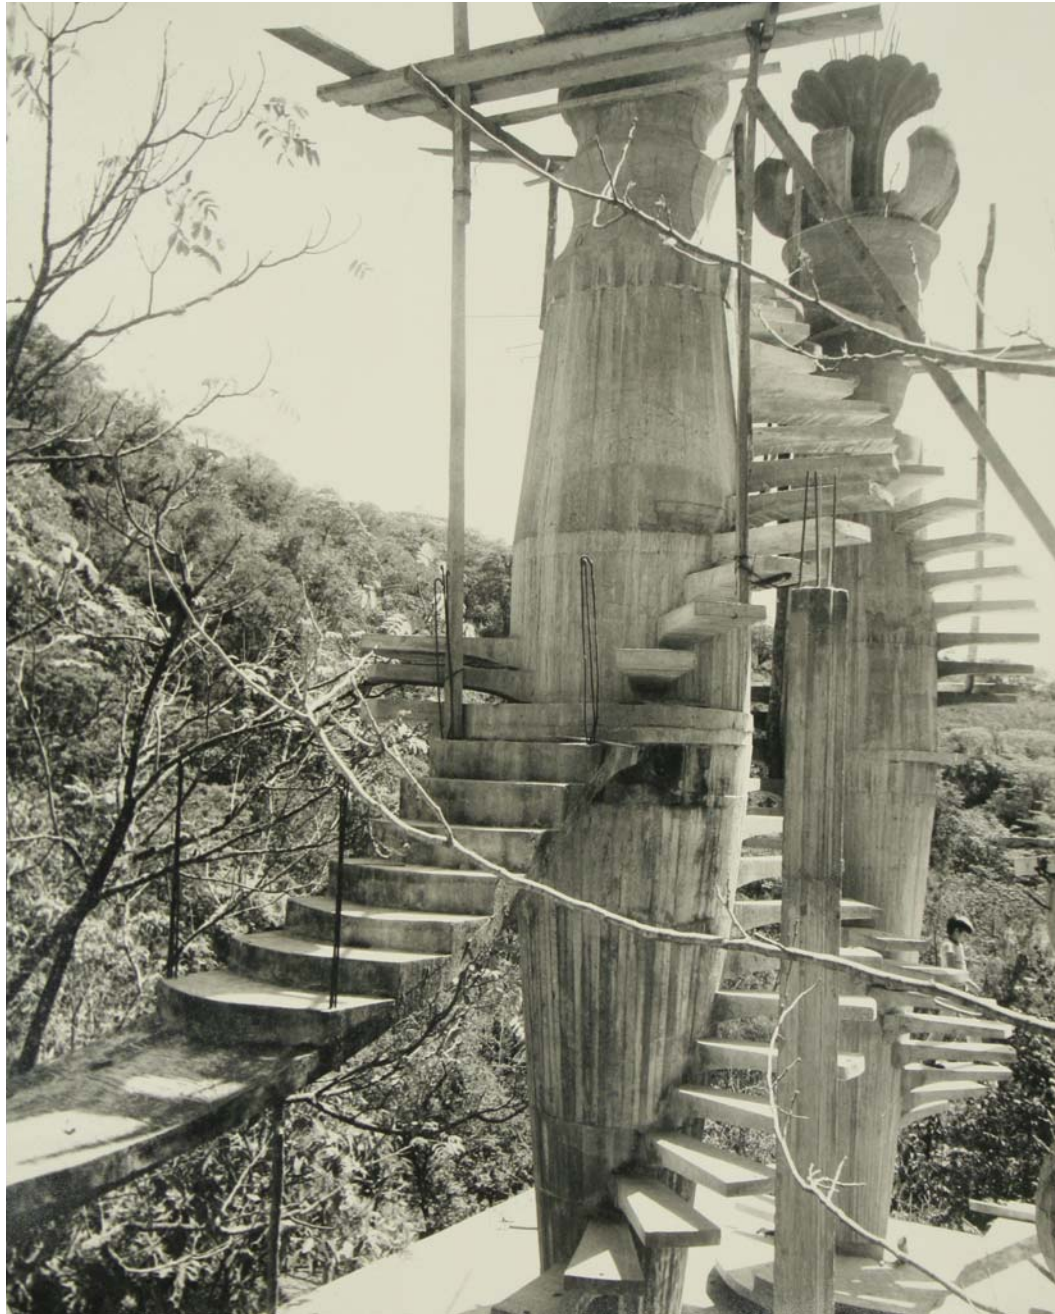
CONSTRUCTION OF *STAIRWAY TO THE SKY*, CIRCA 1965. SOURCE: EJA, WEST DEAN COLLEGE.

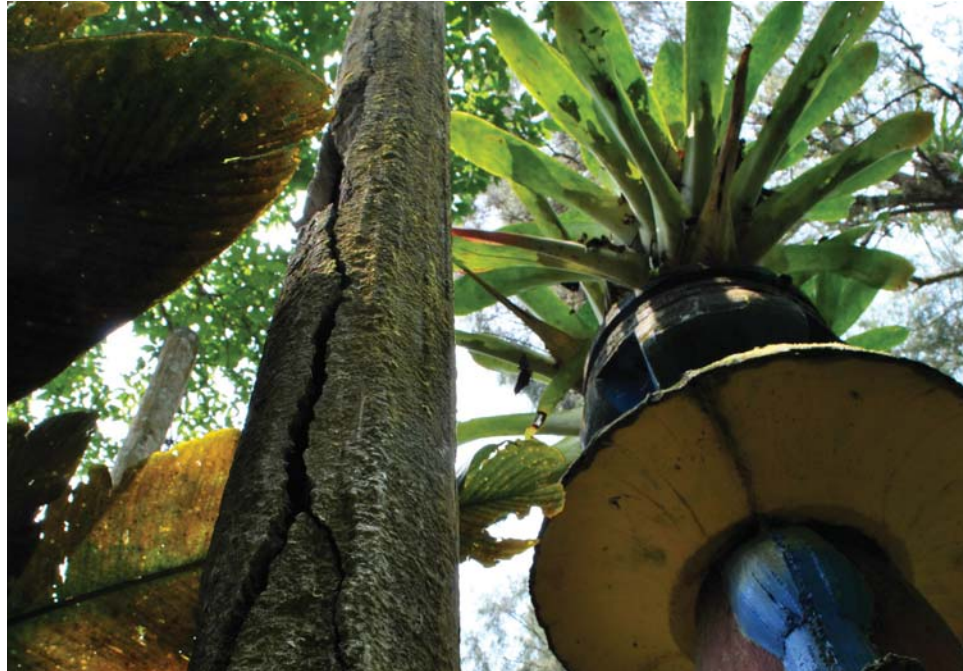
CRACK FORMATIONS IN A COLUMN OF *HOMAGE TO MAX ERNST* RESULTING FROM LACK OF MAINTENANCE. *SOURCE: AUTHOR, 2010.*

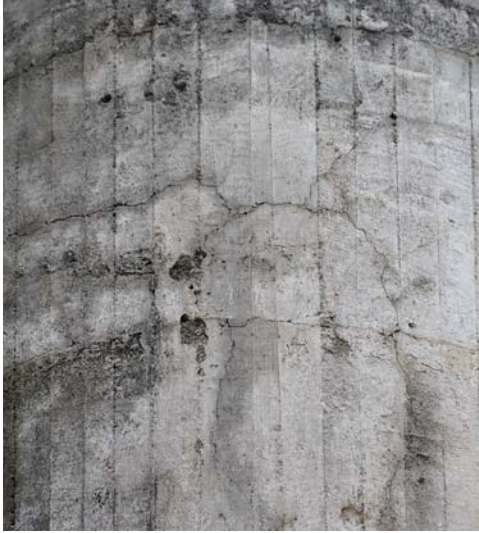
## CRACKING

A SERIES OF CRACKS IN CONCRETE NEAR AND ROUGHLY PARALLEL TO JOINTS, EDGES, AND STRUCTURAL CRACKS

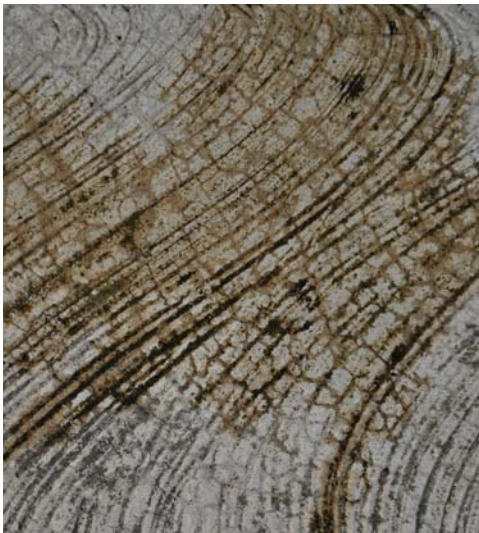
## PATTERN CRACKING (FINE)

FINE OPENINGS ON CONCRETE SURFACES IN THE FORM OF A PATTERN; RESULTING FROM A DECREASE OF VOLUME NEAR THE SURFACE, OR INCREASE IN VOLUME OF THE MATERIAL BELOW THE SURFACE, OR BOTH

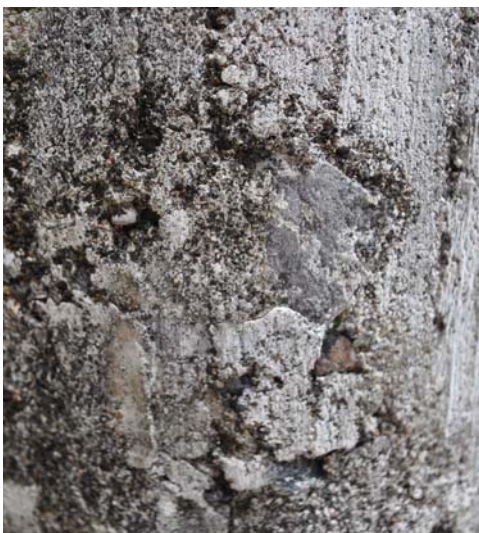
## SCALING

LOCAL FLAKING OR PEELING AWAY OF THE NEAR-SURFACE PORTION OF HARDENED CONCRETE OR MORTAR; ALSO OF A LAYER OF METAL

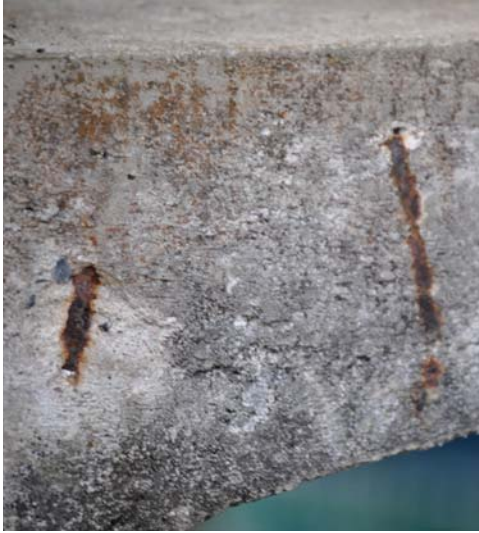
## CORROSION

DESTRUCTION OF METAL BY CHEMICAL, ELECTROCHEMICAL, OR ELECTROLYTIC REACTION WITH ITS ENVIRONMENT

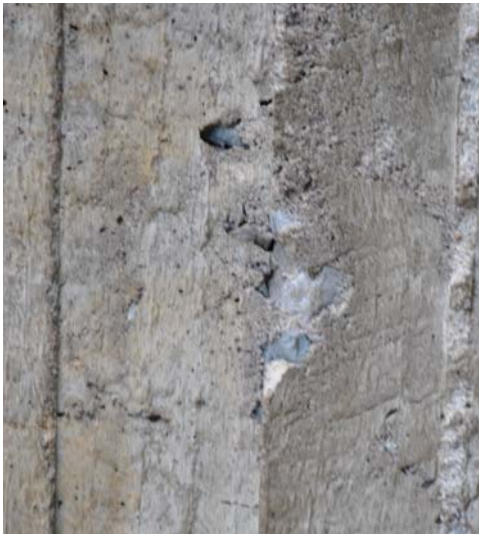
## SPALL

A FRAGMENT, USUALLY IN THE SHAPE OF A FLAKE, DETACHED FROM A LARGER MASS BY A BLOW, BY THE ACTION OF WEATHER, BY PRESSURE, OR BY EXPANSION WITHIN THE LARGE MASS

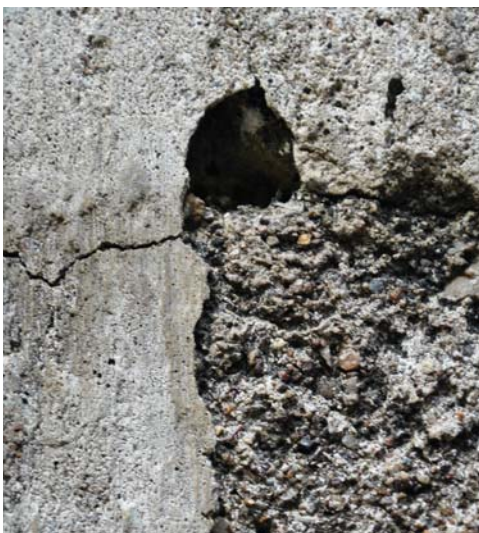
## POPOUT

THE BREAKING AWAY OF SMALL PORTIONS OF A CONCRETE SURFACE DUE TO LOCALIZED INTERNAL PRESSURE WHICH LEAVES A SHALLOW, TYPICAL CONICAL, DEPRESSION

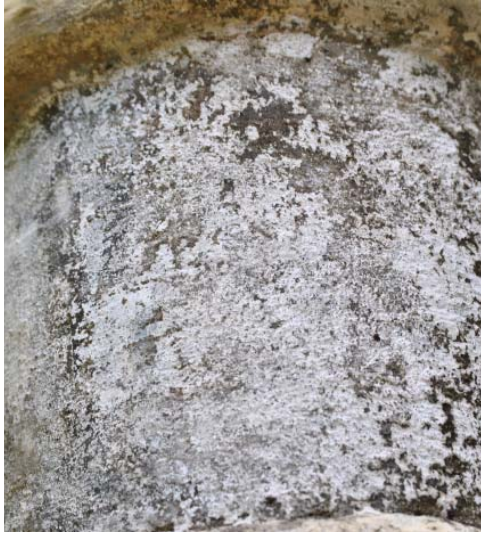
## BIODETERIORATION

MECHANICAL, CHEMICAL, OR AESTHETIC DETERIORATION RESULTING FROM THE GROWTH, MOVEMENT, OR METABOLIC PROCESSES OF AN ORGANISM

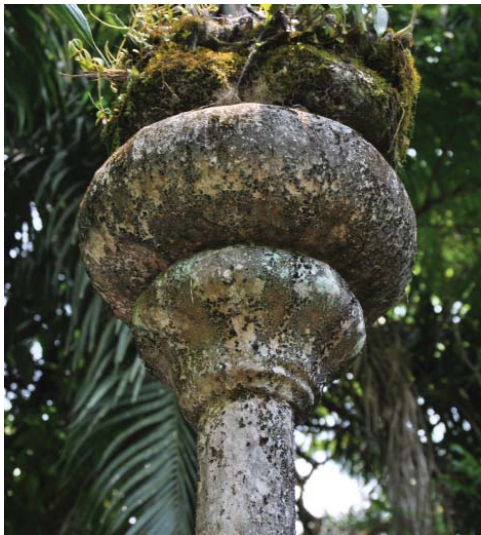
## BIOLOGICAL COLONIZATION BY HIGHER PLANTS

A STRUCTURE IS COLONIZED BY HIGHER PLANTS, I.E. ORCHIDS, SHRUBS; MOVEMENT AND GROWTH CAUSES MECHANICAL DAMAGE OF THE SUBSTRATE

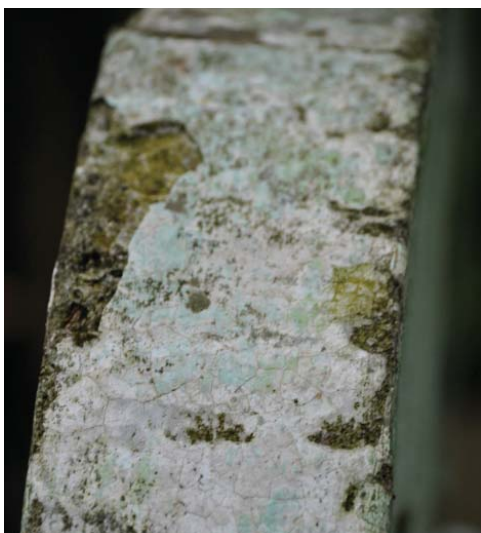
## BIOLOGICAL COLONIZATION BY MICROORGANISMS

COLONIZATION OF MICROORGANISMS, I.E. FUNGI, BACTERIA; MAY CAUSE MECHANICAL AND/OR CHEMICAL DETERIORATION OF THE SUBSTRATE

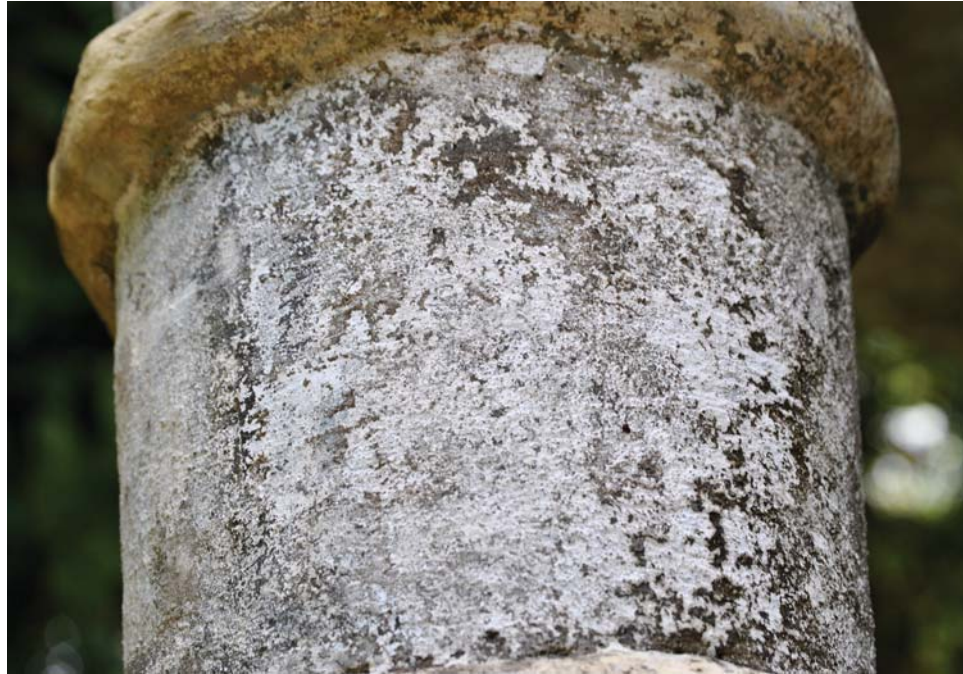
BLACK FUNGAL GROWTH, COLUMN, *EDWARD JAMES'S HOUSE*. SOURCE: AUTHOR, 2010.
