**CHARACTERIZATION OF EARTHEN ARCHITECTURAL SURFACE
FINISHES FROM KIVA Q,
CLIFF PALACE, MESA VERDE NATIONAL PARK
COLORADO**

A THESIS

Historic Preservation

1999

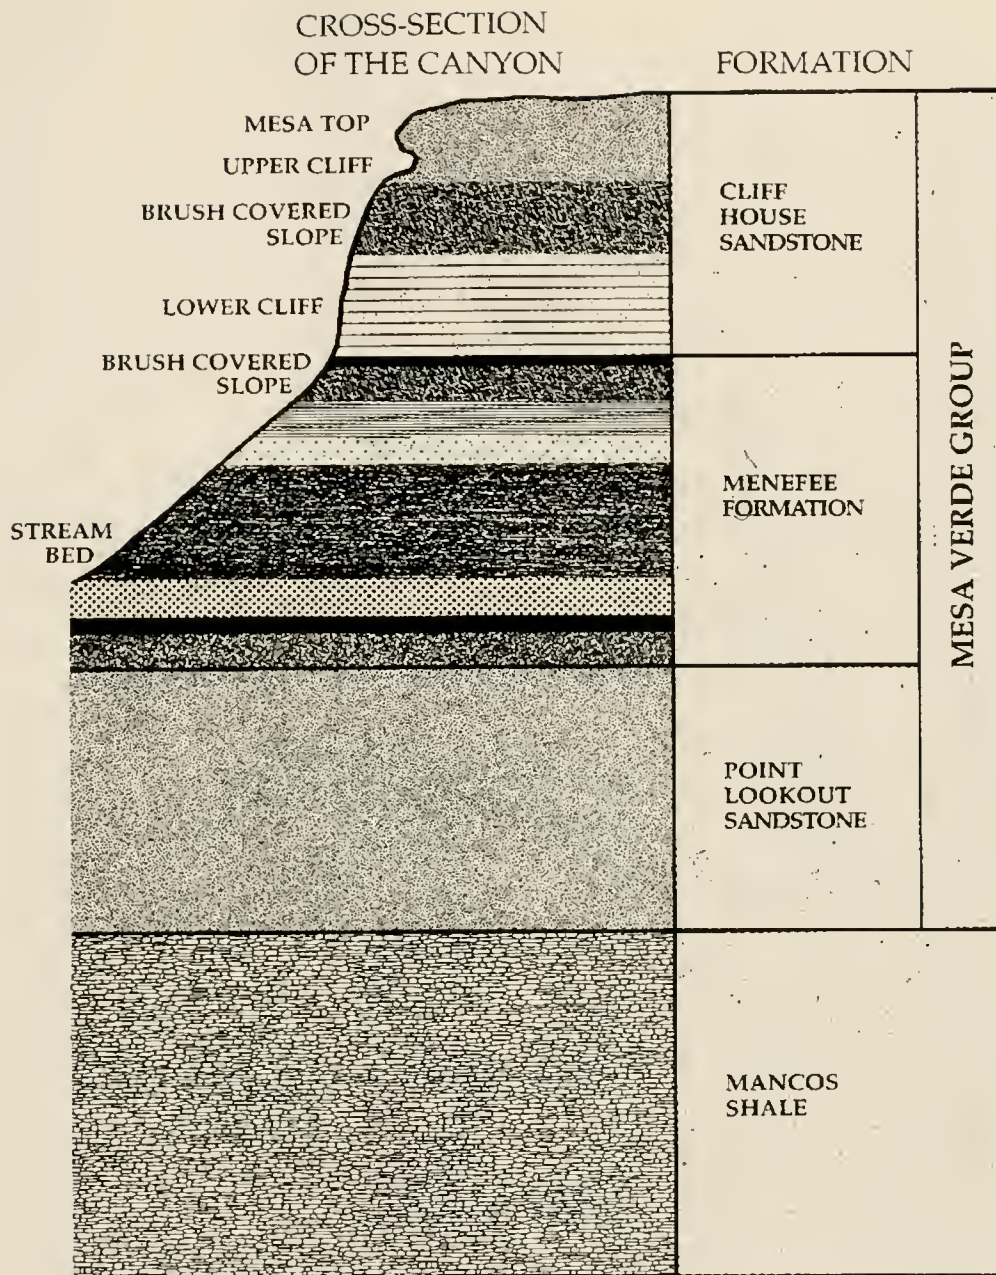
Figure 1. Mesa Verde geology. From Gilbert R. Wenger, *The Story of Mesa Verde National Park* (Mesa Verde National Park, CO: Mesa Verde Museum Association, 1997), p. 10.

Volcanic activity was very influential to the geology of the area, forming many of the mountain ranges, including the San Juan Mountains. Furthermore, volcanic eruptions are responsible for deposits of bentonite, a clay mineral resulting from the alteration by weathering of volcanic ash, within all of the Mesaverde formations.³ The mesatop soils of Mesa Verde are primarily wind-blown loess, although soils formed from weathered sandstone may be found in the higher reaches. Mesa Verde soils vary in carbonate content according to the carbonate content of the underlying sandstone. In the southern region of the mesa the soil surface is highly calcareous.⁴

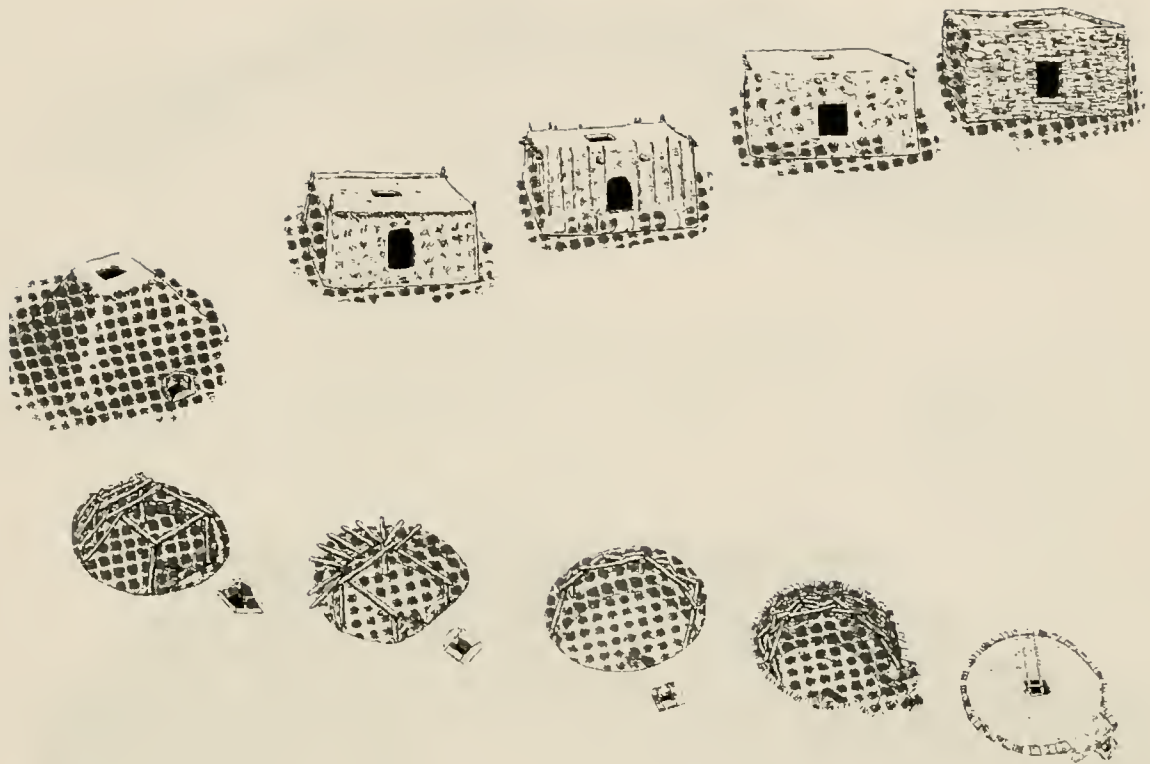
Figure 4. Development of the Ancient Puebloan pithouse to the pueblo and the kiva.
From Gilbert R. Wenger, *The Story of Mesa Verde National Park* (Mesa Verde National Park, CO: Mesa Verde Museum Association, 1997), p. 40.

of the pithouse became taller as the pithouse became deeper, forming a feature called the banquette in the kiva. Masonry pillars, known as pilasters in the kiva, gradually replaced the vertical posts resting on the bench of the pithouse supporting the roof structure. The roof structure of the pithouse evolved from a post-and-beam configuration to a crib roof resting on the log or stone pillars, and the kiva shares the characteristic crib roof. The interior features of the pithouse and kiva are also similar, both having a central hearth, a ventilator, a deflector to prevent drafts from extinguishing the fire, and a cylindrical opening in the floor known as a sipapu to the modern Hopi (Figure 7). The sipapu represents the opening to the lower world from which the ancestors of the Hopi emerged. The antechamber of the pithouse was phased out in the single-room kiva, though a vestige persists in the form of ventilation shafts, tunnels leading to other rooms, and possibly the recess present in the southern end which imparts the characteristic keyhole shape of many kivas in Mesa Verde.

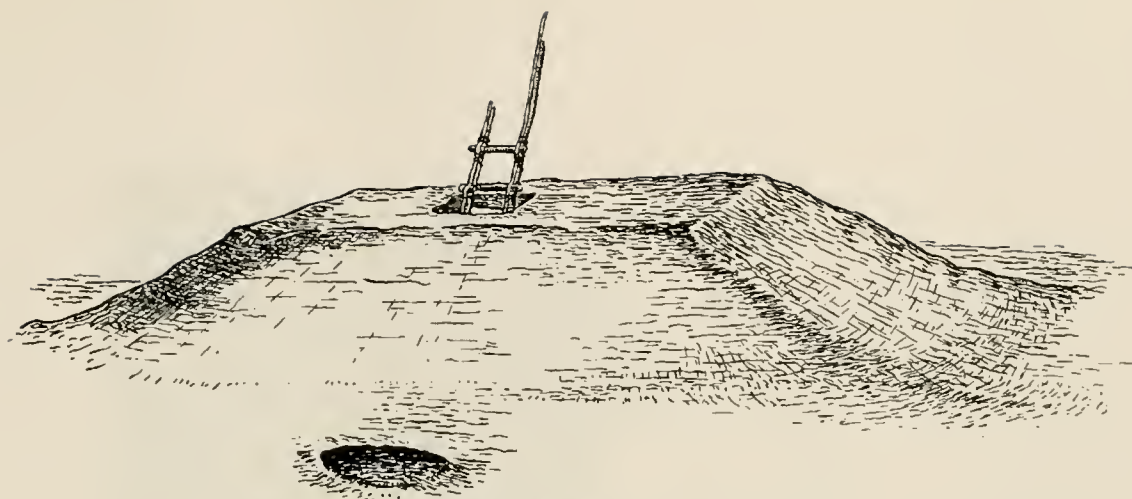
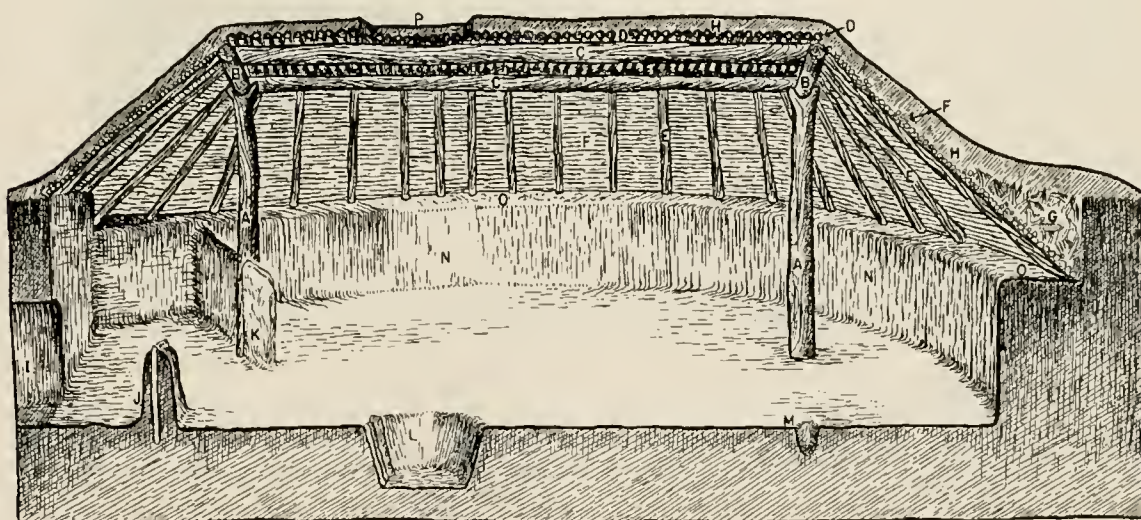
PLATE 5—Postulated Method of Roof Construction of First Pithouse

A. Main support posts.
B. Main stringers.
C. Secondary stringers.
D. Slender poles or withes.

I. Tunnel to antechamber.
J. Deflector.
K. Wingwall
L. Firepit

M. Sipapu.
N. Plastered walls.
O. Bench.
P. Smokehole and hatchway.

Figure 5. Schematic of Late Modified Basket Maker pithouse. From James A. Lancaster, et al., *Archaeological Excavations in Mesa Verde National Park, Colorado, 1950* (Washington, D.C.: National Park Service, 1954), p. 13.

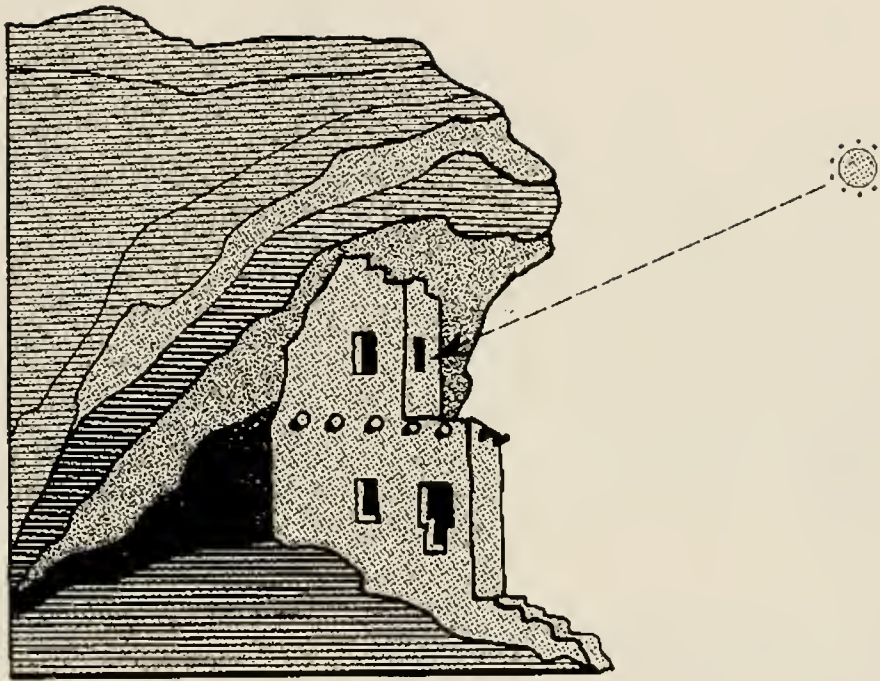
Figure 6. Schematic of Classic Pueblo alcove cliff dwelling. From Gilbert R. Wenger, *The Story of Mesa Verde National Park* (Mesa Verde National Park, CO: Mesa Verde Museum Association, 1997), p. 17.

These alcoves were formed by an erosional weathering process in the uppermost sandstones of the upper Cliff House formation. Water percolating through the porous sandstone stops where it meets a thin but impermeable layer of shale, then runs down along the shale layer until it seeps out at a canyon wall. At these seep points, the sandstone is worn away by mechanical and chemical processes. Rainwater combines with atmospheric carbon dioxide to form a weak carbonic acid, which dissolves the calcium carbonate cementing material of the sandstone. The sandstone disintegrates, and alcoves occur at these interfaces of the sandstone and shale. Deeper alcoves are formed where a layer of bentonite up to a foot thick occurs above the shale layer. Bentonite, a smectite clay, has a tendency to absorb water, resulting in a major increase in its volume. The resultant swelling of the bentonite layer causes pressure where it contacts the sandstone, speeding up the deterioration of the sandstone layer.¹⁵ The villages of the cliff-dwelling Ancestral Puebloans were often constricted by the shallow spaces of the alcoves, and the architecture reflected the upward movement necessary to expand in the close quarters. The tall square and round towers of the Classic Pueblo period represent the apex of Ancient Pueblo architecture at Mesa Verde (Figure 6).

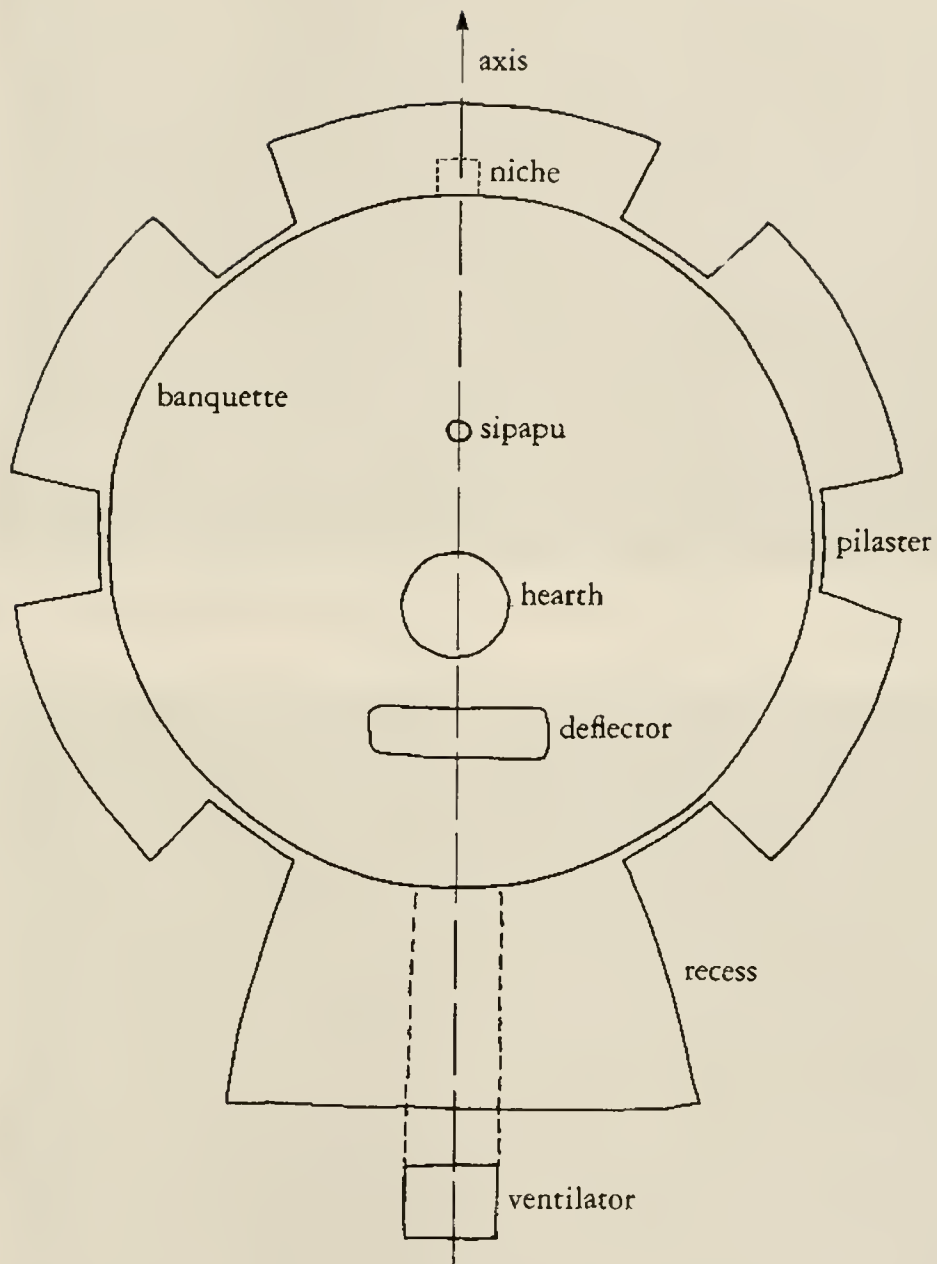
Figure 7. Typical Mesa Verde kiva plan. From William M. Ferguson and Arthur H. Rohn, *Anasazi Ruins of the Southwest in Color* (Albuquerque: University of New Mexico Press, 1987), p. 29.

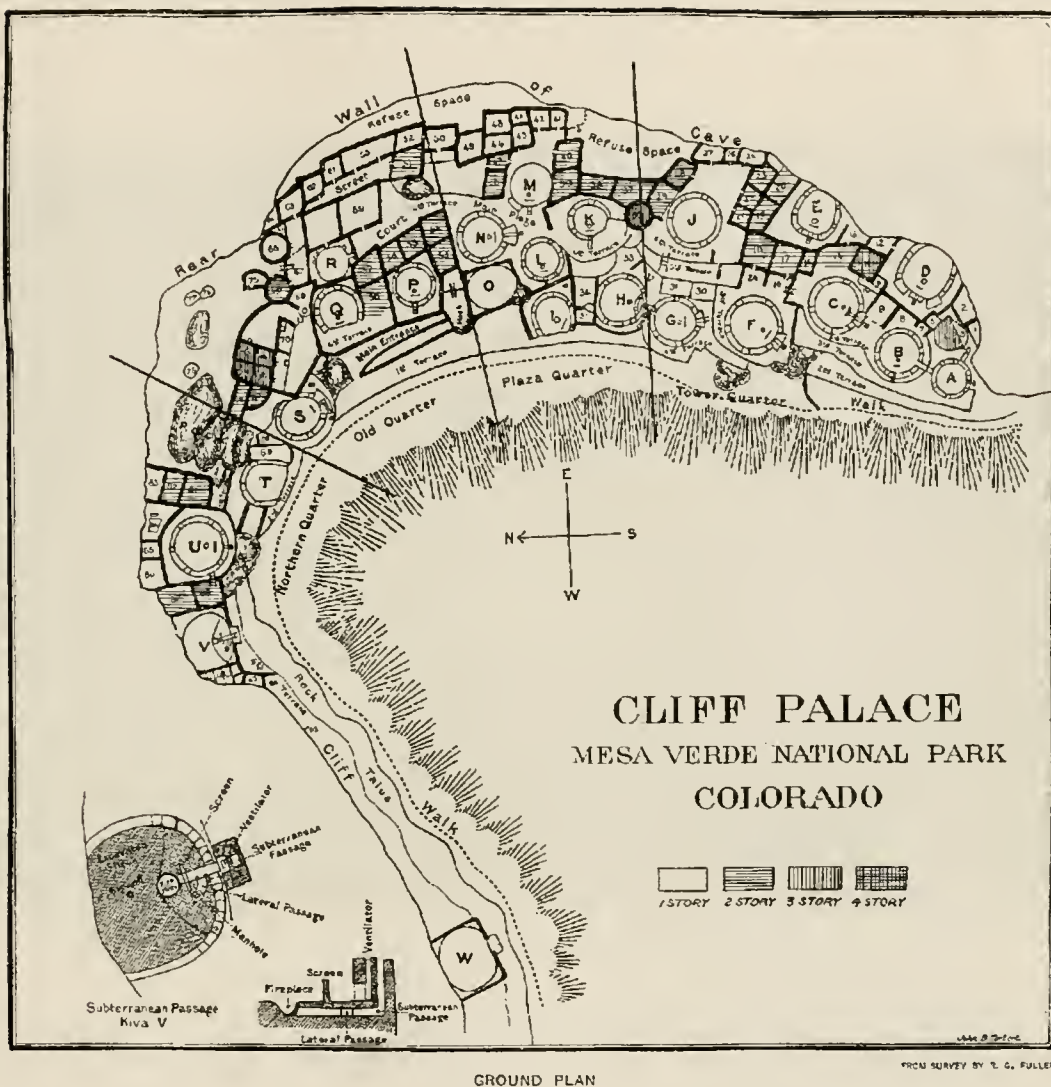
Figure 10. Plan of Cliff Palace. From Jesse Walter Fewkes, *Antiquities of the Mesa Verde National Park: Cliff Palace*, Smithsonian Institution Bureau of American Ethnology Bulletin 51 (Washington, D.C.: Government Printing Office, 1911) Plate 8.

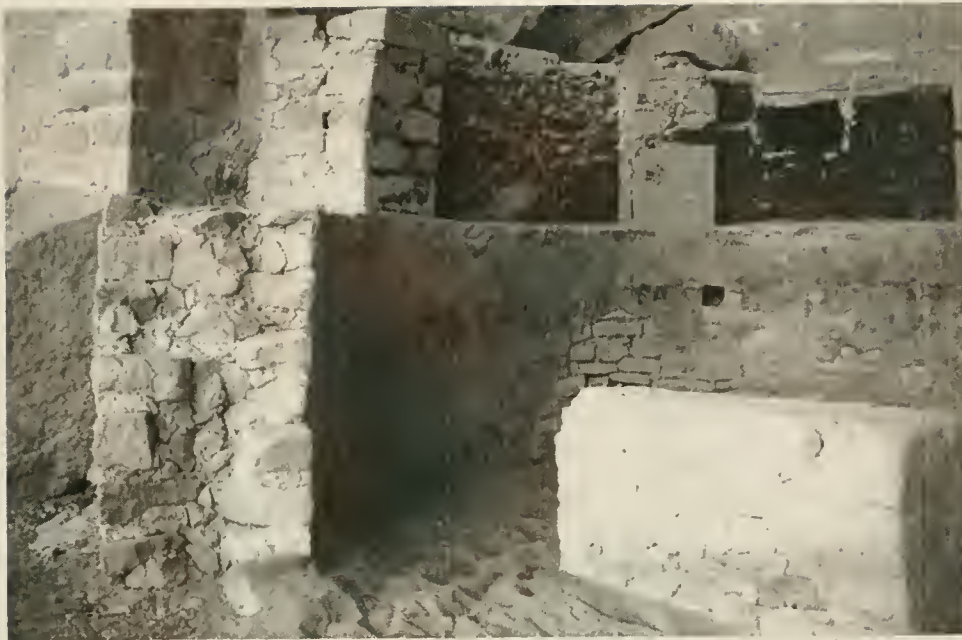
Figure 12. Kiva Q, north wall, deflector.

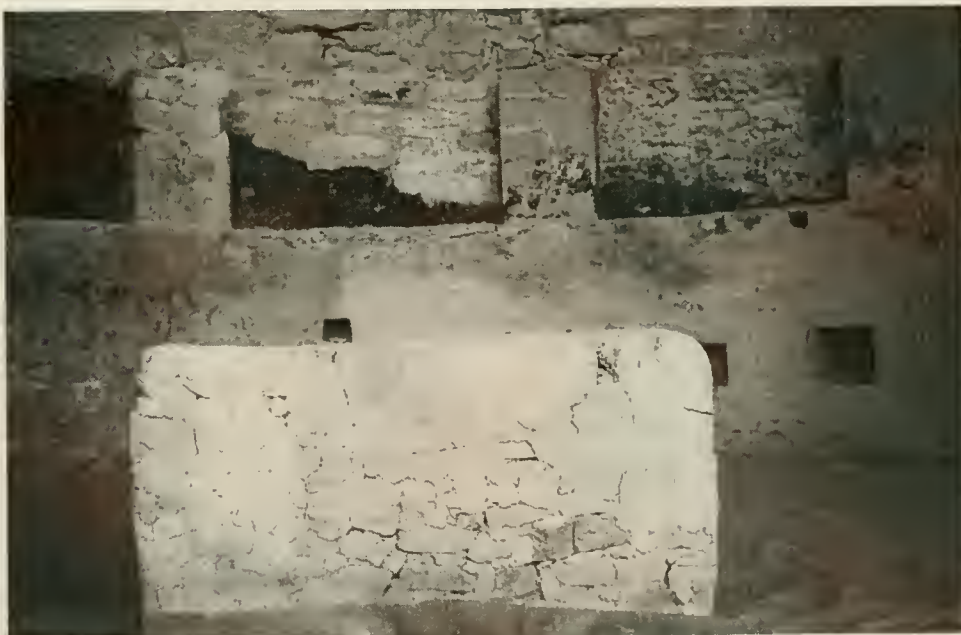
Figure 13. Kiva Q, east wall, deflector.

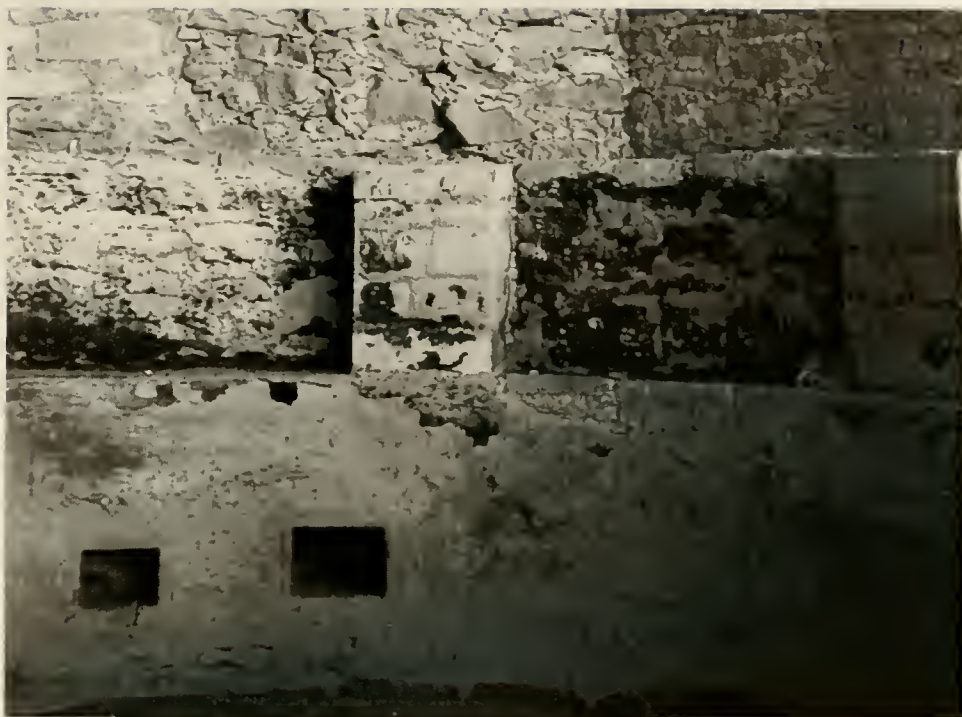
Figure 14. Kiva Q, south wall.

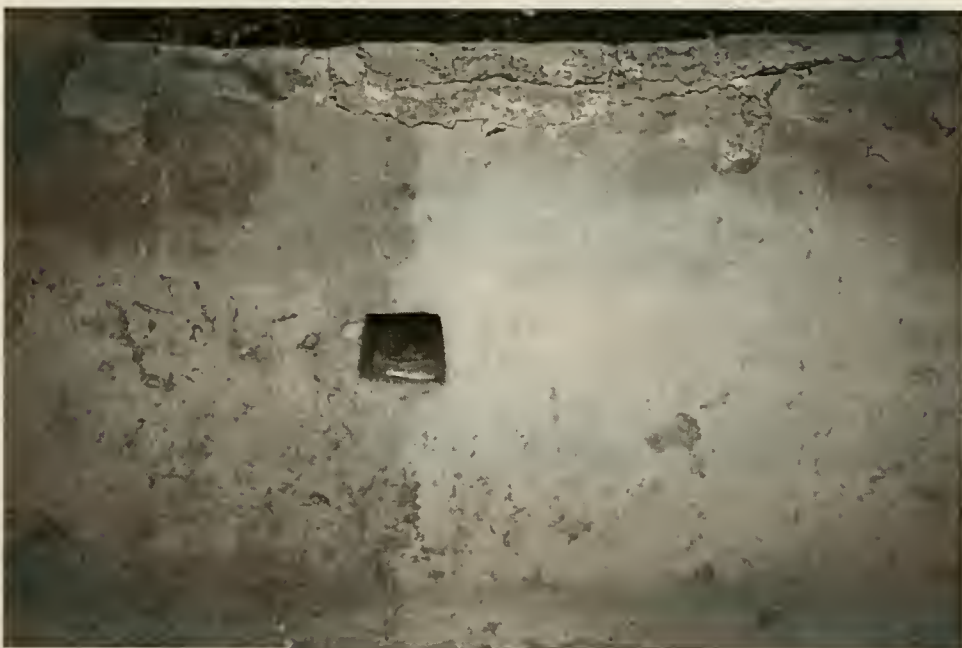
Figure 15. Kiva Q, dividing line in the uppermost finish layer.

The surface finishes of Kiva Q, where extant, vary in condition. The finishes of the south end are in better condition than those elsewhere, but most of the plaster exhibits areas of flaking and detachment from the masonry, as well as delamination between layers of finish. The walls of Kiva Q were finished several times with washes and plasters from earthen materials such as soil and sand, and added color using inorganic and organic colorants to delineate architectural and symbolic elements. The most distinctive feature of Kiva Q observed in the uppermost layer of plaster is a hemispherical division of the kiva running from the top of the banquette to the floor through the center of a niche (Figure 10). This dividing line is created by the interface of the two different shades of reddish-brown plaster used to cover the north and south halves of the kiva. Although the line on the east wall is clear, a corresponding line cannot be confirmed on the destroyed west wall.

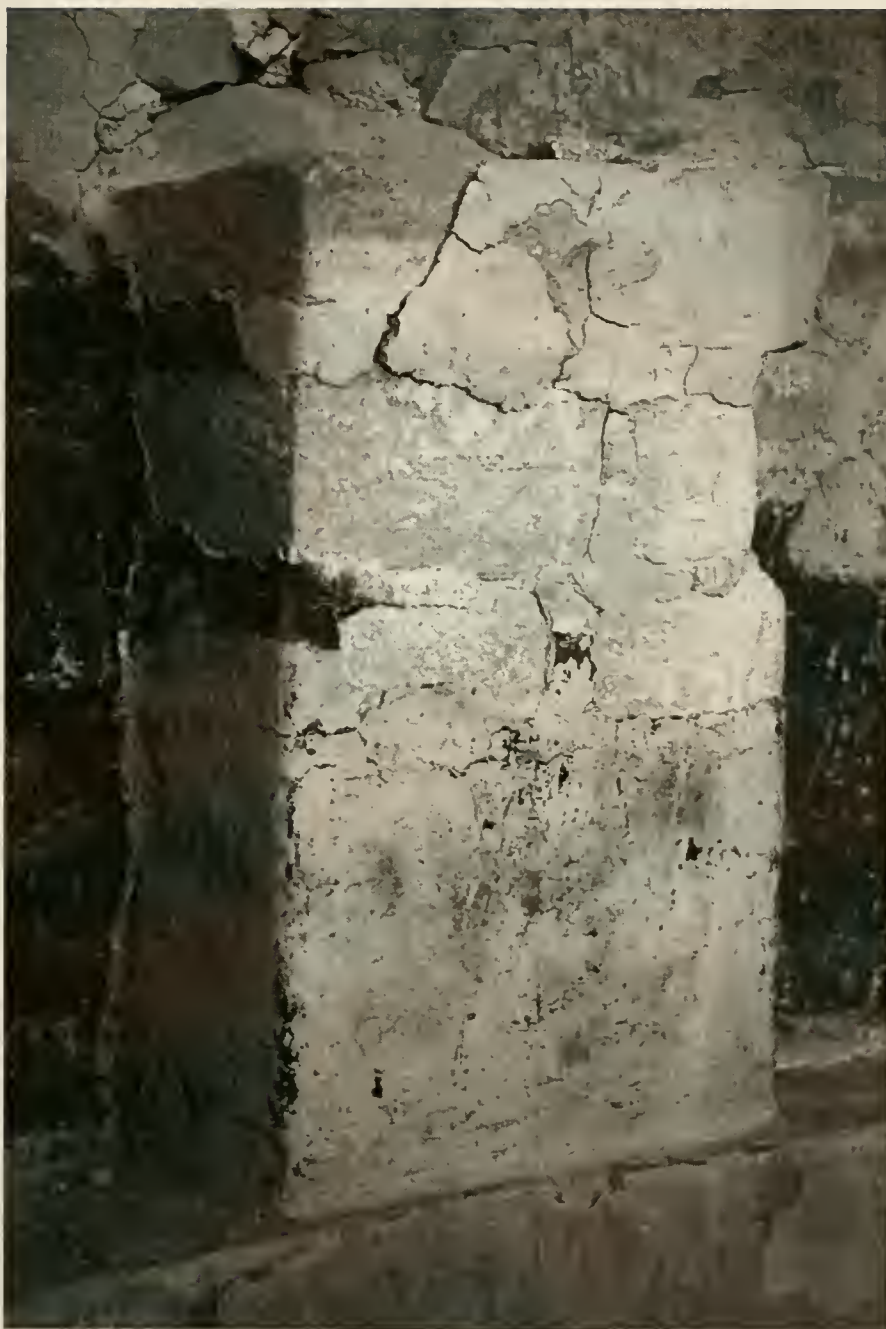
Figure 16. Kiva Q, Pilaster 3 with hand print designs

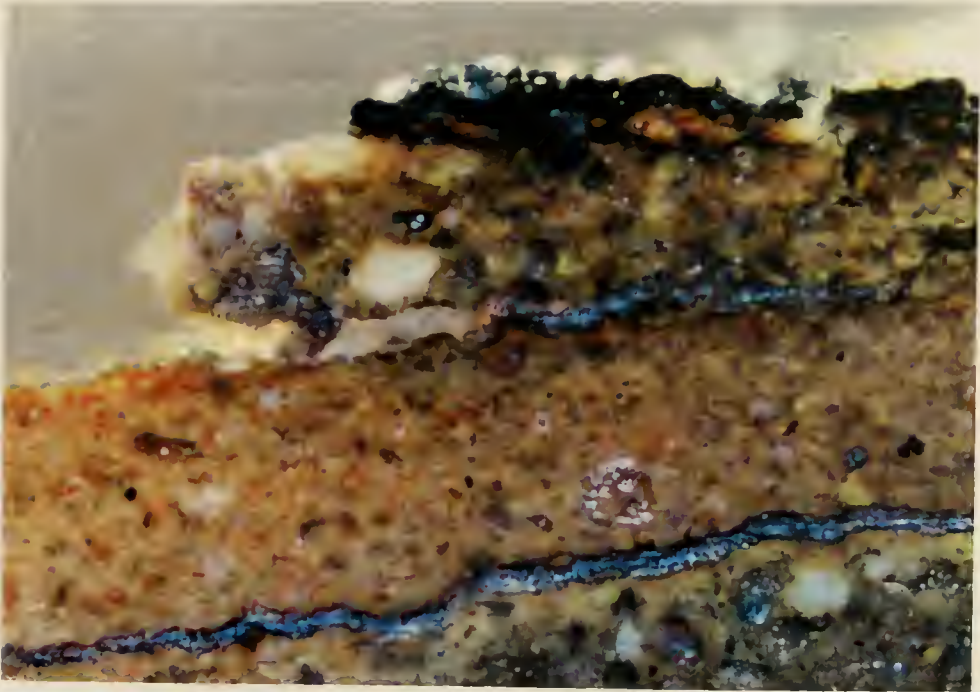
Figure 18. Sample 6 cross section. Reflected light, 10x magnification.

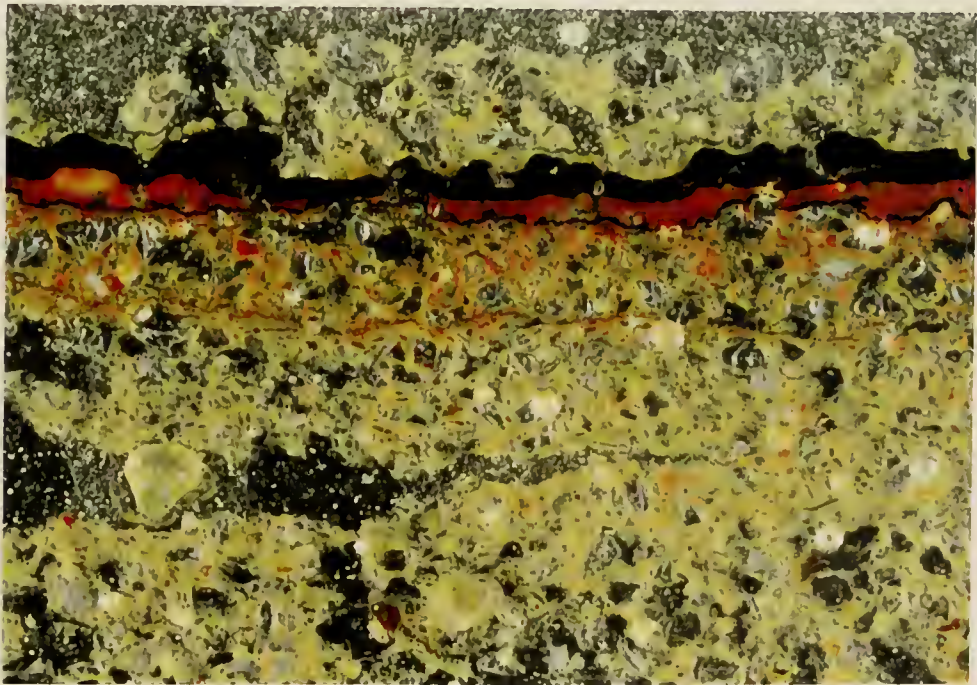
Figure 19. Sample 6 thin section. Pseudo-darkfield reflected light, 10x magnification.

microscope equipped with a quartz halogen DDL projector lens Darklite Illuminator.[™] Examination of the thin sections under this illumination gave a clear image of the layer structure of the samples and realistic color representation. The micromorphology of key samples was characterized by describing the coarse and fine fraction in terms of color and texture, particle size, shape, and sorting, and other visual characteristics (see Appendix F). Stratigraphies identified under these light conditions were used to build speculative temporal finish sequences for the kiva.

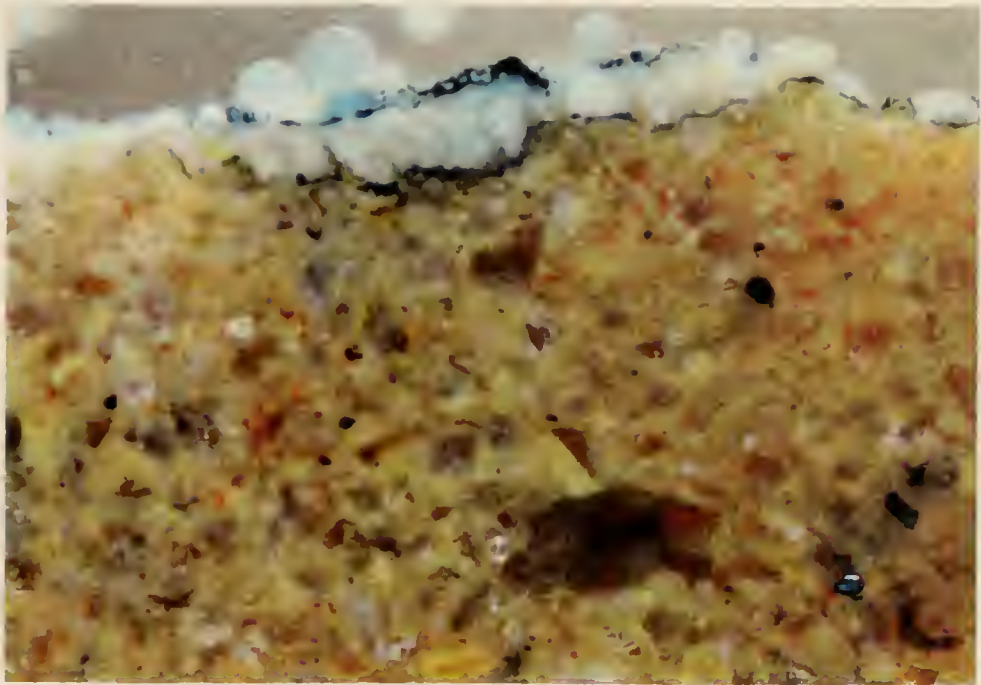
Figure 20. Sample 10 cross section. Reflected light, 10x magnification.

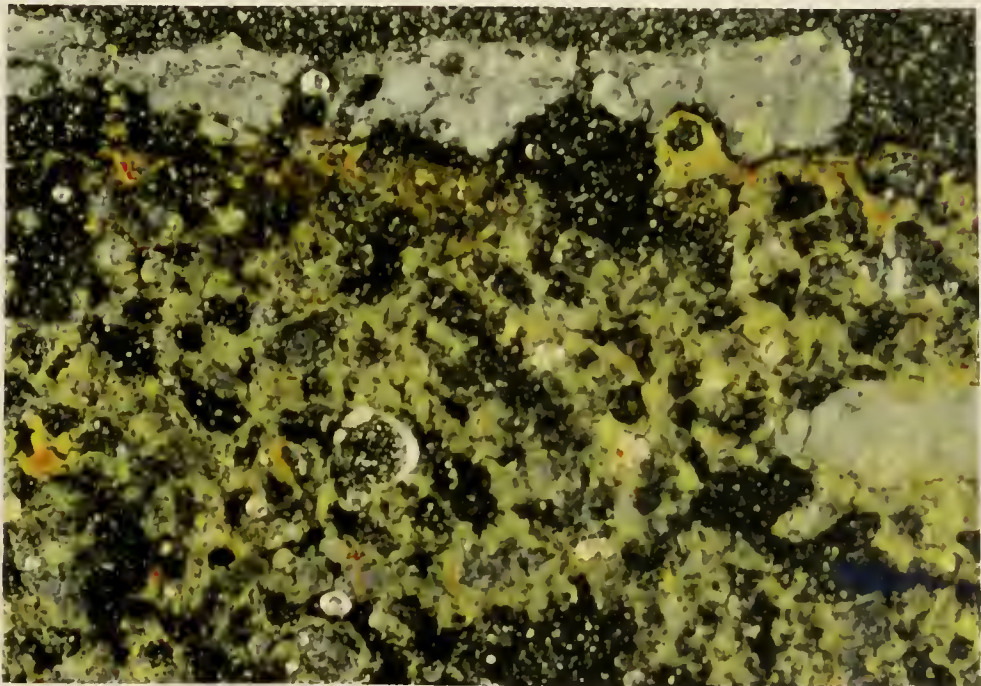
Figure 21. Sample 10 thin section. Pseudo-darkfield reflected light, 10x magnification.

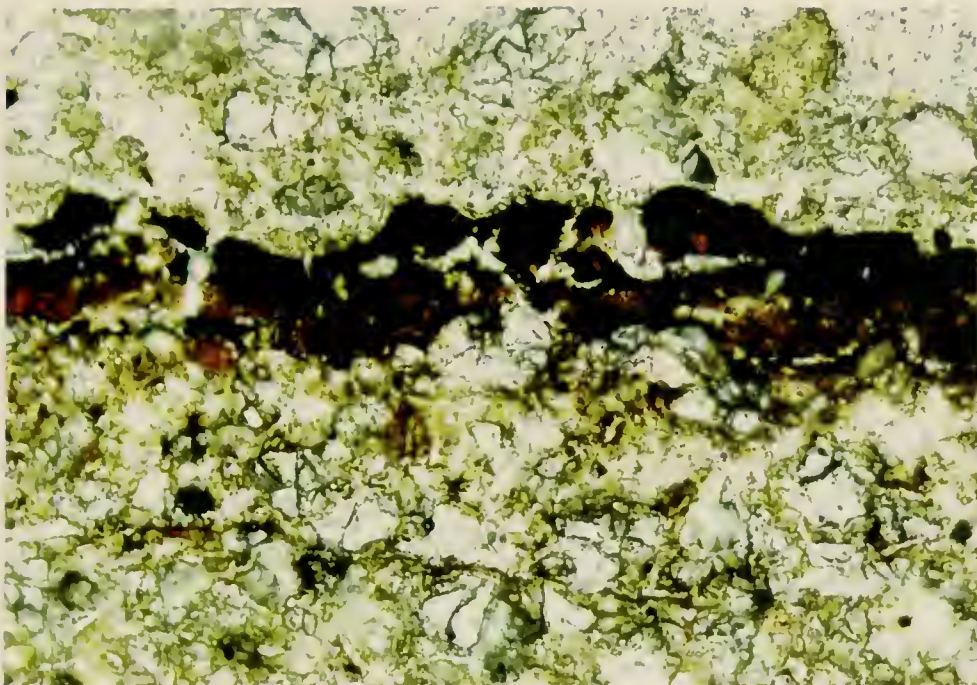
Figure 22. Sample 6 thin section. Plane polarized light, 100x magnification.

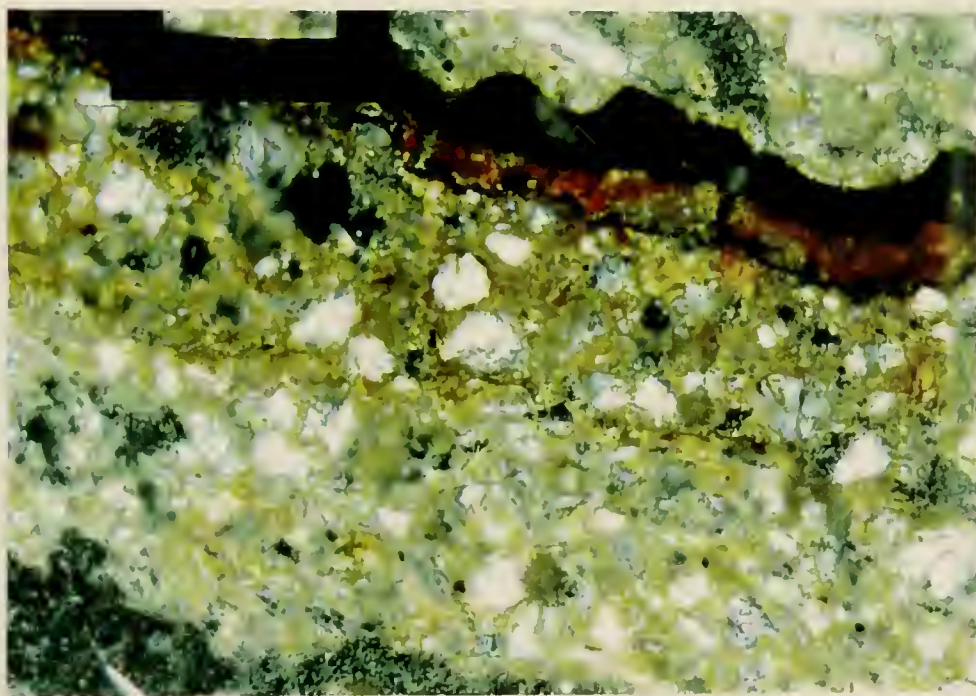
Figure 23. Sample 6 thin section. Cross polarized light, 100x magnification.

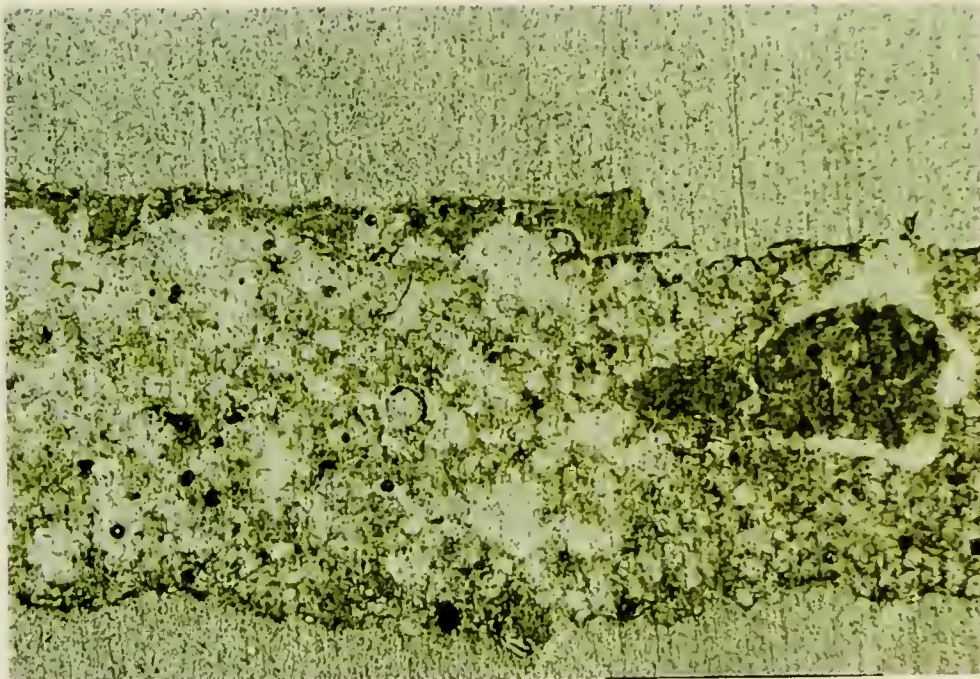
Figure 24. Sample 10 thin section. Plane polarized light, 25x magnification.

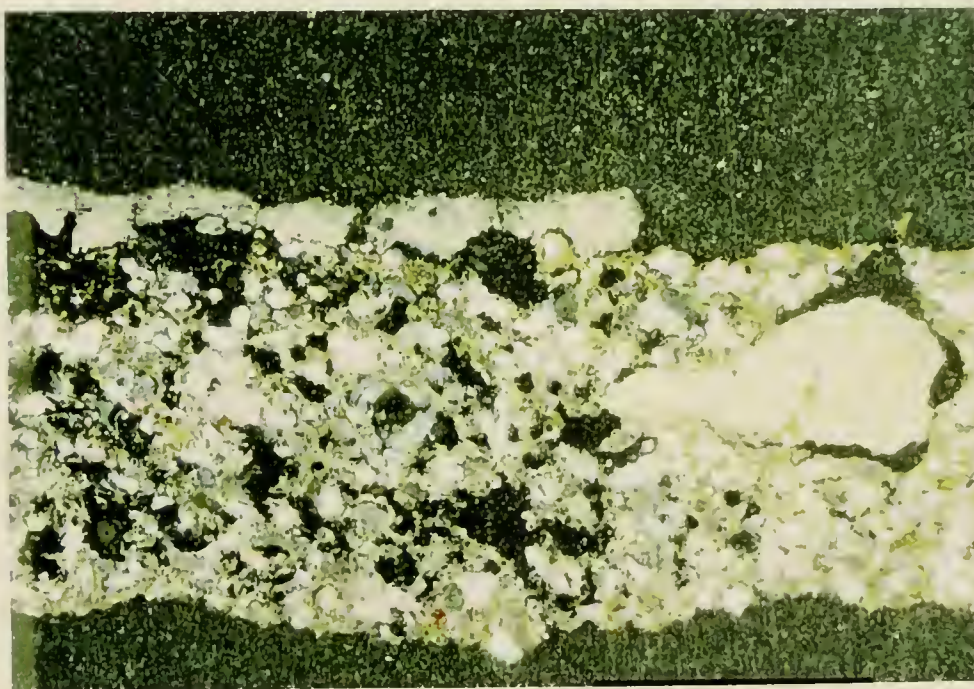
Figure 25. Sample 10 thin section. Cross polarized light, 25x magnification.

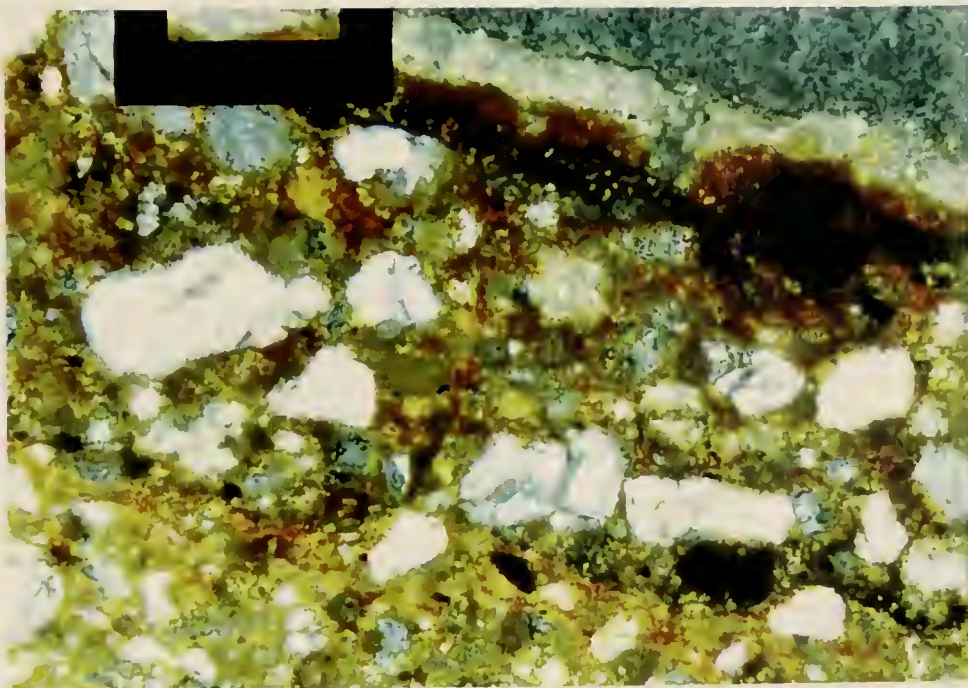
Figure 26. Sample 11b thin section. Cross polarized light, 100x magnification.
Fractured quartz grains.

The aggregate, or coarse fraction, of these samples is chiefly quartz. Quartz grains, occurring in a wide range of particle sizes, comprise up to 60% of these stratigraphies. In almost every sample, the quartz grains are fractured in such a way that suggests they were mechanically crushed rather than weathered or naturally compromised. Plagioclase feldspar grains were also identified. Large inclusions were commonly observed in the thin sections. Most of these inclusions are calcareous blebs (calcite, dolomite), fossils, and the aforementioned ferromagnesium minerals. (See Appendix F for micromorphological descriptions.)

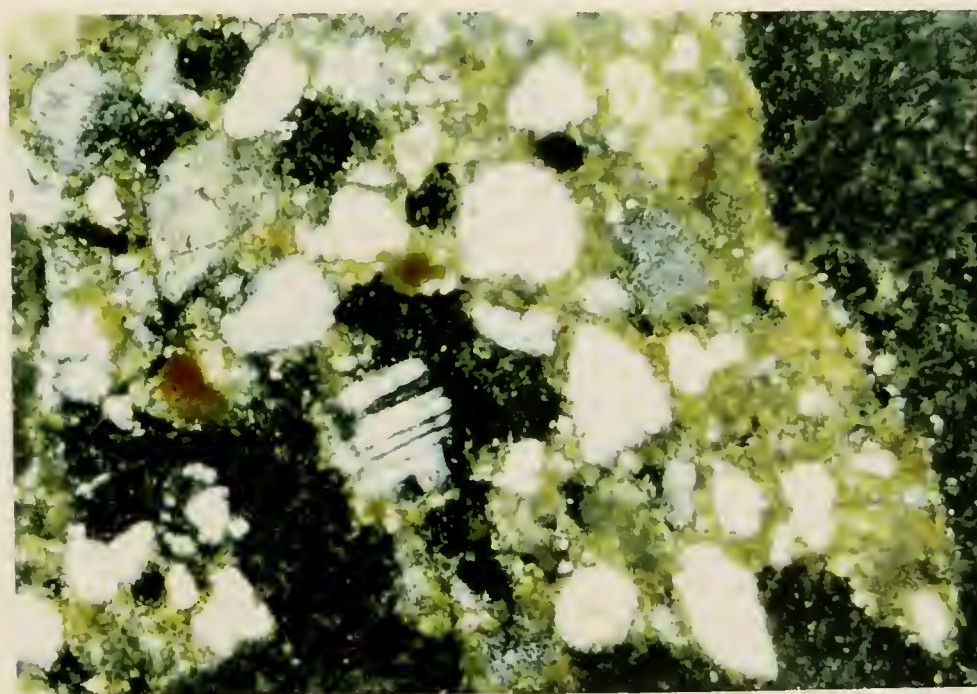
Figure 27. Sample 8 thin section. Cross polarized light, 100x magnification.
Feldspar twinning.

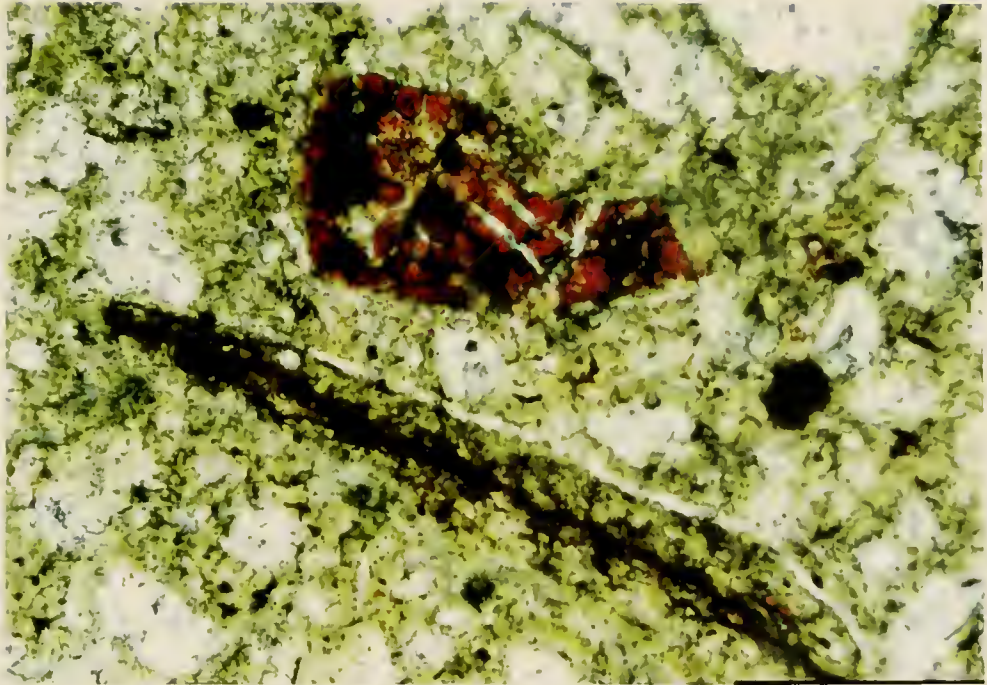
Figure 28. Sample 4 thin section. Plane polarized light, 100x magnification.
Ferromagnesium particles in matrix.

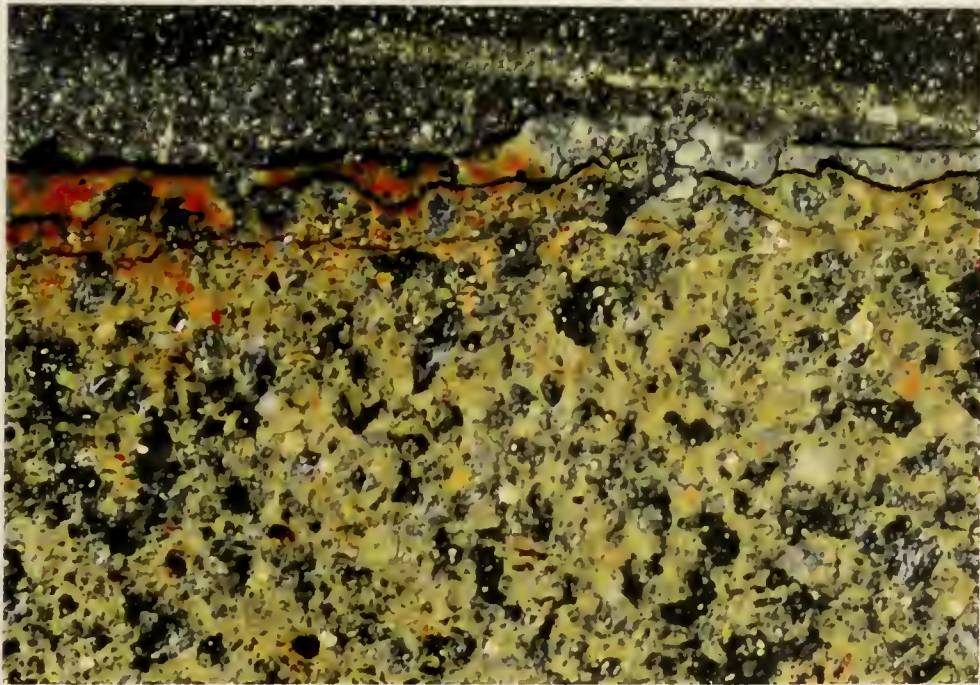
Figure 29. Sample 2 thin section. Pseudo-darkfield reflected light, 10x magnification.
Juncture of red and white finishes in one layer.

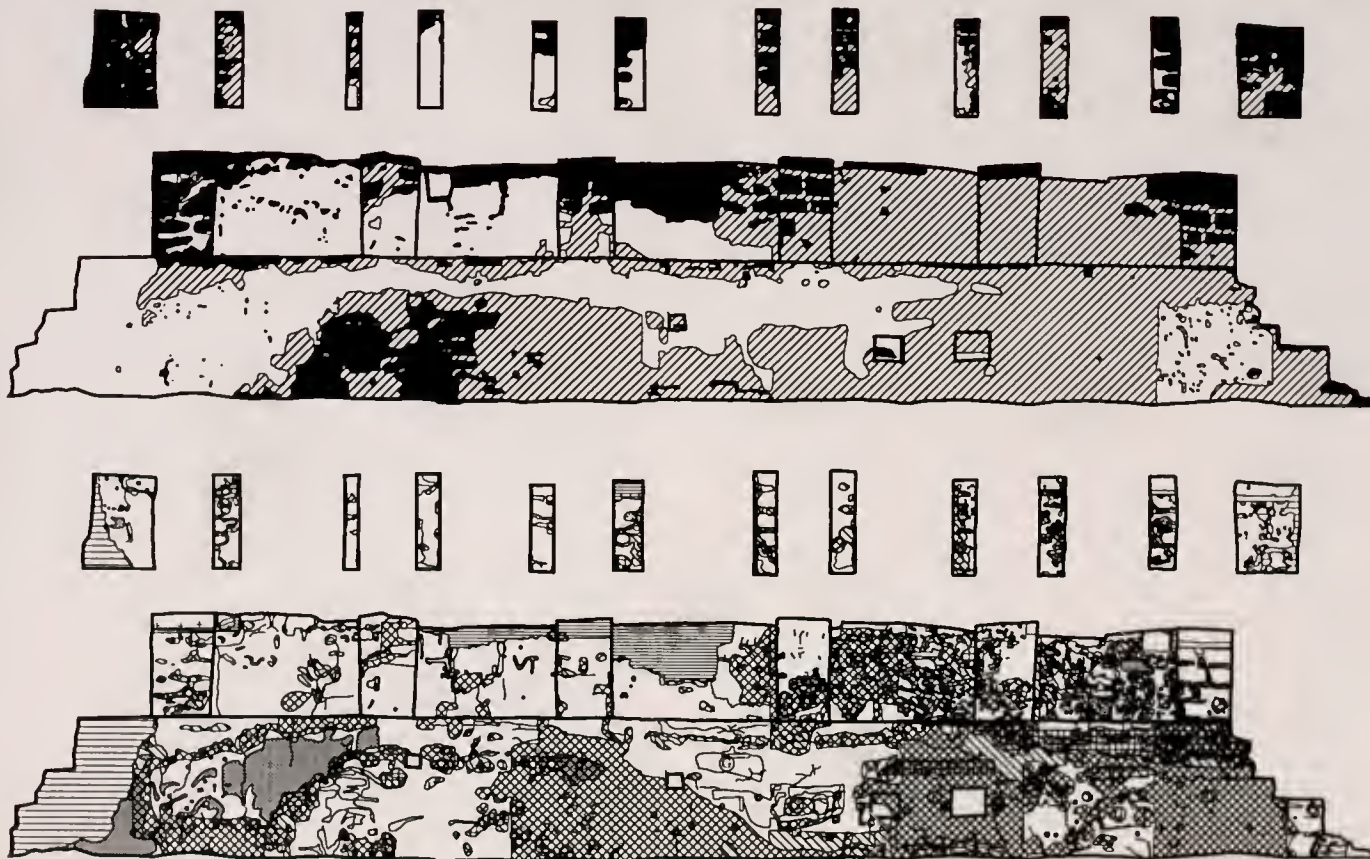
KIVA Q

- a Slight elevation in the plaster to the left and right of both niches. At the right niche, a vertical strip of strong plant material shows behind stone elevations (see sketch in visible).
- b Mostly blind cleavage, not all treatable.
- c Partially blind cleavage, probably not all treatable.
- d Delamination/flaking is partially/heavily blind. Treatment would be possible in all instances.

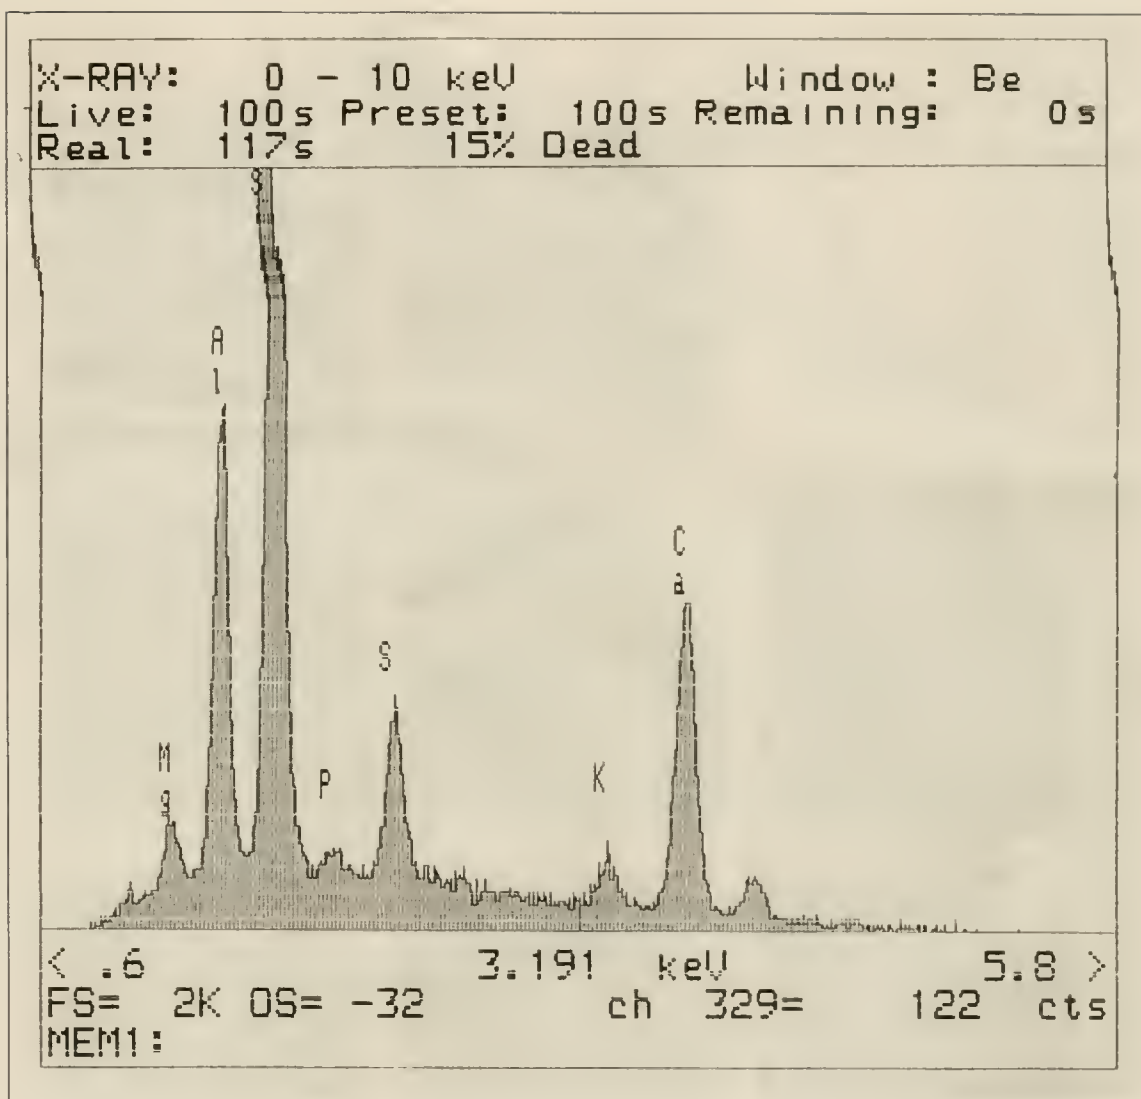
SEM/EDS Spectrum of Sample 11, Kiva Q
