**CHARACTERIZATION OF EARTHEN ARCHITECTURAL SURFACE
FINISHES FROM KIVA Q,
CLIFF PALACE, MESA VERDE NATIONAL PARK
COLORADO**

A THESIS

Historic Preservation

1999

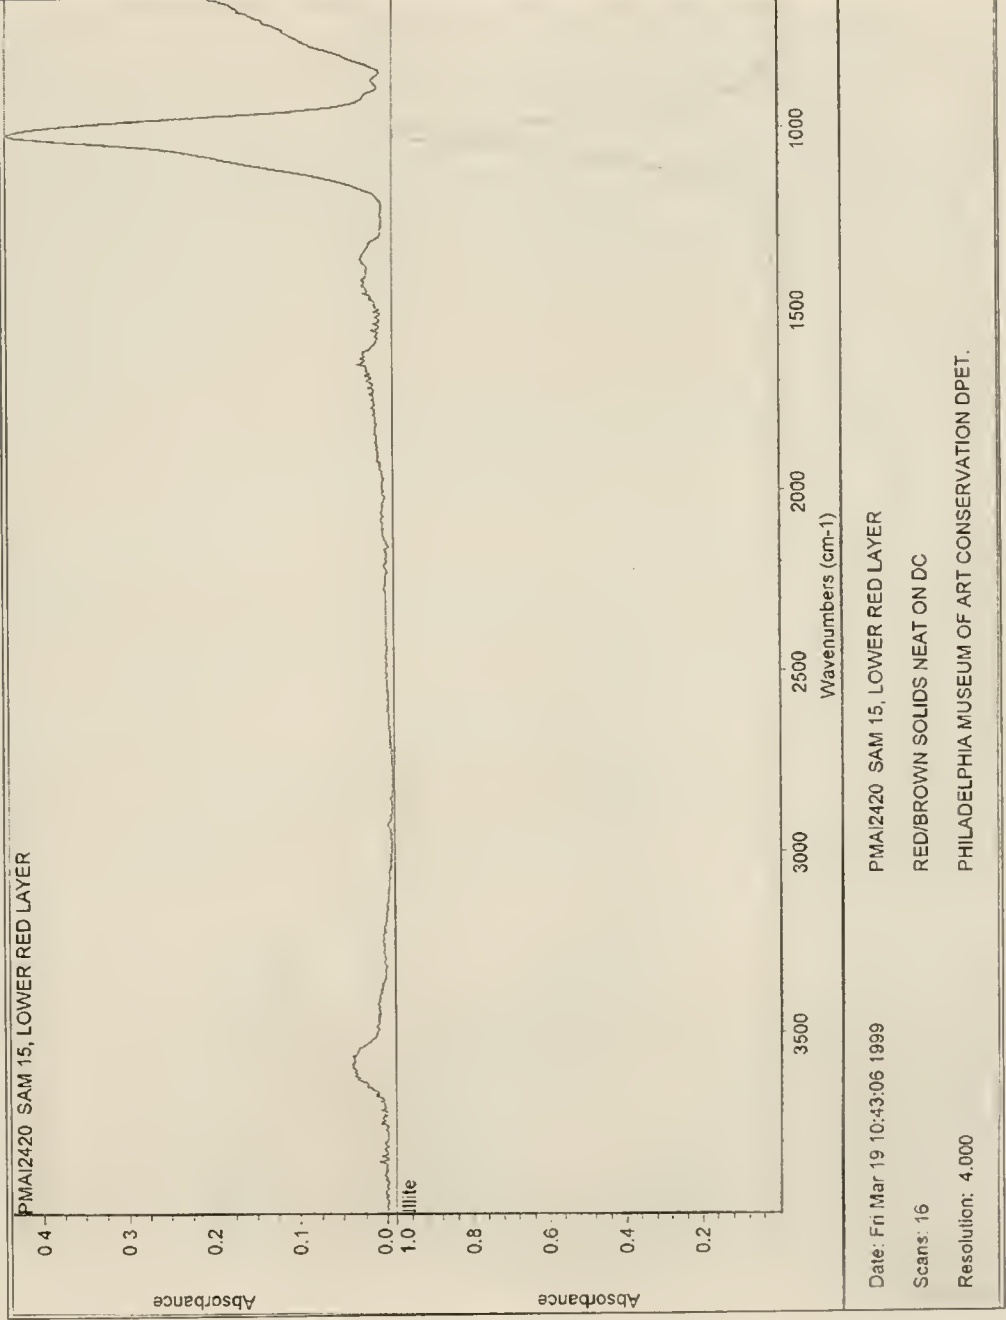
Infrared Spectrum of base plaster from Sample 15, Kiva Q

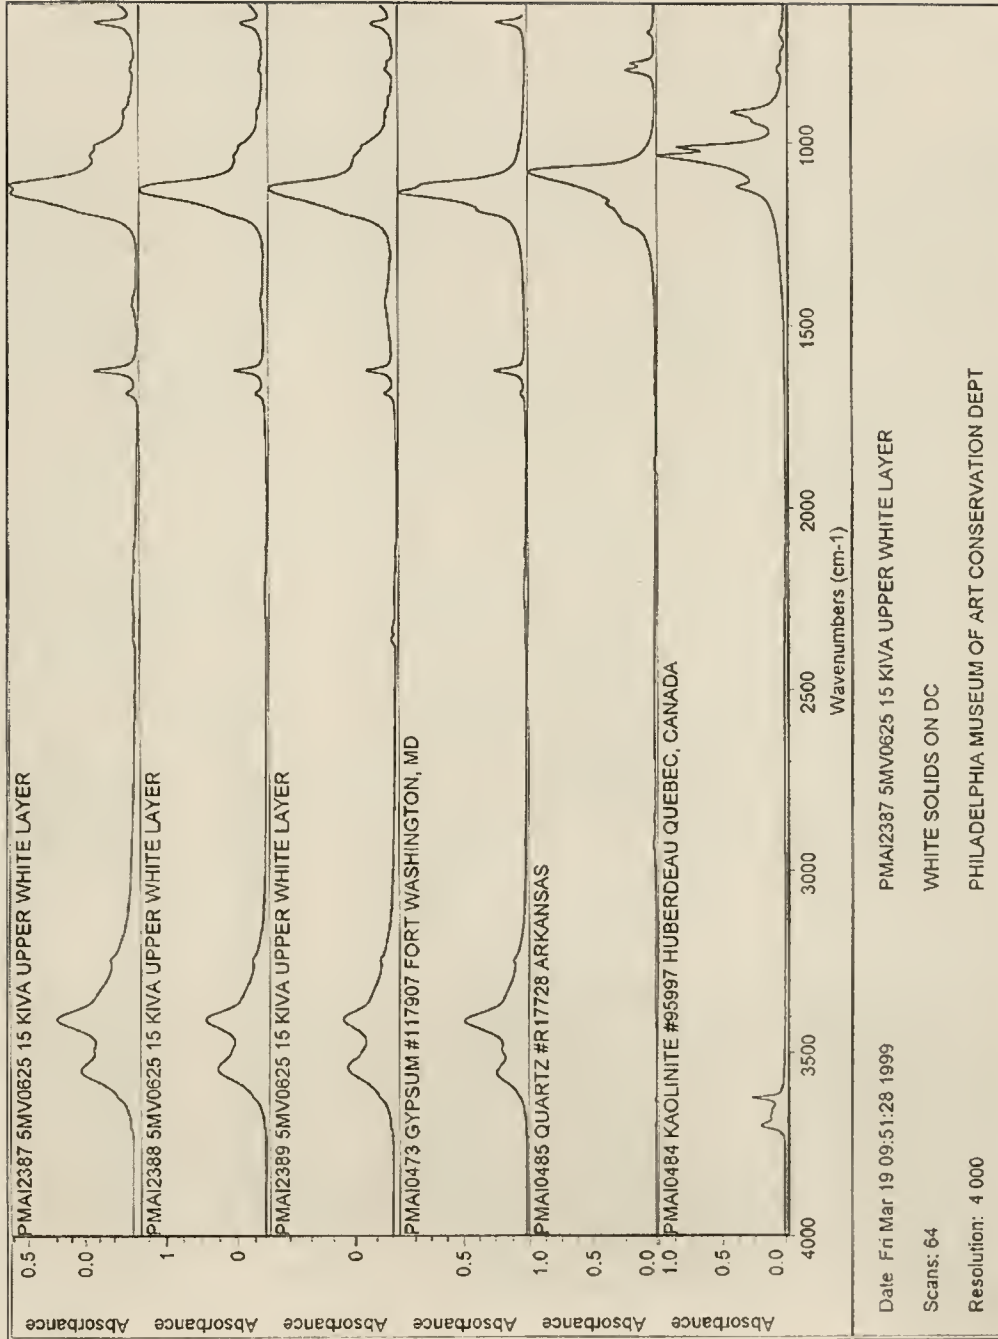
Infrared Spectrum of white pigment from Sample 15, Kiva Q

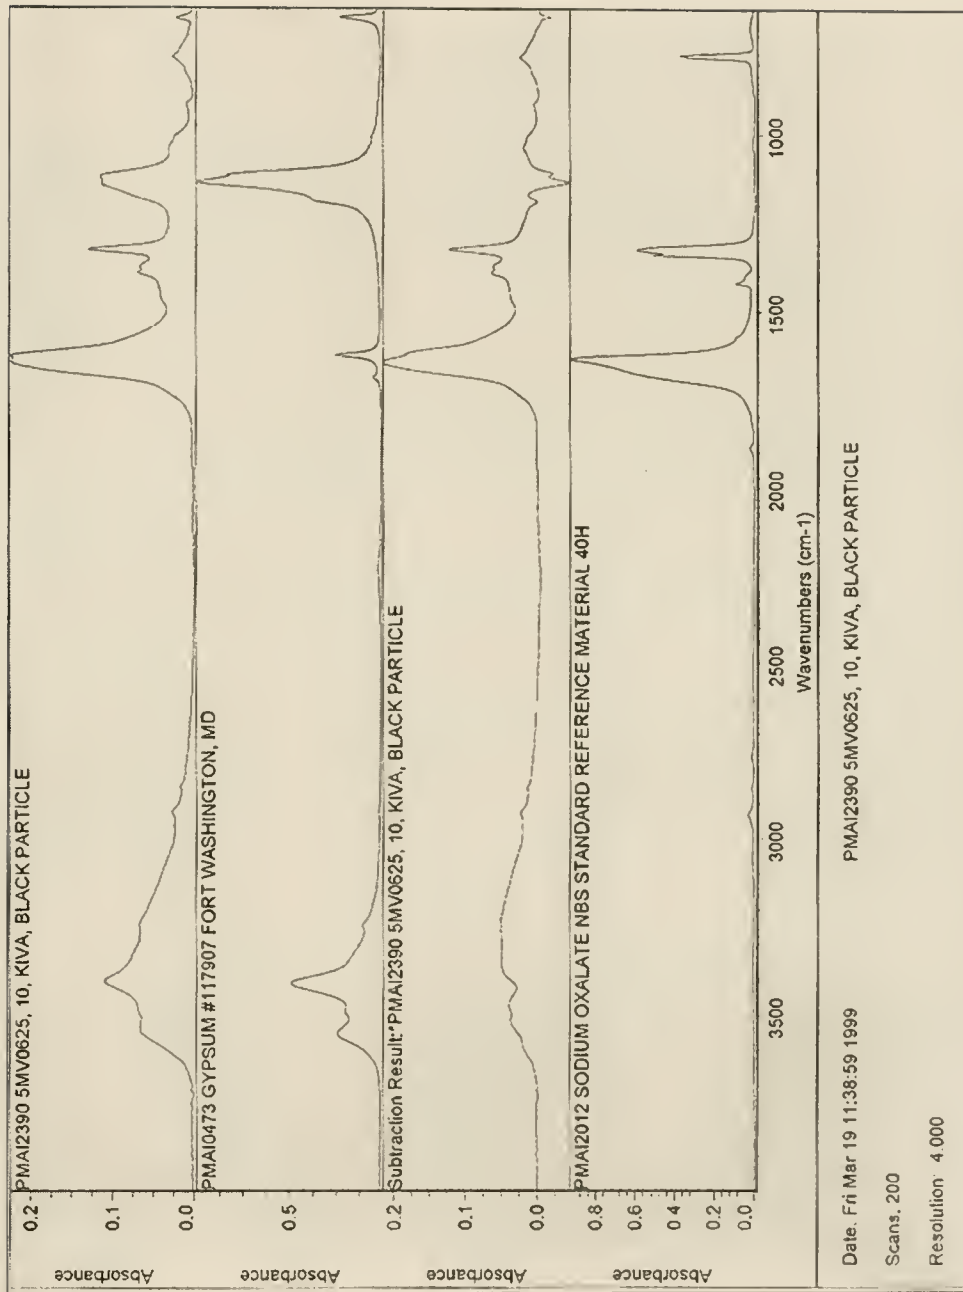
Infrared Spectrum of black pigment from Sample 10, Kiva Q

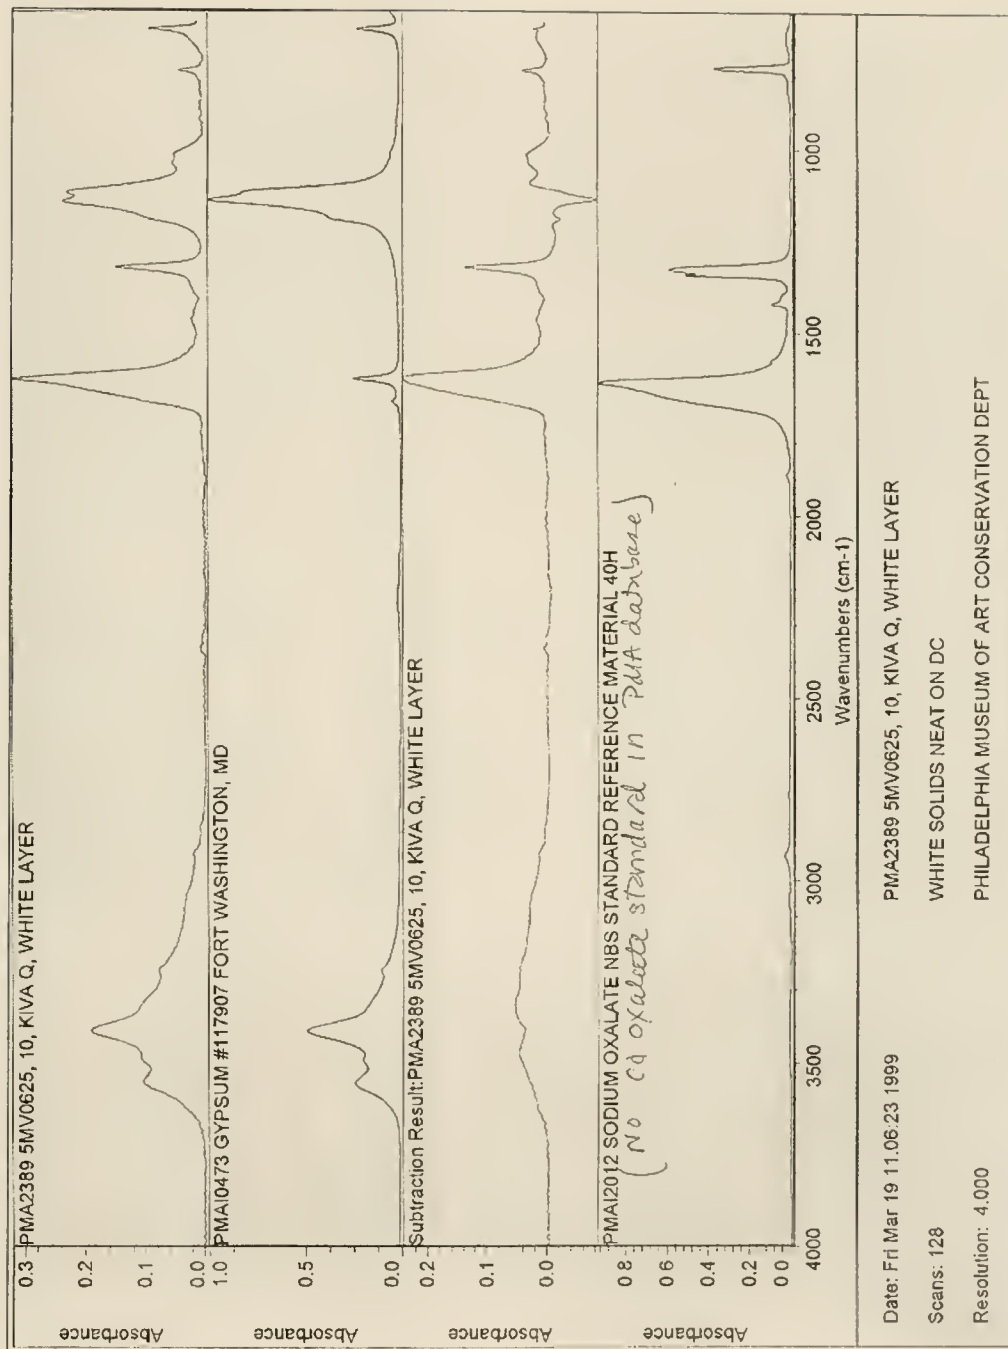
Infrared Spectrum of white pigment from Sample 10, Kiva Q

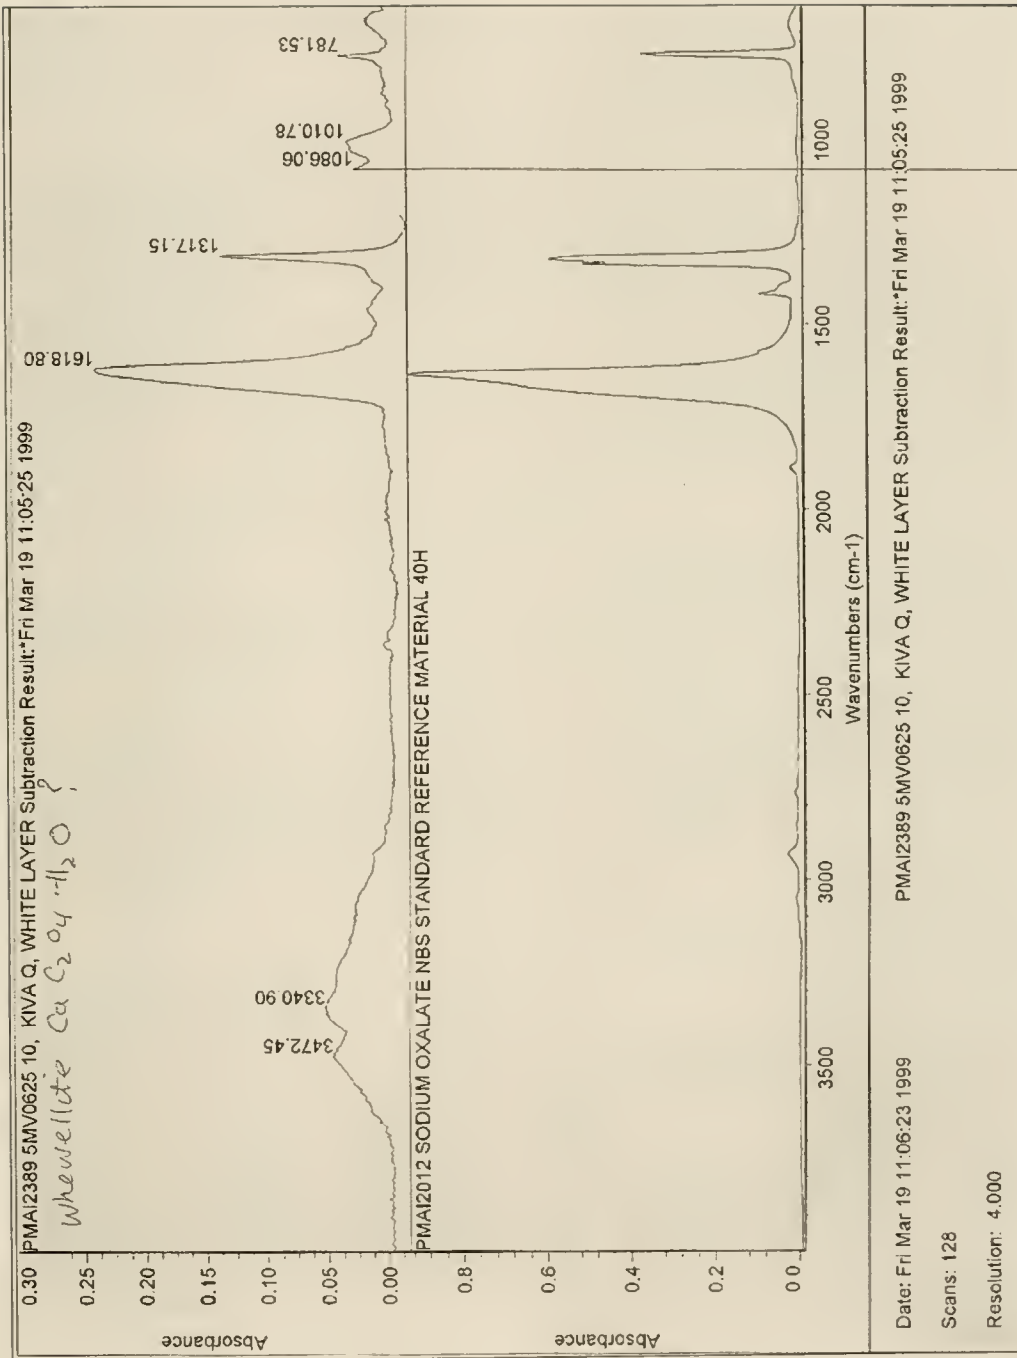
Infrared Spectrum of white pigment from Sample 10, Kiva Q
