PERFORMANCE OF THE ROOF STRUCTURE AT THE WAGNER FREE  
INSTITUTE OF SCIENCE: A COMPUTATIONAL SIMULATION AND ITS  
IMPLICATIONS FOR PLASTER CONSERVATION

Katharine Helene Woodman

MASTER OF SCIENCE OF HISTORIC PRESERVATION

2010

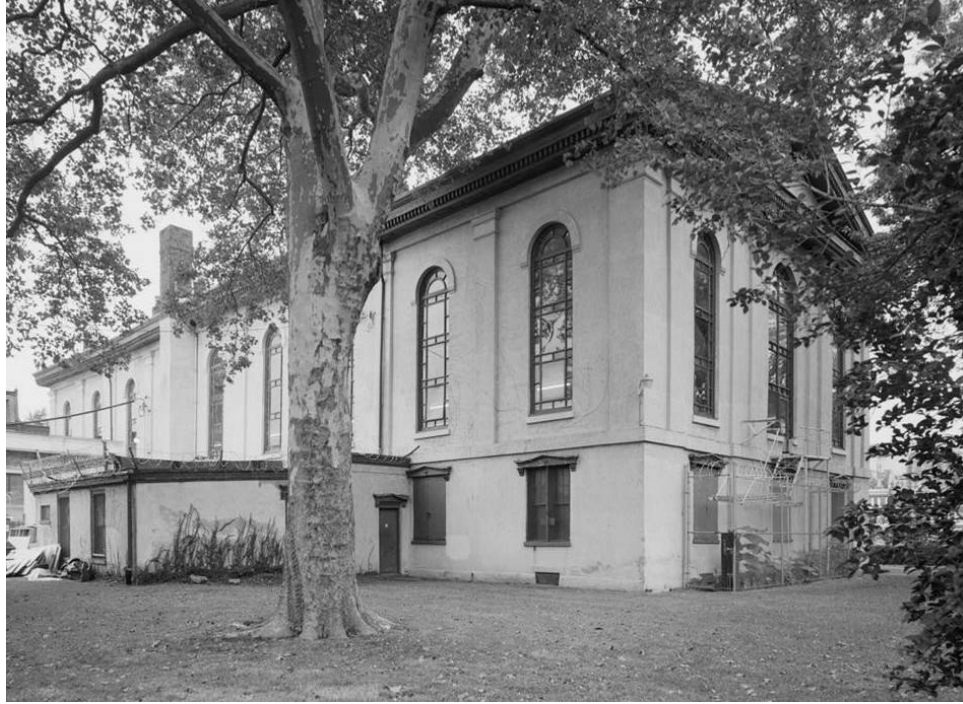
**Figure 7: Southwest Perspective of the Wagner Free Institute (Photograph by Joseph Elliot for the Historic American Building Survey)**

windows in the exterior bays, which flanked a wooden entrance portico. The east and west elevations were segmented into nine bays separated by single pilasters and pierced by two story windows. The composition was completed by a classical dentil cornice; however, the walls, which were to have been rendered and incised to mimic ashlar, were left unfinished. (Figure 7)

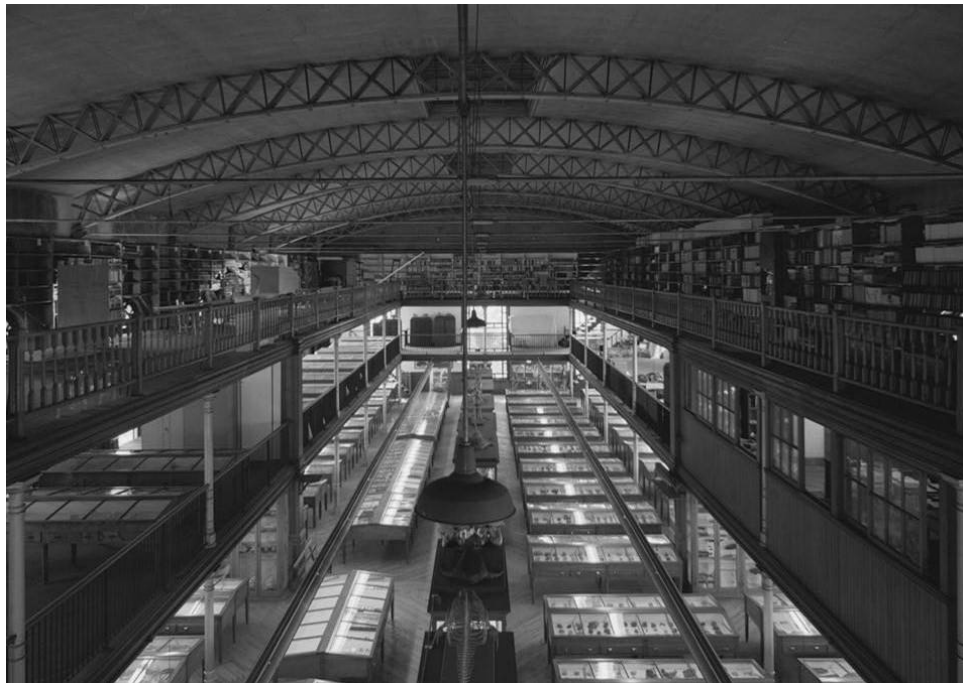
**Figure 8: Barrel Vaulted Ceiling and Arched Trusses of the Wagner Institute (Photograph by Joseph Elliot for the Historic American Building Survey)**

The industrial nature of the exposed columns was reinforced by the use of eight arched trusses that composed the roof structure. In contrast to the more traditional construction of the rest of the building, the trusses represented a nascent, state of the art technology, customarily seen at that era in bridges or train sheds construction. In fact, this particular truss system was based on the patent by Philip Quigley<sup>39</sup>, who, prior to becoming a founding partner in the bridge building firm of Stone, Quigley and Burton in 1851, had been chief bridge engineer of the Philadelphia, Wilmington and Baltimore Railroad.<sup>40</sup> Just seven years prior to the construction of the Wagner Institute, this railroad company had completed the nation's first vaulted train shed at the Broad and Prime Street Station in Philadelphia, boasting a curved roof supported by "arched Howe trusses of wood."<sup>41</sup> (Figure 9) Both the Broad Street Station and Wagner roof trusses appear to have been adaptations of the Howe truss<sup>42</sup>, a popular system for bridges at the time. (Figure 10) The Howe truss is composed of two identically sized chords which are tied together by a system of vertical rods and diagonal bracing. In the case of the Broad Street station, all of these elements were construction of wood, while the Wagner adaptation employed

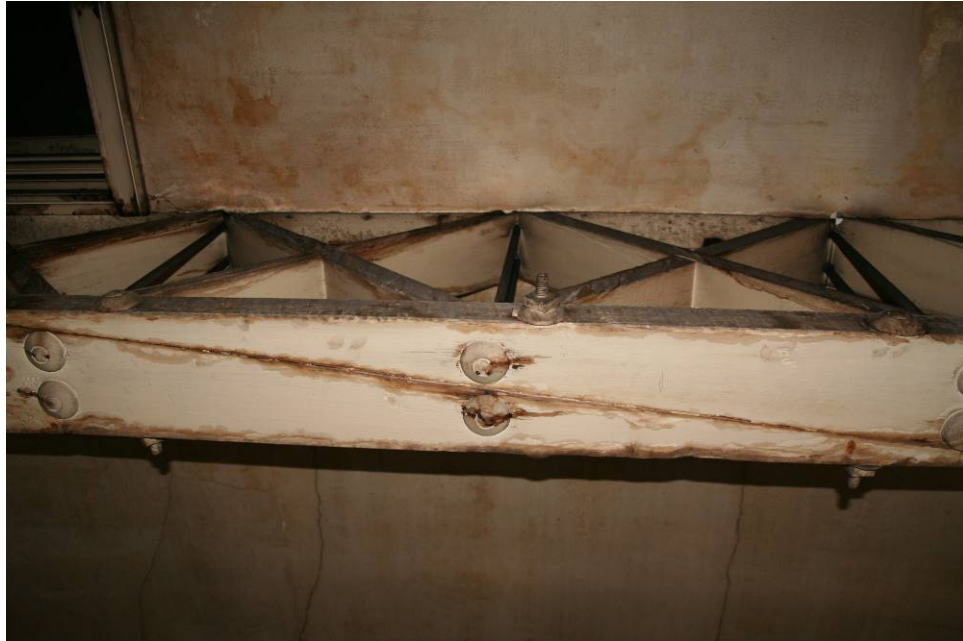
**Figure 18: Typical bottom chord splice. Note water staining and loss of paint. (Photograph by author)**

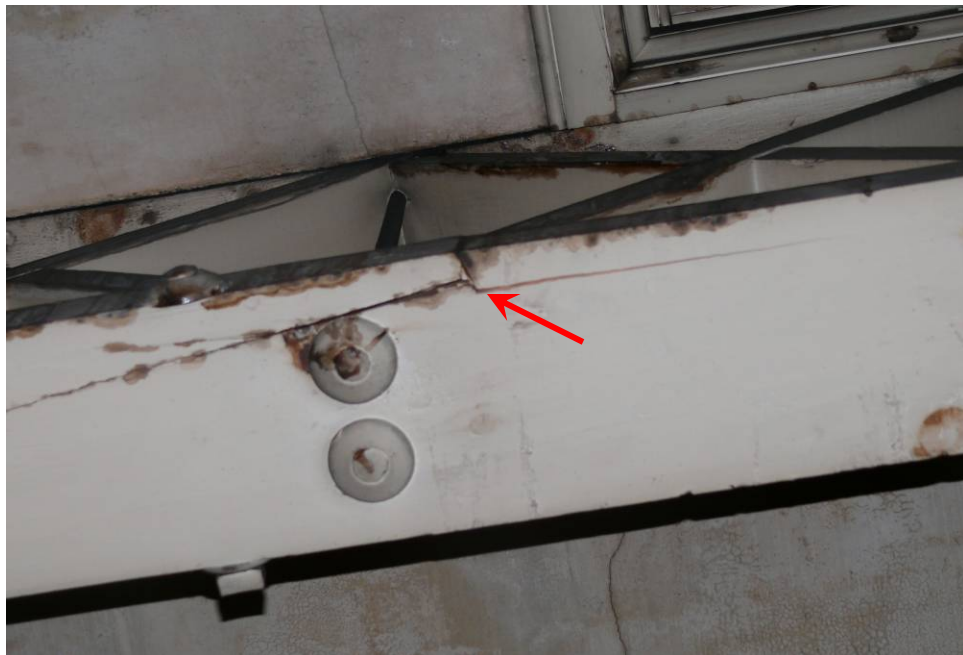
**Figure 19: Detail of typical shear failure parallel to the grain at end of scarf splice. (Photograph by author)**

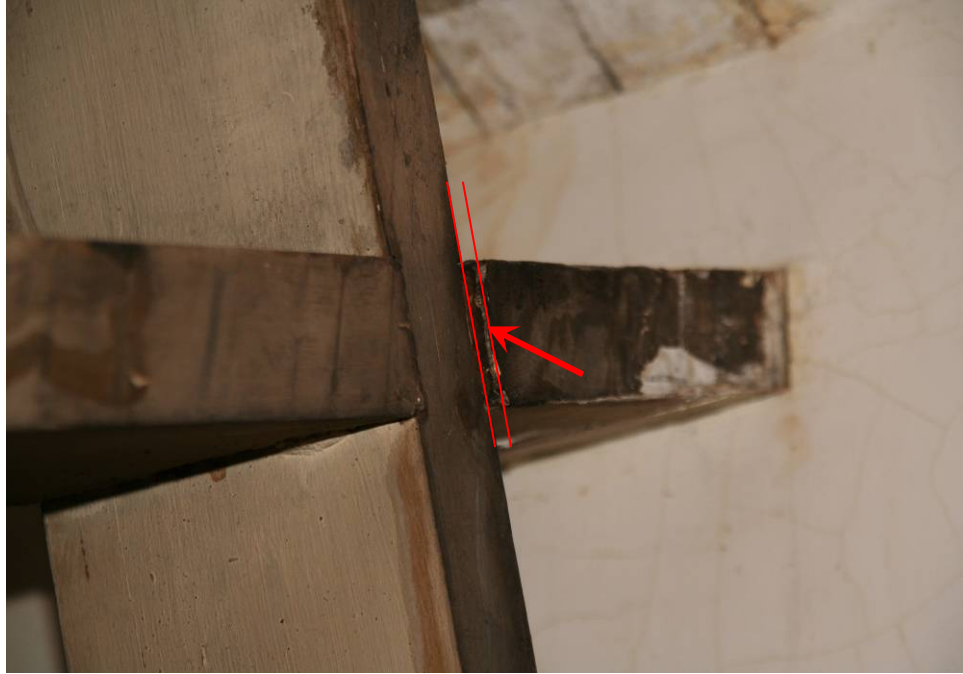
**Figure 20: Movement of wood cross braces (Photograph by author)**

The diagonal cross braces of the truss panels show water stains on their surface, but do not appear to be threatened by decay or structural overstress. In fact, a number of the diagonal spacers were observed to be loose, many of them separated from either the main diagonal or the iron bearing block by up to ¼ inch. In multiple instances, these blocks also appear to be shifted out of the vertical plane of the truss by up to ½ inch. The bracing members also appear to be rotating out of the vertical plane in many instances, corresponding to the lateral displacement of the bottom chords relative to the top chord. (Figure 20)

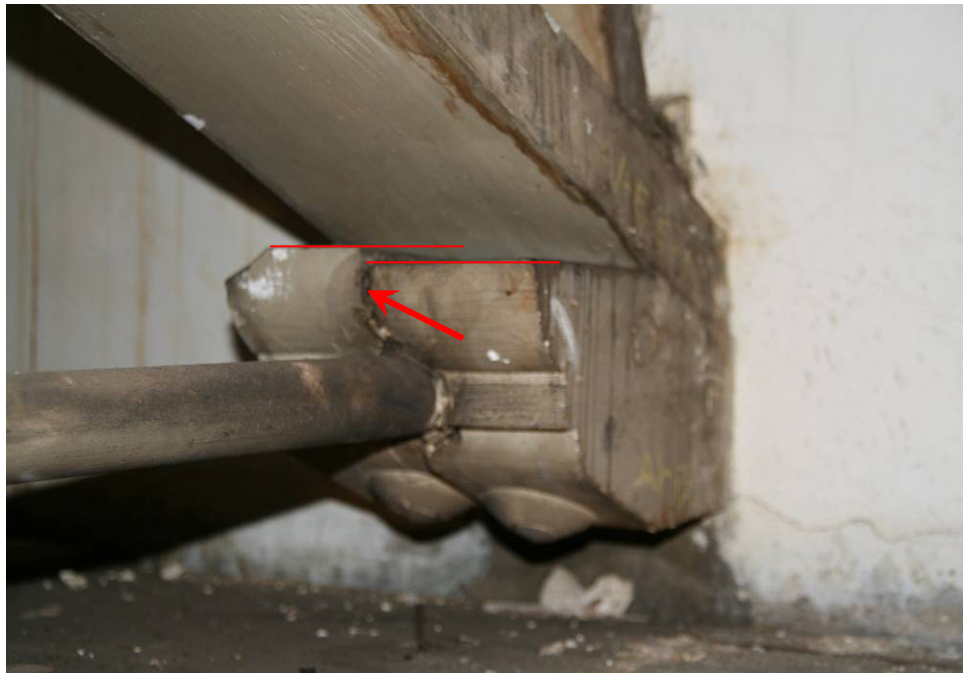
**Figure 21: Shifting of the two bearing block pieces relative to one another (Photograph by author)**

The bearing blocks extend to the cornice fascia, and have therefore been susceptible to roof and gutter leaks. This exposure has resulted in some superficial decay of the outside end of the bearing block. While this is a concern, it does not appear to have any adverse structural implications with respect to vertical bearing on the wall or restraint of the tie rod ends. No overwhelming evidence of crushing of the bearing block due to the tie rod plates was observed. However, in the many instances the two pieces of the bearing block have shifted vertically relative to each other. In trusses 1-4, the southern half of the bearing block appears to be displaced vertically up to ¼ inch relative to the northern bearing blocks at both ends. Conversely, the bearing block pieces display the reverse of this in trusses 5-8. The shifting of these bearing blocks appears to correspond to the direction of lateral rotation of the truss about its bearing points. (Figure 21)

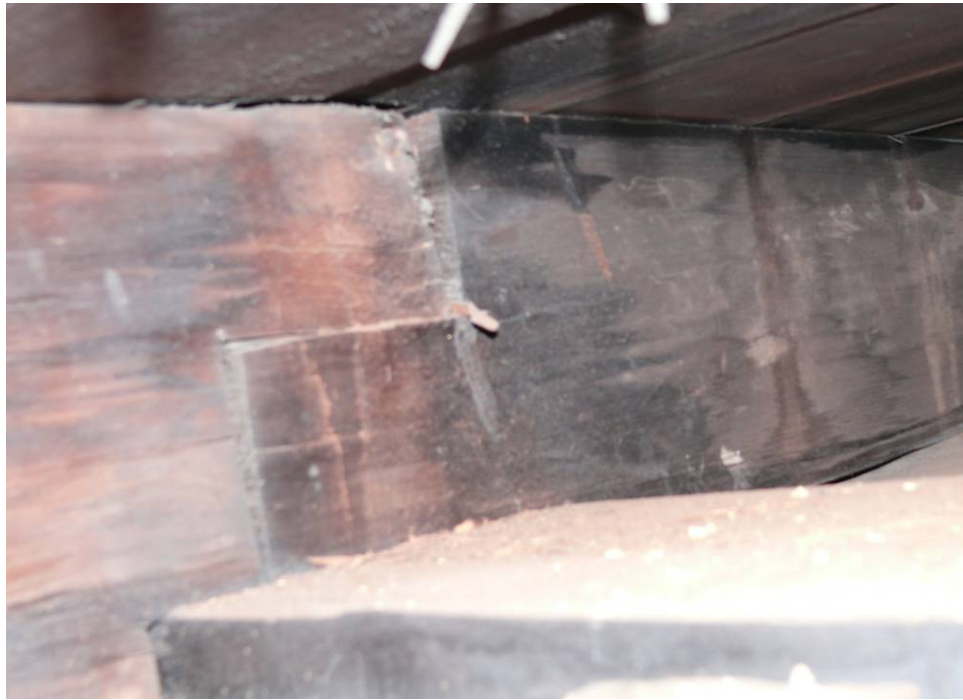
**Figure 22: Original Purlins. Note lapped splice and lack of mechanical connection. (Photograph by author)**

Purlins were inspected through a combination of roof probes performed by Marlene Goeke in 2008<sup>62</sup>, and through an area of plaster loss at bay three of the ceiling. The purlins do not show any adverse structural overstress or displacement. Some water staining is observed, but this does not appear to have resulted in significant water damage. With the exception of the 4 or 6 bolted connections, the purlins are attached to the trusses by means of toe nail connections. According to the Keast & Hood report, a number of these mechanical connections are missing. This raises some concerns as to the lateral stability of the trusses, as well as the performance of the roof due to wind uplift conditions. (Figure 22, Figure 23)

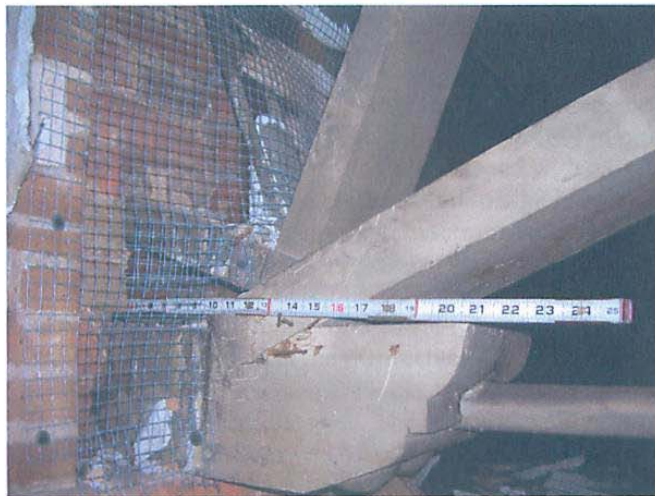
*Bolster receiving the bottom chord and 1 5/8" tie rod  
Gredell & Associates, 8 July 2008*

The primary structure of the roof is comprised of eight (8) tied, two hinged arch timber trusses that clear span east-west approximately 57'-4" and bear on 16" brick masonry exterior walls with integral pilasters. The trusses are on approximately 17' centers with an 8' rise from the bearings to the crown. The truss is framed with 2 ½" x 7 ¾"

(flat) top and bottom chords, 1 ¾" x 6" diagonals seated on cast iron shoes fixed with 2-5/8" diameter wrought iron rod verticals at approximately 25" centers. The arched truss is tied with a 1 5/8" diameter horizontal rod set in the vertical center of 7 ½" x 6" bolster blocks that bear on the masonry. The blocks extend to the fascia board of the eave construction. The rod is fixed at the exterior end of the blocks with a 5" x 1/2" x 5" plate washers and nut assembly.
