(IN)FORMING AND PRESSING MATTERS: LAYING THE FOUNDATIONS
FOR THE PRESERVATION AND INTERPRETATION OF THE
WESTERN CLAY MANUFACTURING COMPANY

A THESIS

Historic Preservation

MASTERS OF SCIENCE IN HISTORIC PRESERVATION

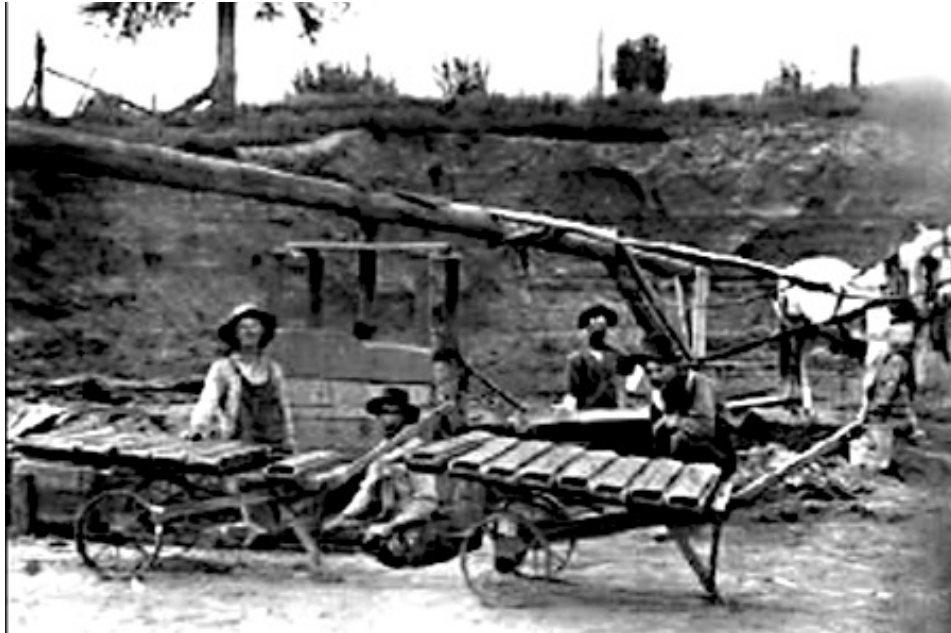
Figure 2.10: Horse operated pug mill at the Soft Salida Brick Company. Image courtesy of the Salida Library. From <http://cozine.com/2009-october/the-story-of-soft-salida-brick/>.

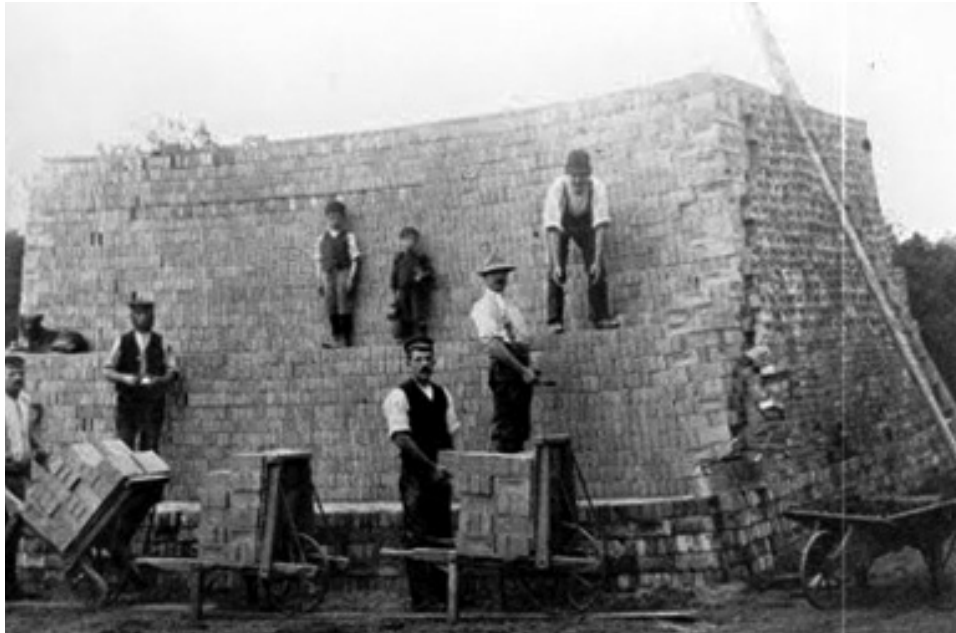
Figure 2.12: "Men building a clamp kiln to fire the raw brick. Photographer unknown, circa 1900. From Old Canal Pottery, <http://madpotter-oldcanalpottery.blogspot.com/>.

Both clamps and scove kilns were temporary forms, but of the two, clamp kilns were more basic in design.⁷⁴ Constructed on level ground, clamp kilns took a rectangular shape and sloped inward as they rose in height. At their bases, a checkerboard pattern of previously burnt bricks was laid, the empty spaces between the bricks being in-filled with fueling materials.⁷⁵ Unfired or “green” bricks were then stacked on top of each base in a manner that allowed for several holes, or “eyes” to locate in the sidewall near the kiln’s base.⁷⁶ The sidewalls and the top of this clamp were then stacked with an additional layer of previously fired brick. Once the form was completed to size, additional fueling material was stuffed into the “eyes” and the entire structure was subsequently ignited⁷⁷ (Fig. 2.12). In contrast to clamp kilns, scove kilns were constructed in sections so that arched firebox openings could be built into the base and connect to an interior firebox that would run the length of the kiln. This kiln’s walls, however, also sloped as they rose skyward.⁷⁸ With the exception of the base, the lining of the fireboxes, a scove kiln was constructed with green bricks. After firewood was set into the tunnels and the kiln ignited, then an exterior layer of previously burnt brick was applied to the exterior of the kiln. To help insulate this kiln and prevent heat from escaping, this outer layer of brick was then daubed over with mud⁷⁹ (Fig. 2.13). While neither of these firing methods was particularly efficient, each proved advantageous to early brickmakers because it could be erected and fired wherever clay was dug and a brickmaking enterprise founded.⁸⁰

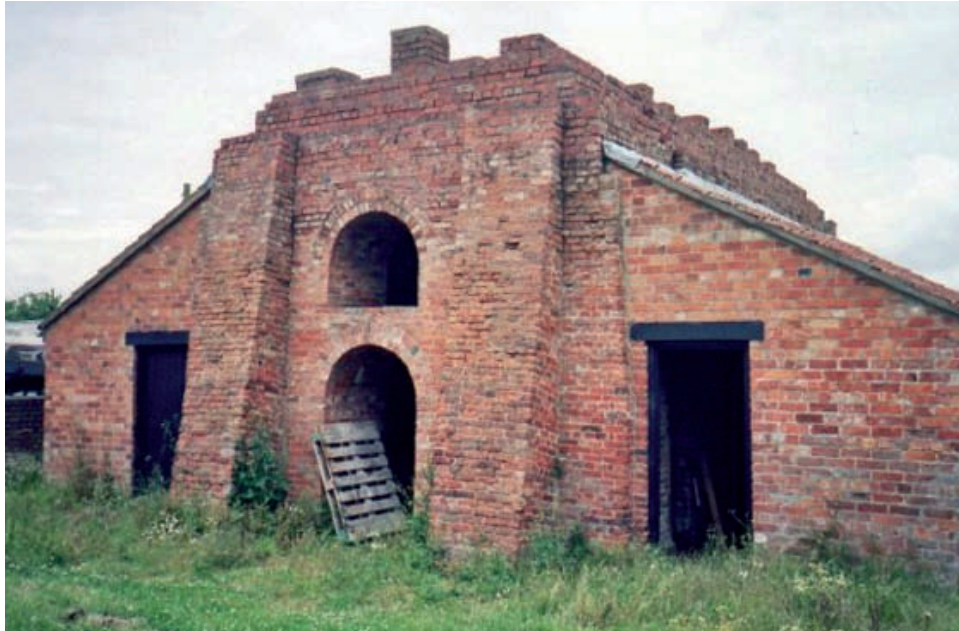
Figure 2.14: Modified version of a Scotch Kiln. "Baumber Brick Kiln." Ken Redmore, photographer, 2006. Society for Lincolnshier History and Archaeology. Image from <http://slha.org.uk/slha/Main/GalleryBricks>.

kiln was also a class of updraft kiln⁸⁷ (Fig. 2.14). Unlike clamp and scove kilns, the base, walls, and firebox tunnels of a Scotch kiln were permanently constructed of burnt bricks that were set in mortar.⁸⁸ At each end of the kiln was an opening that allowed for the loading and unloading of the structure. These openings were, of course, sealed during the burning process and deconstructed once the firing process was complete.⁸⁹ As a consequence, the only temporary major feature of a Scotch kiln was its roof. This feature was, however, even rendered permanent by the early 1890s as small technological advancements in the brickmaking industry were constantly being made⁹⁰ (Fig. 2.15). Therefore, while it is unclear if Charles Bray ever outfitted his Scotch kilns with permanent roofs, the opportunity did exist to further improve both the effectiveness and the permanency of this kiln type.⁹¹

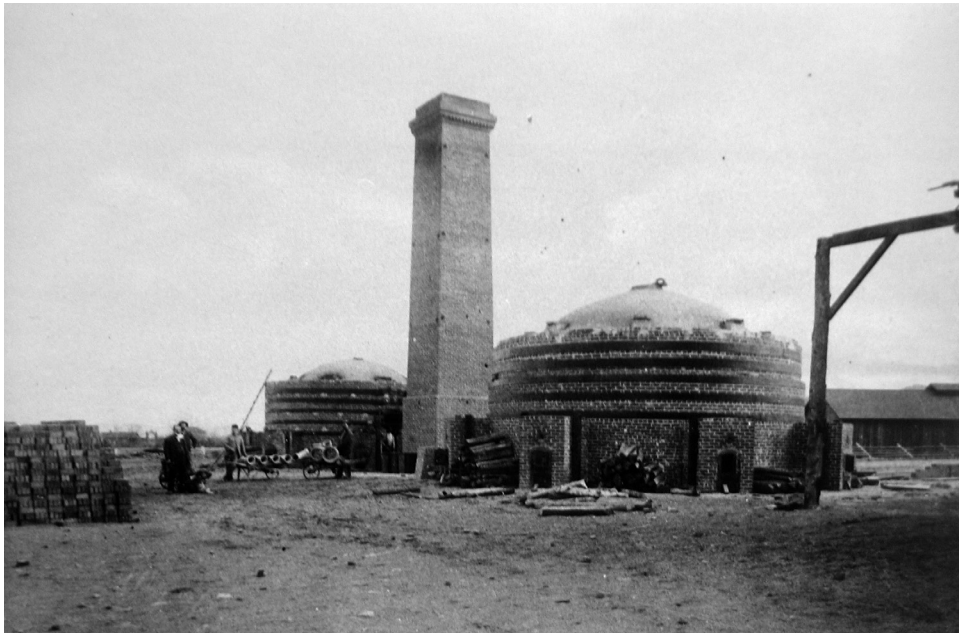
Figure 2.16: "Early beehive kilns at either the Kessler or Western Clay Works." Courtesy of the Montana Historical Society, Helena, MT.

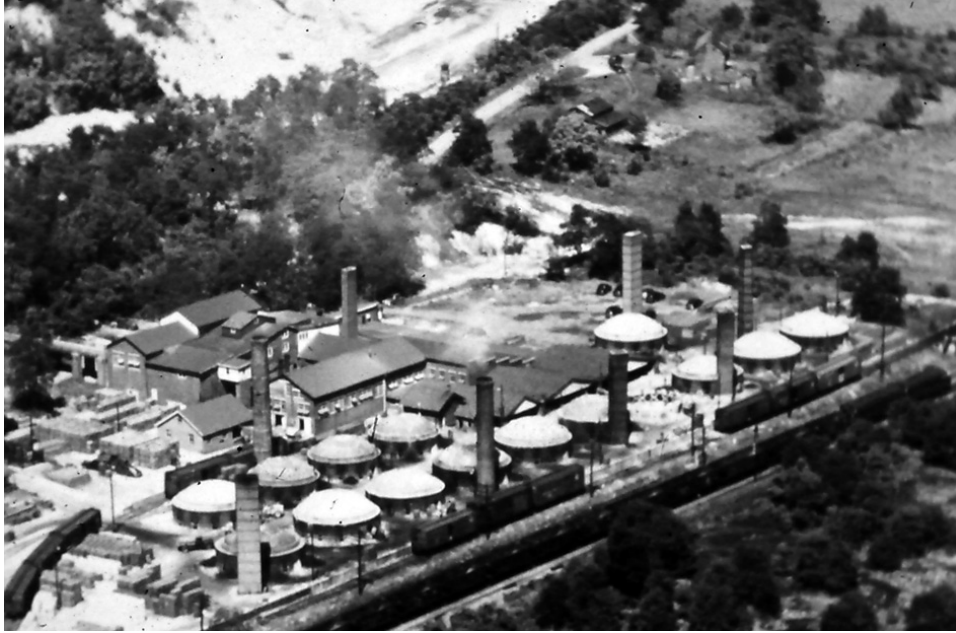
Figure 2.18: Image showing the location and arrangement of beehive kilns. Image of the North Mountain Brick Plant in Eastern West Virginia. Photographer unknown, circa 1950. Image Courtesy of Jeff Hollis, Continental Brick Company, Martinsburg, WV.

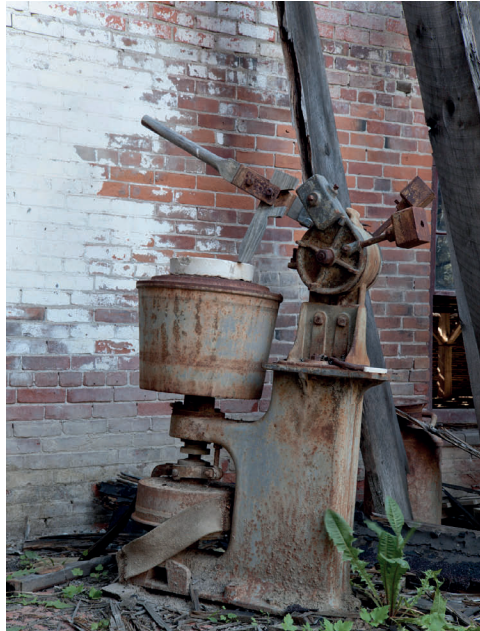
Figure 2.34: Western Clay's flowerpot press. Joe E. B. Elliott, photographer, July 2011.
Courtesy of the University of Pennsylvania Architecture Conservation Laboratory.

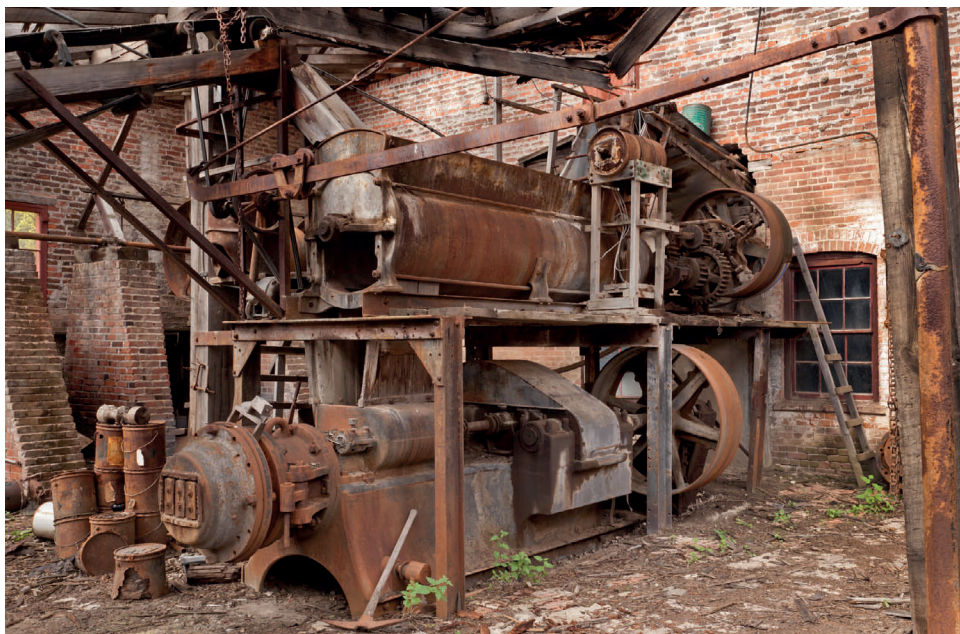
Figure 2.35: Western Clay tile shop pug mill. Joe E. B. Elliott, photographer, July 2011.
Courtesy of the University of Pennsylvania Architecture Conservation Laboratory.

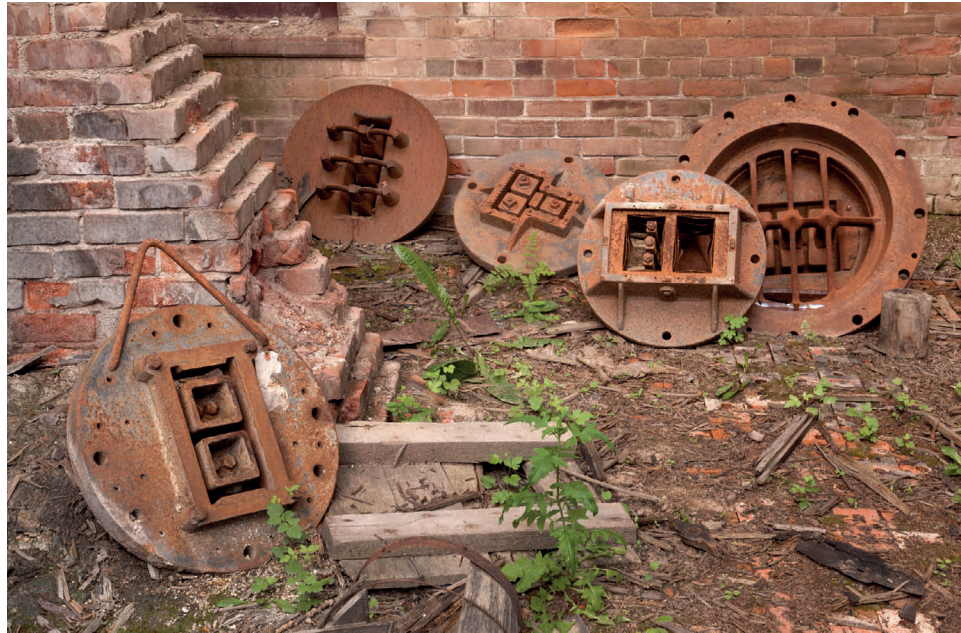
Figure 2.36: Hollow clay product dies at Western Clay. Joe E. B. Elliott, photographer, July 2011. Courtesy of the University of Pennsylvania Architecture Conservation Laboratory.

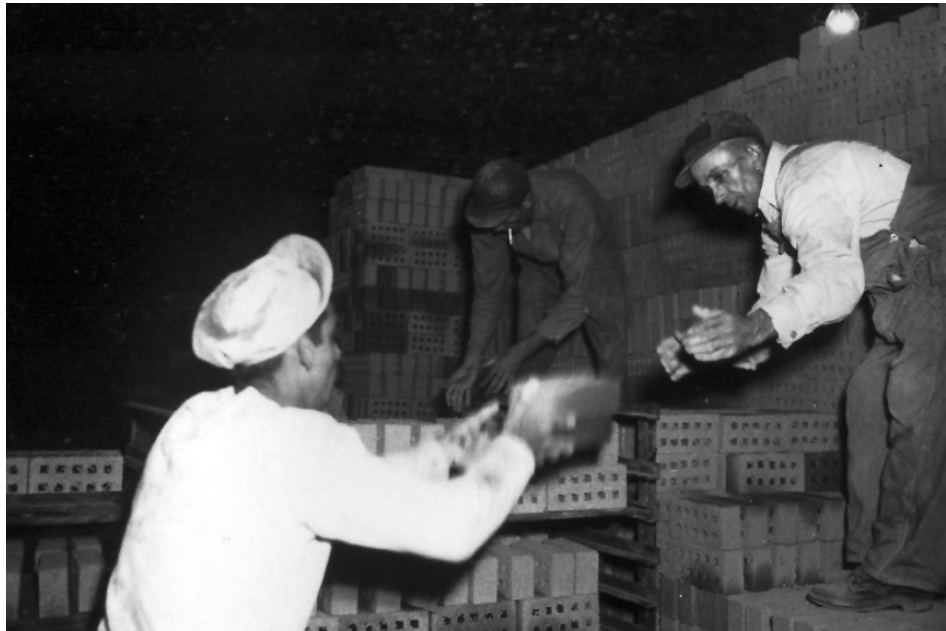
Figure 2.42: Image of a setting gang. "Continental Brick, Arlie's Gang." Photographer unknown, circa. 1940. Image Courtesy of Jeff Hollis of the Continental Brick Company, Martinsburg, WV.

Before the firing of a kiln could begin, it first had to be loaded or "set" with the unfired products. Like the skill of brickburning, setting, was one of the few other "arts" of the brickmaking process. This process alone could take a vetted and dexterous "gang" of five men, directed by a foreman or head setter, the better part of a day to complete³⁰⁰ (Fig. 2.42). Once

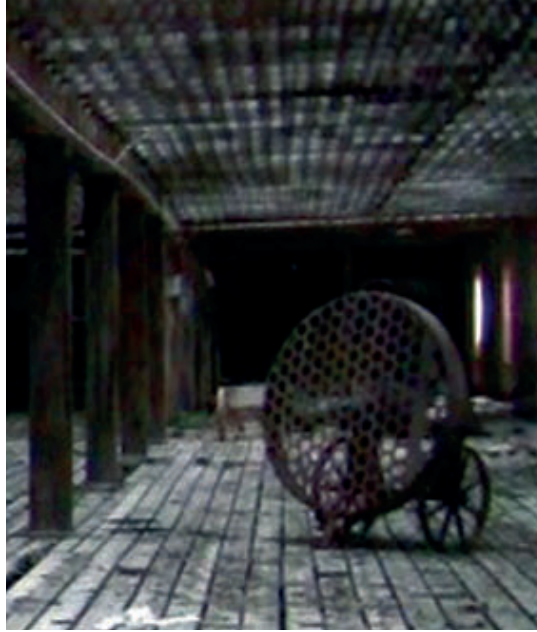
Figure 2.44: Large metal fan used to facilitate the cooling of kilns. Image courtesy of author, 2011.

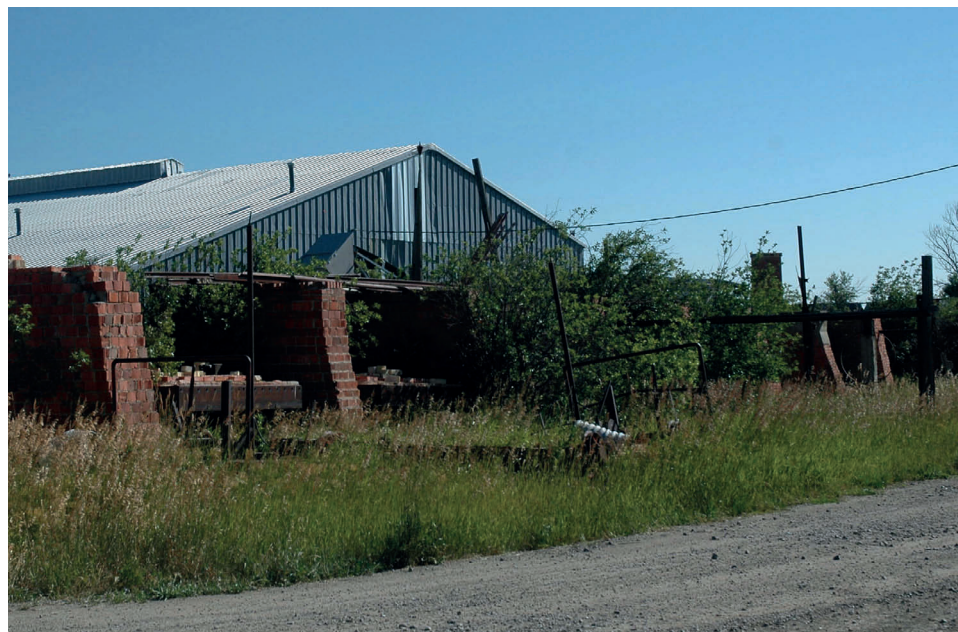
Figure 3.4: Remains of Western Clay's brick railroad piers. Image courtesy of author, 2011.

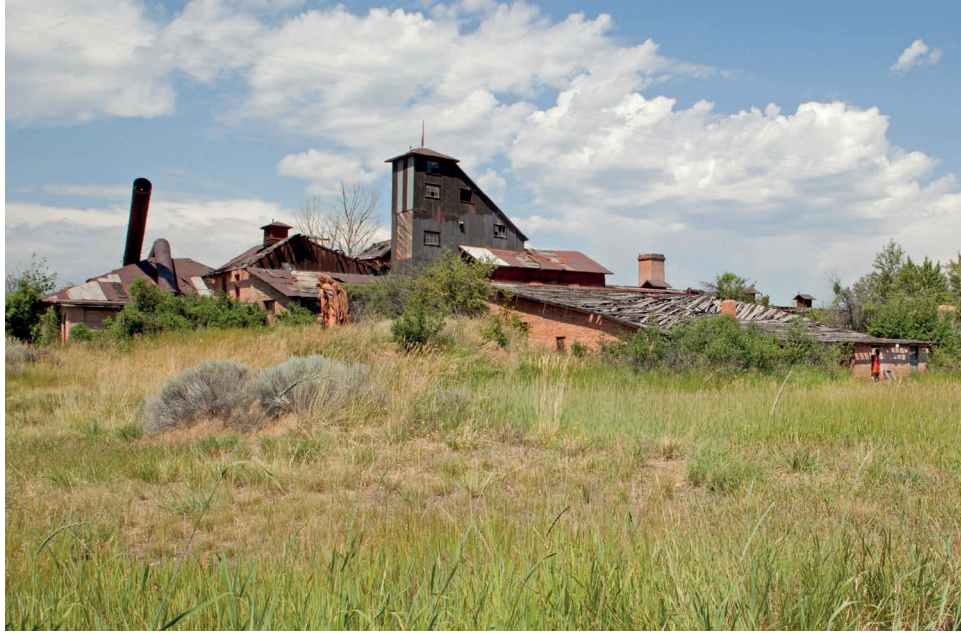
Figure 3.5: Compilation of buildings comprising part of the Western Clay Tile Works. Pictured are the power House, the machine shop, the elevator tower, and a section of the clay storage room. Joe E. B. Elliott, photographer, July 2011. Courtesy of the University of Pennsylvania Architecture Conservation Laboratory.

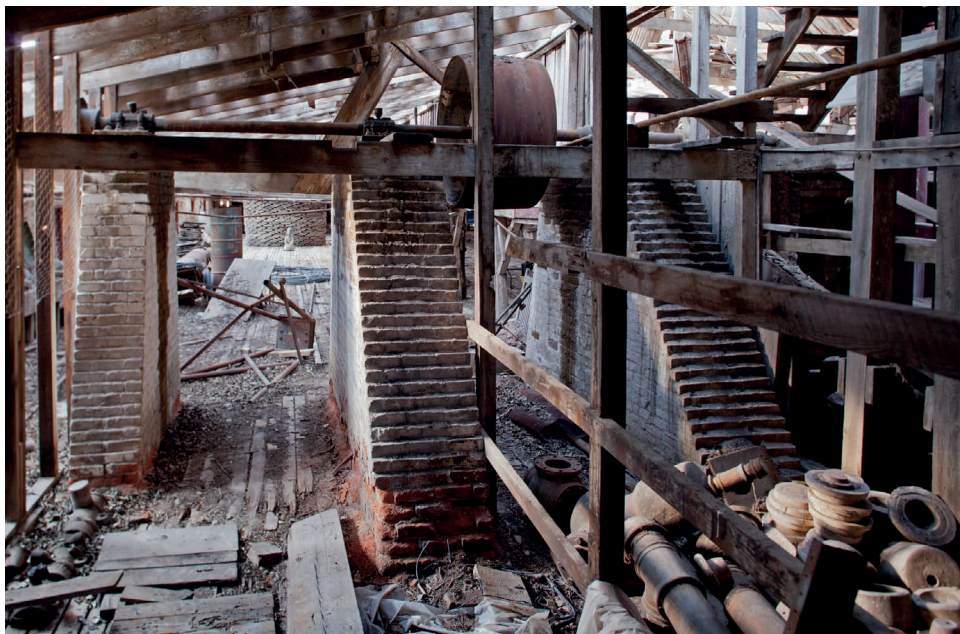
Figure 3.8: Western Clay's line shaft and belts in relation to the tile shop drying room (in background). Joe E. B. Elliott, photographer, July 2011. Courtesy of the University of Pennsylvania Architecture Conservation Laboratory.

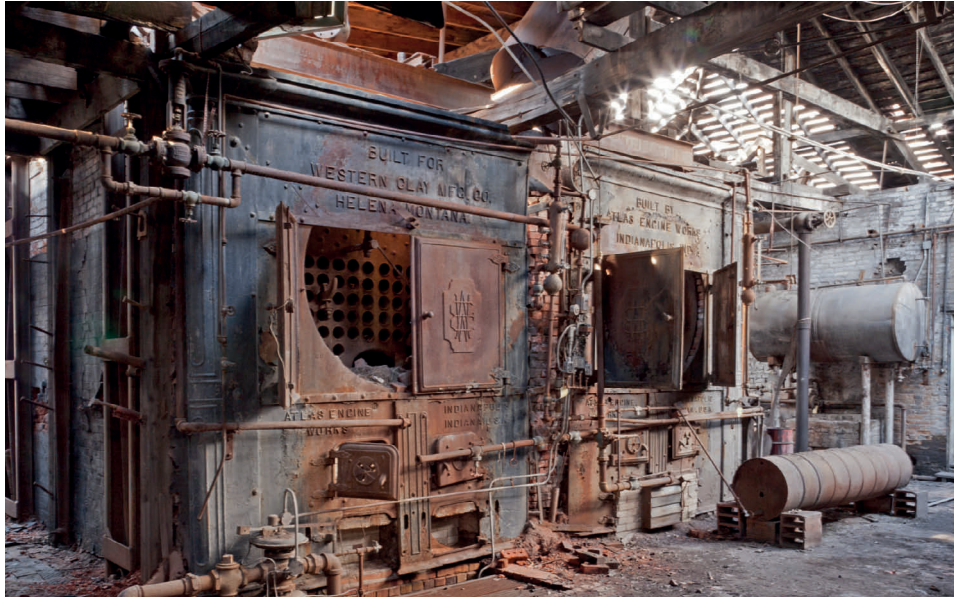
Figure 3.9: Western Clay boiler. Joe E. B. Elliott, photographer, July 2011. Courtesy of the University of Pennsylvania Architecture Conservation Laboratory.

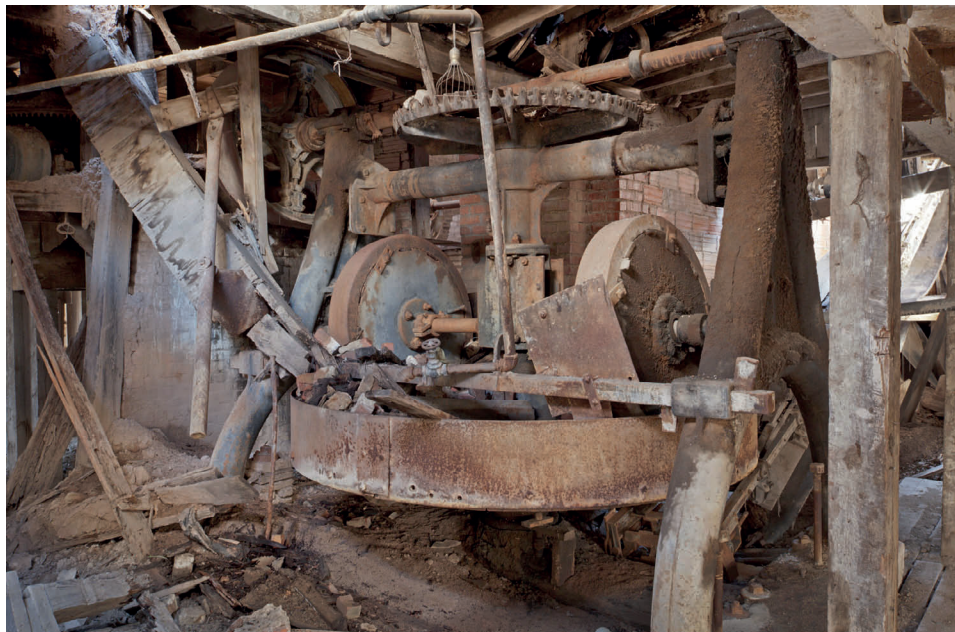
Figure 3.10: Western Clay dry pan. Joe E. B. Elliott, photographer, July 2011. Courtesy of the University of Pennsylvania Architecture Conservation Laboratory.

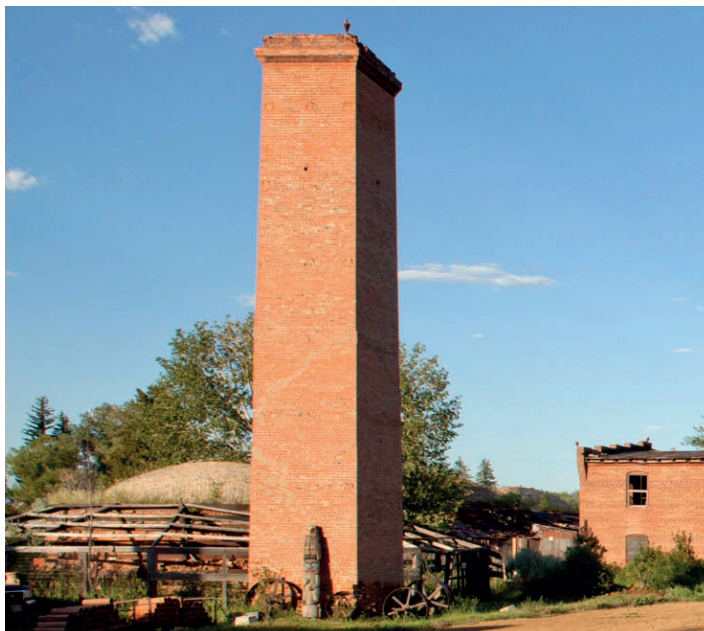
Figure 3.13: Illustration of and underground flue system and "section showing method of constructing perforated kiln floors." Images from "Clay Products Manufacturing," *Ceramic data book*, (Chicago, Ill: Industrial Publications, 1935), 182.

Resulting from the fact that the underground flue system and the chimneystack to which each kiln's flues connected were part and parcel of the downdraft kiln technology, any preservation efforts directed at the former company's beehive kilns must take both the perforated floors and the extant chimneystacks into consideration. Undoubtedly, the interestingly shaped kiln buildings are the most visually arresting structures. To preserve these kilns without also making visible the perforated flooring pattern of each and preserving the chimneystack to which each kiln's flue system is linked would do this technology a great narrative disservice. This technology was not simply an above-ground, beehive-shaped, brick walled and metal-banded structure capped with a dome; rather, these kilns were carefully designed above- and below-ground structures with an integrally associated chimneystack. Again, it is worth considering the case of the remains of the United Clay kilns on the grounds of the USNA. Those that have been taken down to a height of three to four feet, that have been capped, and that have had both their respective floors filled in and their chimneystack's razed can no longer tell the story of a technology or a step in a larger manufacturing process (reference Fig. 3.19).

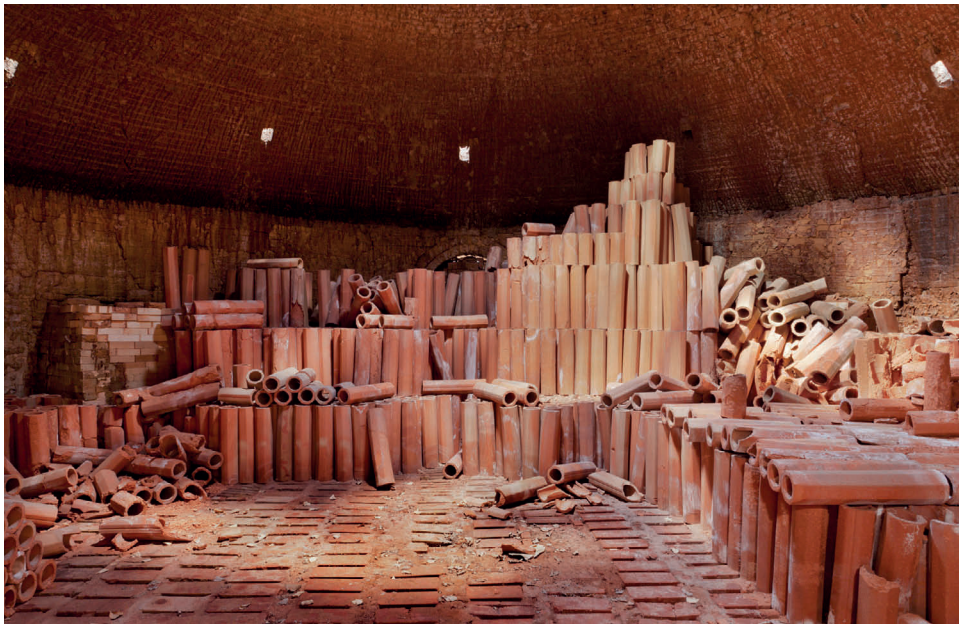
Figure 3.16: Western Clay kiln "Number 8," stacked with drain pipe. Joe E. B. Elliott, photographer, July 2011. Courtesy of the University of Pennsylvania Architecture Conservation Laboratory.

in their collective ability to tangibly reveal how such products were set for proper firing within a round kiln (Fig. 3.16). It is exceptionally rare to find an example of either fired or unfired brick or structural and hollow clay tile products stacked within a kiln—much less a well-intact, early twentieth-century beehive kiln.³⁸⁹

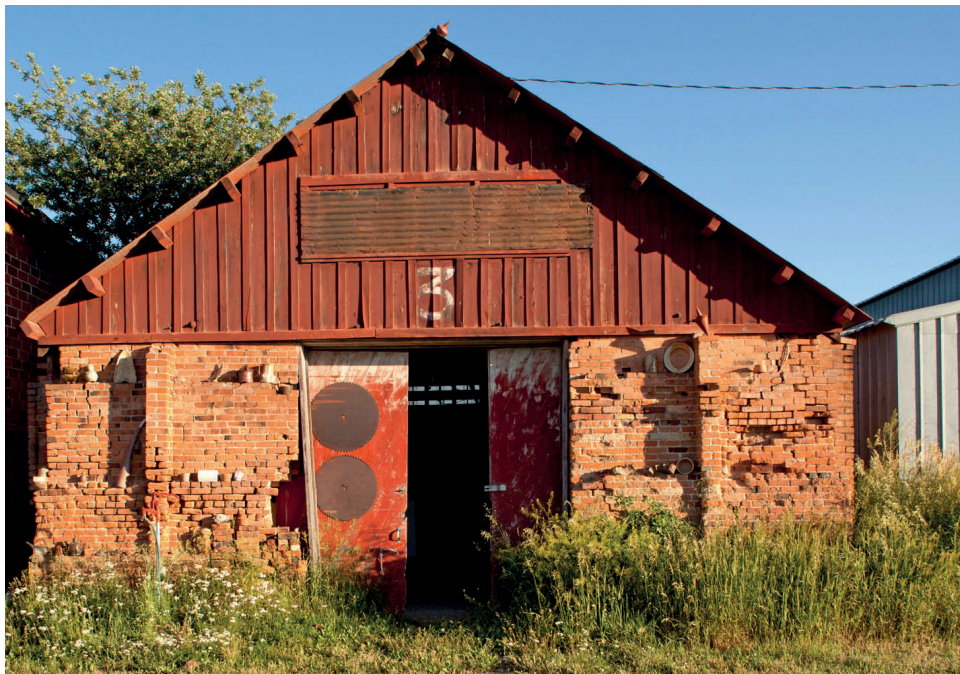
Figure 3.18: Warehouse number 3, Scotch Kiln. Joe E. B. Elliott, photographer, July 2011.
Courtesy of the University of Pennsylvania Architecture Conservation Laboratory.

(Fig. 3.17). In contrast, “Warehouse number 3,” is in poor condition—its brick is deteriorating, it has suffered greatly from the loss of mortar, and each of its four façades evidences missing brick (Fig. 3.18). Still, each of its walls remains largely intact and if one looks closely at the exterior, he or she can even see where, along both the east and west sidewalls, the kilns firebox openings were located.³⁹⁴ As a consequence of the building possessing most of its late nineteenth- to early twentieth-century building materials, overall, “Warehouse number 3” evidences a high degree of integrity. Unlike the “Summer kiln pad,” the level of “Warehouse number 3’s” integrity positions this kiln to be much more easily interpreted as a technology.

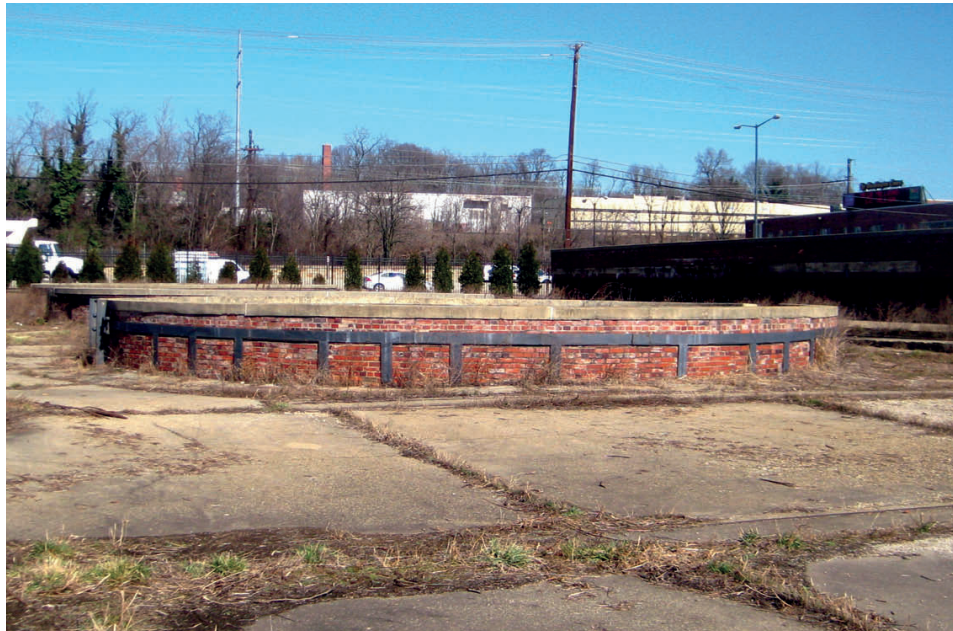
Figure 3.19: Preserved remains of a United Clay Brickworks beehive kiln. Courtesy of Author, 2012.

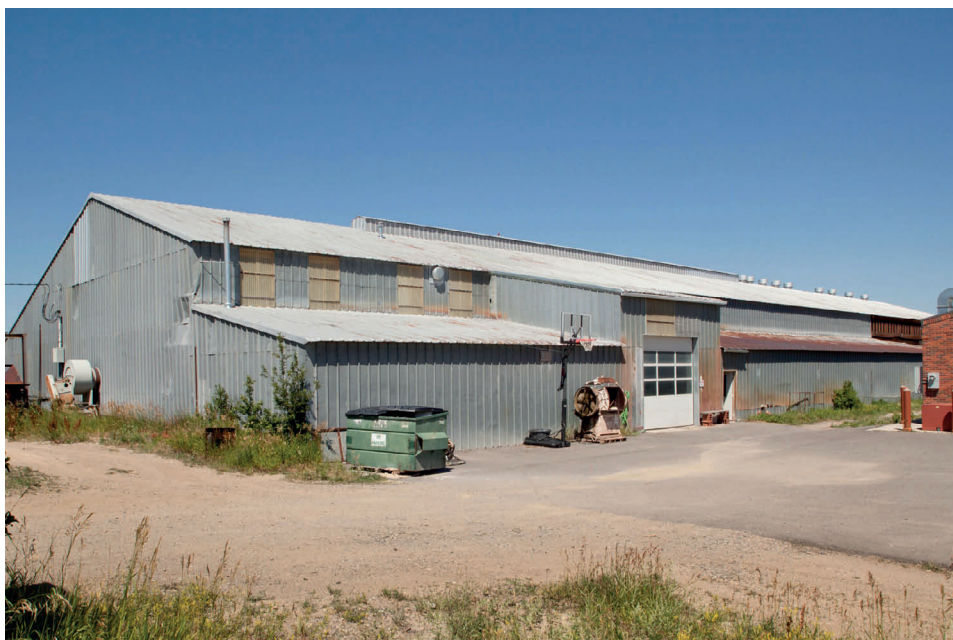
Figure 3.20: Building housing the Western Clay tunnel kiln. Joe E. B. Elliott, photographer, July 2011. Courtesy of the University of Pennsylvania Architecture Conservation Laboratory.

Today, the metal shed that housed the tunnel kiln is extant (Fig. 3.20). This kiln has, however, been physically compromised as a result of the adaptive use of the space inside the tunnel kiln shed (Fig. 3.21). Additionally, the recent construction of several ABF buildings on the principal manufactory grounds has severed both the direct visual and the physical—in terms of transfer tracks—connection of this tunnel kiln with both the brick and tile shop. Therefore, in terms of their setting and association, this tunnel kiln and the building that houses it are now lack integrity. The kiln itself is also lacking integrity with regard to its materials. Although this kiln was U-shaped, only one leg of the greater U exists. Still, due to being sheltered from the elements by the larger shed in which it is housed, this remaining section of the kiln is in good physical condition. Thus, at least some portion of the greater story of this particular kiln technology can be told via the extant material fabric. While the compromised physical integrity, setting, and association of this kiln type may inhibit the telling of a rich history of this particular technology, I still recommend to Western Clay's stewards that the remaining section of this tunnel kiln, along with the shed that houses it, be preserved. Having this third-generation kiln technology on site, and being able to compare and contrast it—especially in terms of labor intensity and firing methods—with the other two kiln technologies helps to round out the picture both of Western Clay's evolution as well as the progression of brick and hollow and structural clay tile industries firing technologies. As touched on previously, Western Clay stands as extraordinary example of a site that has examples of all three of the industry's main kiln types. Keeping all three kiln types,

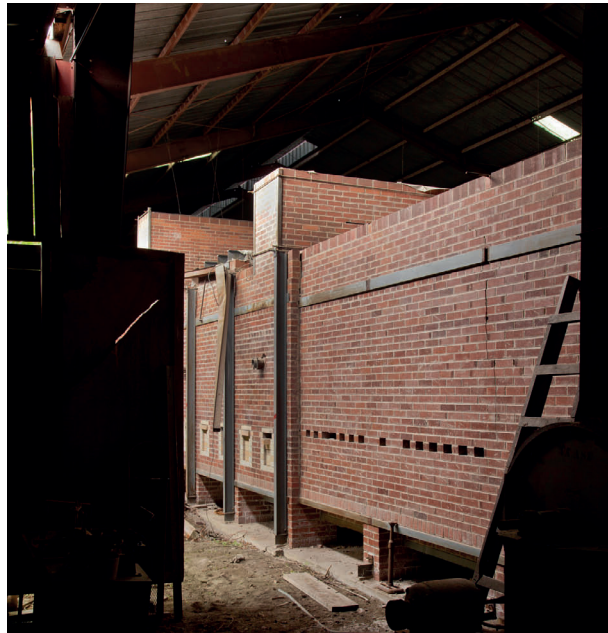
Figure 3.21: Western Clay tunnel kiln. Joe E. B. Elliott, photographer, July 2011. Courtesy of the University of Pennsylvania Architecture Conservation Laboratory.

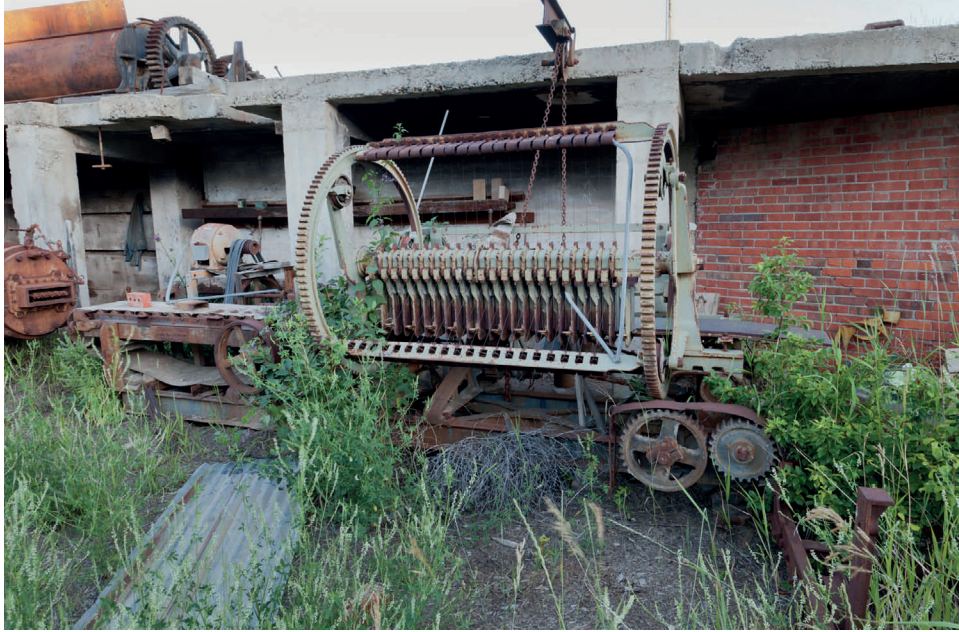
Figure 3.23: Brick shop machinery, in situ. Joe E. B. Elliott, photographer, July 2011. Courtesy of the University of Pennsylvania Architecture Conservation Laboratory.
