CULTURAL LANDSCAPE
PRESERVATION ISSUES-
TSANKAWI MESA,
BANDELIER NATIONAL MONUMENT

A THESIS

HISTORIC PRESERVATION

1998

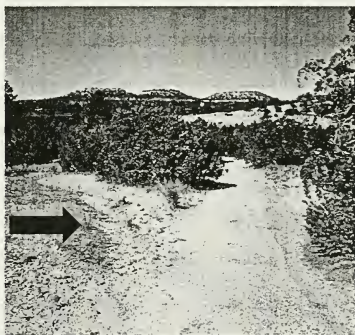
Figure 7: One of many runoff gullies along the paved entrance trail, 1997

Forty feet from the gate is a sandy wash from rainwater runoff traveling over the path into a stone culvert which continues due north into a wash two feet below trail grade. Twenty feet further is the Visitor’s Center, built in 1989 of stabilized adobe and vertical wood sheathing around a trailer that originally sat on the site. The Center is unmanned but has water hookups and a trailer pad behind formerly used by seasonal rangers during the summer and fall. Its covered porch contains two picnic benches and four restrooms in the rear screened by a wooden fence. Visitor information is posted in glass cases facing the trail. Vegetation

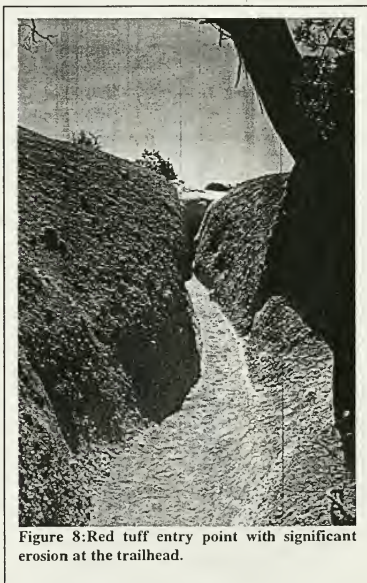
Figure 8: Red tuff entry point with significant erosion at the trailhead.

serious drainage issue. At the “watch children” sign, the asphalt ends, and a volunteer trail leads southeast to an unofficial perimeter trail around the mesa. Tuff deterioration at this trail entrance is severe and active (see Figure 8 and Photos 5 and 6 in Appendix 6.1). Late nineteenth/early twentieth century modifications of the trail were made, presumably to facilitate visitor entry and control deterioration. Steps, visible in the earliest

photographs, and presumably non- prehistoric in origin (ca. 1930), have now given way to a ramped entrance. Erosion probably due to continued deterioration of the passage from the mechanical abrasion of visitor's hands, boots, and backpacks, as well as from wind and rain and freeze-thaw cycling has contributed to the widening of the path and debris deposition on the ground. At the end of the passage are several hand and foot holds worn into the rock.

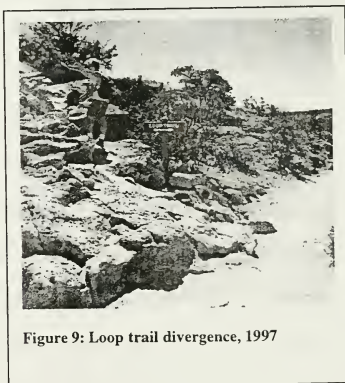
Figure 9: Loop trail divergence, 1997

At this point the “loop trail” sign indicates the trail split and official circulation direction. Here the trail changes nature (see Figure 9). Running up slope to the north, the trail becomes rougher with more deeply incised prehistoric paths, boulders, and switchbacks. The trail here is severely worn with significant foot traffic abrading the surrounding area and deeply channeling the trail itself, often with multiple parallel grooves (see Appendix 2, Photos 13 and 14). Significant rock debris collects in the deep trails, indicating active erosion. This deteriorated condition continues strongly until marker #6.

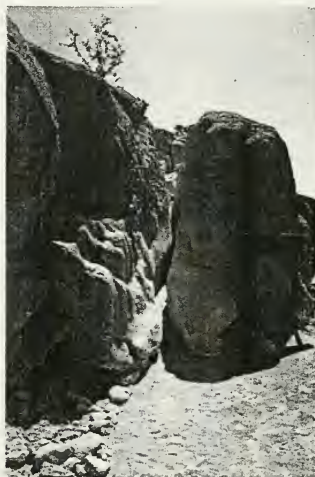
Figure 12: Severe crevice erosion between Markers #6 and 7, 1997

ubiquitous hump-backed flute player. Across from the panel is a volunteer trail leading behind some boulders to a fine panel not normally visible to the public depicting a katchina-like figure with feather headdress. Immediately to the right of the panels is a deep trail crevice, originally the prehistoric trail to the mesa top, and the Park Service alternative route via a ladder beyond. This crevice is arguably the most deteriorated portion of the prehistoric trail. Historic photographs indicate a ground loss of over four feet of tuff since the turn of the century. The walls have also been severely eroded and the crevice widened by visitor traffic (see Figure 12 and Appendix 6.1, Photos 3 through 8).

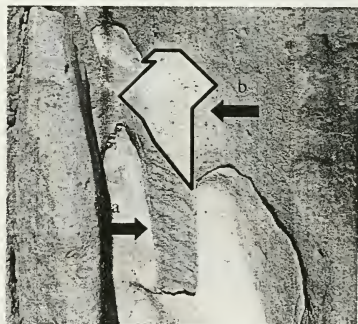
Figure 14: Broken tuff fin (a) and abrasion (b) between Markers # 14 and 15 above ladder, 1997

The descent from the mesa top to the primary cavate group of the southeast face is severely worn from the descending abrasion of visitor footsteps. Significant fins between worn depressions, similar to those between markers #4 and #6 (one is in fact broken off, see Figure 14), make the descent difficult and dangerous.

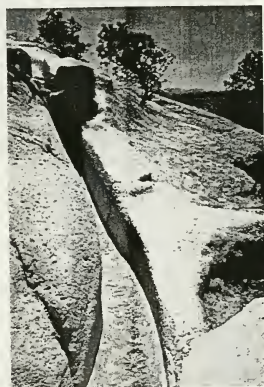
Figure 17: South side trail rut over three feet deep with adjacent surface scouring, 1997

Just beyond marker #19, the trail reaches its maximum trough depth on the south side of over three feet deep with significant associated wear (see Figure 17). The cavates in the red tuff below are easily visible from this section. Beyond marker #19 the trail reaches the Otowi tuff caprock, here broken by a series of geologic joints parallel perpendicular to each other and responsible for the jagged edge loss. The trail continues with little wear back to the junction near marker #4.

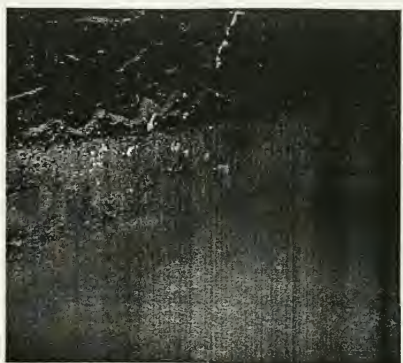
Figure 19: Cavate interior with niches, dado, and petroglyphs, 1997

complex plaster finishes of two or more colors. The ceilings are almost always smoke blackened with visible digging stick construction marks. There are often petroglyphs incised into this blackened layer that display a white sgraffito like figure from the substrate showing through. These often depict katchina, Kokopelli, and Awanyu (feathered serpent) figures (see Figure 19).

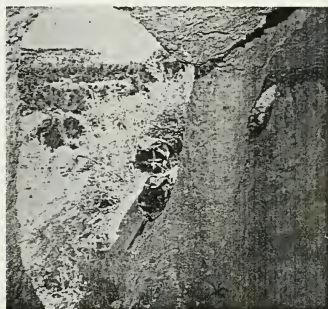
Figure 20:Eroded interior cavate entry

nature of a visit to Tsankawi, virtually all the cavates along the trail are visited by large numbers of people. The deleterious effects of such heavy visitation are immediately visible. Though the majority of the cavates are structurally stable, much surface damage is done by natural processes and visitation. The entrances to the cavates bear what may be the most significant damage. Heavy abrasion is visible from foot traffic to higher cavates, and entrance openings. Inside, detaching plaster and eroded tuff result from moisture percolation and salts and are often visible on the walls immediately around the entrances (see Figure 20). As well, the plaster floor directly inside the door is usually broken and worn away.

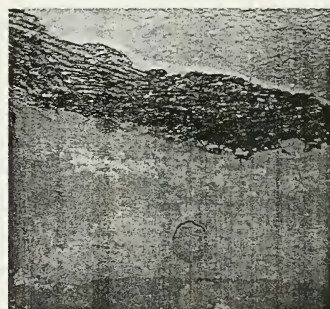
Figure 21: Fallen cavate ceiling, 1997

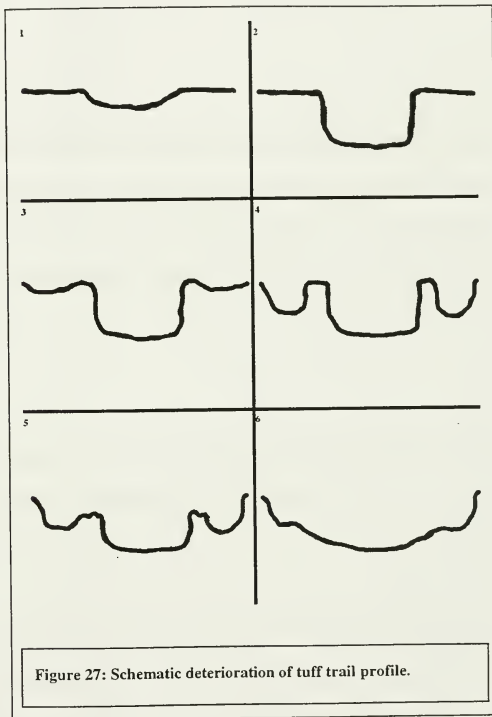
1. Initial prehistoric wear
2. Prehistoric/historic trough creation
3. Visitors avoiding trail due to depth begin to walk on either side, creating adjacent trails
4. Visitors continue this use pattern until tuff fins form on either side of the main trail

5. Tuff fins break off and create a much wider trail
6. Tuff fins are worn down and a wider area of tuff is exposed as the trail.

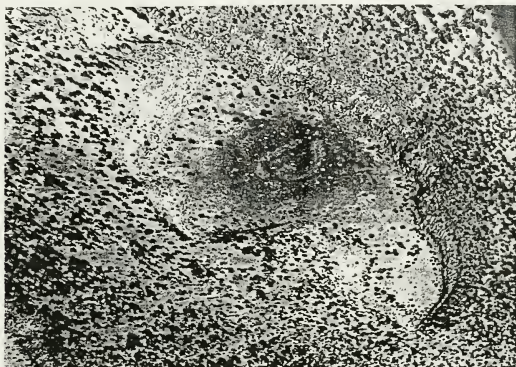
Photo 3: mesa top pueblo, aerial, Charles A. Lindberg, 1929. Note absence of the pueblo volunteer trails as established later in Photo 4. (Museum of New Mexico Photo Archives)

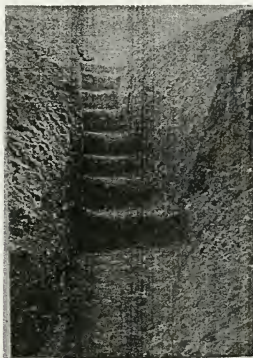
Photo 5: Carved red tuff stairs, ca. 1920. (Bandelier National Monument Archives)

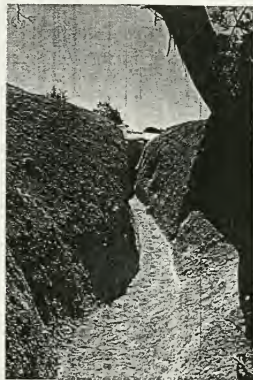
Photo 6: Severely eroded red tuff trailhead, not loss/removal of stairs, 1997 (Bandelier National Monument Archives)

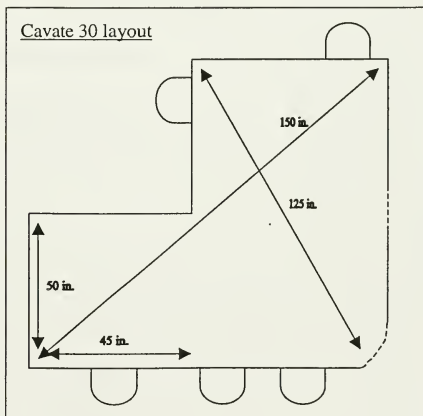
- Due to the complexity of this cavate, a description is used instead of the numerical rating of Structural Feature Conditions.
- The south and west walls are extremely friable and have lost all plaster.
- The north wall of the alcove in good condition with plasters and soot intact.
- The north and east walls of the main chamber is in fair condition with partial plasters and soot.
- The interior of the south (ext.) wall is heavily eroded and there is a loss of greater than 1in. due to water and salts.
- Fifty percent of the ceiling is lost with loss up to 7in. thick. The remaining ceiling is a detached slab 1in. thick.
- The rounded niche retains white plaster.
- The primary damage is the result of poorly compacted fed tuff and severe water penetration through percolation and wind driven rain.

- The cavate retains high structural integrity but is very fragile and unstable.
