# Paper Mill Run Riparian Zone Management Plan and Partial Restoration

An independent study project report by The Walter W. Root Endowed Arboriculture Intern (2016-2017)

**DATE:** March 2017

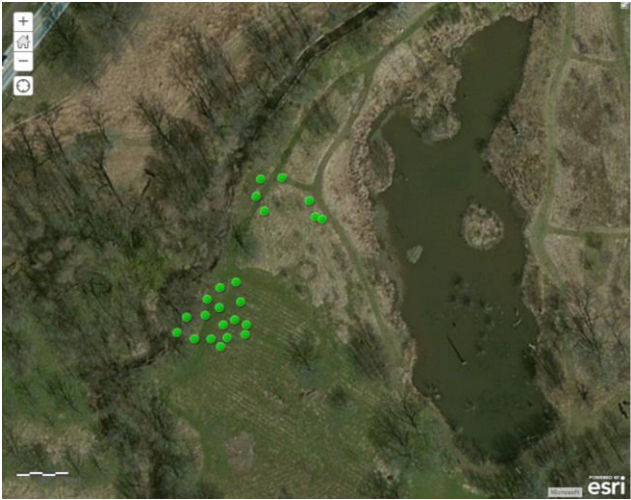
Figure 3: Active Project Planting Zone, showing new trees.

A smaller section at the beginning of this riparian zone was designated as the active project area where riparian restoration would begin (see Figure 3). The active work area was mapped out using the ArcGIS Collector™ online function, in which one can use aerial images and GPS coordinates to map an area in square feet (see Figure 4). This information was used to order an appropriate amount of native grass seed mix to be planted in the work area. This grass seed mix would be seeded in the fall of 2017 following an application of aquatic-safe herbicide to kill any existing herbaceous plants. This would rid the area of invasive herbaceous grasses and forbs and reduce competition for the native seed mix.

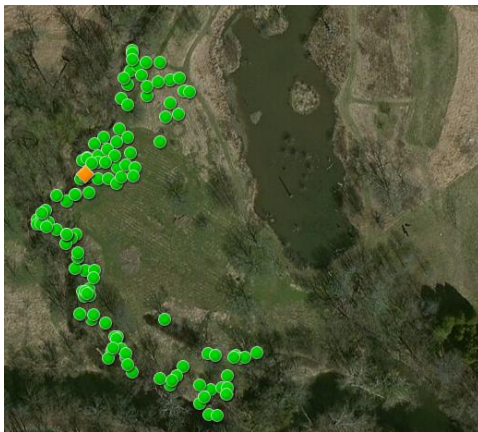
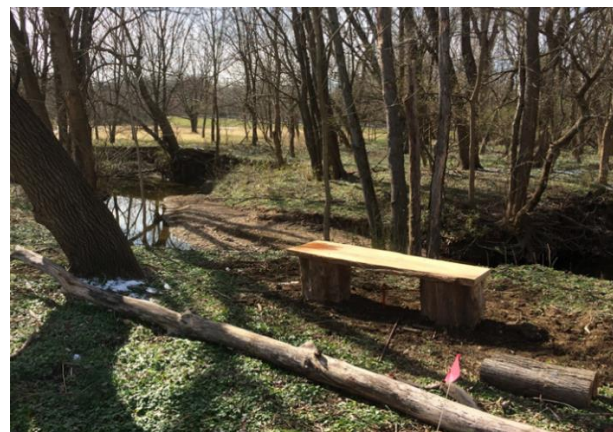
Figure 5: Bench location is indicated by orange diamond; Bench image.

To enhance the public appeal of the area, a bench was built at the end of the planting area, and its location is indicated on the ArcGIS Collector™ map (See Figure 5). This bench

was built using rot resistant *Robinia pseudoacacia* (Black Locust) wood from a tree that was cut down from the property of the Morris Arboretum about five years ago. The wood was milled using a chain saw mill, and was stored in the Bloomfield Farm barn. This board was mounted to two legs made of Black Locust logs standing upright. These logs were buried one foot at the base to aid in stabilization, and were made to look like tree stumps in the ground. In the middle of these legs, a four foot long rod was drilled into the ground. This rod had a disc on the bottom to anchor it in the ground, and an eye on the top end to be used to anchor the bench. To anchor the bench to the ground, tree support cable was passed through this eye and anchored to both of the legs of the bench using lag hooks, as demonstrated on pages 138 – 140 under the “Cabling Installation Techniques” section in chapter nine of the Arborists’ Certification Study Guide 2010 version (Lilly, S. J., 2010). This serves not only to anchor the bench in the case of a flood, but also to demonstrate tree support systems used by arborists.
