Watch It! I'm Growing Here: Inventory, Assessment, and Recommendations of the University of Pennsylvania's Street Tree Surface Treatments

Amanda Wood
University of Pennsylvania

An independent study project report by The Martha S. and Rusty Miller Endowed Urban Forestry Intern (2018-2019)

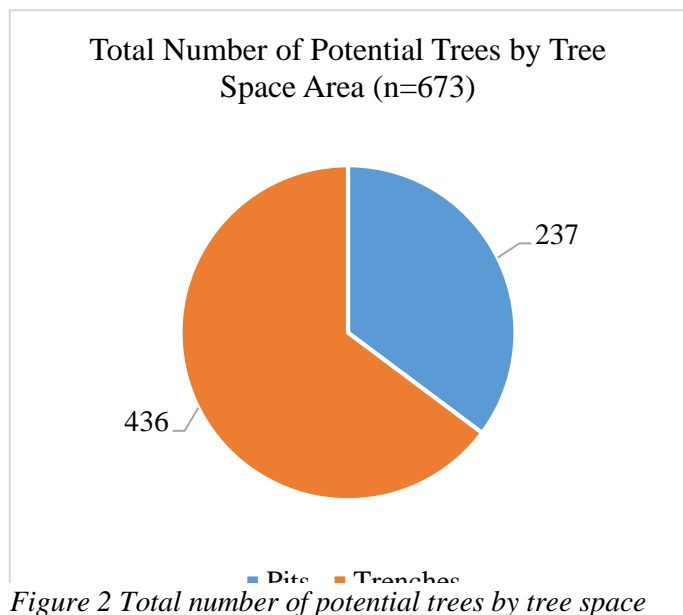
Figure 2 Total number of potential trees by tree space area. Potential tree spaces includes present trees and vacancies, highlighting the tree holding capacity of tree spaces.

In the study site, there are 342 street tree planted areas for pits and trenches. Out of the 342 street tree areas, there were 237 pit spaces and 105 trenches with 436 total potential tree spaces (Figure 1).

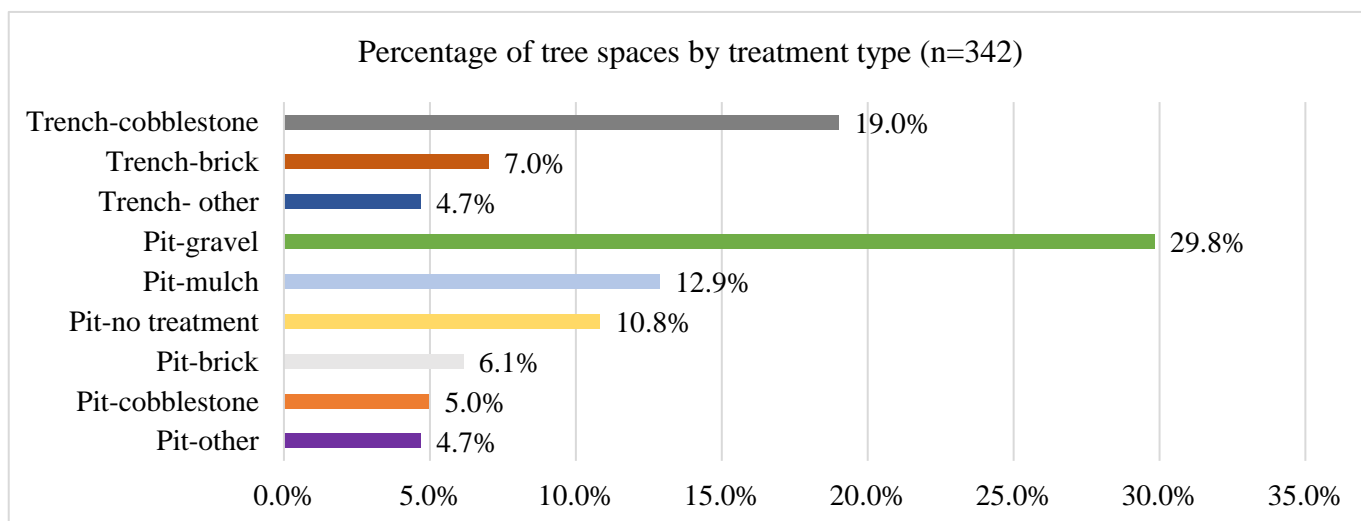
Figure 1 Percentage of tree spaces by treatment types. Also includes tree vacancies.

Fourteen different surface treatments were documented on Penn’s campus in the study site. In the

tree pits, the gravel surface treatment was the most numerous, and in trenches, cobblestone surface treatments were the most numerous (Figure 2). Listed in the “trench-other” category is also “trench-planted” at 0.6%, “trench-gravel” at 1.8%, and “trench-paver” at 2.3%. In the other category for pits, there is 0.3% pits with pavers, 1.5% planted pits, and 2.9% pits with metal grates.

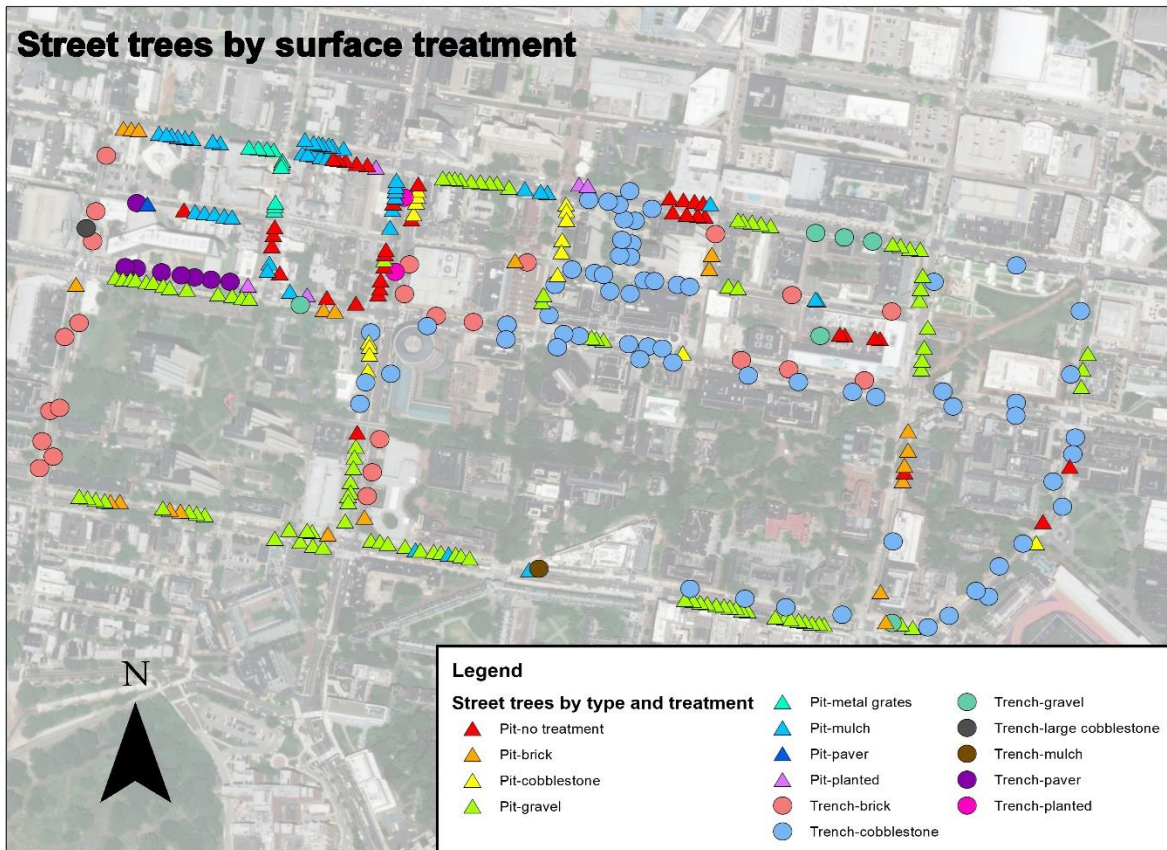
Figure 3 Street tree areas by surface treatment on Penn's campus

Of the trench surface treatment types, cobblestone is the highest due to the University of Pennsylvania's Facilities and Real Estate's (FRES) adoption of a cobblestone standard surface treatment. Pits with gravel treatment were almost evenly distributed while trenches with cobblestone were mostly focused on Walnut Street, near the Inn at Penn, and 33rd Street (Figure 3).

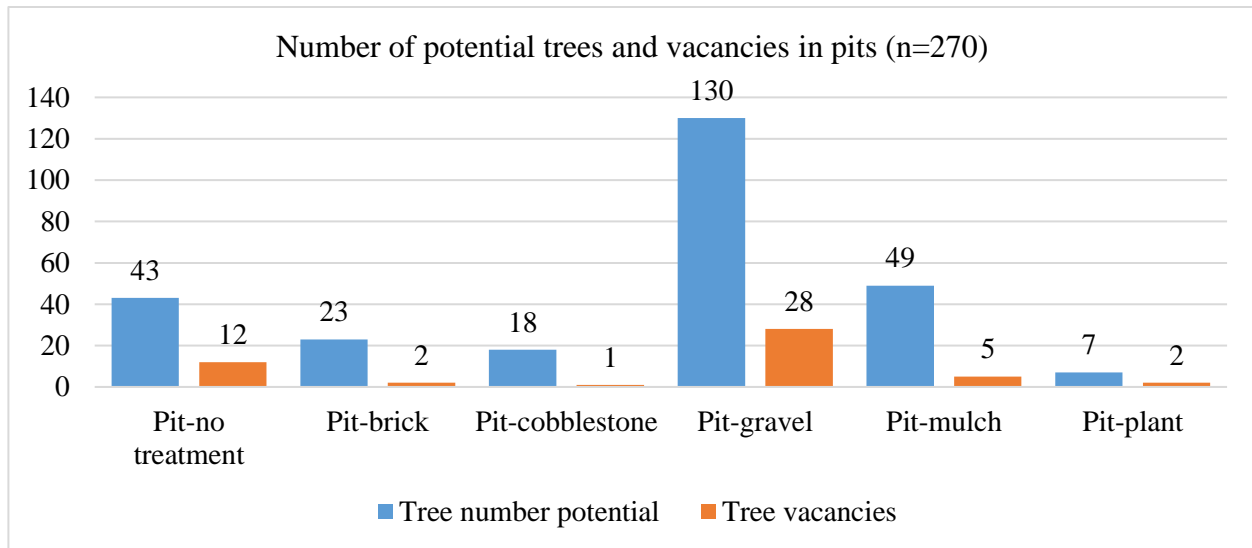
Figure 5 Number of potential trees and vacancies in pits (n=270)

During data collection, **tree vacancies** were observed in both pits and trenches. Of the vacancies there were 50 observed pit vacancies out of 270 spaces. For trenches there were 26 trees removed out of 436 total trees (Figures 4 and 5).

For tree vacancies in pit areas, there was a higher number of trees missing in planted pits (28.6%), but there was a smaller sample size of that surface treatment. The second highest vacancy rate was in pits with no treatment, at 27.9%. In trenches, there was only one trench with pavers, making it an outlier. Between trenches with brick treatment and cobblestone treatment, brick-treated trenches had a higher vacancy rate (29.0%) than cobblestone treated trenches (15.0%). This is most likely due to the cobblestone trenches being the newer standard and are planted with newer trees. These trees are usually under a two-year warranty, allowing for a higher likelihood that dead trees would be replaced more readily than trees in the brick surface treatment.

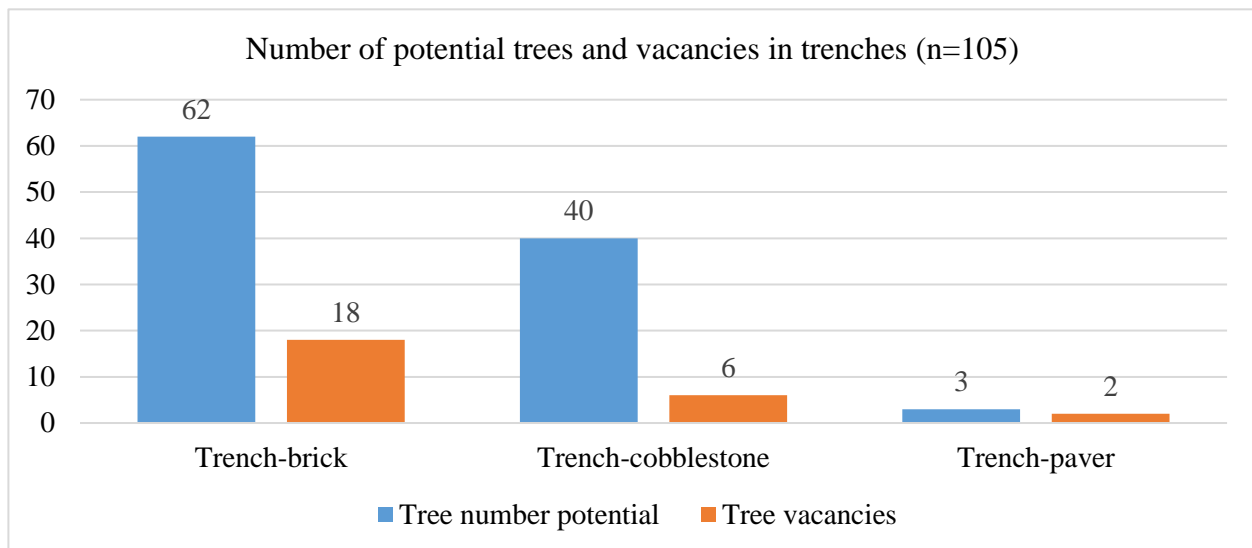
Figure 4 Number of Potential trees and vacancies in trenches (n=105)
