First Pacemaker in a Dog: A Historical Note

J Vet Intern Med 2003;17:713–714

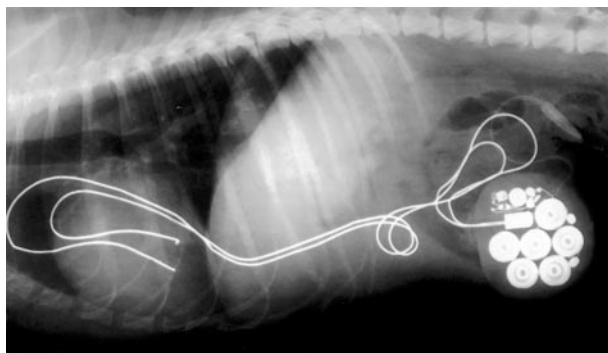
Fig 1. Lateral radiograph made 5 weeks after surgery in 1967. The pacemaker was positioned between the internal and external abdominal oblique muscles in the left paralumbar fossa. (*J Am Vet Med Assoc* 1968;152:1099–1109; with permission.)

The 1st Pacemaker used clinically in a 10-year-old male Basenji dog was implanted in 1967 because the dog had recurrent congestive heart failure because of complete heart block. A fixed-rate (now called VOO) 70-beats per minute (bpm), bipolar pacemaker was placed in the left paralumbar fossa and 2 leads were passed subcutaneously and attached to the left ventricular epicardium through a separate thoracotomy.

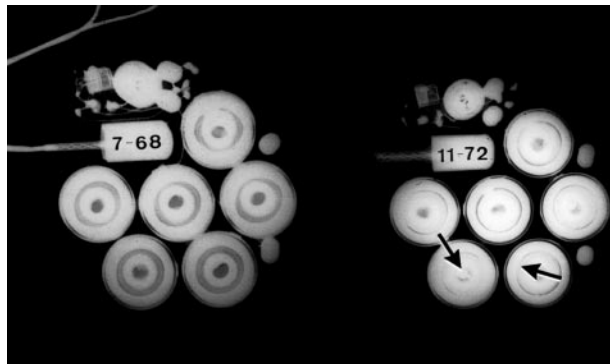
Fig 2. Radiographs of pacemaker in situ 15 months after implantation (left) and 5½ years after implantation (right). The radiolucent central cores and insulating rings between electrode cylinders in the batteries became filled by corrosion material (arrows) leading to battery failure.

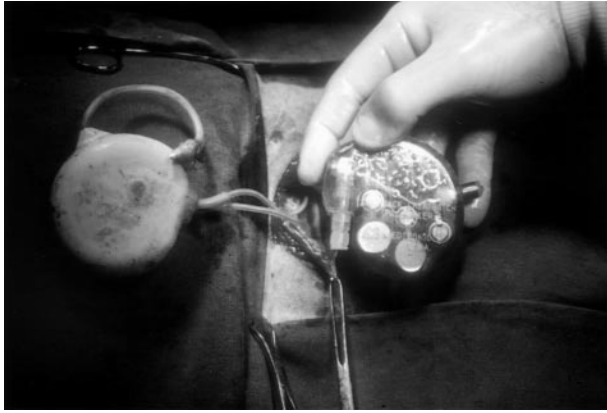
Fig 4. Photograph at surgery. The silicone-coated pacemaker on the left was removed easily from its fibrous pocket and replaced by the urethane-coated replacement pacemaker.

The dog (Fig 3) was still in good physical condition at 15½ years of age, and surgery was performed to replace the pacemaker. No adhesions were observed on the silicone-covered pulse generator, and it was lifted easily out of a connective tissue pocket (Fig 4). A temporary pacemaker was not available and cardiac arrest occurred as expected when the pacemaker was disconnected (Fig 5). The heart stopped for 22 seconds before the 1st ventricular escape beat occurred. A 2nd escape beat occurred 5.5 seconds later and was followed by subsequent beats after progressively shorter intervals stabilizing at 25 beats/min within the next 30 seconds. The replacement pacemaker was attached to the existing leads and placed in the old generator pocket after cutting small holes in the ventral aspect of the fibrous pocket to

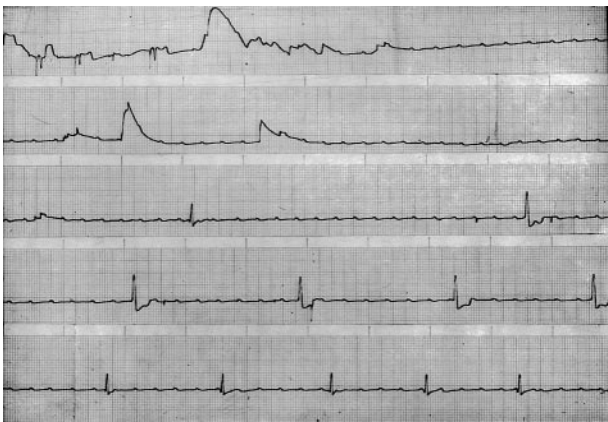
Fig 5. Continuous electrocardiogram recording when the pacemaker leads were disconnected. The 1st ventricular escape beat occurred after a 22-second period of arrest, followed by a 2nd beat in 5.5 seconds and progressively more rapid ventricular beats (25 mm/s, 1 cm/mV).

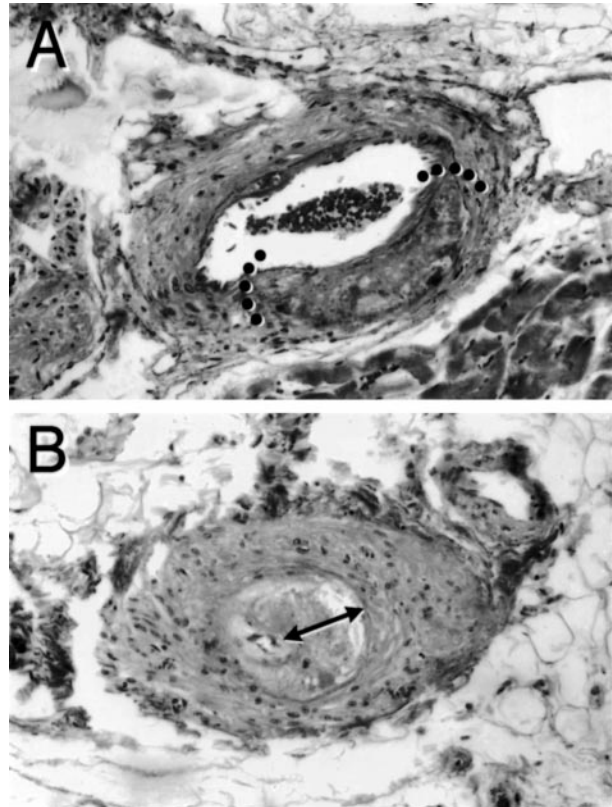
Fig 6. (A) Small coronary artery in the basilar portion of the interventricular septum. Note the crescent-shaped area of medial necrosis between dotted lines. (B) Coronary arteriole in the interventricular septum near the bundle of His. Note the extensive intimal plaque with necrosis (arrows), which nearly occludes the vessel. Pentachrome stain 100 \times .

almost completely occluded (Fig 6). Although at least 6 years had elapsed since the onset of heart block, it is probable that coronary artery disease and ischemia or infarction of the A-V node was the cause of complete heart block in this dog.
