**AN EVALUATION OF MECHANICAL PINNING  
TREATMENTS FOR THE REPAIR OF MARBLE  
AT THE SECOND BANK OF THE UNITED STATES**

A THESIS

Historic Preservation

2004

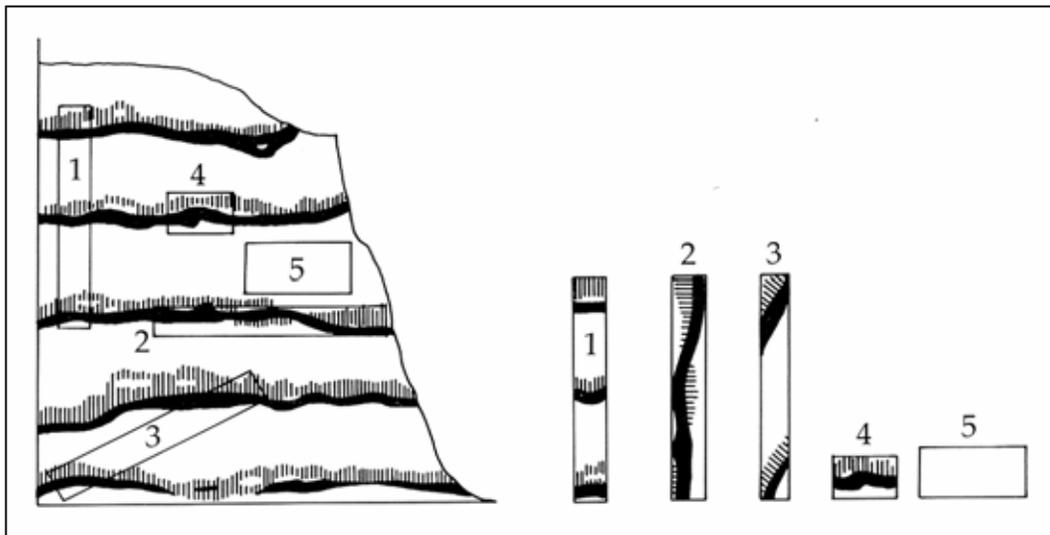
**Figure 2.2 Marble from the same quarry face**

Block 5 most closely resembles marble quarried for the columns.

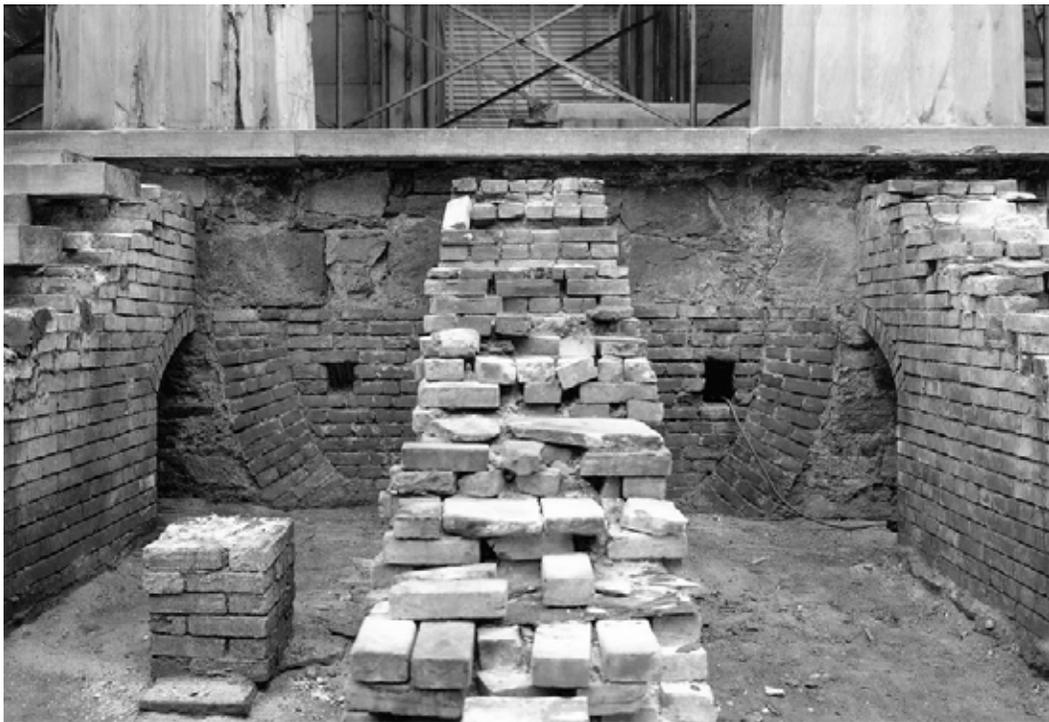
**Figure 2.4 Original foundation work of the north portico, 1964**  
Independence National Historical Park

Both north and south porticoes rest on foundations that include inverted arches to insure support of the columns. Strickland most likely learned of this technique from Latrobe, with whom he had apprenticed. Latrobe specified reversed arches in several buildings he designed, and John Haviland in *The Builders' Assistant* of 1818 describes their employment, “... so that if the foundations sinks the arches may resist the reaction of the ground; and then the whole wall will sink uniformly, or descend in one

body” (Haviland, 1818: 106) Archaeological excavations of the site in 1964 indicated the arches of the north portico were functioning as intended since no cracks were evident in the stone supports. (*HSR*, 1964: 1)

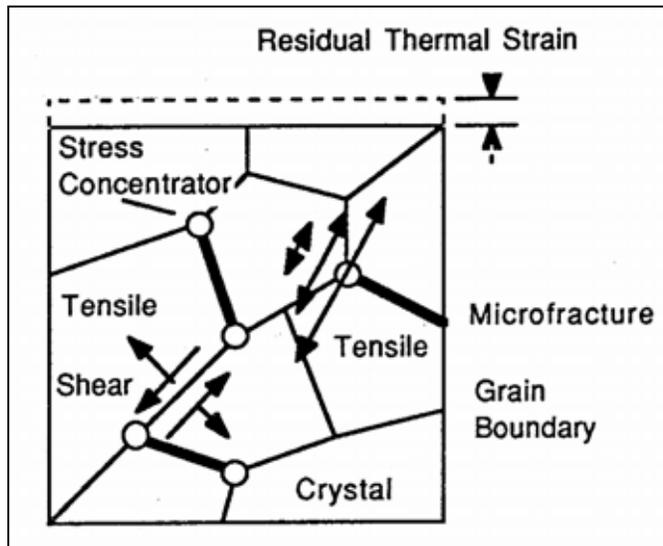
**Figure 2.5 Thermal strain process in marble**  
 Sage. "Thermal microfracturing of marble", 1988.

Mineralogical characteristics of Pennsylvania Blue marble, such as composition, grain shape, and texture, are undoubtedly related to some of the types of stone deterioration found at the Second Bank. The main constituent of marble, calcite, is known to be thermally anisotropic, as several studies on marble deterioration have examined. (Zezza: 1985; Sage: 1988; Lindborg: 2000; Siegesmund: 2000; Weiss: 2002; Zeisig: 2002) Because of this property, thermal expansion of calcite crystals differs along different crystallographic axes and is often non-reversible. As a result, temperature changes in the material create tensile strains that can lead to micro-fractures.

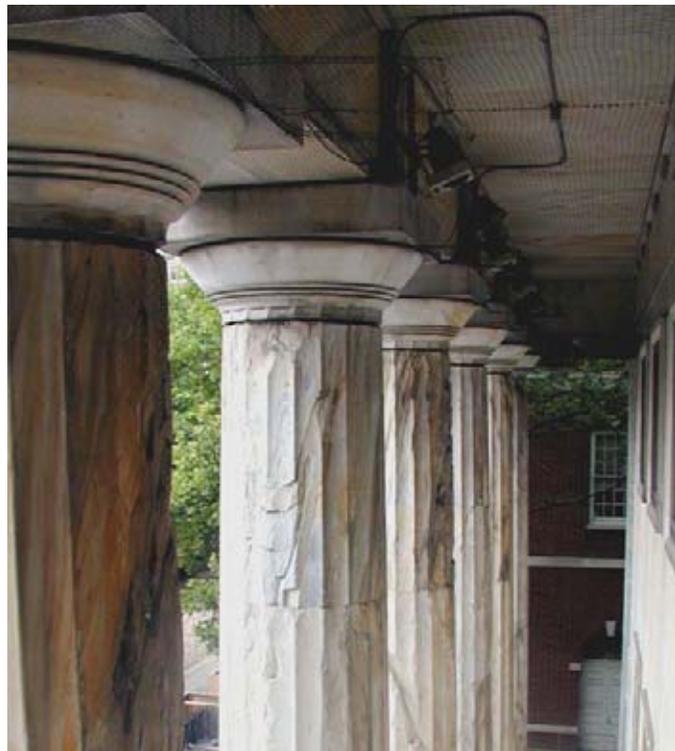
**Figure 2.6**  
**Interior of the South**  
**portico, 2003**  
ACL, University of Pennsylvania

The arrises are projecting elements of the columns, extending out one inch from the flutings. Because of their shape, the arrises, as well as the columns as a whole, are affected multi-directionally by cyclical weathering phenomena, such as thermal movement, and, with the presence of water, freeze-thaw cycling that can cause structural stresses leading to cracking and spalling. For these types of decay mechanisms directional exposure, and in the case of heat induced degradation, thermal properties of the stone play a role. Thermal conductivity, specific heat, and reflective characteristics of the stone can affect the surface temperature and depth of heat transfer. In addition, the presence of soiling can significantly raise the surface temperature of the marble when exposed to solar radiation, as well as increase the transfer of heat from stone surface to substrate, and increase the rate of temperature decrease when cooled; creating an asymmetrical pattern of surface heating and cooling. (McGreevy, 2000: 269) The fact that deterioration is significantly greater on the south portico, which receives less shading than the north facade, points to the possibility that conditions such as cracking and spalling are a result of thermal degradation.

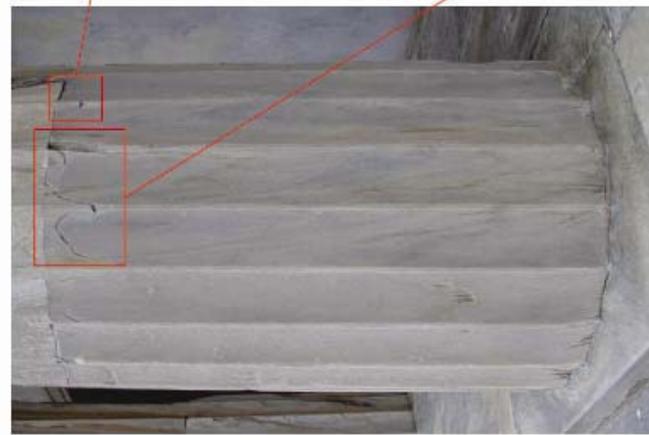
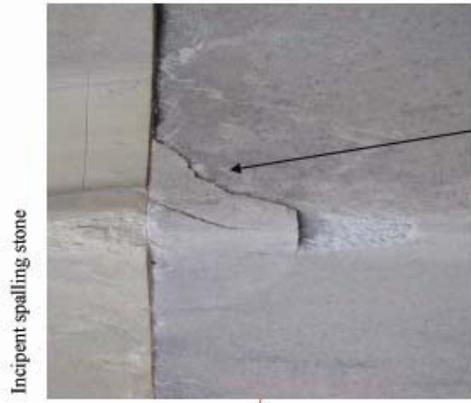
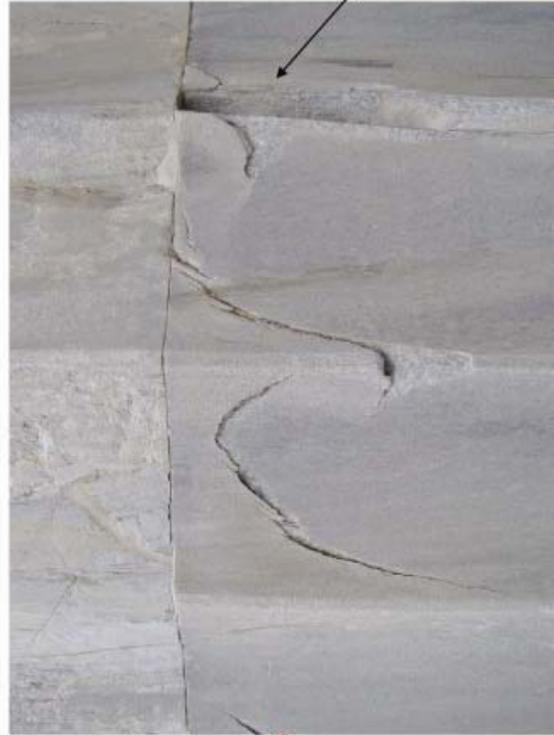
**Figure 2.7 North portico, column 7**  
**SECOND BANK OF THE UNITED STATES**  
**INDEPENDENCE NATIONAL HISTORICAL PARK**

**Column 7, drum 1**

Crack of 1/8" width

Incipient spalling stone

Dimensional loss of arris

Incipient spalling stone and dimensional loss

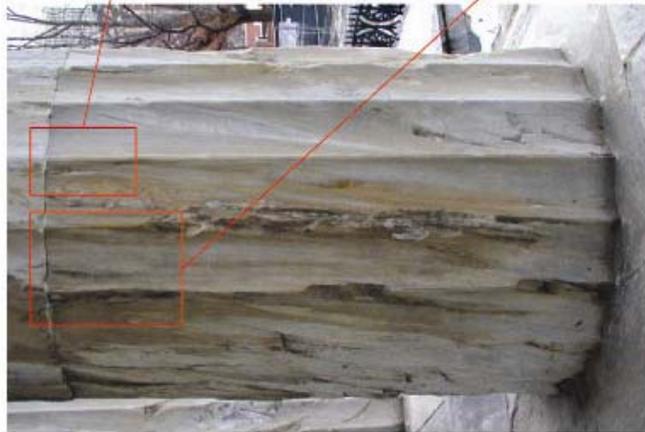
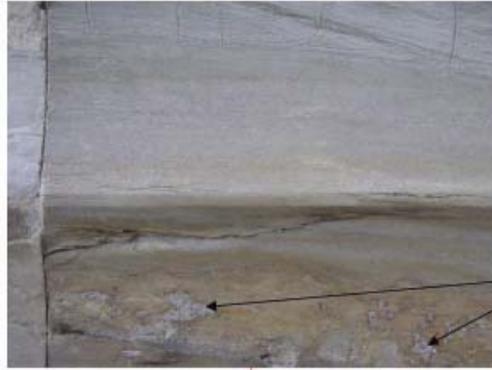
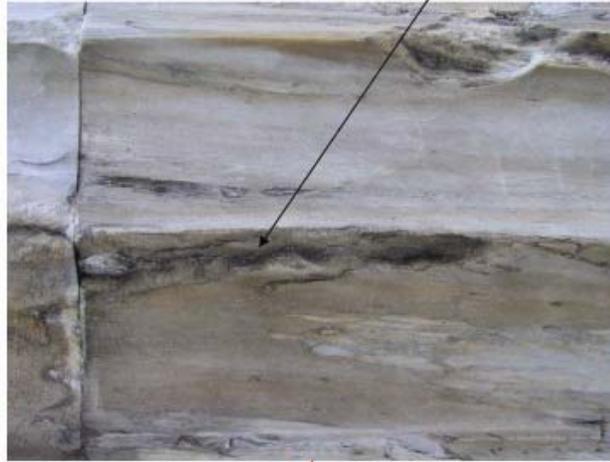
**Figure 2.8 South portico, column 3**  
**SECOND BANK OF THE UNITED STATES**  
**INDEPENDENCE NATIONAL HISTORICAL PARK**

Incipient spalling stone

Mineral inclusions,  
possibly quartz

Dimensional loss, now soiled, is indicative  
of the shape of spall on other arris

**Column 3, drum 1**

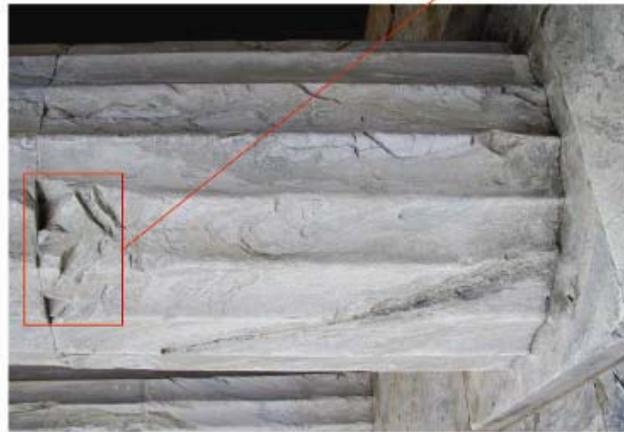
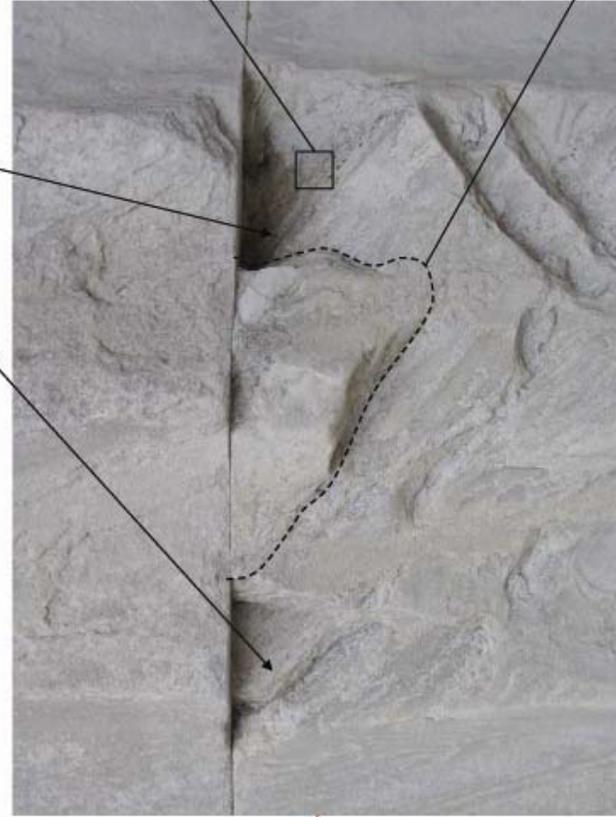
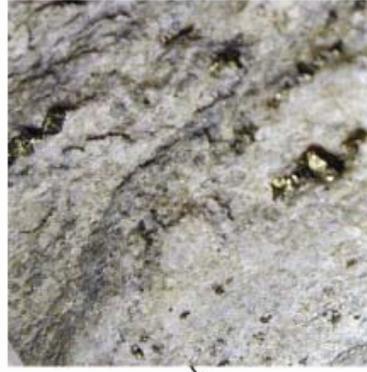
**Figure 2.9 South portico, column 5**  
**SECOND BANK OF THE UNITED STATES**  
**INDEPENDENCE NATIONAL HISTORICAL PARK**

Column 5, drum 1

Dimensional loss indicative of shape and shear plane of spall

Band of pyrite inclusions where loss has already occurred

Early stages of planar separation or incipient spalling

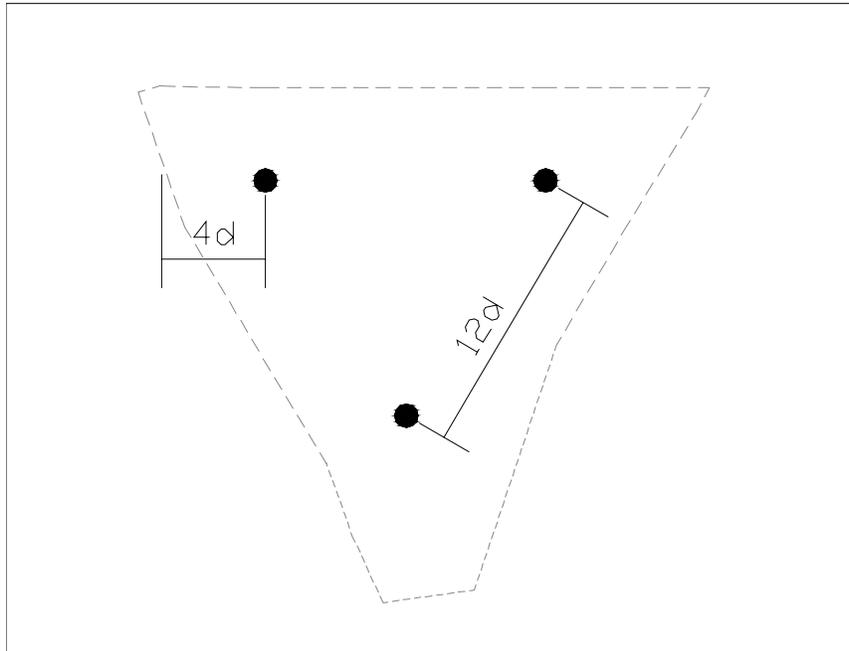
**Figure 4.1 Example of pin spacing distances on spall**

- Minimum thickness of spall that can be pinned = 3/4 inch
- Pin diameter is determined by calculation of shear strength
- Minimum pin diameter = 1/8 inch
- Maximum pin diameter = 1/4 spall thickness
- Minimum pin embedment depth in spall = 2/3 spall thickness
- Minimum pin embedment depth in substrate = equal to the embedment depth in  
the spall, but not less than 4 pin diameters
- Effective embedment depth in substrate will be determined by testing
- Spacing of pins = 12 pin diameters
- Minimum spacing = 6 pin diameters
- Edge distance = 4 pin diameters

It will be necessary to define areas where pins can be inserted by subtracting out areas that do not meet minimum requirements of thickness and edge distance. The 'pinnable' area will be the thickest part of the spall and in most cases include the arrises. Ideally, pins inserted through the thickest sections allow for the most contact between pinning surface and stone. The span of multiple pins within the area of stone that can be pinned should be maximized to give the most coverage, and the pins' locations should divide the weight of the spall as evenly as possible. In arranging multiple pins within the spall the layout should be symmetrical in order to avoid eccentricities of load on the pins. (Ambrose, 2002: 327)

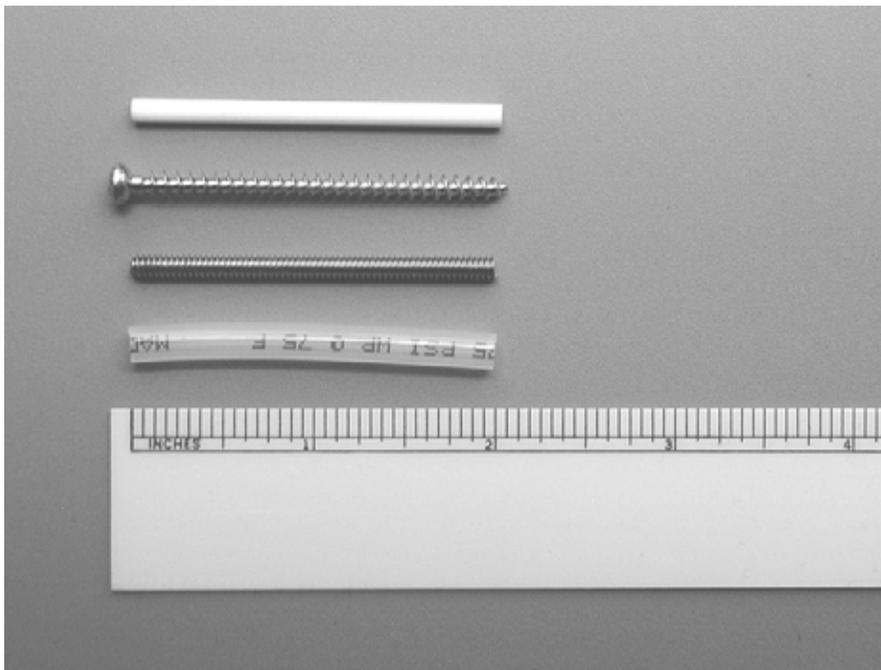
**Figure 5.1 Pins and sleeves used for testing program**

From top to bottom: ceramic pin, bone screw, stainless steel threaded pin, nylon tubing used for sleeve

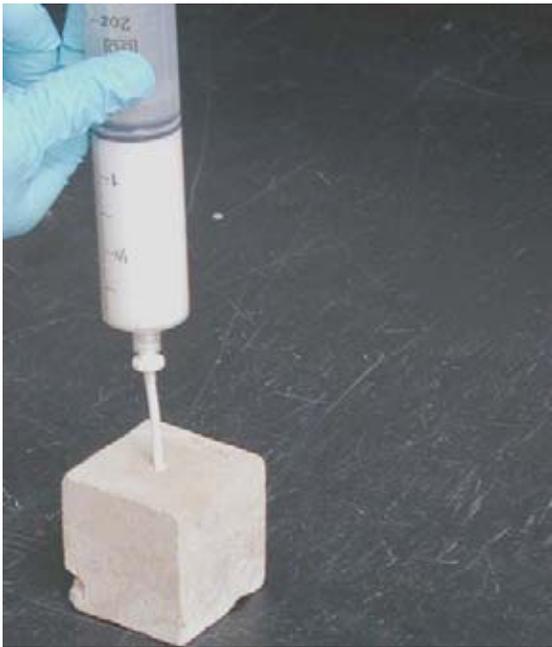
**Figure 5.2 Injection of B-72 adhesive**

The B-72 adhesive was injected using a 50cc luer lock style syringe. Instead of a needle, Teflon tubing (1/8" O.D.) was attached to the syringe using a luer lock fitting.

Adhesive was injected beginning at the bottom of the hole, slowly withdrawing the syringe to fill the hole to the stone surface. The pin was then pushed into the hole, twisting the pin during insertion. Back pressure was applied using a 1/4" thick cosmetic sponge surrounding the hole and pin. Assemblies were set with the pin in a vertical position during the cure time of the adhesive.

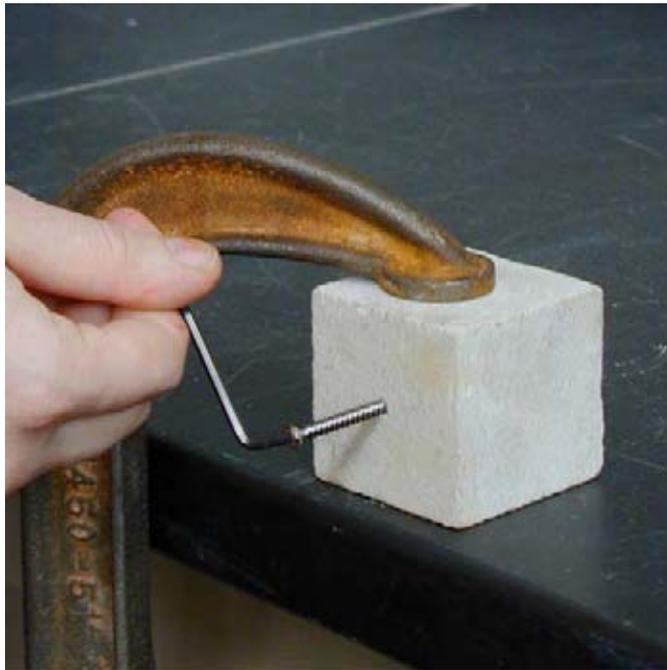
**Figure 5.4 Application of bone screw with hex key**

Bone screws were inserted into an undersized hole using a hex key. Application required occasionally backing out the screws in order to remove stone debris cut by the threads.

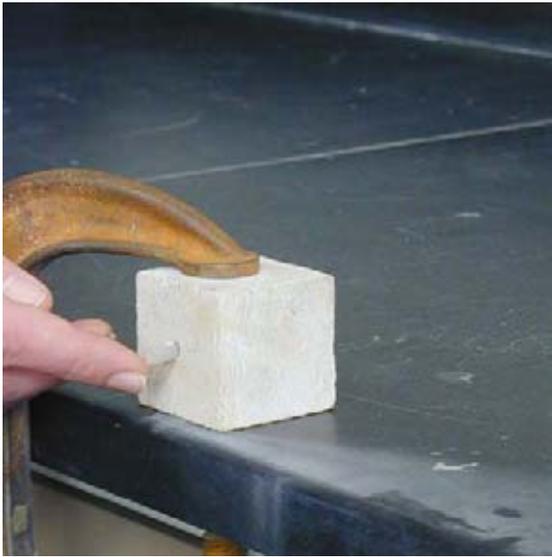
**Figure 5.5** Insertion of nylon sleeve

Nylon tubing of the required length was inserted into the hole. The pin was applied using a tool fabricated from a hexagonal shape steel bar. One end of the pin was screwed into the tool, which was then used to torque the pin into the nylon sleeve, first by hand and then using a wrench attached to the tool. After application the tool was unscrewed from the pin.

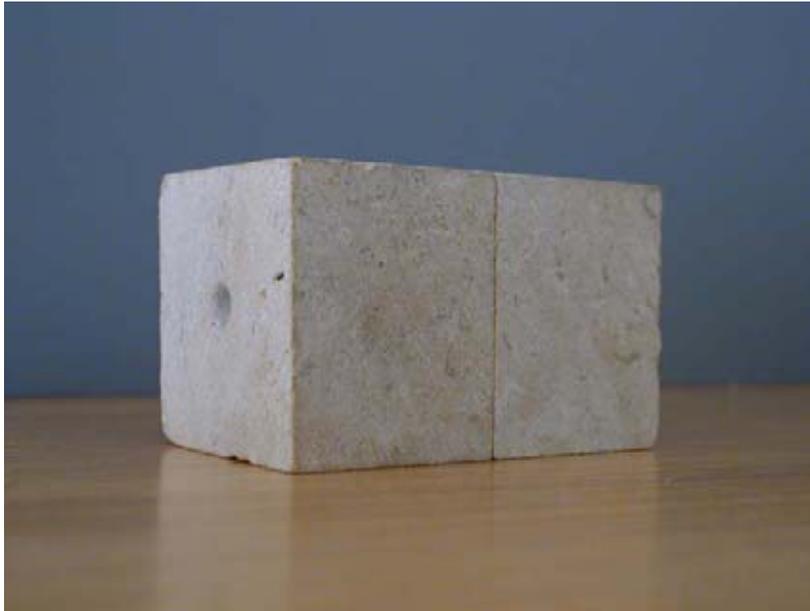
**Figure 5.7** Assembly for bending test

an assembly with a 3" total length and a 2 1/2 " length hole. (See Figure 5.8) This allowed for application of a 2" length pin through one end, and when installed would be equidistant of 1" on each side of the joint, with a 1/2" recess at the application end. The five pinning methods were each tested with 2" embedment in the assembly for a total of five assembly types, each type tested in triplicate. Since a precise fit between the two pieces was required to form a uniform joint and level edge of the stone surfaces, the samples were cut from the same block of stone. In some cases drilling through the entire sample resulted in spalling around the circumference of the hole when the drill bit exited the stone. For this reason, the two parts were drilled separately rather than attempting to drill them as an assembly. Where spalling occurred in drilling through one half, these pieces could then be turned around so the damaged face would be at the exterior surface of the assembly instead of the joint. To ensure alignment of the holes between the two halves, the first part of the assembly was used as a guide in order to drill a starter hole on the second half. The first piece was then removed and the sample drilled to 1" depth.

Since bone screws have a 6 mm head and the friction fit system requires an oversized tool for installation, countersunk holes of 1/4" diameter and 1/2" in depth corresponding to the 1/2" recess below the stone surface were drilled on assemblies for both these pinning methods

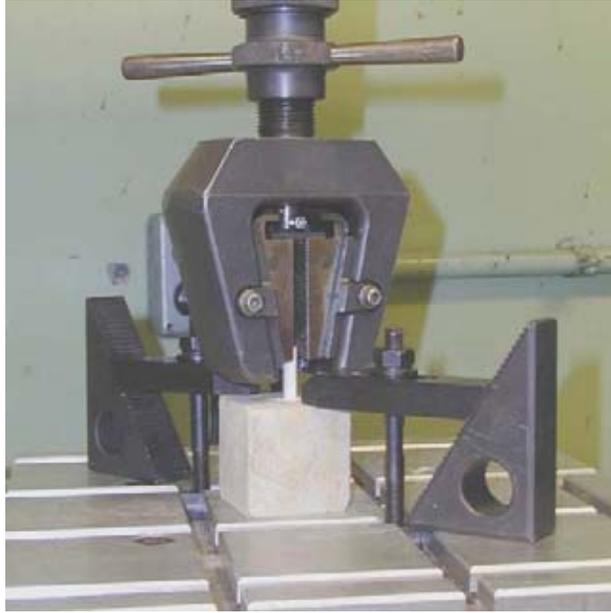
**Figure 5.9 Setup for pullout tests**

Eleven different assembly types were tested, each type in triplicate for a total of 33 tests. Assemblies were secured to the testing platform with clamps at two opposite diagonal corners. Load was applied to the free end of the pin, perpendicular to the stone surface at a rate of 0.1 inches/minute.

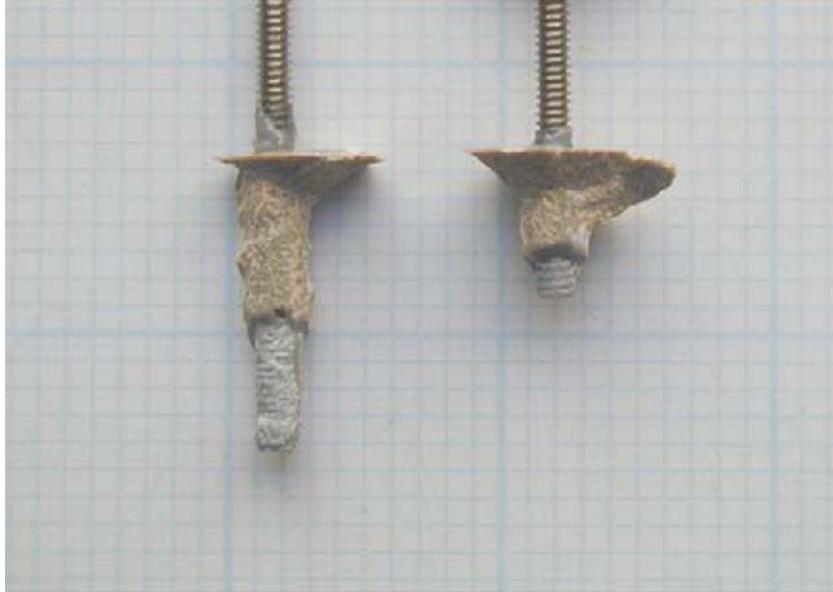
**Figure 5.10 Cone shape failure from epoxy seated pins at 1" and 1/2" embedment depths**

The results of testing showed that a system using stainless steel pins seated in epoxy (P1, P2) provides the greatest tensile strength. This was not an unexpected result. The epoxy seated steel pin at 1/2" embedment (P2) had a mean pullout load of 649 lbf, while those assemblies at 1" embedment (P1) had a mean pullout load of 1162 lbf. Both of these pinning systems, though at different loads, failed causing a circular detachment of stone about 3/4" diameter at the surface centered on the pin; and where the pins were completely removed, a cone shaped volume of stone surrounding the pin was observed.

In some cases cracks appeared on the face and sides of the assembly. While this should not be dismissed, it was felt that the cracks were primarily an influence of the placement of the clamps holding the stone in place. The depth of the failure cone attached to the pin was approximately 1/4". Below the failure cone, the epoxy was bonded to the pin, with a thin layer of stone grains adhered to the adhesive. Taking into account the surface area of stone detachment with the maximum load, the failure of the P2 assemblies are consistent with the known tensile strength of the stone, which is 761 psi. The P1 assemblies, however, demonstrate failure occurring along with a similar cone shape segment of stone attached to the pin, but when maximum load was achieved for a 1" embedment. One explanation for this might be that the stress distribution along the 1" length of the bonded pin gives a greater load capacity, but the characteristics of failure are similar because of the stress concentration near the surface where the stone has the least resistance.

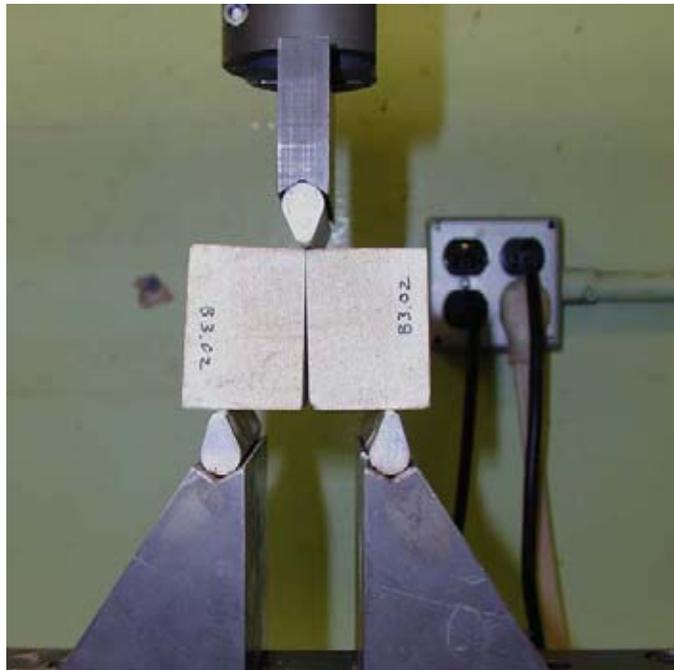
Figure 5.11 Setup for bending tests

Two-part assembly is laid horizontally on the supporting blades spaced 2 inches apart and equidistant from the loading blade, with all three blades parallel. Load is applied at a rate of 0.1 inches/minute.

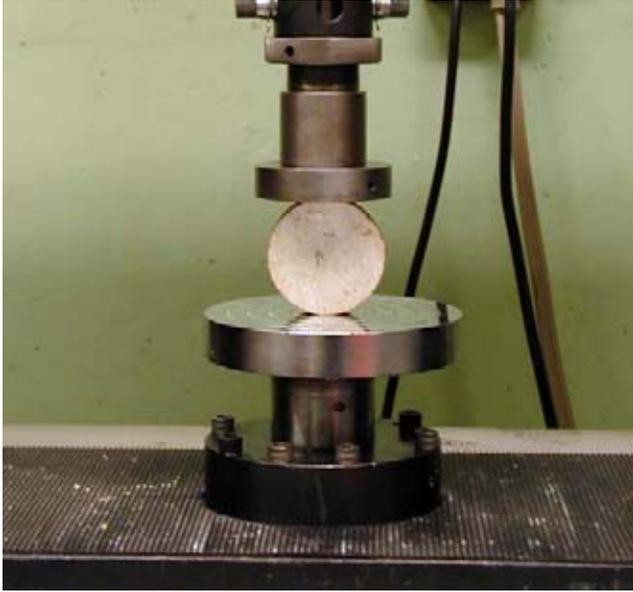
Figure D.1 Testing setup for splitting tensile strength

The samples used for testing were circular discs, 5 in total, with diameters of 2.75" and thickness of 1". Prior to testing the stone discs were washed with deionized water and a nylon bristle brush, and then allowed to air dry for 24 hours. A compressive load was applied diametrically at a rate of 0.005 inches/minute.
