Report	Document No:
	Surface Treatment and Adhesion Study	Revision: D
		Author: Maegan DeLessio, Pat Watson

In photolithography, it is often the case that the resist has difficulty adhering to a wafer due to its hydrophobic nature. The purpose of this study was to determine the best method for avoiding such adhesion problems. This study describes that four different surface treatments, (1) No bake before resist coating, (2) Bake at 115°C before priming, (3) SURPASS coating, and (4) HDMS priming, are examined for UV lithography of sub-ten micron-sized lines and pillar arrays, and that HDMS vapor priming is the most effective surface treatment in promoting adhesion.

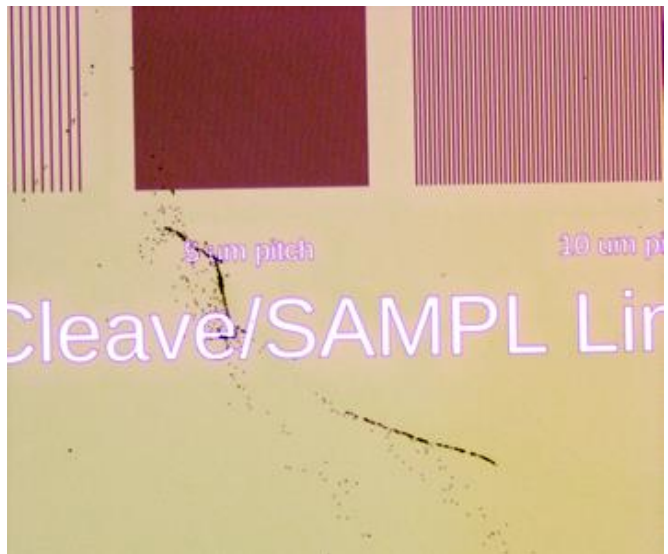
Figure 4: 2 μm pillar array deposited along the surface of the wafer

Wafer treatment	Result	Comments	Image
No bake before resist coating	Poor adhesion: micron line and pillar array	Poor adhesion of 02/10-micron lines ² and 2 μm pillar array; 2 μm pillar dots observed deposited across surface; no adhesion of 1 μm pillar array	Fig: 1, 2, 3, 4
Bake at 115°C before priming	Poor adhesion: micron line and pillar array	Poor adhesion of 02/10-micron, 02/02-micron lines, and 2 μm pillar array; 2 μm pillar dots observed deposited across surface; no adhesion of 1 μm pillar array	Fig: 5, 6, 7, 8
SURPASS coating	Poor adhesion: pillar array	Poor adhesion of 2 μm pillar array; disappearance of pillar dots more gradual than previous two treatments; no dots observed deposited across surface; no adhesion of 1 μm pillar array	Fig: 9, 10, 11, 12
HDMS priming	Good adhesion	No adhesion of 1 μm pillar array; all other features in tact	Fig: 13, 14, 15, 16

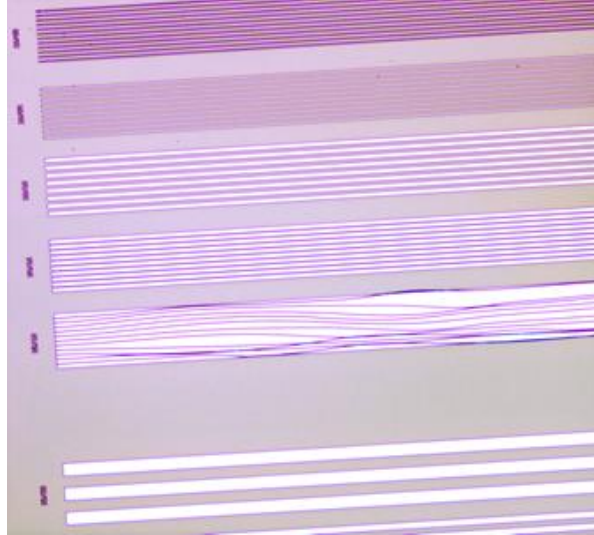
Figure 6: Poor adhesion of 02/10-micron lines on different area of the wafer

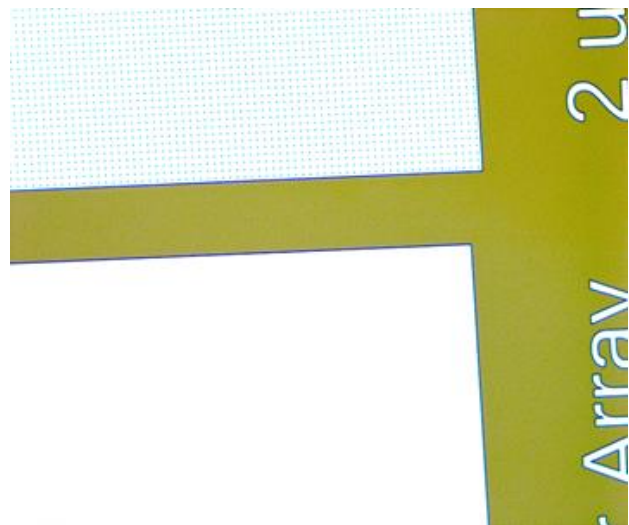
Figure 16: Absence of 1 μm pillar array, with 2 μm array for comparison (consistent feature across all wafers)

First, this study showed that developed features are often subject to adhesion problems. 2 to 10 μm width lines as well as 2 μm diameter pillar arrays were observed to have variable degrees of adhesion depending on the wafer-surface treatment; in wafers produced through less effective surface treatments, the developed features adhered poorly. 1 μm diameter pillar arrays were missing on all wafers, regardless of surface treatment, suggesting that the process conditions and/or photomask properties were inappropriate for features of this size.
