ADAPTIVE USE PROPOSAL FOR THE HEADQUARTERS OF THE
HISTORICAL SOCIETY OF SCHUYLKILL COUNTY

A THESIS

Historic Preservation

1997

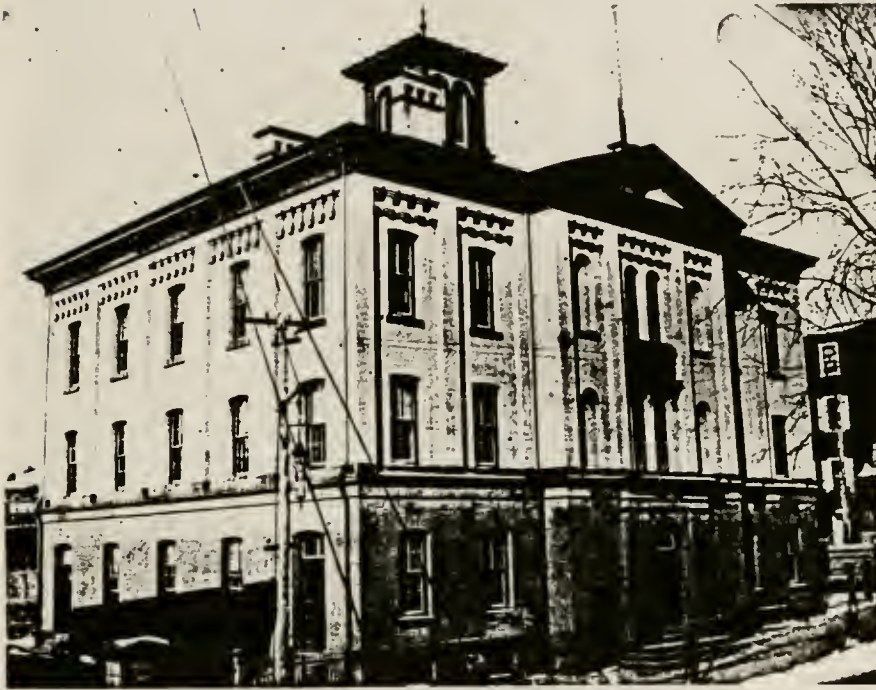
Illustration 2: Female Grammar School, Pottsville, before 1900.

overhanging eaves with brackets, arched windows, and entrance tower with projecting portico.⁴⁸

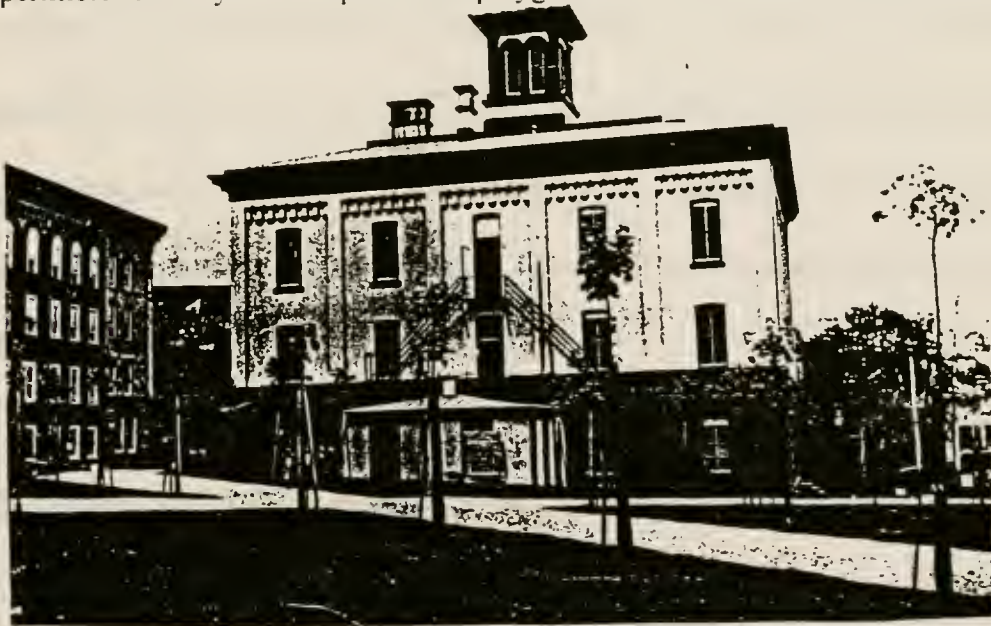
Illustration 8. View of Female Grammar School playground looking to the northeast (Race Street in foreground) Pottsville, date unknown

The Female Grammar School lot only provided two narrow play yards on each side of the building. These play yards were probably large enough for the proper exercise activities for girls, but as boys were added and the cemetery was removed, a larger playground was necessary. An early photograph (illustration 8) shows the larger playground with shade trees planted in neat rows and a low masonry wall around the perimeter of the yard to separate the playground from the sidewalk and the street.

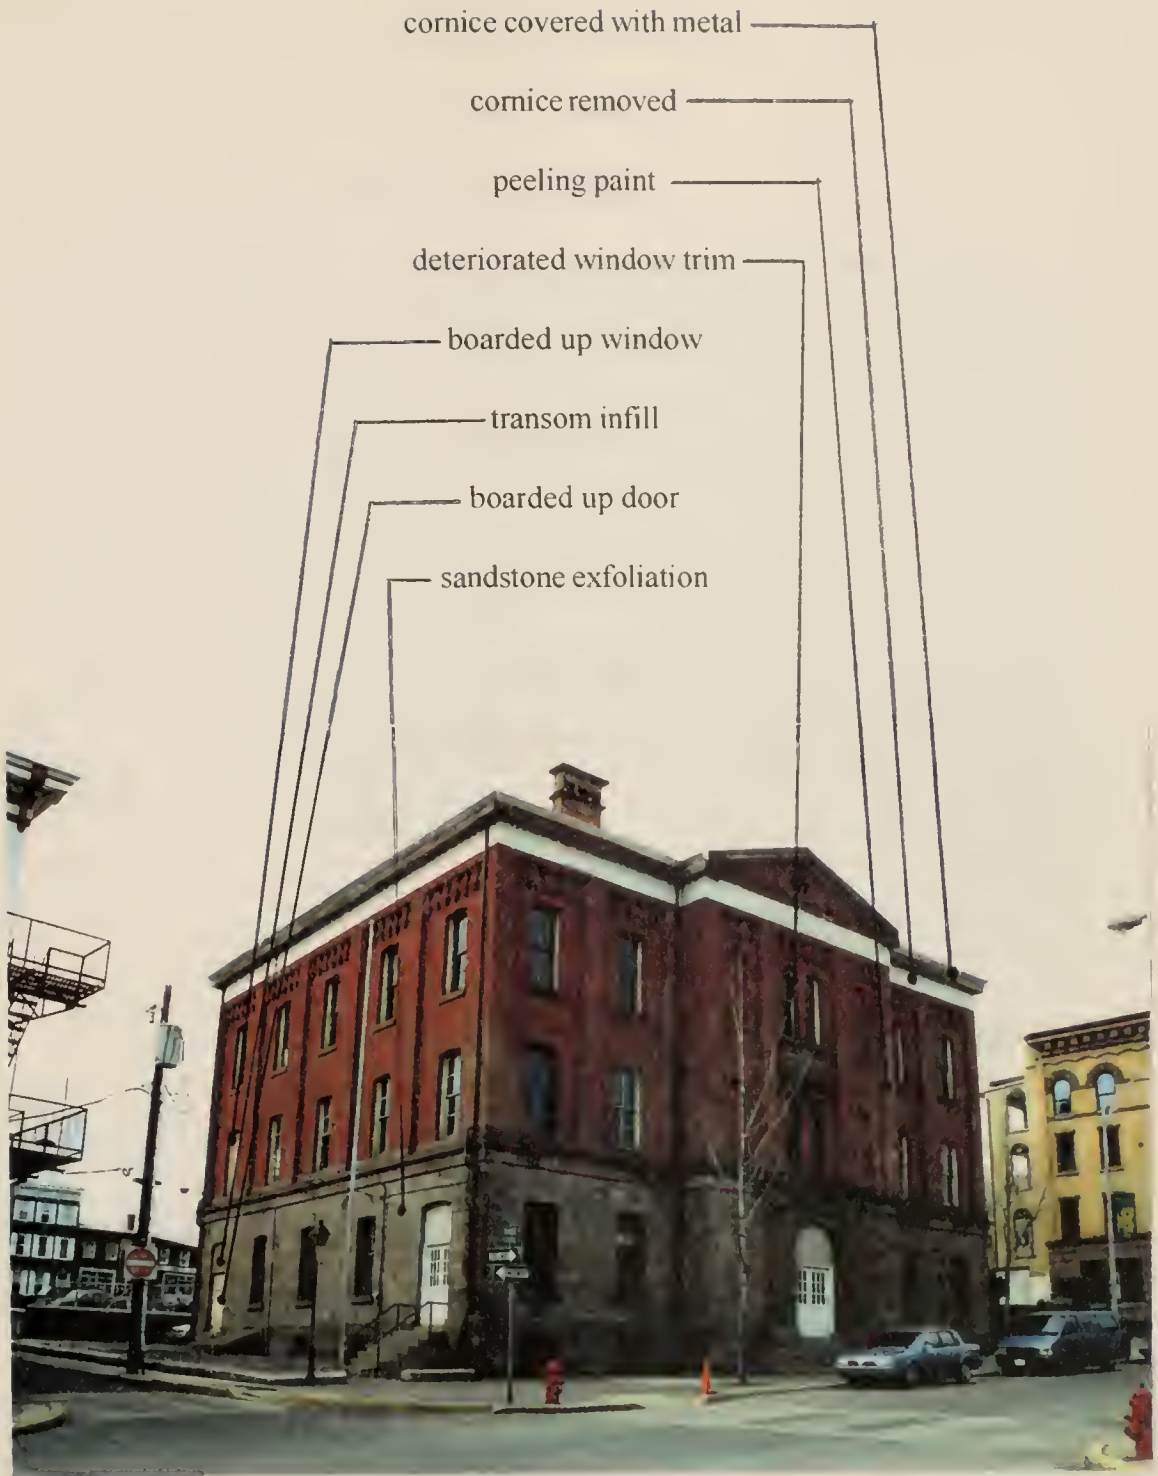
The exterior of the building is in poor condition due to the state of certain areas of sandstone, the deterioration of window trim and sash and significant mortar loss. Areas of sandstone are suffering from weathering and exfoliation. Weathering is “the natural disintegration of the surface, edges, corners and carved details of masonry. It is caused...by conditions such as wind, windblown particles and rain.”¹ Exfoliation is “the splitting apart of the outer surface of the natural stone into thin layers that peel off. This is a natural condition in sedimentary stones where exfoliation occurs along bedding planes.”² The deteriorated surface of the stone allows water to penetrate and increase the severity of the problem. The sandstone areas suffering from exfoliation and weathering are concentrated along the belt course, near the ground in the water table, and on the stone pilasters and entablature at the front entrance.

According to historic photographs, the brick of the Female Grammar School was originally painted. The surface has been painted numerous times and the layers are currently peeling. This peeling is caused by having moisture trapped between paint layers and by the exposure to the deteriorating effects of the sun and the weather. There is evidence of significant mortar loss in the brick and in the sandstone areas.

The areas of the sandstone that are suffering from exfoliation and weathering and the areas of brick where the paint is peeling are also areas where there is significant mortar loss. The function of a mortar joint is to transfer the load of the wall between masonry units, to provide a connection between units, and to create a weather resistant surface.³ By function, the mortar joint is supposed to weaken and deteriorate in order to save the stone or brick. The substantial loss of mortar allows water to penetrate into the masonry wall and cause spalling or exfoliation.

The downspouts are not conducting water properly and the exterior masonry near the downspouts has water staining and biological growth. The biological growth contains damaging soils and lichens which trap moisture against the surface and thus increase the problem of exfoliation or spalling. Aside from the discoloration and biological growth, the water running down the building at the downspouts introduces additional moisture to the masonry wall which accelerates mortar loss, exfoliation and weathering.

Illustration 9. View of the southeast corner of the Female Grammar School showing the existing condition of exterior materials

The sandstone and brick should be cleaned in order to eliminate areas of biological growth and paint. These areas should be cleaned with a low water pressure wash and a natural bristle scrub brush. A mild soap or organic chemical might be necessary to remove areas of paint or staining. Before using, a small area should be tested to determine if the soap or chemical solution has an adverse effect on the masonry surface. In accordance with the cleaning, the gutters and downspouts should be cleaned and repaired in order to properly conduct water.

Each piece of sandstone should be assessed to determine if the stone should be kept, be repaired, or be replaced according to the amount of damage caused by weathering, exfoliation, or biological growth. Repairing and replacing with new stone is difficult due to the difference in color. In this case it is possible to repair the face of the stone with a cement patch mixed with pigments to match the existing color. For this process, the loose or flaking areas of the stone are cut away to ensure that the cement will be applied to sound material behind. The new surface is scored so that the cement patching compound will form an adhesive bond with the stone backing.²

The masonry walls should be repointed where needed. Old mortar should be carefully removed from the joint with a hammer and chisel. Then the joint should be brushed with a stiff brush to remove loose material. The new mortar should match the old mortar in mixing proportion and application style. Portland cement creates a harder

The brick surface of the Female Grammar School was originally painted to prevent the penetration of moisture into the inner area of the wall. The brick surface should be prepared for painting after being cleaned and repointed. The preparation of the surface includes cleaning the surface with a mixture of trisodium phosphate (TSP) and water. The surface should be allowed to dry for three days of warm weather before the primer coat is applied. Paint that creates an impermeable layer should be avoided because trapped moisture will cause peeling or blistering.⁸

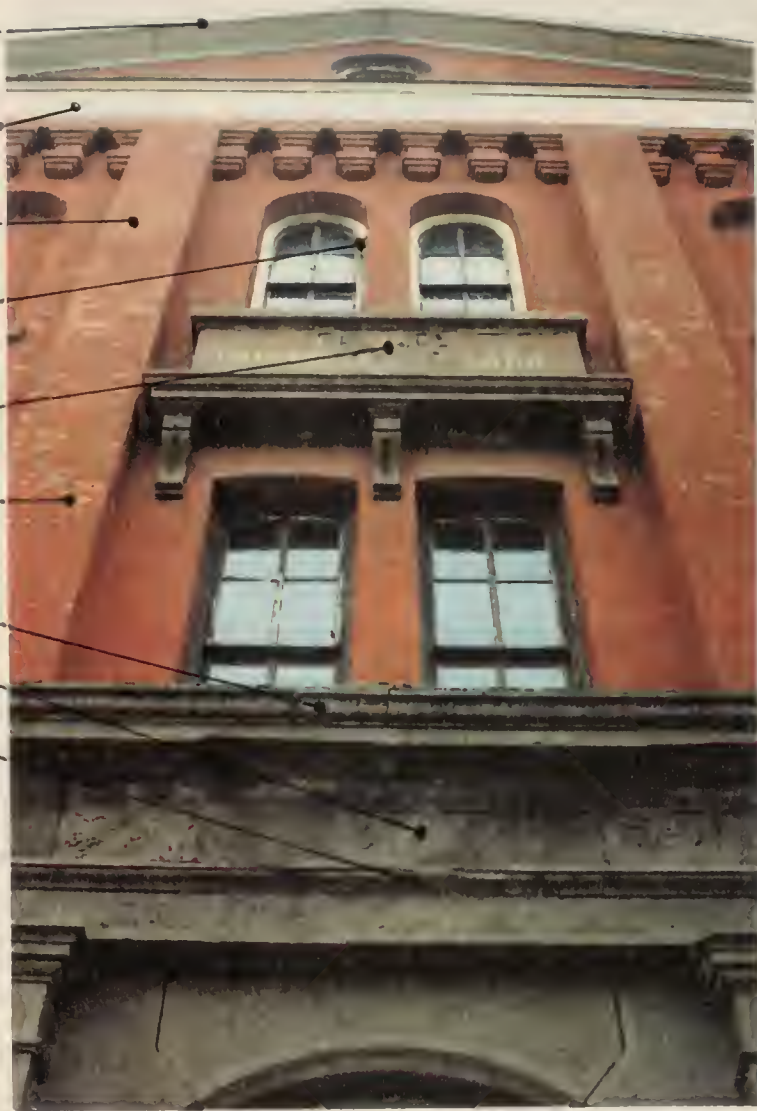
Illustration 11 Detailed view of the east elevation of the Female Grammar School showing the existing condition of exterior materials

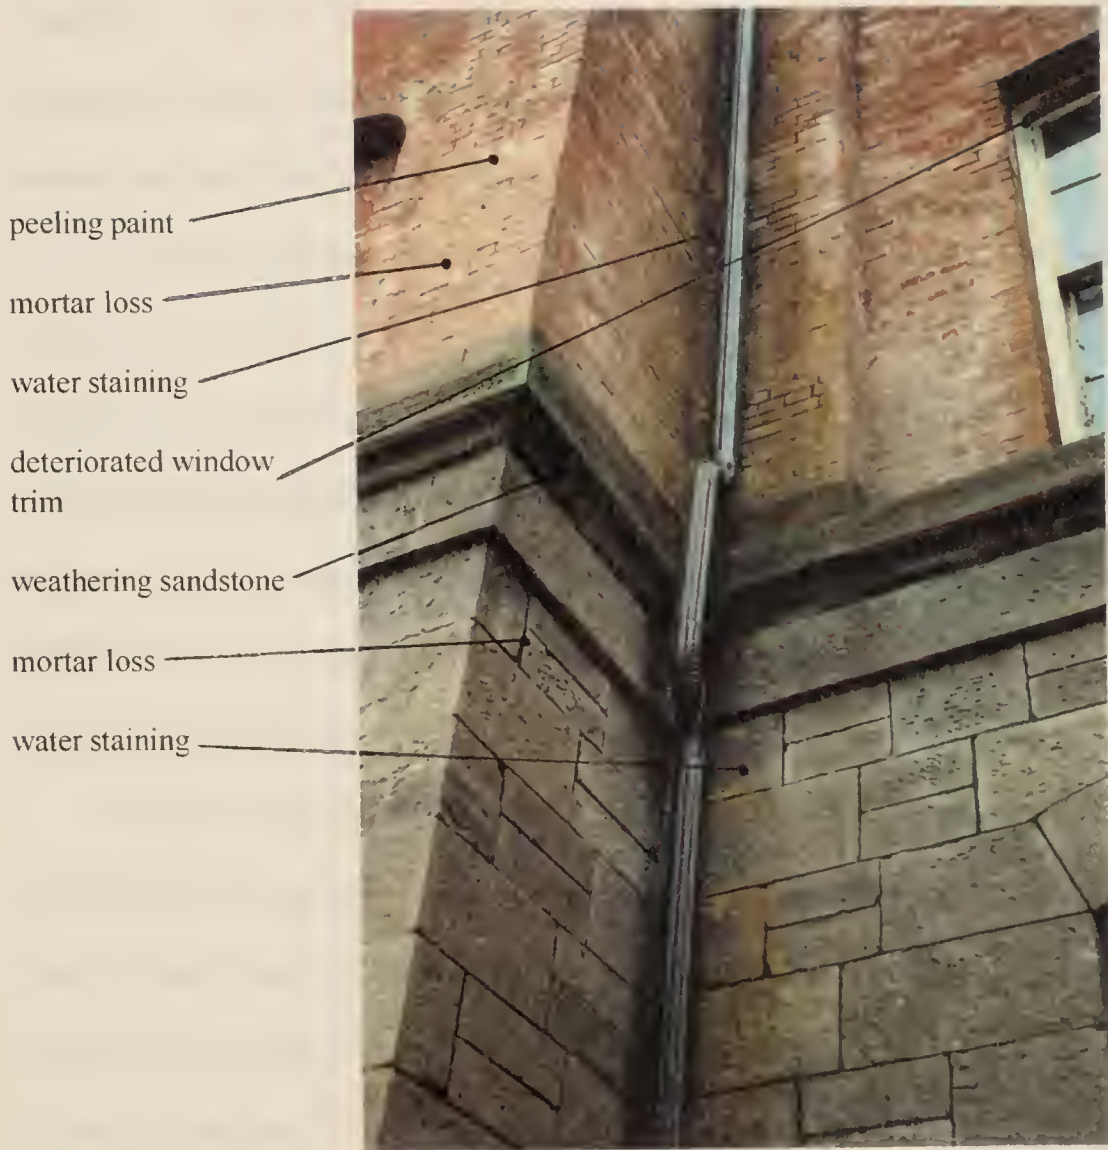
Illustration 12: Detailed view of the east elevation of the Female Grammar School showing the existing condition of exterior materials.

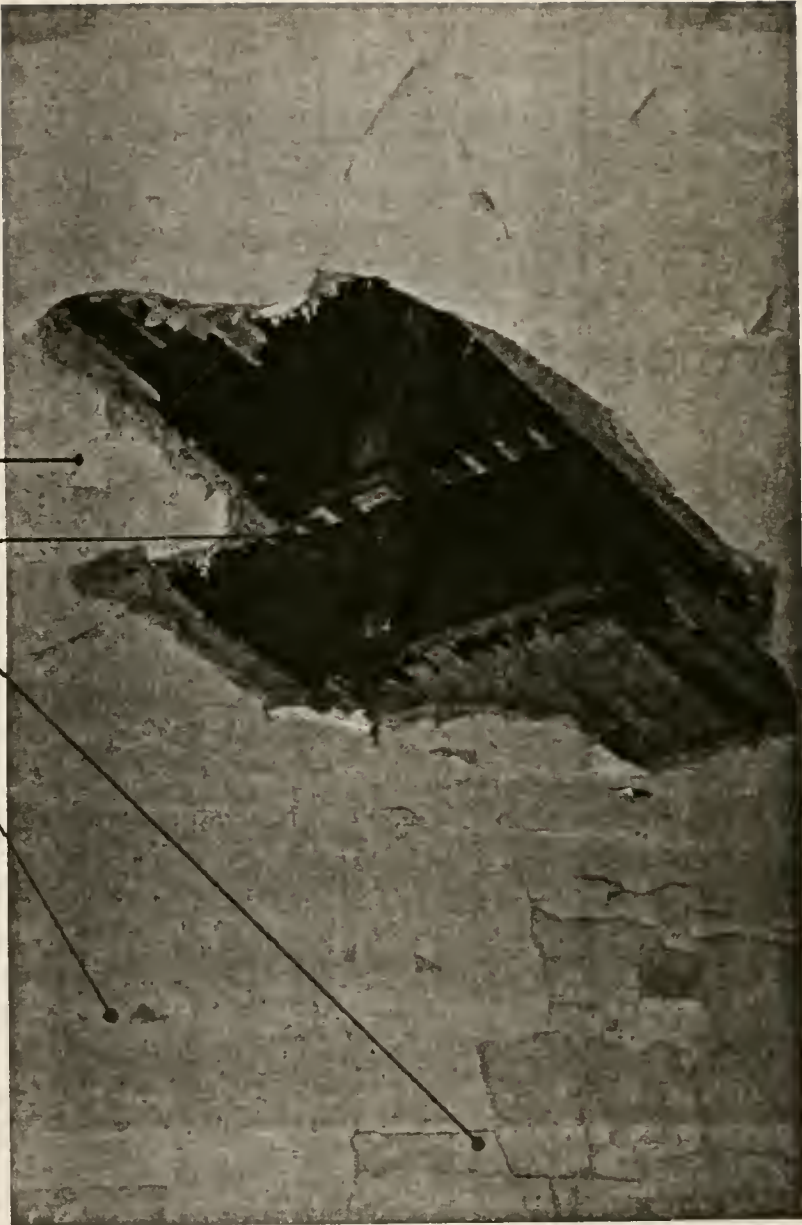
The painted surfaces of the plastered interior walls and ceilings are peeling and cracking. This damage is probably caused by the recent periods of vacancy when the building was not heated during the winter months. The plaster would absorb the moisture in the air which would collect behind the paint layers which causes the paint to break its adhesion to the plaster or to other layers of paint. Winter cycles of humid and dry air with constant cold temperatures will also cause the plaster to produce hairline cracks which aid in breaking the adhesion between paint layers and the plaster surface.

In some areas plaster and lath are missing. Field inspection did not suggest a reason for the loss of material in these areas. In fact, it seems that the missing areas of plaster and lath occur in the ceiling on every floor near the air duct passages in the walls. The loss of plaster and lath is probably due to human intervention and not the product of the lack of maintenance.

cracks in plaster

peeling paint

Illustration 13. Detailed view of the ceiling in a classroom of the Female Grammar School showing the existing condition of interior materials.

The areas of plaster loss and large cracks should be patched. The plaster on the walls is scored to look like stone and this pattern should be reproduced in patched areas in order to retain the original character. In order to repair a section of missing plaster, remove the loose plaster from around the area. Metal lath should be nailed and wired to the existing structure and three coats of plaster should be applied to the area in the same manner as plaster on a new wall. The finish coat should be feathered over the existing finish coat around the edges after it has been dampened.¹² After the plaster cures for a week cracks might be visible where the new finish coat meets the existing coat. The new cracks and existing cracks should be filled and then covered with fiberglass tape "...which is coated with flexible patching compound that is feathered into the surrounding plaster."¹³ Once sanded and painted the tape will not show and the crack will not reappear.¹⁴

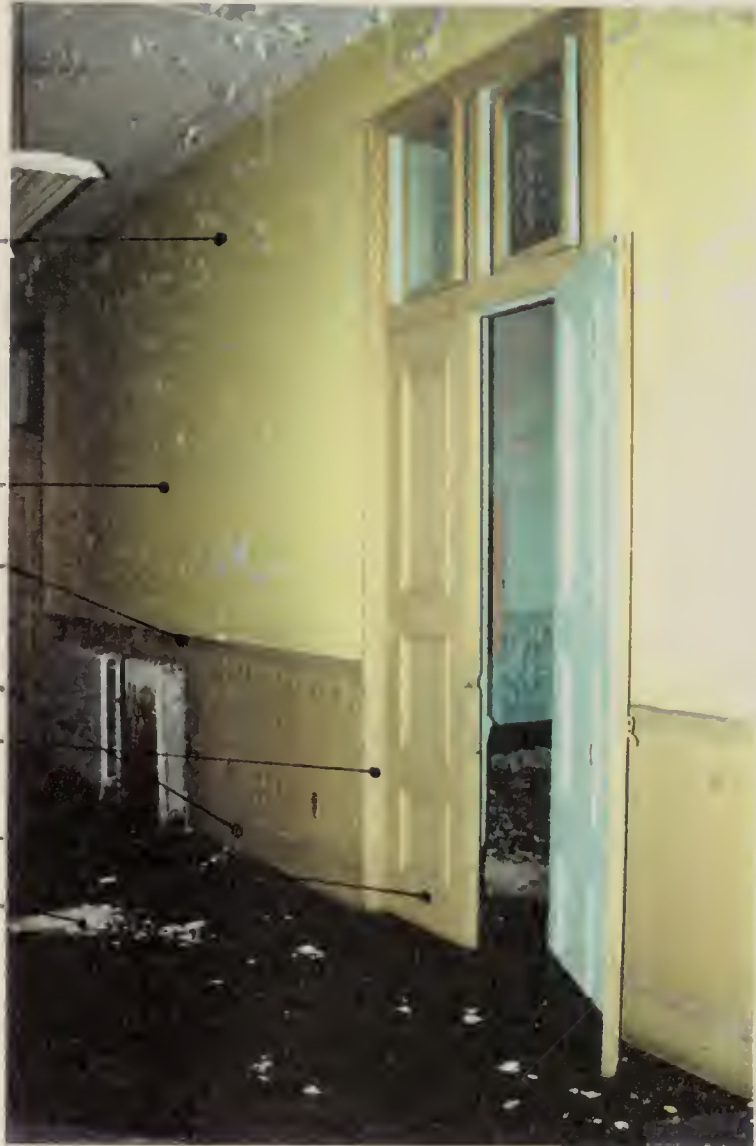
Illustration 14: View of the main corridor in the Female Grammar School showing the existing condition of interior materials

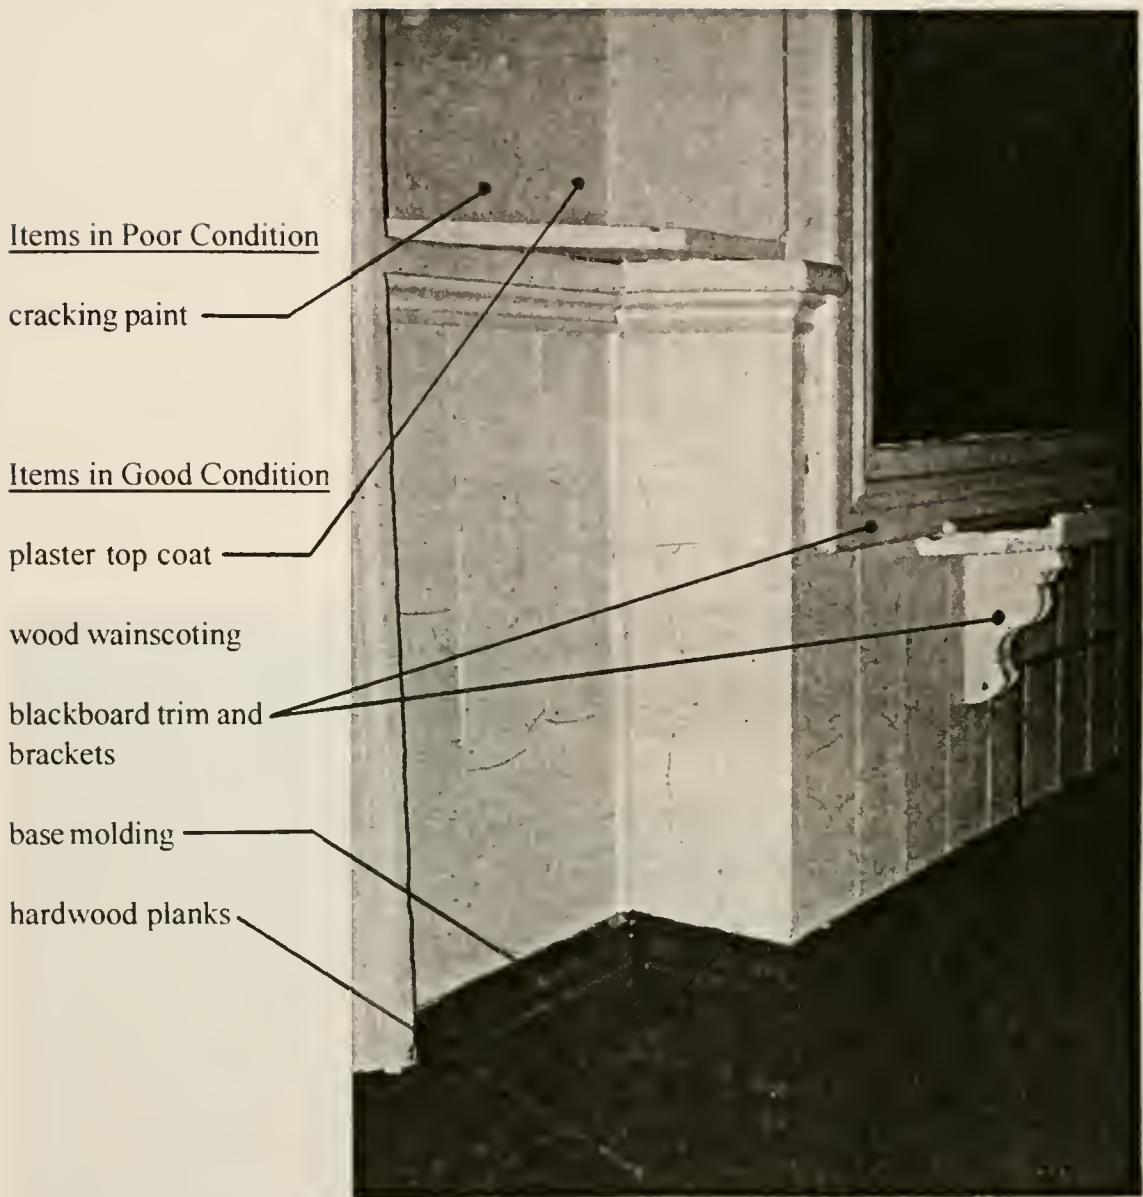
The condition of the windows vary. Some windows suffer from deterioration at the sills, lower sashes, and frames. These conditions are caused by water penetration from the exterior to the interior or from interior condensation. The moisture held in the wood causes water staining, cracking and rot. Over time some of the windows and transoms were removed and boarded up or filled in with brick. Others remain in poor condition.

Illustration 15 Detailed view of a classroom in the Female Grammar School showing the existing condition of interior materials

deteriorated sash

deteriorated lower jamb trim

deteriorated sill

wood wainscoting

upper jamb trim

The wood trim of windows and doors should be assessed to determine if areas need repair or replacement. Dutchman repair is a method for patching wood where “pieces of new wood [are] inlaid into voids left by the removal of damaged wood.”⁹ Two part epoxy patching compound can also be used to rebuild lost areas of wood trim. The epoxy can be sanded and painted once it has cured.¹⁰ Replacement of wood trim should match the existing trim of the building in profile and size. Regardless of the method of needed treatment, the trim should be prepared for being repainted. The preparation of the trim includes the removal of existing paint with a scraper and sandpaper. An organic paint stripper might be needed to remove areas of paint. Lightly sand the surface with the grain to be repainted making sure that the repaired areas are smooth with the existing
