AN EXAMINATION AND ANALYSIS OF FUGA'S  
*SCALINATA DELLE UNDICI FONTANE AND PROSPETTIVA*

A THESIS

Historic Preservation

2005

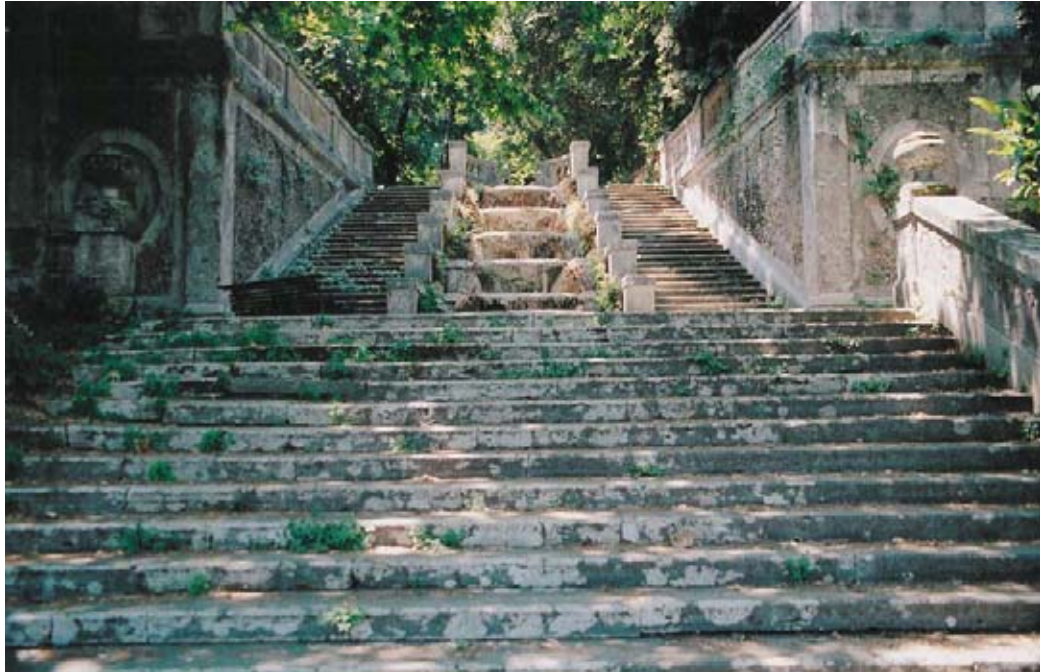
*Figure 1.1: The Scalinata delle Undici Fontane (Sardegna, 2003)*

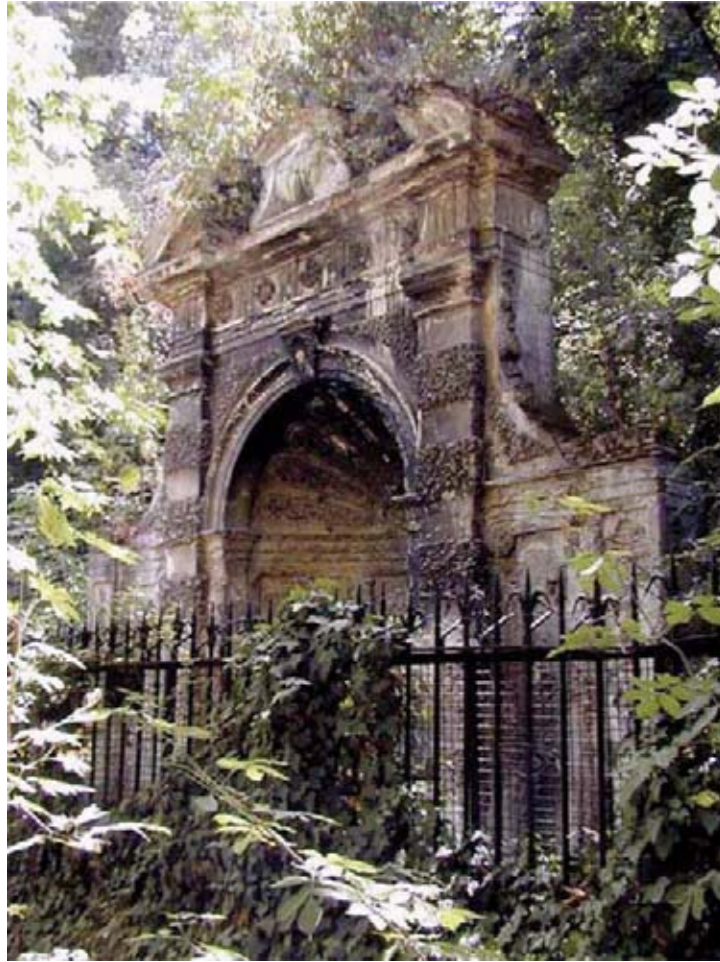
Figure 1.2: The *prospettiva* (University of Pennsylvania, *The Orto Botanico and the Scala d'Acqua of Rome*, 2002)

Many pieces of Christina's collection of arts and antiquities are still present in the gardens today. Christina's two large marble bathtubs reside in the greenhouses, and now are filled with plants. When the statue of Cornelius was placed in the niche in the *prospettiva* after Fuga's work in 1741, an antique pedestal from Christina's collection was used as its base, and is still present in the niche today.

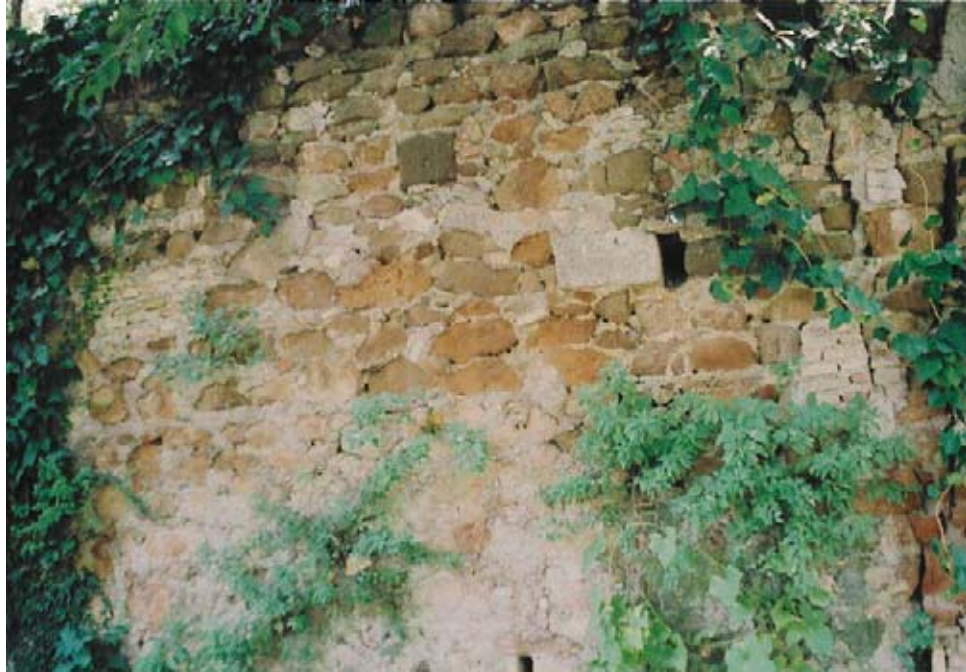
*Figure 2.2:* Typical tuff stone ranging in color from buff to yellow in the old *scalinata* walls. (Sardegna, 2002)

The old walls that flank the *scalinata* are most notably from a different era. They are constructed from irregular tuff rock, instead of brick and travertine. What little finish surfaces remain are different as well. These walls appear to have been part of an earlier grotto rather than a nymphaeum. There are also elements which suggest that the north and south portions may not have been built at the same time, or were built by two groups of workers. Drains in these walls are of different configurations: those of the old south wall use bricks laid horizontally with the headers facing outward, and those of the old north wall use bricks laid vertically with the side edges facing outward. The stones also vary slightly in some places. There are small areas of irregularly shaped red-brown tuff (*Figure 2.3*) and yellow tuff in the old north wall that differ from the irregularly shaped tuff stones that vary

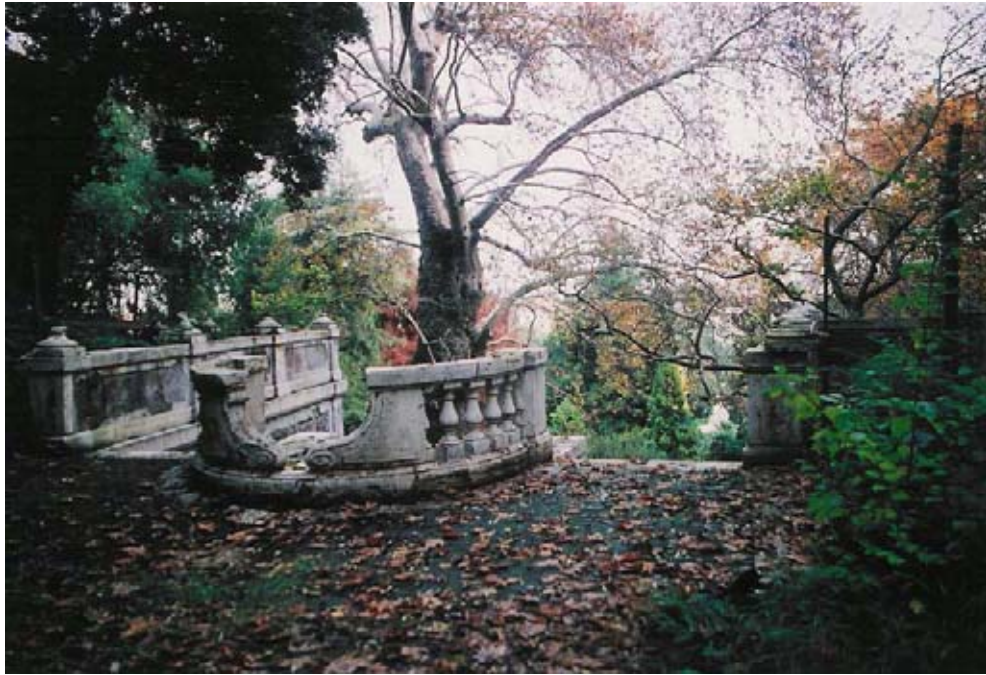
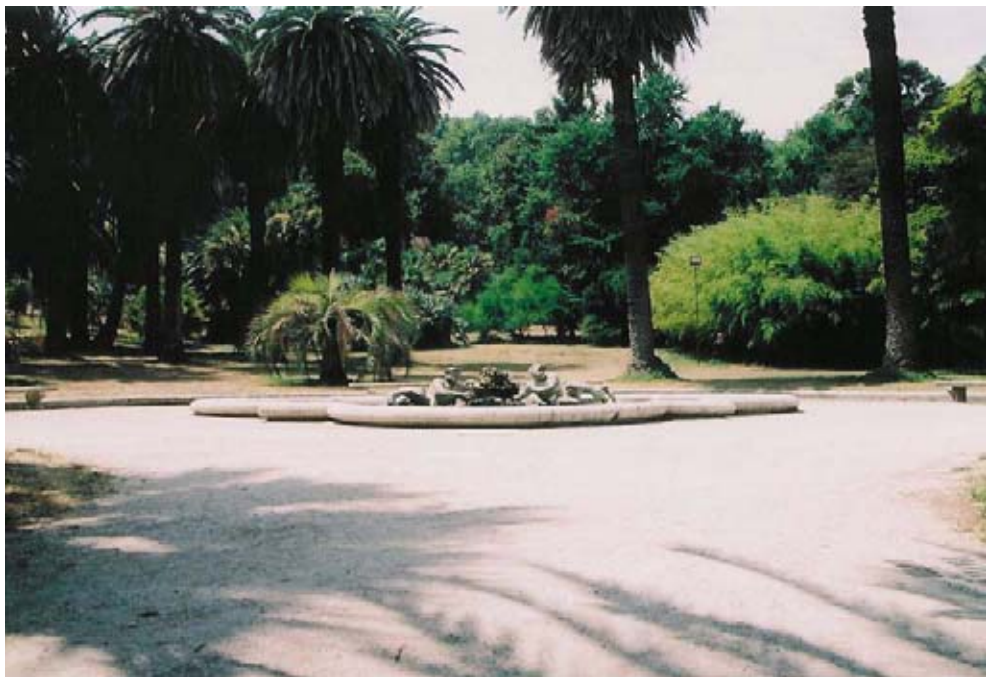
*Figure 3.7: Axial views from the top of the scalinata (top) and from the Fontana dei Tritoni (bottom). Compare to the eighteenth century views in Figure 6.11 and Figure 4.3 (Sardegna, 2002)*

The palazzo and part of the grounds were sold to the Italian state in 1872. The palazzo became the seat of the Accademia Nazionale dei Lincei, and was eventually made into a museum. The grounds on the upper part of the Janiculum hill were incorporated into a park which is managed by the state. The remainder of the grounds became the botanical gardens or Orto Botanico, managed by the University of Rome-La Sapienza. In the transformation from private garden to botanical garden, the emphasis shifted from the arrangement of the plants to the plants themselves. Significant changes were made to the garden’s layout in an effort to incorporate plant specimens according to scientific principles. The parterres disappeared, the central axis was disrupted, and the unimpeded axial view from the palazzo to the *prospettiva* obscured by a collection of palm trees (*Figure 3.7*). Today,

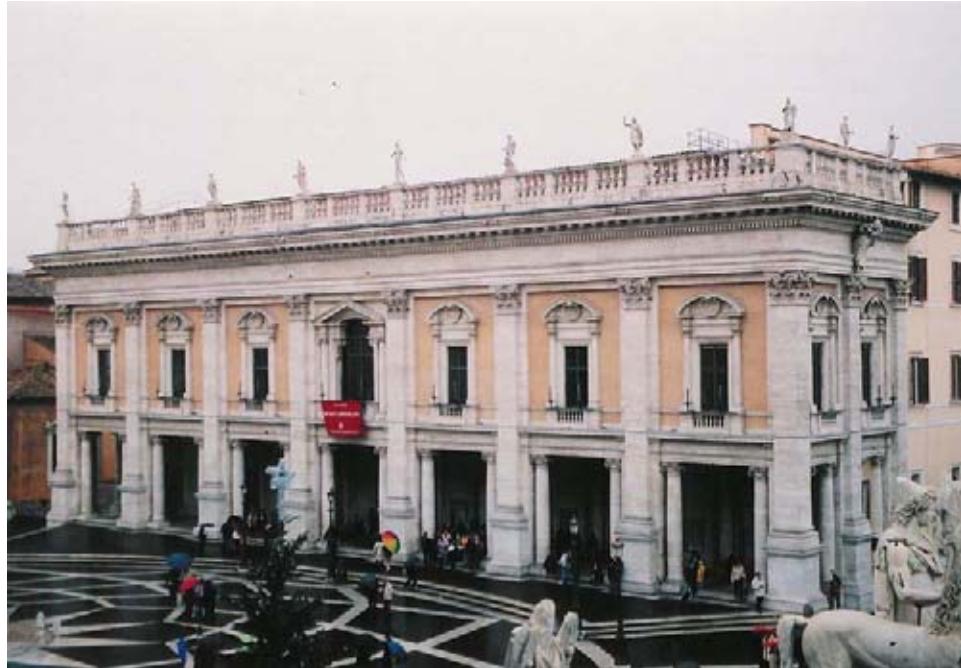
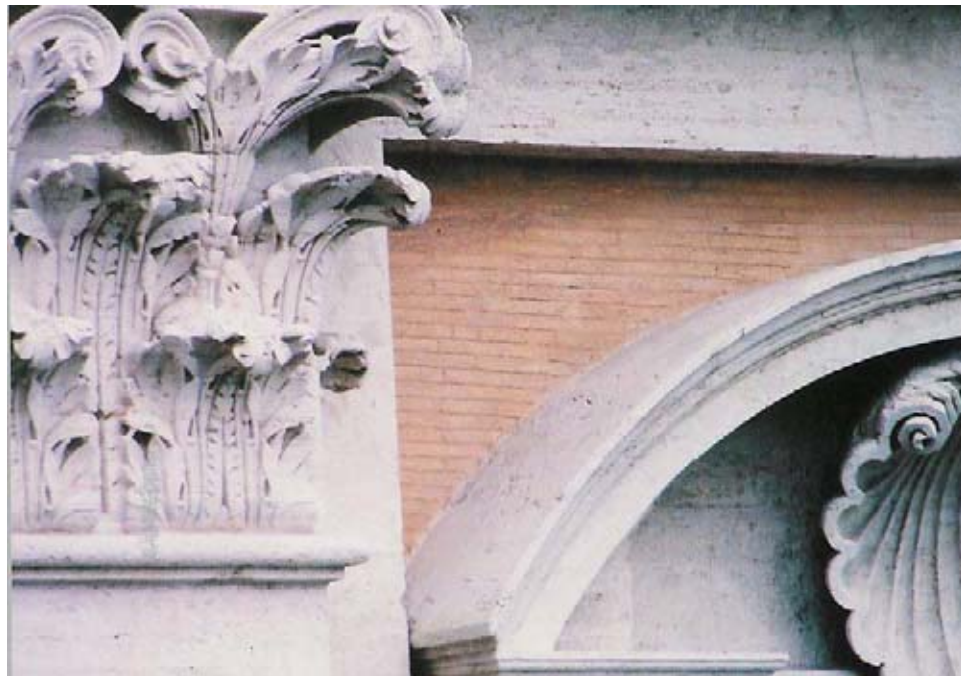
*Figure 4.4: An example of travertine and cortina finishes used on the Capitoline Palaces, and a detail of the cortina finish (Sardegna, 2004)*

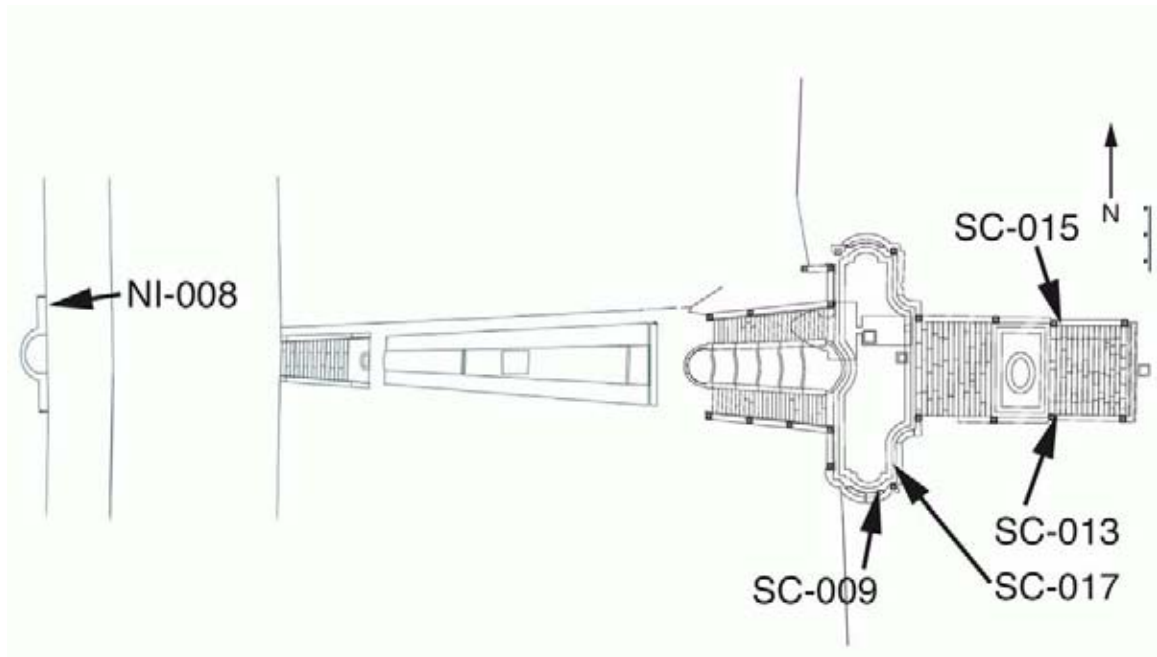
Figure 5.1: Locations of samples exhibiting travertine colored limewash

Surfaces decorated with a travertine color finish typically have layers varying in color from pale cream to yellow. The variations in color are used to mimic the natural coloration of travertine stone. The travertine finish gives the appearance of stone and corresponds to those areas where stone is used for structural reasons, such as the foundation and cap elements. Much of the *scalinata* plaster would have been painted a travertine color. This color was found on samples from frame elements, pilasters, and most flat surfaces. All early finishes appear to be limewashes.

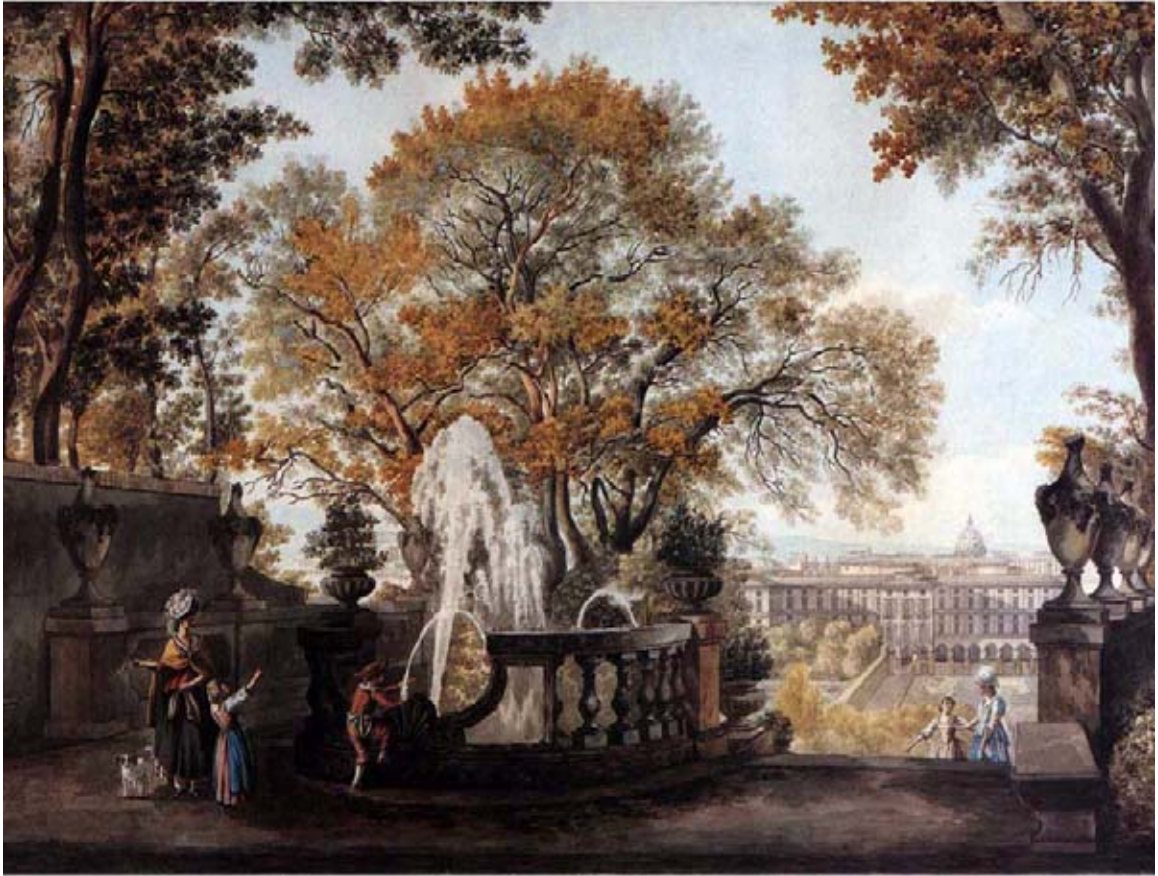
*Figure 5.11: Watercolor depicting the top of the scalinata, 1780 (University of Pennsylvania, *The Orto Botanico and the Scala d'Acqua of Rome*, 2002, p. 37.)*

The appearance of the pink and orange colors in Sample SC-012 on the pilaster suggests that the pilasters were originally colored cortina. This color placement is supported by the coloration in a watercolor dated 1780, soon after the water stair was constructed (*Figure 5.11*). The pilasters visible at the top of the water stair are a mottled pink, a similar color to the interior fields and a darker color than the neighboring frames. The two colors found in Sample SC-012 could be used to create this mottled appearance. These two colors are similar to the colors found during the survey of the faades of the Capitoline Palaces in the areas which were originally cortina.<sup>2</sup>

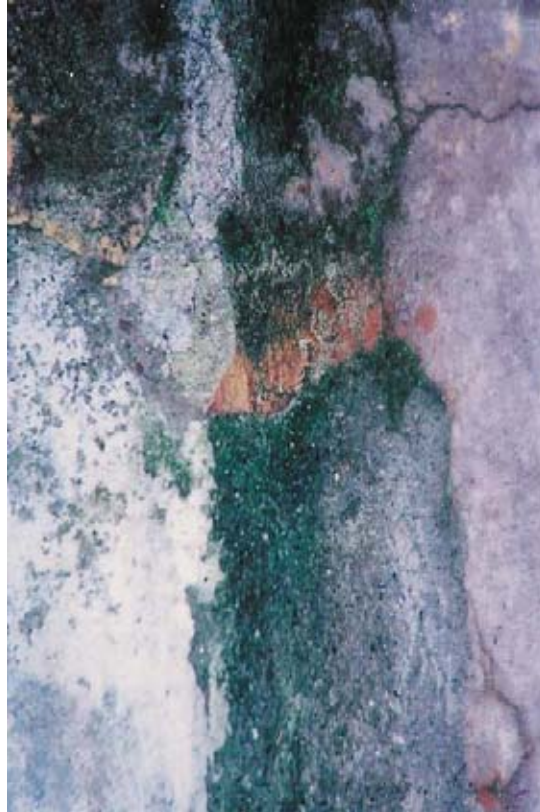
*Figure 5.13:* Exposed site of sample SC-012. The grey field below the exposed orange finish plaster appears to be a more recent repair.

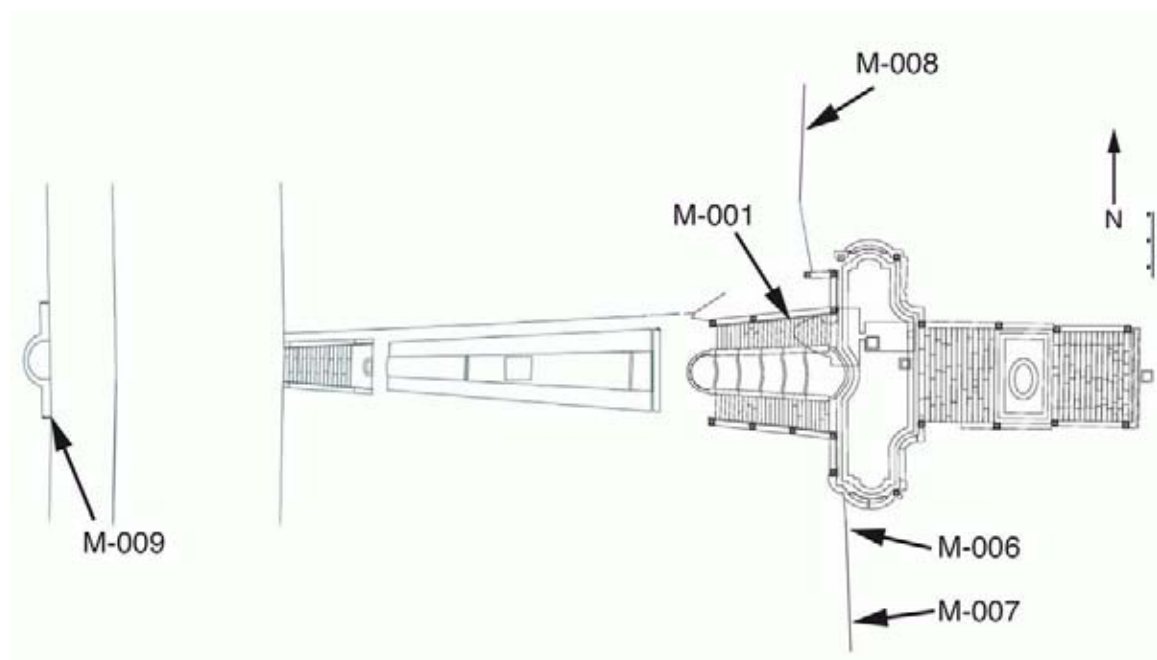
Figure 6.1: Locations of the samples chosen for mortar analysis.

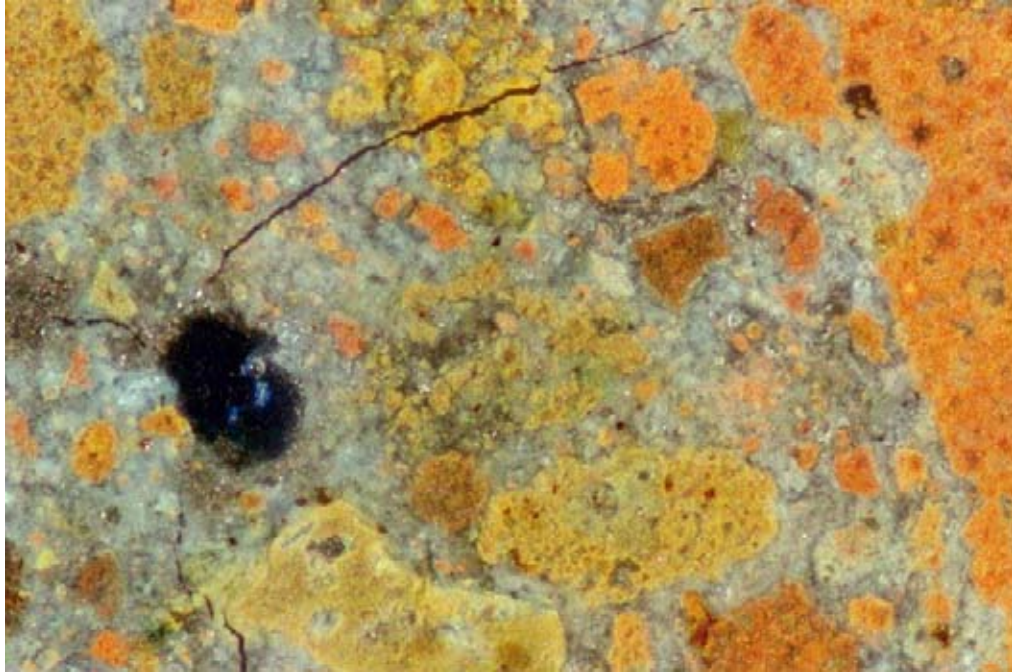
*Figure 6.6: Sample M-009 (25x magnification)*

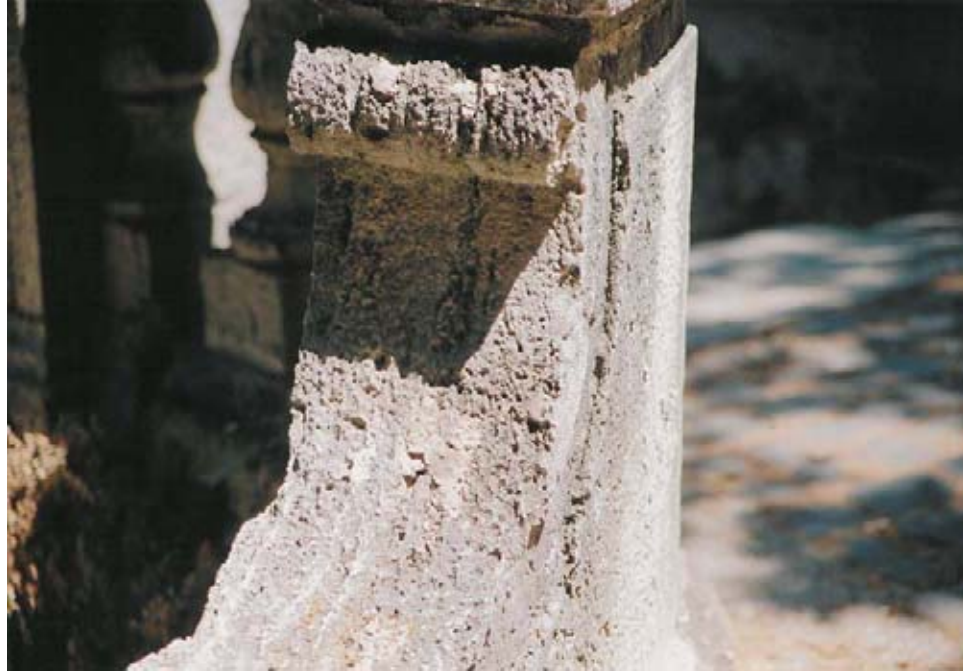
*Figure 7.2: Pitted travertine surface on the scalinata baluster. (Sardegna, 2002)*

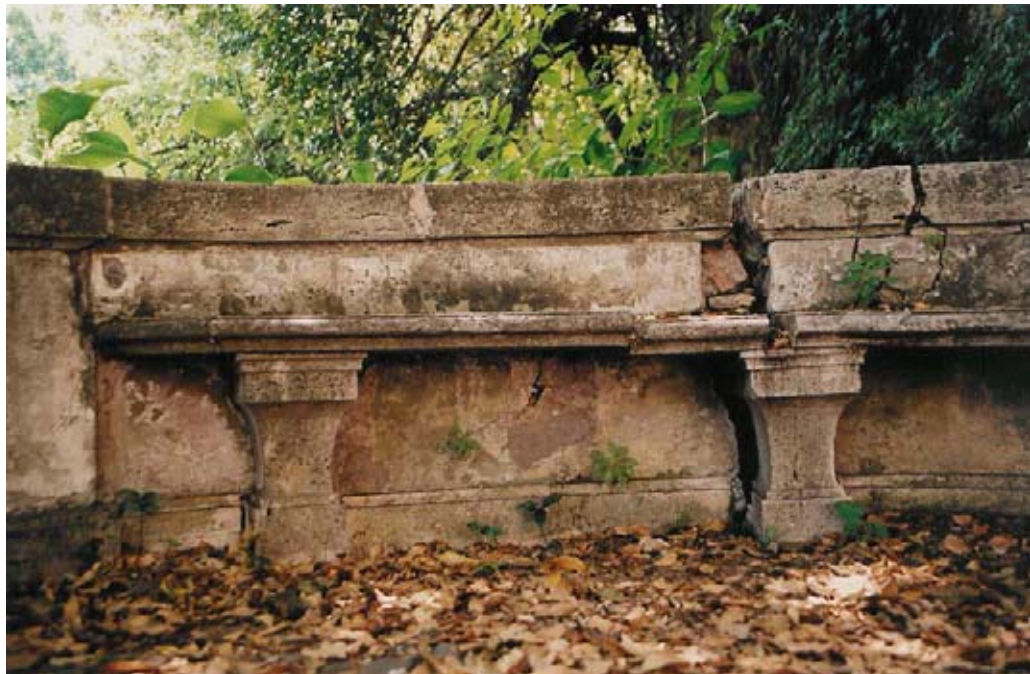
*Figure 7.3: Displaced masonry on the scalinata near the plane trees. (Sardegna, 2002)*

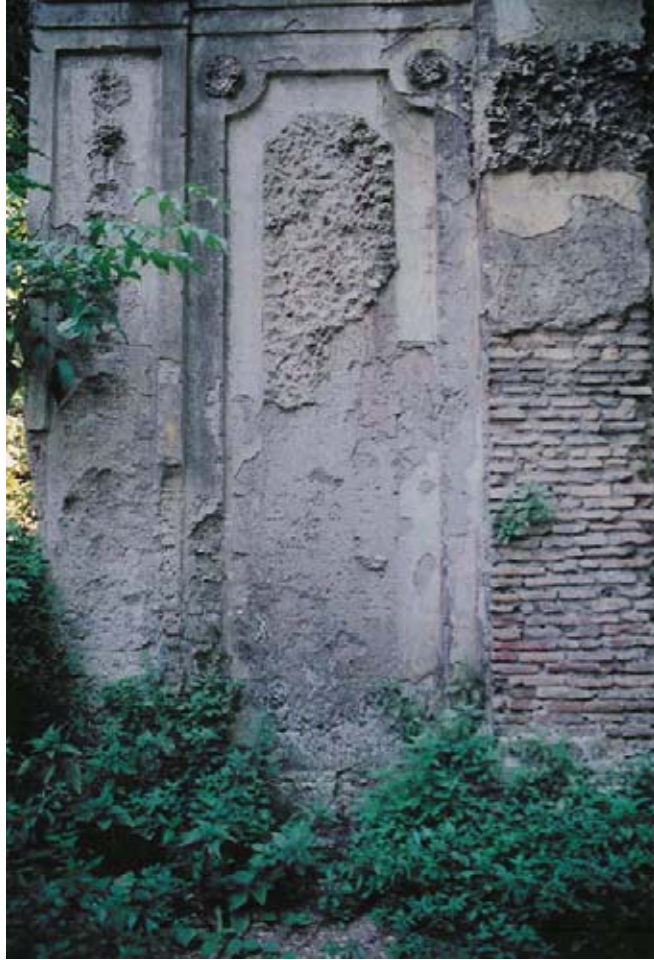
*Figure 7.5: Example of damage to spugne textured surface caused by roots; also visible on right is missing plaster and exposed brick. (Sardegna, 2002)*

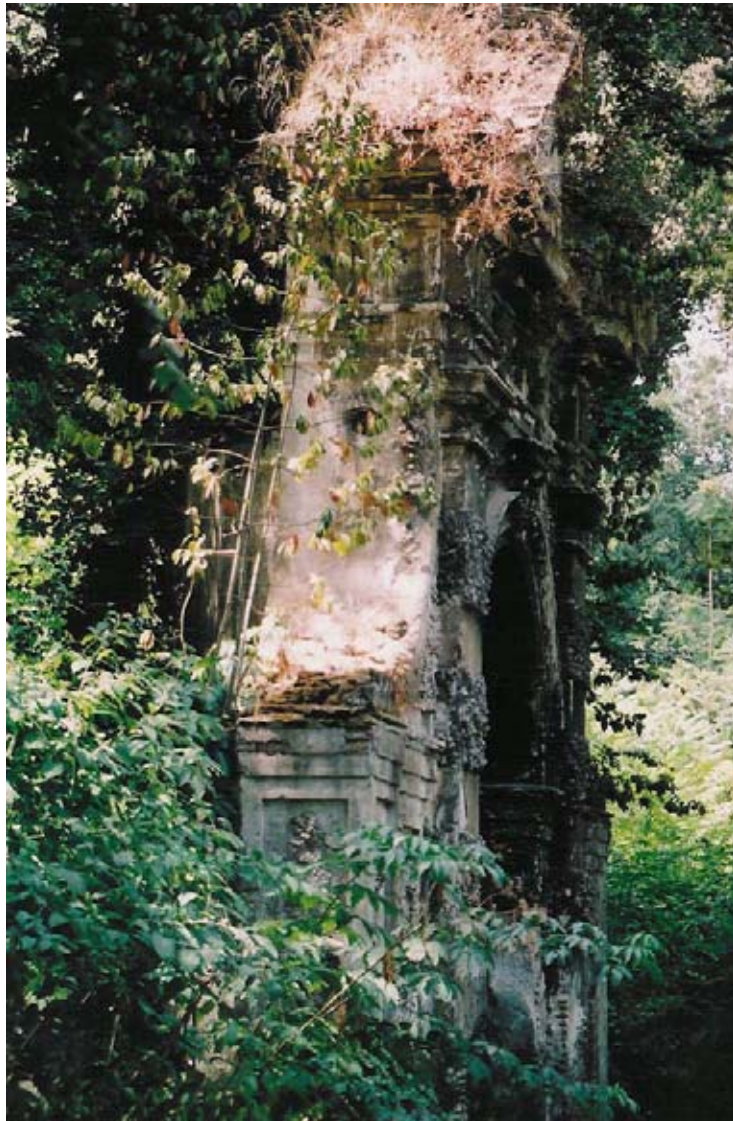
*Figure 7.6: Biogrowth on prospettiva. (Sardegna, 2002)*
