**A Comparative Study of Infrared Thermography (IRT) And Radio Frequency  
Identification (RFID) as Methods to Measure Moisture Levels in Adobe Walls**

A THESIS

Historic Preservation

MASTER OF SCIENCE IN HISTORIC PRESERVATION

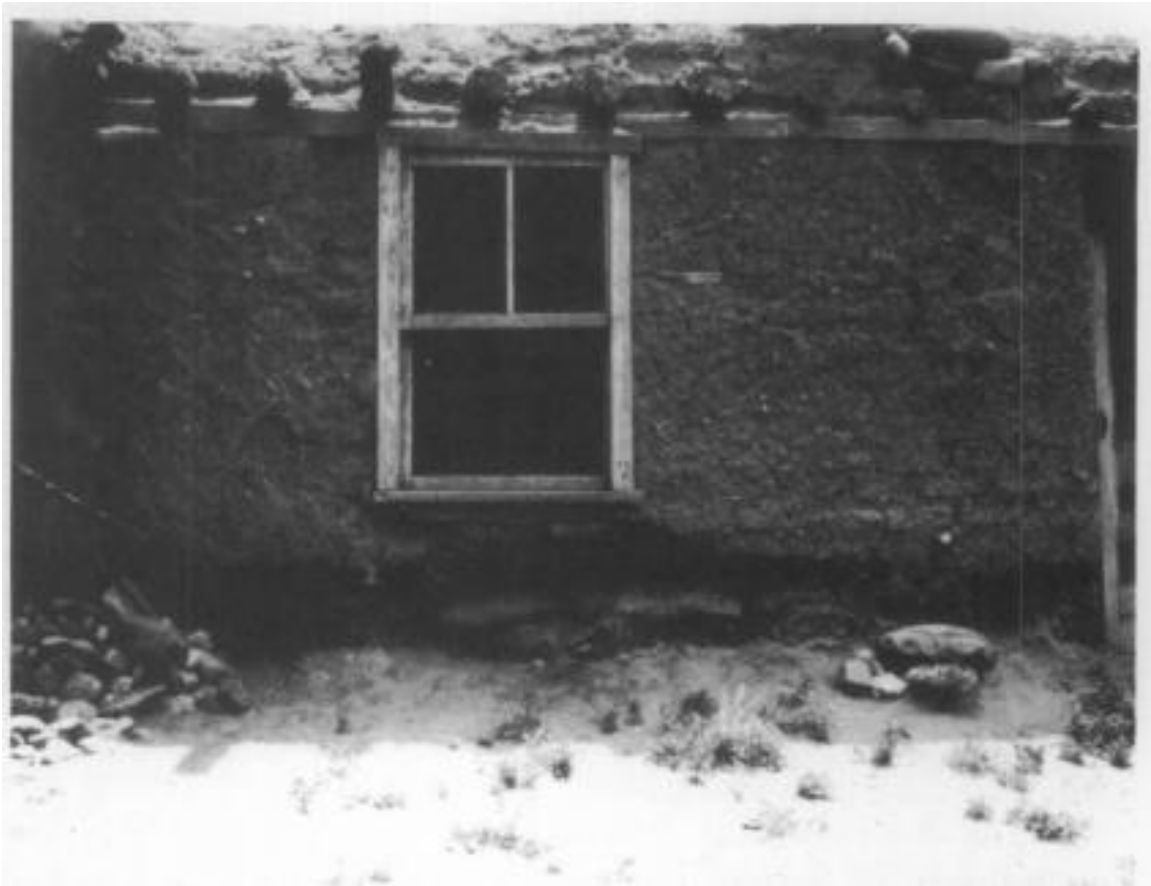
*Figure 3.2: base erosion. image from National Park Service*

Erosion and spalling at the base of walls is a very common form of damage observed in adobe structures. This damage is usually caused by the uptake of ground water by capillary action due to the absence of damp-proof membranes and courses at the foundation level<sup>16</sup>. Basal erosion can also be the result of the splashing of falling rainwater against the wall.

When moisture gets trapped into the base of an adobe wall, it fills the pores of the adobe and mortar, the latter usually also of clay and sand. Depending on the temperature and relative humidity conditions, moisture can evaporate, suffer freeze-thaw cycles, condense or deposit soluble salts within the adobe. Gradually, these mechanisms generate internal cracking and cause the material to lose cohesion and

disintegrate from the rest of the body; this in turn results in characteristic undercutting within the wet zone. The outcome of the deterioration processes is the formation of continuous deep horizontal fissures at the boundary between the ground or base and the adobe wall. The main problem arising from deterioration at the base of the wall is the loss of support under loading, which introduces load-bearing eccentricities into the structure and may eventually lead to overturning<sup>17</sup>.

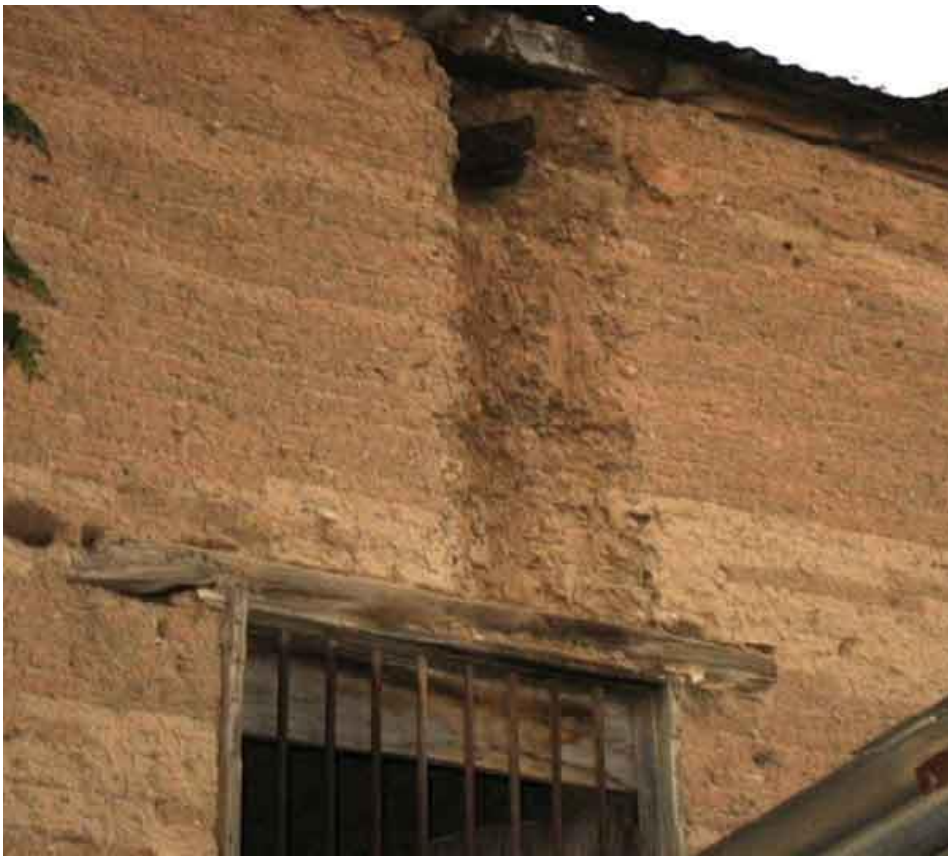
*Figure 3.3: deterioration at the top of adobe walls. Image available online*

When the upper part of an adobe structure is not adequately protected, water penetrates pre-existing micro-cracks formed immediately after drying and worsening over time from the material's expansion and contraction during repeated wetting and drying cycles. As in the case of basal erosion, excessive water will dissociate the clay binder from saturated areas causing mass disintegration, erosion and crack widening. Larger vertical structural cracking induced by seismic action, ground settlement or overloading, and flawed construction (e.g., unbonded wythes) offers a channel for liquid water entry. When water penetrates cracks the deterioration mechanisms described above occur. Deterioration at the top of adobe structures produces a saw-toothed effect laterally observed as serrations<sup>18</sup>. When no measures for the protection and repair of the affected areas are taken, the serrations gradually become wider and progress downwards. Ultimately, large vertical fissures and cracks are formed, and the wall appears as a series of pinnacles standing between eroded zones. As a result, the area of the masonry that can sustain loading is reduced and vertical planes of weakness develop. The latter negatively affects the resistance of the wall to out-of-plane loading and influences the seismic behavior of the structure as well. Deterioration at the top of adobe walls may also induce decay to surface coatings and may lead to the deformation of roof beams and window lintels. The removal of soil particles from the upper part of earthen structures is, in some cases, accentuated by wind action, as surfaces which have

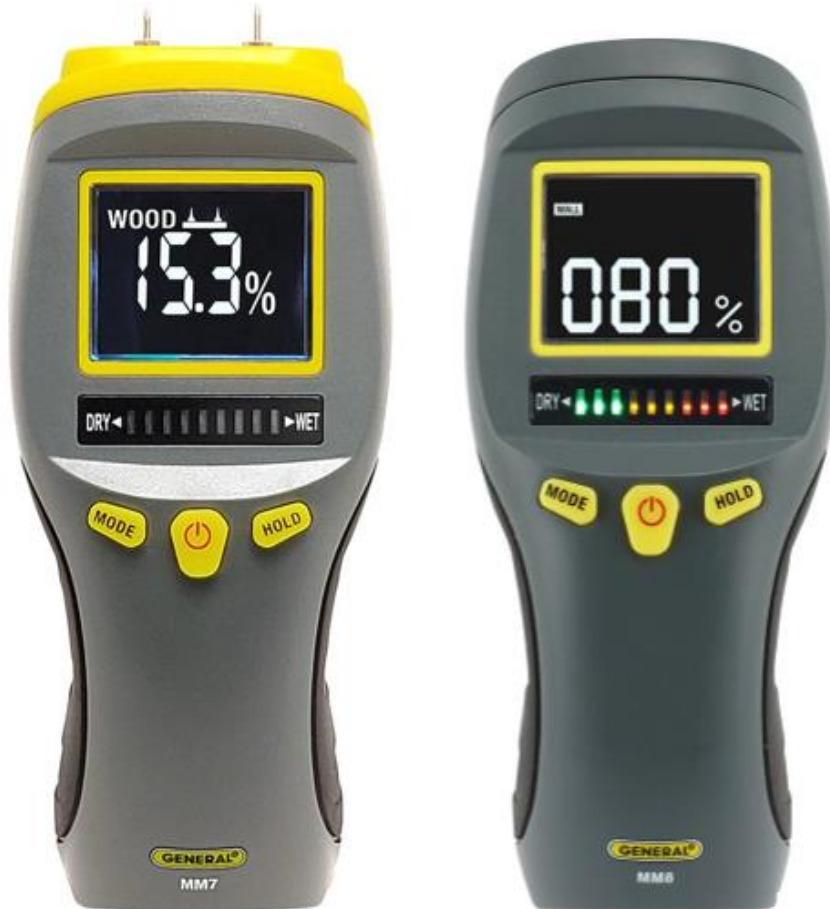
Figure 4.2 : pin-type moisture meter and pinless moisture meter. Image from home depot website.

Electrical properties of materials can be very sensitive to the presence of water; however, good sensor design is important. There are several limiting factors which should be considered before electrical techniques are used. Commercial devices are often calibrated to give an absolute moisture content reading for a generic material, such as timber; readings with other materials give comparative measurements, but

without further calibration they cannot give an accurate absolute measurement of the moisture content. Good electrical contact between the device and the material being measured is essential; for certain materials this can be problematic and give inconsistent measurements. The accuracy and quality of results from electrical techniques are also affected by local temperature variations, the presence of dissolved salts in the pore solution and the presence of metallic components close to the measurement point. Variations and uncertainty in the materials used within the construction also limit the accuracy of these techniques. Commercial microwave moisture meters are available which measure the dielectric constant of the medium in contact with the instrument and can assess the moisture content to a depth of 50 mm (2 inches) into a material.<sup>28</sup> Use of these devices is generally limited to concrete. An advantage is that calibration for different densities of materials is not necessary. However, the presence of metallic components and certain ceramics within the measurement volume can give misleading results.

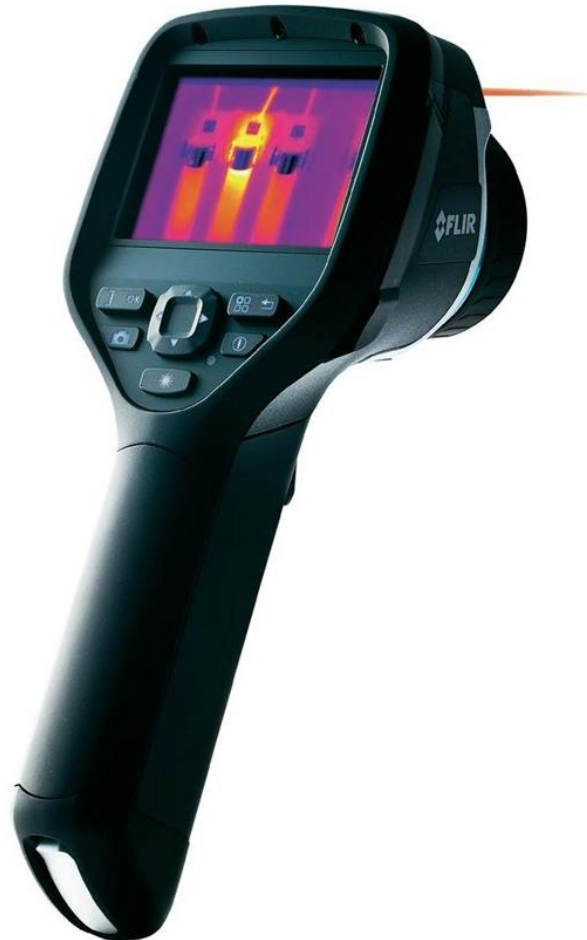
*Figure 5.1 : Flir E60 infrared camera.  
Image from FLIR website*

The infrared camera can detect small differences in surface temperatures by receiving the different amount of infrared energy that the surface emits. However, first we need to know out how the moisture content interacts with the surface temperature patterns. Basically, excess moisture creates surface temperature differences in five ways. The first is the most common and most visually apparent in water damage situations:

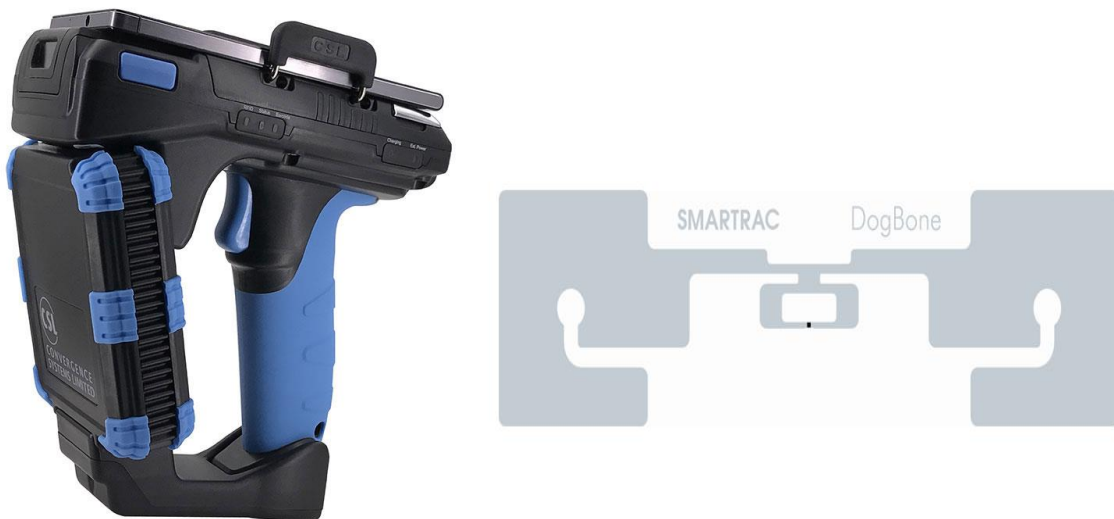
Figure 5.2: UHF RFID handheld sled reader and RFID tags. image from onvergence Systems Limited website and smartrac website.

The RFID reader used in this experiment was a CS108 Convergence Systems Limited sled handheld reader which is the longest read range UHF RFID handheld sled reader in the world. The read range of this reader is up to 20 meters with linear polarized antenna (tag and environment dependent) and the frequency range is 902-928 MHz. The accuracy of the signal strength the reader receives is unknown but from the preliminary test, the accuracy is not high, and the received signal was easily affected by the environment. Operating ambient temperature ranges were from  $-20^{\circ}\text{C}$  to  $+55^{\circ}\text{C}$  ( $-4^{\circ}\text{F}$  to  $+131^{\circ}\text{F}$ ). The reader works with all Android phones or iPhones, so the data can be viewed on phone and real-time transmitted to a laptop.

The tags used were manufactured by Smartrac<sup>®</sup> and are classified as EPC Class 1 Gen 2, a UHF wireless communication standard. All tags in this class can communicate with any commercially available transceiver of the same class. The tags measure approximately 3.8" by 1.1".

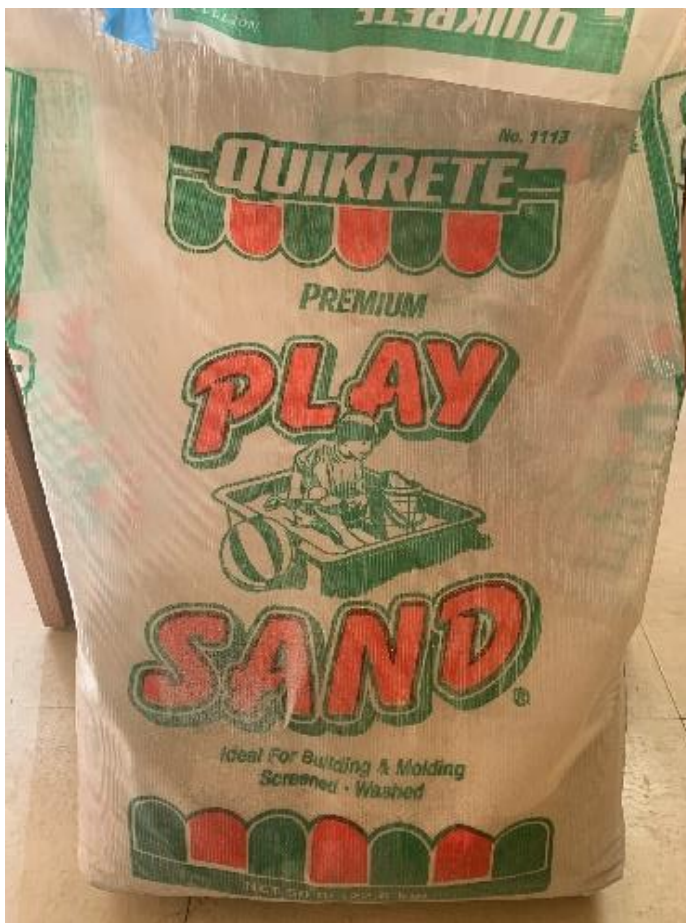
Figure 6.1: The brown sand

The selected sand type was a commercial builder's sand 'Quikrete' brown play sand, which is a specially graded fine quartzitic sand that has been washed, dried and screened. This sand displays high permeability, high porosity when packed and is easy to dry making it a desirable test medium for this investigation to provide stable calibration data.

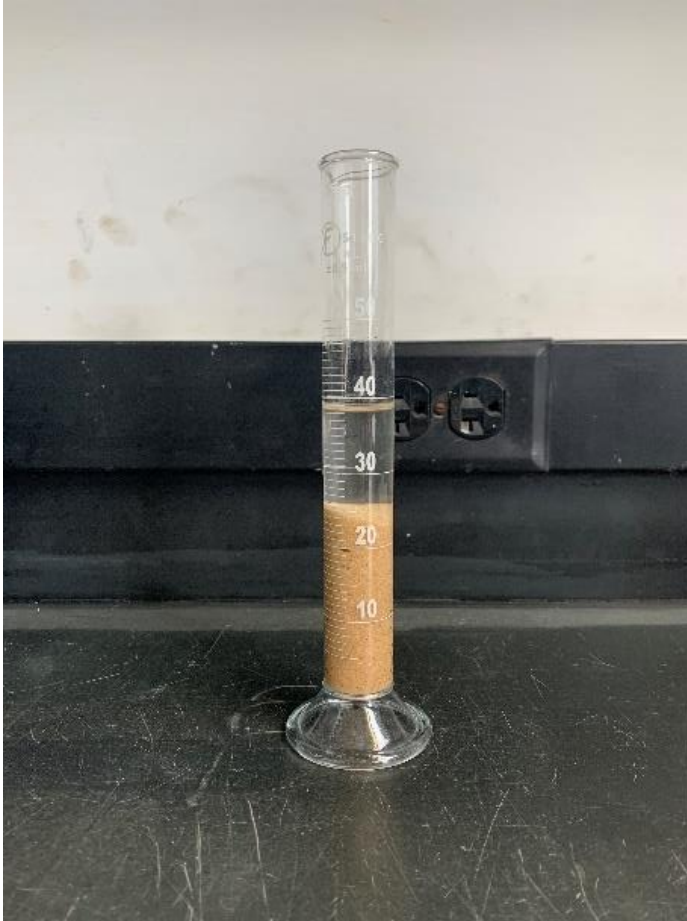
The apparent density of the brown sand can be calculated by conducting volumetric and gravimetric analyses of a measured sample. The real density of the sample was determined using a fluid displacement method. The apparent and real densities of each sample were compared to determine the porosity of various granular beds.

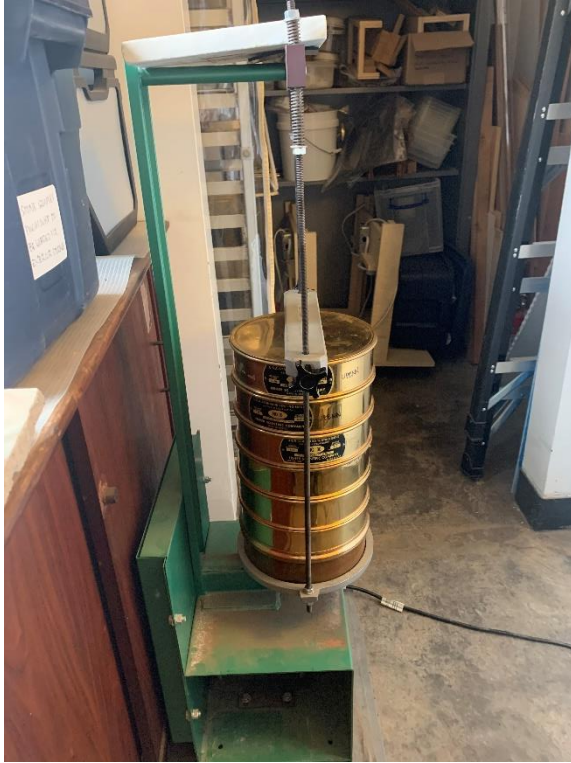
Figure 6.3: Sieve machine.

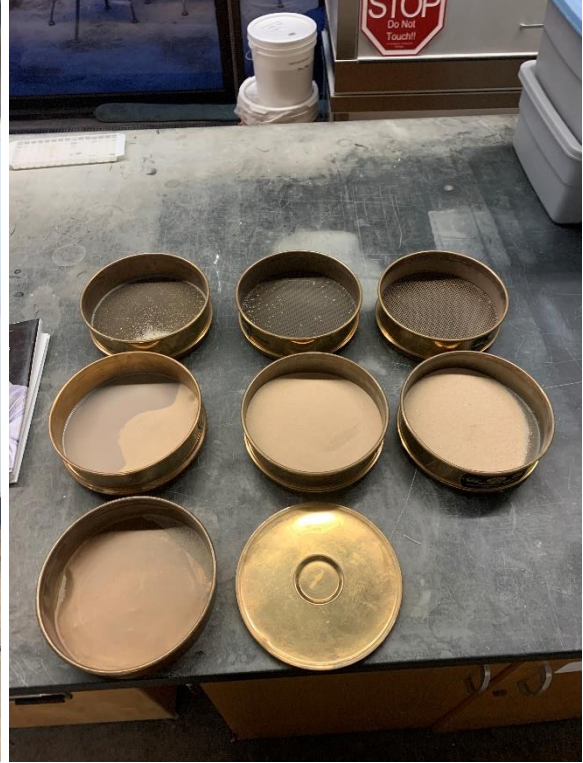
Figure 6.4: Sieve result

Sieve number	Screen size (um)	Msx (g)	%Msx	%Mpt
8	2360	0	0	100
16	1180	1.24	0.1	100
30	600	20.67	1.6	99.9
50	300	456.03	35.2	98.3
100	150	703.99	54.4	63.1
200	75	101.95	7.9	8.7
Pan	1	10.06	0.8	0.8

This brown sand is a very fine sand of small grain sizes mainly varying from 150-300  $\mu\text{m}$ . There is almost no grain fraction larger than 600  $\mu\text{m}$  because the passing percentage of the first two sieves are both 100%.

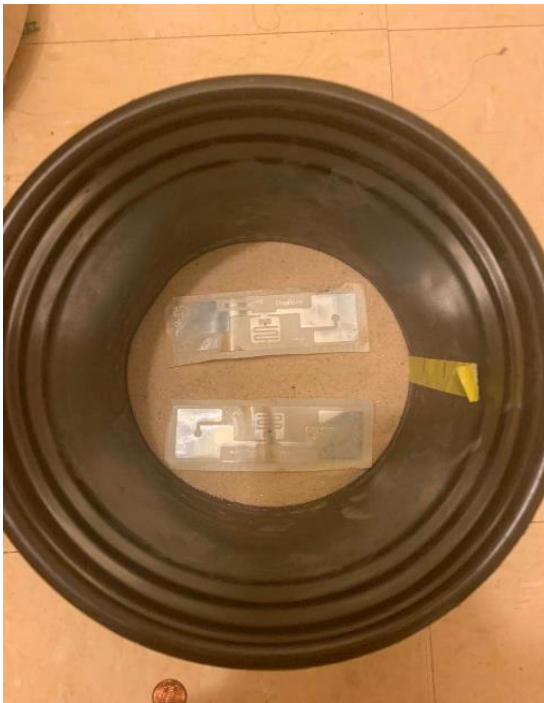
Figure 6.6 : insert RFID tags

Therefore, in the preliminary test, RFID tags were embedded at three different depths: 1 inch, 2 inches and 3 inches from the top surface. Before embedment, all tags were renamed and checked to ensure they worked. After assembling the sample, the sample was fully saturated (until water flowed out from the bottom drainage hole). The result showed that the 2 tags at a 3 inch depth could not be read while the tags at 1 and 2 inches were readable. Therefore, tags were placed at a maximum distance of 2" from the top of the sample

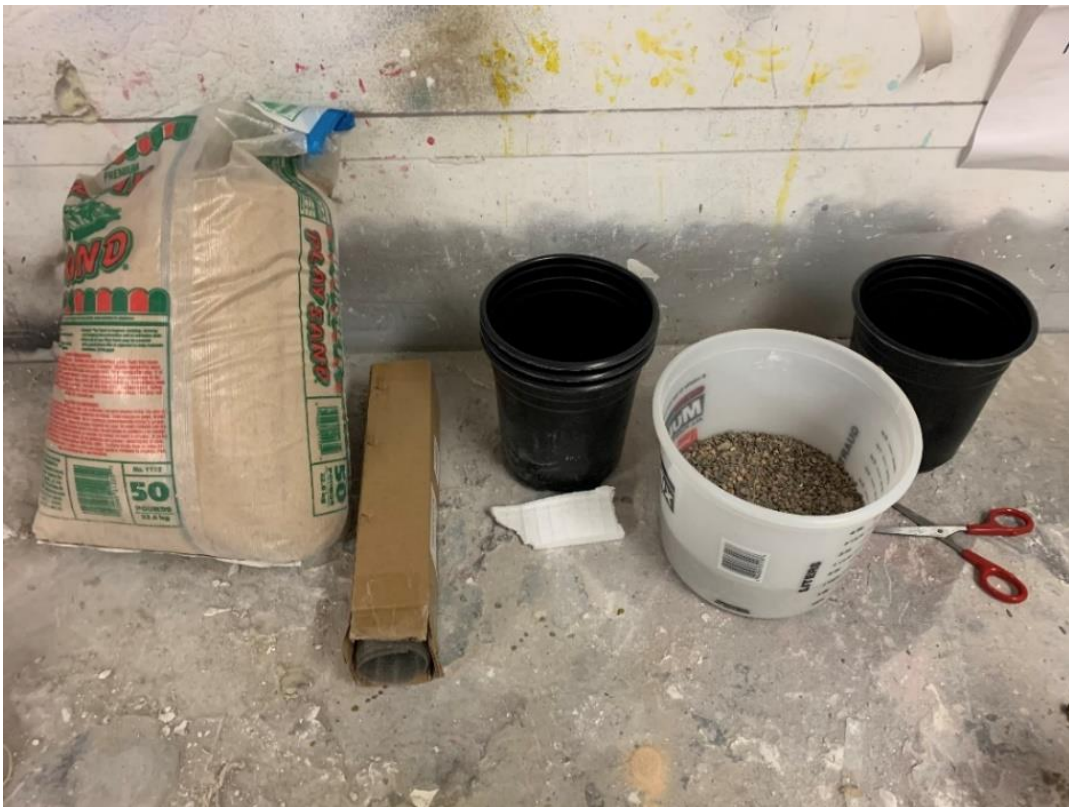
Figure 6.7: Test materials

Sample components (from left to right):

1. Quikrete brown play sand.
2. 304 Stainless Steel Woven Mesh Sheet (ASTM E2016-06)
3. Plastic containers
4. Gravel

First, a layer of steel mesh was put on the bottom of the plastic containers to prevent the gravel from flowing from the drainage hole. Afterwards, one-inch of gravel was laid on top of the metal mesh to enhance drainage . Another layer of steel mesh was put on the gravel layer to contain the sand above. Four inches of sand was then laid on the top and two RFID tags were embedded two inches from the top). The containers were tapped repeatedly to insure uniform compaction of the sand. This scheme was designed to produce five samples in the same experiment. One sample was used as a control group (dry) and the others were tested -all wet using IRT, RFID and gravimetric analysis. Because the samples were not completely dry after they were assembled, weighing and labeling the samples was postponed after oven dry for 48 hours.

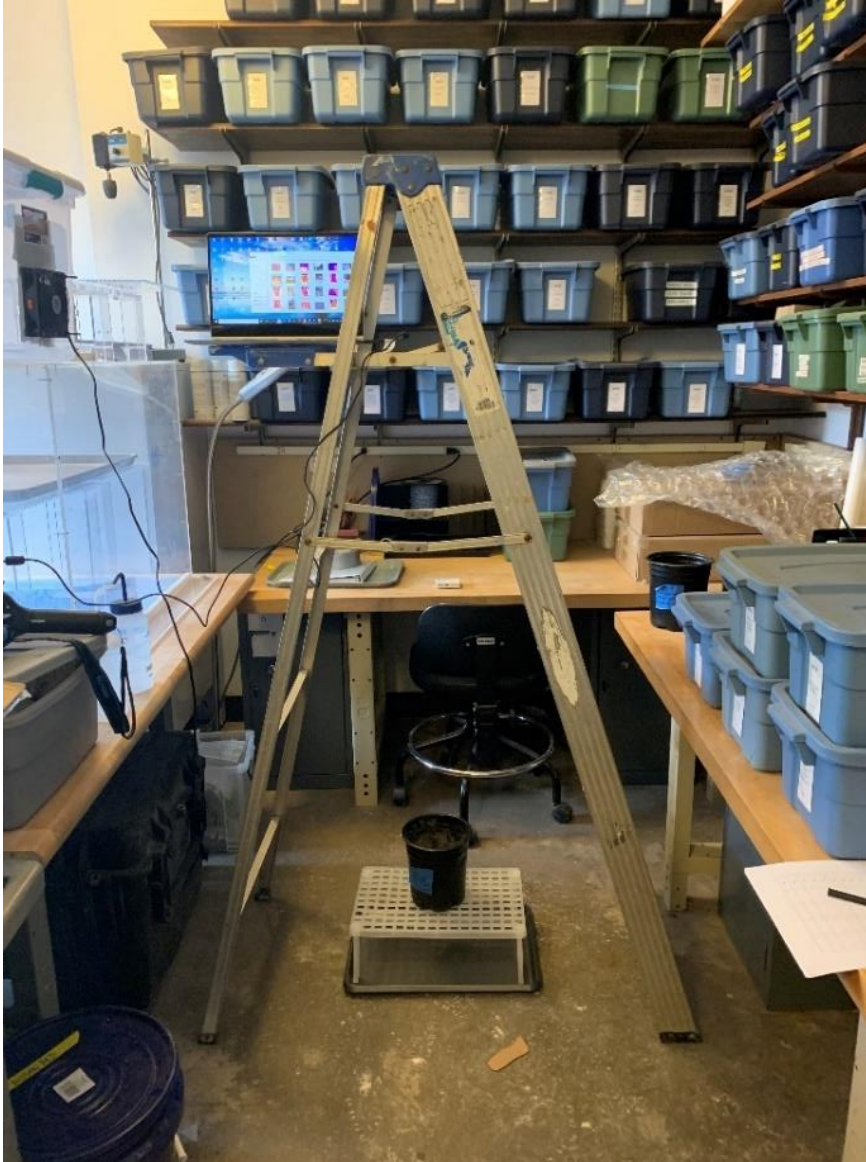
*Figure 6.9: Test set-up*

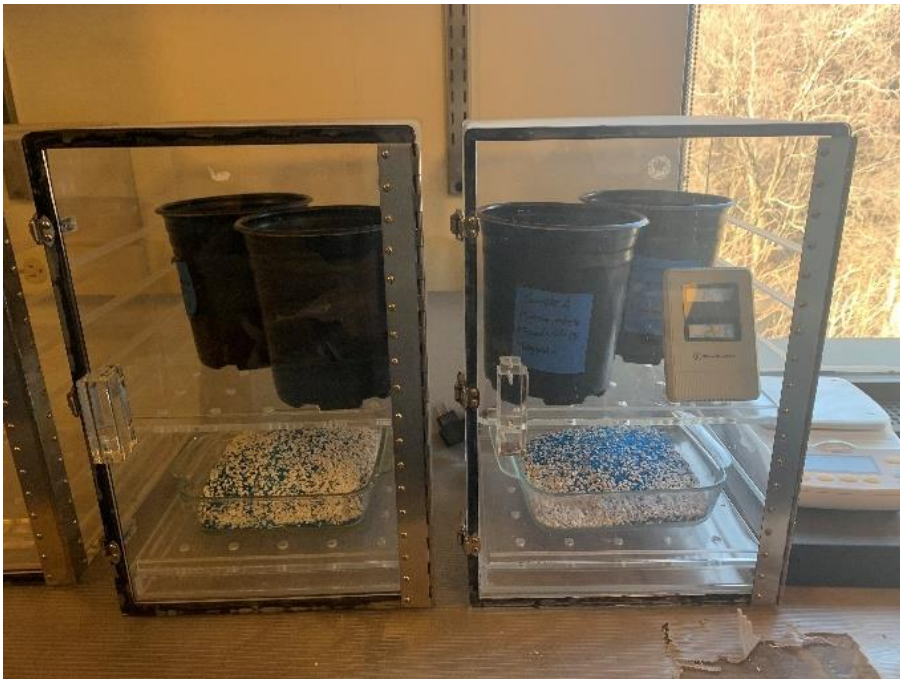
*Figure 6.10: samples in drying cases.*

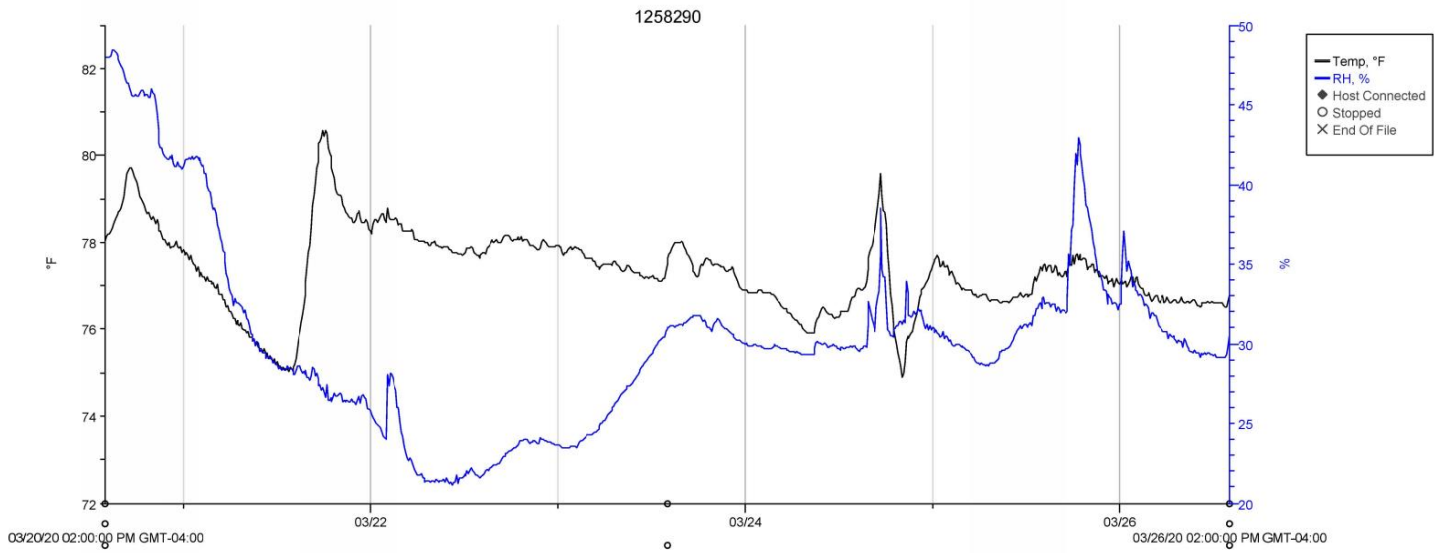
### The environmental temperature and RH% between 03/20/2020 to 03/26/2020

The second round of tests started on 20th March. Thermal images were taken between 3/20/20 to 3/26/20 which resulted in 8 sets of data for room conditions that ranged from 75.89°F- 80.58°F and 21.73%- 47.88%RH. Due to the outbreak of COVID-19, the university and laboratory were shut down. Therefore, the second-round of tests was done at another location with different environmental conditions with the first test.

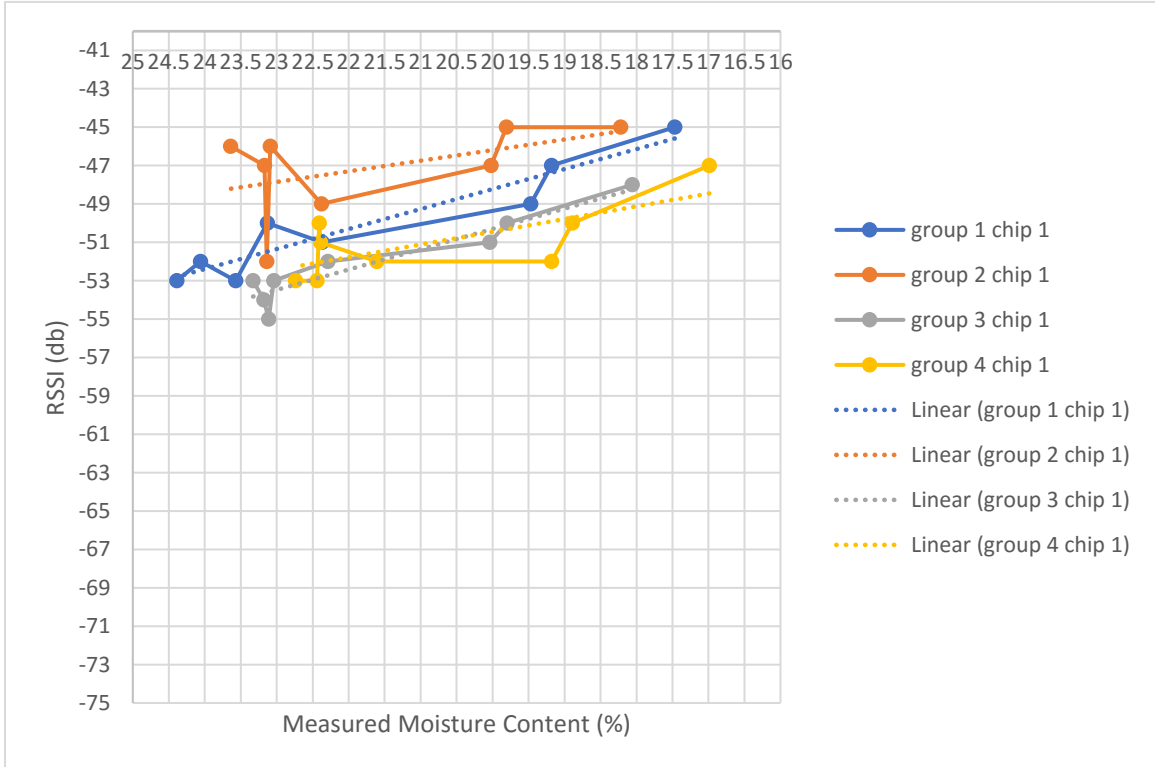
Figure 7.4.5: Graphical analysis of RSSI data of chip 1 from 1st-round test.

The relationship between the measured moisture content and the received signal strength from embedded tags was analyzed. Each sample was embedded with 2 RFID tags. In Figure 7.4.5, the received signal strength data of chip 1 in each sample from the first-round test is presented. In Figure 7.4.6 the received signal strength data of chip 2 from the first-round test is presented. Next, in Figure 7.4.7, the received signal strength data of chip 1 from the second-round test is presented. In Figure 7.4.8 the received signal strength data of chip 1 from the second-round test is presented.

Firstly, all groups in the two rounds of tests show a linear relationship between RSSI and measured moisture content. However, there is a significant difference of slope between the 2 tags which were embedded for each sample. This may be due to mutual interference between the two tags, especially when the sample was saturated, and the tags' signals were weak. When the sample was almost dry, the signal was strong enough for both tags to signal almost the same.

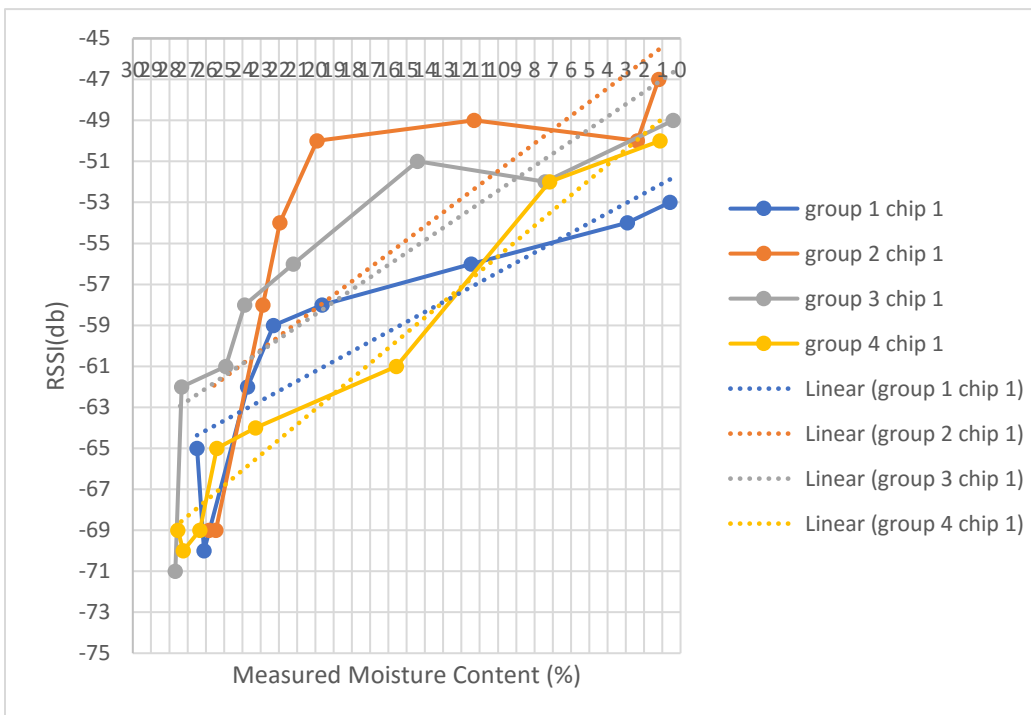
Figure 7.4.7: Graphical analysis of RSSI data of chip 1 from second-round test.

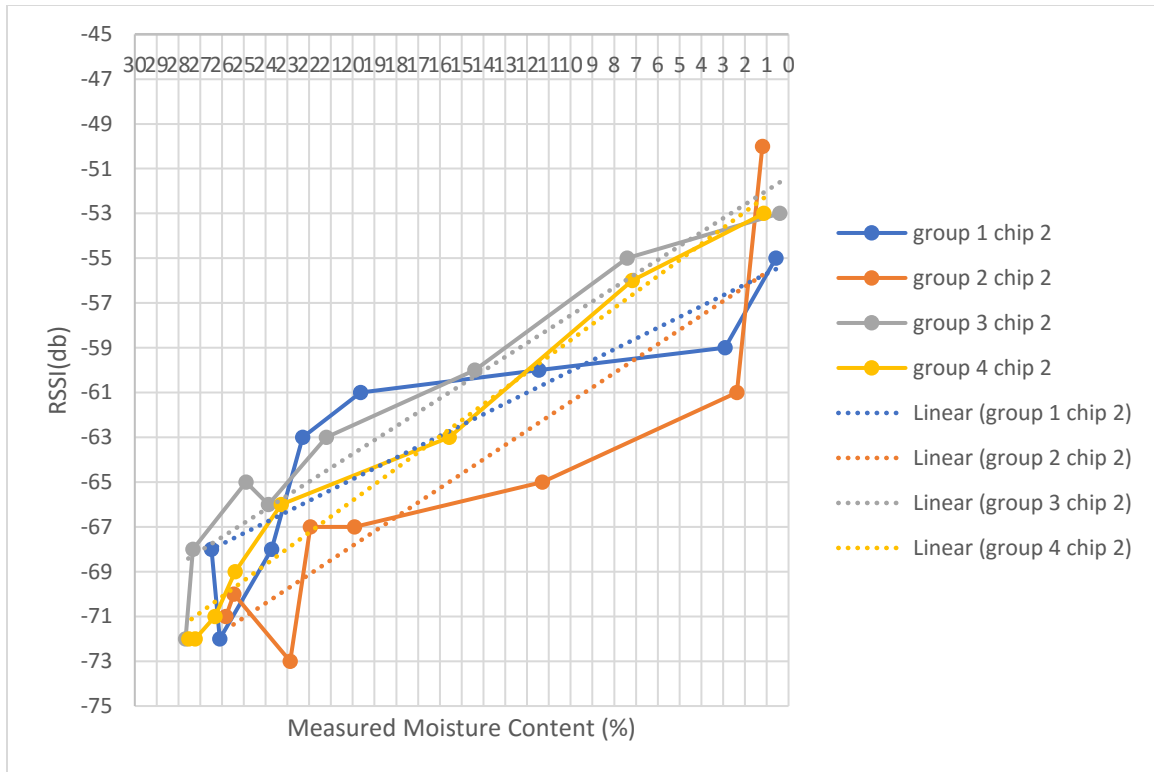
Figure 7.4.8: Graphical analysis of RSSI data of chip 2 from second-round test.
