J Vet Intern Med 2003;17:713–714

First Pacemaker in a Dog: A Historical Note

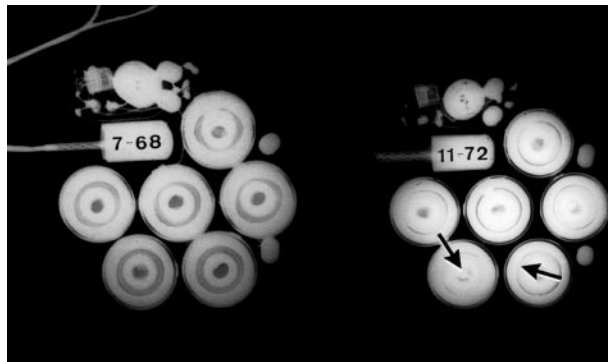
Fig 2. Radiographs of pacemaker in situ 15 months after implantation (left) and 5½ years after implantation (right). The radiolucent central cores and insulating rings between electrode cylinders in the batteries became filled by corrosion material (arrows) leading to battery failure.

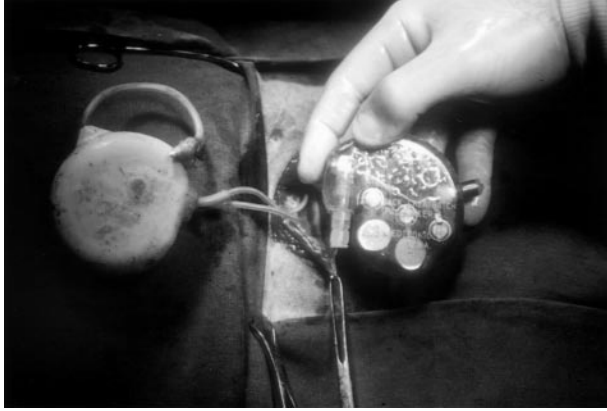
Fig 4. Photograph at surgery. The silicone-coated pacemaker on the left was removed easily from its fibrous pocket and replaced by the urethane-coated replacement pacemaker.

The dog (Fig 3) was still in good physical condition at 15½ years of age, and surgery was performed to replace the pacemaker. No adhesions were observed on the silicone-covered pulse generator, and it was lifted easily out of a connective tissue pocket (Fig 4). A temporary pacemaker was not available and cardiac arrest occurred as expected when the pacemaker was disconnected (Fig 5). The heart stopped for 22 seconds before the 1st ventricular escape beat occurred. A 2nd escape beat occurred 5.5 seconds later and was followed by subsequent beats after progressively shorter intervals stabilizing at 25 beats/min within the next 30 seconds. The replacement pacemaker was attached to the existing leads and placed in the old generator pocket after cutting small holes in the ventral aspect of the fibrous pocket to

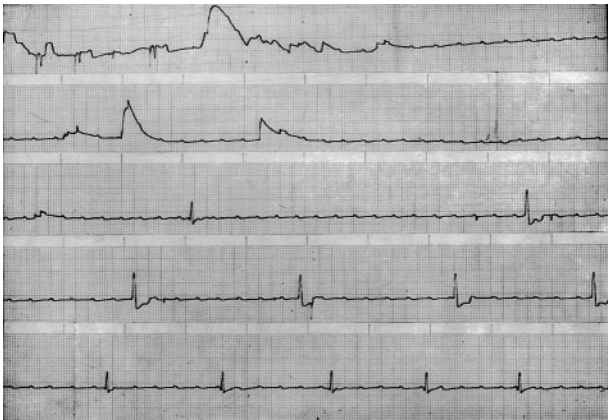
Fig 5. Continuous electrocardiogram recording when the pacemaker leads were disconnected. The 1st ventricular escape beat occurred after a 22-second period of arrest, followed by a 2nd beat in 5.5 seconds and progressively more rapid ventricular beats (25 mm/s, 1 cm/mV).

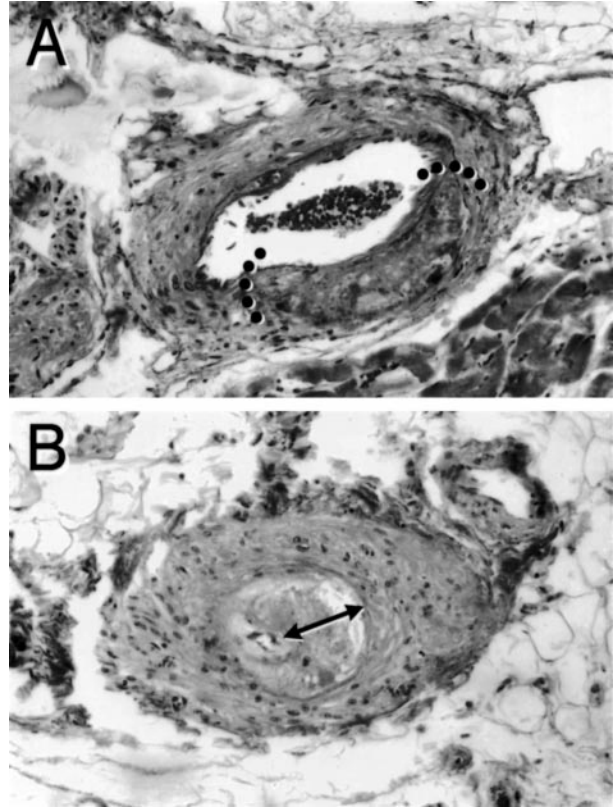
Fig 6. (A) Small coronary artery in the basilar portion of the interventricular septum. Note the crescent-shaped area of medial necrosis between dotted lines. (B) Coronary arteriole in the interventricular septum near the bundle of His. Note the extensive intimal plaque with necrosis (arrows), which nearly occludes the vessel. Pentachrome stain 100 \times .

almost completely occluded (Fig 6). Although at least 6 years had elapsed since the onset of heart block, it is probable that coronary artery disease and ischemia or infarction of the A-V node was the cause of complete heart block in this dog.
