CLEANING METHODS FOR THE REMOVAL OF LIMEWASH  
FROM PAINTED PLASTER SURFACES:  
UTILIZING ION EXCHANGE RESINS ON THE INTERIOR ARCHITECTURAL FINISHES  
OF THE CAPILLA DE NUESTRA SEÑORA DEL ROSARIO IN  
IGLESIA SAN JOSÉ, IN SAN JUAN, PUERTO RICO

A THESIS

Historic Preservation

MASTER OF SCIENCE IN HISTORIC PRESERVATION

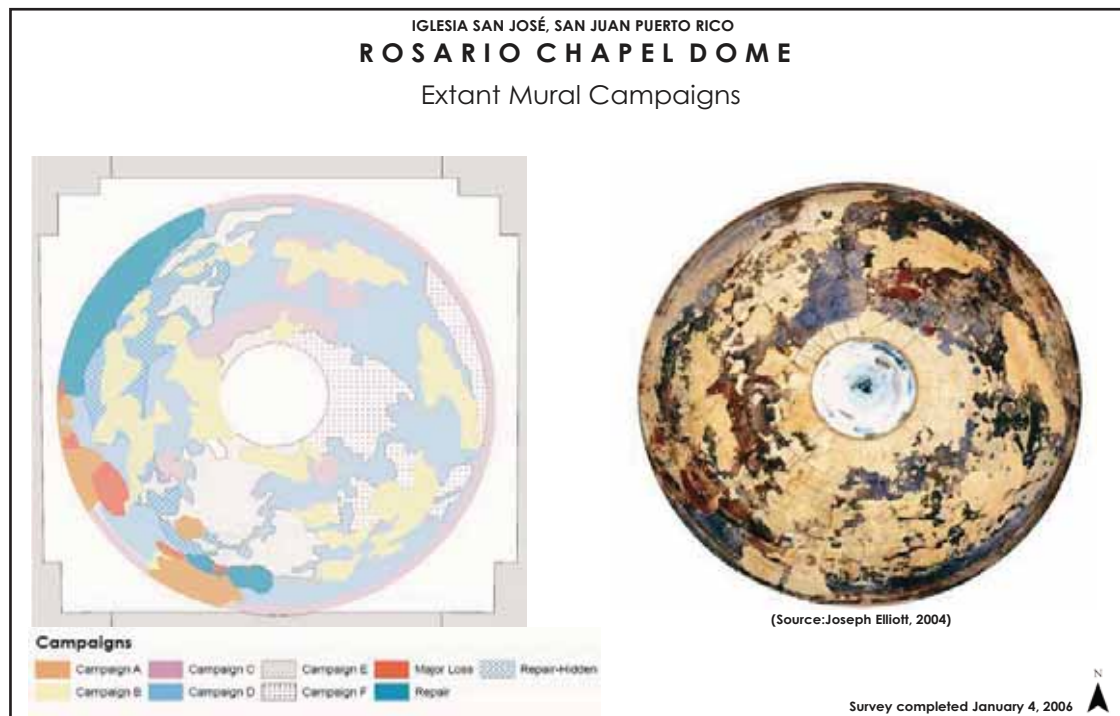
**Figure 2.4: Painting campaign map for Rosario Chapel dome (Source: Silva, 113).**

intact of the decorative layers. This is likely due to the fact that the design layer was applied directly onto the lime plaster substrate, and that it was protected for years under lime-washes and later painting. These superimposed campaigns became heavily damaged and fragmented from salts, biogrowth, and loss (see fig. 2.4).<sup>14</sup>

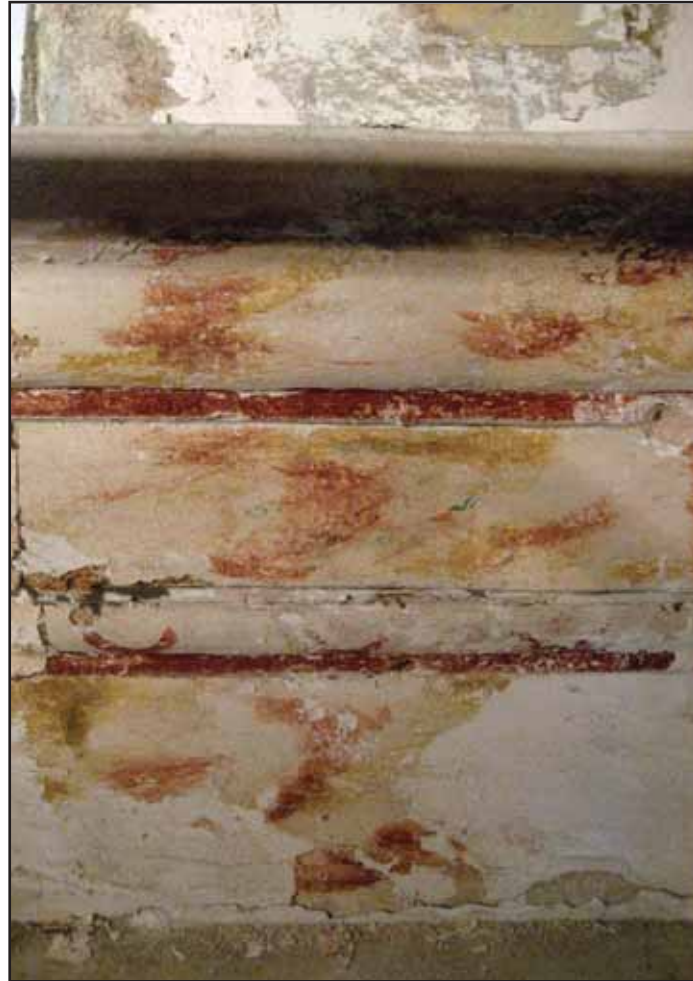
**Figure 2.6: Faux marbling on sanctuary cornice  
(Source: Johnston and Silva, 17).**

The faux marbling scheme appears on the original chapel cornice (see fig. 2.6). The painters used red ochre, yellow ochre, and green pigments in a freehand technique. Two fillets were painted in solid dark red and the cyma reversa received the same pigment in a pattern of semicircles.<sup>17</sup>

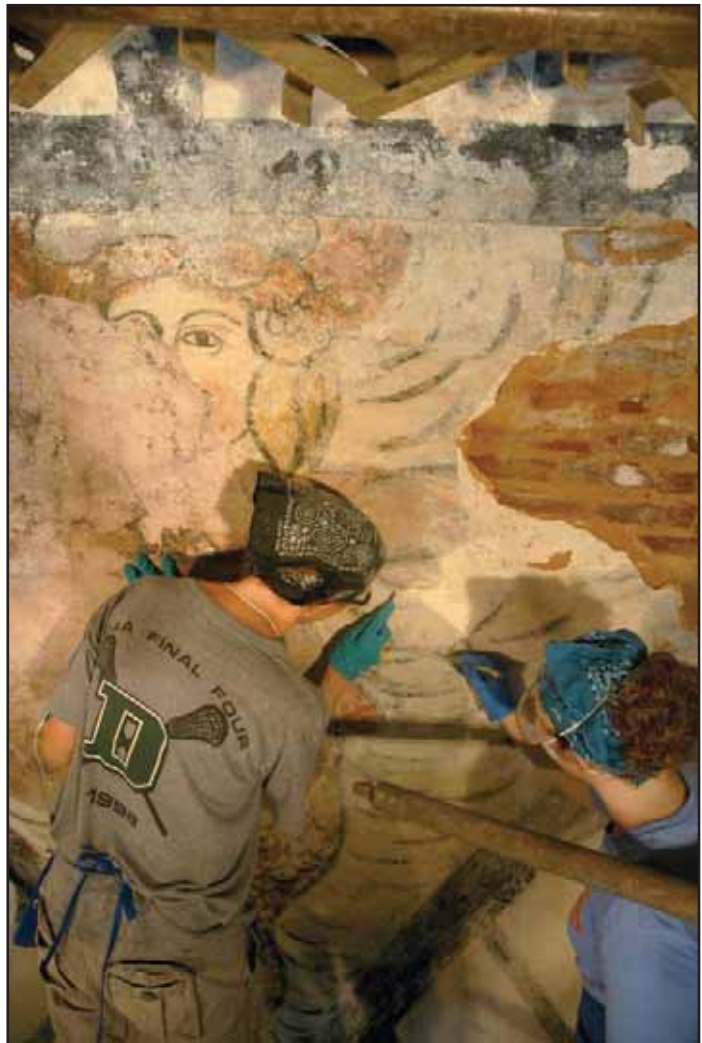
**Figure 3.2: Mechanical cleaning of *la sirena* in Rosario Chapel (Source: Johnston and Silva, 96).**

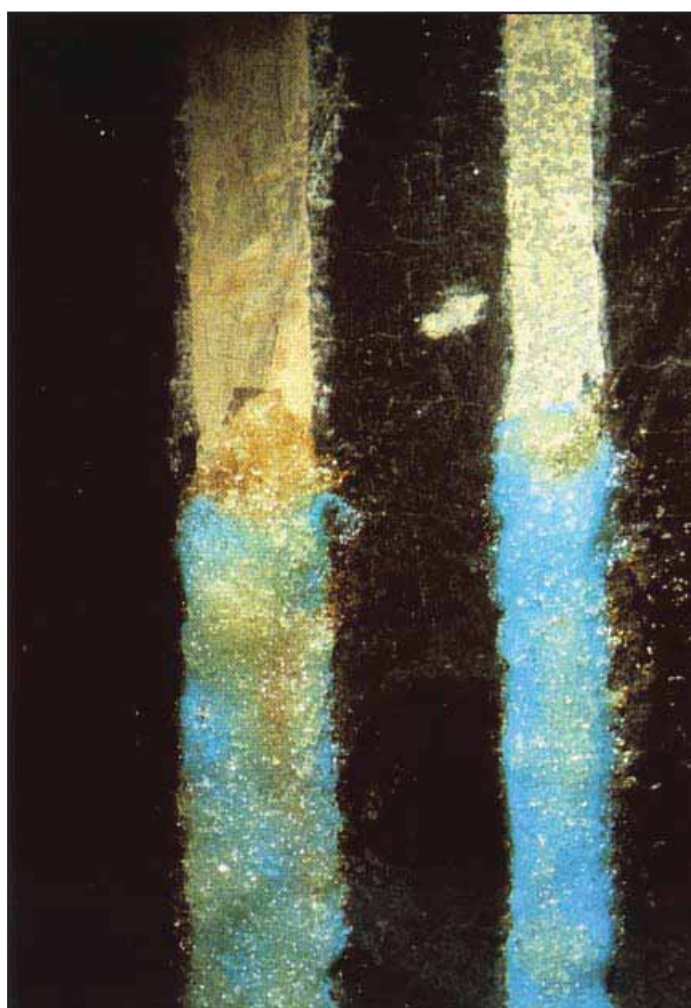
**Figure 4.5: Detail of painting containing azurite. Upper part undergoing ion exchange resin treatment, lower part after removal of dried resin (Source: Heimberg, color plate).**

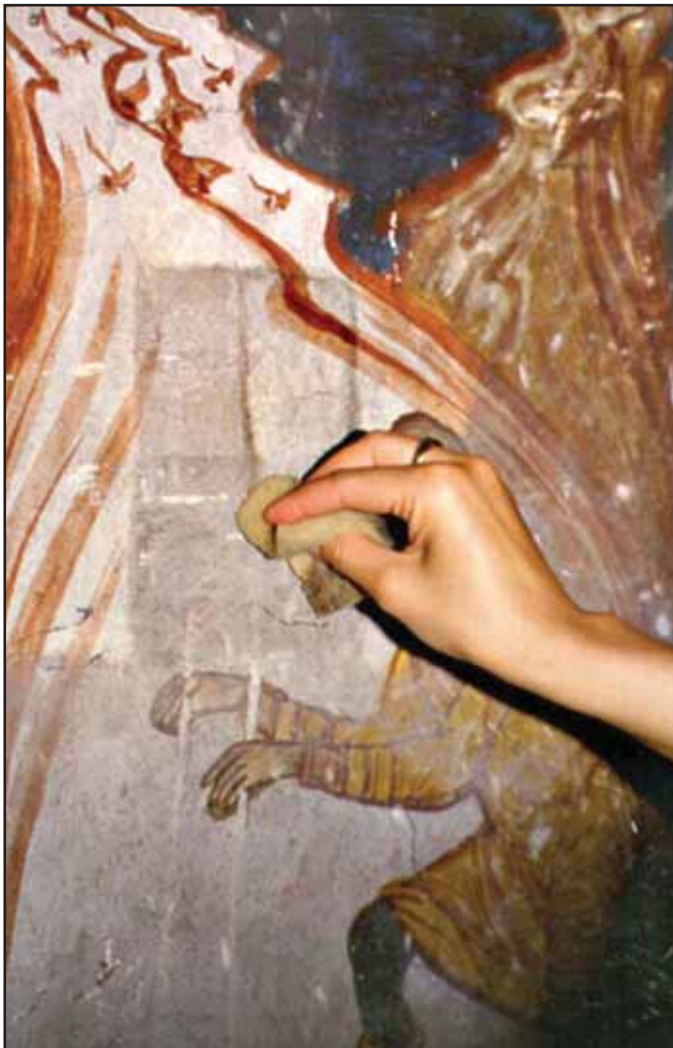
**Figure 4.6: Cleaning mural with ion exchange resin through Japanese paper (Source: Metaneira).**

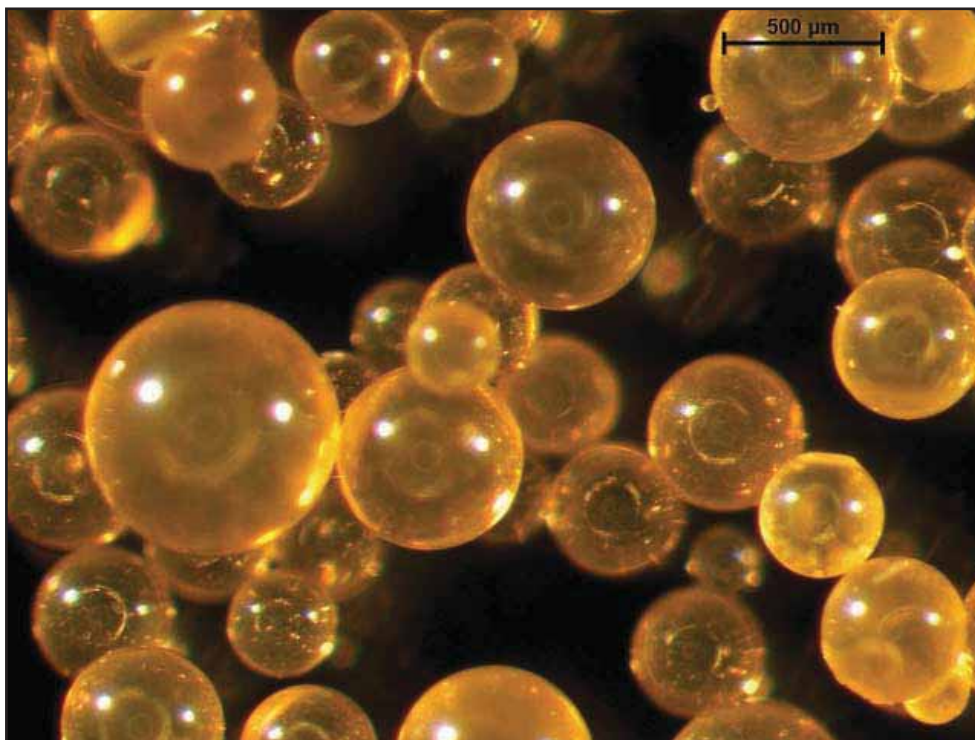
**Figure 5.1: Lewatit CNP 80, viewed at 115x magnification on a Leica MZ16 stereomicroscope, with quartz-halogen illumination using a Leica KL2500 LCD, 3200 K, and additional Volpi Intralux 5000-1 dual gooseneck fiber optics (Source: C. Smith, 2009).**

lic acid functional groups. It is shipped in hydrogen ( $H^+$ ) form. The matrix is a crosslinked polyacrylate. It is sold as solid, opaque yellow-white beads, U.S. mesh 12-50 (see fig. 5.1).<sup>14</sup> It releases a slight naphthalene odor. It poses little or no hazard if spilled, as it does not contain any hazardous components, however the beads may make surfaces slippery. The resin is slightly flammable. It is safe for operators to handle, although it may cause mechanical irritation if introduced into the eyes. Even so, it is not expected to cause any adverse acute or chronic health effects. It is not carcinogenic. Its transportation is non-regulated. The pH for CNP 80 is neutral to slightly acidic.<sup>15</sup>

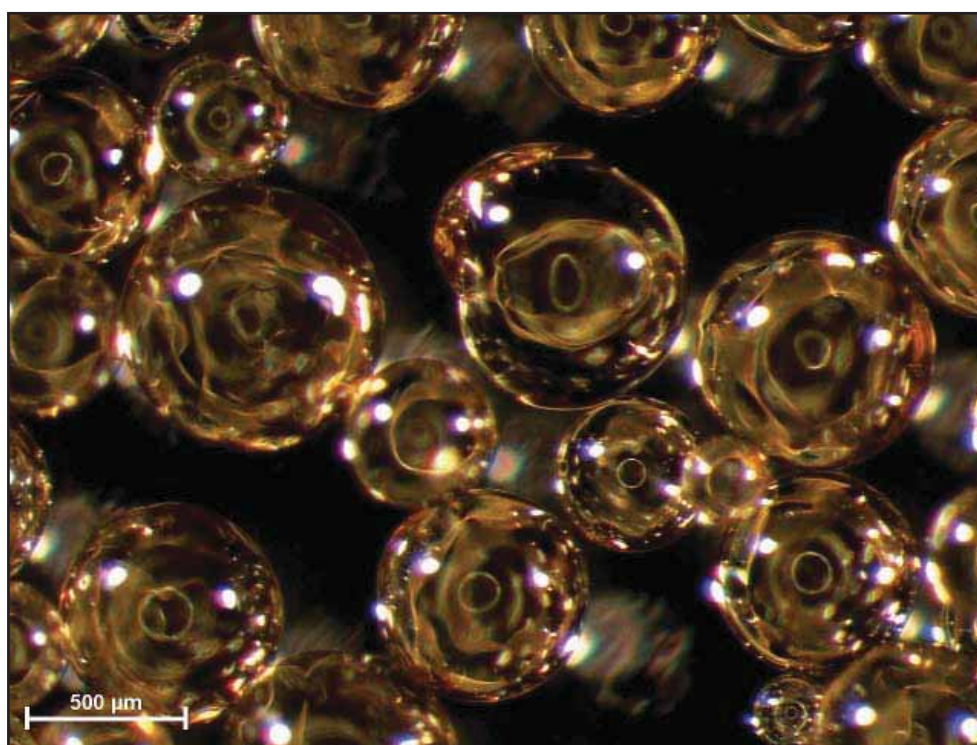
**Figure 5.4: USF C-211 H, viewed at 115x magnification on a Leica MZ16 stereomicroscope, with quartz-halogen illumination using a Leica KL2500 LCD, 3200 K, and additional Volpi Intralux 5000-1 dual gooseneck fiber optics (Source: C. Smith, 2009).**

USF C-211 H is the proprietary name of a high capacity, eight-percent cross-linked gel strong acid cation exchange resin manufactured by Siemens Water Technologies Corp. Chemically it consists of a sulfonated copolymer matrix of styrene and divinylbenzene with sulfonic acid functional groups. It is shipped in hydrogen (H<sup>+</sup>) form.<sup>32</sup> It is sold as solid spherical beads (see fig. 5.4). It releases either no odor or a slight amine odor. It poses little or no hazard if spilled, however the beads may make surfaces slippery. It is safe for operators to handle; it does not have any severe acute or chronic health problems associated with it. C-211 H can temporarily cause a mild irritation and redness of the skin, and it may cause se-

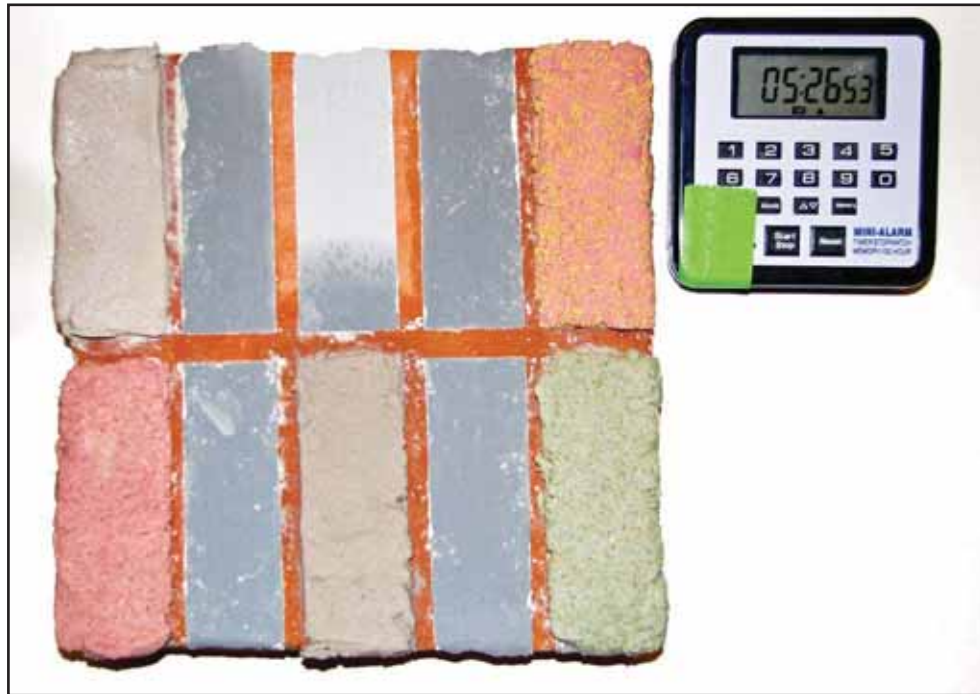
Figure 5.7: Tile covered with fresh resin formulations. Counterclockwise from bottom: C-211 H, control, C-211 Na, CNP 80, TP 207 (Source: C. Smith, 2009).
