**A PROGRAM OF INVESTIGATION AND LABORATORY RESEARCH OF
ACRYLIC-MODIFIED EARTHEN MORTAR USED AT THREE PREHISTORIC
PUEBLOAN SITES**

Robert Lyle Hartzler

**Presented to the Faculties of the University of Pennsylvania in Partial Fulfillment of the
Requirements for the Degree of Master of Science**

1996

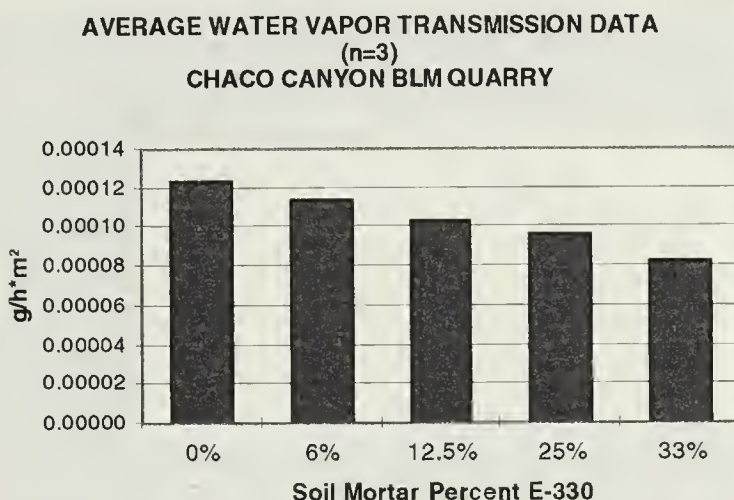
Figure 12. With increasing amounts of Rhoplex E-330 in the Chaco Canyon BLM Quarry earthen mortar samples, the ability to transmit water vapor was impaired. The vertical axis of the graph is water vapor passing through the sample in grams/hour·m². This performance was typical of the amended soils; more E-330, less permeability.

As anticipated, the WVT rate decreased as the amount of polymer in the sample increased. Two slight anomalies were recorded in the Aztec Ruins data and the New Mexico adobe soil. In each case one set of earthen mortar samples did not follow the expected trend. More than likely, however, these differences were due to inconsistencies of the soil samples.

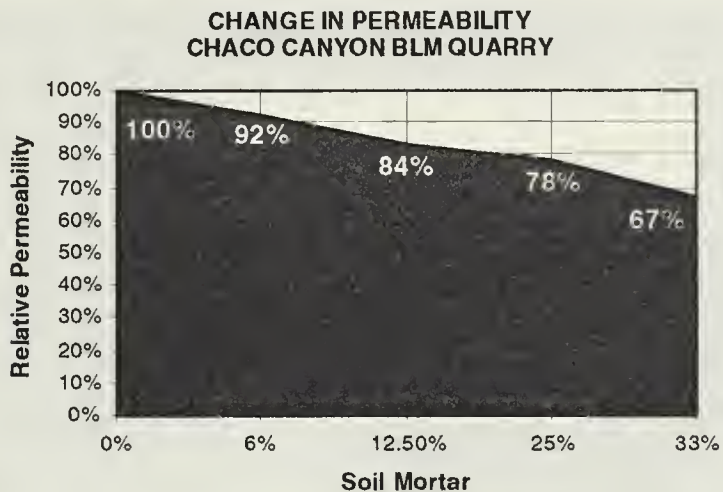
Figure 13. Assuming the unamended (0% E-330) Chaco Canyon BLM Quarry earthen mortar sample is as permeable as this soil ever is, this graph compares the relative permeability of the amended samples of the same soil. In this example, the 33% E-330 sample is only 67% as permeable as the unamended sample.

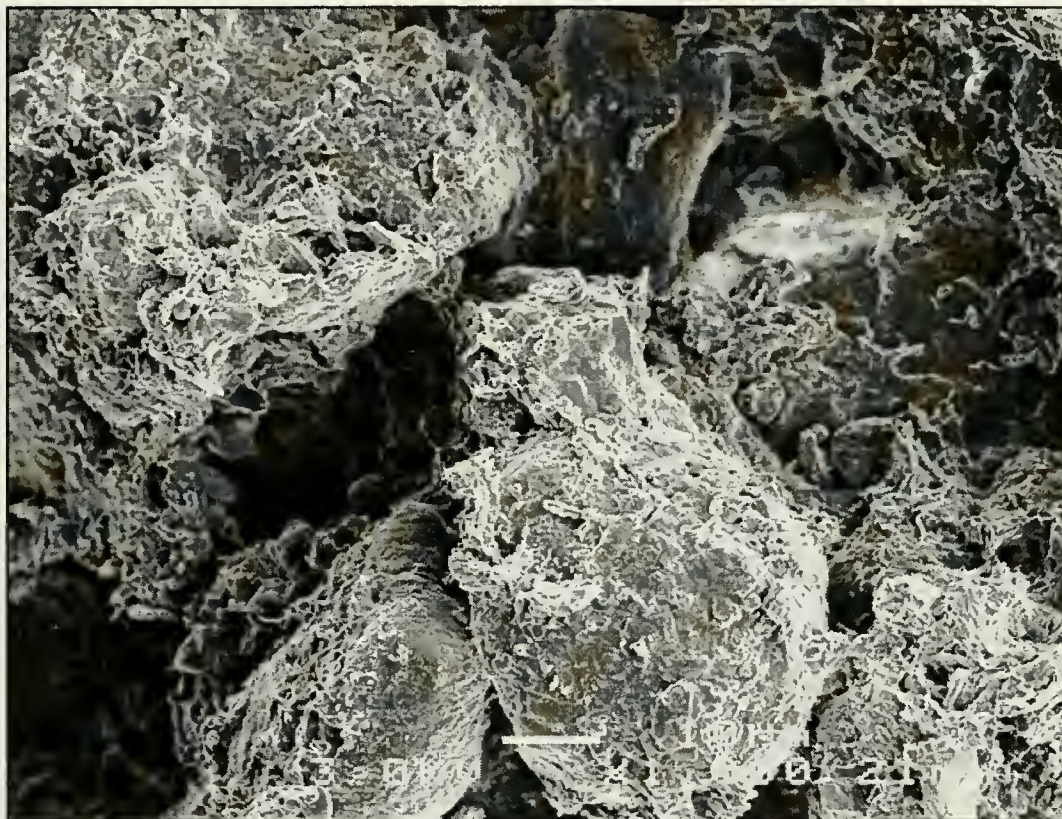
Figure 21. Mesa Verde Blend earthen mortar, 0% E-330, 1,000x magnification. In this sample of unamended Mesa Verde Blend earthen mortar, the soil particles stand out in sharp relief. Compare with the amended Mesa Verde Blend earthen mortar, *Figure 22*. White bar is 10 μ m.

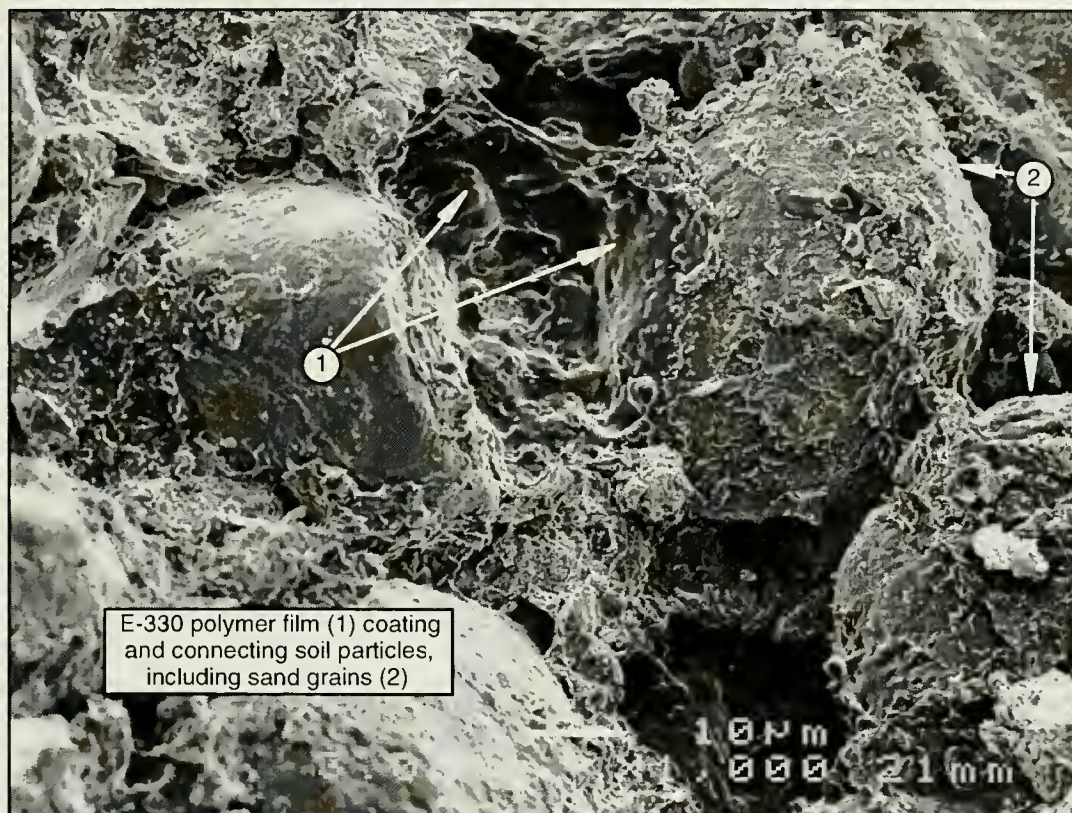
Figure 22. Mesa Verde Blend earthen mortar, 33% E-330, 1,000x magnification. The smooth Rhoplex polymer coating can be seen in a valley of the amended earthen mortar, covering the mineral fragments beneath. White bar is 10μm.

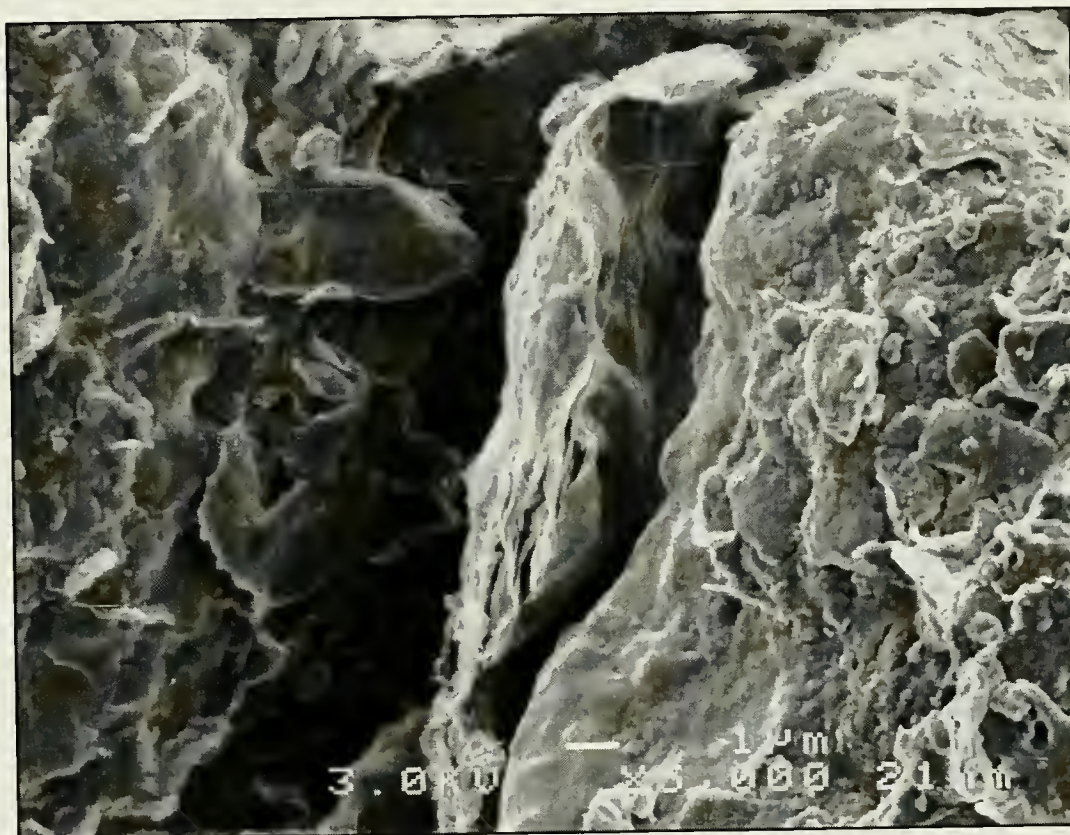
Figure 23. Mesa Verde Blend earthen mortar, 0% E-330, 5,000x magnification. The microcracks in this unamended earthen mortar sample are clean, with no debris or mineral connections between one side and the other. Compare with the amended mortar in *Figure 24*. White bar is 1 µm.

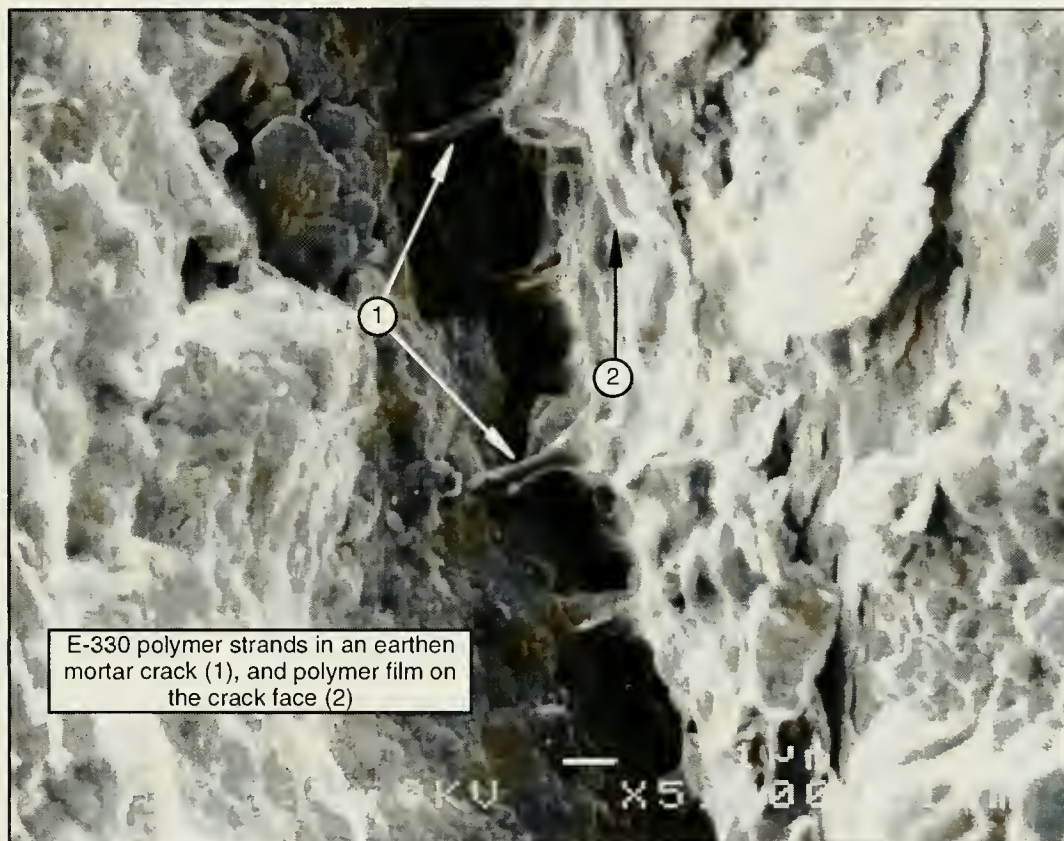
Figure 24. Mesa Verde Blend earthen mortar, 33% E-330, 5,000x magnification. The polymer strands connecting one side of an earthen mortar microcrack with the other are typical of the appearance of Rhoplex E-330 in a fine-textured soil. They probably result from soil contraction during drying, and coalescence of the polymer concentrated in the mortar voids. White bar is 1 µm.

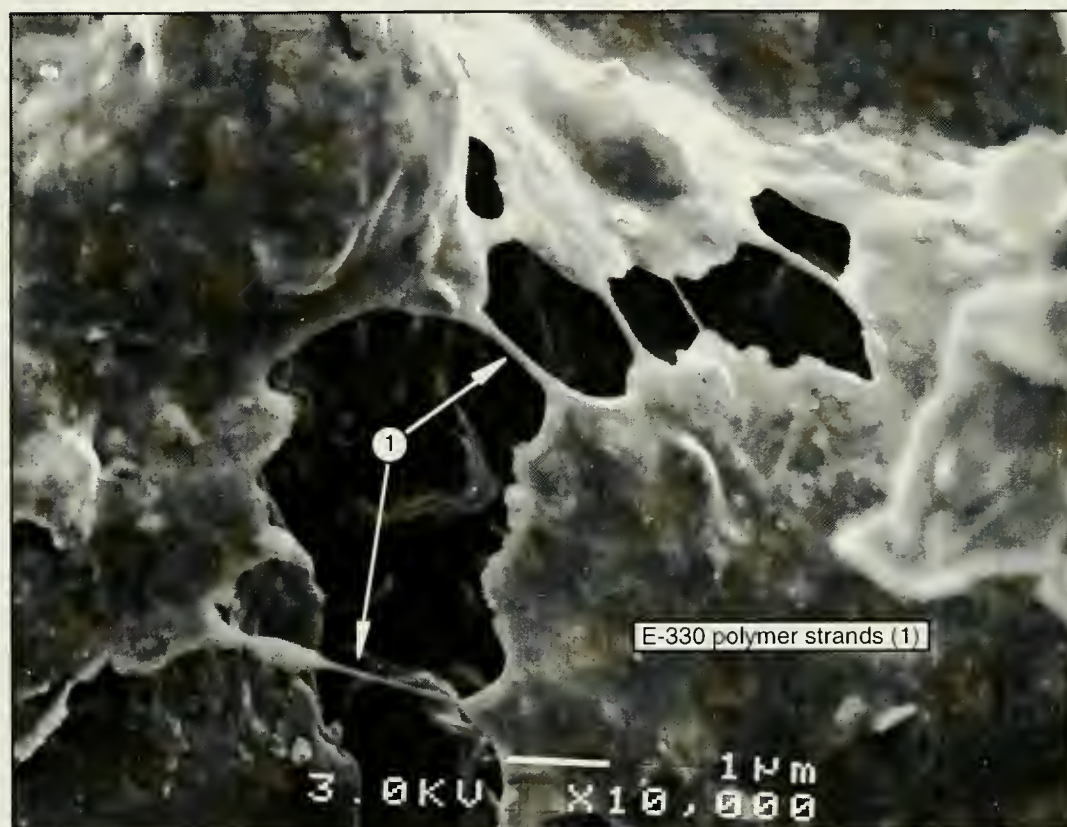
Figure 25. Far View Ruin amended earthen mortar, Mesa Verde, 10,000x magnification. This sample was taken from a dry, intact, piece of amended mortar (between 25% and 33% E-330) at Far View Ruin, on the top of Chapin Mesa. The same distinctive polymer strands seen in the laboratory samples made with Mesa Verde Blend also are visible here. Another view of the sound Far View amended earthen mortar is shown in *Figure 26*. White bar is 1 μm .

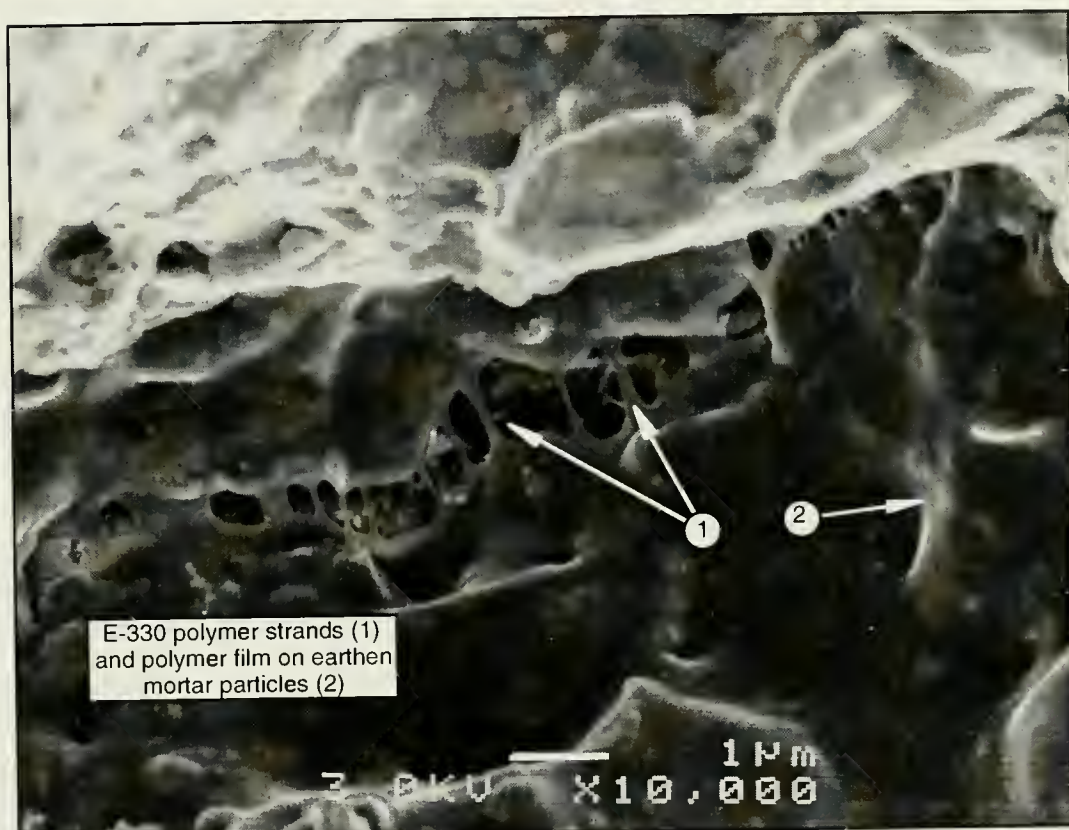
Figure 26. Far View Ruin amended earthen mortar, Mesa Verde, 10,000x magnification. The polymer strands bridging an amended earthen mortar crack and the smooth polymer coating on the earthen mortar face are visible in this sample of undeteriorated mortar. (Mortar contains between 25% and 33% E-330.) White bar is 1 µm.

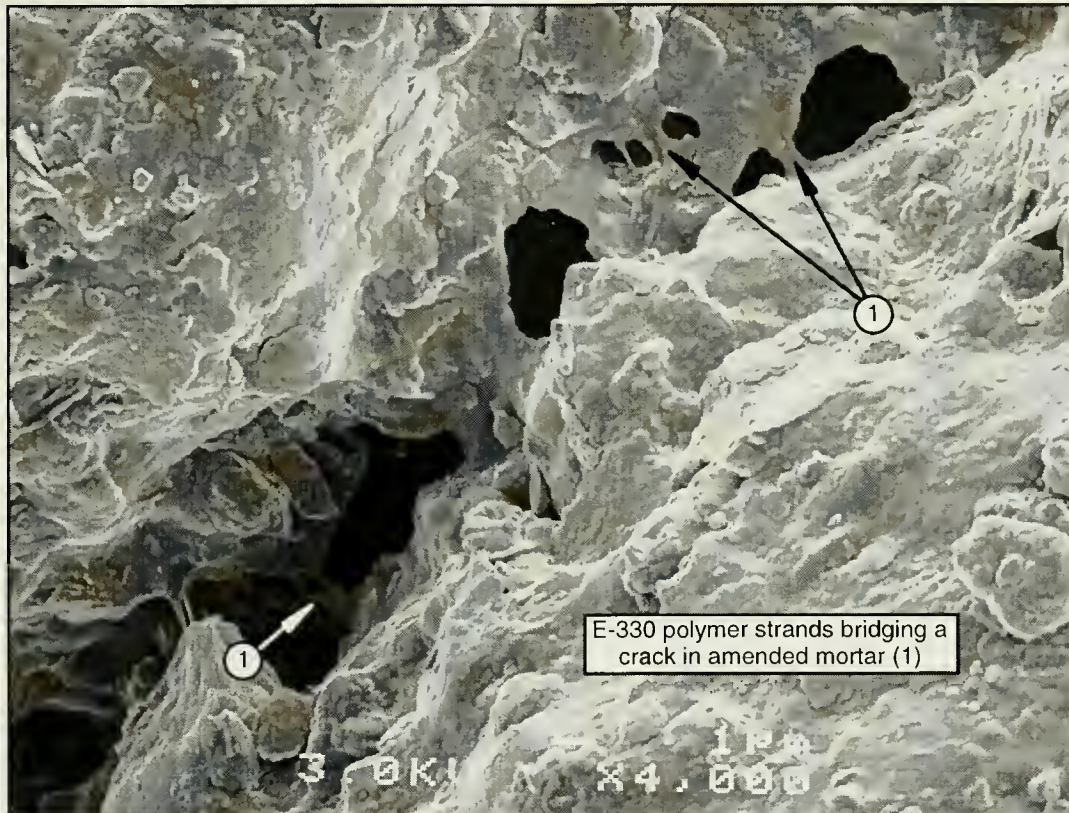
Figure 29. Chaco Canyon South Gap amended mortar, 29% E-330, 4,000x magnification. The E-330 polymer strands are revealed in this sample of mortar from Dennis Fenn's test wall near the visitor center at Chaco Canyon. The mortar was installed in 1976, and is still in sound condition. South Gap soil is a sandy soil (85% sand, 15% silt and clay). White bar is 1 μm .

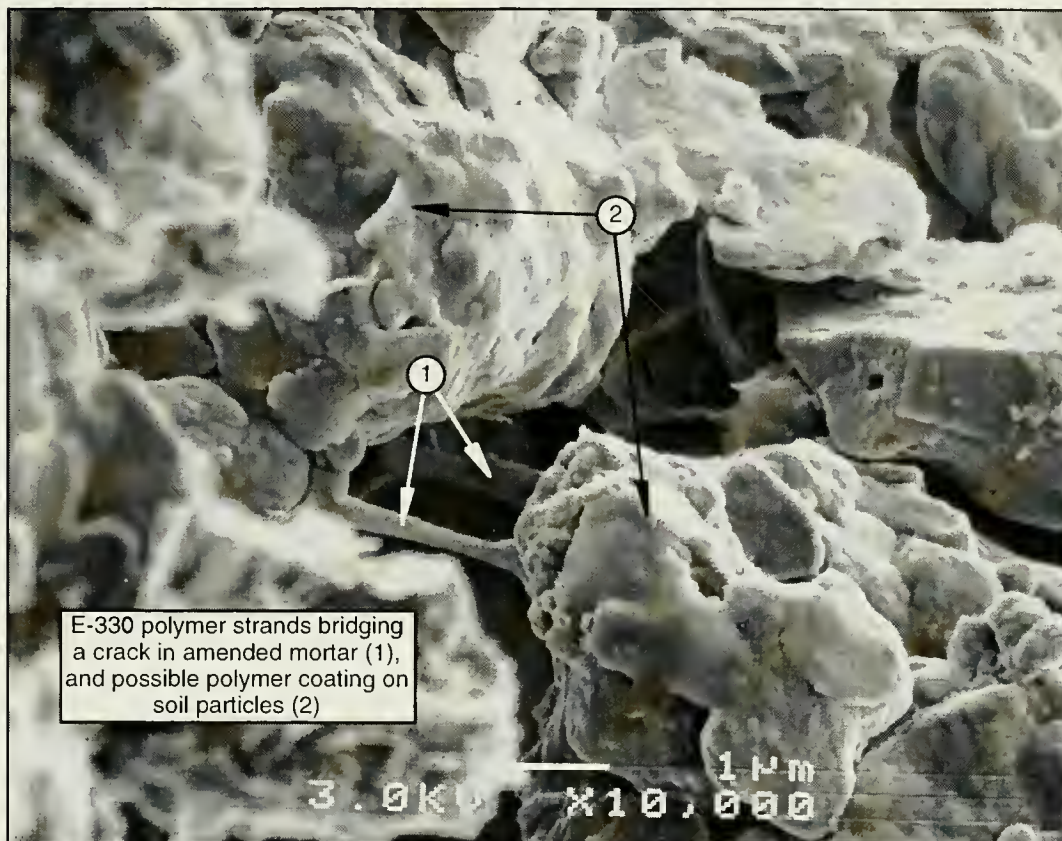
Figure 30. Chaco Canyon South Gap amended mortar, 29% E-330, 10,000x magnification. Another view, at higher magnification, of the polymer strands in the Fenn mortar, and possibly the polymer coating on the soil particles. The polymer strands are less frequent in sandy soils than in soils more rich in clay, possibly because the soil shrinks less while drying, forming fewer microcracks. White bar is 1 μm .

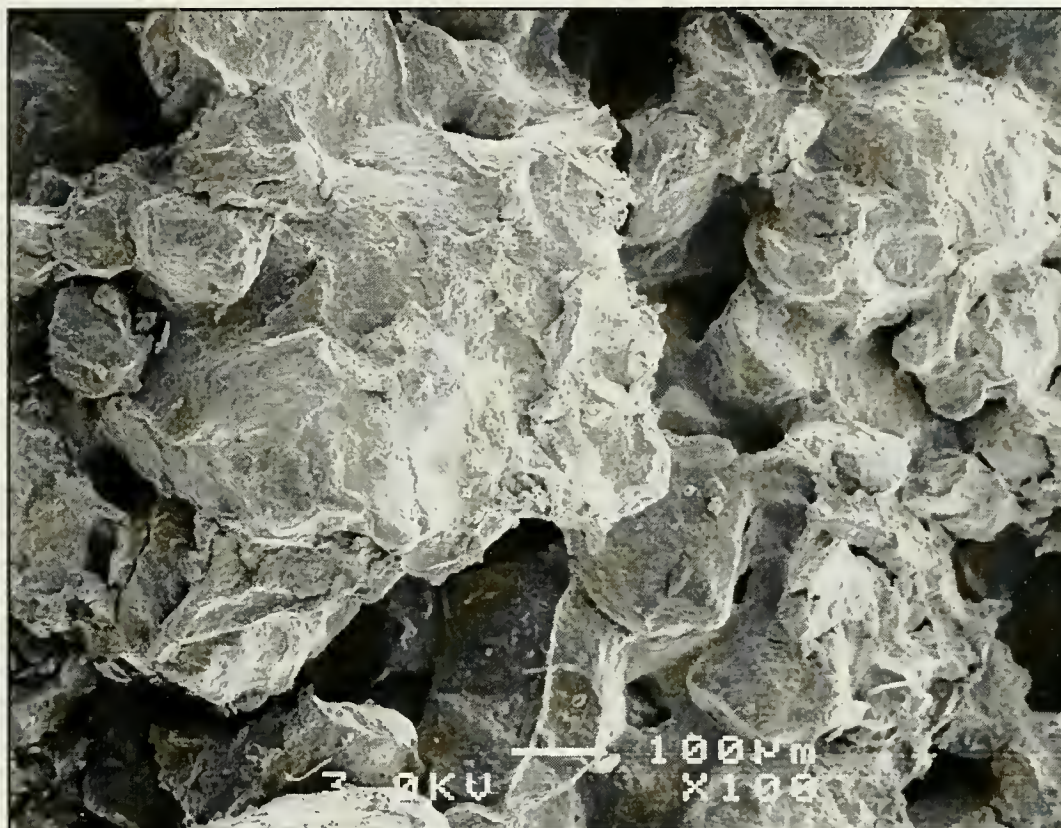
Figure 31. Butterbaugh amended adobe, 25% E-330, 100x magnification. This sample was taken from an adobe brick made by Darrell Butterbaugh in 1975 and placed on the roof of the University Museum in Philadelphia that year. Made from an obviously sandy soil, the adobe is still intact. Compare the soil texture with *Figure 32*, a Mesa Verde amended mortar. Both images are 100x magnification. White bar is 100 µm.

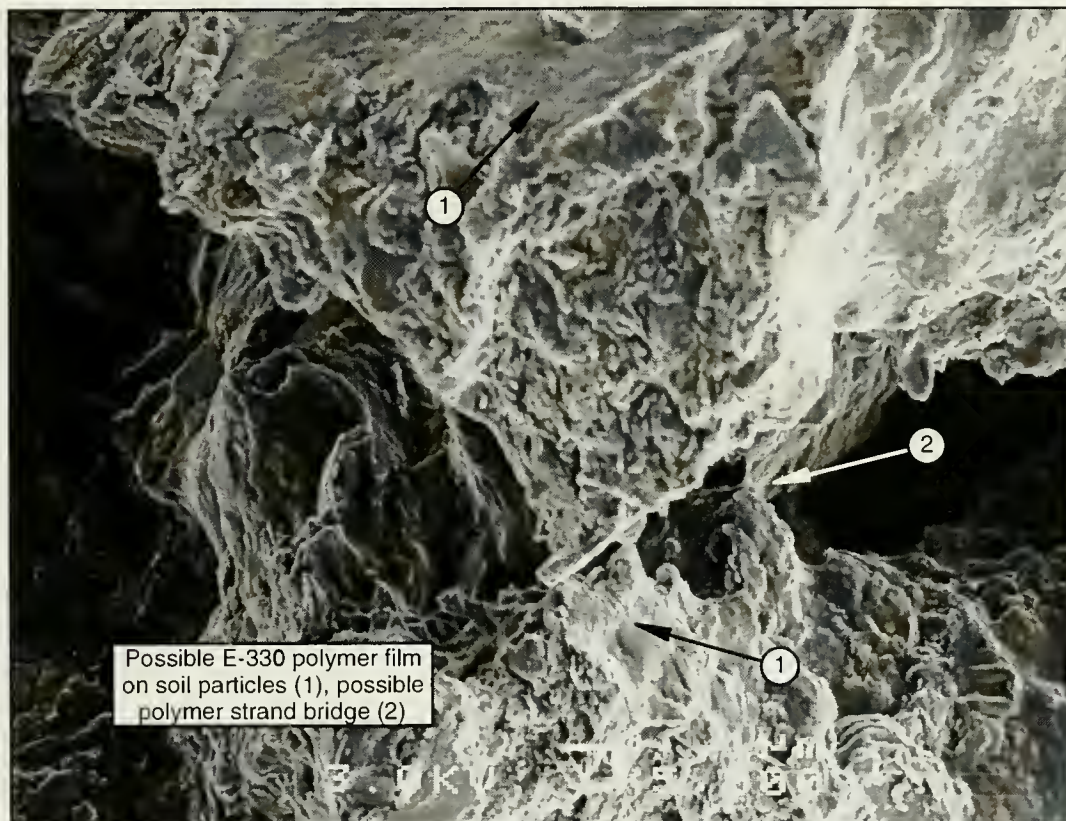
Figure 33. Butterbaugh amended adobe, 25% E-330, 5,000x magnification. Distinct polymer strands, such as those seen in the Mesa Verde soils, or in Fenn's earthen mortars, were not found in Butterbaugh's adobe soil. Because the polymer adhered the soil grains so well, it wasn't possible to accurately measure the particle size distribution of this soil. But simple visual inspection revealed a primarily sandy mix, with sharp-edged particles. The soil probably shrank very little while drying. White bar is 1 μm .
