AN EVALUATION OF HISTORIC CEMENT STUCCO USING CONDITIONS ASSESSMENT METHODOLOGY AND DIGITAL VISUALIZATION TOOLS, GRAND TETON NATIONAL PARK, USA

A THESIS

MASTER OF SCIENCE IN HISTORIC PRESERVATION

2018

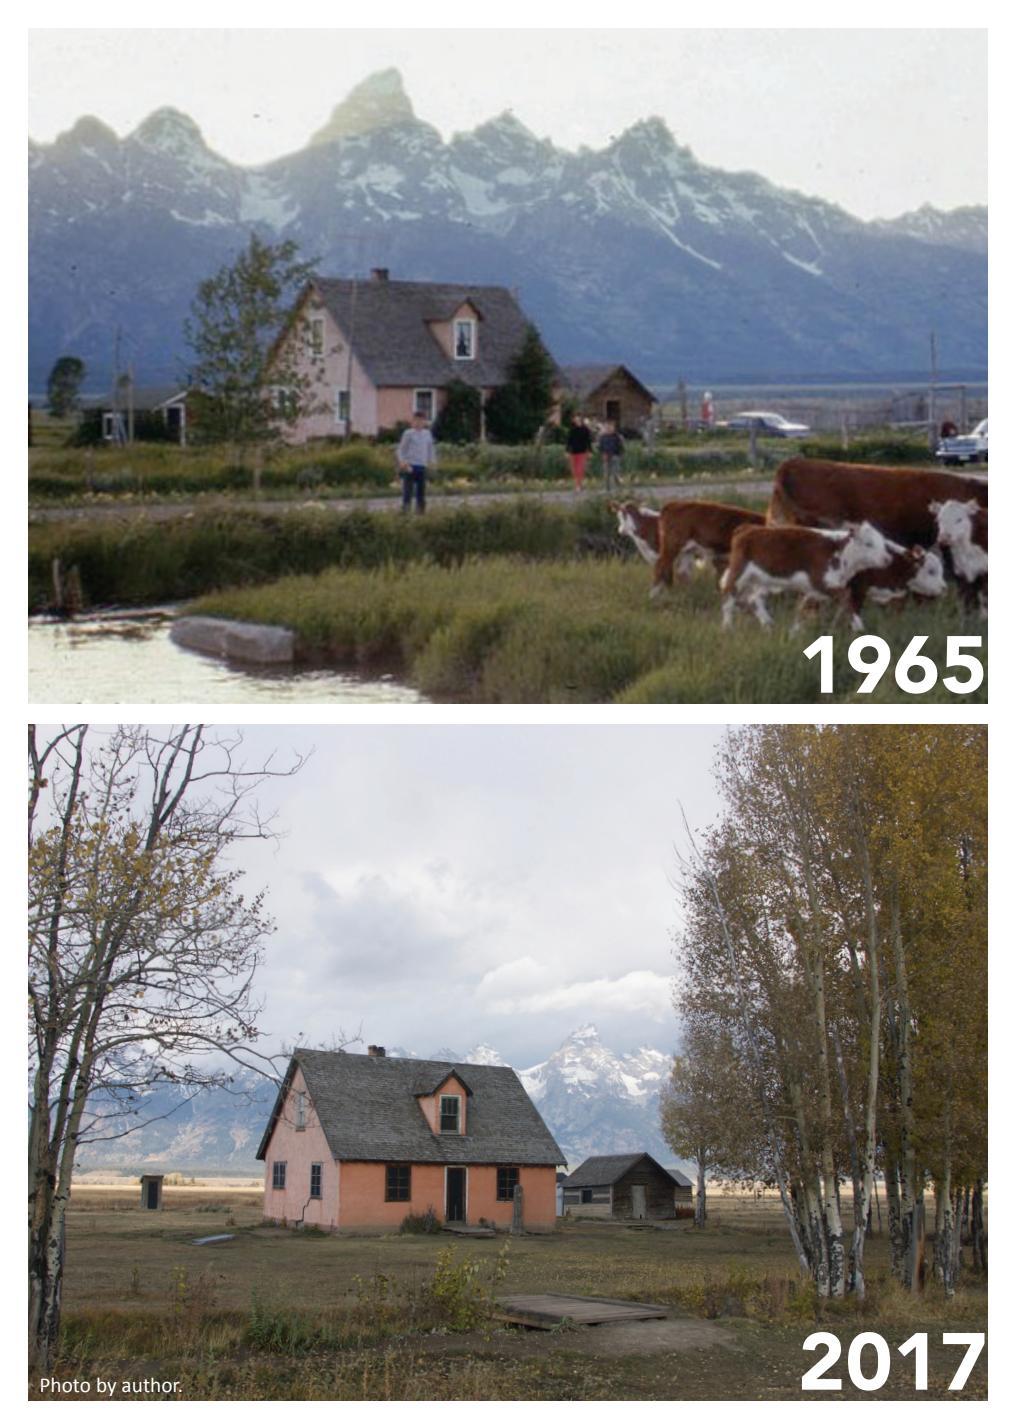
Figure 2.4 A comparison of photographs from the early 1960s to the present confirms that the John Moulton homestead still has high integrity. The historic photo also shows how the visible the structure would have been during the period of significance when the aspens in the front yard were much smaller. (Source: Best of the Tetons, https://www.bestofthetetons.com/2014/04/08/the-moulton-barns-1963-1965/)

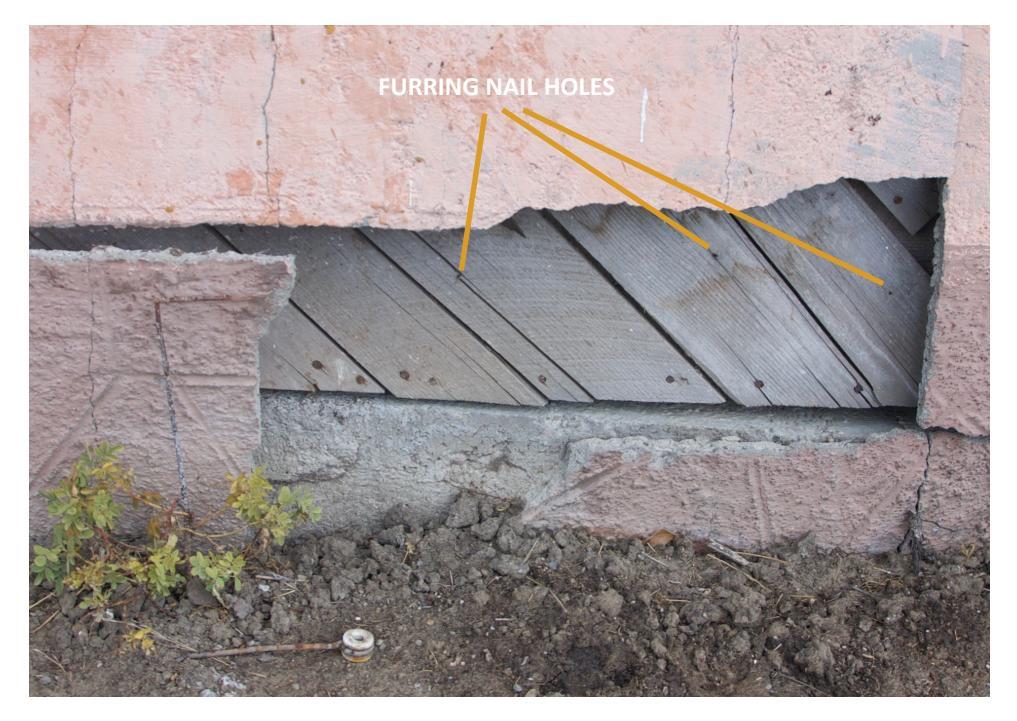
Figure 3.3 Section detail, based on product literature and observations at the site; this system provides a suitable substrate reinforcement for the stucco to be applied. Haphazard holes from the furring nails indicate that the lath was not attached using furring strips. (Photo by author, 2017)

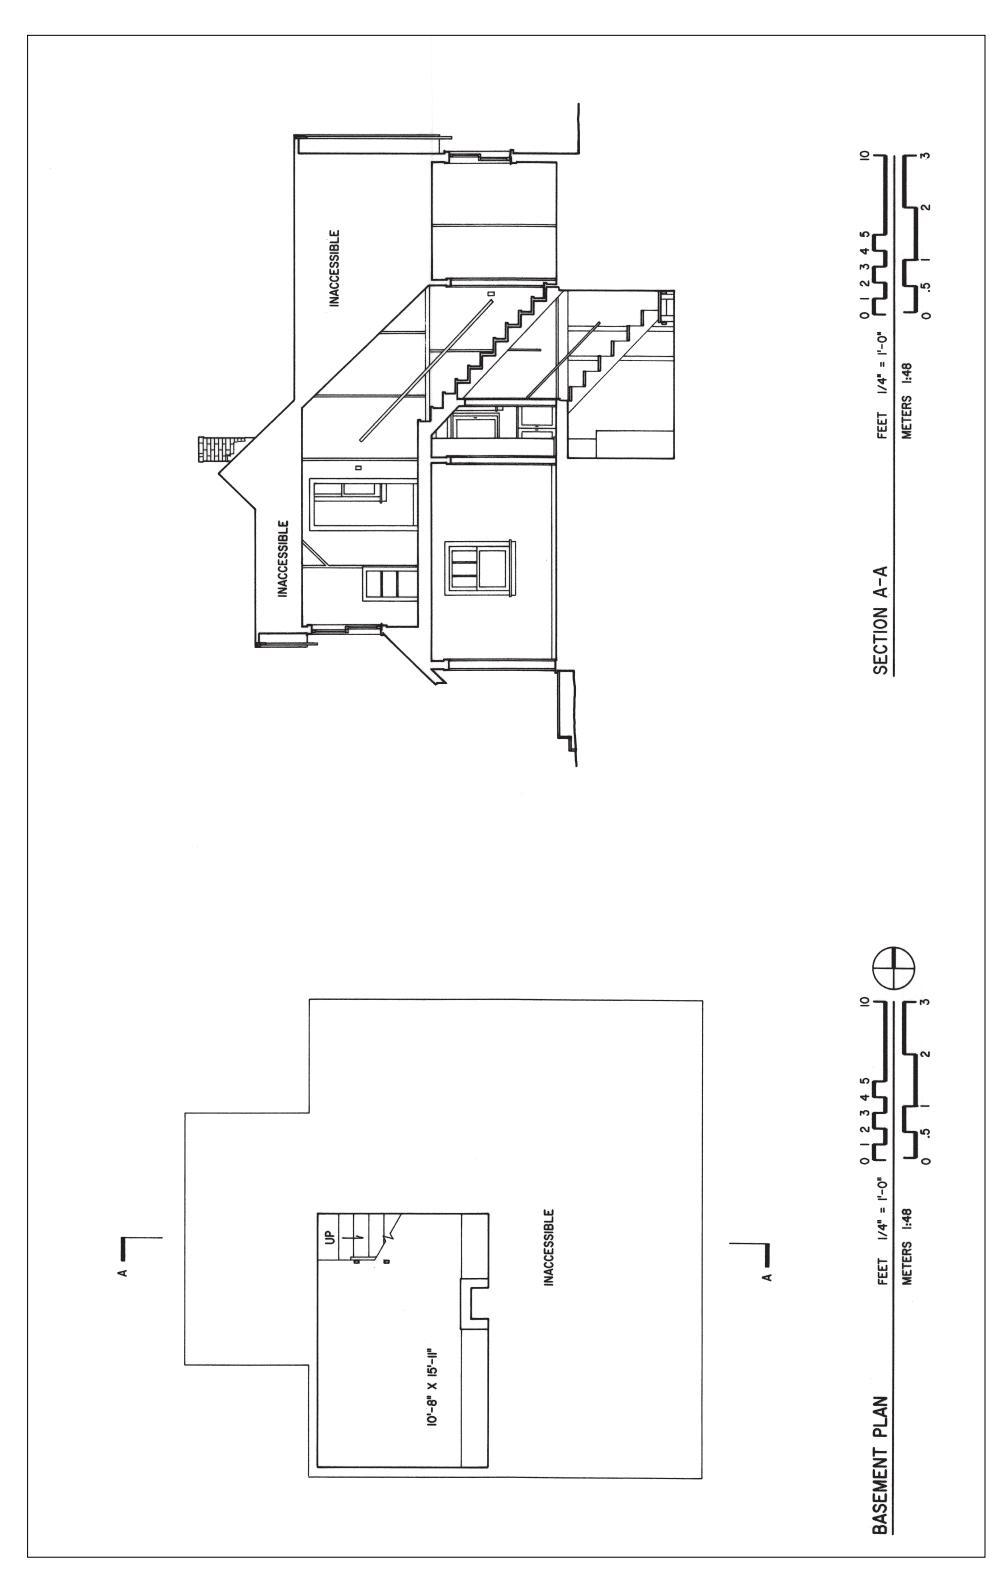
Figure 3.10 Plan of the John Moulton Homestead basement. (Historic American Buildings Survey, WY-152-A)

The condition of the foundation can be inferred from a number sources. This report does not purport to be a comprehensive or finalized analysis of the conditions affecting the foundation but discusses the inferences that can be made regarding its condition. According to the National Register nomination, other structures in the Mormon Row district are built on foundation walls made of concrete or native stone, but these are typically shallow enough that the entire structure can buoyantly rest on top of the alluvial clays. The J. Moulton house is similarly built on a concrete wall foundation, but a cellar under the southwest portion of the structure which extends below the frost line renders that part of the house rigid. The north and east parts of the house are cantilevered and move differentially to the southwest, likely causing the large diagonal cracks evident on the south and north elevations *(Figure 3.10)*. The Reed

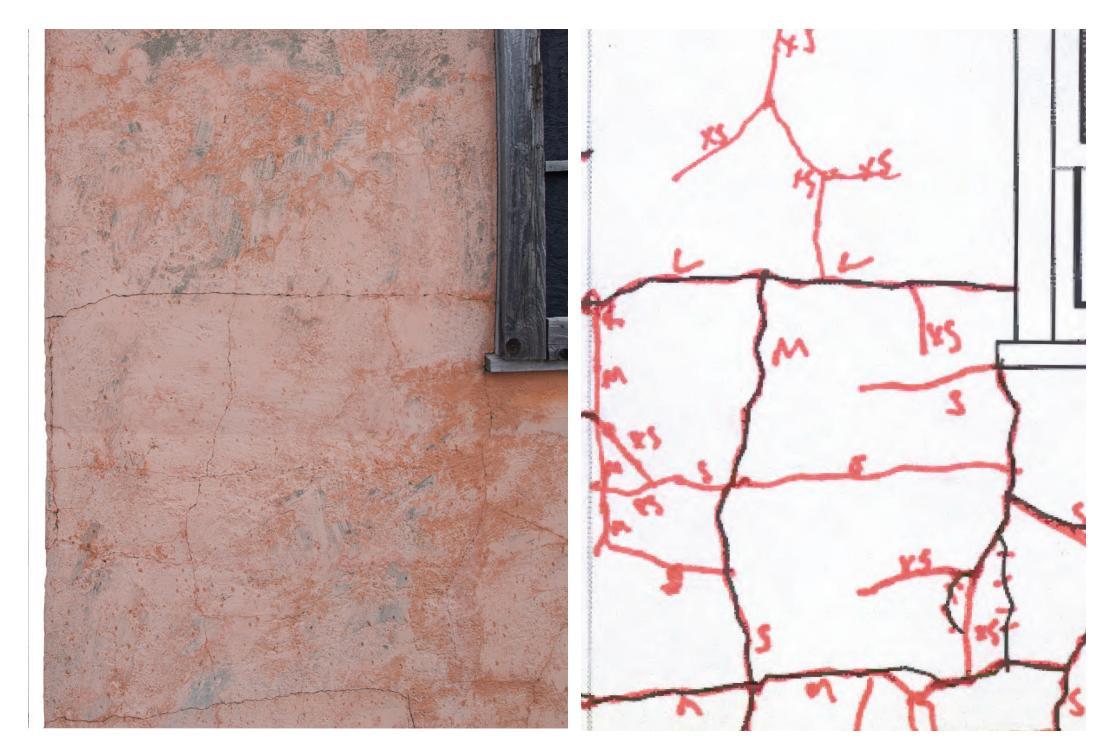
Figure 5.3 Cracks were confirmed and then annotated according to size, extra small to extra large; those which were not evident in photos were traced onto elevations in the field.

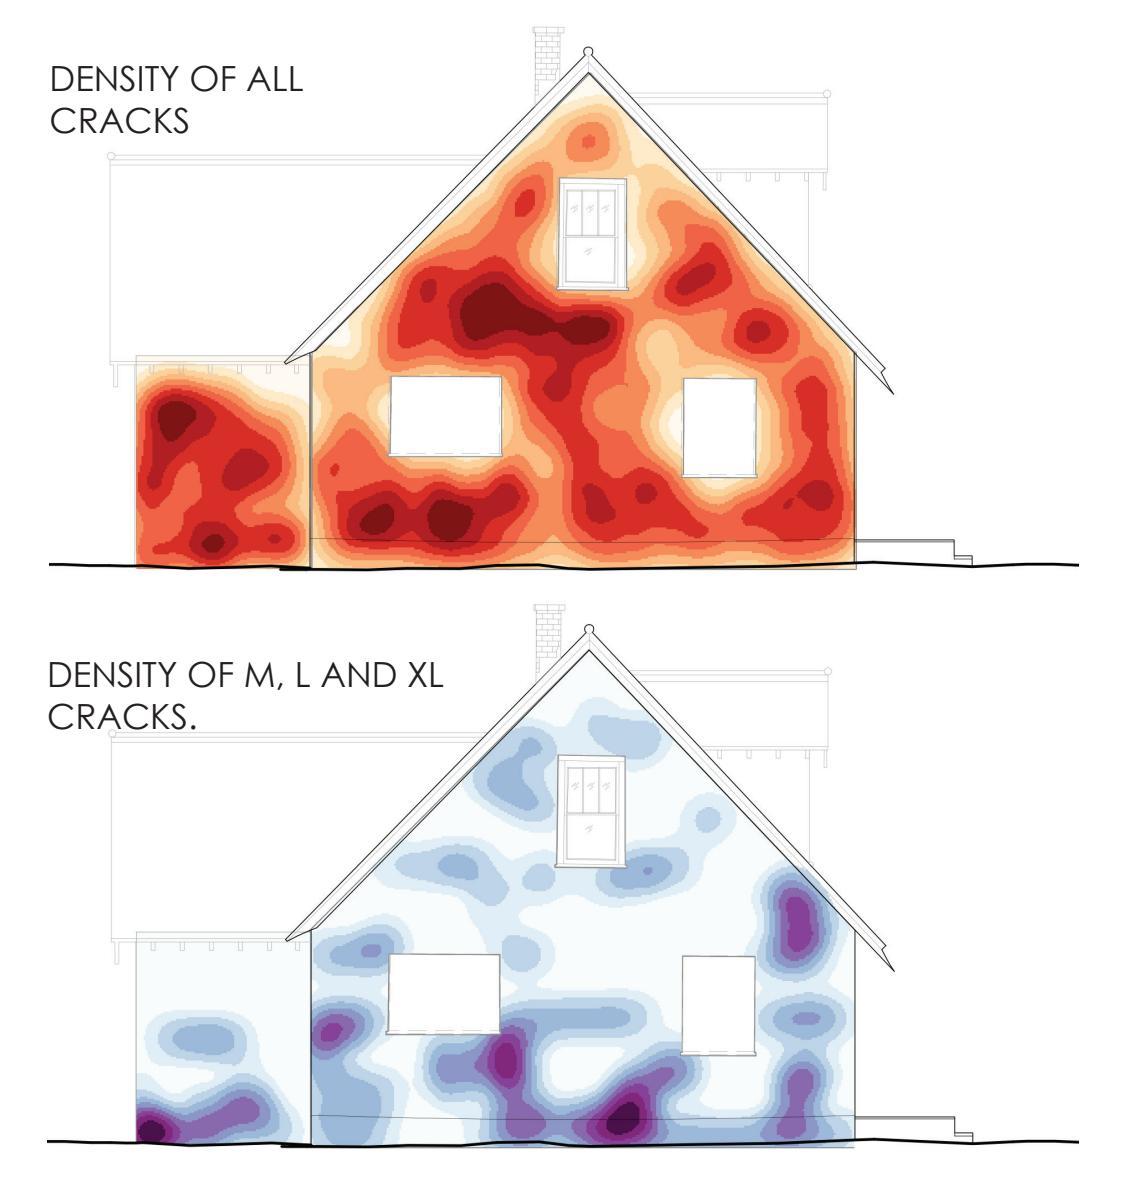
Figure 6.1 Density graphics for the south elevation produced using the Kernal Density Tool in Spatial Analyst. The area of each pixel is 1 in., and the search radius is 25 in. (Graphics by author, 2018)

interpretation is generalized, as GIS can only represent the surface where cracks are visible; it cannot approximate the depth of hairline or small cracks, which may only be superficial. Based on the findings of the laboratory testing, micro cracks demonstrate the effects of water and carbonation, so this is not a gross exaggeration. The bigger cracks map can show the distribution of cracks which are associated with structural movement and shear forces on the stucco; these tend to occur at the base and corners of the structure, as well as corners of openings.

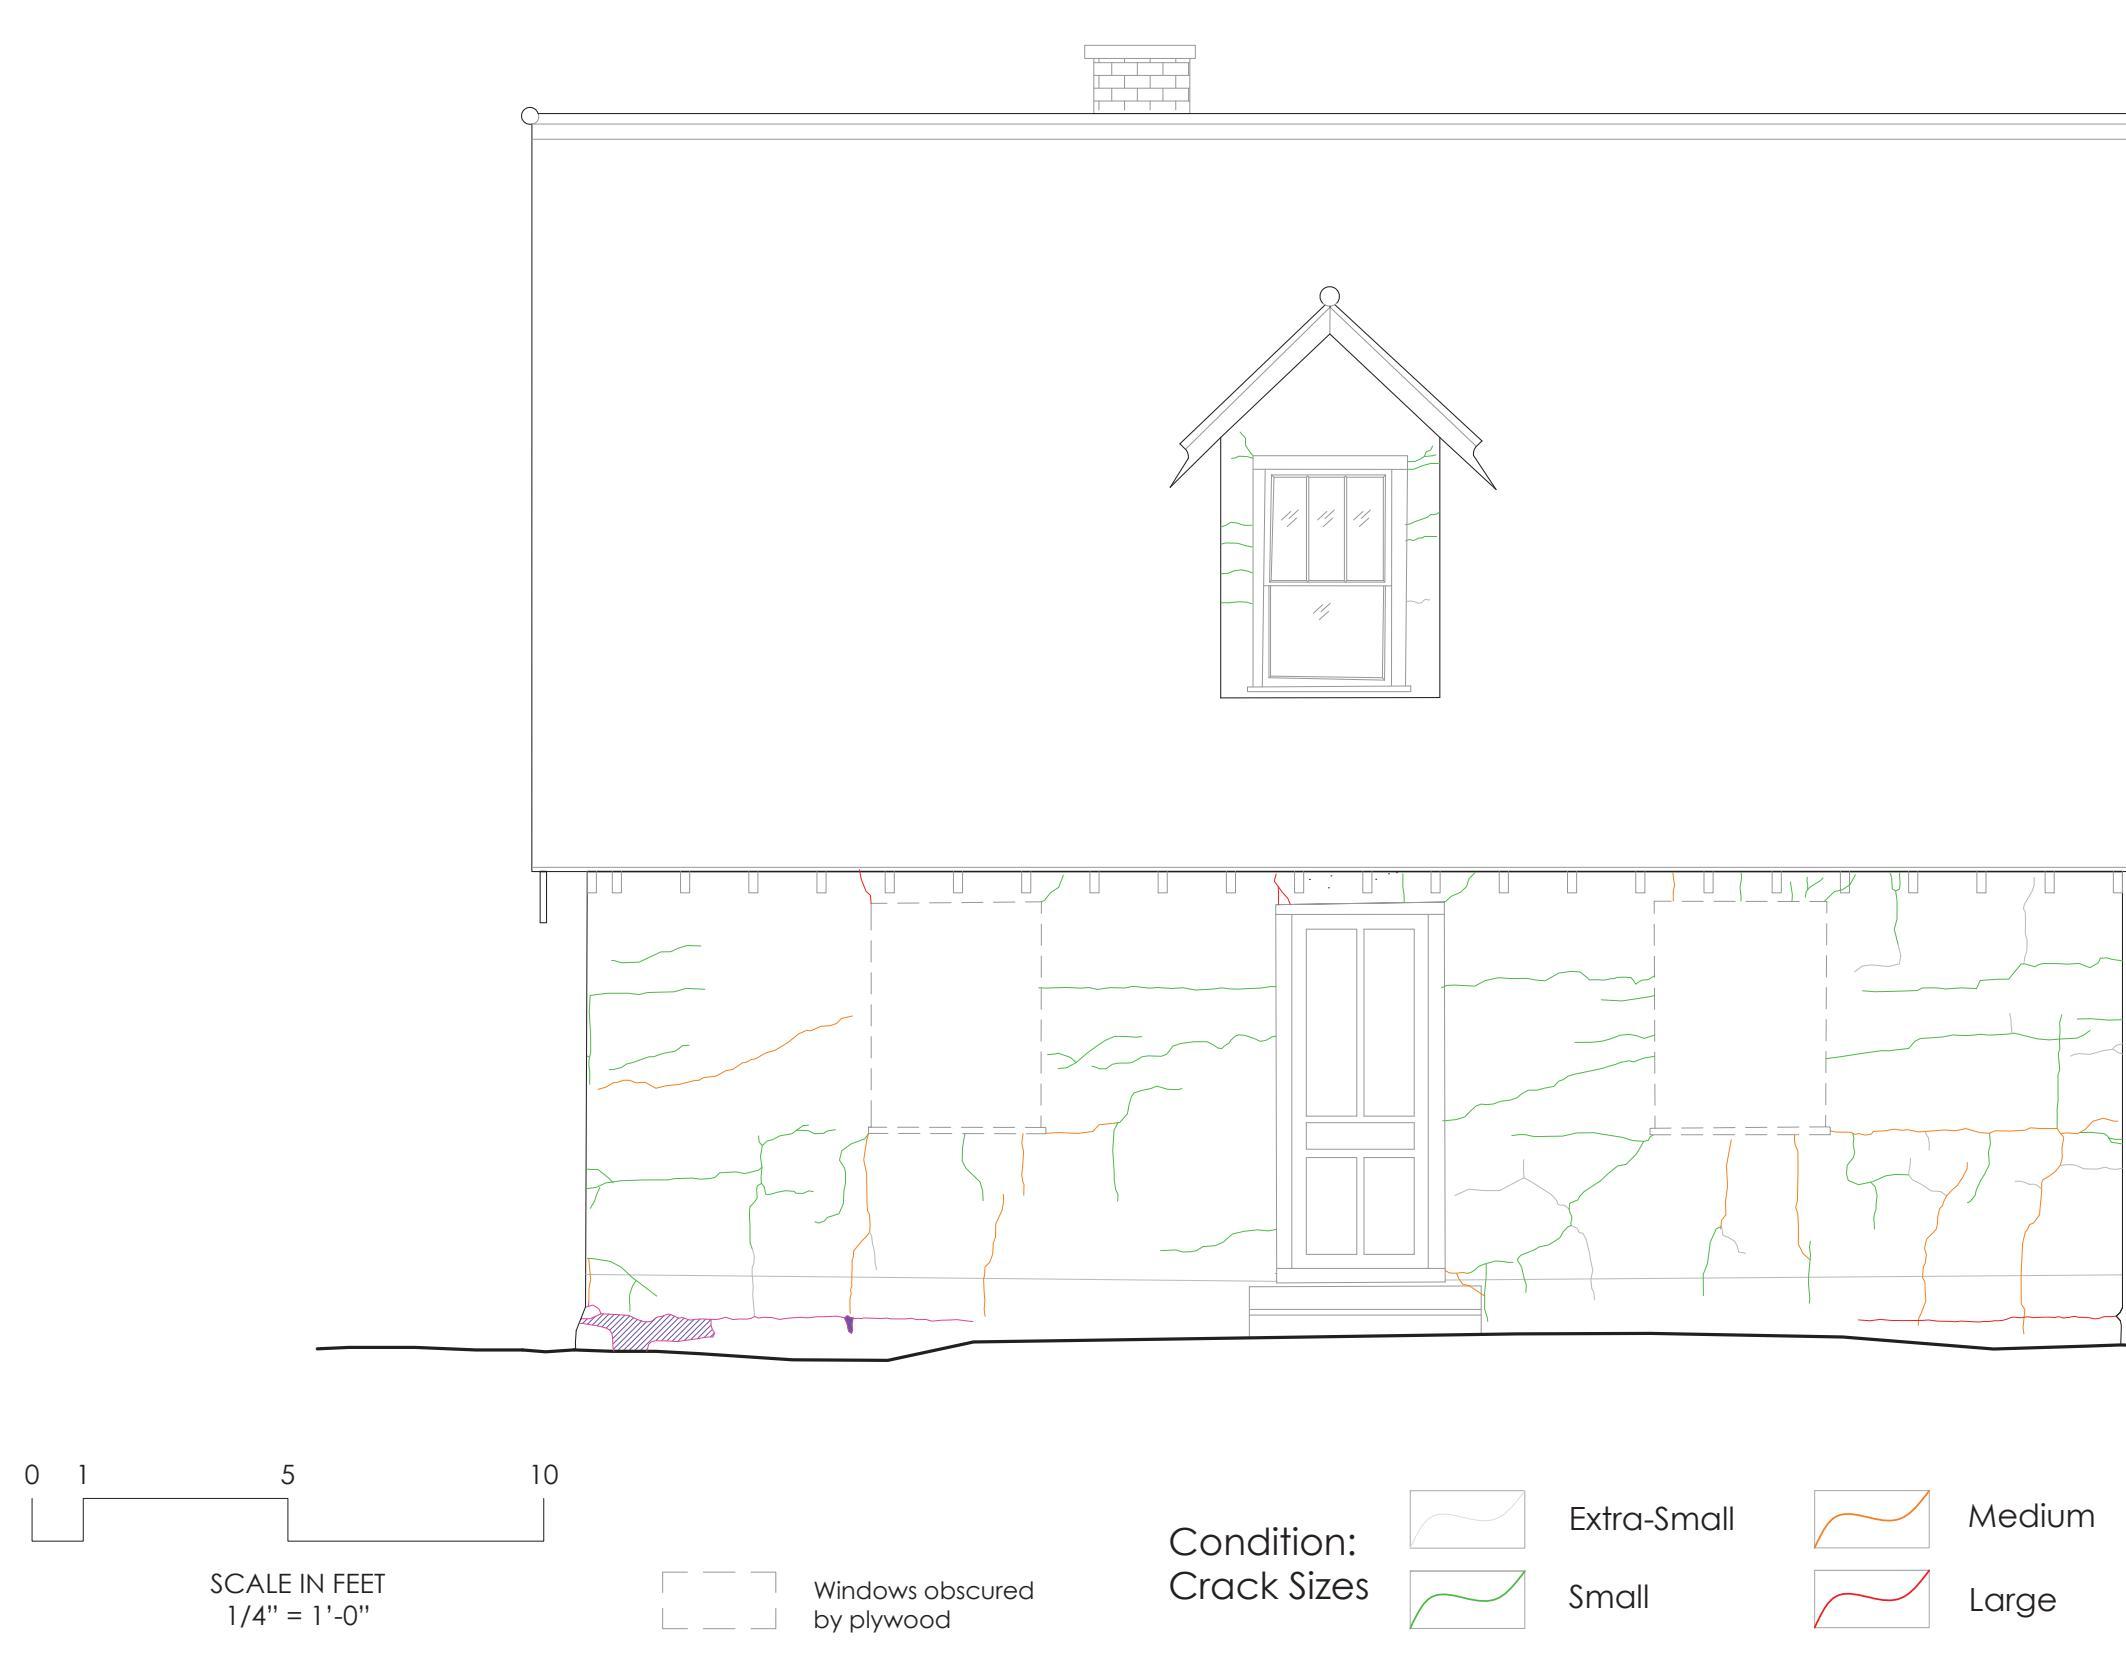
N. SHEET IDENTIFICATION: Appendix Bii Conditions
		DESCRIPTION Crack conditions on east elevatio
	Extra-Large Loss	JOHN MOULTON HOMESTEAD 13040 Antelope Flats Road Grand Teton National Park, Moose, Wyoming

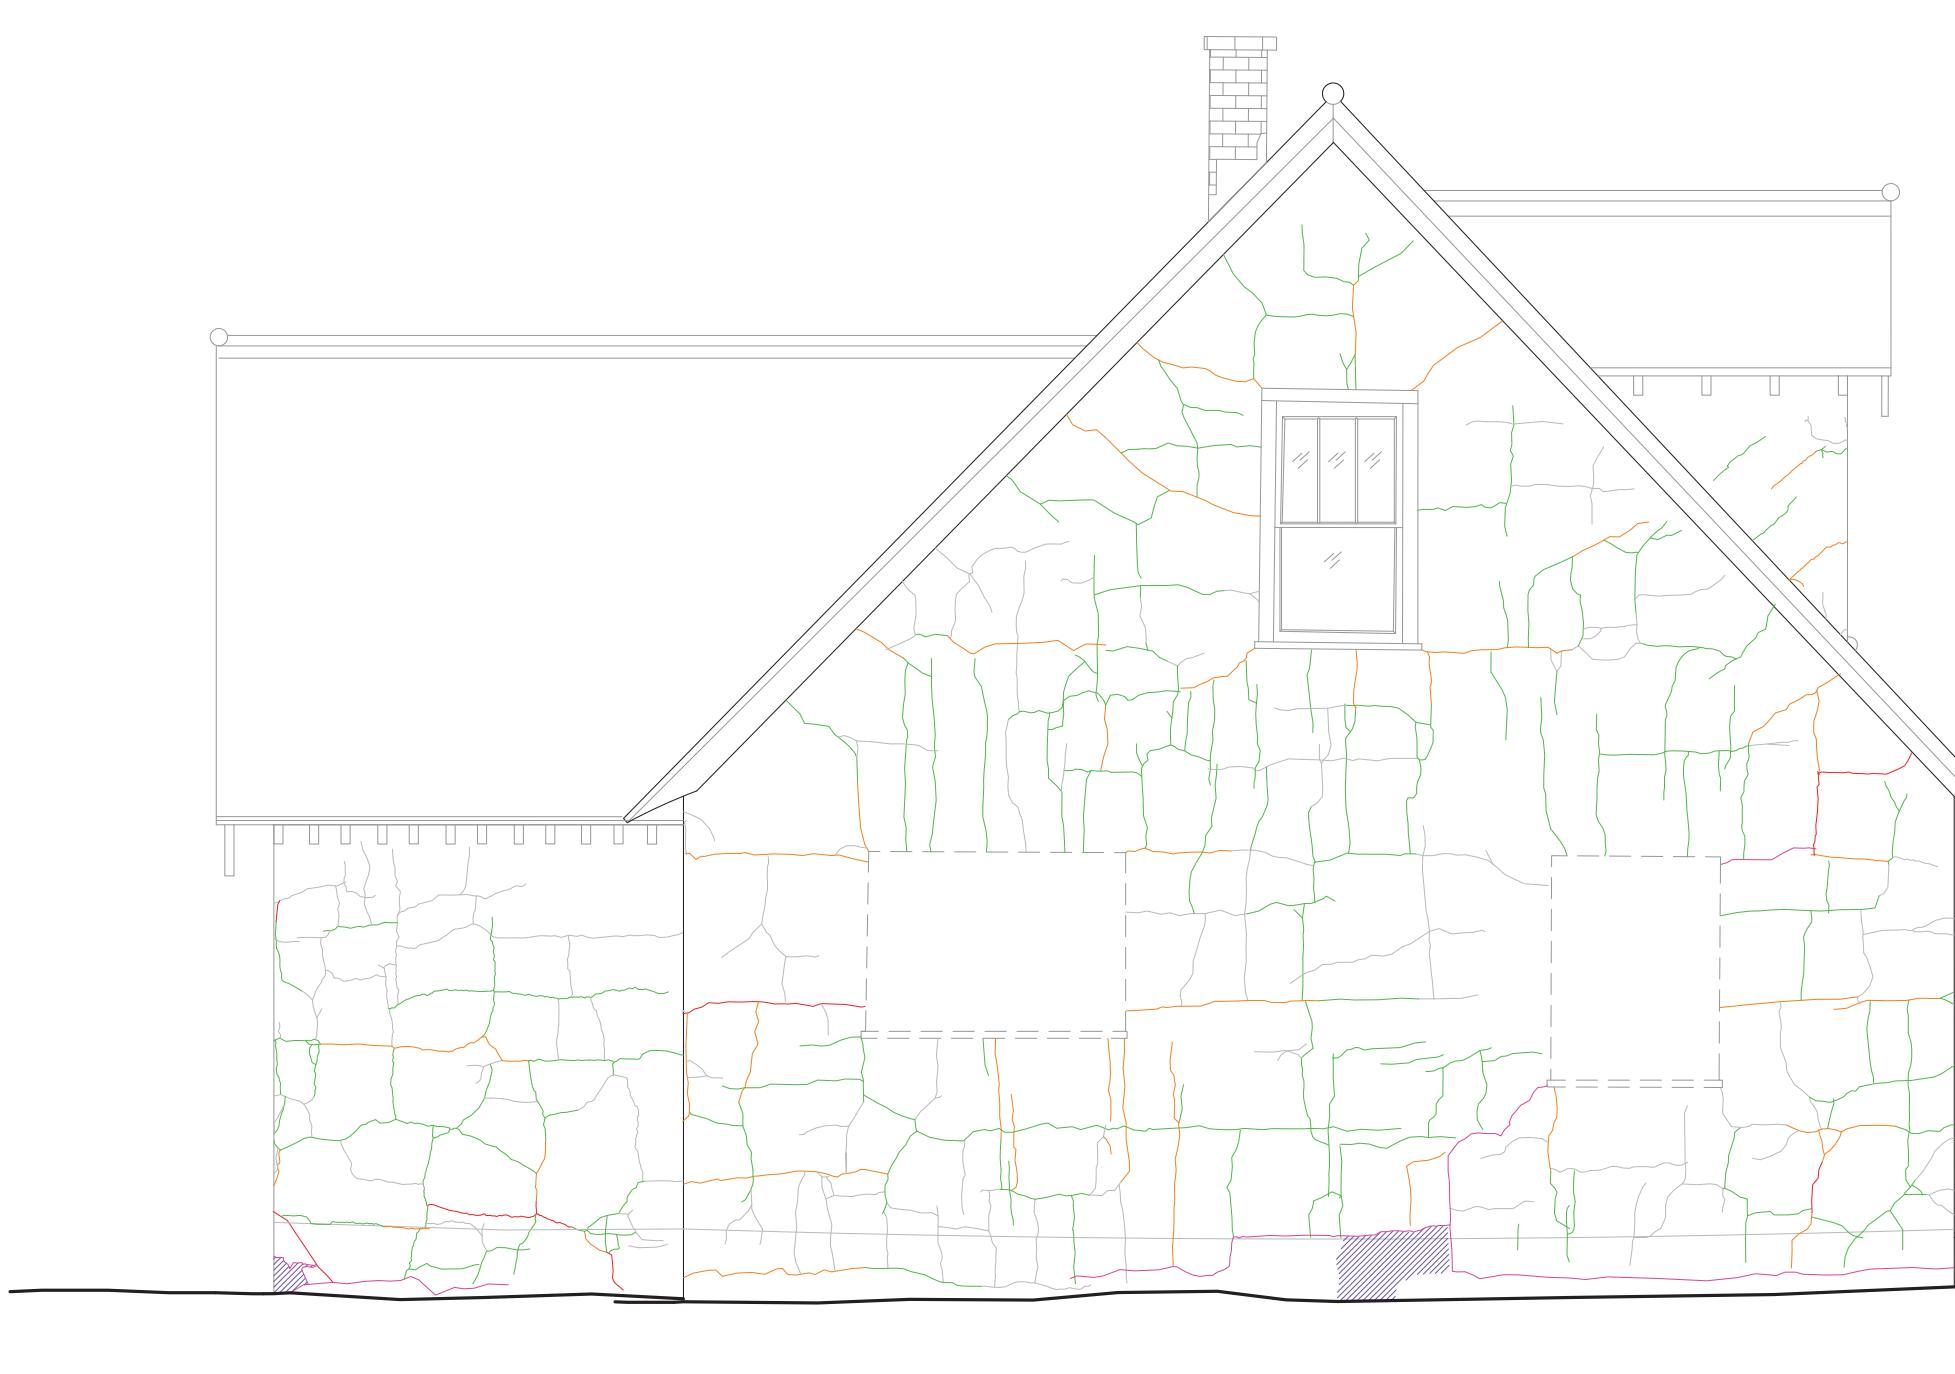
SHEET IDENTIFICATION: ADDADIA	elevation.
	DESCRIPTION	Crack conditions on south
Extra-Large Loss	JOHN MOULTON HOMESTEAD	Grand Teton National Park, Moose, Wyoming

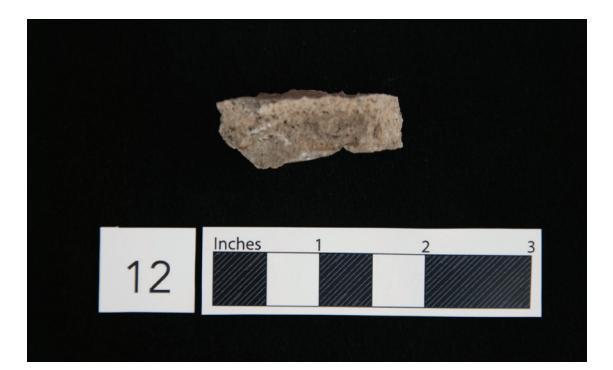
JMH 12 taken from the base of the north elevation near the east corner. Photo by author, 2017.

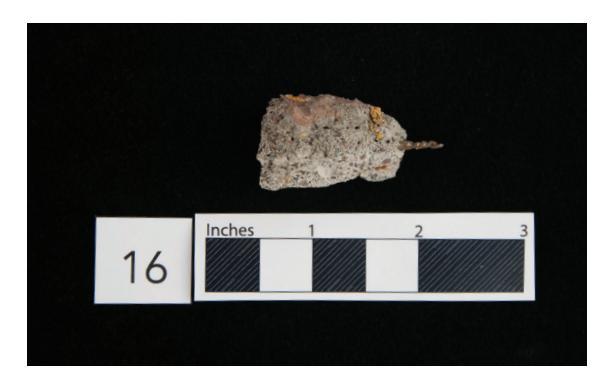
JMH 16 taken from base of the south elevation near east corner. Photo by author, 2017.

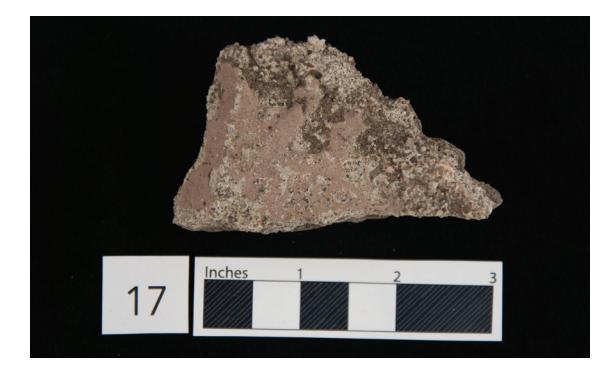
JMH 17 taken from base of the east elevation near the south corner. Photo by author, 2017.

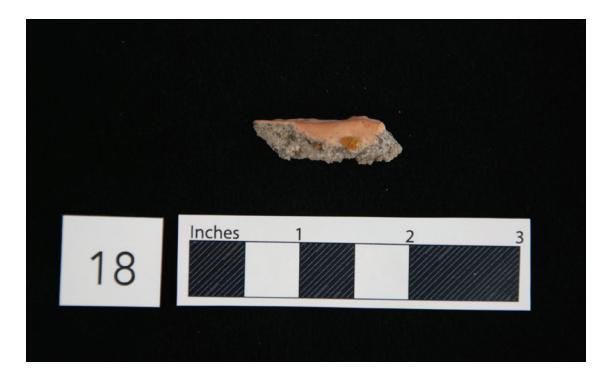
JMH 18 taken from the northwest corner of the L addition. Photo by author, 2017.

Sample is curved and has a thicker finish coat paint layer, likely the result of application.

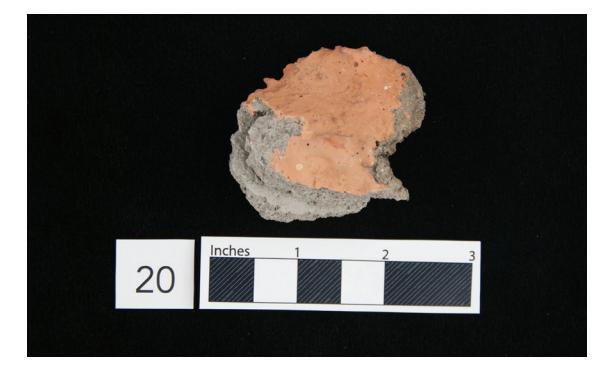
JMH 20 taken from corner of north and east elevation under the eave. Photo by author, 2017.

The bulk sample has poor interlayer adhesion, perhaps due to faulty application/installation. Sample taken to characterize unexposed cement matrix.

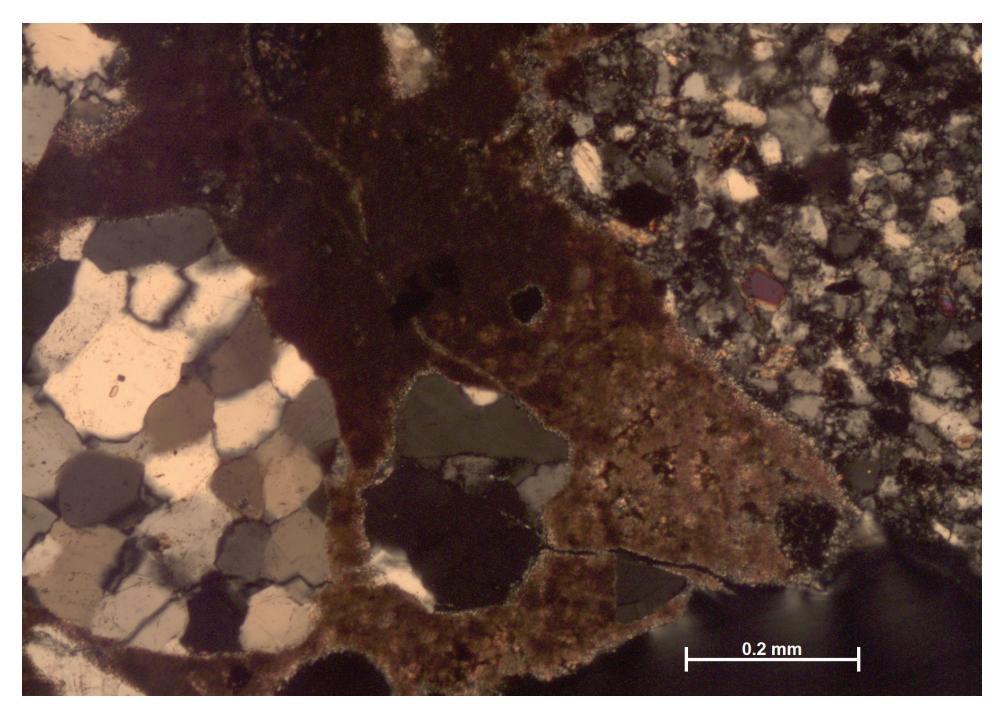
Figure Diii.3 Some microcracking was evident in some samples on the posterior surface of the coarse coat; in these cases carbonation was affecting both the exterior and interior faces of the stucco. (JMH 16, XPL, 100x magnification)

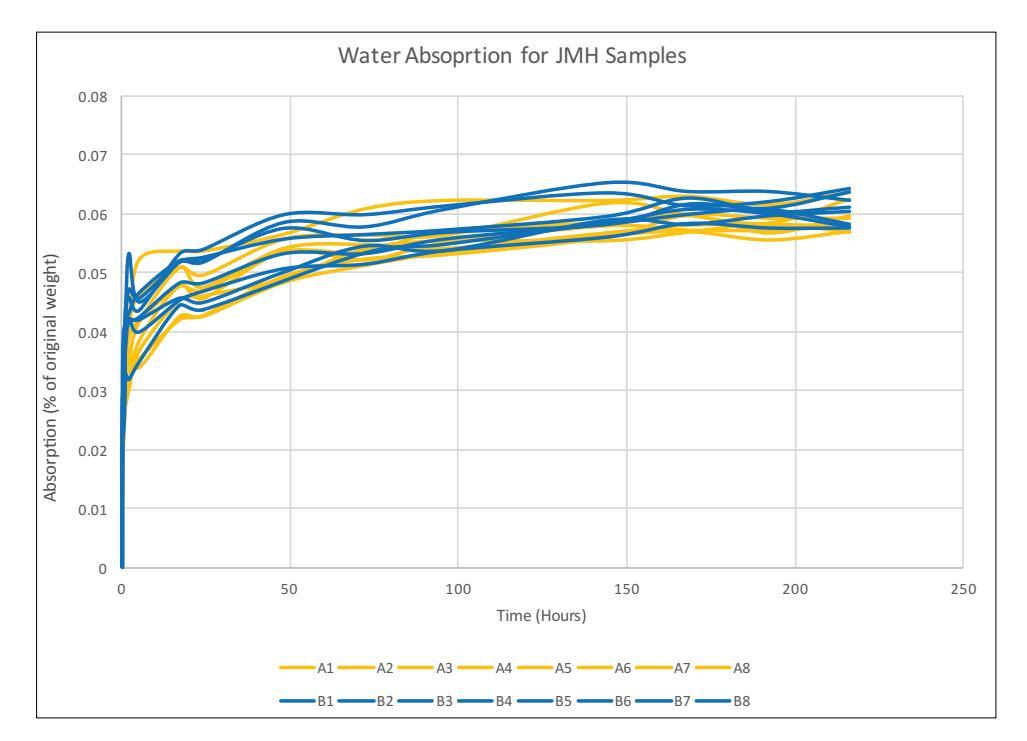
Ultimately, both Group A and Group B had similar results. The average water absorption for all samples was approximately 6% and the average percent porosity of the samples is 12.98% \pm 1.47%. This figure is similar to results for commercially available building limestone (0.95 to 17%) and sandstone (1.9 to 22%), suggesting that the cement has a similar capacity to absorb water as stones deemed durable in exposure.⁵

Figure Div.3. Water Absorption Rate for Samples. The rate of absoprtion did not differ between Group A (yellow) and Group B (blue).

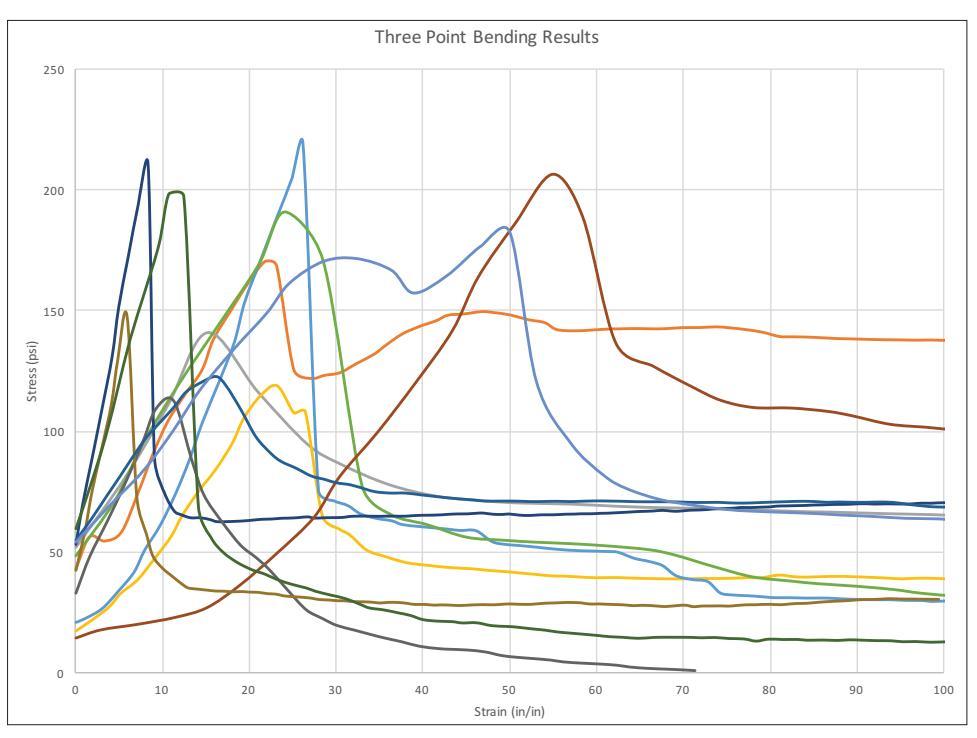
With a couple of exceptions, the behavior of failure conformed to expectations for brittle materials (*Figure Dv.3*). The Modulus of Rupture for samples tested varied widely; the average value was 1493.96 psi with a standard deviation of 376.83 psi (*Figure Dv.4*). This figure is similar to the lower range obtained for architectural limestone and sandstone. The thickness of the sample had no discernible correlation to its modulus of rupture; it is possible that the adhesion of the cement matrix to the wire cloth within the sample contributes to strength of the material in bending.⁹

Figure Dv.3. Stress-Strain Curves derived from three point bending data.

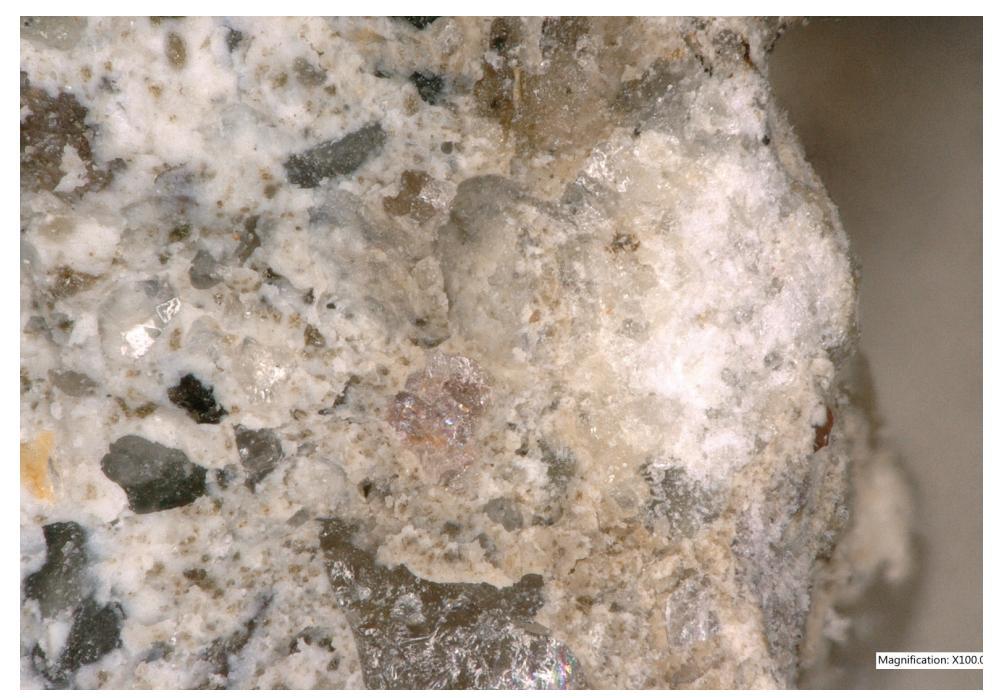
The presence of salt is worrisome, as the repeated crystallization and dissolution in the pores can cause cracking and spalling of the surfaces.¹¹ To approximate the risk that these materials pose in the cement, it is essential to determine whether the salt content is likely to increase or remain the same. The sulfate originates either from external or internal sources. Soil surveys in the area indicate that there is a low likelihood that components within the soil may contribute to electrochemical and physical deterioration of concrete; these are based on evaluations of sulfate and sodium content and acidity of the soil.¹² The primary internal source for sulfate is a high content of gypsum included in the initial portland cement mixture to deter early set. A second possibility is the mineral content of the water used to mix the concrete, likely from the Kelly Warm Spring via the Mormon Ditch. Further testing is required to identify the source of the sulfate.

Figure Dvi.1 Photomicrograph of JMH 17 reveals white substance at the interface of the brown coat and finish coat. Magnification 100x (Photo by M.-C. Boileau, 2018)

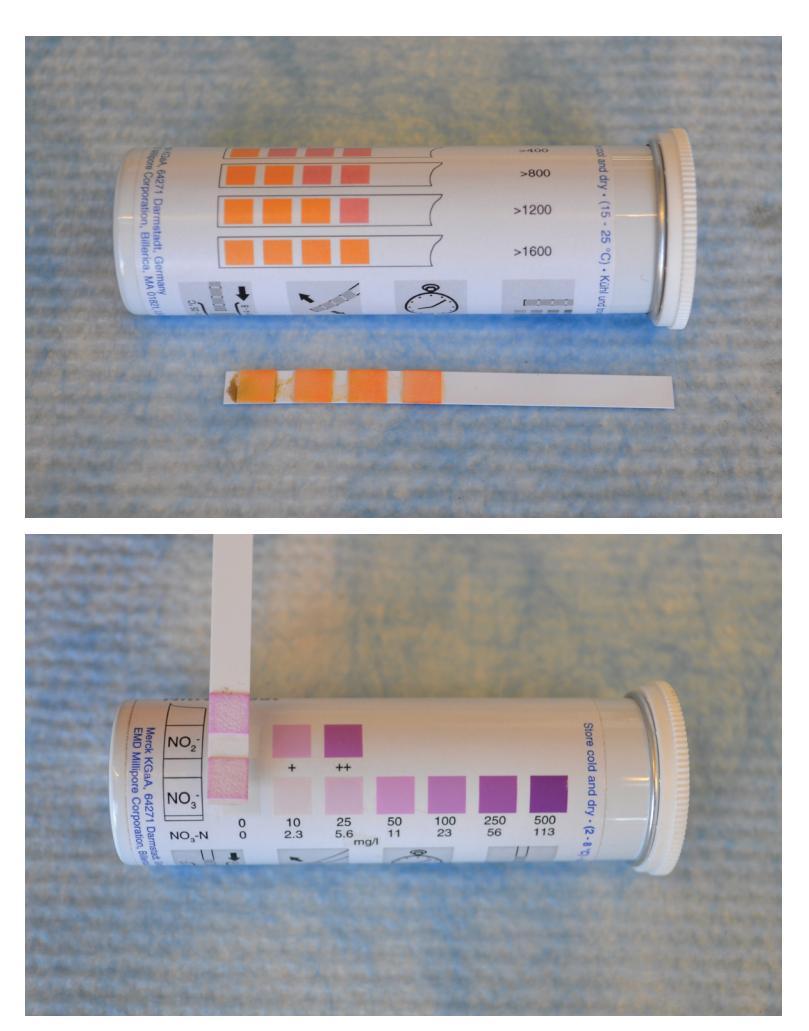
Figure Dvi.3 Test strips indicate that the sample contains both sulfates (top) and nitrates (below). (Photo by the author, 2018)
