THE NEW HOPE EXPERIMENT: AN INVESTIGATION AND CONSERVATION PLAN FOR THE
ANTONIN AND NOÉMI RAYMOND FARM

A THESIS

Historic Preservation

MASTER OF SCIENCE IN HISTORIC PRESERVATION

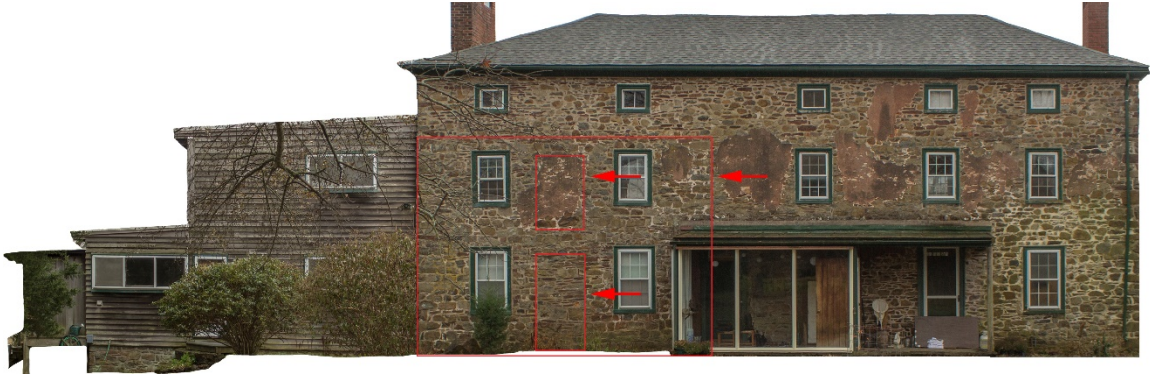
It is the current hypothesis that this structure began as a single-cell 1-1/2 story house, which was expanded concurrently with the growth and prosperity of the Ross family. This hypothesis is supported by several factors: First, construction seams are visible on the north façade, with the ghost outline of an infilled central door and upper story window also visible on the same elevation (Figure 7). Secondly, a foundational wall in the basement lines up with one of the construction seams, and an investigation of the first-floor joists from the basement shows a change in construction technology on either side of the wall (Figure 8). The joists to the east of

Figure 7. North elevation with arrows and red lines indicating the presence of a construction seam evident in the masonry. Photo Credit: Anthony Hita, November 11, 2017, indication alterations by author.

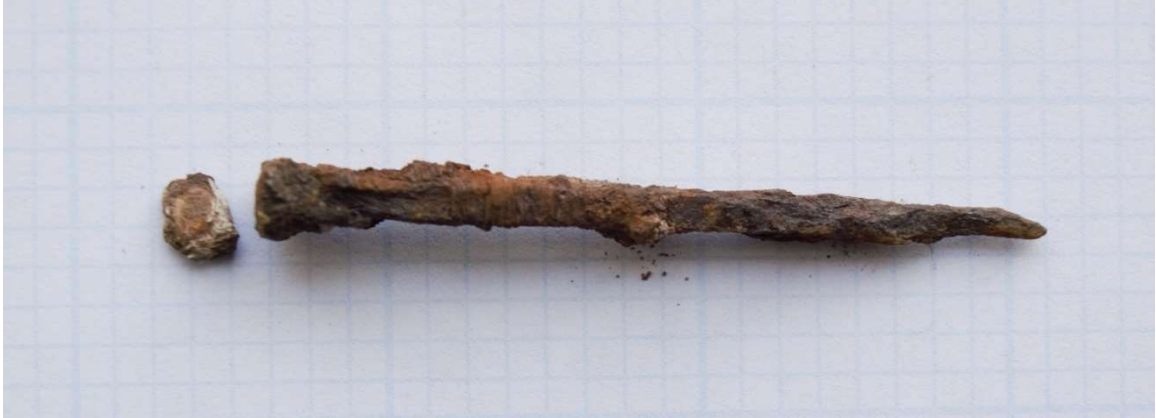
Nails extracted from the Raymond farm house include all types, wrought, cut and wire, reflecting the evolutionary nature of the structure. A singular wrought nail was pulled from a northern interior window surround where material loss of the wood exposed the head and a black iron stain was being created by corrosion of the nail. This nail tapers on all sides to come to a distinct point (Figure 17). Unfortunately, corrosion obscured the head type and caused the top of the head to delaminate from the body of the nail upon extraction. Though corrosion covers the majority of the nail creating lateral striations, the wood-like in-line grain is visible, confirming it to be wrought.

Figure 17. Nail extracted from the interior window surround of the window to the east of the front door on the north facade. Technological features indicate this is a wrought nail. Source: Author.

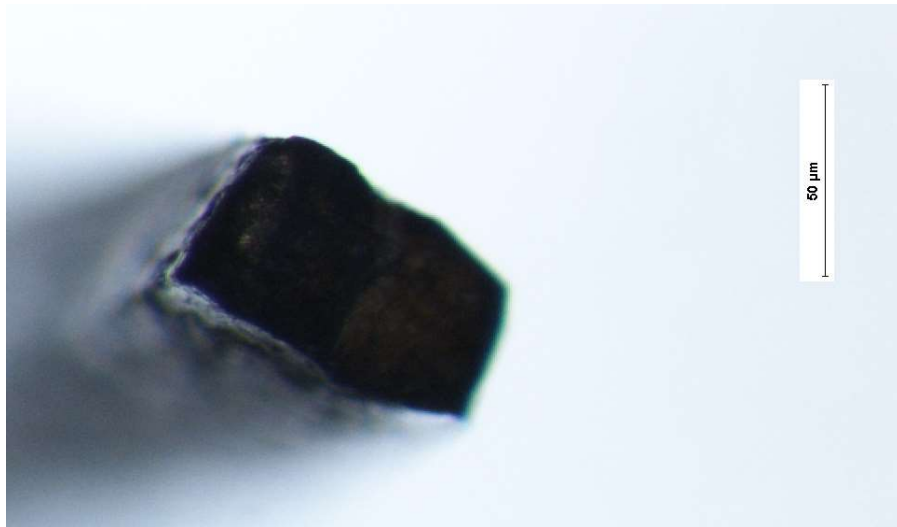
A detached piece of applied moulding belonging to the standalone southern door on the first floor proves to be a useful feature to be used in the dating process by examination of both the nails and the moulding itself. These nails are smaller yet have dateable diagnostic features. These nails are classified as cut based upon the taper on only two sides, and a rounded point. While not readily visible to the naked eye, small burrs on the same side of the nail can be seen when viewed under magnification (Figure 18). The cross-grain can be seen along the longer face of the nail, which identifies it as a likely type 5 or 6 nail from the Wells chronology (Figure 19). The only feature of these nails that differs is the pinch, however these nails are still embedded in the detached piece of applied moulding, therefore head type and pinch are not able to be discerned. Both types 5 and 6 were in production roughly around the same time, from 1805-1840, which falls in line with the general trend of the older types found due to slow dissemination to the rural areas, and this information points to use in the 1850s Van Sandt building campaign.

Figure 18. Small Burrs appearing on the same face of the same cut nail in Figure 18. Magnified 10x. Source: Author.

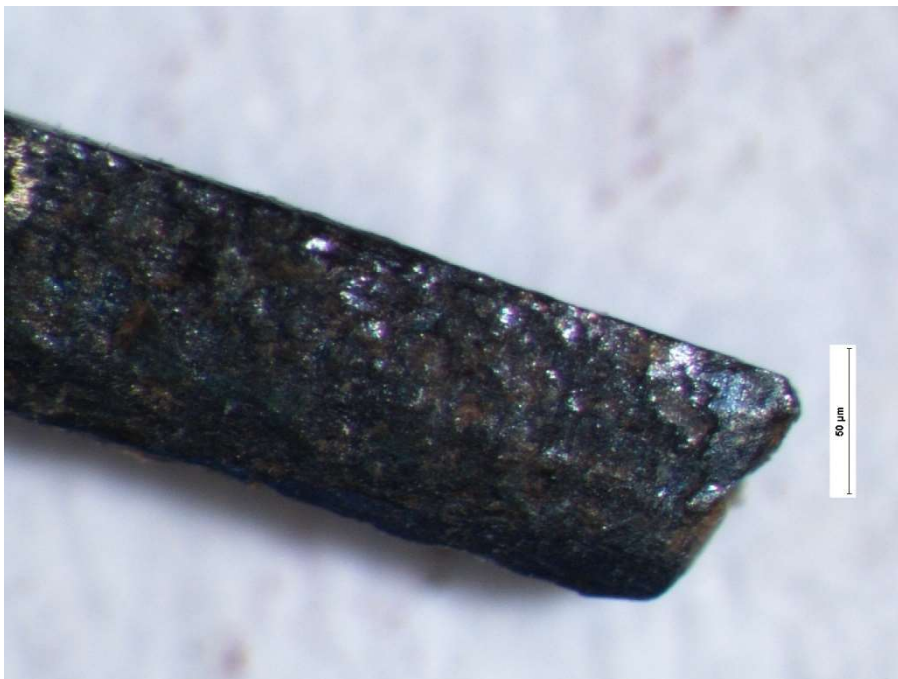
Figure 19. Cross-grain visible on a nail embedded in a piece of detached applied moulding. Magnified 10x. Source: Author.

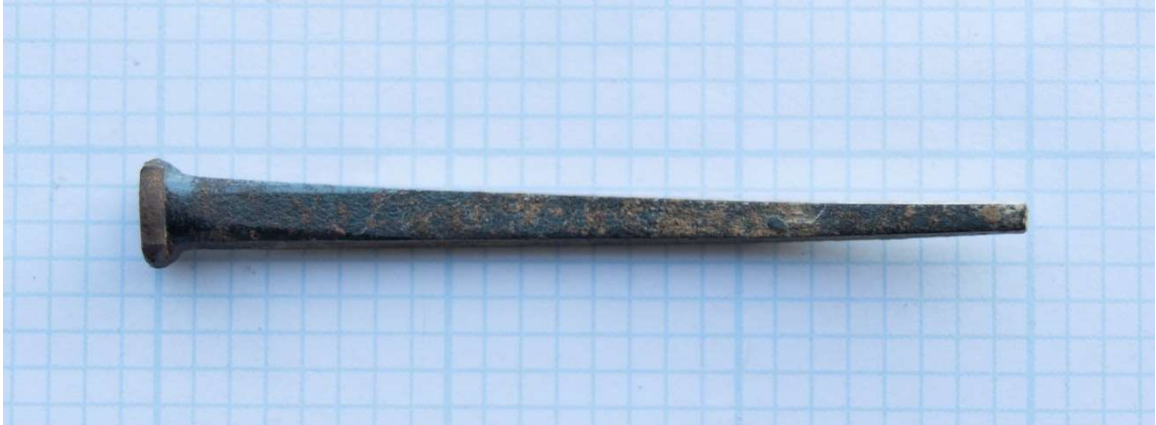
The fasteners that penetrate through the first-floor boards into the basement were investigated and appear to be mostly cut nails, with a very small percentage of more modern wire nails in select areas. One of the flooring nails was extracted and examined, and shows a taper on only two sides, flat point, which are indicative of most styles of cut nails, however the

nail is face-pinched, burrs are located on the same side, the head is uniformly thick and sturdy, and the grain direction runs longitudinally (Figure 20). These features match the nail type 8 described in Well's nail chronology, which saw use in Louisiana between 1820-1890. While this is a large date range, it was likely implemented during the 1850s Van Sandt building campaign, as any other owners would have been working in an era of readily available wire nails. While the earliest dates associated with this type of nail predate this construction campaign, the rural nature of the house likely prevented quick dissemination of construction materials. Therefore, nails that had been produced almost a decade before might just be introduced in the New Hope area market much later than more urban centers. While the Raymonds were historically minded in their intervention of the house, cut nails are much costlier than wire nails during their intervention. Correspondence between the Raymonds and their Japan office during this construction phase convey a sense of financial stress, so it is very unlikely that they would have invested in reproduced cut nails to use in the flooring. Aside from the rectangular-headed cut nails described above, two flooring brads with a characteristic L-shaped head are present in the second-floor west bedroom's floor. These types of brads begin to appear in the early 1800s and are prominently used for flooring, however they continue to be produced through the present, therefore dating based solely on these nails is not advised.⁶⁸ However, this knowledge combined with the use of other cut nails in the lumber one can infer that the earliest dates of implementation are the early 1800s.

Figure 20. Cut nail extracted from the first-floor boards. Diagnostic features described by Wells indicate this nail was likely produced between 1820-1890. Source: Author.

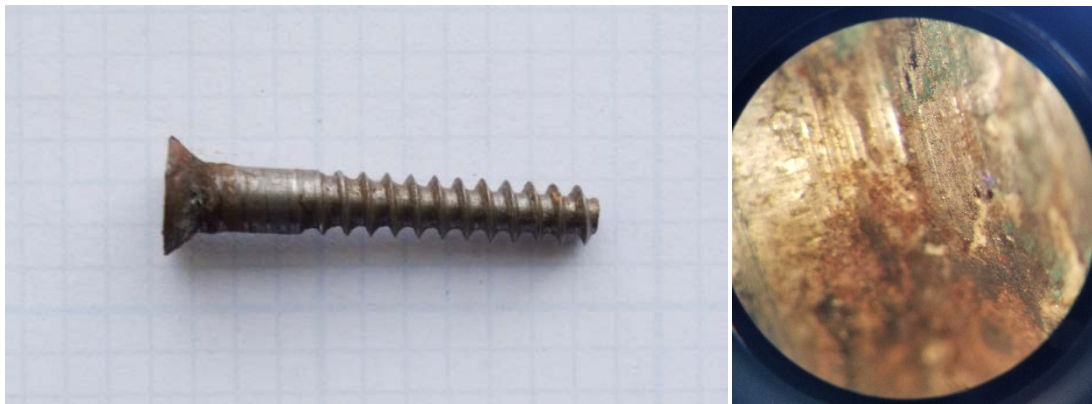
A screw removed from the butt hinge of the southern door with the detached applied moulding supports the evidence from the moulding and nail that infers that it was put into place in the 1850s Van Sandt building campaign (Figure 21). The head shows circular marks on the underside indicative of machine heading, has a very slight taper, and terminates in a blunt edge

rather than a point, signifying that it was likely produced between 1837 and 1846. Again, the rural nature of the site likely kept this screw from being disseminated to the area until slightly later than was the norm. This hinge utilizes all screws of this type, cementing the likely date ranges for the piece. A screw with the same diagnostic features was also extracted from the hinge of the southern batten door on the west interior elevation, however other screws from the hinges of these doors proved to be post-1846 gimlet screws, indicating that they were likely rehung later than 1850.

Figure 21. Screw extracted from the main southern door on the first floor. The blunt tip and circular marks under the head (right) indicate it was made sometime between 1837-1846 when the advent of gimlet pointed screws made these obsolete. Right image magnified 10x. Source: Author.

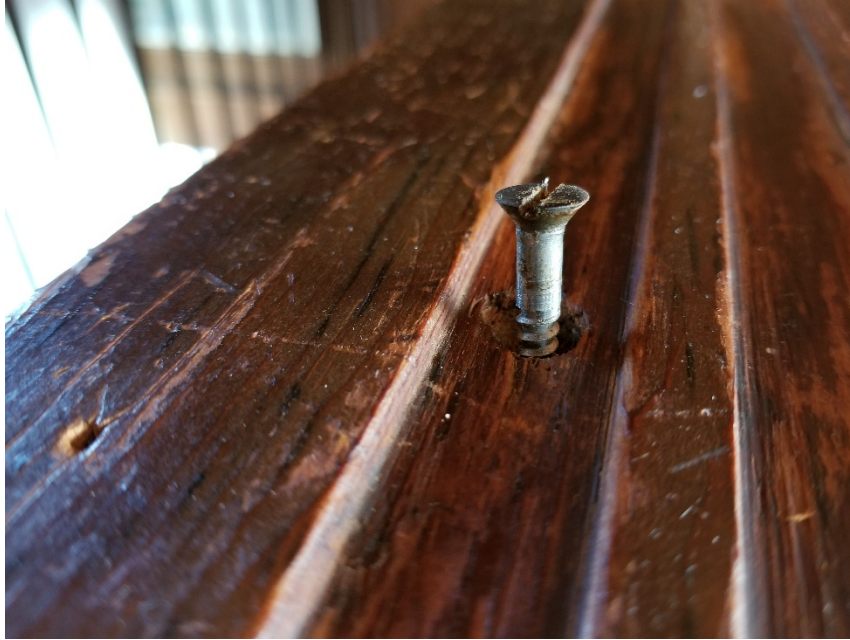
Figure 22. Screw extracted from the mezzanine-level fusuma track that creates the division between the hallway and lightwell area. Source: Author.

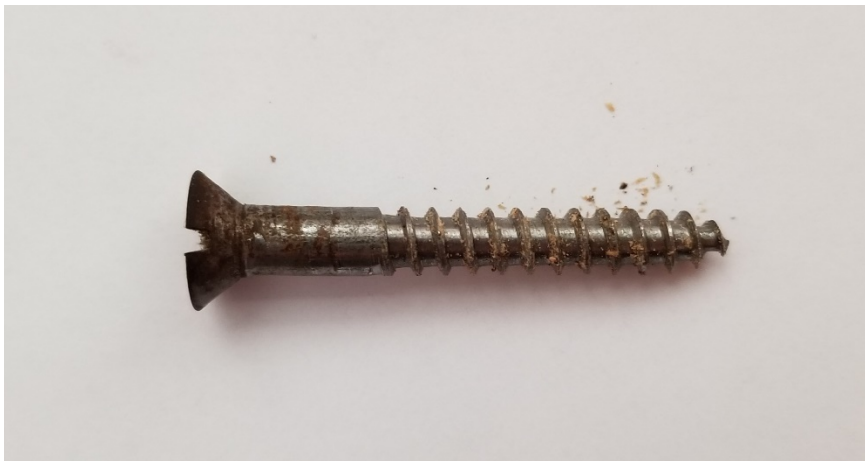
Modern styles of screws are found in the known Raymond campaign, including the lightwell fusuma tracks, some areas of the interior woodworking, as well as in the butt hinges of many interior doors (Figure 22). Though the wooden elements of the main stair from the first to second floor have been determined to likely be a part of the 1780s campaign, modern screws were extracted from it, acting as another indicator that the stair was moved to its present location during the Raymond campaign (Figure 23).

Figure 23. Screw removed from the stair baluster railing on the second floor showing machined head and gimlet point, indicating the likely manufacture date to be post 1846. Though the woodwork is likely from the 1780s campaign, the presence of modern screws supports the hypothesis that it was moved to its current location during the Raymond campaign. Source: Author.

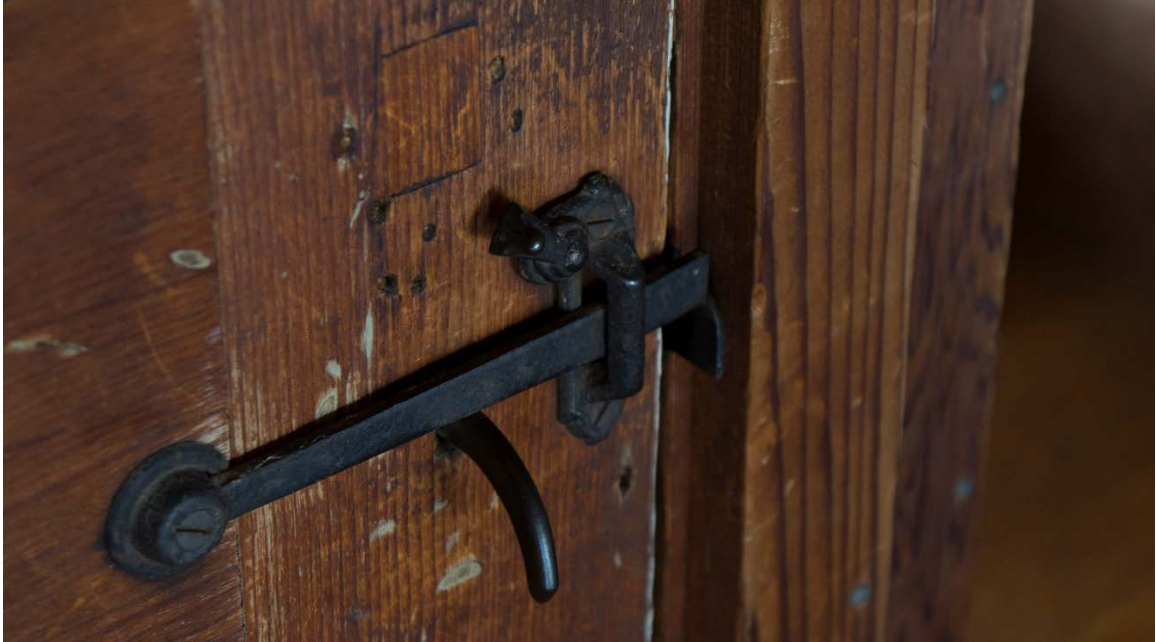
While early Suffolk latches were wrought, cast iron latches came into use as early as the late 18th century.⁷³ Other thumb latches on several interior doors utilize a curved lift, however the smoothness of their metal and the newness of their fasteners indicate that they were cast rather than wrought and are likely modern reproductions of this style of thumb lift. The one exception of a thumb latch that appears to be from a pre-modern era is present in a closet door on the third floor to the west of the stair. This latch appears to be a cast Suffolk latch, showing a coarse finish, and a downward turned lift, indicating it was produced after 1800 (Figure 25). The cusps are trefoil shaped, which was a popular style in the New Jersey area.⁷⁴

Figure 25. Cast iron thumb latch located on a third-floor hallway closet. The downturned lift indicates it was produced after 1800. The handle is on the interior, indicating the door was moved to its current position in the Raymond campaign. Source: Author, March 16, 2018.

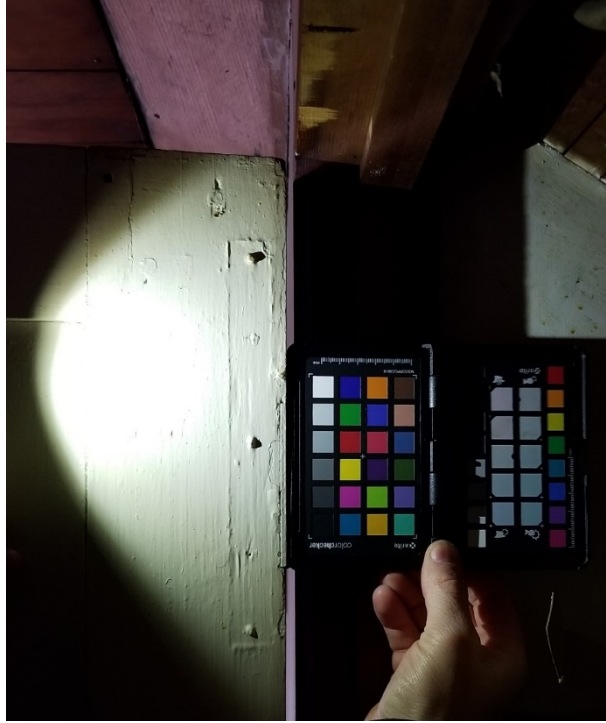
With origins in the Medieval period, the H hinge was the most used style of hinge hardware through the Colonial period.⁷⁵ H Hinges were usually hand-wrought iron that were fastened to the door and surround either by relatively expensive wood screws or by clinching the nails, thus making the door difficult to remove. The distinctive shape of these hinges allowed for the nails to be spread out over a larger area of the door, which prevented issues that arose with splitting the wood along the grain when fasteners were clustered together. While no H hinges are currently present at the farm house, a third-floor west bedroom closet door shows the ghost of a previous H hinge on its interior (Figure 26). This ghost is situated under a layer of paint, indicating that this door was likely from the pre-Revolution period, but moved at some point to its current location utilizing a different style of hinge.

Figure 26. Ghost of a previous “H” hinge on a third floor door, indicating it was moved to its current location. Source: Author, February 19, 2018.

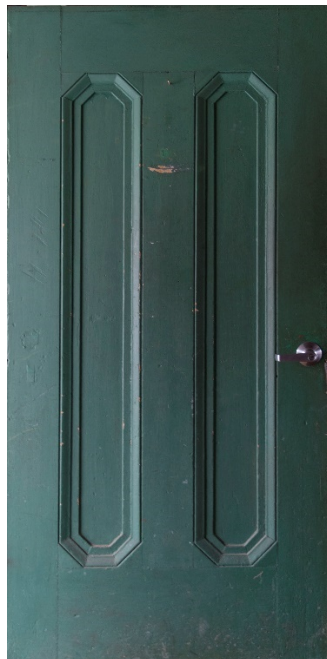
There are some moulding types that indicate definitively that they were made post 1810 as defined by McNulty, thereby falling into the 1850s Van Sant construction campaign. The three main doors on the first floor, two on the north façade and one on the south are built using applied mouldings in the form of elongated hexagons and rectangles (Figure 29). Also, the two panels stretch the majority of the length of the door without break by a horizontal rail, a style

Figure 29. Style of door used on the first-floor main openings on the north and south elevations. Distinctive elongated hexagonal moulding is applied to the panel with small finishing nails, inferring they were constructed in the early-mid 1800s. Source: Author.

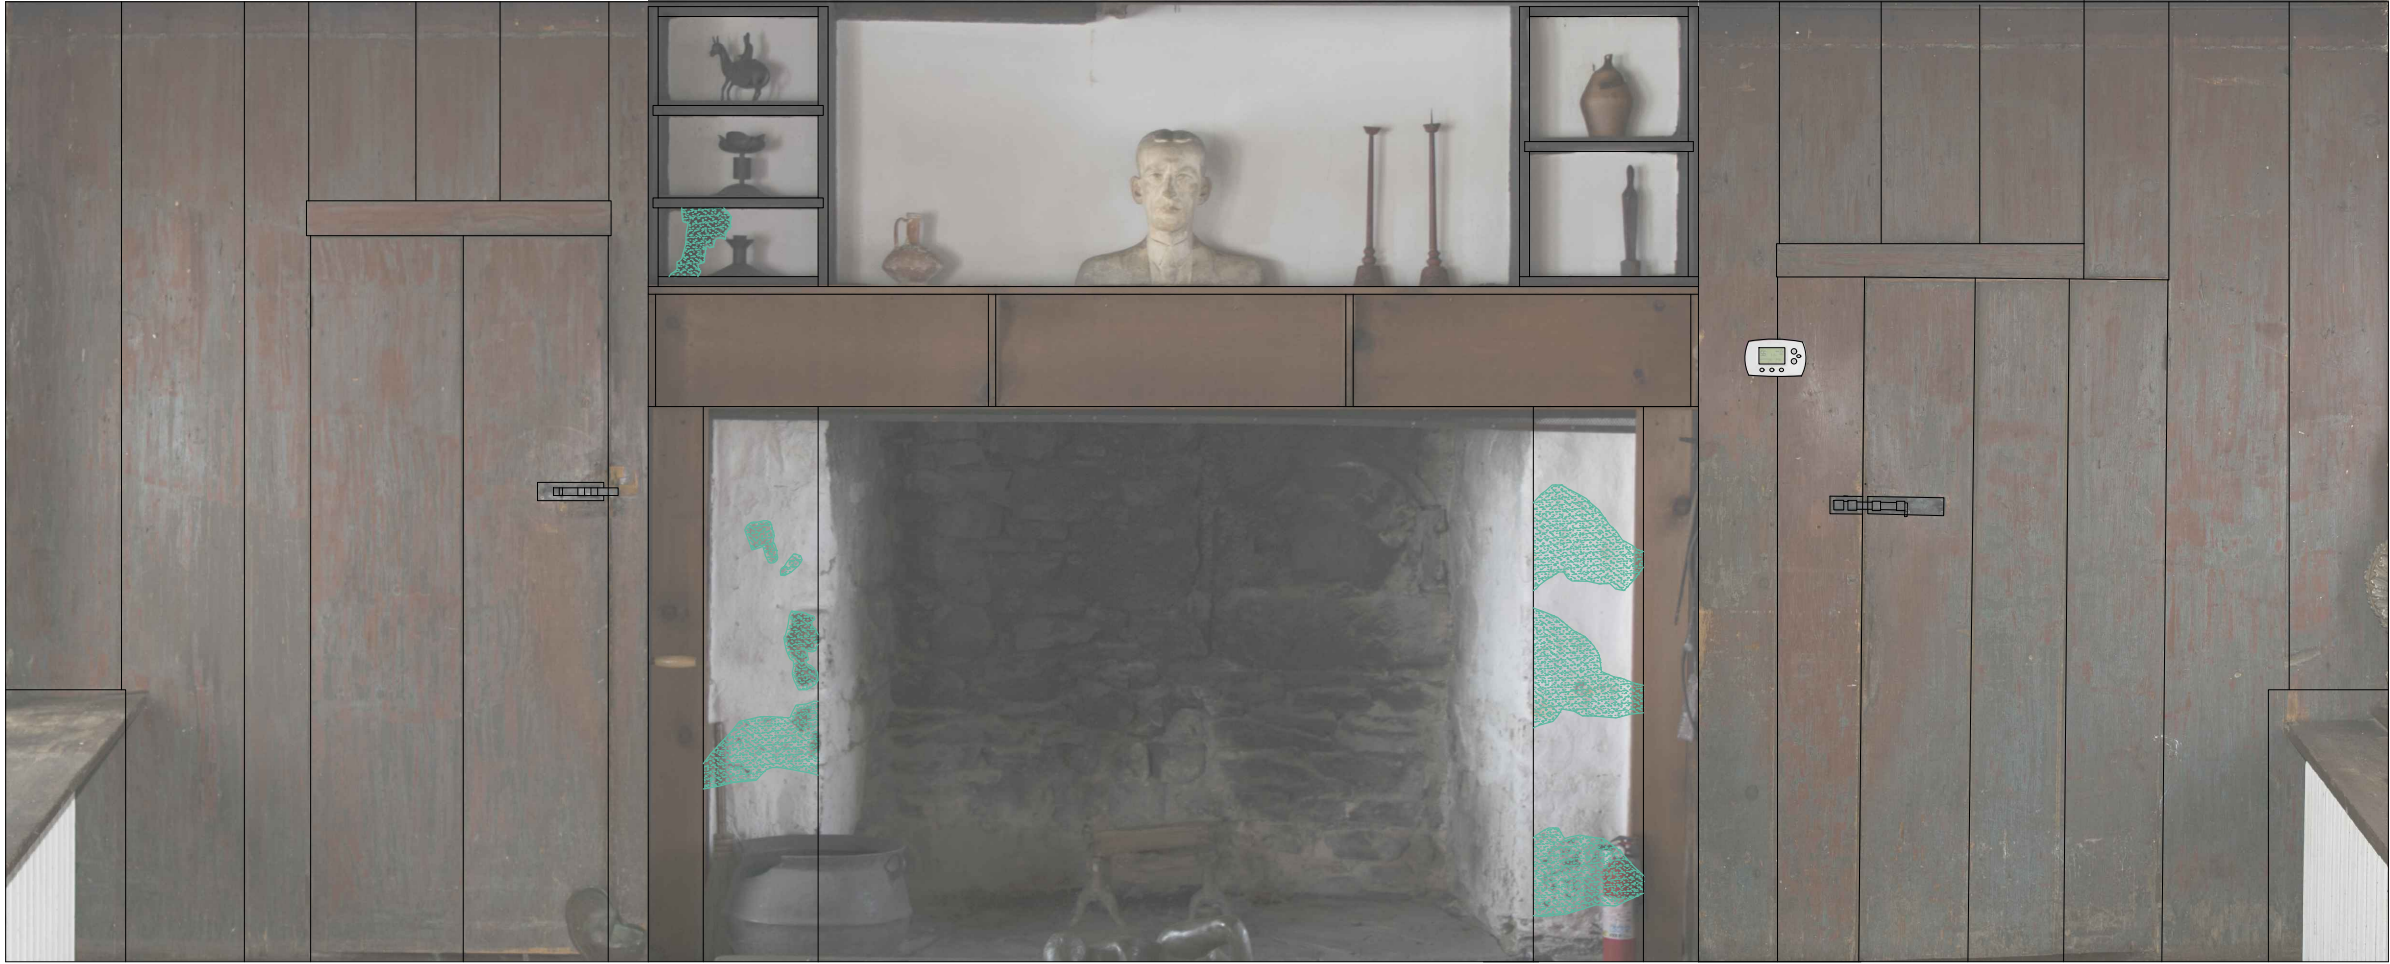
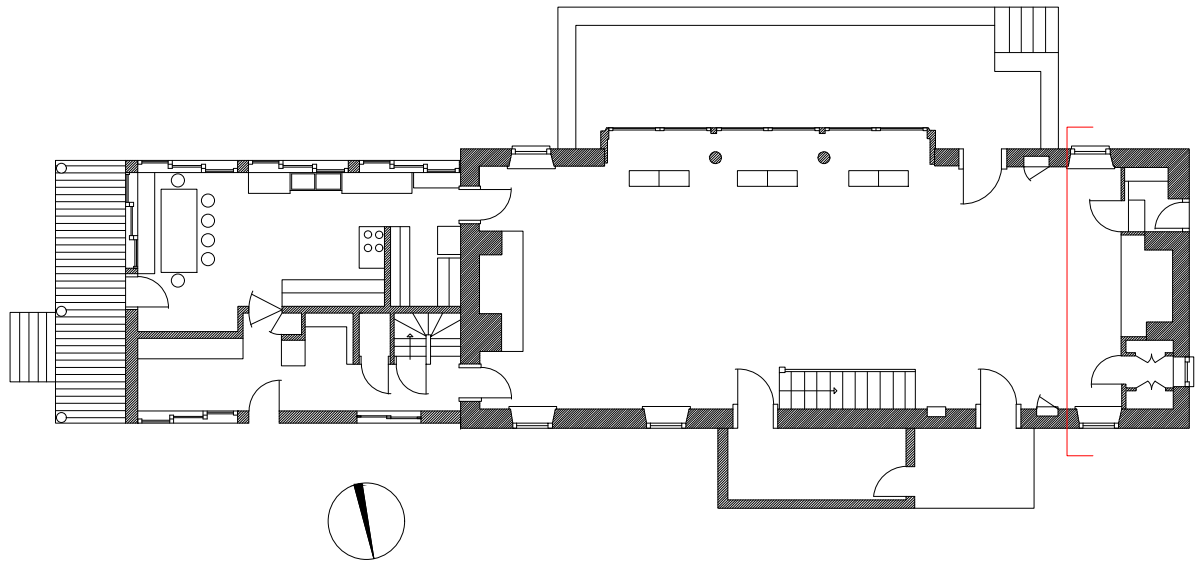
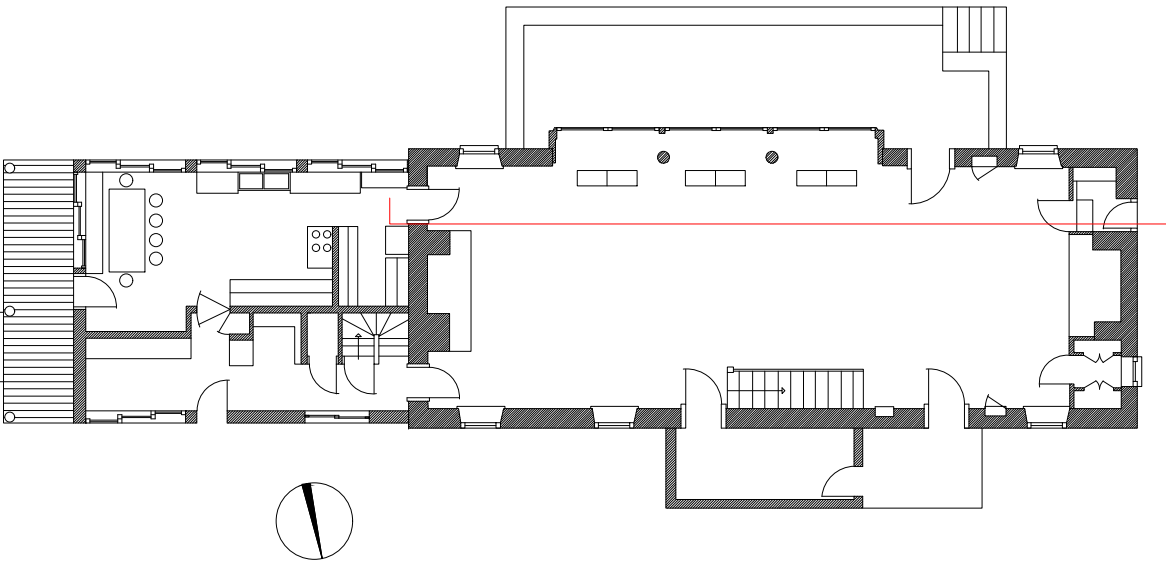
Sheet #
1.2

Finish Failure

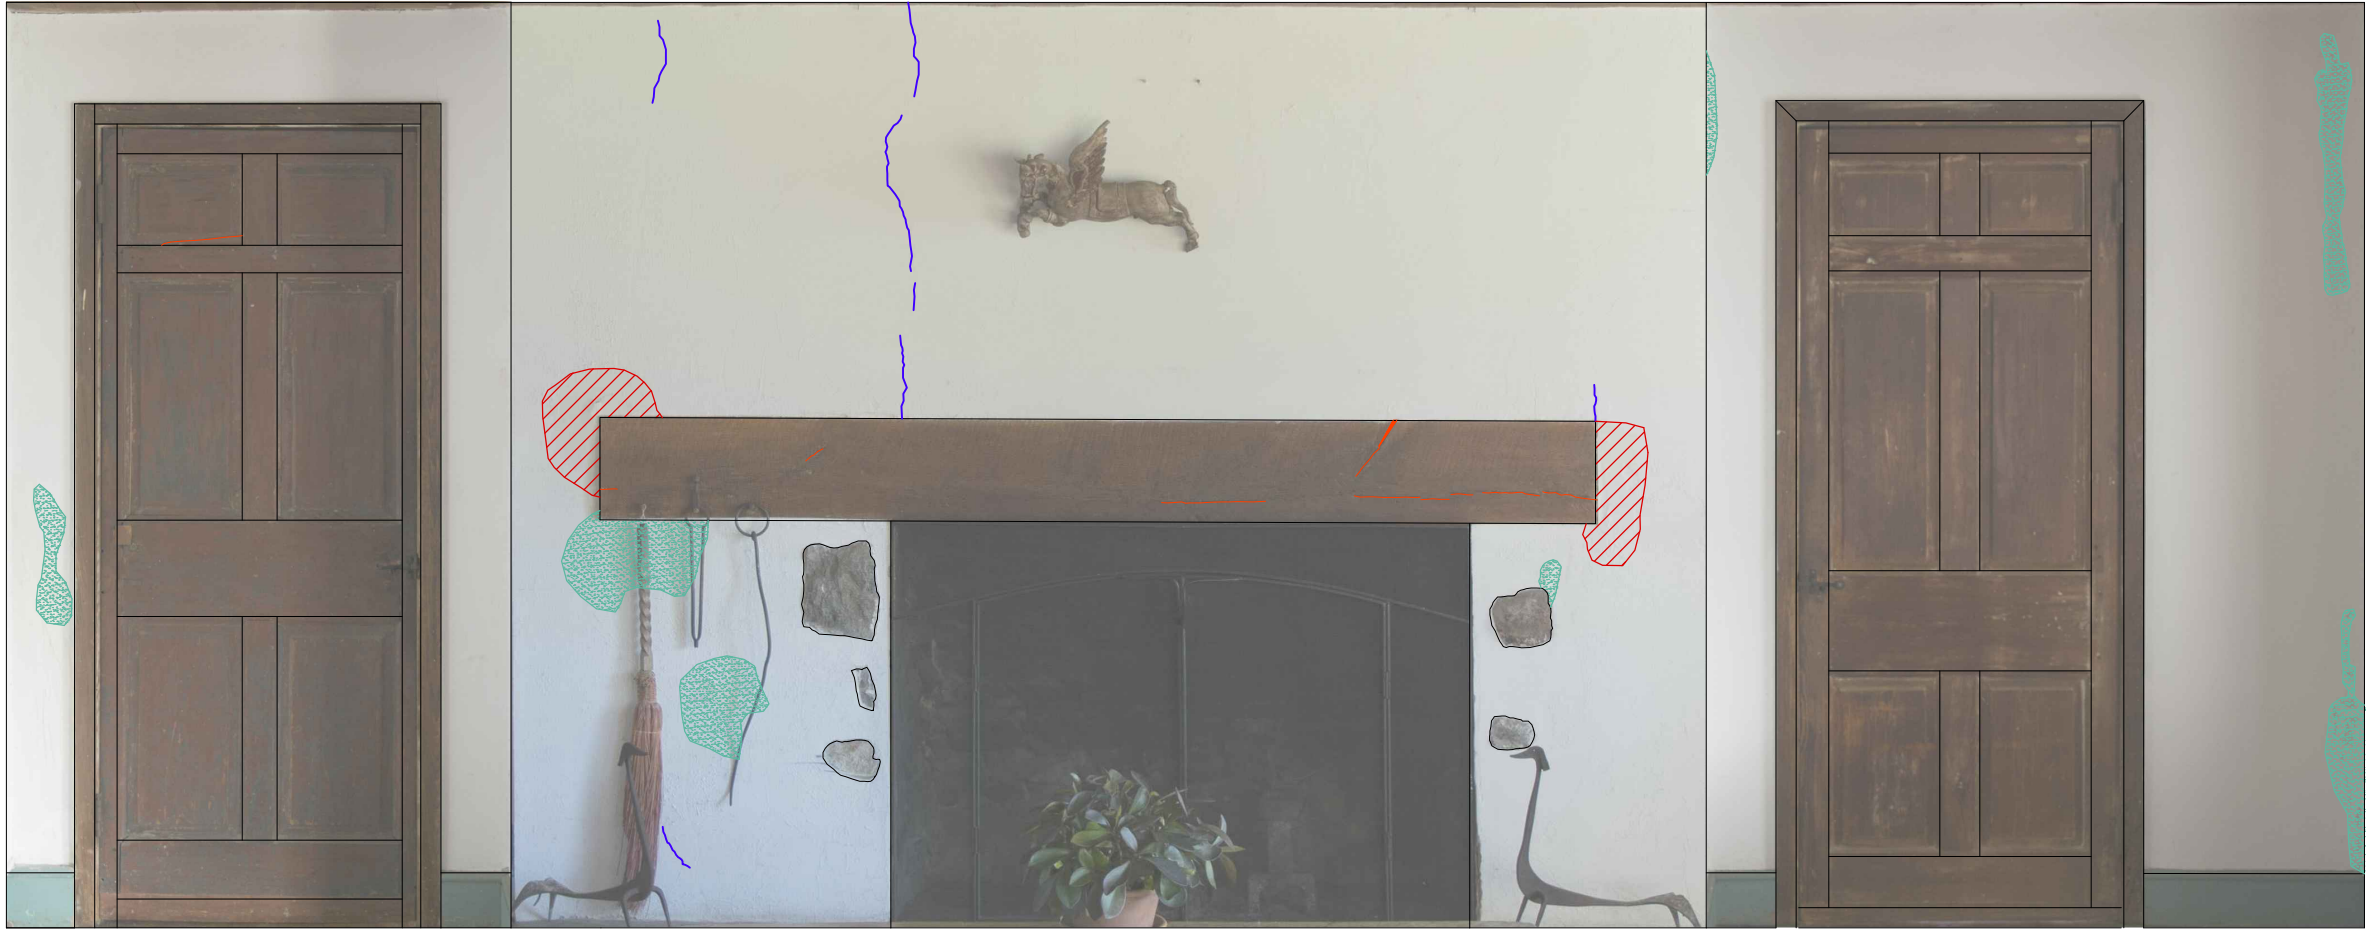
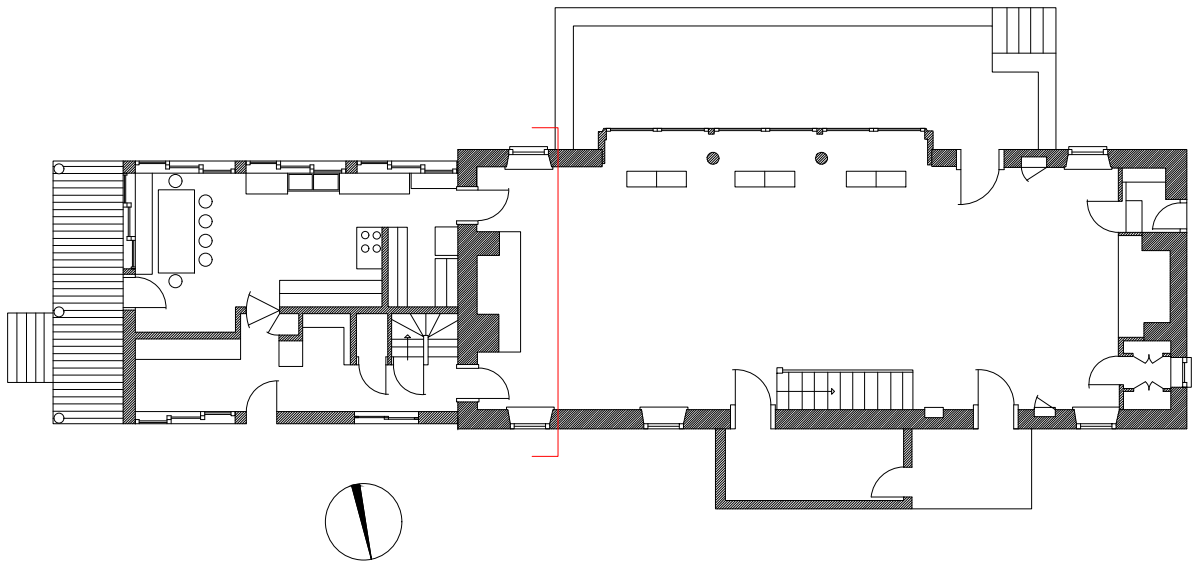
1.4

- Finish Failure
- Previous Repair
- Plaster Crack
- Wood Check or Split

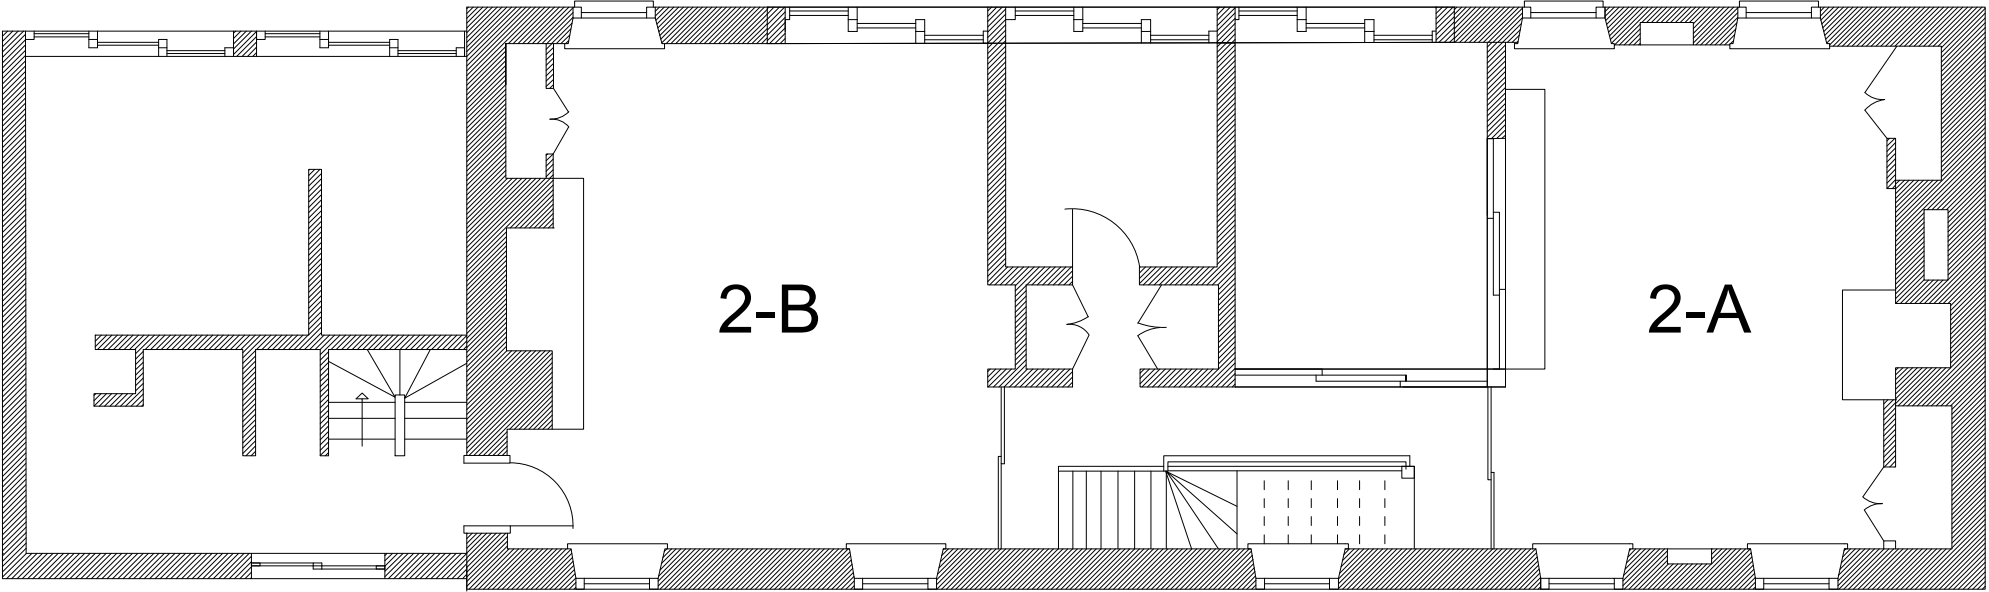
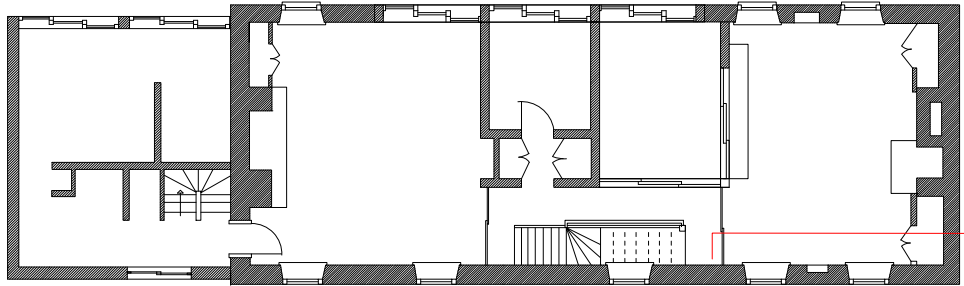
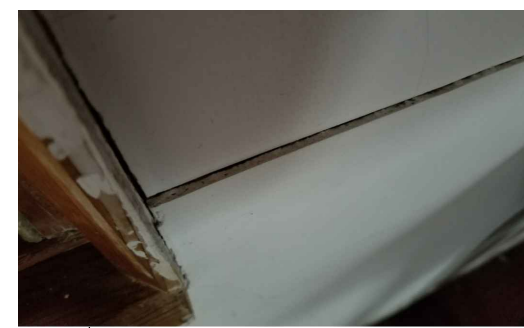
Sheet #
2.1

- Finish Failure
- Previous Repair
- Major Insulation Crack

Generalized Microcracking of Insulation

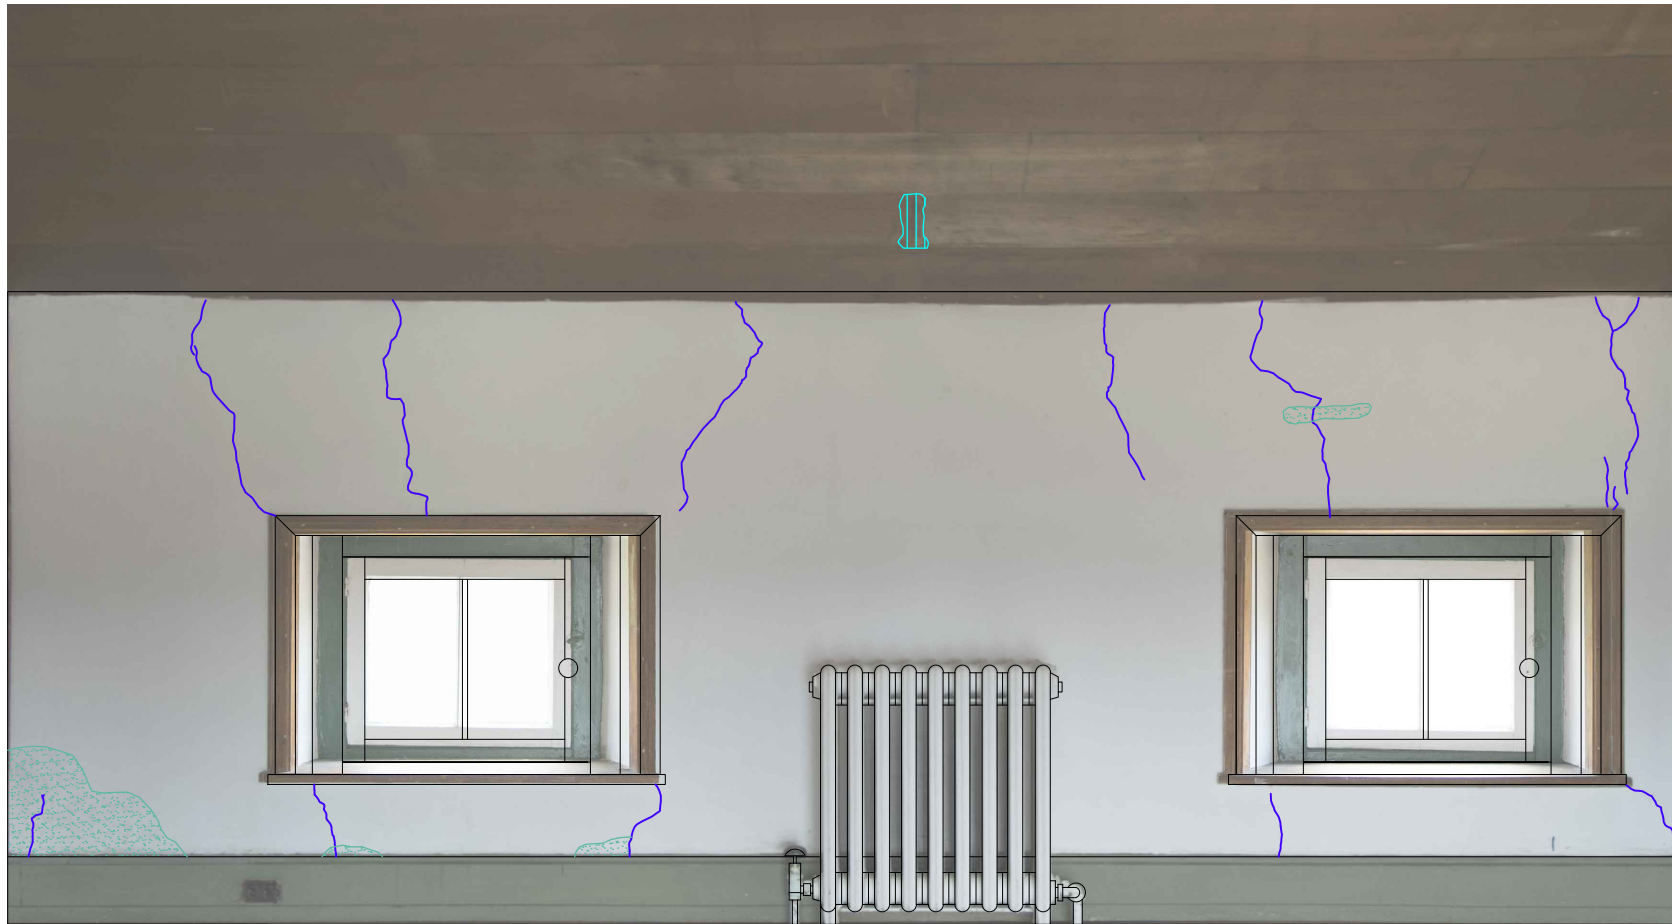
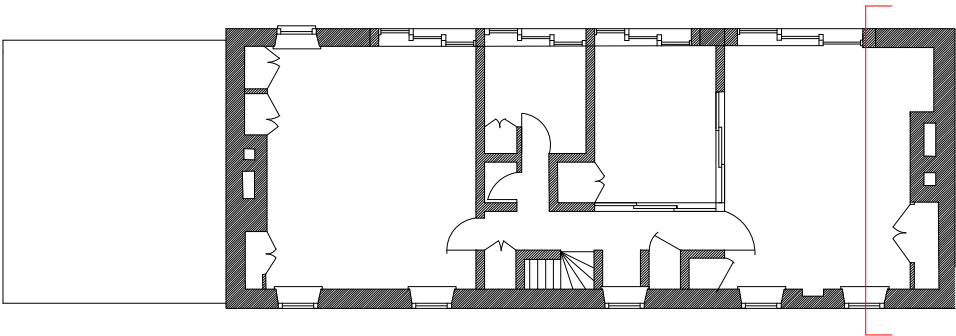
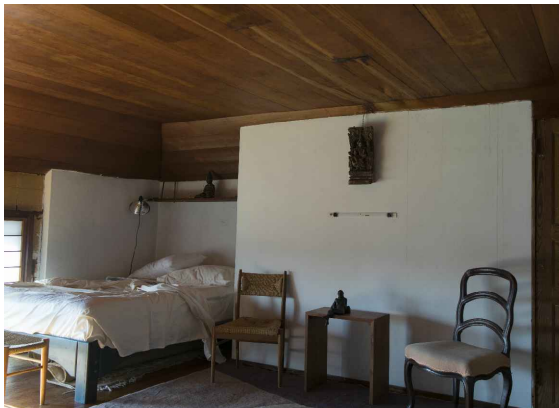
Sheet #
3.2

- Water Staining
- Previous Repair
- Delaminating Veneer
- Loss of Veneer
- Plaster Crack

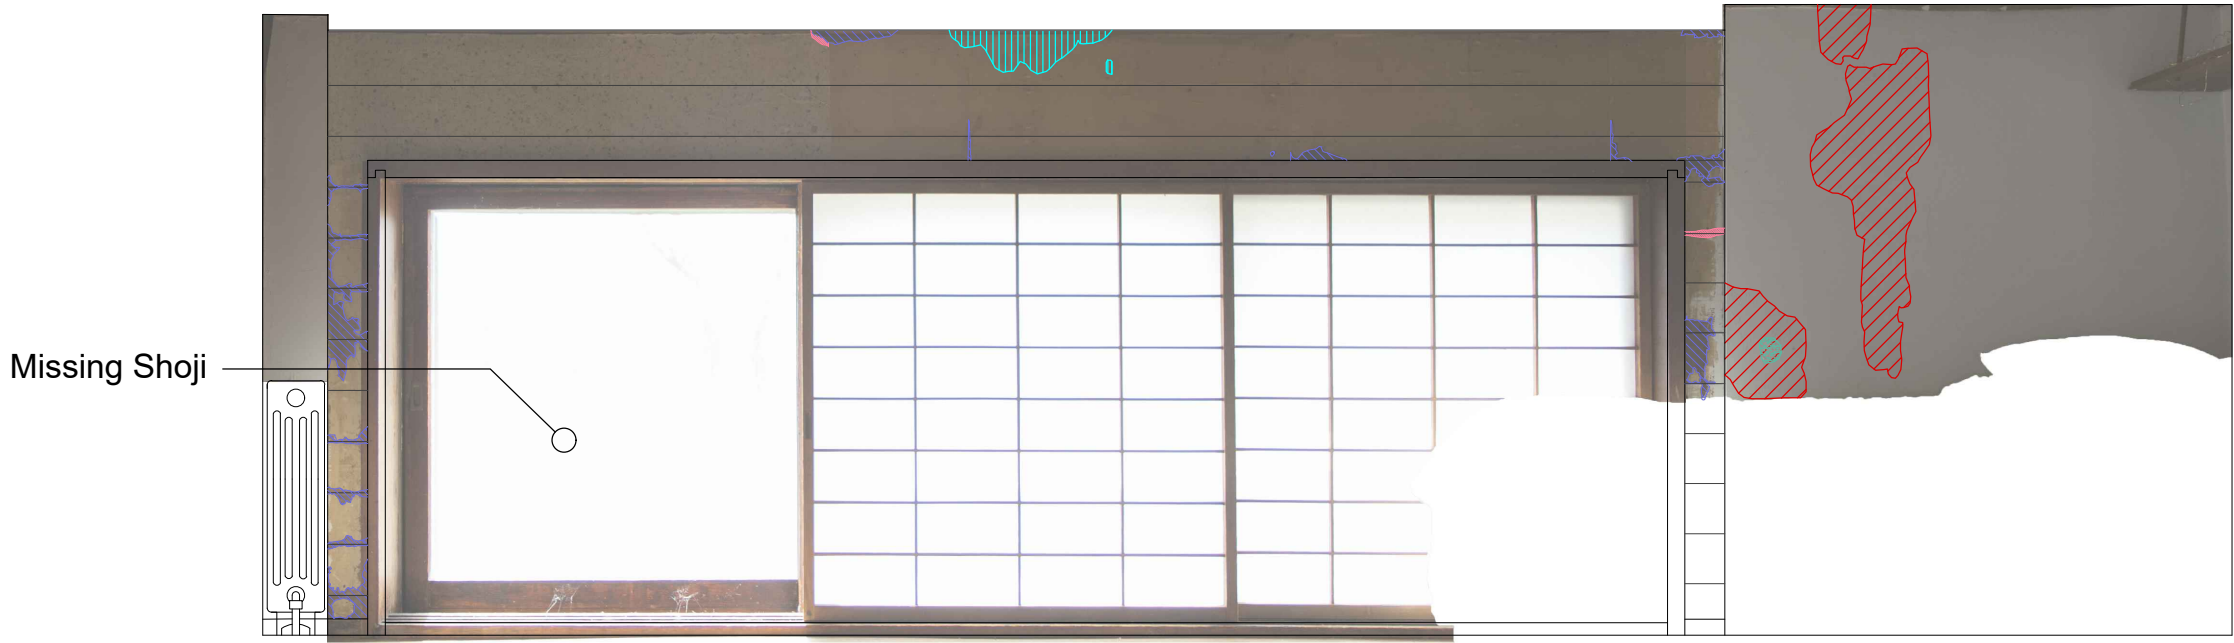
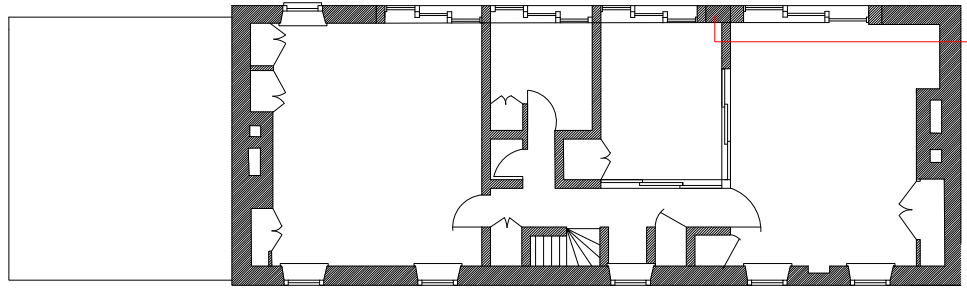
Farm House -
Room 3-A
West Interior Elevation

-   Finish Failure
-   Paper Loss
-   Paper Delamination
-   Previous Repair

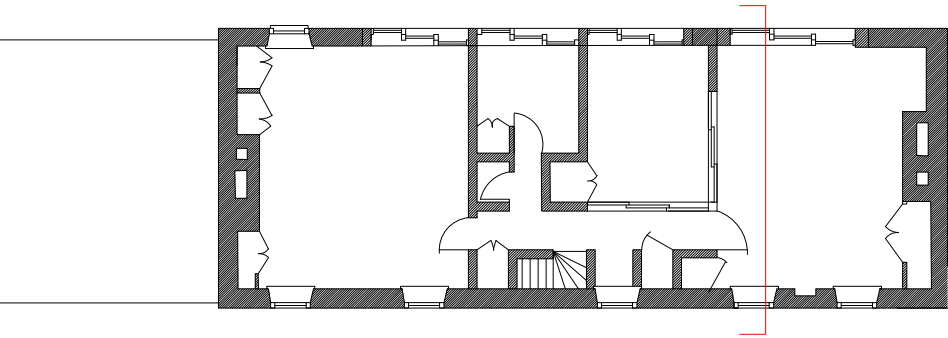
3.4

- Finish Failure
- Paper Delamination
- Paper Loss

Fusuma missing decorative paper

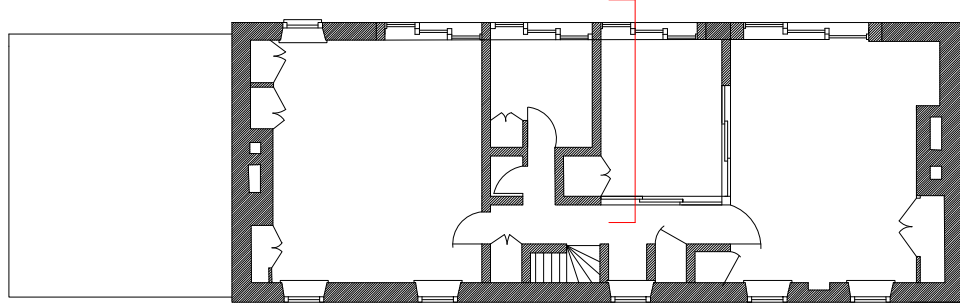
Farm House - Room 3-B
North Interior Elevation

Water Staining
-

Water Repellant Coating

Ghost of previous kitchenette unit

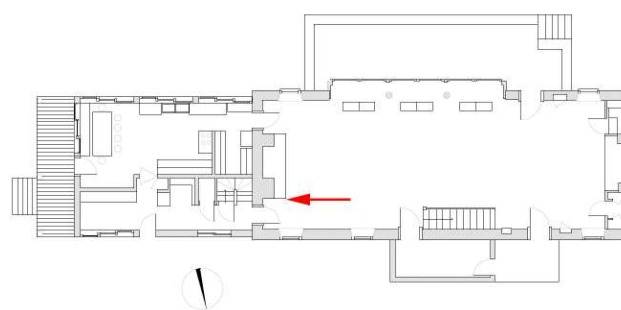
Notes: First floor main room. Hot water pipe embedded in the masonry travelling from the water heater in the basement to the upper floor radiators. This constant heat in the winter causes finish failure on the surrounding wall surfaces. This heating system is eventually leaking into the attic space above the layer of blown insulation.

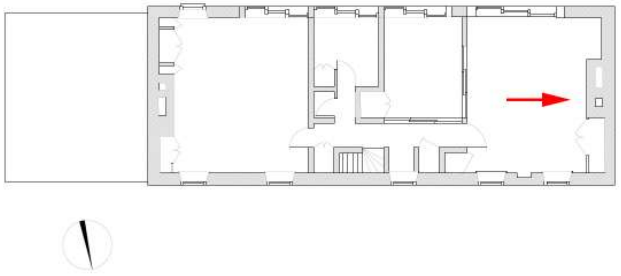
Notes: Third floor western bedroom. Heat trapped in the attic is entering the bedroom through joints in the woodwork at between the wood and masonry. Small amounts of liquid water is also likely leaking through the roof to enter the interior here.

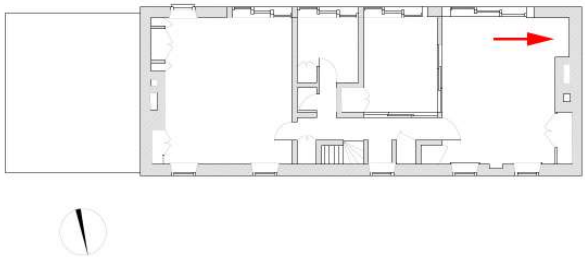
Notes: Third floor western bedroom. Heat trapped in the attic is entering the bedroom through joints in the woodwork at between the wood and masonry. Small amounts of liquid water is also likely leaking through the roof to enter the interior here.

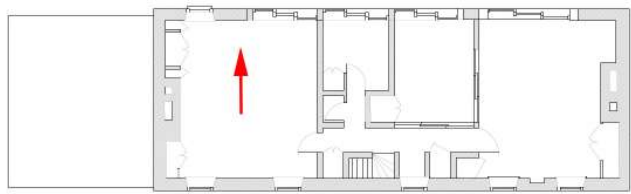
Farm House - 3-B South Interior Elevation

Notes: Third floor eastern bedroom south wall. Areas of higher thermal activity are areas that show black iron water staining. Mild cupping allowing heat trapped in the attic space to enter the room through crevices in the wood. Surrounding wood likely retaining heat due to higher moisture content, indicative of an active leak.
