THE NEW HOPE EXPERIMENT: AN INVESTIGATION AND CONSERVATION PLAN FOR THE
ANTONIN AND NOÉMI RAYMOND FARM

A THESIS

Historic Preservation

MASTER OF SCIENCE IN HISTORIC PRESERVATION

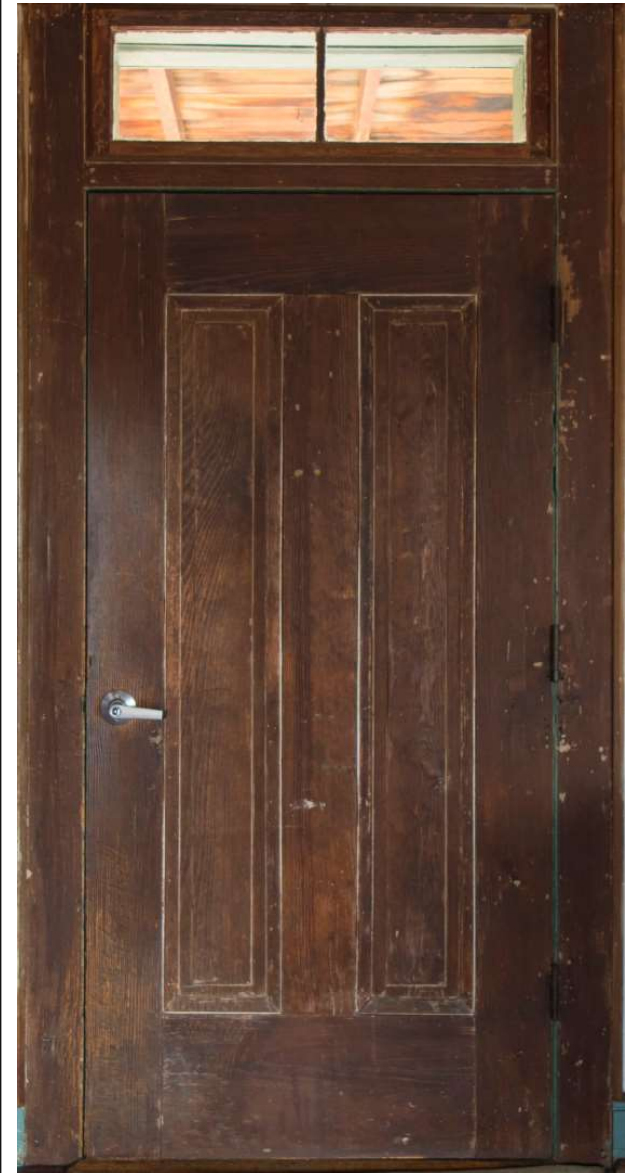
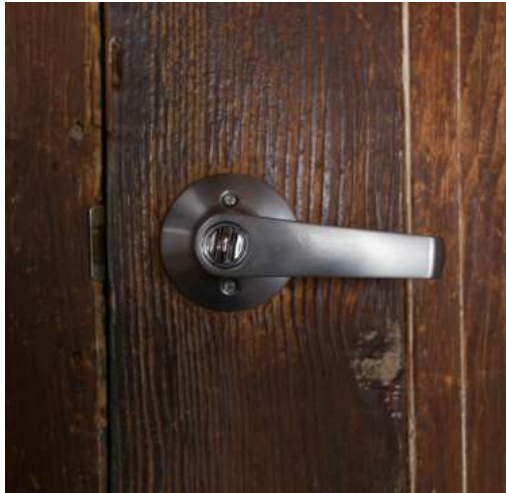
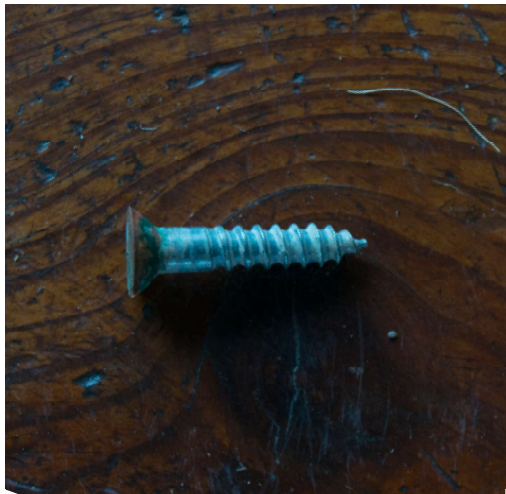
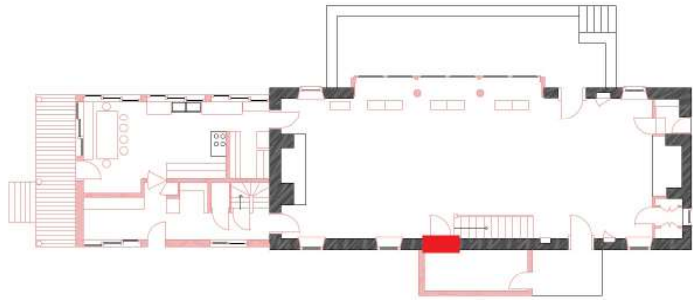
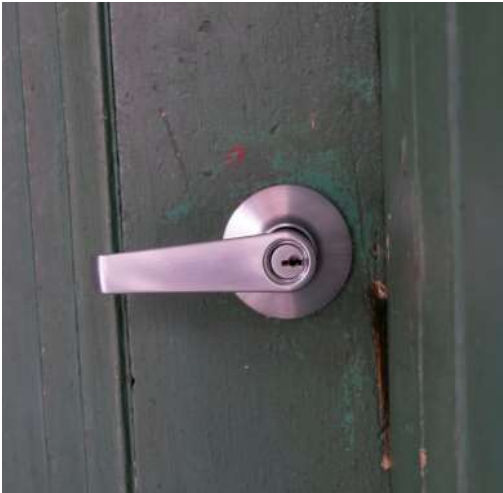
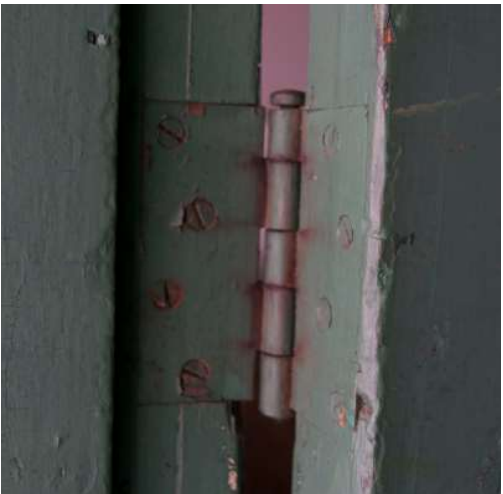
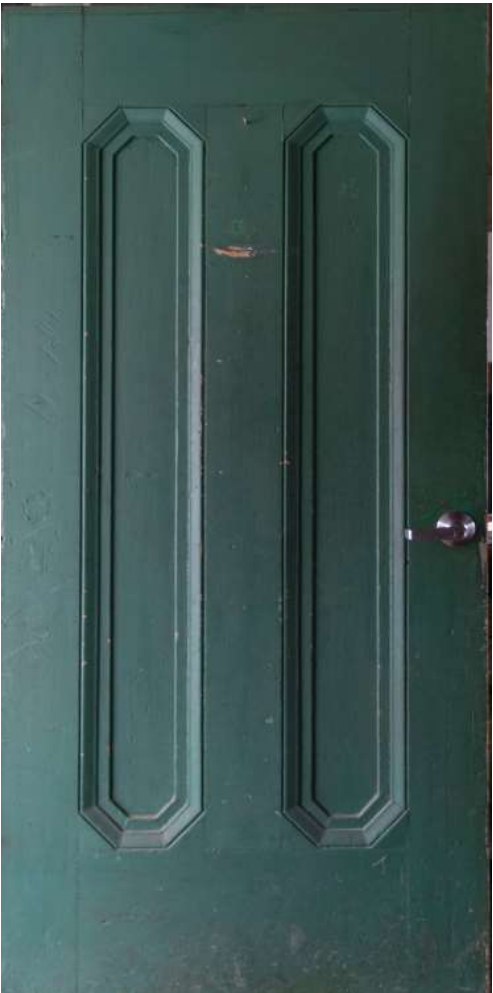
Notes: Modern interventions on the exterior side of the transom. (not pictured). Door matches style of two other first-floor doors. on north and south elevations. Two extracted screws show post-1846 gimlet points. Door was likely rehung during Raymond campaign.

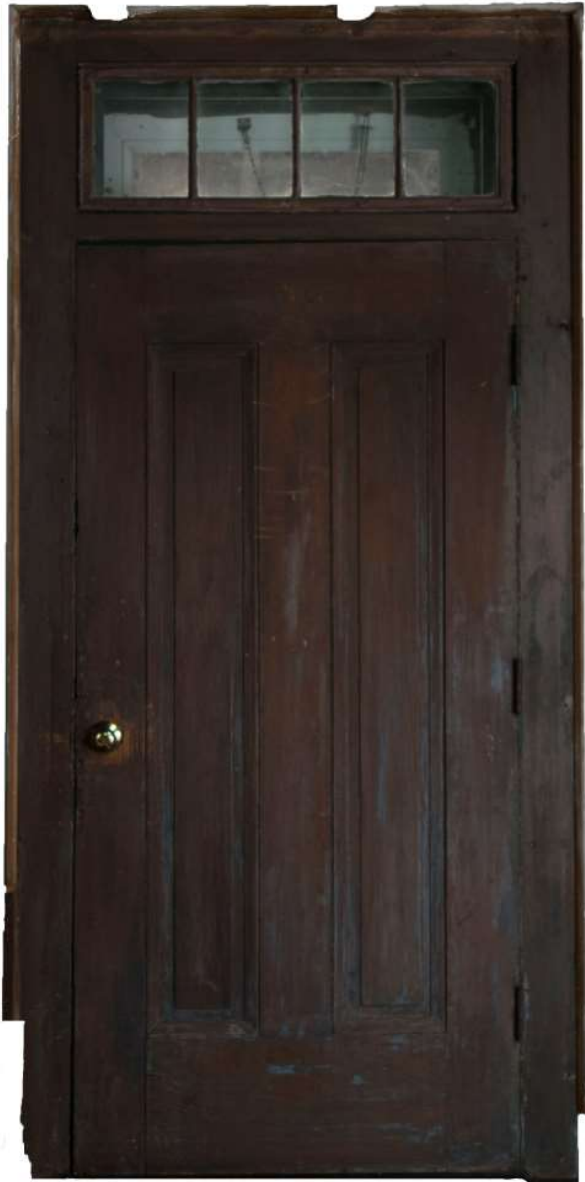
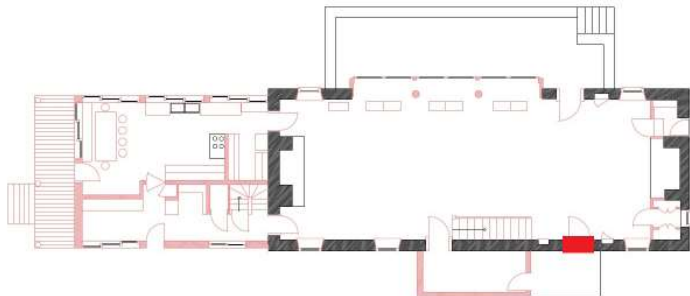
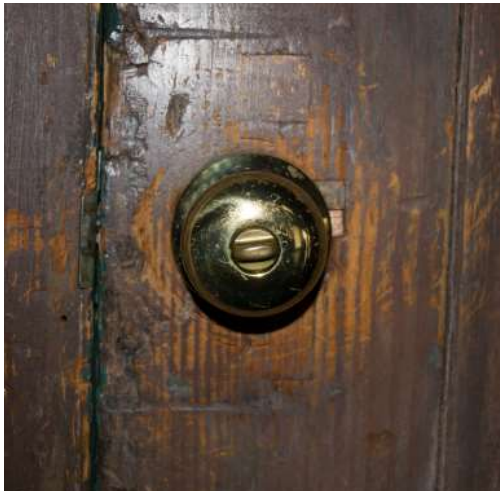
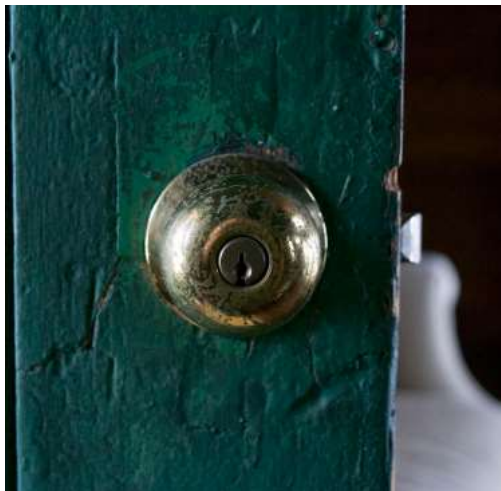
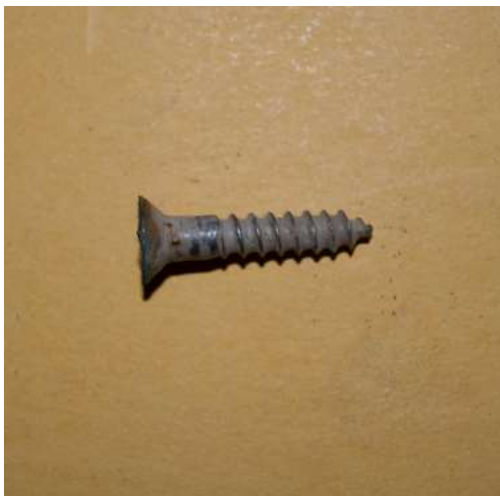
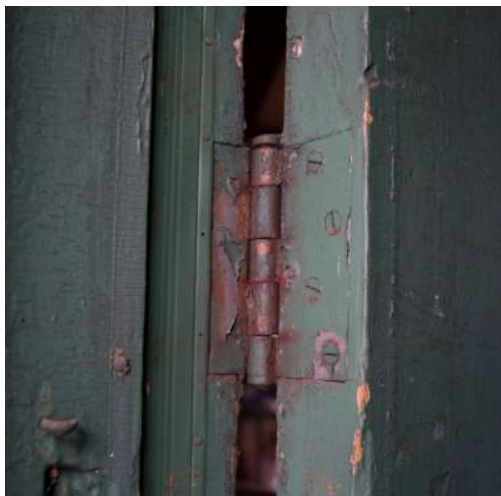
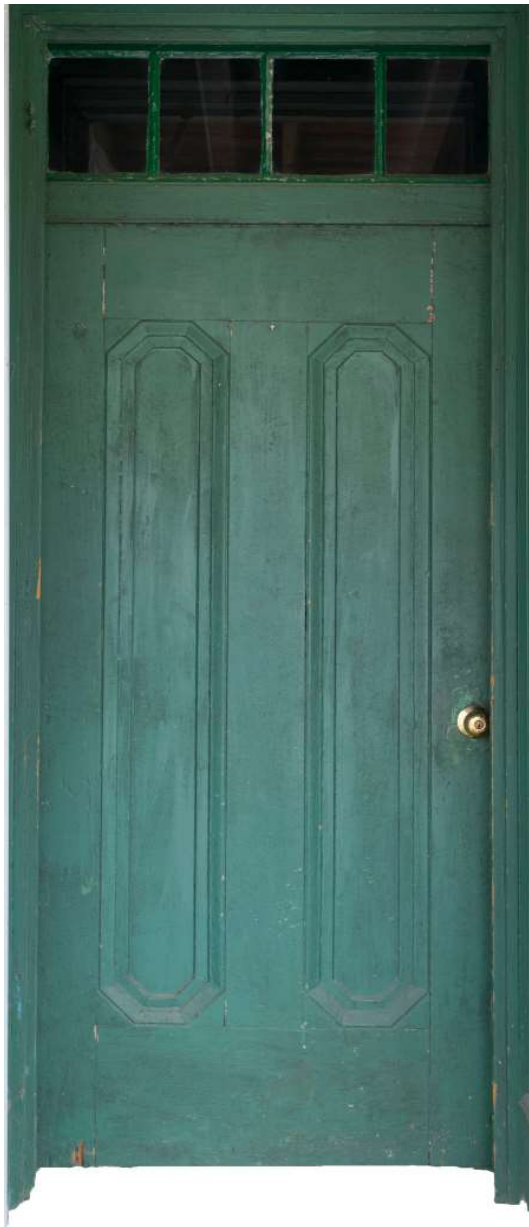
Hardware: Modern twist knob						Moulding: Ogee and Fillet Applied Moulding						Notes: Hinges partially blocked by modern features used to rehang door and implement modern storm door. Elongated hexagonal shape on exterior is the same as other main door on north facade. Modern screws and handle.								
Fasteners: Post1846 gimlet screw						Proposed Origin Dates: 1850s Van Sandt campaign														
The Raymond Farm Center for Living Arts and Design 6370 Pidcock Creek Road New Hope, PA Spring 2018												Door Typology Recorded and Prepared by Sara Gdula			Farm House - 1-A North Door			Sheet # D1.2		
University of Pennsylvania Graduate Program in Historic Preservation

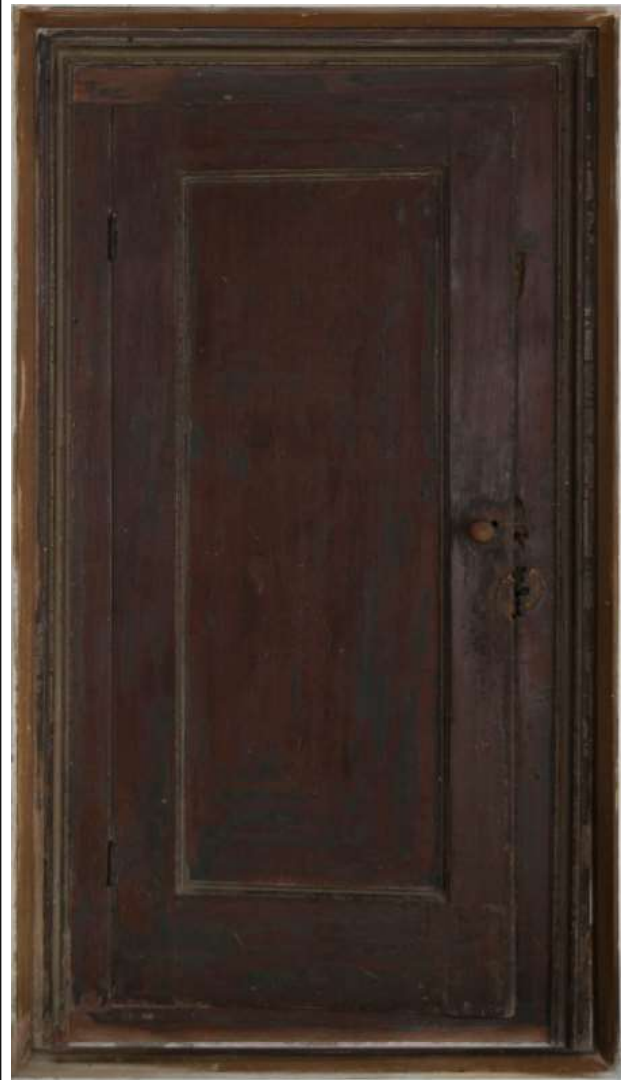
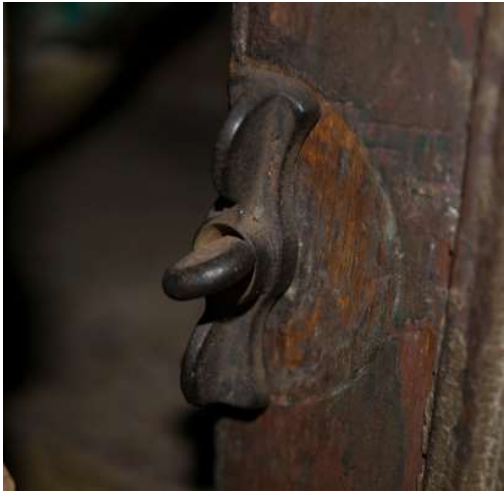
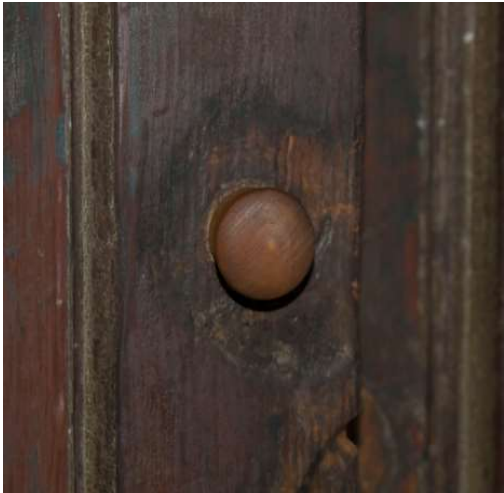
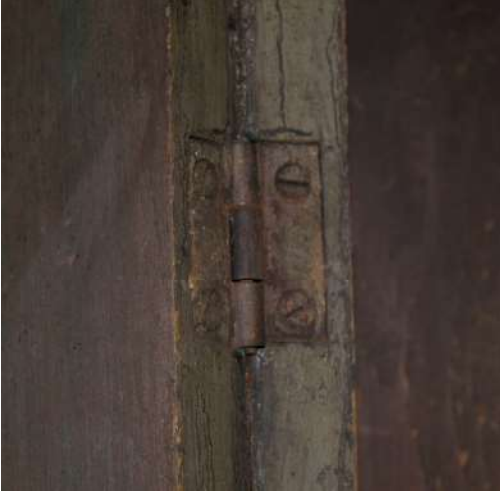
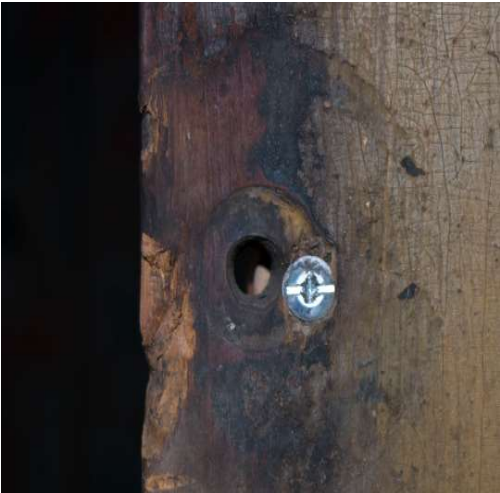
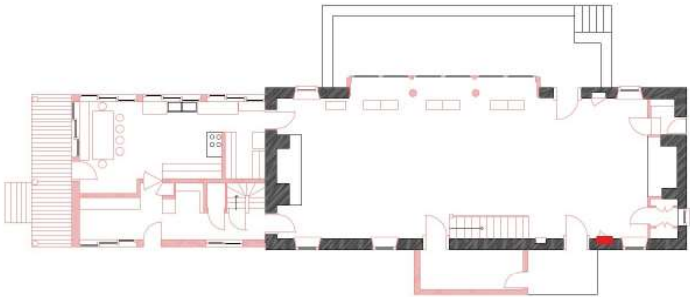
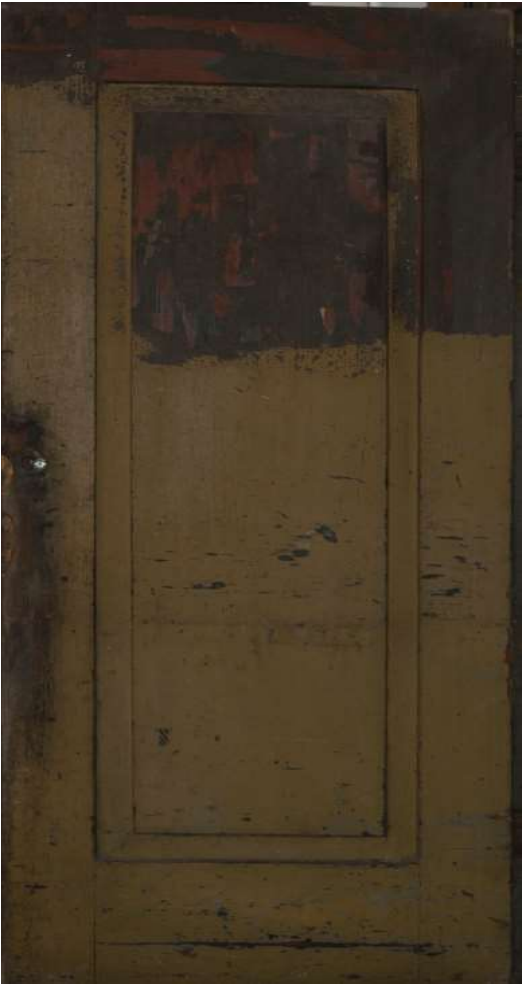
Notes: Unit emedded into the surrounding masonry. Fasteners in the hinge were unable to be extracted. Exterior seemingly stripped of paint, however some finishes still extant in recesses of mouldings. Interior painted with pale olive green finish.

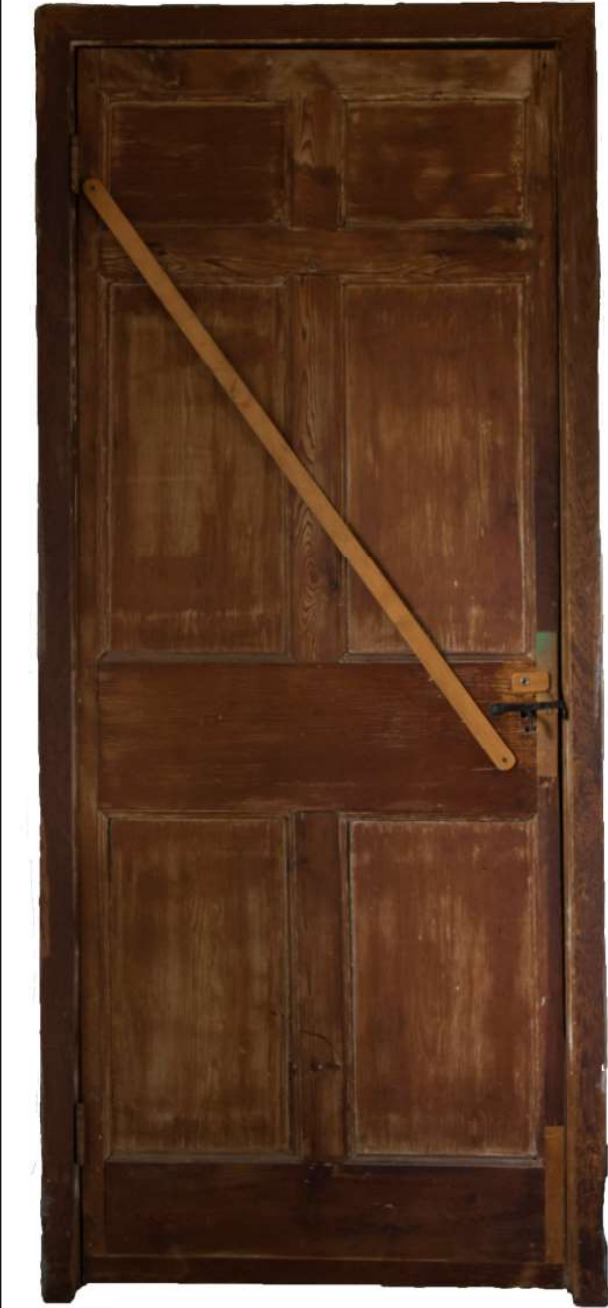
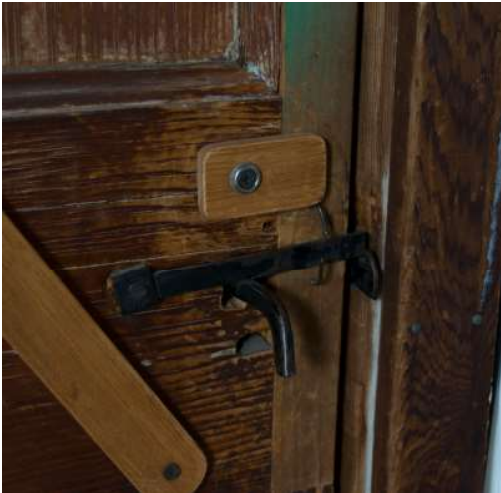
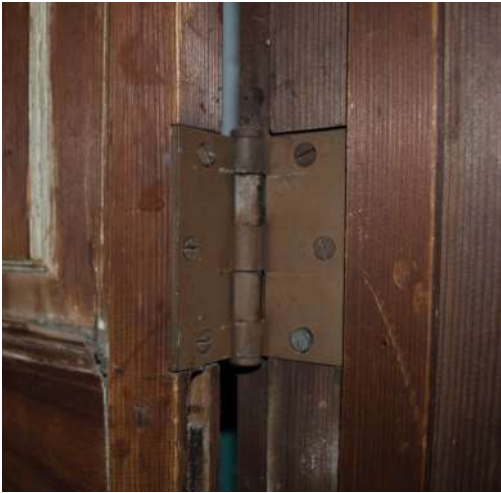
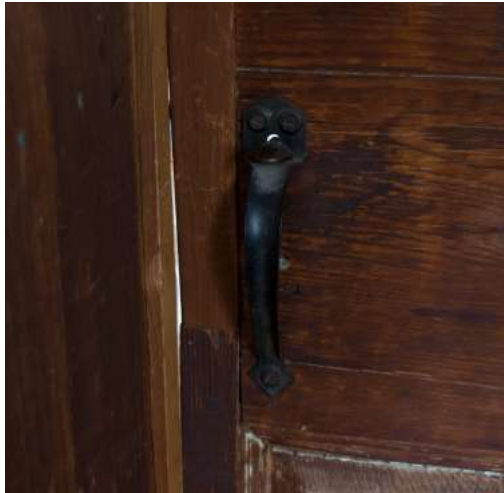
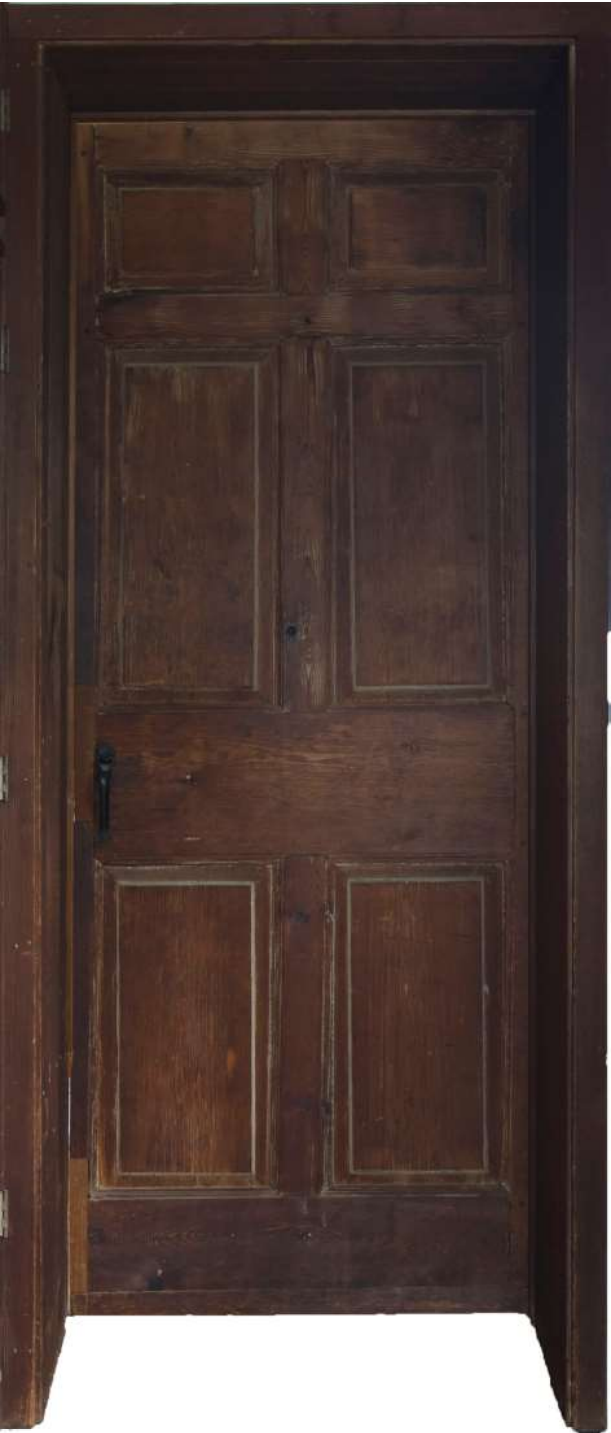
Hardware: Modern Reproduction Thumb Latch
Cast Butt Hinge

Notes: Wood members likely Colonial, moved to current location during Raymond campaign. Scarring from previous hardware present. Extension on bottom rail to fit the portal. Mostly stripped of paint, white remnants on panel moulding.

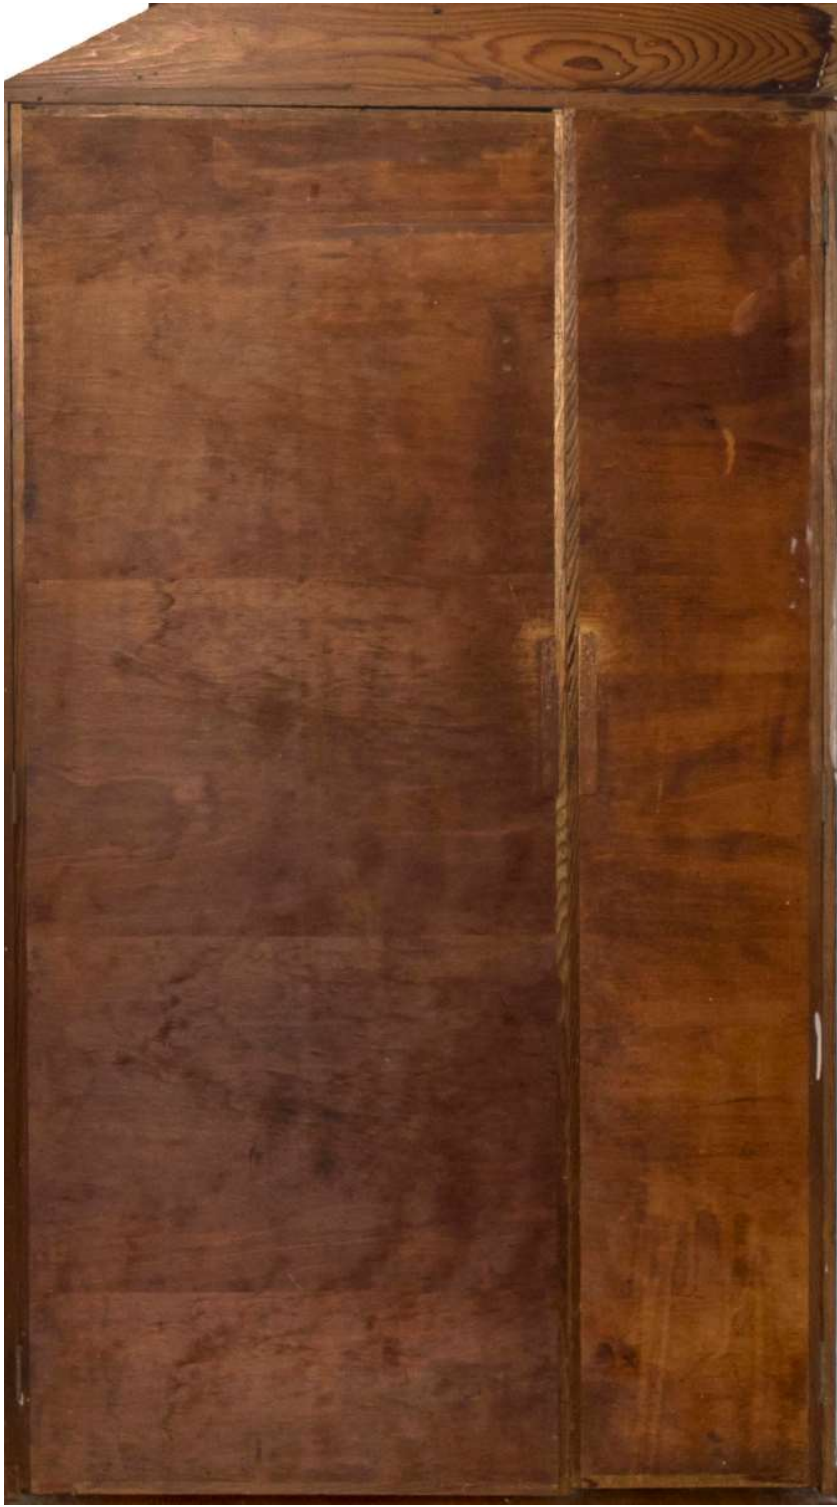
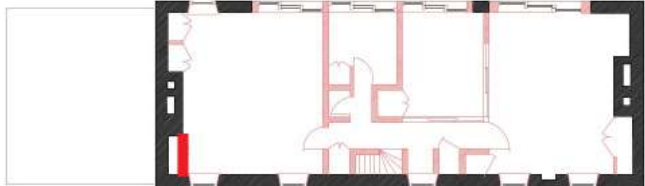
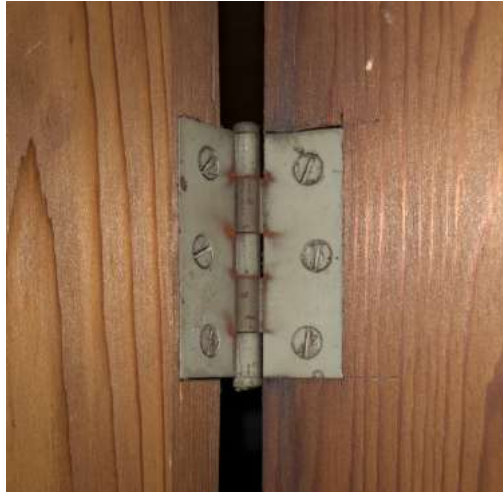
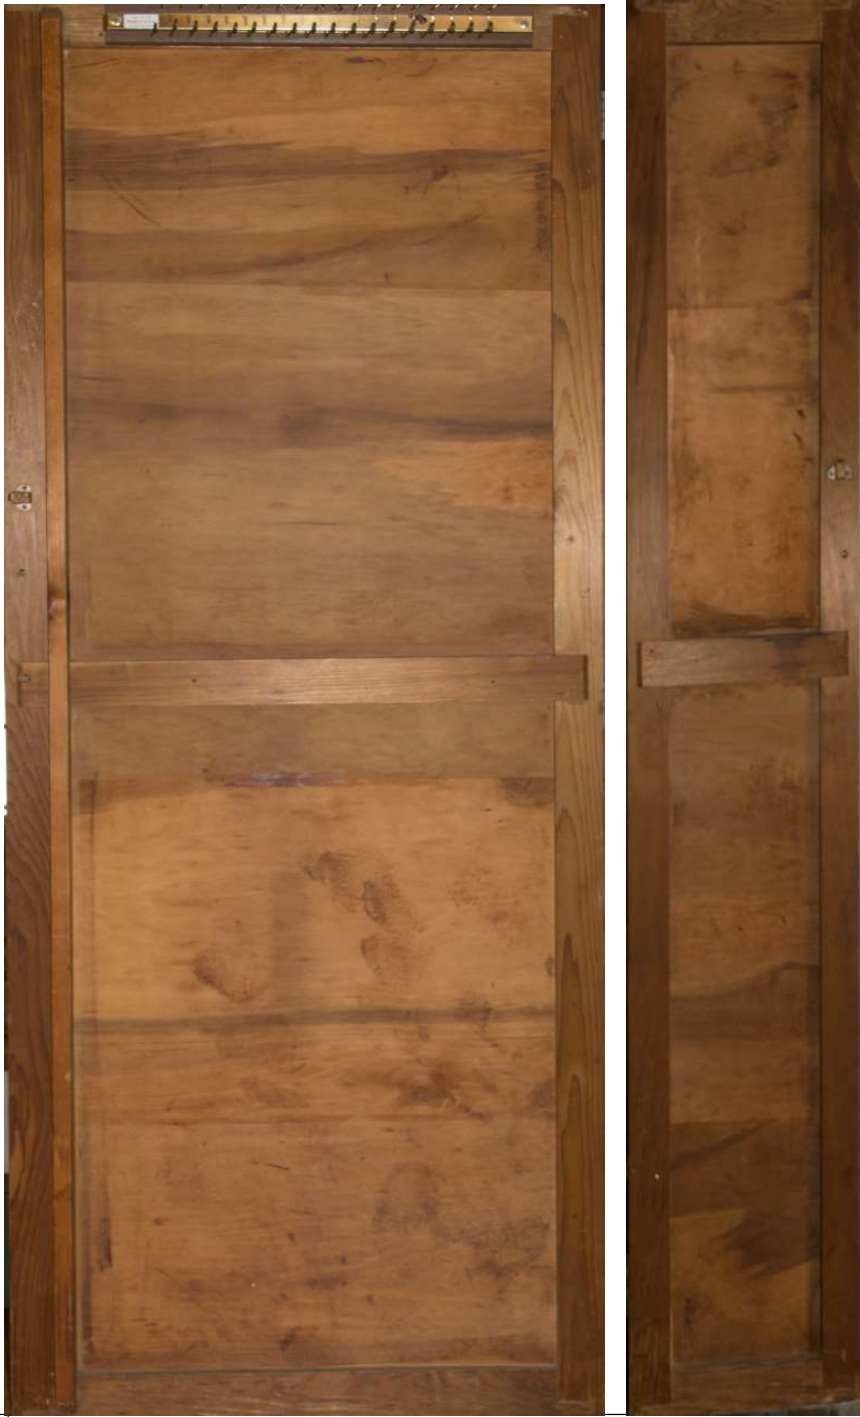
Sheet # D3.2	
Hardware: Embedded pull handle Cast Iron Butt Hinge		Moulding: None		Notes: Plywood door finished with cedar veneer. Likely constructed on-site.		The Raymond Farm Center for Living Arts and Design 6370 Pidcock Creek Road New Hope, PA Spring 2018			
Fasteners: Modern Gimlet Screws		Proposed Origin Dates: 1939 Raymond		Door Typology Recorded and Prepared by Sara Gdula				Farm House - 3-B East Elevation North Door	
				University of Pennsylvania Graduate Program in Historic Preservation

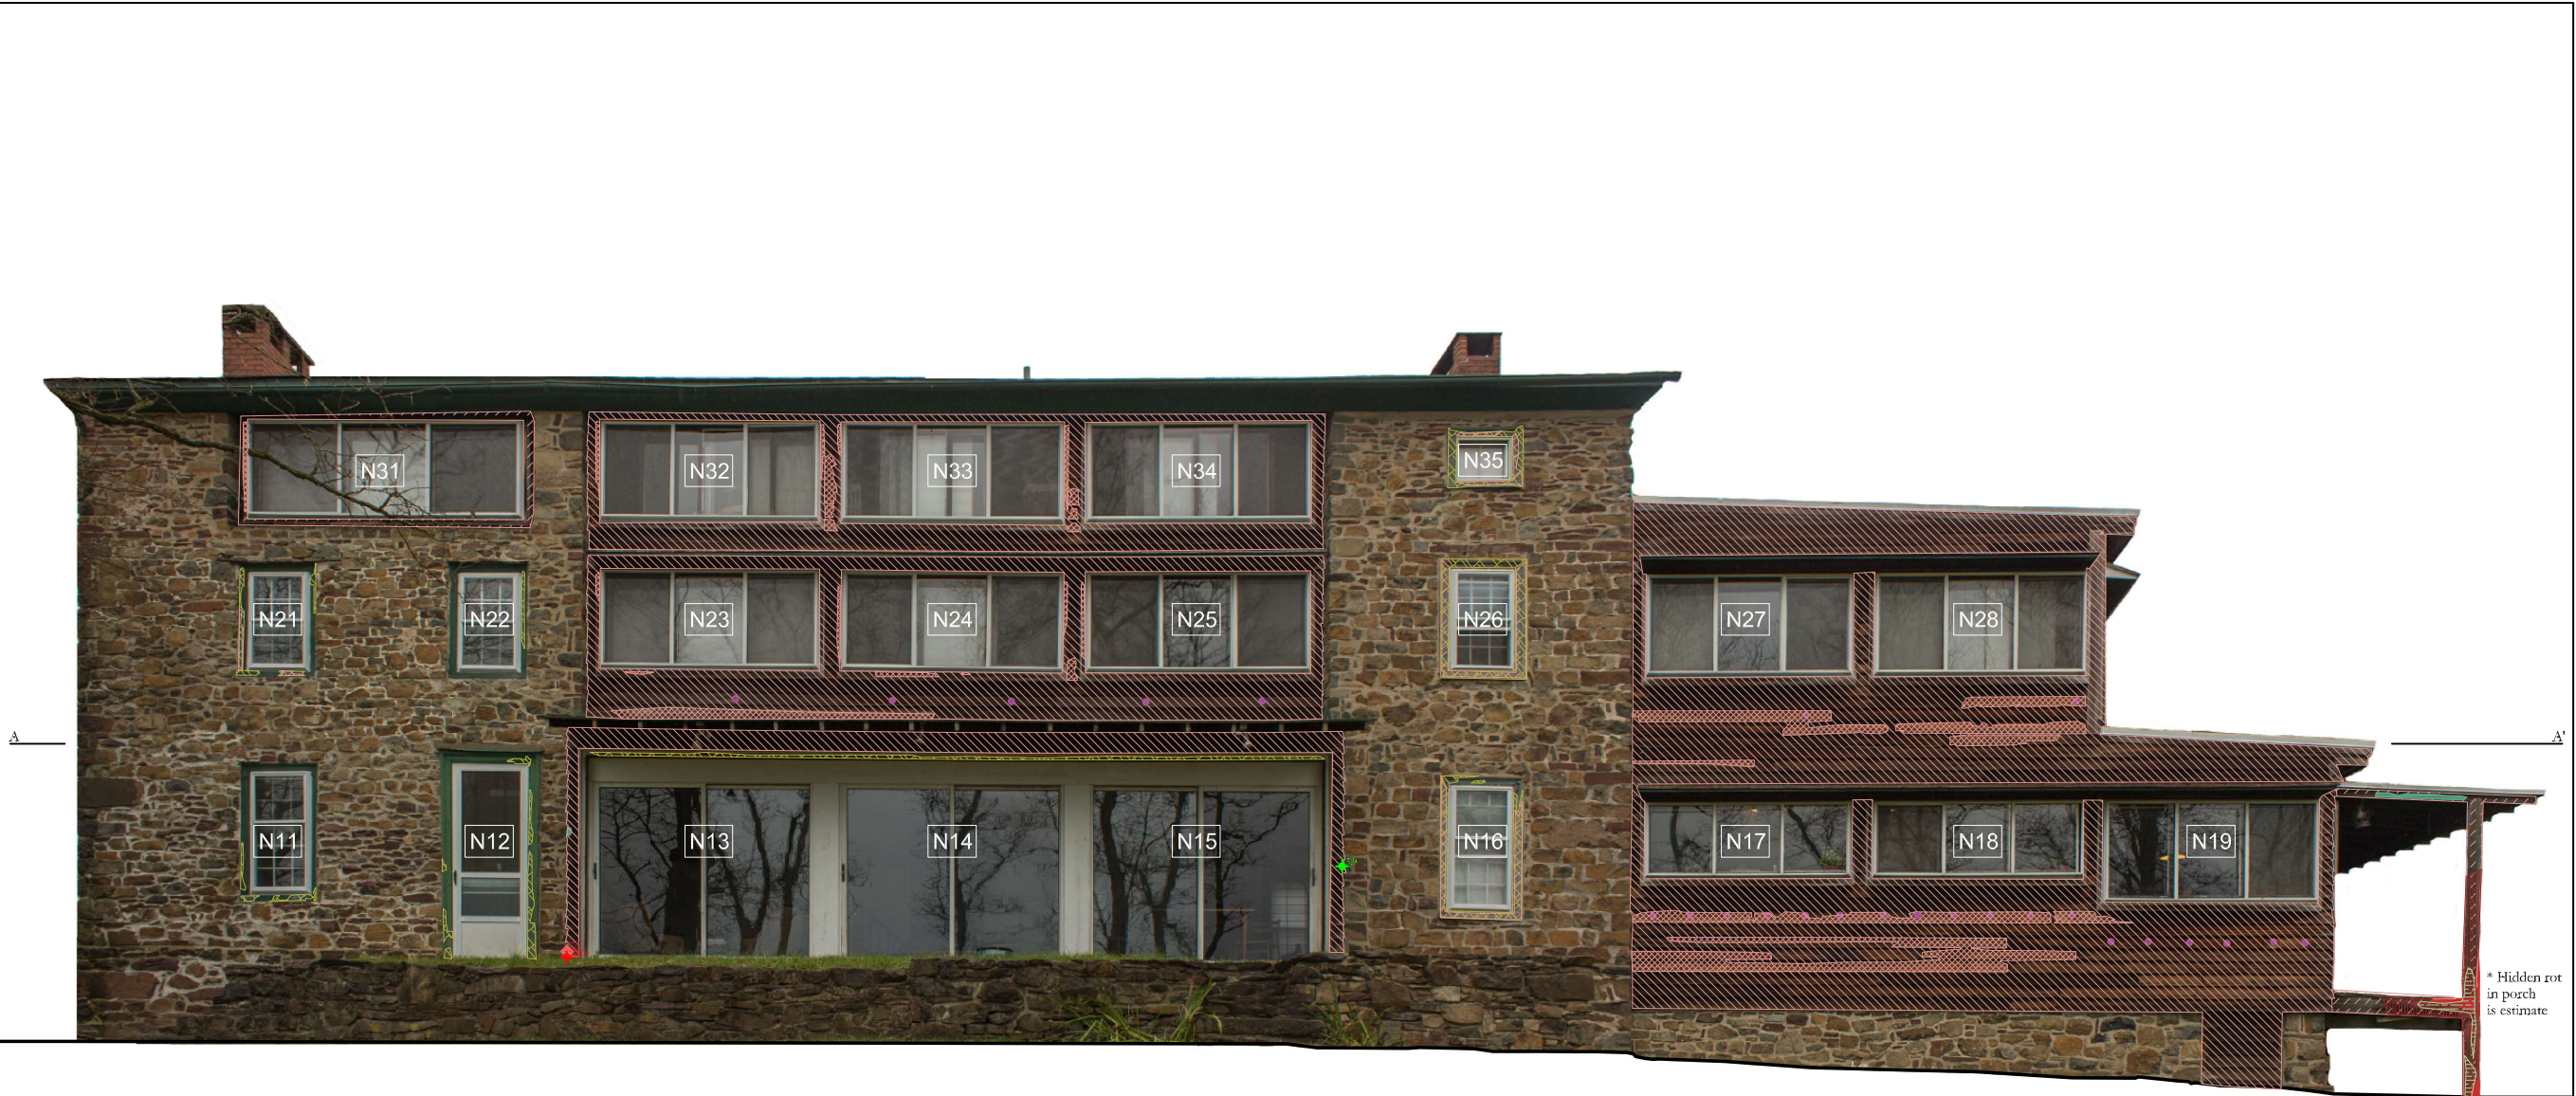
South elevation

Exterior Conditions Survey: Conditions Glossary
Alberto Calderón-González, Anthony Hita
Plan 2 of 3: South Elevation 1:75

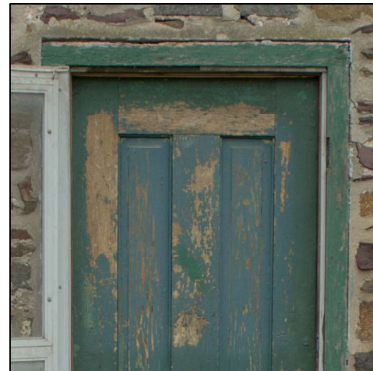
Condition: Finishes failure

Definition: Degradation or adhesion failure of surface finishes exposing wood underneath.

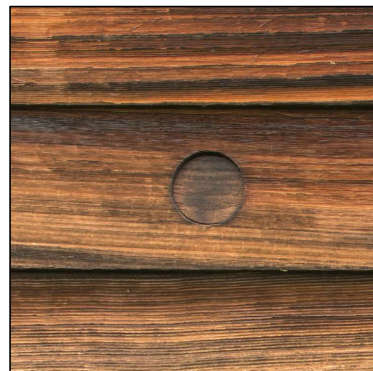
Condition: Repairs or replacements

Definition: Non-historic wood elements introduced to replace damaged or removed wood. Does not include elements added due to a change in design, e.g. the Raymonds' additions

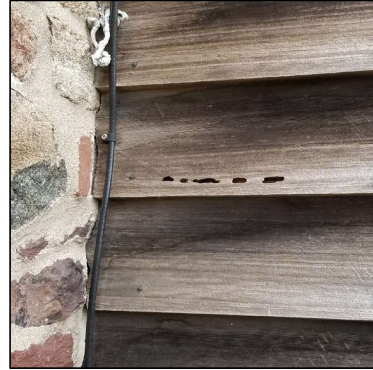
Condition: Insect infestation

Definition: Infestation by wood-destroying insects causing loss of wooden material.

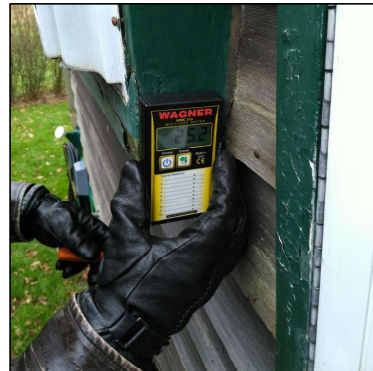
Condition: Moisture content

Definition: Moisture reading using a MMC 210 moisture meter calibrated for a specific gravity of 0.35. The moisture reading accounts for a depth of 3/4" and is only slightly affected by weather conditions. (a) Moisture above 15%. (b) Moisture below 14.99%

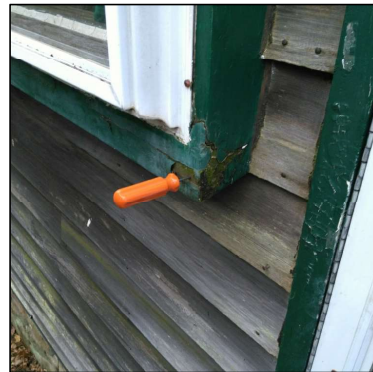
Condition: Wood softness

Definition: Lack of resistance of the wood to penetration with a Malco A0 steel awl. Typically indicates wood rot.

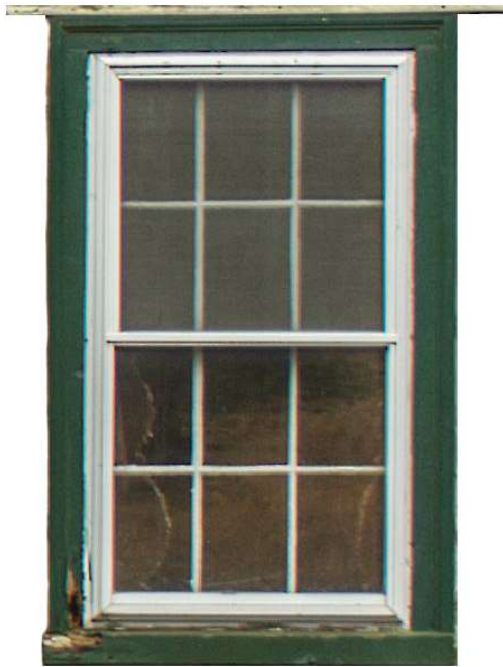
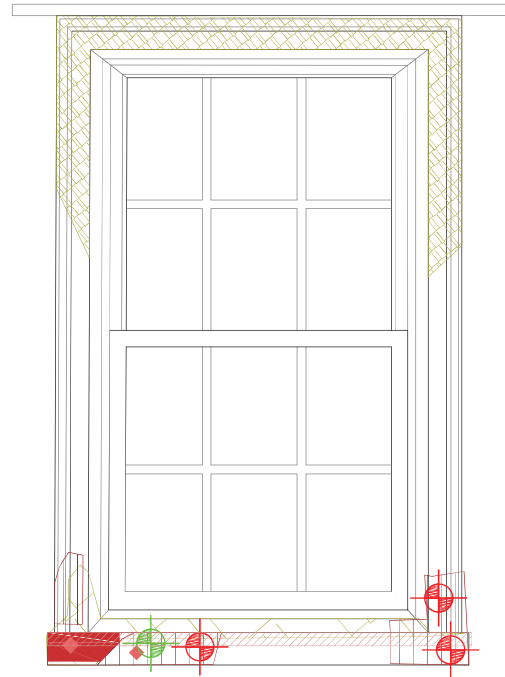
Typical Window Showing Typical Conditions Legend

Finishes failure

Brown rot, visible

UV damage: moderate

Brown rot, internal

Moisture content: above/below 15%
