Summer 2008 • Volume 47 • Number 2

Calcium Tartrate Tetrahydrate Preconsolidation of Salt-contaminated Limestone at Mission San José y San Miguel de Aguayo

JENNIFER CORREIA AND FRANK MATERO

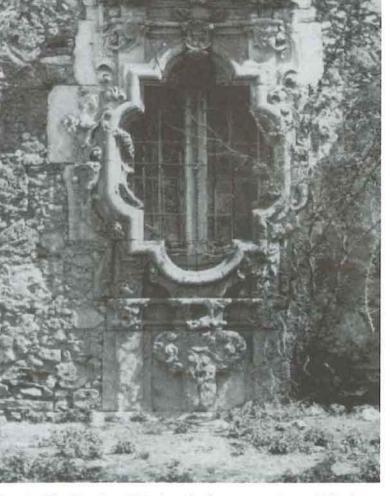
Fig. 1. The Sacristy Window before excavation of the base, Mission San Jose y San Miguel de Aguayo, San Antonio, Texas, Wister Collection, 1893, Texas State Library, copy from NPS Archives.
