CHARACTERIZATION AND CONDITIONS ASSESSMENT
OF THE
SACRISTY WINDOW
MISSION SAN JOSÉ Y SAN MIGUEL DE AGUAYO
SAN ANTONIO, TEXAS

Katherine Ann McDowell

A THESIS

1997

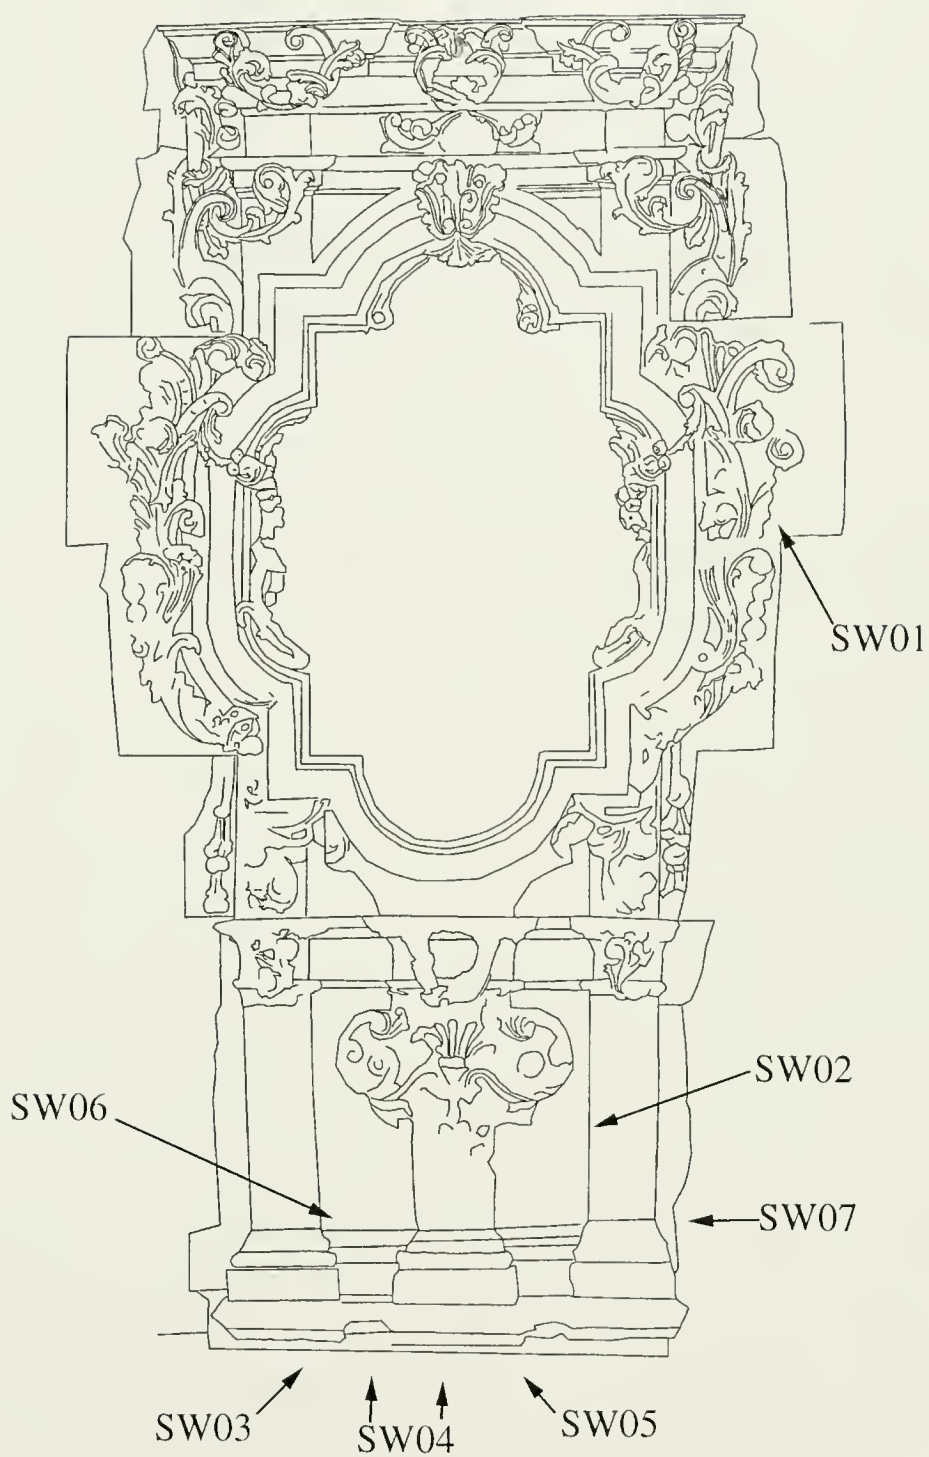
The primary sample (SW01, *Figure 11*) of stone was obtained from an area of delamination and black biological growth at the upper right side of the window. The sample was removed with a chisel and measured approximately 1 cm square. The white and tan areas represent interior surfaces; the black coated surfaces represent the side and top, while the appearance of green biological growth marks the back surface. This sample was taken from an area that was delaminating and it appears that the back surface had already begun to separate from the stone behind it. Biological growth was visible in this small fracture. The sample separated easily from the stone supporting it with one blow of the hammer and chisel. This sample (SW01, *Figure 11*) was used for thin section petrography, scanning electron microscopy (SEM) examination, and energy dispersive spectroscopy (EDS) analysis.

The second sample (SW02, *Figure 11*) obtained was a small piece, measuring approximately 1 x 1.5 cm, which was delaminating from the base of the window in an

Several small samples were taken from the base of the window which had already fallen to the ground as active delamination. The stone appears to be the same stone which composes the window due to its color and the fossil inclusions. These samples were weathered to the extent that it could not be determined which face represented an exterior surface and which part of the window they came from. It is likely that they all came from the base of the Sacristy window due to the high degree of deterioration and the similarity of the stone. The largest sample (SW03, *Figure 11*) was used to determine water absorption and weighs approximately 20 grams. Two smaller samples (SW04, *Figure 11*) were utilized for determining acid soluble fraction of the stone. Another sample was used for thin section petrographic analysis, SEM, and EDS (SW05, *Figure 11*). Soluble salts were also brushed from an area of visible efflorescence (SW06, *Figure 11*).

One large piece of a hard buff mortar was taken which had fallen from the lower right side of the window (SW07, *Figure 11*). Due to the hardness of this mortar, it had not experienced erosion and it was easy to determine the original location of the piece. The mortar has a smooth texture and shows evidence of being work by a trowel. The mortar is in good condition, with the exception of multiple hairline cracks, and appears to be much harder than the stone. The repairs which utilized this mortar, occurred sometime after 1950, when the base of the Sacristy window was excavated from the rising grade level. Due to the friability of the stone and the hardness of the mortar, it was not feasible to take more mortar samples without causing damage to the stone. This sample (SW07,

Figure 11. Diagram of Sample Locations. Arrow indicates where samples were taken.

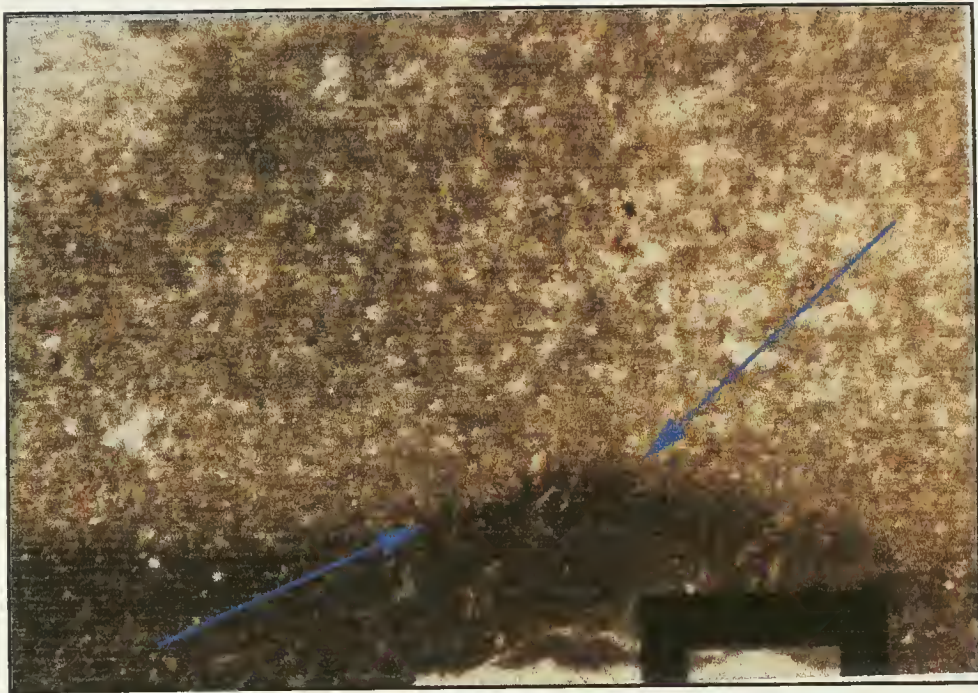
The analysis revealed that two types of micro-fabrics exist within the limestone sections that were examined. One is fine-grained, loosely cemented and white to yellow in color (Munsell 2.5Y/8/2 - 2.5Y/7/6). This fine-grained material contains many voids, especially in areas within the skeletal remains of fossil inclusions. The other material is a more compact, coarser grained limestone bound in a more opaque, well-cemented matrix. This micro-fabric may be linked to the more iron rich patination at the stone's surface. This material contains different kinds and sizes of fossils. A visible boundary exists between these two micro-fabrics (*Figure 12*).

Figure 12. Thin section of SW01 showing the heterogeneous character of the limestone. A boundary exists between the fine-grained and coarse-grained, well-cemented brown matrix. Magnified 25x, Plane polarized light.

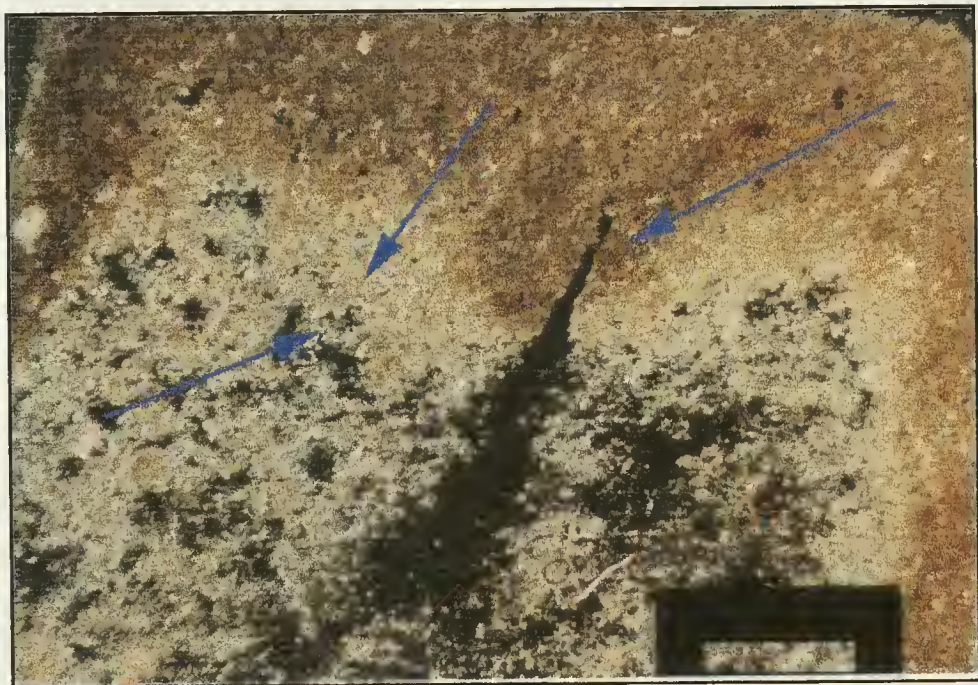
The fine-grained material is easily eroded and prone to disintegration (*Figure 13*), while the coarser grained material is well cemented and shows little sign of decay (*Figure 14*). The stone is very heterogeneous in composition and therefore subject to differential erosion. The mineralogical composition of the stone is therefore an important factor in its decay. The surface of the stone reveals the differential weathering of the stone (*See Chapter 4-Conditions Survey*). Skeletal remains and vermiculation can be seen on the surface where the finer-grained material has easily eroded away, leaving the well-cemented matrix and calcareous skeletons behind. The calcium carbonate within the fossil shells was protected from being compacted during sedimentation, and is therefore not as well cemented as the areas which lay outside of these large fossils (*Figure 15*).

Figure 13. Thin section of SW01 showing the fine-grained and disintegrating matrix. Magnified 25x, Crossed polarized light.

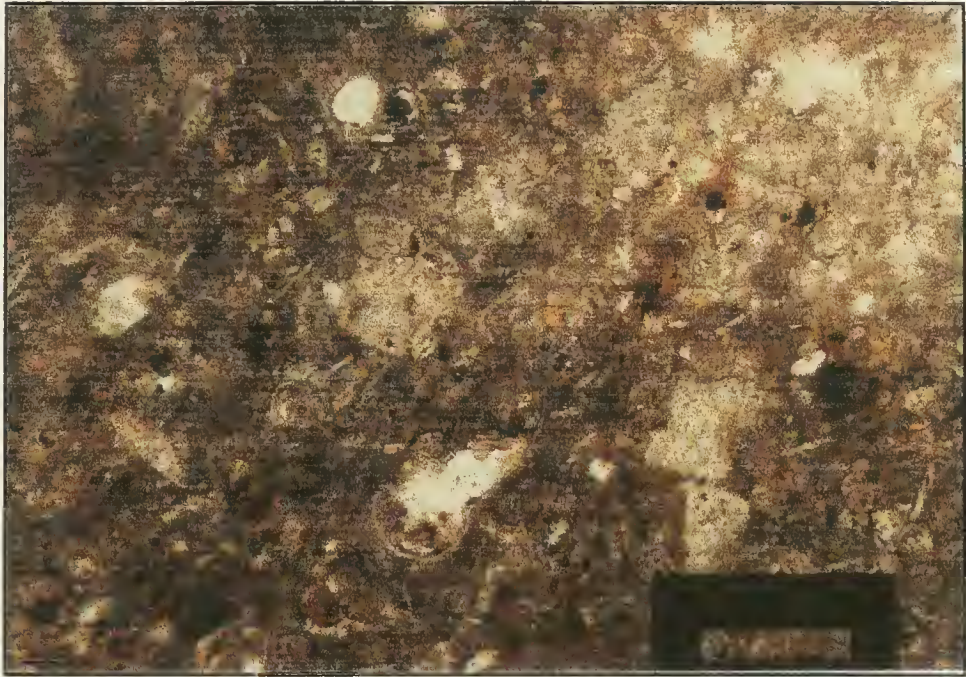
Figure 14. Thin section of SW01 showing the fossils in coarse-grained, well-cemented, more opaque matrix. Magnified 25x, Plane polarized light.

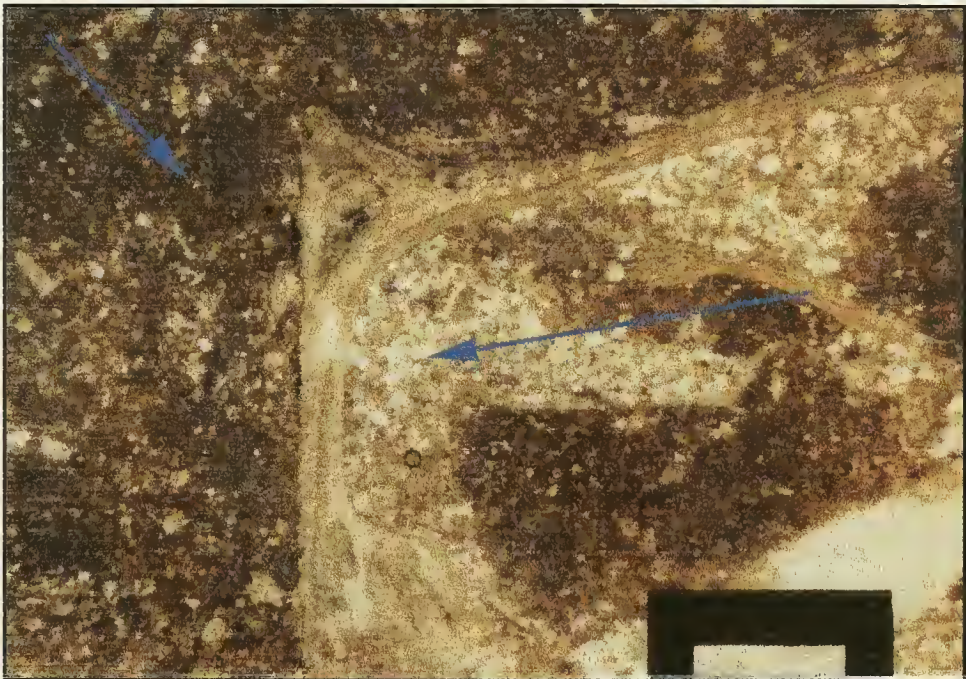
Figure 15. Thin section of SW05 showing the fine-grained material within the fossil and the well-cemented, more opaque matrix outside the fossil. Magnified 25x, Plane polarized light.

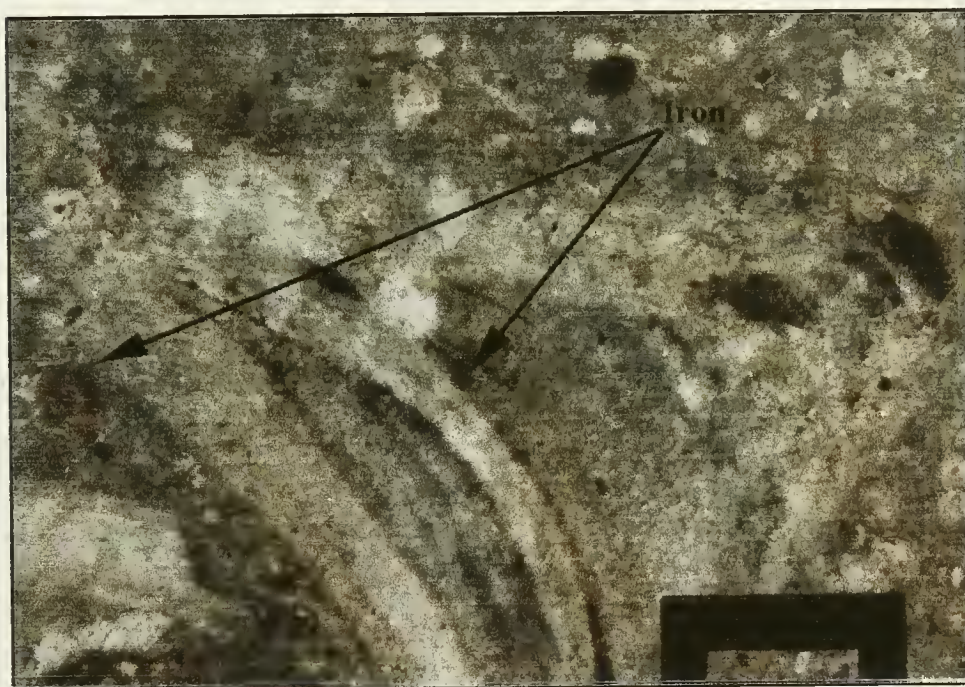
Figure 17. Thin section of SW05 showing iron deposits in the stone. Magnified 100x, Plane polarized light.

Iron is the primary accessory mineral in the stone as well as a colorant (Figure 17). The surface patination may be linked to the alteration of ferrous-to-ferric hydroxide components in the stone changing to yellow-ochre at the stone surface by oxidation and hydration of the ferrous iron in the stone.¹⁵⁷ According to Winkler, iron is the most common and strongest pigment in sedimentary rocks.¹⁵⁸ Iron oxides which are distributed heterogeneously may result from minerals such as pyrite, or limonite.¹⁵⁹ Winkler also states that “many gray limestones,...tend to change color readily to yellow of cream on buildings and in quarries. In nature, the carbonate rocks exposed of only recently remain gray or bluish gray.”¹⁶⁰

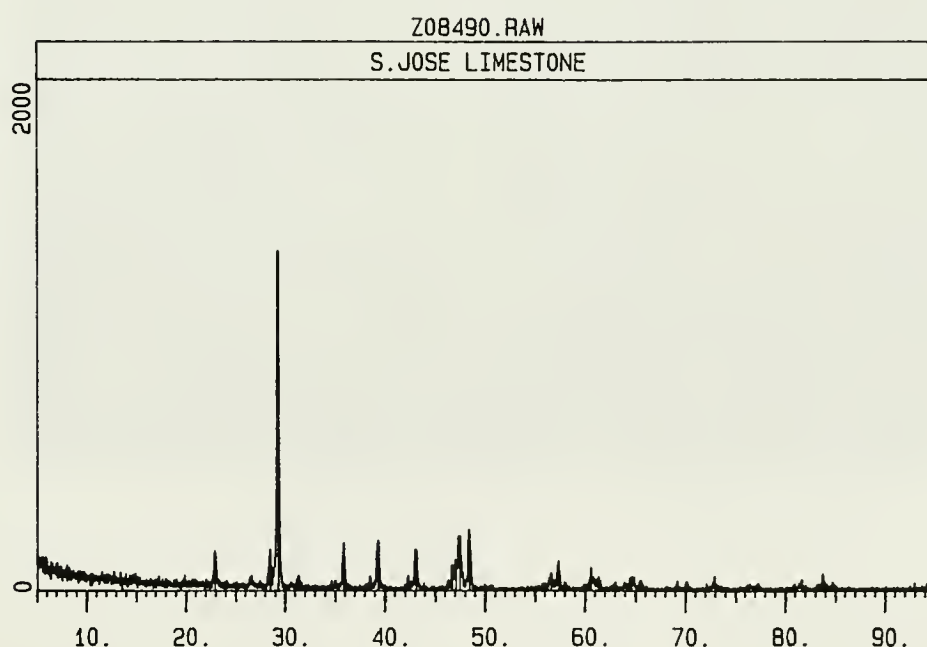
Half of the sample obtained from the delaminating base of the window (SW02) was crushed into a fine powder in order to perform X-ray diffraction. The test was run for 30 minutes from 10 to 90 degrees, which may not have been long enough to obtain information on the trace minerals present in the stone. The peaks which formed corresponded solely to calcium carbonate and did not indicate any accessory minerals, including magnesium carbonate (Figure 19).

Figure 19. X-ray diffraction peaks corresponding to CaCO_3 .

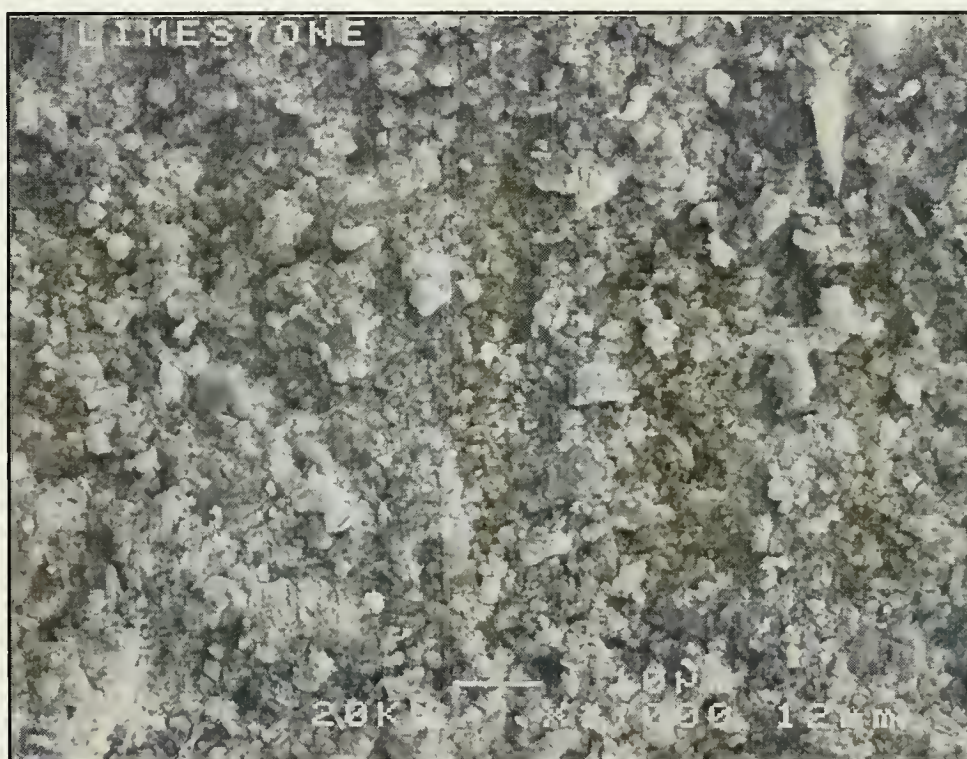
SEM/EDS was performed on two samples (SW01/SW05) from the Sacristy window with the assistance of Rollin E. Lakis, Ph.D., at the Laboratory for Research on the Structure of Matter at the University of Pennsylvania.¹⁶⁴ The first sample, from the upper right side of the Sacristy window (SW01)¹⁶⁵ revealed the presence of iron and organic growth on the stone. The micrograph, showing a magnification of 1000X, illustrates the fine-grained structure of this limestone (Figure 20). It was not visually apparent whether biological growth was causing any deterioration to the stone.

*Figure 20. Scanning Electron micrograph of sample SW01.
Showing fine-grained chalk magnified at 1000X.*

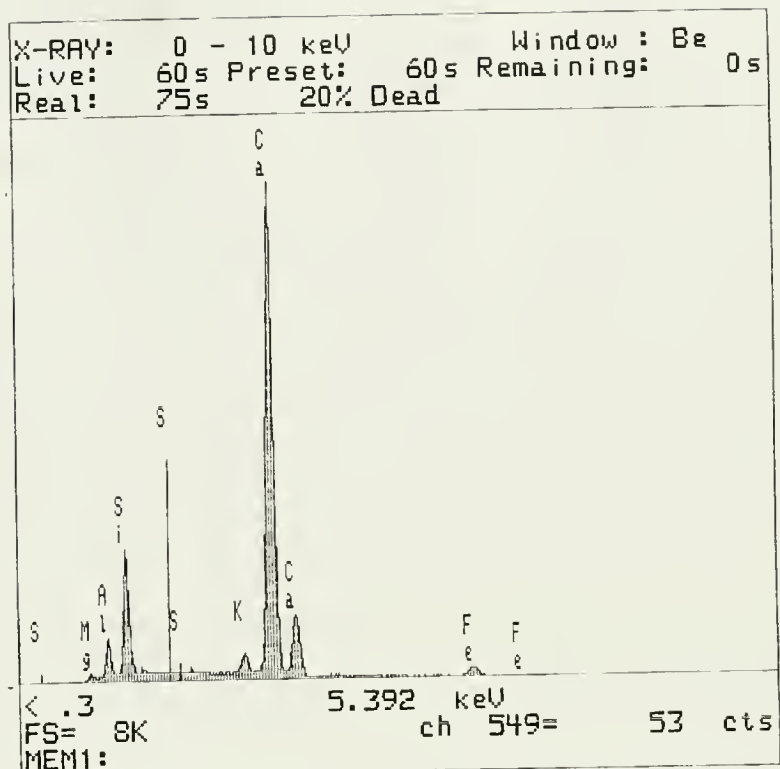
This sample is composed of principally calcium carbonate and small amounts of silica and alumina which make up clays in the stone. Trace elements include magnesium, potassium, and iron (*Figure 21*). The iron in this sample can be seen with the naked eye in the distinct color change within the sample. This darker color also corresponds to the darker, well cemented matrix revealed through thin section petrography. The relative purity of this stone and its fine-grain further support its classification as a chalk.

Figure 21. EDS Spectrum for sample SW01

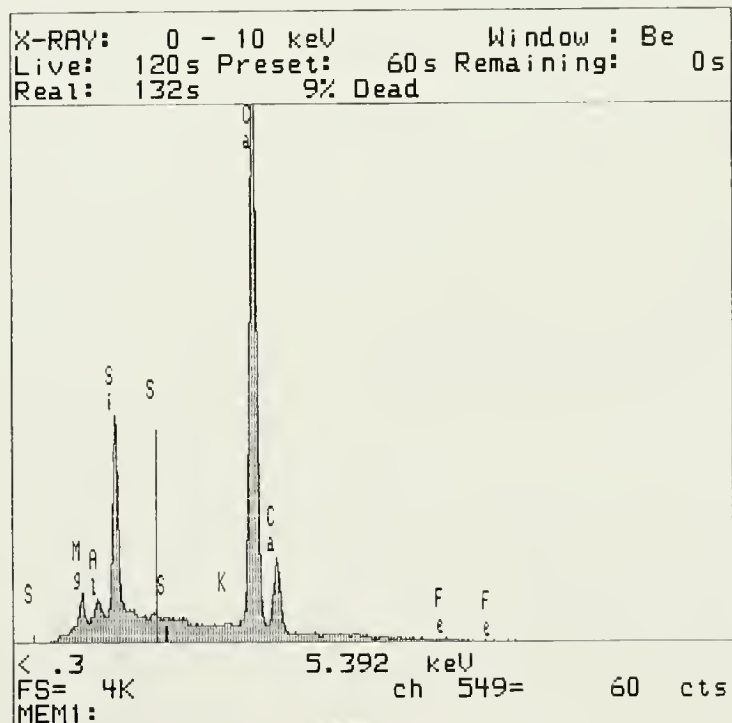
The second sample (SW05) examined was a small piece which presumably fell from the base. This sample was primarily calcium carbonate, including alumina and silica. Small amounts of magnesium, phosphorous, sulfur, and potassium were also identified. Little to no iron exists in this sample (*Figure 22*). The high amount of silicon in some places may indicate a layer of water repellent. The presence of sulfur may correspond to the sulfates, i.e. soluble salts, in this area of the window; however, no salt crystals were seen with the scanning electron microscope. The lack of iron and the higher amounts of clays in this area of the window may indicate another factor affecting the deterioration.

Figure 22. EDS Spectrum for sample SW05

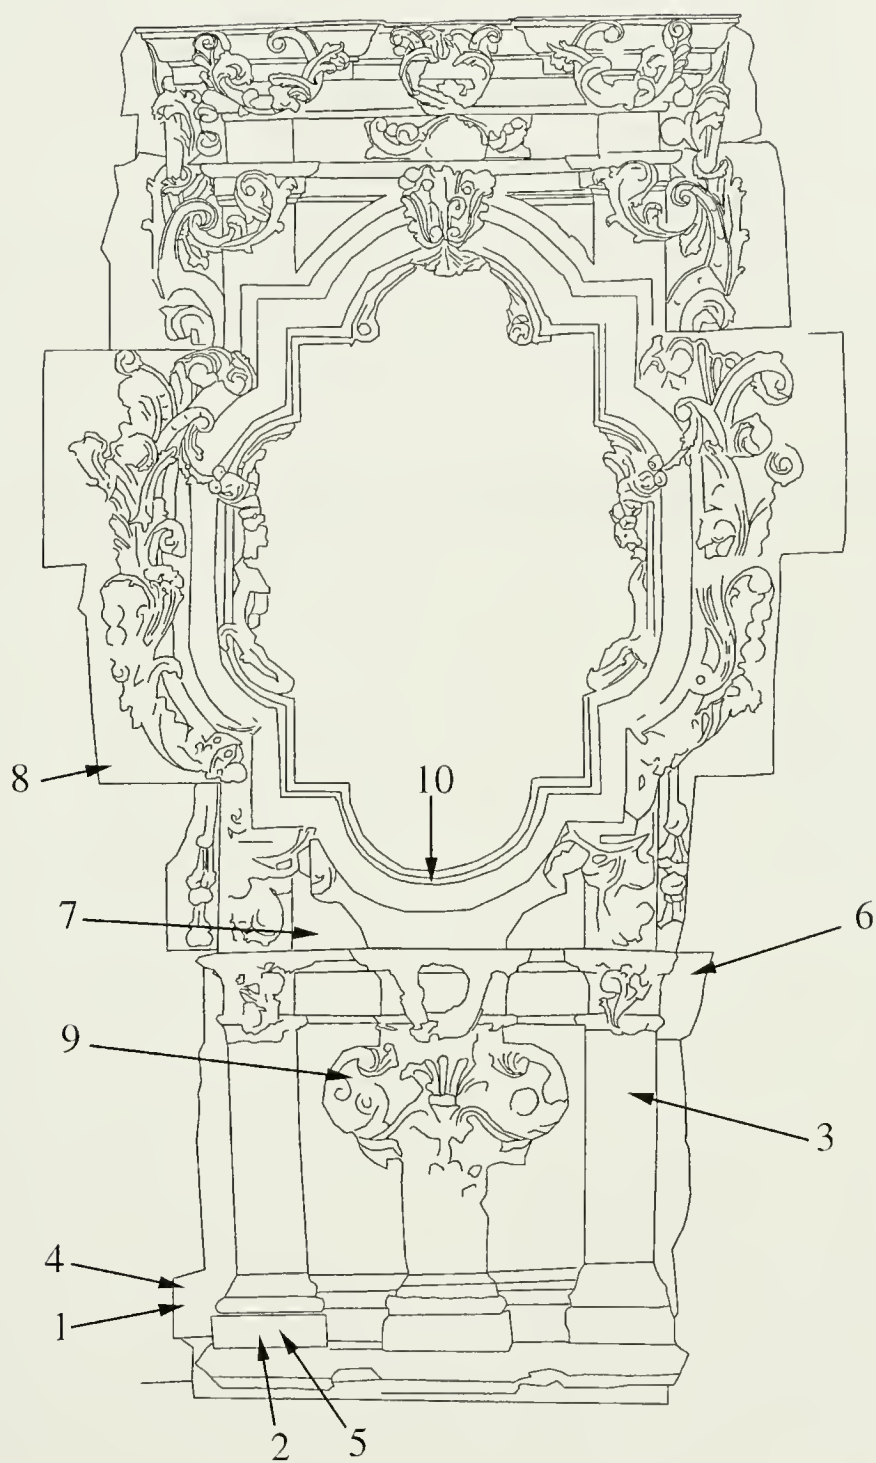
Methodology - Ten locations of the Sacristy window were field tested for their rate of water absorption under low pressure. The tests were performed on two mild days in January 1997. All ten surfaces on which the tests were performed were smooth, flat, and

Figure 25. Test Locations for Rilem II.4, Water Absorption under Low Pressure.

did not display any disaggregation, however, all displayed some erosion of the surface.

Results - The following numbers represent locations tested: (See *Figure 25* for exact test locations.)

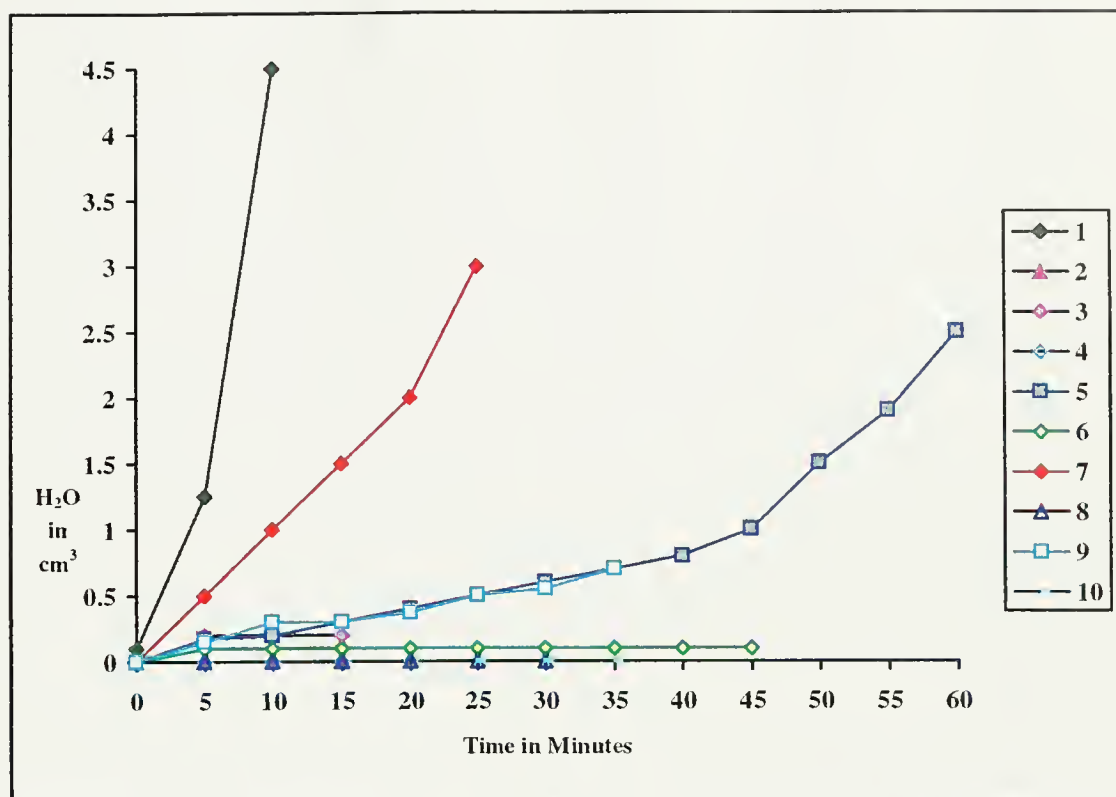
Figure 26 .Water absorption under low pressure. X-axis represents time in minutes. The Y-axis represents the volume of water absorbed in cm³

Of the ten areas tested, only three areas had a steady intake of water (Figure 26) while the other areas remained constant. These locations which absorbed water included locations 1, 5, 7 and 9. The rate of water absorption for each of these samples ranges from .02 - .45 cm³/minute. This might suggest that a water repellent is still active on the surface of much of the stone, since the stone is otherwise considered to be porous and permeable. However, the last record of a surface treatment being applied to the walls of the Sacristy was in 1975. The walls do not bead when wet; therefore, it is possible that the surfaces which were tested, which are all sound stone, have a higher density than the stone which was tested for water absorption. Cayeux has suggested that chinks which

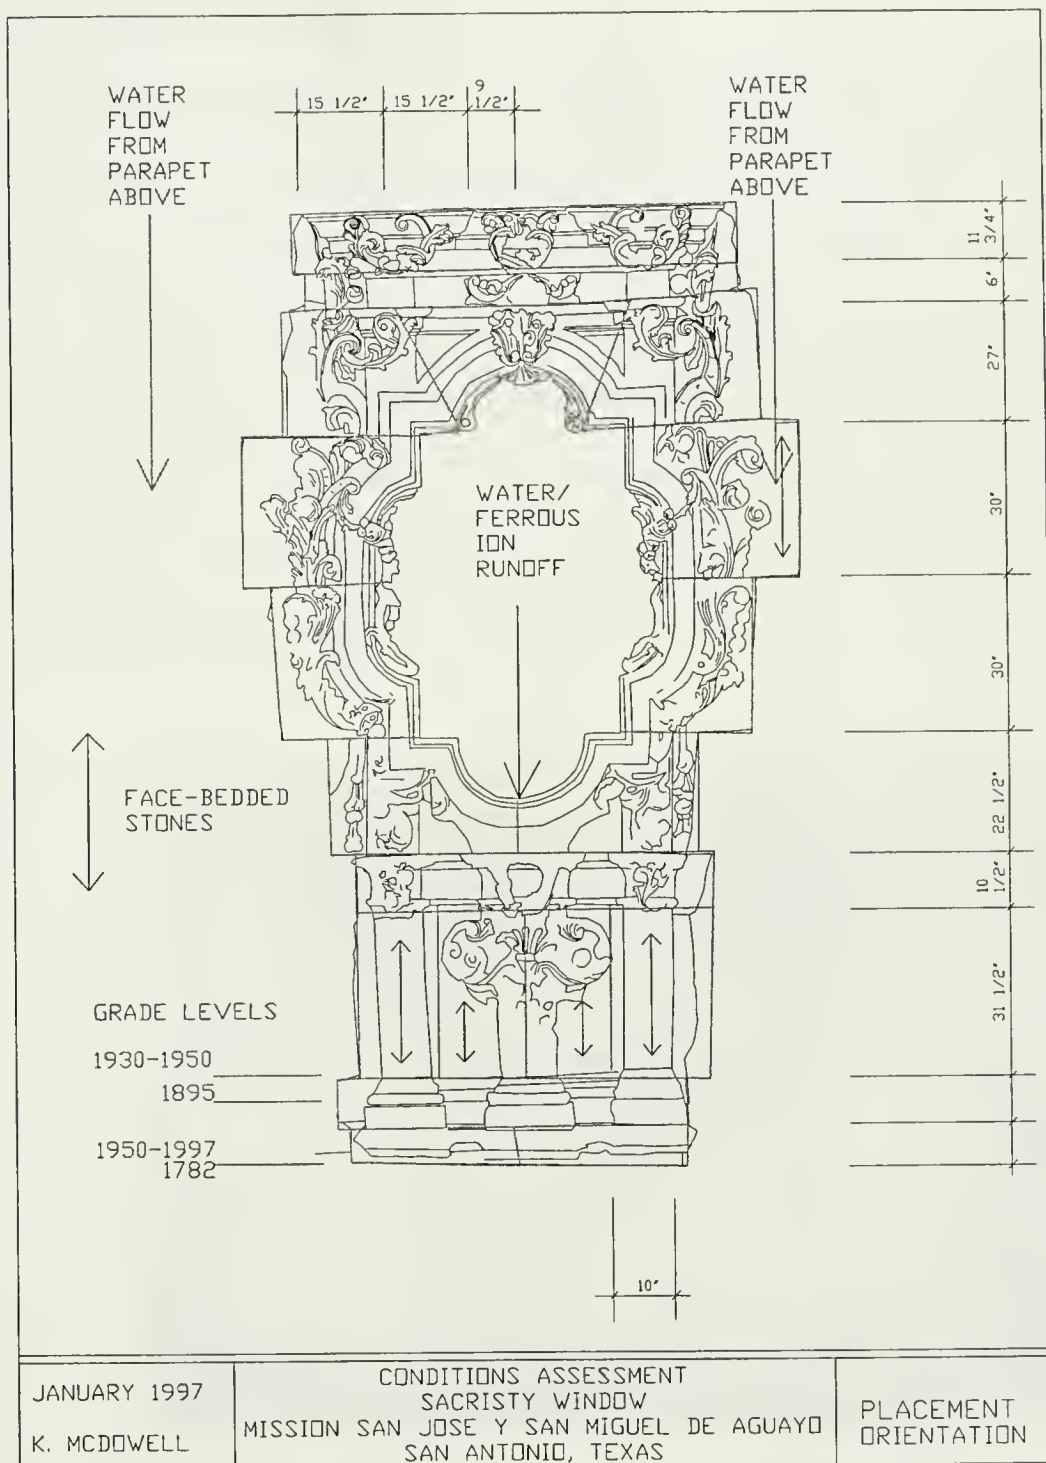
The placement and orientation of stones in the Sacristy window is also a contributing factor in the decay of the stone. Face bedding of stones, in which the units are laid perpendicular to their natural bedding planes is a primary factor in the decay at the base of the Sacristy window. This is why stone should be “quarry-bedded” in a building, i.e., laid as it is found in the quarry. Face bedding encourages macroscopic failure in the form of flaking and delamination due to the stone’s inability to resist the vertical pressures of the weight from above when the grain on which it breaks most easily is not at a right angle to such pressures.”¹⁹⁴ Face bedding also exposes the vulnerable bed planes to water penetration and delamination. The water and moisture at the bottom of the window in the form of rising damp from the grade below and any water collected in the excavated trench in front of the window exacerbates an already compromised situation of face bedded stones. The lower blocks appear to have been face bedded when their length needed to be exploited to achieve a certain height without having any joints, i.e., in the formation of the pilasters which are approximately 31 inches in height. There is also a failure of stones in the arch construction around the top of the window surround, caused by not placing the stone at right angles to the thrust of the arch. The problem of face bedding stones can also be seen at the base of the facade at Mission Concepción.

Figure 28. Stone Placement and Orientation Diagram.

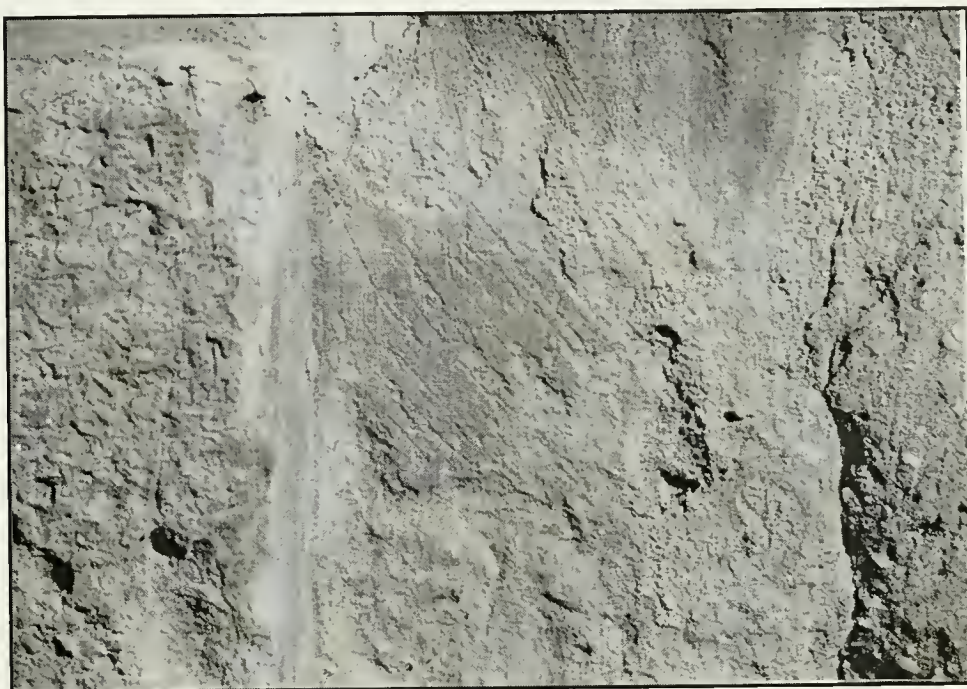
Areas of original tooling still extant on the surface. Tool marks occur primarily in the flat areas between pilasters. Tooling marks suggest that a saw may have been used to cut the stone blocks.

Figure 44. Original surface tooling marks visible in the area between the center and right pilaster.

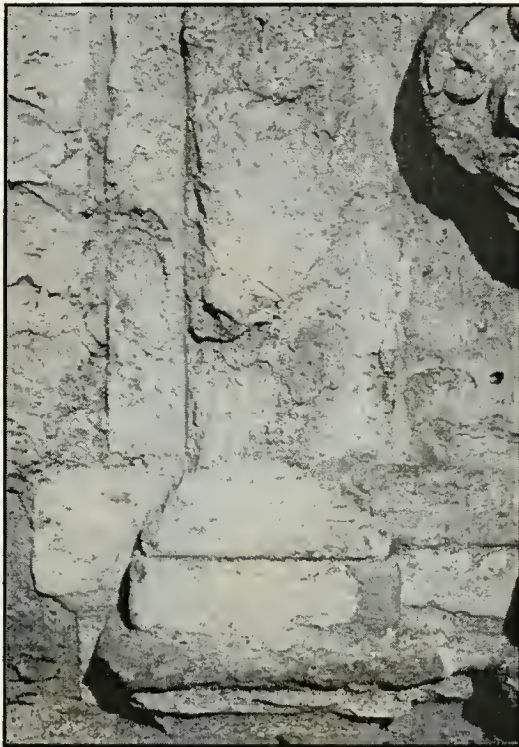
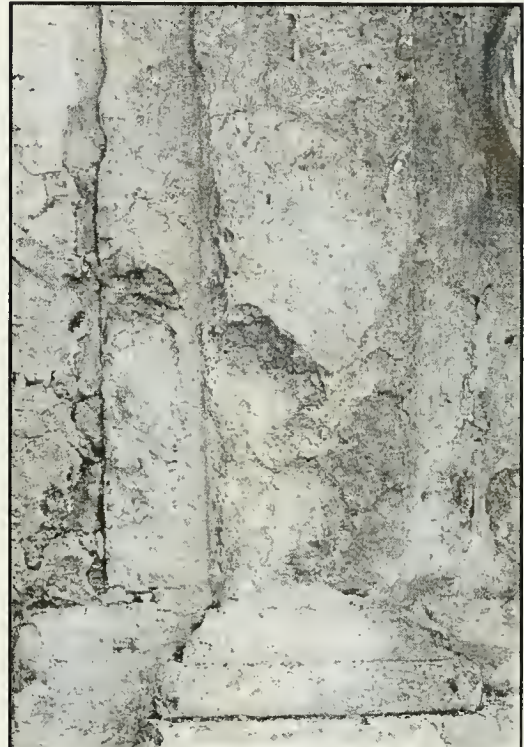
The general condition of the base of the Sacristy window is worse than was observed in January 1997 at the time of the Condition Survey. The left pilaster has increased surface areas which display a chalky white efflorescence. Increased flaking is also occurring in areas adjacent to the losses previously mentioned. The increased damage and the degree of change can be directly related to the abundant rainfall in San Antonio in the spring of 1997. As the author began making observations and photographing during an extended drought in South Texas, the changes over the summer, fall and winter of 1996 were minimal. However, the precipitation figures for the first six months of 1997, indicate that San Antonio has received 22.06 inches, while 15.57 inches

is the normal accumulation through June.²⁰⁰ The increase in the amount of water and the increase in the number of salt crystallization cycles has visibly affected the stone.

Figure 50. Left pilaster in January 1997 compared with pilaster in June 1997. Note the loss of material and increase in efflorescence.

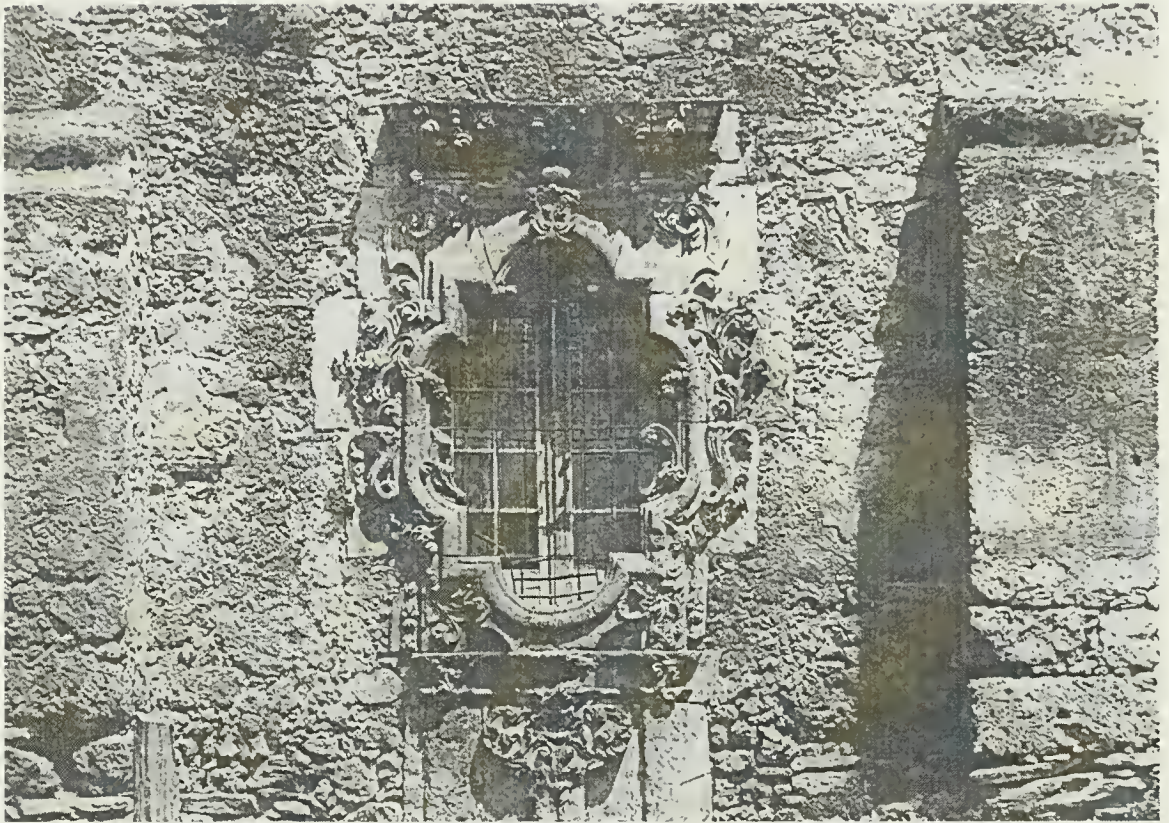
Figure 51. Early photograph of Sacrsity Window. The photograph is labeled 1920, however, the left side of the window shows scrolls which are absent from photographs in the 1890s. Ernst Schuchard Collection - Mission Scrapbook. Daughters of the Republic of Texas Library.

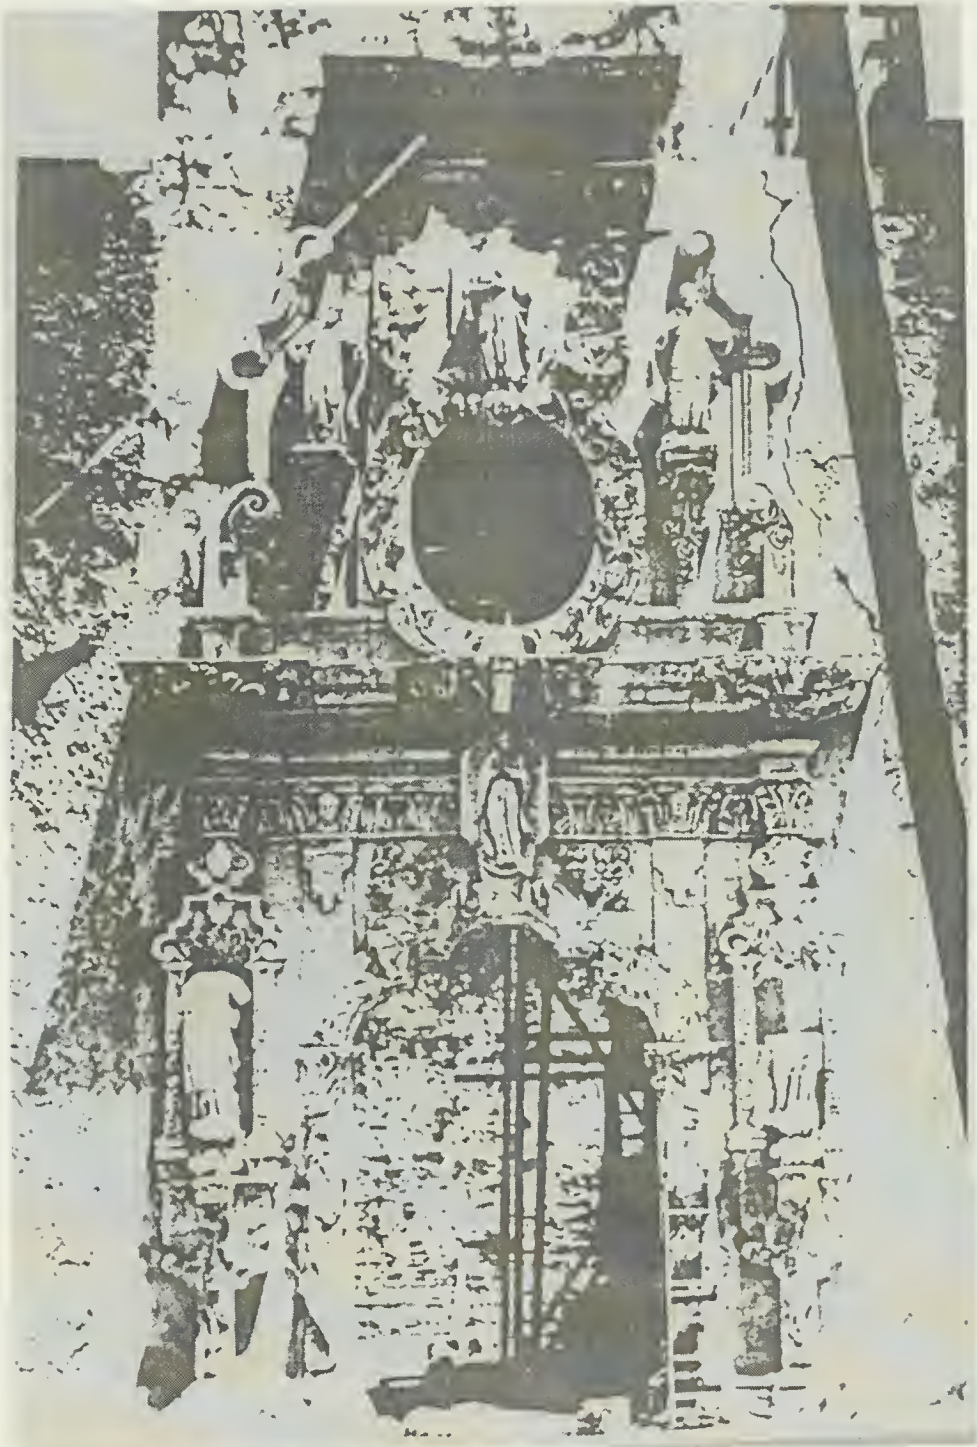
Figure 57. Facade ca. 1917. The shoring within the church represents the restoration project by Fr. Hume in 1917. (San Antonio Express-News Collection at the Institute of Texan Cultures, #69-8663).

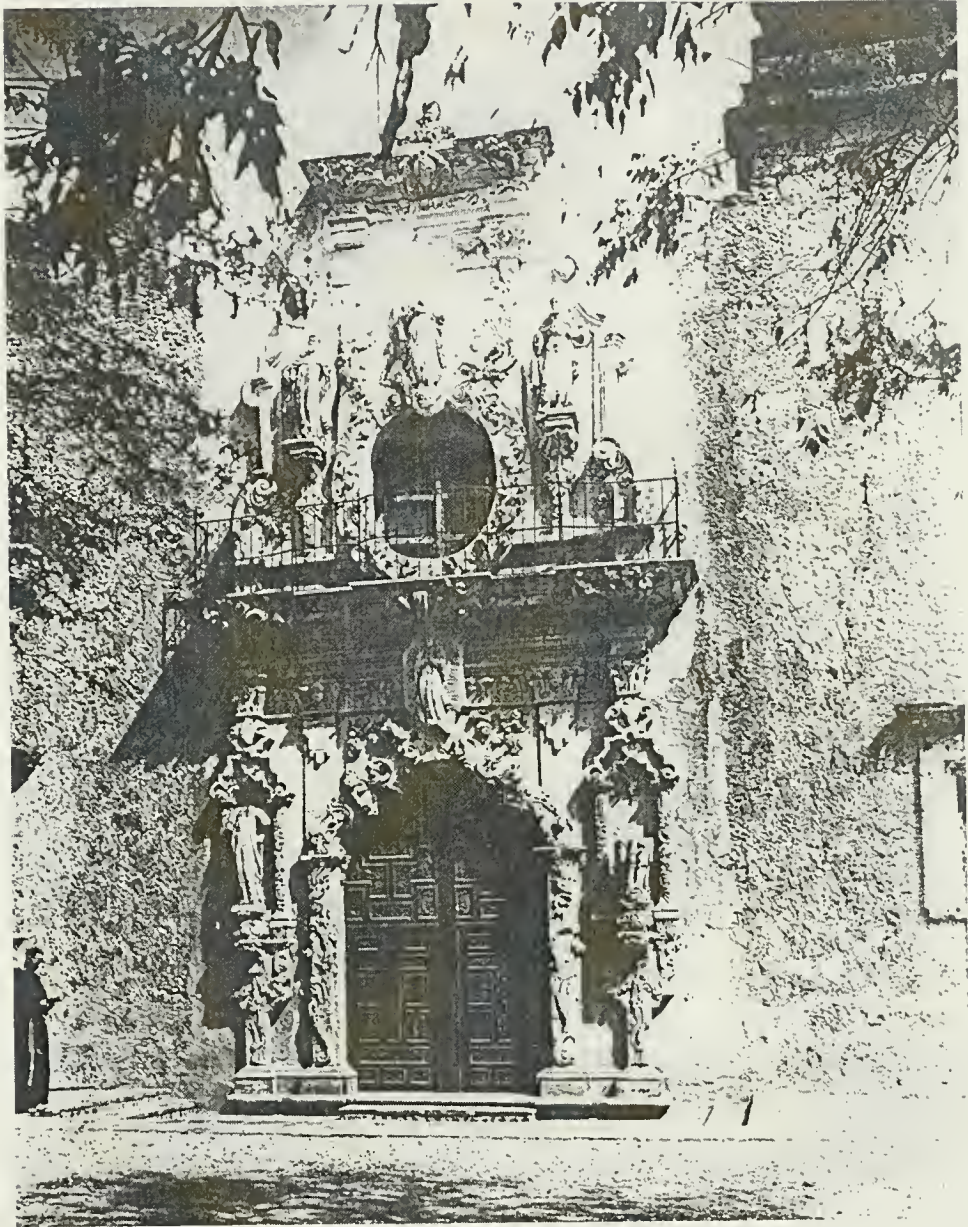
Figure 58. Facade in 1947, before Lenarduzzi restoration. (Ernst Schuchard Collection - Mission Scrapbook. Daughters of the Republic of Texas Library.)

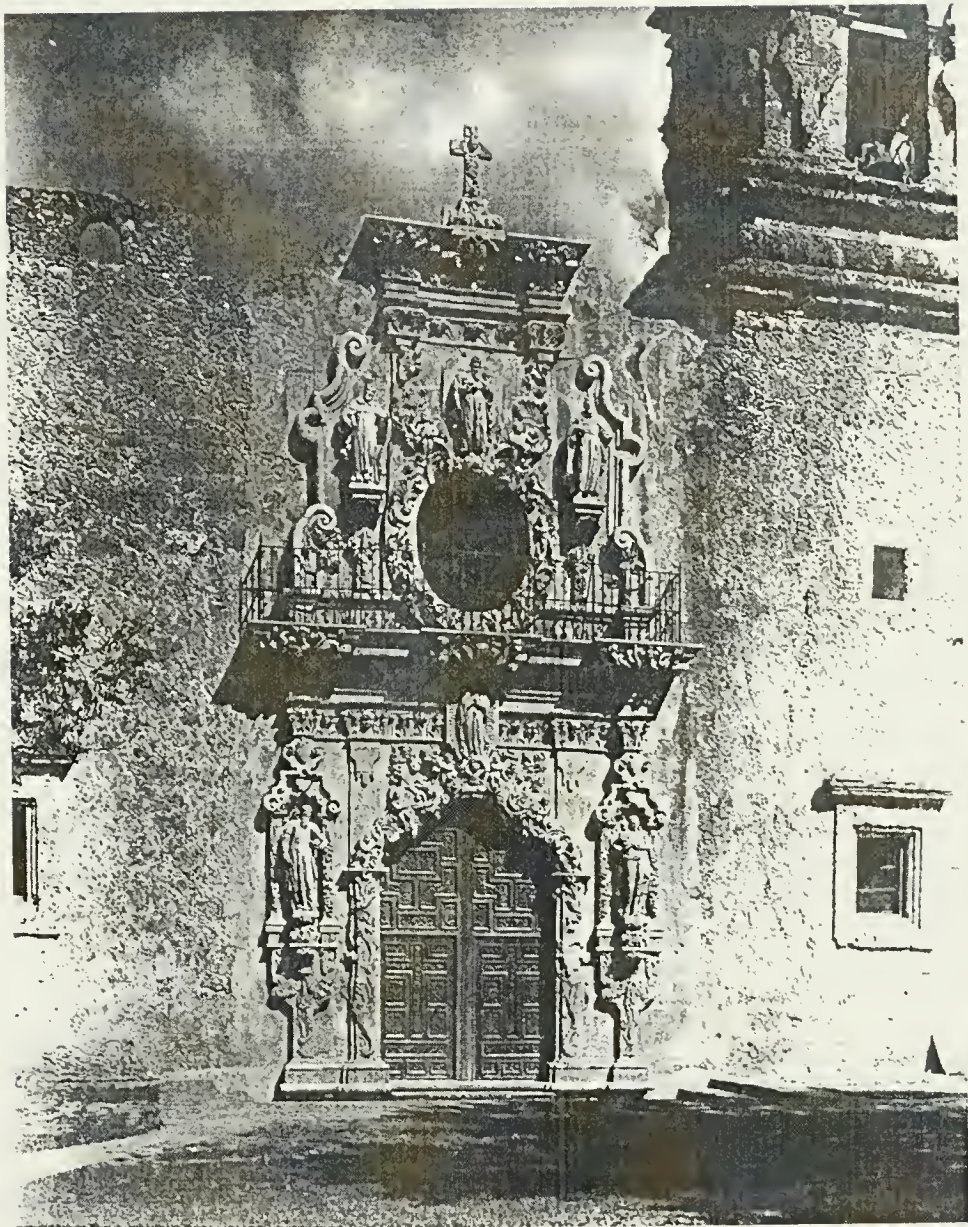
Figure 59 . Facade in 1949, after Lenarduzzi restoration. (Ernst Schuchard Collection - Mission Scrapbook. Daughters of the Republic of Texas Library.)

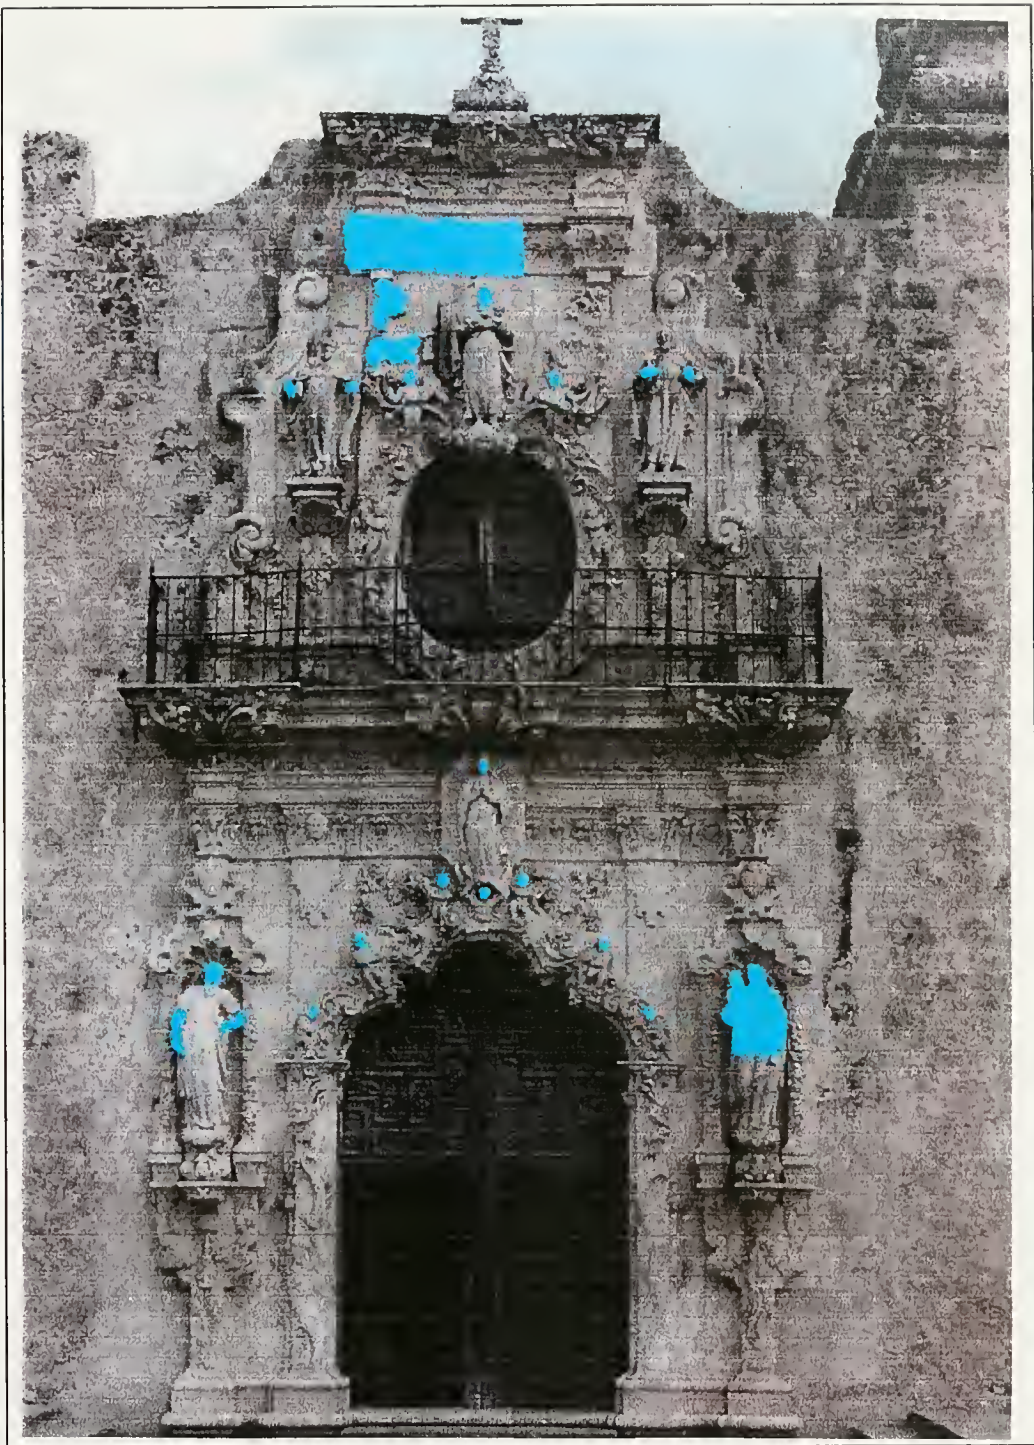
Figure 60. Facade of Mission San José showing areas restored by Lenarduzzi in 1948 using Austin Stone.
