# ASSESSING THE DETERIORATION OF PENNSYLVANIA MARBLE IN WILLIAM STRICKLAND'S MECHANICS' BANK

# A THESIS

# MASTER OF SCIENCE IN HISTORIC PRESERVATION

2018

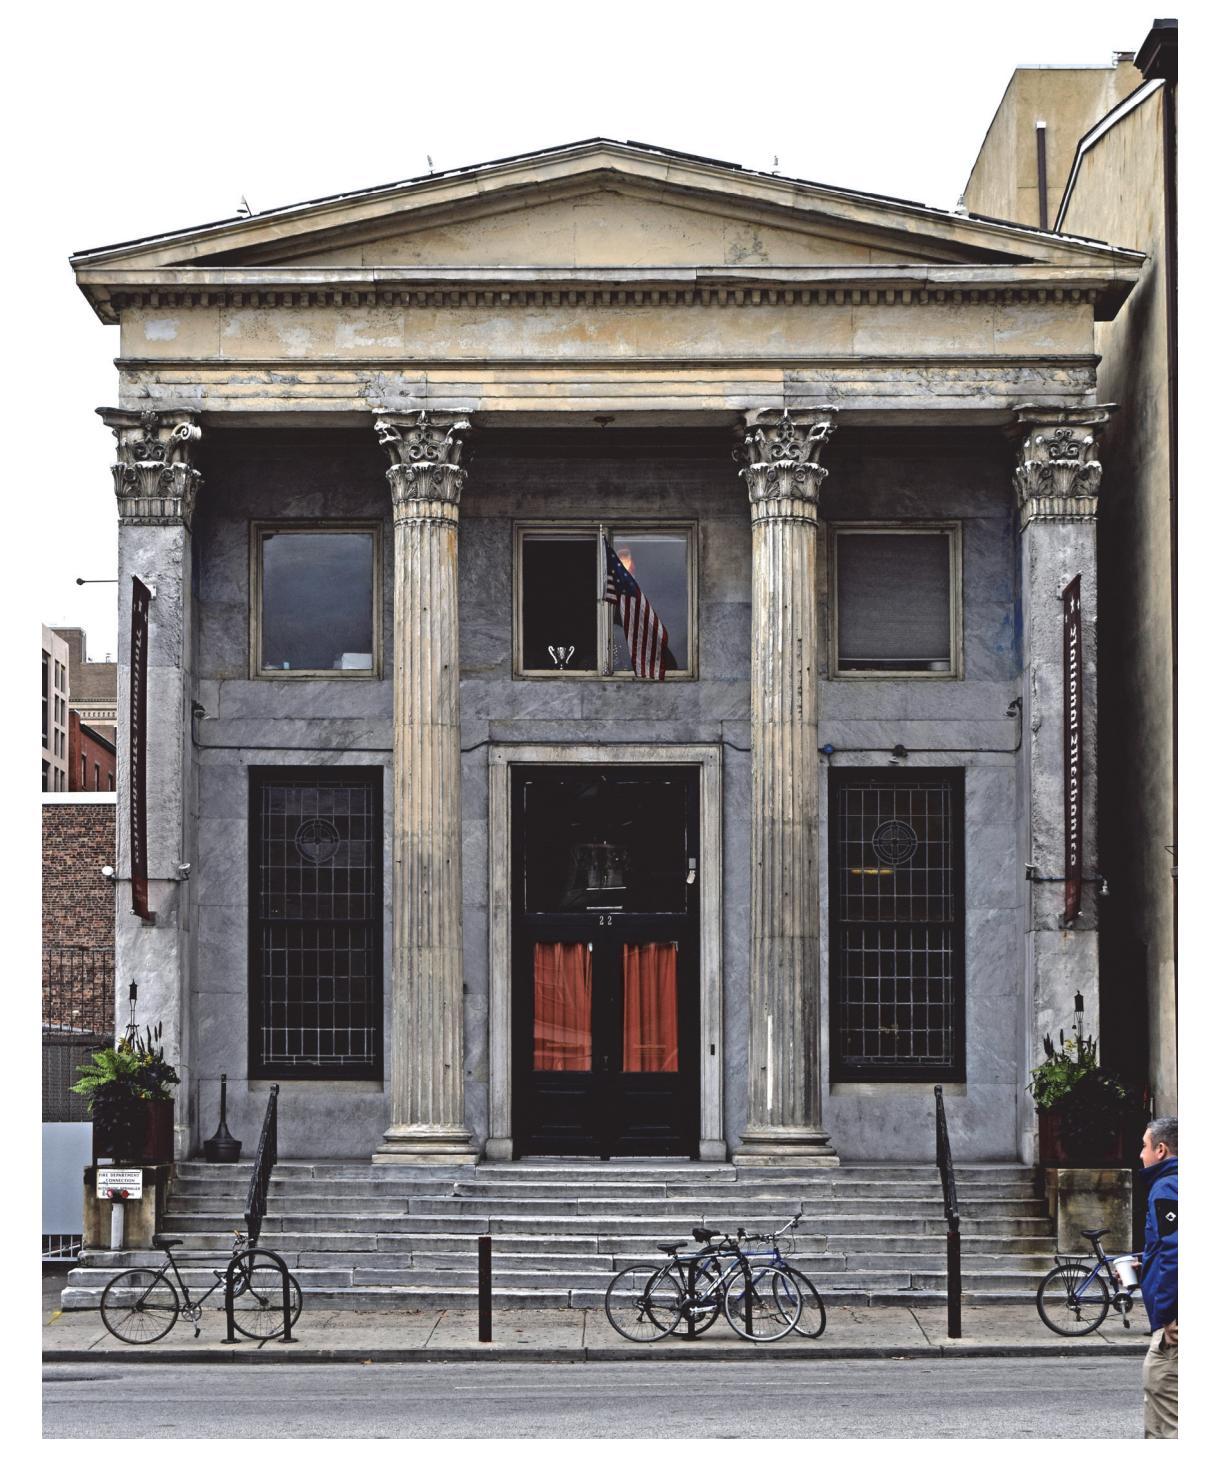
Figure 1: The Mechanics' Bank building in late 2017.

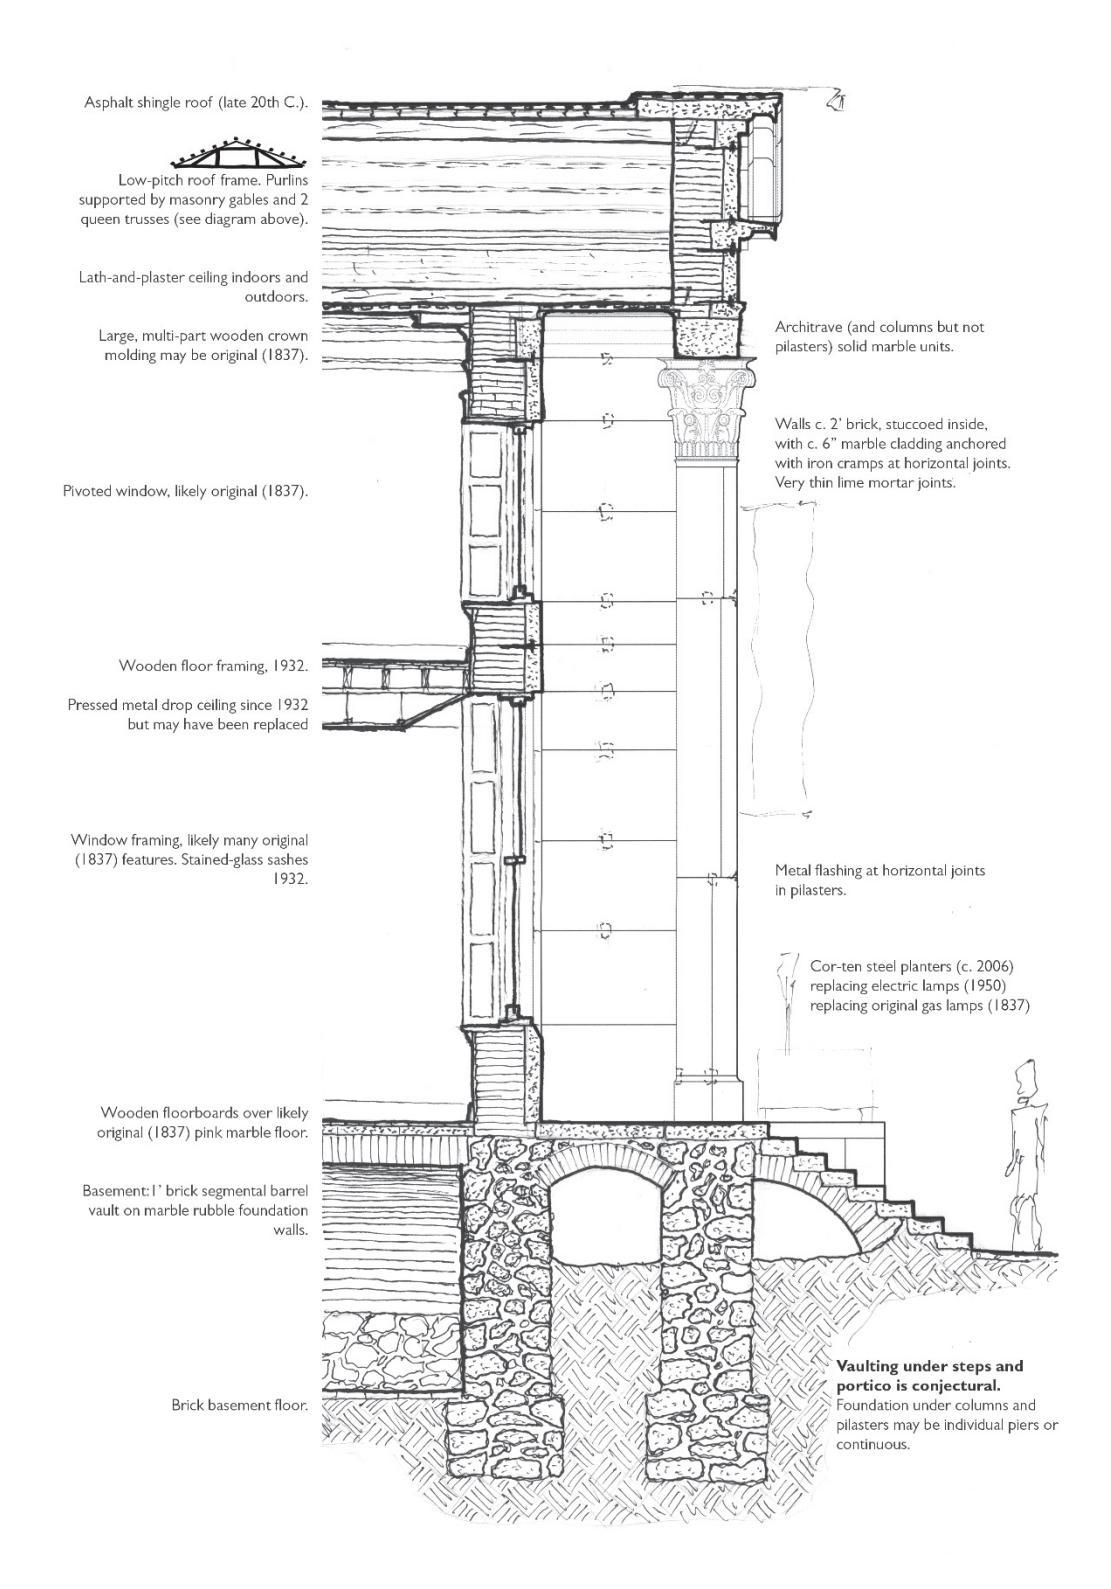
Figure 5: Section through façade showing building assembly. The building's marble-clad brick walls, held together by iron cramps, rest on a vaulted foundation. Second floor added 1930.

underneath the columns and antae could not be examined, since physical removal of material would be necessary for its observation; it may be a parallel and similarly constructed wall, or piers functioning as individual footings. For the same reason, it was not possible to determine the type of foundation underneath the portico and the steps; the floor slabs may be resting directly on the ground, or may be set on brick arches or vaults (there is precedent for this in Strickland's Second Bank building). Due to their displacement, it is likely that at least the lower two or three steps are set on the ground directly.

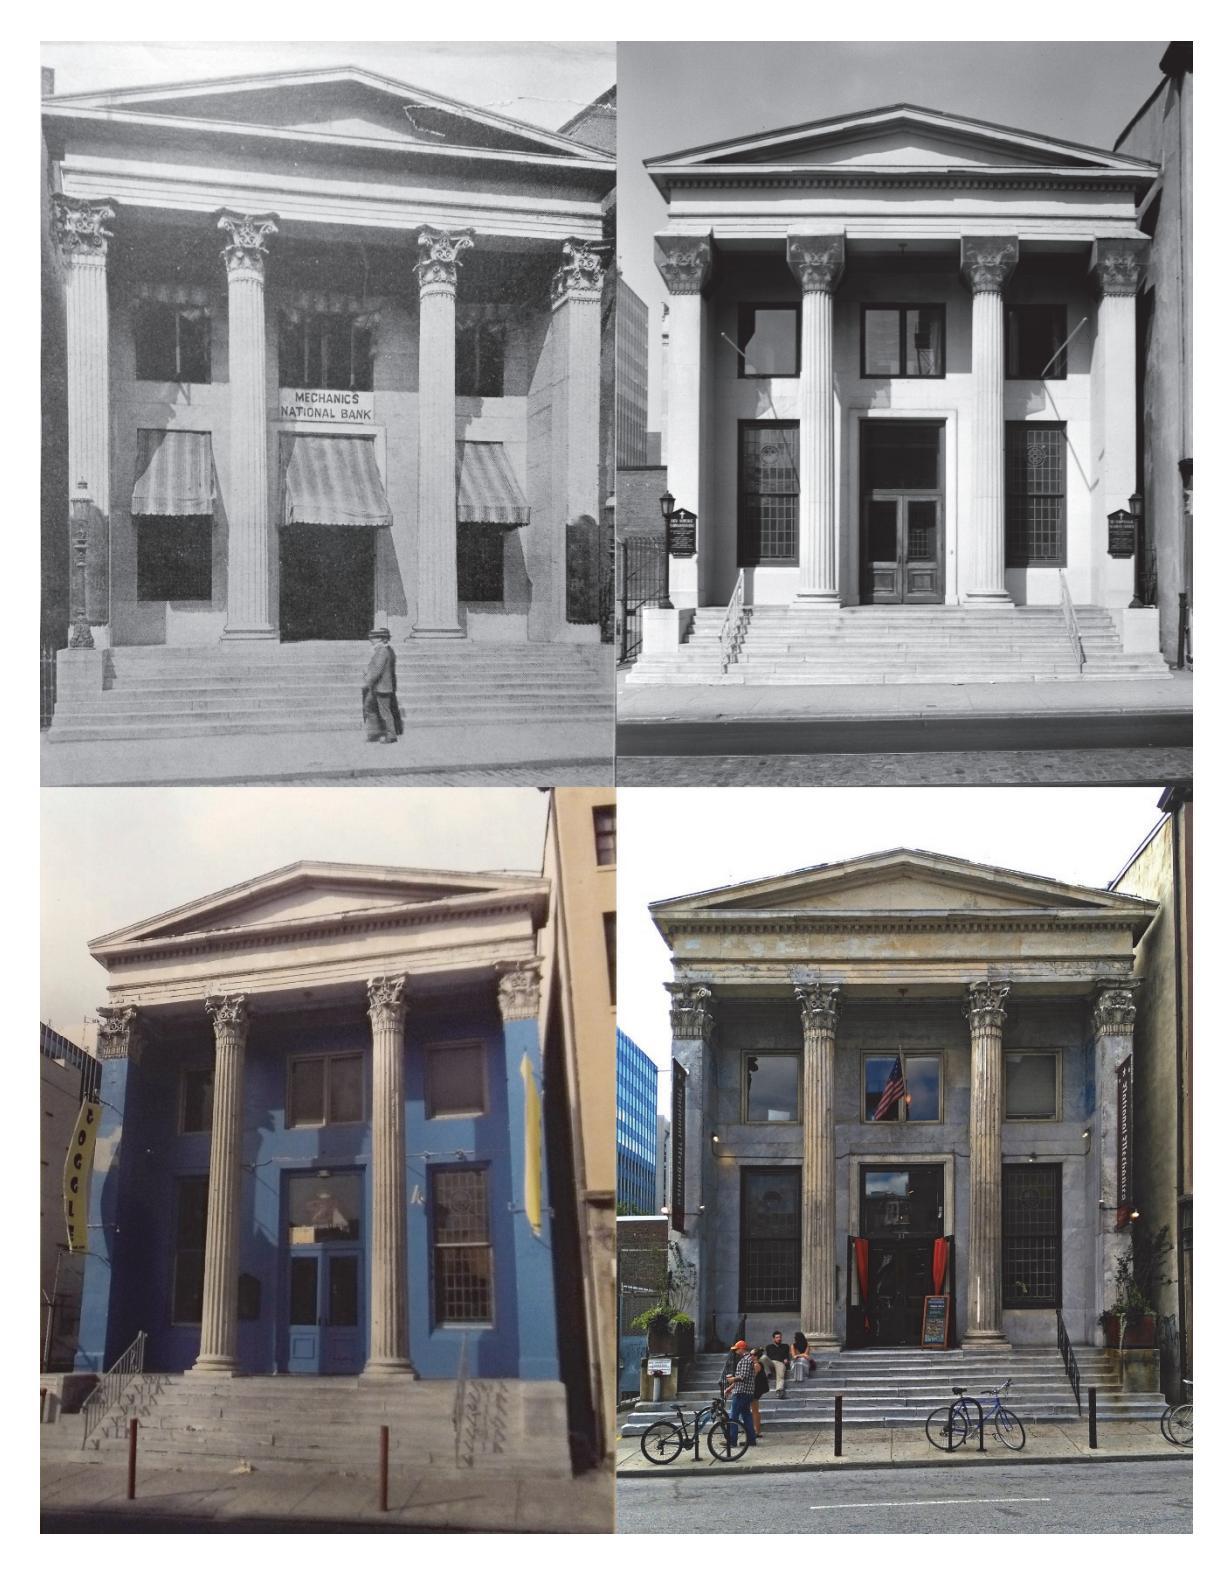
operations.<sup>50</sup> Photographs from 1898-1901 show the building in what appears to be a good state of conservation (Fig. 6). The façade marble seems to be exposed, with all the joints clearly visible; fluting is present not only on the columns, but also on the front of the antae pilasters (since disappeared); and the detailed capitals seem to be mostly complete, with the exception of the more exposed volutes at the corners of the building. The façade is fitted with signs showing the name of the bank both on the antae and over the entrance, and ornate Empire-style cast iron lamps on the cheek walls of the steps. There is a good chance that these may have been original to the building, since they are very similar (the shaft, specifically, is identical) to those installed in 1832 at the Franklin Institute, now the Philadelphia History Museum.<sup>51</sup> All doors and windows are fitted with striped awnings, and the second-floor windows have flagpoles attached to their sills.

Figure 6: The façade underwent successive transformations throughout the twentieth century. Left to right and top to bottom: 1901 (King), 1957 (HABS), 2004 (PRHP), and 2018.

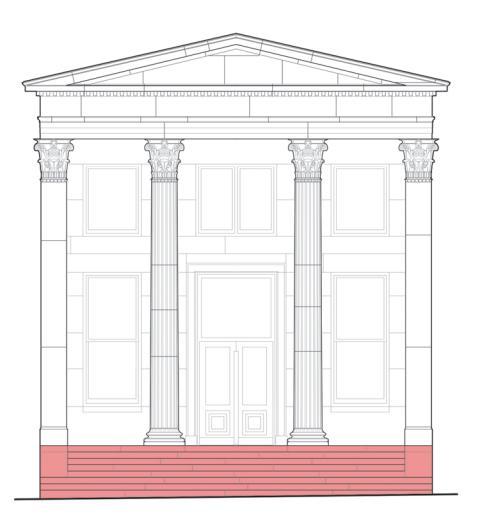
Figure 7: Location of steps within the Mechanics' Bank façade.

The steps present by far the highest degree of displacement of stone units anywhere in the building (Fig. 8). The central steps, furthest from the cheek walls, show inward and downward movement; the three lower steps also present outward tilting. This seems to suggest a subsidence of the foundation structure and has caused wide open joints between the stones, some of which have been repointed with a mortar that is already separating.

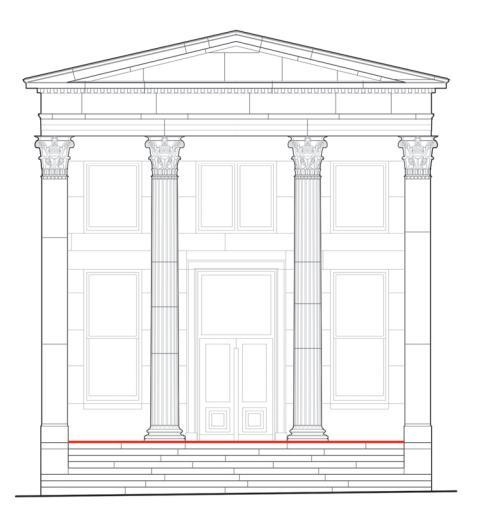
Figure 9: Location of pronaos floor within the Mechanics' Bank façade.

The pronaos floor is composed of large face-oriented blue marble slabs with horizontal bedding. The edge of the floor towards the steps shares many of the steps' conditions, such as differential erosion at edges, and the central slab is tilted outwards since it rests on the subsiding central section of the steps.

A major cross-shaped crack with shearing displacement at the northwesternmost stone slab, prolonged as moderate cracks into the two adjacent stones (Fig. 10), is consistent with an as yet undocumented impact or point load episode. One of the quarters into which the crack divided the stone has been infilled with repair mortar. One of the slabs between the columns is divided by two parallel cracks – one of them infilled - into three separate parts; this stone also shows evidence of former metallic features in the form of drill holes. These features have not been identified, nor is their connection with the cracking clear; the cracking could also be connected to the displacement of the steps. Apart from these two cases there is little cracking of the floor slabs.

Figure 10: Conditions at floor, left-right and top-down: cracking and displacement at center, with holes for metal attachments; soiling and metallic staining at south wall; cross-shaped crack (mortar repair at bottom left).

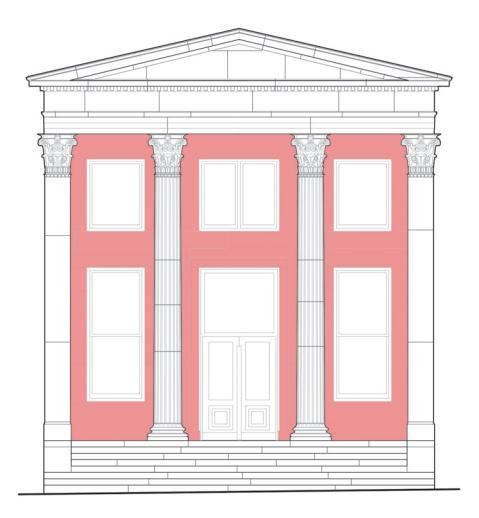
Figure 11: Location of pronaos wall within the Mechanics' Bank façade.

The pronaos walls include both the back wall of the pronaos and the interior surface of the antae behind the pilasters. These are clad in large, regular units of Pennsylvania blue marble with few inclusions, approximately 6" thick and face-oriented with the exception of the edge-oriented horizontal lintel above the central window . Being a protected, flat area with few outstanding reliefs or edges, there is little dimensional loss or major structural cracking visible throughout; microcracking, associated with foliation planes, appears only at the one edge-oriented unit. Some structural movements, much less pronounced than at the steps and floor, are evident from open joints and a small number of structural cracks above the door on both sides, exacerbated by very thin mortar joints and hard repointing (Fig. 12).

Figure 12: Conditions at pronaos walls, left-right and top-down: contour scaling and repointing; top of north anta with paint coating; open joints, soiling and electrical conduit; mortar causing marble flaking at south jamb.

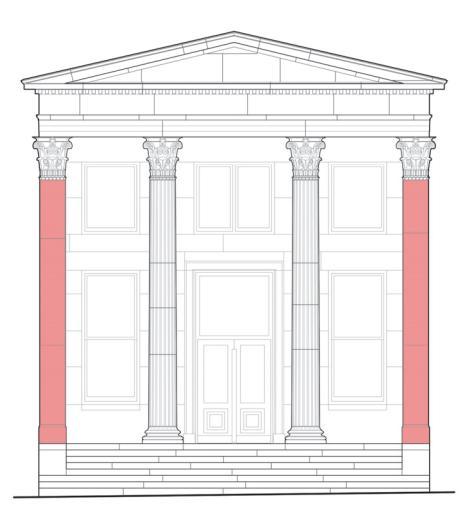
Figure 13: Location of pilasters within the Mechanics' Bank façade.

The two pilasters capping the antae at the corners of the building are composed each of three courses of long, vertical stone units, plus a small base. Each course consists of three units, their depths ranging from 4" to 10", wrapped around the brick core. Front-facing units are face-oriented and originally showed fluting which was tooled back at some point between 1930 and 1950. Side-facing units are face-oriented on the exterior north elevation; edge-oriented vertical on the exterior south elevation; and a mixture of both on the interior elevations.

A small amount of structural movement seems to have caused cracking and incipient spalling at the lower unit of the north pilaster's south elevation; as well as the opening of the joints between the pilasters and the anta walls, which have been partially repointed (Fig. 14).

Figure 14: Conditions at pilasters, left-right and top-down: structural spalling (north inward); spalling and erosion (south inward); paint residue and severe friability (south); soiling and large spalling (north at alley).

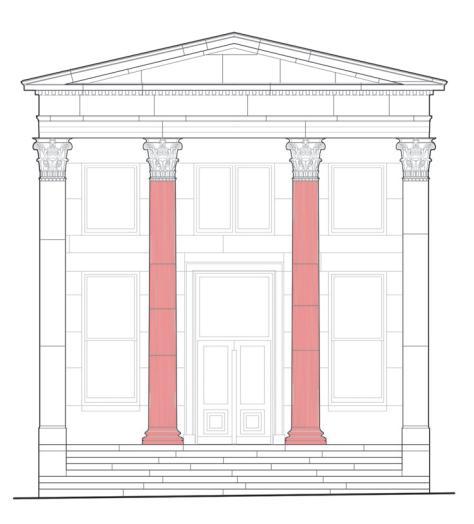
Figure 15: Location of columns within the Mechanics' Bank façade.

The two columns are each composed of three solid drums plus a base. Most of the drums present vertical bedding, excluding the top south drum with diagonal beds. Among the rest, all the drums are face-oriented when seen from the front excluding the middle north, which is edge-oriented.

The column bases have horizontal bedding and present some microcracking associated with the bedding as well as significant erosion with loss of detail; but little friability. This pattern is concentrated especially in exposed areas facing east and southeast (Fig. 16). Metallic staining is also pervasive on exposed areas, but its cause is not clear; it may have been caused by metallic elements higher up that have since been removed, such as the capital cages. The more protected areas facing west and northwest show less influence of these conditions, but have a substantial amount of encrusted soiling. The south base shows structural cracking connected to the movement of the floor slabs.

Figure 16: Conditions at columns, left-right and top-down: microcracking, erosion and staining (north base); electric conduit (south); spalling of fluting and repair (north); diagonal cracking and incipient spalling (south).

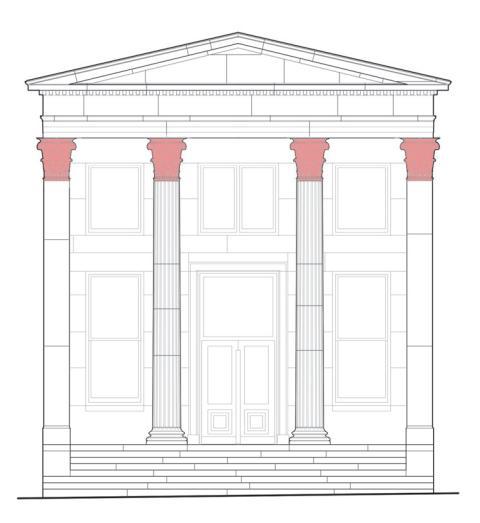
Figure 17: Location of capitals within the Mechanics' Bank façade.

The four capitals seem to be made of a different type of marble from the rest of the building, although this could not be confirmed; they present no clear evidence of foliation. Each capital, including the abacus, is made of one single block of marble. Many elements – most notably the volutes, fleurons, and tips of the acanthus leaves – were originally carved in very high relief with large amounts of openwork.

Most of the more fragile elements have been lost to spalling throughout all the capitals. This includes the tips of practically all acanthus leaves; the tips of most of the openwork volutes, with only one intact and one damaged volute left (at the two south capitals); and the fleurons, only one of which is preserved at the south pilaster capital (Fig. 18). Friable areas and encrustation are present in the vicinity of the spalled areas and, especially, above the volutes and at and between the helices. This suggests the transformation of the marble into gypsum as a possible cause of the dimensional loss, though it does not confirm it. Generally speaking, the exposed elevations (facing east) show the greatest amount of deterioration, while the protected areas (facing west at the column capitals and north at the south pilaster capital) show the lowest amount. Among the exposed areas, those at the pilaster capitals show the largest amount of deterioration, including cracking and incipient spalling at the lower corners of the south unit that is not present at the other capitals. The abaci show differential erosion with loss of detail at the originally sharp tips, and soiling at the lower part of the scotia molding. The southwest tip of the abacus at the southern column capital has spalled together with the volute underneath.

Figure 18: Conditions at capitals, left-right and top-down: friability and spalling (south pilaster); abacus spalling (north column); intact leaf tips and metal spikes (south column); only intact volute and fleuron (south pilaster).

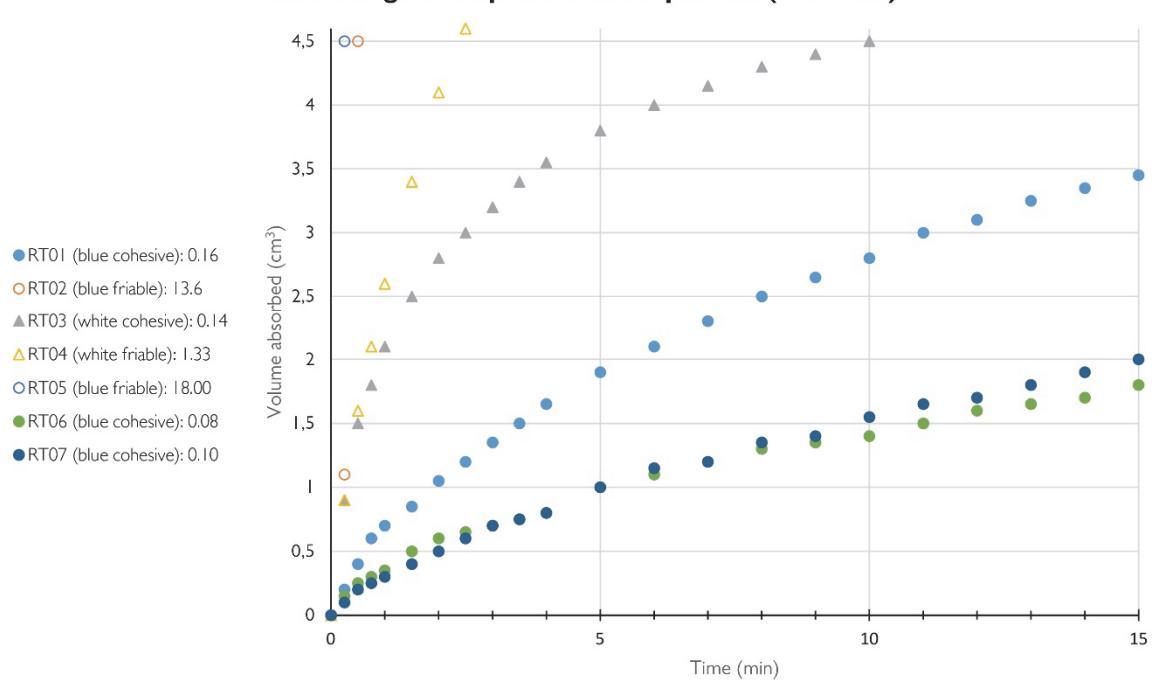
Rilem absorption testing revealed significant differences between the blue and white marbles, and especially between cohesive and friable marble (Fig. 22, Table 5). Cohesive blue marble showed the flattest absorption curves and lowest absorption rates at plateau, followed by cohesive white marble, which showed a similarly low absorption rate but a steeper initial curve. Loss of cohesion in marble, which involves the separation of grains forming cracks that act as interconnected pores, predictably increased absorption rates dramatically. The increase was high for white marble but much more so for blue. This suggests that initial loss of cohesion can create an avenue for water infiltration and, therefore, accelerate the rate of deterioration.

The second peculiarity is the much smaller variation under loss of cohesion for white marble as compared to blue. An explanation behind this may be that the white units were smaller and more irregular with the more and less cohesive areas closer together, and therefore external factors affected absorption rates.

Figure 22: Rilem absorption curves at different test locations. In sound condition, the marble used on the floor has the slowest absorption rate, and white marble has a faster absorption rate than blue. Loss of cohesion causes a dramatic increase in absorption rates.

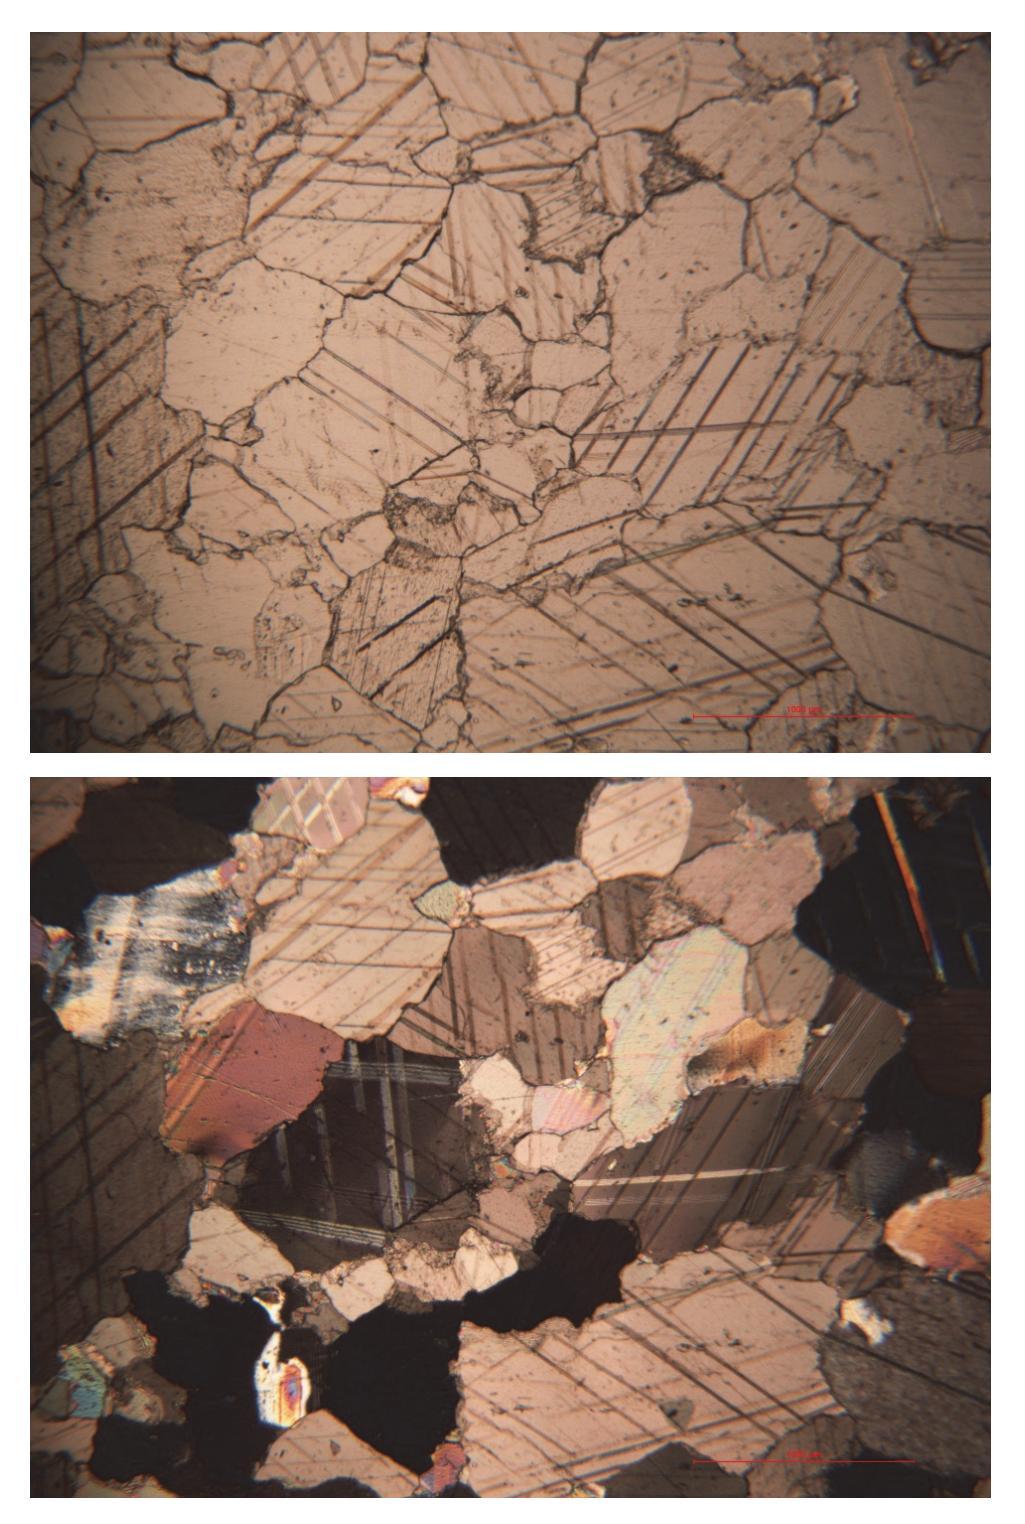
Figure 23: Sample SS03 under PPL and XPL (40x). Note microcline feldspar crystal at top left.

Blue samples presented a significant degree of variation. Sample SS03 showed the least amount of foliation, with a granoblastic texture; and the most irregular grain boundaries, with few triple junctions (Fig. 23). It had the largest amount of accessory minerals by volume, consisting of large orthoclase and microcline crystals and a few large, weathered crystals that may also be feldspar. The macroscopically visible crust on the sample was determined to be only a thin soiling layer, with shallow weathering of the outermost crystals and no gypsum crust formation (Fig. 24). No cracks, either inter- or intragranular, were present.

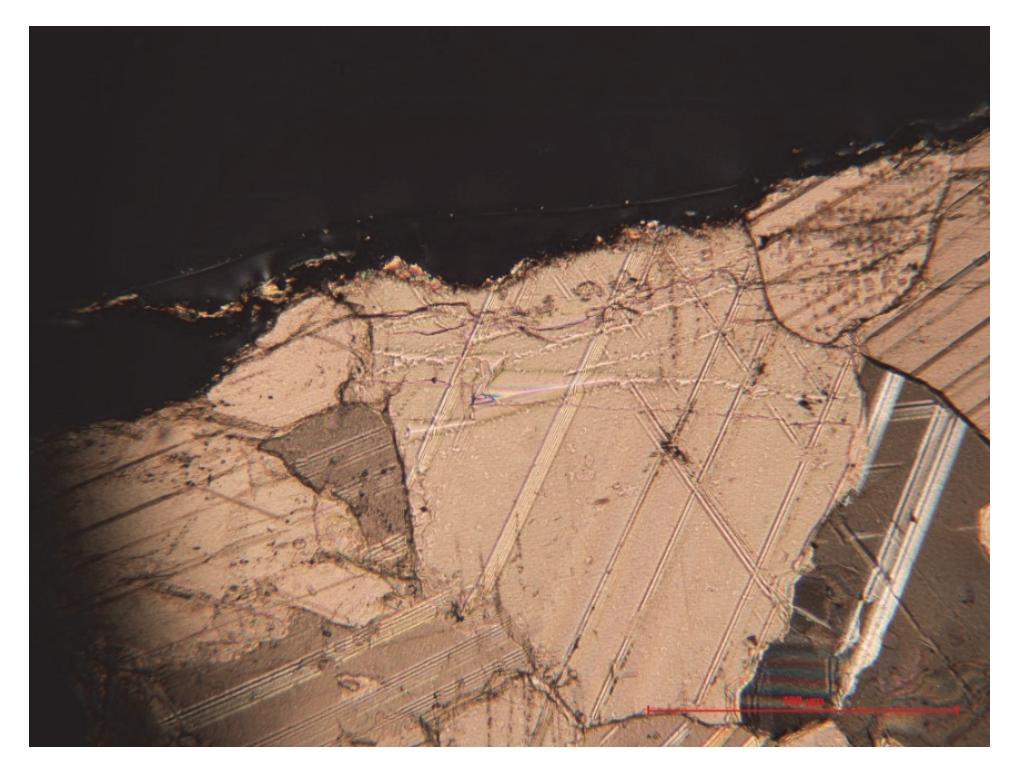
Figure 24: Surface weathering and soiling in SS03. XPL (100x).

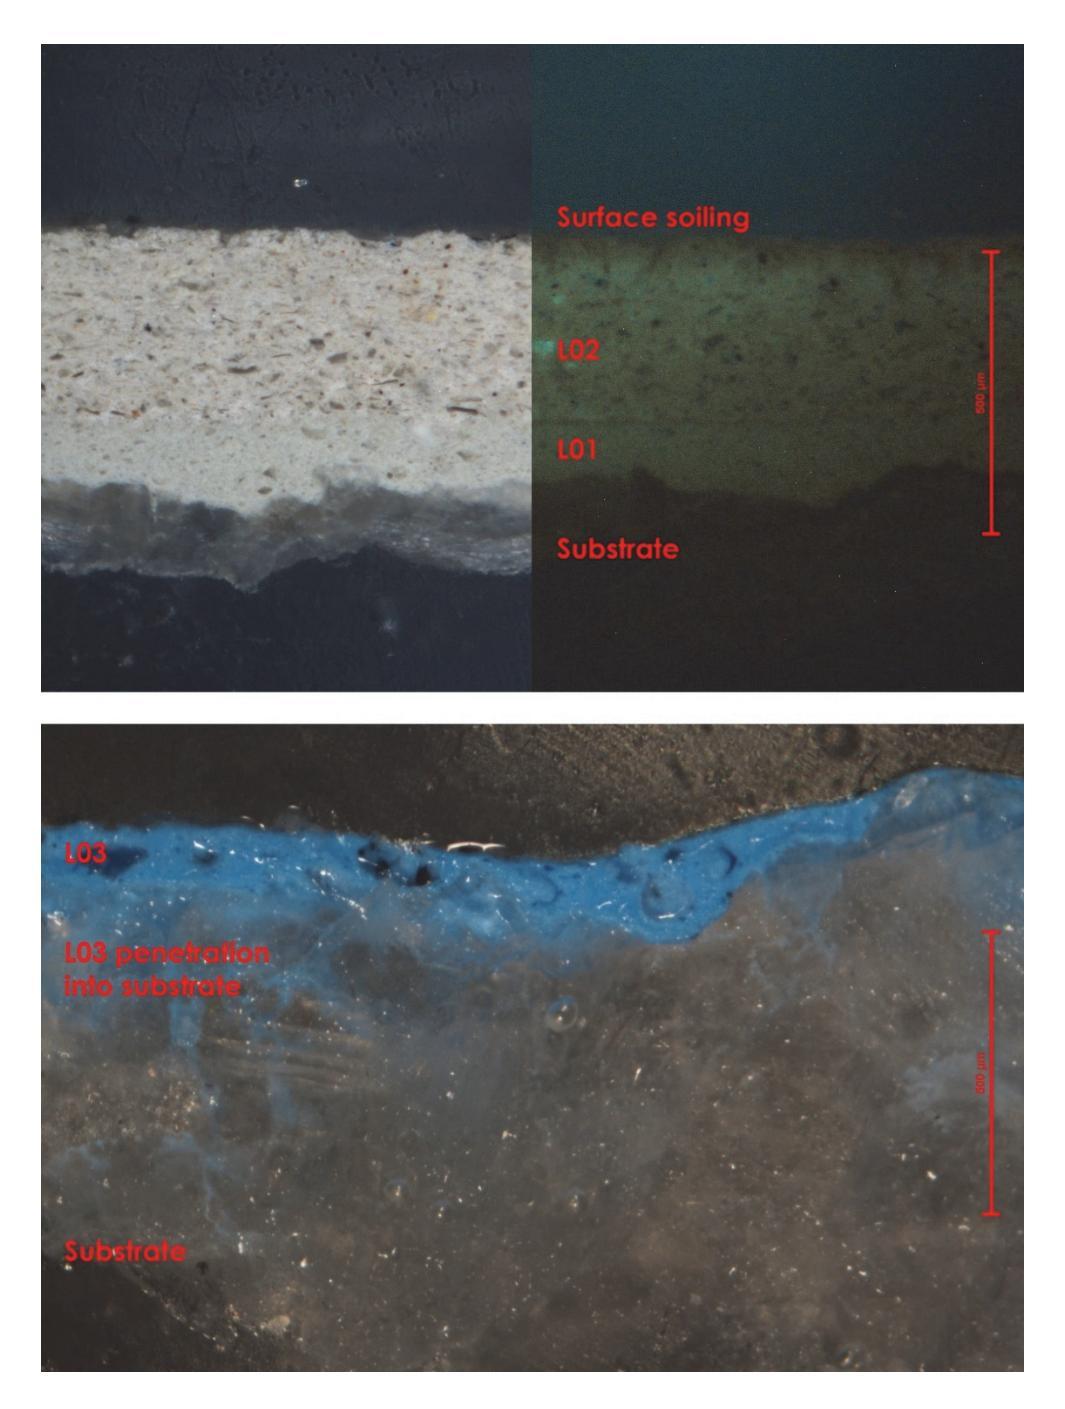
Photomicrographs of the cream layers on the south column (Fig. 33) show that two layers, L01 and L02, were applied successively. Both show visible pigment grains in a white binder with yellowish-green fluorescence that suggests an oxidized drying oil as a binder,

The photomicrographs of the blue paint show the residue left inside a joint at the north pilaster. Only one layer of paint, L03, is visible showing no visible pigment grains and no autofluorescence, which is consistent with modern acrylic paints. Very little soiling is perceptible, but there is substantial penetration into the substrate, which indicates that the marble had lost its intragranular cohesion before the paint was applied. L03 is well documented to have been the outcome of a painting campaign in 2004. The commercial name of the paint used, Biloxi blue, is used by many suppliers; this makes it difficult to determine the exact product used. Since the sample is from an open joint, the direct application of the paint on the stone here is not representative of the whole surface, and in many places it would have been applied over the cream paint.

Figure 33: Sample PS2-02 above (4x, visible and blue-violet UV light) shows two layers of cream paint. Sample PS1-01 below (4x, visible light, UV not shown since no fluorescence detected) shows one layer of blue paint.

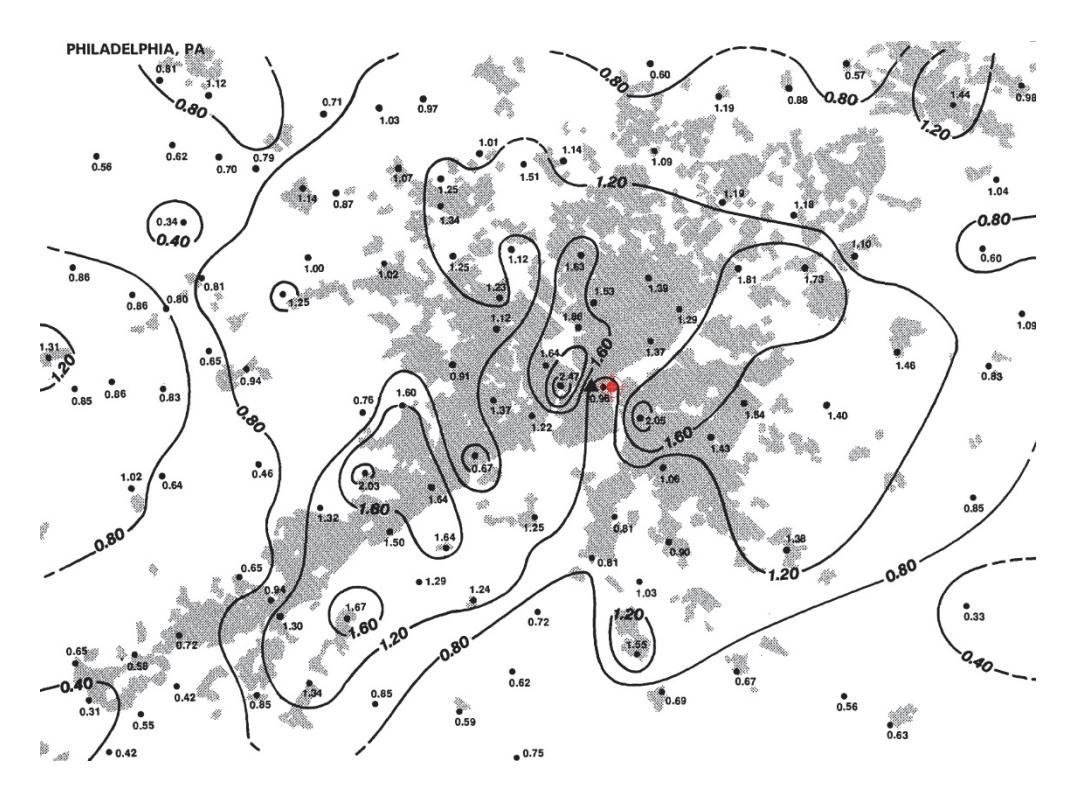
The effect of pollutant gases in the atmosphere, especially sulfur dioxide (SO<sub>2</sub>), was observed by Meierding to have a greater impact on the durability of marble than acid rain.<sup>80</sup> Sulfur dioxide, in the presence of water, reacts with the calcium carbonate and turns it into water-soluble calcium sulfate (gypsum) that is easily washed away. This causes an erosion that is stronger in areas with present or past abundance of coal gases, especially former industrial areas; according to Meierding's data, the erosion rate in Philadelphia's Old City would be close to 1mm/100yrs, or about 2mm in the Bank's lifespan on average (Fig. 35). The concentration of atmospheric SO<sub>2</sub> in Philadelphia peaked between c. 1930 and 1950; this was immediately prior to the restoration campaigns where it was decided to paint the façade, while photographs predating this peak show little apparent deterioration of the stone (Fig. 36).

Figure 35: Dimensional loss rates for marble tombstones in the Philadelphia area (mm/100yr); red dot shows

Mechanics' Bank. A correlation with SO2 pollution is visible. Adapted from Meierding, 578.

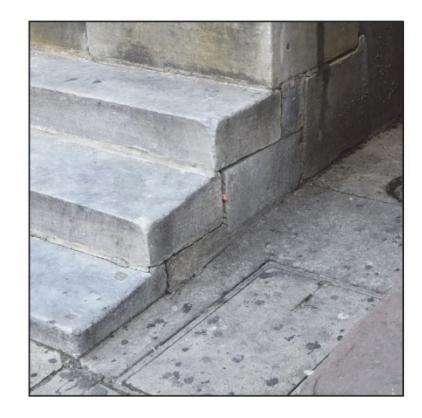
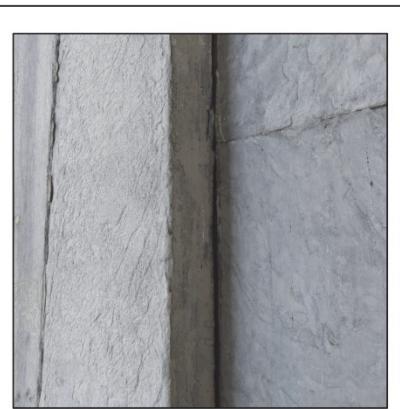
Condition: Dimensional loss

Definition: Loss of stone elements at least 2sq in in area, and  $\ensuremath{\mathrm{I}/2^{*}}$  deep. May or may not be connected to spalling.

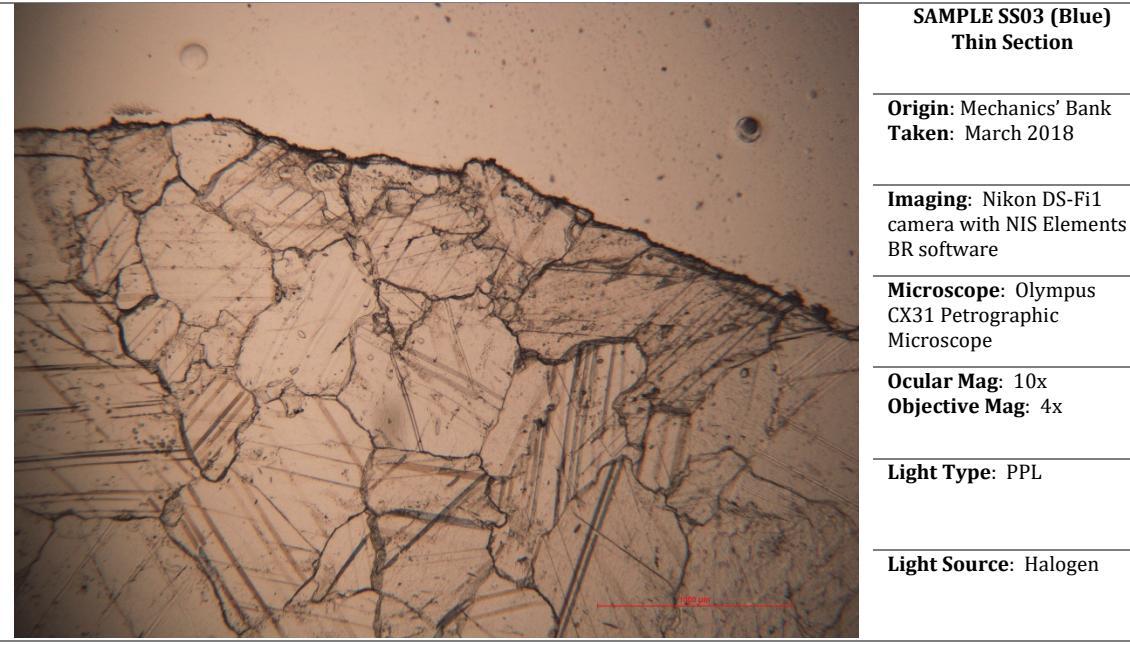
**NOTES:** Surface at area with encrusted soiling. Texture is granoblastic. Soiling only thin layer on grains, with some weathering of grains but no evidence of gypsum crust. Medium-sized subhedral and anhedral grains, equant to subelongate. No intra- or intergranular cracking and no damage at cleavage planes. Irregular boundaries between grains with few triple junctions.

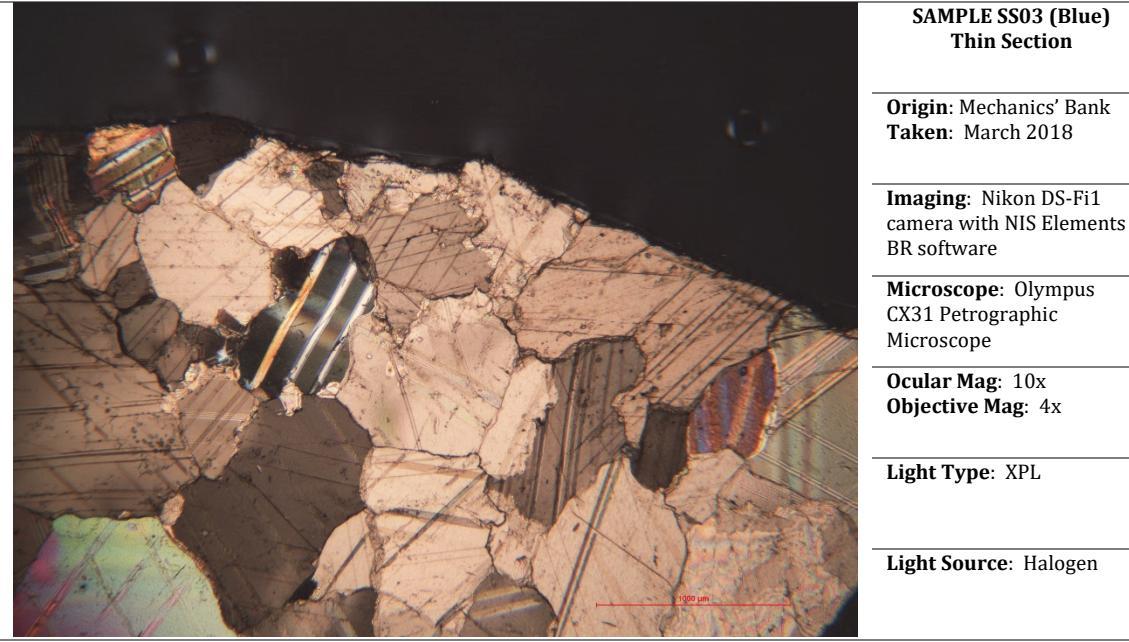
**NOTES:** Surface at area with encrusted soiling. Primary mineral calcite/dolomite evidenced by rhombohedral cleavage and high order birefringence cream colors.

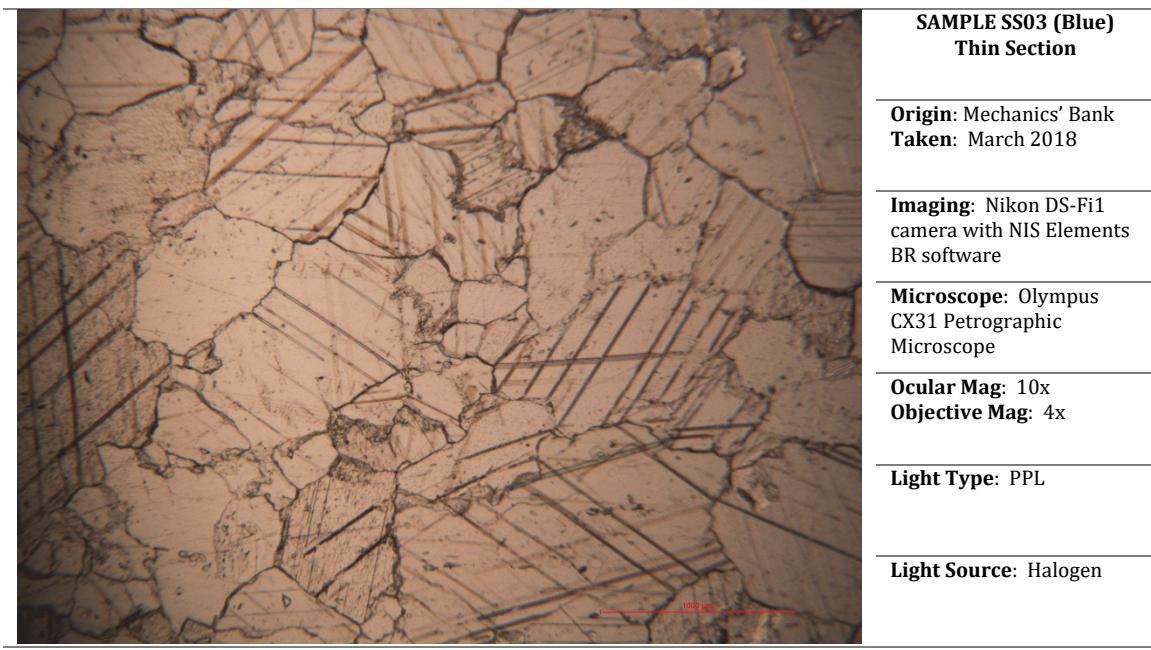
**NOTES:** Interior of sample. Texture is granoblastic. Medium-sized subhedral and anhedral grains, equant to subelongate. No intra- or intergranular cracking and no damage at cleavage planes. Irregular boundaries between grains with few triple junctions.

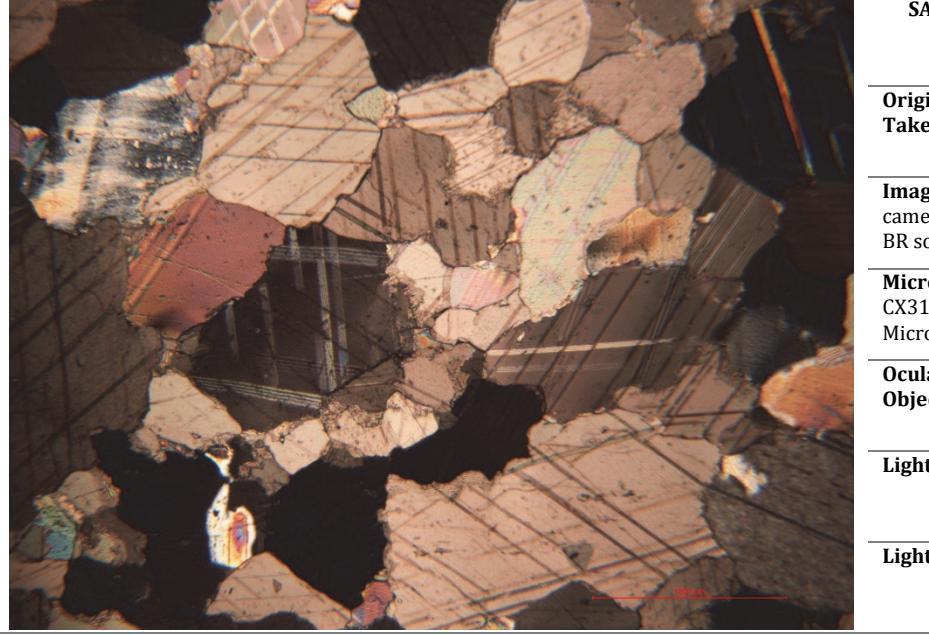
SAMPLE SS03 (Blue) Thin Section

**NOTES:** Interior of sample. Primary mineral calcite/dolomite evidenced by rhombohedral cleavage and high order birefringence cream colors. Some large grains of accessory minerals including probable microcline feldspar evidenced by hatched twinning (top left).

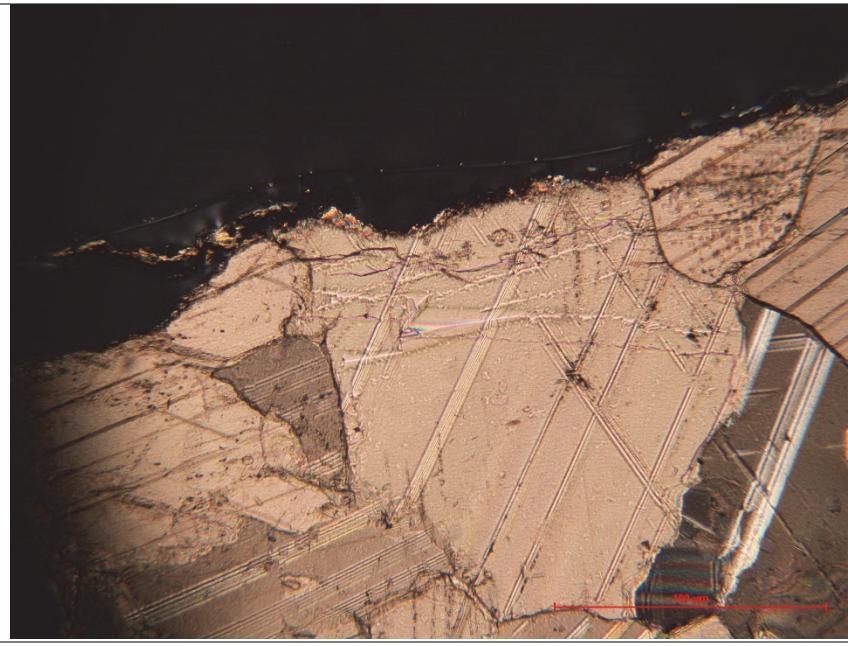
SAMPLE SS03 (Blue) Thin Section

NOTES: Surface showing soiling layer and alteration of crystals.

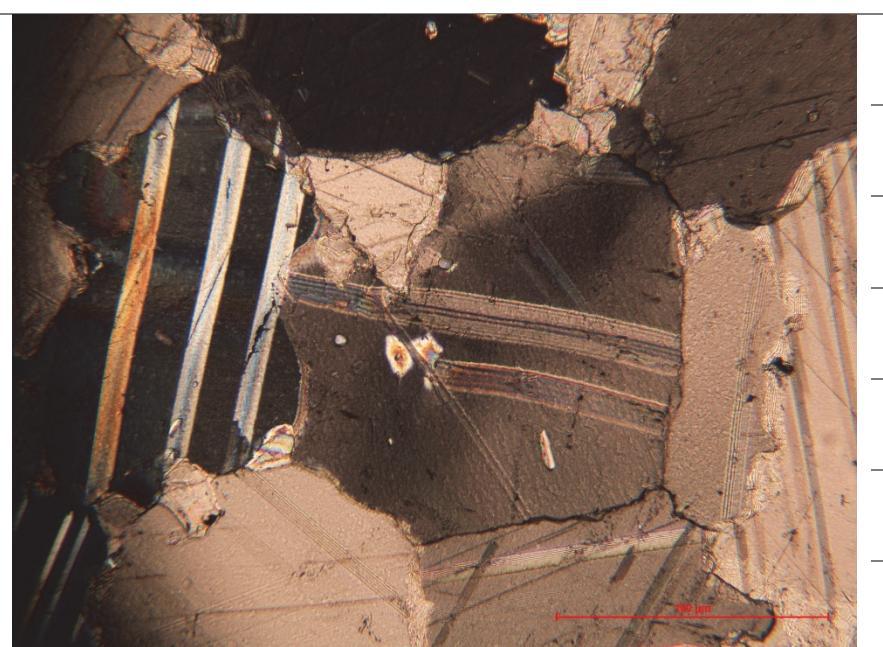
SAMPLE SS03 (Blue) Thin Section

NOTES: Accessory mineral with undulose extinction (possible feldspar).

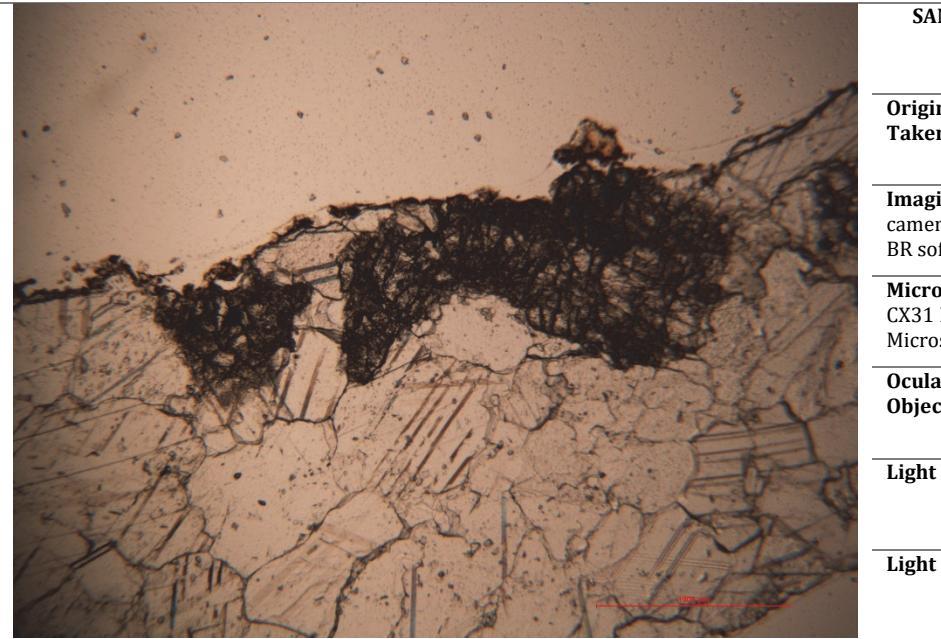
SAMPLE SS03 (Blue) Thin Section

NOTES: Large grain of accessory mineral with severe weathering making identification difficult.

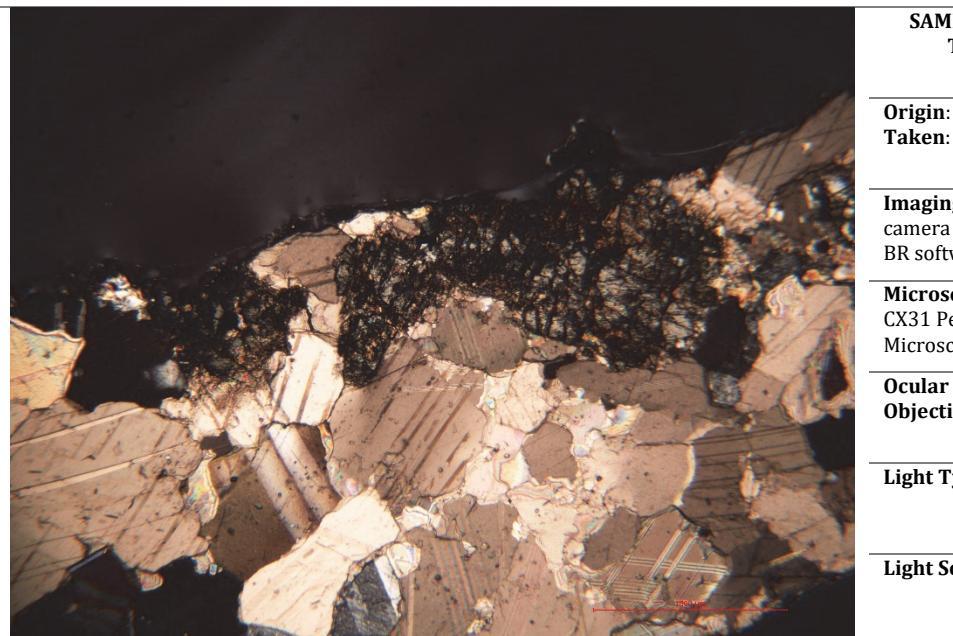
**NOTES:** Large grain of accessory mineral with severe weathering making identification difficult.
