# ASSESSING THE DETERIORATION OF PENNSYLVANIA MARBLE IN WILLIAM STRICKLAND'S MECHANICS' BANK

# A THESIS

# MASTER OF SCIENCE IN HISTORIC PRESERVATION

2018

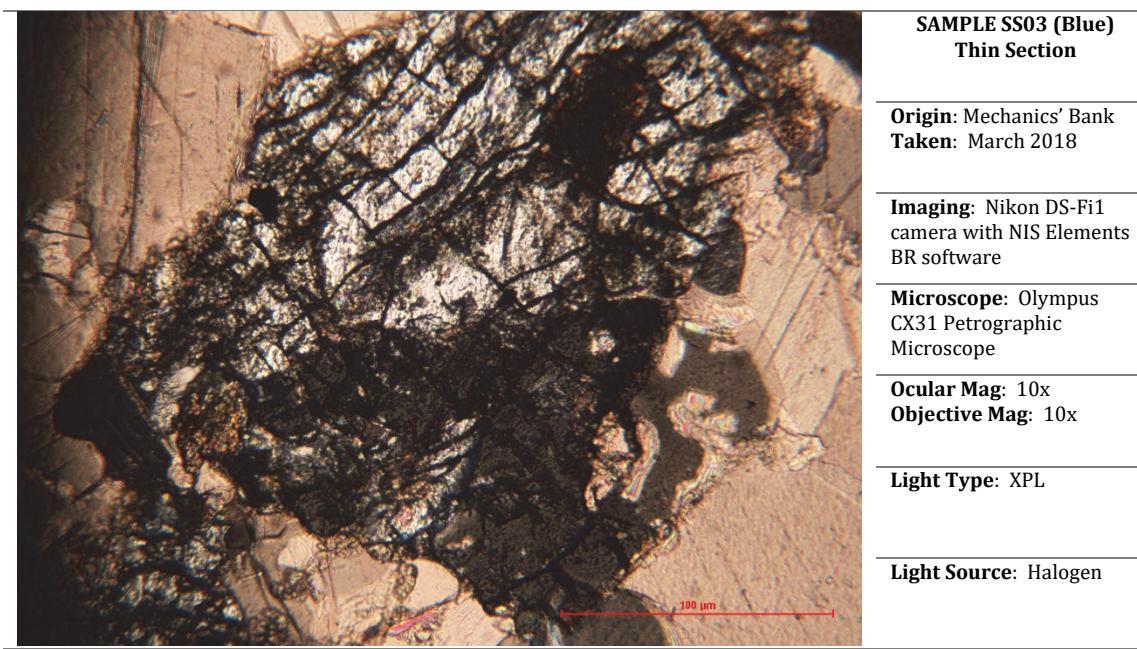
**NOTES:** Grain of same mineral showing simple twinning in XPL which suggests it may be feldspar.

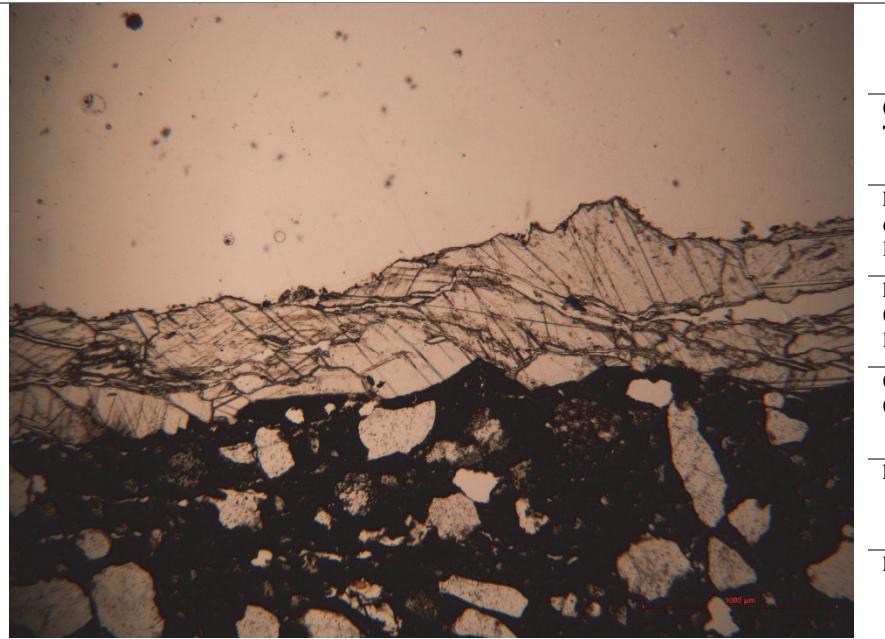
SAMPLE SS04 (Blue) Thin Section

**NOTES:** Surface at interface with mortar M02. Texture is foliated. Sample too small and fragmented to observe microstructure.

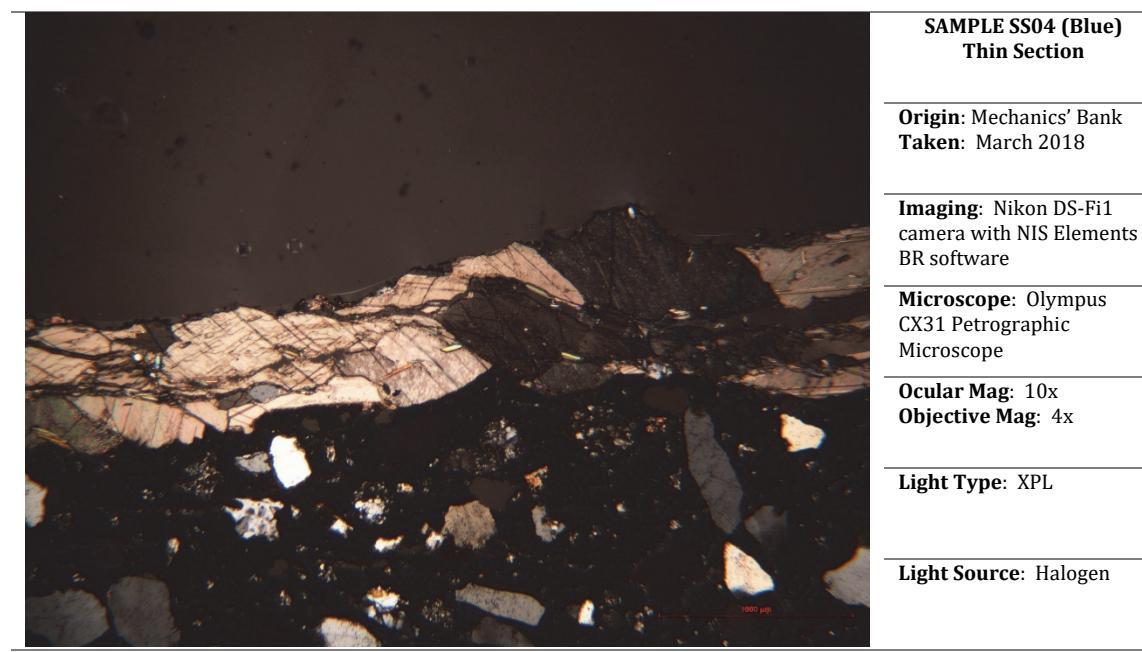
**NOTES:** Surface at interface with mortar M02. Primary mineral calcite/dolomite evidenced by rhombohedral cleavage and high order birefringence cream colors. Some small grains of accessory minerals including quartz evidenced by high relief and lower first order gray color (center left) and mica laths (extreme left).

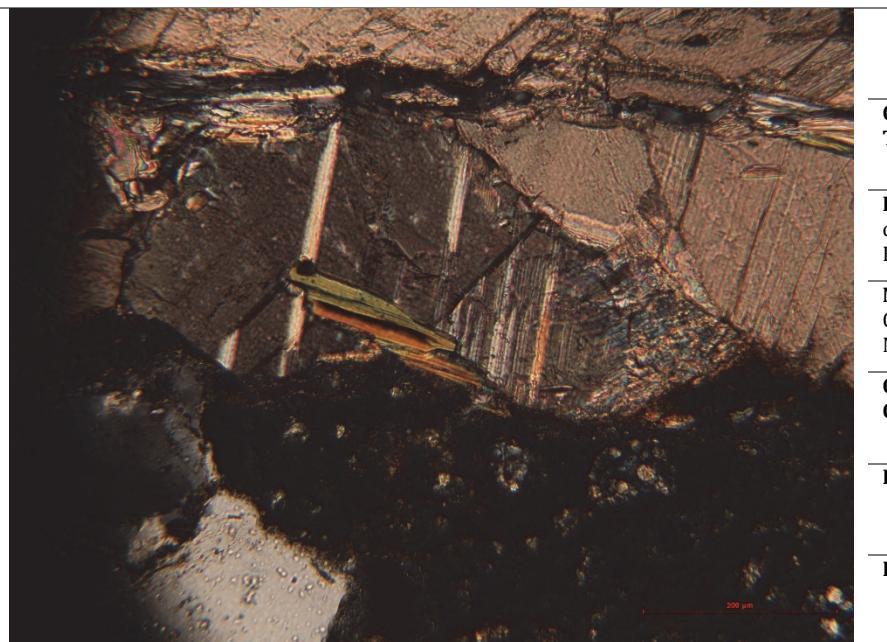
SAMPLE SS04 (Blue) Thin Section

**NOTES:** Detail of platy micaceous lath, probably muscovite (bottom) and intragranular crack (top) with lenticular crystals in crack that suggest possible formation of gypsum.

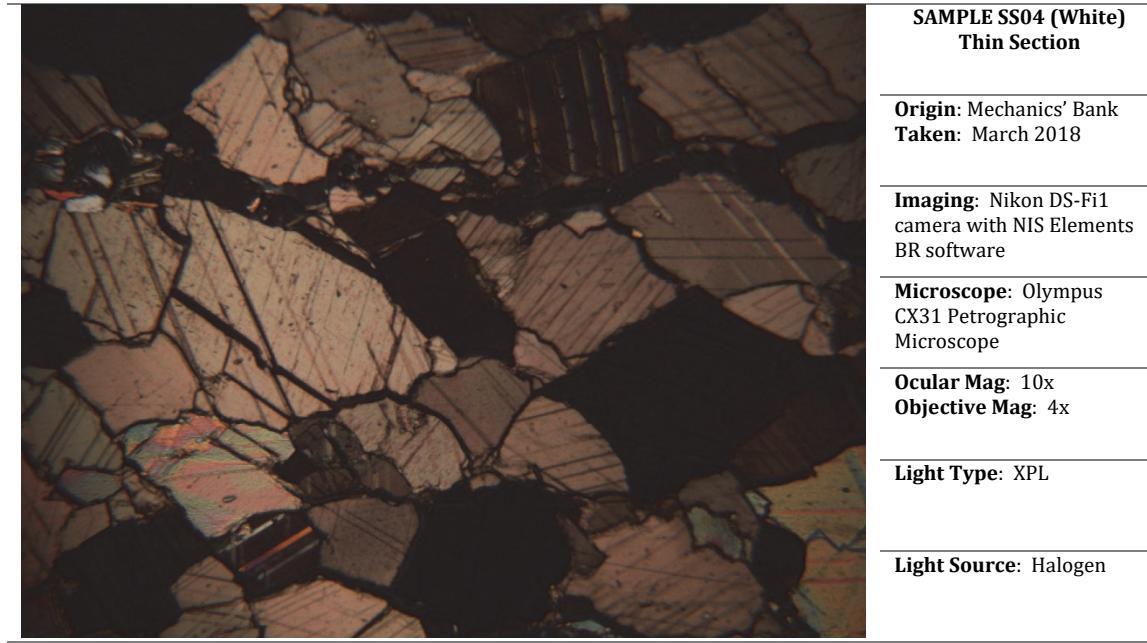
**NOTES:** Interior of sample. Primary mineral calcite/dolomite evidenced by rhombohedral cleavage and high order birefringence cream colors. Some small grains of accessory minerals, esp. at cracks.

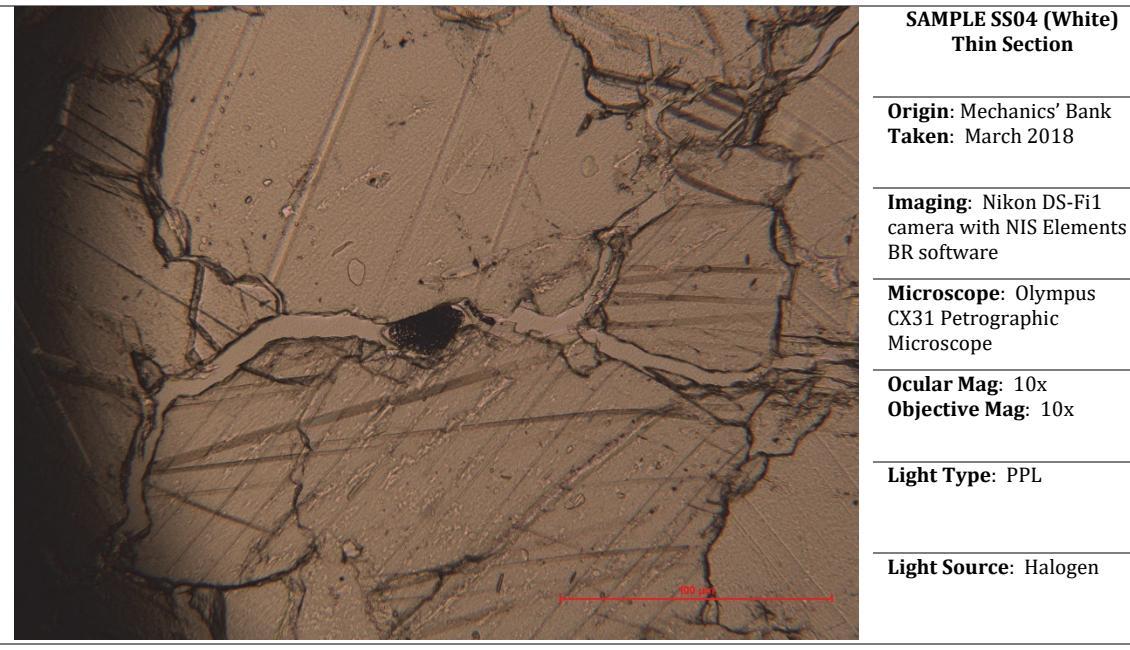
**NOTES:** Small crystal of opaque mineral at crack. Mineral not identified but may be graphite, as suggested by common presence as accessory mineral in marble and identification by Kimmel (1996).

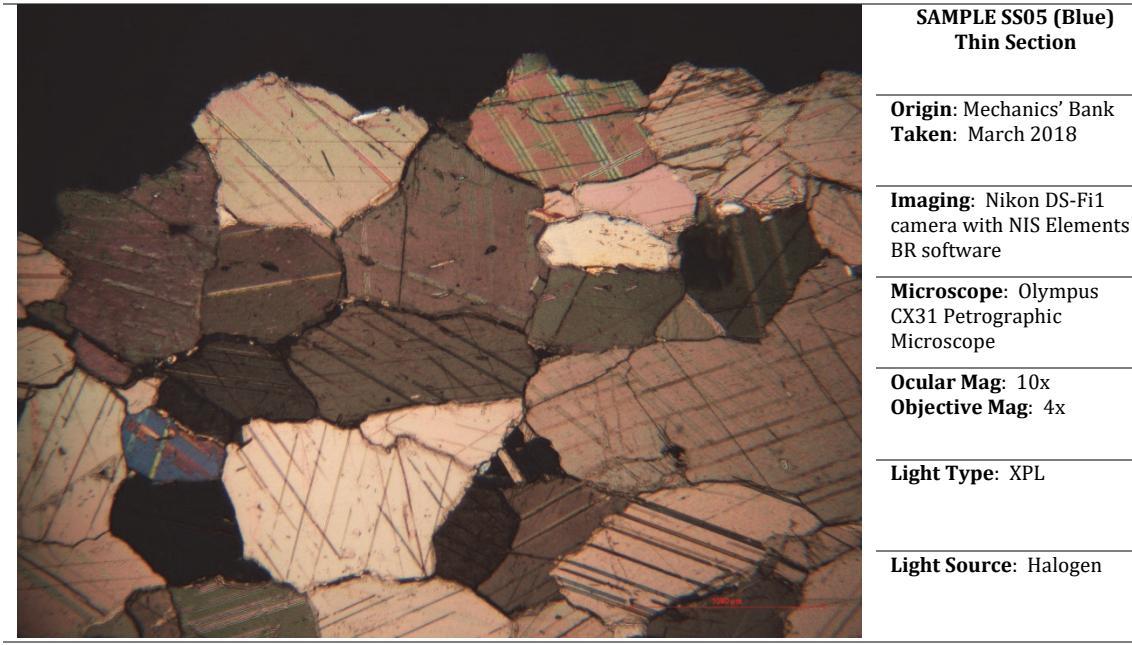
**NOTES:** Surface. Primary mineral calcite/dolomite evidenced by rhombohedral cleavage, polysynthetic twinning along cleavage and high order birefringence cream colors. Small micaceous laths, probably muscovite (center top right) and some crystal growth within cracks (left).

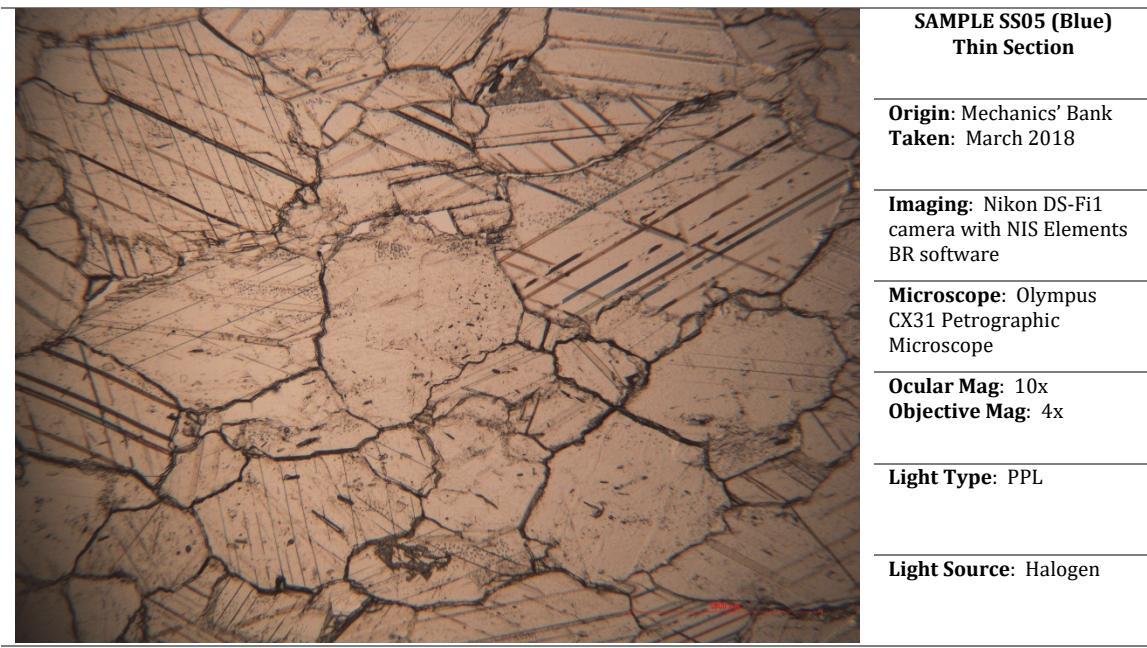
**NOTES:** Interior close to surface. Texture is granoblastic to foliated. Medium-sized, mostly subhedral grains, subequant to subelongate. Small amount of intergranular cracking. Boundaries between grains less irregular than SS03 and SS04 with some triple junctions.

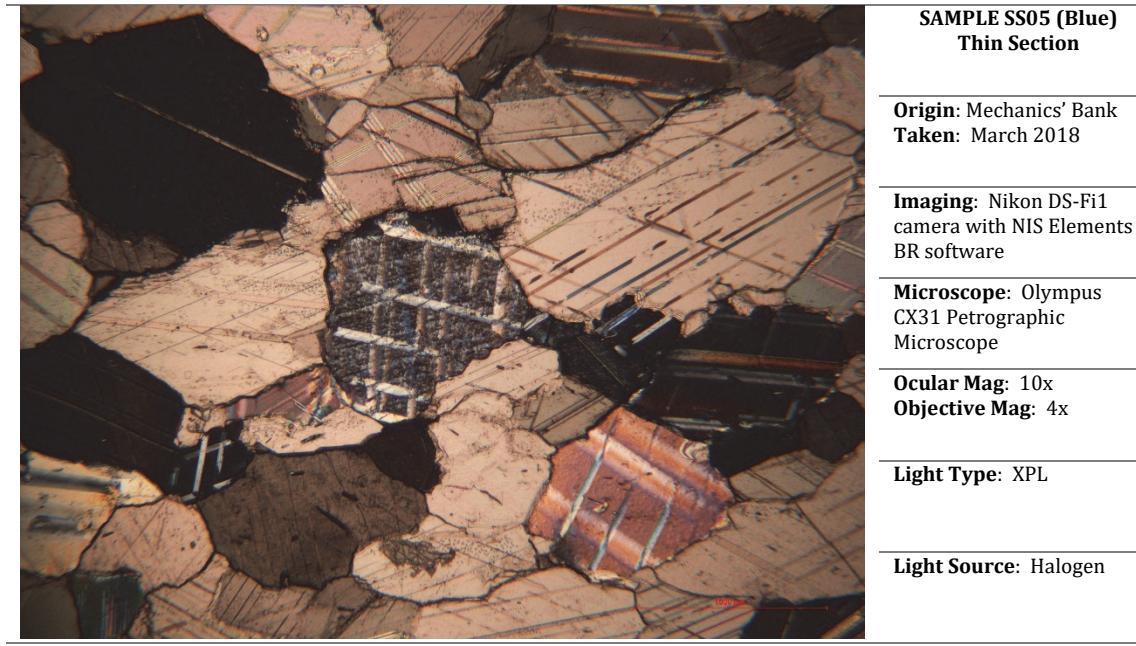
**NOTES:** Interior close to surface. Primary mineral calcite/dolomite evidenced by rhombohedral cleavage, polysynthetic twinning along cleavage and high order birefringence cream colors.

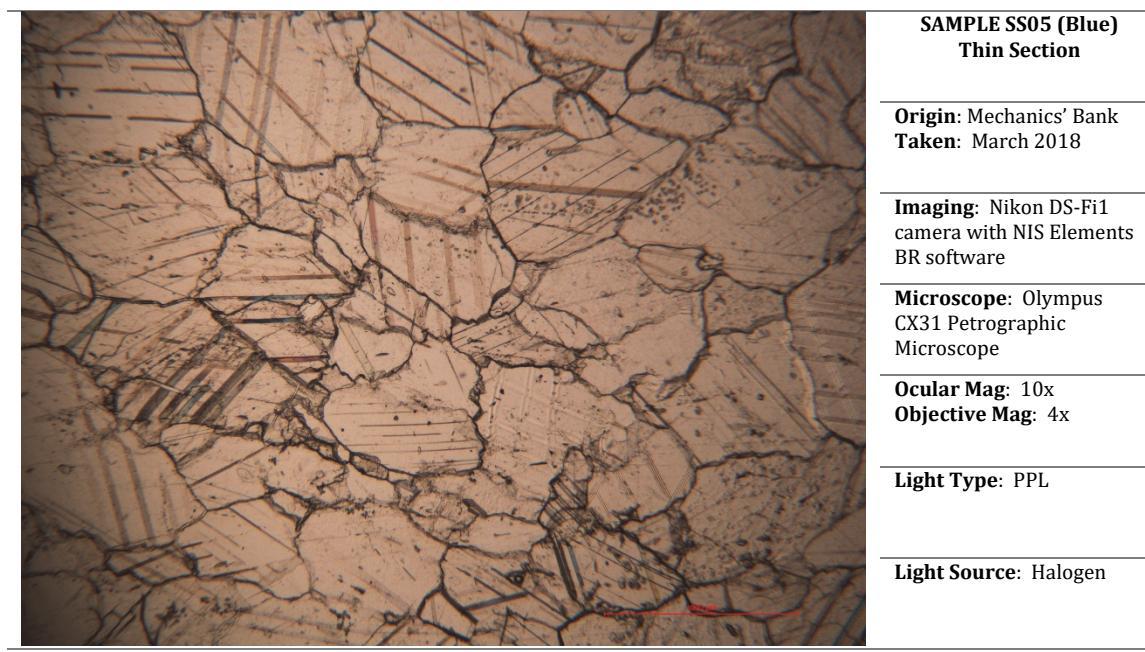
**NOTES:** Interior. Texture is granoblastic to foliated. Small to medium-sized, mostly subhedral and some anhedral grains, equant to subelongate. No inter- or intragranular cracking. Boundaries between grains less irregular than SS03 and SS04 with some triple junctions.

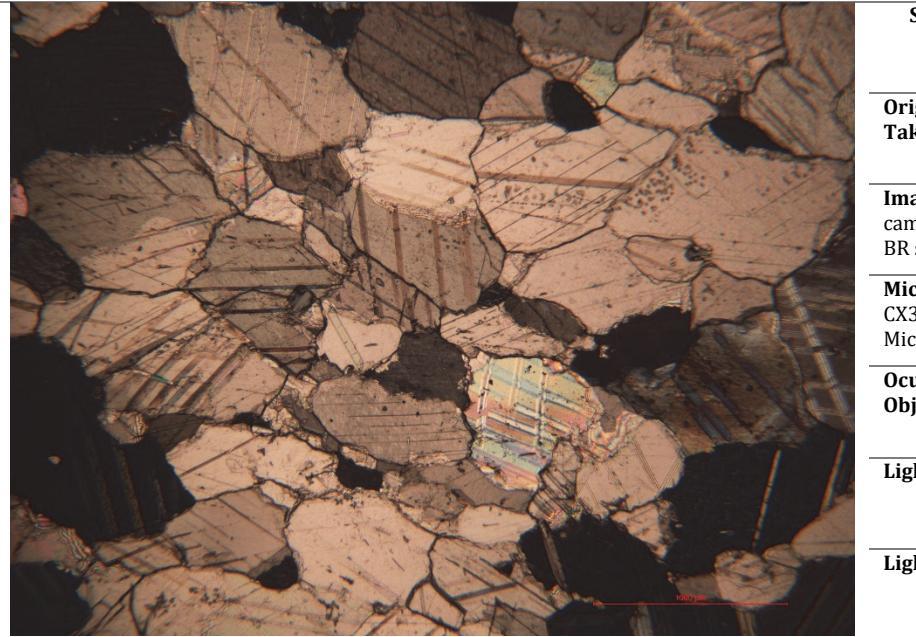
SAMPLE SS05 (Blue) Thin Section

**NOTES:** Interior. Primary mineral calcite/dolomite evidenced by rhombohedral cleavage, polysynthetic twinning along cleavage and high order birefringence cream colors.

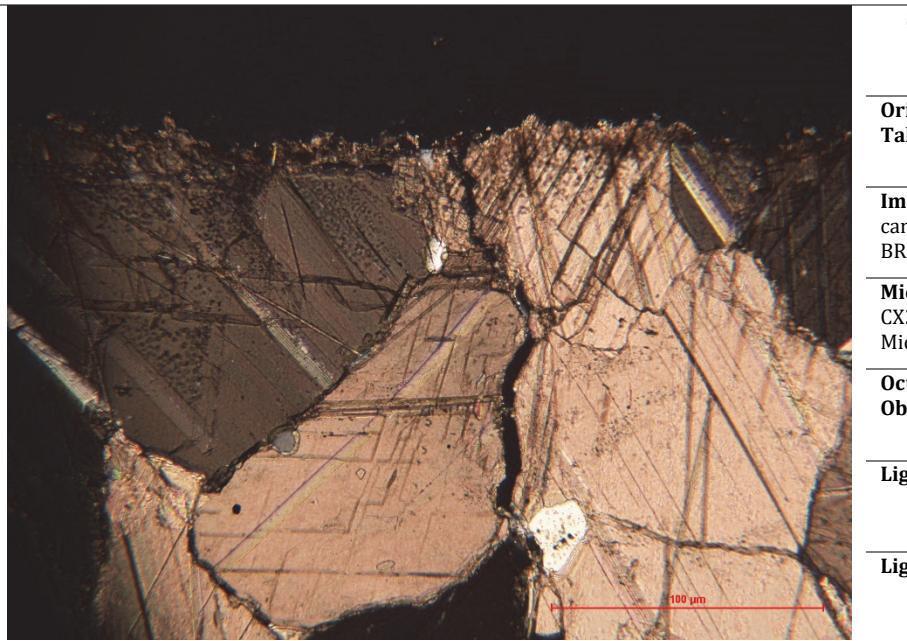
SAMPLE SS05 (Blue) Thin Section

**NOTES:** Surface showing weathering of calcite to a shallow depth. Note also small cracking along cleavage planes (right) and a very small quartz grain (center left).

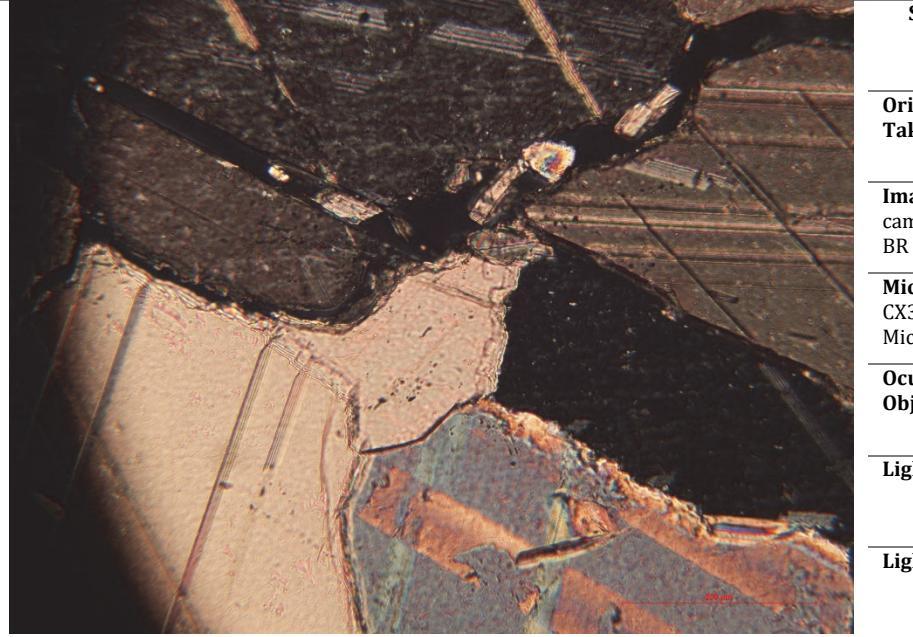
SAMPLE SS05 (Blue) Thin Section

**NOTES:** Crystal growth inside cracks suggests crystallization of unidentified soluble salts, such as gypsum, causing the splitting.

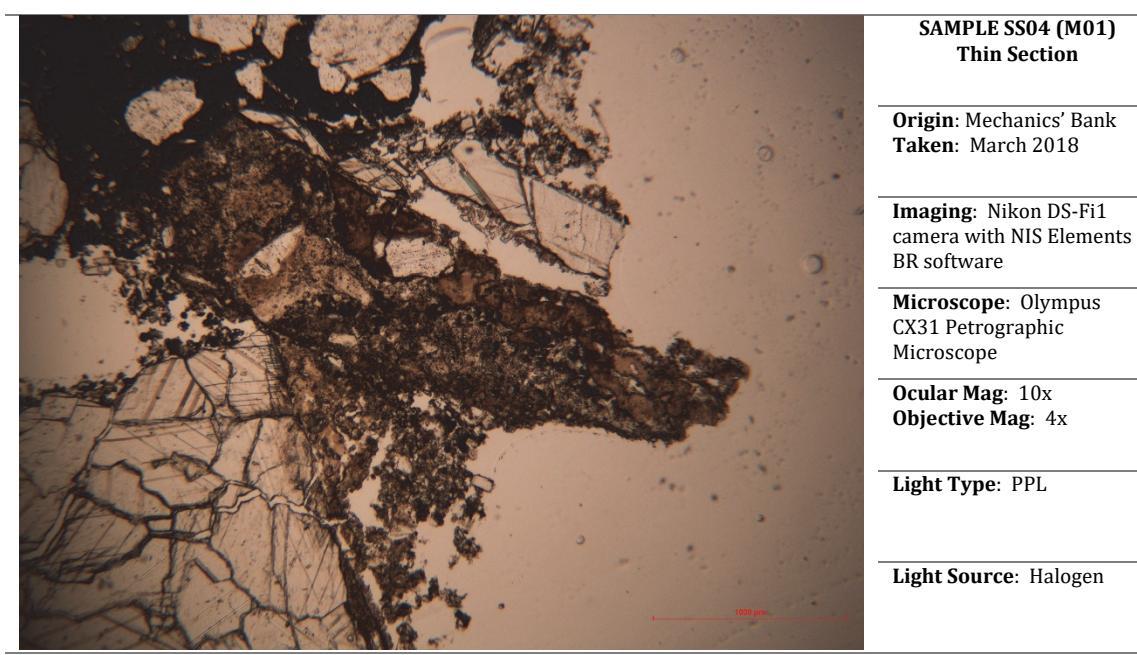
**NOTES:** Mortar 1 was the original pointing mortar. Small and deteriorated sample allows little information to be extracted about the microstructure.

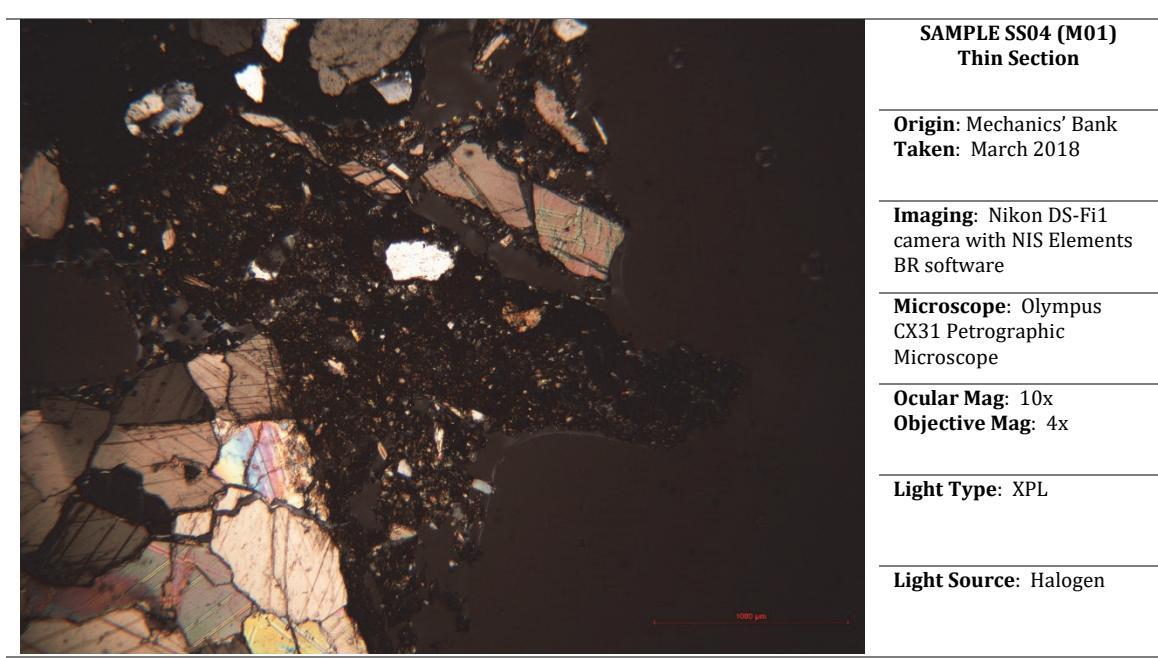
**NOTES:** XPL shows a carbonated lime mortar (evidenced by brown-colored binder) with very little aggregate in small subangular particles.

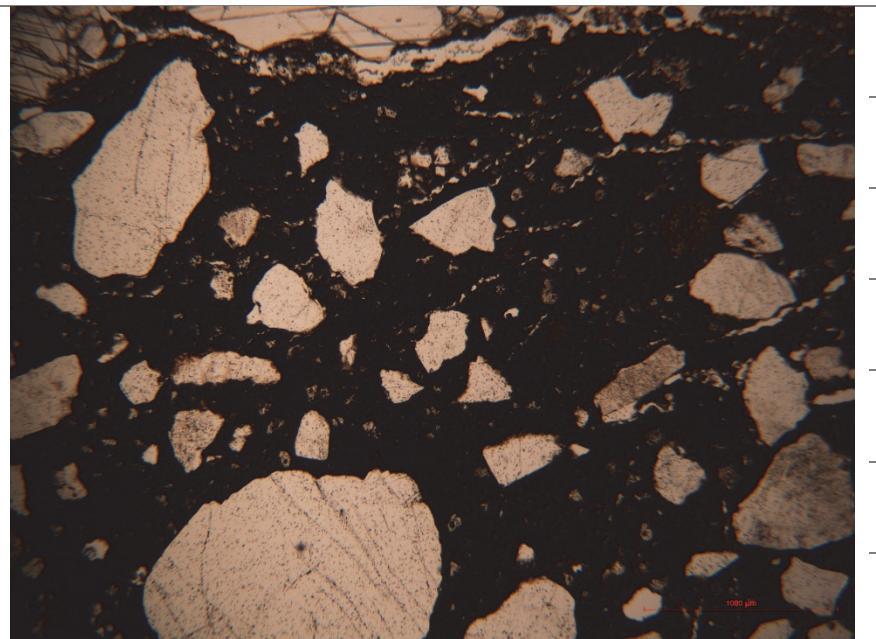
SAMPLE SS04 (M02) Thin Section

**NOTES:** Mortar 2 was the first repointing campaign. Opaque binder suggests Portland cement. Large well-graded aggregate, sub-rounded to sub-angular, in an approx. 1:1 binder-aggregate ratio. Cracking of binder may be related to drying or, more likely, be mechanical cracking associated with the movement of the joint.

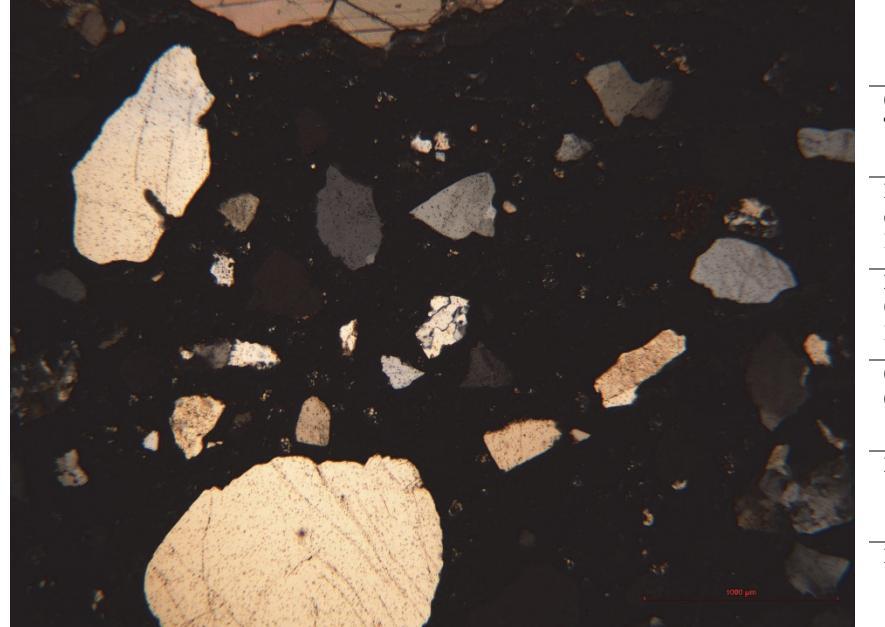
#### SAMPLE SS04 (M02) Thin Section

NOTES: Aggregate appears to be composed primarily of quartz grains with some feldspar grains (center left).

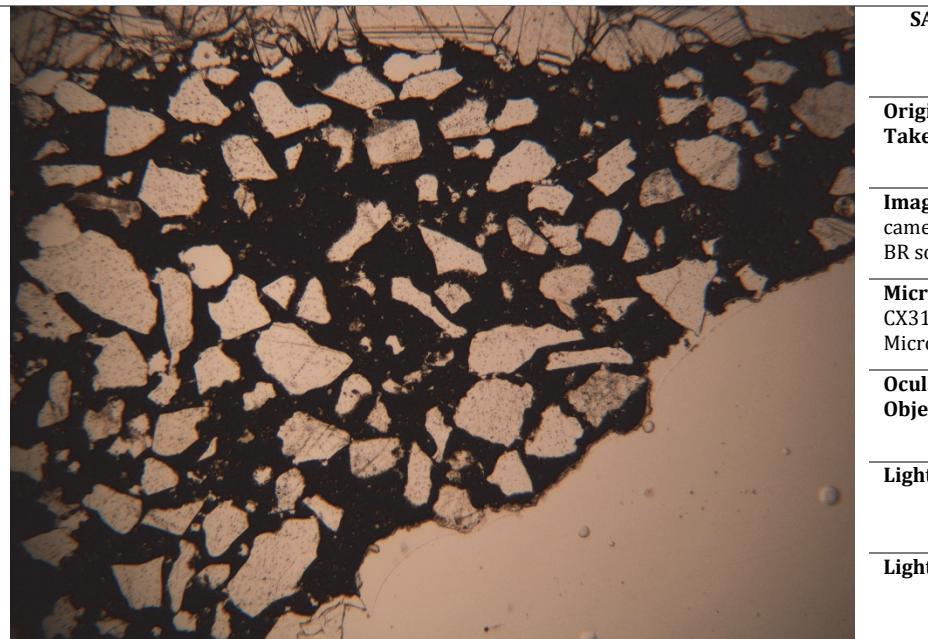
SAMPLE SS04 (M03) **Thin Section**

NOTES: Mortar 3 was the second pointing campaign. Opaque binder suggests Portland cement. Small well-sorted aggregate, sub-angular to angular, in an approx. 1:2 binder-aggregate ratio.
