# MANAGING CHANGE: THE ROLE OF DOCUMENTATION AND CONDITION SURVEY AT MESA VERDE NATIONAL PARK

FRANK G. MATERO

**ABSTRACT**—The approximately 600 cliff dwellings in Mesa Verde National Park in Colorado represent the apex of architectural sophistication of the Northern San Juan Ancestral Puebloan culture. The cliff dwellings, the final product of 600 years of cultural development on the Mesa Verde, were built between A.D. 1200 and 1300, and were abandoned shortly thereafter. The spectacular setting and the well-preserved state of these masonry structures and their surface finishes resulted in Mesa Verde's being the first nomination by the U.S. government to the World Cultural Heritage Sites List. Moreover, descendants of these ancient peoples, the Pueblo Indians of Arizona and New Mexico, continue to venerate these sites, representing a cultural continuity unique for North America. Excavation and preservation have been continuous since Mesa Verde became one of the first national parks in 1906. The structures interpreted to the public have been preserved over the years with a minimum of repair and replacement, resulting in a cultural resource of great integrity and authenticity.

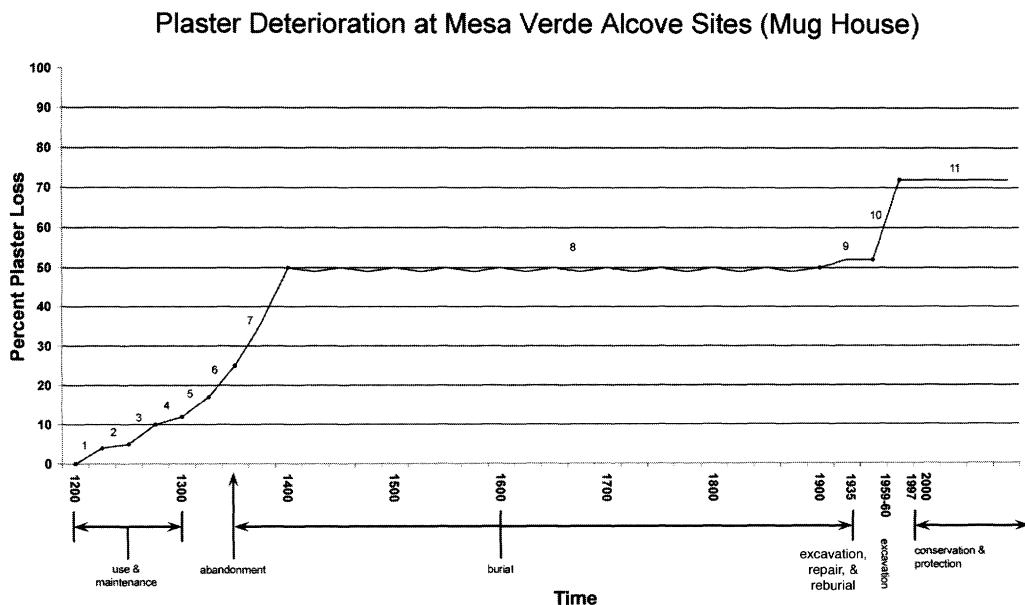
Fig. 1. Proposed life cycle for Kiva C, Mug House, Mesa Verde. Courtesy Architectural Conservation Laboratory, University of Pennsylvania

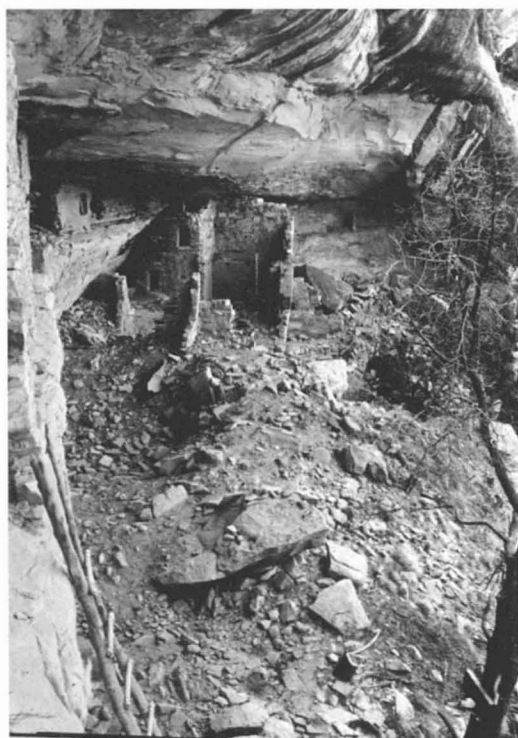
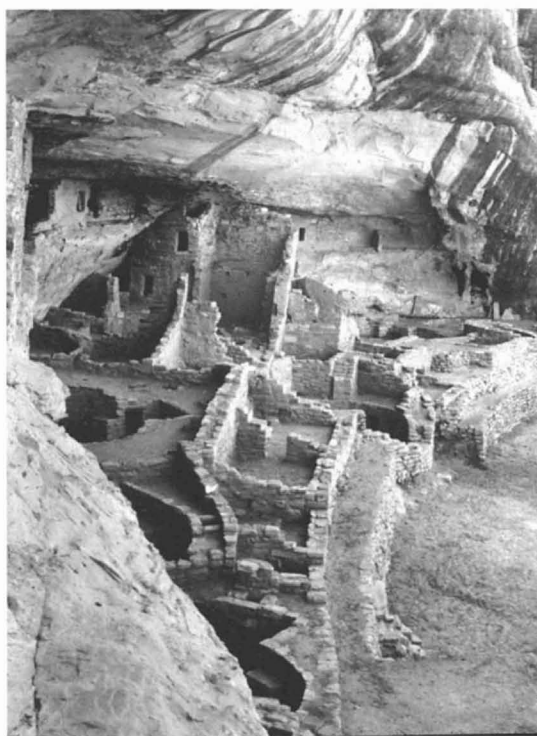
documentation both before and after excavation and stabilization in 1959–60 by Arthur Rohn (fig. 3). Kiva C was chosen as the representative unit to be fully documented, with an architectural database and a 53-sector digitized graphic condition survey, due to the significance, extent, and poor condition of its mural paintings (fig. 4, see page 59) and the opportunity to reassess a previous pilot treatment program executed in 1981 by Paul Schwartzbaum and Constance Silver (Silver 1982).

Fig. 3. Mug House, before (a) and after (b) excavation and stabilization in 1959–60. Courtesy of NPS-MEVE

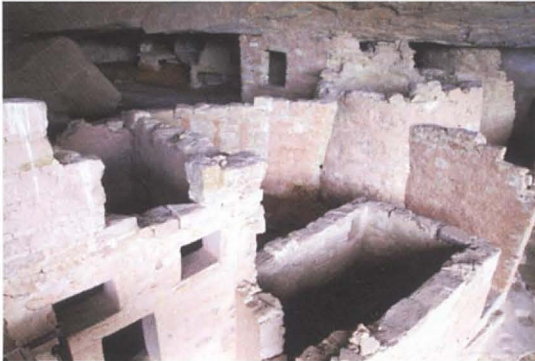
Fig. 2. Extant exterior and interior architectural surface finishes at Speaker Chief House, Cliff Palace, Mesa Verde. Courtesy Architectural Conservation Laboratory, University of Pennsylvania
